Building and Timber Pest Inspection Report

Inspection Date: Wed, 18 Mar 2026

Property Address: 7 Kurumba St, Kippa-Ring QLD 4021,
Australia

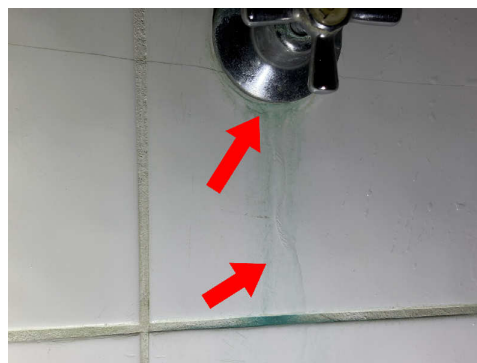
Finding: Family bathroom - shower taps leaking

Information: At the time of the inspection, it was noted that the hot and cold taps for the shower in the family bathroom were leaking when turned on. This may be due to general wear and tear.

A licensed plumber should be engaged to carry out this repair. This should be done as a short term priority.

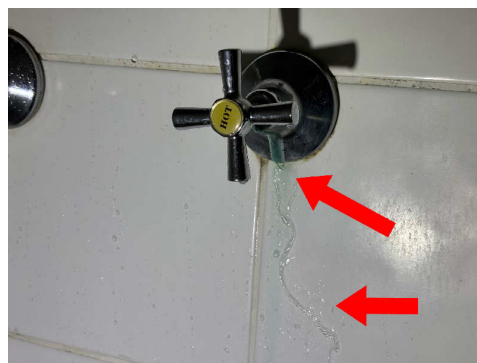
Finding: Ensuite - shower tap leaking

Information: At the time of the inspection, it was noted that the shower hot tap was leaking when turned on. A stain can be seen on the shower wall below the tap. This may be due to general wear and tear.

A licensed plumber should be engaged to carry out this repair. This should be done as a short term priority.

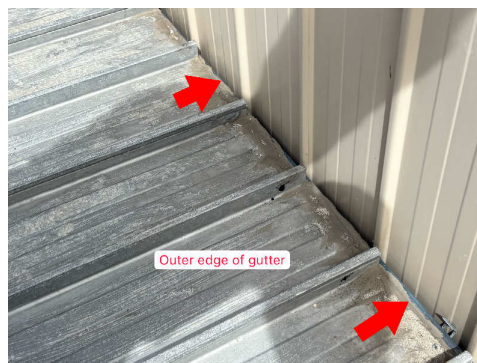
Finding: Roof sheeting - rusted

Information: At the time of the inspection, it was noted that there were several areas of rust on the outer edged of the roof sheeting over the study/entry area. It was also found that the roof sheets extend to the outer edge of the gutter and sealant has been applied to this junction.

The effectiveness of the gutter has been compromised. Moisture will now flow over the gutter and into the area between the garage/shed and the dwelling.

If the rust extends past the rear line of the gutter then the roof sheeting in this area will need to be replaced.

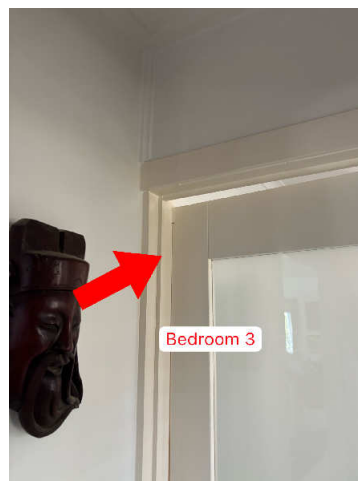
Finding 3.15

Building:	Main Building
Location:	All Internal Areas
Finding:	Doors - Binding during normal operation
Information:	At the time of the inspection, it was noted that the doors to bedroom 2 and 3 were binding during normal operation. This appears to be general wear and tear.
	For minor causes, a qualified carpenter or building maintenance professional should be appointed to perform minor rectification works at client discretion.

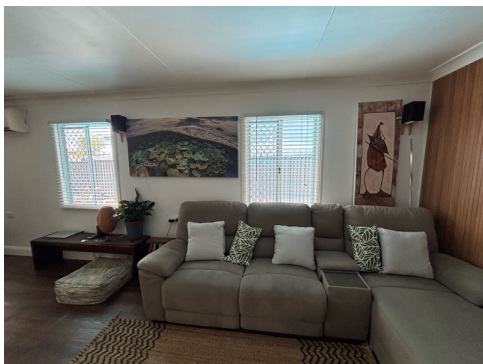
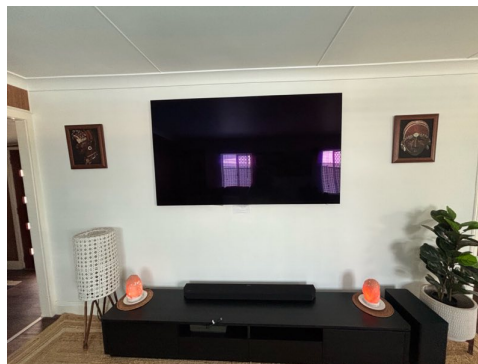
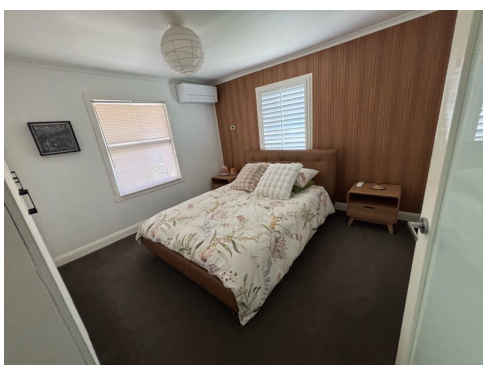
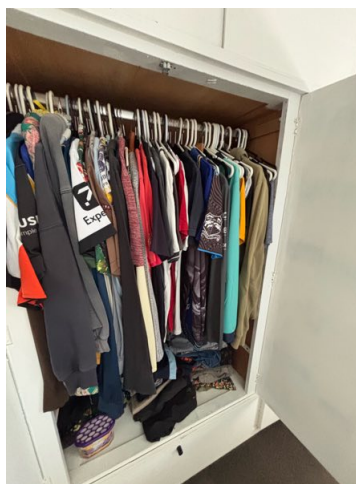
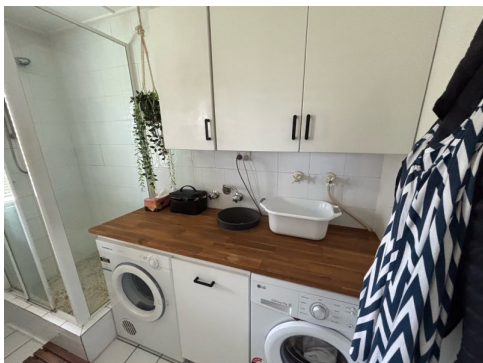
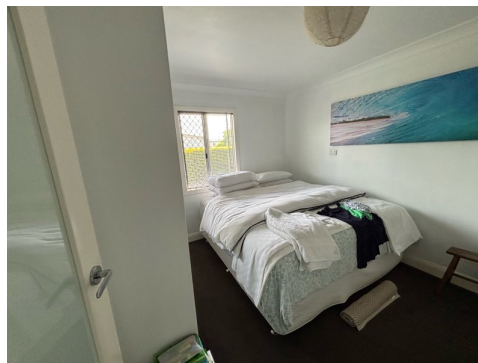
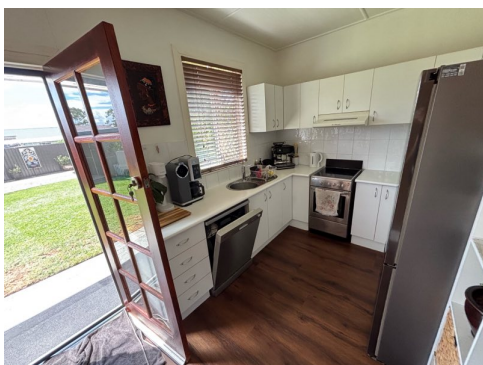
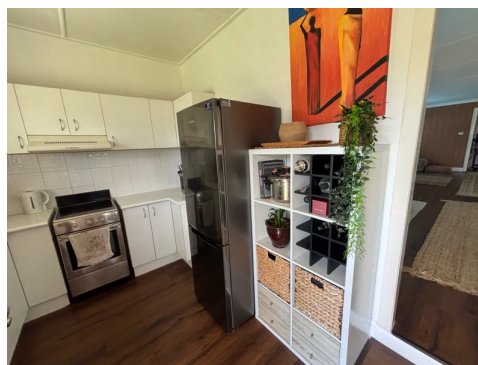
Finding: Obstructions and Limitations - Internal areas

Information: These photographs are an indication of the obstructions and limitations which impeded full inspection of the property of the internal areas at the time of inspection. These obstructions can hide an array of defects and should be removed to allow full inspection to be carried out. A re-inspection is recommended once the areas are made accessible.

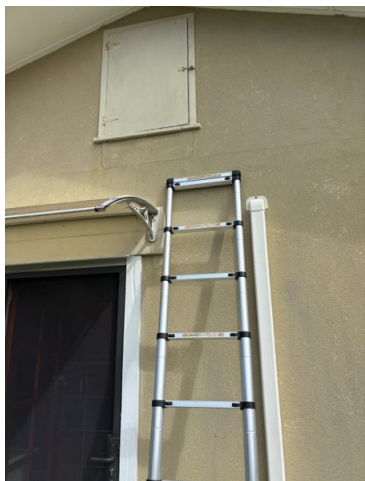
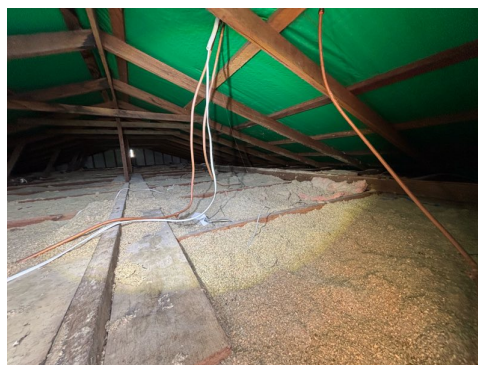
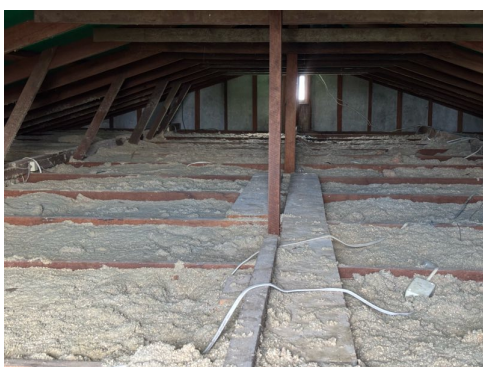
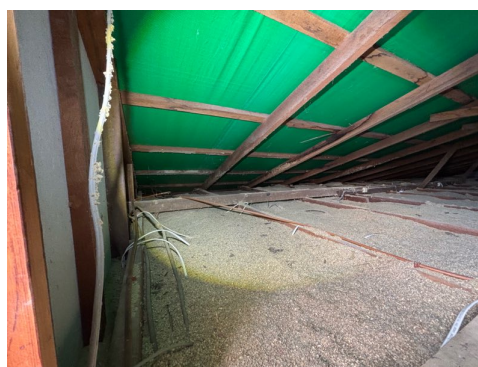
Finding: Obstructions and Limitations - Roof cavity

Information: These photographs are an indication of the obstructions and limitations which impeded full inspection of the property of the roof cavity at the time of inspection. These obstructions can hide an array of defects and should be removed to allow full inspection to be carried out. A re-inspection is recommended once the areas are made accessible.

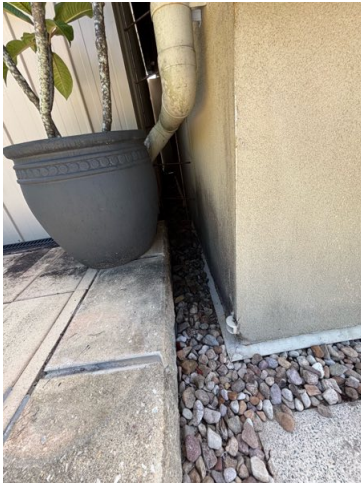
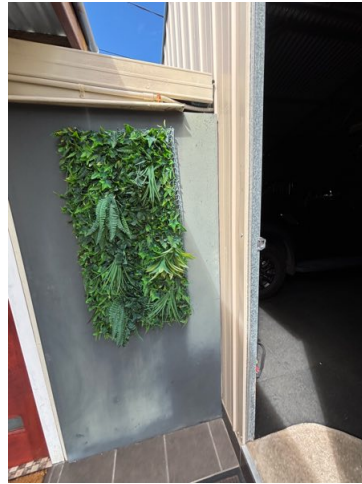
Finding: Obstructions and Limitations - External areas

Information: These photographs are an indication of the obstructions and limitations which impeded full inspection of the property of the external areas at the time of inspection. These obstructions can hide an array of defects and should be removed to allow full inspection to be carried out. A re-inspection is recommended once the areas are made accessible.
