Building and Timber Pest Inspection Report

Inspection Date: Sat, 14 Feb 2026

Property Address: 36 Wallis St, Seymour VIC 3660, Australia

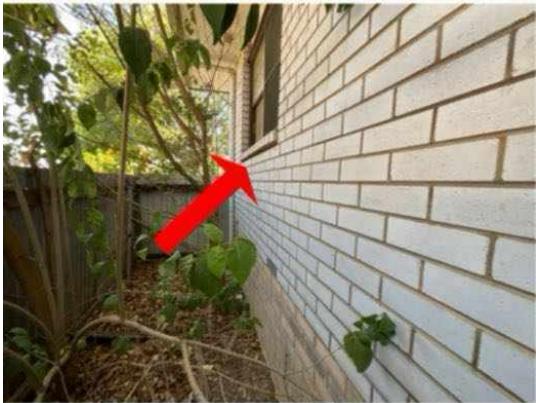
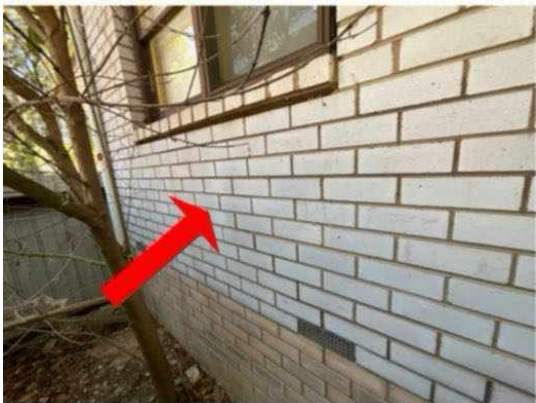
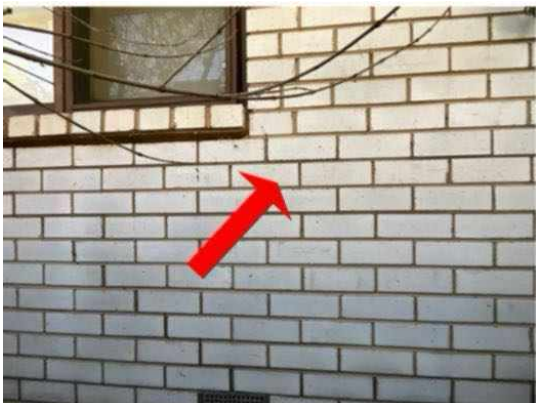
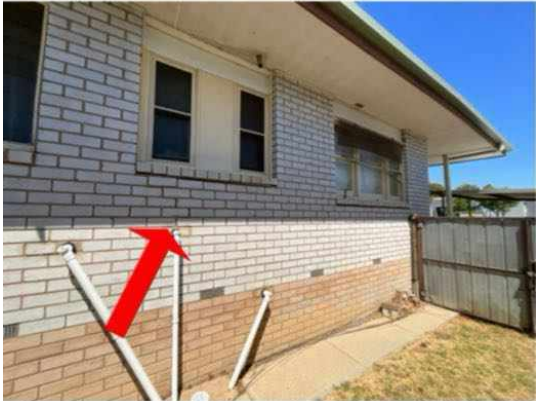
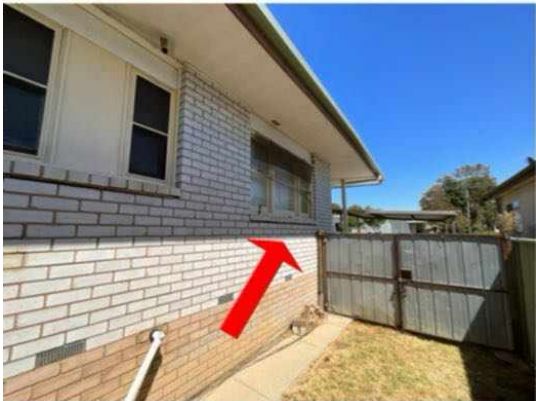
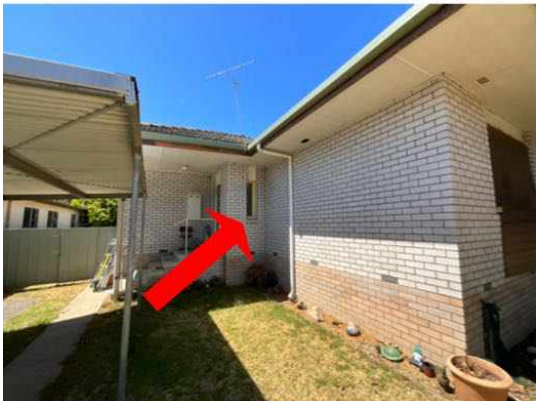
Building: Building 1
Location: Yard - Side, front, back
Finding: Brickwork - Step cracking
Information: Step cracking was identified to the brickwork in this area at the time of inspection. Step cracking, which is similar to other forms of cracking, has a variety of possible causes. However, the most common is the subsidence of adjacent footings.

Step cracking is a relatively common defect, and is most likely to occur adjacent to windows, doors and other openings. Mortar failure in the gaps between affected bricks indicates the stresses and tensions affecting the wall.

Where step cracking is extensive or severe, the client is advised to consult a structural engineer. Minor step cracking can be used as a warning sign to address factors causing stress to the wall, which can include the effect of surrounding trees, water leaks, soil erosion, or even the presence of reactive soils in the surrounding area.

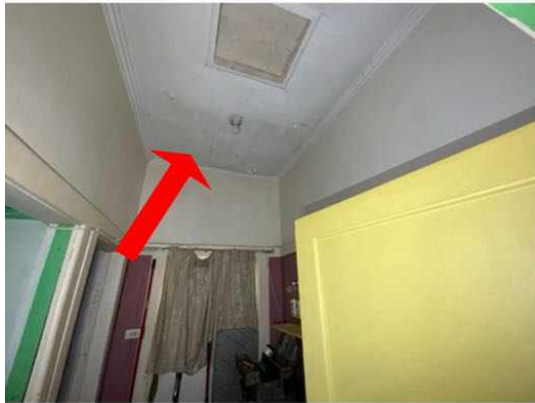
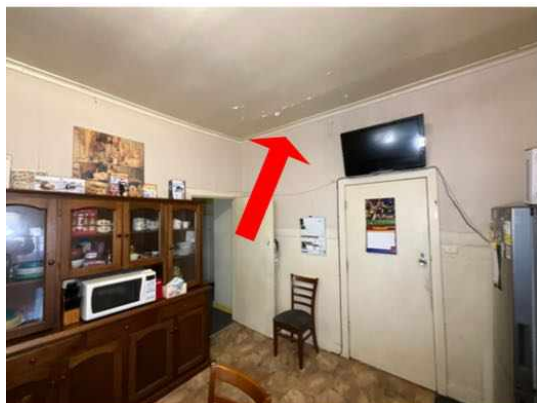
Building: Building 1
Location: Laundry, Wc, living, kitchen
Finding: Painted surface - Flaking
Information: Sections of paint in this area was found to have deteriorated. Paint flaking is generally an indication of excessive moisture in the area, that is currently hidden by the painted surface.

The presence of excessive moisture can have major implications on associated building elements if left unattended. While only seemingly minor at this stage, the damage cannot be determined due to the paint obstructing any further inspection of the damage.

A qualified Painter should be contacted at the Owner's discretion to re-paint the ceiling.

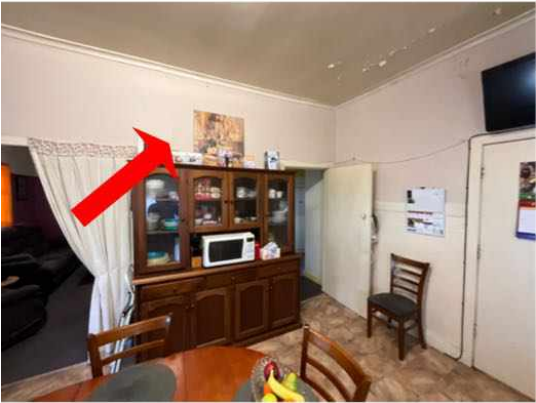
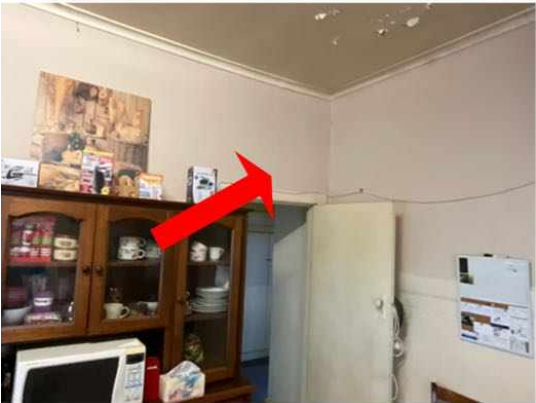
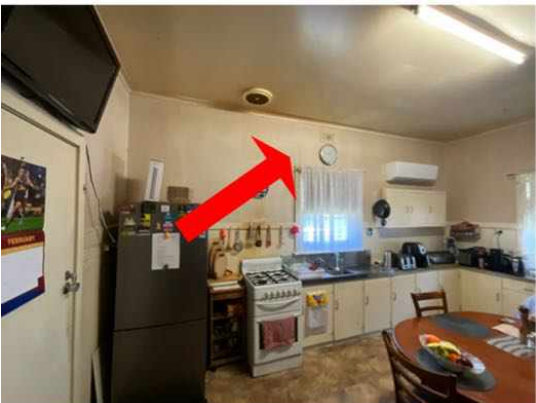
Finding 3.06

Building:	Building 1
Location:	Hall, kitchen
Finding:	Cracking - Damage Category 2 - Noticeable (up to 5mm)
Information:	Noticeable cracks are a common occurrence as a result of many primary defects. Such causes may include age, general wear and tear, expected building movement, general expansion/contraction of building materials in different weather conditions, and/or minor failings in the installation or application of building materials.

Noticeable cracks may result in minor sticking or jamming of associated doors and windows, which require easement. However, noticeable cracks are easily filled and repaired. A plasterer can be consulted to install an expansion joint at this point to allow for this movement during different weather conditions.

Monitoring of all cracking should be conducted frequently. Always contact a building inspector should cracks widen, lengthen, or become more numerous. Additionally, your building inspector should also be contacted if associated building elements such as doors and windows become more difficult to operate over time.

Relevant tradespeople, such as carpenters, painters and plasterers, should be appointed to perform remedial works, as deemed necessary.

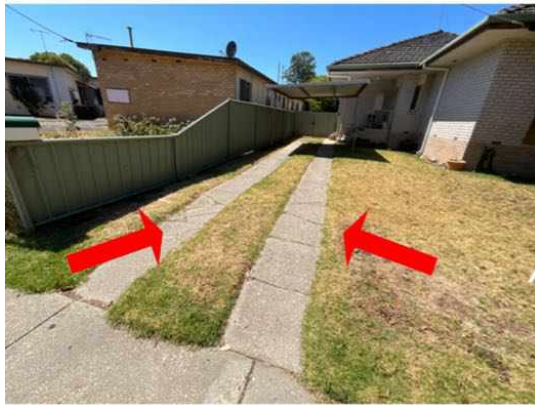
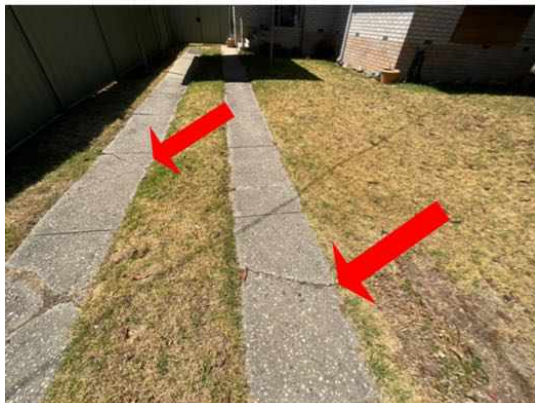
Cracking to this degree may also be due to poor original installation of the concrete. Factors such as poor compaction of the sub surface and/or inadequate reinforcing of the slab may create cracking and other secondary defects. Wide cracks may also have a more significant structural cause, such as subsidence of soils.

Where the crack is located adjacent to structural elements of the building, the advice of a Structural Engineer is advisable before undertaking repairs. Significant repair and likely replacement of the concrete paving is probable.

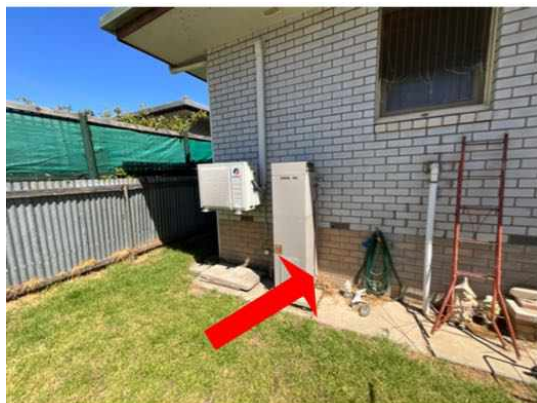
These damp conditions can lead to secondary defects such as rot, rust or corrosion of associated building elements, the formation of fungal decay, or even the creation of potential slip hazards. When coupled with poor site drainage, pooling of water may also attract termite activity to this area.

It is highly recommended that a licensed plumber be appointed to connect the HWS overflow in order to prevent such an environment from being created. These minor works should be carried out as soon as possible.

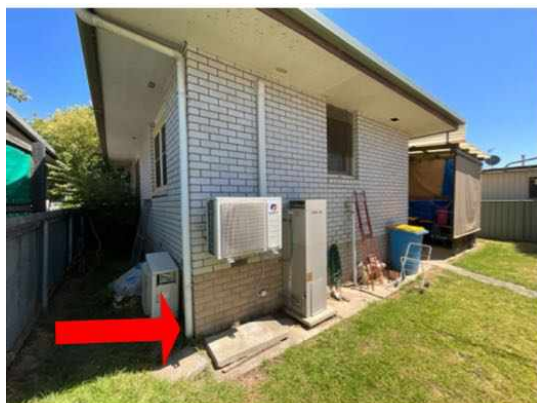
Finding 6.02

Building:	Building 1
Location:	Yard - Side, back
Finding:	Stormwater drain - Not connected
Information:	The roof plumbing is not adequately connected to stormwater drainage on the site. This disconnection negatively impacts the functional capacity of the roof plumbing.

Where roof plumbing doesn't drain adequately, the area at the base perimeter can become excessively damp, potentially creating an environment that is susceptible to rust and corrosion of surrounding building elements, as well as attracting termites and other pests.

It is highly recommended that a plumber be appointed to further inspect the area and to install adequate drainage equipment where necessary.

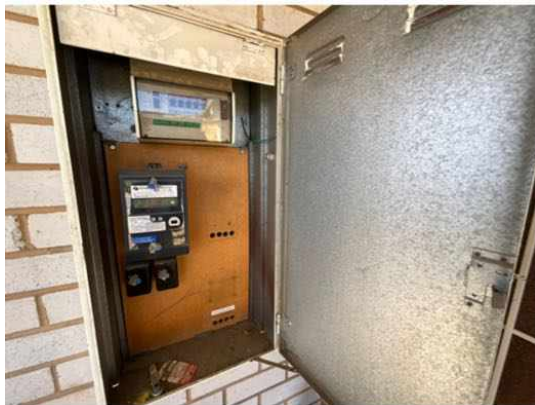
A durable notice should be placed in the switchboard unit to indicate current termite barriers. At the time of inspection, it appeared as though no termite management system has been installed, with no evidence to suggest preventative works taking place.

The client may consider gaining further advice from a pest controller as to the costs and procedures involved with this application. It is recommended that obtaining such advice be a short-term priority.

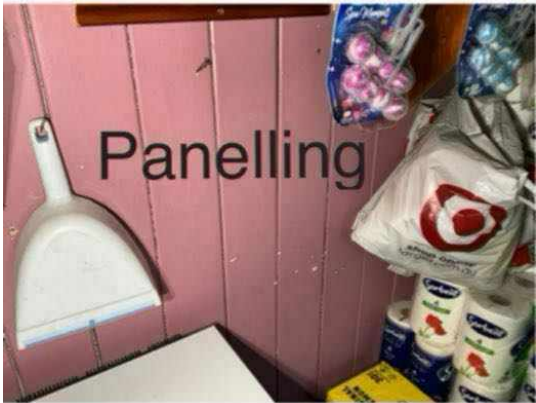
Building:	Building 1
Location:	All Areas
Finding:	Additional Photos - Obstructions and Limitations
Information:	These photographs are an indication of the obstructions and limitations which impeded full inspection of the property at the time of inspection. These obstructions can hide an array of defects and should be removed to allow full inspection to be carried out. A re-inspection is recommended once the areas are made accessible.
