Building Inspection Report

Inspection Date: Thu, 12 Feb 2026

Property Address: 22 Cavendish Ave, Blacktown NSW 2148,
Australia

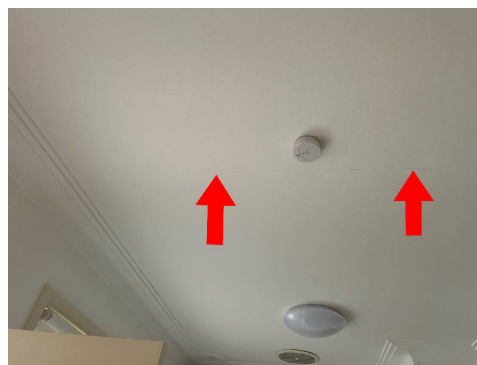
Defects 3.01

Finding: Ceiling – Hairline Cracking to Plasterboard

Information: Hairline cracking was observed to the plasterboard ceiling within the kitchen area, extending horizontally across the ceiling surface in proximity to the smoke alarm. The cracking appears fine and linear in nature and is consistent with minor movement or joint separation within the plasterboard lining. Such cracking commonly occurs due to normal building movement, minor structural settlement, or seasonal expansion and contraction of framing timbers.

At the time of inspection, the cracking appeared minor and did not display significant displacement, sagging, or evidence of active water staining. While currently considered a minor defect, if left unaddressed the cracking may widen over time and require more extensive rectification. It is recommended that a qualified plasterer assess and repair the affected area as required. Repairs can be undertaken as part of routine maintenance in the short to medium term, with ongoing monitoring for any signs of further movement.

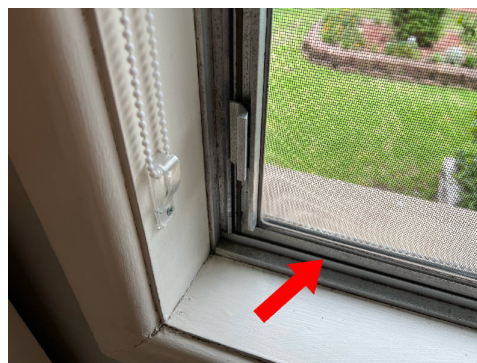
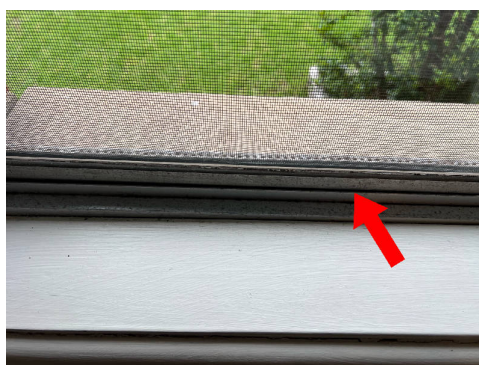
Defects 3.03

Information: The sliding window within the bedroom area was noted to be stiff during operation. Increased resistance was evident when attempting to open and close the sash, which may be attributable to debris accumulation within the track, minor distortion of the frame, worn rollers, or general age-related wear. No obvious signs of significant frame damage were observed at the time of inspection; however, dirt and debris were visible within the track which may be contributing to restricted movement.

Windows that do not operate smoothly can pose a safety concern, particularly where they may be required for ventilation or emergency egress. It is recommended that the window tracks be cleaned and the rollers and hardware inspected. If stiffness persists following cleaning and lubrication, further assessment and adjustment by a qualified window technician or carpenter is recommended. Rectification should be undertaken in the short term to ensure safe and functional operation.

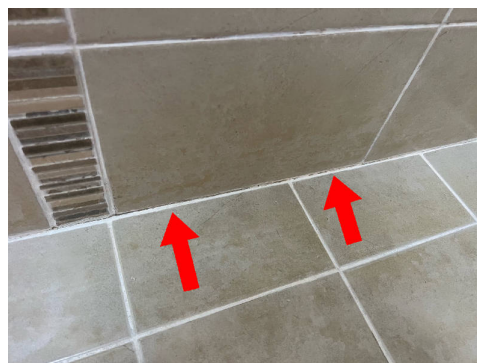
Defects 3.04

Finding: Deteriorated Sealant to Shower Wall and Floor Junction

Information: Sealant was observed to be deteriorated along the junction between the shower wall tiles and the floor tiles. This condition was evident at the base of the tiled wall within the shower area. Sealant at this junction is designed to prevent water from penetrating behind tiles and into the wall and floor substrates.

The absence of effective sealant increases the risk of water ingress, which can lead to moisture damage, deterioration of waterproofing membranes, and potential concealed damage over time. It is recommended that a suitably qualified tiler or bathroom repair specialist reapply appropriate waterproof sealant to this area in the short term to reduce the risk of ongoing moisture-related issues.

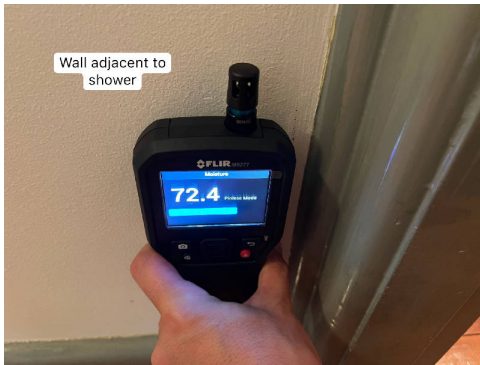
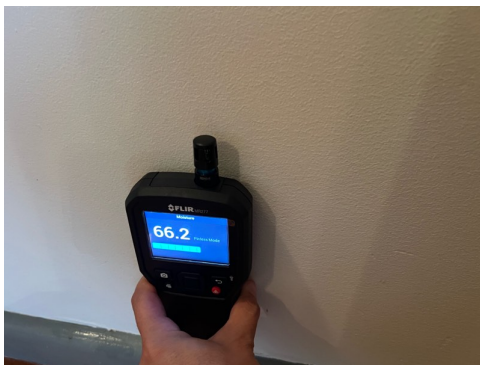
Defects 3.05

Finding: Internal Wall – Elevated Moisture Readings Adjacent to Shower

Information: Elevated moisture meter readings were recorded to the lower section of the internal wall adjacent to the shower recess. Readings in the medium to high range were obtained using a non-invasive moisture meter, indicating the likely presence of excess moisture within the wall lining or substrate. No invasive testing was undertaken; however, the readings are considered abnormal for a dry internal wall surface.

Elevated moisture in this location may be associated with shower recess waterproofing failure, leaking plumbing components, or deterioration of seals and grout. Prolonged moisture exposure can lead to damage of wall linings, deterioration of framing timbers, and potential mould growth if not addressed. It is recommended that a licensed plumber and/or bathroom specialist further investigate the source of moisture and carry out repairs as required. Rectification should be undertaken in the short term to prevent further damage.

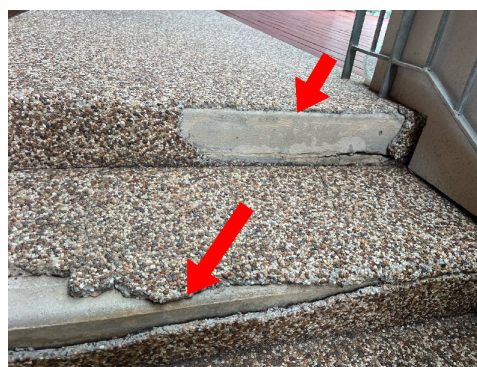
Defects 3.07

Building: Main Building
Location: Rear Elevation
Finding: External Stairs – Deteriorated Concrete and Spalling to Treads

Information: Deterioration and surface spalling were observed to the external concrete stairs at the front entry. Sections of the exposed aggregate finish have broken away from the stair treads and risers, with areas of underlying concrete visible. Localised cracking was also noted to the riser at the landing. The damage appears consistent with age-related wear, weather exposure, and possible moisture ingress contributing to breakdown of the surface finish.

The deterioration has resulted in uneven tread surfaces which may present a trip hazard and may continue to worsen if left unaddressed. Ongoing exposure to the elements may lead to further delamination of the aggregate topping and progressive deterioration of the underlying concrete substrate. It is recommended that a qualified concreter or builder assess the stairs and carry out repairs as required. Rectification should be undertaken in the short term to ensure safe access and to prevent further deterioration.

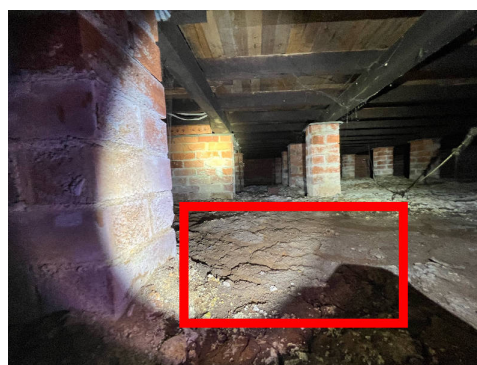
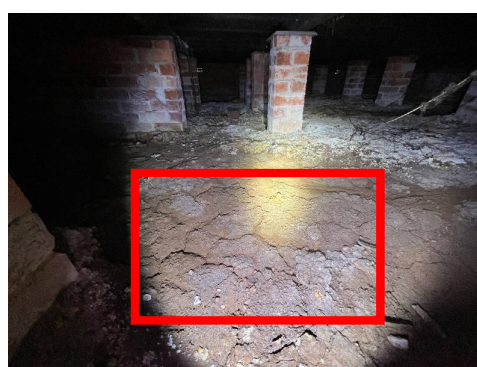
Defects 3.08

Building: Main Building
Location: Subfloor
Finding: Localised Moisture to Ground Surface

Localised areas of damp ground were observed within the subfloor space. Sections of the soil surface displayed visible moisture and cracking consistent with fluctuating moisture levels. The brick piers and visible timbers appeared serviceable at the time of inspection; however, elevated ground moisture was noted in some areas.

Excess moisture within a subfloor can contribute to increased humidity, potential timber deterioration, and may create conditions conducive to fungal decay or termite activity if not adequately managed. The moisture observed may be associated with poor drainage, inadequate subfloor ventilation, or seasonal ground conditions. It is recommended that surface drainage around the dwelling be reviewed and that subfloor ventilation be maintained to assist with moisture control. Monitoring is advised, and further assessment by a suitably qualified contractor should be undertaken if moisture levels persist or increase.

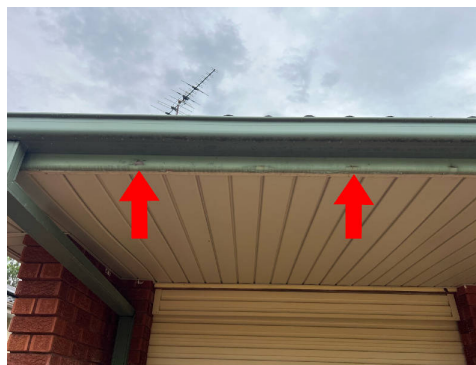
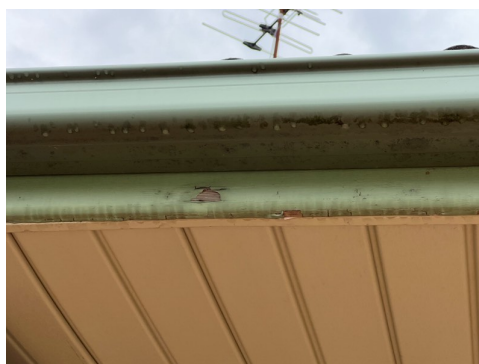
**Defects 3.09**

Finding: Fascia wood rot

Information: Sections of the fascia board were noted to be affected by timber rot and deterioration. The damage appears to be associated with prolonged exposure to moisture, likely from roof or gutter overflows in this area. Rotting timber can weaken structural integrity, compromise the support for gutters, and provide entry points for pests.

If left untreated, the decay may spread to adjoining timber elements and result in more extensive repairs being required. It is recommended that the affected sections be removed and replaced with new, treated timber, and that the source of moisture ingress (such as leaking or overflowing gutters) be identified and rectified.

Repairs should be carried out by a licensed carpenter or builder, with further inspection of roof plumbing by a roof plumber if leaks are contributing to the issue.

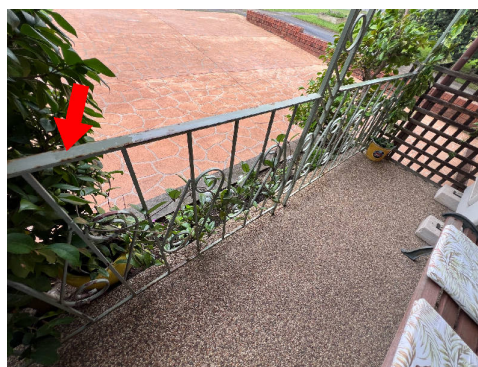
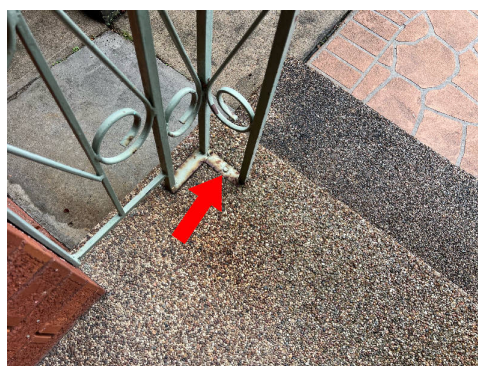
Defects 3.10

Finding: Corrosion to Metal Balustrade Base

Information: Corrosion was observed to the metal balustrade at the front porch, particularly at the base connection where the railing is fixed to the concrete surface. Paint breakdown and surface rusting were noted around the base plate and fixings.

While currently assessed as a minor defect, corrosion at balustrade base connections can progress over time if not treated, particularly where exposed to weather and moisture. Ongoing deterioration may lead to weakening of the railing and potential safety concerns if left unaddressed. It is recommended that the affected areas be cleaned, treated for corrosion, and recoated with a suitable protective finish. Repair or replacement of sections may be required if deterioration advances.

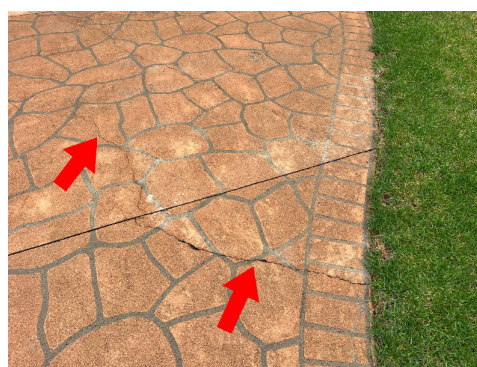
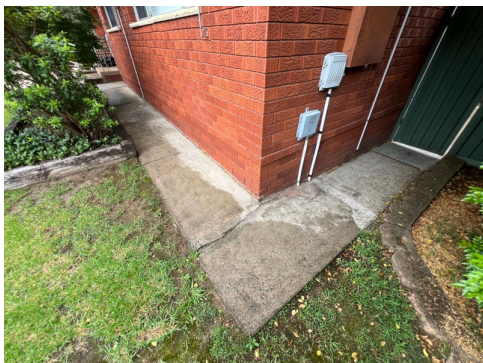
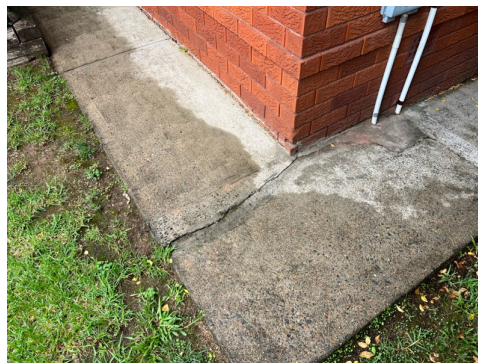
Defects 3.11

Finding: Cracking to Driveway and Side Path

Information: Cracking was observed to sections of the driveway surface as well as to the concrete pathway along the side of the dwelling. The cracks appear to extend through the surface finish and substrate in areas, indicating movement within the underlying base material. The affected sections were noted externally at ground level adjacent to the dwelling perimeter and within trafficked surface areas.

Cracking of external hard surfaces commonly occurs due to ground movement, soil reactivity, settlement, or long-term wear. While the cracking currently appears localised, continued movement may result in further separation, trip hazards, water ingress beneath slabs, and progressive deterioration if not addressed. It is recommended that the affected areas be monitored and assessed by a suitably qualified concreter or paving contractor, with repairs carried out as required to prevent further deterioration.

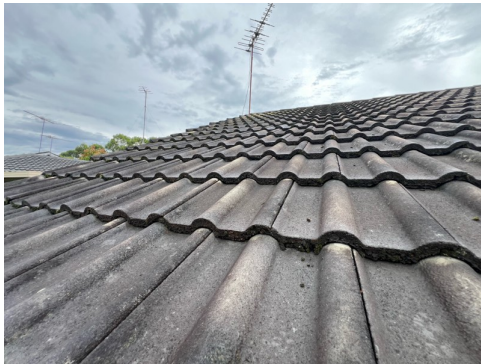
Defects 3.12

Information: The roof tiles were observed to be weathered and showing signs of age-related surface deterioration. Erosion to tile edges and surface wear were noted, along with areas of moss and organic growth. No widespread cracking or significant displacement was observed at the time of inspection from the accessible vantage points.

Roof tiles naturally deteriorate over time due to prolonged exposure to weather conditions. Surface erosion and organic growth can increase water absorption and may contribute to reduced service life if not maintained. While currently considered a minor defect, continued weathering may lead to increased porosity, cracking, or water ingress over time. Periodic maintenance and inspection by a suitably qualified roofing contractor is recommended to prolong the life of the roof covering.

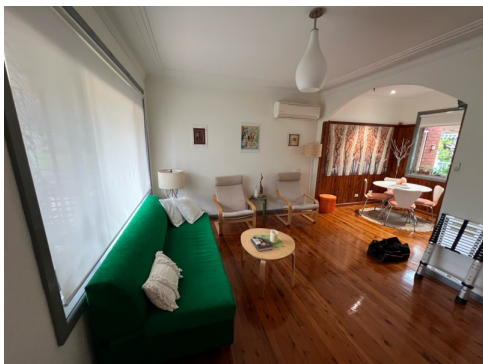
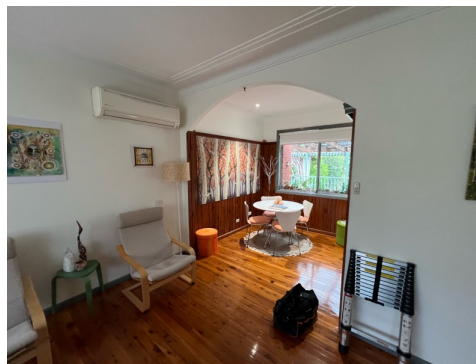
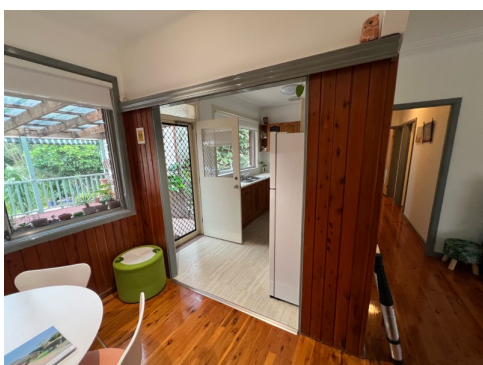
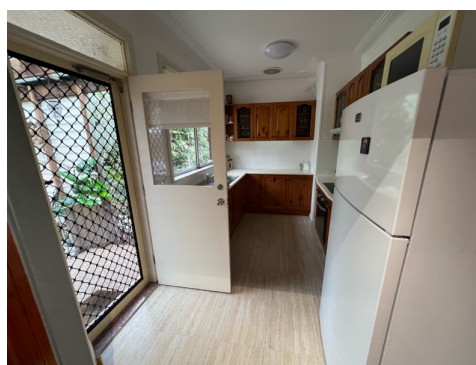
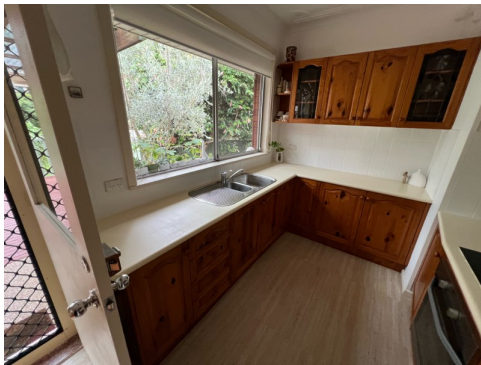
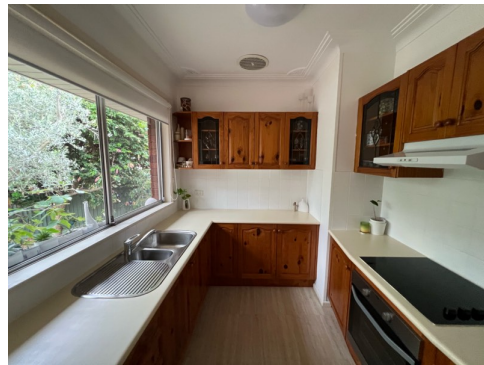
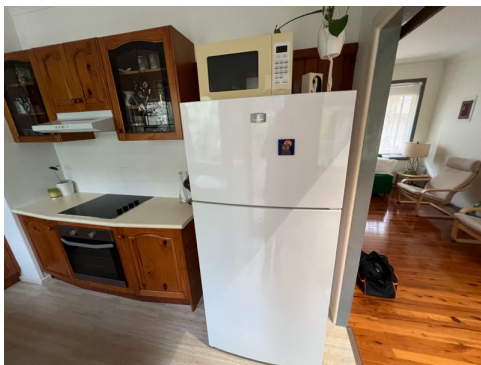
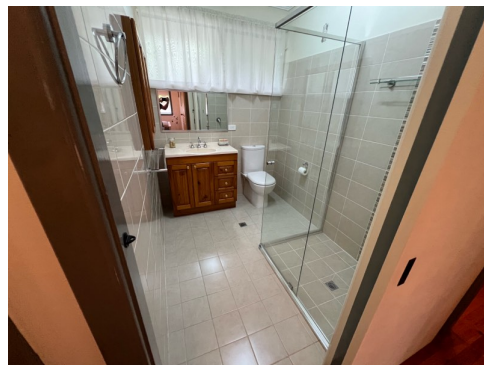
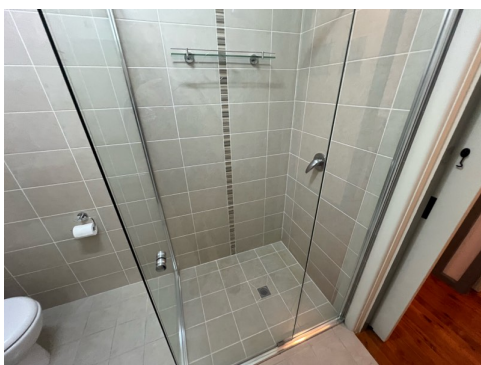
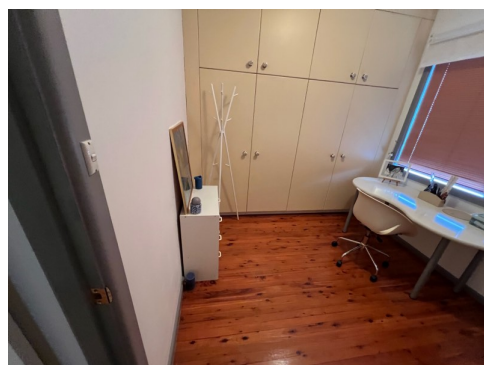
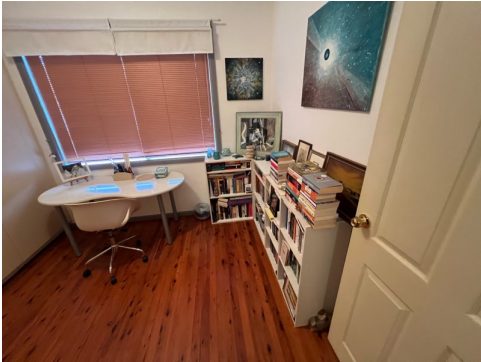
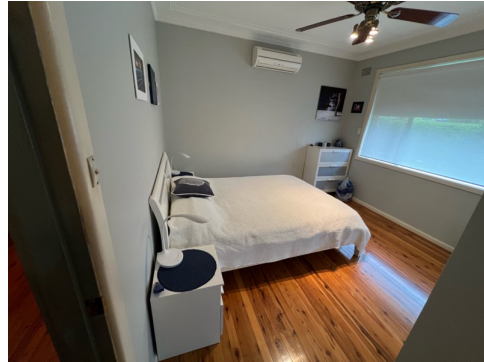
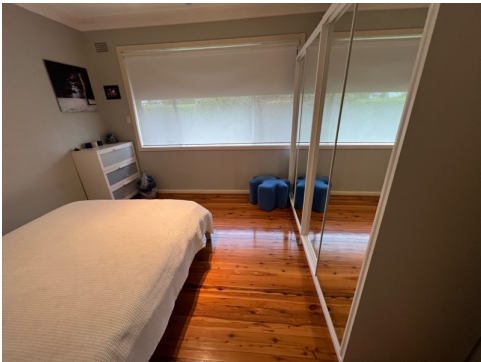
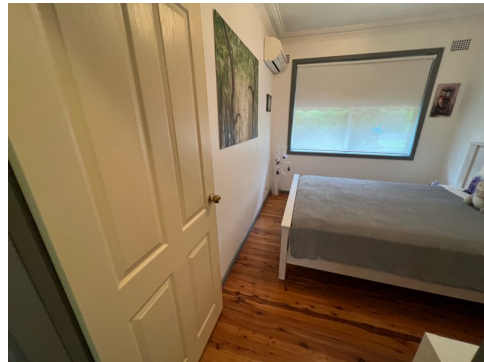
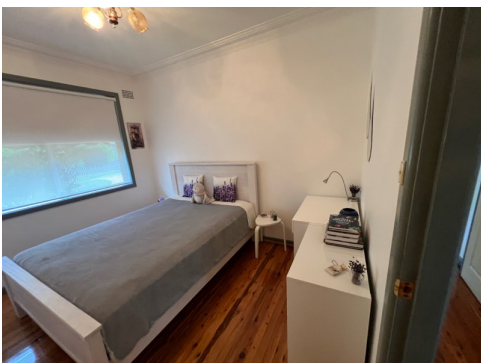
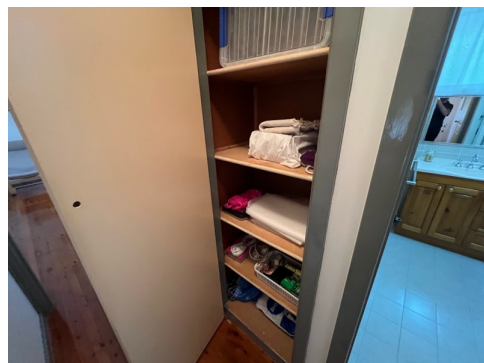
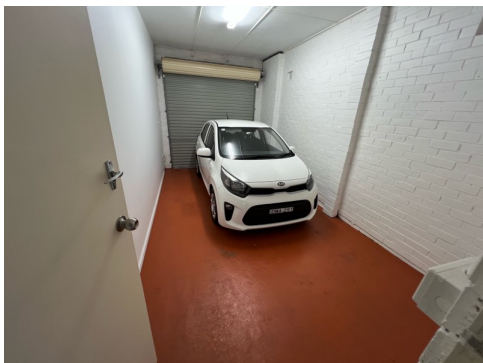
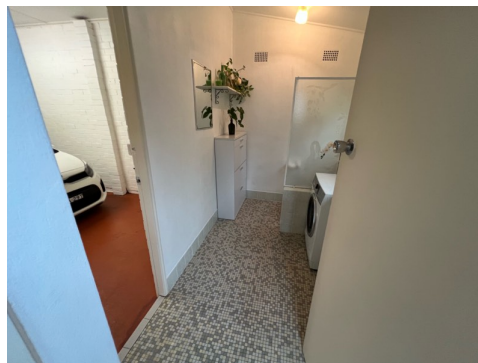
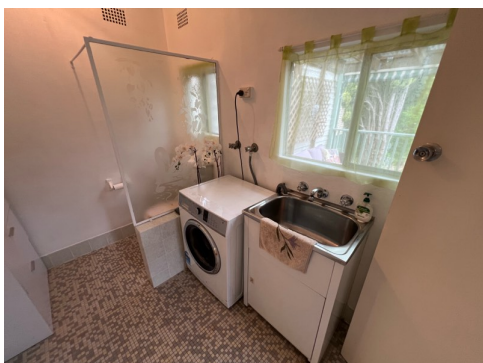
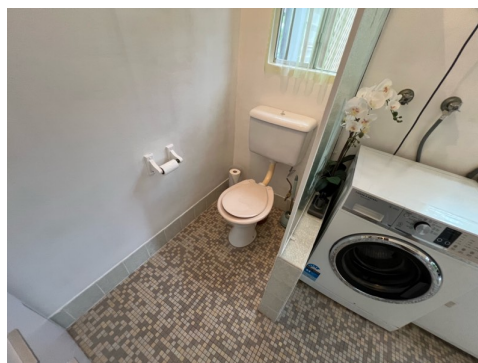
Finding: Additional Photos - Obstructions and Limitations

Information: These photographs are an indication of the obstructions and limitations which impeded full inspection of the property at the time of inspection. These obstructions can hide an array of defects and should be removed to allow full inspection to be carried out. A re-inspection is recommended once the areas are made accessible.

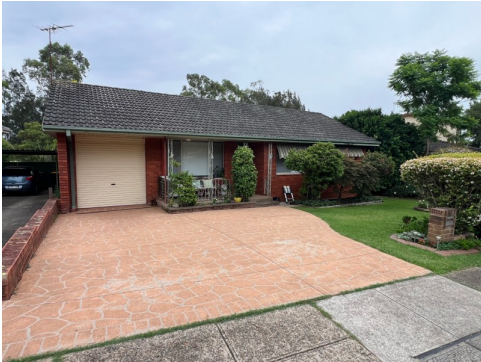
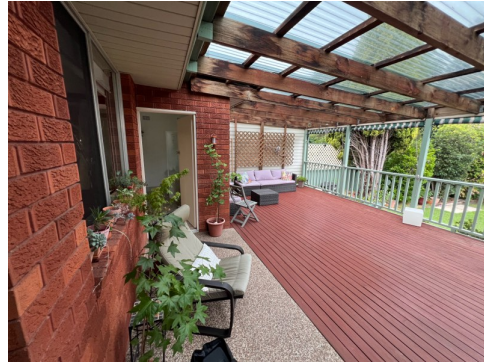
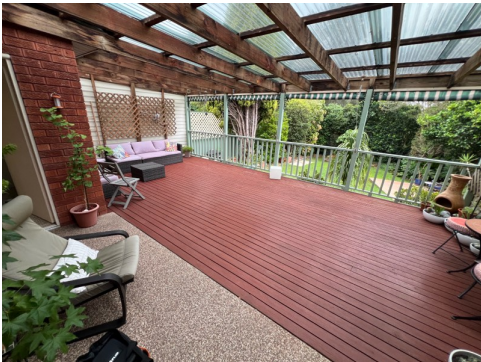
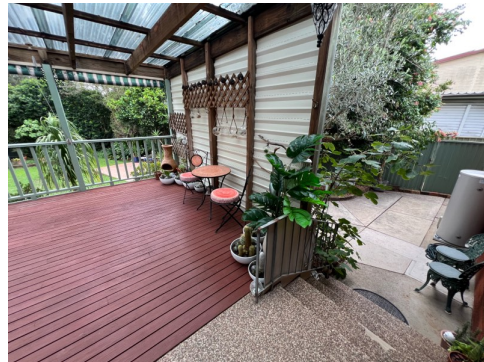
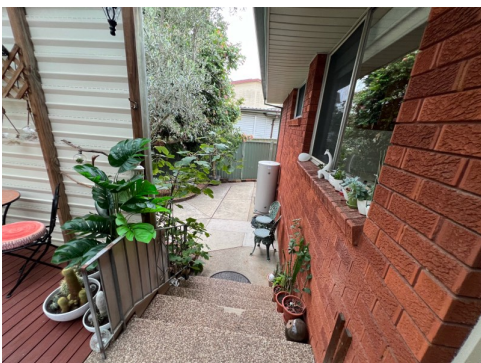
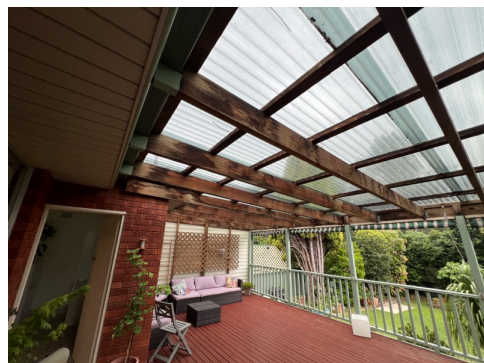
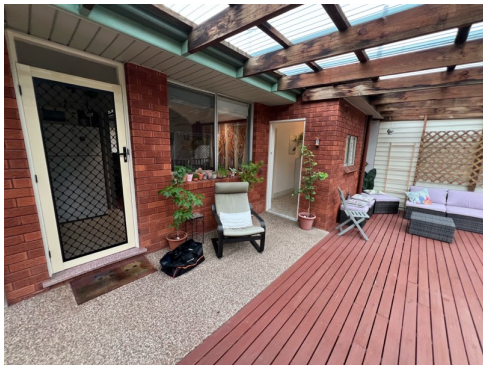
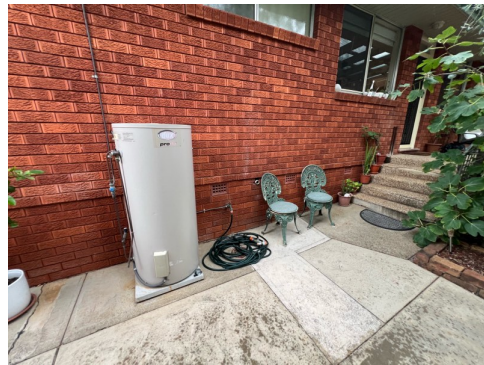
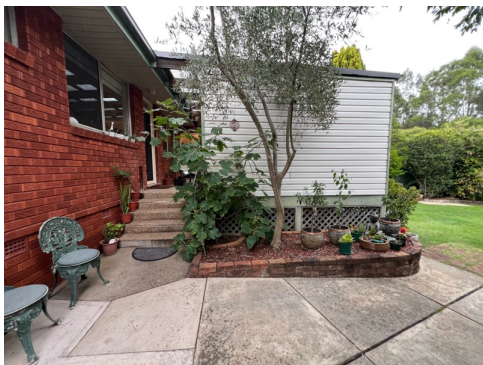
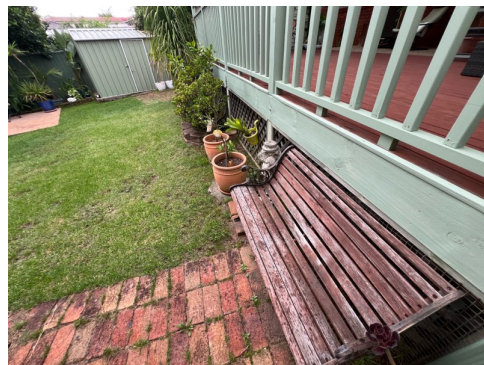
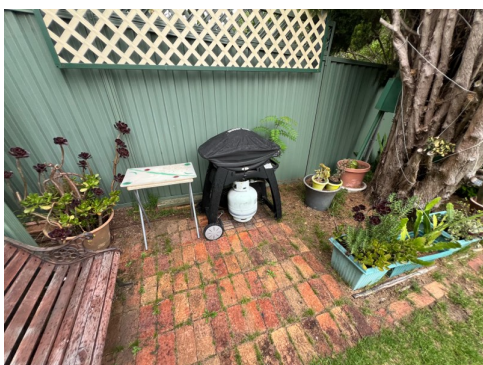
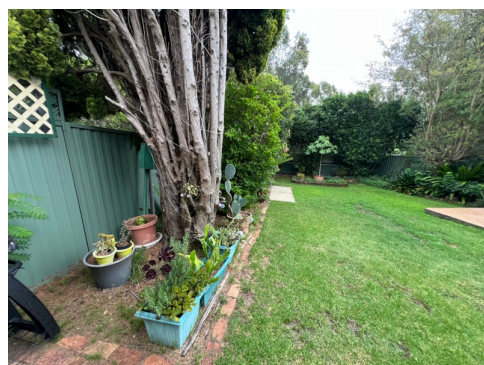
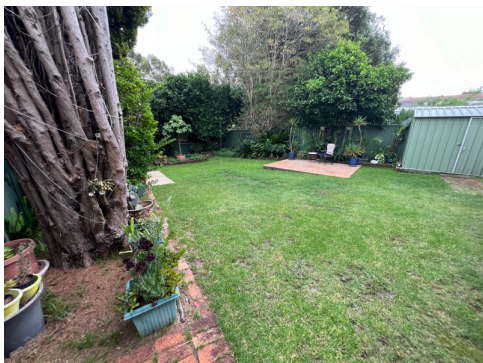
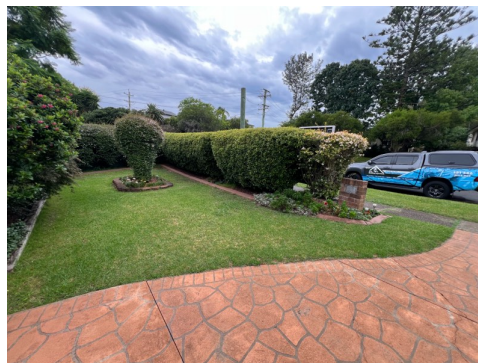
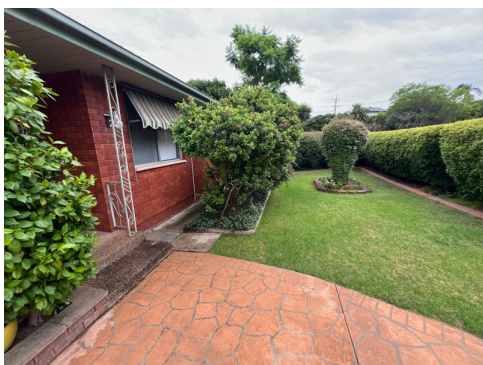
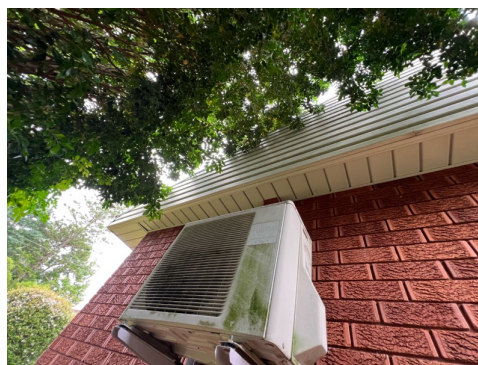
Finding: Additional Photos - Obstructions and Limitations

Information: These photographs are an indication of the obstructions and limitations which impeded full inspection of the property at the time of inspection. These obstructions can hide an array of defects and should be removed to allow full inspection to be carried out. A re-inspection is recommended once the areas are made accessible.

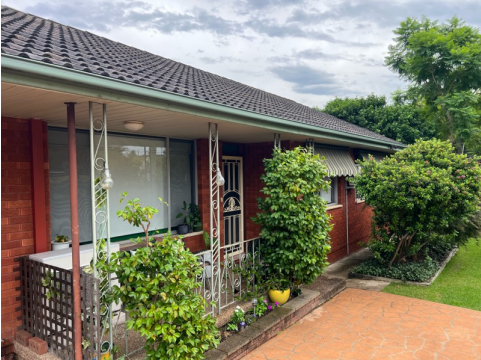
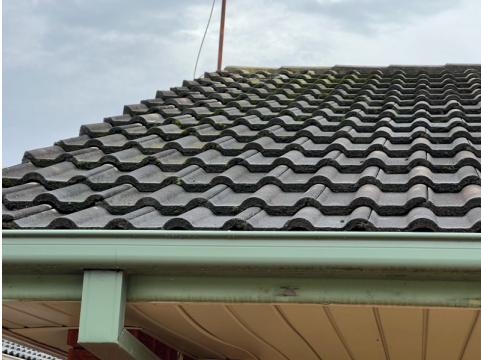
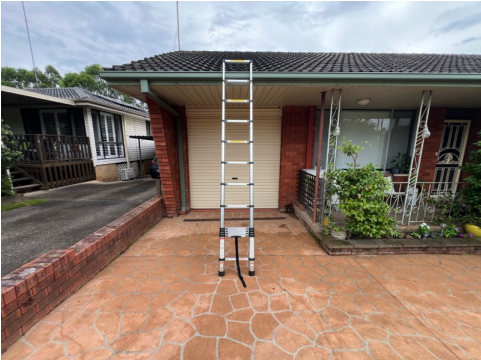
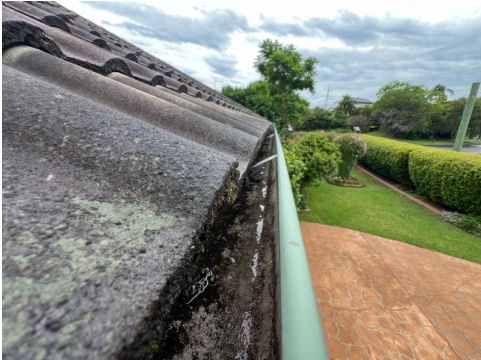
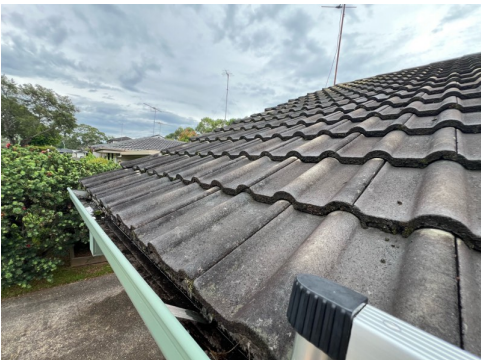
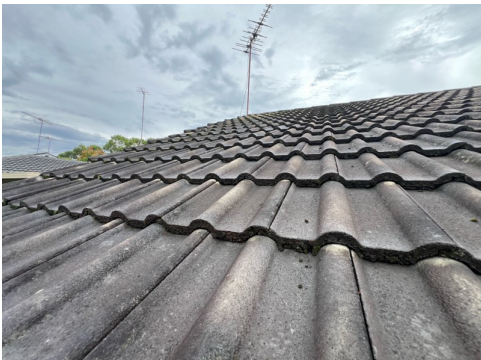
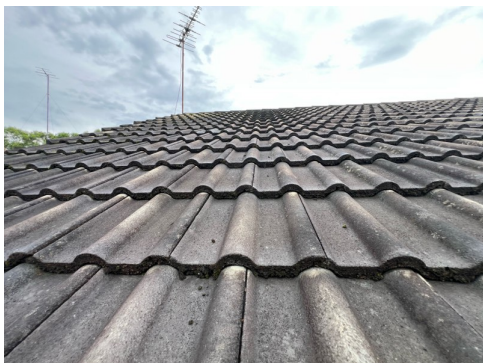
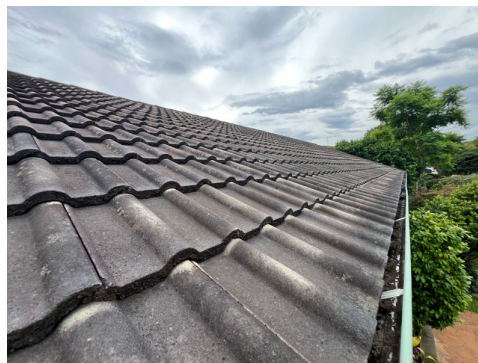
Finding: Additional Photos

Information: Additional photos are provided for your general reference

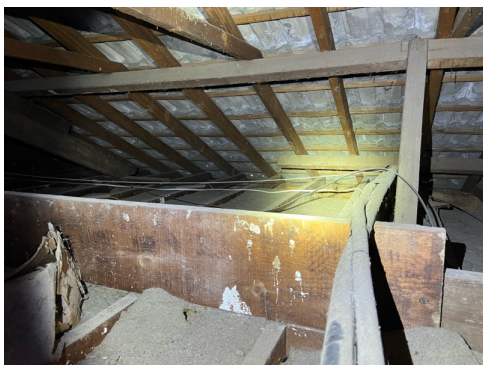
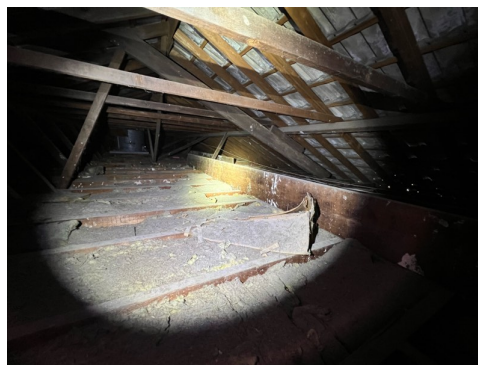
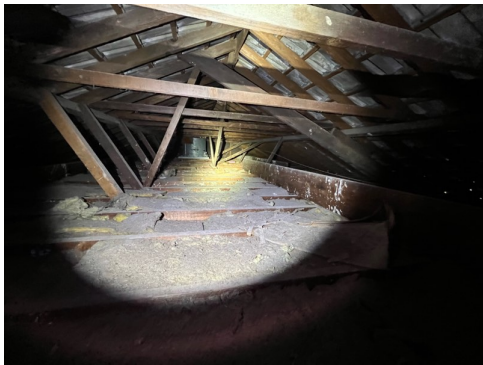
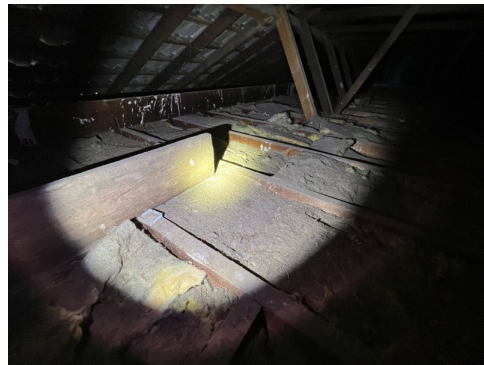
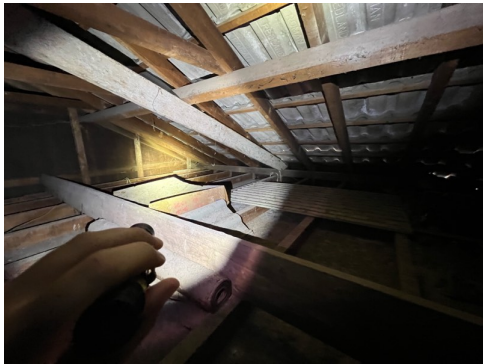
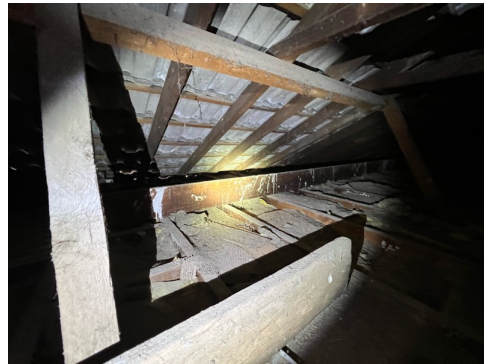
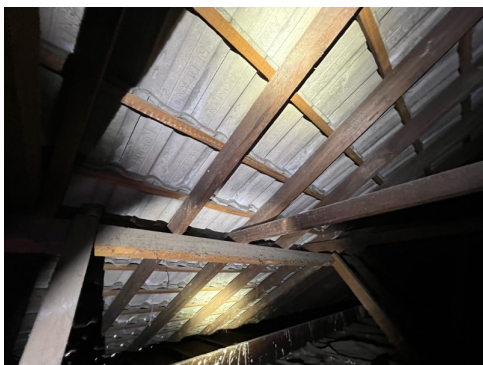
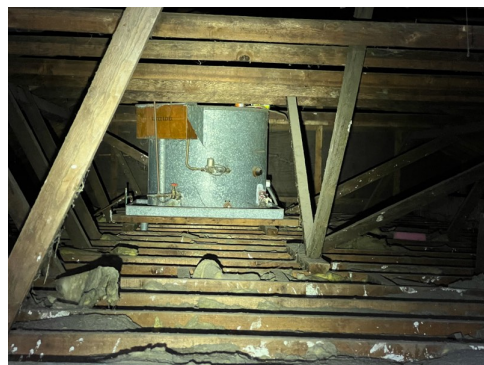
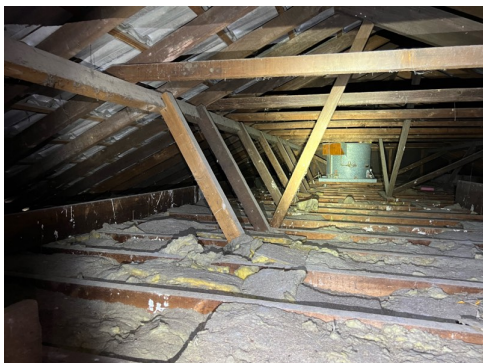
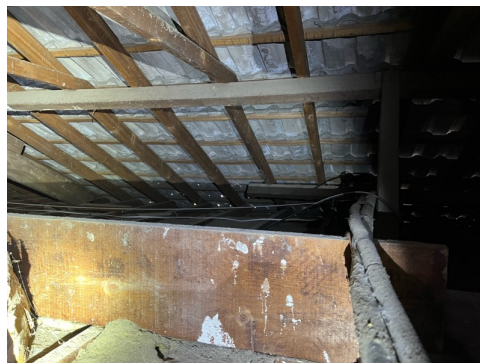
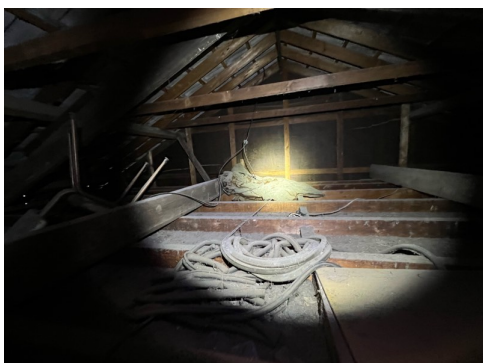
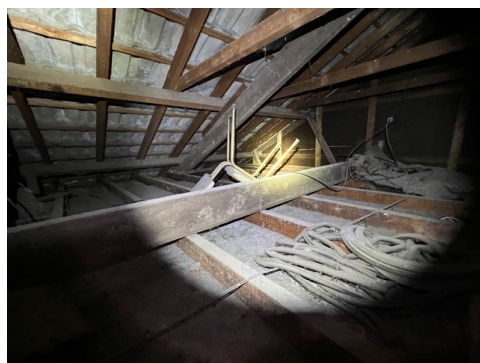
Finding: Additional Photos

Information: Additional photos are provided for your general reference

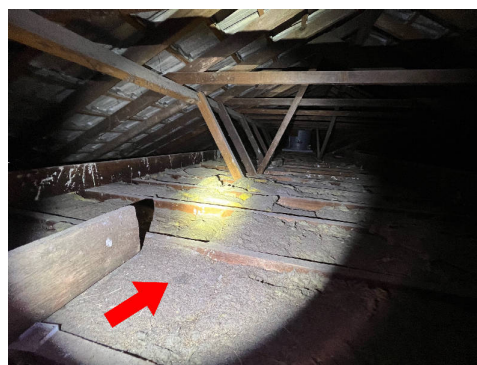
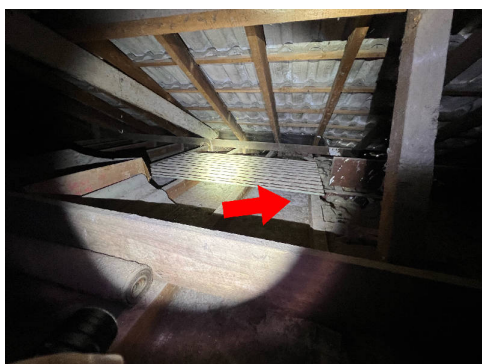
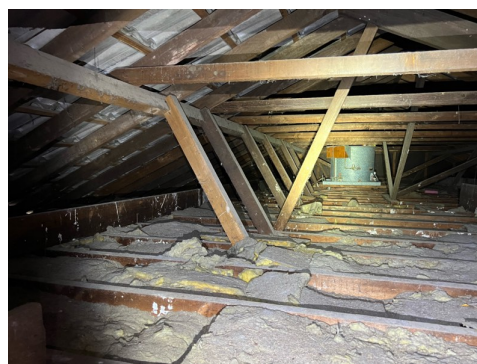
Information: Within the roof space, the existing bulk insulation was observed to be aged, compressed and unevenly distributed, with some sections displaced or providing inconsistent coverage. The insulation appears to be of an older style typical of the era of construction.

While no immediate defect was identified, older or uneven insulation may reduce the overall thermal efficiency of the home when compared to modern standards. Upgrading the insulation may improve comfort and energy performance. This item is provided for your information and can be considered as a future improvement if desired.

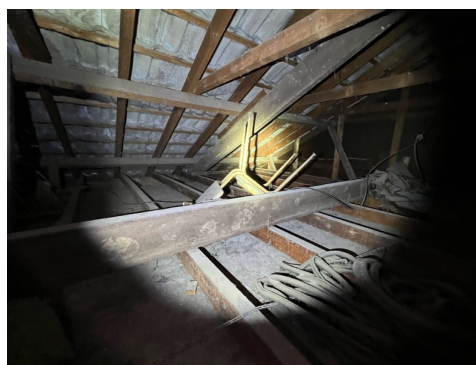
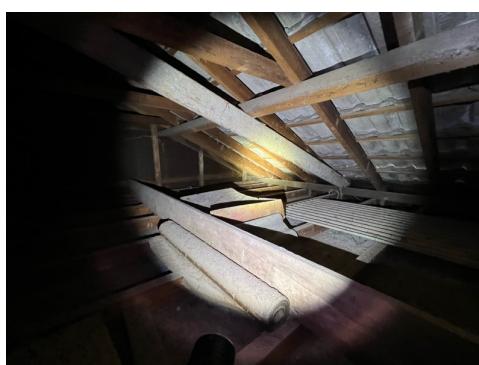
Information: Loose debris and stored materials were observed within the roof space, including sections of old insulation, loose cabling and miscellaneous items resting across ceiling joists. The presence of debris can restrict safe access for maintenance and may contribute to reduced ventilation or concealment of defects.

While no immediate structural defect was identified, accumulation of debris within the roof space is not considered best practice and may present a minor safety risk when accessing the area. It is recommended that the roof space be cleared of unnecessary materials by a suitably qualified person to improve accessibility and allow clearer monitoring of the structure and services. This item can be addressed as a maintenance matter in the short term.

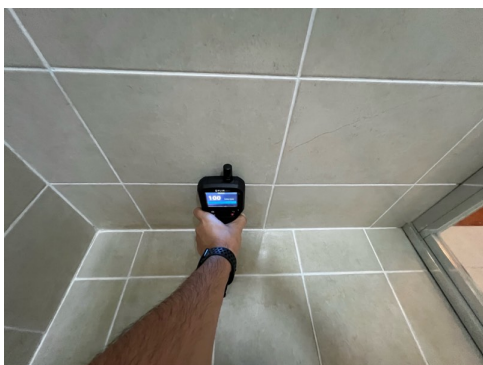
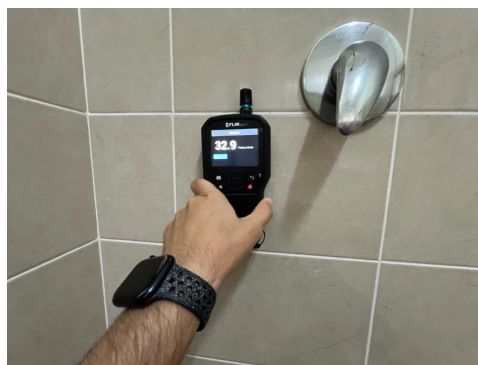
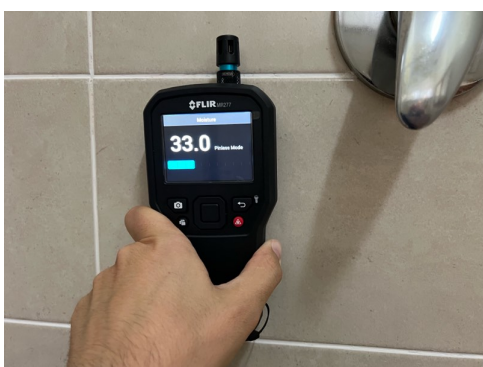
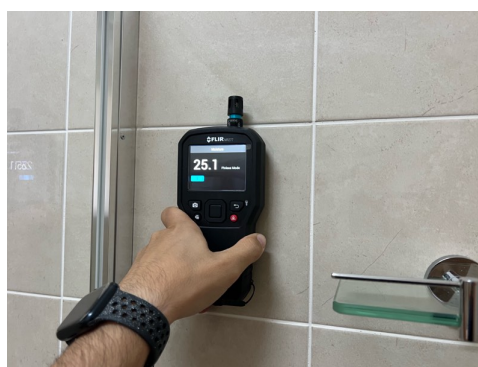
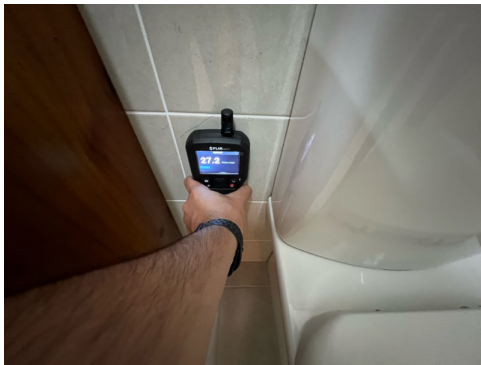
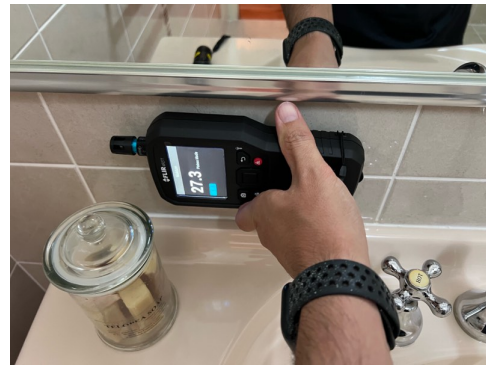
Finding: Moisture Meter Readings - For Information Only

Information: Moisture testing was undertaken to selected accessible internal surfaces using a noninvasive moisture meter at the time of inspection. Readings obtained provide an indicative assessment only and are intended as a guide to assist in identifying areas that may warrant further investigation.

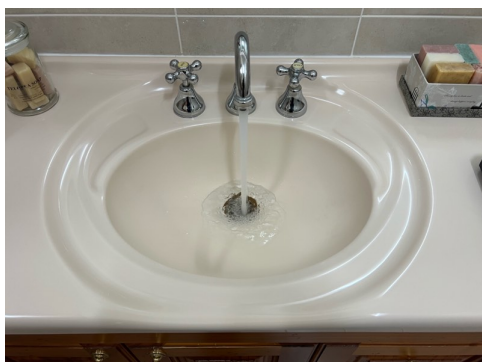
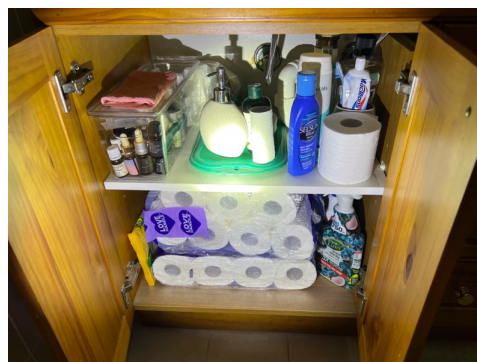
Information: All taps, mixers, and toilets were tested for correct operation, except where access was restricted. The shower recess waterproofing was assessed by conducting noninvasive moisture readings to the walls in and around the shower recess. No abnormal or significant moisture variations were detected within the areas tested. In addition, a visual inspection of the surrounding wall surfaces did not reveal any visible signs of recent or ongoing water damage where inspection was possible.

Based on the above observations, there is no conclusive evidence to suggest the presence of an active shower recess leak at the time of inspection, other than any issues already identified elsewhere in this report. It is therefore reasonable to assume that the shower waterproofing is currently performing as intended. However, it should be noted that if the shower has not been used for an extended period prior to the inspection, moisture readings may not accurately reflect underlying conditions and may result in misleading outcomes. As this inspection is limited to visual and noninvasive methods in accordance with pre-purchase inspection standards, it is not possible to definitively confirm the absence of leaks. If a higher level of certainty is required, a specialist invasive inspection is recommended
