Building and Timber Pest Inspection Report

Inspection Date: Wed, 11 Mar 2026

Property Address: 8 Drinan St, Branxton NSW 2335, Australia

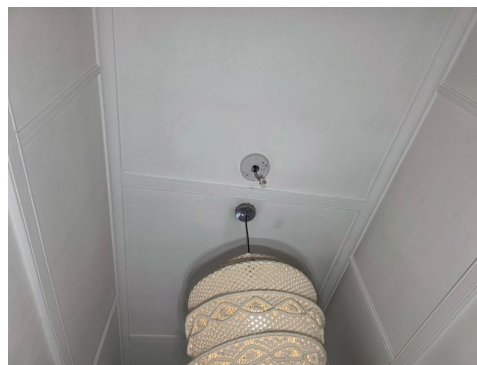
Information: A smoke alarm connection point was observed in the hallway; however, no smoke alarm unit was installed or connected at the time of inspection. The absence of a functioning smoke alarm in this location reduces early fire detection capability and may delay occupant warning in the event of a fire.

A licensed electrician should be engaged to assess and rectify as required. This should be done without delay.

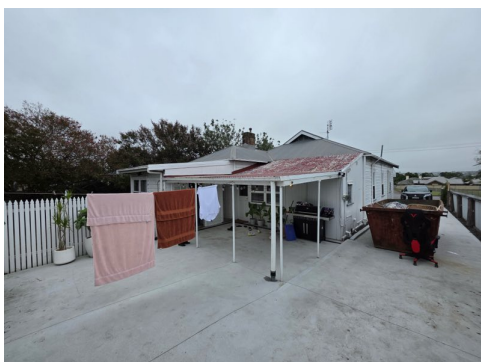
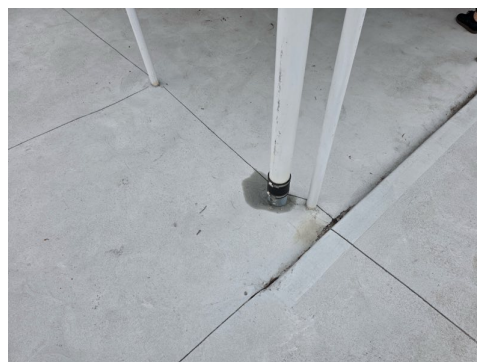
Finding 3.02

Finding: Moisture Marking at Downpipe Base – Rear Alfresco Roof

Information: A wet mark was observed around the base connection of the downpipe serving the alfresco roof at the rear of the property. The moisture marking indicates the presence of water at this location, however the source of the moisture could not be confirmed during a visual, non-invasive inspection.

A licensed plumber should be engaged to carry out further investigation and rectify as required. This should be done as soon as practicable.

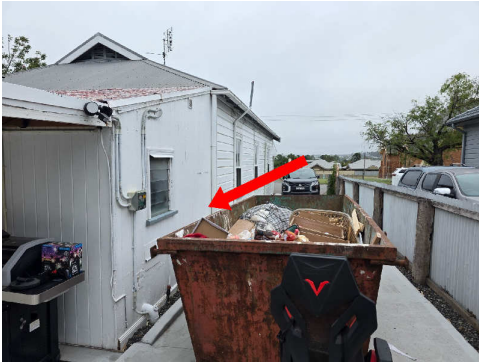
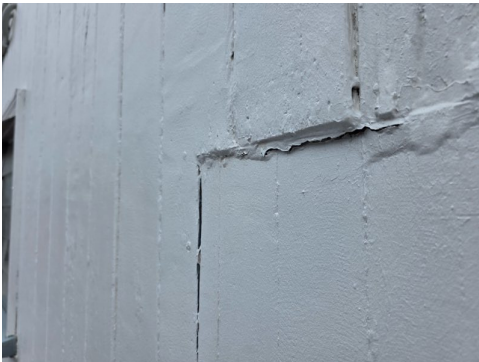
Finding 3.03

Finding: Weatherboard Cladding Open Joints and Patch Repairs – Bathroom Wall (External)

Information: The external weatherboard cladding to the bathroom wall shows several areas where joints are opening and previous filler repairs have been applied. An old service penetration appears to have been filled using a circular cut-out piece approximately 50mm in diameter, likely from melamine material. Open joints and patched penetrations may allow moisture entry into the wall cavity over time.

A licensed carpenter should be engaged to assess and rectify as required. This should be done as soon as practicable.

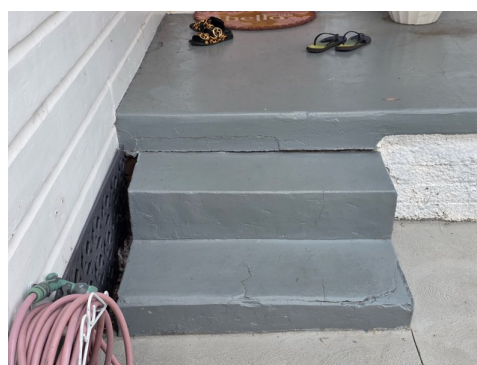
Finding 3.04

Information: Minor subsidence was observed at the two concrete steps leading to the front verandah. The movement appears limited and may be longstanding; however, the duration or progression of the movement cannot be determined during a visual inspection.

A licensed builder should be engaged to assess and rectify as required. This should be done at the owner's discretion.

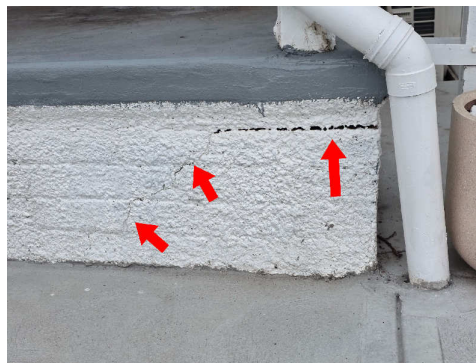
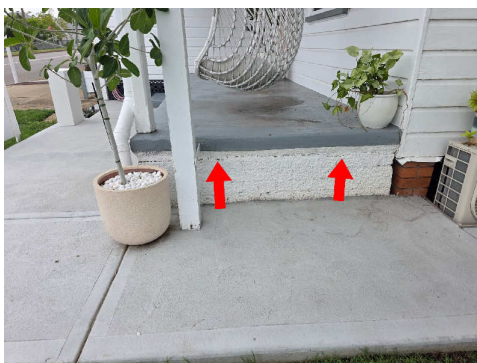
Finding 3.05

Finding: Cracking to Brick Nib Wall Supporting Front Verandah

Information: The front verandah consists of a concrete slab supported by a rendered brick nib wall. Cracking was observed in the rendered brickwork supporting the verandah. While the cracking may be associated with historical settlement, the extent or progression cannot be determined during a visual, non-invasive inspection.

A licensed builder should be engaged to assess and rectify as required. This should be done at the owner's discretion.

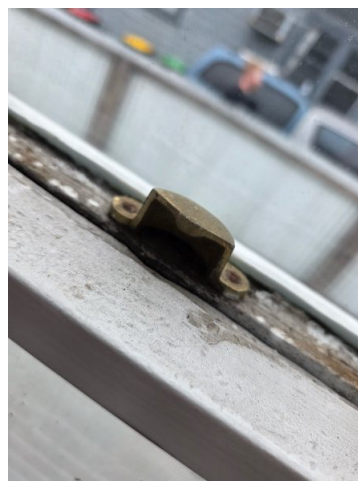
Finding 3.06

Finding: Missing Window Latch – Bedroom 4

Information: The window in Bedroom 4 was observed without a latch mechanism installed. Without a latch the window may not close or secure properly.

A licensed carpenter should be engaged to assess and rectify as required. This should be done as soon as practicable.

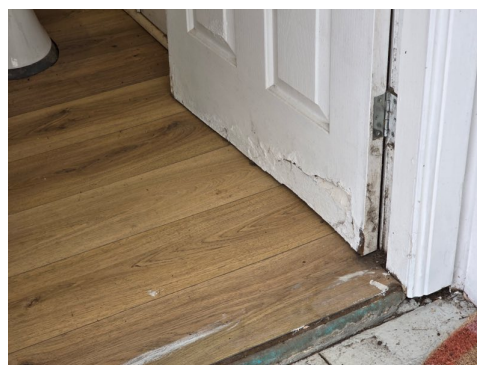
Finding: Damaged Door – Alfresco WC

Information: The door to the WC located within the alfresco area shows significant deterioration to the lower section. The base of the door has been previously patched and filled and is in poor condition, indicating deterioration of the door material.

A licensed carpenter should be engaged to assess and rectify as required. This should be done at the owner's discretion.

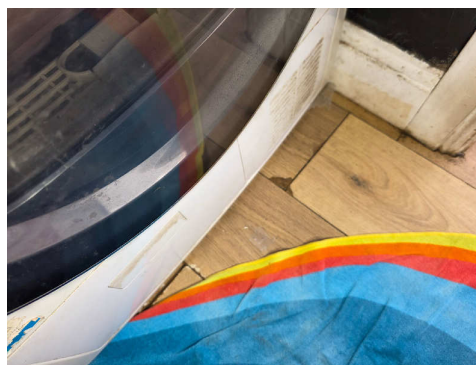
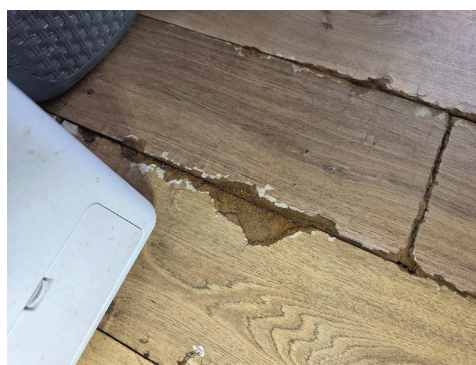
Finding 3.09

Finding: Water Damage to Laminate Flooring – Rumpus Room

Information: Significant swelling, lifting and deterioration of laminate flooring boards was observed in the rumpus room, particularly in the area adjacent to the washing appliances and external door. The boards have expanded and broken down, exposing the fibreboard core material. This type of deterioration is typically associated with ongoing or repeated moisture exposure.

A licensed builder should be engaged to investigate the source of moisture and replace the damaged flooring as required. This should be addressed as soon as practicable to prevent further deterioration of the floor covering and any underlying materials.

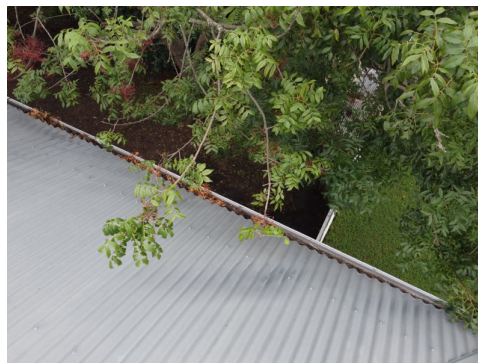
Finding 3.10

Information: The gutter along the side of the property was observed to be full of leaves, likely due to overhanging trees in this area. Accumulated debris can obstruct water flow and may cause water to overflow during rainfall events.

A builder should be engaged to assess and rectify as required. This should be done as soon as practicable.

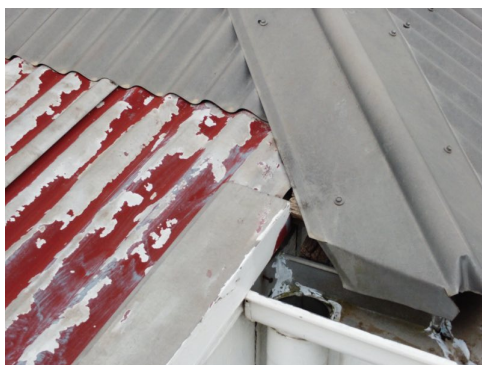
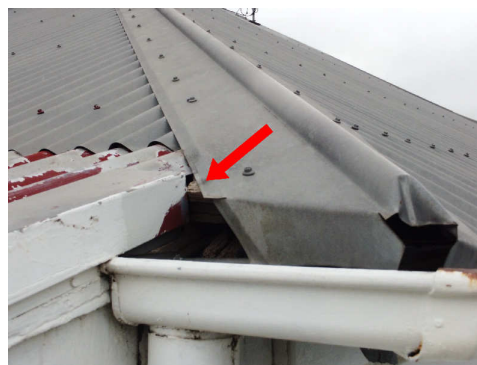
Finding 3.11

Information: At the lower end of the hip section of the main roof above the bathroom area, a small triangular section of what appears to be roof batten was visible and not covered by flashing. Exposed timber components in roof areas may be subject to weather exposure and gradual deterioration over time.

A licensed builder should be engaged to assess and rectify as required. This should be done as soon as practicable.

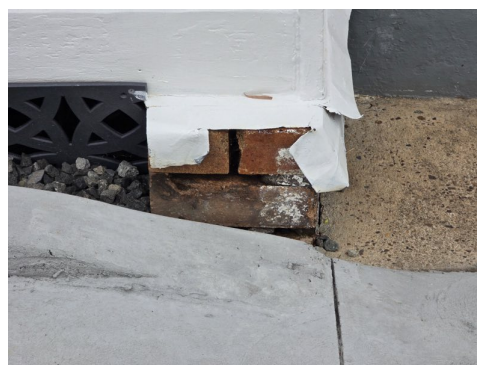
Finding 3.12

Finding: Subfloor Pier Mortar Deterioration – Front Corner Beside Driveway

Information: Subfloor access was significantly restricted at the time of inspection, limiting visibility of the supporting piers. One of the only clearly visible piers, located at the front corner of the dwelling beside the driveway, showed signs of mortar erosion to the brickwork joints. Mortar deterioration to brick subfloor piers is a common age-related condition in older dwellings. A brief visual check into a small section of the subfloor through a screen used to block access indicated the visible ground surface appeared dry and the limited piers visible in that area appeared serviceable; however, the condition of the remaining subfloor piers could not be confirmed during this visual, non-invasive inspection.

A licensed bricklayer should be engaged to carry out further investigation and rectify as required. This should be done as soon as practicable.

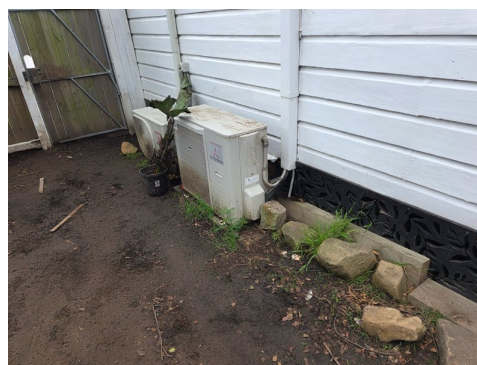
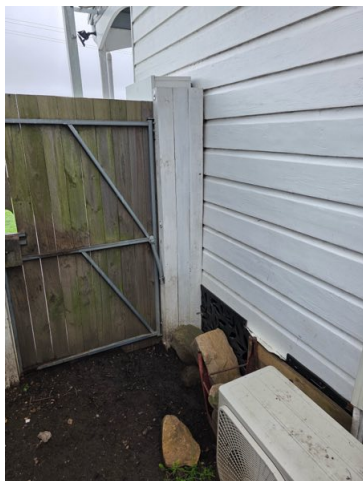
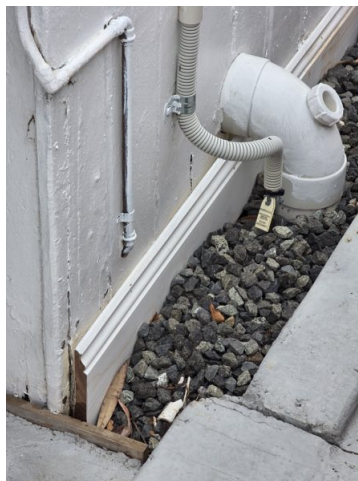
Information: Timber elements in direct contact with the ground, and consequently exposed to moisture or dampness, create conditions conducive to termite activity. Whether timber is used as part of a building structure, such as a fence or retaining wall, or stored as unused material, it can attract termite infestations.

When exposed to excessive moisture, timber begins to decay and develop wood rot. Any timber in direct contact with the ground - especially untreated or non-durable timber - provides an easy entry point for subterranean termites into the material.

To minimize the risk of termite attack, it is recommended to remove any materials that could foster termite activity. If removal is impractical or undesirable, it is strongly advised that termite or timber pest inspections be conducted every 6 to 12 months to protect the property from potential infestation.

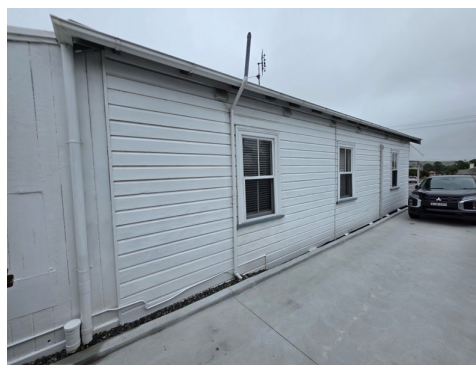
Finding 6.02

Finding: Ventilation - Inadequate subfloor ventilation

Information: Subfloor ventilation appears to be inadequate in one or more areas beneath the dwelling. Poor airflow can result in elevated moisture levels, which in turn create conditions conducive to fungal decay and termite activity. Signs of dampness or musty odours may also indicate restricted air movement.

Improved cross-ventilation should be established to help manage moisture and reduce the risk of concealed timber pest attack. A licensed builder should assess the subfloor and install additional vents or mechanical ventilation as needed. This should be addressed as soon as practicable.

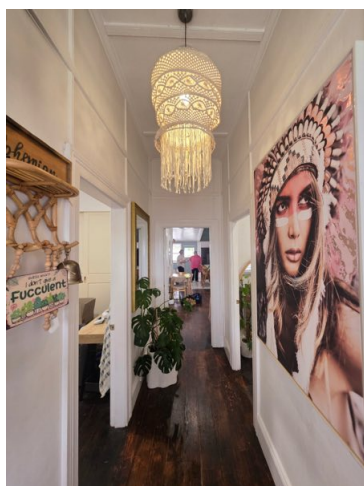
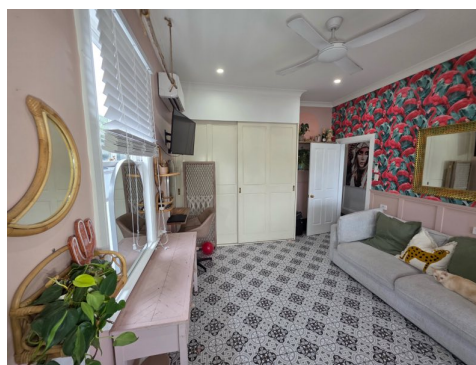
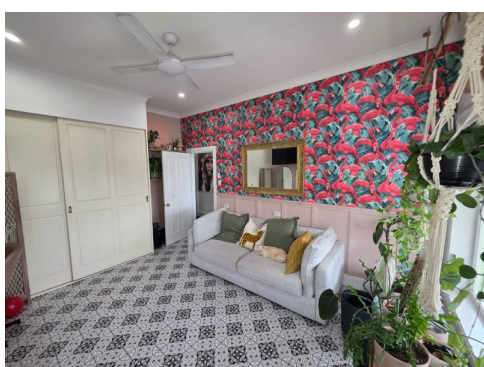
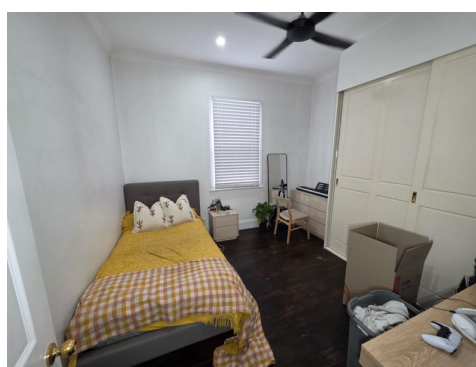
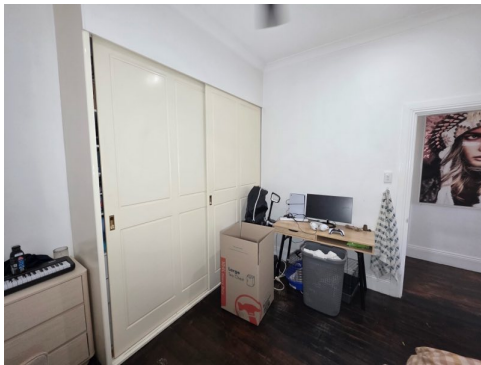
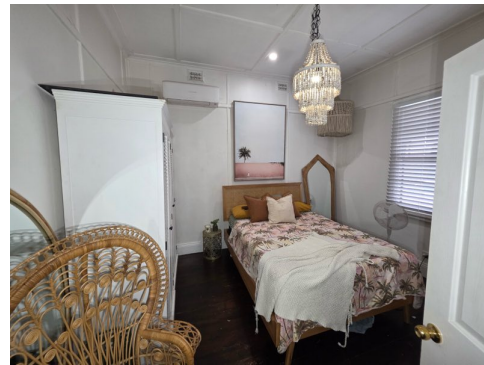
Finding: Additional Photos - Obstructions and Limitations

Information: These photographs are an indication of the obstructions and limitations which impeded full inspection of the property at the time of inspection. These obstructions can hide an array of defects and should be removed to allow full inspection to be carried out. A re-inspection is recommended once the areas are made accessible.

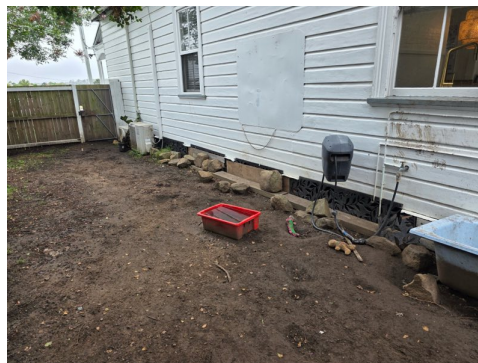
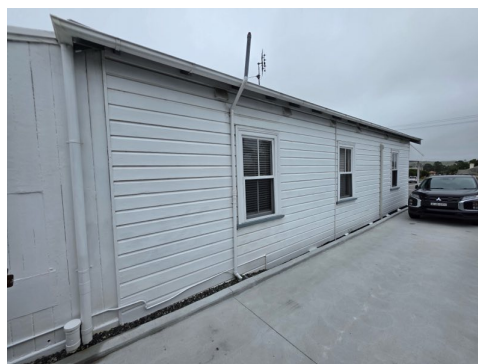
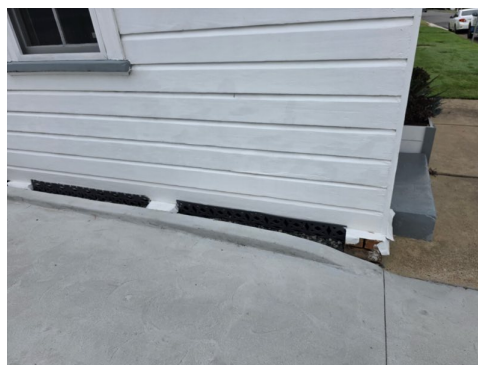
Finding: Access - Subfloor inaccessible

Information: The subfloor was inaccessible due to restricted access at the time of inspection. As a result, concealed structural defects, timber damage, or conditions conducive to deterioration could not be ruled out in this area. This has been noted for your information.

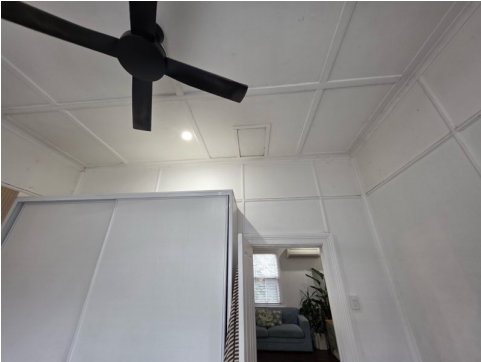
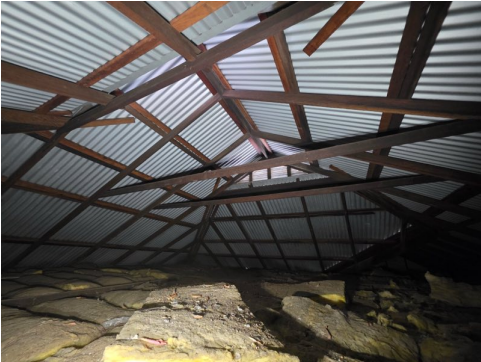
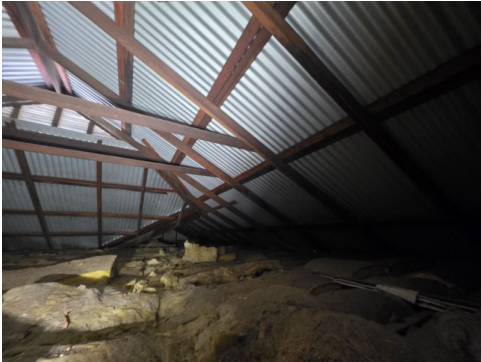
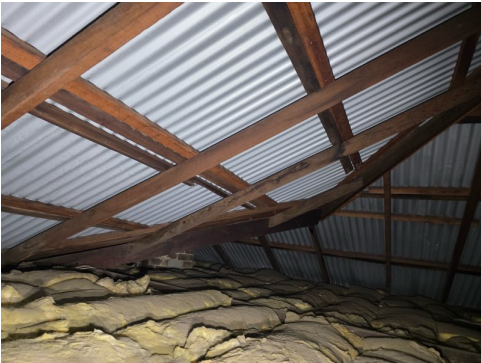
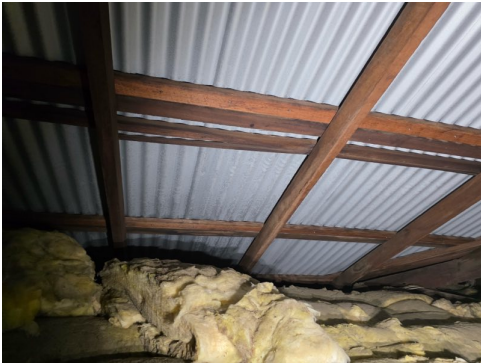
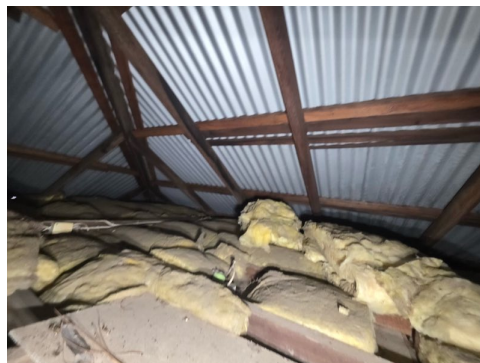
Finding: Roof Void Access Restricted – Roof Space

Information: The roof void could not be fully accessed due to height and hatch access limitations. A limited visual observation was made from the hatch opening only, which restricts the ability to inspect roof framing, insulation, and other concealed roof components throughout the full roof space.

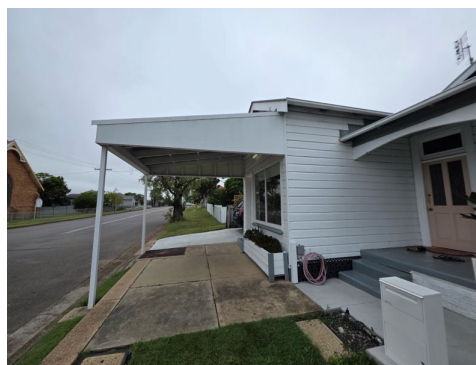
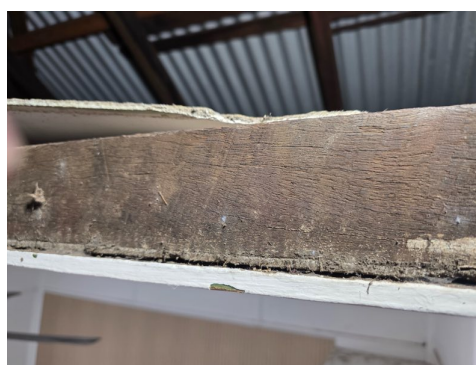
Building: Main Building
Location: Linings
Finding: Asbestos - Suspected Asbestos-Containing Materials (ACMs)

Reporting on asbestos is outside the scope of this inspection. Suspected asbestos-containing material (ACM) was observed in the ceiling linings bed 4 and the canopy over the street at the front of the property. Based on our experience in the building industry, there is a higher risk that the identified building elements contain asbestos, particularly given that any home constructed prior to 1990 may contain asbestos in various forms.

No sample testing has been undertaken to confirm the presence of asbestos. We strongly recommend a separate Asbestos Inspection and Condition Audit be carried out by a licensed assessor, which may include laboratory testing for definitive confirmation.

In the meantime, the client is advised to act with caution, especially when considering any disturbance of the material through wear and tear, renovations, extensions, demolition, or maintenance activities.

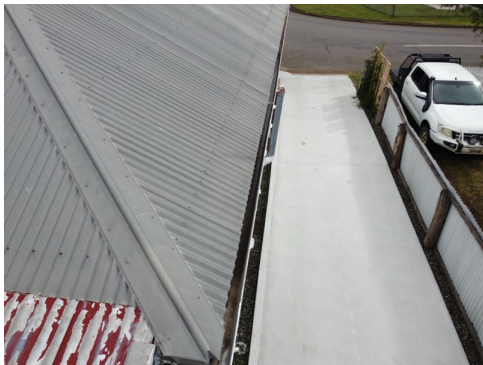
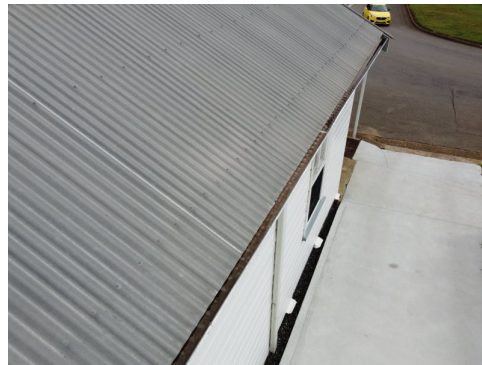
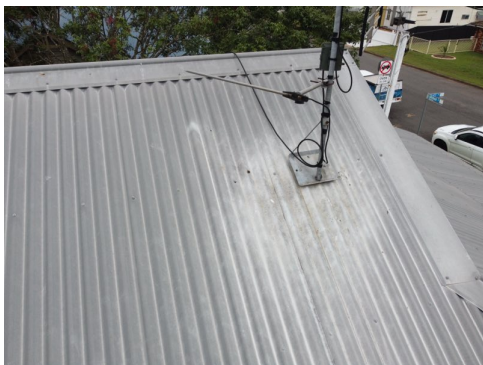
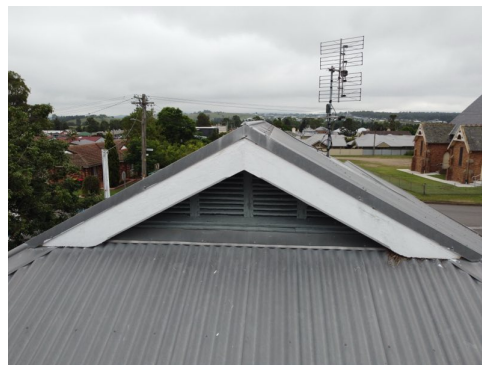
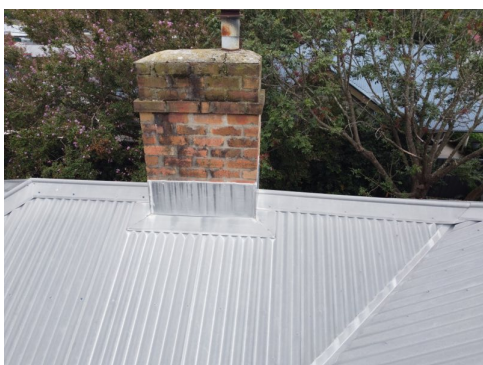
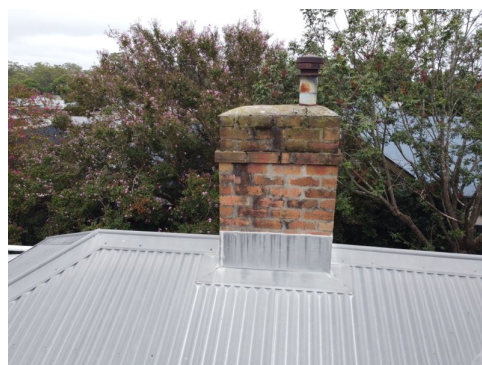
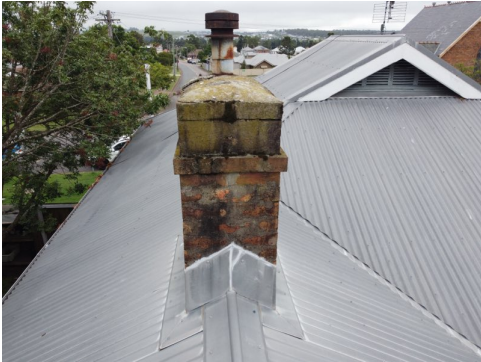
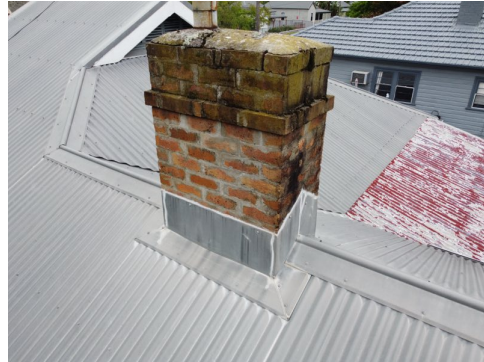
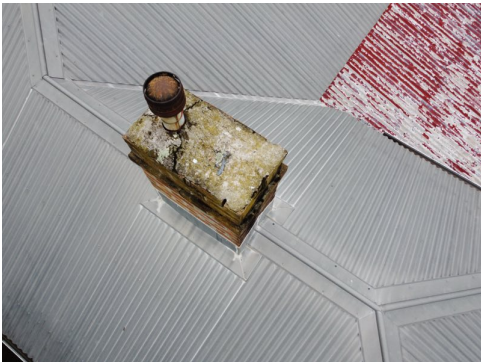
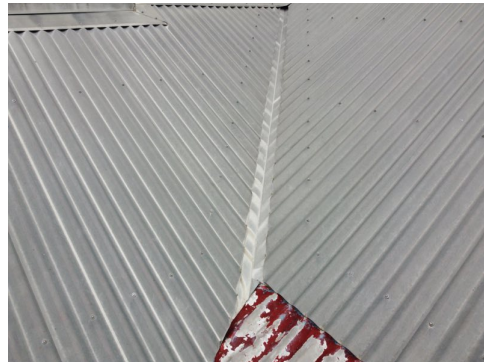
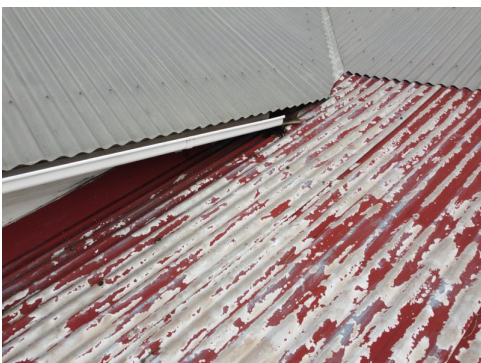
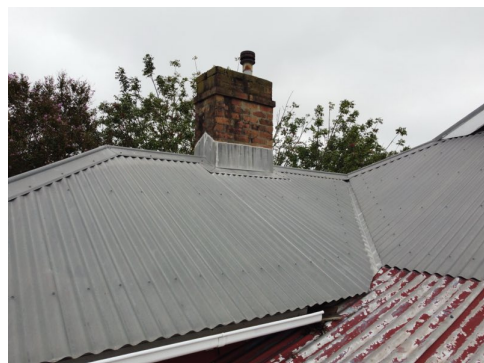
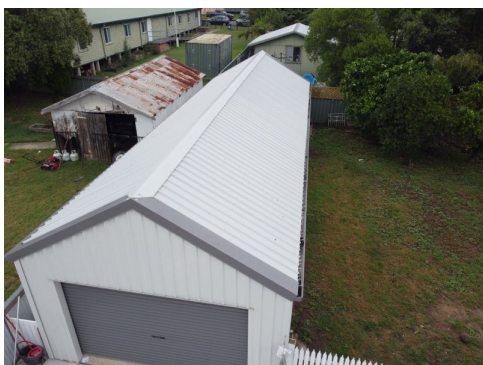
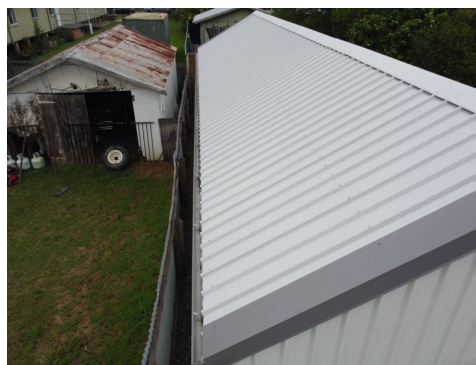
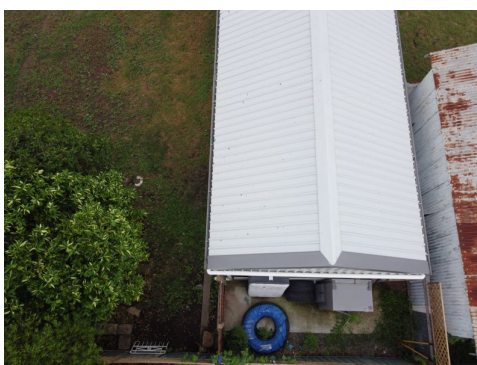
A number of supplementary photographs of the roof exterior have been included for general reference. These images were taken from accessible vantage points around the property at the time of inspection and are provided to assist with overall understanding of the roof condition.

The photographs included are indicative only and do not constitute an exhaustive record of all areas of the roof. Roof areas may be partially obscured by height, pitch, weather conditions, or surrounding structures. The inspection of the roof exterior was limited to what could be safely viewed from ground level and other accessible locations.

These photographs should not be relied upon as confirmation that the roof covering is free of defects.

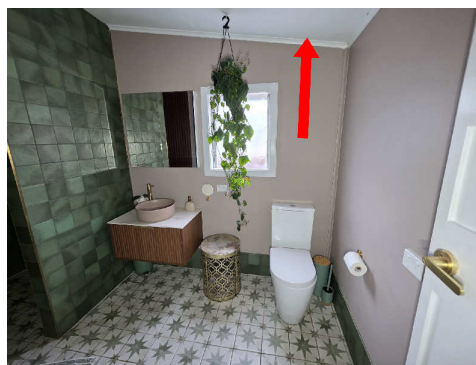
Noted Item

Building: Main Building

Information: Portions of the dwelling incorporate raked/vaulted ceilings and no roof void access was available at the time of inspection. The roof framing, sarking, insulation and flashing junctions could therefore not be visually inspected. Internal ceiling linings were checked and no active moisture staining or distortion was observed at the time of assessment.

Concealed roof construction limits the ability to identify early roof leaks or flashing defects, as moisture entry may not become visible internally until deterioration is advanced or after periods of heavy rainfall. The inspection of these areas is therefore restricted. The ceilings should be monitored during occupancy and any future staining, dampness or mould growth should be investigated by a licensed builder without delay.

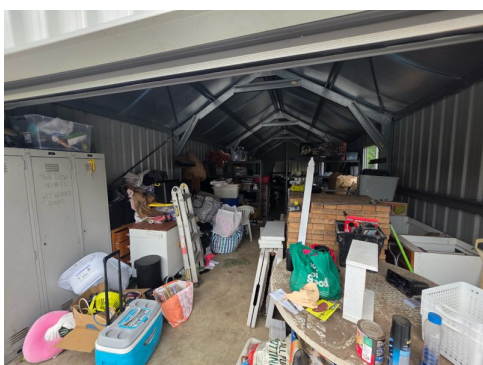
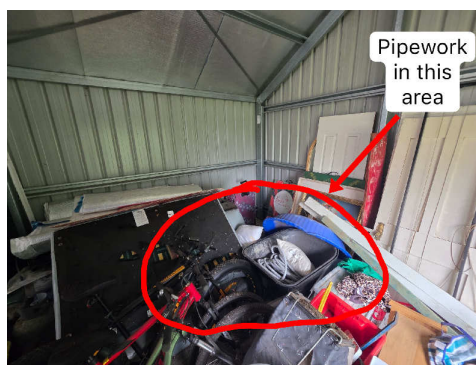
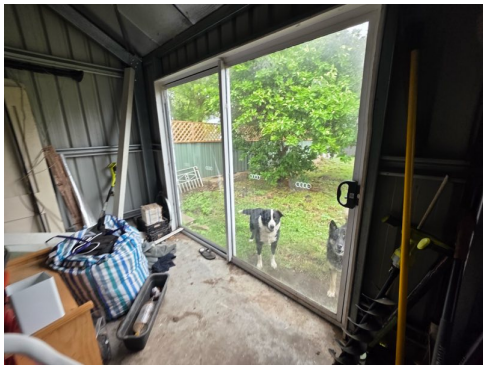
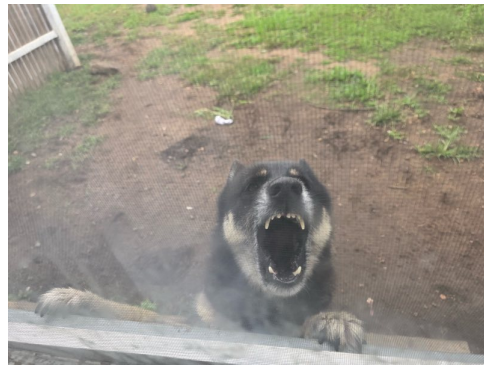
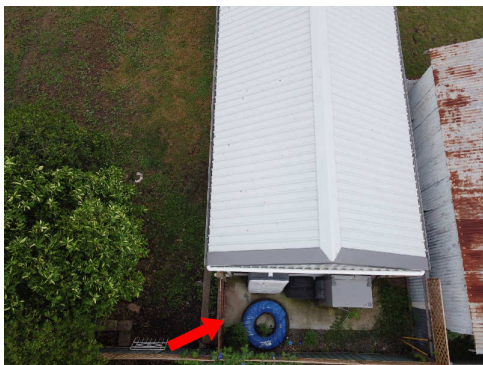
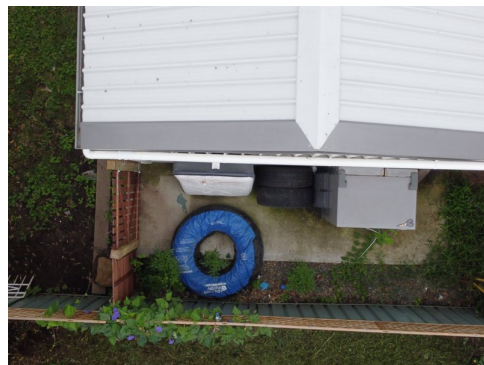
Noted Item

Building: Shed

Finding: Plumbing Provisions to Rear Shed – For Information

Information: The rear shed was largely full of stored items at the time of inspection, which prevented a clear view of the floor area. The current owner advised that plumbing provisions have been installed within the concrete slab at the rear of the shed for a toilet, shower, and vanity basin. No pipework or plumbing connections were visible at the time of inspection due to the stored items covering the slab surface. A concrete slab was also observed outside the rear wall of the shed which appears prepared to accommodate a water tank. This information is provided for general awareness.
