Building and Timber Pest Inspection Report

Inspection Date: Fri, 23 Jan 2026

Property Address: 8 Hervey St, Elmore VIC 3558, Australia

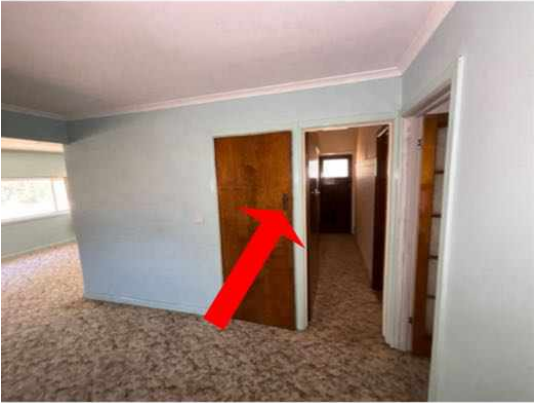
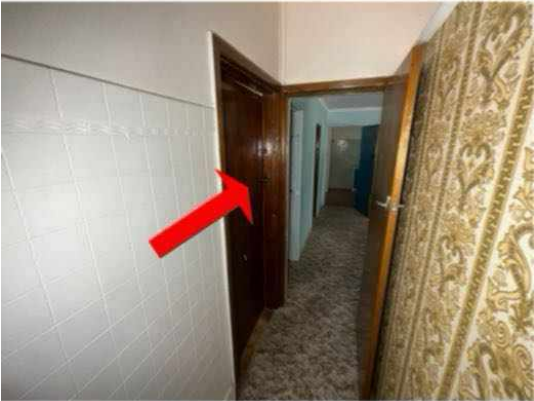
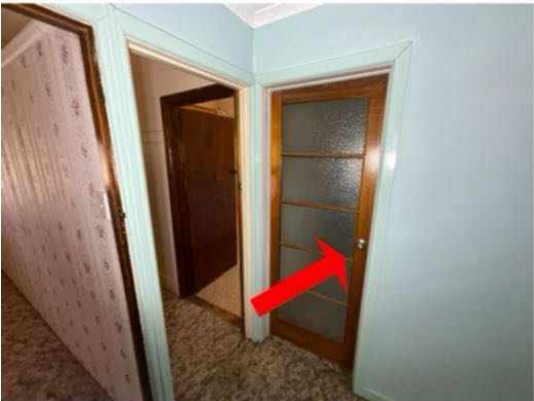
This is a common defect and is expected in a property of this age, whether being due to substandard installation or general deterioration of the door hardware.

Readjustment of the striker plate is recommended at client discretion. Works such as these can be completed by a general handyman or qualified carpenter.

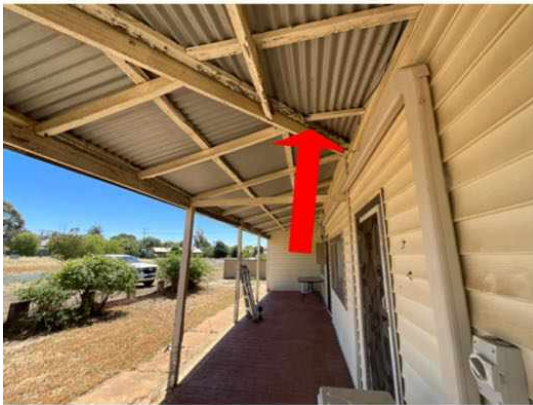
Finding 3.05

Building:	Building 1
Location:	All External Areas
Finding:	External painting deteriorated
Information:	Much of the external paintwork including but not limited to windows, fascias, guttering, veranda and other external fitments have been neglected and require attention to prepare and re-paint.

Whilst incomplete or missing paint finish is generally an appearance defect, it can also lead to the development of secondary building defects over time. Incomplete areas of paint finish expose the area to moisture, potentially accelerating the deterioration of underlying building materials.

Degraded paint finishes should be sanded back, filled, leveled and painted, as applicable. Where inadequate or missing paint protection has led to the deterioration of the associated building element, repair and/or replacement of this building element may be required.

A painting contractor should be appointed as soon as possible to perform necessary works to aid the appearance of the affected area and to ensure the area is protected against further deterioration. Alternatively, the homeowner following manufacturer instructions may perform these works.

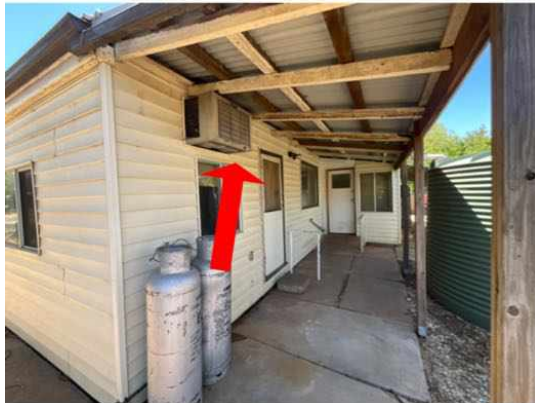
Such leaking creates an environment which is conducive to an array of defects, including water damage to associated building elements and the attraction of termite or timber pest infestation.

It is highly recommended that a licensed plumber be appointed to connect the A/C overflow in order to prevent such an environment from being created. These minor works should be carried out as soon as possible.

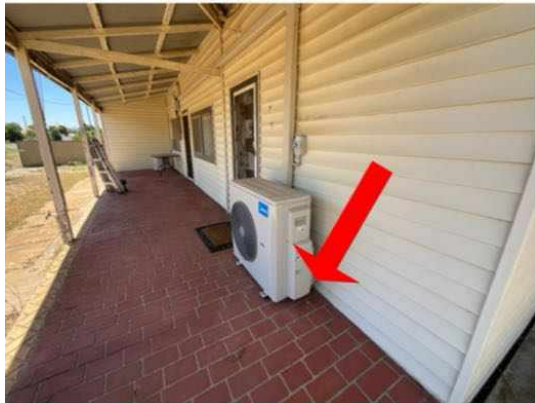
Finding 6.03

Building:	Building 1
Location:	Verandah
Finding:	Air conditioner - Disconnected overflow
Information:	The Air Conditioner (A/C) overflow was found to be disconnected from storm water drainage and is creating excessive moisture in the surrounding area.

Such leaking creates an environment which is conducive to an array of defects, including water damage to associated building elements and the attraction of termite or timber pest infestation.

It is highly recommended that a licensed plumber be appointed to connect the A/C overflow in order to prevent such an environment from being created. These minor works should be carried out as soon as possible.

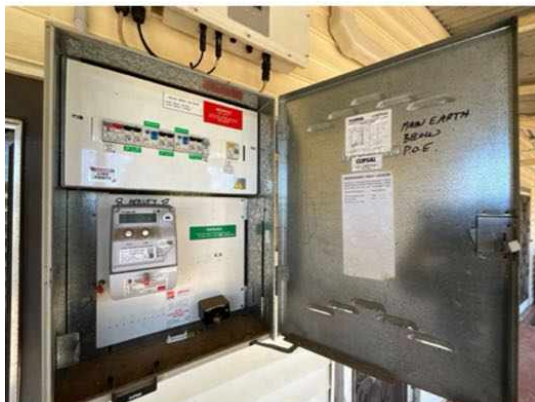
A durable notice should be placed in the switchboard unit to indicate current termite barriers. At the time of inspection, it appeared as though no termite management system has been installed, with no evidence to suggest preventative works taking place.

The client may consider gaining further advice from a pest controller as to the costs and procedures involved with this application. It is recommended that obtaining such advice be a short-term priority.

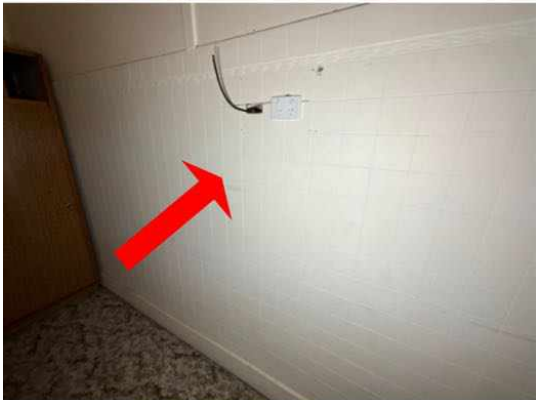
As Asbestos Reporting is outside the scope of this report, we advise that you consider a separate Asbestos Inspection and Condition Audit, which can include the taking of samples for definitive confirmation of the presence of Asbestos.

In the interim, the client is advised to act with caution, especially when considering any damage to building materials general wear and tear renovations extensions demolition and general maintenance activities due to the suspected presence of Asbestos.

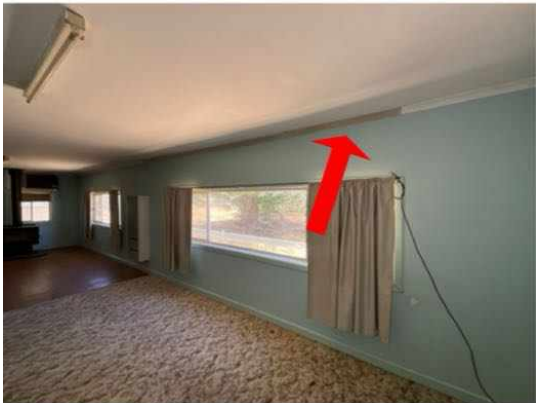
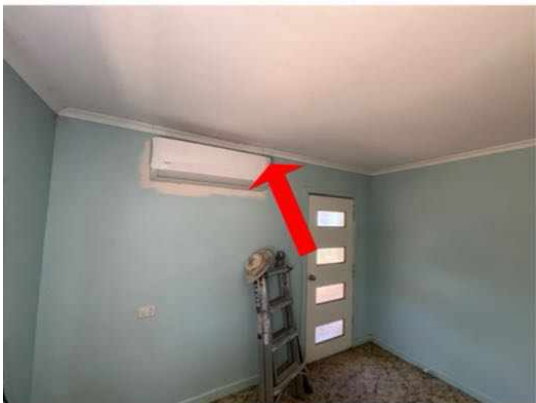
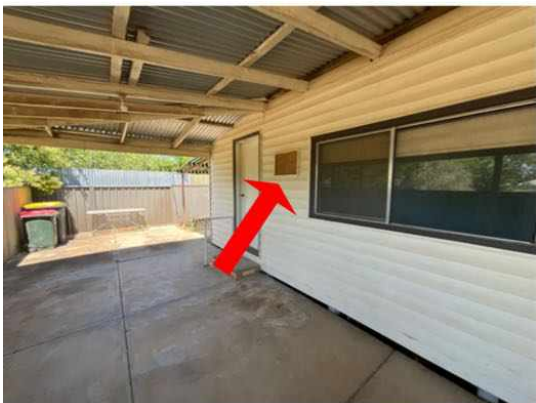
Building: Building 1
 Location: Verandah, living, carport
 Finding: Installation - substandard or incomplete
 Information: The installation of this building element appears to have been completed to a substandard level of workmanship or is incomplete. Generally substandard repairs or installation are related to poor workmanship, the use of inappropriate materials, or a failure to complete installation to a suitable standard.

Where installation is substandard and/or incomplete, the client should contact the responsible trade to undertake rectification. Unfinished and substandard building works are likely to degrade more quickly and may create potential for secondary defects to associated building elements.

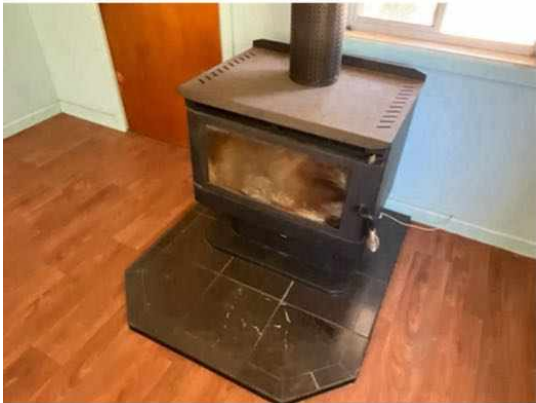
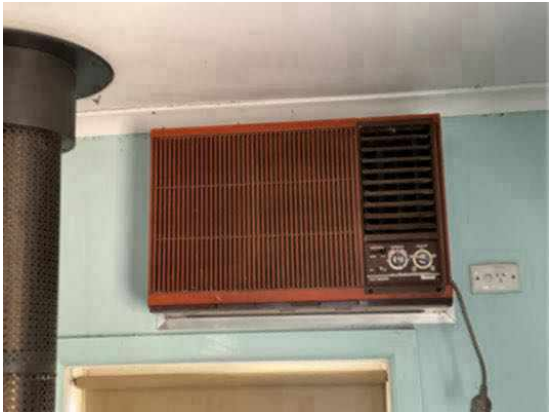
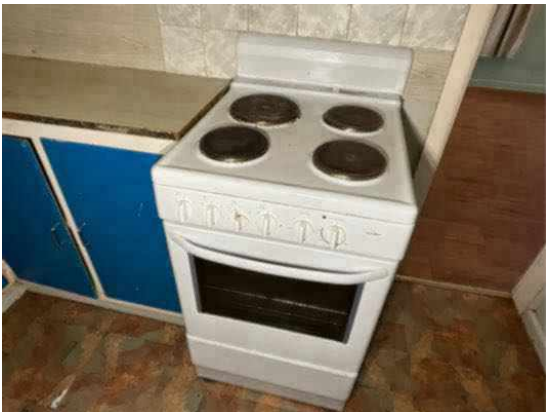
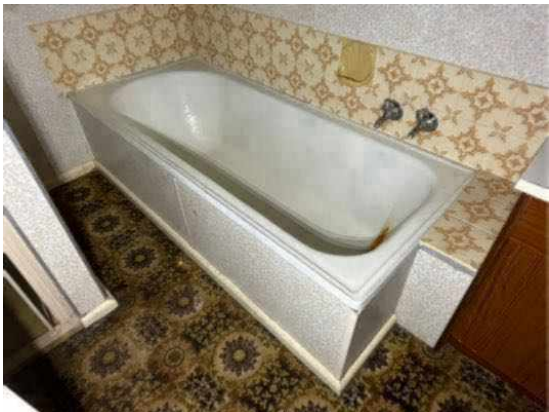
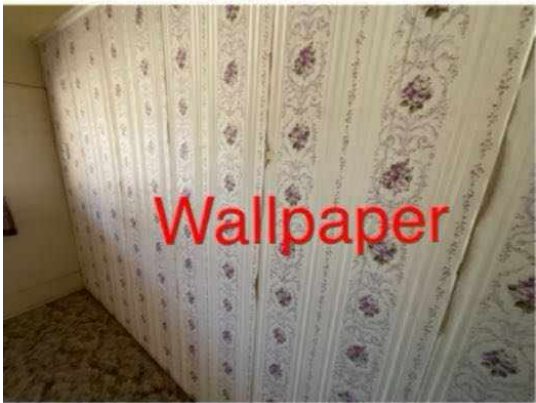
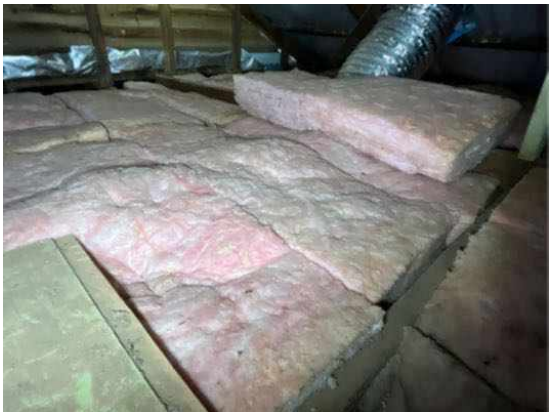
Noted Item

Building: Building 1
Location: All Areas
Finding: Additional Photos - Obstructions and Limitations
Information: These photographs are an indication of the obstructions and limitations which impeded full inspection of the property at the time of inspection. These obstructions can hide an array of defects and should be removed to allow full inspection to be carried out. A re-inspection is recommended once the areas are made accessible.
