Building and Timber Pest Inspection Report

Inspection Date: Thu, 19 Mar 2026

Property Address: 41 Brennon Rd, Gorokan NSW 2263,
Australia

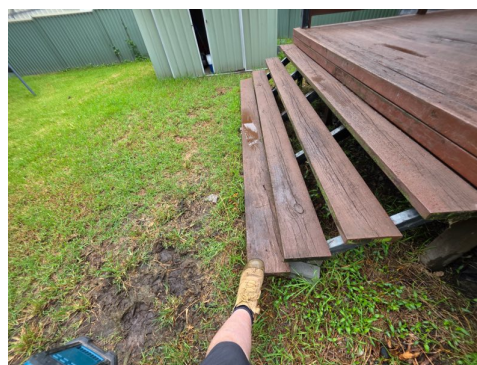
Finding: Loose and non-compliant step – Rear deck stairs

Information: The bottom step to the rear deck stairs is loose and has an inconsistent rise and run compared to the other steps.

This presents a trip hazard and may worsen with continued use.
A qualified carpenter should be engaged to assess and rectify as required.
This should be done without delay.

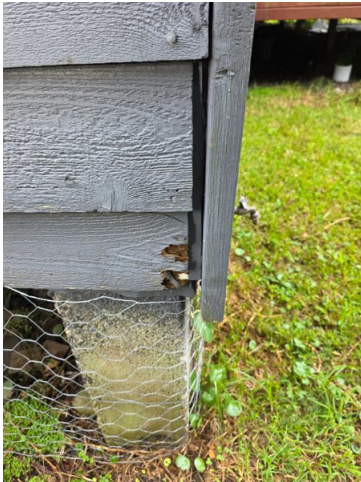
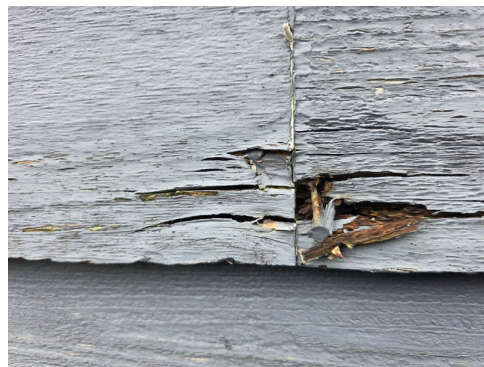
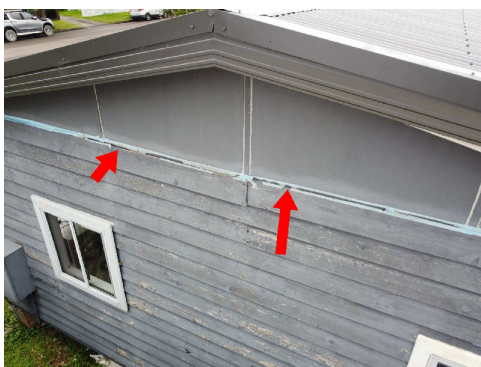
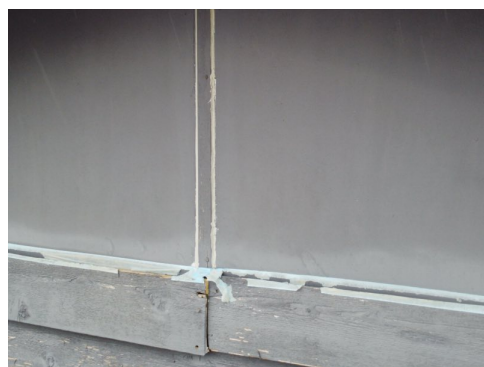
Finding 2.01

Finding: Deteriorated weatherboards and joints / Inadequate wall junction detail / Deteriorated wall plate ends – External walls and roof perimeter

Timber weatherboards show signs of fungal decay, with movement, warping, and separation at joints. Sealant to junctions is no longer effective, and underlying wall linings appear to include suspected asbestos sheeting. A junction detail was observed where weatherboards extend beyond adjacent gable end sheeting, with deteriorated tape and no effective sealing. This creates an opening for water entry behind the cladding. Timber elements, likely wall plate ends, extend beyond the wall line and show signs of past fungal decay. These have been partially filled but remain exposed, with some internal framing visible.

This condition may allow moisture ingress and may lead to ongoing deterioration of external wall components and concealed materials. A qualified carpenter should be engaged to carry out further investigation and rectify as required. This should be done as soon as practicable.

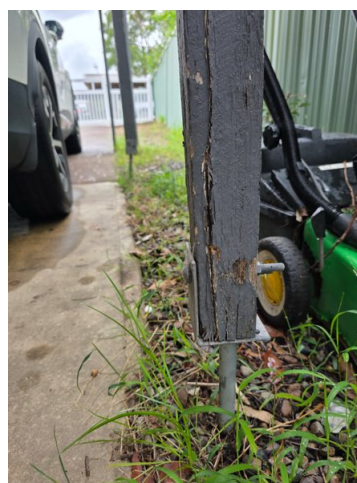
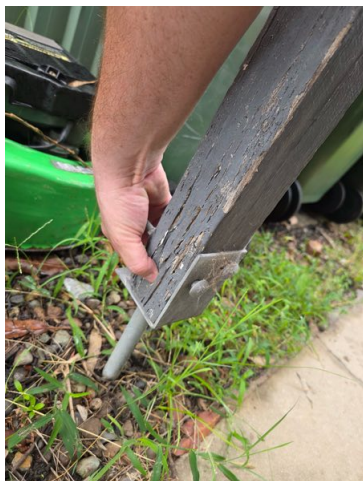
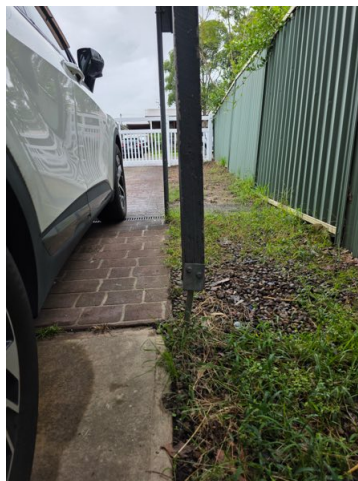
Finding 2.02

Finding: Decayed and unstable posts – Carport

Information: Carport posts show fungal decay at their bases. One post is loose within its metal shoe with unsecured fixings, and another is installed in a leaning stirrup. The timber at the base of at least one post is soft.

This affects the stability of the structure and may lead to further movement or failure if deterioration continues.

A qualified carpenter should be engaged to carry out further investigation and rectify as required. This should be done as soon as practicable.

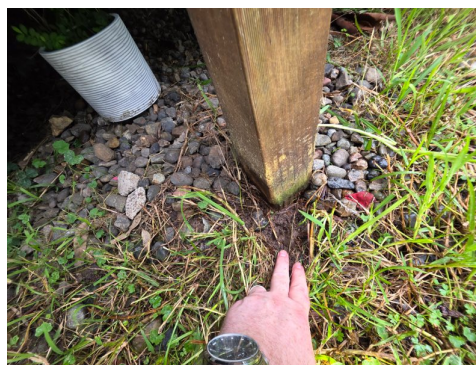
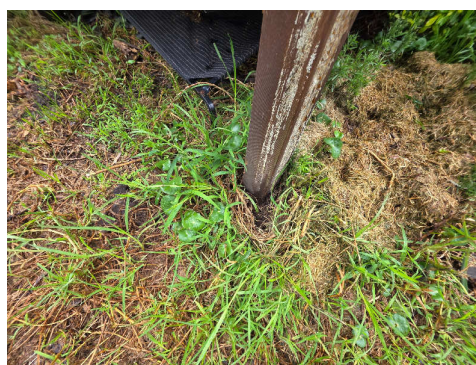
Finding 3.01

Finding: Timber posts in contact with ground and early decay – Rear deck

Information: Timber posts supporting the rear deck are installed in direct contact with the ground. Minor fungal decay was observed at the base of these posts, indicating early-stage deterioration. The full extent of any internal decay could not be determined at the time of inspection. These timber posts are not designed for in ground contact.

This condition may lead to progressive deterioration of the timber and could affect the long-term performance of the supporting elements if not addressed. A licensed builder should be engaged to carry out further investigation and rectify as required. This should be done as soon as practicable.

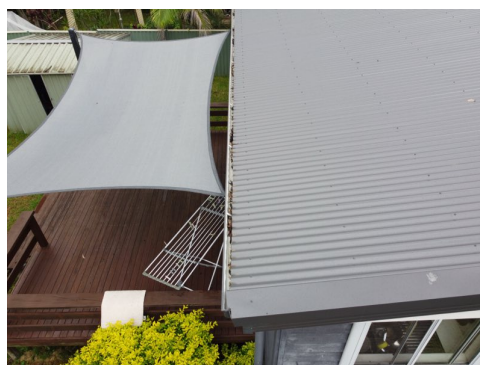
Finding 3.02

Finding: Leaking gutter, debris build-up, and inadequate fall – Carport and rear gutters

Information: The carport gutter is leaking, with water discharging onto an adjacent post and contributing to saturated ground conditions below. Debris was observed in sections of the guttering, and the carport gutter contains standing water, indicating inadequate fall toward the downpipe. Additional leaf litter is present in the rear gutters. From what can be seen, these conditions are restricting proper drainage.

This may accelerate deterioration of adjacent structural elements and contribute to ongoing moisture exposure. A licensed plumber should be engaged to clean, assess, and rectify the guttering, including correcting the fall as required. This should be done as soon as practicable.

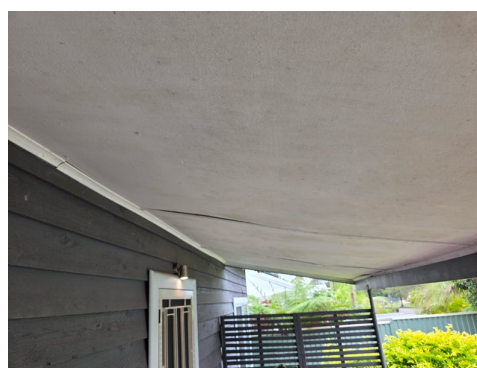
Finding 3.03

This indicates deterioration or loss of fixing support and may worsen over time.

A qualified carpenter should be engaged to assess and rectify as required. This should be done as soon as practicable.

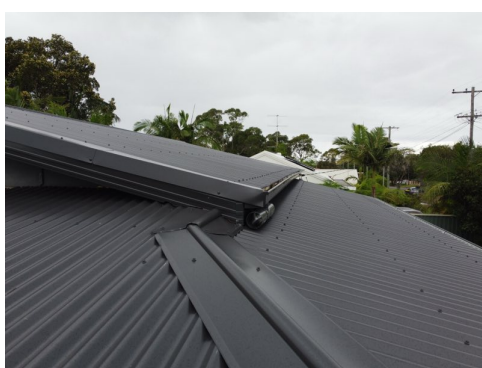
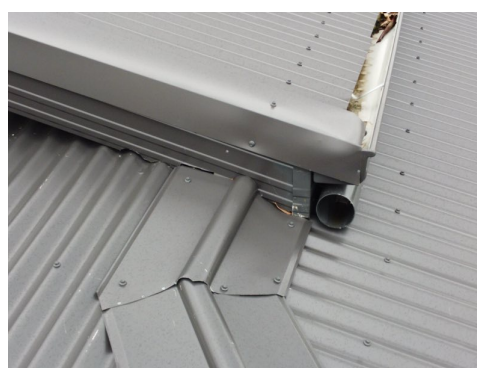
Finding 3.04

Finding: Suspected Improper flashing detail

Information: The flashing detail at the junction between the barge capping, fascia and hip flashing appears to be incorrectly formed, with a section of flashing mechanically fixed (riveted) from the barge capping directly into the end of the gutter. This arrangement does not present as a standard or well-executed termination detail and may affect how water is directed and discharged at this point. From what can be seen, the installation appears improvised and may not provide a consistent, watertight transition.

A licensed roofer should be engaged to assess the flashing detail and rectify if required to ensure a proper and effective water-shedding arrangement. This should be addressed as soon as practical.

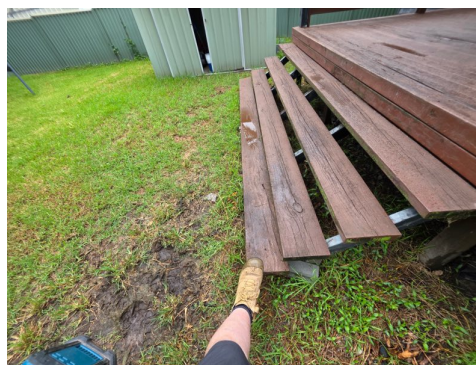
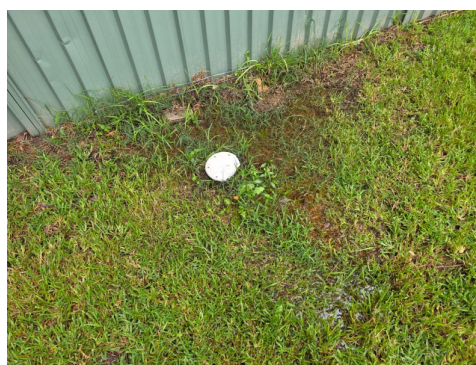
Finding 3.05

Information: The site exhibits poor drainage, with soggy ground conditions and areas of water accumulation observed around the property. Very wet conditions were also noted to the subfloor area. The extent to which this condition may impact the structure could not be determined at the time of inspection.

This indicates inadequate surface water management, which may contribute to moisture-related deterioration of building elements over time if conditions persist.

A licensed plumber should be engaged to carry out further investigation and rectify as required. This should be done as soon as practicable.

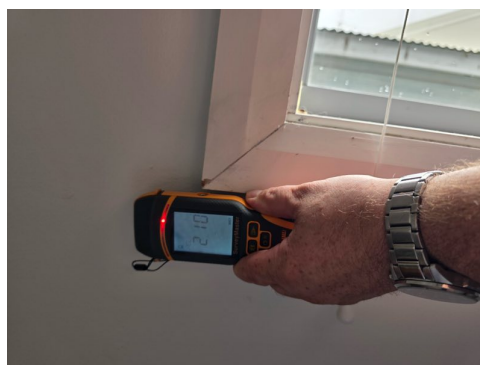
Finding 3.06

Finding: Moisture damage and swelling – Bedroom window area

Information: Elevated moisture readings were detected to a bedroom windowsill, with associated swelling to the adjacent architraves. This is consistent with moisture ingress, possibly from window sealing, although the exact source could not be confirmed.

This may lead to further deterioration of internal finishes and concealed framing if not addressed.

A qualified carpenter should be engaged to carry out further investigation and rectify as required. This should be done as soon as practicable.

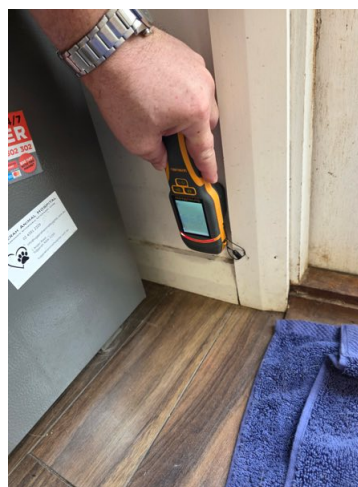
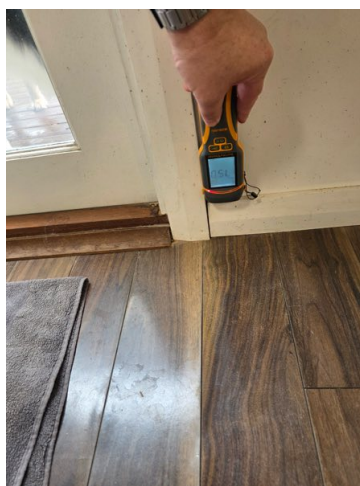
Finding 3.07

Finding: Elevated moisture readings – Rear doorway (both sides)

Information: Elevated moisture readings were recorded to wall areas on both sides of the rear doorway. No visible signs of active leakage were observed at the time of inspection, and the source of the moisture could not be confirmed.

This indicates a potential moisture issue in a high-risk area that may develop into visible damage if conditions persist. Monitoring is recommended, and further investigation should be undertaken if mould, discolouration, or paint deterioration becomes evident.

A licensed builder should be engaged to carry out further investigation and rectify as required. This should be done as soon as practicable.

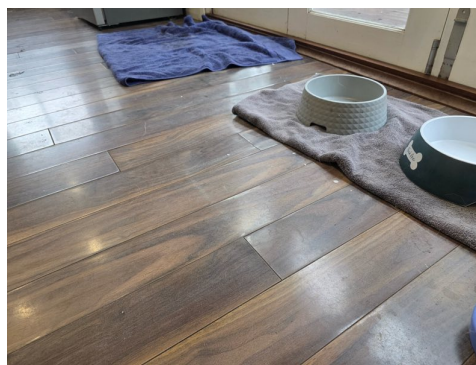
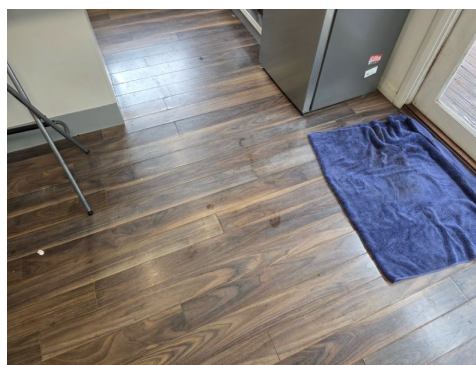
Finding 3.08

Information: Flooring adjacent to the rear doors shows minor swelling, cupping, and localised discolouration, consistent with moisture exposure. The extent of any underlying damage could not be determined.

This indicates moisture has affected the flooring in this area and may continue to cause deterioration if the source is ongoing.

A licensed carenter should be engaged to carry out further investigation and rectify as required. This should be done as soon as practicable.

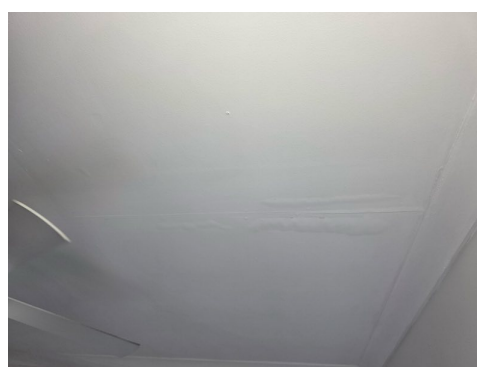
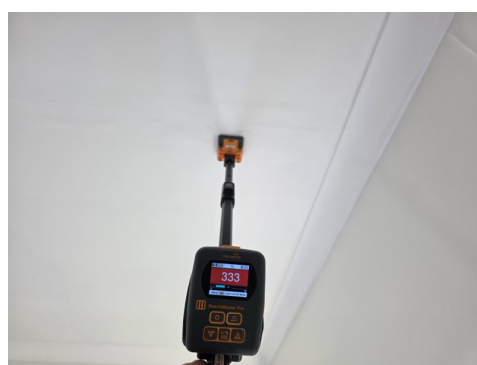
Finding 3.09

Finding: Ceiling lining deterioration – Bedroom 3

The ceiling lining in Bedroom 3 shows localised delamination of the plasterboard paper surface. Moisture readings in this area were inconclusive, with elevated readings noted more broadly across the ceiling, suggesting possible non-moisture influences; however, moisture ingress cannot be ruled out.

This condition may worsen if moisture is present, leading to further deterioration of the ceiling lining. Monitoring is recommended, and further investigation should be undertaken if additional deterioration, discolouration, or mould growth occurs.

A licensed builder should be engaged to carry out further investigation and rectify as required. This should be done as soon as practicable.

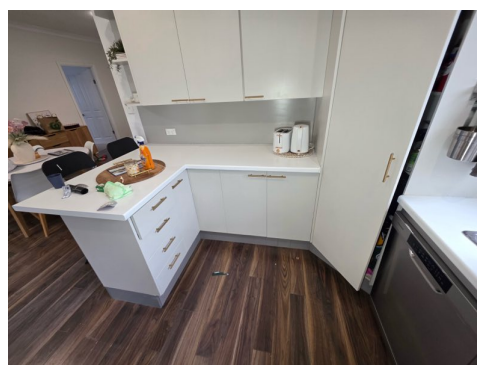
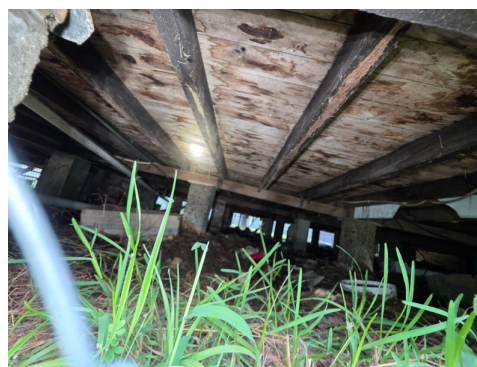
Finding 3.10

Building: Main Building
 Location: Kitchen
 Finding: Uneven and bouncy flooring – Kitchen

The kitchen floor was noted to feel bouncy underfoot and slopes across the room. This is consistent with movement or unevenness in the supporting structure, although the exact cause and extent could not be confirmed during a visual inspection.

This may indicate subfloor movement or deterioration that could worsen over time and affect floor performance.

A licensed builder should be engaged to carry out further investigation and rectify as required. This should be done as soon as practicable.

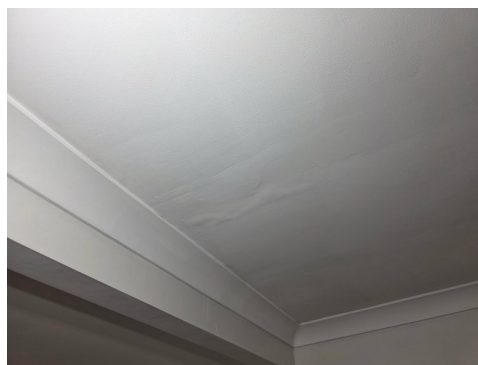
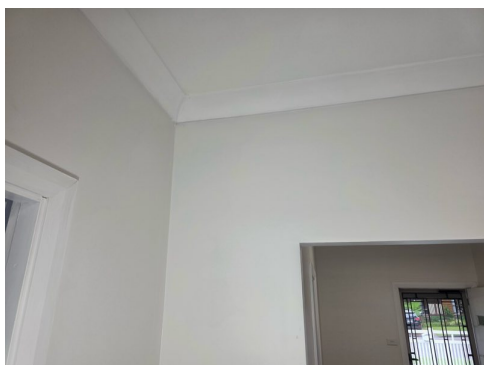
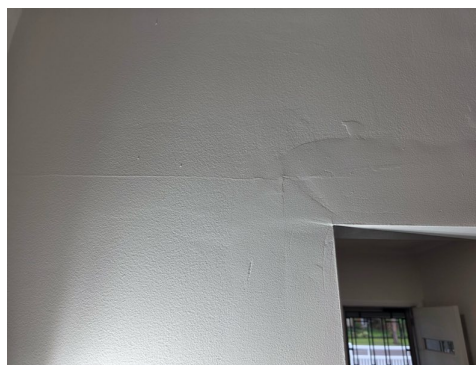
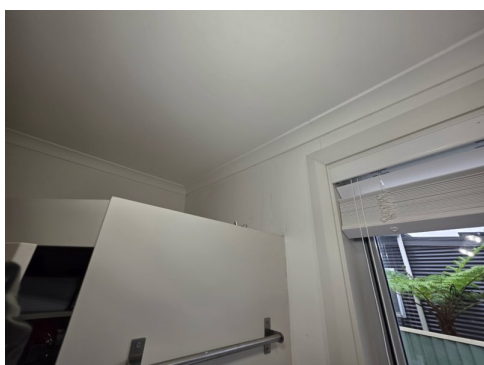
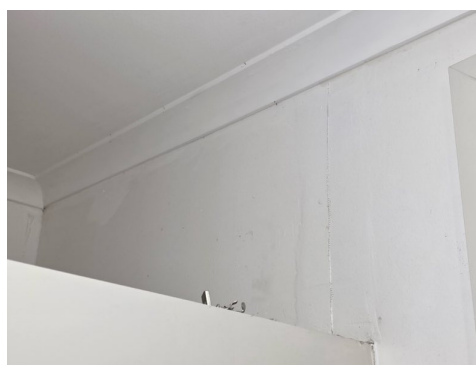
Finding 3.11

Patch repairs were observed to walls and ceilings throughout the property that have not been adequately sanded or finished, with filler visibly proud of surrounding surfaces. This results in an uneven appearance and indicates incomplete finishing works, which may affect overall presentation and durability of painted surfaces.

This condition is cosmetic in nature and may require further finishing to achieve an acceptable standard. Photos are indicative of the defect throughout.

A qualified tradesperson should be engaged to assess and rectify as required. This should be done at the owner's discretion.

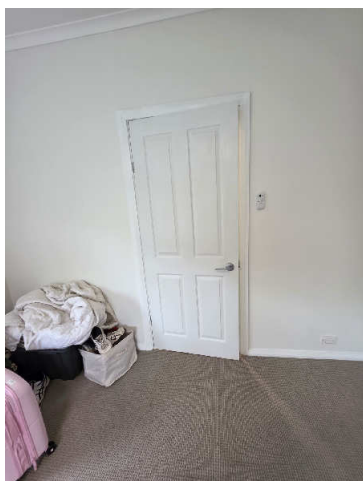
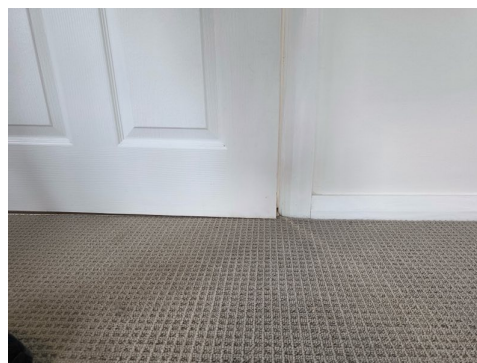
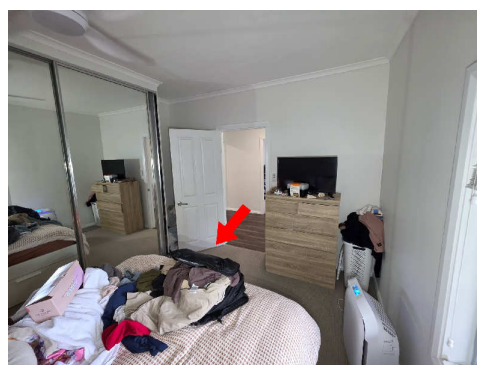
Finding 3.12

Information: The doors to all bedrooms were noted to rub slightly on the recently installed carpet. This appears to be due to reduced clearance following new floor coverings. the owner advised

This may cause ongoing wear to both the carpet and door edges if not addressed.

A qualified carpenter should be engaged to assess and rectify as required. This should be done at the owner's discretion.

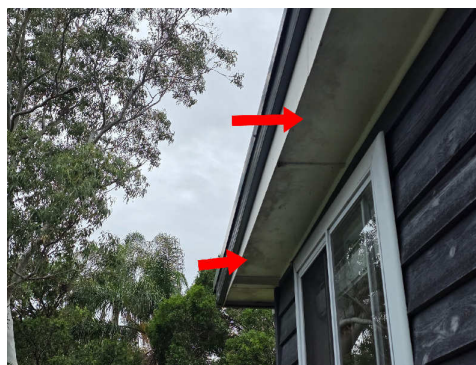
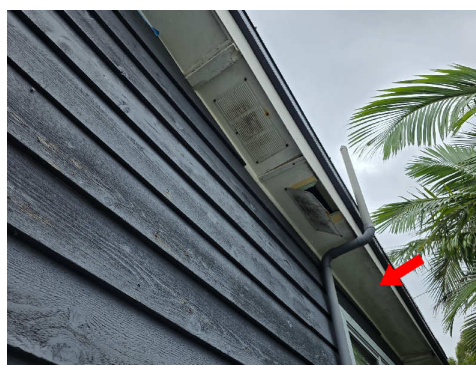
Finding 3.13

Information: Mould growth was observed to the rear face of the gable end wall sheeting and to the underside of the eave linings along both sides of the house. The extent of mould and any associated moisture source could not be determined at the time of inspection.

This indicates prolonged moisture presence in these areas, which may contribute to material deterioration and potential health concerns if widespread.

A licensed builder should be engaged to carry out further investigation and rectify as required. This should be done as soon as practicable.

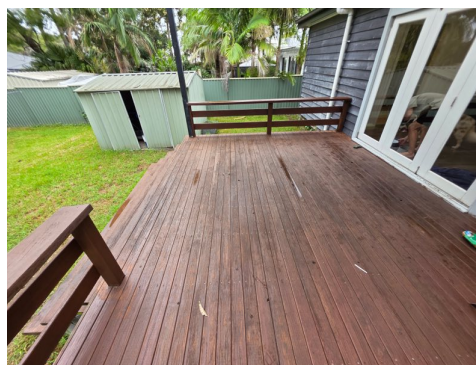
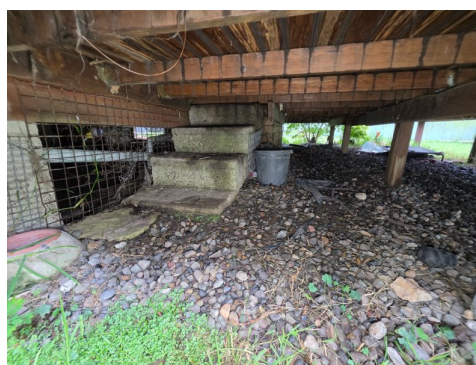
Finding 3.14

Information: An elevated external deck was observed at the rear of the property. Even if the structure appears sound or recently built, it may still pose a safety risk if inadequately supported. A detailed structural assessment is required to confirm its stability and load-bearing capacity.

A structural engineer should be engaged to carry out this assessment without delay. Until this has been completed and any necessary rectification works undertaken, users should take care not to overload the structure.

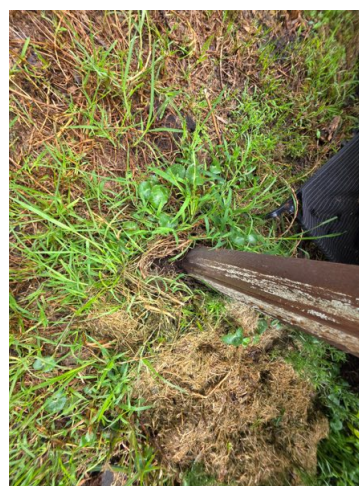
Timber elements in direct contact with the ground, and consequently exposed to moisture or dampness, create conditions conducive to termite activity. Whether timber is used as part of a building structure, such as a fence or retaining wall, or stored as unused material, it can attract termite infestations.

When exposed to excessive moisture, timber begins to decay and develop wood rot. Any timber in direct contact with the ground - especially untreated or non-durable timber - provides an easy entry point for subterranean termites into the material.

To minimize the risk of termite attack, it is recommended to remove any materials that could foster termite activity. If removal is impractical or undesirable, it is strongly advised that termite or timber pest inspections be conducted every 6 to 12 months to protect the property from potential infestation.

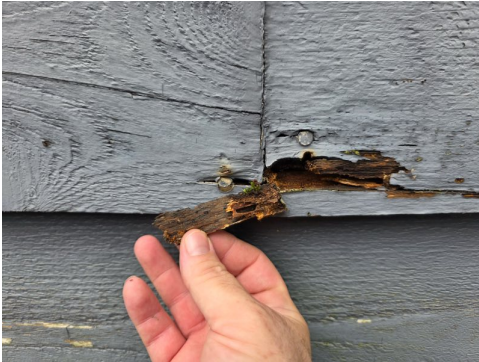
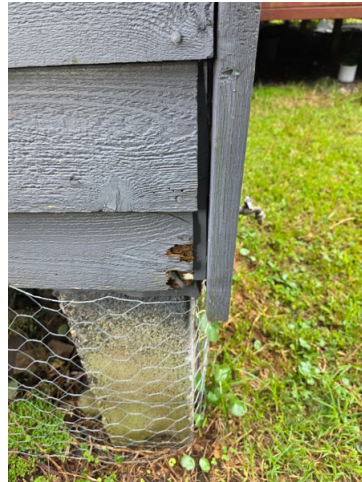
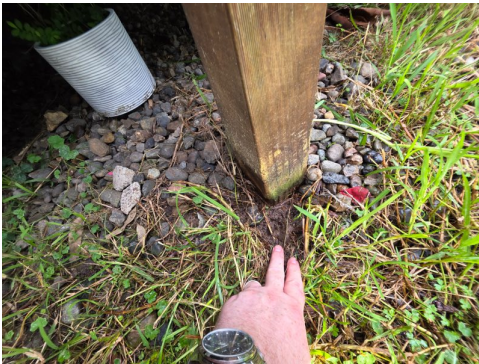
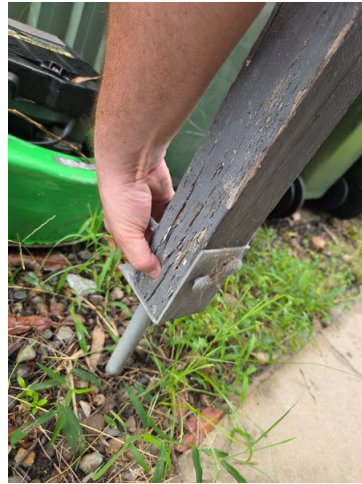
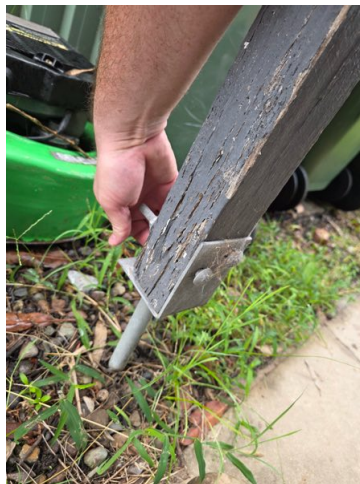
Finding 7.01

Finding: Fungal decay - weatherboards and deck

Information: Fungal decay was observed to sections of the external timber weatherboards and to the base of a timber posts supporting the verandah/deck at the rear of the property and the carport along the side of the property. This condition indicates prolonged moisture exposure and may contribute to ongoing timber deterioration and conditions conducive to termite activity if not addressed.

A licensed builder should be engaged to carry out further investigation and rectify as required, and regular timber pest inspections should be carried out every 6–12 months to monitor for any further activity. This should be done as soon as practicable.

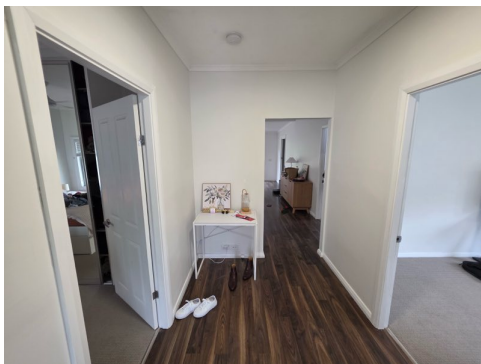
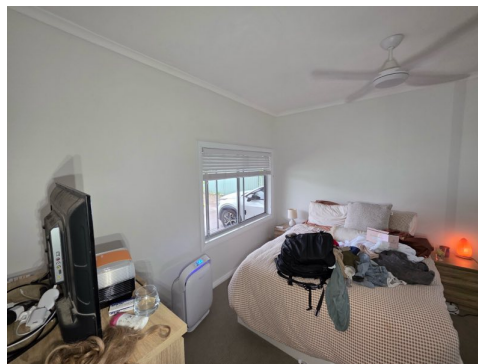
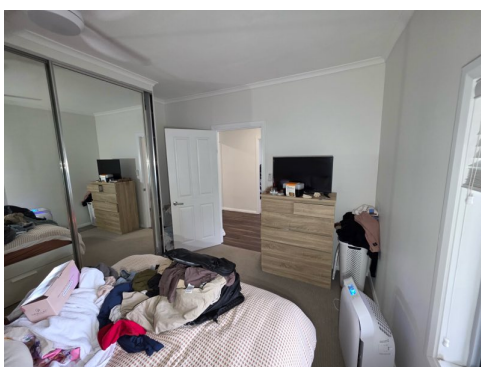
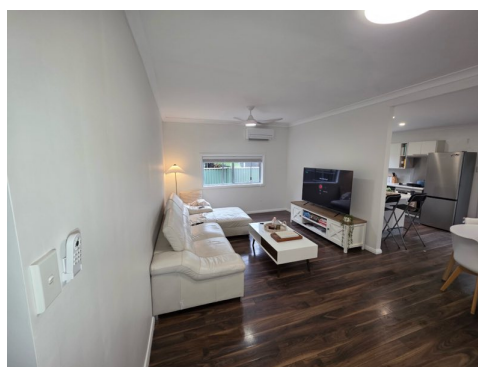
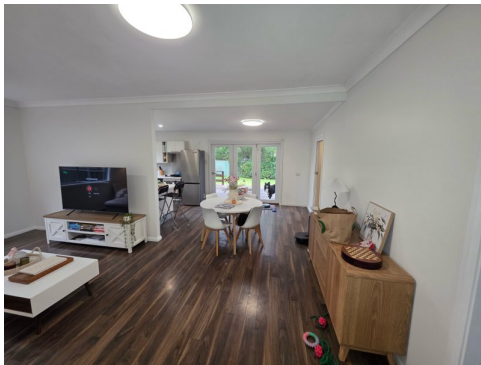
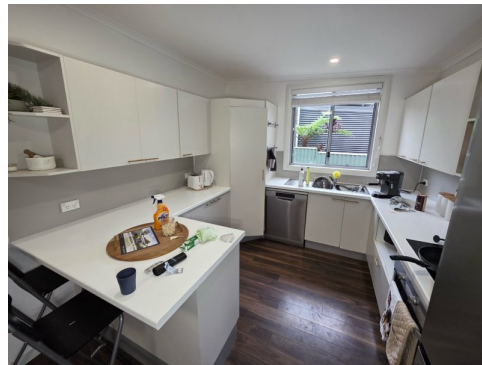
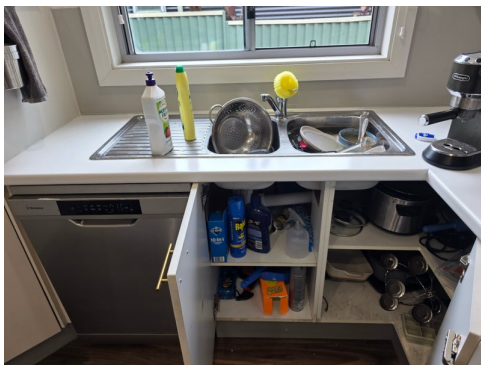
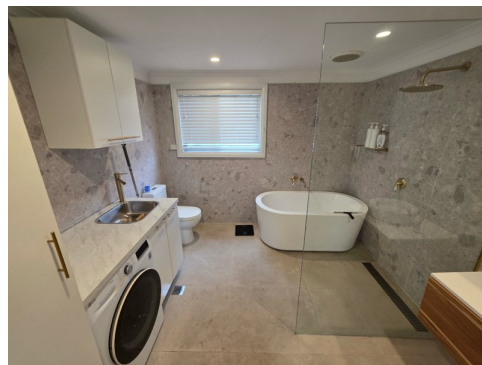
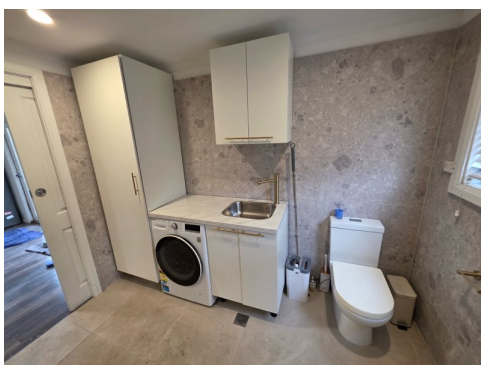
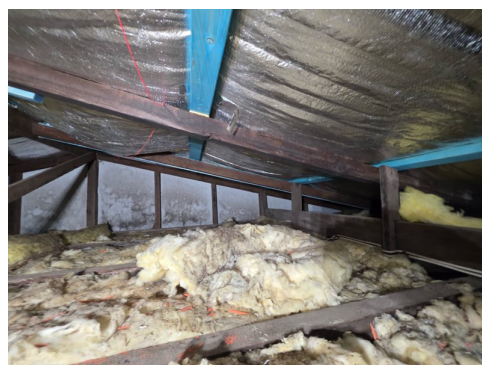
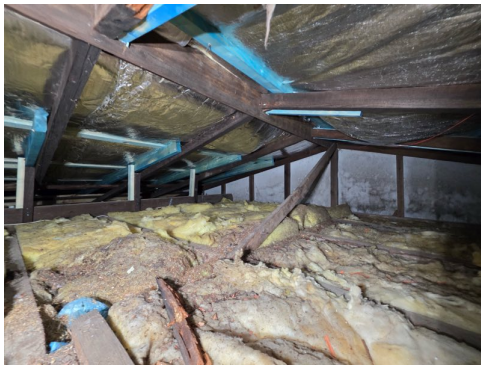
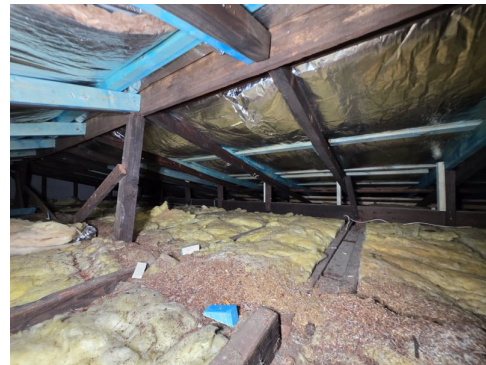
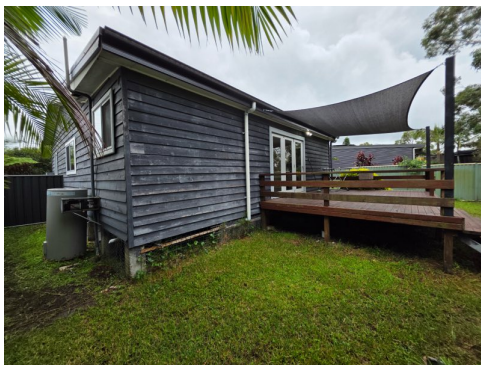
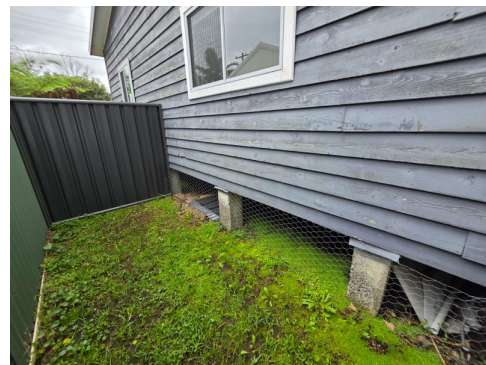
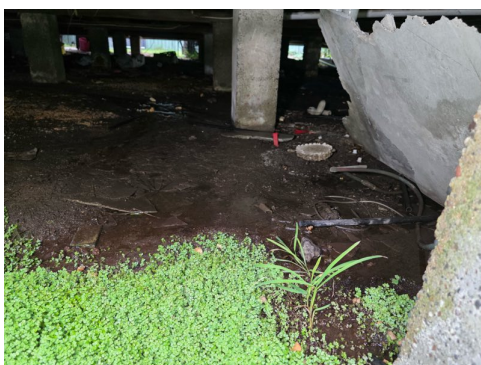
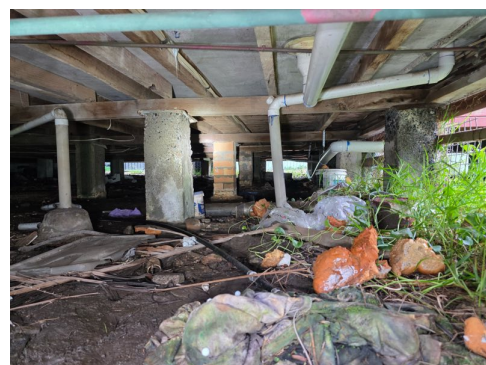
Finding: Additional Photos - Obstructions and Limitations

Information: These photographs are an indication of the obstructions and limitations which impeded full inspection of the property at the time of inspection. These obstructions can hide an array of defects and should be removed to allow full inspection to be carried out. A re-inspection is recommended once the areas are made accessible.

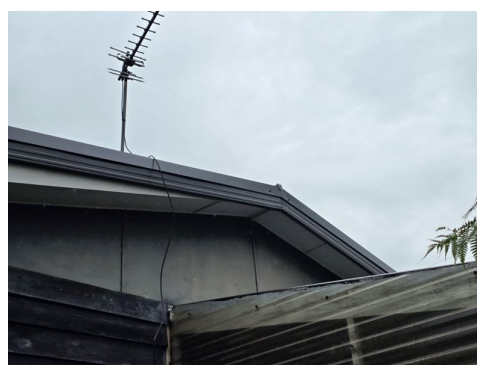
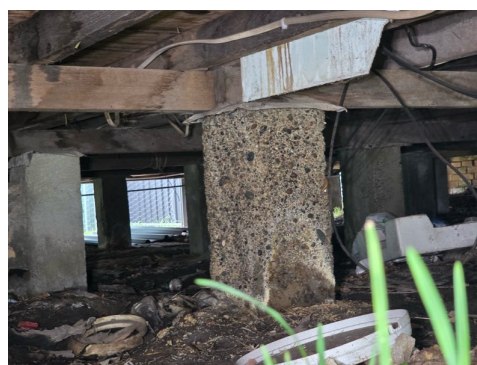
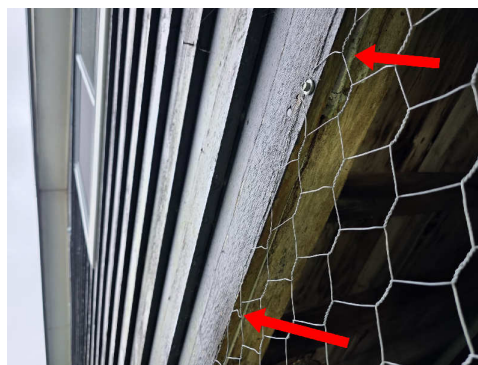
Information: Reporting on asbestos is outside the scope of this inspection. Suspected asbestos-containing material (ACM) was observed in the meter box, subfloor floor sheet debris, external wall linings behind weatherboards and the gable ends of the roof void. Based on our experience in the building industry, there is a higher risk that the identified building elements contain asbestos, particularly given that any home constructed prior to 1990 may contain asbestos in various forms.

No sample testing has been undertaken to confirm the presence of asbestos. We strongly recommend a separate Asbestos Inspection and Condition Audit be carried out by a licensed assessor, which may include laboratory testing for definitive confirmation.

In the meantime, the client is advised to act with caution, especially when considering any disturbance of the material through wear and tear, renovations, extensions, demolition, or maintenance activities.

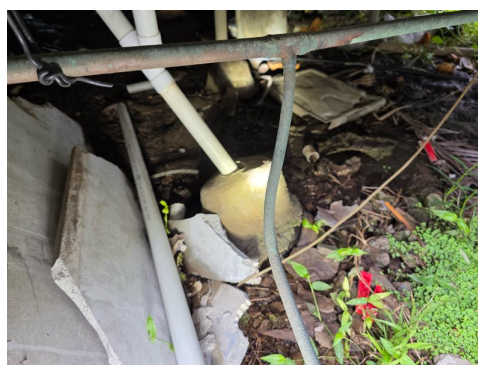
Information: Earthenware drainage pipes were identified on the property. These materials are rigid and commonly subject to cracking or displacement due to ground movement or root intrusion.

This may result in reduced performance or failure of the drainage system. It would be worth engaging a licensed plumber to carry out a further investigation to determine the condition of the in-ground pipework. This should be done as soon as practicable.

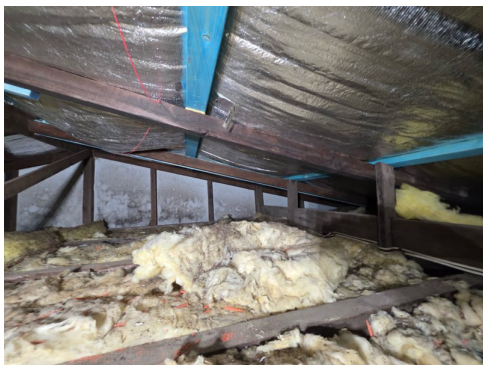
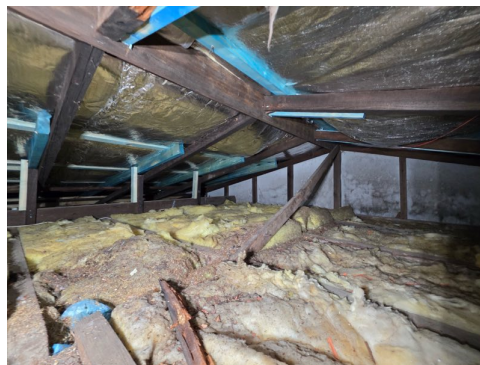
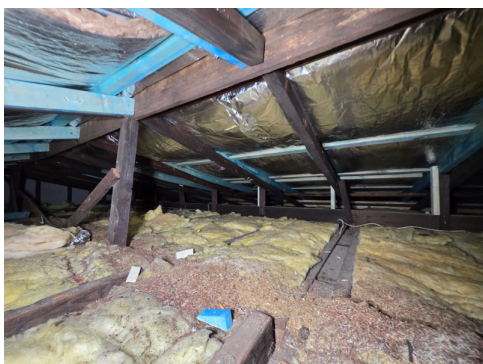
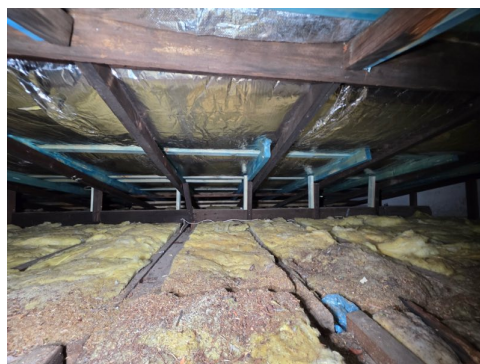
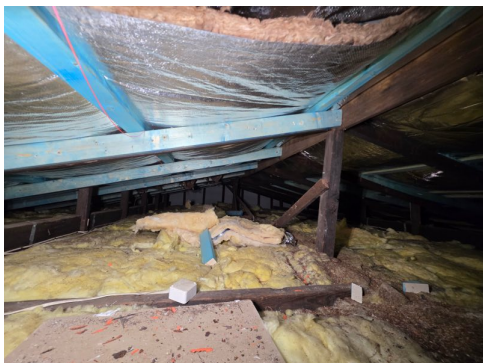
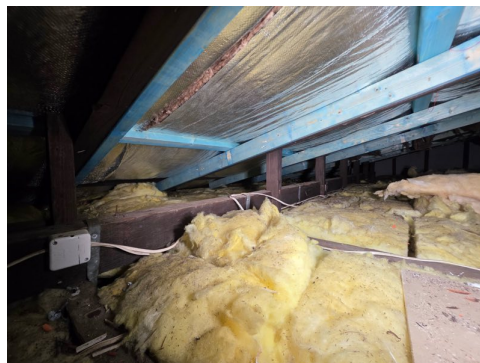
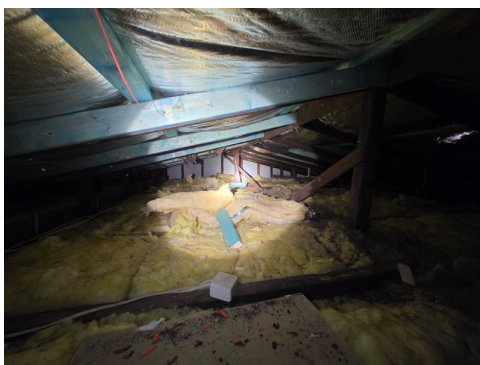
Finding: Access - Roof void

Information: The roof void was not entered due to size restrictions, access limitations, and/or safety concerns. Inspection was carried out from the internal access hatch only, with observations limited to what could be safely viewed and photographed from this position.

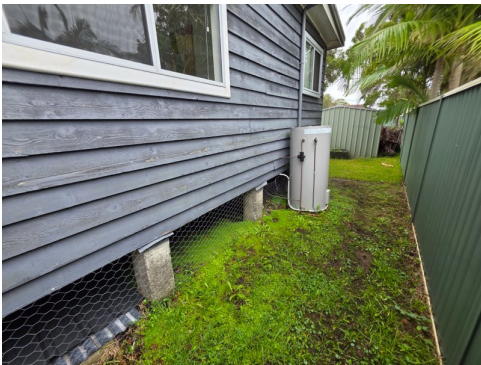
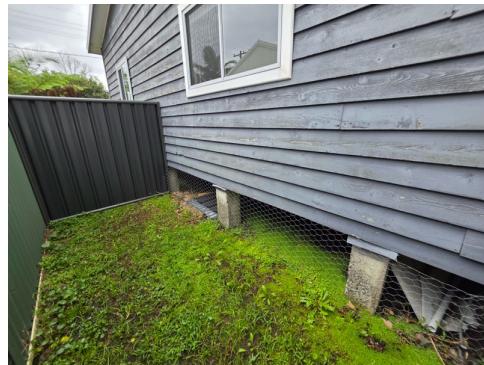
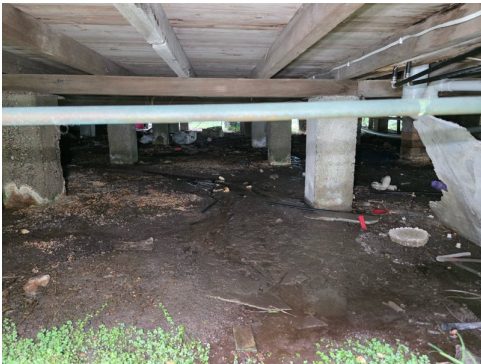
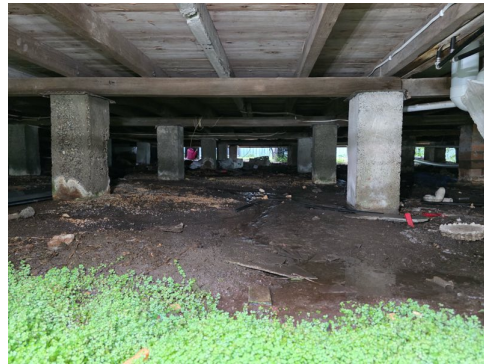
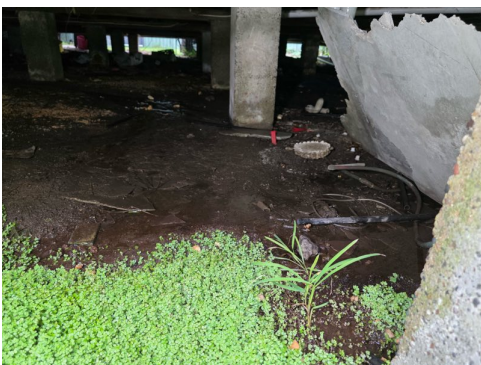
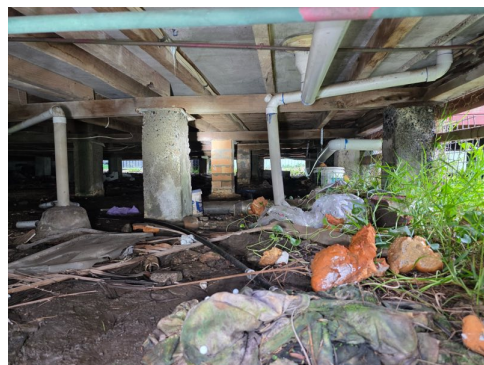
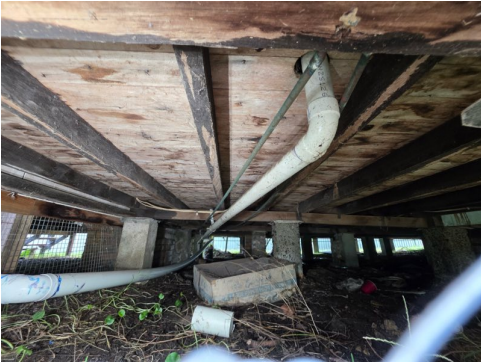
Finding: Access - Subfloor

Information: The subfloor area was not accessed due to unsafe conditions, and/or obstructions. Inspection of the subfloor was carried out from the perimeter of the property only.
