# Building and Timber Pest Inspection Report

Inspection Date: Tue, 27 Jan 2026

Property Address: 1/17 Banool Cct, Bomaderry NSW 2541,  
Australia

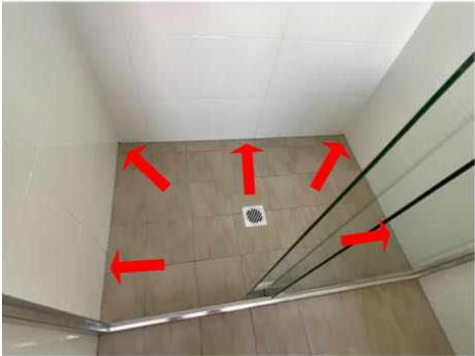
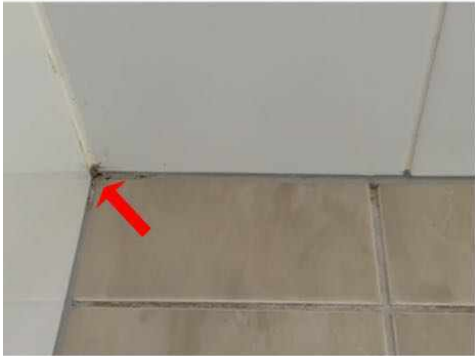
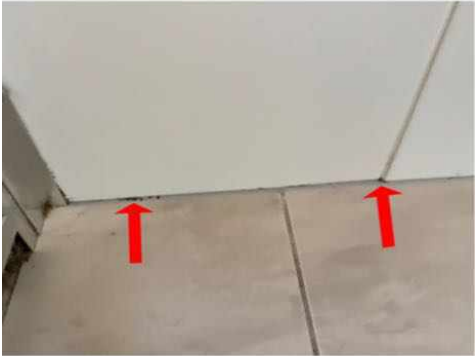
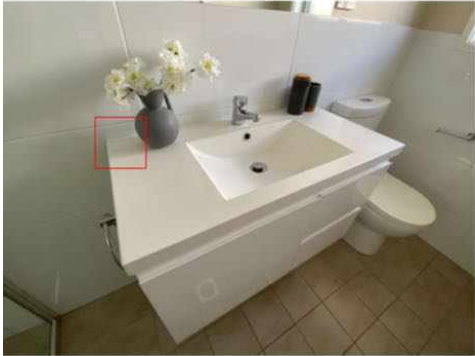
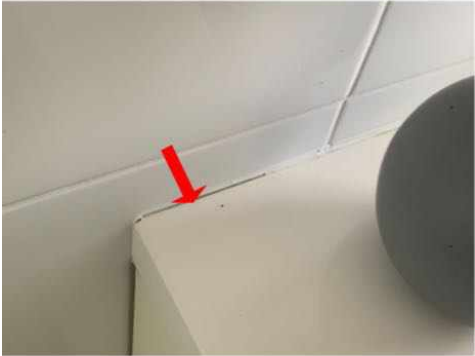
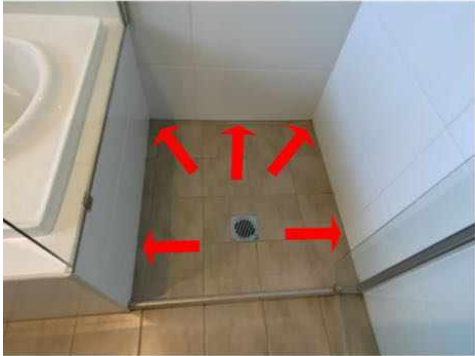
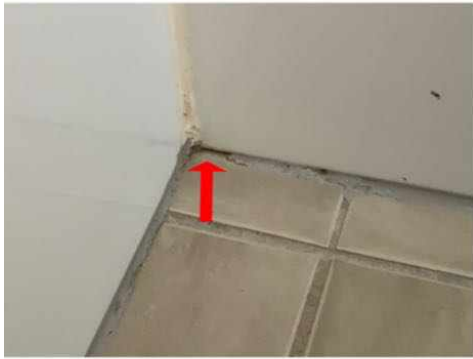
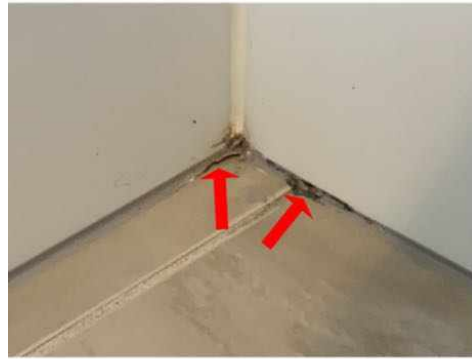
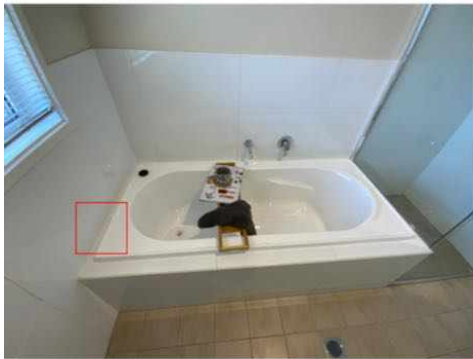
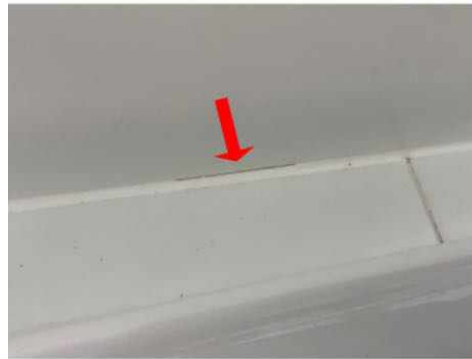
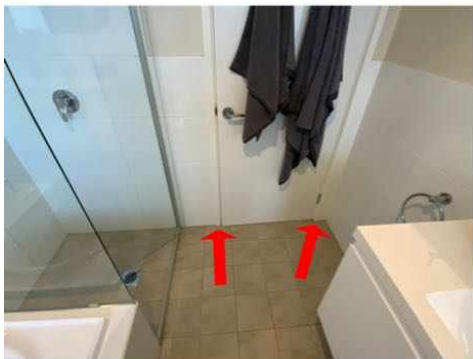
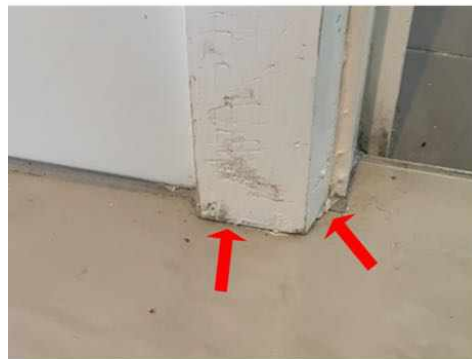
Building:	Main Building
Location:	All Wet Areas
Finding:	Sealant or Grout - Deteriorated, Missing or substandard installation
Information:	Sealant appears to be inadequate to these tiled areas. The different materials and floor areas move at different rates therefore cracking the grout at this point. A flexible sealant is required to allow for this expansion & contraction while keeping the joint water tight and without holes for long term care of all building materials.

Apply a flexible sealant to match the grout that is best suited to the purpose as per product specifications. Regular maintenance &/or replacement of damage or missing sealant is highly recommended to the kitchen benches/splashbacks, vanity top to wall/splashback, laundry tub edge/splashback, wet areas floor edges and the shower floor & wall corners for the long term care of your property.

As a main priority remove damaged grout where applicable and thoroughly clean the area from old sealant, grout and soap scum. (Mouldy sealant is usually caused by dirt & scum sitting behind the sealant from the sealant not sticking adequately to the dirty surfaces).

spray area with spray & wipe (or similar to avoid sealant smearing up the wall) then finally run your finger over the sealant to give a smooth final finish.

Regular maintenance &/or replacement of damage or missing sealant is highly recommended for the long term care of your property.

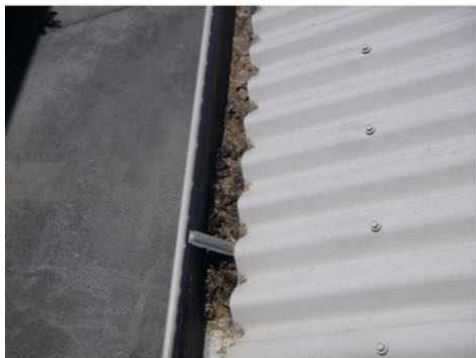
### Finding 3.02

Blocked gutters are likely to lead to high levels of moisture in the affected areas. Such moisture will not only cause rust and decay of the associated building materials, but can also provide conditions that are conducive to termite and timber pest activity. Blockages in gutters should therefore be removed immediately to ensure dry conditions are maintained.

Consult a Licensed Plumber for further specific advice on remedial works that may be required. In the interim, it is highly advised that blocked gutters be removed by the homeowner or a general handyperson as a matter of urgency.

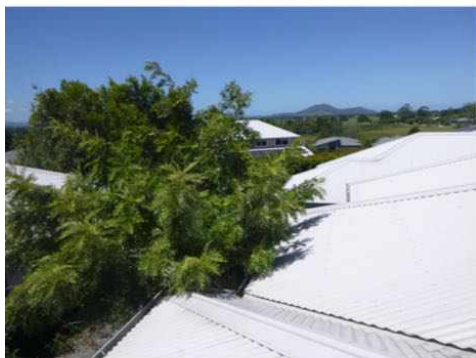
### Finding 3.03

Building:	Main Building
Location:	Roof Exterior
Finding:	Trees - Overhanging and filling gutters
Information:	Overhanging trees often result in excessive amounts of leaf debris accumulating in gutters.

Gutters are a critical part of the building's management of storm water and rain. It is therefore important that they be kept clear to prevent secondary damage to associated building elements, including exterior and interior walls, ceiling linings and any adjoining building elements. Where gutters are blocked, pooling of rainwater is likely to occur, fast-tracking rust and corrosion of the roof plumbing elements.

It is highly advised that all overhanging tree branches be removed as soon as possible to prevent any further damage. Repair and/or replacement of sections of damaged guttering may also be required where the extent of the damage necessitates.

Such works should be performed by the homeowner; however, appointment of a landscape contractor or an arborist may be required. Consultation with a licensed roof plumber is required where guttering has been damaged.

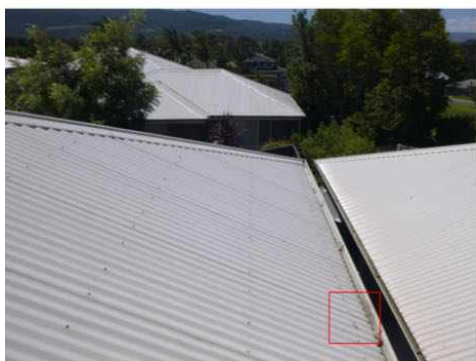
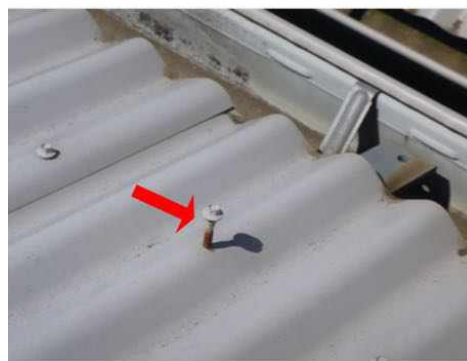
### Finding 3.04

Building:	Main Building
Location:	Roof Exterior
Finding:	Installation - substandard or incomplete (Loose roofing screw)
Information:	The installation of this building element appears to have been completed to a substandard level of workmanship or is incomplete. Generally substandard repairs or installation are related to poor workmanship, the use of inappropriate materials, or a failure to complete installation to a suitable standard.

Where installation is substandard and/or incomplete, the client should contact the responsible trade to undertake rectification. Unfinished and substandard building works are likely to degrade more quickly and may create potential for secondary defects to associated building elements.

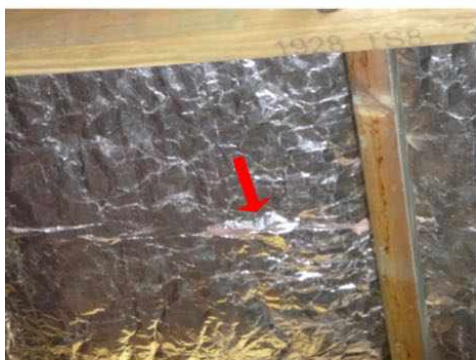
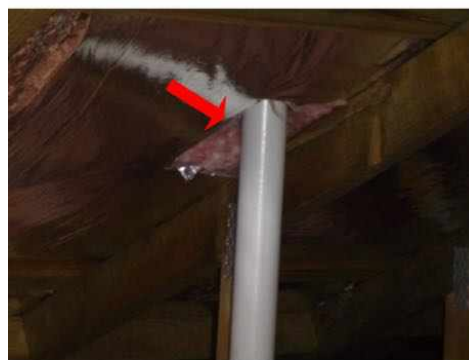
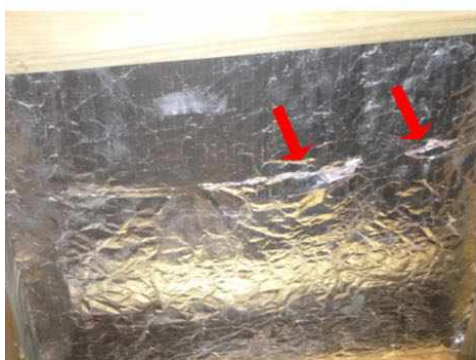
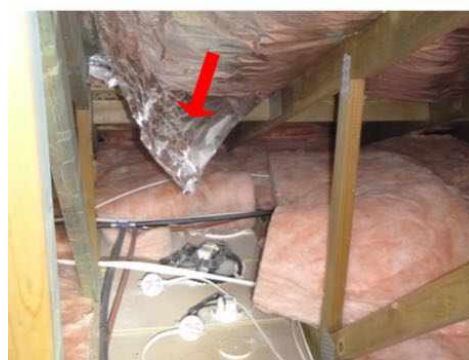
### Finding 3.05

Building:	Main Building
Location:	Roof Void
Finding:	Sarking - Damaged or Loose
Information:	Sarking to under the roofing material is damaged, loose or has holes and gaps. Sarking acts as an insulator, helps with noise reduction & is a second barrier against water penetration from broken or slipped tile leaks & condensation.

A Builder, Carpenter or handyman will be able to repair the holes with pieces of sarking and AS4254 tape specific foil tape for this product.

Consult a builder or insulation specialist for further advice.

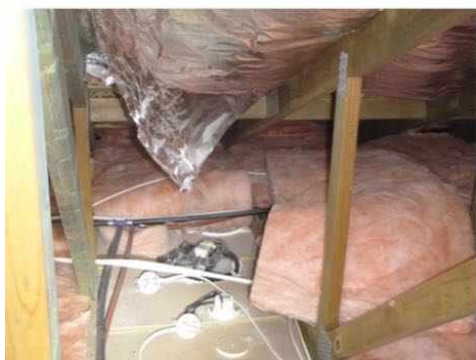
### Finding 3.06

Building:	Main Building
Location:	Roof Void
Finding:	Exhaust fans - Sarking on roof (Ducting, Roof Vent or Eave Vents are required)
Information:	On inspection of the roof void, it was observed that the exhaust fans to the bathroom and ensuite do not exhaust directly to the outside of the building, which is required by the NCC if sarking has been fitted, as it has in this home.

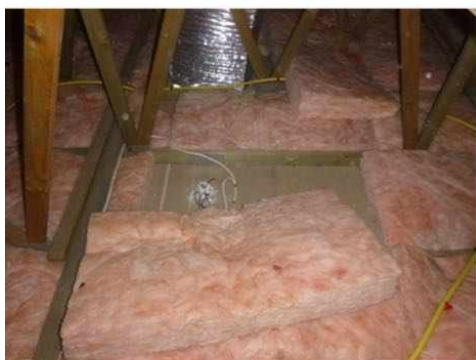
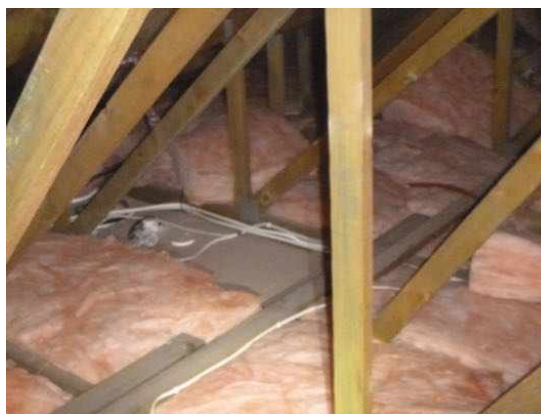
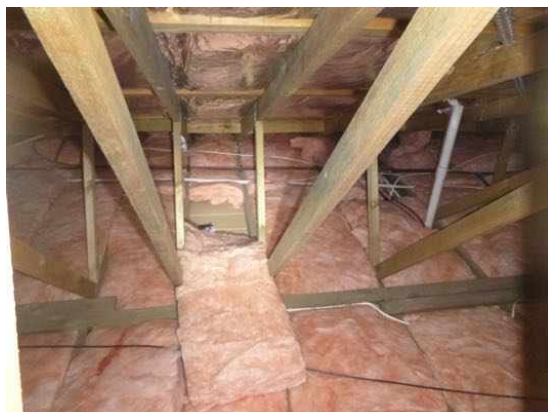
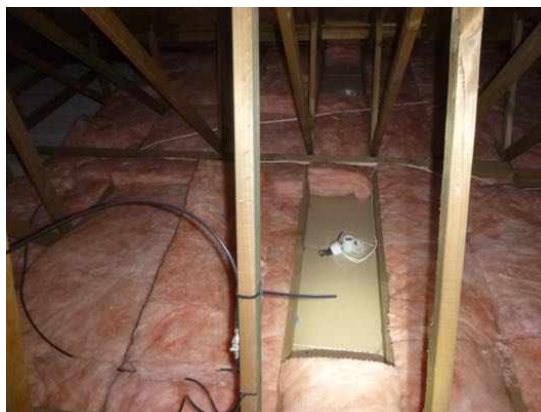
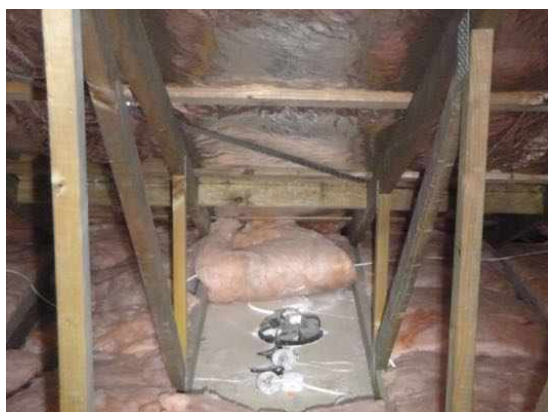
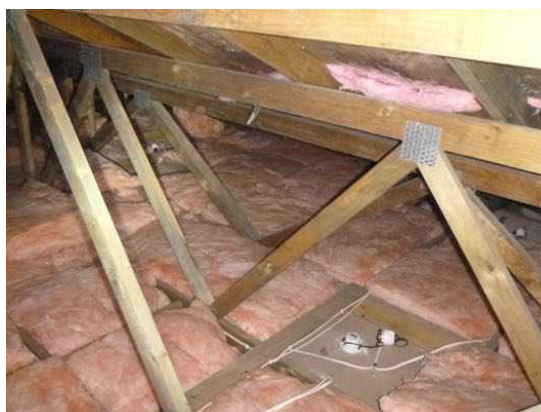
### Finding 3.07

Building:	Main Building
Location:	Roof Void
Finding:	Ceiling Insulation - Inadequately installed to some areas
Information:	Upon inspection of the roof void it was noted that the insulation has been pulled back from a few areas and not adequately put back in place.

The level of insulation in the property does not meet current Australian Standards. Installation of adequate insulation is required and should be conducted as soon as possible.

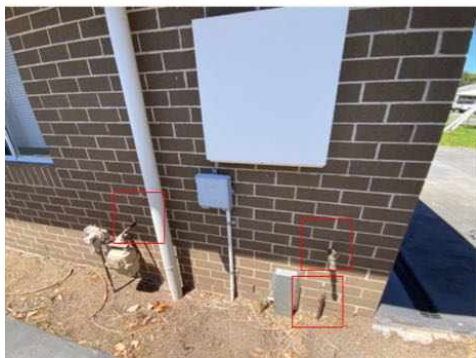
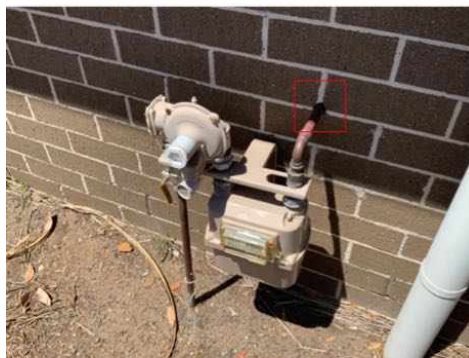
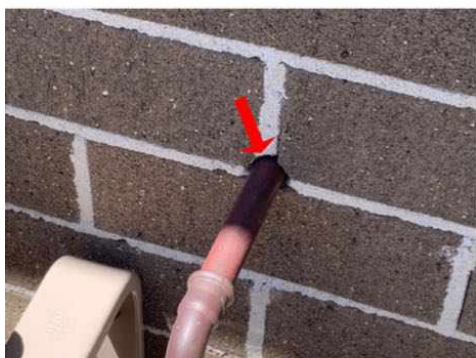
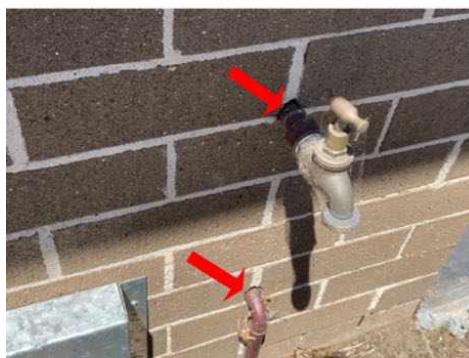
### Finding 3.08

Building: Main Building  
 Location: Exterior walls - left side  
 Finding: External walls - Holes  
 Information: Significant holes were identified around pipe penetrations in this wall section. It is suspected that the installation of this pipework was completed to a substandard level of workmanship or is incomplete.

Gaps and holes around pipework makes the area susceptible to insect and vermin ingress, as well as allowing water penetration to the cavity wall. As such, associated building elements are likely to deteriorate at an accelerated rate, and major implications are expected if holes around the pipework are left unmanaged.

All excessive holes, gaps or cracks should be adequately filled by a suitable sealant or trimmings as soon as possible to prevent any further damage. Such works may be conducted by a general handyperson or licensed plumber.

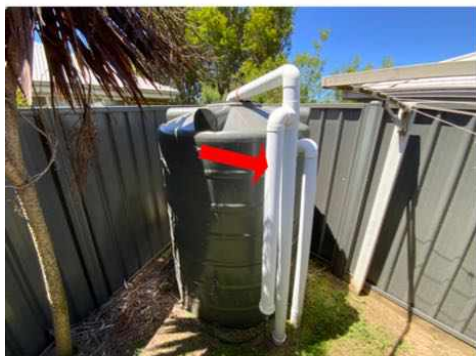
### Finding 3.09

Building:	Main Building
Location:	Yard - Back
Finding:	Paint finish - Incomplete to some areas (PVC pipes not painted - externally)
Information:	The paint finish in this area was identified as being incomplete at the time of inspection. The exposed PVC downpipes and fittings should be painted or covered. PVC piping is not UV rated on its own and will perish and become brittle over time if not adequately painted or protected from UV rays. PVC piping is not UV rated on its own and will perish and become brittle over time if not adequately painted or protected from UV rays.

A painting contractor should be appointed as soon as possible to perform necessary works to aid the appearance of the affected area and to ensure the area is protected against further deterioration. Alternatively, the homeowner following manufacturer instructions may perform these works.

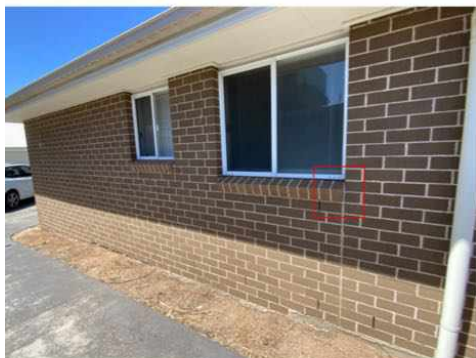
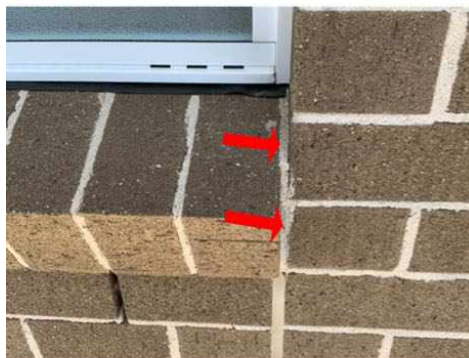
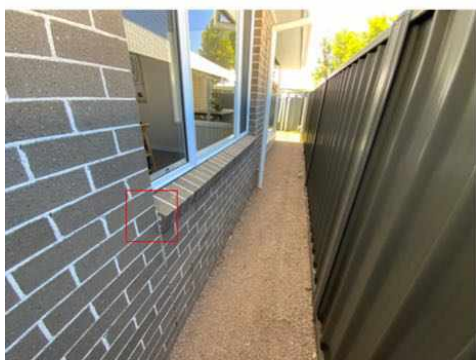
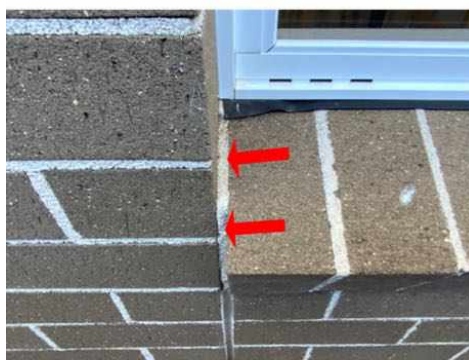
### Finding 3.10

Building:	Main Building
Location:	Exterior walls
Finding:	Articulation joints - Inadequate (not sealed)
Information:	The articulation or control joints throughout the exterior brickwork were deemed as insufficient at the time of inspection. The joints job is to allow the brick walls to expand and contract as required during different weather conditions.

Articulation joints must be cleaned of all non-compressive material and then sealed with an appropriate flexible sealant. Failure to perform these necessary works is likely to lead to excessive moisture ingress into these joints during extreme weather conditions, which may carry major implications for associated building elements if left unmanaged.

These preventative works are important in ensuring the structural integrity of the associated brickwork. Appointment of a qualified builder or builder or carpenter is advised to perform remedial works as necessary.

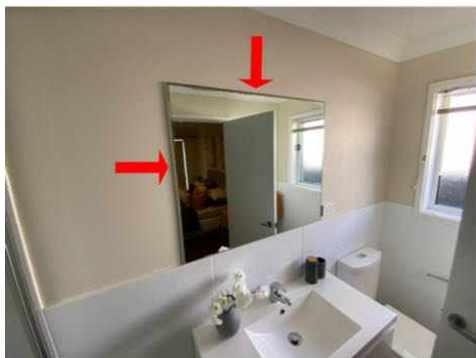
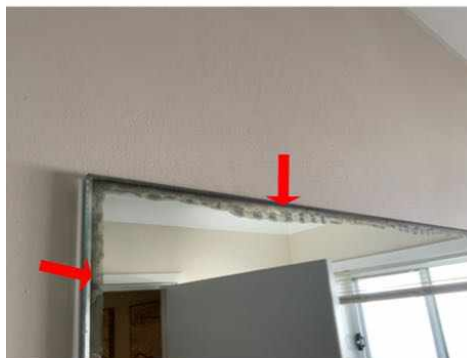
### Finding 3.11

Building:	Main Building
Location:	Ensuite - Master
Finding:	Mirror Desilvering
Information:	Mirror desilvering or mirror rot is caused by moisture penetrating between the layer of glass and the layer of backing metal. Once water vapour has penetrated, the metal that makes your mirror shiny begins to react and oxidize (rusts), turning black.

Typically, the layer between the glass and metal becomes separated when the edge of the mirror is regularly exposed to powerful chemicals, most commonly ammonia. Once the separation occurs, any moisture — even just steam from showering can begin to cause the black spots to appear.

In some cases rectification is possible but replacement is generally the best option.

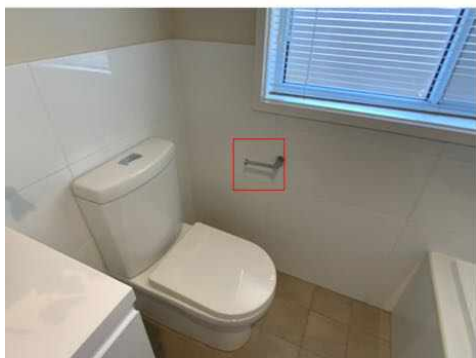
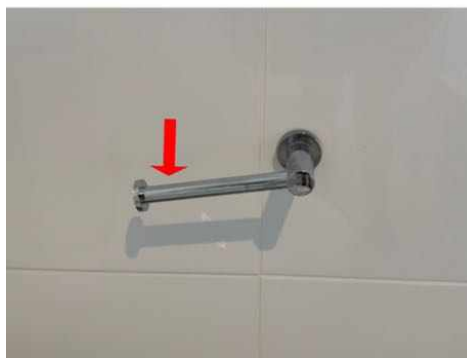
Building:	Main Building
Location:	Bathroom
Finding:	Fitting or fixture - Loose
Information:	The fitting in this area is loose and requires adjustment to tighten.

If left unmanaged, the fitting may further deteriorate, causing potential for the development of other minor secondary defects.

A relevant tradesperson should be appointed to perform these rectification works at discretion of the client.

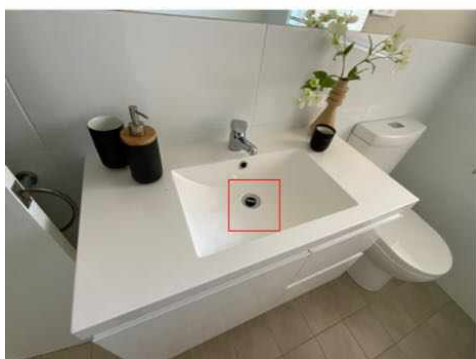
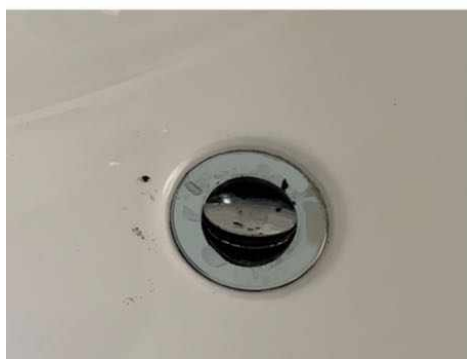
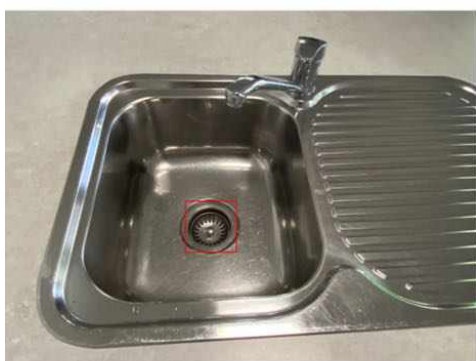
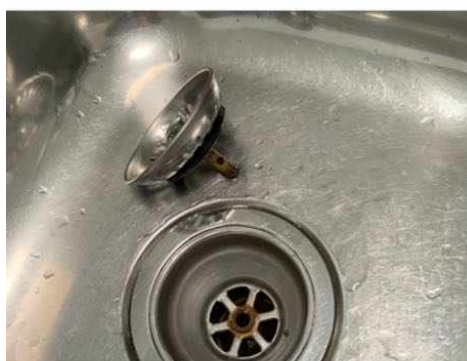
### Finding 3.13

Building:	Main Building
Location:	Bathroom & Kitchen
Finding:	Building elements - Not operating (sink plugs not draining or lifting adequately- replacement or maintenance of the plugs are required)
Information:	Non-operational items should be addressed to ensure that the full function of the building structure is available. Where some building elements are not operating as intended, it is possible that secondary building defects could arise due to their non-operation.

Repair and/or replacement of the faulty building element is recommended. It is highly recommended that the relevant tradesperson be engaged to perform any necessary works.

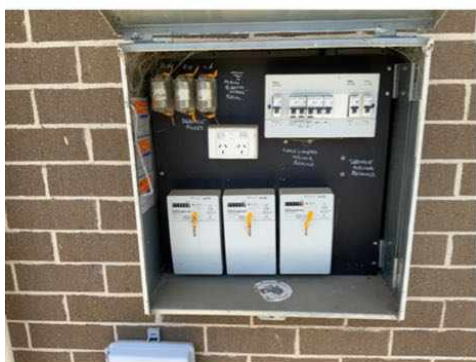
Building:	Main Building
Location:	All Areas
Finding:	Termite Management System - no evidence of a chemical installation
Information:	The application of a post-construction chemical termite barrier is highly recommended for all properties, particularly if live termite activity has been found on the site previously. Such barriers are highly effective in preventing termite attack on any timber

A durable notice should be placed in the switchboard unit to indicate current termite barriers. At the time of inspection, it appeared as though no termite management system has been installed, with no evidence to suggest preventative works taking place.

The client may consider gaining further advice from a pest controller as to the costs and procedures involved with this application. It is recommended that obtaining such advice be a short-term priority.

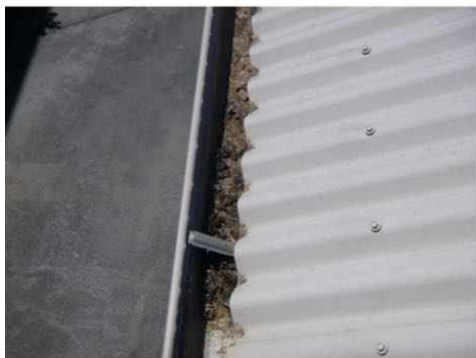
## Finding 6.02

Building:	Main Building
Location:	Roof Exterior
Finding:	Gutters - Blocked
Information:	Roof plumbing structures, such as guttering and downpipes, should be free of all debris to prevent blockages. Blockages of the guttering and downpipes will lead to pooling and accumulated water overflows, which is likely to subsequently flood eaves and exterior walls.

Blocked gutters are likely to lead to high levels of moisture in the affected areas. Such moisture will not only cause rust and decay of the associated building materials, but can also provide conditions that are conducive to termite and timber pest activity. Blockages in gutters should therefore be removed immediately to ensure dry conditions are maintained.

Consult a Licensed Plumber for further specific advice on remedial works that may be required. In the interim, it is highly advised that blocked gutters be removed by the homeowner or a general handyperson as a matter of urgency.

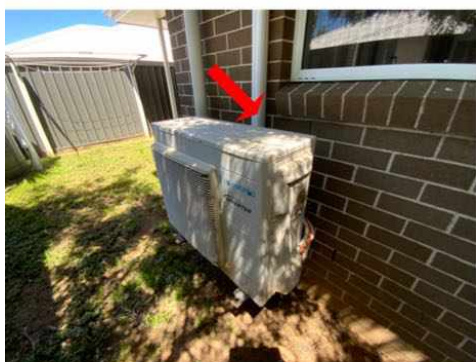
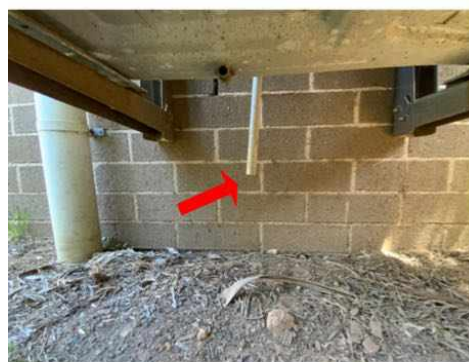
### Finding 6.03

Building:	Main Building
Location:	All Areas
Finding:	Air conditioner - Disconnected overflow
Information:	The Air Conditioner (A/C) overflow was found to be disconnected from storm water drainage and is creating excessive moisture in the surrounding area.

Such leaking creates an environment which is conducive to an array of defects, including water damage to associated building elements and the attraction of termite or timber pest infestation.

It is highly recommended that a licensed plumber be appointed to connect the A/C overflow in order to prevent such an environment from being created. These minor works should be carried out as soon as possible.

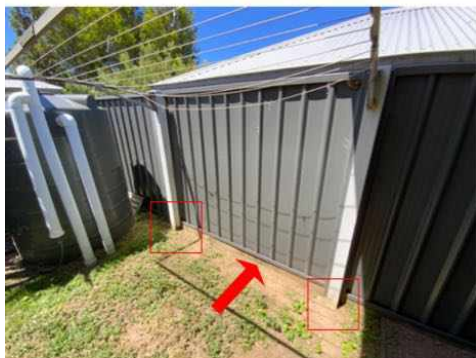
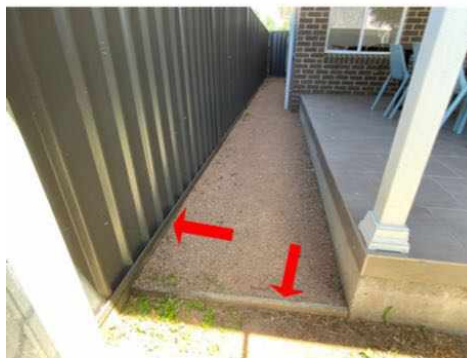
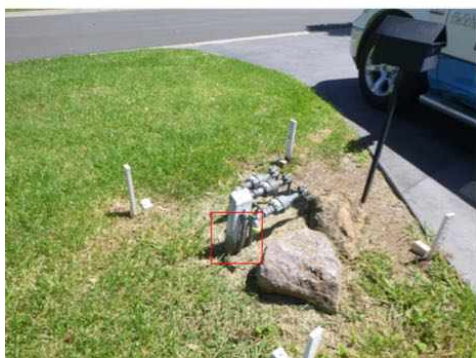
### Finding 6.04

Building:	Main Building
Location:	All Areas
Finding:	Timber in ground contact
Information:	To reduce the risk of timber pest attack it is essential that timber used in a hazardous environment (e.g. in direct contact with the ground or frequently exposed to damp

conditions) is of sufficient durability and/or is adequately preservative treated.

Untreated timbers in direct contact with the ground are likely to develop severe wood rot and/or fungal decay if left unattended creating attraction for subterranean termites to infest the timbers from surrounding areas.

If untreated or non-durable timbers are found to be in a hazardous environment it is highly advised that replacement of these building elements be performed as soon as possible to aid the protection of the property against termite / timber pest attack.

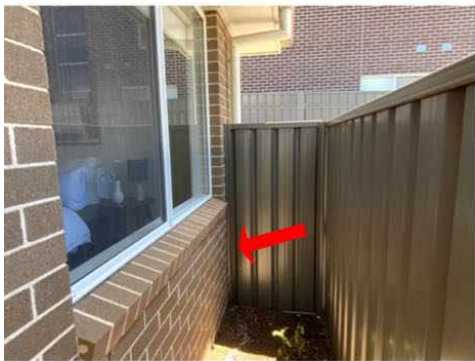
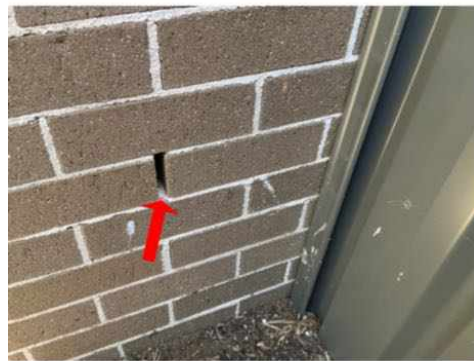
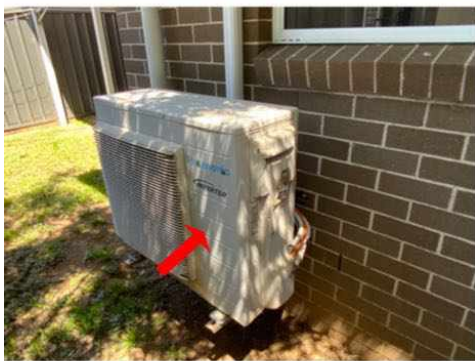
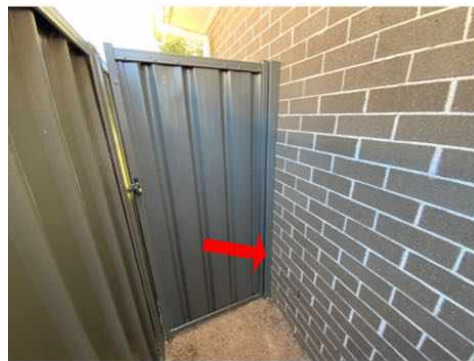
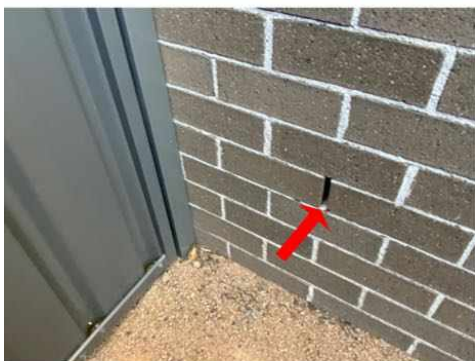
### Finding 6.05

Building:	Main Building
Location:	Exterior walls
Finding:	Bridging or breaching of termite barriers - weep holes
Information:	Bridging is the spanning of a termite barrier or inspection zone so that subterranean termites are provided with passage over or around that barrier.

Weep holes in the exterior brickwork of the property are designed to allow condensation that may build up between the brickwork and subsequent timber framework to drain from within the wall hence preventing any deterioration of the

Additionally build-up of moisture is likely to occur if weep holes are covered further attracting termite activity to these areas.

It is highly recommended that weep holes are left exposed in all areas throughout the external property. Therefore if any termite activity leading into weep holes becomes easily detectable during frequent pest inspections.

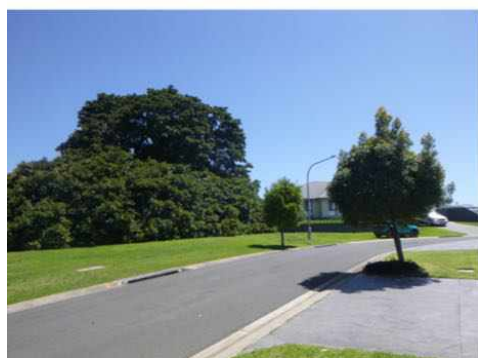
## Finding 6.06

Building:	Main Building
Location:	All Areas
Finding:	Trees within 50m of the property
Information:	Trees within 50m of the property can be conducive to termite activity. It is recommended an invasive inspection of all trees with 50m to the property be carried out by a qualified pest control expert.

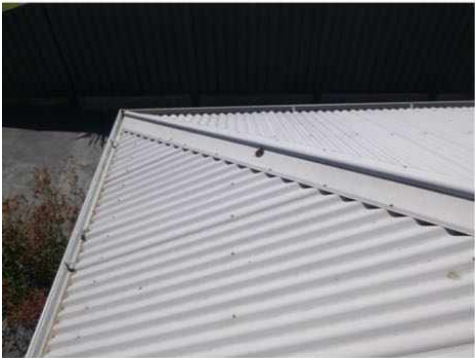
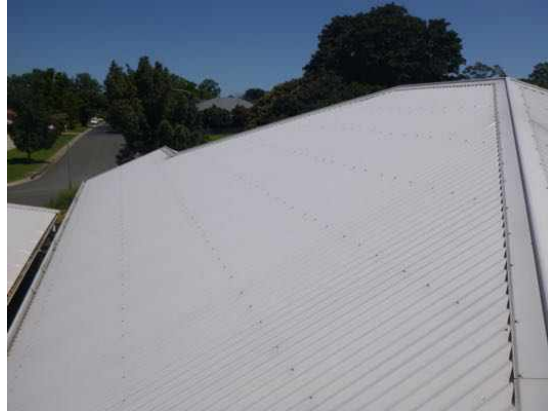
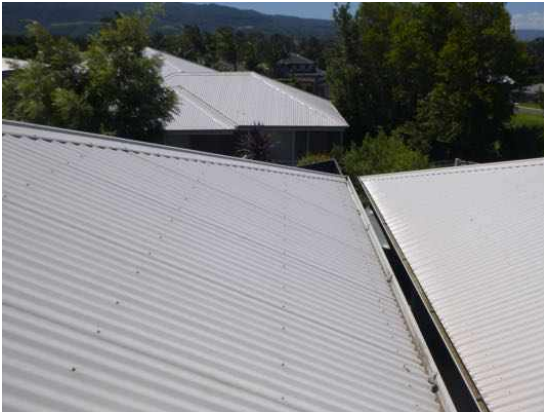
Building: Main Building  
Location: Roof Exterior  
Finding: Additional Photos - Obstructions and Limitations  
Information: These photographs are an indication of the obstructions and limitations which impeded full inspection of the property at the time of inspection. These obstructions can hide an array of defects and should be removed to allow full inspection to be carried out. A re-inspection is recommended once the areas are made accessible.

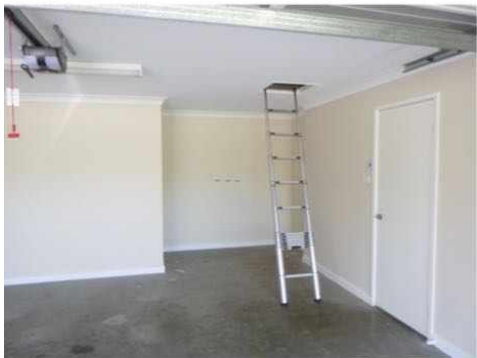
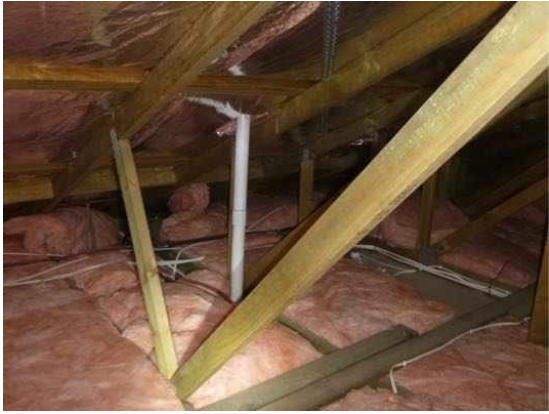
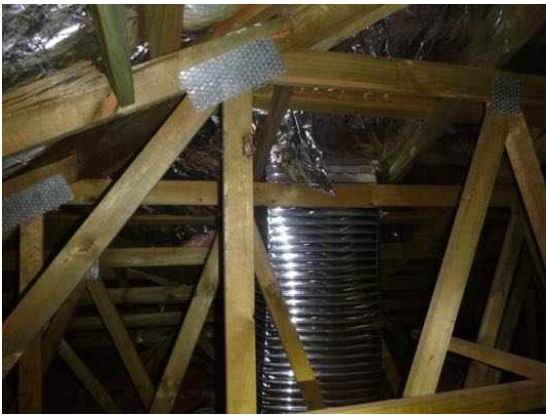
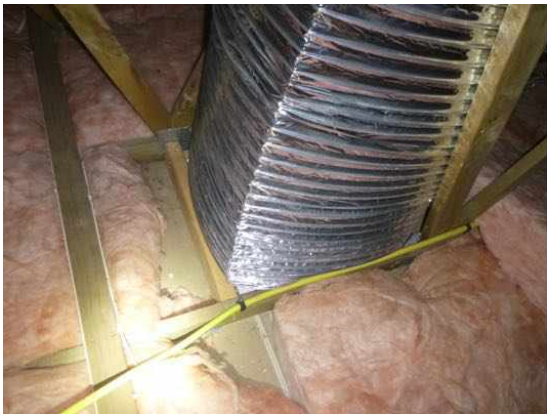
Building:	Main Building
Location:	Roof Void
Finding:	Additional Photos - Obstructions and Limitations
Information:	These photographs are an indication of the obstructions and limitations which impeded full inspection of the property at the time of inspection. These obstructions can hide an array of defects and should be removed to allow full inspection to be carried out. A re-inspection is recommended once the areas are made accessible.

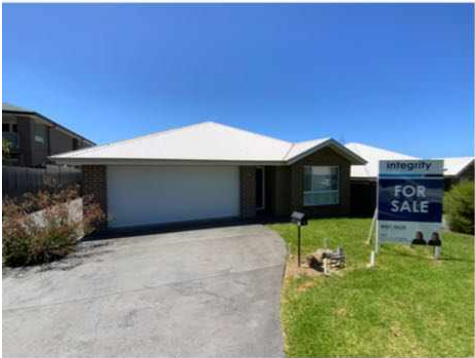
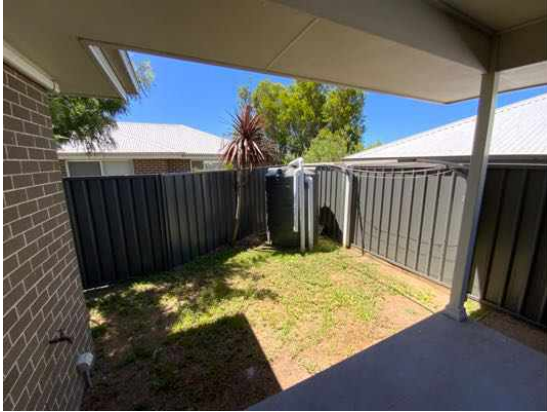
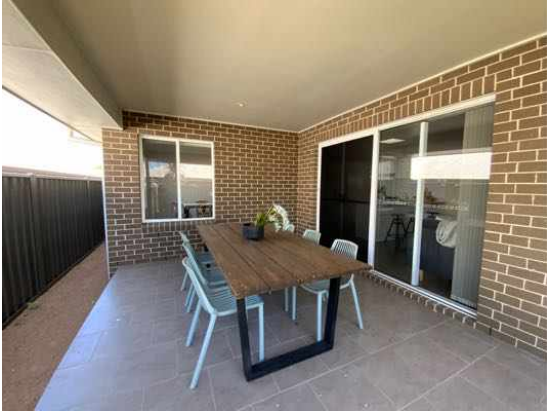
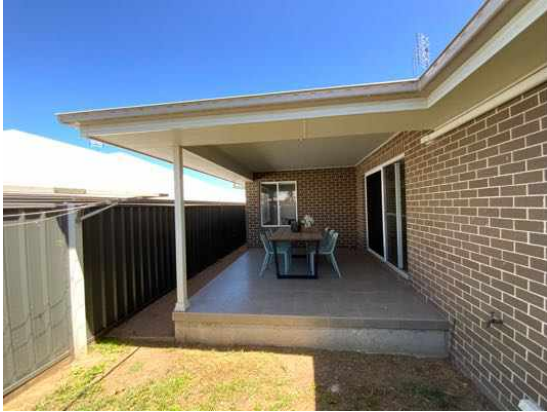
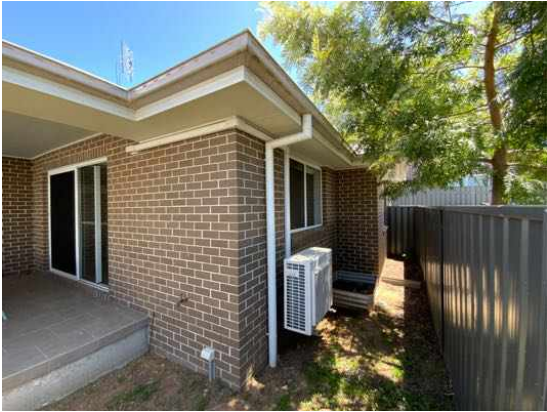
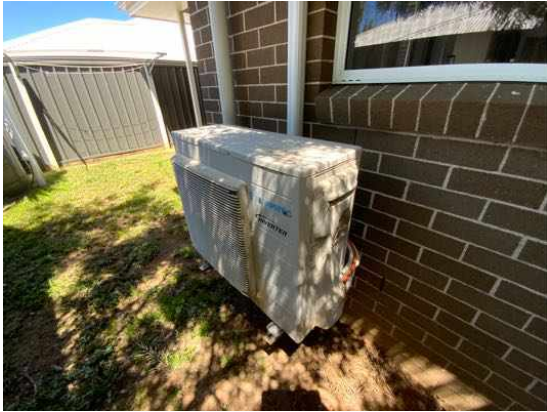
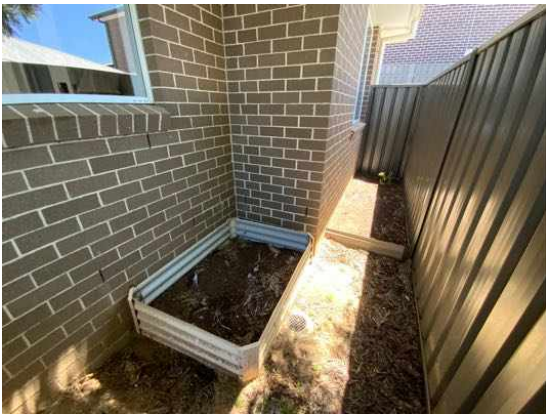
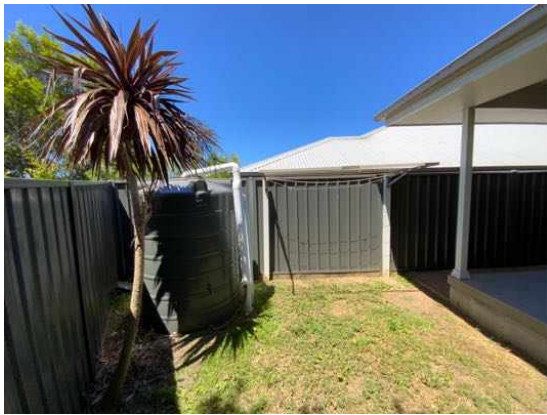
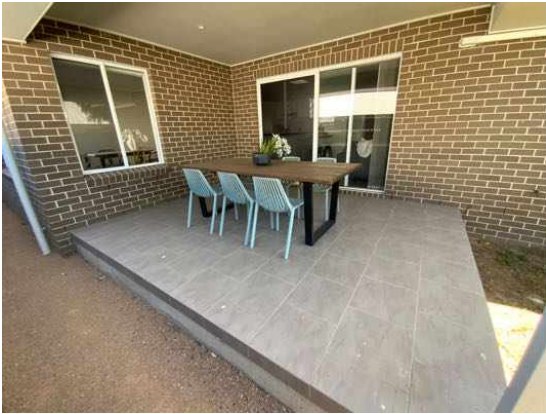
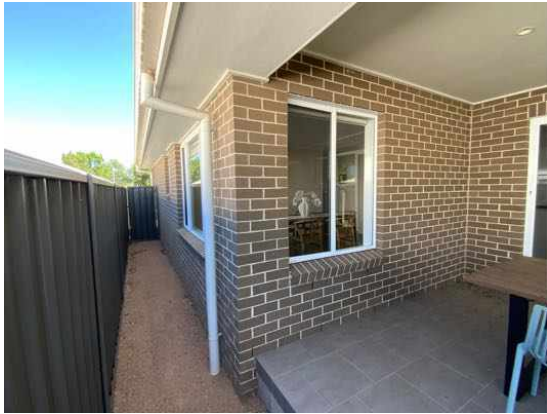
Building: Main Building  
Location: All Areas  
Finding: Additional Photos - Obstructions and Limitations  
Information: These photographs are an indication of the obstructions and limitations which impeded full inspection of the property at the time of inspection. These obstructions can hide an array of defects and should be removed to allow full inspection to be carried out. A re-inspection is recommended once the areas are made accessible.

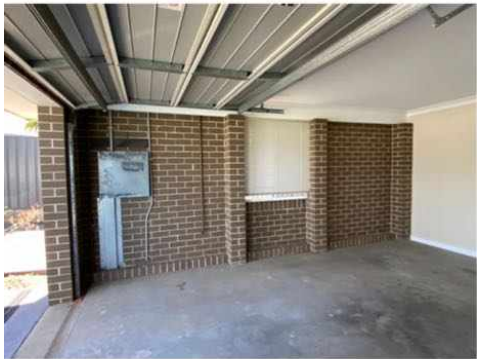
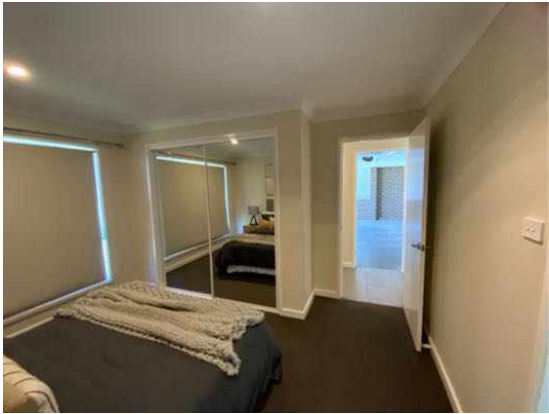
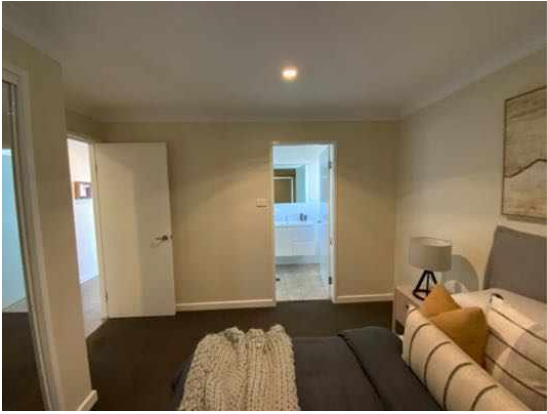
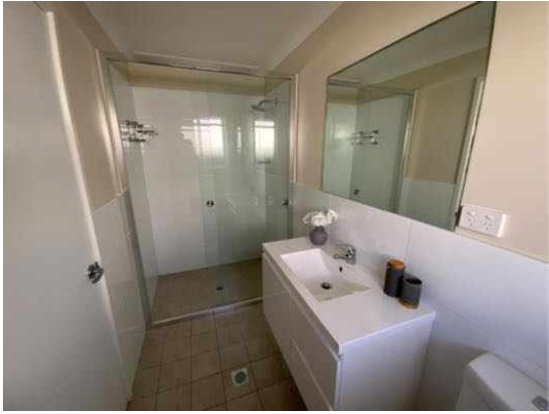
Building: Main Building  
Location: All Areas  
Finding: Additional Photos - Obstructions and Limitations  
Information: These photographs are an indication of the obstructions and limitations which impeded full inspection of the property at the time of inspection. These obstructions can hide an array of defects and should be removed to allow full inspection to be carried out. A re-inspection is recommended once the areas are made accessible.
