# Building and Timber Pest Inspection Report

Inspection Date: Tue, 27 Jan 2026

Property Address: 1/17 Banool Cct, Bomaderry NSW 2541,  
Australia

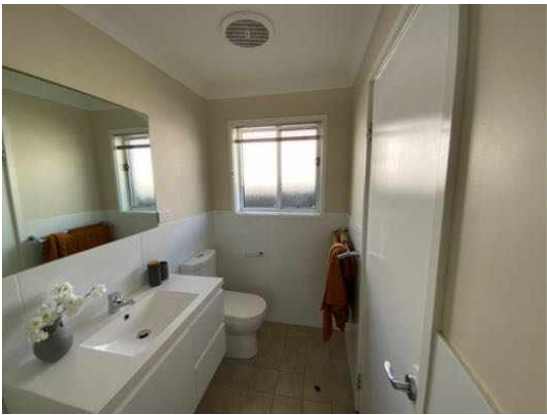
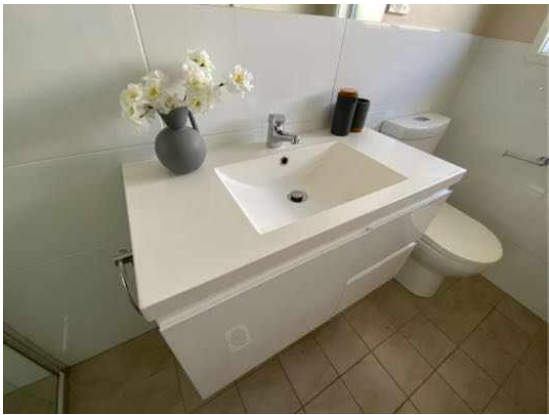
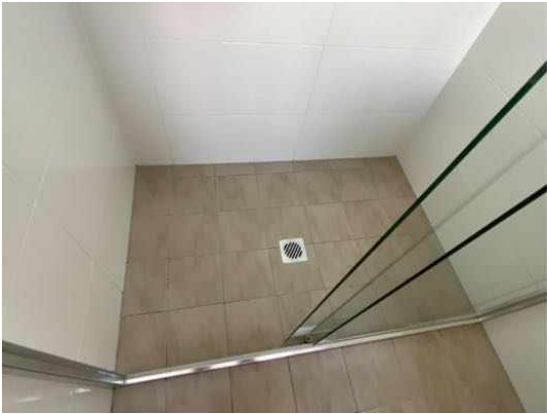
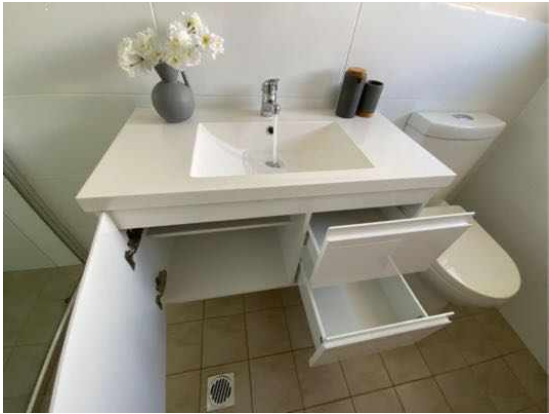
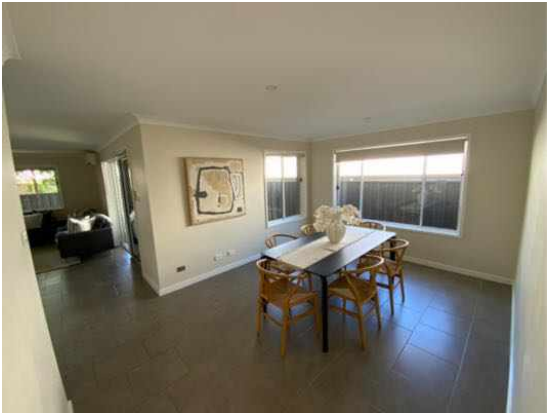
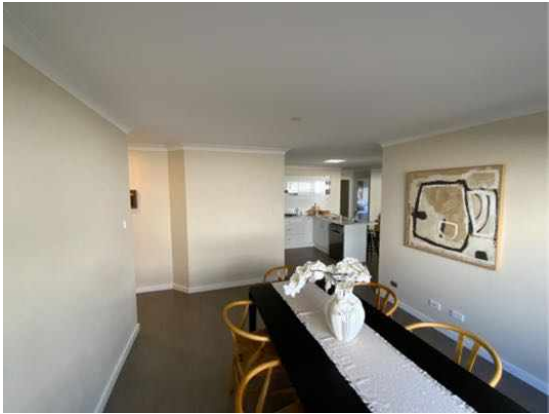
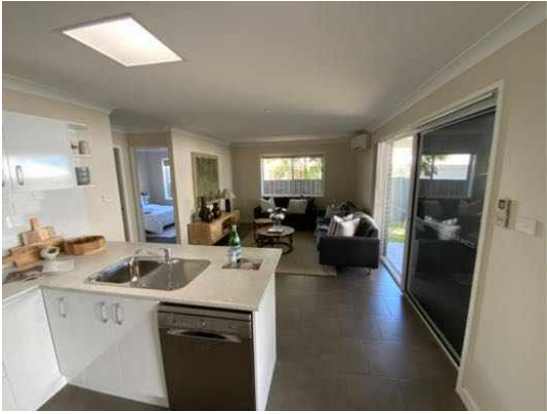
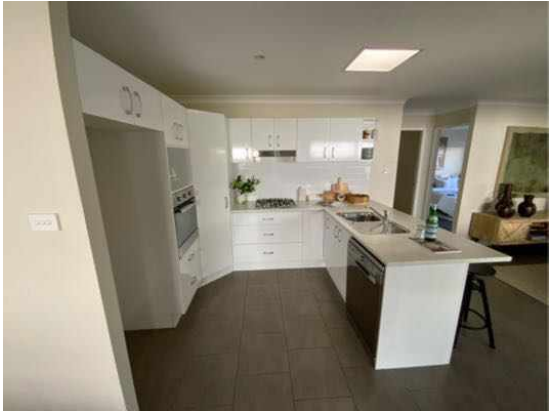
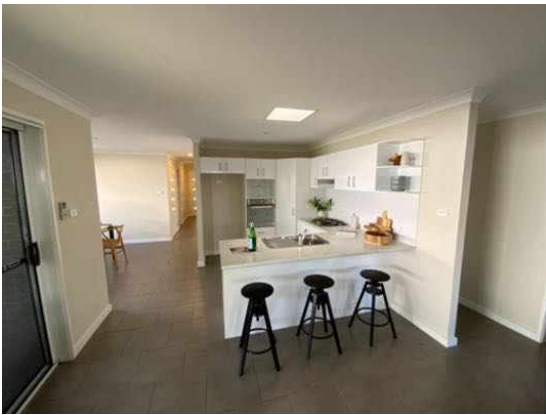
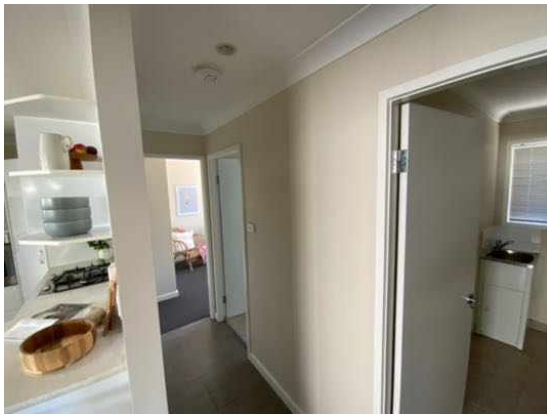
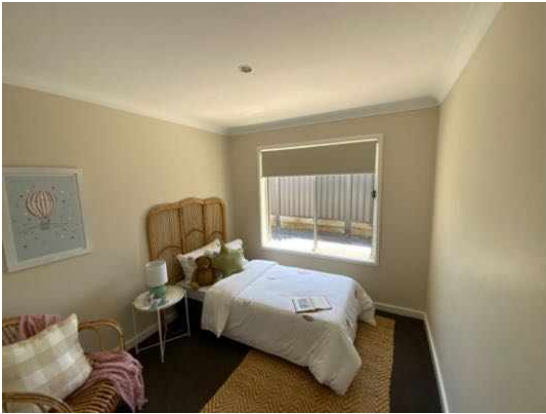
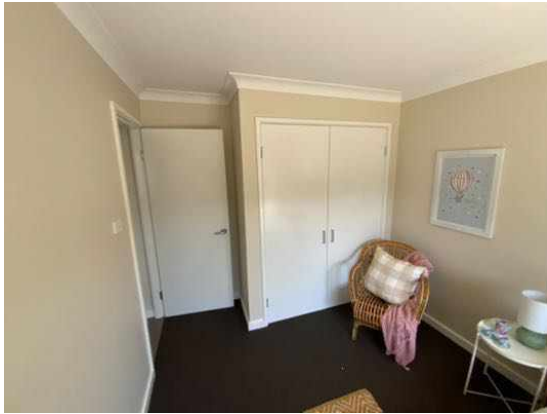
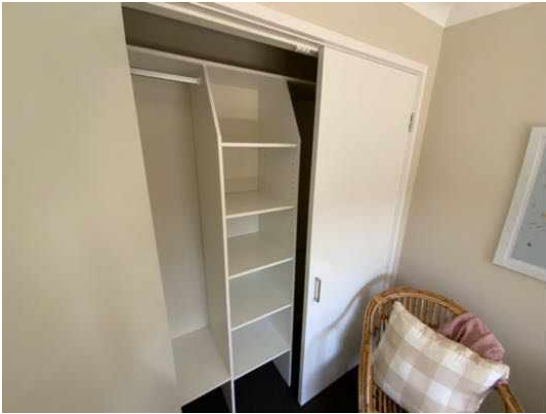
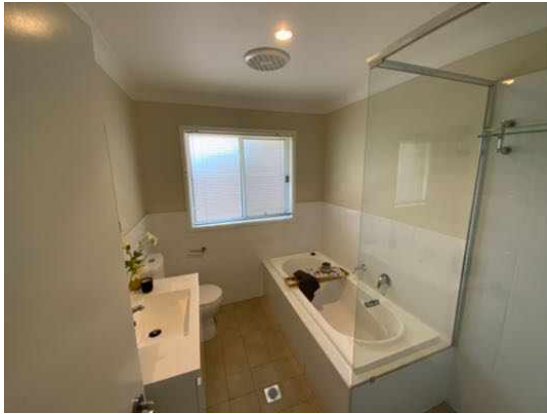
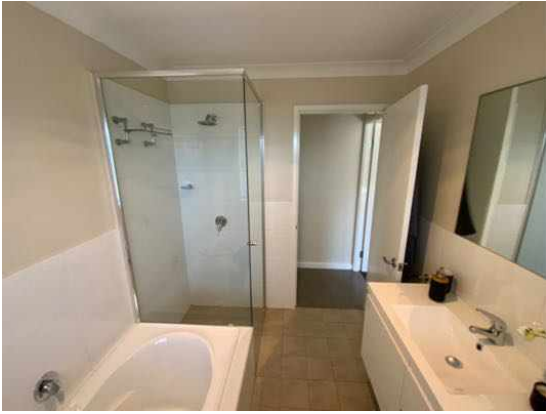
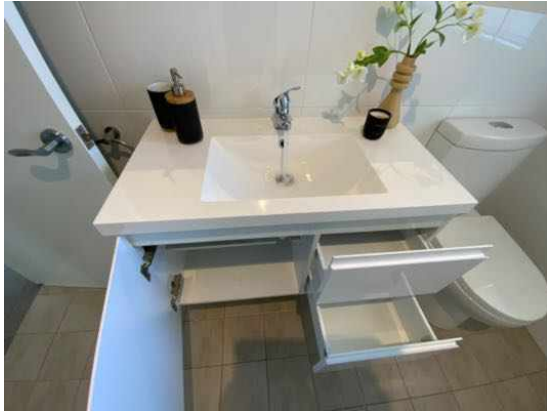
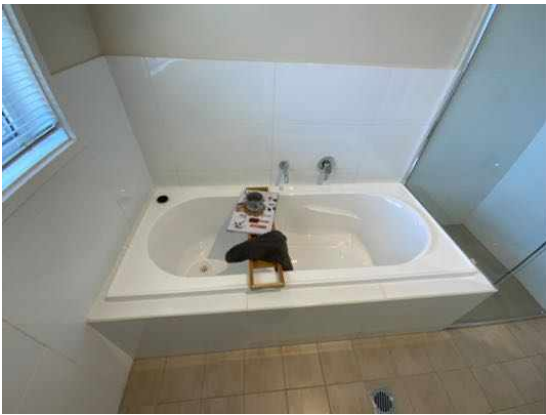
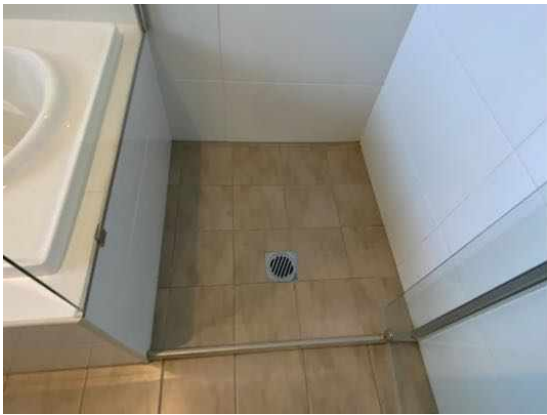
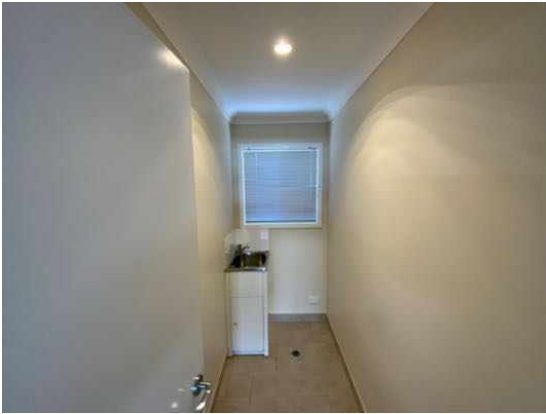
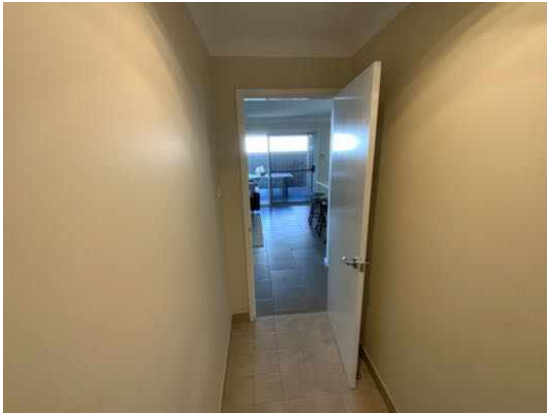
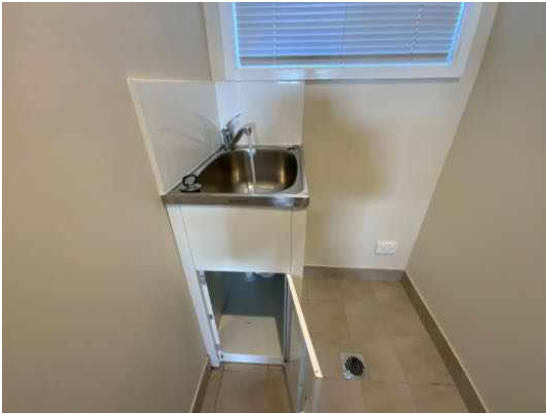
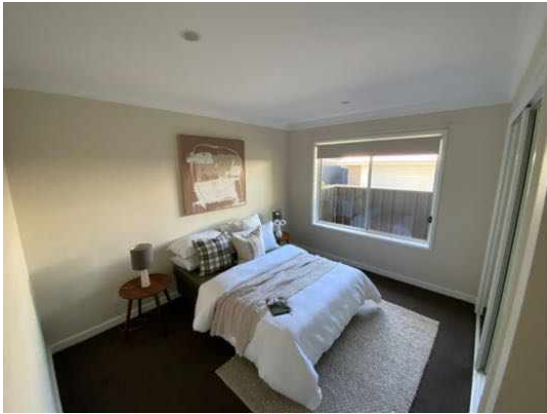
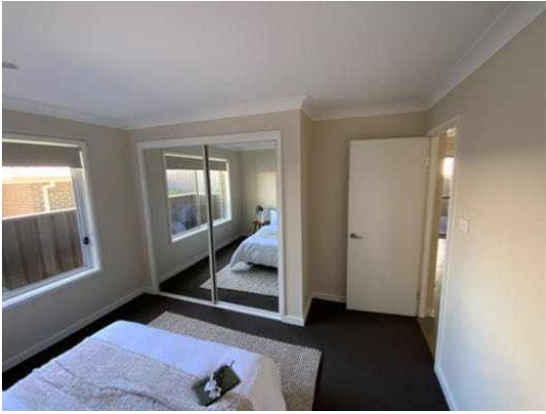
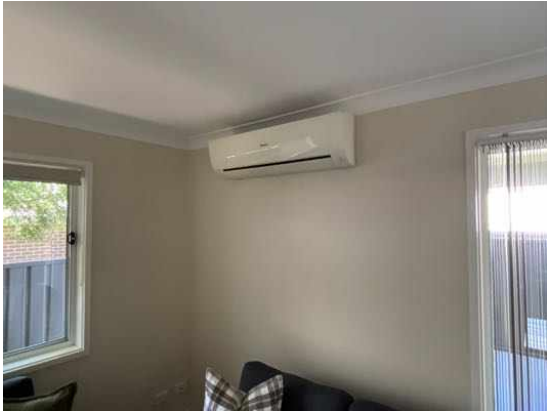
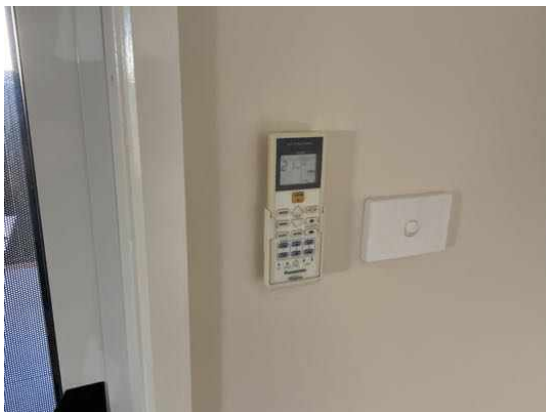
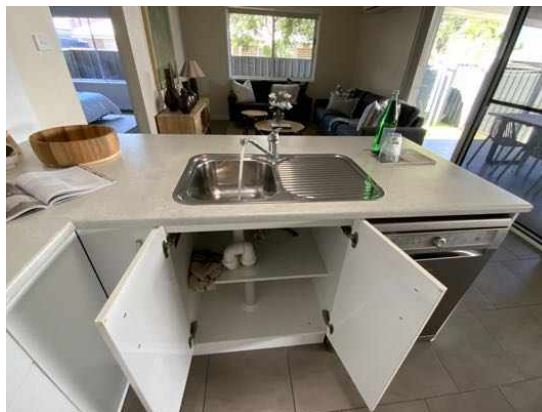
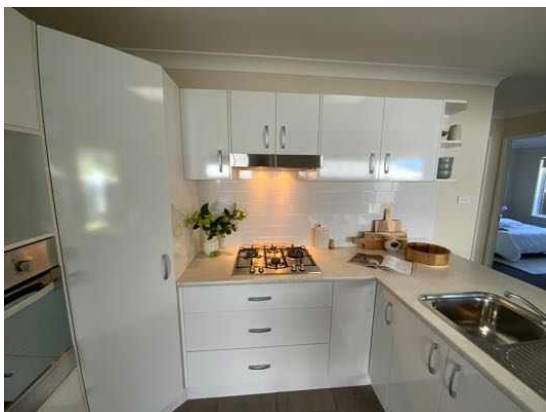
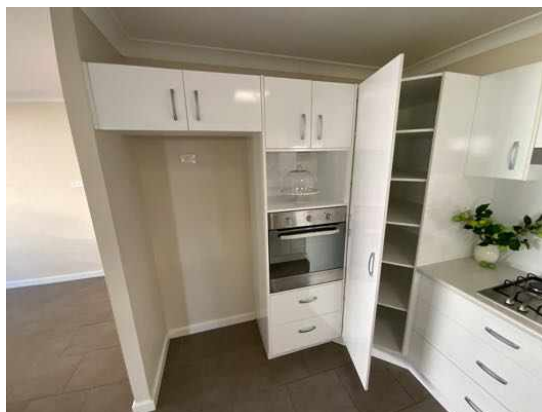
Building: Main Building  
Location: All Areas  
Finding: Additional Photos - Obstructions and Limitations  
Information: These photographs are an indication of the obstructions and limitations which impeded full inspection of the property at the time of inspection. These obstructions can hide an array of defects and should be removed to allow full inspection to be carried out. A re-inspection is recommended once the areas are made accessible.

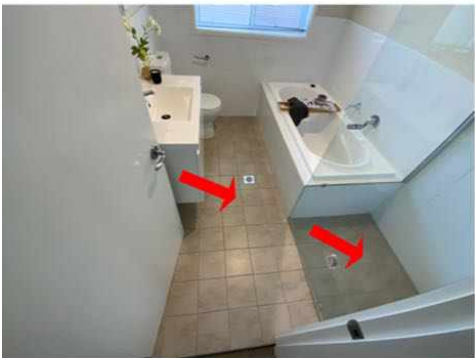
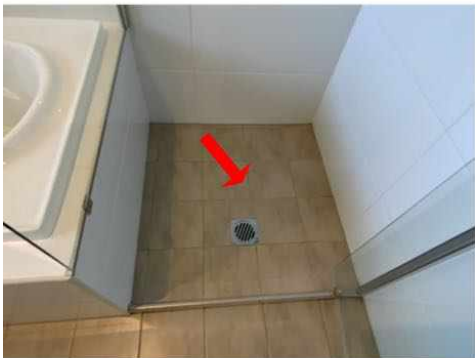
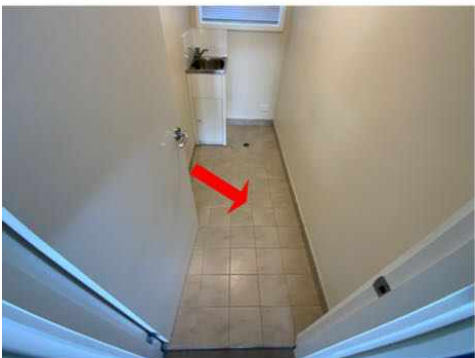
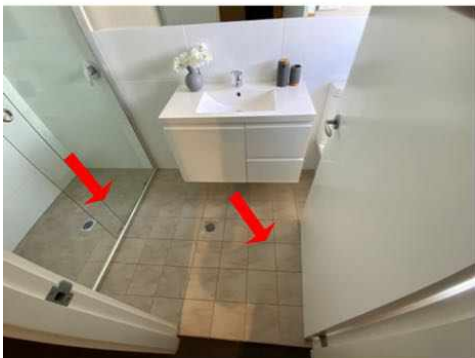
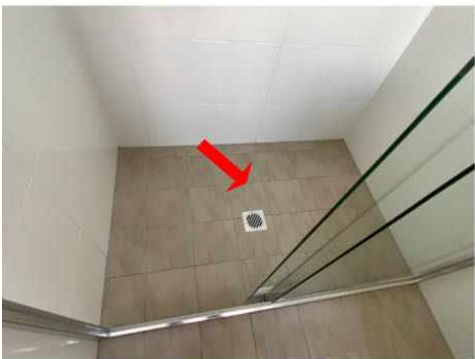
Building:	Main Building
Location:	All Wet Areas
Finding:	Water Proofing Membranes - Information Only
Information:	Internal Water Proofing Membranes, are crucial in preventing water ingress into the property is important to know that the Membrane System used is to Australian Standards and has been installed correctly.

With older property's where this information is unavailable all wet areas should be monitored. Generally waterproofing certificates are only valid for approximately 7-8yrs. If any leaks, water staining, peeling or bubbling of the paint become evident to any adjacent walls or ceilings below a licensed builder or waterproofing specialist is recommended to investigate further.

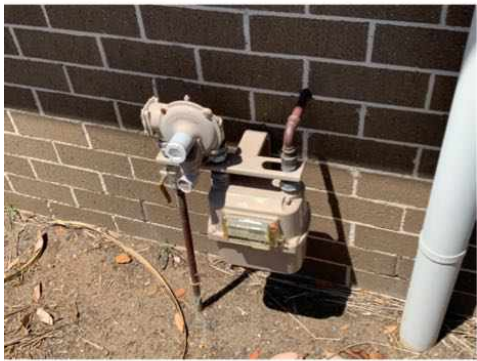
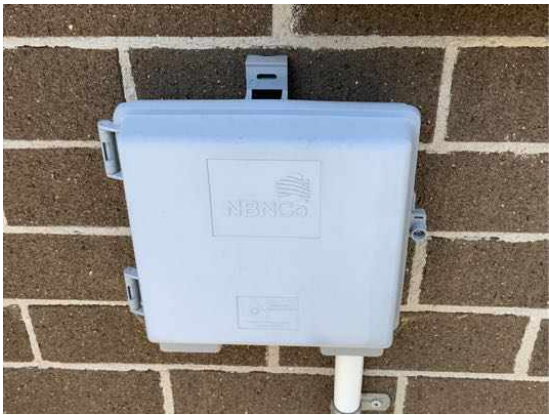
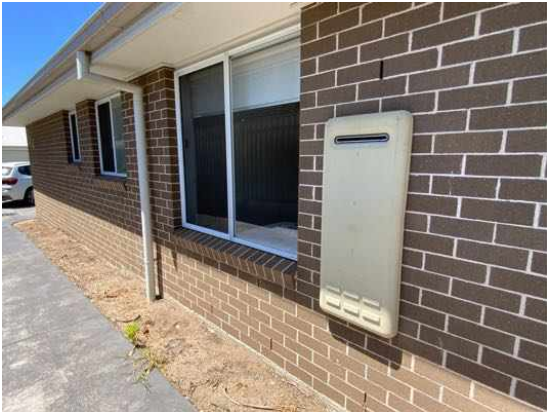
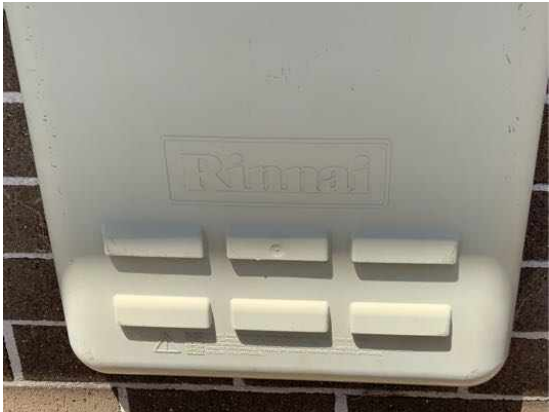
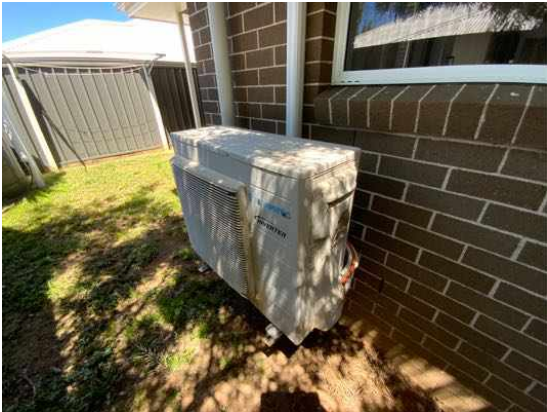
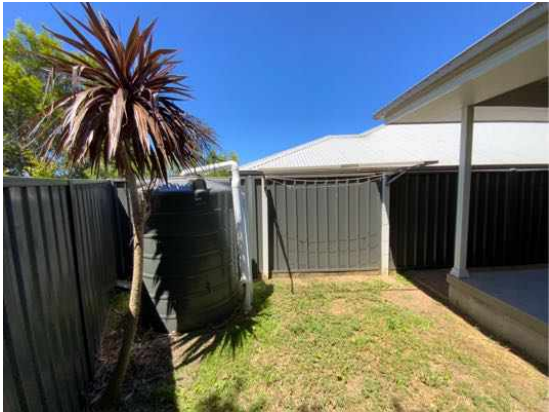
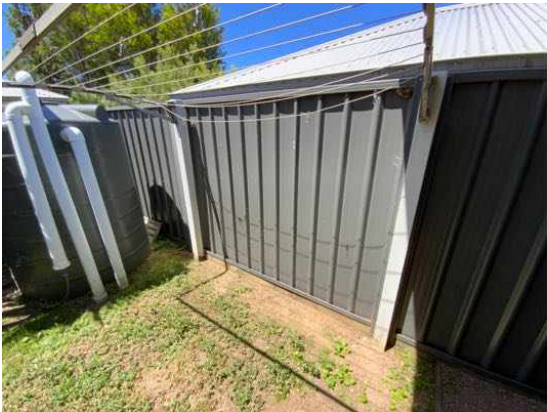
Building: Main Building  
Location: All Areas  
Finding: Additional Photos  
Information:

Additional photos are provided for your general reference. Arrows have been included to highlight areas of importance. Please discuss these photos with your building consultant for clarification.

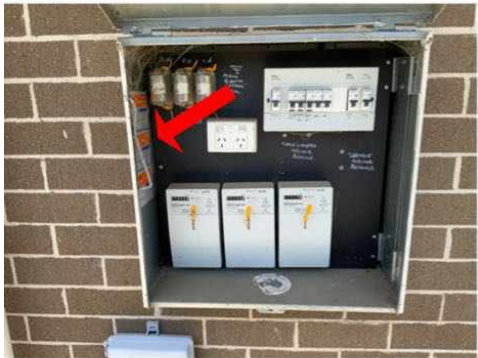
## Noted Item

# The following items were noted as - Evidence of a previous termite management program

Where a Termite Management System has been identified you should refer to the type of barrier date of installation warranty conditions and any documentation provided by a builder or past owner. Consult the company who installed the barrier to confirm whether the system is still under warranty.

Most chemical termite management systems expire and require replenishment and all physical systems are primarily designed to prevent concealed entry.
