# Building and Timber Pest Inspection Report

Inspection Date: Wed, 18 Feb 2026

Property Address: 76A Kingborn Ave, Seaton SA 5023,  
Australia

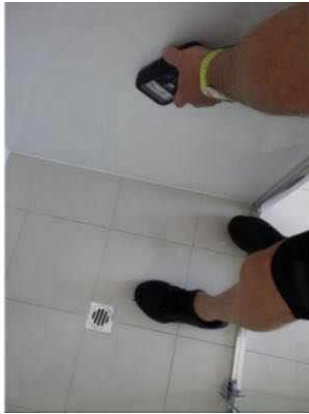
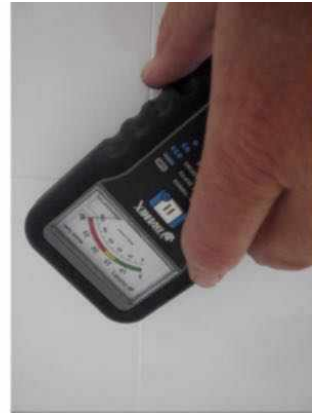
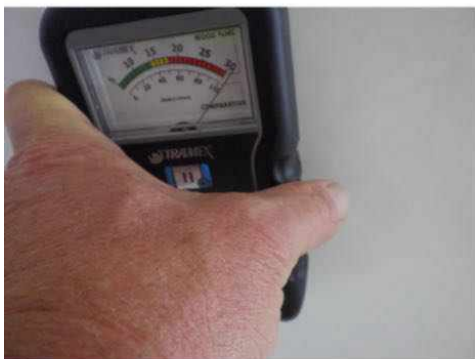
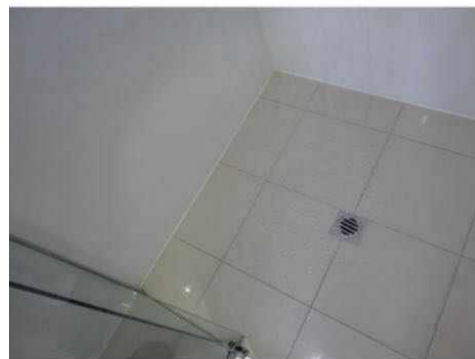
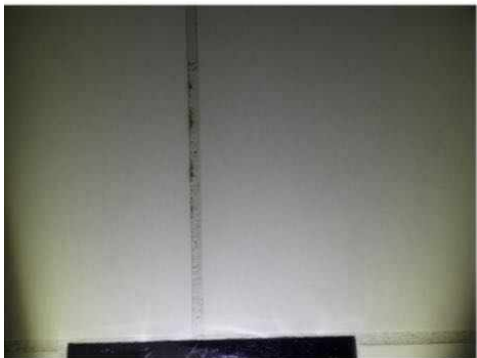
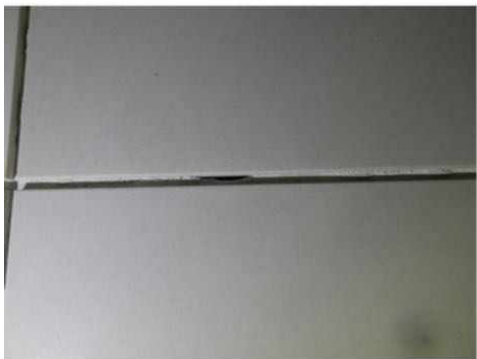
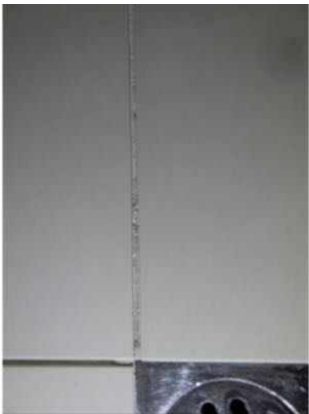
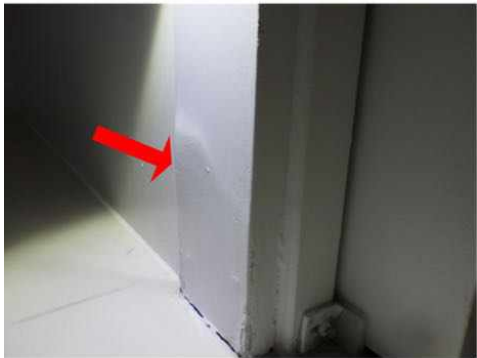
Building:	Building 1
Location:	Upstairs bathrooms
Finding:	Shower - Damp
Information:	Damp was evident to the lower wall to the shower alcoves at the time of inspection. Minor moisture damage is also evident to the door frame entering the bathroom.

This defect is quite common, and is suspected to have been caused by moisture permeating through the tiling, grouting and or sealant in this area, which shows evidence of minor deterioration.

Leaking pipes within the adjoining wall is also a possible cause however it seems unlikely in this instance as there was no high readings around the taps nor transferring to the other side of the wall.

Consultation with a qualified plumber or bathroom sealant specialist is advised in the short term to identify the cause of damp and to perform remedial works as required.

Always ensure that sealant and grout is in good condition to prevent any moisture issues occurring in the future. Sealant and grout should be maintained every five years at a minimum and it would appear that the silicon and grout in this instance is original.

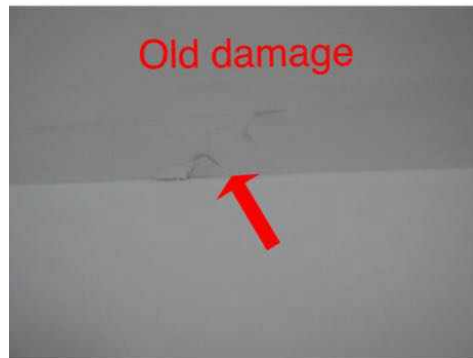
### Finding 3.01

Building: Building 1  
Location: Exterior walls - upper  
Finding: External Sealant - maintenance required  
Information: It was noted on inspection that sealant is showing evidence of repair at the rear upper wall of the dwelling with water appears to be some small old damage to the ceiling below. However the side is still in original condition and should be over sealed to ensure adequate sealing of the dwelling, and the front hoods also require sealant

Secondary defects can occur if maintenance is not carried out ranging from moisture in walls to deterioration of adjacent building elements

Flexible and materials should be applied to affected areas to prevent any subsequent water damage that can occur. Regular maintenance and replacement of damaged/ deteriorated sealant is highly recommended as this is a regular wear and tear defect.

Repairs are required and should be carried out by a licensed sealant specialist at your soonest convenience.

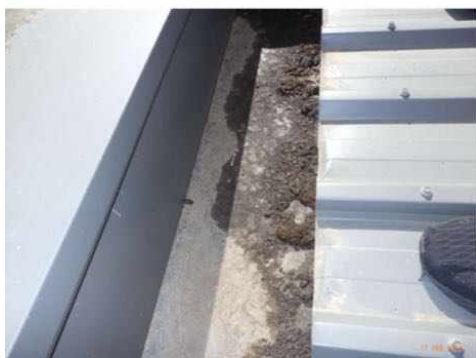
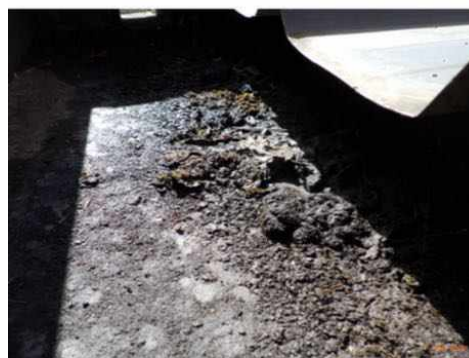
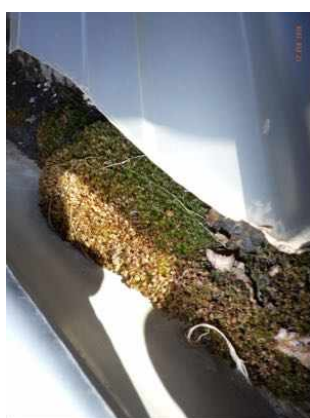
### Finding 3.02

Blocked gutters are likely to lead to high levels of moisture in the affected areas. Such moisture will not only cause rust and decay of the associated building materials, but can also provide conditions that are conducive to termite and timber pest activity. Blockages in gutters should therefore be removed immediately to ensure dry conditions are maintained.

Consult a Licensed Plumber for further specific advice on remedial works that may be required. In the interim, it is highly advised that blocked gutters be removed by the homeowner or a general handyperson as a matter of urgency.

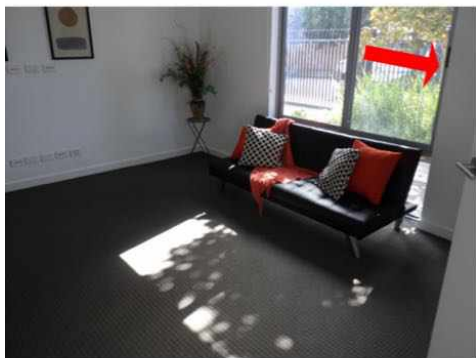
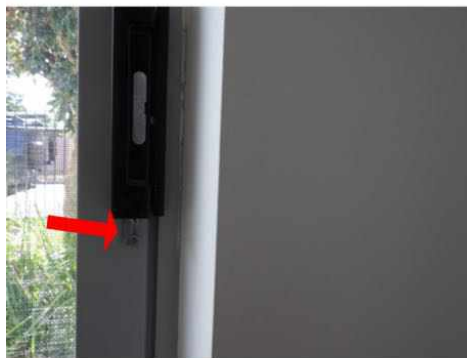
Building:	Building 1
Location:	Bedroom 4
Finding:	Window lock - damaged
Information:	The window lock to the lower bedroom did not appear to be operating correctly at the time of inspection. This window latch appears different to the rest indicating that the locking mechanism may be damaged or missing.

Where locks have deteriorated to a point where they are no longer usable, the security of the property is immediately compromised.

Repair/ replacement of the lock is highly recommended.

Consultation with a locksmith or general handyman is required to gain further advice on any added security that may be available for the area.

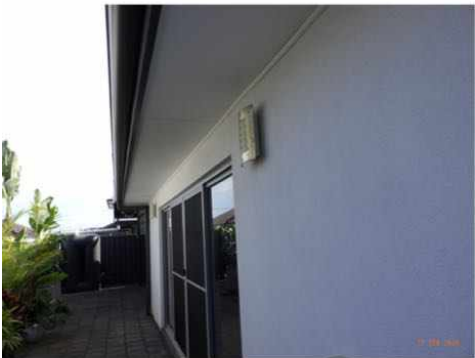
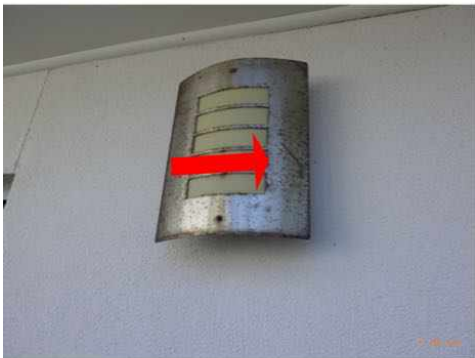
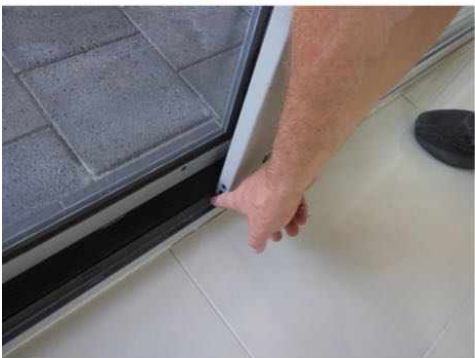
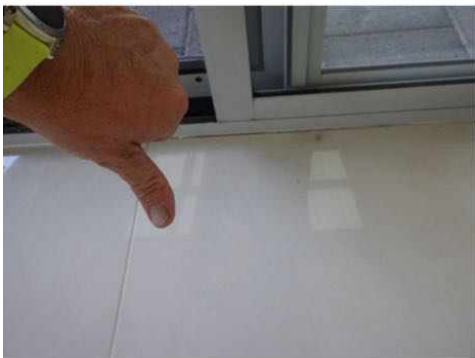
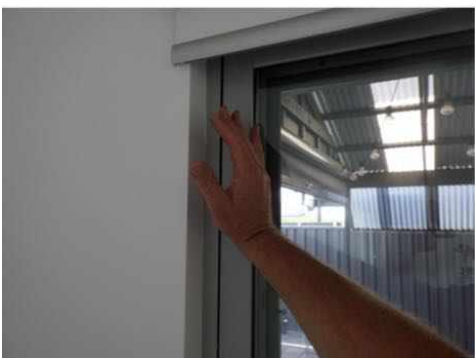
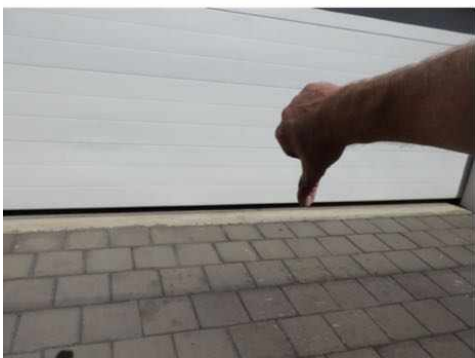
### Finding 3.05

Building:	Building 1
Location:	All Areas
Finding:	Minor defects present
Information:	There were several age and maintenance related defects evident to the dwelling at the time of inspection. These defects include but are not limited to

- Exterior lights rusting.
- Side sliding door rollers deteriorated.
- Garage roller door malfunctioning. Service required.
- Bathroom kickers deteriorated.

Appropriate licensed trades people could be appointed to make repairs at the discretion of the client.

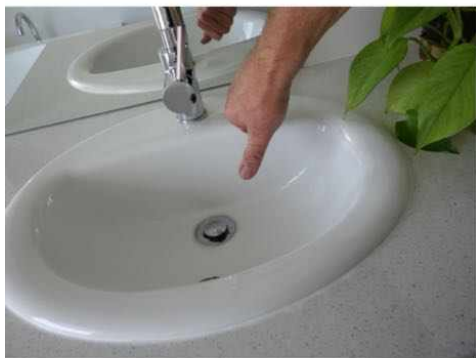
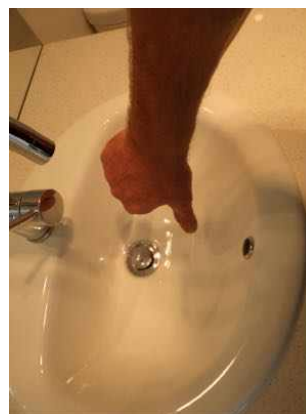
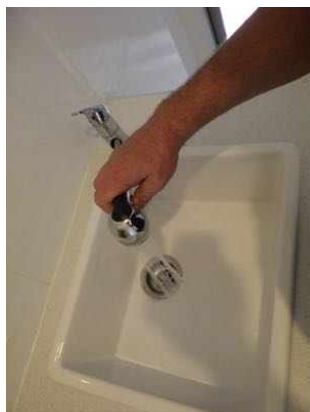
### Finding 3.06

However Issues noted by the inspector include but are not limited to

- Drain plugs corroded and likely require replacement.
- Loose laundry sink outlet.

It is highly recommended that the client makes contact with a licensed plumber to make required investigations and adjustments prior to any further secondary defects being created.

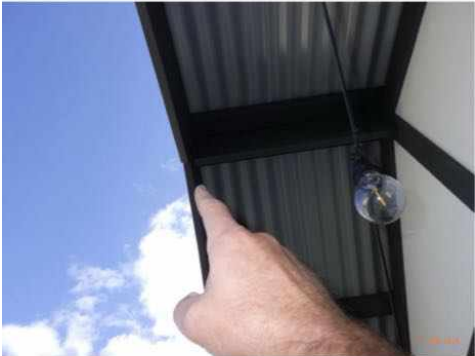
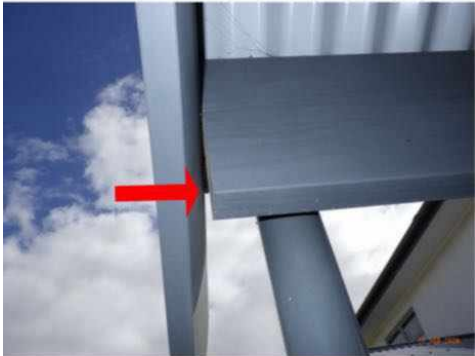
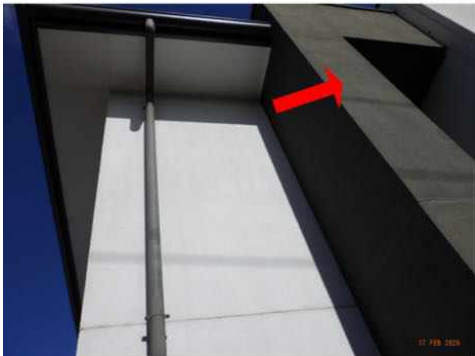
### Finding 3.07

Building:	Building 1
Location:	Pergola
Finding:	External painting deteriorated
Information:	Some of the external paintwork including but not limited to the pergola have been neglected and require attention to prepare and re-paint.

It was also noted that the pergola barge beam is twisted and will require reattaching or replacement.

A painting contractor should be appointed as soon as possible to perform necessary works to aid the appearance of the affected area and to ensure the area is protected against further deterioration. Alternatively, the homeowner following manufacturer

instructions may perform these works.

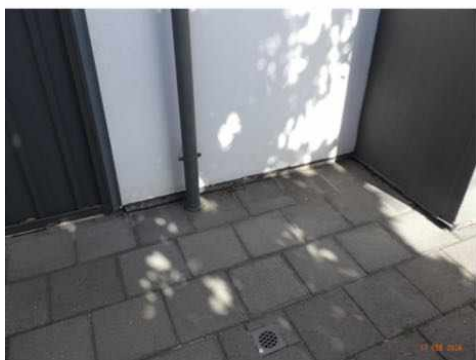
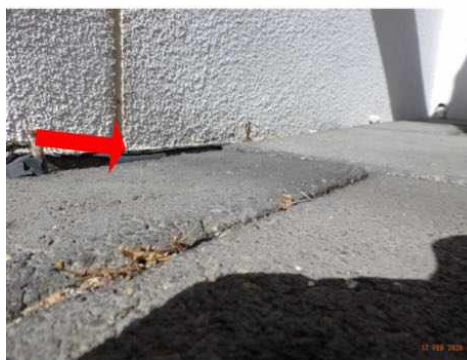
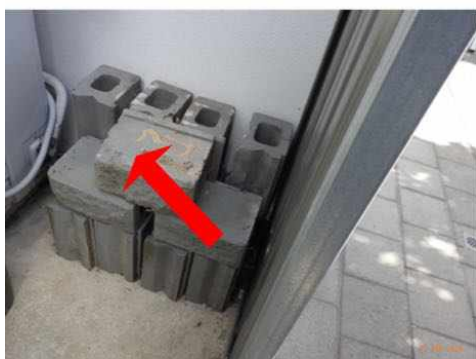
If the slab edge is not properly exposed there is a high risk of concealed termite attack which your inspector will likely not be able to see. Sometimes, in order to determine the type of slab, a suitably qualified person such as an architect or builder may be required to consult construction plans.

Where the slab edge cannot be properly inspected, it is highly recommended that termite or timber pest inspections be carried out every 6-12 months to aid protection of the property against infestation and termite treatment advice is followed closely.

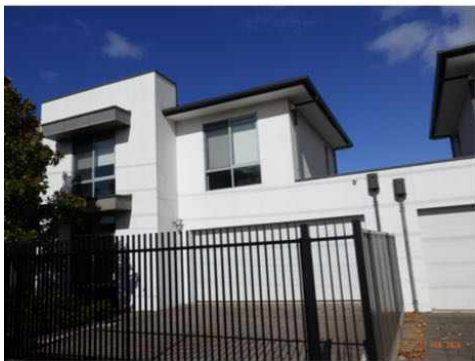
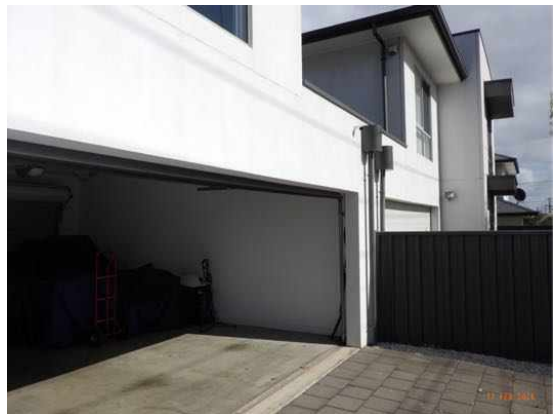
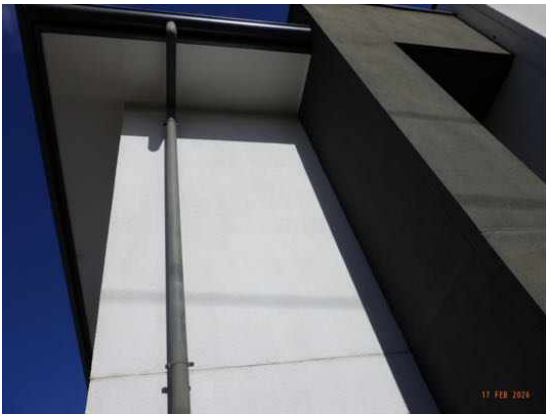
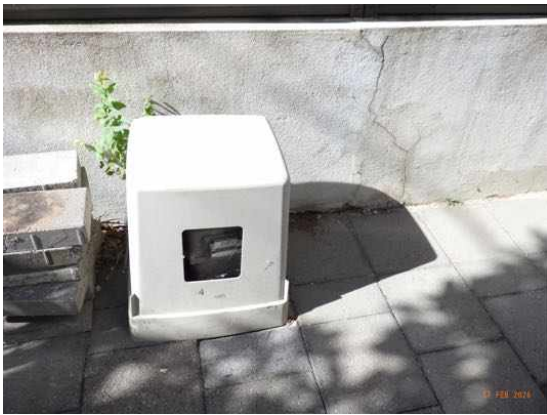
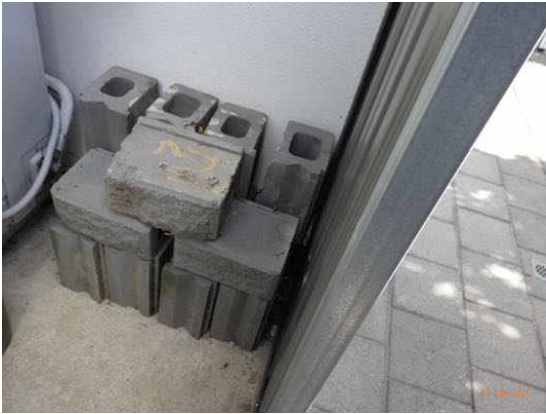
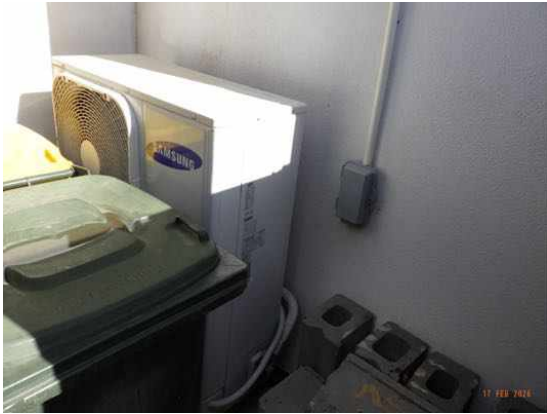
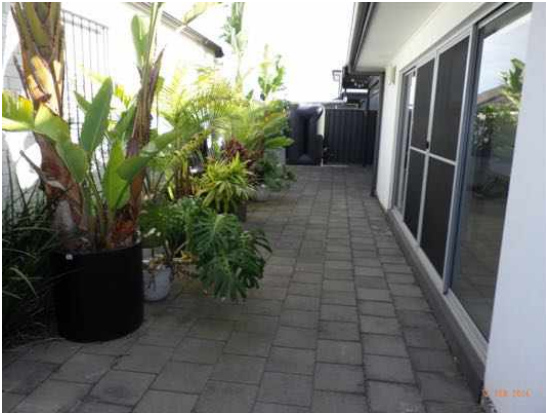
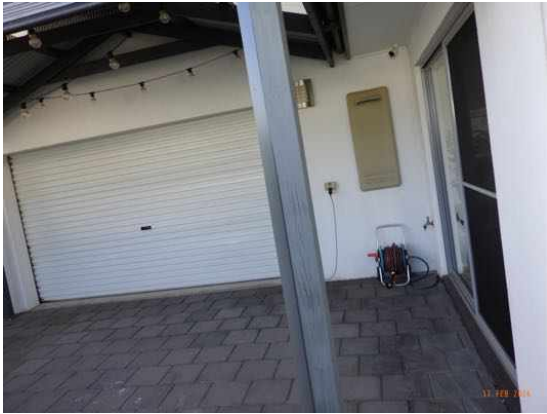
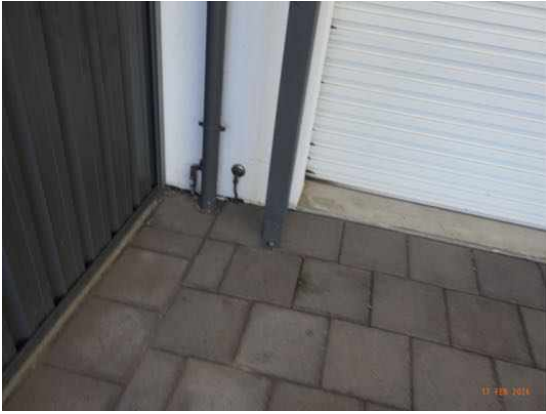
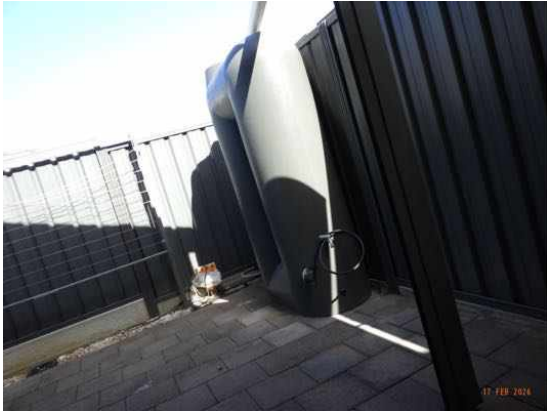
Building: Building 1  
Location: All Areas  
Finding: Additional Photos - Obstructions and Limitations  
Information:

These photographs are an indication of the obstructions and limitations which impeded full inspection of the property at the time of inspection. These obstructions can hide an array of defects and should be removed to allow full inspection to be carried out.

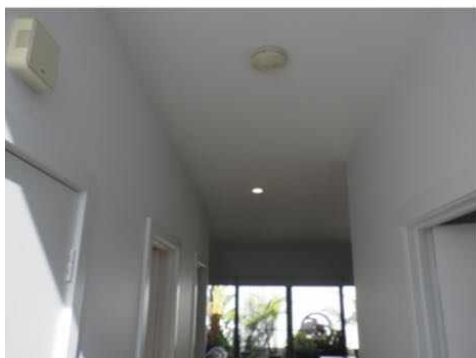
Noted Item

Building: Building 1  
Location: Downstairs  
Finding: Smoke Detectors and Alarms  
Information: Reporting on Smoke Detectors or Alarms, including hard wired smoke detection systems and their legislative requirements, is outside the Scope of this Report.

Please note that this defect is highlighted as a caution only. We suspect, based on our experience in the building industry, that the absence of smoke detectors, or their poor condition, should be addressed as a matter of urgency to improve occupant safety.

Always ensure sufficient working and suitable smoke detectors are installed prior to occupying any building. Additionally, it is advised that all smoke detectors be tested by the homeowner on a monthly basis.

Please refer to AS3786 and state based legislation, which may also apply.
