Building and Timber Pest Inspection Report

Inspection Date: Mon, 9 Mar 2026

Property Address: 10 Peace Ave, Pymble NSW 2073, Australia

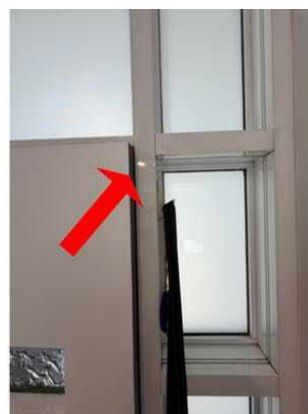
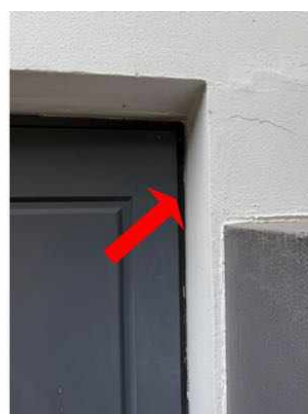
Building: Main Building
Location: All Internal Areas
Finding: Doors - Binding/Jamming
Information: Binding and/or jamming of several doors throughout the property were evident during standard operation. This defect inhibits the functionality of affected doors as well as creating potential for secondary defects to associated building elements, such as damage to the floor covering.

A door that binds to flooring or to the associated door frame may have several causes, ranging from minor defects, such as poor installation of the door or deteriorated hinges, through to major structural issues, such as damage to subfloor structures.

Where door binding/jamming appears to indicate major structural issues, a registered builder specialising in re-stumping should be appointed to provide an estimate on the cost of rectification.

For minor causes, a qualified carpenter or general handyperson should be appointed to perform minor rectification works at client discretion.

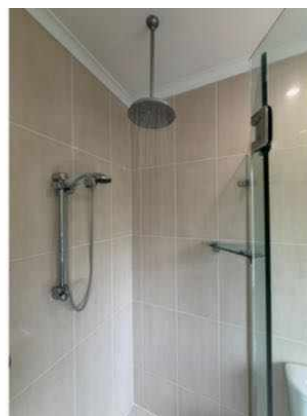
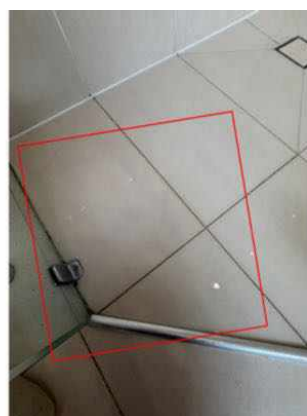
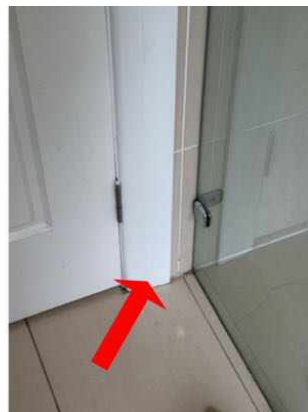
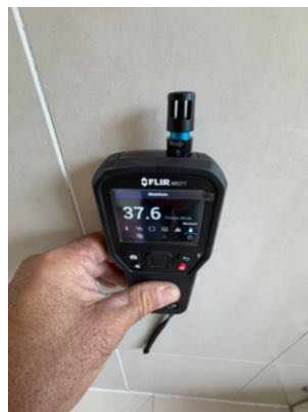
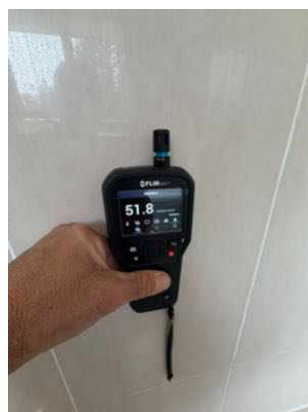
Finding 3.03

Location: Bathroom
Finding: Shower–Water Pooling
Information: At the time of inspection, one section of the floor tiling within the main bathroom shower was observed to be incorrectly graded, resulting in water pooling in that area. The affected tile falls back toward the shower screen rather than toward the waste, which may allow water to sit against the screen or track toward adjoining building elements.

Although no active leakage outside the shower screen was observed at the time of inspection, elevated moisture readings were detected in the adjacent door architrave. The architrave was also noted to be deteriorated and showing signs consistent with previous wood rot that appears to have been painted over. This indicates that moisture ingress has likely occurred in the past.

It is recommended that the affected architrave be removed and replaced, and the shower floor grading be assessed and rectified as required to prevent ongoing or future moisture issues. Moisture readings taken to the remaining shower walls were within normal limits at the time of inspection.

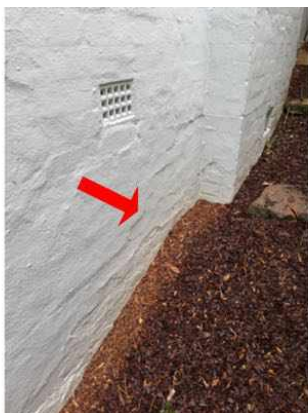
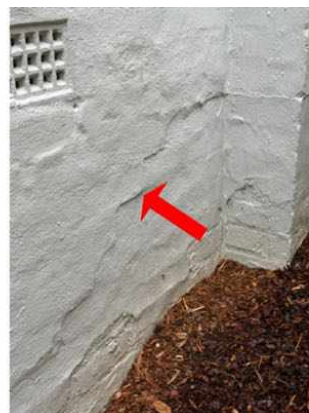
Finding 3.04

Building: Main Building
 Location: External LHS
 Finding: Brickwork - Step cracking
 Information: Step cracking was identified to the brickwork in this area at the time of inspection. Step cracking, which is similar to other forms of cracking, has a variety of possible causes. However, the most common is the subsidence of adjacent footings.

Step cracking is a relatively common defect, and is most likely to occur adjacent to windows, doors and other openings. Mortar failure in the gaps between affected bricks indicates the stresses and tensions affecting the wall.

Where step cracking is extensive or severe, the client is advised to consult a structural engineer. Minor step cracking can be used as a warning sign to address factors causing stress to the wall, which can include the effect of surrounding trees, water leaks, soil erosion, or even the presence of reactive soils in the surrounding area.

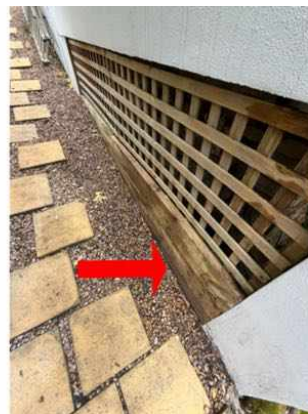
Building:	Yard
Location:	Yard
Finding:	In ground contact
Information:	Any timbers in direct ground contact provide opportunity for concealed termite entry and are likely to be subject to premature rot and decay as the soil retains moisture or damp conditions against the timbers.

Treated Timbers can decay or be poorly treated at manufacturing and as they degrade overtime can allow for termite attack.

Remove any timber that is in direct contact with external grounds. Consider replacement with more durable materials i.e. non timber elements. Frequent pest inspections are advised to readily identify any termite activity in these areas.

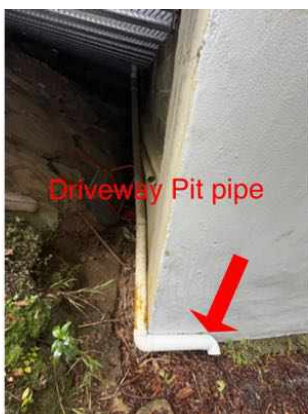
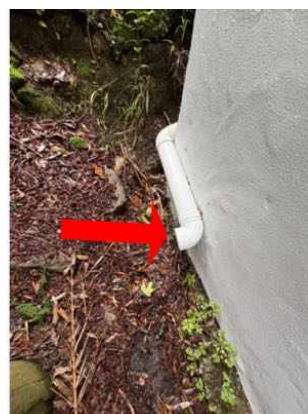
Finding 6.02

Building:	Main Building
Location:	Downpipes
Finding:	Downpipe(s)-not connected
Information:	The roof plumbing is not adequately connected to stormwater drainage on the site. This disconnection negatively impacts the functional capacity of the roof plumbing.

Where roof plumbing doesn't drain adequately, the area at the base perimeter can become excessively damp, potentially creating an environment that is susceptible to rust and corrosion of surrounding building elements, as well as attracting termites and other pests.

It is highly recommended that a plumber be appointed to further inspect the area and to connect all downpipes adequately as soon as possible.

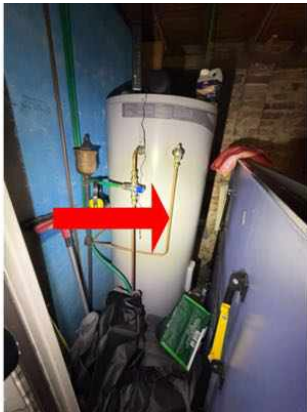
Finding 6.03

Building:	Main Building
Location:	Hot Water/AC units
Finding:	Overflows not plumbed to drainage
Information:	The overflow is not plumbed or connected to suitable drainage, which has resulted in the surrounding area becoming excessively damp.

These damp conditions can lead to secondary defects such as rot, rust or corrosion of associated building elements, the formation of fungal decay, or even the creation of potential slip hazards. When coupled with poor site drainage, pooling of water may also attract termite activity to this area.

It is highly recommended that a qualified plumber be appointed to install adequate drainage to the overflow. These works will ensure that the area remains dry and free of any secondary defects.

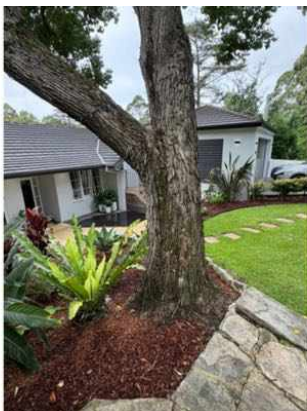
Finding 6.04

Building:	Main Building
Location:	Yard
Finding:	Large trees/stumps within 30m of house
Information:	There are a number of large trees/stumps within 30m of the house which may contain natural termite activity. It is important to monitor these areas to ensure no natural activity is allowed to progress into the main house.

Regular inspections are recommended. Consider test drilling any large trees.

A pest controller can be contacted to carry out such testing at the owners discretion.

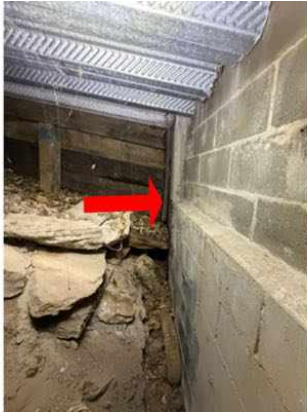
Building:	Main Building
Location:	All Areas
Finding:	Fungal decay - present at the time of inspection
Information:	Fungal decay also known as wood decay or wood rot occurs when timbers and other cellulose building materials are exposed to damp conditions on an ongoing basis. This could be the result of exposure to weathering in the long term or the pooling of water or absorbed moisture from other abutting building materials or a shower leak. It is advisable to remove these affected timbers to prevent any chance of termite attack in the future.

Wood decay is more susceptible to termite attack and these timbers should be replaced to limit termite attack.

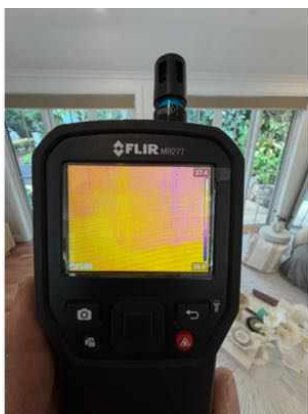
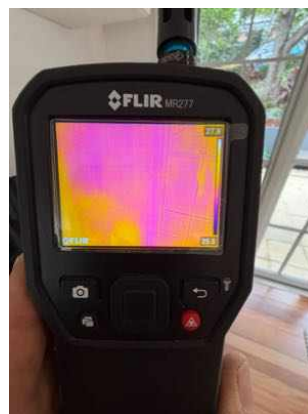
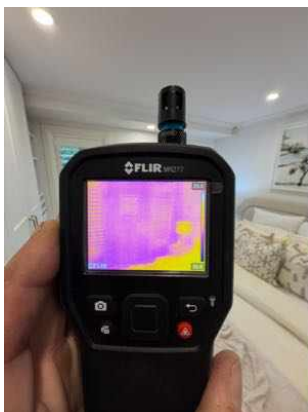
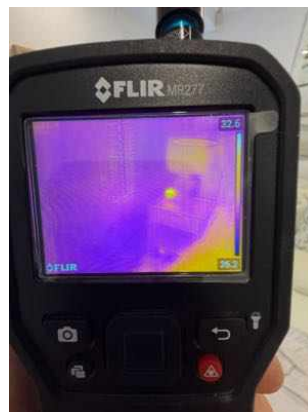
Building:	Main Building
Location:	All Internal Areas
Finding:	For your information-Thermal camera
Information:	AS 3660.2:2017 is the recommendation for the carrying out of 'Additional Tests' using specialist non-destructive tools:

A thermal imaging inspection was carried out throughout the interior of the house using a Flir MR277 thermal camera. No thermal anomalies were noted that would be consistent with any current termite activity, however various factors must be taken into effect which may hamper or impede the reading obtainable by the imager. These factors include obstructions, ambient temperature, wall material and thickness etc. If any surface is restricted visually or otherwise, a proper thermal reading is not possible and is not within the scope of this inspection. Any findings or otherwise is reported on at the time of the inspection only.

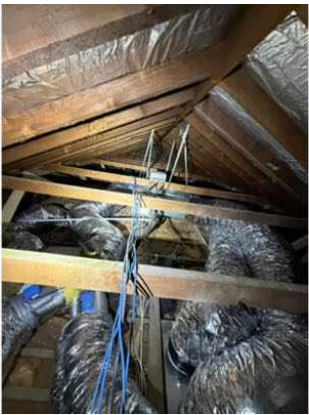
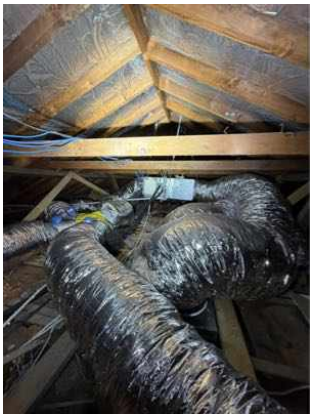
Building:	Main Building
Location:	Roof Void
Finding:	Obstructions and Limitations-Roof Void
Information:	<p>These photographs are an indication of the obstructions and limitations that impeded the full inspection of the roof cavity at the time of inspection. Note that the insulation covered nearly all the ceiling joists, which are a major structural element of the ceiling; the inspection was also limited to areas with an allowable crawl space of 600mm x 600mm, in particular towards the external walls where the roof line diminishes, it was not accessible. These obstructions and limitations can hide an array of defects and should be removed to allow a full inspection to be carried out. A re-inspection is recommended once areas are made accessible.</p>

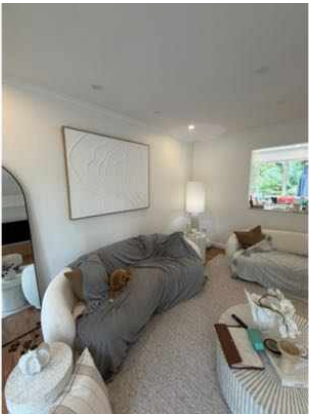
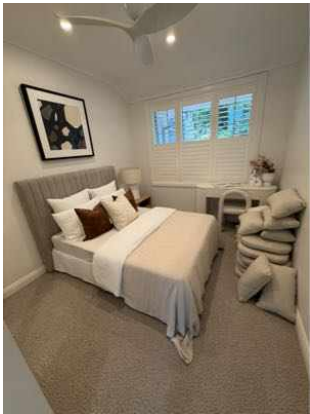
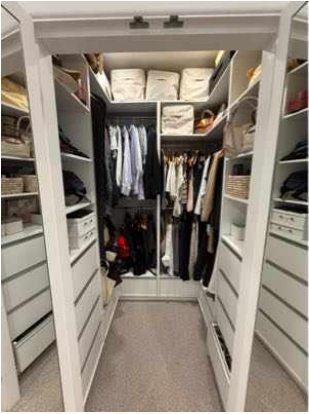
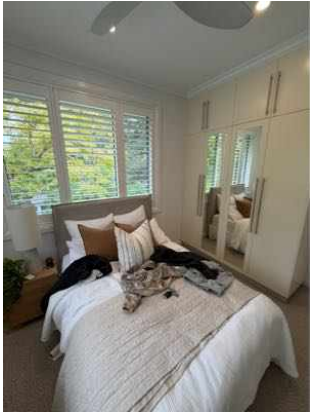
Building: Main Building
Location: Internal Areas
Finding: Obstructions and Limitations-Internal areas
Information: These photographs are an indication of the obstructions and limitations which impeded full inspection of the internal areas at the time of inspection. These obstructions can hide an array of defects and should be removed to allow a full inspection to be carried out. A re-inspection is recommended once the areas are made accessible.

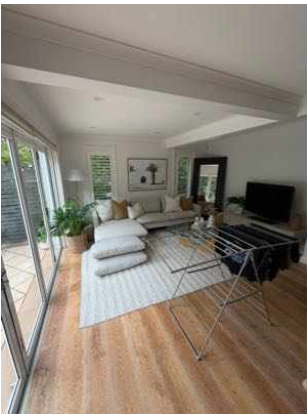
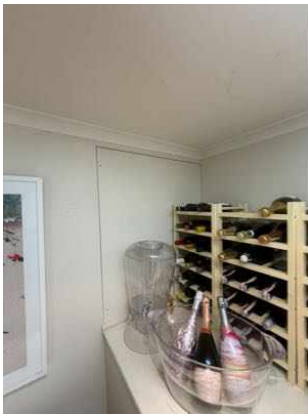
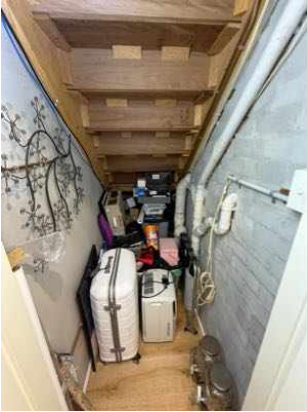
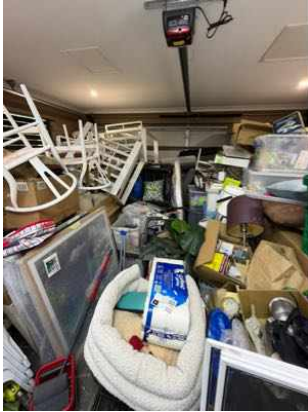
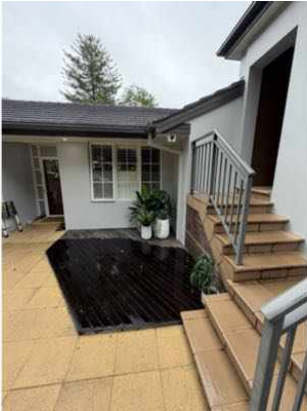
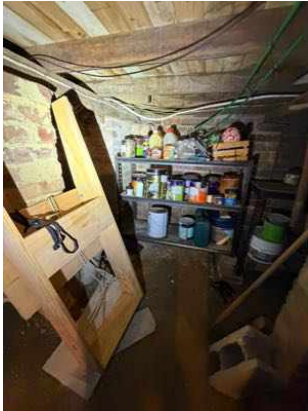
Building: Main Building
 Location: External Areas/Sub-Floor
 Finding: Obstructions and Limitations-External Areas/Sub-Floor
 Information: These photographs are an indication of the obstructions and limitations which impeded full inspection of the external areas/subfloor at the time of inspection. These obstructions can hide an array of defects and should be removed to allow full inspection to be carried out. A re-inspection is recommended once the areas are made accessible.

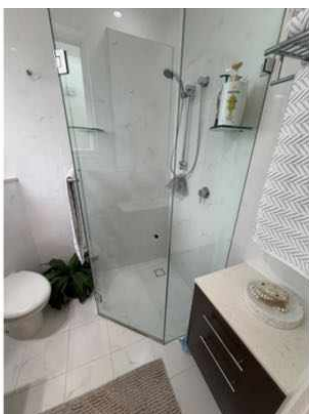
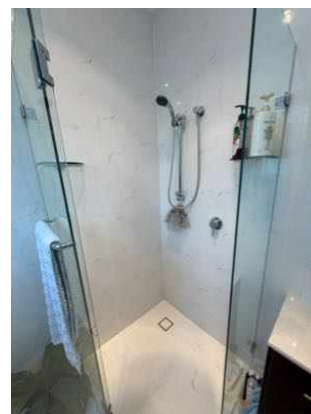
However, it should be noted that the waterproofing systems to shower areas are concealed behind tiles and wall linings and cannot be directly inspected during a visual building inspection. As such, it is not possible to confirm whether the waterproofing has been installed in full compliance with current standards.

Based on the observations made at the time of inspection, no defects were evident and the showers appeared to be functioning as intended. Ongoing monitoring and regular maintenance of seals and grout are recommended to help prevent future water ingress.

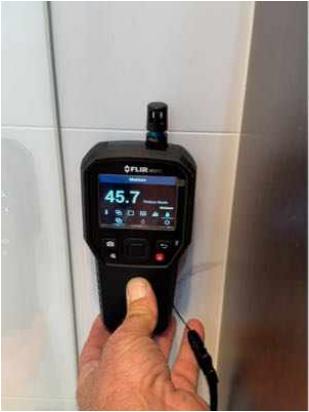
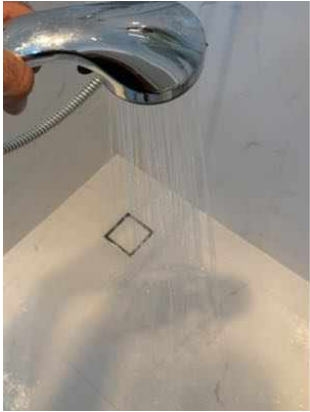
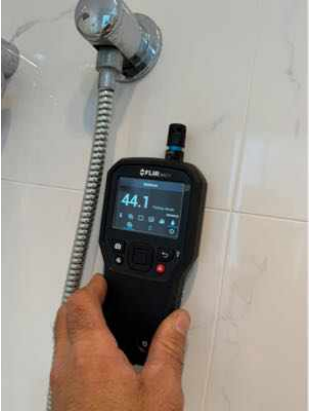
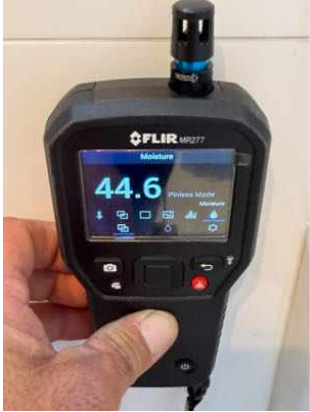
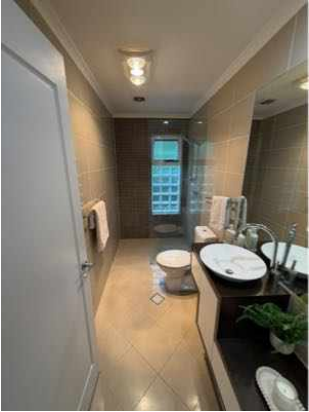
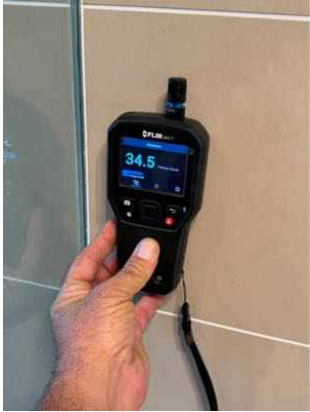
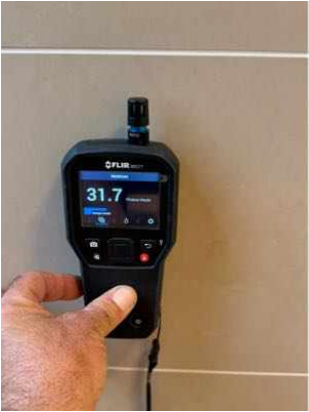
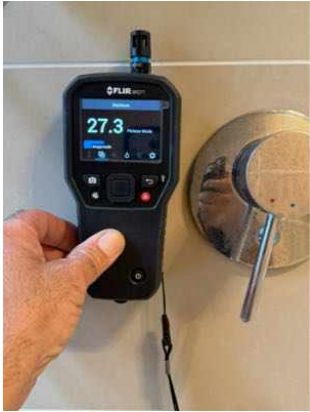
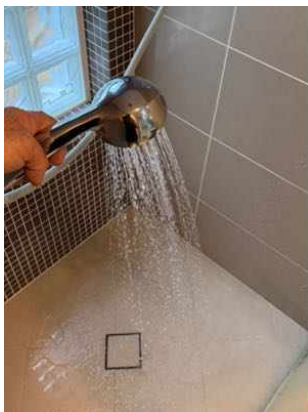
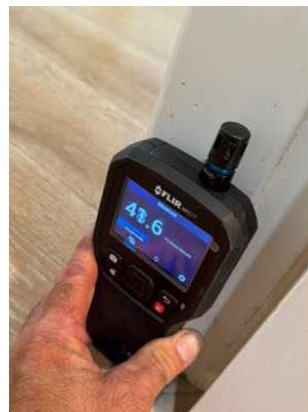
Finding: Shower/s Condition

Information: At the time of inspection, the showers within the dwelling were flood tested, checked for signs of leakage and tested for elevated moisture readings in the surrounding wall and floor areas. No visible leaks, moisture intrusion, or abnormal moisture readings were detected during the inspection, and the shower areas appeared to be performing satisfactorily at that time.

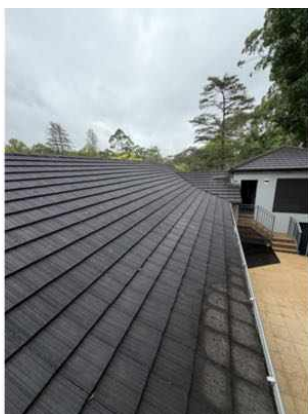
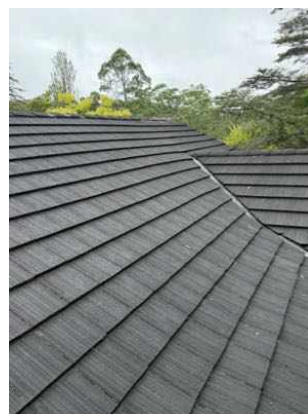
Building: Main Building
 Location: Roof Exterior
 Finding: FYI-Roof tiles - Weathered
 Information: Upon inspection of the exterior roofing, the majority of roof tiles were considered to be in a fair condition. While weathering of the tiles is consistent with the age of the property, maintenance works are required.

5 or 6 tiles were observed to be cracked at the lower corners which should be replaced.

Isolated areas of mortar have come loose and minor cracking is also present. Re-pointing and re-sealing the may be considered as an interim solution by the client to help preserve and extend the life span of the tiles.

Where left unmanaged, deteriorating roof tiles are likely to lead to a number of secondary defects, including minor water leaks and weather exposure to internal roofing structures.

Consultation with a roofing contractor is highly advised to gain advice on cost of remedial works that may be required in the short to medium term. Remedial works are likely to increase the longevity of the exterior roofing structure.

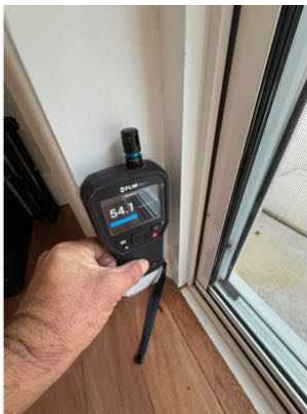
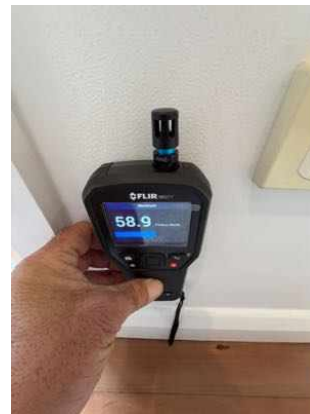
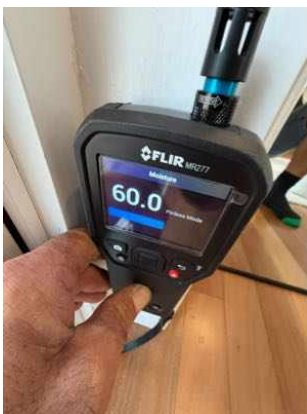
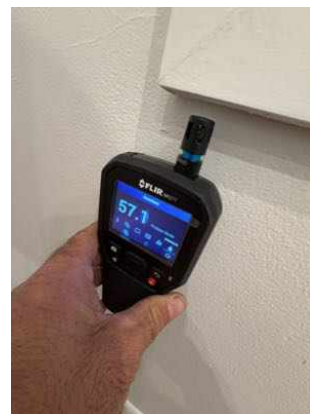
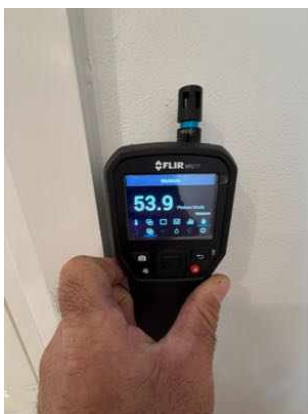
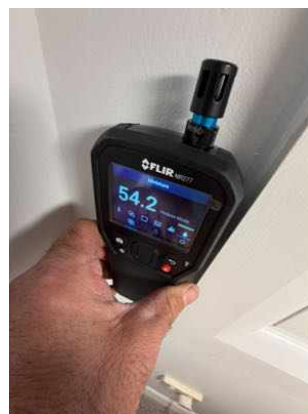
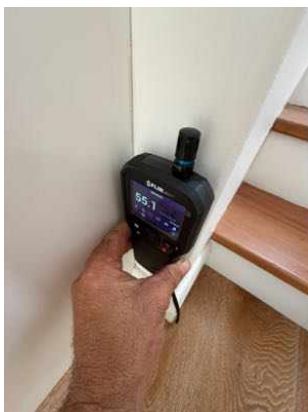
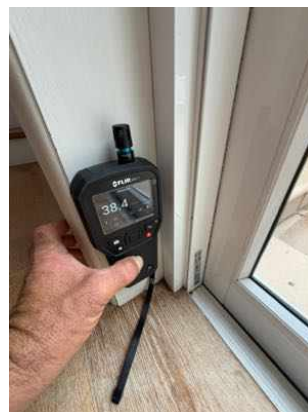
Building: Main Building
Location: All Areas
Finding: FYI-Moisture Readings
Information: Moisture readings taken during the inspection were recorded using a FLIR MR277 moisture meter, which provides numerical values rather than direct percentage readings. These values are not expressed as a percentage of moisture content but rather as relative indicators of moisture presence within building materials. Each material-such as plasterboard, timber, tile or concrete wall surfaces -has its own baseline range of ambient moisture, and the meter’s readings reflect deviations from that baseline.

In short, while percentages are familiar, the meters numeric scale offers a more nuanced and material - sensitive method of identifying moisture issues. Elevated readings – especially those exceeding baseline values by around 20 points or more – are flagged for further investigation, even if no visible damage is present.

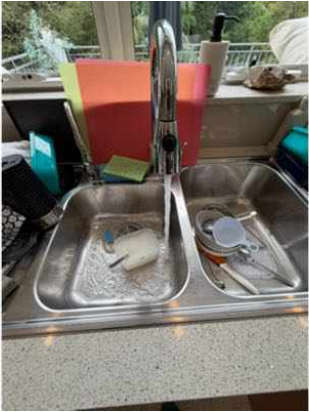
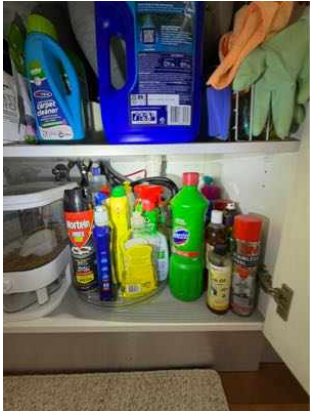
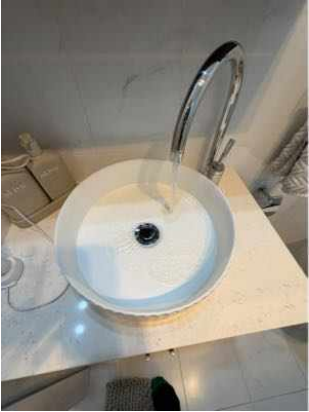
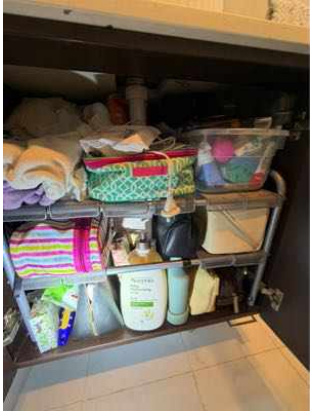
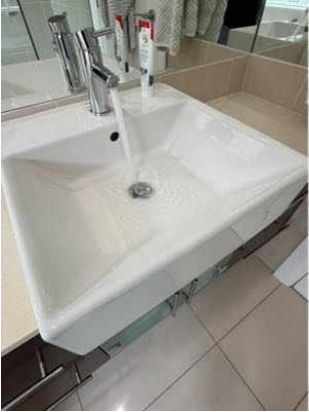
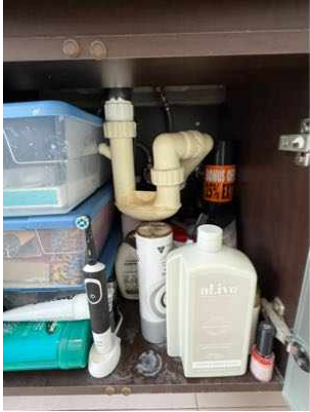
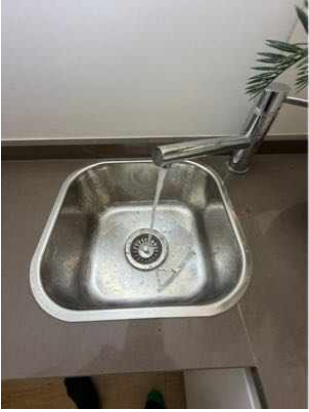
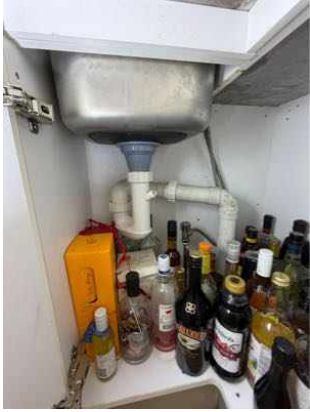
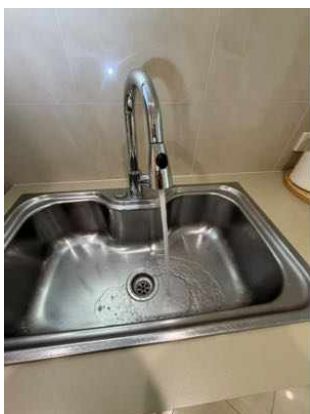
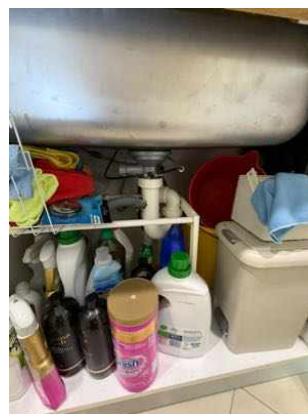
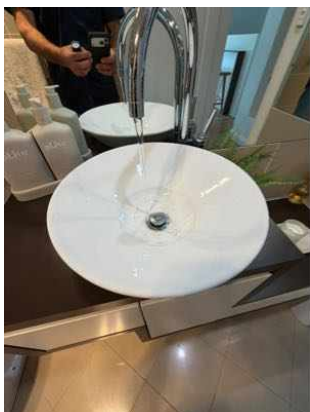
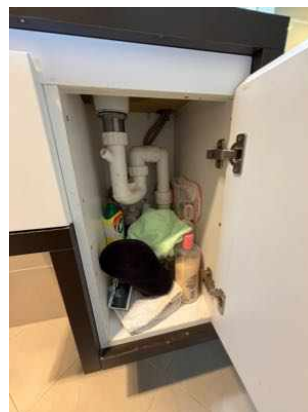
Building: Main Building
 Location: Cabinetry Plumbing
 Finding: FYI-Cabinetry Plumbing
 Information: All cupboards where sinks and basins with drainage plumbing were inspected no evidence of leaks were present at the time of inspection.

NOTE: Please be aware that although cupboards have had a thorough inspection, obstructions in cupboards may conceal potential water damage, prevent a full inspection and conditions can change after the initial inspection was carried out, therefore damage may be found after obstructions are removed.

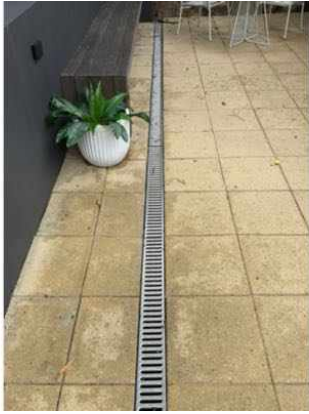
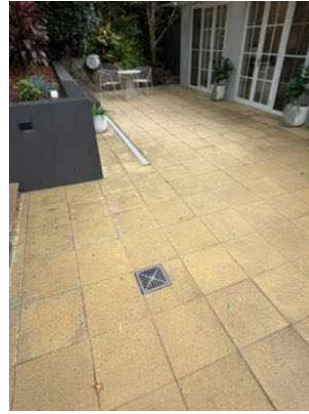
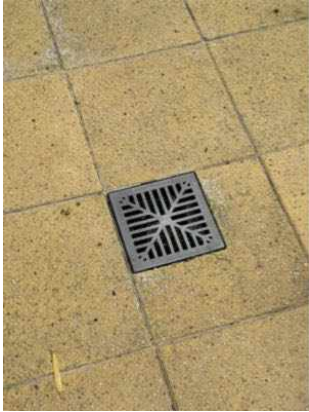
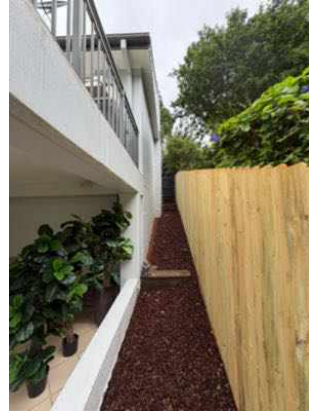
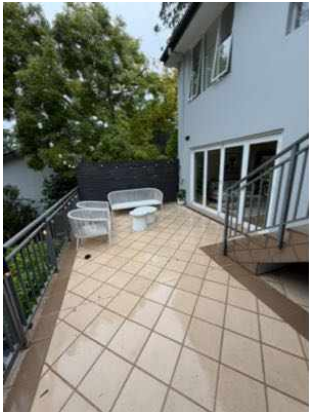
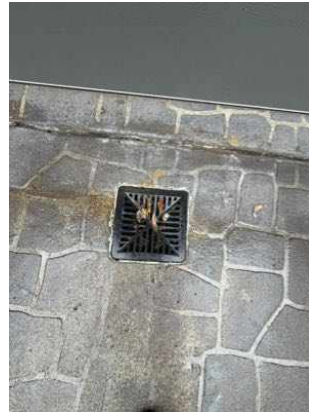
The general adequacy of site drainage is not included in the standard property inspection report. Comments on surface water drainage are limited as where there may have been either little or no rainfall for a period of time, surface water drainage may appear to be adequate during the inspection but then during periods of heavy rain may be found to be inadequate.

Any comments made in this section are relevant only in light of the conditions present at the time of inspection. It is recommended that a smoke test be obtained to determine any illegal connections, blocked or broken drains.

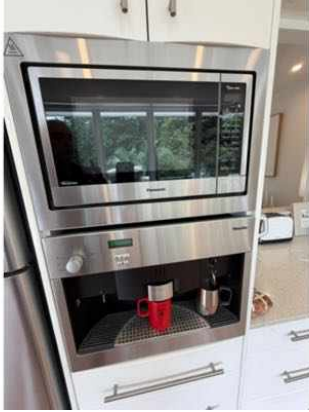
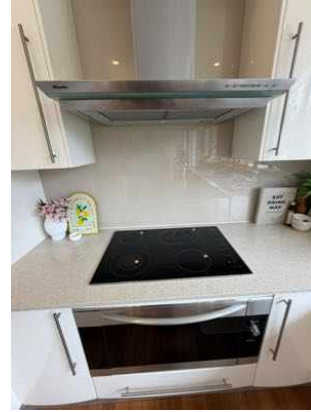
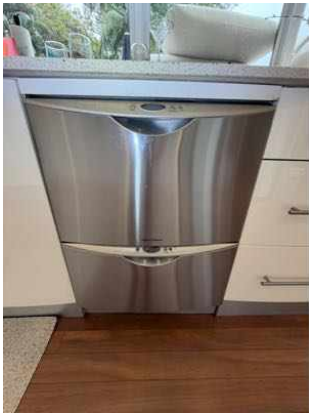
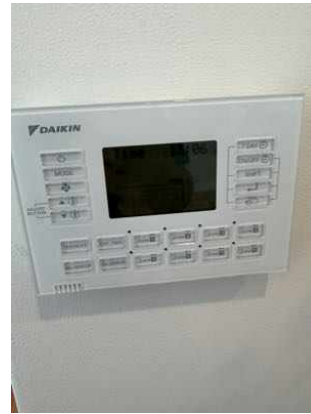
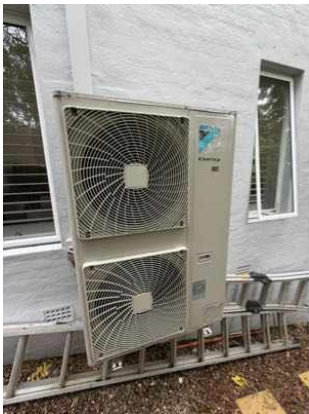
It is highly recommended that the client makes immediate arrangements to have the gas appliances checked by a licensed gas plumber to ensure that the appliances are working safely and efficiently.

We recommend all other installations be checked also.

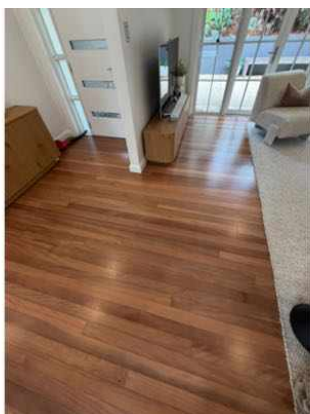
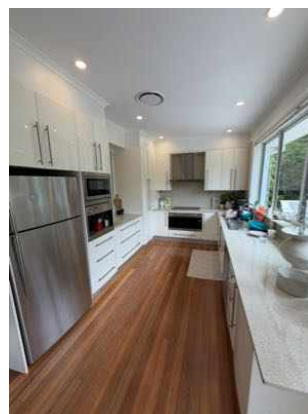
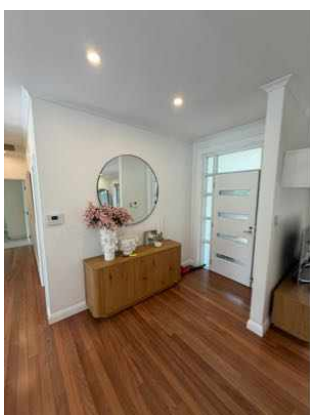
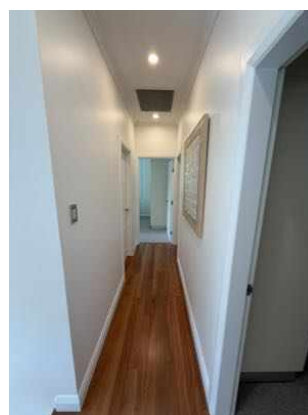
Building: Main Building
 Location: All Internal timber flooring
 Finding: FYI-Internal Timber Flooring
 Information: At the time of inspection, the internal hardwood timber flooring throughout the dwelling was observed to be in good overall condition. No significant defects, excessive

movement, or notable deterioration were identified at the time of the inspection. The flooring appeared to be serviceable and performing as intended.

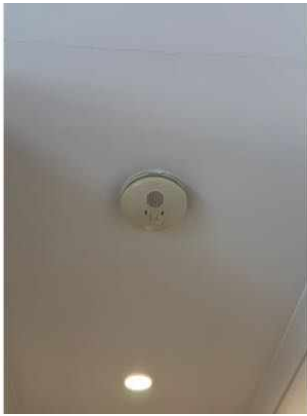
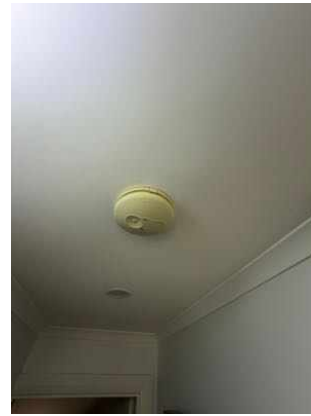
Building: Main Building
 Location: Smoke Detectors
 Finding: FYI-Smoke Detectors and Alarms
 Information: Reporting on Smoke Detectors or Alarms, including hard wired smoke detection systems and their legislative requirements, is outside the Scope of this Report.

Please note that this defect is highlighted as a caution only. We suspect, based on our experience in the building industry, that the absence of smoke detectors, or their poor condition, should be addressed as a matter of urgency to improve occupant safety.

Always ensure sufficient working and suitable smoke detectors are installed prior to occupying any building. Additionally, it is advised that all smoke detectors be tested by the homeowner on a monthly basis.

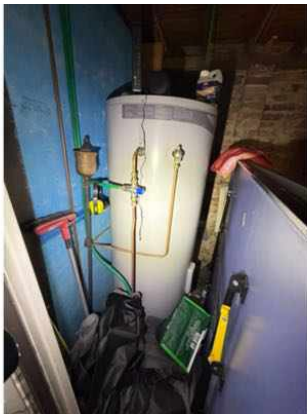
Building: Main Building
 Location: Hot Water System
 Finding: FYI-Hot Water Unit
 Information: The HWS appeared to be in good condition at the time of inspection. For the date of manufacture - (see attached photo)

Water pressure appears to be normal, however, this is not an opinion of a licensed plumber. No water hammer was noted when taps are turned off fast.

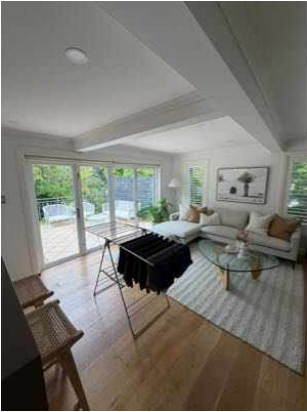
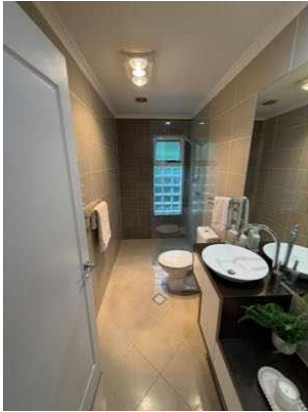
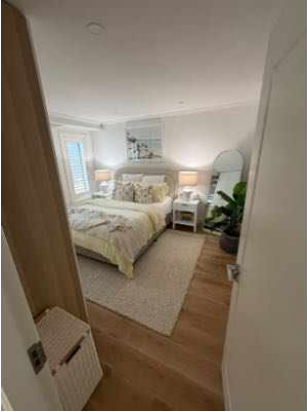
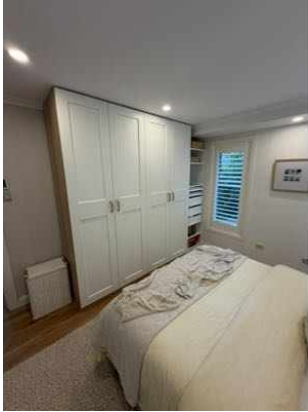
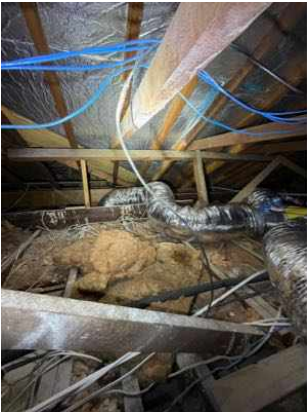
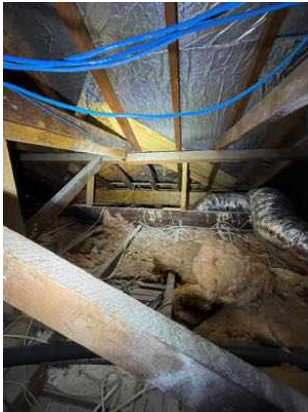
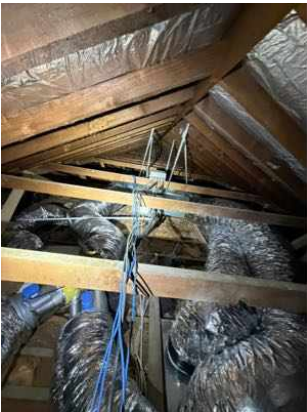
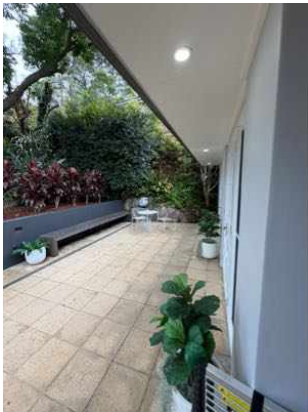
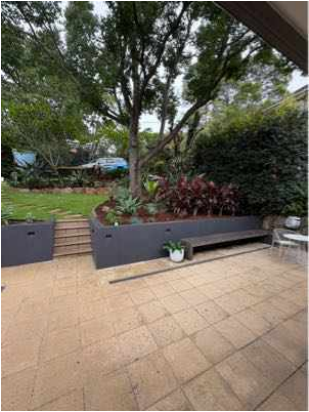
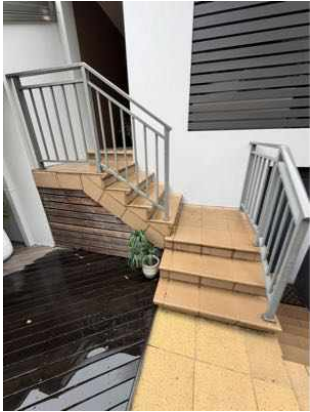
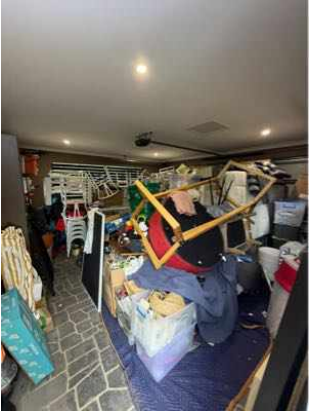
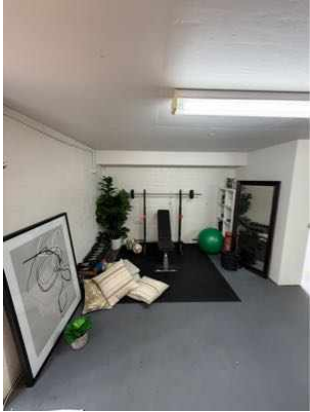
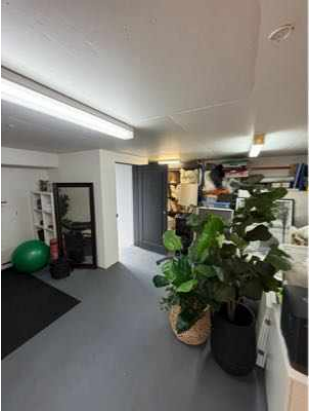
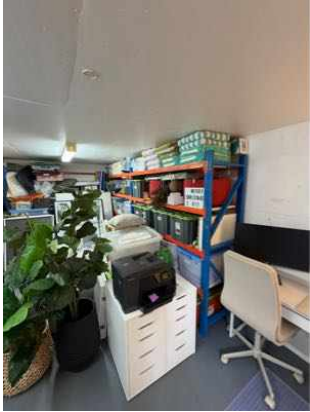
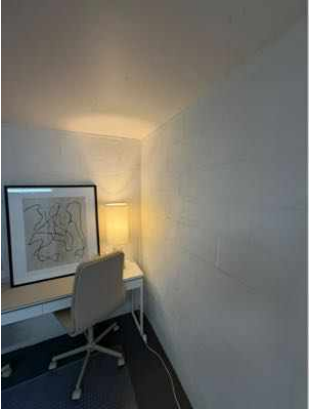
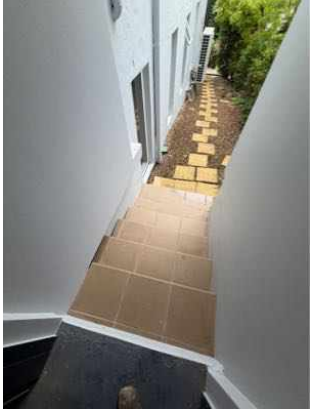
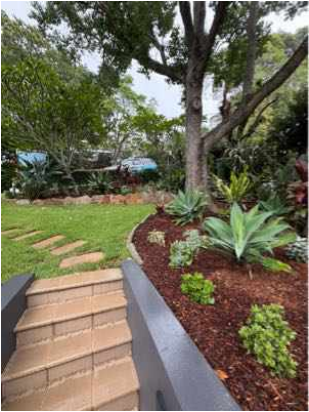
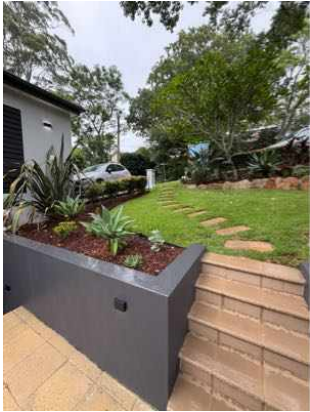
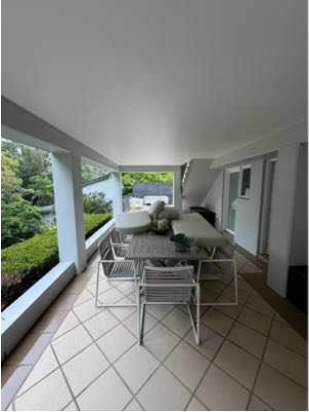
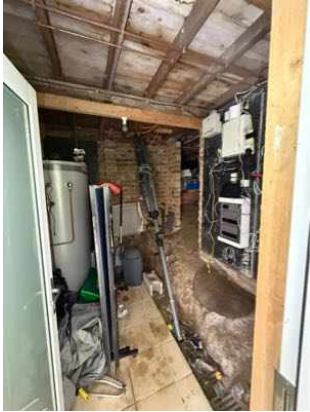
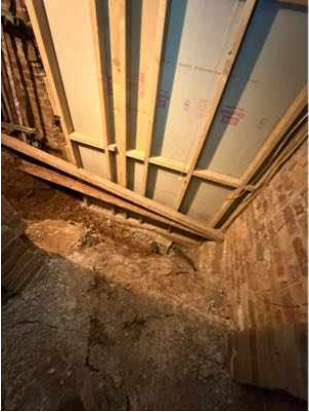
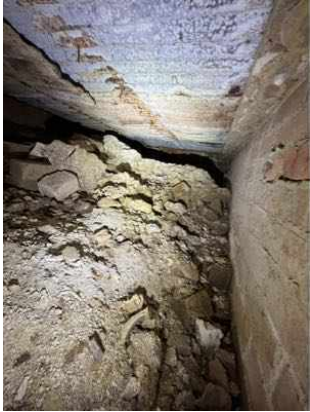
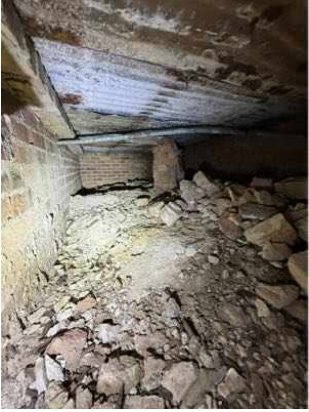
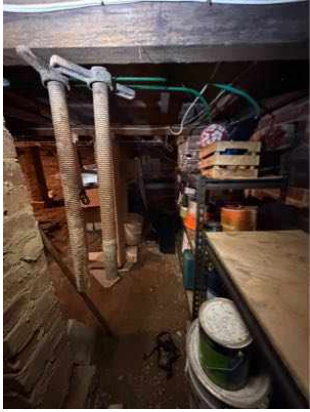
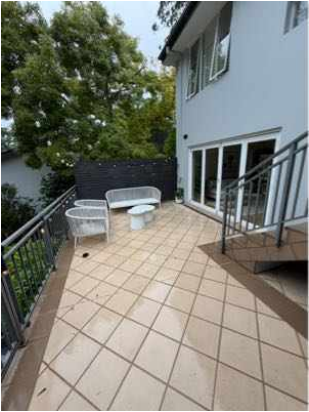
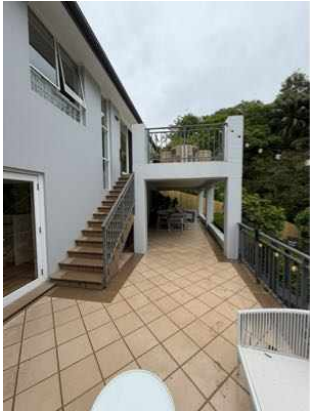
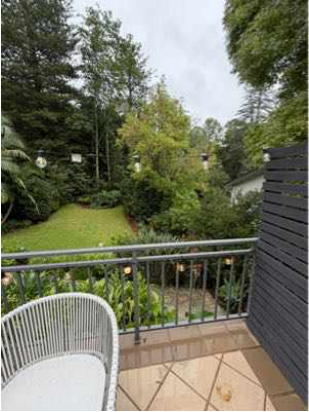
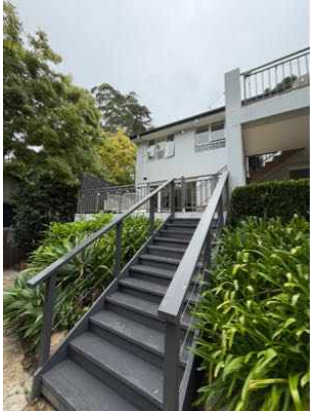
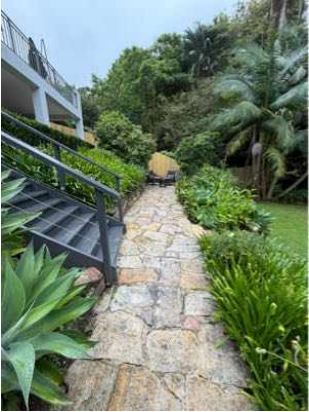
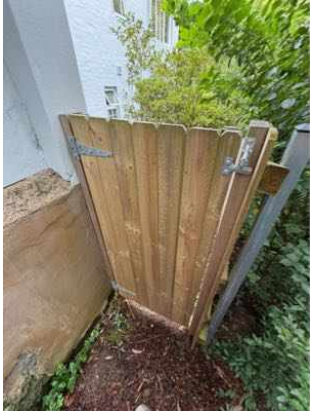
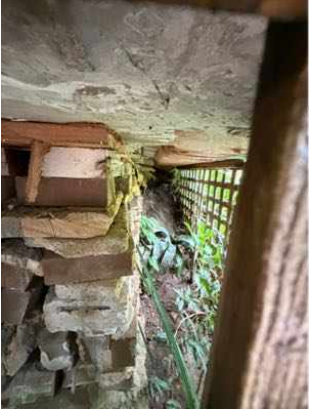
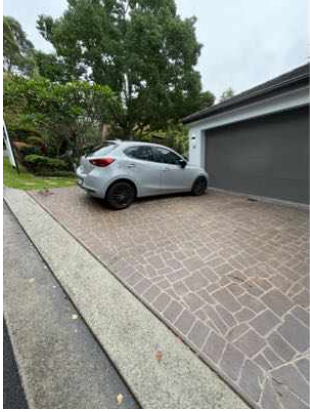
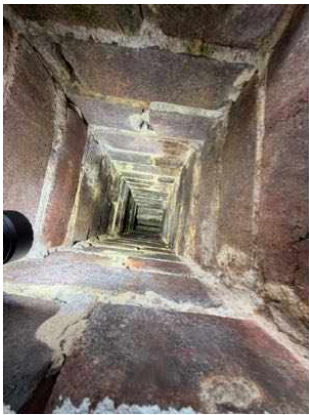
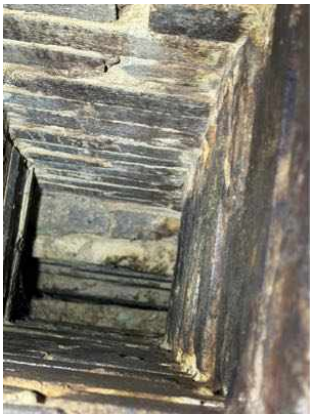
Building: Main Building
 Location: All Areas
 Finding: FYI-Additional Photos
 Information: Additional photos are provided for your general reference and may include obstructions, testing of water and windows, moisture readings or minor maintenance items.

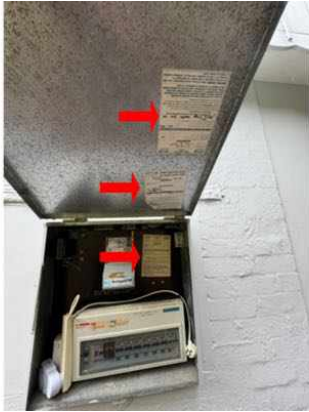
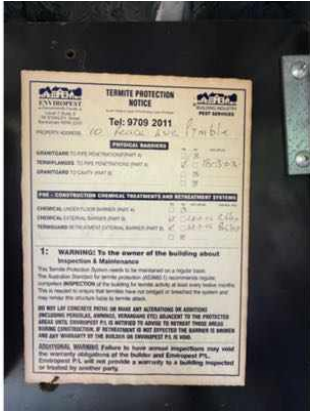
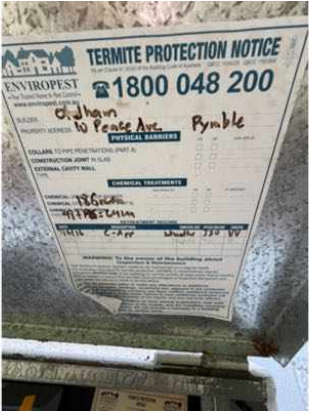
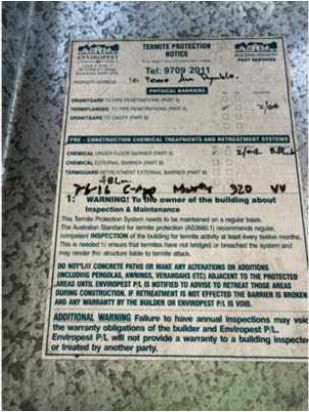
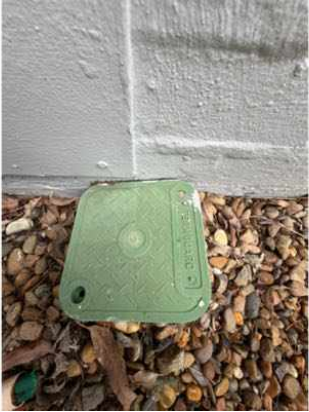
The following items were noted as - Evidence of a previous termite management program

Where a Termite Management System has been identified you should refer to the type of barrier date of installation warranty conditions and any documentation provided by a builder or past owner. Consult the company who installed the barrier to confirm whether the system is still under warranty.

Most chemical termite management systems expire and require replenishment and all physical systems are primarily designed to prevent concealed entry.
