Building and Timber Pest Inspection Report

Inspection Date: Wed, 11 Feb 2026

Property Address: 63 Bennett Rd, Thurgoona NSW 2640,
Australia

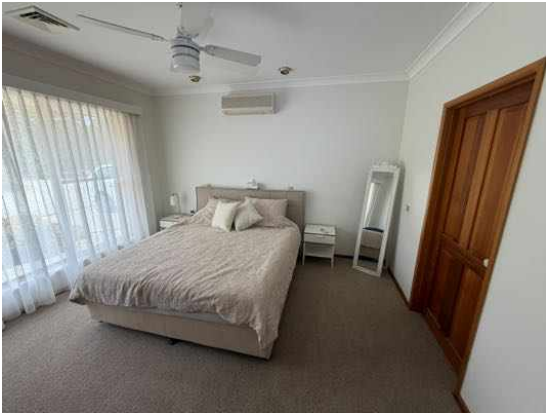
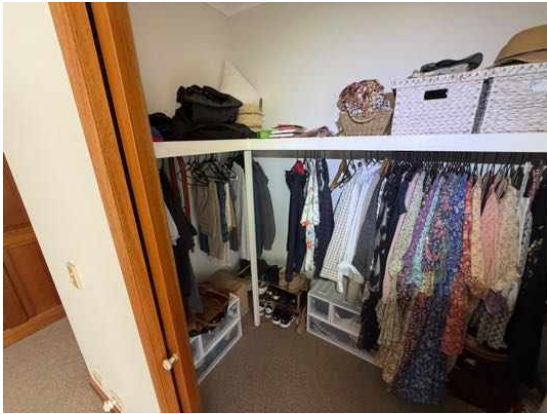
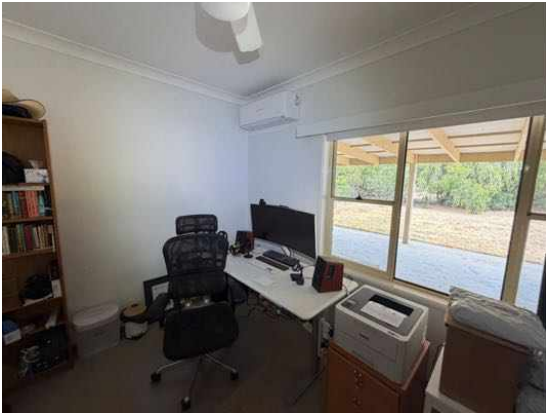
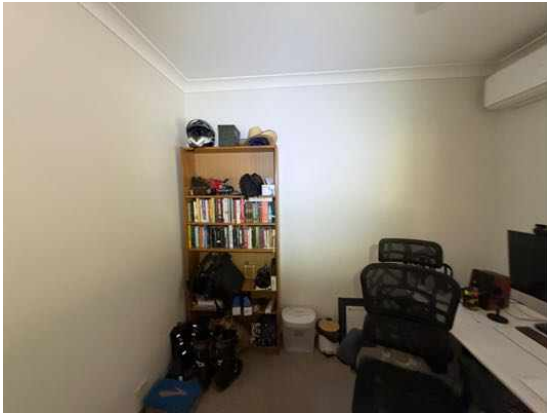
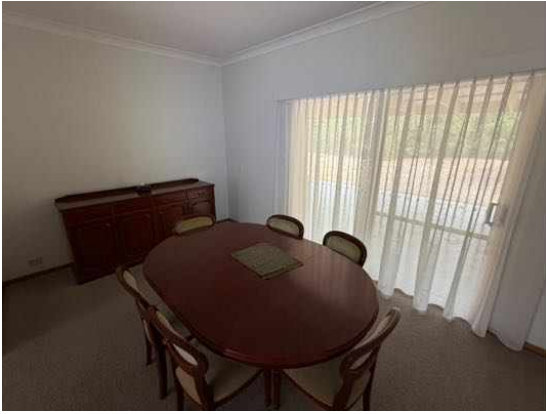
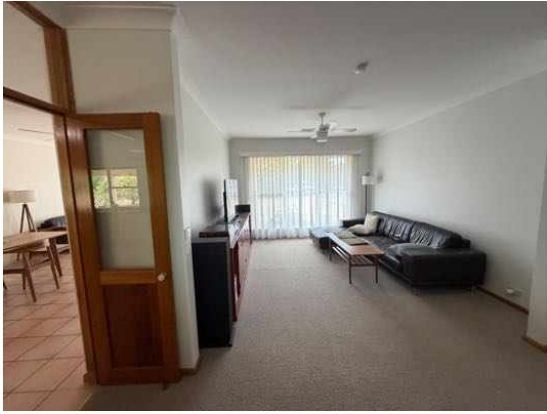
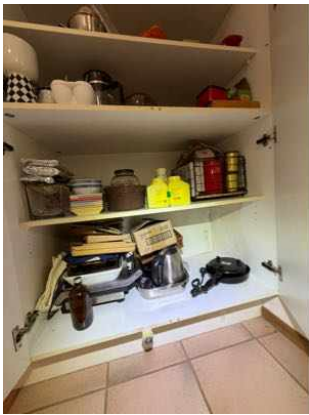
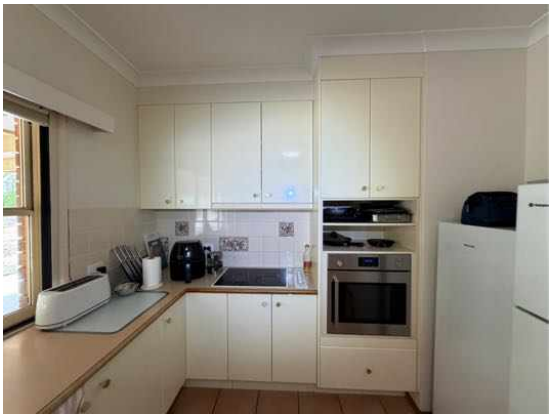
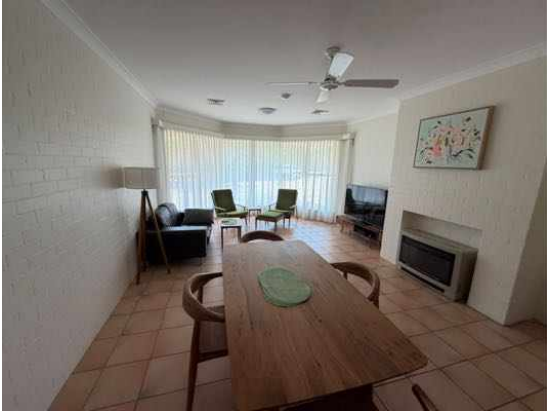
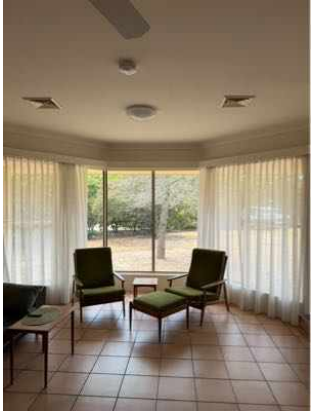
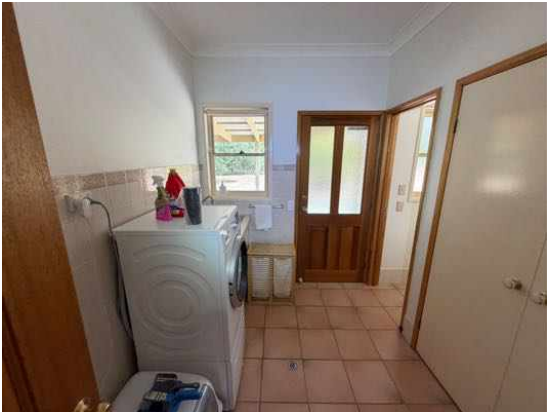
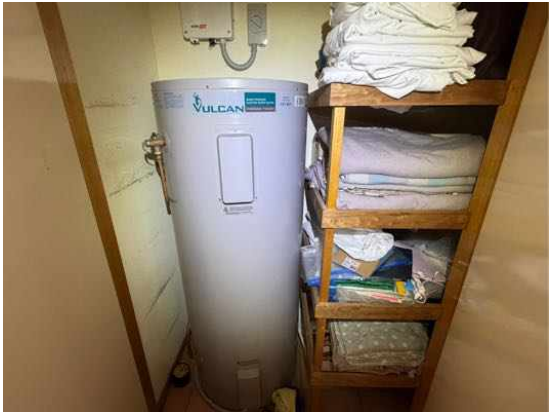
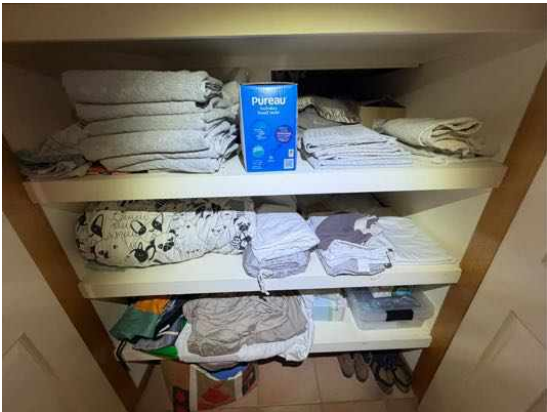
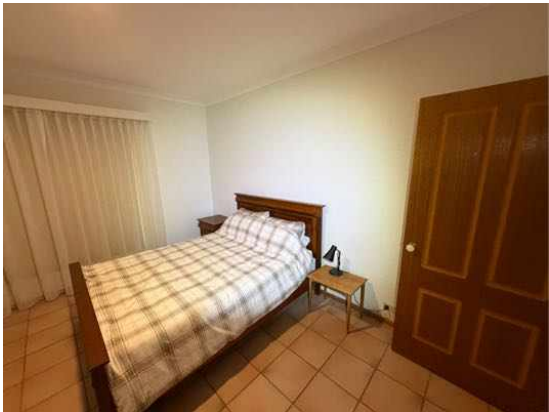
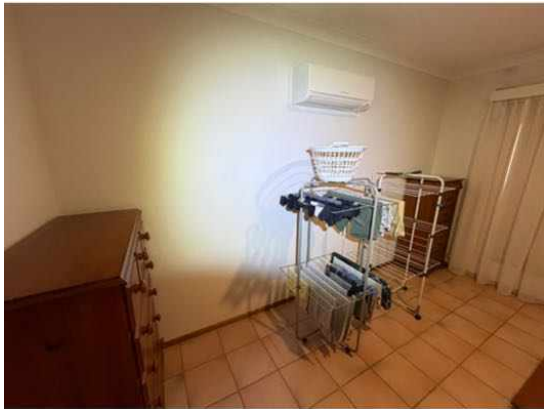
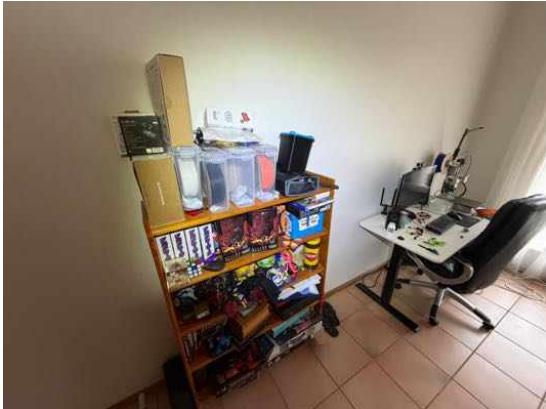
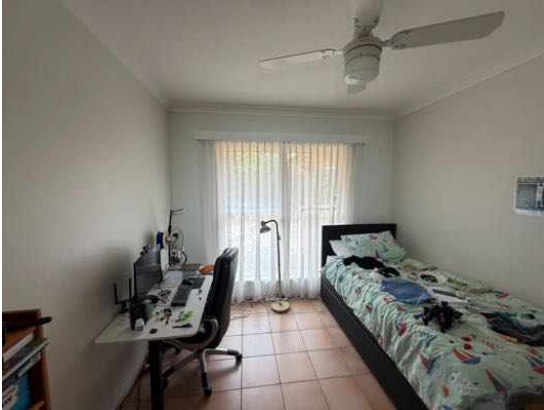
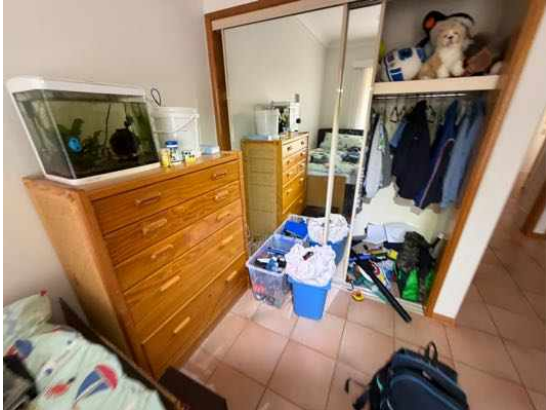
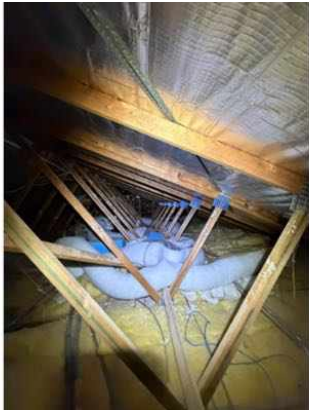
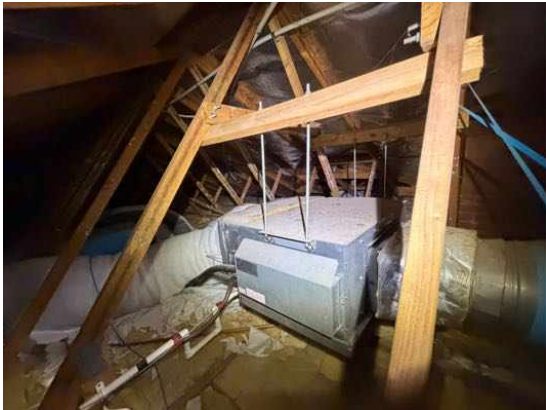
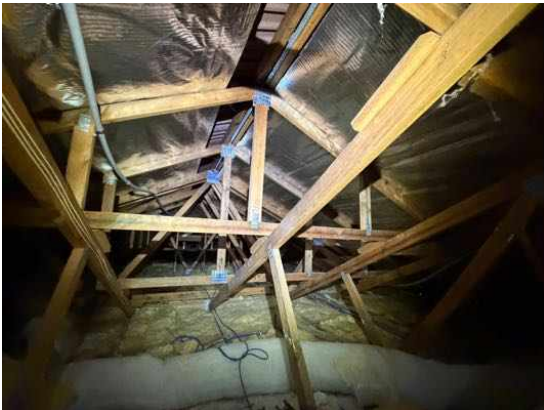
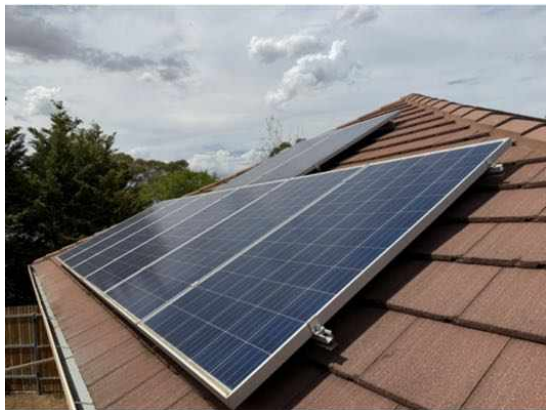
Building: Main Building
Location: All Areas
Finding: Additional Photos - Obstructions and Limitations
Information: These photographs are an indication of the obstructions and limitations which impeded full inspection of the property at the time of inspection. These obstructions can hide an array of defects and should be removed to allow full inspection to be carried out. A re-inspection is recommended once the areas are made accessible.
