Building and Timber Pest Inspection Report

Inspection Date: Tue, 7 Apr 2026

Property Address: 60 Redgrave Rd, Normanhurst NSW 2076,
Australia

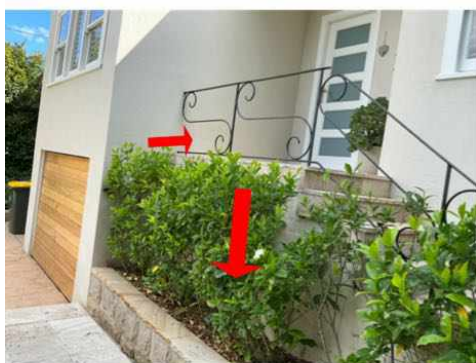
Building:	Main Building
Location:	Entry
Finding:	Spacing Between Balusters - Non Complaint
Information:	At the time of inspection, it was observed that the spacing between the balusters exceeds 125 mm. In accordance with the National Construction Code (NCC) 2022 Volume Two and referenced standards, any openings in a balustrade or barrier must be constructed to prevent a 125 mm sphere from passing through, in order to minimise the risk of falls or entrapment, particularly for young children.

The current baluster spacing does not comply with these safety requirements and may pose a fall or injury hazard. While this may have been acceptable at the time of original construction, it does not meet current Australian safety standards.

It is recommended that the balustrade be modified to reduce the openings between balusters to no greater than 125 mm, in accordance with current NCC requirements, to ensure occupant safety and compliance. Note: This might not be a requirement when the house was built.

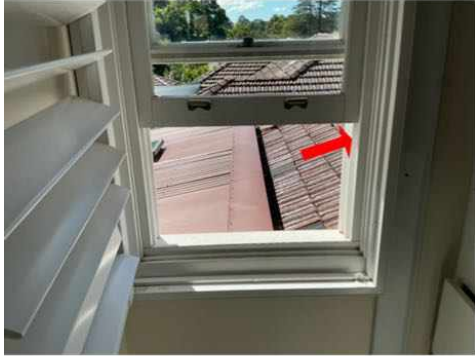
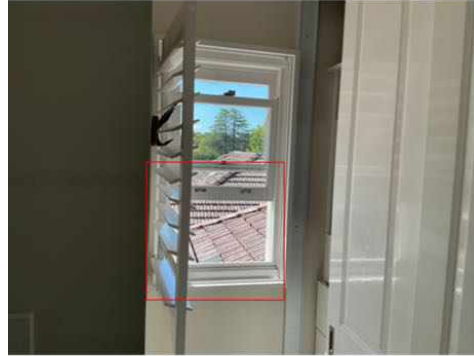
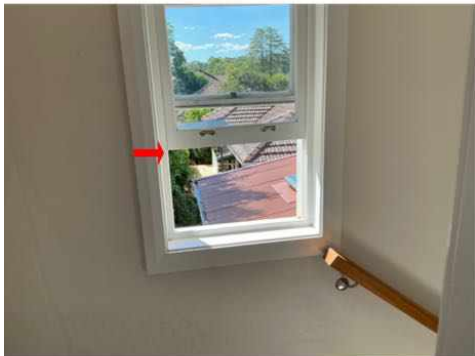
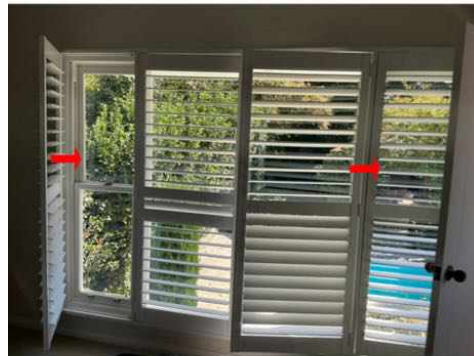
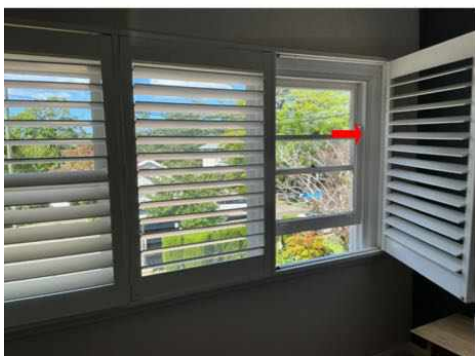
Finding 1.02

Building:	Main Building
Location:	All Areas
Finding:	Window Restrictors - Recommended
Information:	Upstairs windows did not have window restrictors installed. Although not a requirement at the time of construction, it is advisable to install window opening restrictors on all second storey windows with sill heights below 1.7 meter and potential fall of 2 meters or more.

If you live in a strata scheme, window safety devices must be installed on all applicable windows by 13 March 2018. Residents with safety devices installed can still fully open their windows but it's recommended that devices be engaged whenever children are present, to prevent falls.

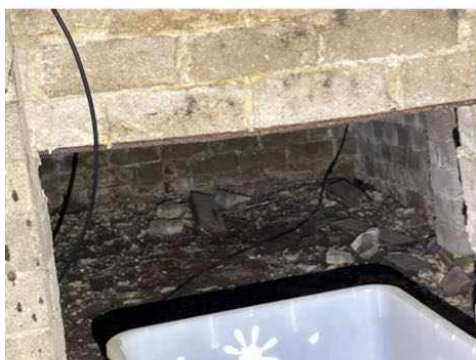
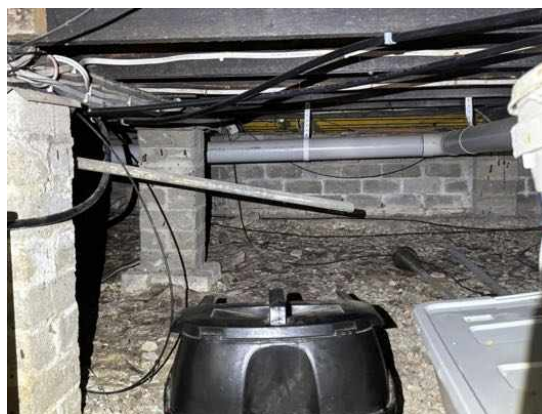
Building:	Main Building
Location:	Subfloor
Finding:	Subfloor Site Drainage - Inadequate
Information:	At the time of inspection, inadequate site drainage was observed under the subfloor, allowing water to accumulate and fail to drain effectively, creating a hazardous condition. This is a common defect in houses constructed on brick stumps, where poor site grading and limited subfloor ventilation can contribute to ongoing moisture retention. The resulting water pooling may lead to structural deterioration from prolonged dampness, mould and mildew growth, and create conditions conducive to termite activity. These issues can also impact indoor air quality and pose safety risks to occupants.

The client is advised to engage a licensed plumber or builder experienced in drainage and foundation work to assess and implement suitable solutions, such as improving site grading, installing appropriate drainage systems, and enhancing moisture barriers. In addition, the installation of mechanical subfloor ventilation is recommended to improve air circulation, assist with moisture control, and reduce the risk of ongoing damp-related issues.

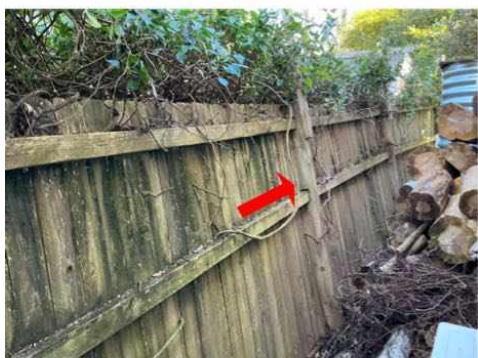
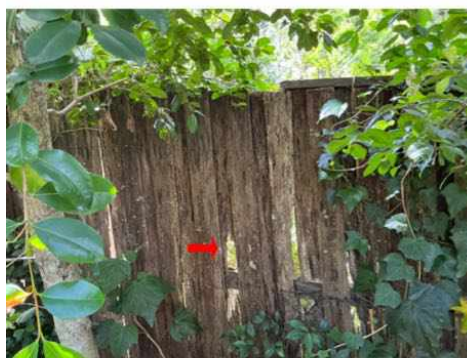
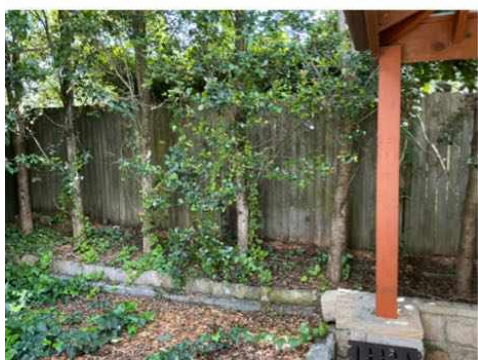
Finding 3.02

Building:	Main Building
Location:	Fencing
Finding:	Fencing - Damaged, Deteriorated & Leaning
Information:	At the time of inspection, the boundary timber fencing was noted to be in a deteriorated condition, with visible weathering, timber decay, and biological growth present across multiple sections. Several fence panels were observed to be leaning and out of alignment, indicating a loss of structural stability over time. In some areas, the timber palings appear aged and weakened, with gaps forming between boards, which may reduce privacy and effectiveness of the fence.

The deterioration is consistent with prolonged exposure to weather and moisture, and

may continue to worsen if not addressed. Vegetation growth and debris accumulation along the fence line may also be contributing to accelerated deterioration and movement.

The client is advised to engage the services of a qualified fencing contractor to assess the overall condition of the fence. Repairs and/or replacement of the damaged and leaning sections are recommended to restore structural integrity and ensure the fence remains safe and functional.

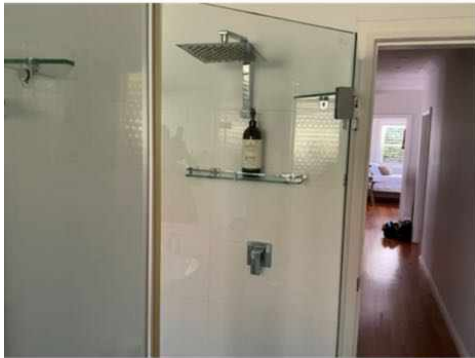
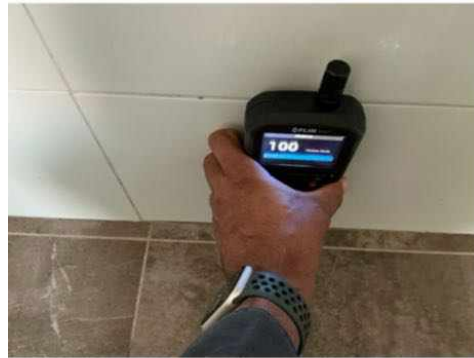
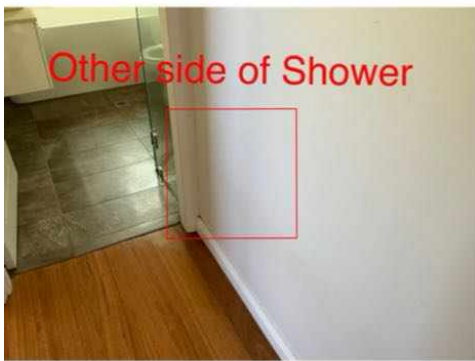
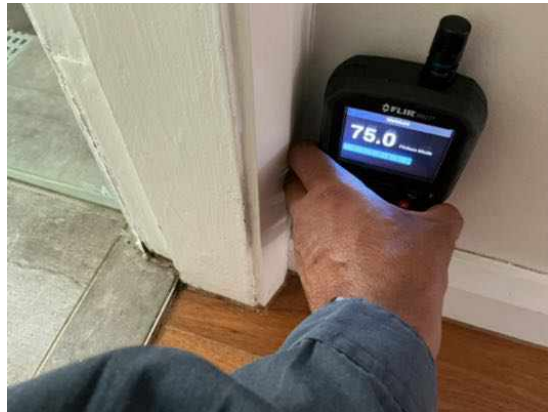
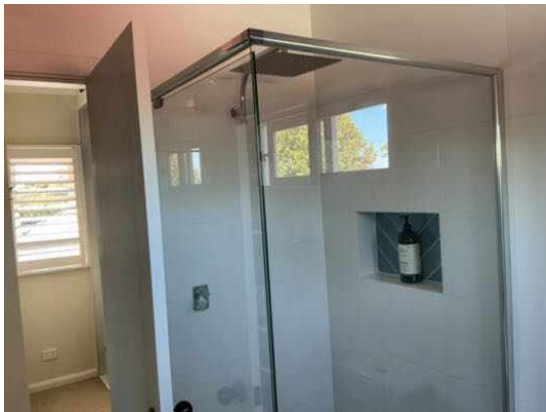
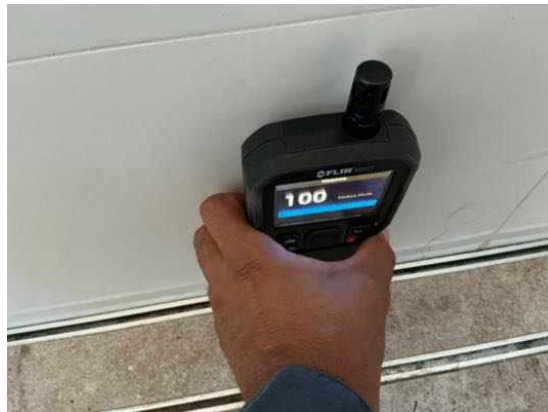
Finding 3.03

Building:	Main Building
Location:	Both Bathrooms
Finding:	Shower Damp - Adjacent Bathroom (Monitoring)
Information:	At the time of inspection, elevated moisture levels were detected on the wall adjacent to the shower area. While no visible water damage or deterioration was noted, the presence of moisture suggests possible seepage or condensation associated with regular shower use.

At this stage, no immediate action is required. However, the area should be monitored over the next 12 months for any signs of deterioration such as staining, bubbling paint, or mould growth. It should be noted that moisture ingress of this nature does not generally resolve without intervention, and at some point remedial works are likely to

be required. Should conditions worsen, the client is advised to engage services of a licensed plumber or waterproofing specialist to rectify the issue of moisture before this minor defect turns into major defect.

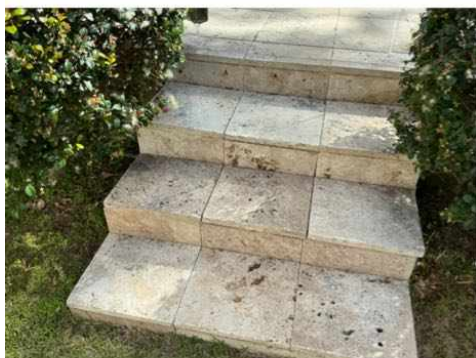
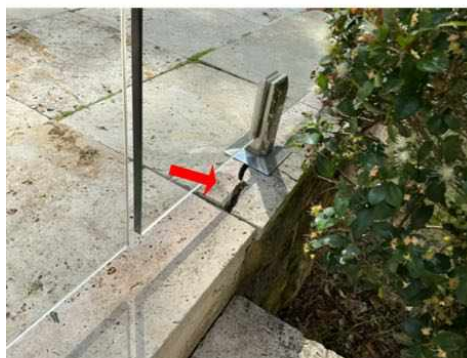
Finding 3.04

Finding: Poolside Tiling - Damaged & Uneven

Information: At the time of inspection, sections of the tiles adjacent to the pool area were noted to be damaged, cracked, and uneven. Multiple tiles appeared to have shifted out of alignment, with visible gaps and level inconsistencies between adjoining tiles. This condition is indicative of movement in the underlying substrate or wear and tear over time.

The uneven surface presents a potential trip hazard, particularly in a wet area such as around the pool. If left unaddressed, further movement and deterioration of the tiles may occur, potentially leading to additional damage and safety concerns.

The client is advised to engage the services of a qualified tiler to assess the affected areas. Replacement of damaged tiles and re-leveling of the uneven sections is recommended to restore a safe, stable, and functional surface.

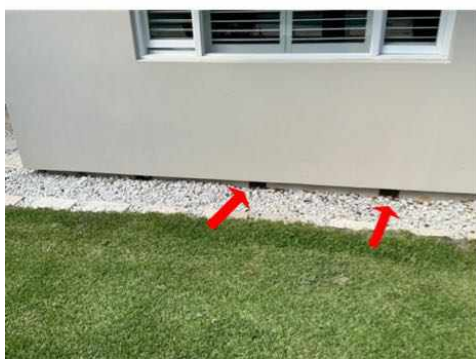
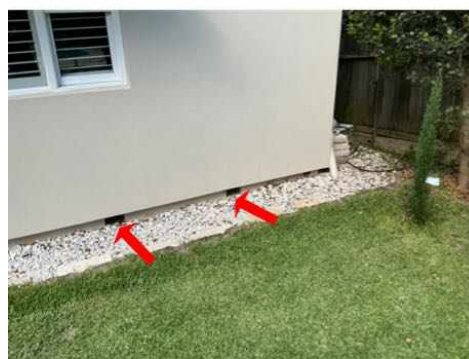
Finding 3.05

Building:	Main Building
Location:	Exterior walls - rear
Finding:	Subfloor Vents - At Ground Level
Information:	At the time of inspection, the subfloor ventilation openings were noted to be positioned at, or below, external ground level. This configuration poses a risk as rainwater and surface runoff can easily enter the vents and flow into the subfloor area, potentially creating ongoing moisture problems, timber decay, mould growth, and structural deterioration. Moist and poorly ventilated subfloor environments also act as conducive conditions for termite activity, attracting and supporting termite colonies beneath the structure.

It is strongly recommended that the client engage a licensed builder to assess and rectify the issue by raising the vent height or modifying the surrounding ground levels and drainage to prevent future water entry and reduce termite risk.

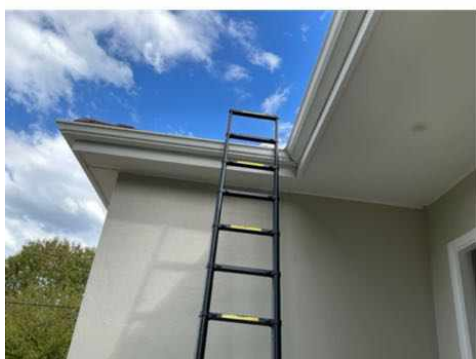
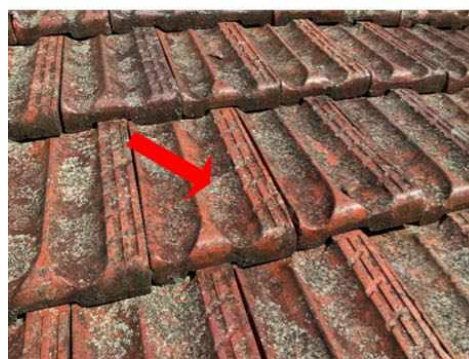
Finding 3.06

Information: Upon inspection of the exterior roofing, the majority of roof tiles were considered to be in a fair condition. While weathering of the tiles is consistent with the age of the property, maintenance works are required like repairing mortar joints.

Concrete roof tiles are typically cleaned to have the visible moss and lichen removed. Concrete tiles are made from a product which is a naturally moist material. Moss and lichen is attracted to the roof tiles surface, and if left will continue to grow and most likely restrict the flow of rain water over the tiles surface, into the roofs gutters. An application of an environmentally friendly anti-fungal solution should be applied to all moss and lichen, prior to undertaking the roof cleaning process.

A roof restoration company can be contacted for further advice at the clients discretion.

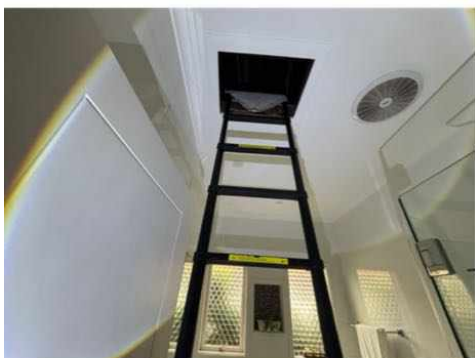
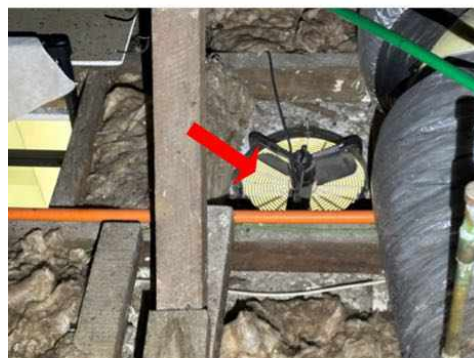
Finding 3.07

Building:	Main Building
Location:	Lower Level Roof Void
Finding:	Vent - Extracted into Roof Space
Information:	During the inspection, it was noted that the exhaust vent has been improperly terminated into the roof space instead of being ducted to the exterior of the property.

This configuration is a defect as it allows moist air to accumulate within the roof cavity, increasing the risk of condensation, mould growth, and deterioration of insulation or timber framing. Proper ventilation is essential to maintain a healthy indoor environment and protect the structural integrity of the building. It is recommended that the vent be appropriately re-routed to discharge externally in compliance with relevant building standards.

A licensed mechanical ventilation contractor/electrician should be appointed as soon as possible to provide further consultation on the scope of these works and to provide quotations for any necessary works.

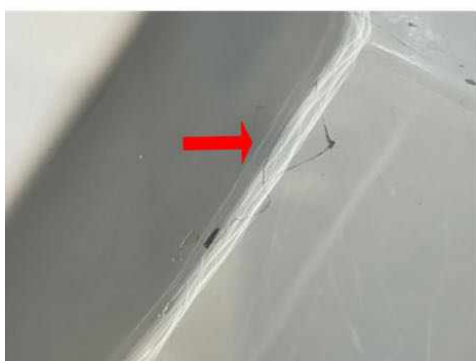
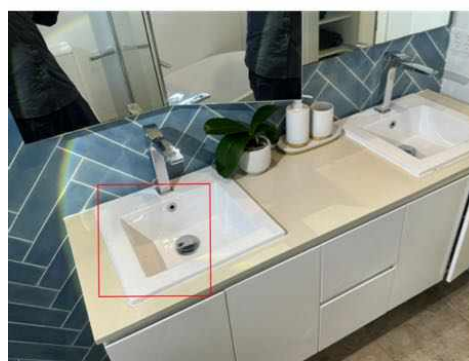
Finding 3.08

Building:	Main Building
Location:	Ensuite - Master
Finding:	Sink - Cracked
Information:	At the time of inspection, a visible crack was noted on the surface of the bathroom sink basin. While the crack appears minor, it may worsen over time due to regular use and moisture exposure. It is recommended to engage a licensed plumber to assess and replace the basin to prevent potential water damage to the underlying vanity unit and maintain the integrity of the bathroom fixture.

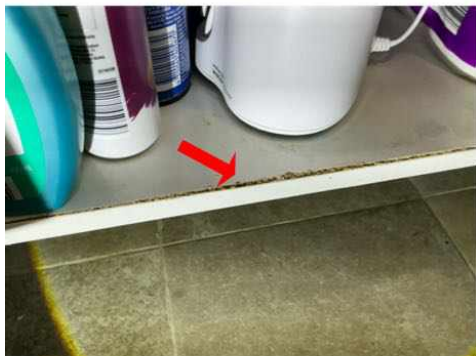
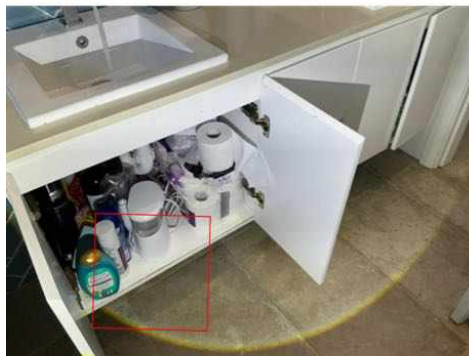
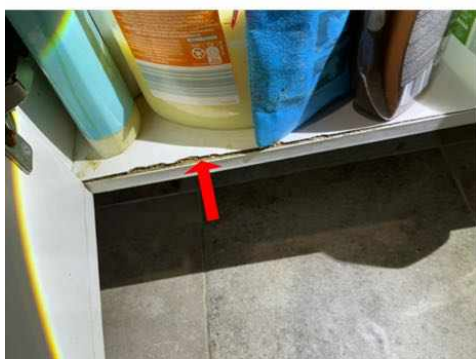
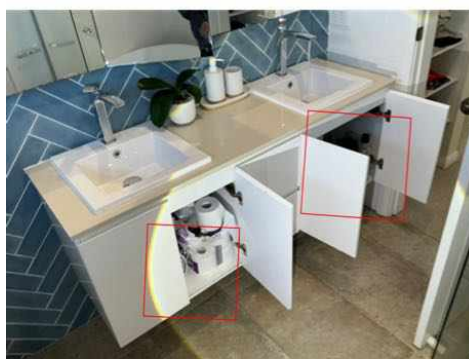
Finding 3.09

Building:	Main Building
Location:	Ensuite - Master
Finding:	Cabinetry - Water Damage
Information:	At the time of inspection, water-damaged cabinetry was observed, indicating previous or ongoing exposure to moisture. The affected sections show swelling, discolouration, and material deterioration, which may reduce the cabinetry's structural integrity and appearance over time. It is recommended that the client engage a cabinet maker to repair or replace the damaged sections and inspect for any underlying leaks or moisture sources to prevent recurrence.

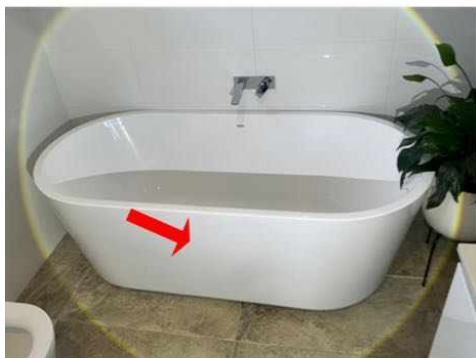
Finding 3.10

Building:	Main Building
Location:	Ensuite - Master
Finding:	Bathtub - Not Attached Securely
Information:	The bathtub in the bathroom is not securely attached to the ground, presenting potential stability and safety concerns.

Proper anchoring is essential to ensure that the bathtub remains firmly in place, preventing movement or tilting when in use. This installation defect may lead to damage over time or create risks for users, particularly if they lean against the bathtub's edge. To rectify this, it is recommended that the bathtub be correctly secured to the floor, in accordance with manufacturer specifications and building standards, to ensure safety and functionality.

The client is advised to engage services of a professional plumber to rectify this issue as soon as possible.

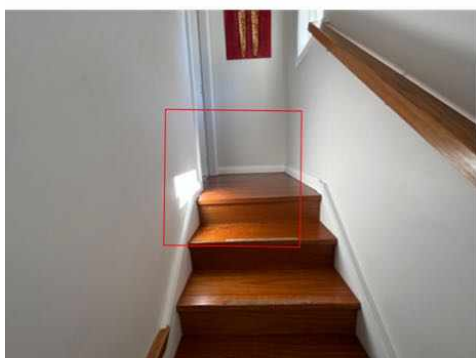
Finding 3.11

Building:	Main Building
Location:	Stairs - Internal
Finding:	Floors & Stairs - Noisy
Information:	At the time of inspection, noise was observed when walking on the stairs and adjoining flooring, along with a slightly bouncy feel underfoot in certain areas. This condition is typically associated with movement between structural components such as stair elements, floorboards, or supporting structures, and may also be influenced by timber expansion and contraction due to changes in humidity.

While commonly related to general wear and tear, if left unaddressed this condition may worsen over time and lead to further movement or deterioration.

It is recommended that the client engage the services of a qualified carpenter or flooring specialist to inspect the affected areas and carry out necessary repairs, including securing, tightening, or packing where required to improve stability and reduce movement and noise.

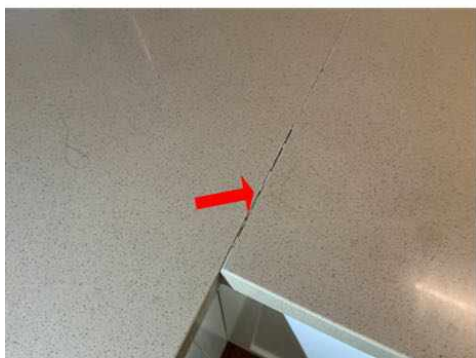
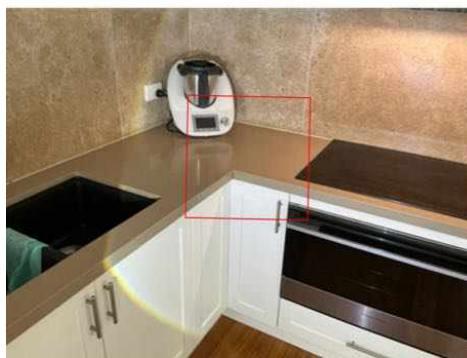
Finding 3.12

Building:	Main Building
Location:	Kitchen

Finding: Sealant - Deteriorating
 Information: At the time of inspection, sections of sealant were noted to be deteriorating. Deteriorated sealant can allow moisture penetration, leading to potential water damage or mould growth if left unaddressed. It is recommended that the affected sealant be removed and replaced by a suitably qualified handyman or plumber.

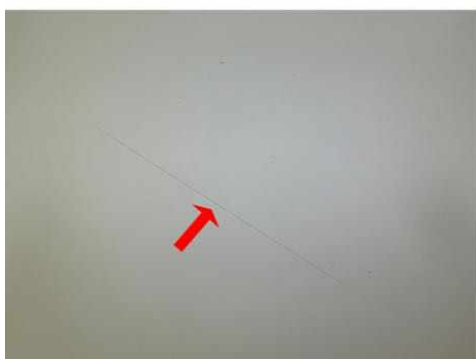
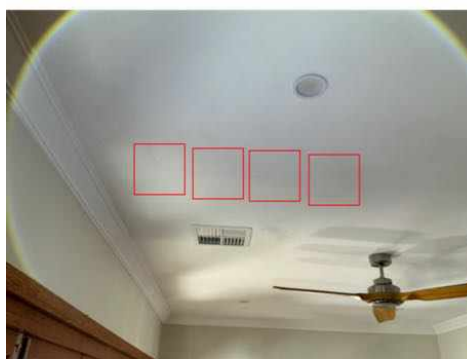
Finding 3.13

Building: Main Building
 Location: Dining Room
 Finding: Cracking - Damage Category 1 - Fine (up to 1mm)
 Information: Although fine cracks are quite noticeable, they are often only considered to be an appearance defect, and usually do not indicate any structural damage. Generally, the cause of a fine crack is indicative of a separation between building materials and finishes (e.g. paint, plaster, etc.) along joins.

Cracking of this nature can generally be repaired with minor sanding, filling and/or repainting. Such works should be performed by a qualified painter or a general handyman.

Monitoring of all cracking should be conducted frequently. Always contact a building inspector should cracks widen, lengthen, or become more numerous.

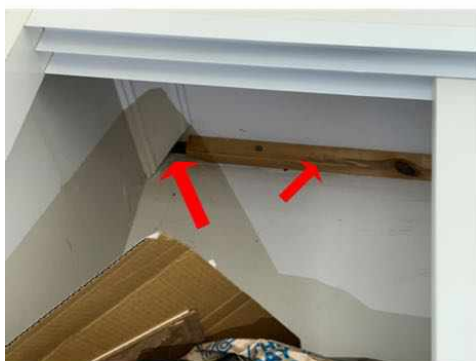
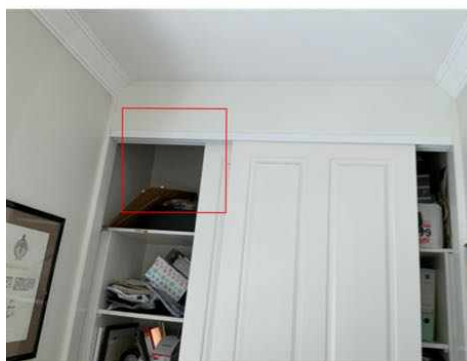
Finding 3.14

Building:	Main Building
Location:	Study
Finding:	Substandard Workmanship – Missing Cornice
Information:	At the time of inspection, the cornice within the closet area was noted to be missing, with a temporary timber piece installed to cover the junction. This is considered substandard workmanship and not a compliant or permanent finish.

The client is advised to engage a qualified tradesperson like handyman to install a proper cornice and finish the area in line with standard building practices.

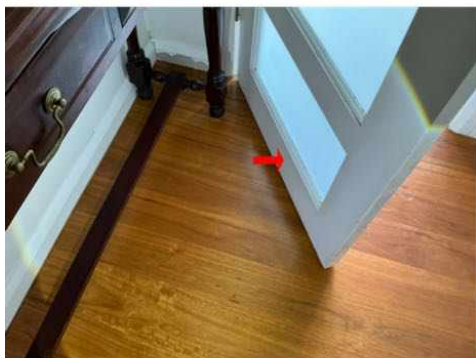
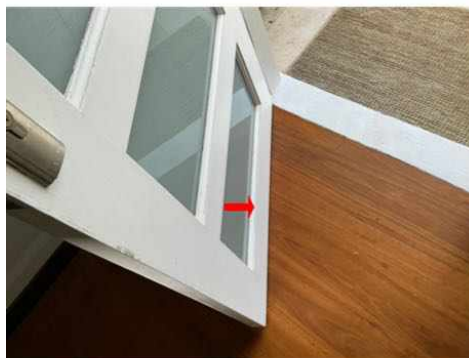
Finding 3.15

Building:	Main Building
Location:	Entry
Finding:	Door Weatherstrip - Missing
Information:	It was noted at the time of inspection, the door weatherstrip was missing.

The absence of a door weatherstrip could be due to wear and tear, improper installation, or deliberate removal. The implications include increased energy loss, reduced insulation, potential water leaks during rain, and a compromised seal, allowing drafts and noise to enter the space. Replacing the missing weatherstrip is advisable to maintain energy efficiency, weather protection, and overall comfort within the enclosed area.

A general handy man should be appointed to install the weatherstrip at owners discretion.

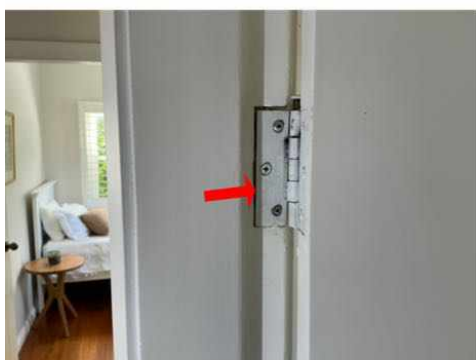
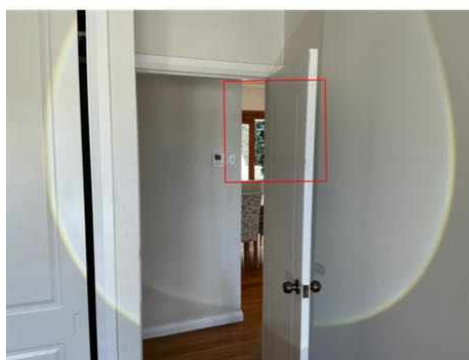
Finding 3.16

Building:	Main Building
Location:	Bedroom 2
Finding:	Door Hinge - Loose
Information:	The door hinge in the affected area was observed to be loose during the inspection.

Loose hinges are typically caused by worn-out screws, improper installation, or prolonged wear and tear over time. This defect can result in the door misaligning, creating difficulty in operation, and potentially leading to further damage to the door or frame.

It is recommended to engage a qualified handyman or carpenter at client's discretion to perform the necessary repairs to restore the door's functionality and prevent further deterioration.

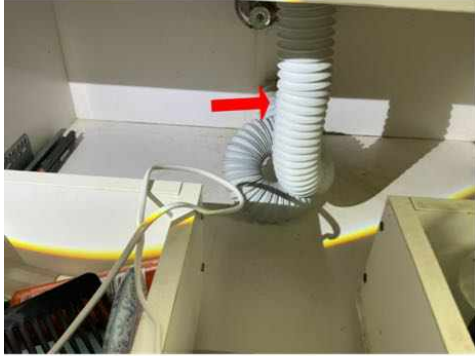
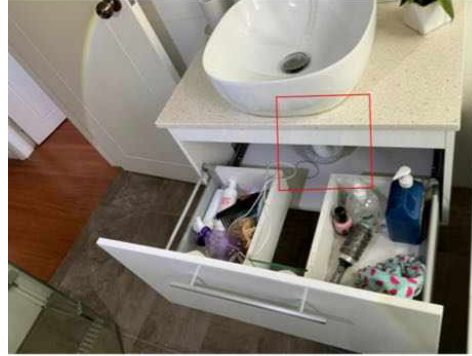
Finding 3.17

Building:	Main Building
Location:	Bathroom
Finding:	Flexible Pipe - Non Compliant
Information:	At the time of inspection, the flexible waste pipe installed beneath the bathroom basin was noted to be non-compliant and not considered a solid, permanent plumbing

connection. The setup is also missing a proper S-trap or P-trap, which is required to prevent sewer odours from entering the home and to ensure correct drainage. A solid, rigid pipe with an appropriate trap should be installed in accordance with standard plumbing practices. It is recommended that a licensed plumber be engaged to replace the current flexible pipe and install a compliant trap assembly.

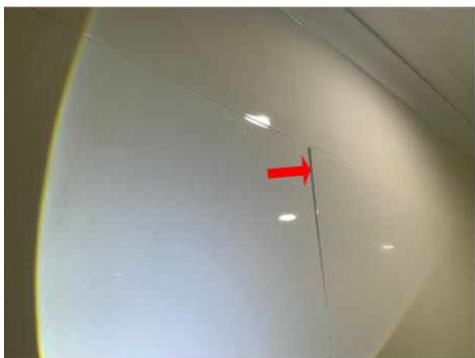
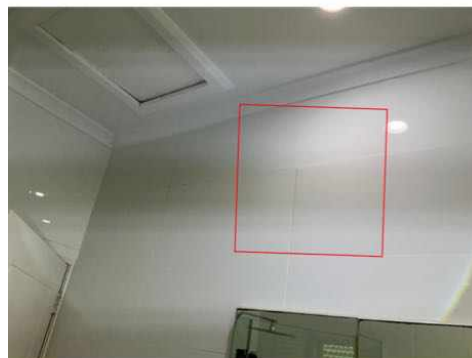
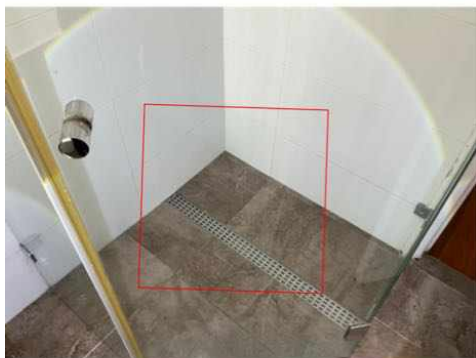
Finding 3.18

Finding: Tiles Coming off & Deteriorating Sealant/Grout

Information: At the time of inspection, sections of tile were noted to be coming loose, with missing or deteriorated grout and sealant in the affected area. This condition may allow water to penetrate beneath the tiles, leading to potential moisture damage, mould growth, or further tile displacement. Rectification by a qualified tiler is recommended to resecure the loose tiles and reapply grout and waterproof sealant to restore the integrity of the surface.

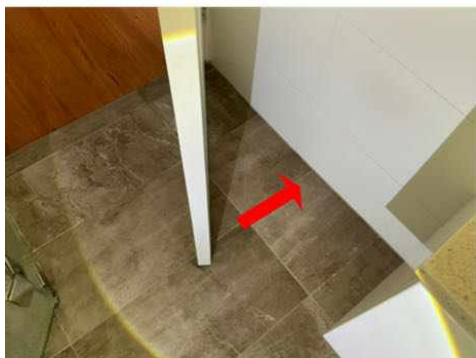
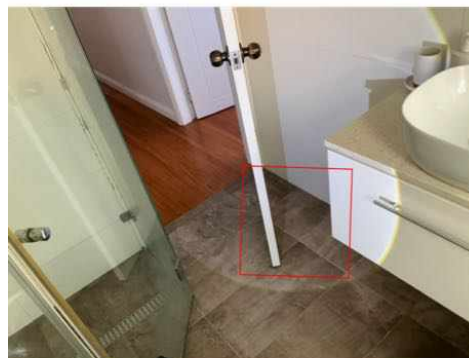
Finding 3.19

Building:	Main Building
Location:	Bathroom
Finding:	Door Stopper(s) - Missing
Information:	At the time of inspection, it was noted that a door stopper was missing in this area.

The absence of a door stopper can lead to potential damage to the door, wall, or surrounding finishes, as the door may swing open too far and impact the wall or adjacent objects. Over time, this can cause dents, scuffs, or even structural damage to the wall or door. It is recommended that a door stopper be installed to prevent further damage and ensure the protection of both the door and the surrounding area.

The client is advised to engage services of a handyman to install the door stopper.

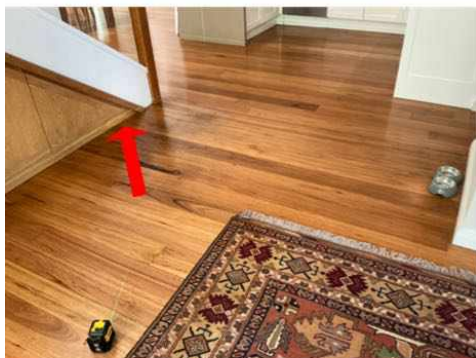
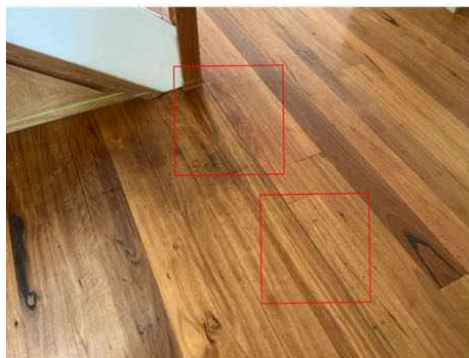
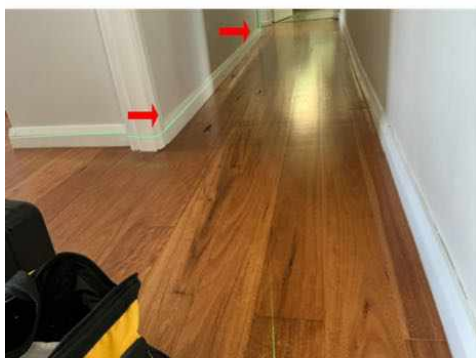
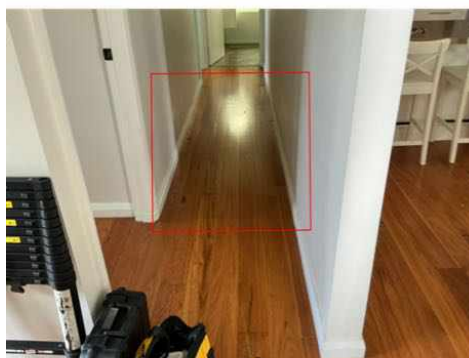
Finding 3.20

Building:	Main Building
Location:	Hallway, Kitchen/Living
Finding:	Flooring - Uneven (Monitoring)
Information:	At the time of inspection, the floor was noted to be uneven. This may be due to general movement, moisture changes, or natural settling. Uneven flooring can create trip hazards, affect how furniture sits, and may lead to further deterioration over time.

No further action is required but the area should be monitored, and if any cracking, shifting, or worsening unevenness is observed, a builder or flooring specialist may be required to assess and carry out any necessary rectification works at the client's discretion.

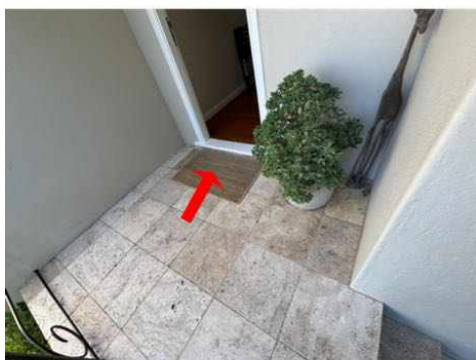
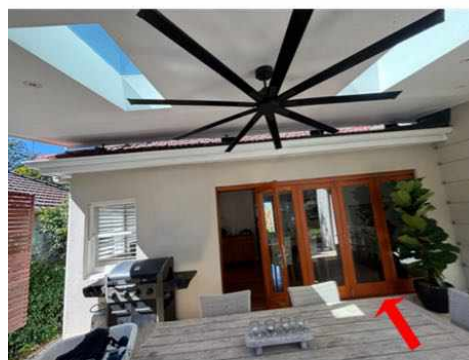
It is important for internal flooring to be raised above adjacent external ground levels. Where external ground levels are above or same level as internal flooring, water pooling and subsequent internal flooding is likely to occur which may attract termite activity to the internal area.

It is highly advised that a landscaper or relevant tradesperson be appointed to lower external grounds that are raised above or same as adjacent internal flooring. Alternatively if external grounds and internal flooring is level installation of a raised door sill may be appropriate in preventing any water pooling in the area. If the client wishes not to make any changes, then a qualified pest controller is recommended for termite treatment around the perimeter of the house and subfloor (if any) as soon as possible.

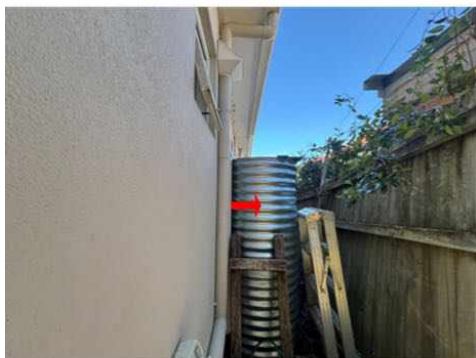
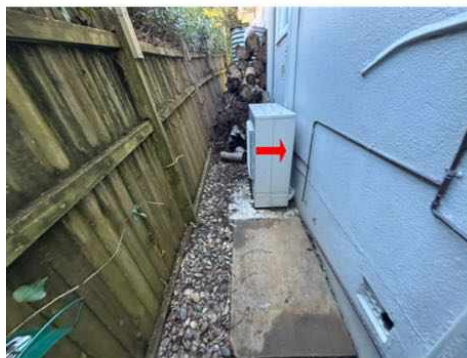
Finding 6.02

Building:	Main Building
Location:	Exterior walls - left side
Finding:	Bridging Appliances/Water Tanks - Attachment to Buildings
Information:	Bridging occurs when items against a building provide a concealed entry point for termites into the building or by passing around a termite management system.

Where any part of an attachment to a building is not isolated and is not provided with a clear gap of not less than 25mm from the building, bridging occurs. Attachments to buildings such as hot water services, downpipes, verandahs, decks, steps, fences, service conduits and the like provide the opportunity for concealed entry.

Building attachments of this nature need to be frequently inspected for termite activity by a qualified inspector.

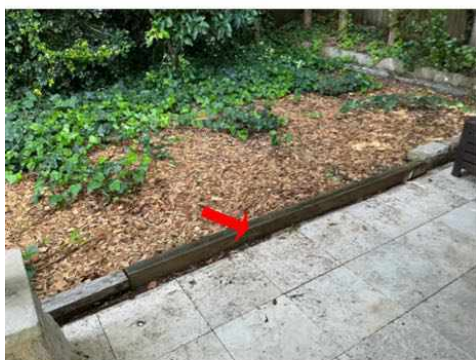
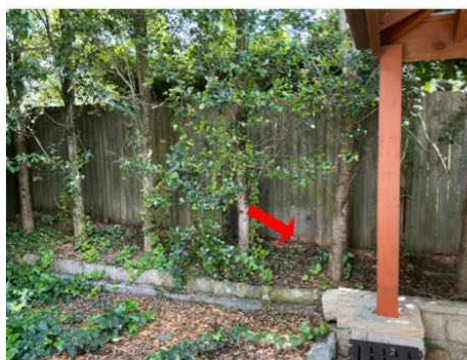
Finding 6.03

Building:	Yard
Location:	All Areas
Finding:	Building Materials in Direct Ground Contact - Conducive to Termites
Information:	Timber elements that are in direct contact with the ground and exposed to moisture or damp conditions are highly conducive to termite activity. This susceptibility arises because timber, when in contact with soil and dampness, creates an environment that is particularly attractive to termites, encouraging infestation and potential structural compromise. Whether the timber is used as a part of the building's construction or incorporated into fencing, its presence near or on the ground can become a pathway for termites to access and damage the property.

When exposed to excessive moisture, timber begins to deteriorate, developing conditions such as wood decay and rot. These compromised areas of timber are even more appealing to termites, as they are easier to infest and consume. This is especially true for untreated or non-durable timber, which lacks the protective treatments that can deter or withstand termite attacks. Termites can use these weakened, moisture-laden elements as a bridge into other parts of the structure, creating an entry point for potential infestations that can spread and cause extensive damage if left unchecked.

For any timber in direct contact with the external ground, special attention is required. The combination of moisture, untreated wood, and direct ground contact not only accelerates the decay process but also provides subterranean termites with a straightforward means of ingress into the structure. This entry can lead to termites moving undetected into other vulnerable areas, resulting in potentially significant structural issues and costly repairs.

To mitigate the risk of termite activity, it is imperative that any such materials or timber elements be appropriately treated or removed as soon as possible. Timbers that are necessary for use should be made durable through appropriate treatments and maintained to ensure they do not create conditions conducive to termites. Additionally, the client is advised to schedule regular termite treatments to maintain an effective barrier against infestations and ensure ongoing protection.

The client is strongly advised to assess the property for any timber elements that may be in direct contact with the ground and ensure prompt action is taken to remove or treat them effectively. Regular inspections, proactive maintenance, and consistent termite treatment are essential steps in minimising the risk of termite attack and protecting the structural integrity of the property. Taking these preventive measures is crucial for maintaining a termite-free environment and avoiding potentially costly damage and future repairs.

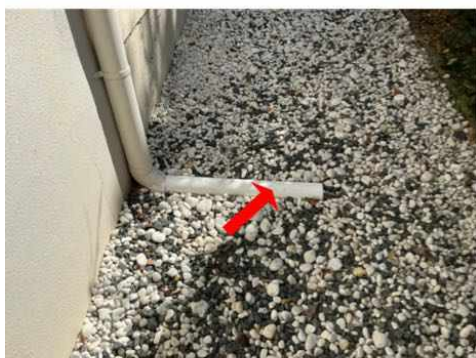
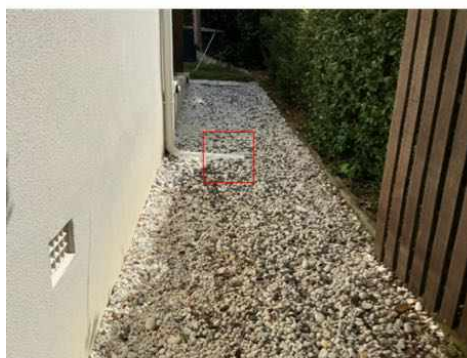
Finding 6.04

Information: The inspection revealed that the roof plumbing system is not adequately connected to the site's stormwater drainage, reducing its functional efficiency. This disconnection can lead to water pooling around the base of the property, increasing the risk of rust and corrosion to building elements, structural damage, and attracting termites due to the persistent dampness.

Improper drainage can also contribute to mould and mildew growth, affecting indoor air quality and health, and may lead to ground movement, causing cracks in walls and other structural issues.

It is strongly recommended that a licensed roof plumber be engaged to assess the system and ensure appropriate connections to stormwater outlets are installed to effectively redirect water away from the structure.

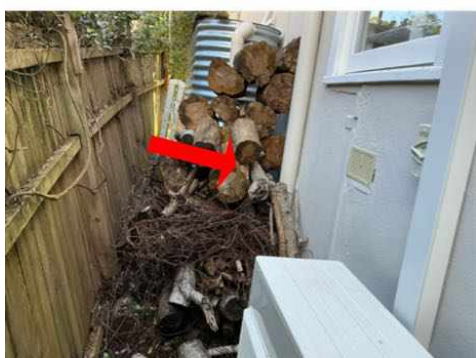
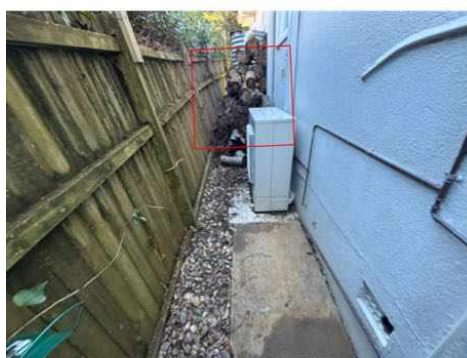
Finding 6.05

Building: Yard
 Location: Yard - Side
 Finding: Stored Timbers - On Site
 Information:

The storage of timber around external areas or within subfloor spaces poses a significant risk of attracting termite activity. Timber left exposed to moisture can develop wood rot, creating an ideal environment for termites and other timber pests. When placed directly on the ground or in damp, concealed subfloor areas, this timber can act as a bridge for termites to enter the structure, potentially causing serious and costly damage.

In addition to termites, stored timber can promote mould, mildew, and fungal growth, which may affect both the structure and the health of occupants.

To reduce these risks, it is strongly advised that any stored timber be removed.

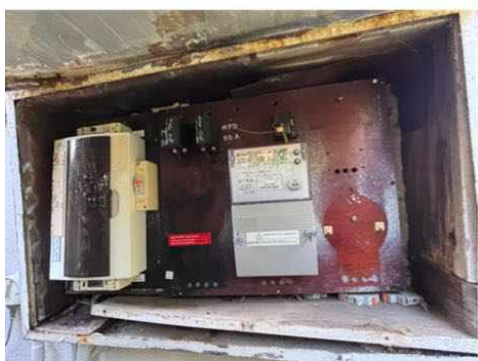
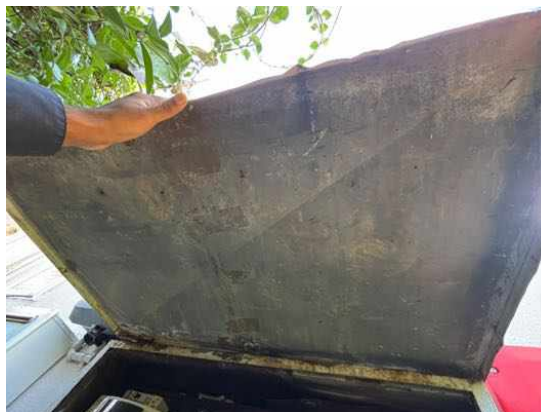
Finding 6.06

Building: Main Building
 Location: Meter Box
 Finding: Termite Management System - No Evidence of Installation
 Information: The application of a post-construction chemical termite barrier is strongly

During the inspection, there was no indication that a termite management system had been installed, nor was there any evidence to suggest that preventative measures had previously been undertaken. The client is encouraged to seek further advice from a licensed pest controller regarding the costs and procedures involved in the application of a termite barrier. Prioritizing this step in the short term is strongly advised to ensure long-term protection.

recommended for all properties, especially if there has been any history of live termite activity on-site. These barriers are highly effective in protecting timber building elements throughout the property by preventing termite attacks. It is also advisable to install a durable notice within the switchboard unit, indicating the presence of any termite barriers for future reference.

Additionally, the client may want to consult with the vendor to determine whether regular Timber Pest inspections, as per AS4349.3 or AS 3660.2, have been conducted in the past. This will provide further insights into any past termite management practices and help inform the appropriate course of action.

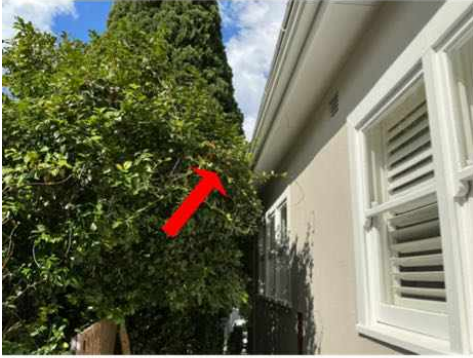
Finding 6.07

Building:	Main Building
Location:	Yard - Side
Finding:	Overhanging Trees/Branches/Roots
Information:	Overhanging trees and exposed roots were noted near the property, which pose potential risks to the structure and surrounding areas.

The overhanging branches can cause damage to the roof, gutters, or walls, particularly during storms or high winds. Additionally, the roots may pose a threat to the foundation by causing ground movement, leading to cracks or uneven settling over time. The accumulation of leaves and debris in gutters and drainage systems can also lead to blockages, contributing to water overflow and potential water damage.

It is recommended that a qualified arborist be engaged to prune back the overhanging branches and assess any potential risks posed by the tree roots to prevent further damage to the property. It is advised to get this fixed as soon as possible. Regular

maintenance should be carried out to ensure the trees are managed effectively and the property remains safe.

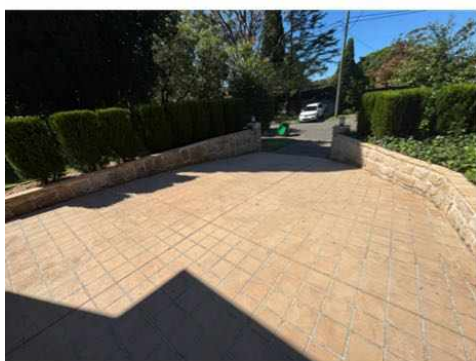
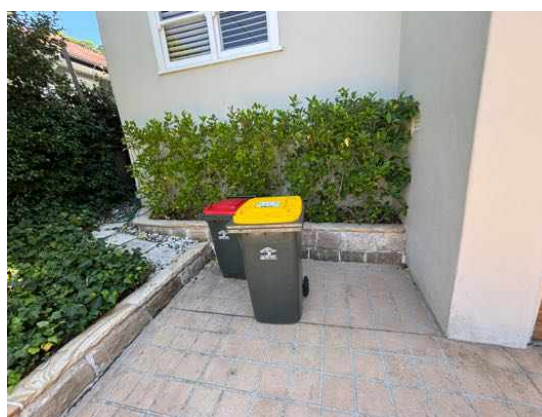
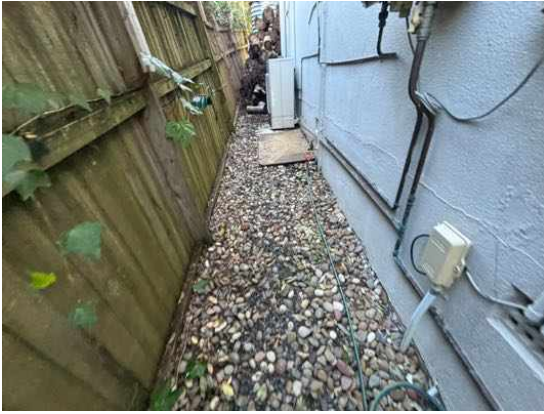
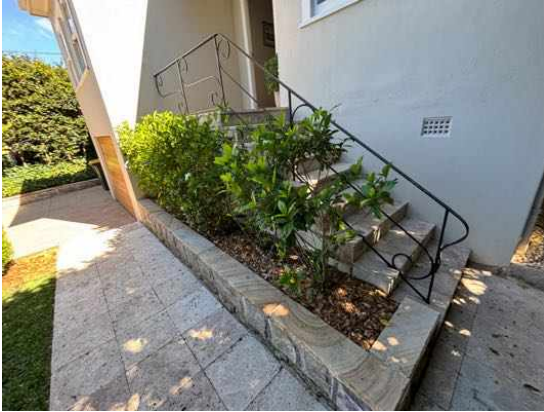
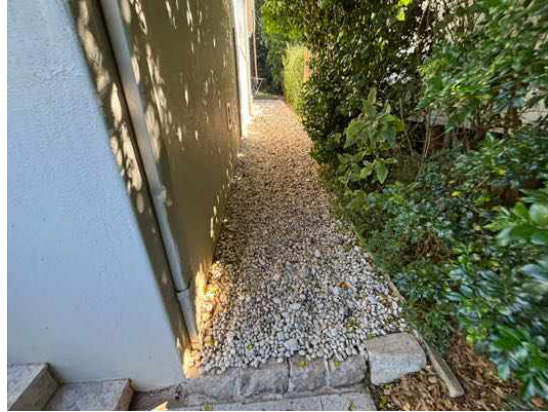
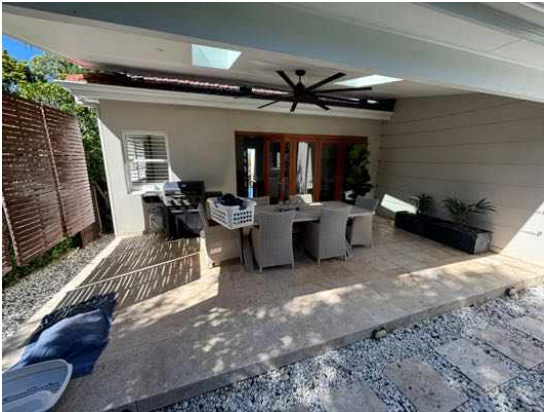
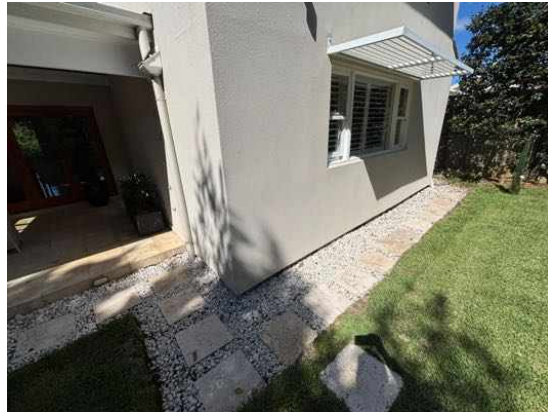
Building: Main Building
Location: All External Areas
Finding: Obstructions and Limitations - External Areas
Information: The attached photographs provide a visual representation of the obstructions and limitations that impeded a full inspection of the external areas of the property at the time of assessment. These obstructions, which may include vegetation, stored items, debris, or other physical barriers, can obscure potential defects and prevent a thorough evaluation of the property's condition. Obstructions of this nature can conceal a wide range of issues, such as structural damage, water ingress, pest infestations, or deteriorating building materials, which may not be visible during the initial inspection.

It is essential that these obstructions be cleared to allow for a comprehensive inspection of the external areas. Removing these barriers will enable a more accurate assessment of the property's condition and allow any hidden defects to be identified and addressed promptly. Failure to do so could result in undetected issues worsening over time, potentially leading to more costly repairs in the future.

Therefore, it is strongly recommended that the obstructions be removed and a re-inspection be scheduled once the affected areas are made fully accessible. This will ensure a complete evaluation of the property's exterior and provide the client with a clear understanding of any potential issues that may have been concealed during the initial inspection.
