Building and Timber Pest Inspection Report

Inspection Date: Tue, 7 Apr 2026

Property Address: 60 Redgrave Rd, Normanhurst NSW 2076,
Australia

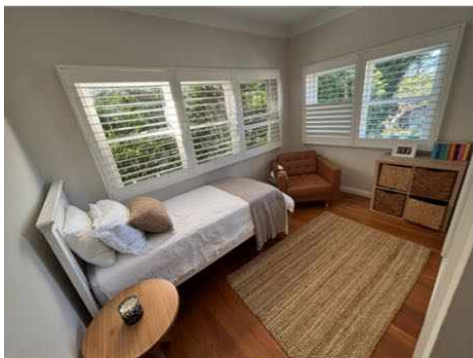
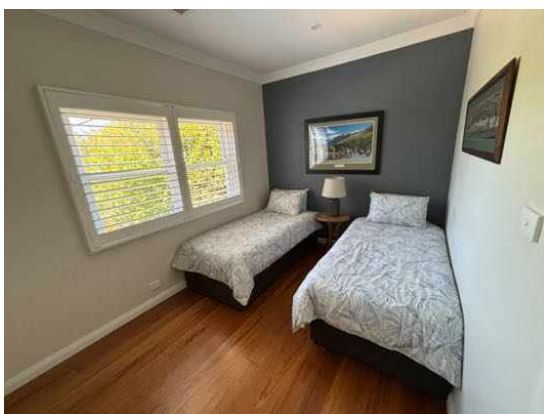
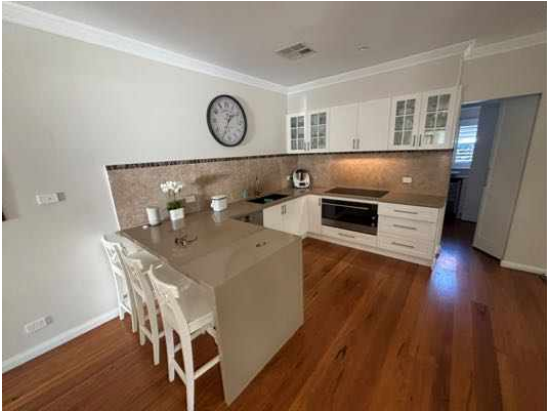
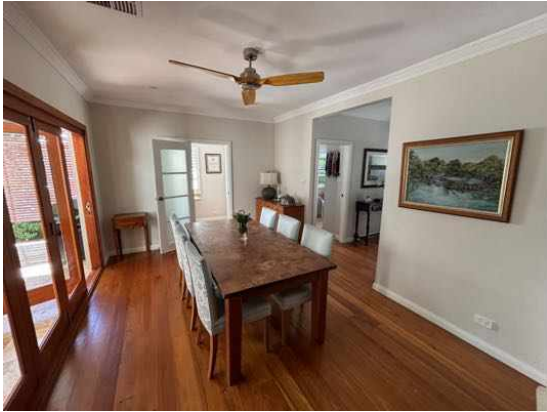
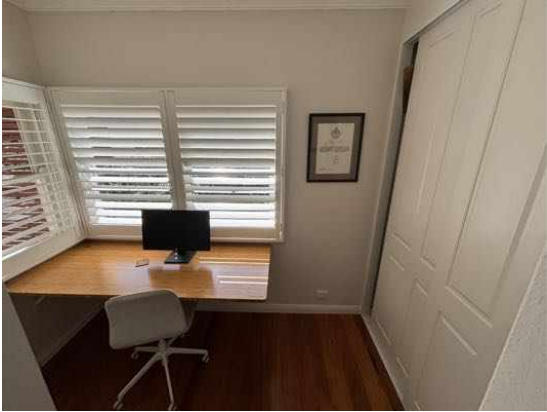
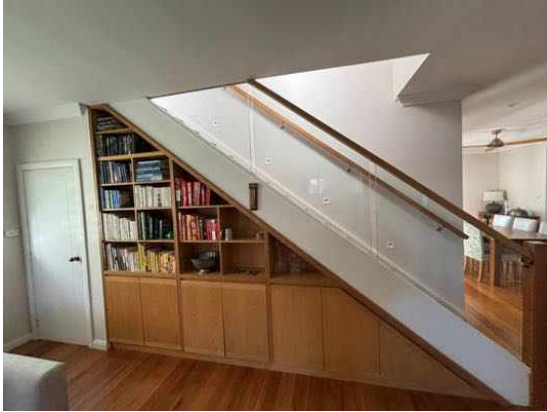
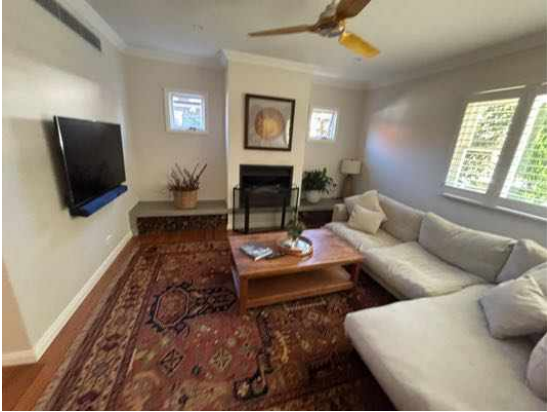
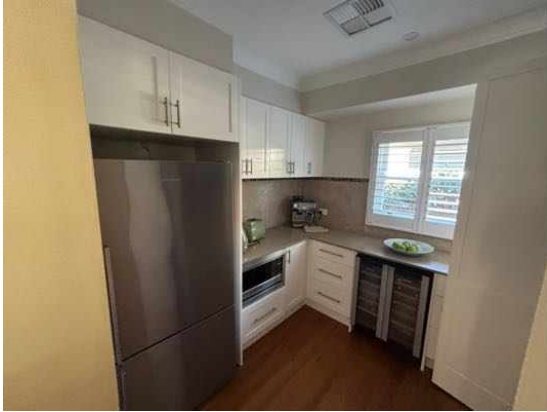
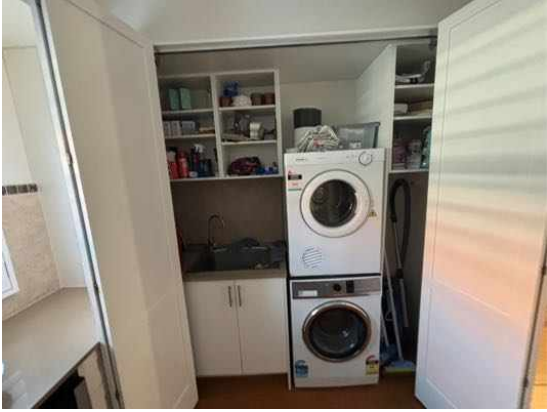
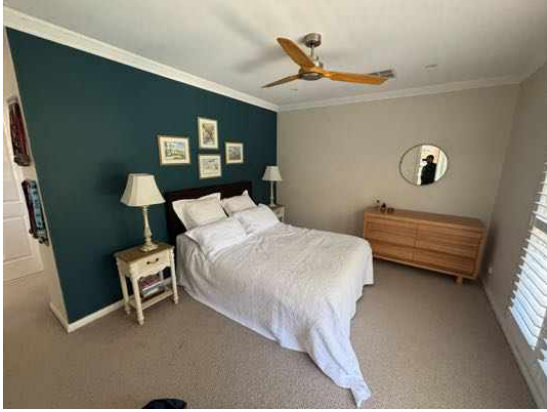
Building:	Main Building
Location:	All Internal Areas
Finding:	Obstructions and Limitations - Internal Areas
Information:	The accompanying photographs provide clear evidence of the obstructions and limitations that restricted a comprehensive inspection of the internal areas of the property at the time of assessment. These obstructions, which may include furniture, personal belongings, stored items, or structural elements such as wall coverings and built-ins, significantly hindered the ability to thoroughly evaluate these areas. It is important to note that such obstructions can potentially conceal a wide array of defects, ranging from hidden structural damage, water leaks, pest infestations, or

electrical issues, to deteriorating materials that may not be visible during the initial inspection.

The presence of these impediments means that critical areas of the property were not accessible, and therefore, any underlying defects that may affect the integrity and safety of the property could remain undetected. These hidden defects, if left unaddressed, could worsen over time and may result in costly repairs or pose potential safety hazards to the occupants.

It is highly recommended that all obstructions be cleared to facilitate a complete and thorough inspection of the internal areas. Once the obstructions have been removed and full access is available, a re-inspection should be carried out to ensure that any previously concealed issues can be properly identified and rectified. This follow-up inspection will provide a more accurate assessment of the property's internal condition and help the client make informed decisions about any necessary repairs or maintenance.

In summary, the limitations encountered during the inspection highlight the importance of ensuring full access to all areas of the property to accurately assess its overall condition. A re-inspection is strongly advised once these areas are made accessible.

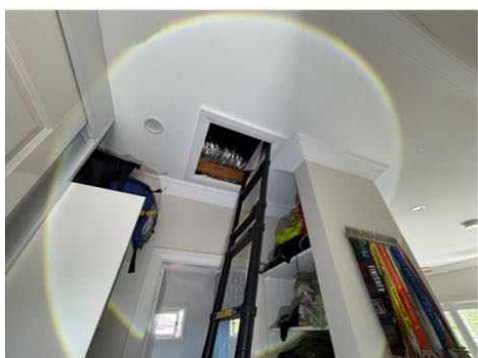
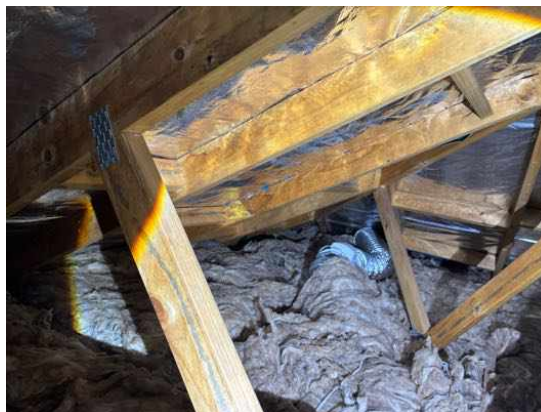
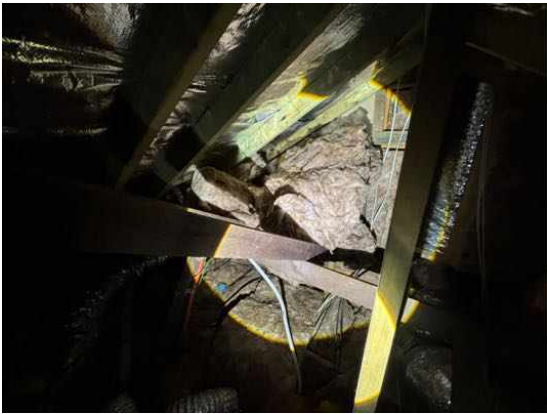
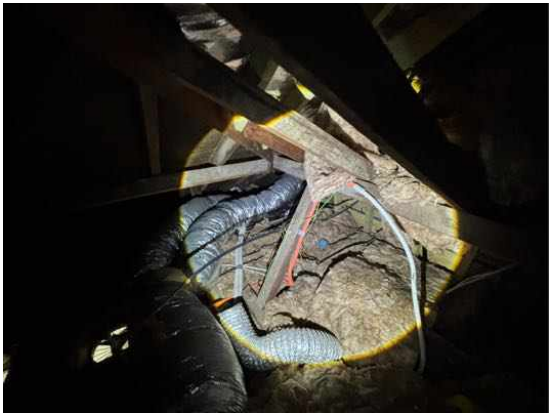
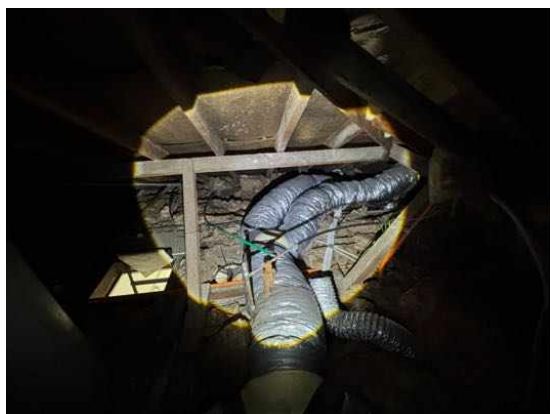
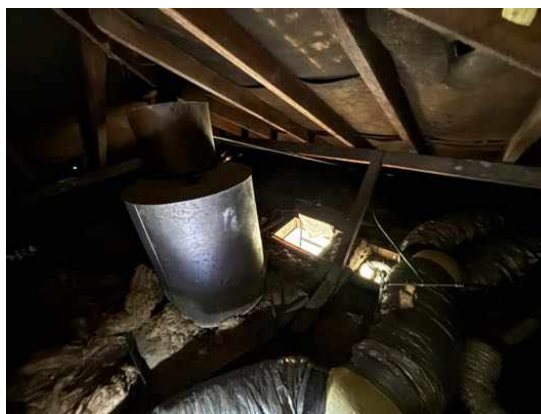
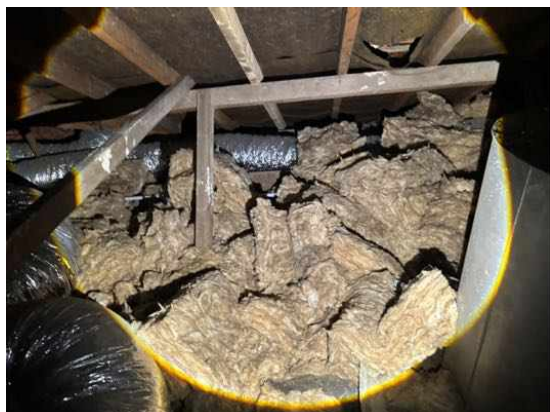
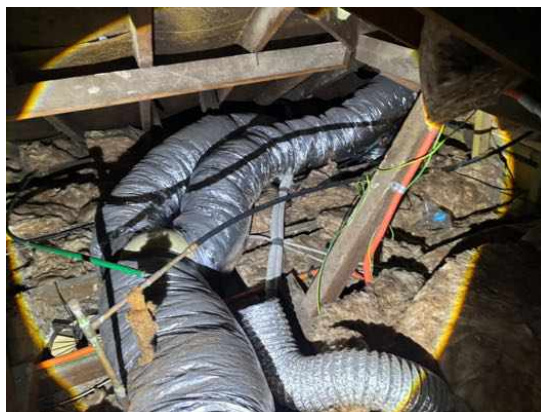
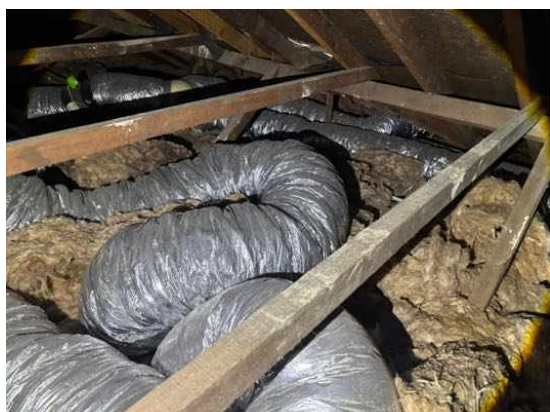
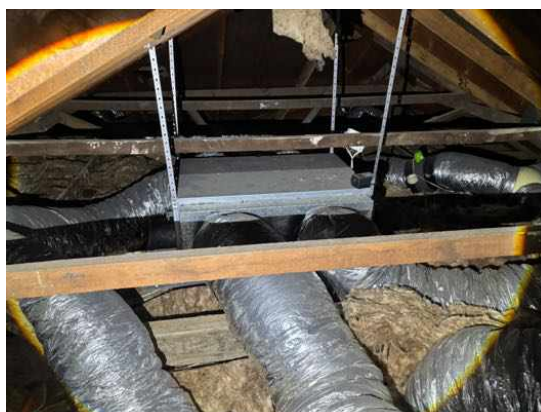
Building: Main Building
 Location: Roof Void
 Finding: Obstructions, Limitations, and General Roof Space Condition
 Information: The photographs provided document both the general condition and the obstructions and limitations that were present in the roof cavity of the main building at the time of inspection. These obstructions—such as insulation materials, stored items, structural elements, or electrical wiring—restricted safe and adequate access to key areas within the roof space. As a result, a comprehensive inspection of all components could not be completed.

Obstructions of this nature may conceal a variety of potential defects, including damaged framing, compromised insulation, evidence of moisture ingress, pest activity, or electrical hazards. While no major issues were observed in the visible areas, the presence of these limitations means that some defects may remain undetected.

It is recommended that these barriers be removed or repositioned to facilitate full and safe access to the roof space. Once clear, a follow-up inspection should be conducted to allow for a thorough assessment of all concealed areas. This will help ensure that the condition of the roof cavity is accurately evaluated and any hidden issues are appropriately identified and addressed.

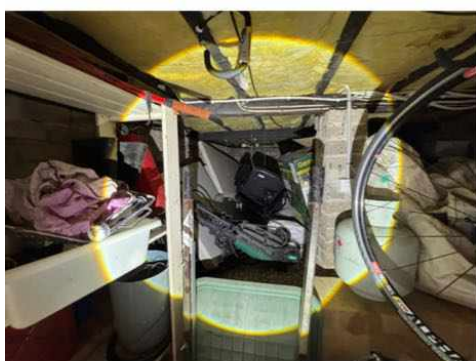
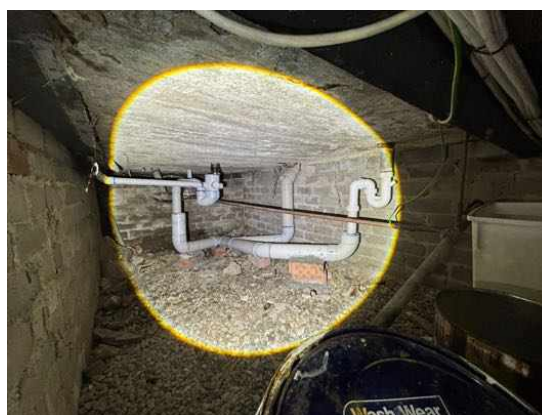
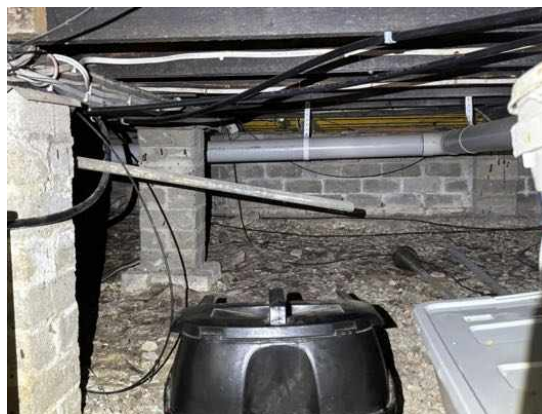
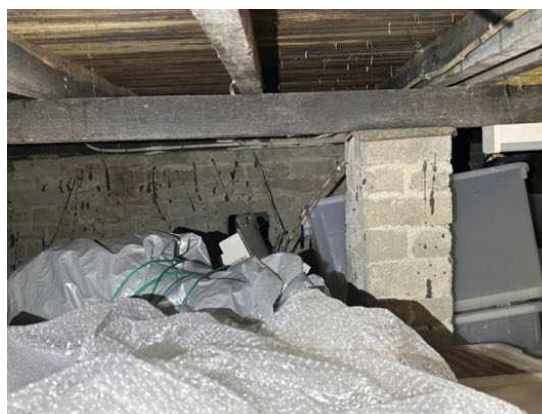
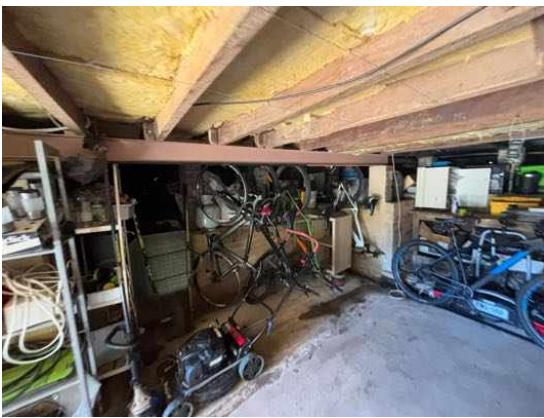
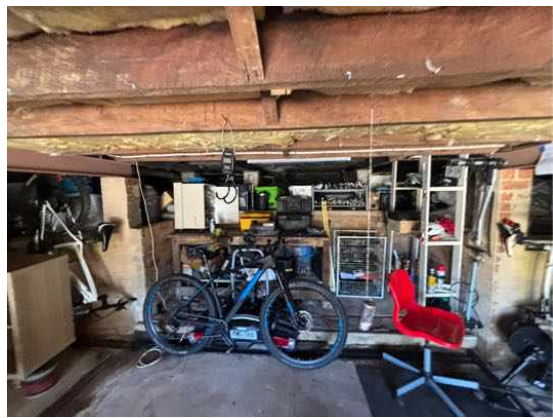
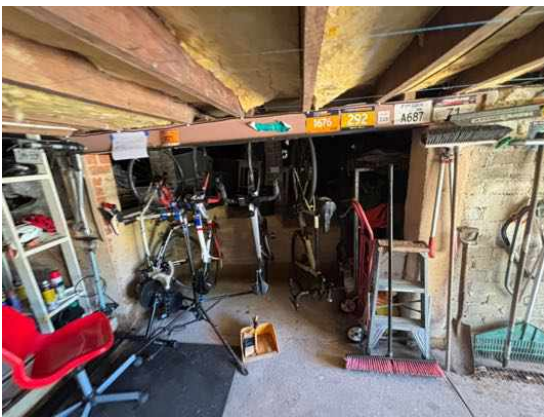
Finding: Obstructions, Limitations, and General Subfloor Condition

important elements such as floor joists, bearers, stumps, drainage, subfloor ventilation, and signs of moisture or pest activity. These obstructions may also conceal defects such as timber decay, water ingress, termite damage, inadequate support, or ventilation issues that are not immediately visible during a limited inspection.

While no major concerns were identified in the accessible areas, a full and unobstructed inspection is necessary to properly assess the overall condition of the subfloor. It is recommended that obstructions be removed and access improved where possible. Once adequate clearance is provided, a re-inspection should be arranged to ensure that any concealed defects can be identified and addressed accordingly. This will assist in providing a more comprehensive understanding of the subfloor's condition and reduce the risk of unforeseen issues.

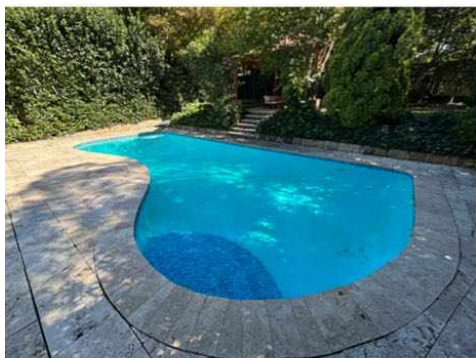
Building:	Main Building
Location:	Pool Area
Finding:	FYI - Pool Area
Information:	This inspection explicitly excludes any assessment of the pool, spa, associated pool equipment, and the surrounding areas. As a standard building inspection does not encompass these elements, it is crucial for the client to understand that no evaluation has been conducted regarding the condition, functionality, or safety compliance of the pool or its associated systems. This includes, but is not limited to, pumps, filters, heating equipment, and structural integrity of the pool or spa surrounds.

To gain a comprehensive understanding of the condition and compliance of these components, it is highly recommended that the client engages a specialist pool inspector. A pool inspection will evaluate the structural condition of the pool, ensure the functionality of all associated equipment, and assess whether the pool and its surroundings meet current safety regulations. In particular, pool safety requirements, including fencing and access controls, are subject to stringent regulatory standards, which must be verified separately by a qualified pool inspector.

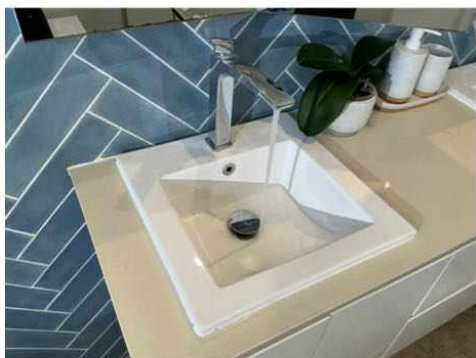
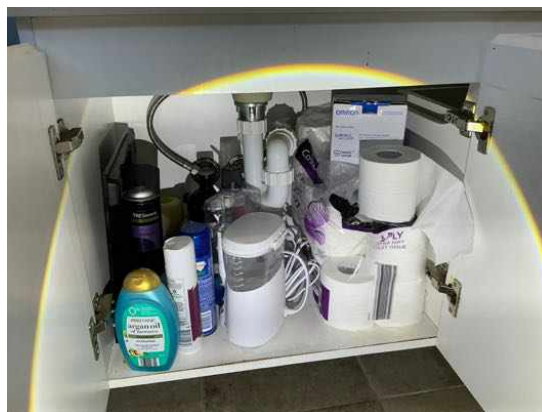
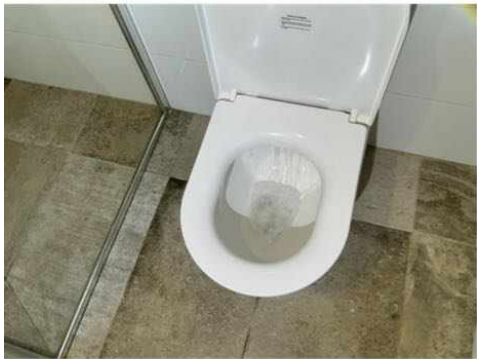
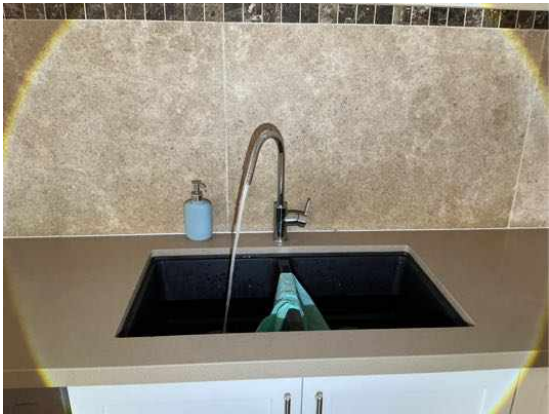
Building: Main Building
 Location: All Areas
 Finding: FYI - Taps, Drainage & Toilets Tested and Cabinetry Obstructions
 Information: During the inspection, all accessible taps, drainage systems, and toilets were tested for water flow and drainage efficiency, and checked for any visible signs of leakage. At the time of the inspection, no issues were noted in these areas. Unless highlighted in a separate defect statement, no immediate remedial work appears necessary. Supporting images may be found in the additional photos section for reference.

It is important to note that while a visual inspection of cupboards and cabinetry beneath sinks and vanities was undertaken, stored personal items and fixtures presented obstructions that limited full visibility of the internal areas. As per standard inspection practices, inspectors are not permitted to move or disturb personal belongings during the inspection process. Therefore, only visible and accessible sections were inspected, and concealed water damage or plumbing defects may not have been detected.

Given this, a re-inspection is recommended after all obstructions have been cleared to allow for a comprehensive assessment of these areas. Regular maintenance and monitoring of plumbing and drainage systems is also advised to ensure ongoing functionality and early detection of potential issues.

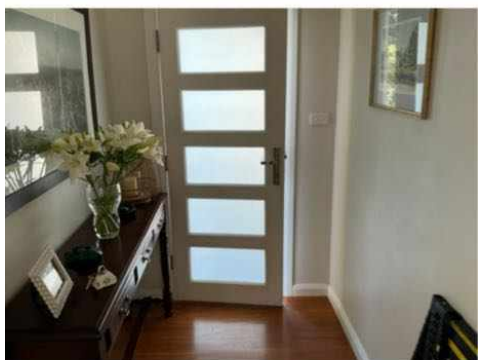
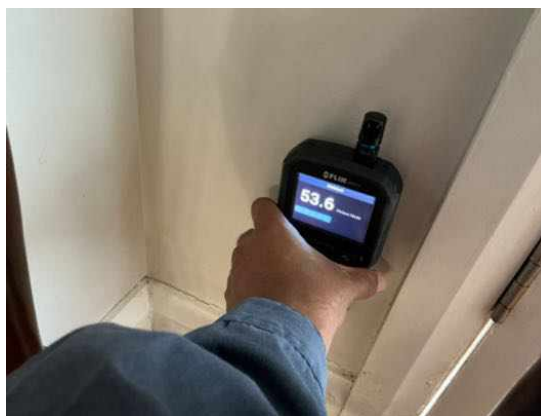
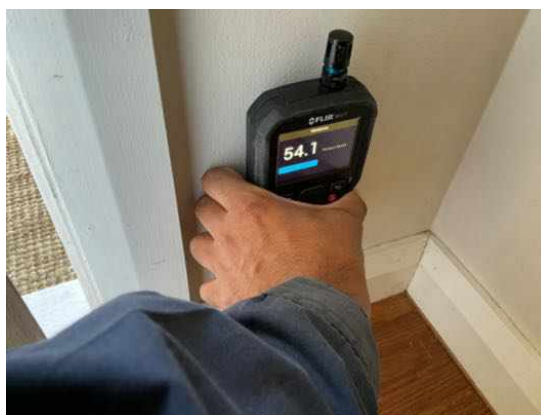
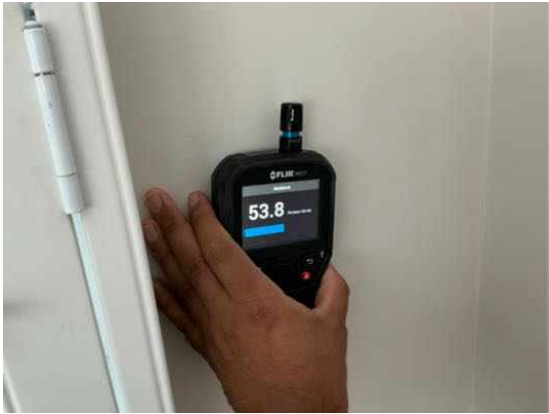
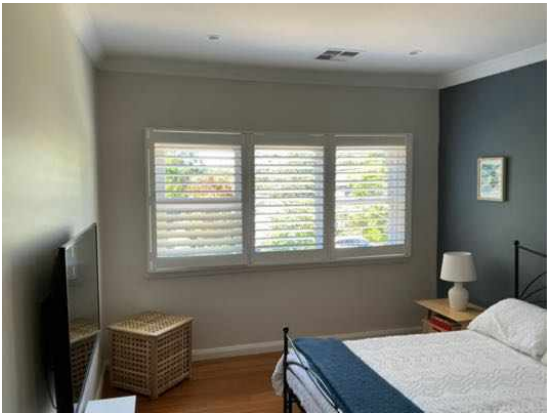
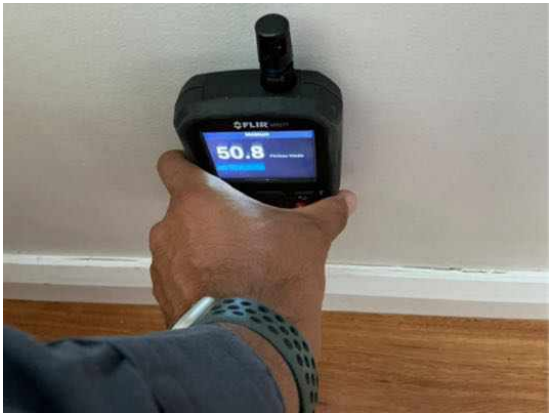
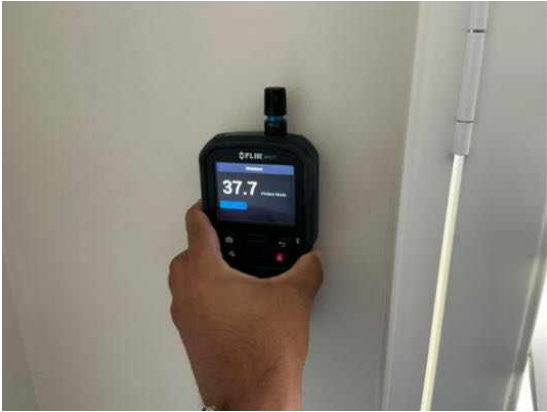
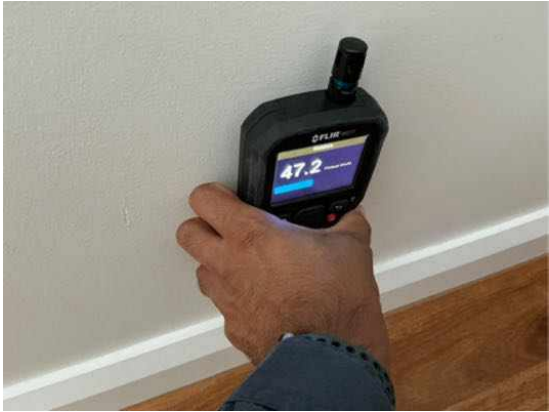
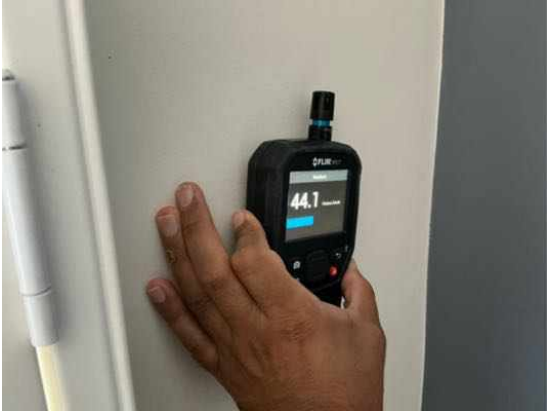
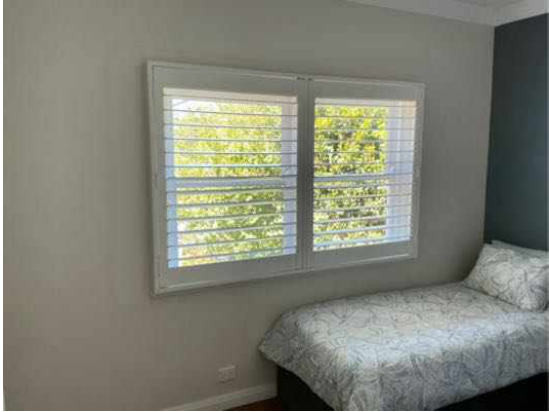
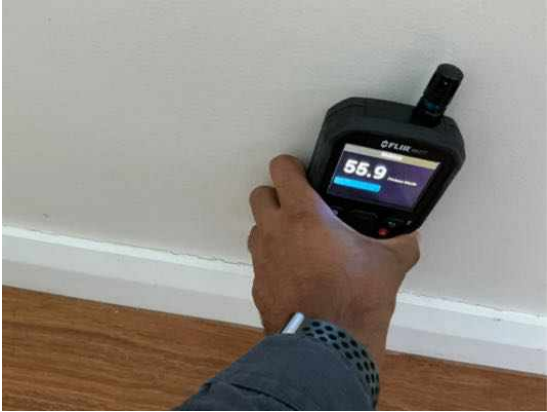
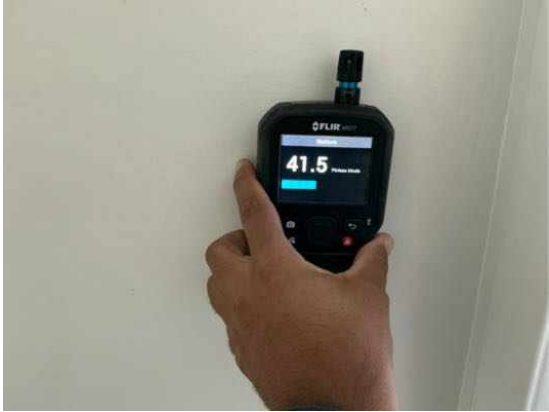
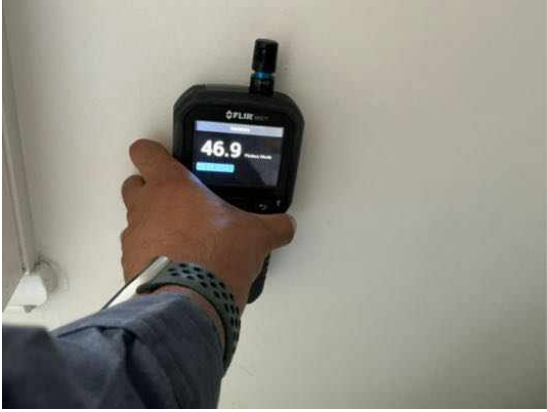
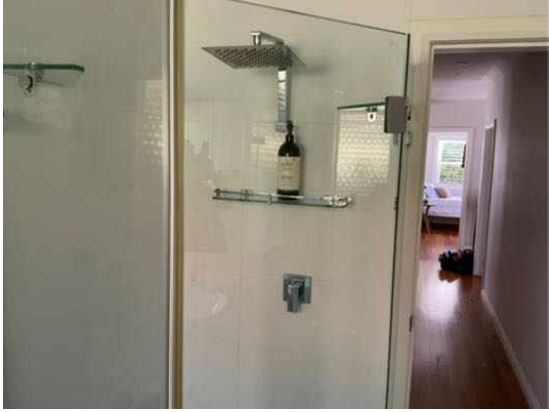
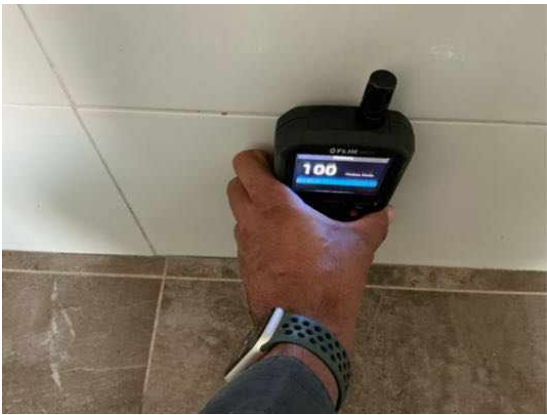
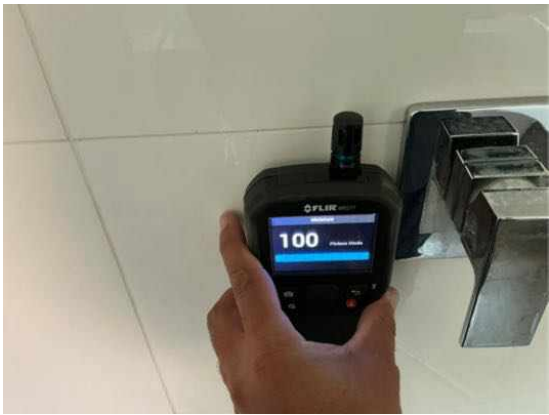
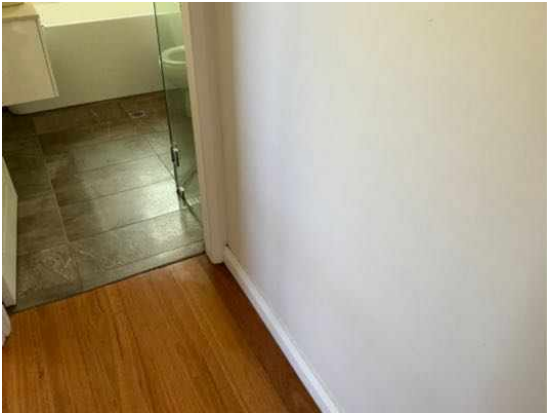
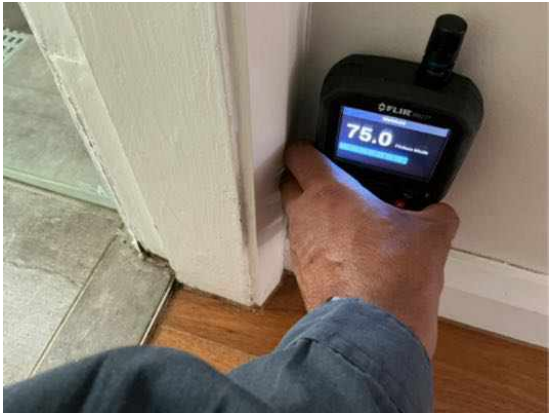
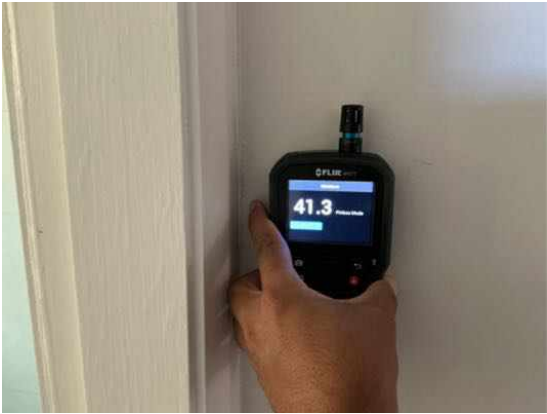
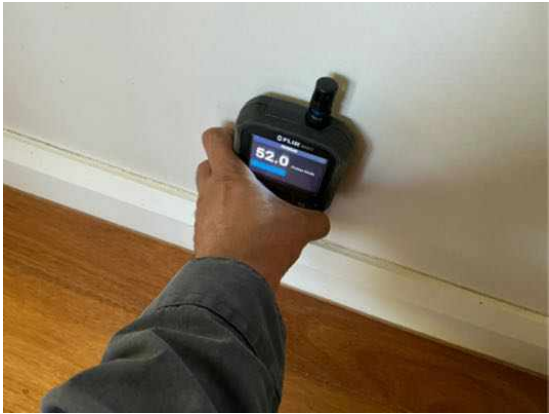
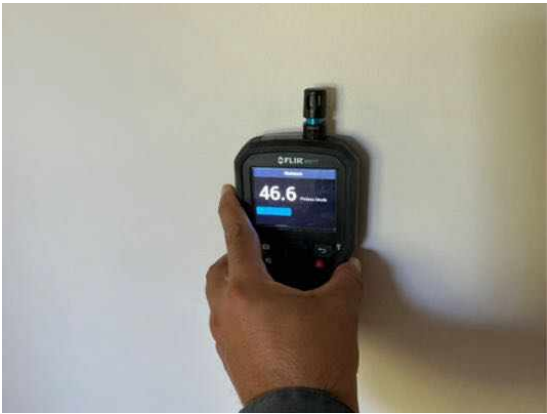
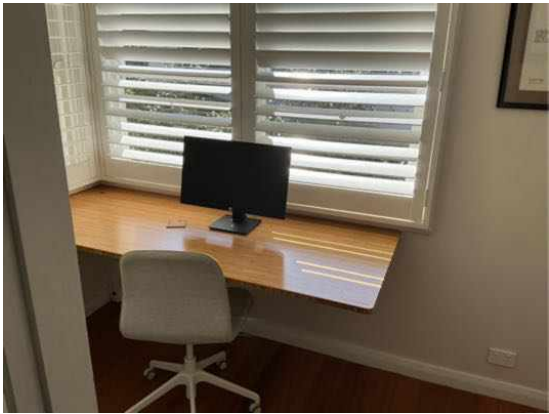
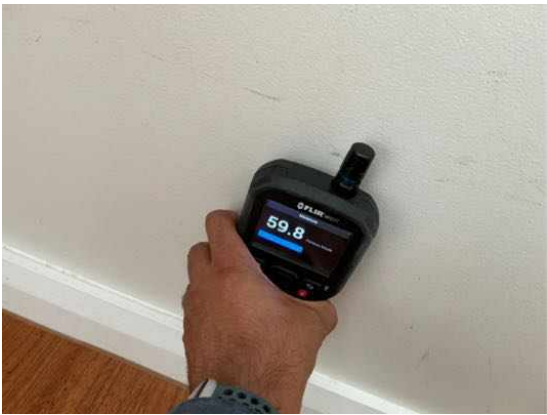
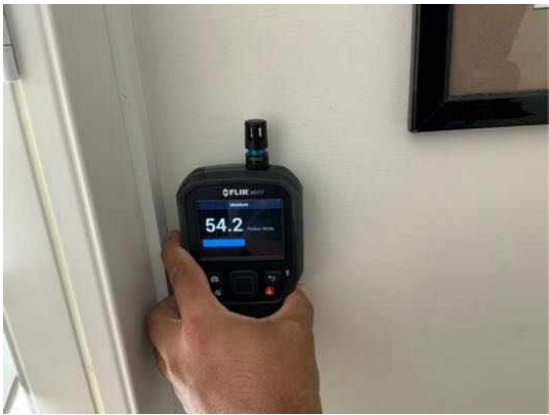
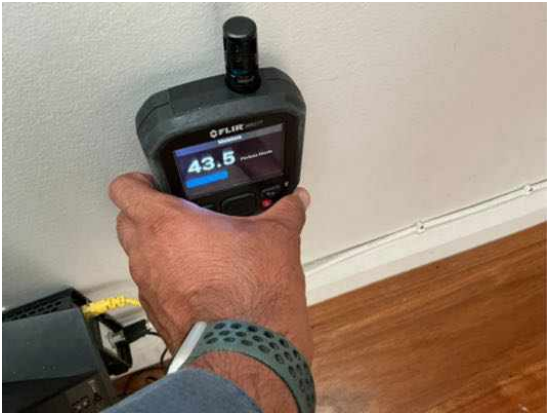
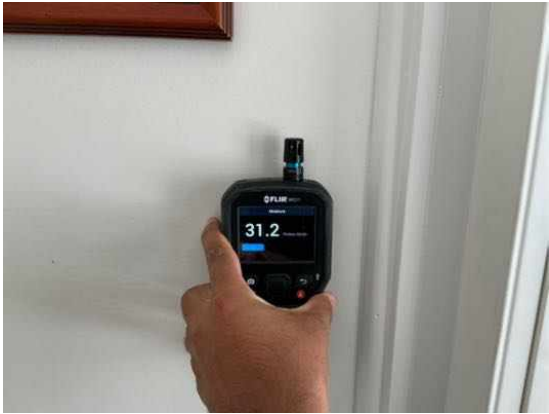
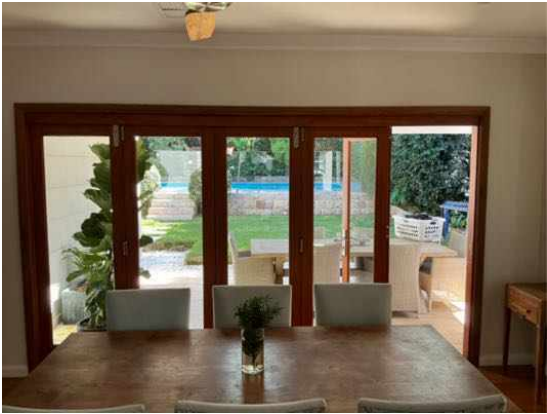
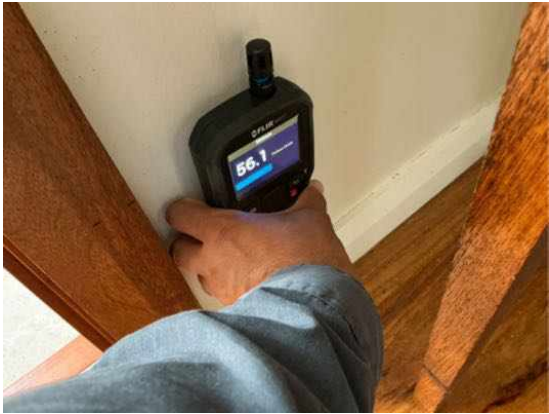
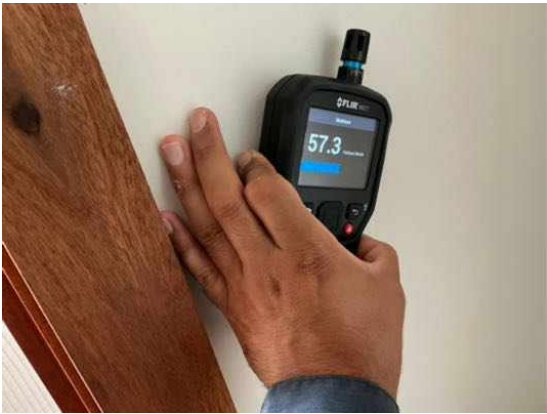
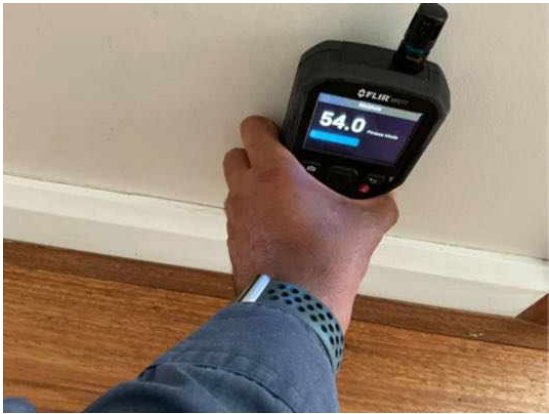
Building: Main Building
Location: All Areas
Finding: Additional Photos - Moisture Meter Readings
Information: Additional moisture meter reading photos have been provided for the property to offer further clarity on areas tested during the inspection. These photos are intended to give a visual reference for the specific locations where moisture levels were measured. These readings were taken at the time of the inspection to assess any potential moisture-related issues within the property. Any defects related to moisture that were identified during the inspection have been separately mentioned in the defect statements within the report.

It is important for the client to understand that moisture levels can fluctuate over time due to various factors, including changes in weather, humidity, and environmental conditions. While the readings reflect the property's moisture levels during the inspection, they may not represent future conditions, and increased moisture could lead to issues such as dampness, mould growth, or deterioration of building materials if left unmonitored.

For further clarification or additional information regarding the moisture readings, the client is encouraged to contact the building inspector directly. Regular monitoring of moisture-prone areas is recommended to ensure any emerging concerns are addressed promptly, particularly during wetter seasons or in high-humidity conditions.

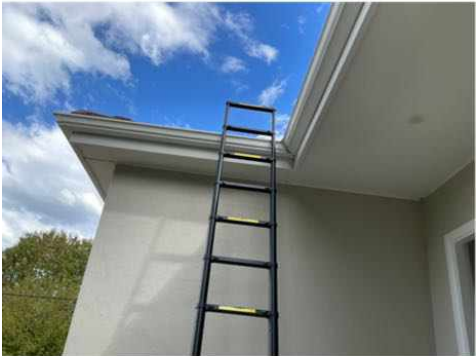
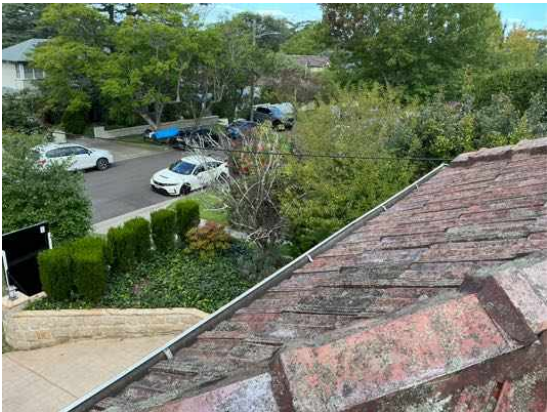
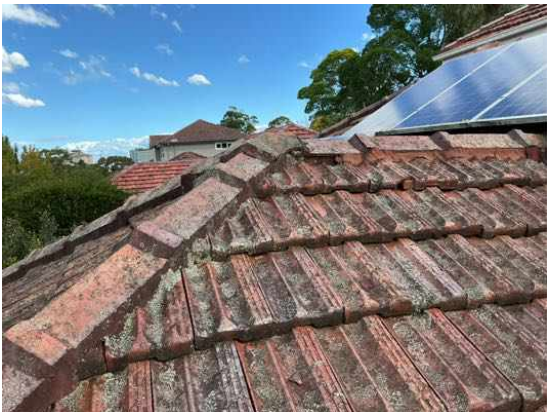
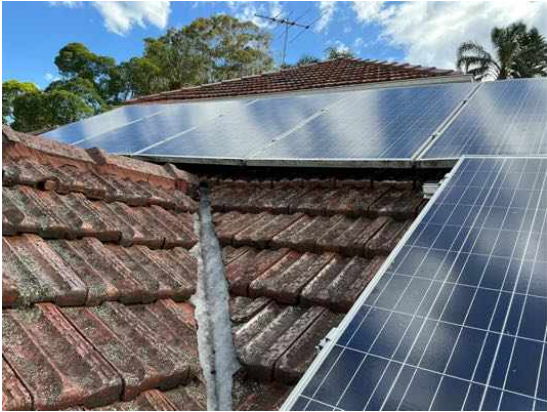
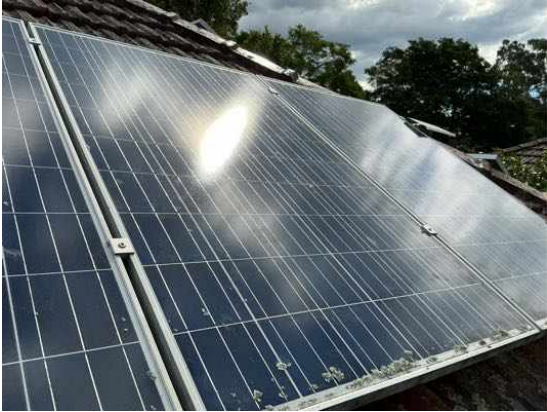
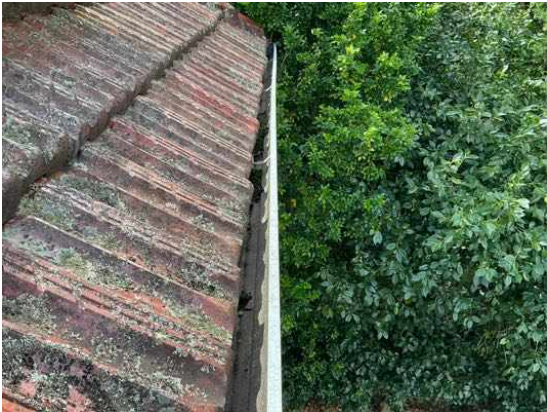
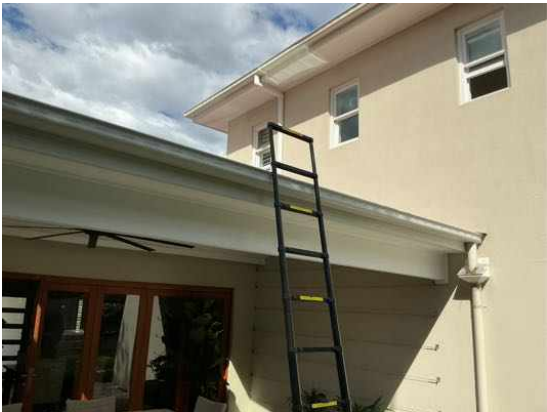
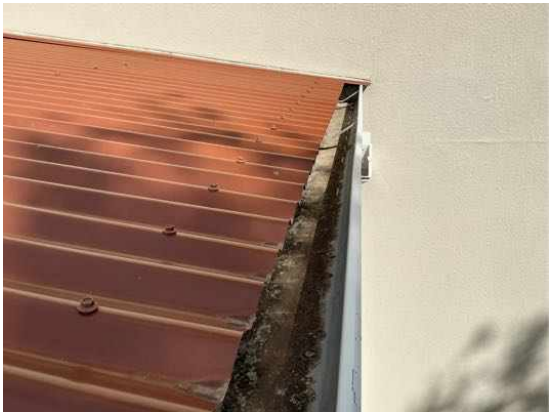
Building: Main Building
Location: Roof Exterior
Finding: Additional Roof Photos
Information: As part of the information provided, please note that the attached roof photos represent the condition of the roof at the time of inspection. These photos are for visual reference only and do not constitute a detailed roofing assessment. Any defects or issues identified with the roof are mentioned separately in the defect statements. It is strongly recommended that the client engage a qualified roofer to conduct a thorough inspection of the roof, ensuring that any potential issues, such as leaks, structural integrity, or wear and tear, are properly identified and addressed.

Additionally, the condition of the roof may change over time due to weather, natural wear, or other unforeseen factors. Regular maintenance and inspections by a licensed professional are advised to ensure the roof remains in good condition and to avoid costly repairs in the future. The information provided in these photos should be considered a snapshot of the roof's condition during the time of inspection and not a guarantee of its future performance.

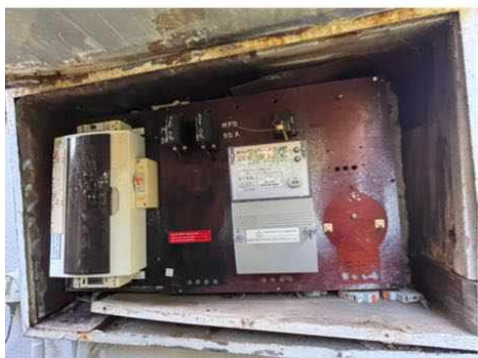
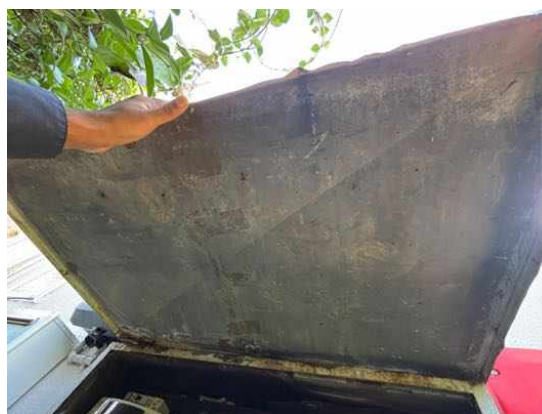
Building:	Main Building
Location:	Meter Box
Finding:	Termite Management Recommendation – No Evidence of Chemical Installation
Information:	At the time of inspection, there was no visible evidence of a chemical termite management system installed around the property. Chemical barriers are a key component of termite protection and are particularly important in preventing concealed termite entry into timber elements of the structure.

In accordance with standard requirements, a durable notice should be located within the electrical switchboard to detail any termite protection systems applied, including chemical treatments. No such notice was observed during the inspection.

It is recommended that the client engage a licensed pest controller to assess the suitability of installing a chemical barrier, and to provide advice on associated costs and procedures. This should be considered a short-term priority, particularly if the property has any history of termite activity or is located in a high-risk area.

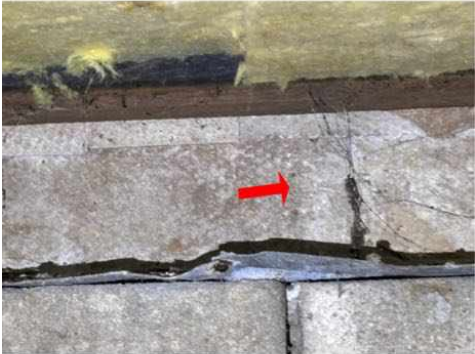
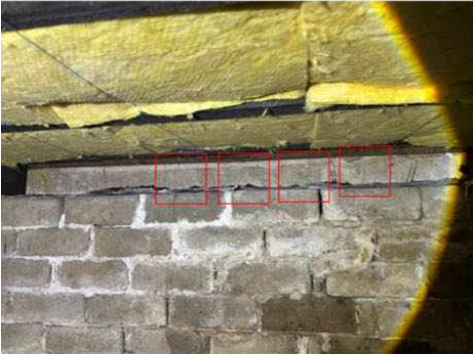
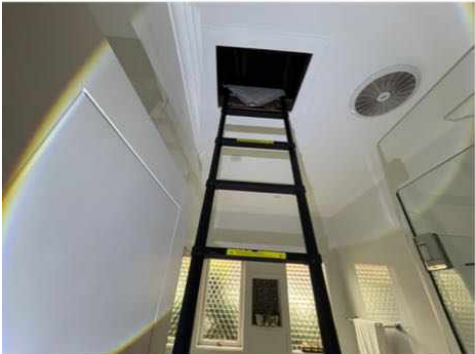
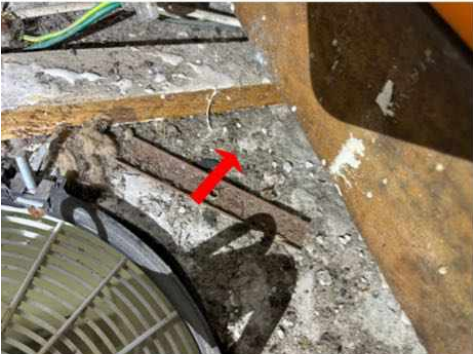
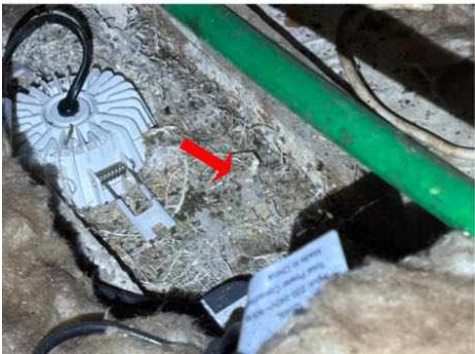
Building:	Main Building
Location:	Roof Space, Cladding
Finding:	Asbestos - Suspected ACM Identified on Site
Information:	Reporting on Asbestos is outside the Scope of this Report. This suspected defect is highlighted as a caution only. We suspect, based on our experience in the building industry, that there is a higher risk of the identified building element containing asbestos.

a separate Asbestos Inspection and Condition Audit, which can include the taking of samples for definitive confirmation of the presence of Asbestos.

In the interim, the client is advised to act with caution, especially when considering any damage to building materials general wear and tear renovations extensions demolition and general maintenance activities due to the suspected presence of Asbestos.

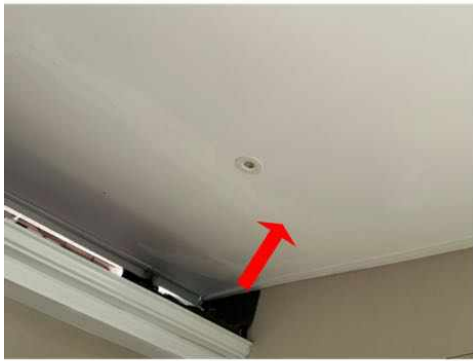
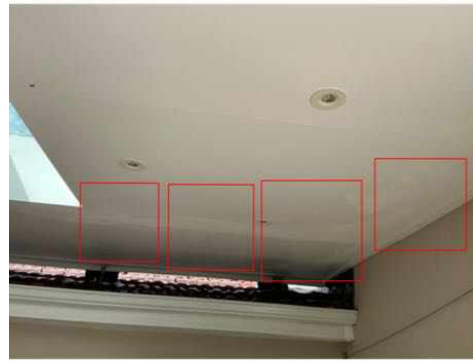
Building: Main Building
Location: Covered Entertainment Area
Finding: Previous Repairs

Information: At the time of inspection, it was noted that some repair work has been previously undertaken in this area. It is advisable for the client to inquire with the previous owner regarding the nature and extent of these repairs, including the specific issues addressed and the methods used for remediation. Understanding the history of the repairs can provide valuable insights into any recurring problems or potential long-term implications.

Additionally, the client should request any available documentation from the current owner that pertains to these repairs. This documentation may include invoices, warranties, or detailed descriptions of the work performed. Such records can help verify the quality and scope of the repairs, ensuring that the necessary steps were taken to address the issues comprehensively. This information will be crucial for future maintenance planning and can provide peace of mind regarding the structural integrity and safety of the property.
