Building Inspection Report

Inspection Date: Wed, 18 Feb 2026

Property Address: 6 Rogers St, Merrylands NSW 2160,
Australia

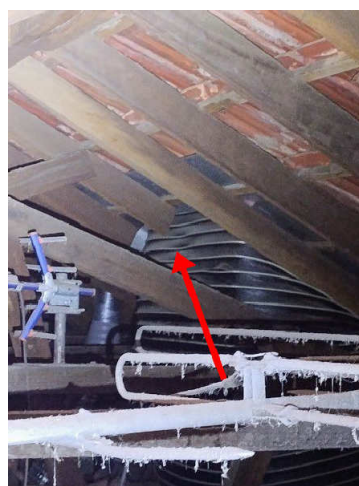
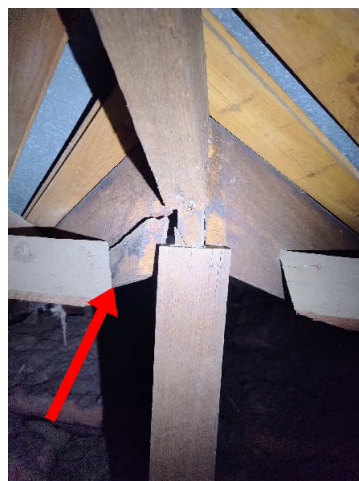
Defects 2.01

Finding: Roof structure - Altered and Damaged - Major Defect

Information: Alterations and damage to the roof structure have observed at the time of inspection. The modifications do not comply with current building practices and standards and require remedial works to reinstate to a suitable standard.

Replacement of major sections of roofing is likely to be required in order to comply with building regulations. Further assessment and necessary works should be performed immediately by a registered builder.

Until works are completed to bring the roofing structure to an appropriate level, the surrounding area should be avoided by all persons as a safety precaution.

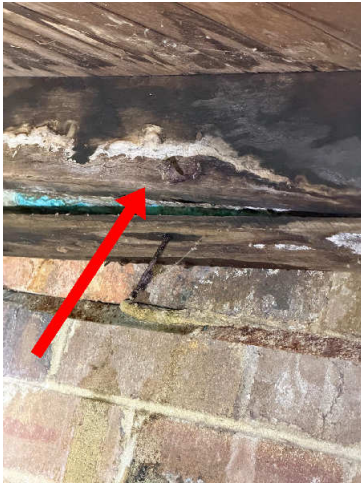
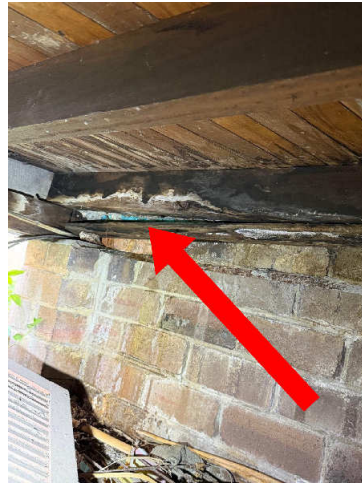
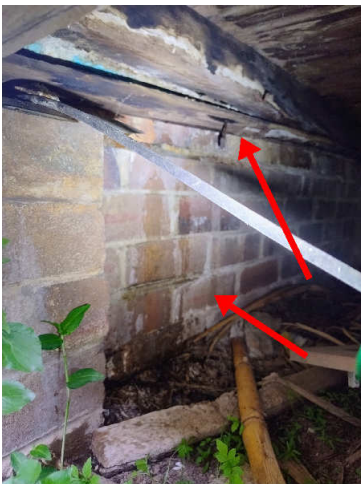
Defects 2.02

Finding: Water leak - Active - Detoriation to timber flooring

Information: Water ponding and active water leak was observed in subfloor at the time of inspection below toilet and bathroom area. Also Tiber structure below floor is deteriorated due to water leak at the time of inspection.

Generally, water leaks occur when a particular area of the property is not weather or water tight. As the surrounding area was found to be very damp at the time of inspection, and the leak was also ongoing and hence requires urgent action.

Regardless of the location, even minor leaks that are left unmanaged can lead to serious damage of associated building elements and result in the need for replacement of building materials. Mould and other hazards such as electrical hazards may also arise if the leak is left to develop.

It is highly advised that the cause of the leak be identified and resolved immediately by a licensed plumber to prevent any further damage. Depending on the extent of the damage previously sustained, repair and/or replacement of any affected building materials may be required.

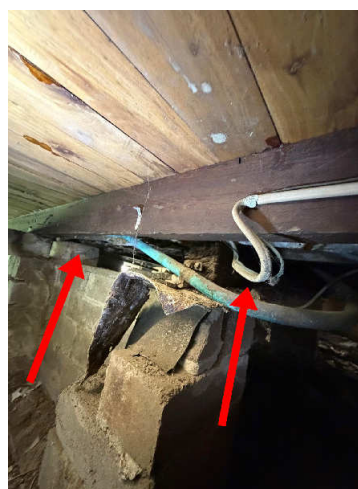
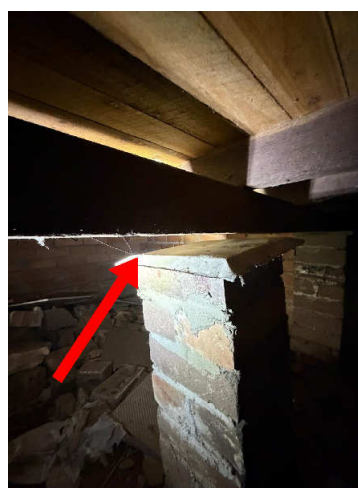
Defects 2.03

Finding: Subfloor stumps - Unstable or deteriorated - Major Defect

Information: Stumps to the subfloor structure are observed unstable and not supporting the wooden floor, indicating that their structural integrity has been affected. The cause of this instability is likely to be movement or extensive wood rot, both of which may deteriorate stumps at a rapid rate.

The stumps are suspected to be failing in their structural purpose, which is likely to lead to a range of major and minor defects. Further (potentially major) damage to the stumps and structure may be imminent if left unattended.

Appointment of a Registered Builder specialising in re-stumping is required immediately to assess the condition of the stumps and provide advice on remedial works. This defect should not be left unmanaged.

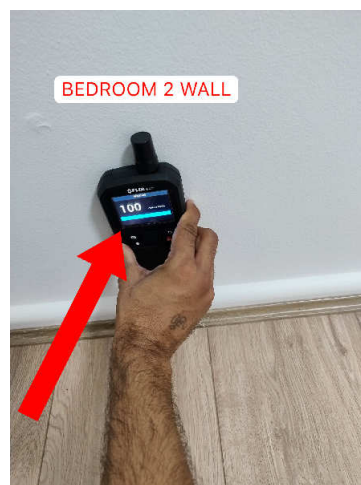
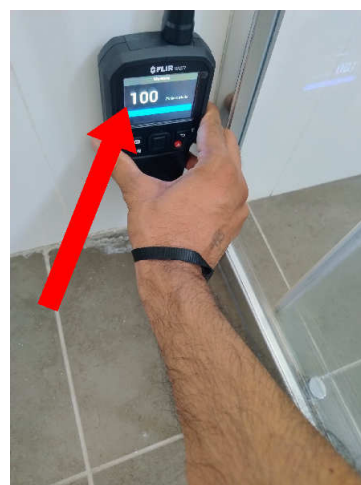
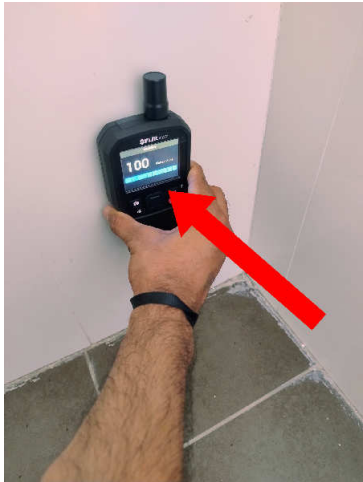
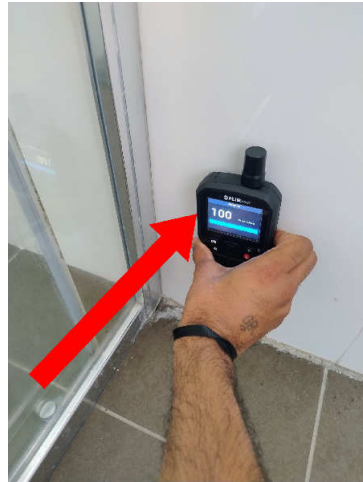
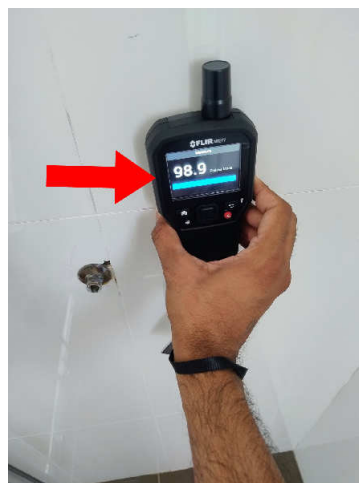
Defects 2.04

Finding: Evidence of Excessive moisture - identified

Information: Evidence of excessive moisture recorded by moisture meter in the shower walls of bathroom.

Excessive moisture can attract termites and produce conditions that promote fungal growth and wood decay.

Excessive moisture is generally caused by deteriorated, inadequate or missing roof drainage, leaking plumbing pipes or fixtures, poorly plumbed HWS overflows or condenser units and poor site drainage.

Prior to any remedial works being performed a qualified plumber should be appointed to further inspect the property and to identify the cause of the excessive moisture. Works to remove affected building elements may then be necessary and should be performed by an appropriate tradesperson.

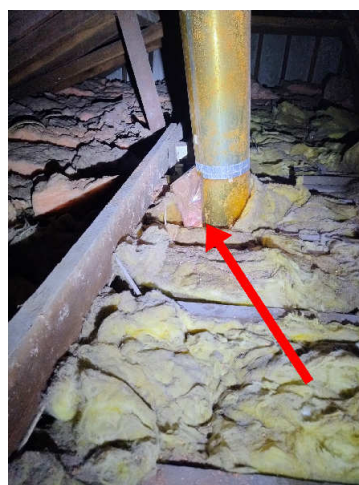
Defects 3.01

Finding: Skylight/flashing - Damaged

Information: The skylight/flashing covering appears to have been subject to minor damage at the time of inspection. The damage to this skylight is likely to allow rain penetration and provides potential for water damage to the surrounding ceiling area.

Repair or replacement of the skylight covering is required to prevent any further damage to the surrounding area. Works should be completed as soon as possible by a qualified carpenter or general handyperson.

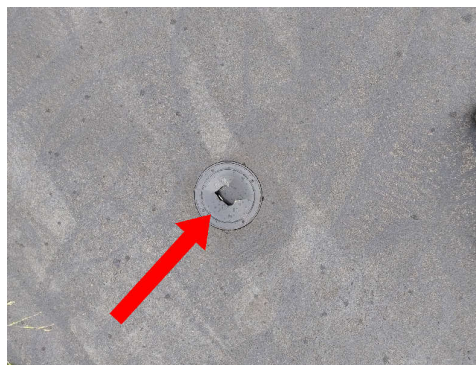
Defects 3.02

Finding: Pipe cover - Broken

Information: Upon inspection of the driveway, broken pipe covering, were identified. Broken and friable plastic cover are generally the result of ageing and weathering or sudden impact of something on it.

If left to further deteriorate, broken and it can lead to secondary damage to the exterior plumbing.

Replacement of broken pipe cover is required and should be performed by a licensed plumber as at the client's discretion.

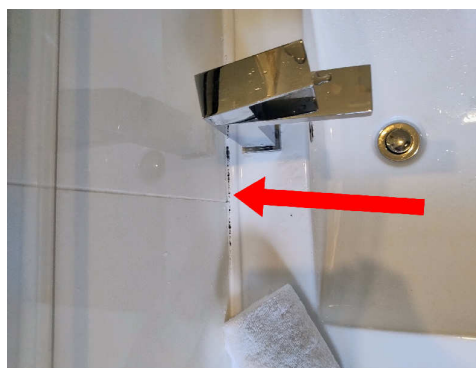
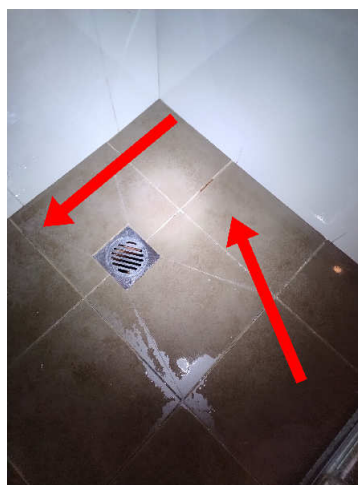
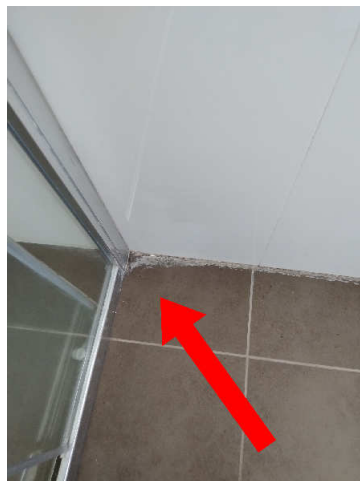
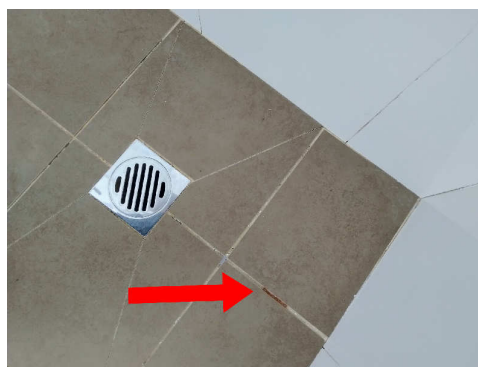
Defects 3.03

Evidence of Mould growth and water efforance was noted in all area of bathroom at the time of inspection. Which is believed to have grown due to lack of ventilation and water leak to the area.

Where evidence of mould growth was noted, there may be environmental, biological or health issues associated with the report. A specialist inspection by a suitably qualified environmental health inspector is warranted, where mould is extensive or where any queries regarding air quality spores or other related issues apply.

Generally, the client is advised to ensure that the general environment is free of moisture and humidity to aid in the prevention of mould formation and development. Any mould found during the inspection should be cleaned immediately by a cleaning contractor or the homeowner as applicable.

Please note that severely affected building elements may require replacement by a registered builder or qualified carpenter.

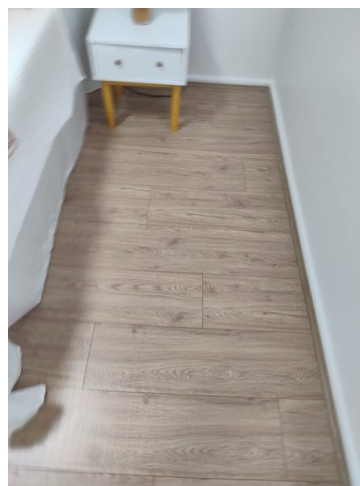
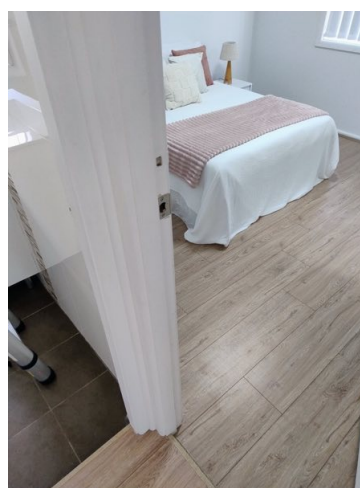
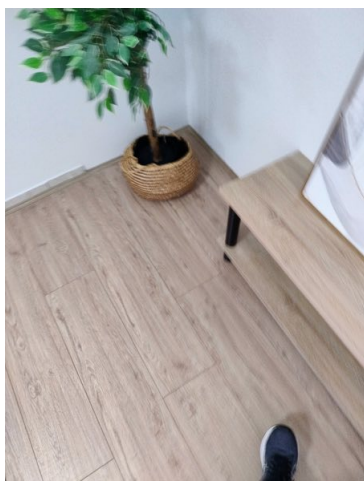
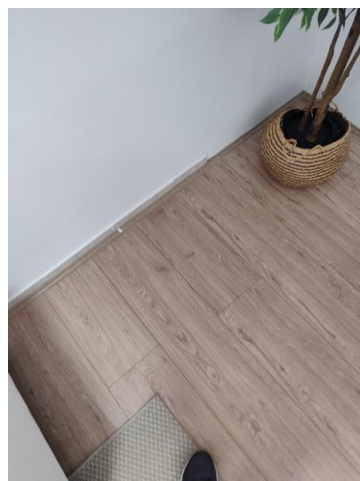
Defects 3.04

Building: Main Building
Location: Bedroom 3 + Living room
Finding: Floors - bouncy

Bouncy floors generally indicate that the floorboards or the subfloor structures are coming loose from the joists that they are installed on. Bouncy flooring may also be the result of gaps between flooring and stumps or joist structures, which require packing.

The client is advised to seek quotations for required repairs from a Registered Builder specialising in re-stumping. The potential resolution may range from packing gaps in subfloor structures through to replacement of subfloor stumps and refixing of flooring.

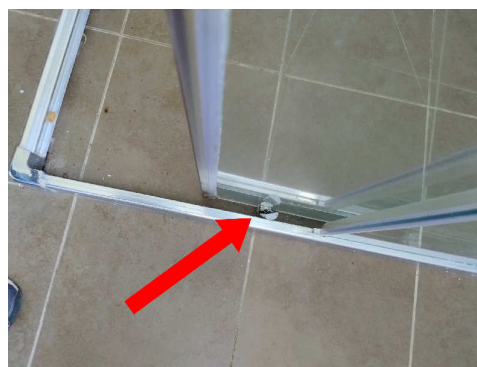
Defects 3.05

Information: The shower water tap and shower door fixings are missing and installation is observed to be substandard at the time of inspection. The primary defects if not attended can become a safety issue of major defects.

Works should be completed as soon as possible by a qualified carpenter or general handyperson or qualified plumber.

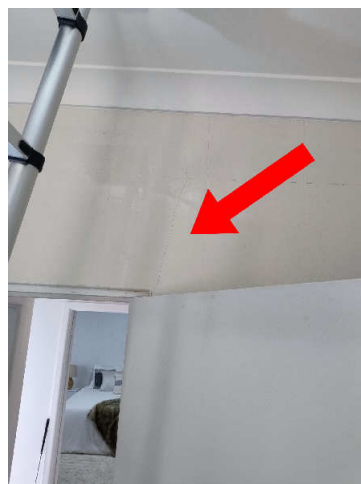
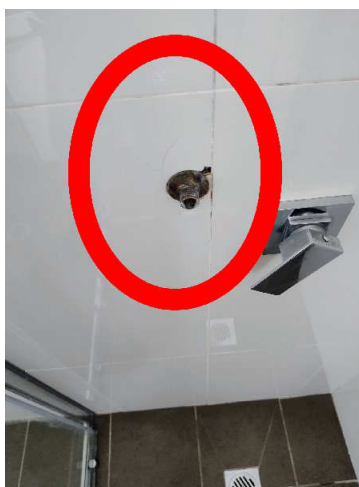
Defects 3.06

Finding: Wall tiles - cracked and broken

Information: Upon inspection of the bathroom, it was noted that wall tiles are cracked.

Cracked tiles in wet area required to be concealed to prevent the water to enter into the other structure of building. Which can lead to secondary defects if not attended.

Such works should be performed prior to final handover.

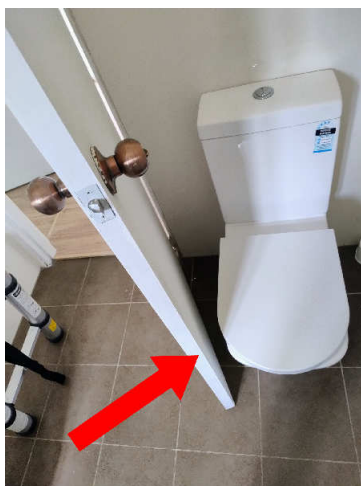
Defects 3.07

Finding: Door stop - Missing

Information: The door stop is missing and door is inadequate to stop the door handle from damaging the toilet pan. Although some building elements may seem irrelevant or unnecessary, all building elements play a key role in the operation and function of the overall structure and its performance.

Re-installation of the door stop is advised as soon as possible to prevent any subsequent damage to the door or associated structures. A general handyman may be appointed to perform these works at client discretion.

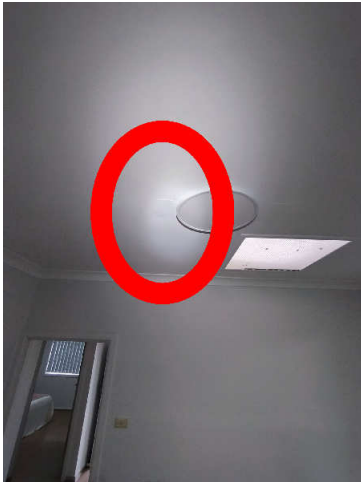
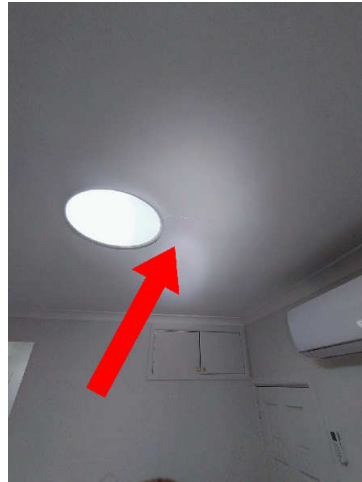
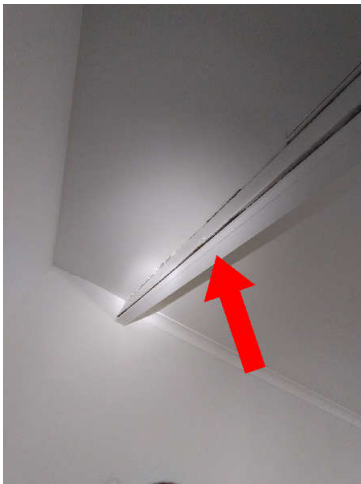
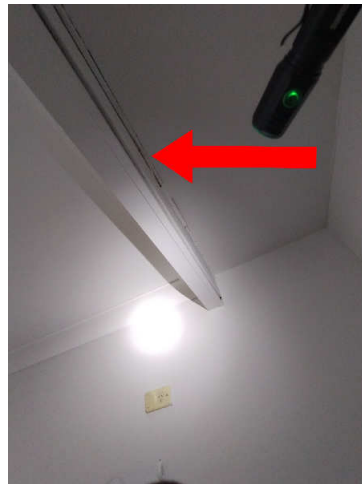
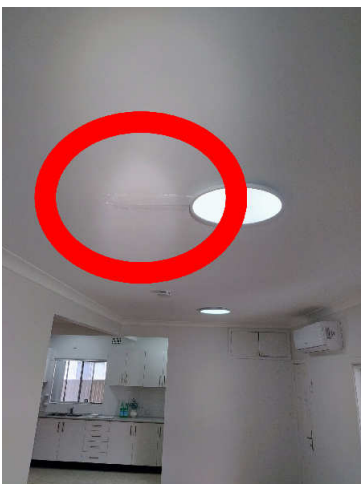
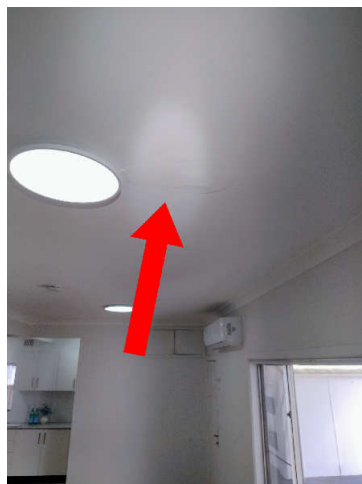
Defects 3.08

Finding: Cracks to internal rendered surfaces - Category 2

Information: Several cracks and patches to ceiling and wall to all internal areas of building was observed at the time of inspection.

The degree of damage falls within Category 2, described as noticeable cracks which are easily filled.

Damage of this category is required to be monitored for a period of 12 months, after which time a crack rated at Category 2 or above is considered a defect that requires rectification. Always contact your building inspector should cracks widen, lengthen, or become more numerous.

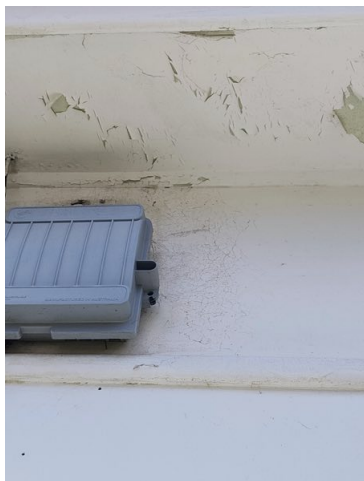
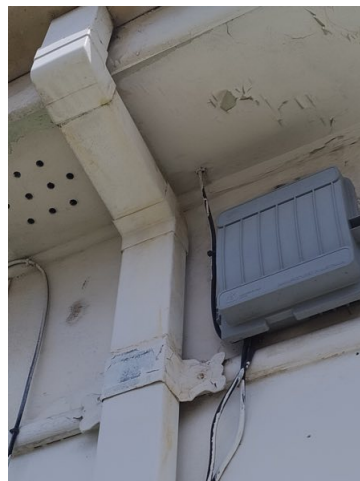
Defects 3.11

Finding: Building element - Damaged

Information: Exterir right side wall was observed to have damage at the time of inspection. Breakage occurs generally when the building materials have either aged and decayed, or as a result of damage (accidental or deliberate).

Repair and/or replacement of broken elements is advised to ensure that additional secondary defects do not arise as a consequence. Such works are necessary, as all building elements play a key role in the operation and function of the overall structure and its performance.

A relevant tradesperson should be appointed to repair or replace the affected building element prior to any subsequent damage being caused.

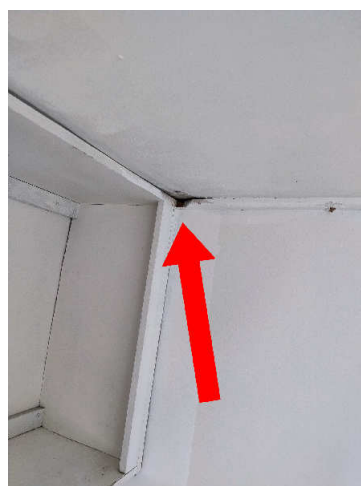
Defects 3.12

Building: Main Building
Location: Laundry
Finding: Wall cladding - dents and damage
Information: Dents and damage was observed in the Laundry walls and ceiling at the time of inspection.
Dents and damage is considered to be a defect under Standards and Tolerances. Works should be fixed as per the client's discretion by a qualified carpenter or general handyperson.

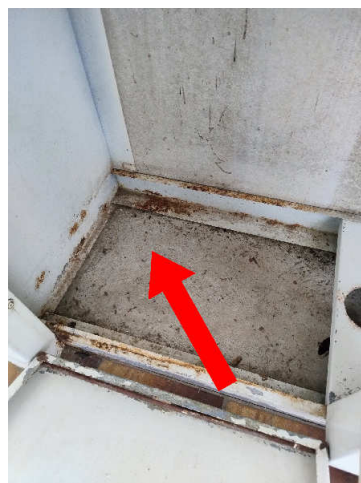
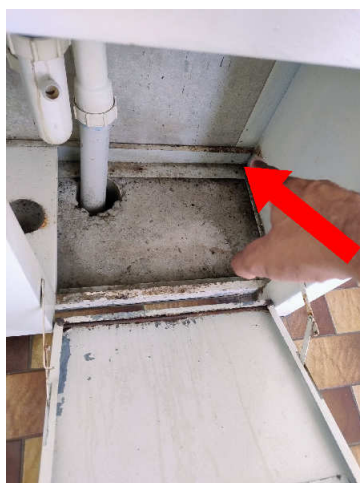
Defects 3.13

Building: Main Building
Location: Laundry
Finding: Joinery - Water stained

Water staining to joinery of laundry area was evident at the time of inspection. Water staining indicates that surfaces have been exposed to excessive moisture over time. The minerals and other elements in the water lead to staining, which may graduate to corrosion and deterioration if left unmanaged.

While mostly an appearance defect, water staining can be indicative of more serious defects, which may be currently concealed by interior ceilings.

Where water staining is active, a licensed plumber must be consulted to identify the cause of the staining and to provide advice on any reparation works that may be required. Replacement of any damaged structures is advised.

Conversely, where water staining is old and inactive, affected building materials may be repaired or replaced at client discretion.

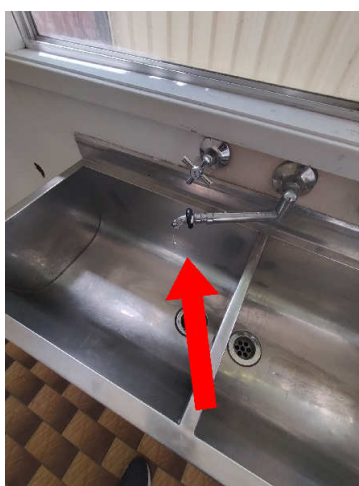
**Defects 3.14**

Finding: Tap - Leaking

Information: The tap in laundry area was found to be leaking at the time of inspection. This is a common defect that is consistent with general ageing of the building element. However, it may be indicative of substandard plumbing workmanship if the tap is relatively new.

While this defect only seems minor, if left unmanaged, it is likely to result in the development of rust, water damage and/or extensive water usage.

It is advised that a handyman or licensed plumber be appointed to perform remedial works on the affected tap. Such works should be performed prior to the development of secondary defects to ensure adequate functionality of all associated building elements.

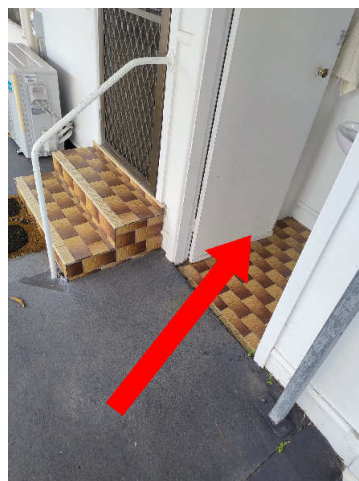
Defects 3.15

Finding: Door stop - Missing and damage to wall

Information: The door stop is missing and not stopping the door handle from damaging the wall at the time of inspection. Although some building elements may seem irrelevant or unnecessary, all building elements play a key role in the operation and function of the overall structure and its performance.

Re-installation or replacement of the door stop is advised as soon as possible to prevent any subsequent damage to the door or associated structures. A general handyman may be appointed to perform these works at client discretion.

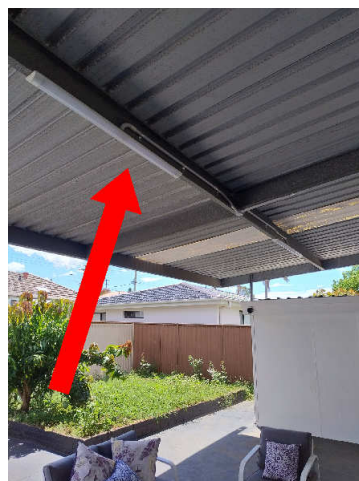
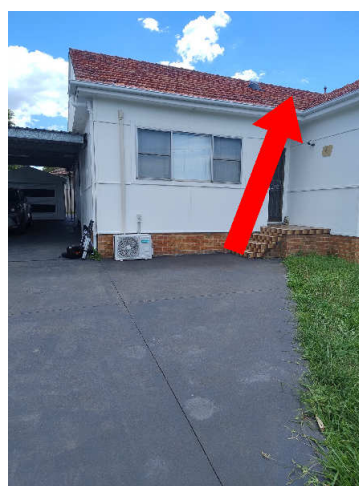
Defects 3.16

Information: Upon inspection of the exterior roofing, the majority of roof tiles were considered to be in a fair condition. While weathering of the tiles is consistent with the age of the property, maintenance works are required.

Isolated areas of mortar have come loose in the valleys and minor cracking is also present. Re-pointing and re-sealing the may be considered as an interim solution by the client to help preserve and extend the life span of the tiles.

Where left unmanaged, deteriorating roof tiles are likely to lead to a number of secondary defects, including minor water leaks and weather exposure to internal roofing structures.

Consultation with a roofing contractor is highly advised to gain advice on cost of remedial works that may be required in the short to medium term. Remedial works are likely to increase the longevity of the exterior roofing structure.

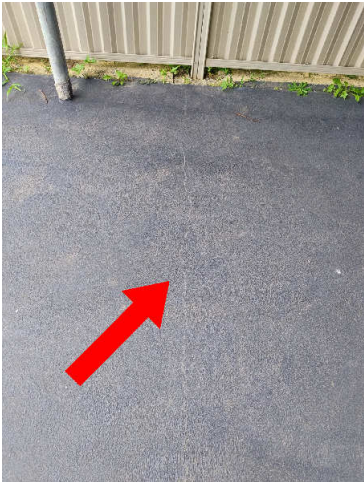
Defects 3.17

Finding: Crack in concrete slab - Category 1

Information: A crack on drive way was observed at the time of inspection. A crack coded as Category 1 was identified in the slab. A Category 1 crack is described as a fine but noticeable crack, with the slab at an otherwise reasonable level.

To be considered Category 1, the approximate width of the crack is less than 1.0mm, or a less than 10mm change in offset when a 3m straight edge is placed over the defect.

Category 1 cracks should be monitored for a period of 12 months. At the end of the monitoring period, identified cracks that are rated greater than Category 2 are considered defects, and require rectification.

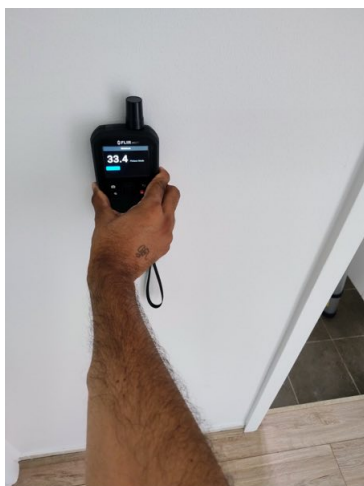
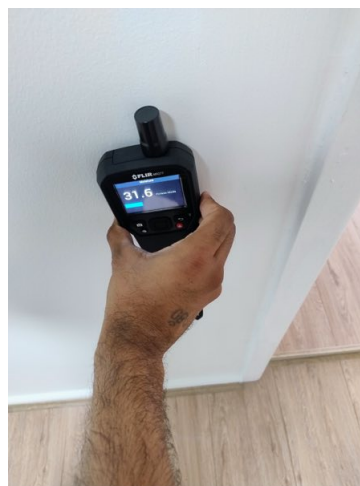
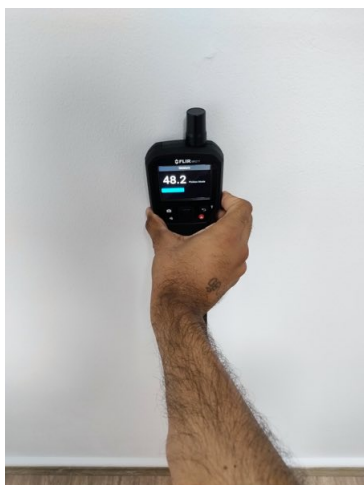
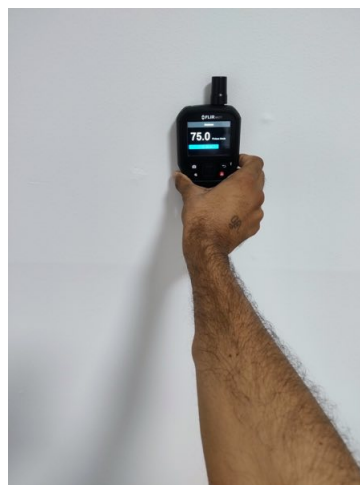
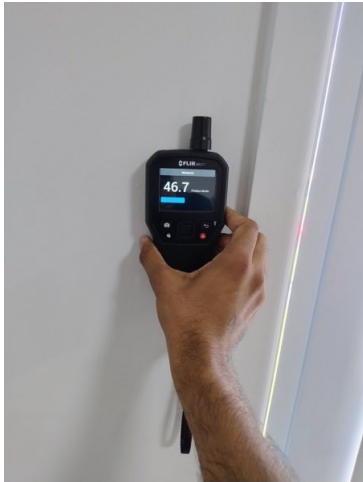
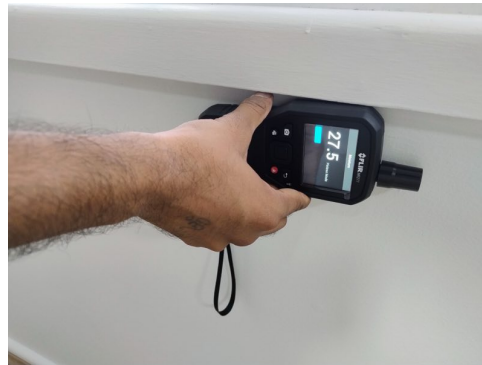
Finding: Additional Moisture reading taken

Information: Moisture reading were taken at the time of inspection as all suspected areas where moisture reading can be high.

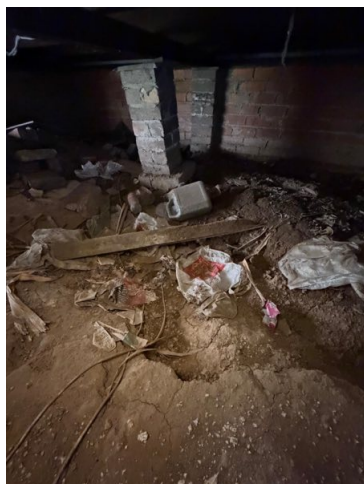
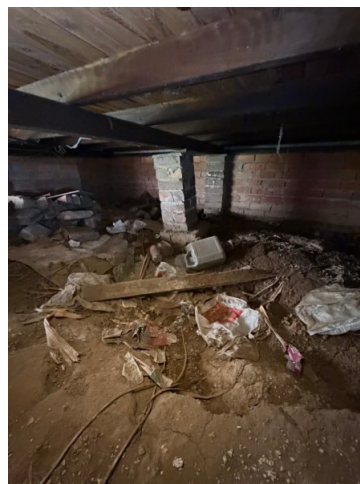
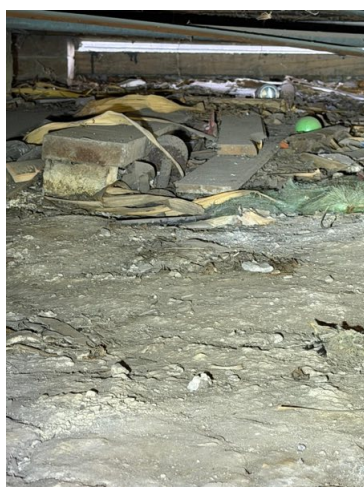
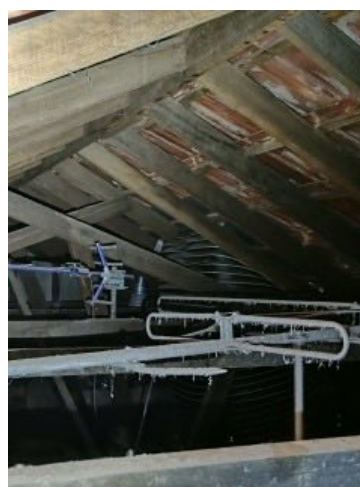
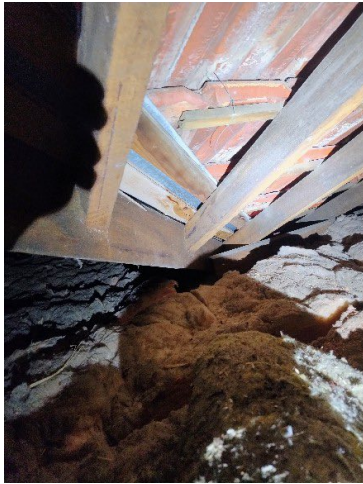
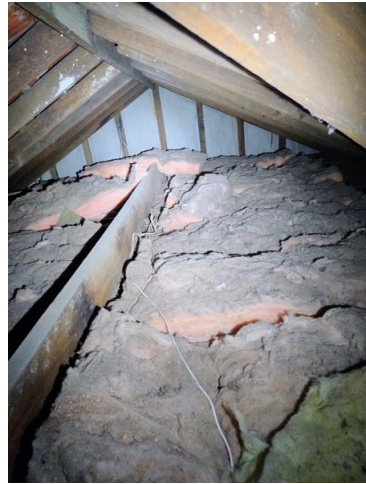
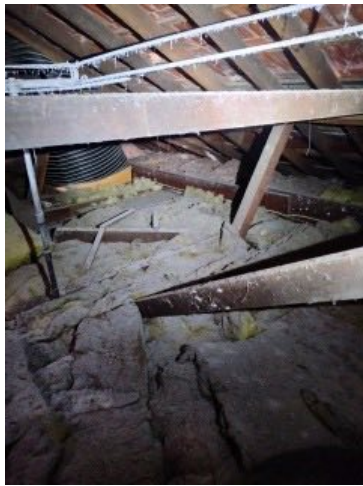
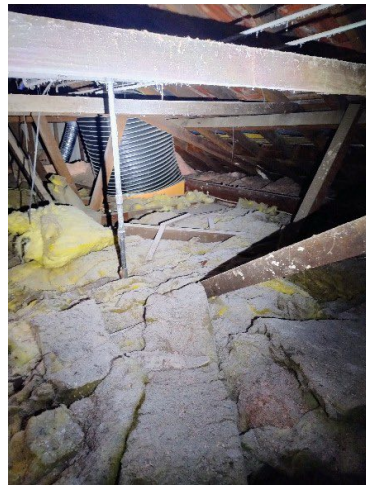
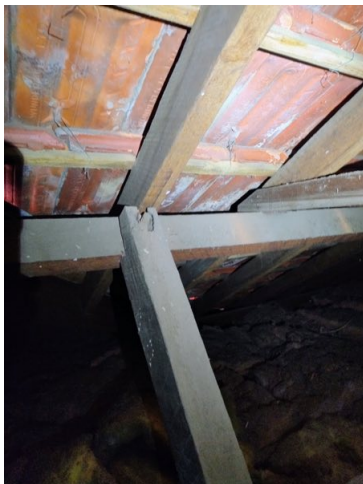
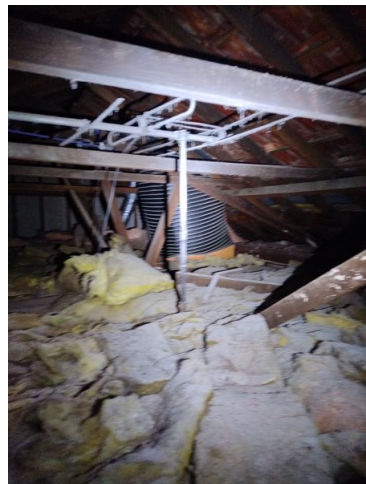
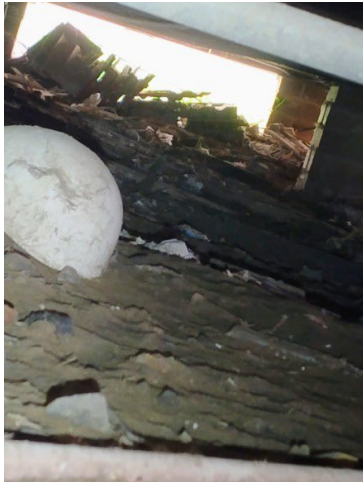
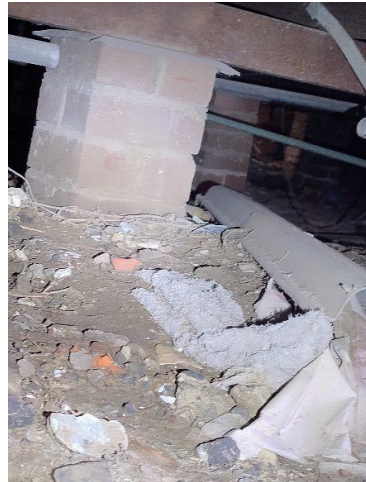
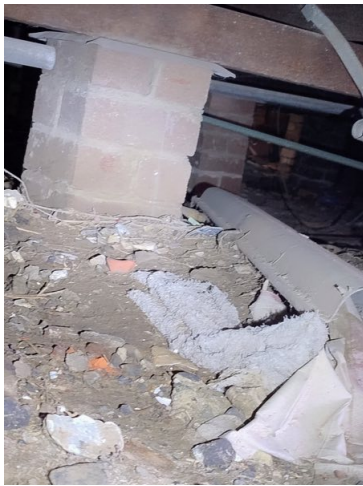
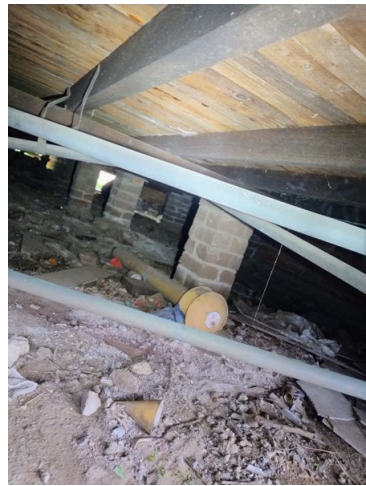
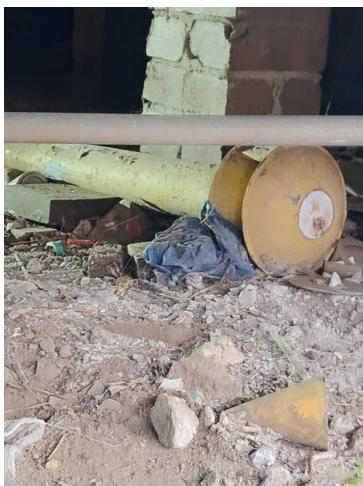
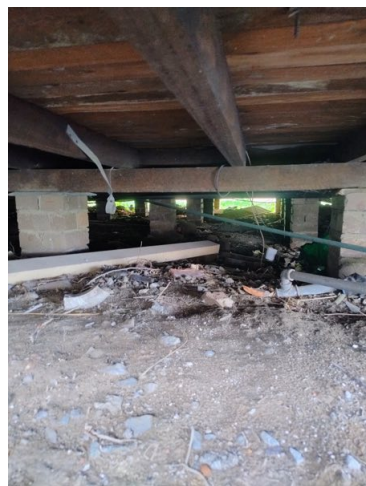
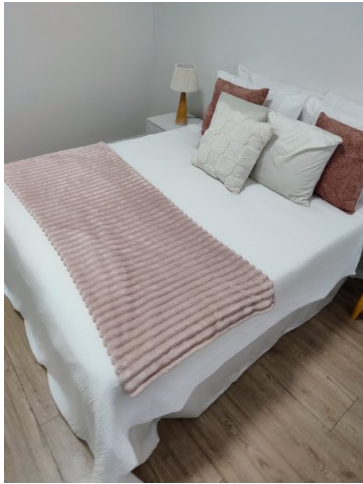
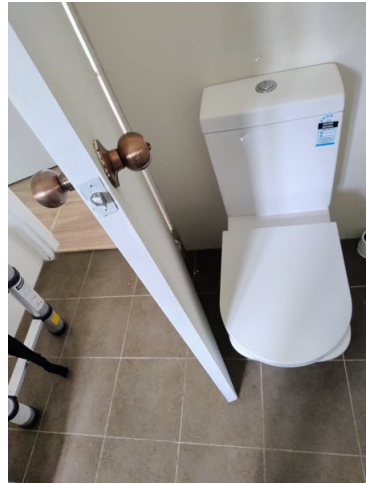
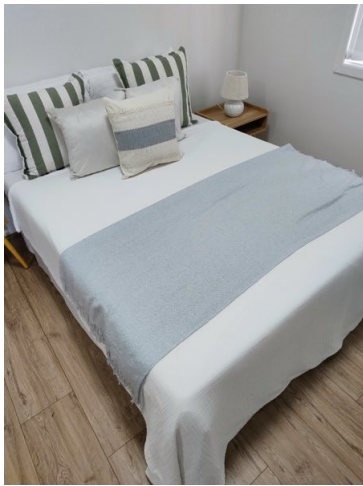
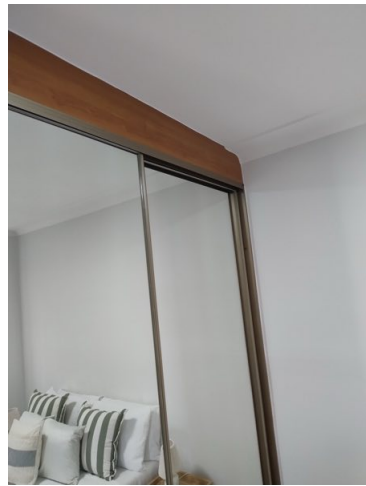
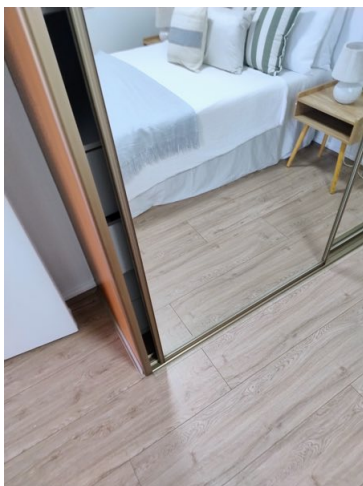
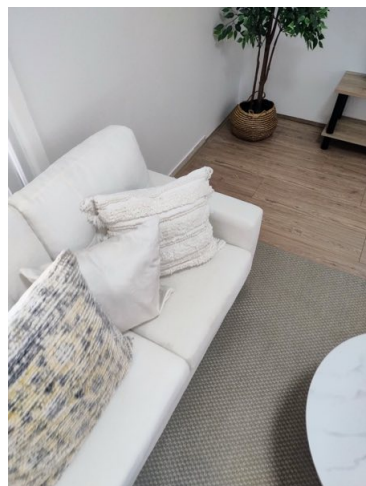
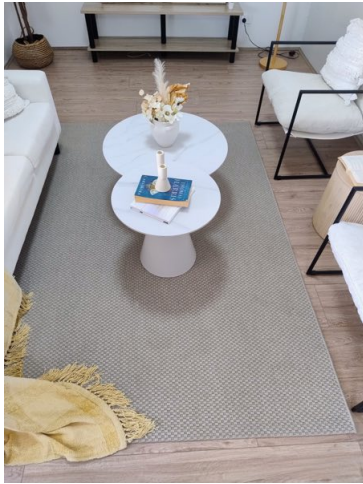
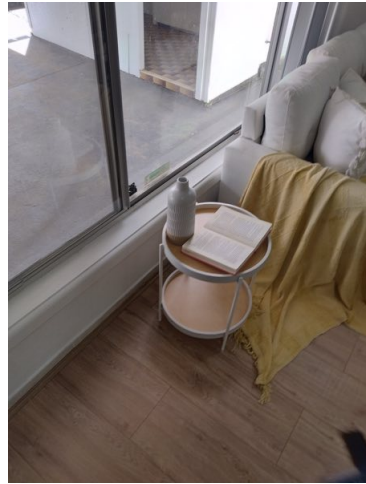
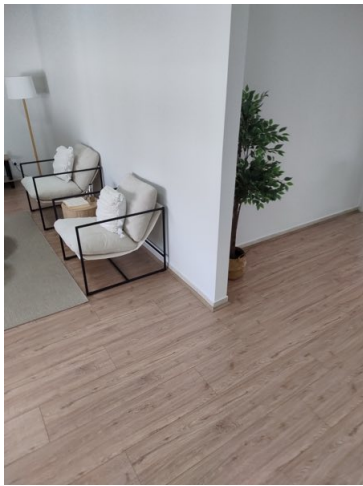
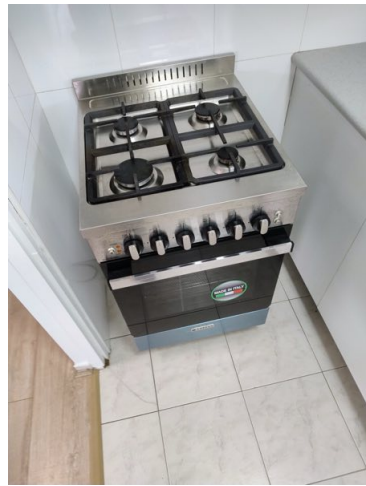
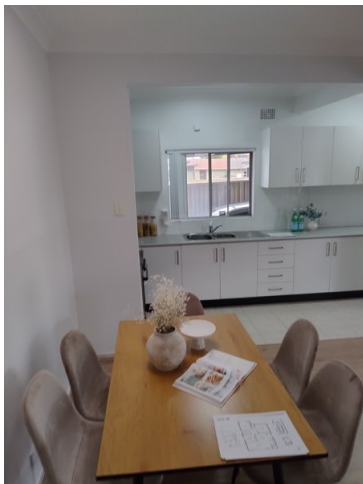
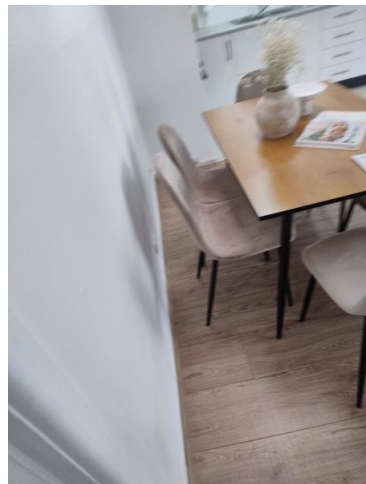
Finding: Additional Photos - Obstructions and Limitations

Information: These photographs are an indication of the obstructions and limitations which impeded full inspection of the property at the time of inspection. These obstructions can hide an array of defects and should be removed to allow full inspection to be carried out. A re-inspection is recommended once the areas are made accessible.
