Building and Timber Pest Inspection Report

Inspection Date: Fri, 6 Feb 2026

Property Address: 17 Wahroonga Rd, Wyongah NSW 2259,
Australia

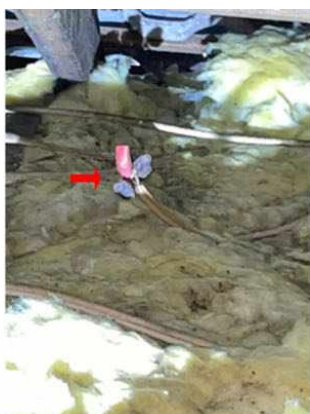
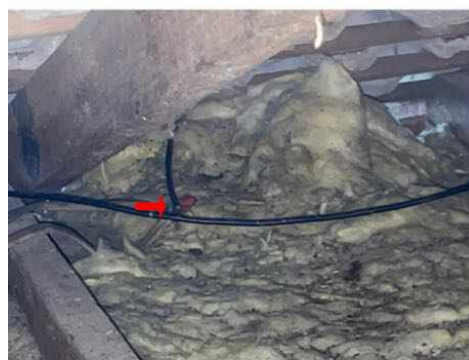
Building:	Main Building
Location:	Roof Void > Rear
Finding:	Electrical junction box - Missing
Information:	Several wiring joins in the roof space are not adequately protected by a junction box. Junction boxes provide a second insulation barrier to adequately seal off and protect the wires, increasing the safety of the immediate environment and ensuring that the wiring is not damaged.

The absence of junction boxes in the roof space poses as an electrical safety hazard, providing risk of electrocution. It appears as though wiring in this area has been completed to a substandard level of workmanship, evidenced by the lack of adequate wiring protection.

Appointment of a licensed electrician is highly advised to provide additional information on the risks of unprotected wiring and to install junction boxes and any other elements as required. Such works should be carried out as a matter of urgency; until this time, any persons within the roof space should exercise a high level of caution.

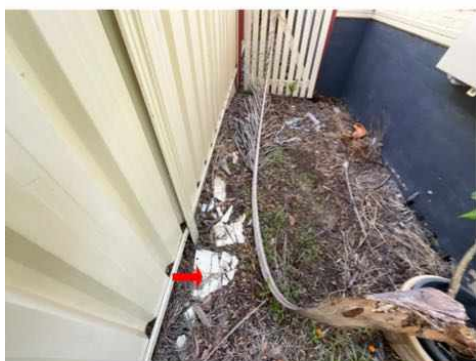
Finding 1.02

Building:	Main Building
Location:	Yard - Front > Front Left
Finding:	Asbestos - Suspected ACM Identified on Site
Information:	Broken fibre cement sheeting to the front of the property was observed. This may potentially contain asbestos. Reporting on Asbestos is outside the Scope of this Report. This suspected defect is highlighted as a caution only. We suspect, based on our experience in the building industry, that there is a higher risk of the identified building element containing asbestos.

As Asbestos Reporting is outside the scope of this report, we advise that you consider a separate Asbestos Inspection and Condition Audit, which can include the taking of samples for definitive confirmation of the presence of Asbestos.

In the interim, the client is advised to act with caution, especially when considering any damage to building materials general wear and tear renovations extensions demolition and general maintenance activities due to the suspected presence of Asbestos.

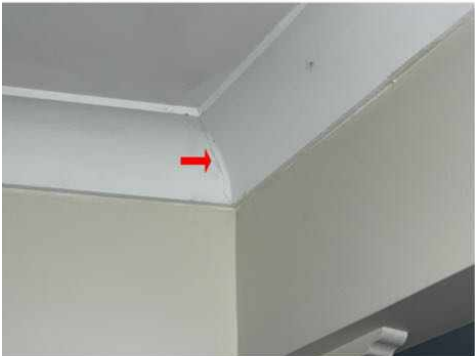
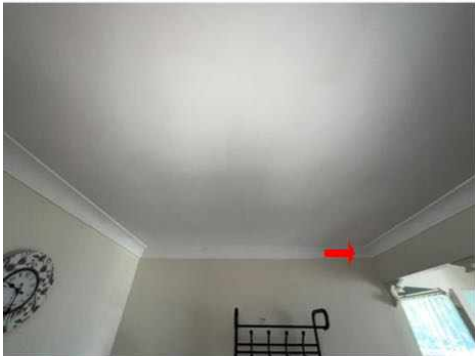
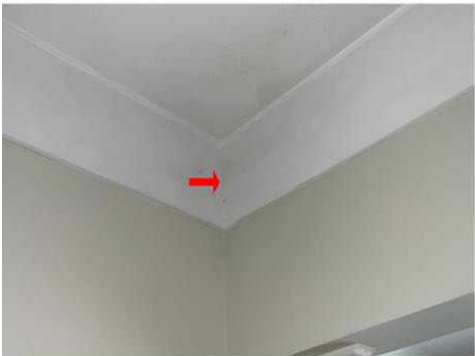
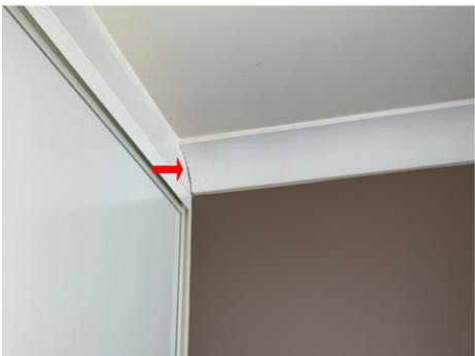
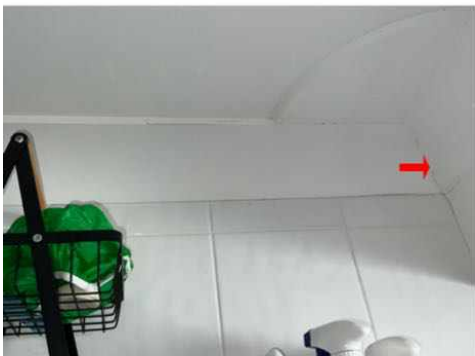
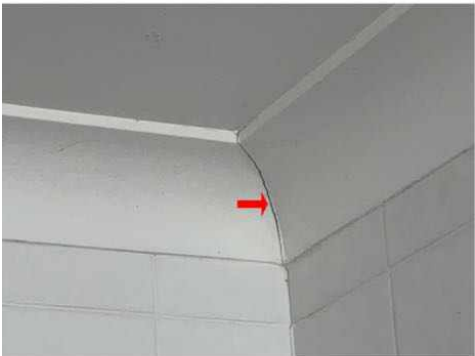
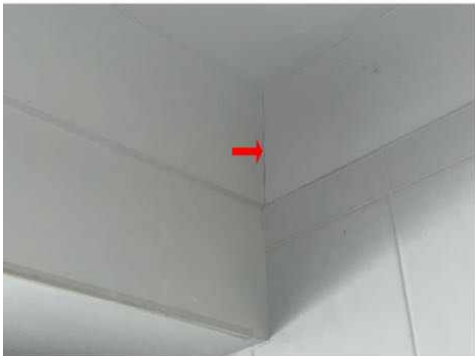
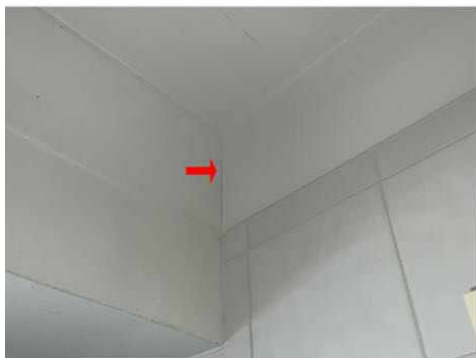
Building:	Main Building
Location:	All Internal Areas > All Areas
Finding:	Cracking - Damage Category 1 - Fine (up to 1mm)
Information:	It was evident at the time of the inspection that there were a number of cracks to the cornice predominantly to the internal mitres. Although fine cracks are quite noticeable, they are often only considered to be an appearance defect, and usually do not indicate any structural damage. Generally, the cause of a fine crack is indicative of a separation between building materials and finishes (e.g. paint, plaster, etc.) along joins.

Cracking of this nature can generally be repaired with minor sanding, filling and/or repainting. Such works should be performed by a qualified painter or a general handyman.

Monitoring of all cracking should be conducted frequently. Always contact a building inspector should cracks widen, lengthen, or become more numerous.

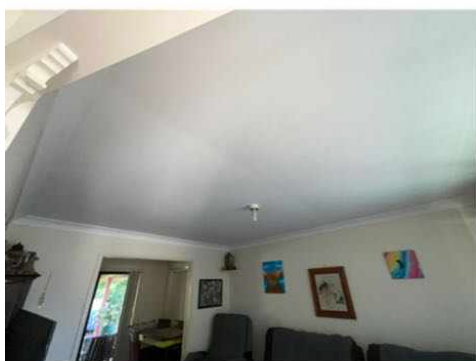
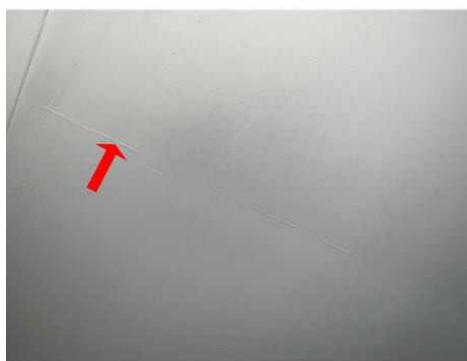
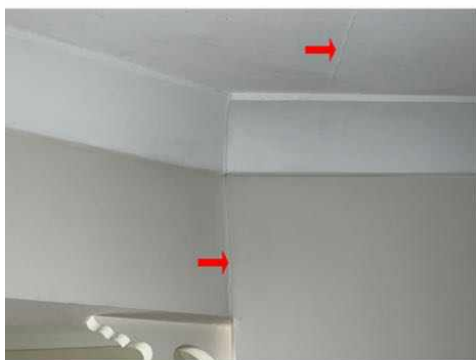
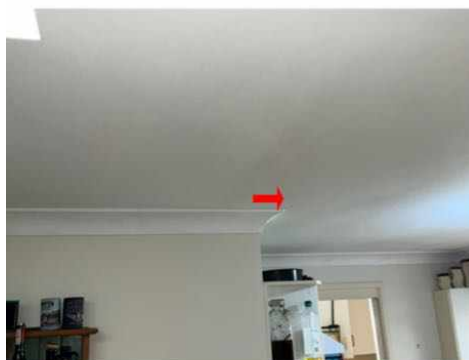
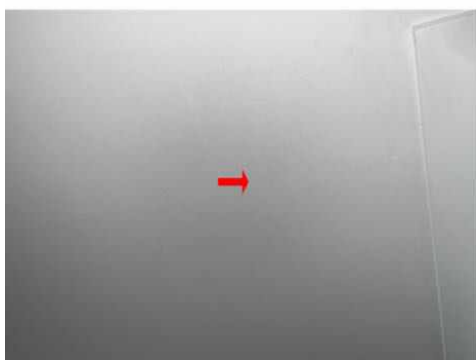
Finding 3.02

Building:	Main Building
Location:	All Internal Areas > All Areas
Finding:	Cracking - Damage Category 1 - Fine (up to 1mm)
Information:	There was some minor cracking to areas of the plasterboard. Although fine cracks are quite noticeable, they are often only considered to be an appearance defect, and usually do not indicate any structural damage. Generally, the cause of a fine crack is indicative of a separation between building materials and finishes (e.g. paint, plaster, etc.) along joins.

Cracking of this nature can generally be repaired with minor sanding, filling and/or repainting. Such works should be performed by a qualified painter or a general handyman.

Monitoring of all cracking should be conducted frequently. Always contact a building inspector should cracks widen, lengthen, or become more numerous.

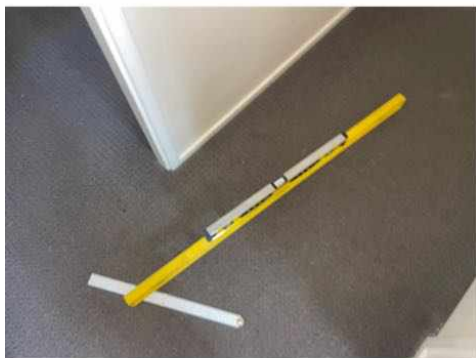
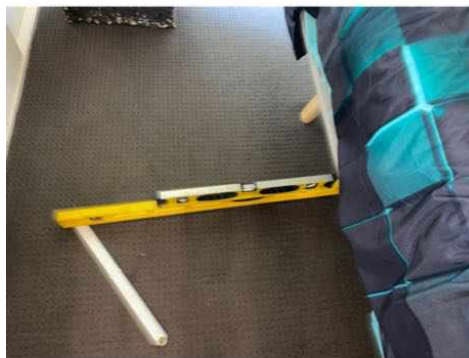
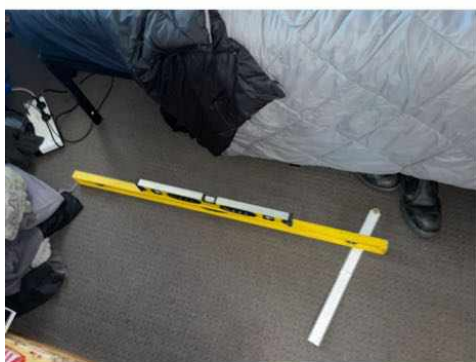
Finding 3.03

Building:	Main Building
Location:	All Internal Areas > All Areas
Finding:	Flooring - Uneven
Information:	The internal flooring to several areas is out of level and uneven approximately 5mm over a 1.2m length. Uneven flooring is likely to indicate minor defects such as expected movement of the foundations of the property, but may also indicate subsidence of the associated subfloor stumps.

It is advised that the flooring be closely monitored to identify any further movement. Where flooring remains relatively unchanged for an extended period of time (i.e. several months), it is likely that this defect has been caused by expected movement of the foundations of the property.

However, where flooring is uneven further, potentially invasive inspection of the subfloor structures and stumps in this area is required. In this case, works to repair are likely to be required, and would be carried out by a registered builder specialising in re-stumping.

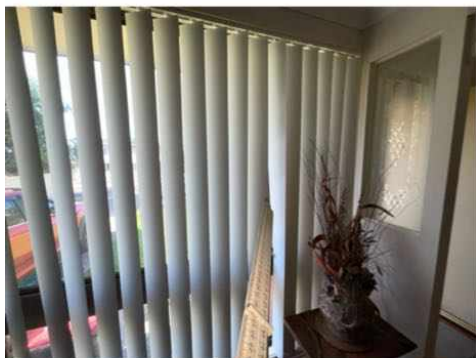
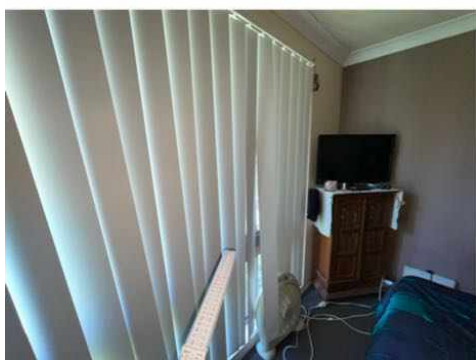
Finding 3.04

Building: Main Building
Location: Living Room > Front Right
Finding: Window - Stiff to slide
Information: The window in this area was jammed and difficult to operate at the time of the inspection. Windows provide ventilation to the adjoining area and should be at a fully operational level to ensure user comfort. Restricted function of the window may also pose as a potential safety hazard if required for emergency egress from the building.

Generally, factors such as general age of the building element and a lack of maintenance are the usual causes for this type of defect.

Replacement of window hardware or frame may be required, as well as minor repairs and cleaning. A registered builder or general handy person will be required to repair the window.

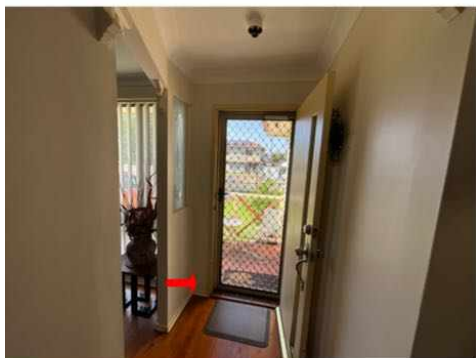
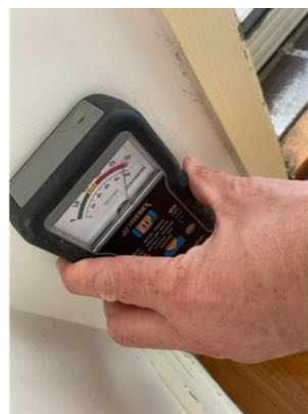
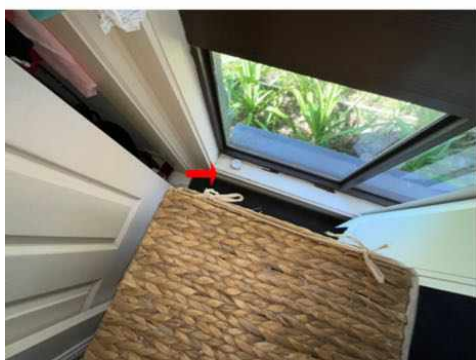
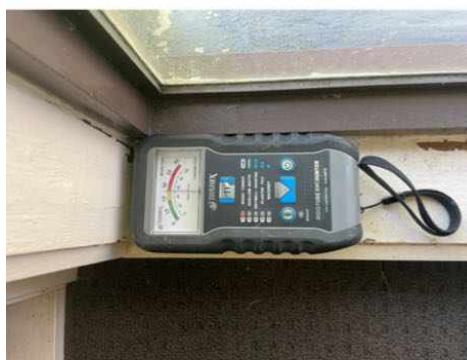
Finding 3.05

Building:	Main Building
Location:	Entry > Front
Finding:	Excessive moisture - identified
Information:	Excessive moisture was evident to the wall adjacent to the front door and the window sill in bedroom 1. Excessive moisture can attract termites and produce conditions that promote fungal growth and wood decay.

Excessive moisture is generally caused by deteriorated inadequate or missing roof drainage leaking plumbing pipes or fixtures poorly plumbed HWS overflows or condenser units and poor site drainage.

Prior to any remedial works being performed a qualified plumber should be appointed to further inspect the property and to identify the cause of the excessive moisture. Works to remove affected building elements may then be necessary and should be performed by an appropriate tradesperson.

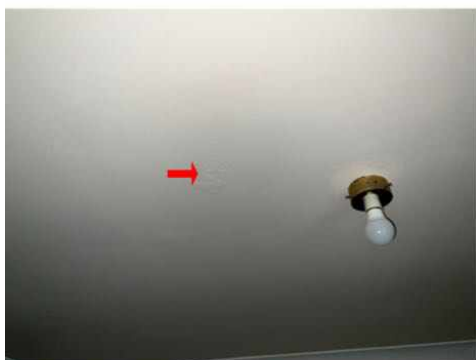
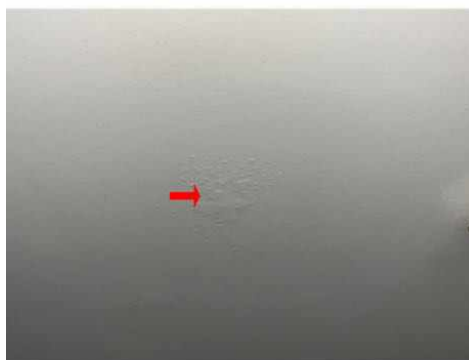
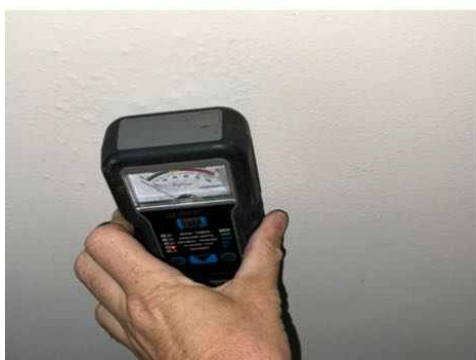
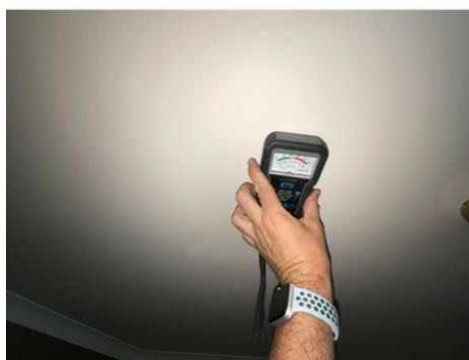
Finding 3.06

Building:	Main Building
Location:	Bedroom > Front Left
Finding:	Ceiling - Water stained
Information:	Water staining or bubbling of paint to ceiling linings in this area was evident at the time of inspection. Water staining indicates that surfaces have been exposed to excessive moisture over time. The minerals and other elements in the water lead to staining, which may graduate to corrosion and deterioration if left unmanaged. No elevated moisture levels were indicated on the moisture meter at the time of the inspection.

While mostly an appearance defect, water staining can be indicative of more serious defects, which may be currently concealed by interior ceilings.

Where water staining is active, a licensed plumber must be consulted to identify the cause of the staining and to provide advice on any reparation works that may be required. Replacement of any damaged structures is advised.

Conversely, where water staining is old and inactive, affected building materials may be repaired or replaced at client discretion.

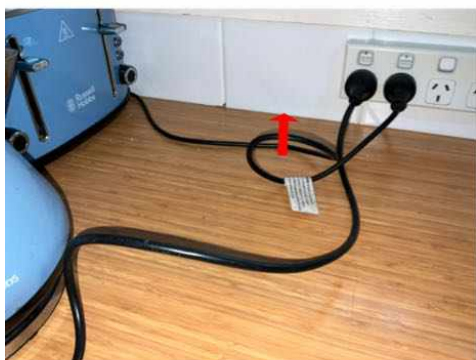
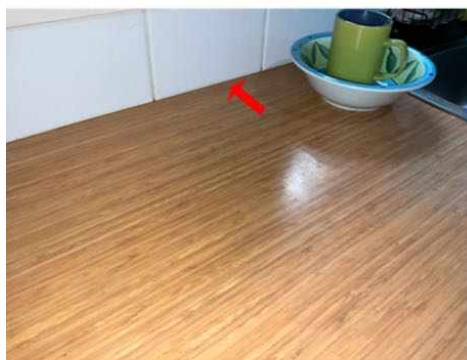
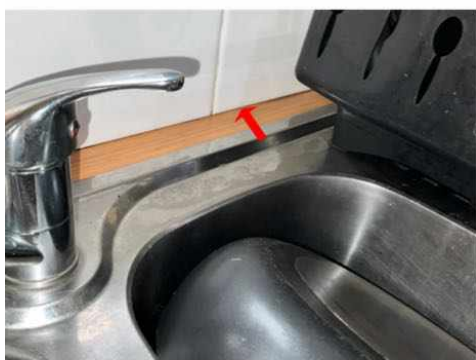
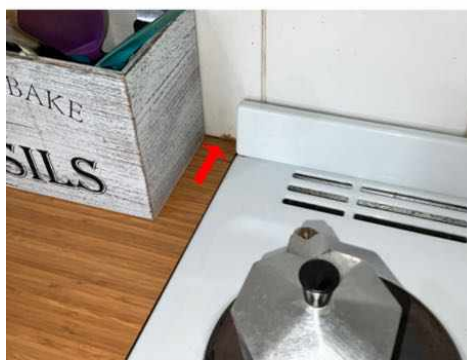
Finding 3.07

Building:	Main Building
Location:	Kitchen > Rear
Finding:	Sealant and grouting - Missing or damaged
Information:	It was noted on inspection that sealant is degraded between the benchtop and the splashback in the kitchen.

Different materials and floor areas move at different rates, generally causing cracking to grout or sealant at this point. A flexible sealant is required to allow for expected expansion and contraction, while keeping the joint water tight and protective of all associated building materials.

Flexible and mould resistant materials should be applied to affected areas to prevent any subsequent water damage that is likely to occur. Regular maintenance and replacement of damage or missing or damaged sealant and grout is highly recommended to the wet areas, as this is a regular wear and tear defect. Sealant and grouting in areas that come into regular contact with water should be maintained for the long term care of your property.

A sealant specialist or tiling contractor should be appointed to complete these works as soon as possible

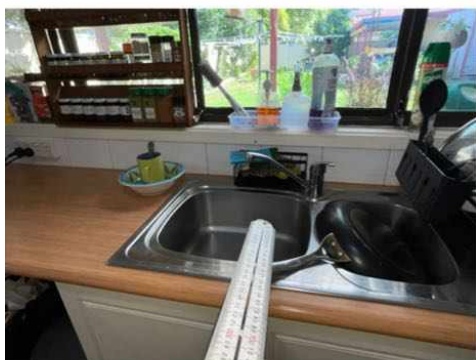
Finding 3.08

Building:	Main Building
Location:	Kitchen > Rear Left
Finding:	Tap - Water hammer
Information:	This tap shows evidence of water hammer being present. Water hammer, a pressure surge resulting when a fluid is forced to suddenly change direction, is a common defect in plumbing fittings, particularly those that are aged and not frequently maintained. Water hammer is generally caused by factors that create high water pressure in the affected plumbing fixture, usually evidenced by a faint banging noise during operation of the affected tap.

Although water hammer is generally considered to be a minor defect, subsequent damage such as erosion of tap hardware and/or water damage to associated building elements is likely to occur if left unmanaged.

A licensed plumber should be appointed as soon as possible to replace any affected tap hardware and perform any remedial works as necessary. Please be advised that the appointment of a cabinet maker or qualified carpenter may be necessary if water damage to associated building elements has occurred.

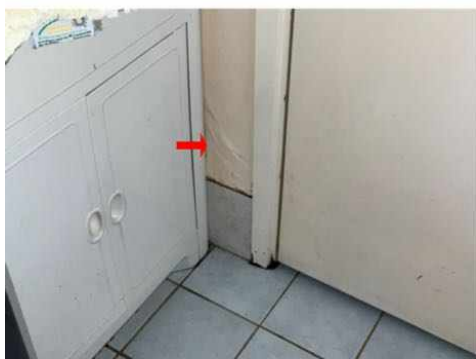
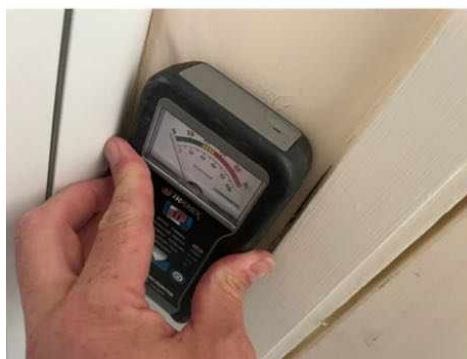
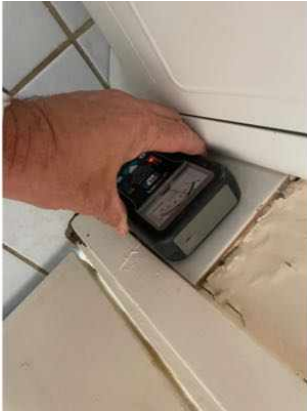
Finding 3.09

Building:	Main Building
Location:	Laundry > Rear Left
Finding:	Walls - Water affected
Information:	Water staining to a section of the wall next to the door in the Laundry was evident at the time of inspection. There was no elevated moisture levels indicated on the moisture meter at the time of the inspection. Water staining indicates that surfaces have been exposed to excessive moisture over time. The minerals and other elements in the water lead to staining, which may graduate to corrosion and deterioration if left unmanaged.

While mostly an appearance defect, water staining can be indicative of more serious defects, which may be currently concealed by wall linings.

Where water staining is active, a licensed plumber must be consulted to identify the cause of the staining and to provide advice on any reparation works that may be required. Replacement of any broken or damaged structures is advised.

Conversely, where water staining is old and inactive, affected building materials may be repaired or replaced at client discretion.

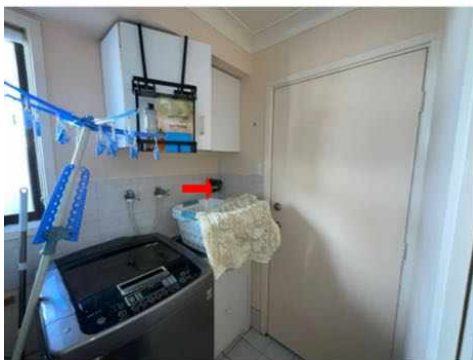
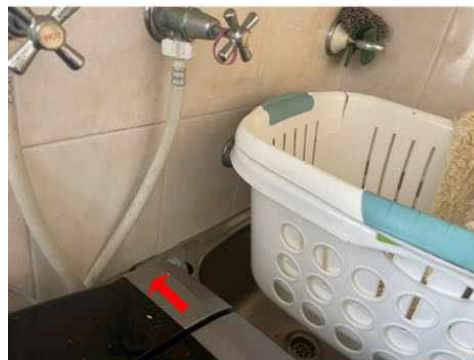
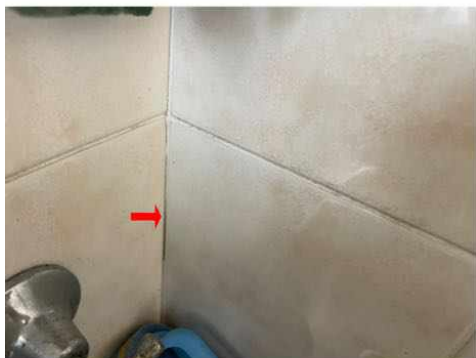
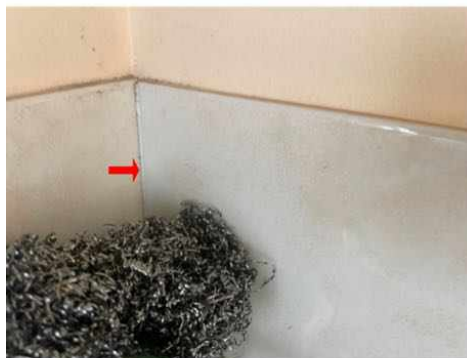
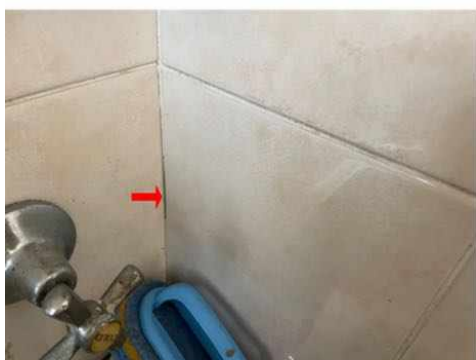
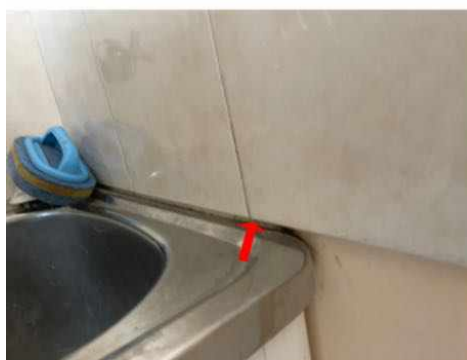
Building:	Main Building
Location:	Laundry > Rear Left
Finding:	Sealant and grouting - Missing or damaged
Information:	It was noted on inspection that sealant or grout is degraded to the laundry tub splashback.

Different materials and floor areas move at different rates, generally causing cracking to grout or sealant at this point. A flexible sealant is required to allow for expected expansion and contraction, while keeping the joint water tight and protective of all associated building materials.

Flexible and mould resistant materials should be applied to affected areas to prevent any subsequent water damage that is likely to occur. Regular maintenance and replacement of damage or missing or damaged sealant and grout is highly recommended to the wet areas, as this is a regular wear and tear defect. Sealant and grouting in areas that come into regular contact with water should be maintained for the long term care of your property.

A sealant specialist or tiling contractor should be appointed to complete these works as soon as possible

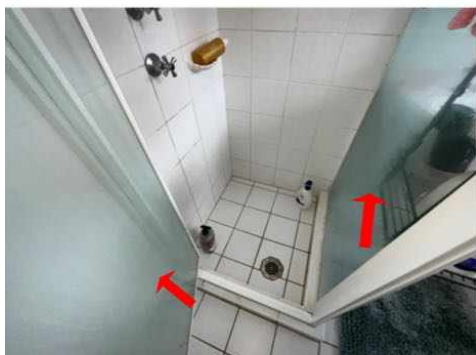
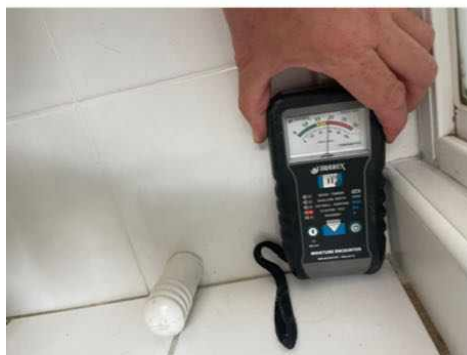
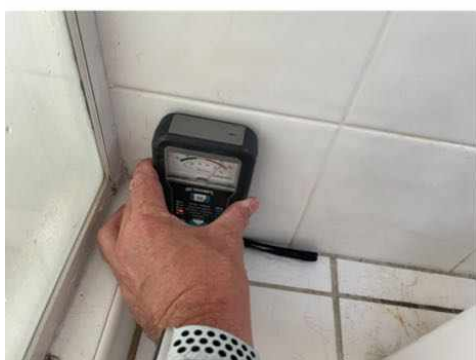
Finding 3.11

Building:	Main Building
Location:	Bathroom > Centre Left
Finding:	Moisture Located Externally to the shower screen
Information:	Damp is evident to the tiling adjacent to the shower screen on the exterior side. The moisture meter showed high levels of moisture. This defect is suspected to have been caused by moisture permeating through the tiling in this area or an inadequate or worn shower screen seal.

Damp (or structural damp) refers to the presence of unwanted moisture in the structure of a building, either as the result of intrusion from outside, or condensation from within the structure. In the shower area, internal water leaks or other sources of excessive moisture are generally the cause of damp.

Unmanaged damp in the shower recess is likely to facilitate the formation and development of mould and fungi growth, decaying associated building materials and compromising their structural integrity. It is important to address damp conditions, as the World Health Organisation notes that excess moisture leads - on almost all indoor materials - to growth of microbes such as moulds, fungi and bacteria, which subsequently emit spores and other matter into the indoor air. Exposure to these contaminants is associated with a wide range of respiratory and other health-related problems.

Consultation with a qualified plumber or bathroom specialist is advised to identify the cause of damp and to perform remedial works as required.

Always ensure that sealant and grout is in good condition to prevent any moisture

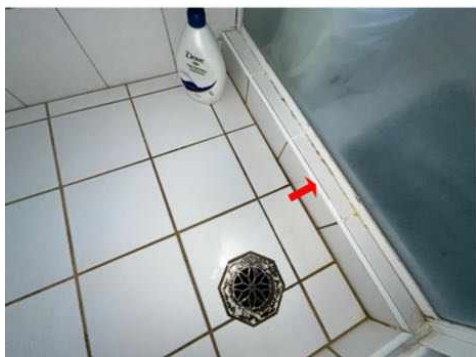
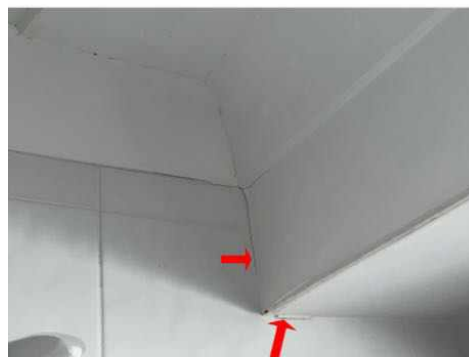
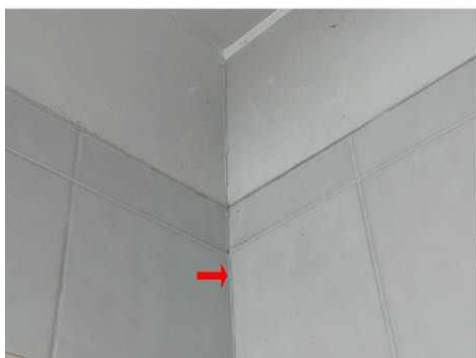
Finding 3.12

Building:	Main Building
Location:	Bathroom > Centre Left
Finding:	Sealant and grouting - Missing or damaged
Information:	It was noted on inspection that sealant or grout is degraded to the tiled shower alcove and or other areas of the bathroom.

Different materials and floor areas move at different rates, generally causing cracking to grout or sealant at this point. A flexible sealant is required to allow for expected expansion and contraction, while keeping the joint water tight and protective of all associated building materials.

Flexible and mould resistant materials should be applied to affected areas to prevent any subsequent water damage that is likely to occur. Regular maintenance and replacement of damage or missing or damaged sealant and grout is highly recommended to the wet areas, as this is a regular wear and tear defect. Sealant and grouting in areas that come into regular contact with water should be maintained for

the long term care of your property.

A sealant specialist or tiling contractor should be appointed to complete these works as soon as possible

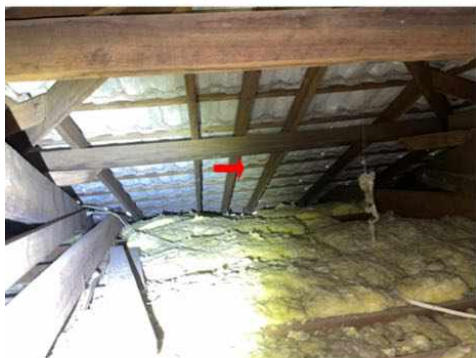
Finding 3.13

Building:	Main Building
Location:	Roof Void > All Areas
Finding:	Sarking - Missing
Information:	Sarking is missing under the roof sheeting. Sarking acts as an insulator that helps with noise reduction and protects against water penetration. Sarking plays a key role in the operation and function of the overall roofing structure and its performance.

Although not a requirement at the time of construction, replacement of any missing building element is advisable (although this can be quite expensive to do after the time of construction). Where sarking is missing, regular inspections of the roof tiles for cracking and potential moisture penetration is required.

Sarking may be retrospectively fitted by a registered builder at the discretion of the client.

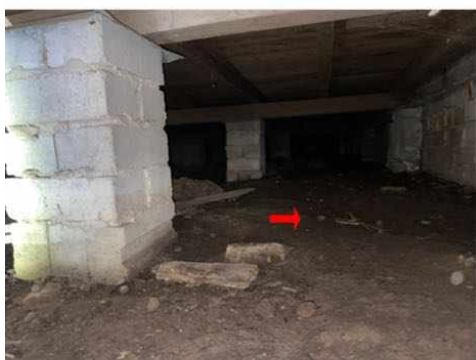
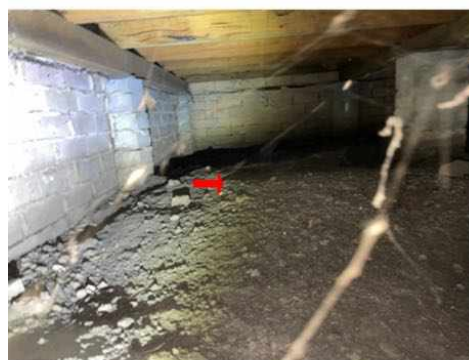
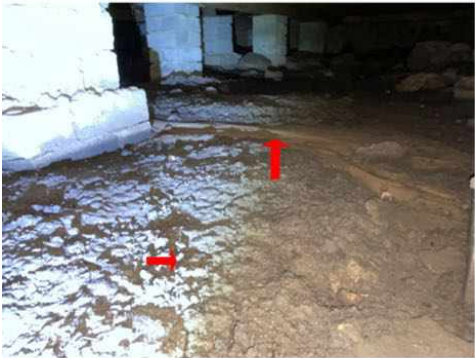
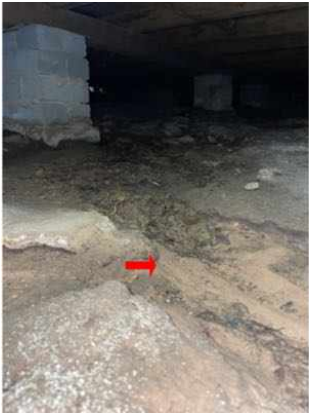
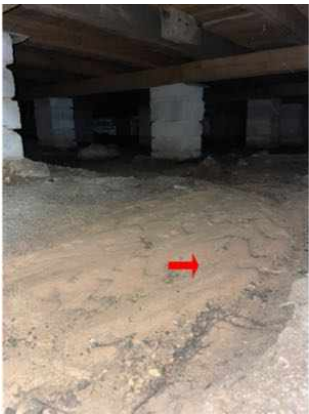
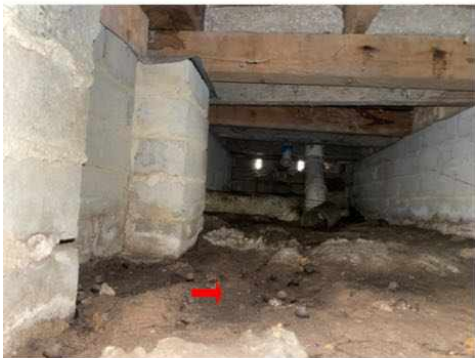
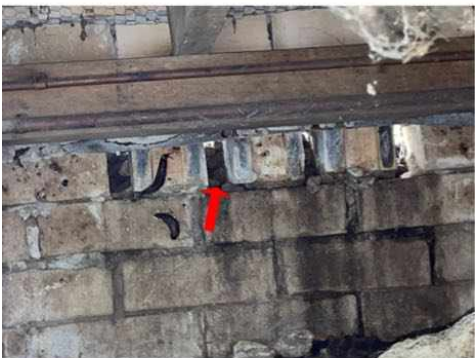
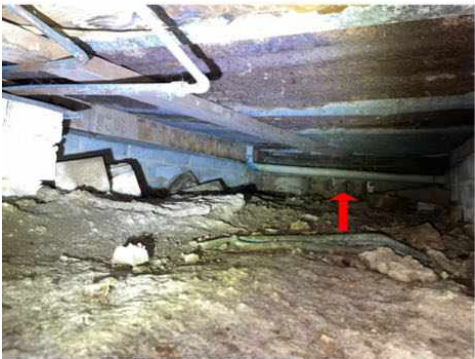
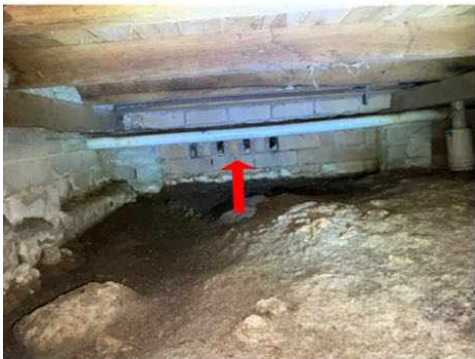
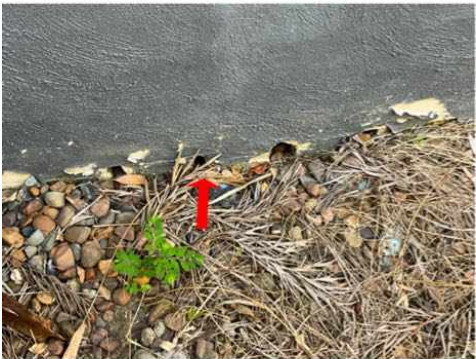
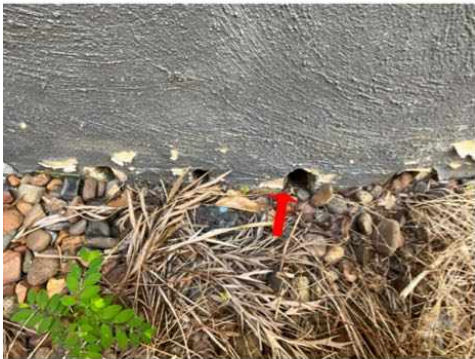
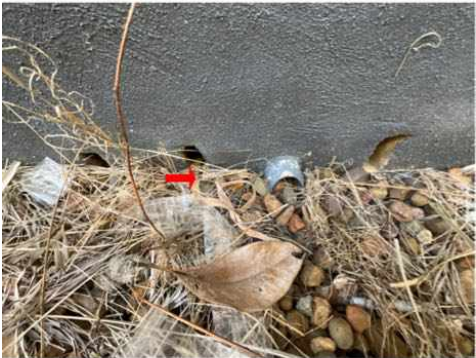
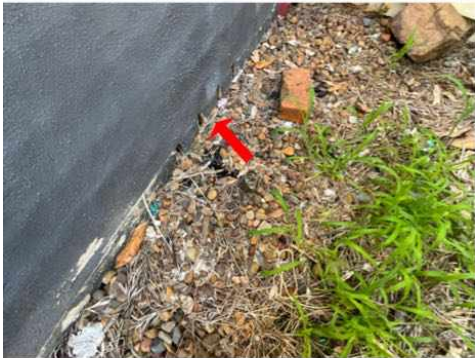
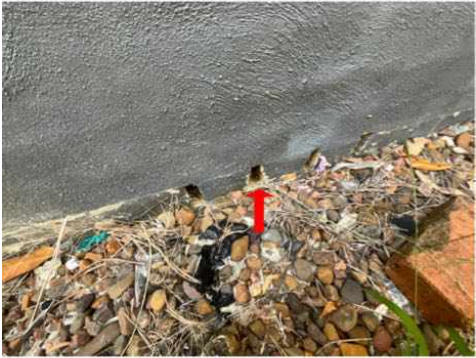
Finding 3.14

Building:	Main Building
Location:	Subfloor > All Areas
Finding:	Subfloor Site Drainage - Inadequate
Information:	The site drainage within the subfloor area was found to be inadequate at the time of inspection. The exterior ground level was higher than the ground level within the subfloor creating damp brickwork and a moist subfloor area surrounding the building thus creating potential for subsequent water damage to associated building elements. This is also apparent as there appears to be some subsidence to the soils within the subfloor space. Poor site drainage can also lead to subsidence of the stumps. In some areas the exterior ground level sits above the vents to which water can enter freely.

It is important that water does not lie against the base of walls; surrounding paths and ground levels should be sloped to drain water away from walls. Stormwater should be carried away by large, regularly cleaned drains. Ground levels may need to be lowered to expose a buried DPC.

Where site drainage is inadequate, installation of an Agricultural (Aggie) Drain may be required. A qualified plumber should be appointed to further inspect the property and perform any remedial works as necessary. Water damage and secondary defects are likely to occur if left unmanaged.

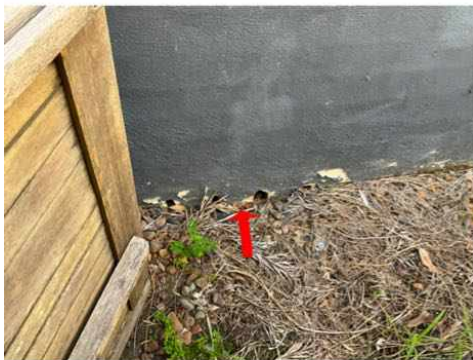
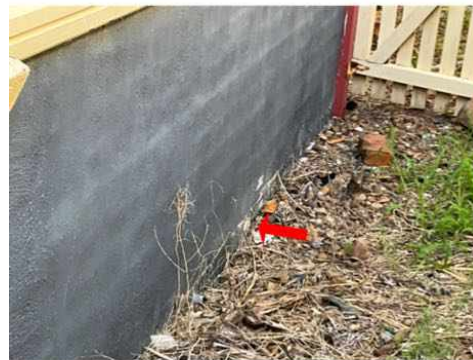
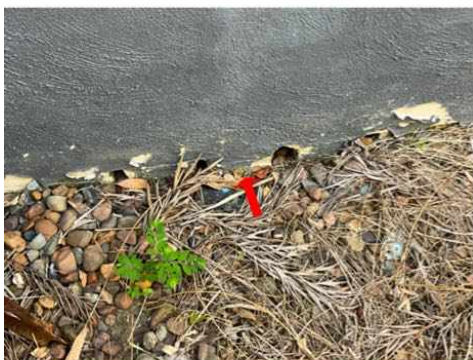
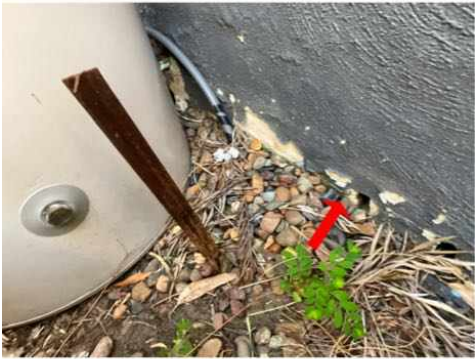
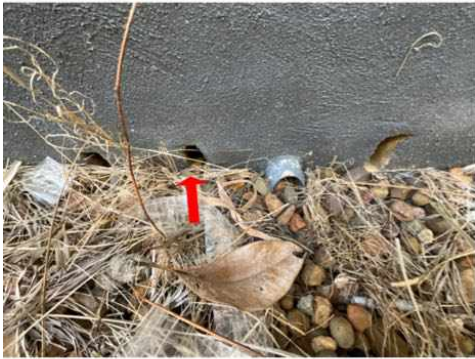
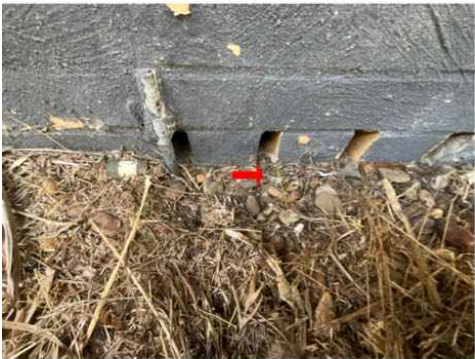
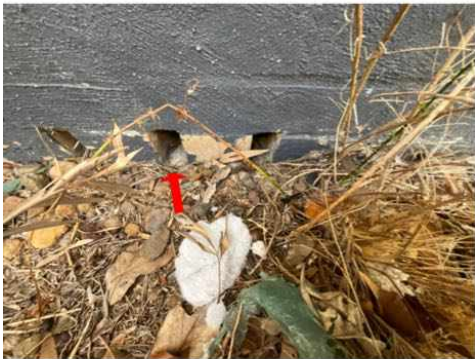
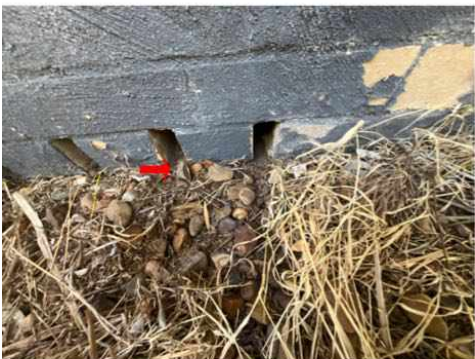
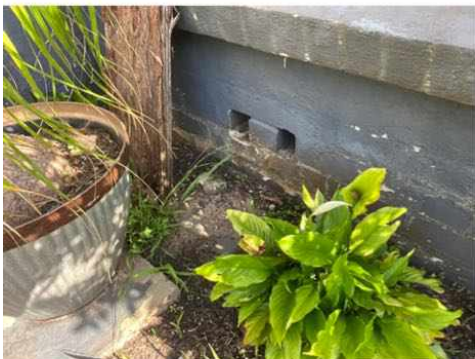
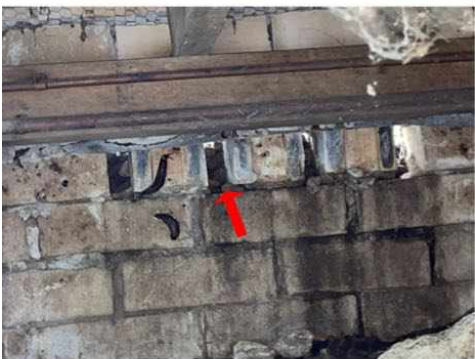
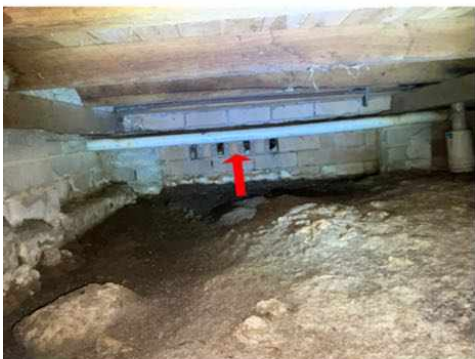
Finding 3.15

Building: Main Building
Location: Subfloor > All Areas
Finding: Subfloor ventilation - Inadequate
Information: Adequate subfloor ventilation aids in preventing excessive moisture wood rot and termite activity by ensuring a dry subfloor environment.

Where ventilation is substandard it is usually caused by factors such as failure to install adequate vents during construction subsequent building works or earth and vegetation covering over vents low subfloor clearance and items or debris in the subfloor restricting airflow.

Subfloor ventilation can be improved in most cases by addressing the causes such as exposing subfloor vents installing additional new vents installing mechanical (forced airflow) ventilation and removing debris from the subfloor.

A registered builder should be appointed as soon as possible to perform these works as necessary.

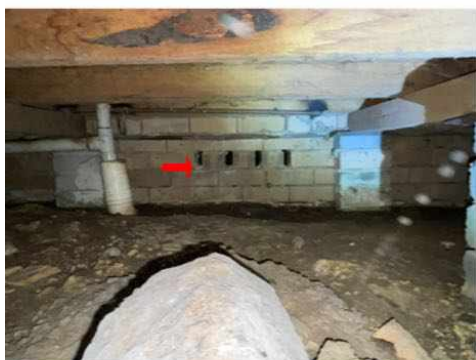
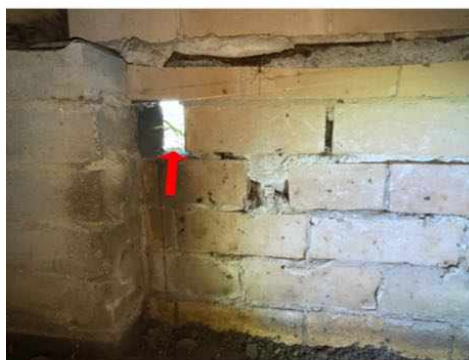
Finding 3.16

Building:	Main Building
Location:	Subfloor > Rear Right
Finding:	Subfloor Stumps - Subsided
Information:	Several subfloor stumps were observed to have subsided slightly, with some appearing to provide reduced or uneven support to the floor framing above. This may indicate minor settlement or movement over time, and some stumps may require packing or adjustment to restore adequate bearing.

If subfloor stumps are not supporting the structure evenly, this can lead to uneven floors, increased movement within the building, and potential long-term stress on the floor framing. Ongoing settlement may also contribute to cracking or misalignment of internal finishes.

It is recommended that a licensed builder or suitably qualified contractor further assess the affected stumps and carry out any necessary re-levelling or packing to ensure the subfloor support system remains stable and effective.

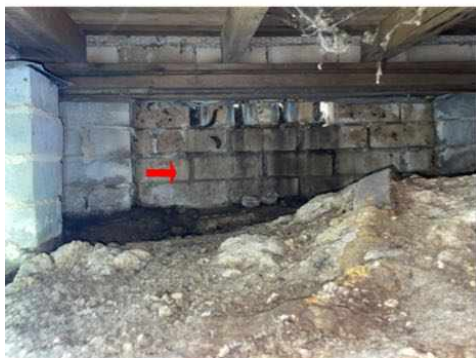
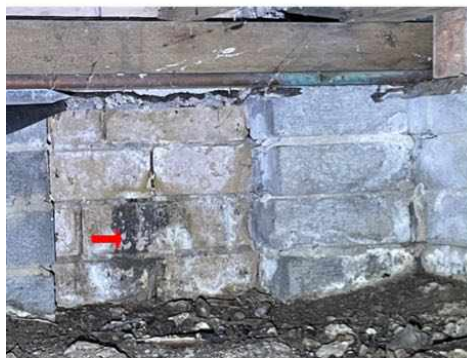
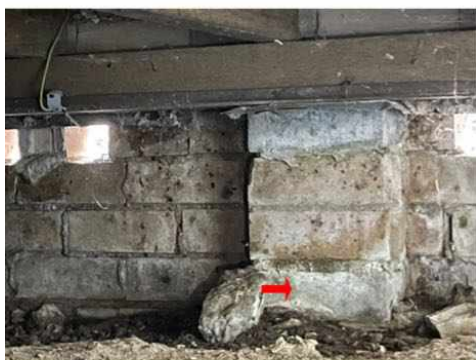
Finding 3.17

Building:	Main Building
Location:	Subfloor > Centre Left,Front,Front Left

It is typically seen as white salt deposits on the surfaces of concrete pavement or mortar between bricks or tiles. While detracting from the overall appearance of the affected area, efflorescence is not likely to develop into secondary damage if left unmanaged.

Generally, soluble salt deposits can be removed by dry brushing with a stiff-bristled brush. Repeated dry brushing is an ideal treatment for eliminating this forming of efflorescence. A cleaning contractor or general handyperson may be appointed to perform these works at the discretion of the client.

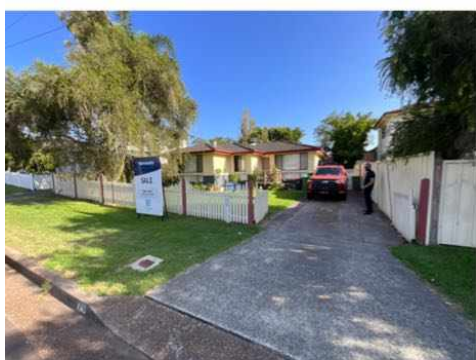
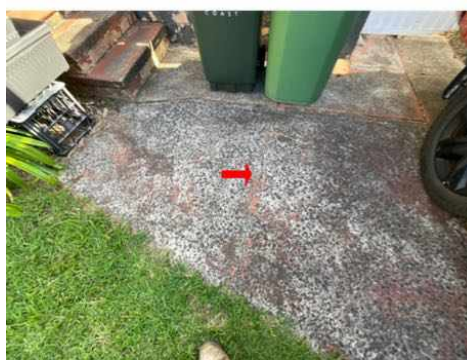
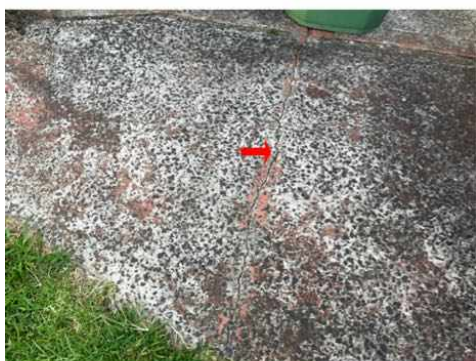
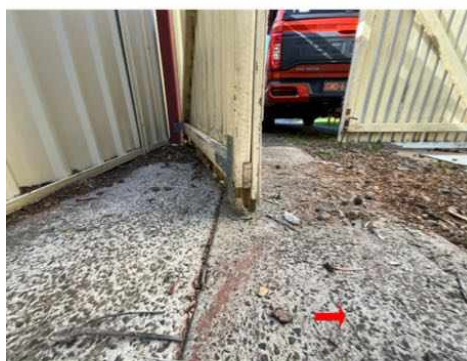
Finding 3.18

Building: Main Building
 Location: Driveway > Front Right
 Finding: Cracking - External Concrete Paving Damage Category 1 - Fine (less than 2mm)
 Information: Fine cracks were identified in external concrete paving. Although fine cracks are quite noticeable, they are often only considered to be an appearance defect, and usually do not indicate any structural damage. To be considered a Category 1 or fine crack, the

crack is found to be less than 2mm in width.

Generally the cause of a hairline crack in existing concrete paving such as driveways and pathways is indicative of the expansion and contraction of the concrete. Such causes are generally due to environmental factors, such as moisture levels, weather conditions, root systems of nearby trees or the soil types on which they are laid.

Fine cracks may also be due to poor original installation of the concrete. Factors such as poor compaction of the sub surface and/or inadequate reinforcing of the slab may create cracking and other secondary defects.

Monitoring of all cracking should be conducted frequently. Always contact a building inspector should cracks widen, lengthen, or become more numerous.

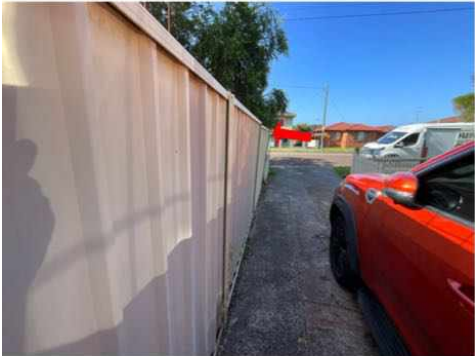
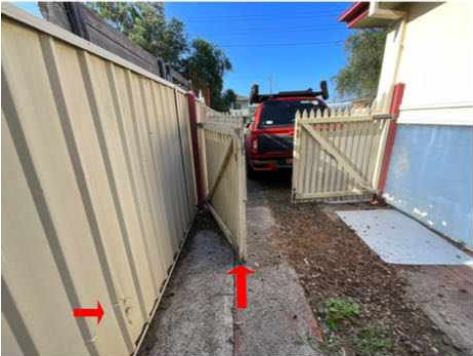
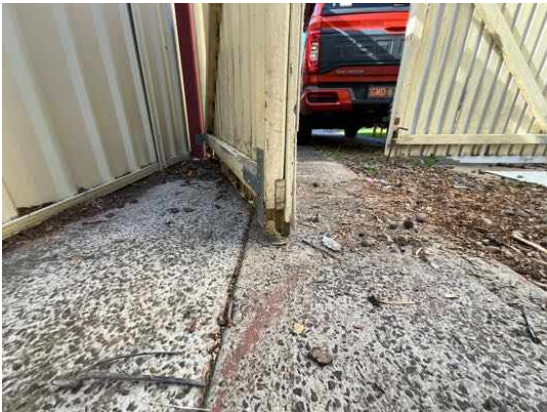
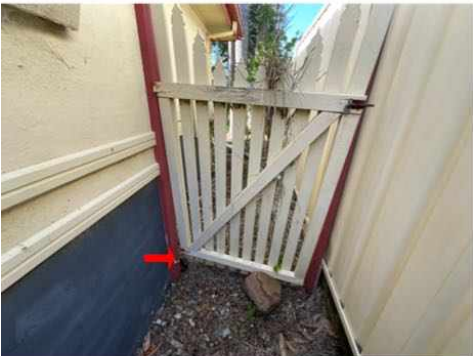
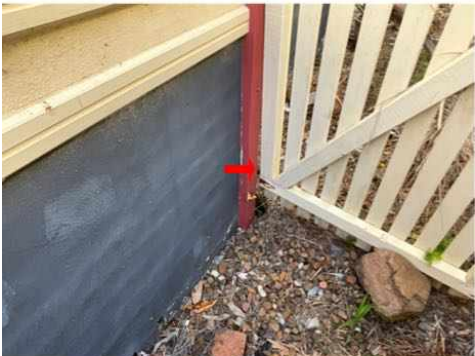
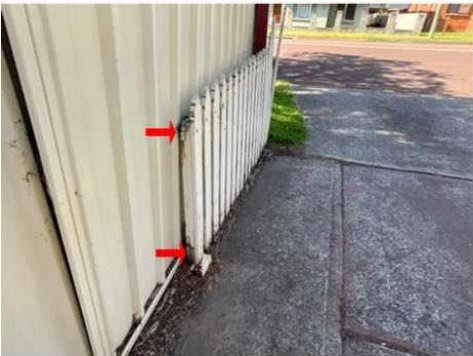
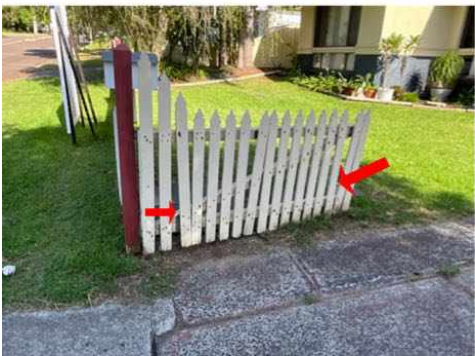
Finding 3.19

Building:	Main Building
Location:	All External Areas > All Areas
Finding:	External Fence - Damaged
Information:	It was observed that there was damage to the metal fabricated fence to various areas of the property, potentially from impact damage. The damaged area will likely degrade/rust at a faster rate.

The client should replace fence at their own discretion. Contact a fencing contractor to

complete works.
