Building and Timber Pest Inspection Report

Inspection Date: Fri, 6 Feb 2026

Property Address: 17 Wahroonga Rd, Wyongah NSW 2259,
Australia

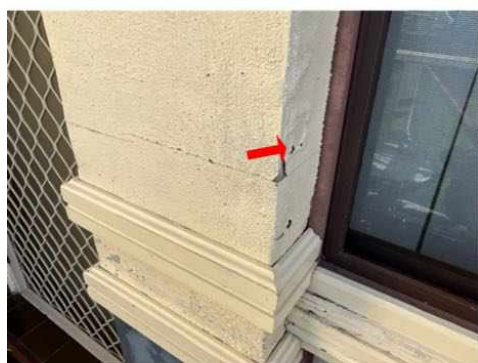
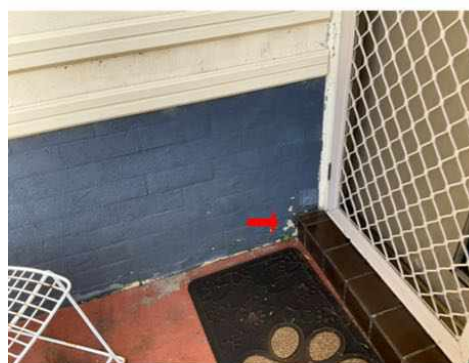
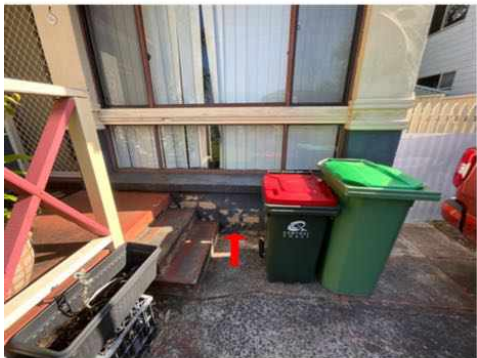
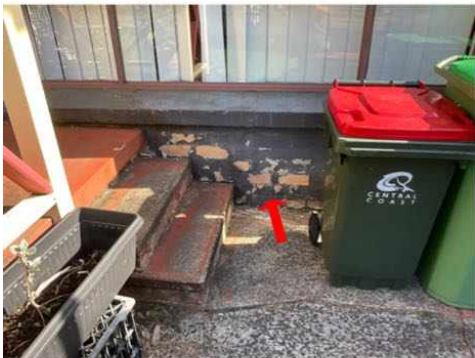
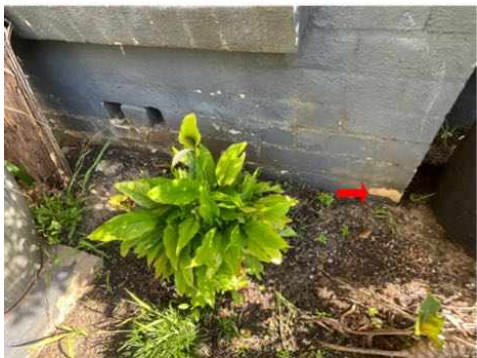
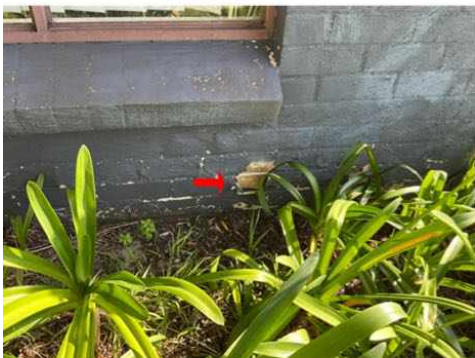
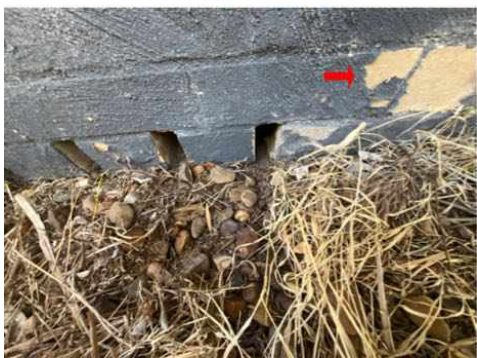
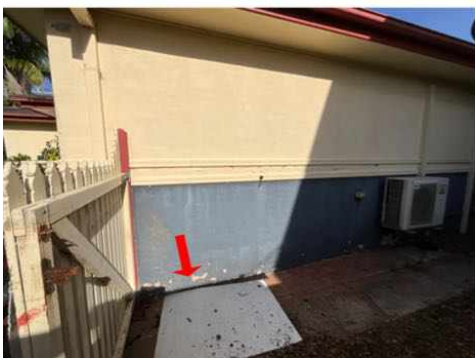
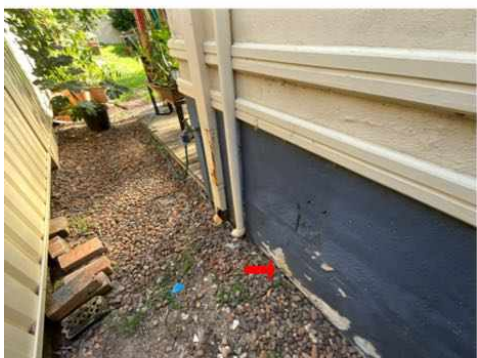
Finding 3.20

Building:	Main Building
Location:	Exterior walls > All Areas
Finding:	External painting deteriorated
Information:	Much of the external paintwork including but not limited to windows, fascias, guttering, veranda and other external fitments have been neglected and require attention to prepare and re-paint.

Whilst incomplete or missing paint finish is generally an appearance defect, it can also lead to the development of secondary building defects over time. Incomplete areas of paint finish expose the area to moisture, potentially accelerating the deterioration of underlying building materials.

Degraded paint finishes should be sanded back, filled, leveled and painted, as applicable. Where inadequate or missing paint protection has led to the deterioration of the associated building element, repair and/or replacement of this building element may be required.

A painting contractor should be appointed as soon as possible to perform necessary works to aid the appearance of the affected area and to ensure the area is protected against further deterioration. Alternatively, the homeowner following manufacturer instructions may perform these works.

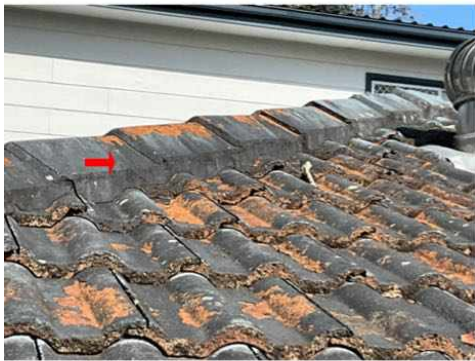
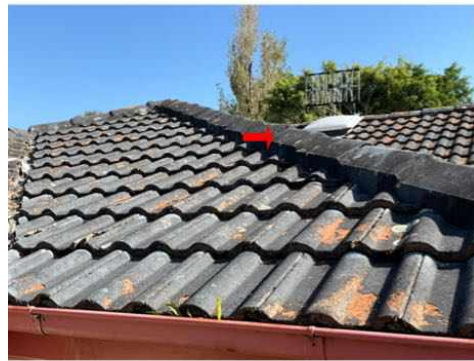
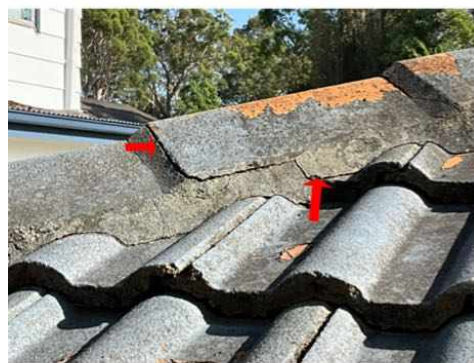
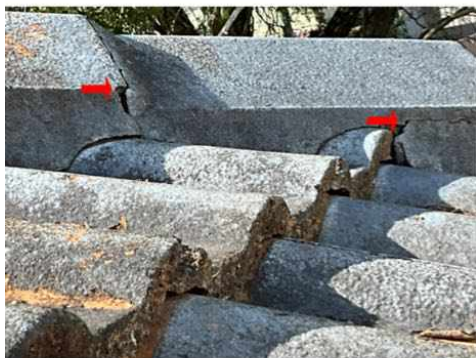
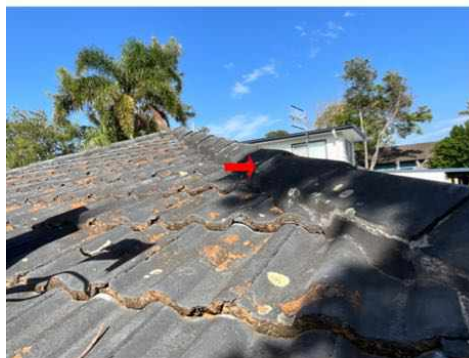
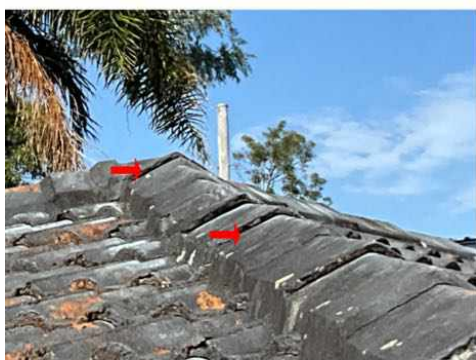
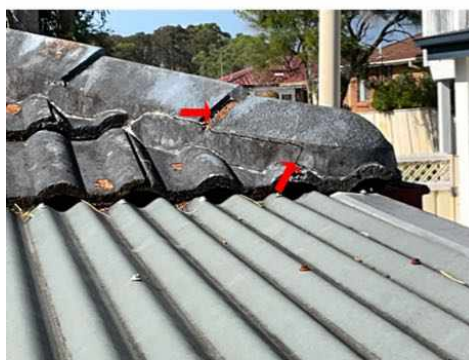
Finding 3.21

Building: Main Building
Location: Roof Exterior > All Areas
Finding: Roof tiles - Weathered
Information: Upon inspection of the exterior roofing, the majority of roof tiles were considered to be in a fair condition. While weathering of the tiles is consistent with the age of the property, maintenance works are required.

Isolated areas of mortar have come loose in the valleys and minor cracking is also present. Re-pointing and re-sealing the may be considered as an interim solution by the client to help preserve and extend the life span of the tiles.

Where left unmanaged, deteriorating roof tiles are likely to lead to a number of secondary defects, including minor water leaks and weather exposure to internal roofing structures.

Consultation with a roofing contractor is highly advised to gain advice on cost of remedial works that may be required in the short to medium term. Remedial works are likely to increase the longevity of the exterior roofing structure.

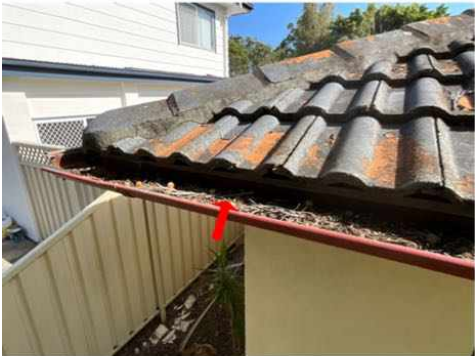
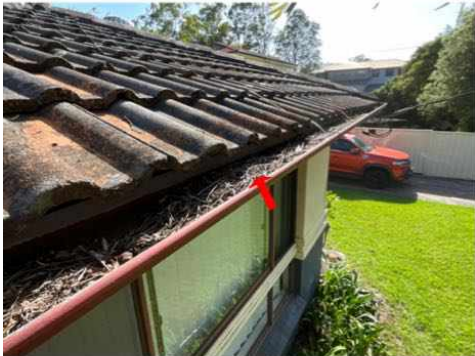
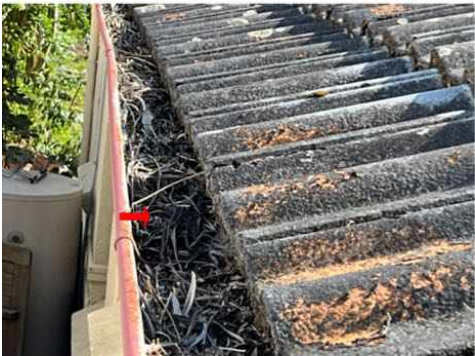
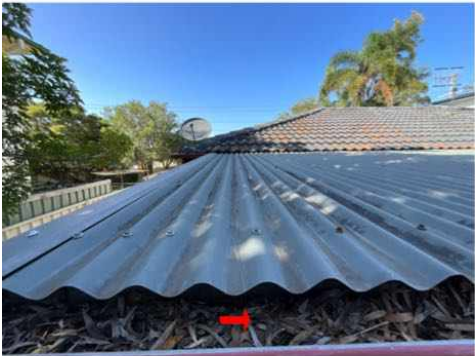
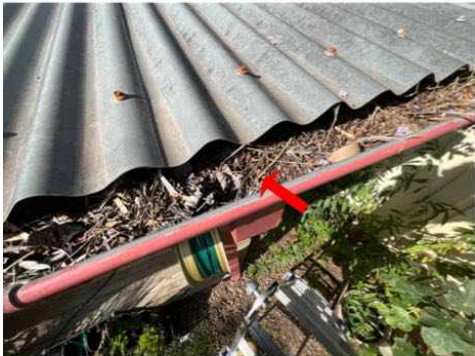
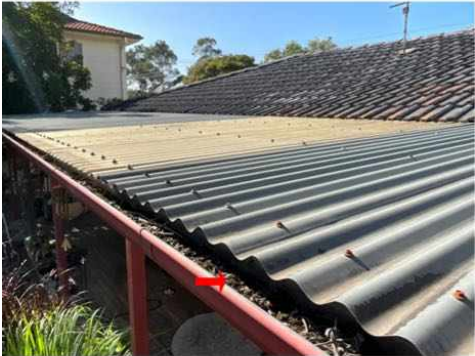
Finding 3.22

Building:	Main Building
Location:	Roof Exterior > All Areas
Finding:	Gutters - Blocked
Information:	Roof plumbing structures, such as guttering and downpipes, should be free of all debris to prevent blockages. Blockages of the guttering and downpipes will lead to pooling and accumulated water overflows, which is likely to subsequently flood eaves and exterior walls.

Blocked gutters are likely to lead to high levels of moisture in the affected areas. Such moisture will not only cause rust and decay of the associated building materials, but can also provide conditions that are conducive to termite and timber pest activity. Blockages in gutters should therefore be removed immediately to ensure dry conditions are maintained.

Consult a Licensed Plumber for further specific advice on remedial works that may be required. In the interim, it is highly advised that blocked gutters be removed by the homeowner or a general handyperson as a matter of urgency.

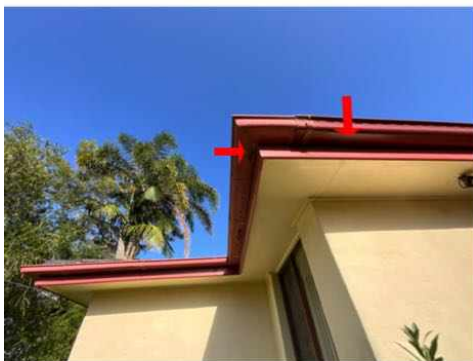
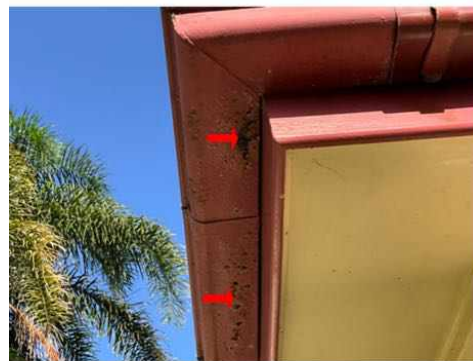
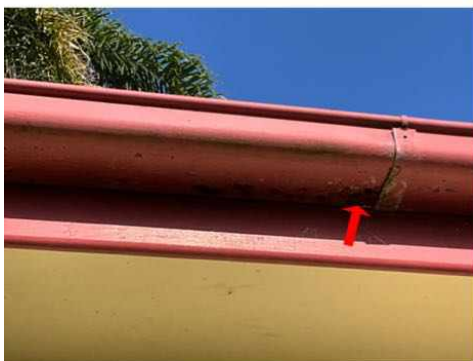
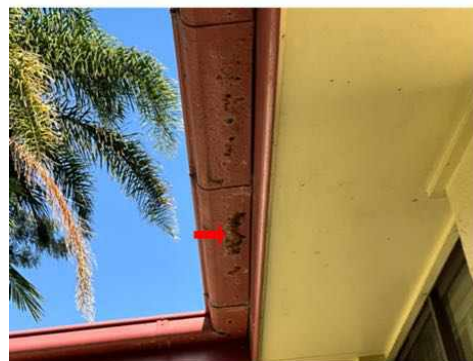
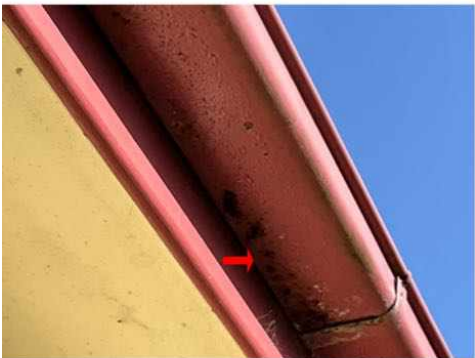
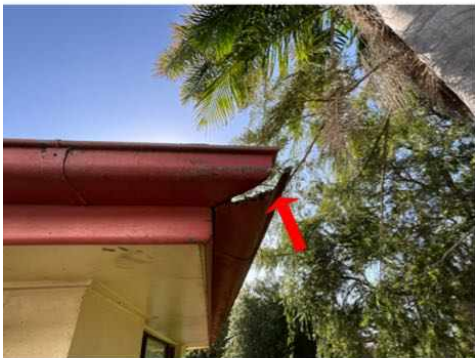
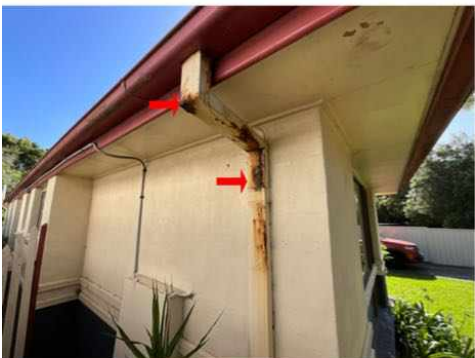
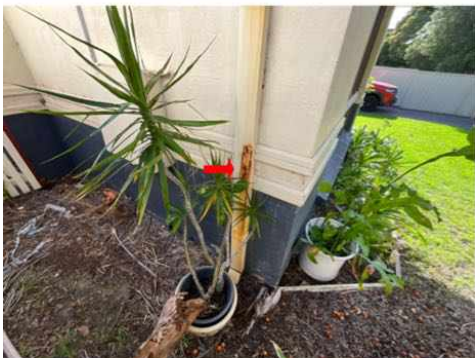
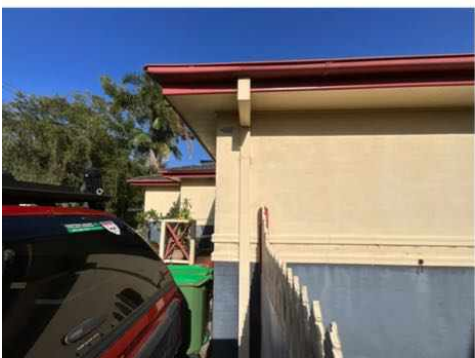
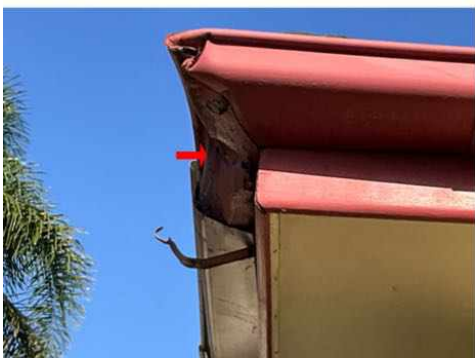
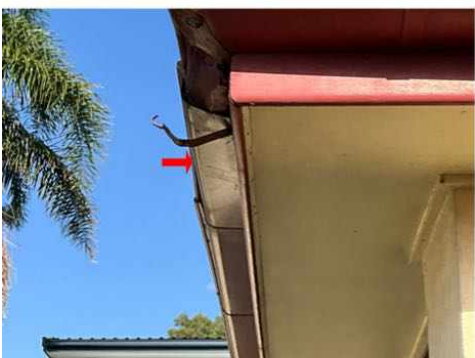
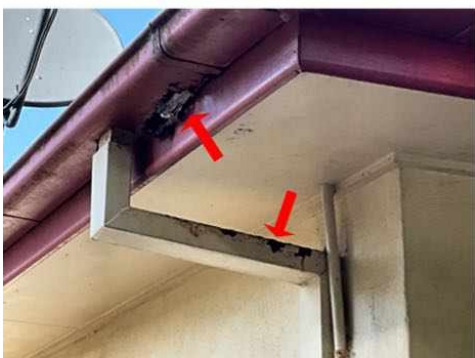
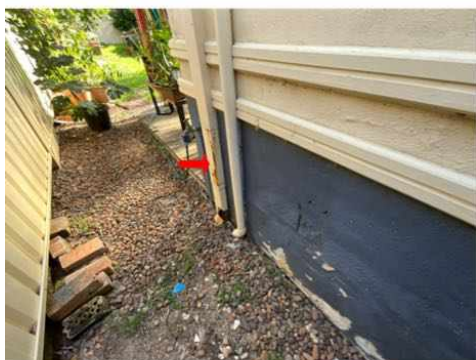
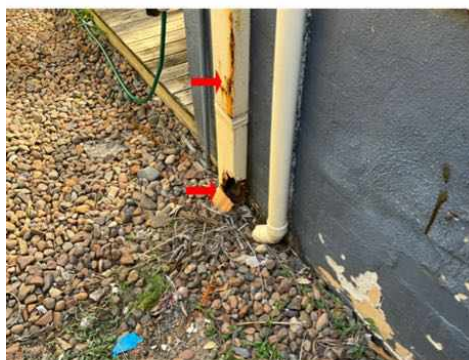
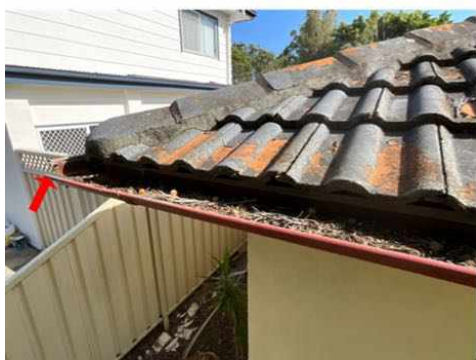
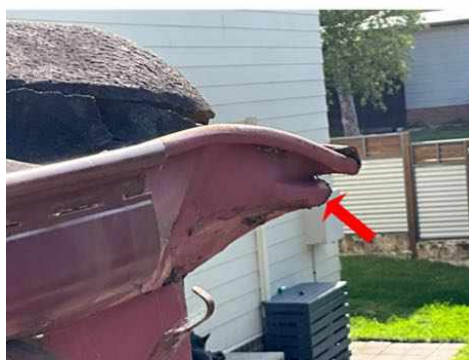
Building: Main Building
Location: Roof Exterior > All Areas
Finding: Roof plumbing - Rusted or corroded
Information: The roof plumbing (Gutters) have areas of rust and corrosion and are broken or damaged in some areas. It is suspected that this has been caused by blockages, resulting in pooling or standing water, that have prematurely rusted elements of the roof plumbing.

Rusted roof plumbing will generally develop holes and leaks that can affect other building elements with poor drainage of storm water. Poorly drained roof areas will also lead to damp conditions surrounding the base perimeter of the building which, if left unmanaged, can lead to a range of secondary building defects.

Repair and/or replacement of rusted roof plumbing is highly required in order to reinstate the roof drainage system to a fully operational level. To further maintain these areas, gutters should be cleaned frequently, allowing the avoidance of any partial blockages.

A licensed plumber or specialist roof restoration company should be appointed to undertake these works. It is advised that such works be completed as soon as possible to prevent any further damage and deterioration.

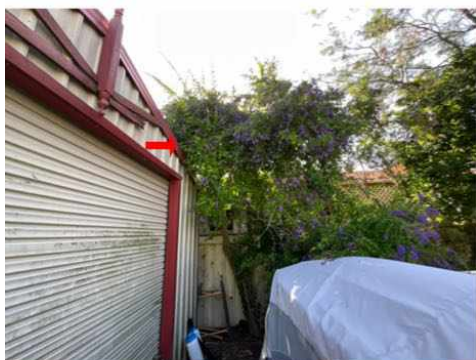
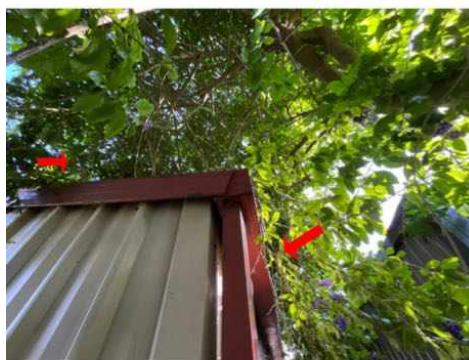
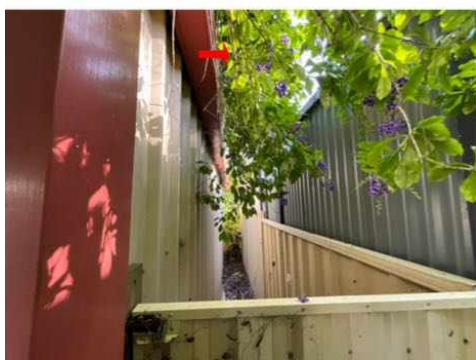
Finding 3.24

Building:	Main Building
Location:	Garage > Rear Right
Finding:	Trees - Overhanging and filling gutters
Information:	Overhanging trees often result in excessive amounts of leaf debris accumulating in gutters.

Gutters are a critical part of the building's management of storm water and rain. It is therefore important that they be kept clear to prevent secondary damage to associated building elements, including exterior and interior walls, ceiling linings and any adjoining building elements. Where gutters are blocked, pooling of rainwater is likely to occur, fast-tracking rust and corrosion of the roof plumbing elements.

It is highly advised that all overhanging tree branches be removed as soon as possible to prevent any further damage. Repair and/or replacement of sections of damaged guttering may also be required where the extent of the damage necessitates.

Such works should be performed by the homeowner; however, appointment of a landscape contractor or an arborist may be required. Consultation with a licensed roof plumber is required where guttering has been damaged.

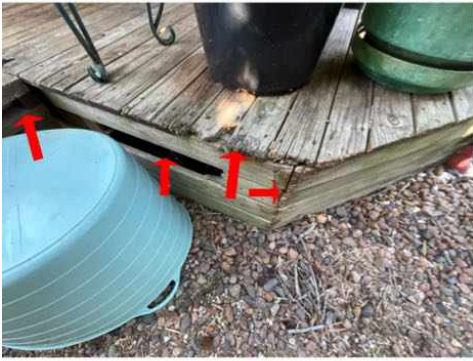
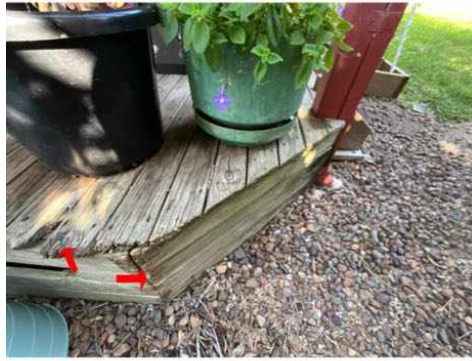
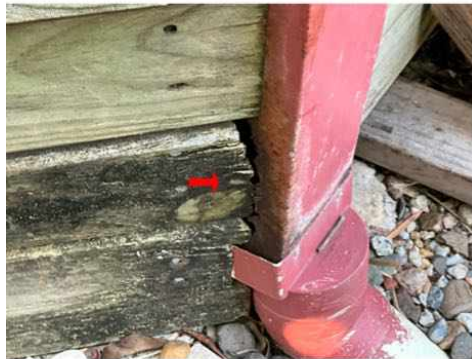
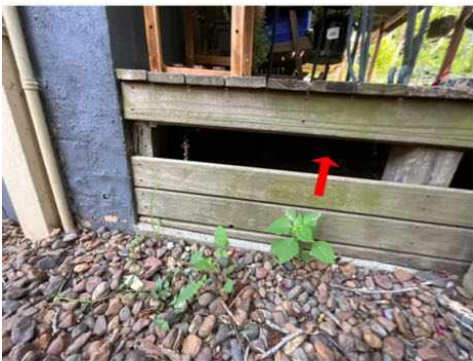
Finding 3.25

Finding: Deck - Damage

Information: The rear external timber deck was observed to show some deterioration, with damage including wood rot, pet-related deterioration, broken or missing plinth boards, and general weathering. The decking also appears not to have been adequately sealed or maintained, which has likely contributed to the ongoing deterioration.

Deteriorated decking timbers may continue to degrade over time, particularly when exposed to moisture and weather. This can reduce the structural integrity of the deck, create potential safety hazards such as unstable or weakened boards, and may allow further water ingress into adjoining subfloor framing.

It is recommended that a licensed builder or qualified carpenter further assess the deck structure and carry out necessary repairs or replacement of damaged timbers. Sealing and protective coating should be applied following rectification to improve durability and reduce further deterioration.

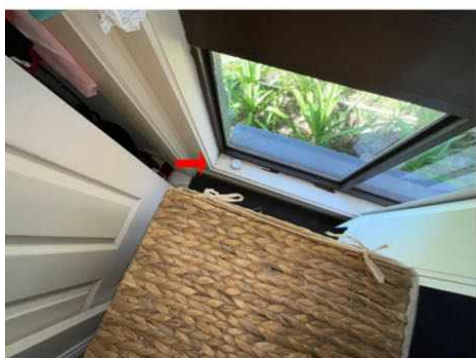
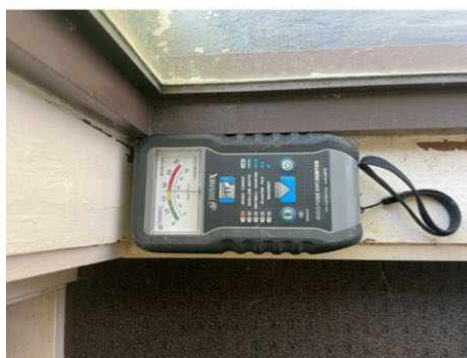
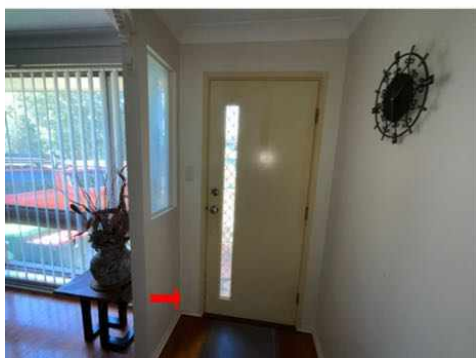
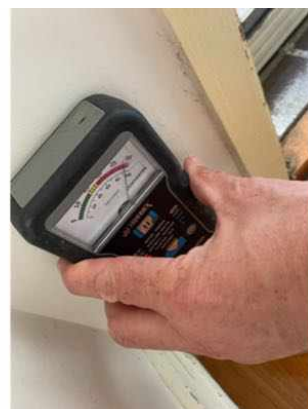
Building: Main Building
 Location: Entry > Front
 Finding: Excessive moisture - identified
 Information: Excessive moisture was evident to the wall adjacent to the front door and the window sill in bedroom 1. Excessive moisture can attract termites and produce conditions that promote fungal growth and wood decay.

Excessive moisture is generally caused by deteriorated inadequate or missing roof drainage leaking plumbing pipes or fixtures poorly plumbed HWS overflows or condenser units and poor site drainage.

Prior to any remedial works being performed a qualified plumber should be appointed to further inspect the property and to identify the cause of the excessive moisture. Works to remove affected building elements may then be necessary and should be performed by an appropriate tradesperson.

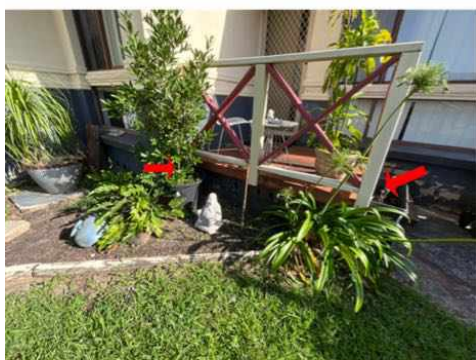
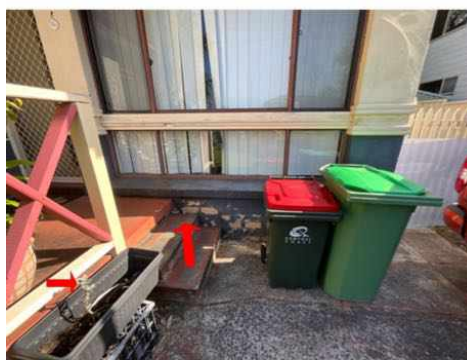
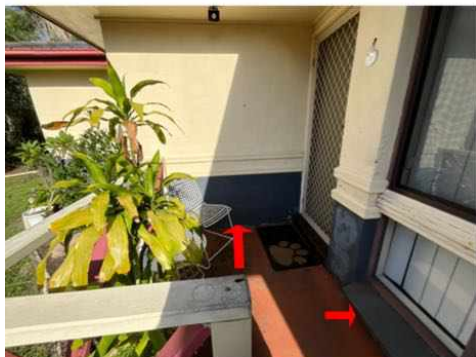
Finding 6.02

The concrete porch abutting was providing a concealed entry point at the time of the inspection. Where the location of the porch is retrospectively installed against an external wall, this provides a concealed entry point for termites.

The client should consider gaining further advice from a timber pest technician as to treatments required in this area. It is recommended that obtaining such advice be a

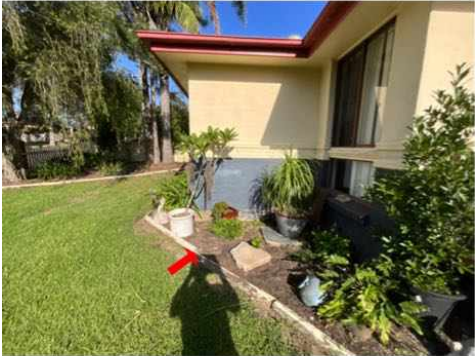
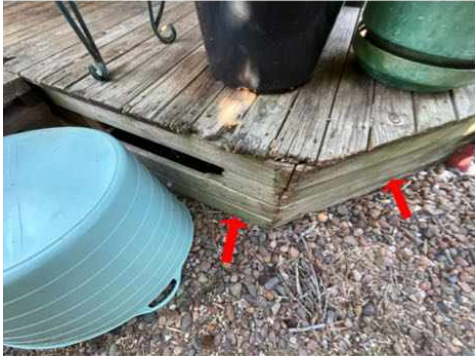
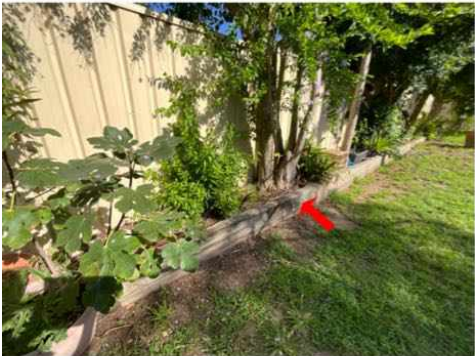
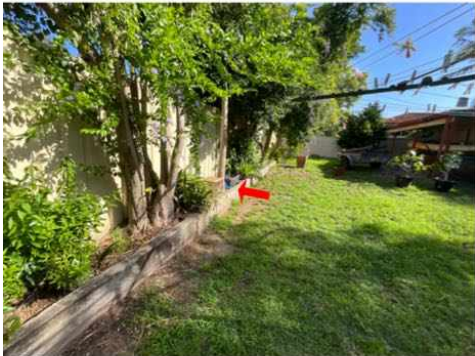
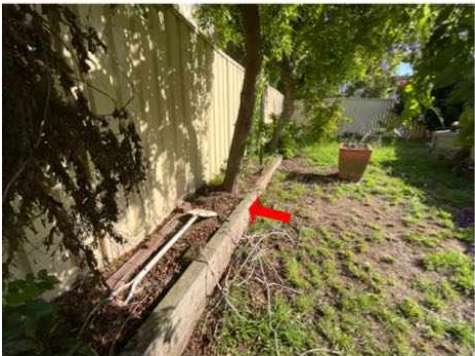
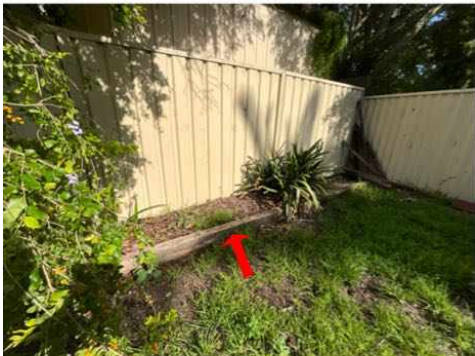
Finding 6.03

Building: Main Building
 Location: All External Areas > All Areas
 Finding: Timber in contact with ground
 Information: At the time of inspection timber was in contact with the ground. Timbers that sit below ground level are likely to absorb moisture from the soil and deteriorate at an accelerated rate as they will be subject to wood rot and also increases the risk of termite activity being present.

If left unattended, replacement of these timbers is likely to be necessary in the short-

term future. It is highly recommended that any timbers in contact with the ground be removed or altered to minimise the risk of wood rot and termite attack. Minimisation of risk / prevention of termite attack is far more adequate than dealing with the presence of termite activity. Contact a builder or carpenter to advise on course of action.

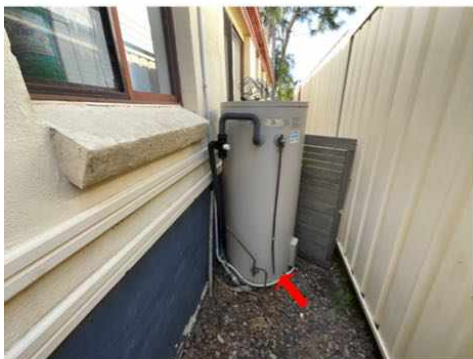
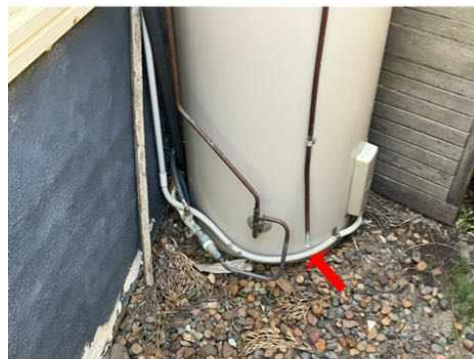
Finding 6.05

Building: Main Building
 Location: Yard - Side > Rear Left
 Finding: HWS Overflow - Not Connected
 Information: The Hot Water System (HWS) overflow was found to be disconnected from storm water drainage and is creating excessive moisture in the surrounding area.

These damp conditions can lead to secondary defects such as rot, rust or corrosion of associated building elements, the formation of fungal decay, or even the creation of potential slip hazards. When coupled with poor site drainage, pooling of water may also attract termite activity to this area.

It is highly recommended that a licensed plumber be appointed to connect the HWS overflow in order to prevent such an environment from being created. These minor works should be carried out as soon as possible.

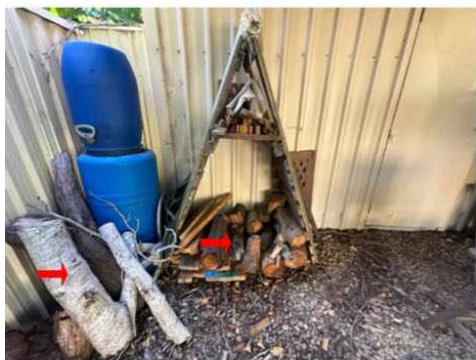
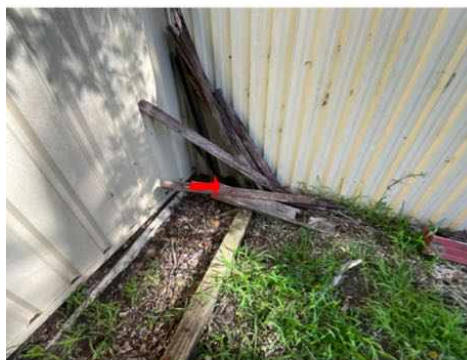
Finding 6.06

Building: Main Building
 Location: All External Areas > All Areas
 Finding: Stored timbers - external area
 Information: The storing of timbers around the external property increases the risk of termite

activity being present. As they are likely to come into contact with weather conditions or excessive moisture wood rot is likely to develop on timbers that are not treated.

It is highly recommended that any stored timbers be immediately removed from areas in which they may attract any termite / timber pest attack. Minimisation of risk / prevention of termite attack is far more adequate than dealing with the presence of termite activity.

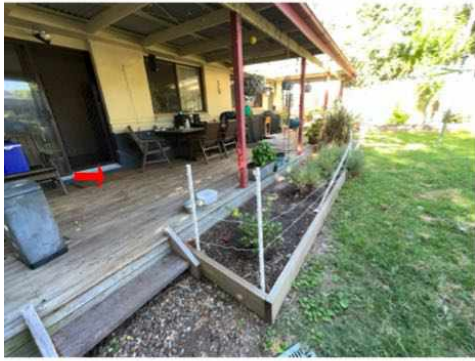
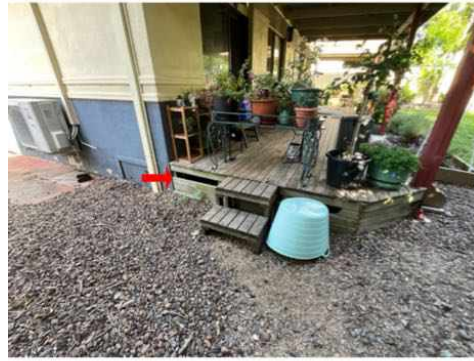
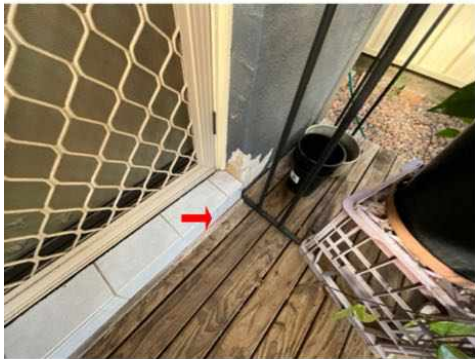
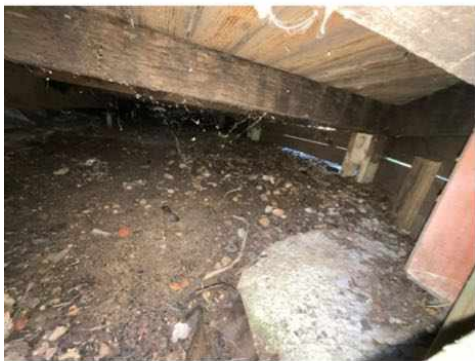
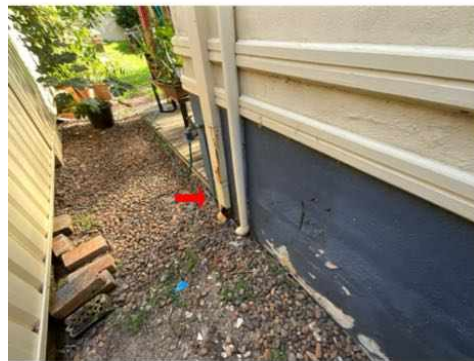
Finding 6.07

Building:	Main Building
Location:	Deck > Rear
Finding:	Bridging of termite barrier - Rear Deck
Information:	The rear deck obscures an area to the rear of the house in which termites might potentially access. Bridging of termite barriers occurs when termites bridge (usually by building a mud tunnel) a termite barrier or inspection zone or where termites have a passage allowing them to bridge the barrier.

Generally this takes the form of finished ground levels external paving or concrete being retrospectively installed above the damp course level the adjacent internal floor level or weep and ventilation holes.

Where bridging has occurred full inspection is prevented and termites may enter a property in a concealed or undetectable manner.

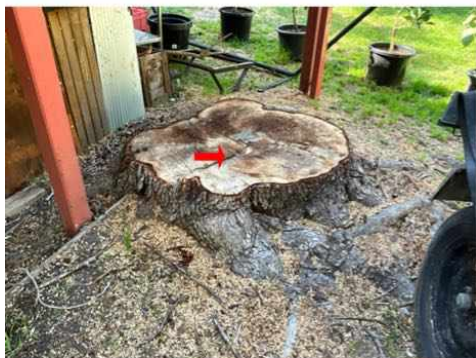
Finding 6.08

Building: Main Building
 Location: Yard - Back > Rear
 Finding: Old Tree Stumps - Found on Property
 Information: Any tree stumps in ground contact provide opportunity for concealed termite infestation and are likely to be subject to decay as the soil retains moisture or damp conditions against the tree stump.

All tree stumps should be removed where possible or alternatively be test drilled and treated. Frequent pest inspections are advised to readily identify any termite activity in these areas.

Timber pest management plan should be implemented and 6-12 monthly Timber Pest inspections carried out in accordance with AS4349.3 or AS 3660.2.

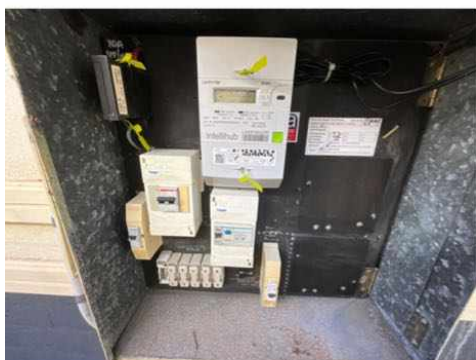
Finding 6.09

Building:	Main Building
Location:	Meter Box > Front Left
Finding:	Termite Management System - no evidence of a chemical installation
Information:	The application of a post-construction chemical termite barrier is highly recommended for all properties, particularly if live termite activity has been found on the site previously. Such barriers are highly effective in preventing termite attack on any timber building elements throughout the property.

A durable notice should be placed in the switchboard unit to indicate current termite barriers. At the time of inspection, it appeared as though no termite management system has been installed, with no evidence to suggest preventative works taking place.

The client may consider gaining further advice from a pest controller as to the costs and procedures involved with this application. It is recommended that obtaining such advice be a short-term priority.

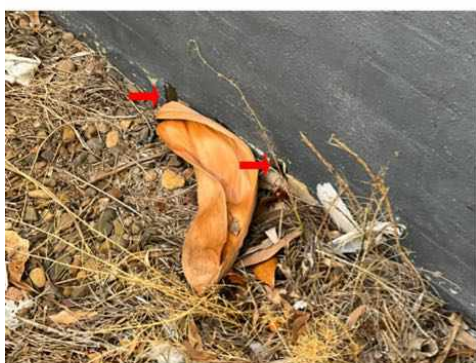
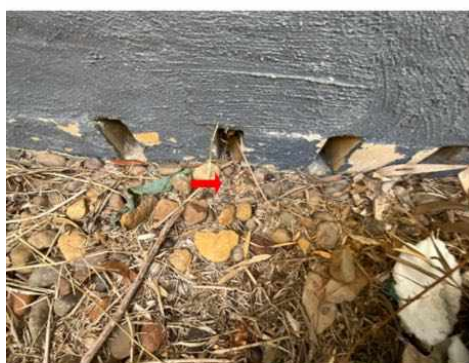
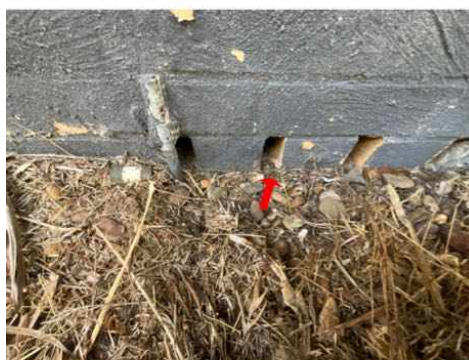
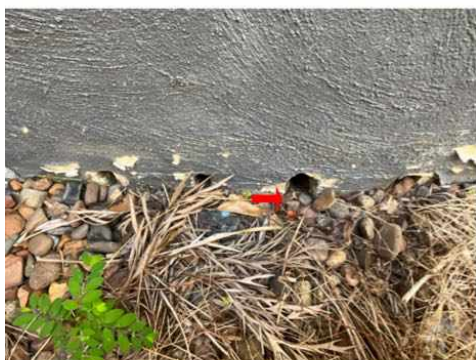
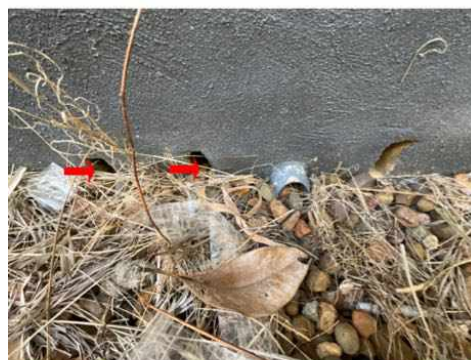
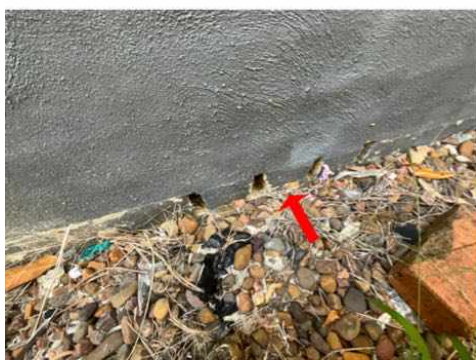
Finding 6.10

Building: Main Building
Location: Exterior walls - left side > Centre Left,Front Left,Rear Left
Finding: Bridging or breaching of termite barriers - ventilation holes
Information: Bridging is the spanning of a termite barrier or inspection zone so that subterranean termites are provided with passage over or around that barrier.

Where weep holes are covered by external ground levels such as paving or garden beds concealed entry is available for termites from these grounds into the brickwork or external wall materials.

It is highly recommended that ventilation holes are left exposed in all areas throughout the external property. Therefore if any termite activity leading into weep holes becomes easily detectable during frequent pest inspections.

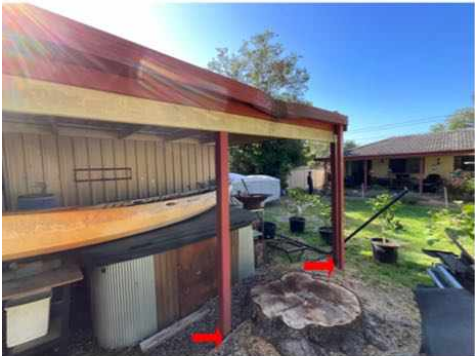
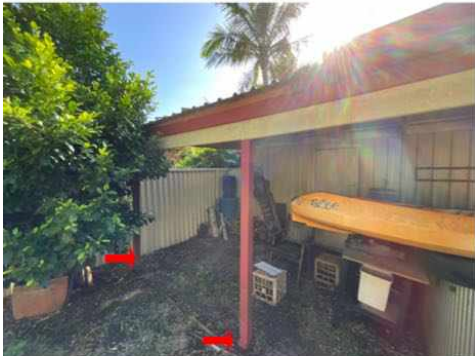
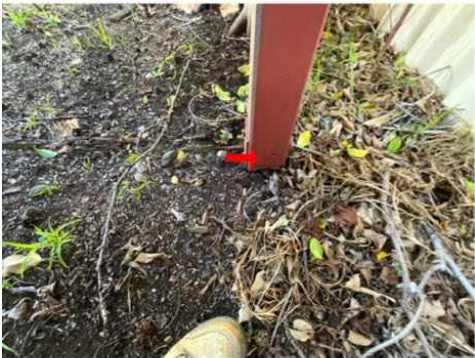
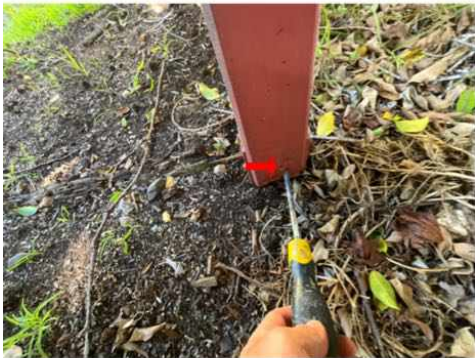
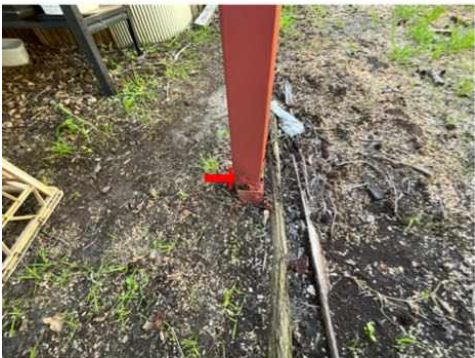
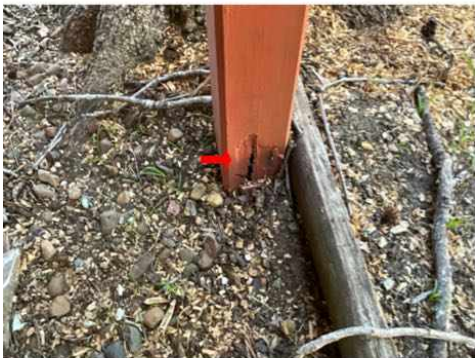
Finding 7.01

Building:	Main Building
Location:	Garage > Rear Right
Finding:	Wood rot = Posts - Garage
Information:	The posts to the awning of the garage show evidence of wood rot. Wood rot, also known as Fungal Decay, occurs when timbers and other cellulose building materials are exposed to damp conditions on an ongoing basis. This could be the result of exposure to weathering over a prolonged period of time, or the attraction of excessive moisture from other abutting building materials. Contributing factors also include poor air ventilation in the area.

Wood rot is often associated with general damp problems and is evidenced by a 'musty' smell or mould and mildew occurring on surfaces. If left unmanaged, damp conditions can lead to further health problems and the decay of timbers will continue.

Early intervention and regular maintenance, particularly of exterior timbers, will prolong the useful life of these building elements. Prior to any works being performed, the cause of the moisture that has created the visible wood rot should be identified and addressed in a suitable manner. Replacement of affected timbers may then be a necessary step in protecting surrounding building elements from such deterioration.

A qualified plumber may be appointed to assess the cause of excessive moisture and to provide advice on any remedial works as required. A qualified carpenter or builder may also be required to replace affected building materials.

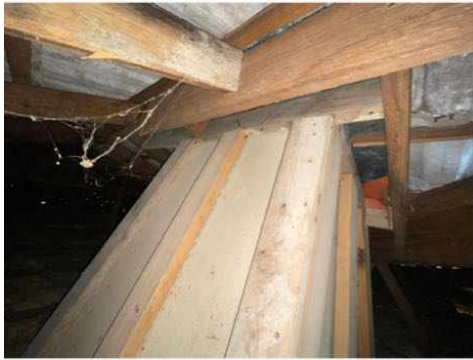
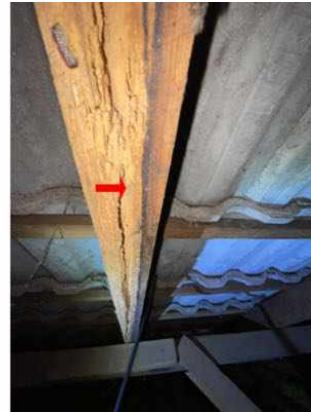
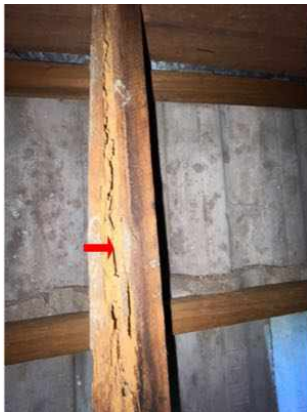
Finding 8.01

Information: Wood borers small beetles that colonise in exposed timber elements are a common timber pest that are regularly mistaken for termites. Although wood borer activity is generally not detrimental to the affected timber they may lead to serious damage and necessitate replacement of certain building elements if left unattended.

The other commonly known borer the Anobium borer is more likely to attack floorboards and may cause severe structural damage to flooring areas.

As no live wood borer activity was identified treatment is not required at this time. Replacement of affected timbers may be considered by the client for superficial reasons.

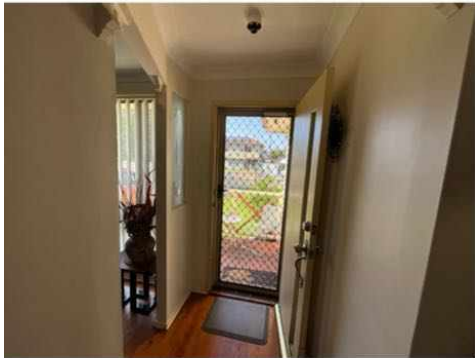
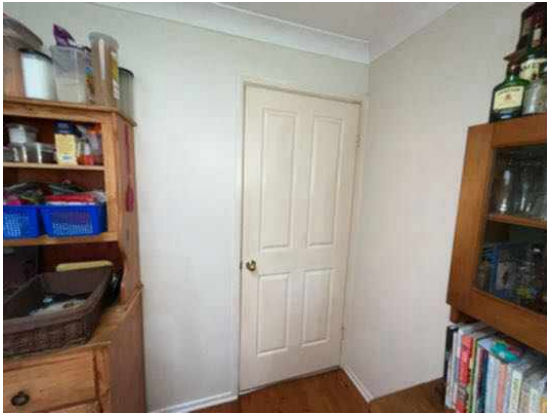
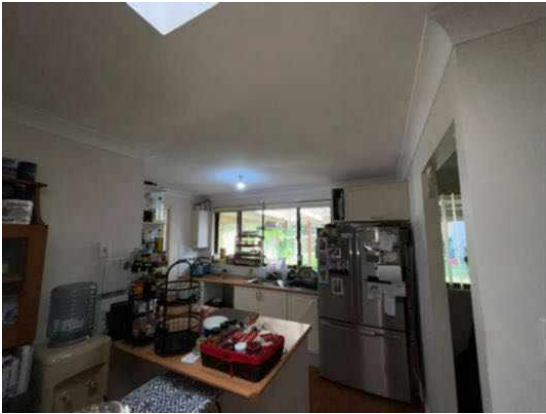
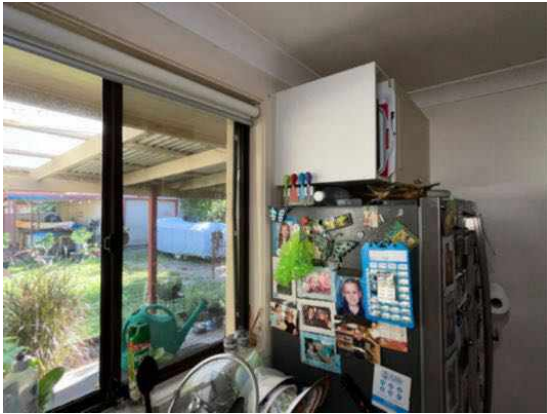
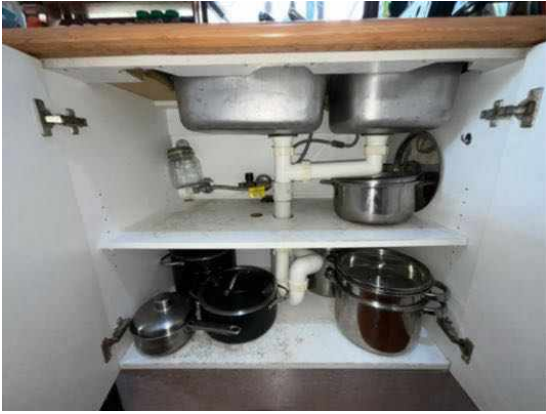
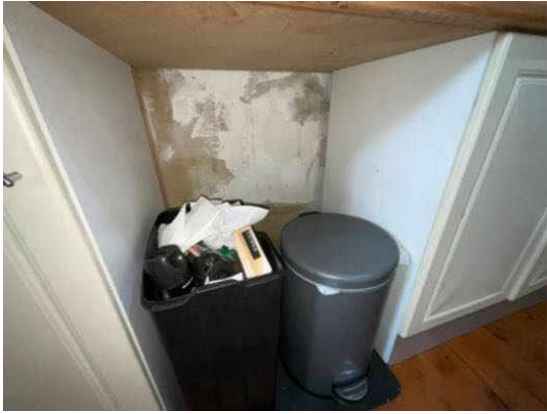
Building: Main Building
Location: All Internal Areas > All Areas
Finding: Additional Photos - Obstructions and Limitations - Internal Areas
Information: These photographs are an indication of the obstructions and limitations which impeded full inspection of the property at the time of inspection. These obstructions can hide an array of defects and should be removed to allow full inspection to be carried out. A re-inspection is recommended once the areas are made accessible.

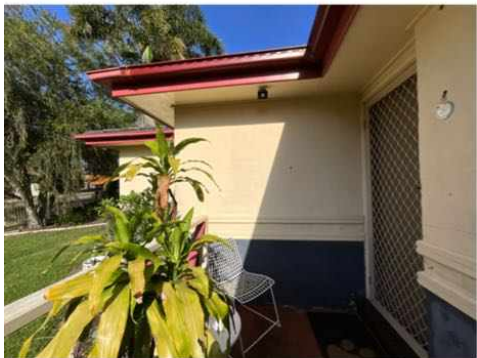
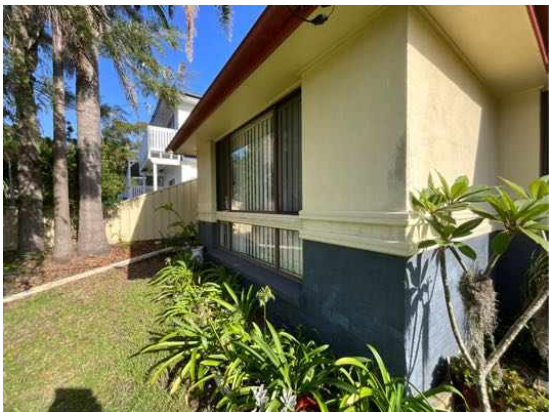
Building:	Main Building
Location:	All External Areas > All Areas
Finding:	Additional Photos - Obstructions and Limitations - External Areas
Information:	These photographs are an indication of the obstructions and limitations which impeded full inspection of the property at the time of inspection. These obstructions can hide an array of defects and should be removed to allow full inspection to be carried out. A re-inspection is recommended once the areas are made accessible.
