Building and Timber Pest Inspection Report

Inspection Date: Fri, 6 Feb 2026

Property Address: 17 Wahroonga Rd, Wyongah NSW 2259,
Australia

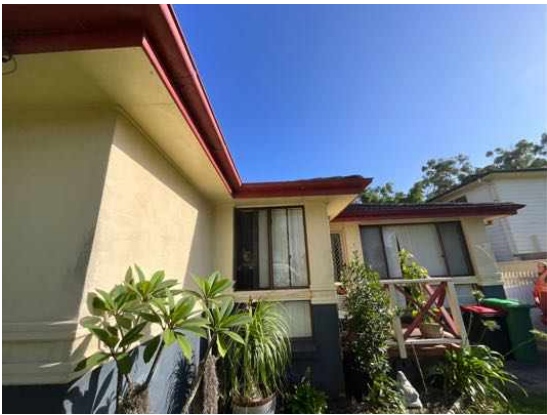
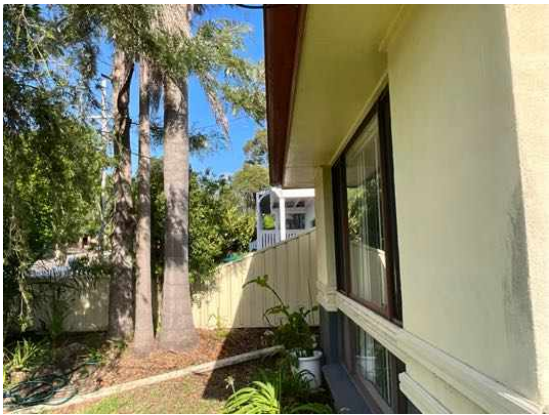
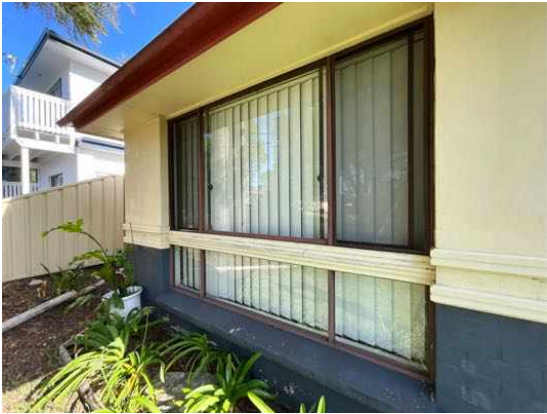
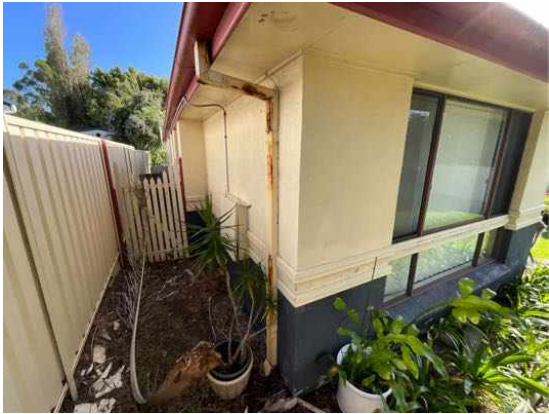
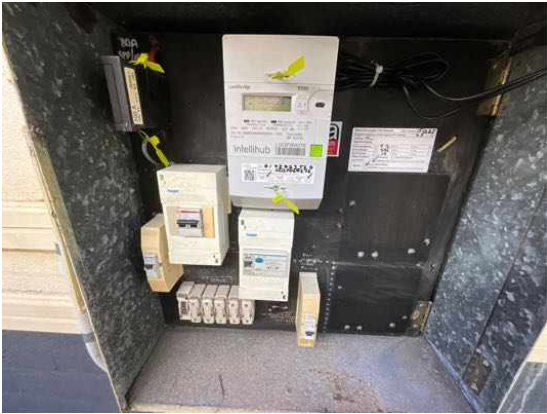
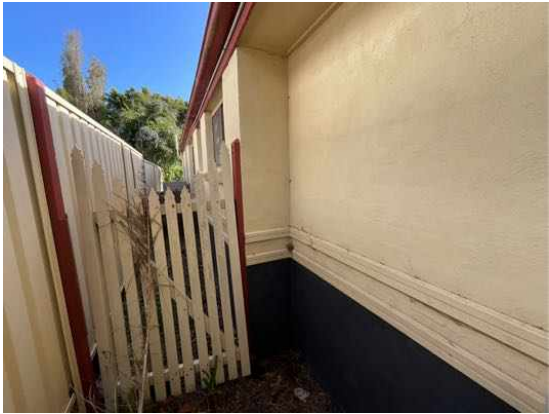
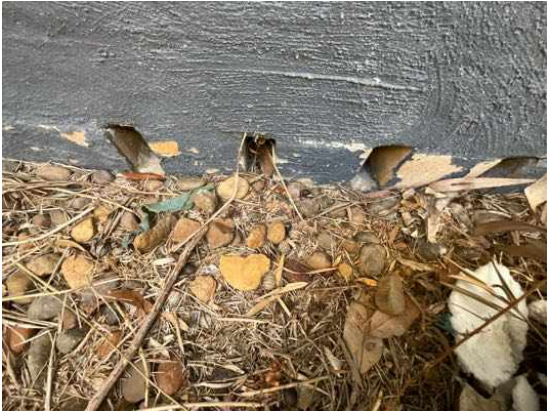
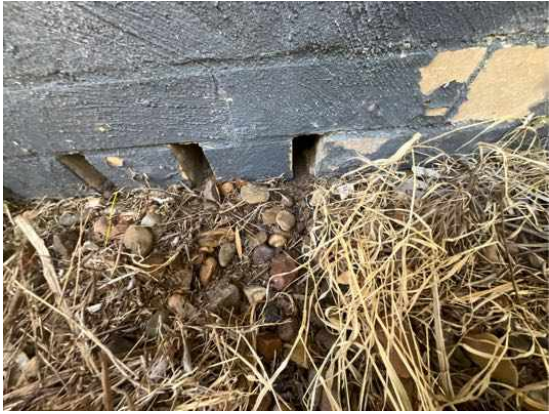
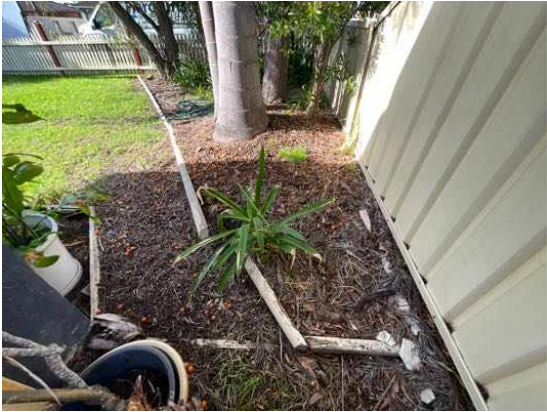
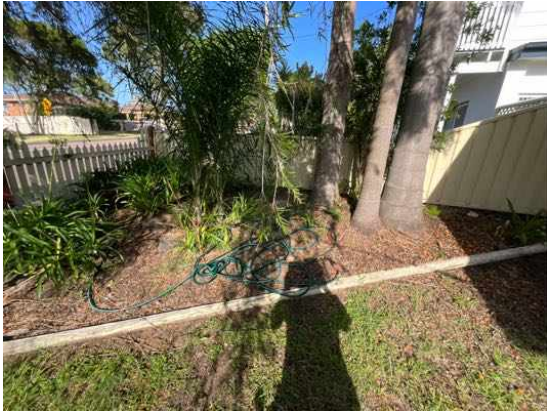
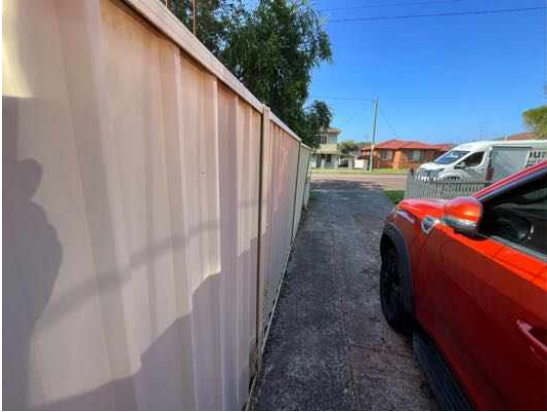
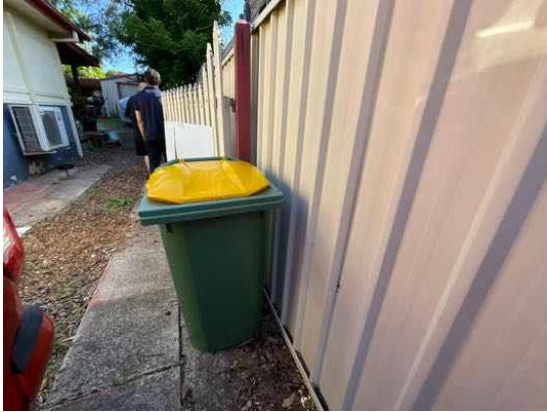
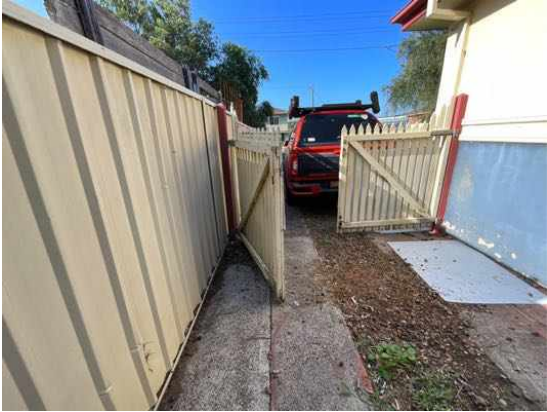
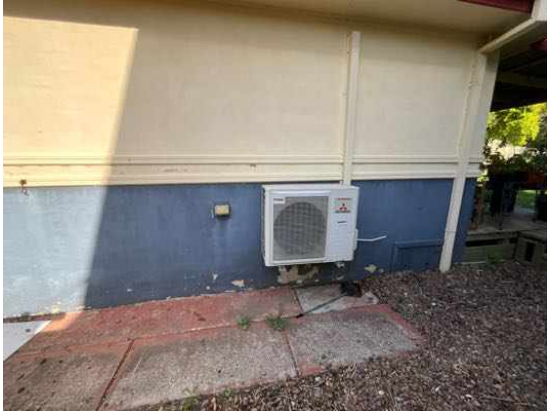
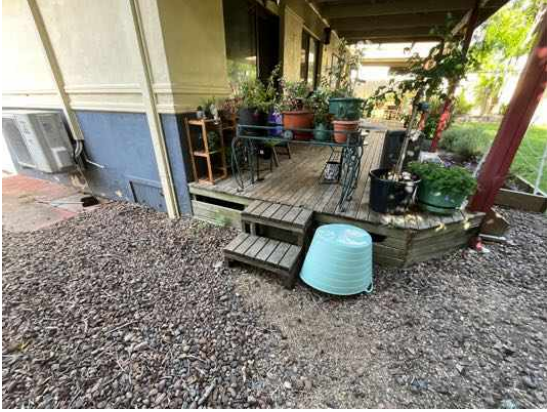
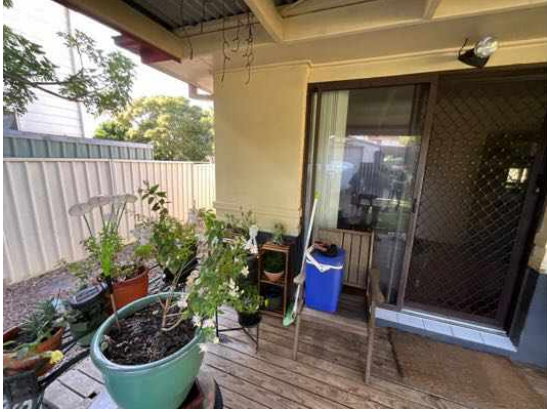
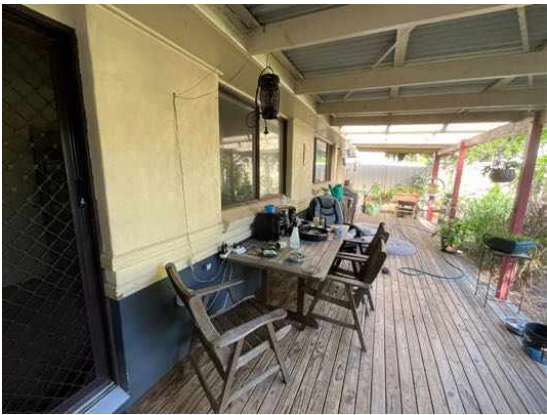
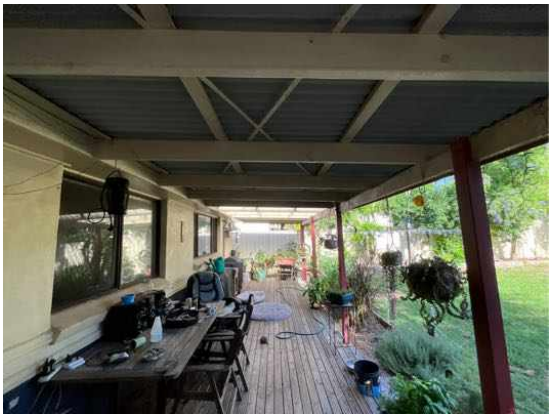
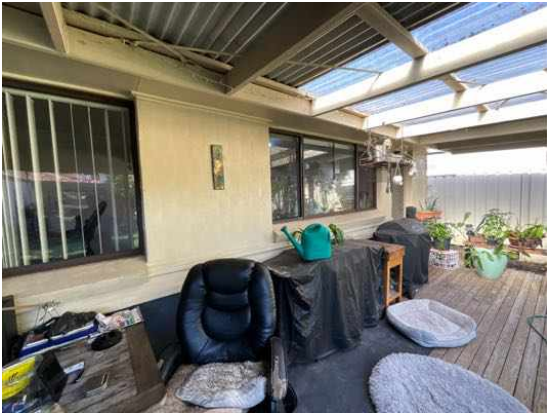
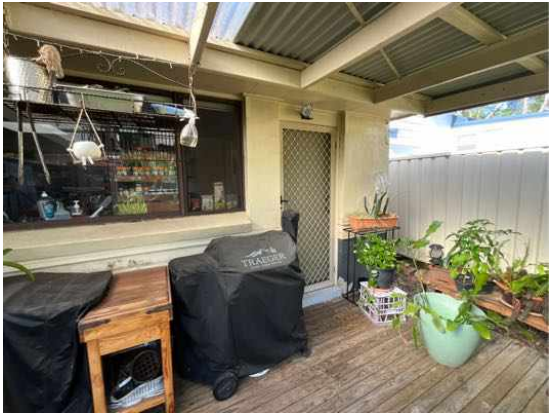
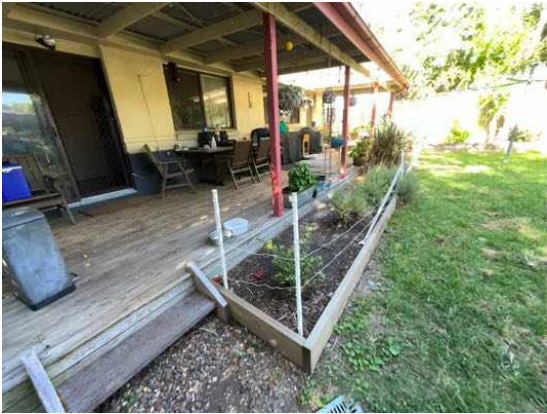
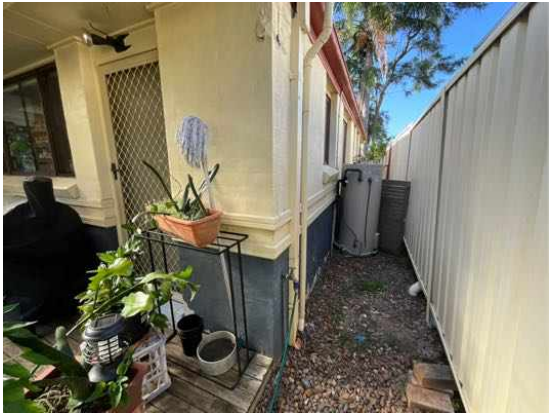
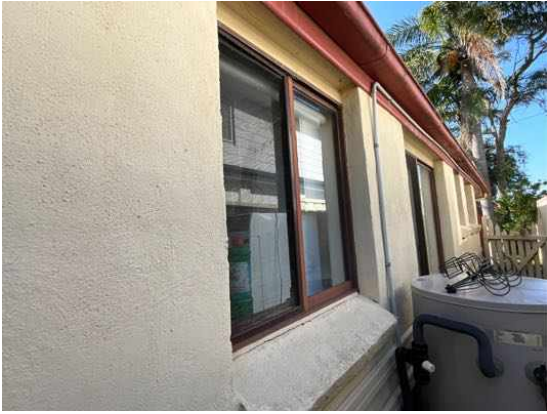
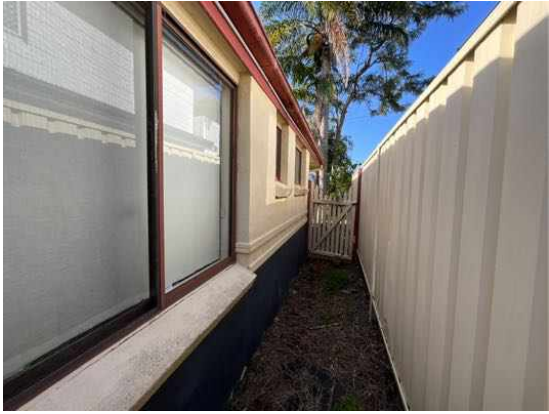
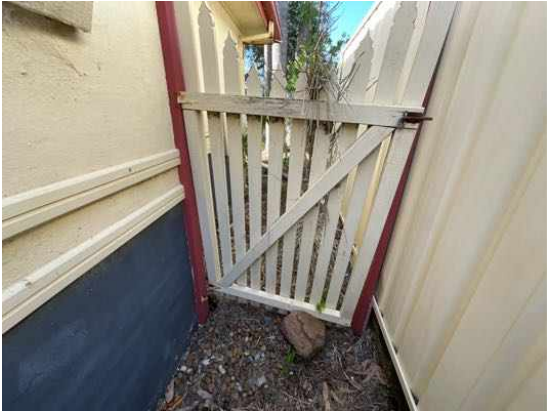
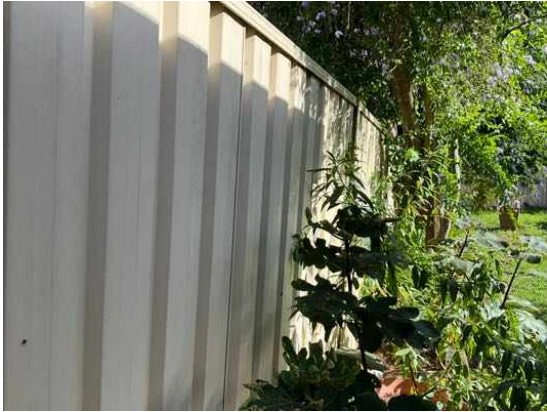
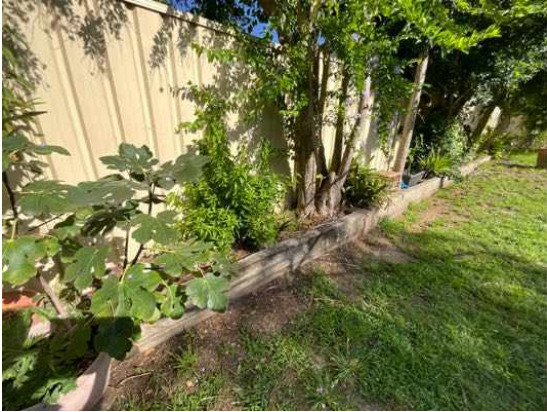
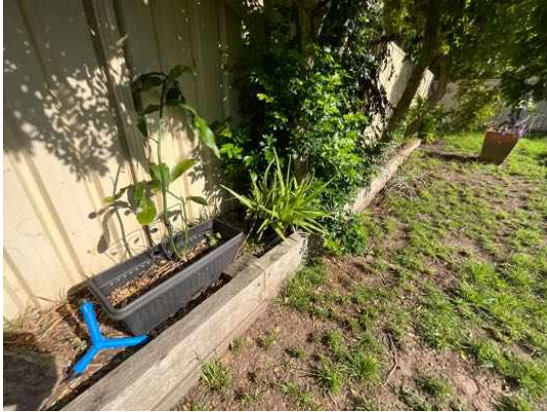
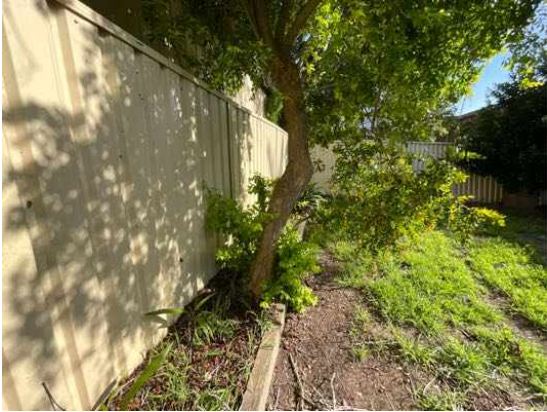
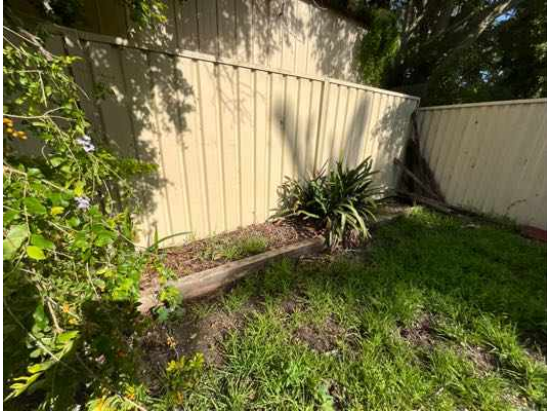
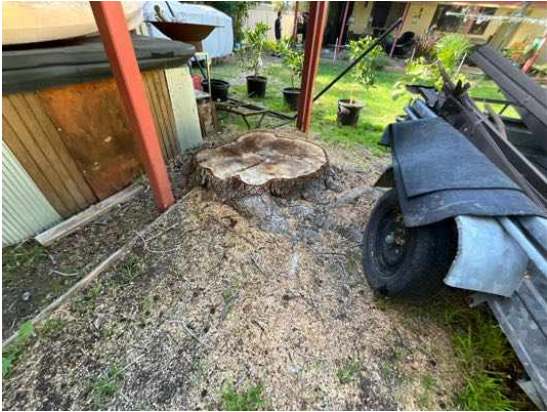
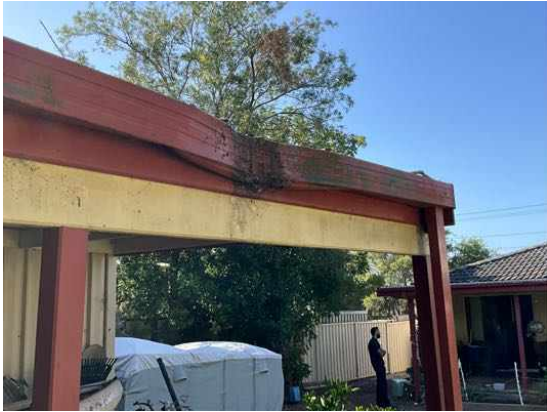
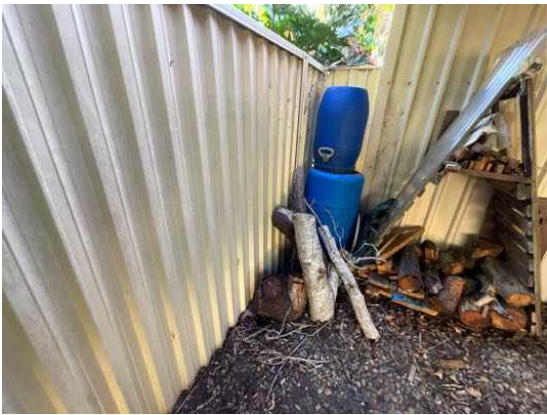
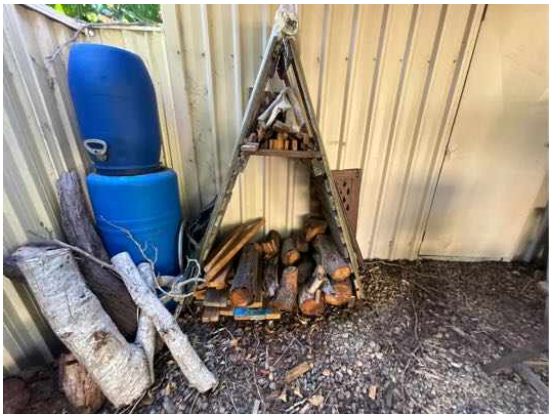
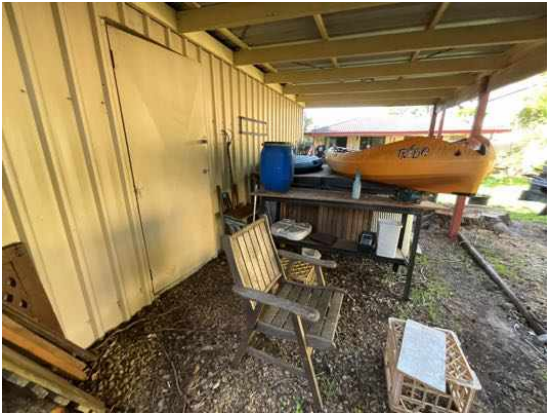
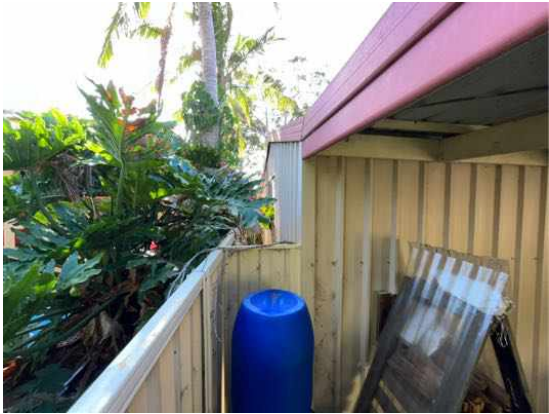
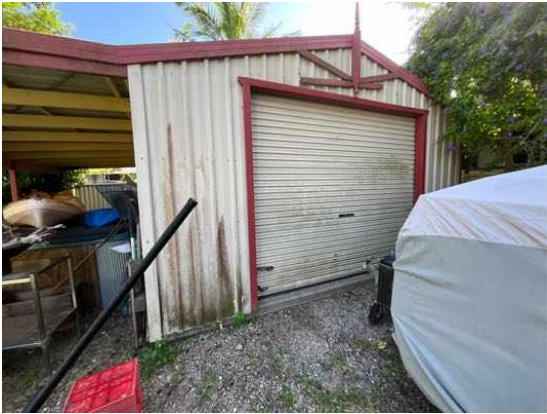
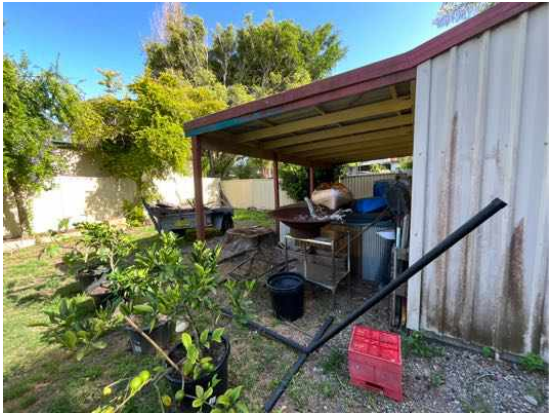
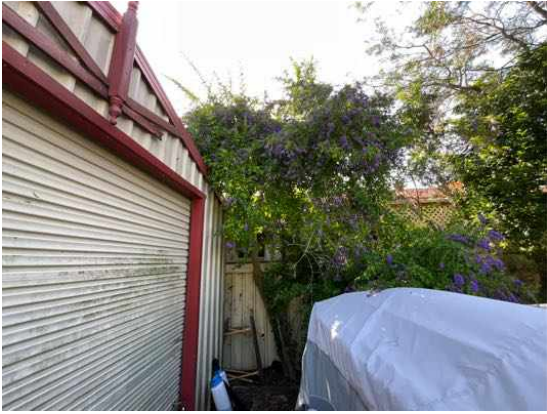
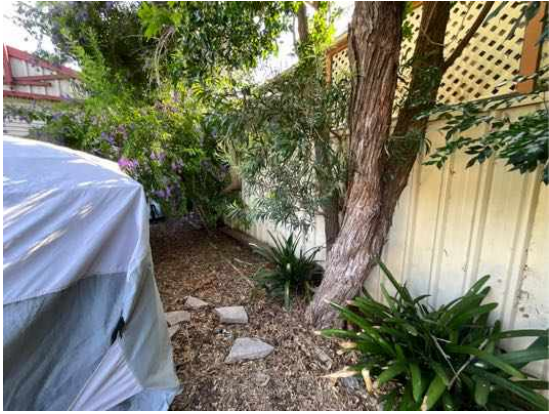
Building:	Main Building
Location:	All External Areas > All Areas
Finding:	Additional Photos - Obstructions and Limitations - External Areas
Information:	These photographs are an indication of the obstructions and limitations which impeded full inspection of the property at the time of inspection. These obstructions can hide an array of defects and should be removed to allow full inspection to be carried out. A re-inspection is recommended once the areas are made accessible.

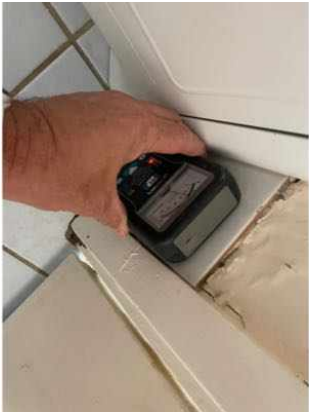
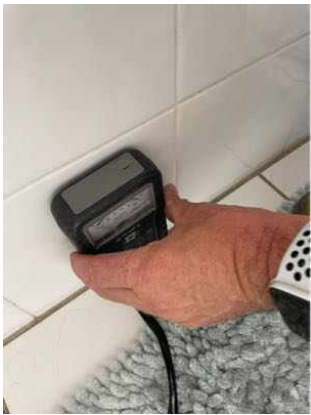
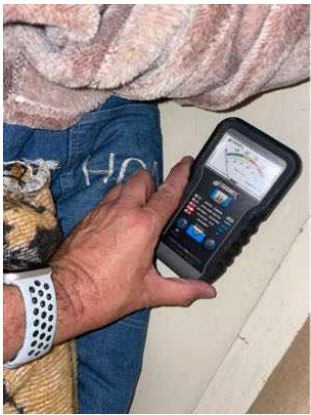
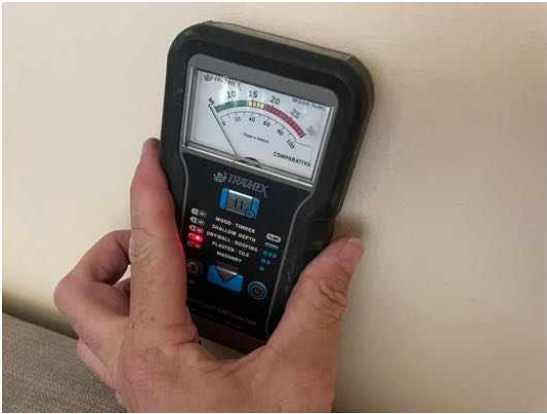
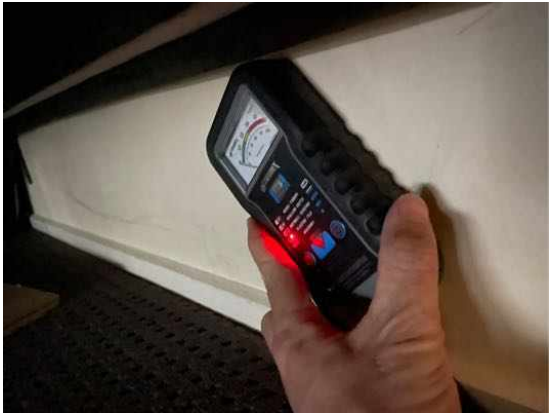
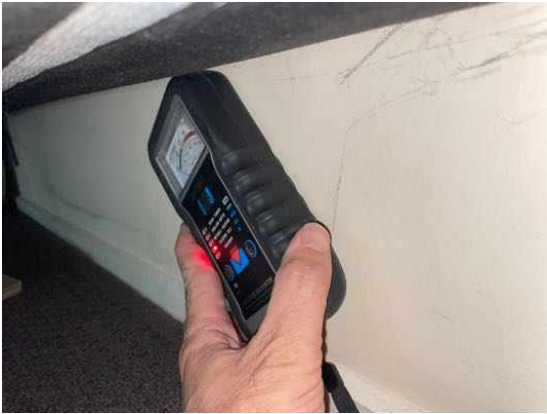
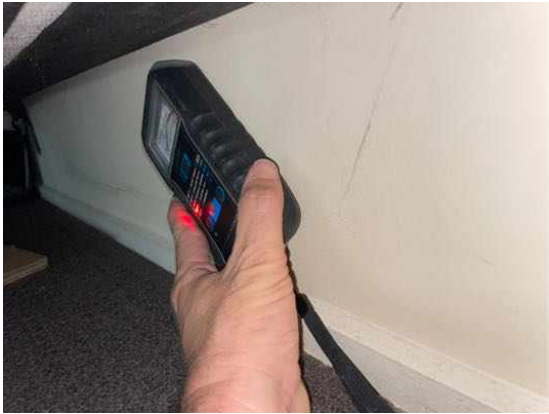
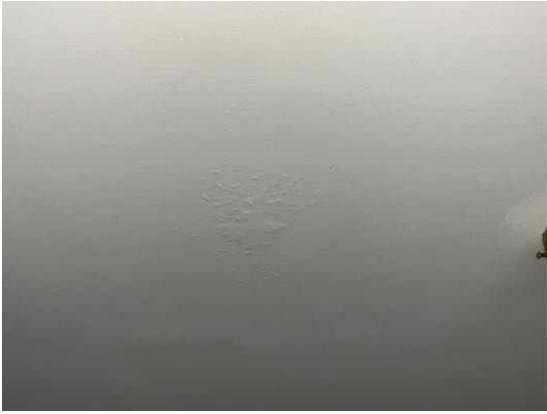
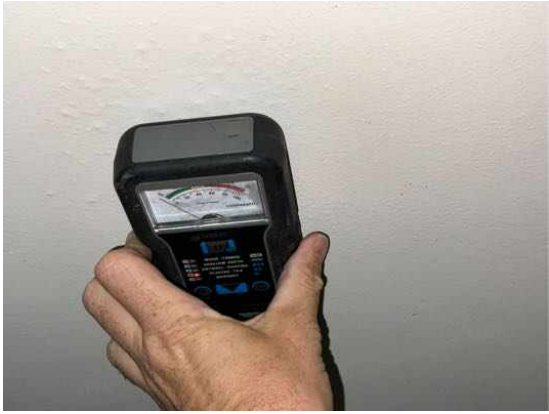
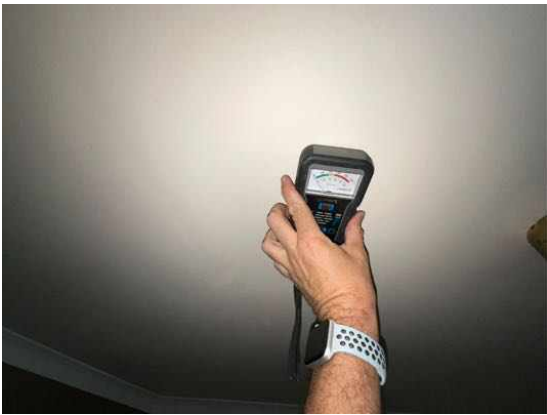
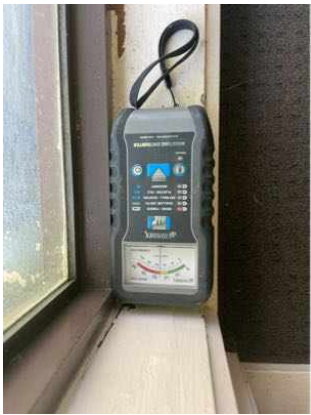
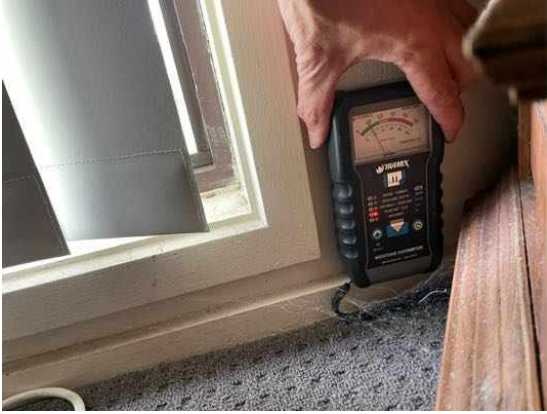
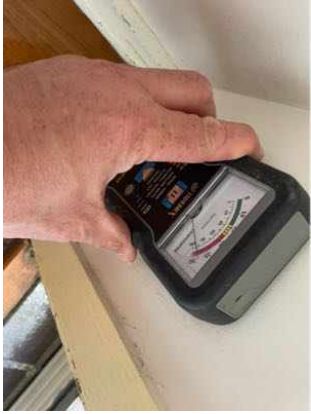
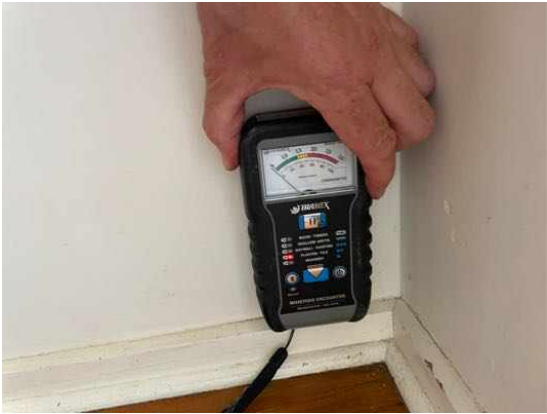
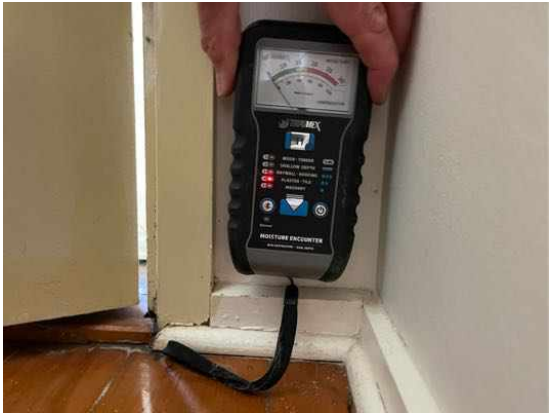
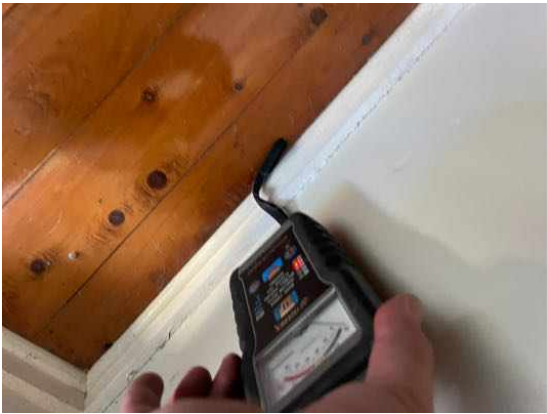
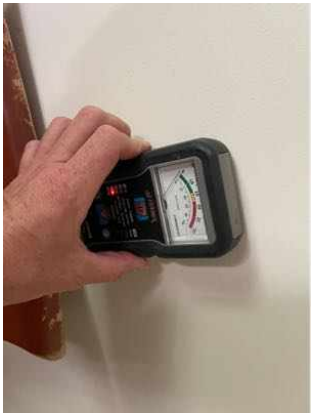
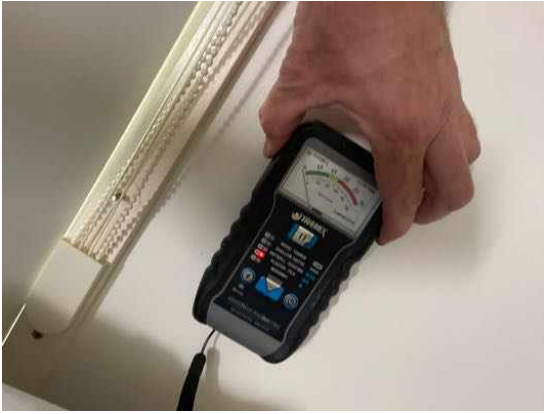
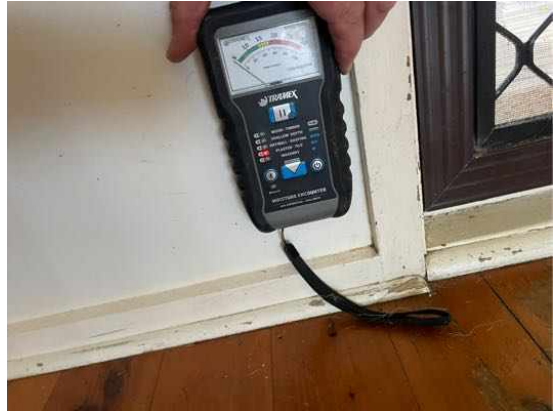
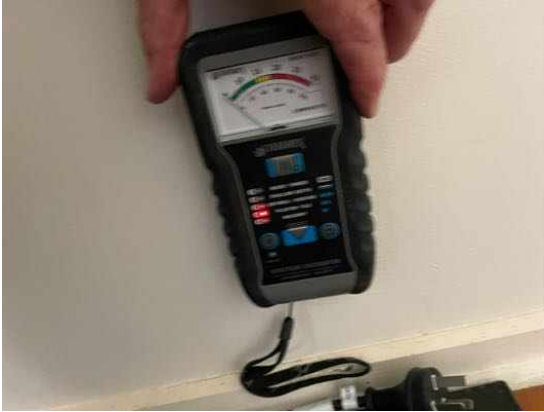
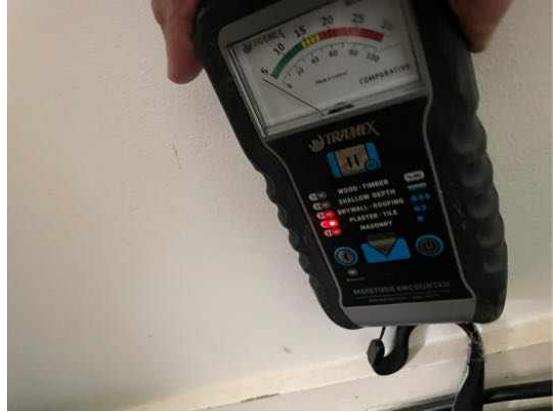
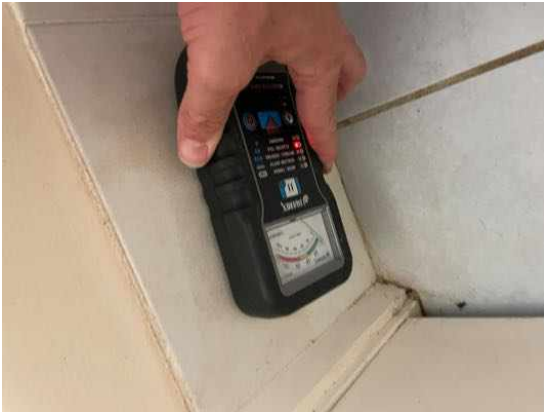
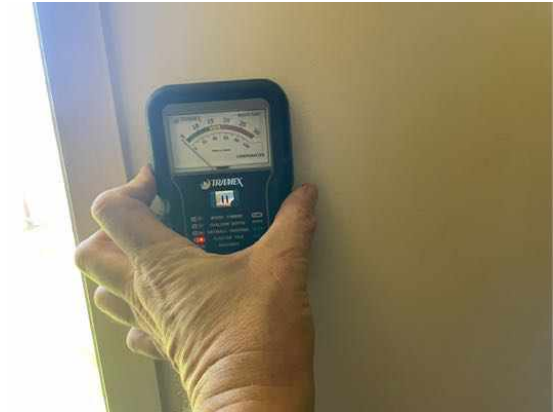
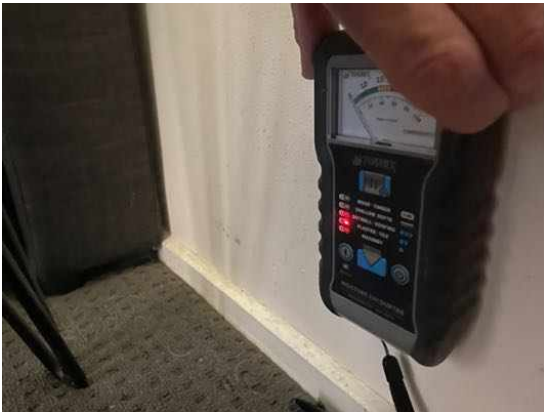
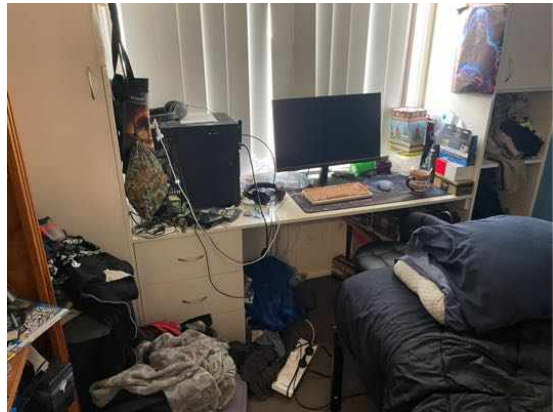
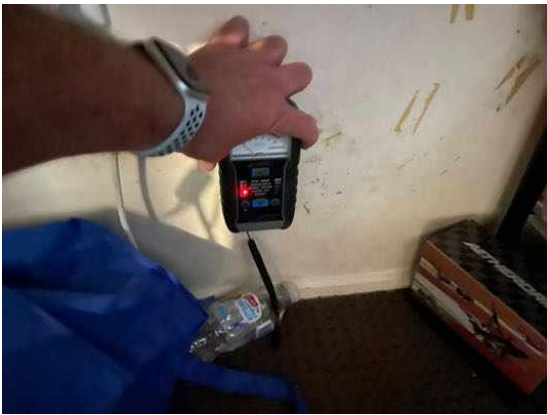
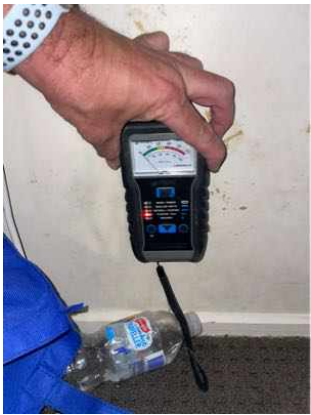
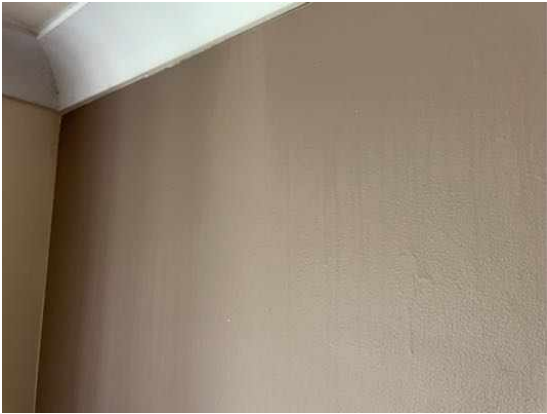
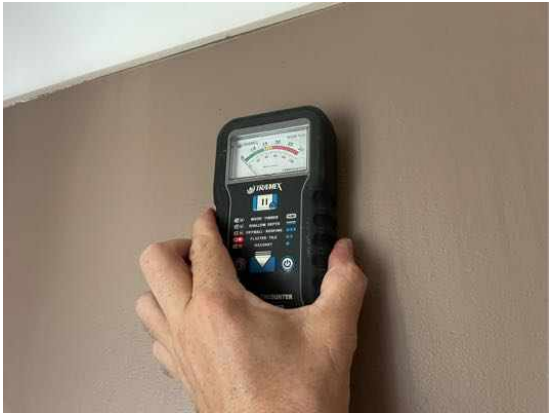
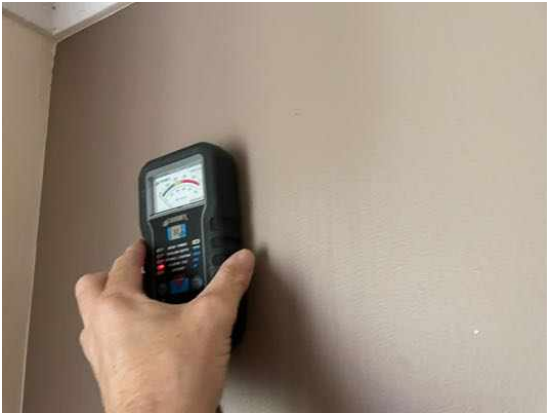
Building: Main Building
Location: All Areas > All Areas
Finding: Moisture Readings
Information: Moisture readings were taken to the wet areas and below and beside windows.
