Building and Timber Pest Inspection Report

Inspection Date: Mon, 26 Jan 2026

Property Address: 8 Poplar Ave, Shepparton VIC 3630,
Australia

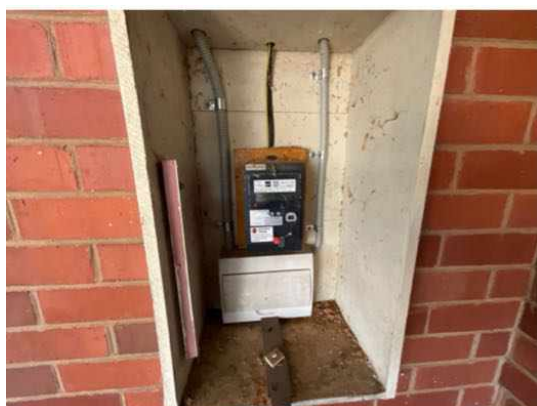
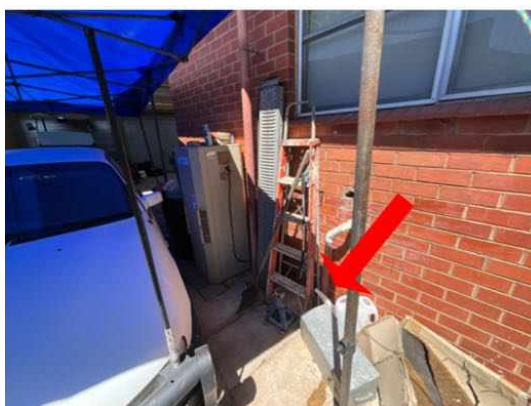
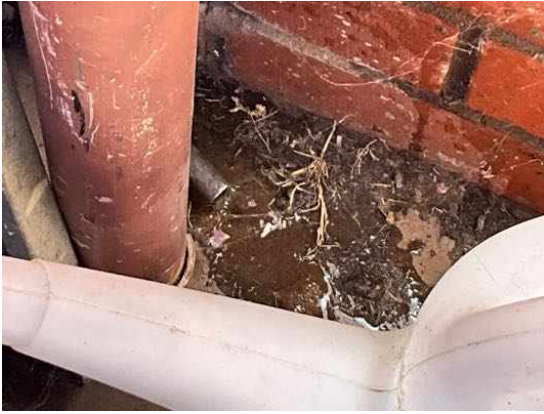
A durable notice should be placed in the switchboard unit to indicate current termite barriers. At the time of inspection, it appeared as though no termite management system has been installed, with no evidence to suggest preventative works taking place.

The client may consider gaining further advice from a pest controller as to the costs and procedures involved with this application. It is recommended that obtaining such advice be a short-term priority.
