## Building Inspection Report

Inspection Date: Wed, 7 Jan 2026

Property Address: 24/5-13 Larkin St, Camperdown NSW 2050,  
Australia

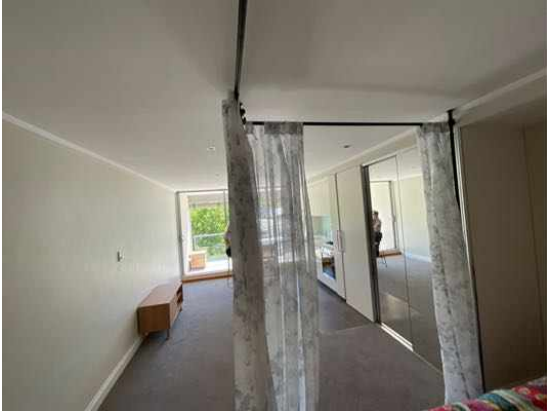
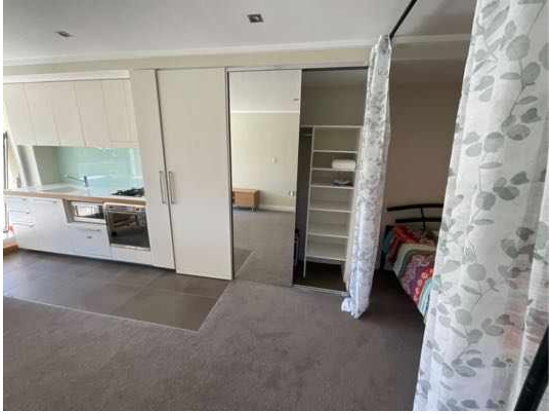
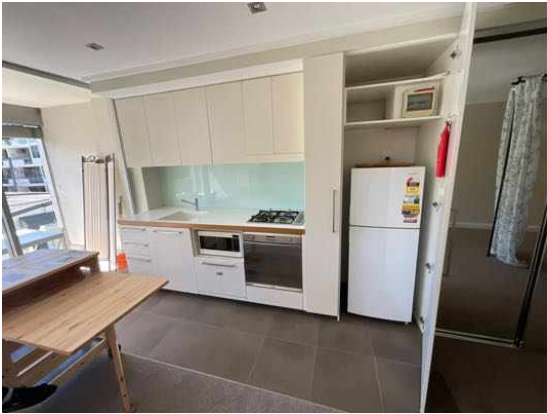
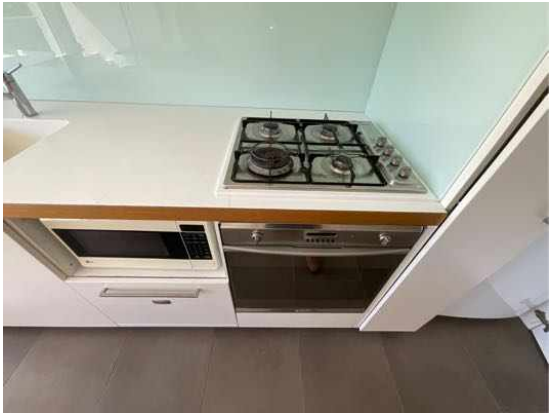
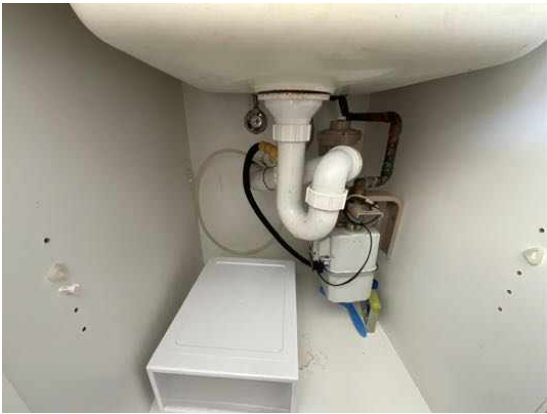
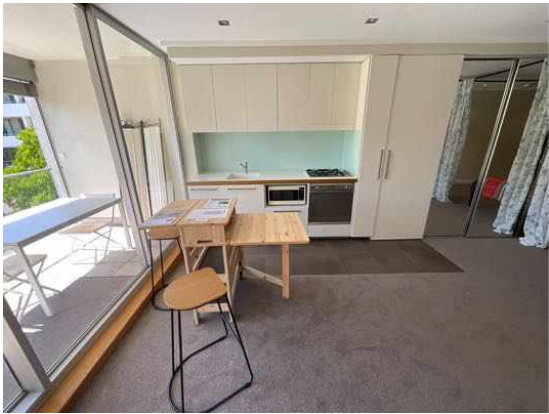
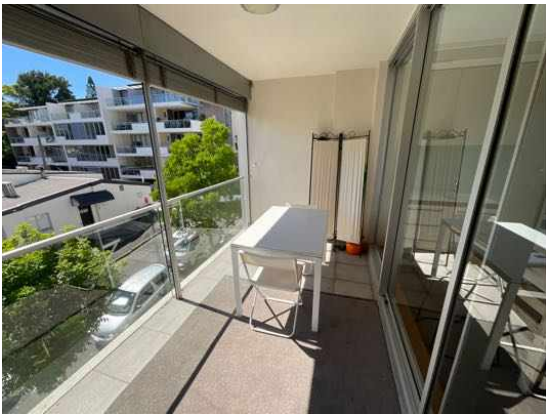
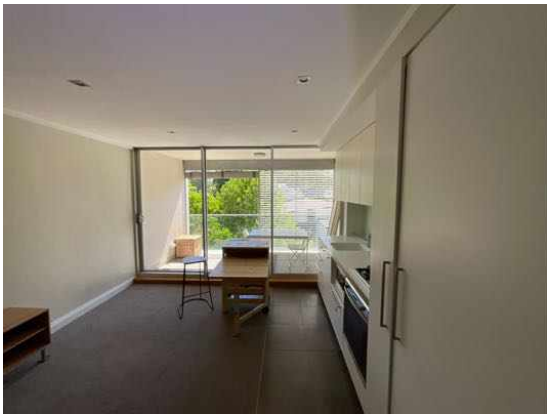
Information: These photographs are an indication of the obstructions and limitations which impeded full inspection of the property at the time of inspection. These obstructions can hide an array of defects and should be removed to allow full inspection to be carried out. A re-inspection is recommended once the areas are made accessible.

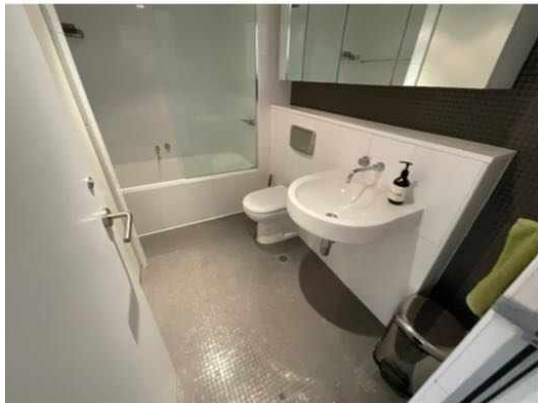
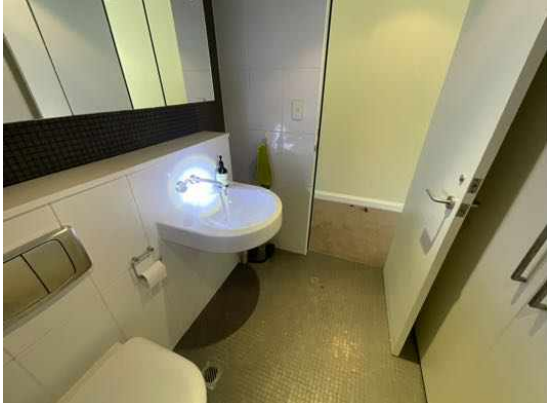
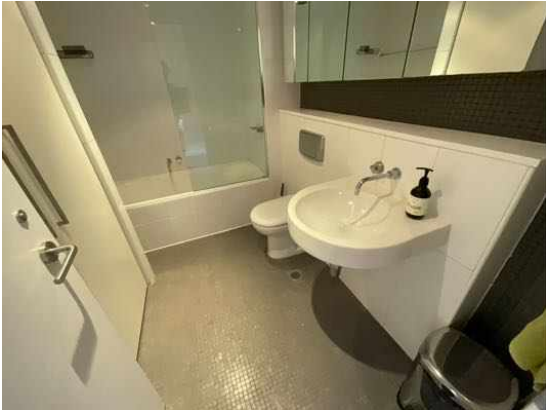
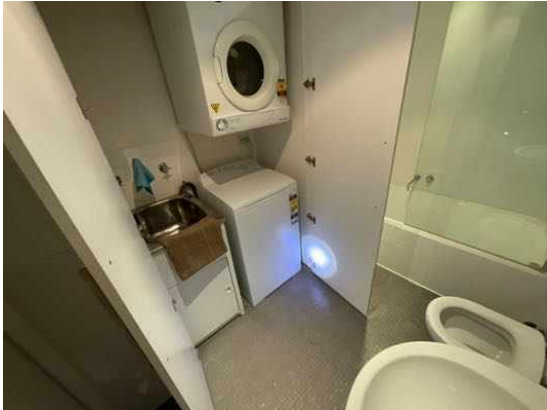
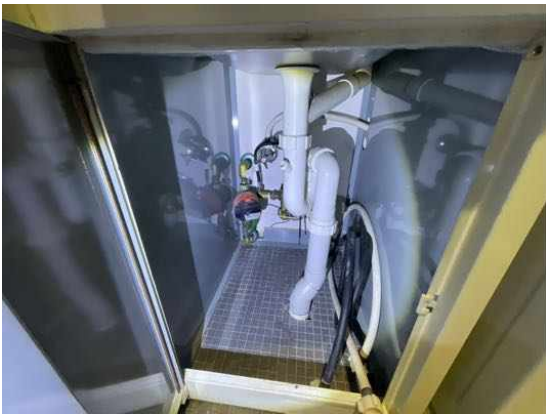
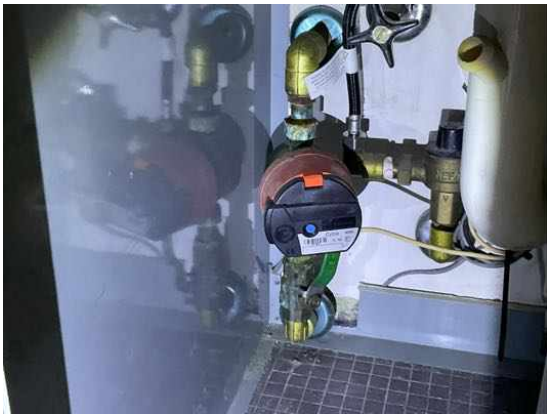
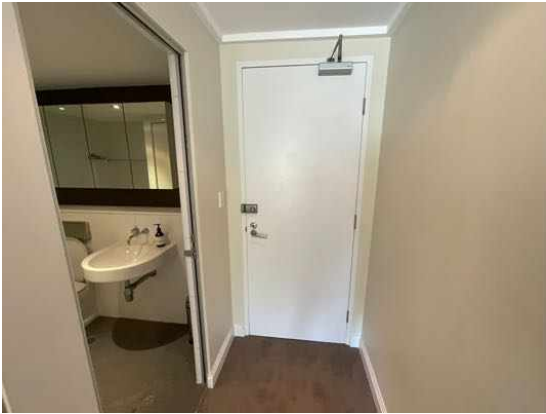
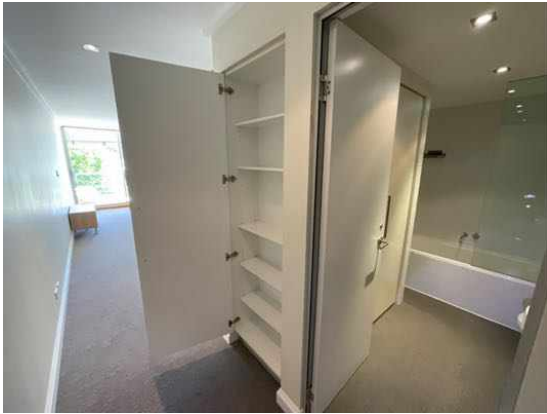
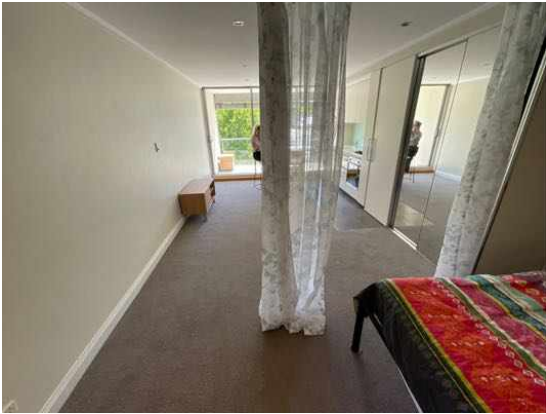
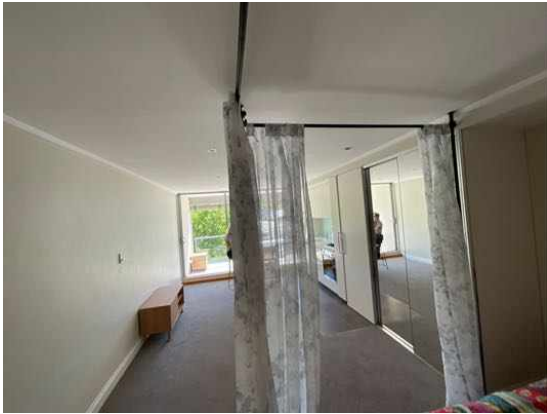
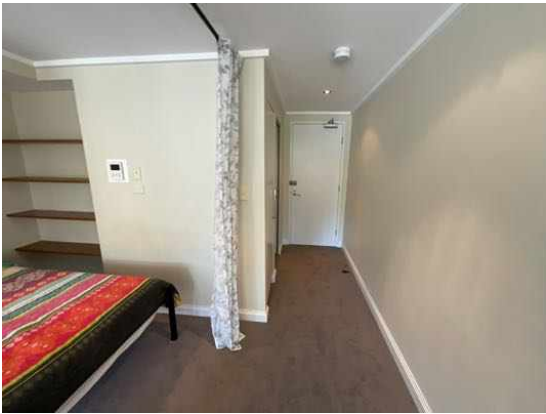
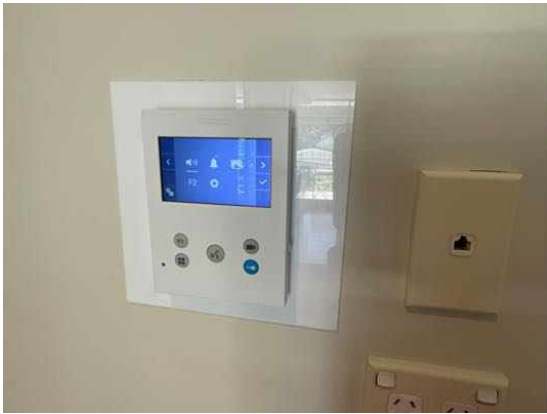
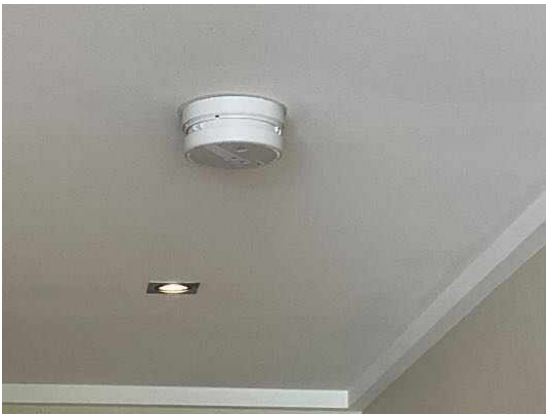
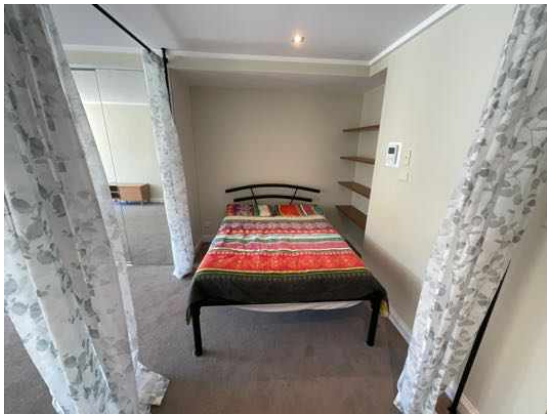
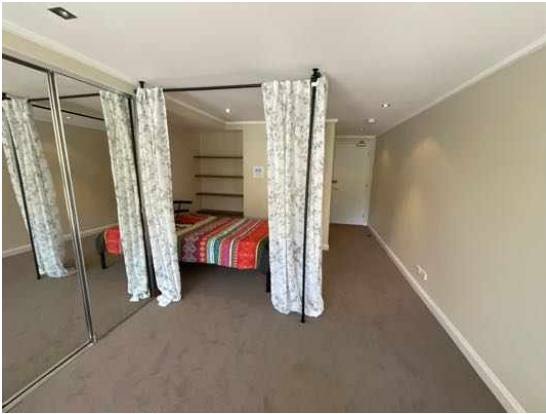
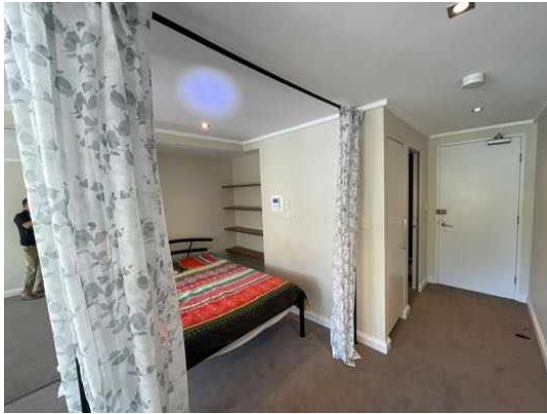
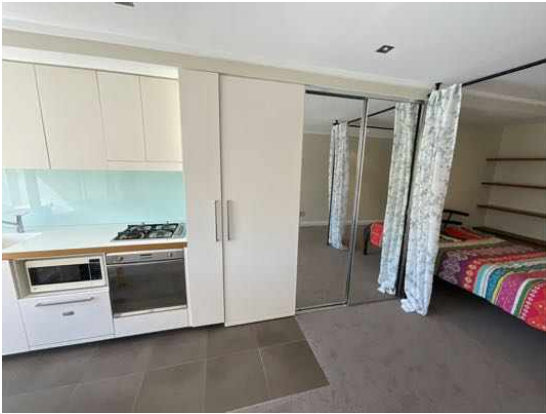
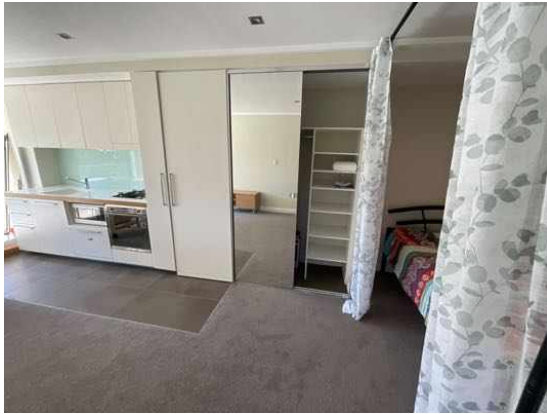
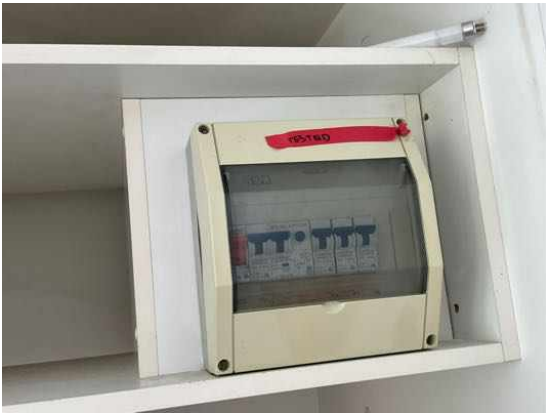
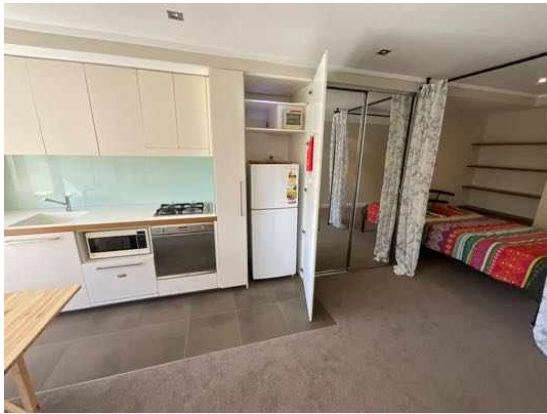
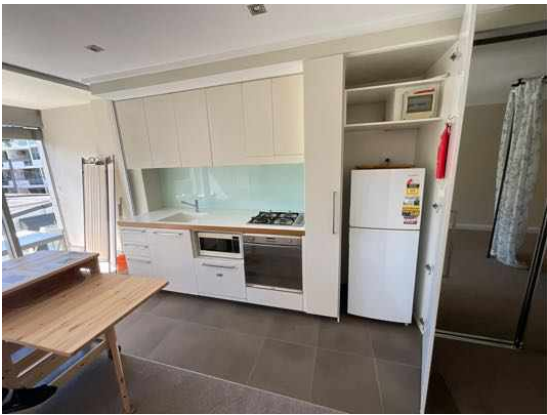
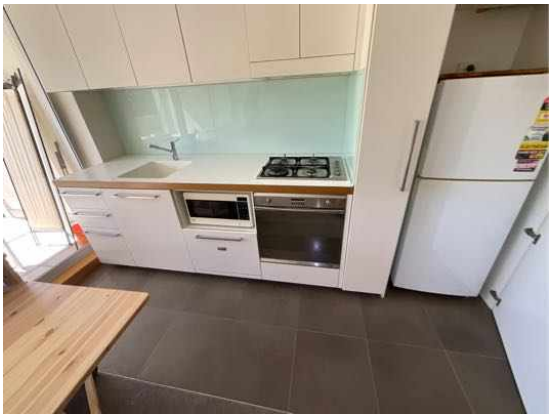
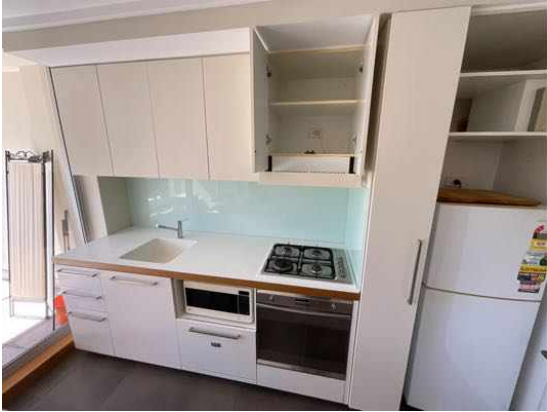
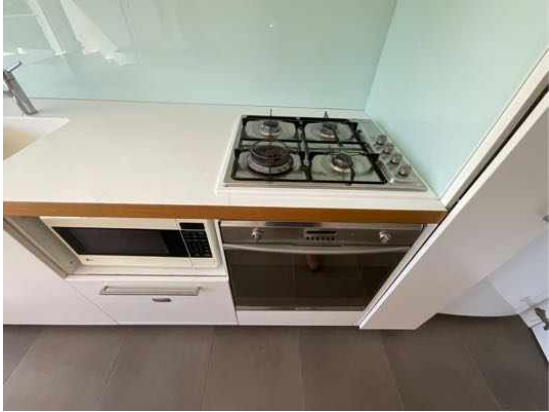
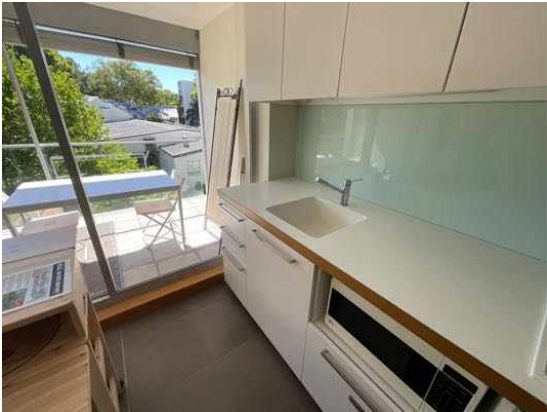
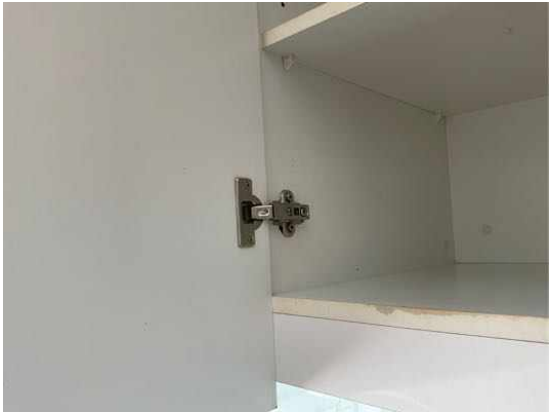
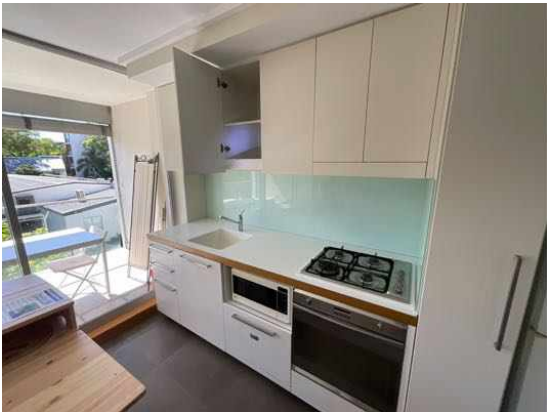
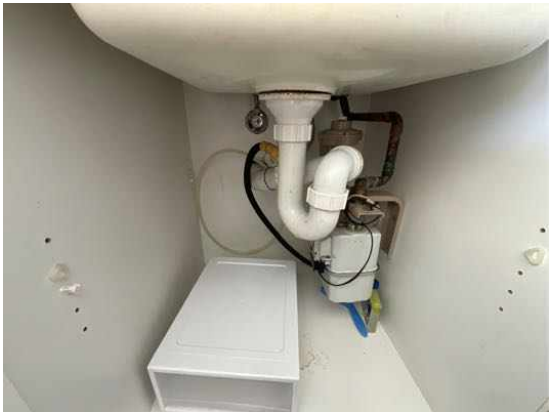
**Noted Item**

Building: Main Building  
Location: All Areas  
Finding: Additional Photos  
Information: Additional photos are provided for your general reference. Arrows have been included to highlight areas of importance. Please discuss these photos with your building consultant for clarification.
