Building and Timber Pest Inspection Report

Inspection Date: Fri, 20 Mar 2026

Property Address: 3 Luss Ct, Glenhaven NSW 2156, Australia

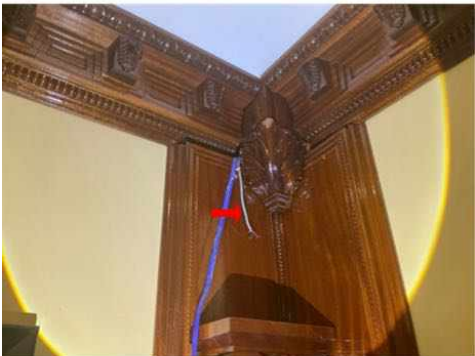
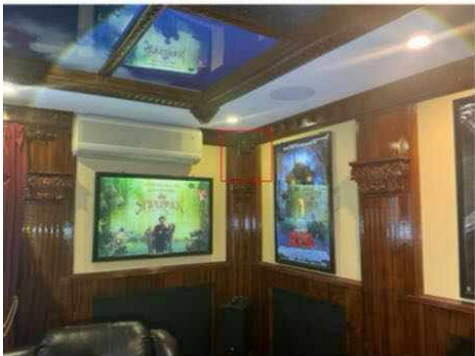
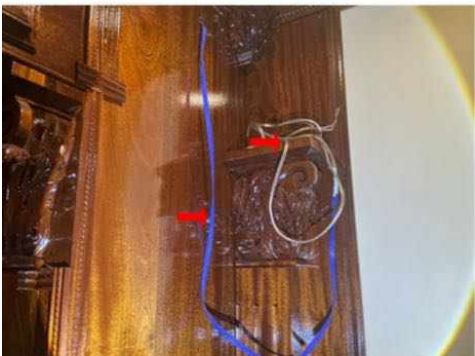
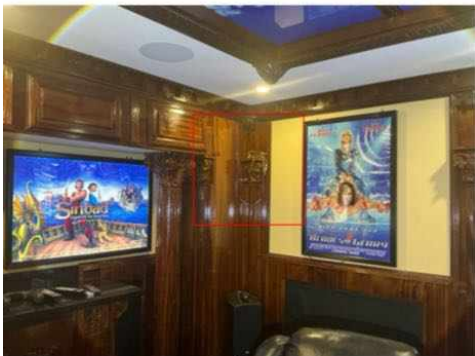
Building: Main Building
Location: Theatre Room
Finding: Exposed Wiring
Information: At the time of inspection, wiring was observed to be exposed and not properly concealed. Exposed wiring presents a safety hazard, as it may be susceptible to damage, accidental contact, and potential electrical risks.

It is recommended that all wiring, whether electrical or communication/cable wiring, be properly enclosed and secured to ensure safety and compliance with acceptable standards. Where the wiring is electrical in nature, a licensed electrician should be engaged to assess and rectify the installation. For non-electrical wiring, a suitably qualified handyman may be engaged to neatly conceal and secure the wiring in a professional manner.

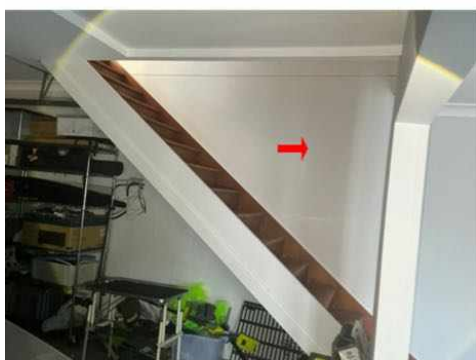
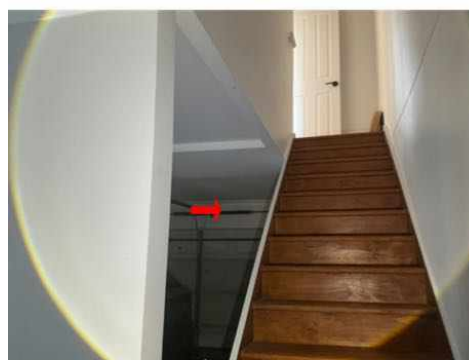
Finding 1.02

Location:	Garage
Finding:	Balusters - Missing
Information:	The absence of balusters on the stairs presents a significant safety defect. Balusters are critical components of a railing system, designed to prevent falls and provide structural support. Their absence creates wide gaps, increasing the risk of accidental falls, particularly for children and pets. This non-compliance with building safety standards poses a serious hazard and must be addressed immediately. Installing properly spaced (not more than 125mm) balusters will enhance safety, ensure compliance with building codes, and provide the necessary structural integrity to the railing system.

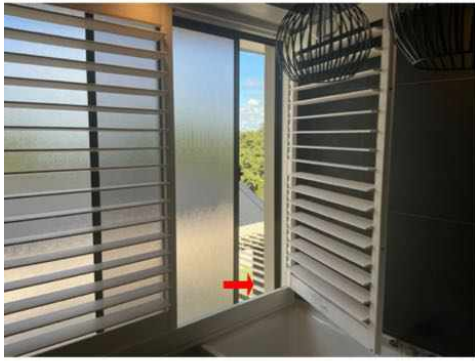
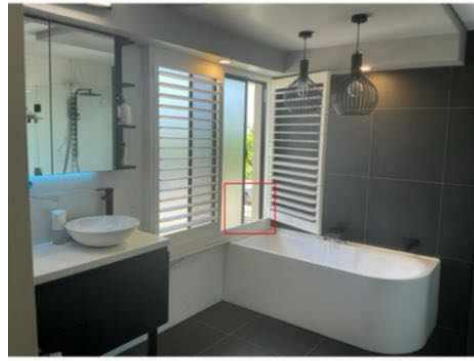
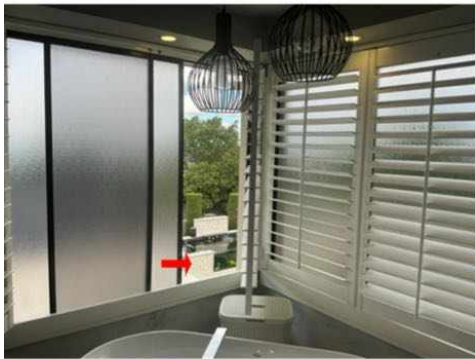
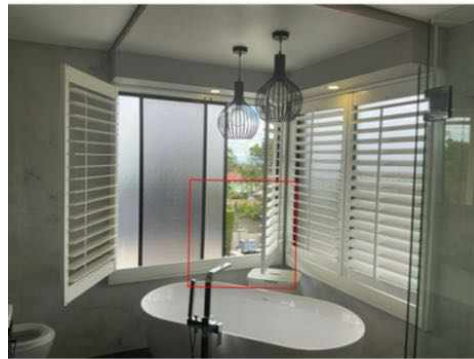
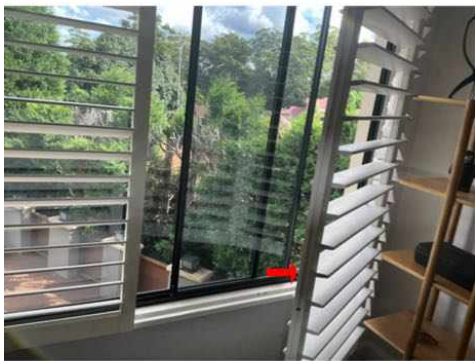
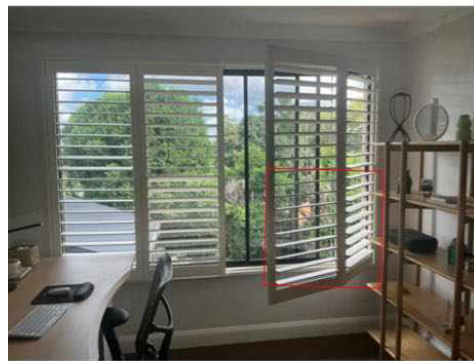
Finding 1.03

Building:	Main Building
Location:	All Areas Upstairs
Finding:	Window Restrictors - Recommended
Information:	Upstairs windows did not have window restrictors installed. Although not a requirement at the time of construction, it is advisable to install window opening restrictors on all second storey windows with sill heights below 1.7 meter and potential fall of 2 meters or more.

If you live in a strata scheme, window safety devices must be installed on all applicable windows by 13 March 2018. Residents with safety devices installed can still fully open their windows but it's recommended that devices be engaged whenever children are present, to prevent falls.

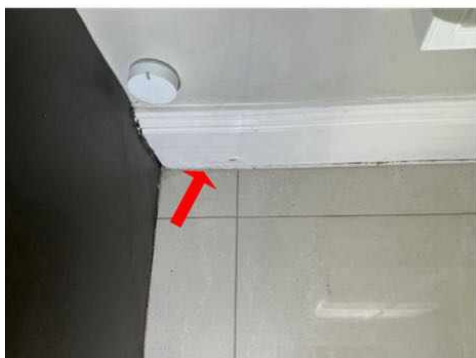
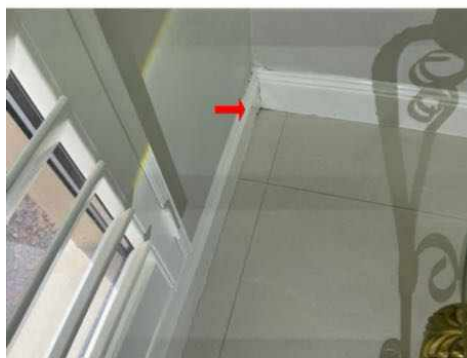
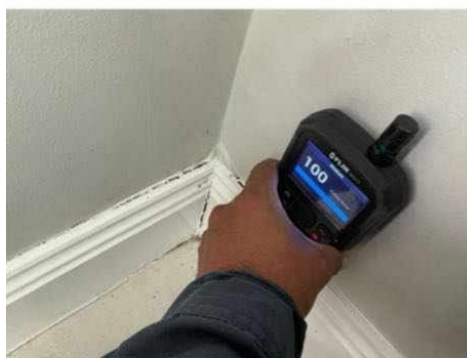
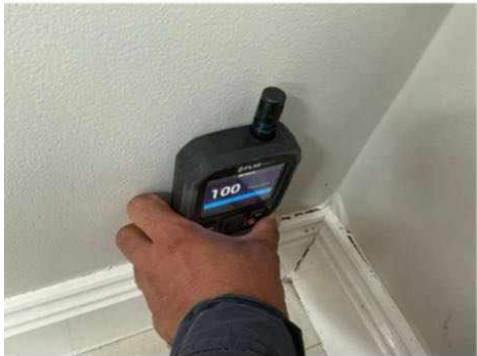
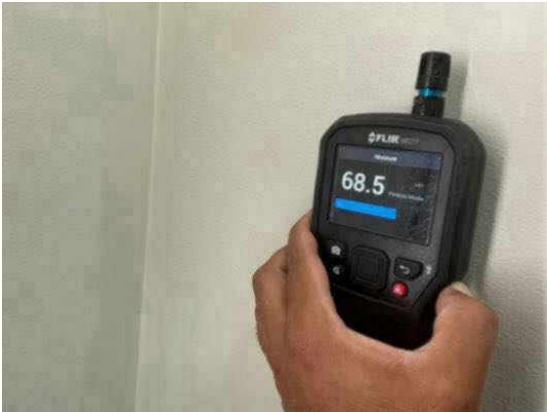
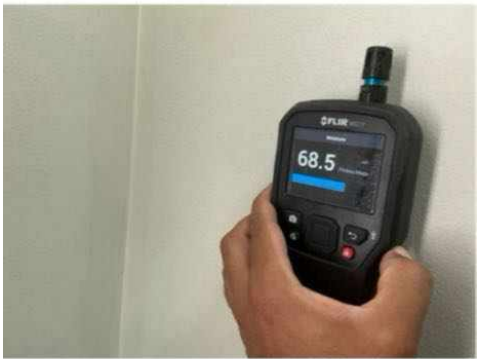
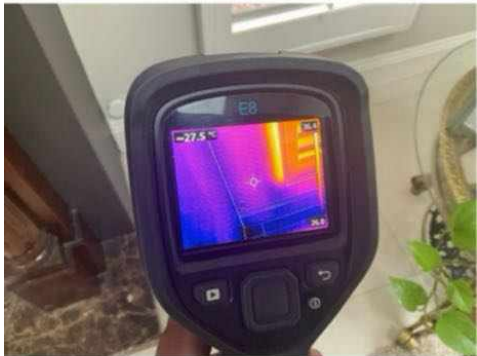
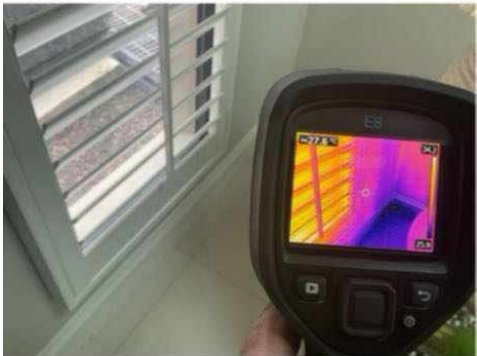
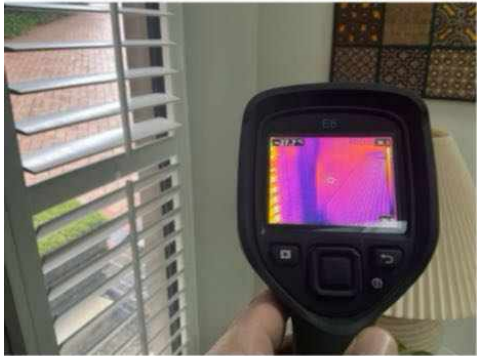
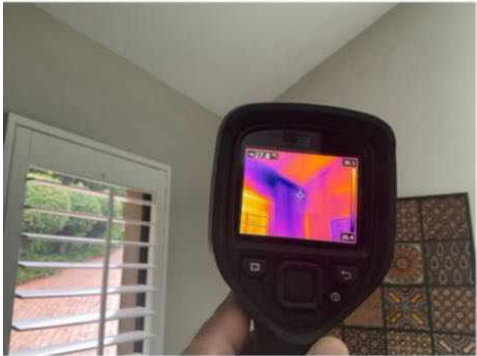
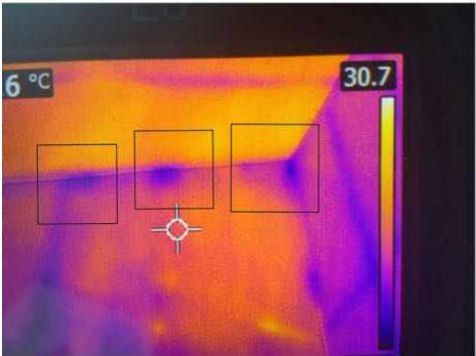
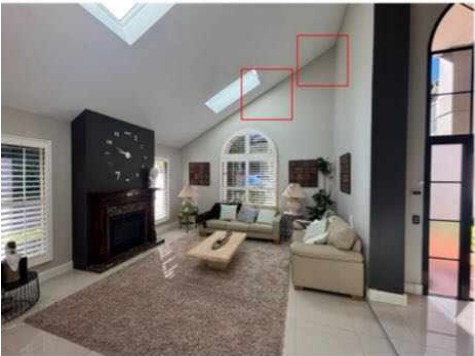
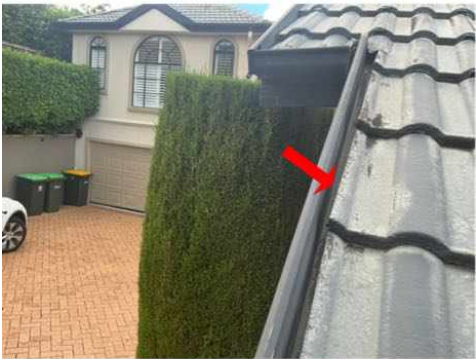
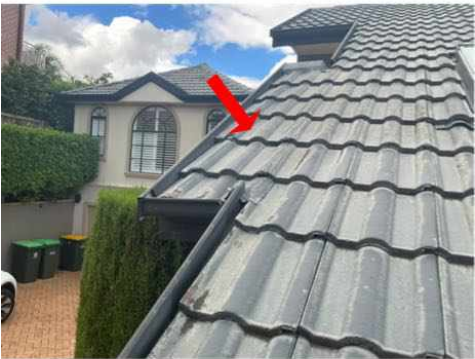
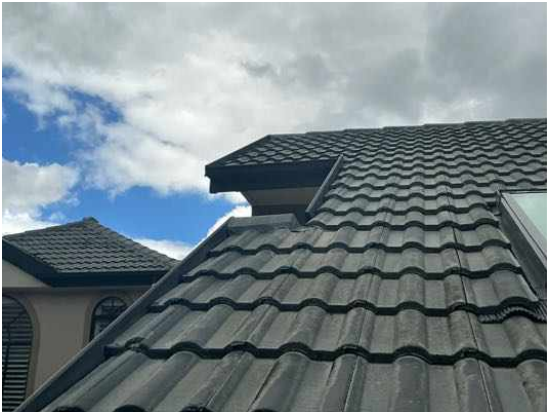
Finding 2.01

Building:	Main Building
Location:	Formal Lounge
Finding:	Active Moisture / Water Ingress
Information:	At the time of inspection, moisture intrusion was detected to the wall and ceiling areas within the formal lounge. Thermal imaging identified temperature variations consistent with moisture presence, and moisture meter readings were recorded at maximum levels, indicating a high degree of saturation within the affected building elements.

Visible signs of water damage were also noted, including deterioration to skirting boards, swelling/softness to finishes, and peeling/bubbling paint, which are consistent with prolonged moisture exposure.

The moisture pattern and location suggest that the water ingress is likely associated with external factors, such as defective or inadequate flashing, sealing failure, or water penetration around adjoining structural junctions. The leak appears to be active at the time of inspection, which may lead to ongoing deterioration of building materials, including plasterboard damage, timber decay, mould growth, and potential structural implications if left unaddressed.

Given the active nature and severity of the moisture ingress, this condition is considered a major defect requiring urgent attention. The client is strongly advised to engage the services of a licensed roofer as a matter of urgency to inspect the roof area, particularly around flashing, junctions, and adjoining surfaces near the affected corner. Any identified defects should be promptly repaired, sealed, or replaced to prevent further water entry.

Following rectification of the source, damaged internal finishes should be reassessed and repaired as required. Ongoing monitoring is recommended to ensure that the issue has been effectively resolved.

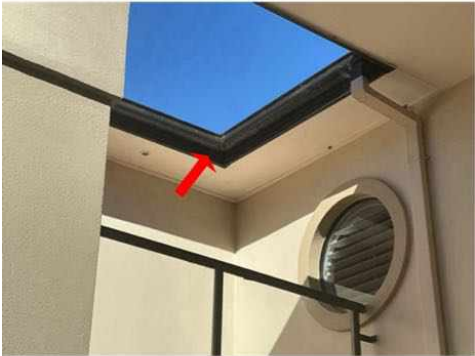
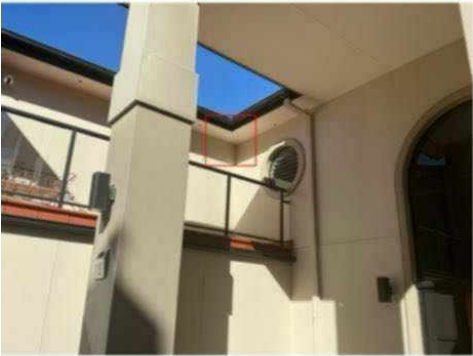
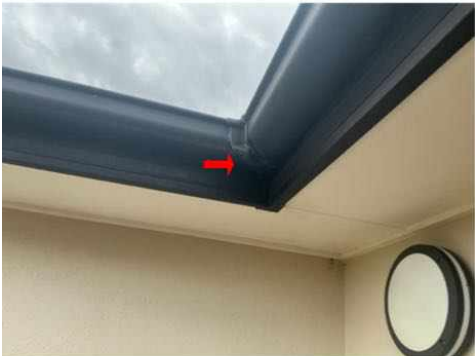
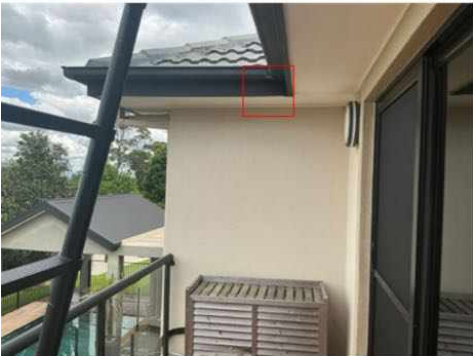
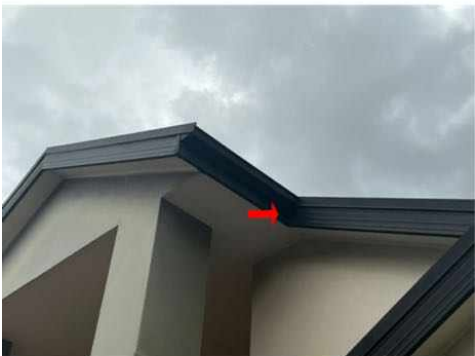
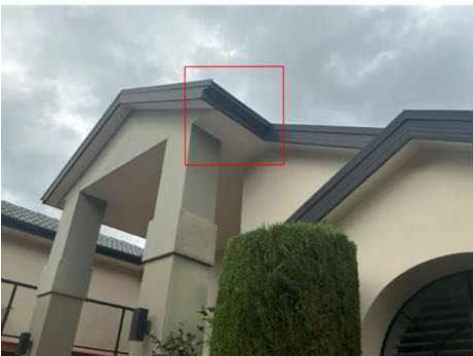
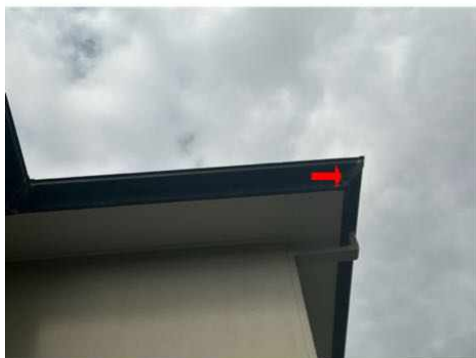
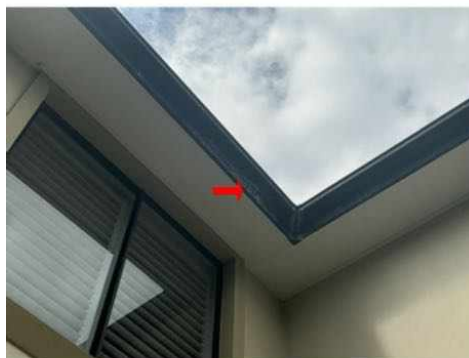
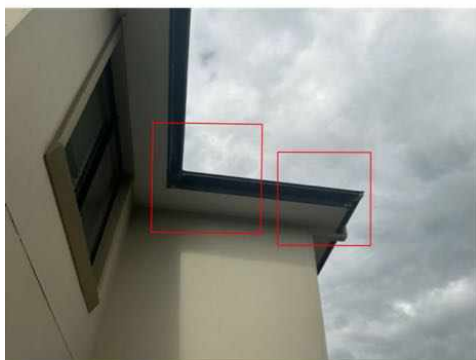
Finding 3.01

Building:	Main Building
Location:	All Areas
Finding:	Gutters - Leaking
Information:	The gutter (roof plumbing) was noted as leaking at the time of inspection. A leaking gutter can stem from various factors that compromise its functionality. One common cause is clogging, where debris such as leaves and twigs obstruct the flow of water, leading to overflow and leakage. Additionally, damage to the gutter system, such as

cracks, holes, or corrosion, can occur over time due to exposure to harsh weather conditions, resulting in leaks. Poor installation practices, including inadequate sealing of seams and joints, can also contribute to leaks. Furthermore, sagging gutters, often caused by improper support or excessive weight from debris, create gaps where water escapes instead of flowing towards the downspout.

The client is advised to engage the services of a roof plumber to fix the issue at owners discretion.

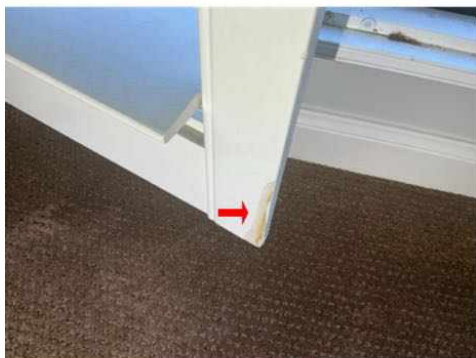
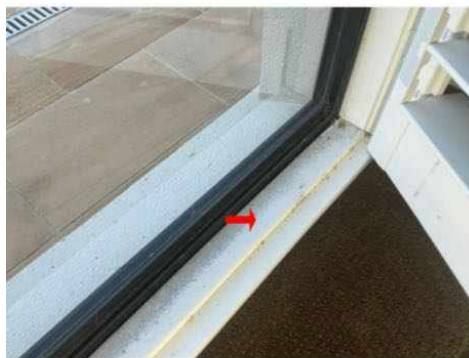
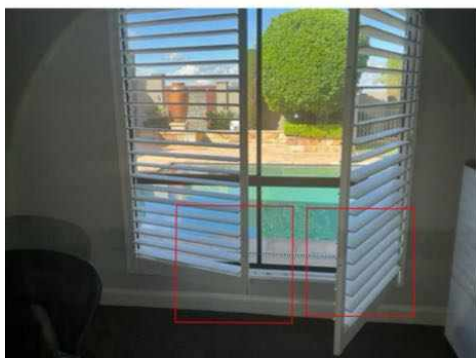
Building:	Main Building
Location:	Home Office
Finding:	Evidence of Previous Moisture Ingress at Window
Information:	At the time of inspection, minor moisture-related staining and deterioration were noted to the lower section of the window frame/joinery. The affected area was dry at the time of inspection, indicating this is likely associated with a previous instance of water ingress rather than an active leak.

Possible causes may include past failure of external seals, wind-driven rain penetration, or minor gaps around the window frame or sill.

No immediate repair is considered necessary at this stage. However, the client is advised to monitor the area over a period of 12 months, particularly during and after heavy rainfall. If any signs of active moisture, swelling, peeling, or further deterioration are observed, a suitably qualified window or building specialist should be engaged to inspect and rectify the issue.

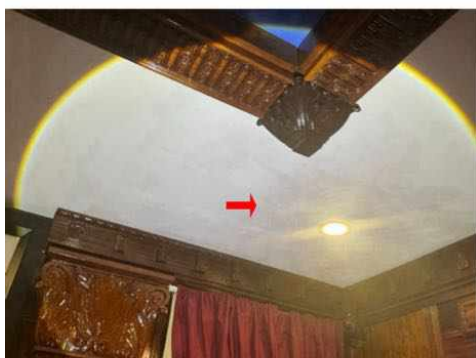
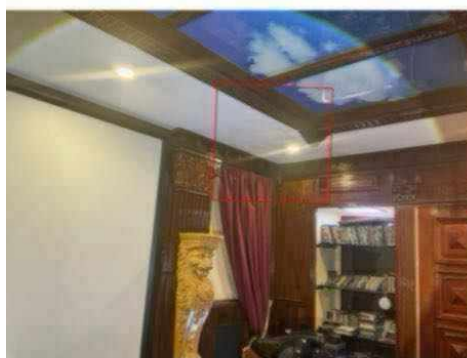
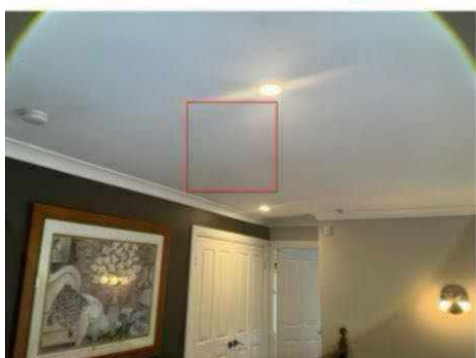
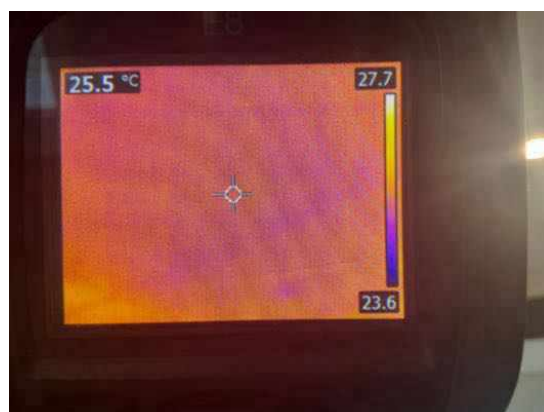
Finding 3.03

Building:	Main Building
Location:	Theatre Room, Upstairs Hallway
Finding:	Previously Patched Ceiling Areas
Information:	At the time of inspection, a number of ceiling areas were observed to have been previously patched and repaired. The finish to these areas was inconsistent with the surrounding ceiling, resulting in a visible variation in texture and appearance.

A thermal imaging camera was utilised during the inspection, and no signs of active moisture or water ingress were detected at the time, indicating that the issue is cosmetic in nature rather than structural or moisture-related.

It is recommended that a qualified painter be engaged to properly prepare, blend, and repaint the affected areas so that they are aligned with the surrounding ceiling finishes and present a consistent, professional appearance.

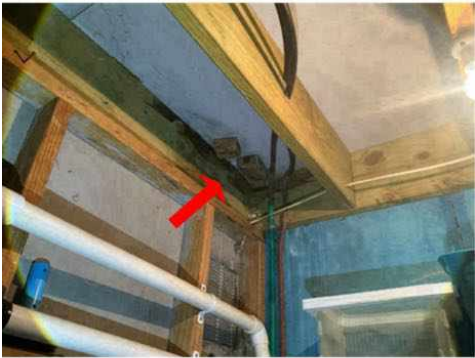
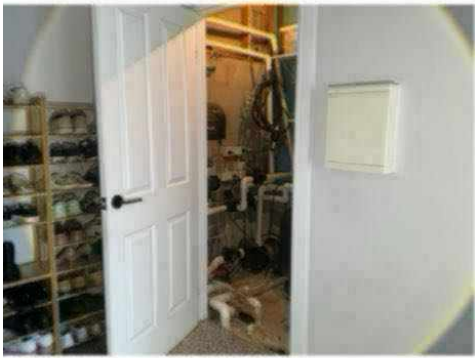
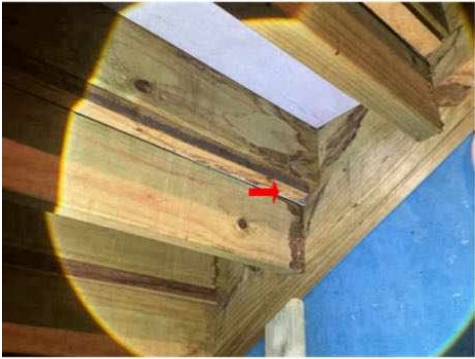
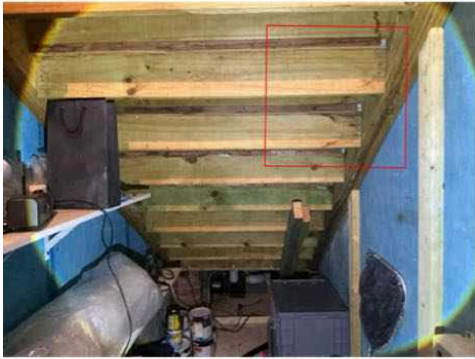
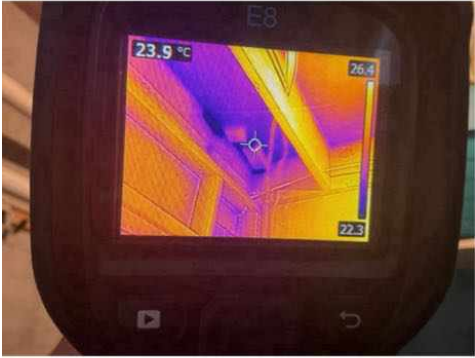
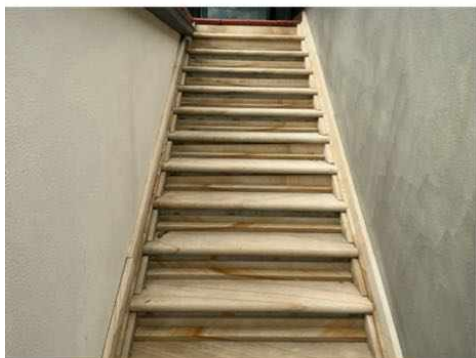
Finding 3.04

Building:	Main Building
Location:	Pool Equipment Room
Finding:	Moisture Ingress to Pool Equipment Room (Below Stairs)
Information:	At the time of inspection, evidence of moisture ingress and water staining was observed to the structural timbers and surrounding areas within the pool equipment room located beneath the stairs. This indicates that water is penetrating into the area from above.

Upon inspection of the stair area above, it was noted that sections appear inadequately sealed, allowing water to enter and migrate into the space below. This condition can lead to ongoing moisture-related deterioration, including timber decay,

mould growth, and potential structural impact if left unaddressed.

It is recommended that a suitably qualified waterproofing or sealant specialist be engaged to inspect the stair area above and carry out appropriate sealing and waterproofing works. All identified gaps, joints, and penetrations should be professionally sealed to prevent further water ingress. Continued monitoring is advised after rectification to ensure the issue has been effectively resolved.

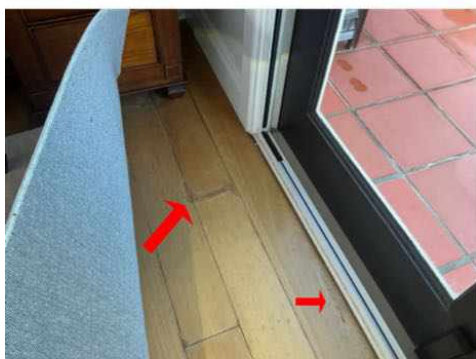
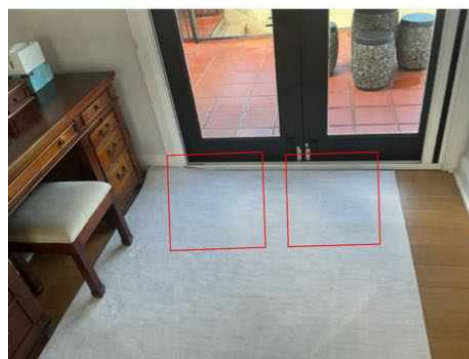
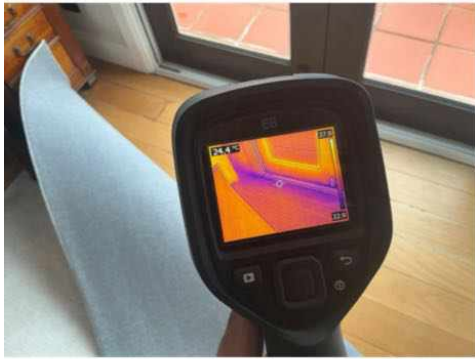
Finding 3.05

Building:	Main Building
Location:	Bedroom 5
Finding:	Moisture Damage to Flooring Adjacent to Balcony Door
Information:	At the time of inspection, moisture-related damage and slight deterioration were noted to the timber flooring adjacent to the balcony door. The affected area showed signs consistent with previous water ingress.

The area was dry at the time of inspection, and thermal imaging did not indicate the presence of active moisture, suggesting that the issue is likely historical rather than ongoing at present.

Possible causes may include water ingress through the balcony door threshold, inadequate sealing, or wind-driven rain entering at the junction.

The client is advised to monitor the area over time for any signs of further deterioration, staining, or moisture presence. If the condition worsens or reoccurs, a suitably qualified sealant or waterproofing specialist should be engaged to inspect the external door area and ensure that all seals and junctions are properly sealed to prevent water from entering the internal space.

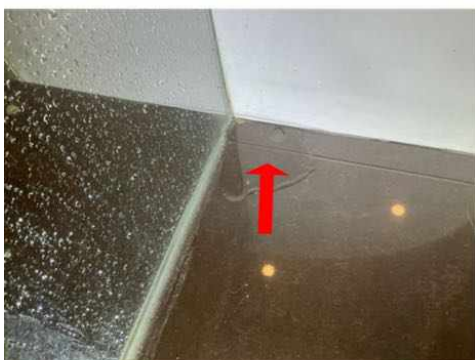
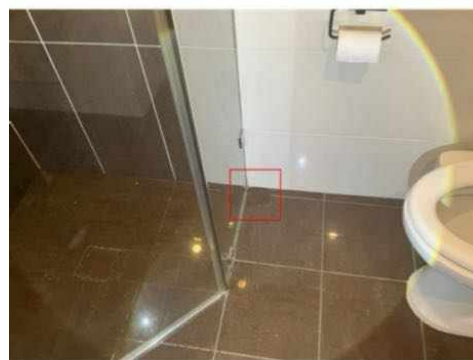
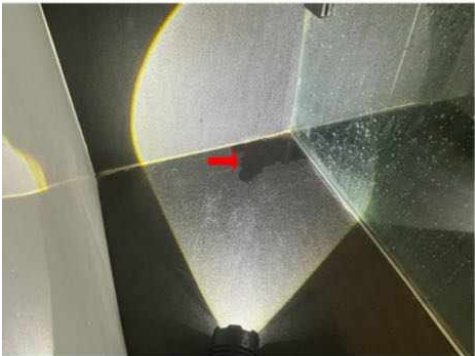
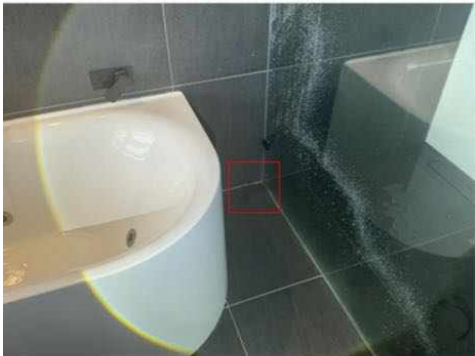
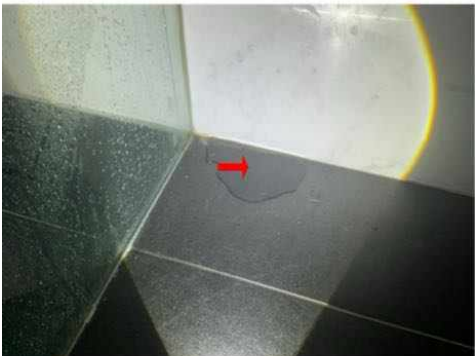
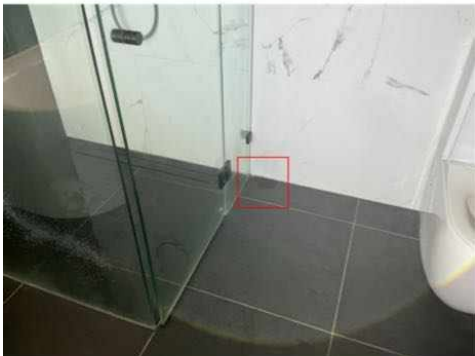
Finding 3.06

Building:	Main Building
Location:	Bedroom 5 En-suite, En-suite Master, Upstairs Bathroom
Finding:	Shower Screen - Leaking (Sides)
Information:	The shower screen was noted as leaking through sides at the time of inspection.

The shower enclosure in the bathroom exhibits a defect characterized by moisture buildup and potential leakage at the base where the shower door meets the wall and floor tiles. Visible signs include deteriorated caulking, indicating that the waterproof seal has been compromised. This issue not only affects the aesthetic appeal of the bathroom but also poses a risk of water damage to adjacent structures and surfaces.

Immediate attention is required to re-caulk and seal the affected areas to prevent further moisture penetration and to maintain the integrity of the shower enclosure.

The client is advised to engage the services of a professional plumber to rectify the issue.

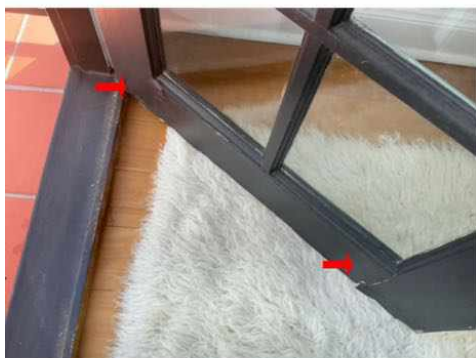
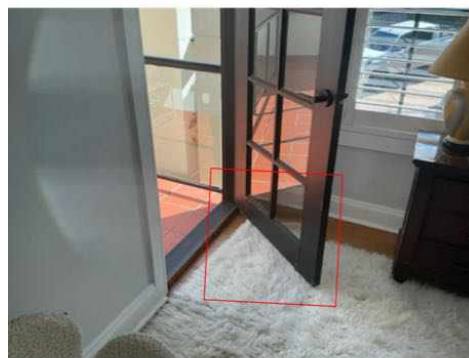
Finding 3.07

Building:	Main Building
Location:	Bedroom 5
Finding:	Door - Water/Moisture Damage
Information:	At the time of inspection, water/moisture damage was noted on this/these door(s) within the property.

The affected doors exhibit signs of swelling, warping, and possible discolouration, which can impair their functionality and compromise their structural integrity. Prolonged exposure to moisture can cause the door material to deteriorate, leading to issues with closing and sealing, and increasing the likelihood of further damage over time. Moisture-damaged doors can also become a breeding ground for mould and mildew, which may pose health risks to occupants if left unaddressed. It is recommended that the damaged doors be repaired or replaced, and that any sources of moisture nearby be investigated and rectified to prevent recurrence.

The client is advised to engage services of a carpenter to rectify or replace the door.

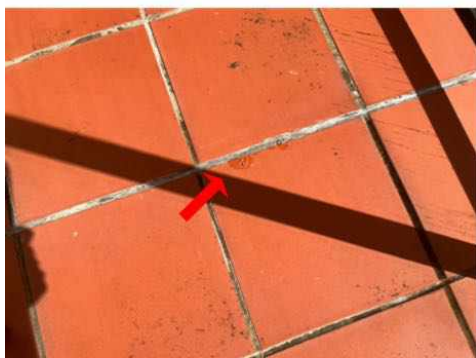
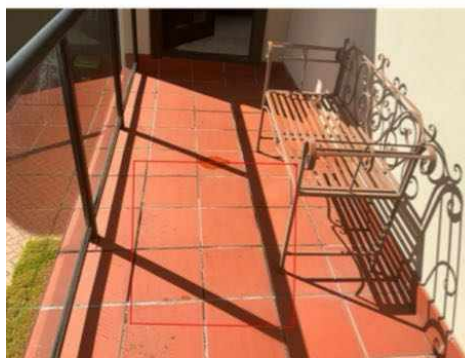
Finding 3.08

Building:	Main Building
Location:	Bedroom 5 Balcony
Finding:	Tiles - Drummy
Information:	Drummy tiled areas were identified at the time of inspection. The term 'drummy' refers to tiles that have become detached from their fixing, despite otherwise being in relatively good condition. Such defects are generally caused by physical or moisture damage to the area. Drummy tiled areas may also be a direct result of poor workmanship during the construction process.

Tiled areas may swell and shrink with changes in air humidity if the area has sustained moisture damage. Any exposure to moisture is capable of causing tiled areas to become drummy and/or cracked over a prolonged period of time. Drummy tiled areas generally require removal and replacement of affected tiles, with adequate sealant and grouting.

Specialist trades are available for these types of services. A registered builder may be required to undertake works if damage is extensive or if secondary building defects have resulted. Otherwise, it is advised that a tiling contractor be appointed to perform works as necessary. Immediate action is recommended to ensure that no further damage is sustained in the affected area.

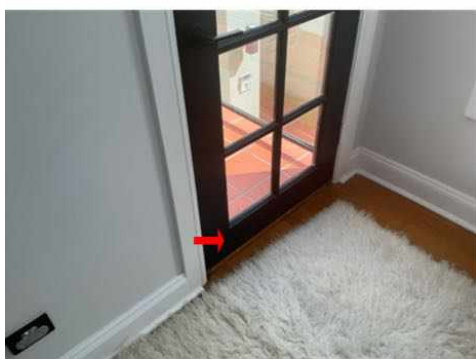
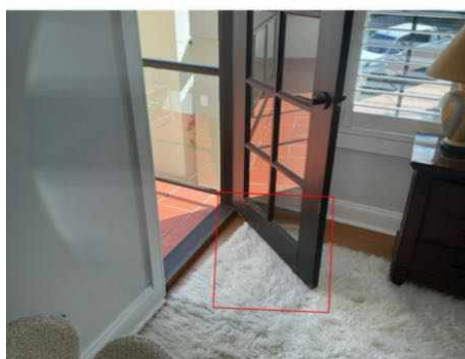
Finding 3.09

Building:	Main Building
Location:	Bedroom 5
Finding:	Door(s) - Binding/Jamming
Information:	At the time of inspection, it was noted that the door was binding or jamming in this area.

Several factors could contribute to this issue, including swelling due to moisture, which can cause wooden doors to expand and fit tightly in the frame. Misaligned or loose hinges may also result in the door sagging or becoming misaligned, making it difficult to close. Over time, wooden doors may warp due to fluctuations in temperature or humidity, leading to improper closure.

It is recommended that a qualified carpenter or handyman be engaged to carry out the necessary repairs to ensure proper door operation.

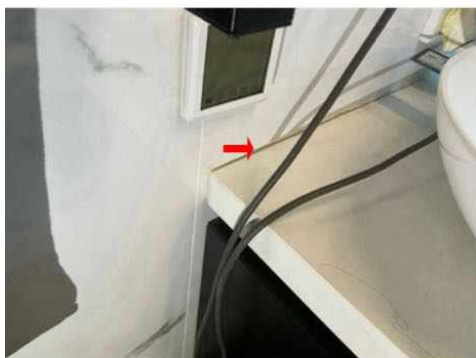
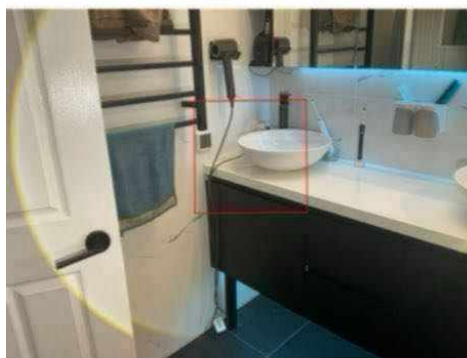
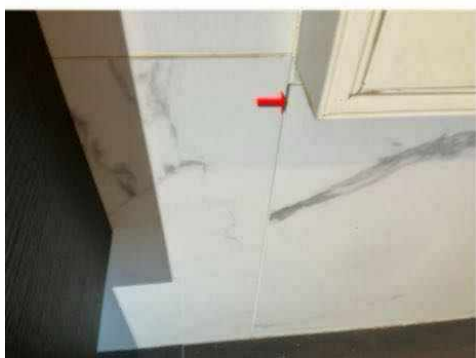
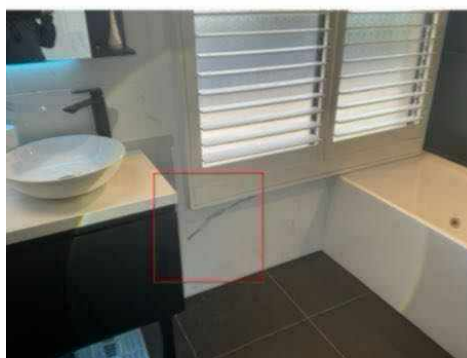
Finding 3.10

Finding: Sealant/Grouting - Missing or Damaged

Information: At the time of inspection, areas of missing and/or deteriorated sealant and grout were noted in this area. This condition can allow water to penetrate behind finishes, which may lead to moisture ingress, deterioration of waterproofing membranes, mould growth, and potential leaks into adjoining areas over time. If left unaddressed, this may result in costly repairs and hidden water damage.

It is recommended that a licensed plumber (or suitably qualified tradesperson experienced in wet area sealing) be engaged to assess the affected areas and reinstate compliant waterproof sealant and grout as required, ensuring all junctions are properly sealed to prevent further water ingress.

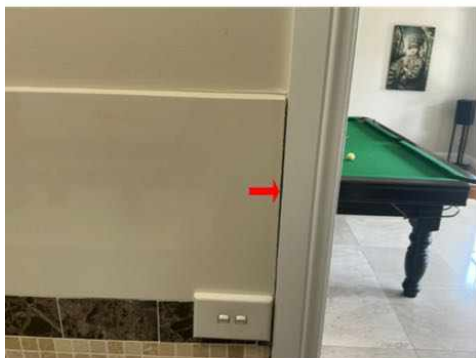
Finding 3.11

Building:	Main Building
Location:	Ensuite - Master
Finding:	Areas - Not Sealed
Information:	At the time of inspection, certain areas were found to be unsealed, which may allow moisture ingress, pest entry, or air leaks. Gaps and unsealed sections can contribute to deterioration over time and reduce the overall integrity of the structure. It is recommended to seal the affected areas to prevent potential damage and ensure better protection against environmental factors.

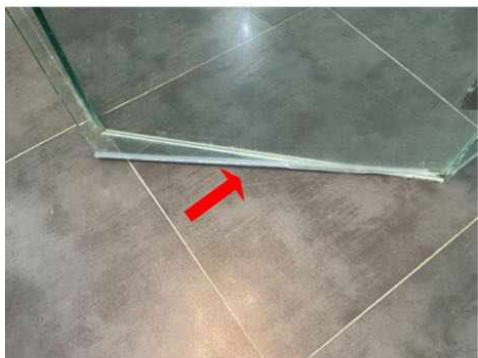
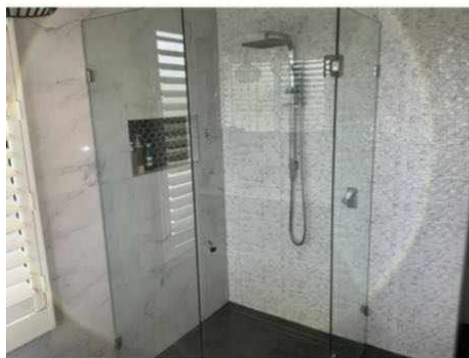
Finding 3.15

Finding: Door Weatherstrip - Missing

Information: It was noted at the time of inspection, the door weatherstrip was missing.

The absence of a door weatherstrip could be due to wear and tear, improper installation, or deliberate removal. The implications include increased energy loss, reduced insulation, potential water leaks during rain, and a compromised seal, allowing drafts and noise to enter the space. Replacing the missing weatherstrip is advisable to maintain energy efficiency, weather protection, and overall comfort within the enclosed area.

A general handy man should be appointed to install the weatherstrip at owners discretion.

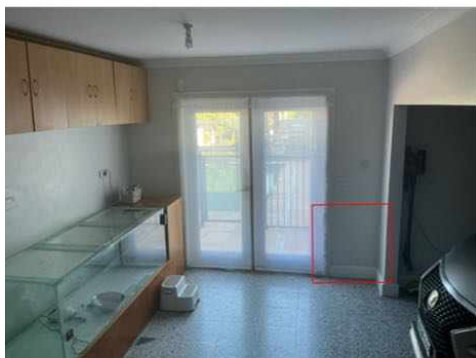
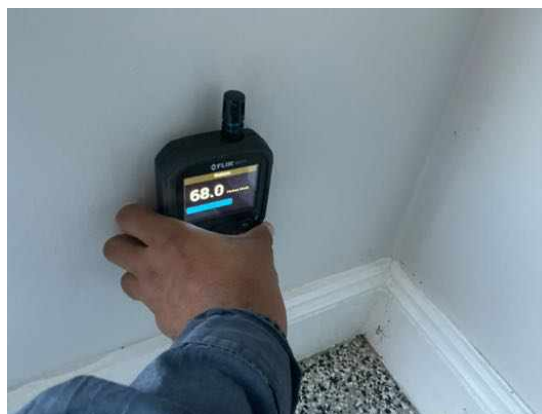
Finding 3.31

Building: Main Building
Location: Garage
Finding: Excessive Moisture - Walls (Monitor)

Information: Excessive moisture was observed in the walls at the time of inspection, indicating potential underlying issues that could be contributing to this condition.

One possible cause is rising damp, where moisture from the ground seeps up through the wall due to a compromised or missing damp-proof course. Additionally, poor drainage around the property can lead to water pooling near the base of the wall, increasing the likelihood of moisture absorption. Inadequate ventilation in the affected area could also exacerbate the problem, as it would prevent moisture from properly evaporating, leading to persistent dampness.

No further immediate action is required; however, the area should be monitored over the next 12 months. Should any signs of dampness, bubbling, or deterioration develop at the base of the wall, engagement of a qualified damp-proofing specialist may be necessary to assess and address any emerging moisture issues.

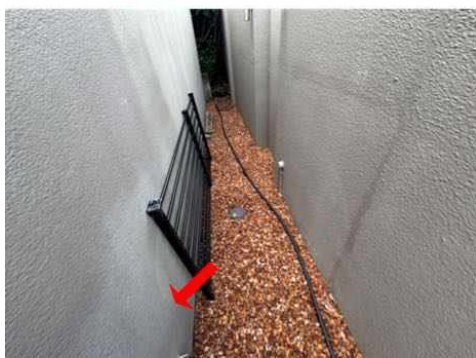
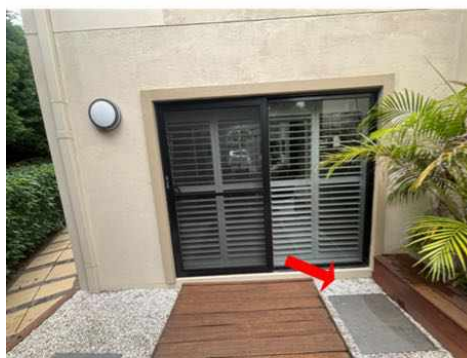
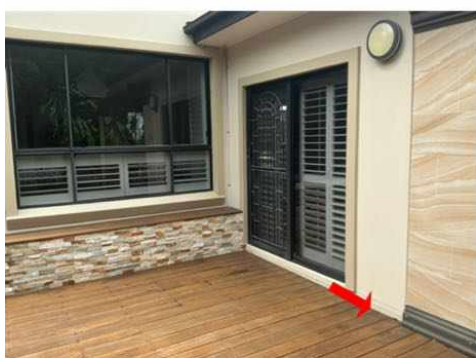
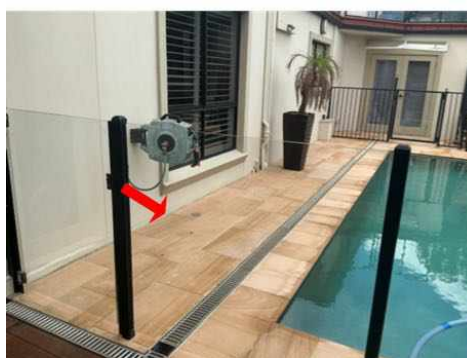
Finding 6.02

Building:	Main Building
Location:	All Areas
Finding:	Bridging or Breaching of Termite Barriers - Adjacent Internal Flooring
Information:	Bridging is the spanning of a termite barrier or inspection zone so that subterranean termites are provided with passage over or around that barrier.

Where external ground levels are above or same level as internal flooring, water pooling and subsequent internal flooding is likely to occur which may attract termite activity to the internal area.

It is highly advised that a landscaper or relevant tradesperson be appointed to lower external grounds that are raised above or same as adjacent internal flooring. Alternatively if external grounds and internal flooring is level installation of a raised door sill may be appropriate in preventing any water pooling in the area. If the client wishes not to make any changes, then a qualified pest controller is recommended for termite treatment around the perimeter of the house and subfloor (if any) as soon as possible.

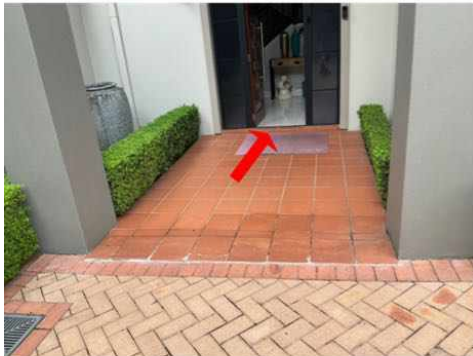
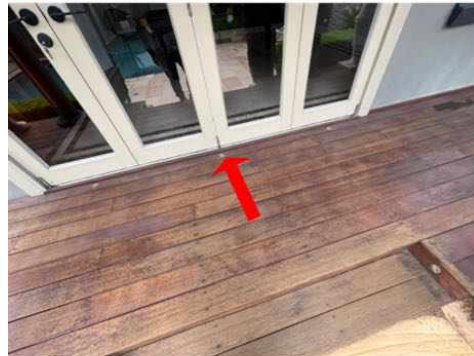
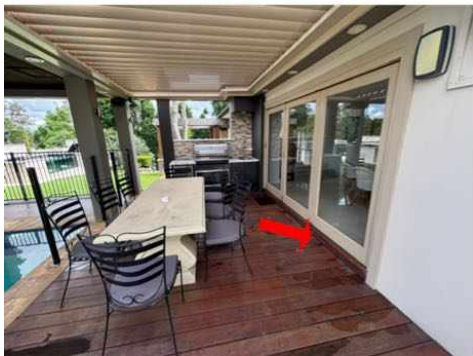
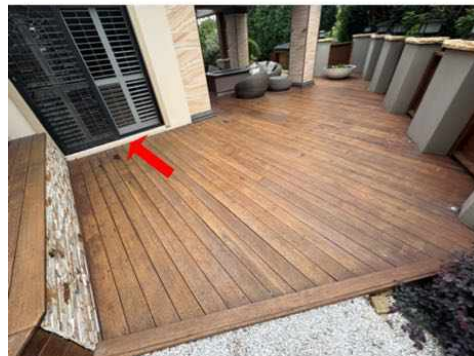
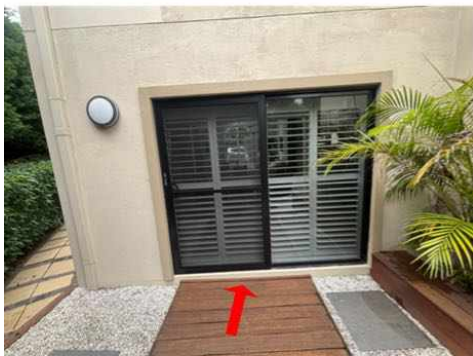
Finding 6.03

Building:	Main Building
Location:	Exterior walls - rear
Finding:	Bridging Appliances - Attachment to Buildings
Information:	Bridging occurs when items against a building provide a concealed entry point for termites into the building or by passing around a termite management system.

Where any part of an attachment to a building is not isolated and is not provided with a clear gap of not less than 25mm from the building, bridging occurs. Attachments to buildings such as hot water services, downpipes, verandahs, decks, steps, fences, service conduits and the like provide the opportunity for concealed entry.

Building attachments of this nature need to be frequently inspected for termite activity by a qualified inspector.

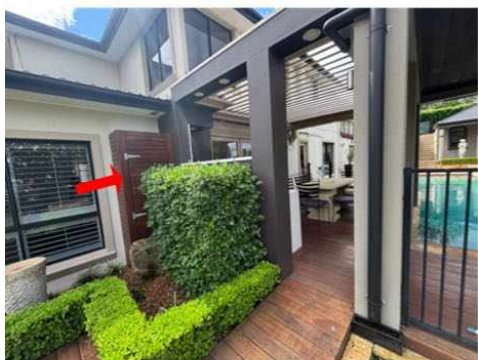
Finding 6.04

Building:	Yard
Location:	All Areas
Finding:	Building Materials in Direct Ground Contact - Conducive to Termites
Information:	Timber elements that are in direct contact with the ground and exposed to moisture or damp conditions are highly conducive to termite activity. This susceptibility arises because timber, when in contact with soil and dampness, creates an environment that is particularly attractive to termites, encouraging infestation and potential structural compromise. Whether the timber is used as a part of the building's construction or incorporated into fencing, its presence near or on the ground can become a pathway for termites to access and damage the property.

When exposed to excessive moisture, timber begins to deteriorate, developing conditions such as wood decay and rot. These compromised areas of timber are even more appealing to termites, as they are easier to infest and consume. This is especially true for untreated or non-durable timber, which lacks the protective treatments that can deter or withstand termite attacks. Termites can use these weakened, moisture-laden elements as a bridge into other parts of the structure, creating an entry point for potential infestations that can spread and cause extensive

damage if left unchecked.

For any timber in direct contact with the external ground, special attention is required. The combination of moisture, untreated wood, and direct ground contact not only accelerates the decay process but also provides subterranean termites with a straightforward means of ingress into the structure. This entry can lead to termites moving undetected into other vulnerable areas, resulting in potentially significant structural issues and costly repairs.

To mitigate the risk of termite activity, it is imperative that any such materials or timber elements be appropriately treated or removed as soon as possible. Timbers that are necessary for use should be made durable through appropriate treatments and maintained to ensure they do not create conditions conducive to termites. Additionally, the client is advised to schedule regular termite treatments to maintain an effective barrier against infestations and ensure ongoing protection.

The client is strongly advised to assess the property for any timber elements that may be in direct contact with the ground and ensure prompt action is taken to remove or treat them effectively. Regular inspections, proactive maintenance, and consistent termite treatment are essential steps in minimising the risk of termite attack and protecting the structural integrity of the property. Taking these preventive measures is crucial for maintaining a termite-free environment and avoiding potentially costly damage and future repairs.

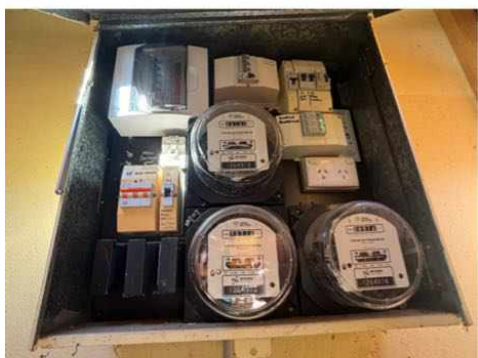
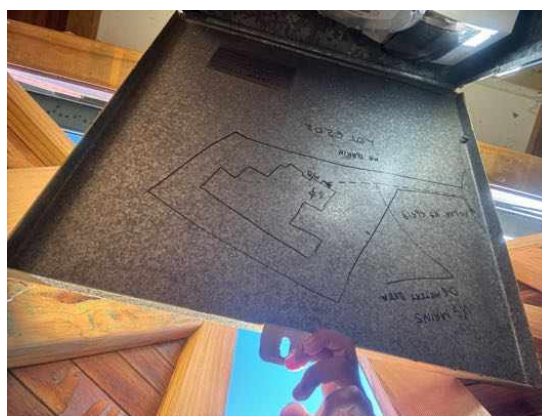
Finding 6.09

Information: The application of a post-construction chemical termite barrier is strongly recommended for all properties, especially if there has been any history of live termite activity on-site. These barriers are highly effective in protecting timber building elements throughout the property by preventing termite attacks. It is also advisable to install a durable notice within the switchboard unit, indicating the presence of any termite barriers for future reference.

been installed, nor was there any evidence to suggest that preventative measures had previously been undertaken. The client is encouraged to seek further advice from a licensed pest controller regarding the costs and procedures involved in the application of a termite barrier. Prioritizing this step in the short term is strongly advised to ensure long-term protection.

Additionally, the client may want to consult with the vendor to determine whether regular Timber Pest inspections, as per AS4349.3 or AS 3660.2, have been conducted in the past. This will provide further insights into any past termite management practices and help inform the appropriate course of action.

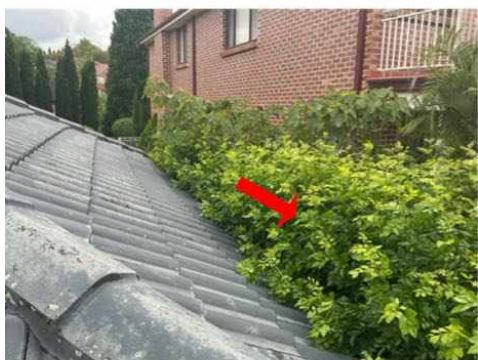
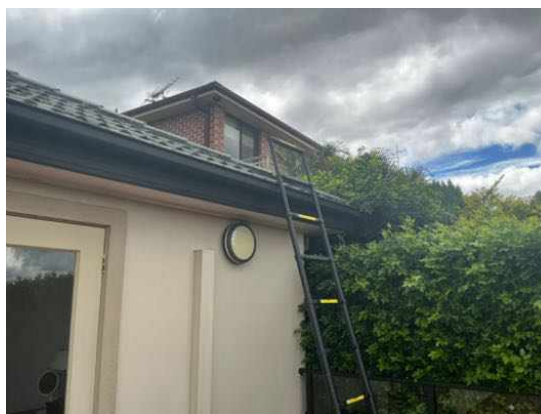
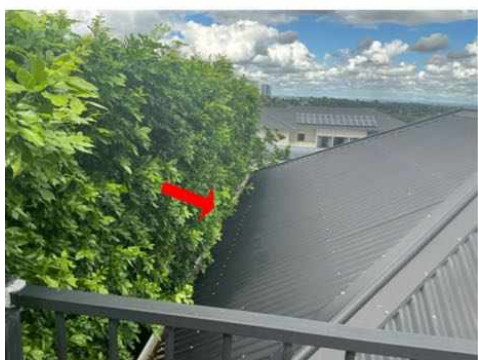
Finding 6.10

Building:	Main Building
Location:	Above Bedroom 5, Pool Room
Finding:	Overhanging Trees/Branches/Roots
Information:	Overhanging trees and exposed roots were noted near the property, which pose potential risks to the structure and surrounding areas.

The overhanging branches can cause damage to the roof, gutters, or walls, particularly during storms or high winds. Additionally, the roots may pose a threat to the foundation by causing ground movement, leading to cracks or uneven settling over time. The accumulation of leaves and debris in gutters and drainage systems can also lead to blockages, contributing to water overflow and potential water damage.

It is recommended that a qualified arborist be engaged to prune back the overhanging branches and assess any potential risks posed by the tree roots to prevent further damage to the property. It is advised to get this fixed as soon as possible. Regular maintenance should be carried out to ensure the trees are managed effectively and the property remains safe.
