Building and Timber Pest Inspection Report

Inspection Date: Fri, 20 Mar 2026

Property Address: 3 Luss Ct, Glenhaven NSW 2156, Australia

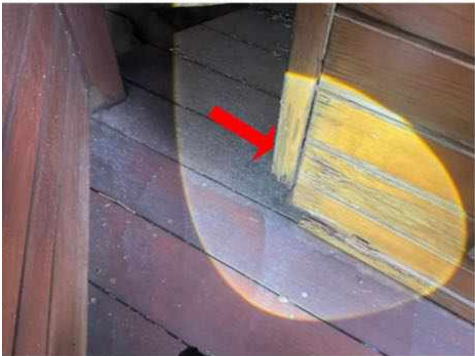
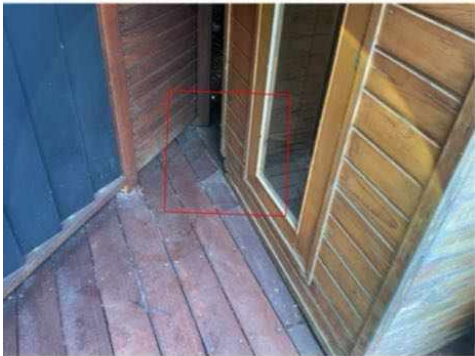
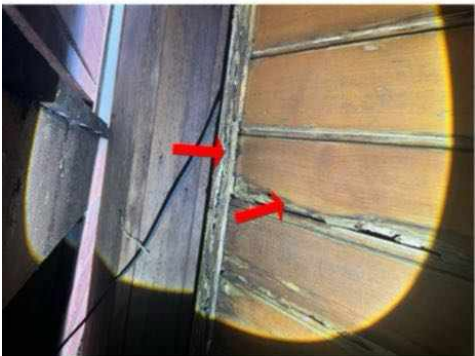
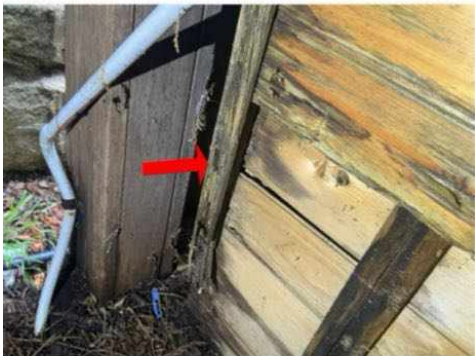
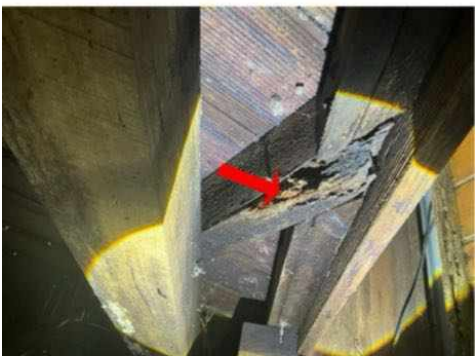
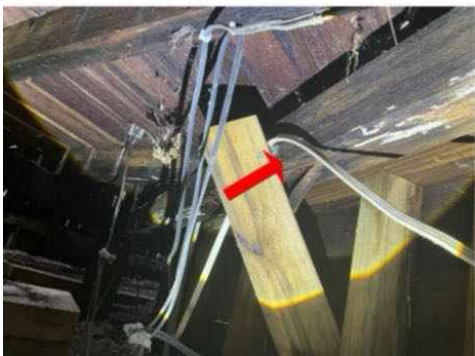
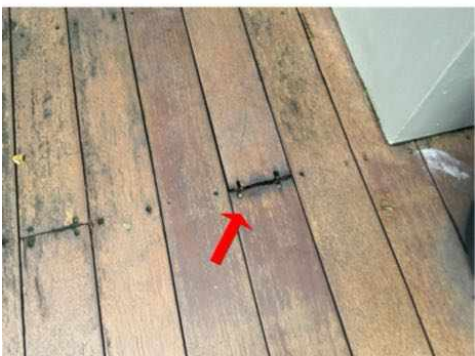
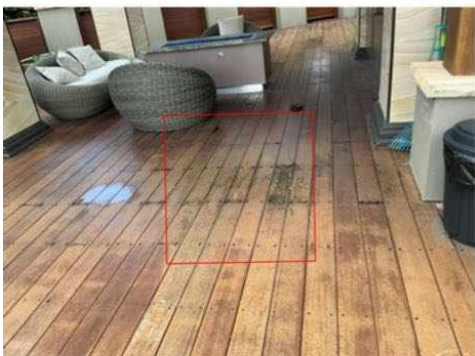
Finding 7.01

Building:	Yard
Location:	Under Deck, Sauna
Finding:	Fungal Decay - Present (Localised)
Information:	Fungal decay, also referred to as wood decay or wood rot, typically occurs when timber elements are exposed to excessive moisture for extended periods. This deterioration process is accelerated by temperatures ranging between 5°C and 40°C, as well as the presence of oxygen. Fungal decay is commonly found in timber components used in external environments, particularly when they are exposed to rain or moisture penetration.

In this instance, although the timber element shows signs of decay, the visible damage appears to be localized to a specific area and has not yet spread to adjoining structures or other parts of the building element. As a result, the fungal decay is likely to be relatively superficial, with minimal impact on the structural integrity or tensile strength of the timber. However, it is advisable to monitor the affected area to prevent further deterioration and address the underlying moisture issue to mitigate future risk.

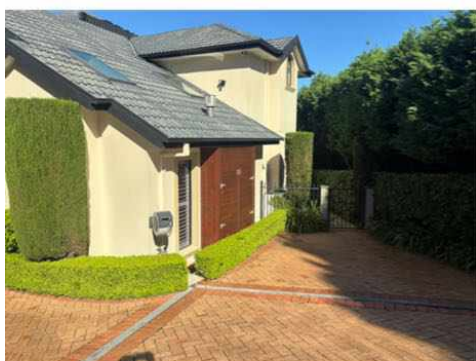
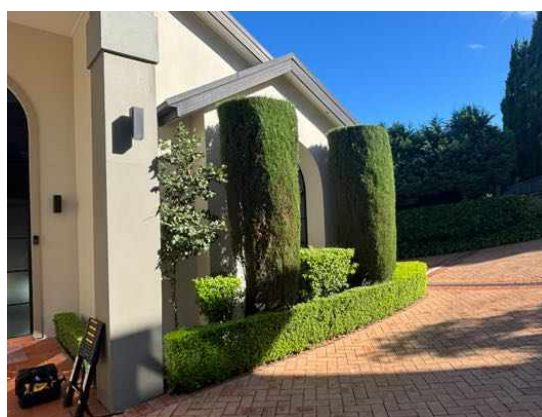
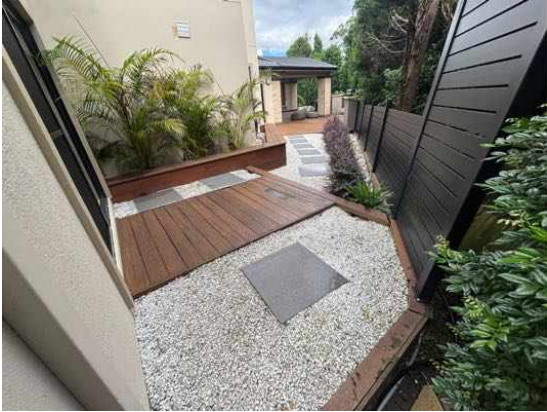
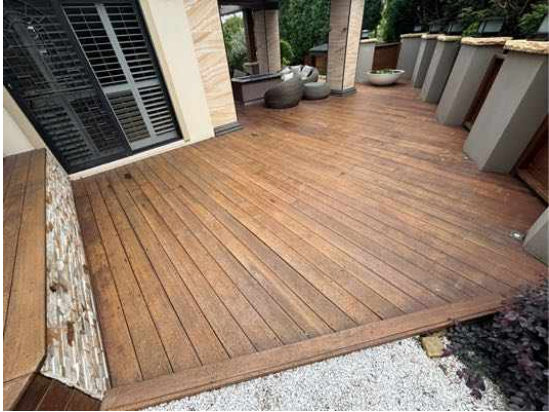
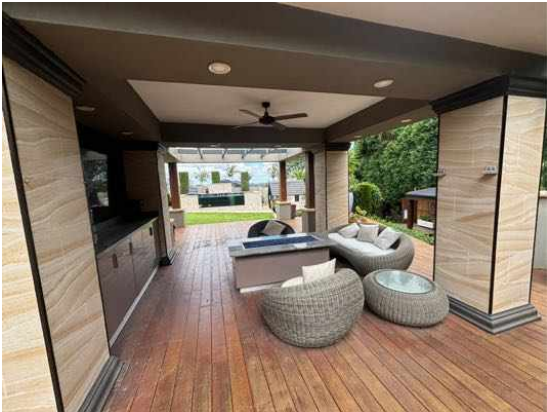
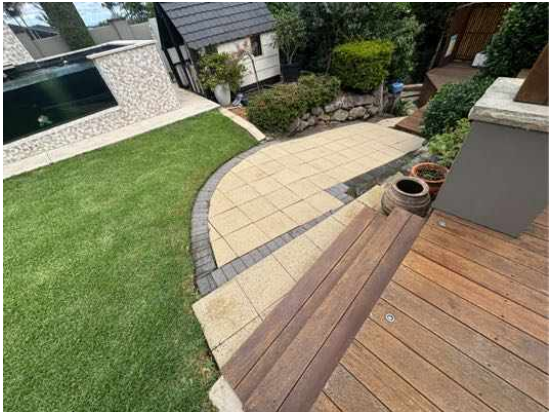
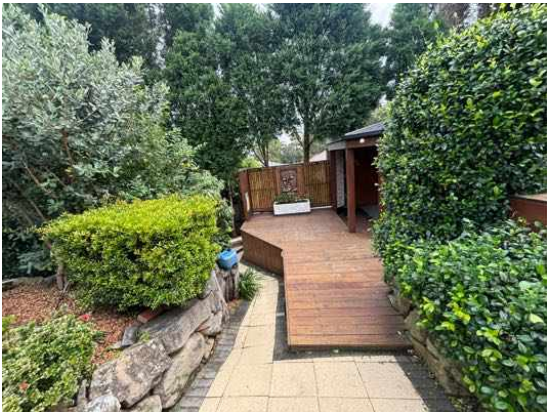
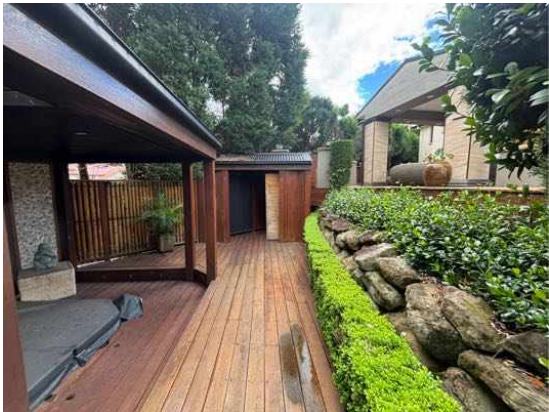
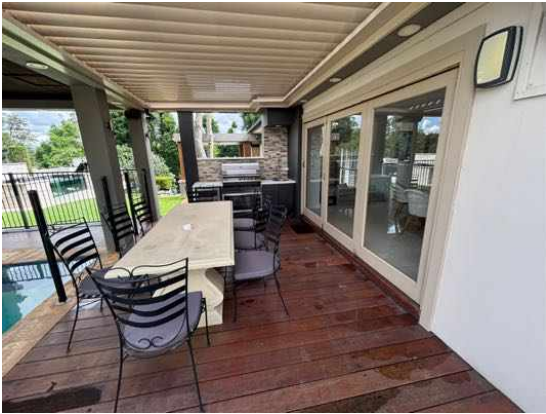
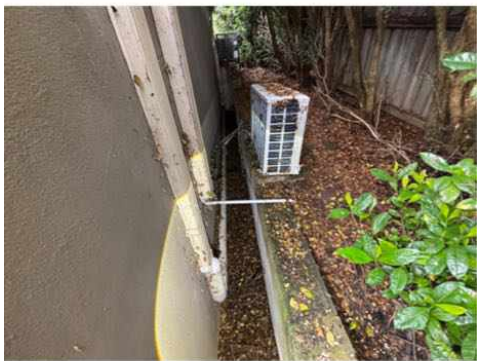
Building: Main Building
Location: All External Areas
Finding: Obstructions and Limitations - External Areas
Information: The attached photographs provide a visual representation of the obstructions and limitations that impeded a full inspection of the external areas of the property at the time of assessment. These obstructions, which may include vegetation, stored items, debris, or other physical barriers, can obscure potential defects and prevent a thorough evaluation of the property's condition. Obstructions of this nature can conceal a wide range of issues, such as structural damage, water ingress, pest infestations, or deteriorating building materials, which may not be visible during the initial inspection.

It is essential that these obstructions be cleared to allow for a comprehensive inspection of the external areas. Removing these barriers will enable a more accurate assessment of the property's condition and allow any hidden defects to be identified and addressed promptly. Failure to do so could result in undetected issues worsening over time, potentially leading to more costly repairs in the future.

Therefore, it is strongly recommended that the obstructions be removed and a re-inspection be scheduled once the affected areas are made fully accessible. This will ensure a complete evaluation of the property's exterior and provide the client with a clear understanding of any potential issues that may have been concealed during the initial inspection.

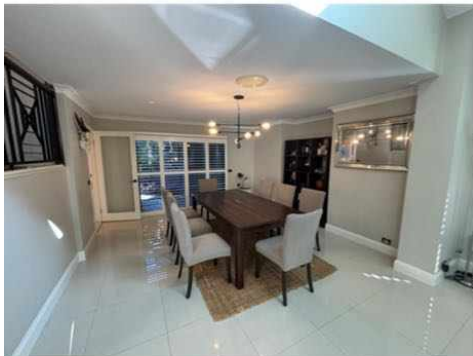
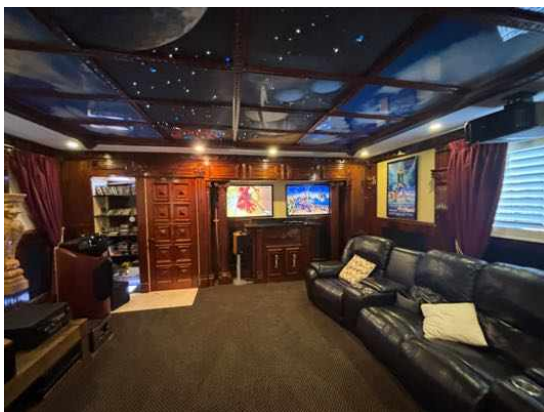
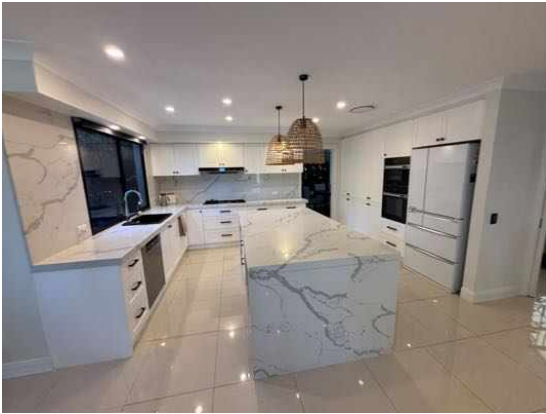
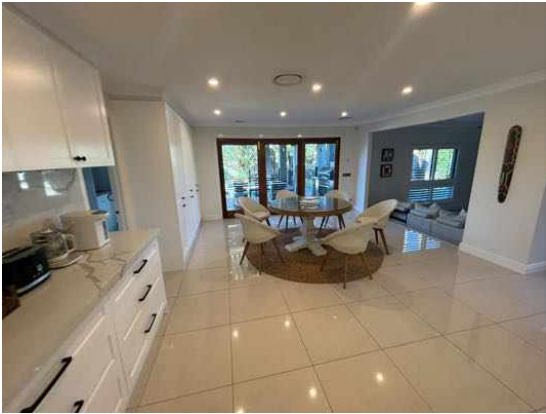
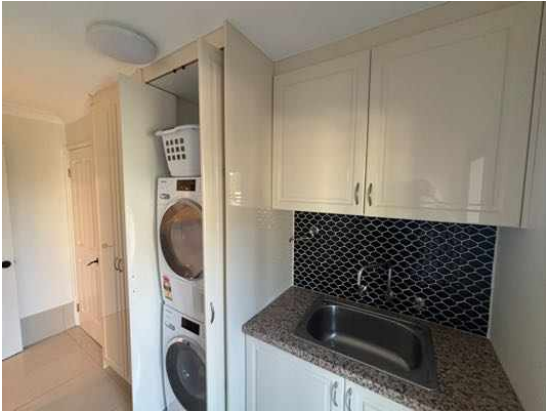
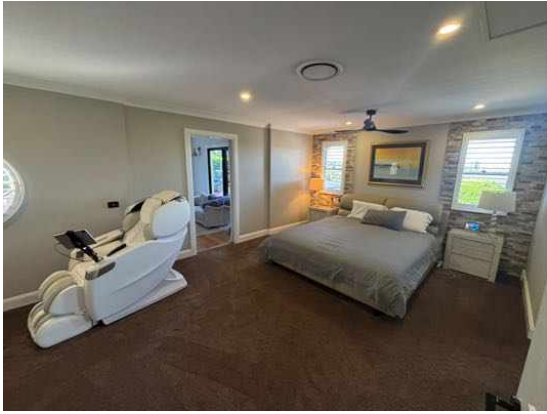
Building: Main Building
Location: All Internal Areas
Finding: Obstructions and Limitations - Internal Areas
Information: The accompanying photographs provide clear evidence of the obstructions and limitations that restricted a comprehensive inspection of the internal areas of the property at the time of assessment. These obstructions, which may include furniture, personal belongings, stored items, or structural elements such as wall coverings and built-ins, significantly hindered the ability to thoroughly evaluate these areas. It is important to note that such obstructions can potentially conceal a wide array of defects, ranging from hidden structural damage, water leaks, pest infestations, or

electrical issues, to deteriorating materials that may not be visible during the initial inspection.

The presence of these impediments means that critical areas of the property were not accessible, and therefore, any underlying defects that may affect the integrity and safety of the property could remain undetected. These hidden defects, if left unaddressed, could worsen over time and may result in costly repairs or pose potential safety hazards to the occupants.

It is highly recommended that all obstructions be cleared to facilitate a complete and thorough inspection of the internal areas. Once the obstructions have been removed and full access is available, a re-inspection should be carried out to ensure that any previously concealed issues can be properly identified and rectified. This follow-up inspection will provide a more accurate assessment of the property's internal condition and help the client make informed decisions about any necessary repairs or maintenance.

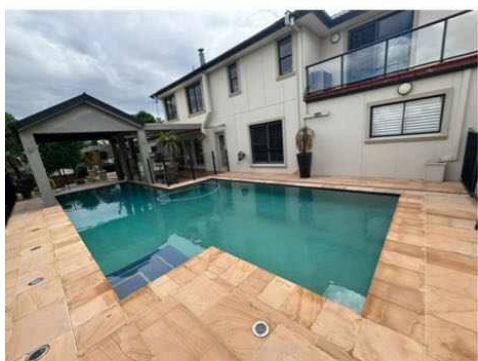
Building: Main Building
Location: Pool Area
Finding: FYI - Pool Area
Information: This inspection explicitly excludes any assessment of the pool, spa, associated pool equipment, and the surrounding areas. As a standard building inspection does not encompass these elements, it is crucial for the client to understand that no evaluation has been conducted regarding the condition, functionality, or safety compliance of the

To gain a comprehensive understanding of the condition and compliance of these components, it is highly recommended that the client engages a specialist pool inspector. A pool inspection will evaluate the structural condition of the pool, ensure the functionality of all associated equipment, and assess whether the pool and its surroundings meet current safety regulations. In particular, pool safety requirements, including fencing and access controls, are subject to stringent regulatory standards, which must be verified separately by a qualified pool inspector.

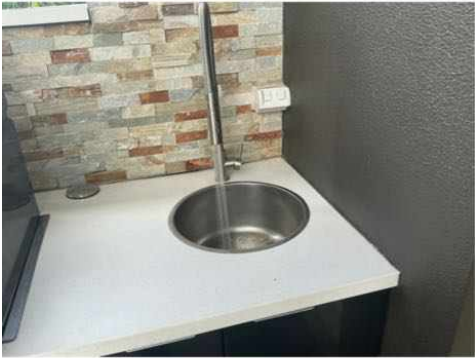
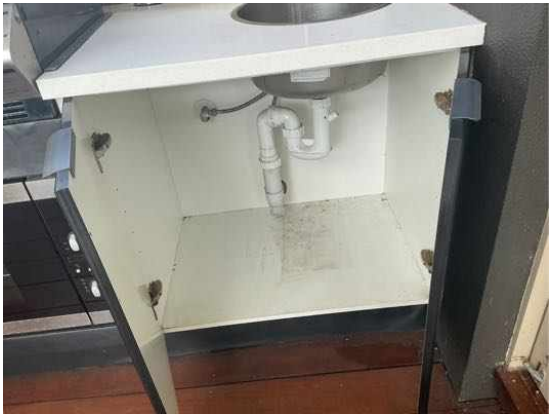
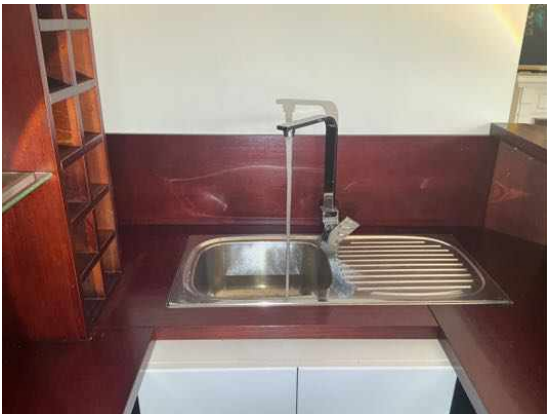
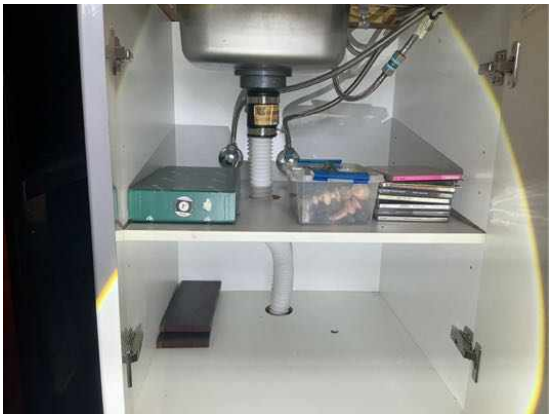
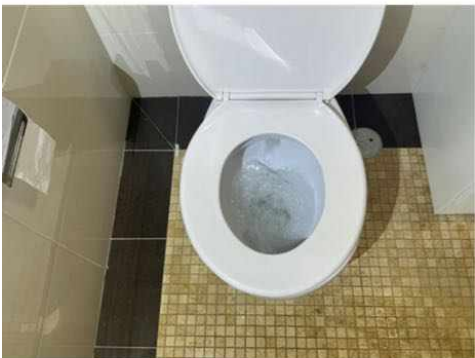
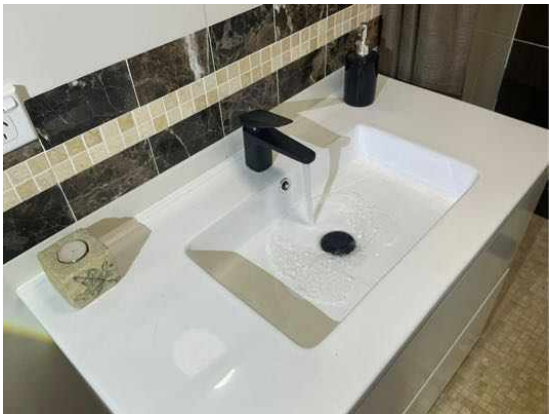
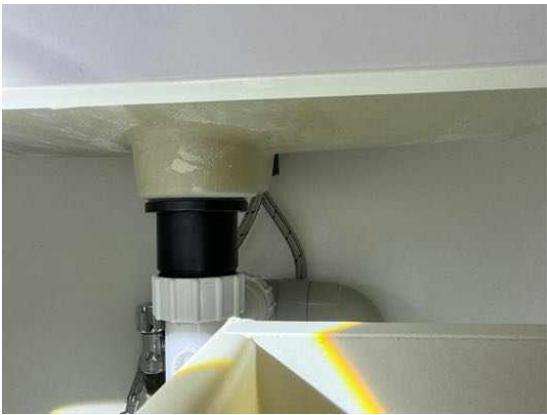
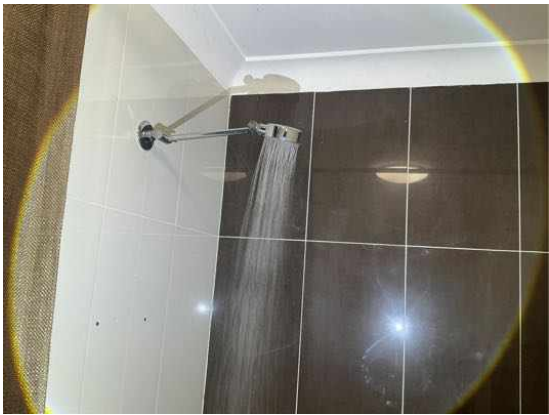
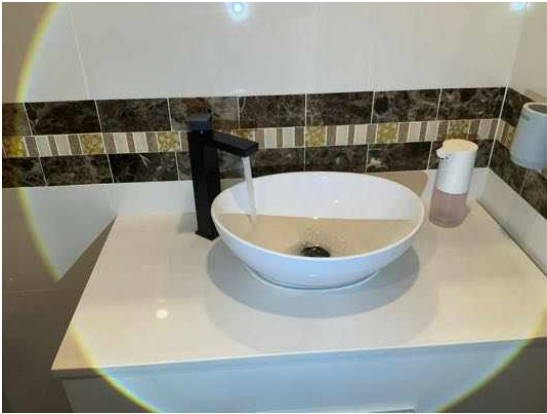
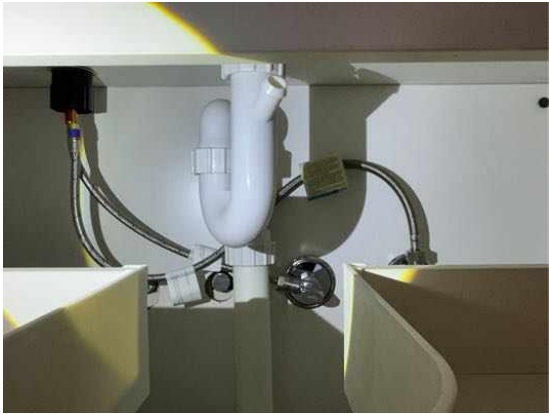
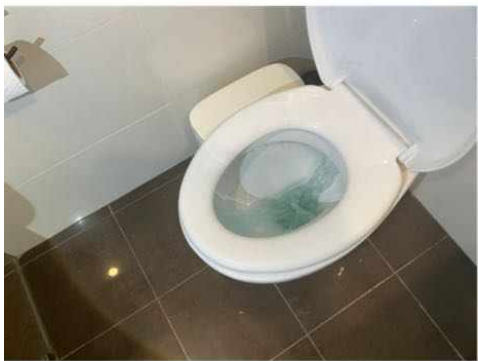
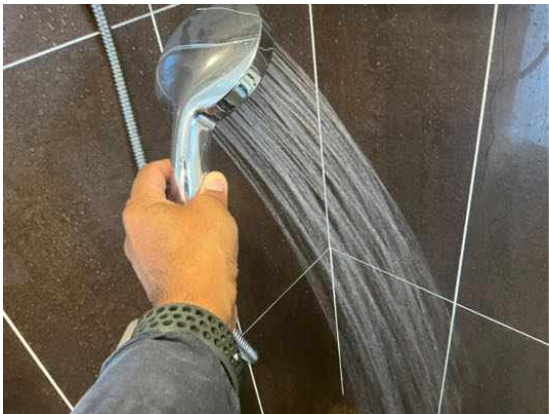
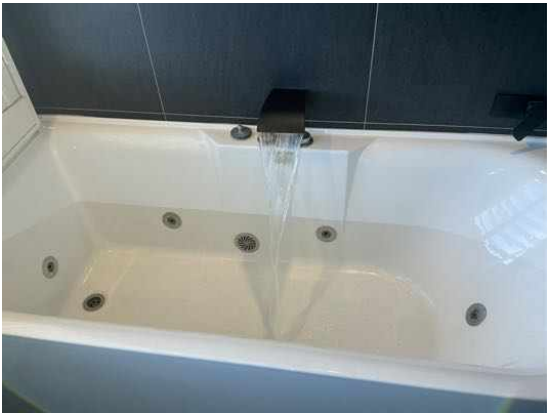
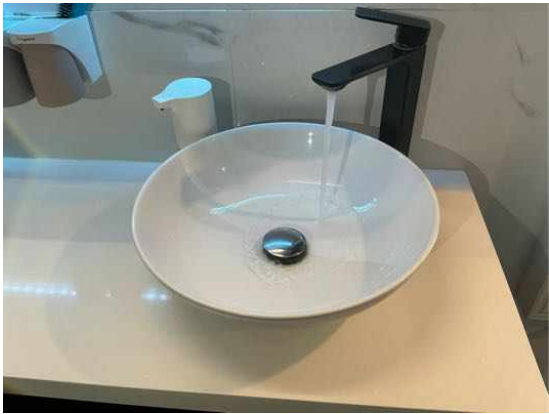
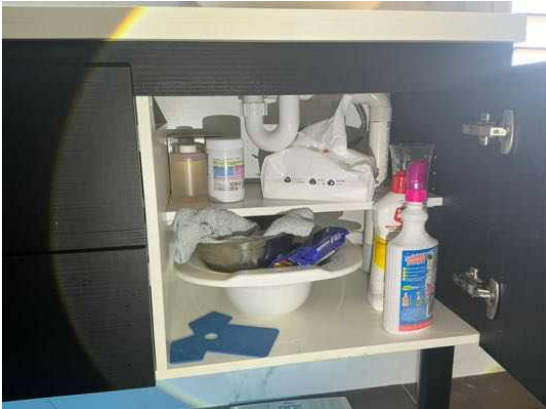
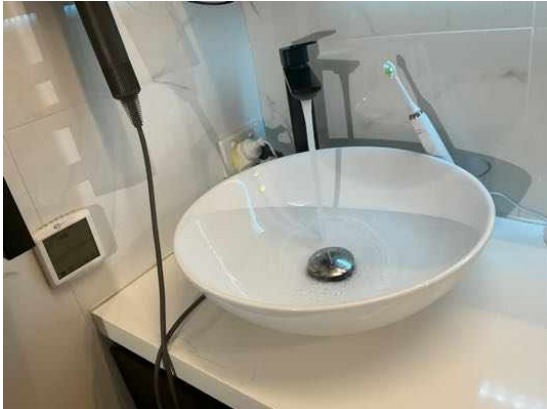
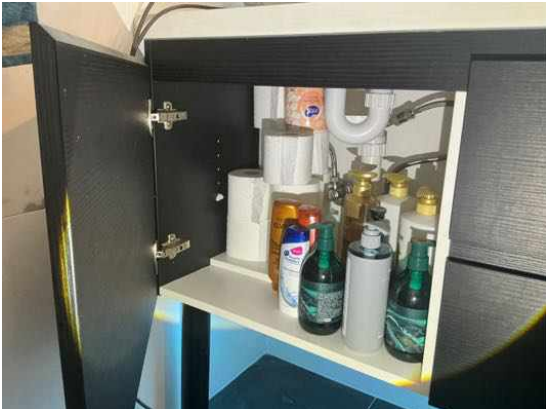
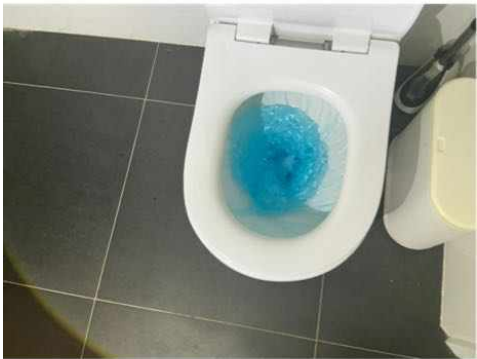
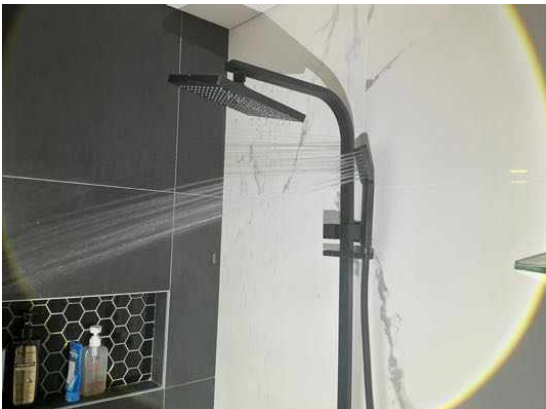
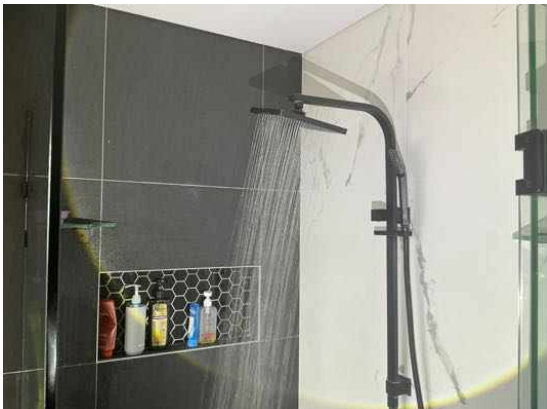
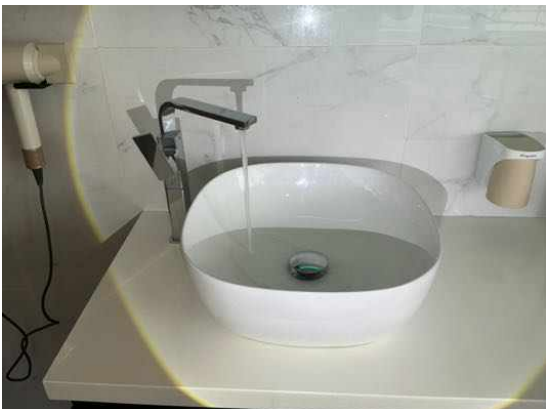
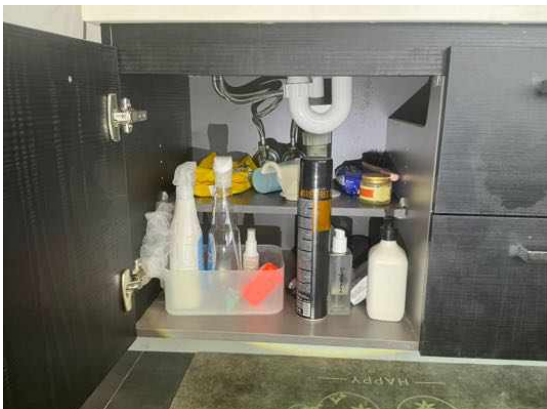
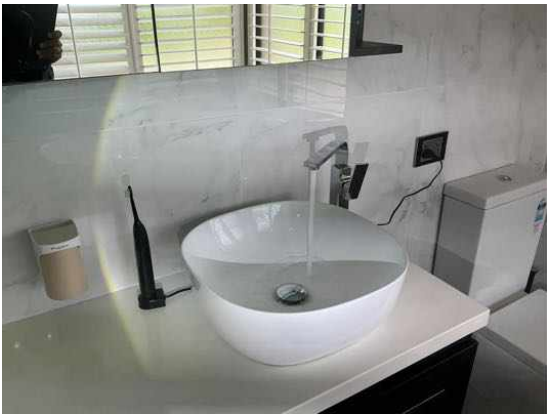
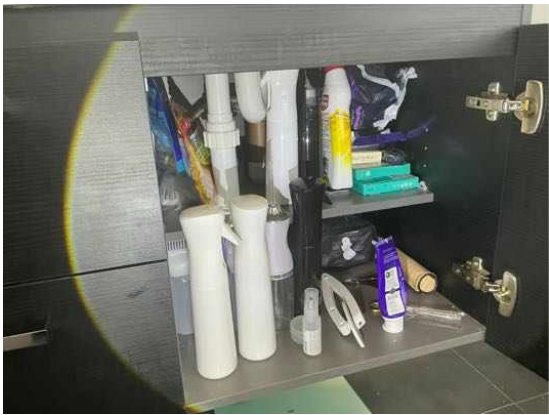
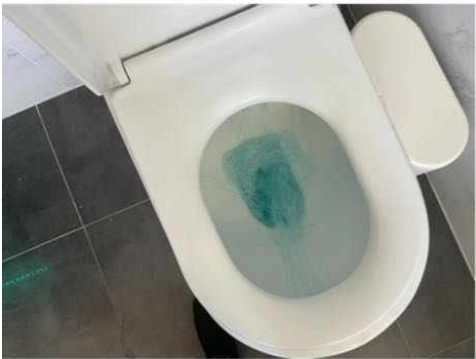
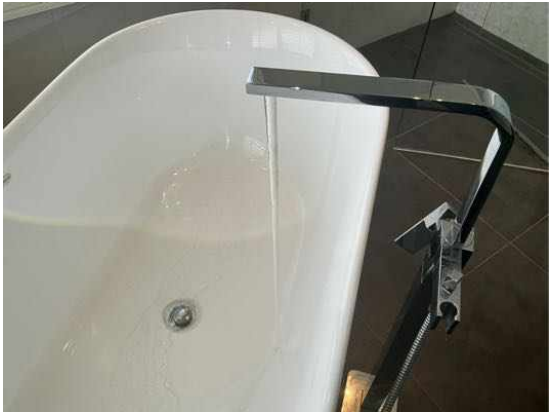
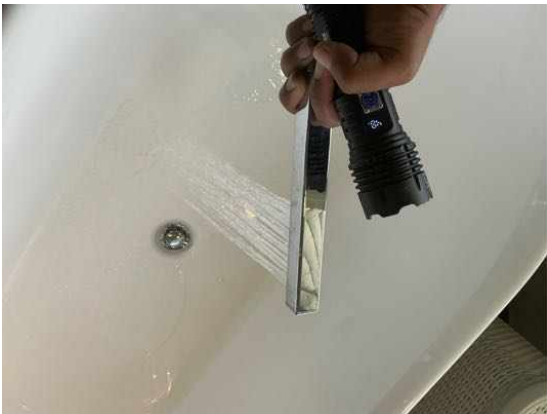
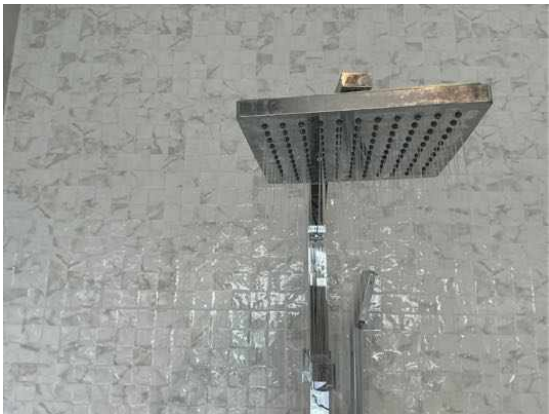
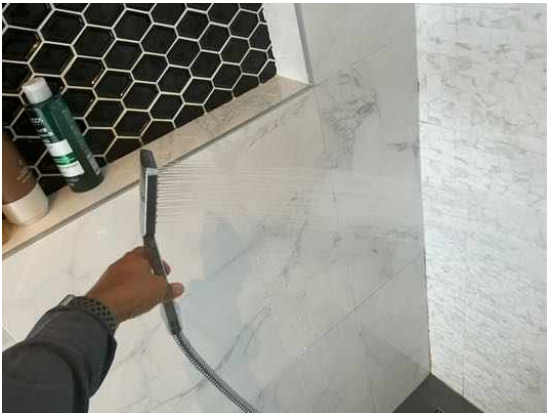
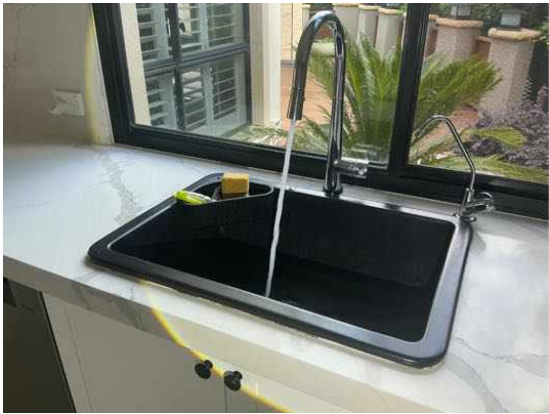
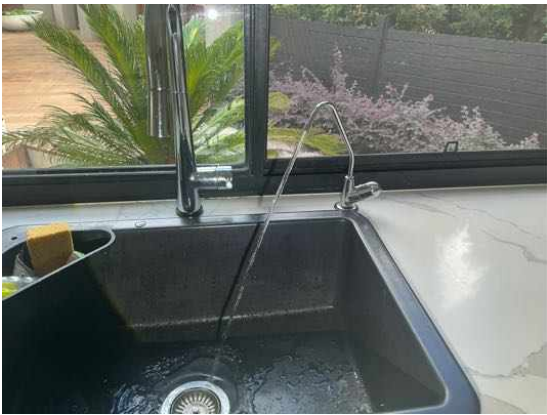
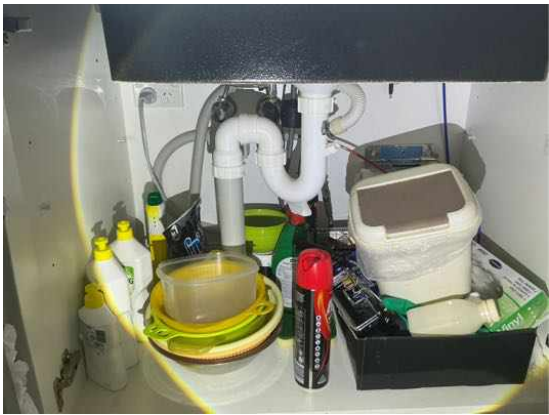
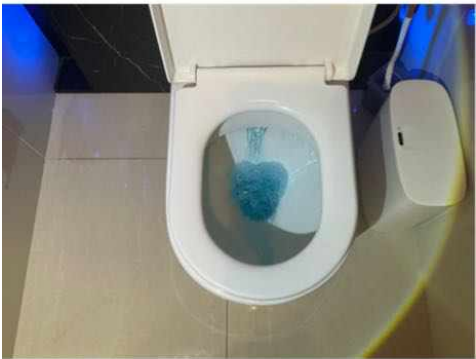
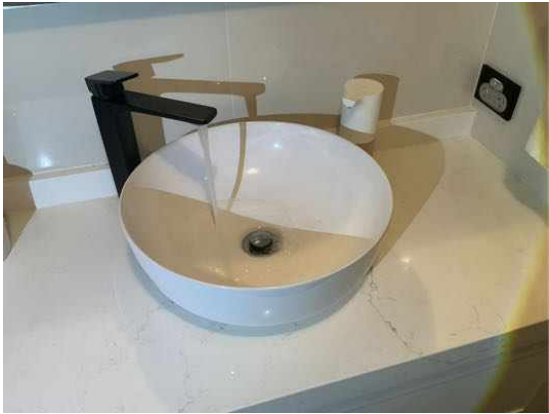
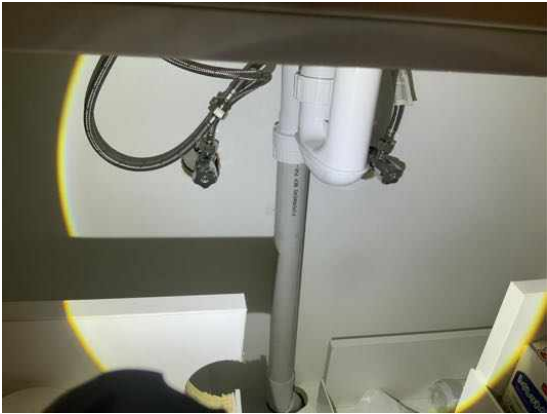
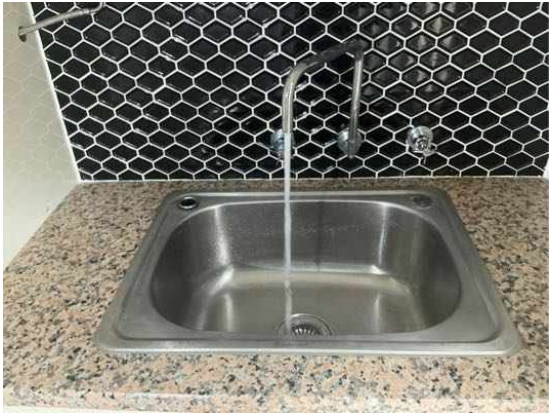
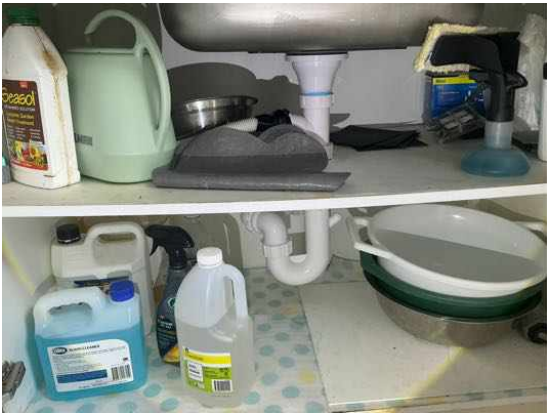
Building:	Main Building
Location:	All Areas
Finding:	FYI - Taps, Drainage & Toilets Tested and Cabinetry Obstructions
Information:	During the inspection, all accessible taps, drainage systems, and toilets were tested for water flow and drainage efficiency, and checked for any visible signs of leakage. At the time of the inspection, no issues were noted in these areas. Unless highlighted in a separate defect statement, no immediate remedial work appears necessary. Supporting images may be found in the additional photos section for reference.

It is important to note that while a visual inspection of cupboards and cabinetry beneath sinks and vanities was undertaken, stored personal items and fixtures presented obstructions that limited full visibility of the internal areas. As per standard inspection practices, inspectors are not permitted to move or disturb personal belongings during the inspection process. Therefore, only visible and accessible sections were inspected, and concealed water damage or plumbing defects may not

have been detected.

Given this, a re-inspection is recommended after all obstructions have been cleared to allow for a comprehensive assessment of these areas. Regular maintenance and monitoring of plumbing and drainage systems is also advised to ensure ongoing functionality and early detection of potential issues.

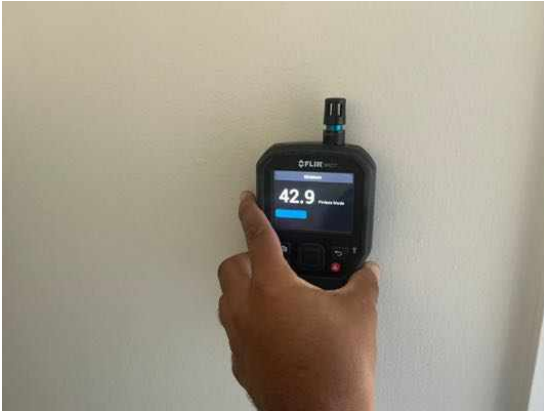
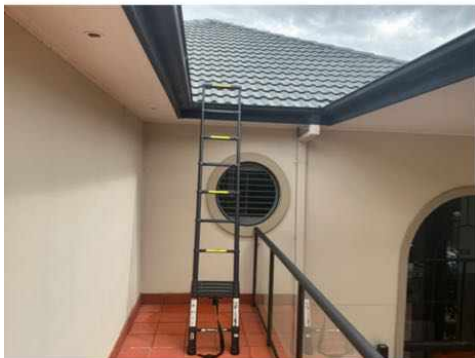
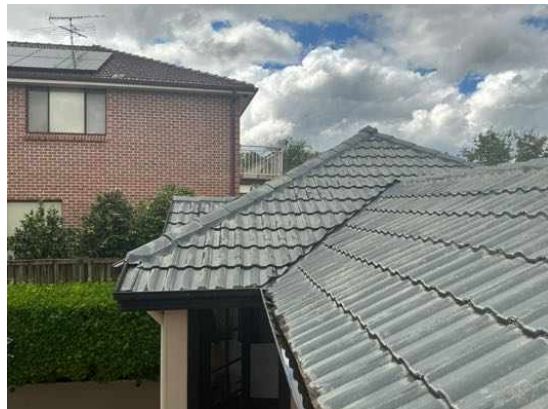
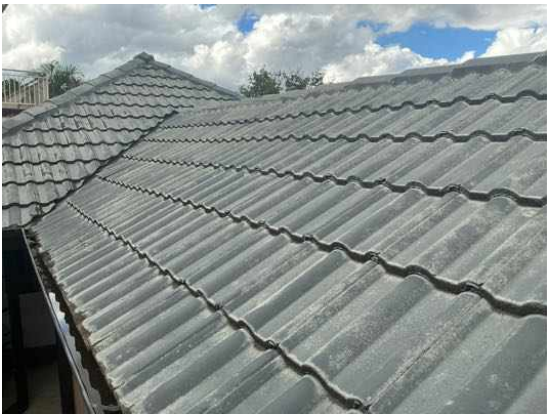
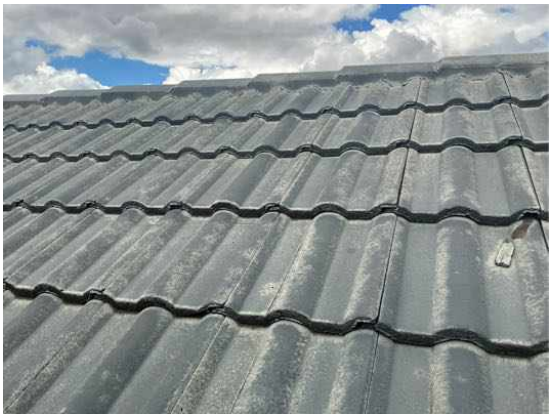
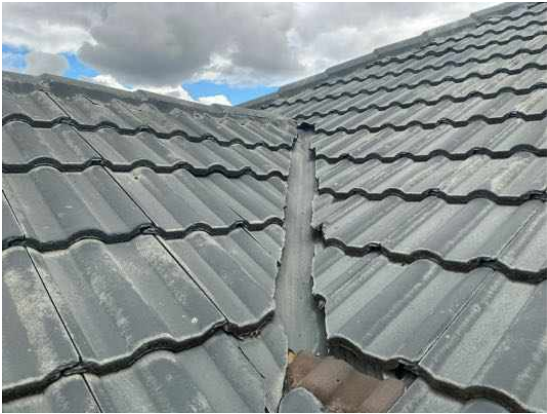
Information: As part of the information provided, please note that the attached roof photos represent the condition of the roof at the time of inspection. These photos are for visual reference only and do not constitute a detailed roofing assessment. Any defects or issues identified with the roof are mentioned separately in the defect statements. It is strongly recommended that the client engage a qualified roofer to conduct a thorough inspection of the roof, ensuring that any potential issues, such as leaks, structural integrity, or wear and tear, are properly identified and addressed.

Additionally, the condition of the roof may change over time due to weather, natural wear, or other unforeseen factors. Regular maintenance and inspections by a licensed professional are advised to ensure the roof remains in good condition and to avoid costly repairs in the future. The information provided in these photos should be considered a snapshot of the roof's condition during the time of inspection and not a guarantee of its future performance.

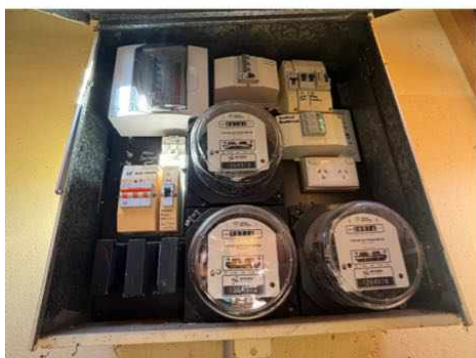
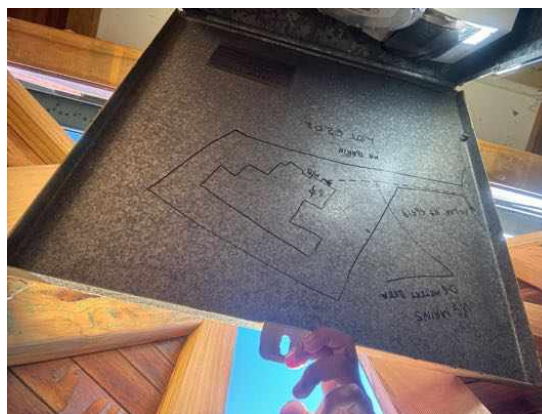
Building:	Main Building
Location:	Meter Box
Finding:	Termite Management Recommendation – No Evidence of Chemical Installation
Information:	At the time of inspection, there was no visible evidence of a chemical termite management system installed around the property. Chemical barriers are a key component of termite protection and are particularly important in preventing concealed termite entry into timber elements of the structure.

In accordance with standard requirements, a durable notice should be located within the electrical switchboard to detail any termite protection systems applied, including chemical treatments. No such notice was observed during the inspection.

It is recommended that the client engage a licensed pest controller to assess the suitability of installing a chemical barrier, and to provide advice on associated costs and procedures. This should be considered a short-term priority, particularly if the property has any history of termite activity or is located in a high-risk area.

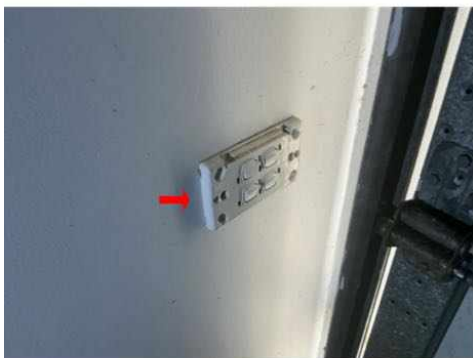
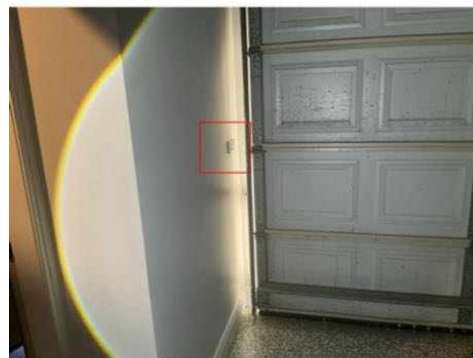
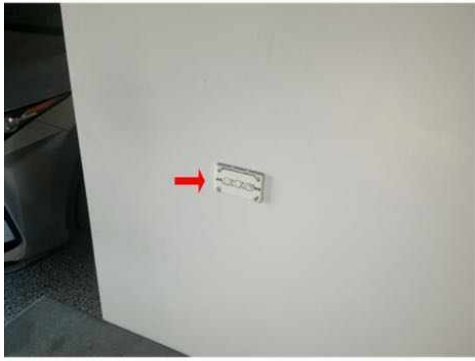
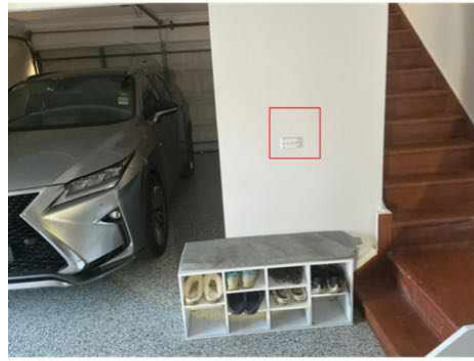
Building: Main Building
 Location: Garage
 Finding: Switches - Cover Plate - Missing
 Information: The switch in this area was found to be missing its cover plate at the time of inspection.

It is recommended to install the new cover plate to make sure the fixture and associated structures are safe and fully operational. A license electrician should be appointed to repair or replace the light switch as soon as possible.
