Building and Timber Pest Inspection Report VR

Inspection Date: Tue, 17 Mar 2026

Property Address: 12 Handley Ct, Blackburn North VIC 3130,
Australia

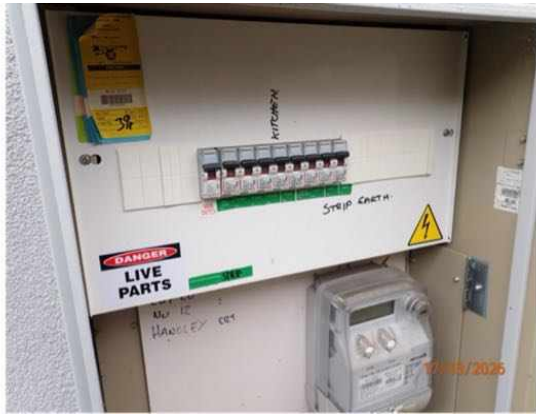
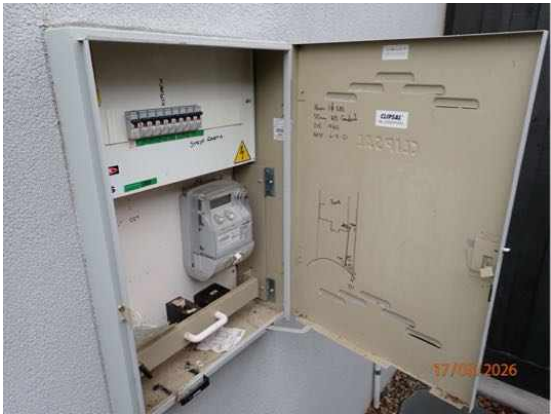
Building: Main Building
 Location: Meter Box
 Finding: Electrical Switch Box
 Information: All electric wiring, meter boxes and appliances need to be checked by a licensed Electrician ensuring any work completed as part of a renovation or extension has been issued with a Certificate of electrical Safety (CES). The checking of any electrical items is out side the scope of this inspection.
