Building and Timber Pest Inspection Report

Inspection Date: Mon, 19 Jan 2026

Property Address: 33 Stewart Street, South Windsor NSW
2756

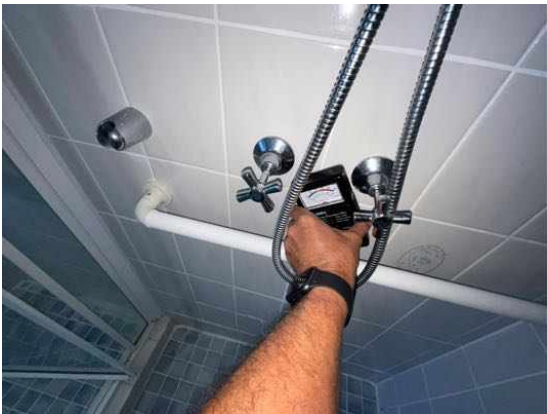
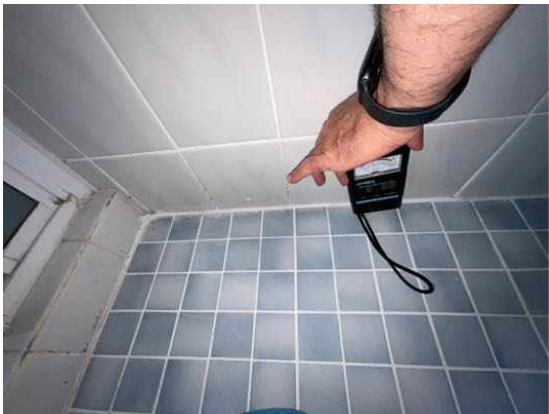
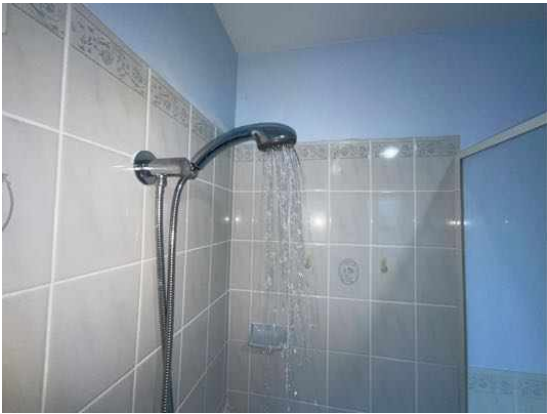
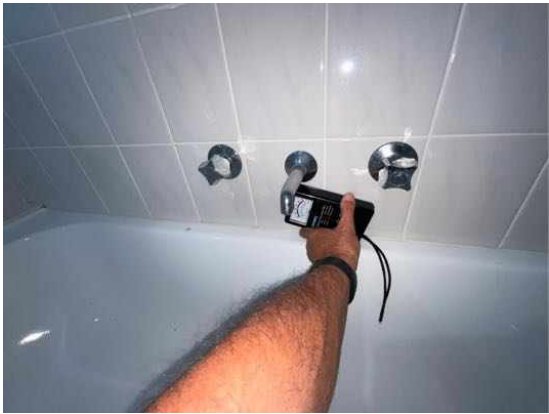
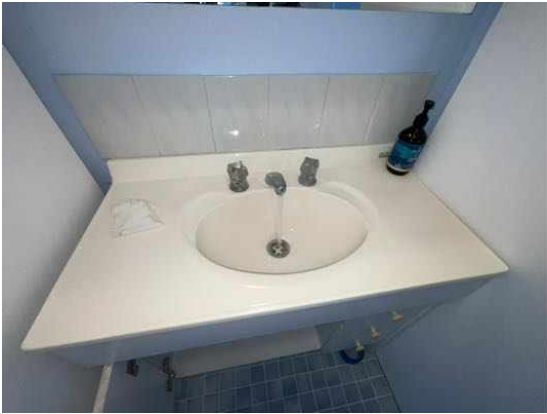
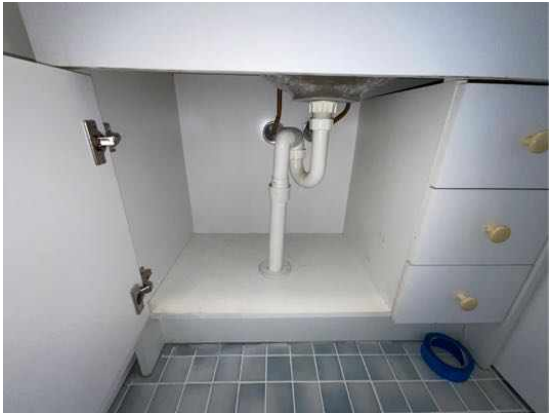
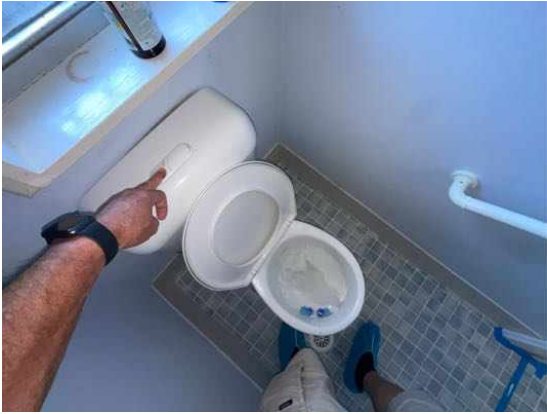
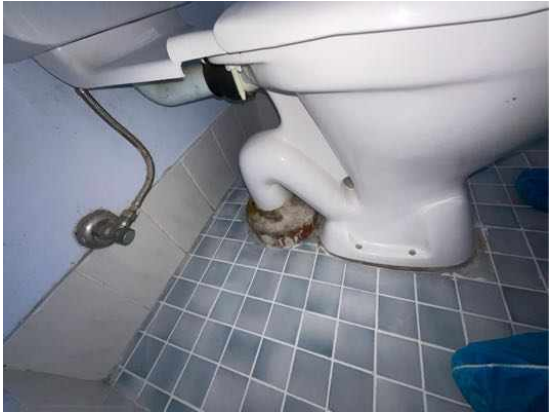
Building: Main Building
 Location: All Areas
 Finding: Ceiling Condition & Observations.
 Information: All areas of the dwelling were inspected, with particular attention given to the ceilings. These were closely assessed for any signs of moisture staining, damage, or visible anomalies that could indicate leaks or other issues.
