Building and Timber Pest Inspection Report

Inspection Date: Tue, 27 Jan 2026

Property Address: 1/20 Lorensen Ave, Coburg North VIC
3058, Australia

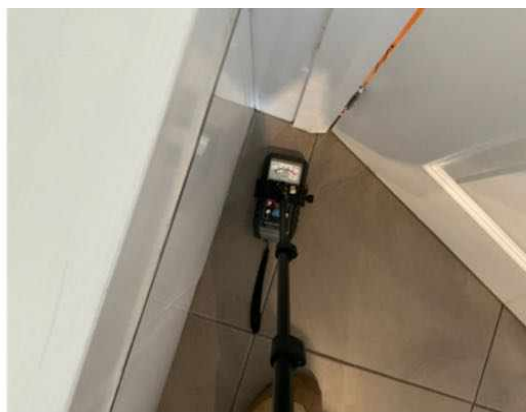
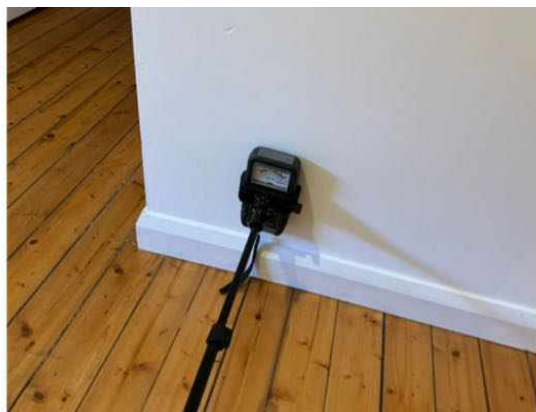
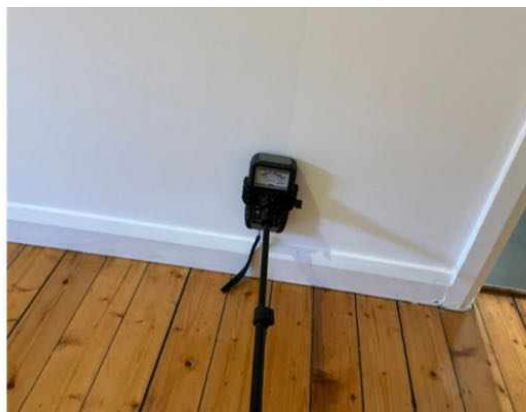
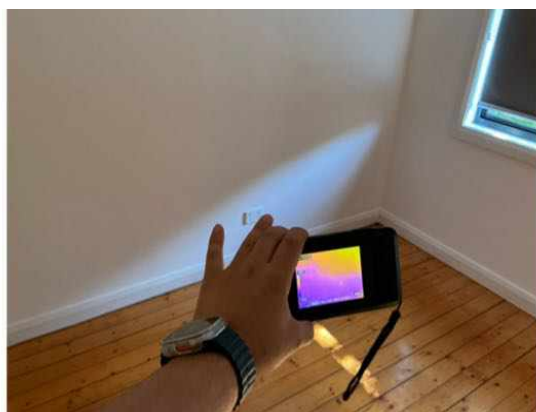
Building:	Main Building
Location:	Bathroom
Finding:	Sealed / Decommissioned Bathtub – Cause Unknown (Further Enquiry Required)
Information:	As observed during inspection, the bathtub within the bathroom had been fully boxed-in/covered and the tap set/fittings had been removed and/or capped off (services appeared sealed at the wall). Due to this non-standard modification, the bathtub could not be operated or tested, and the subfloor beneath this area was not accessible (as noted elsewhere in the report), therefore the condition of concealed plumbing, waterproofing, and the supporting structure could not be confirmed.

No elevated moisture readings were detected around the perimeter of this enclosure at the time of inspection using a moisture meter and thermal camera; however, the reason for the bathtub being sealed remains unknown and should be clarified with the vendor as a priority. Possible explanations may include: (1) a previous leak or waterproofing failure that was isolated by decommissioning the bath, (2) preparation for a renovation/refit that was not completed, (3) prior plumbing defects (e.g., failed waste connection) that were temporarily taken out of service, or (4) intentional removal for safety/maintenance reasons (e.g., reducing water use, child safety, or ongoing mould/odour concerns). Supporting documentation such as invoices, plumber reports, or insurance/renovation records should be requested to confirm the history and scope of any prior works.

It is recommended that this matter be investigated and rectified as soon as practical and prior to reliance on this bathroom. A licensed plumber and, if required, a registered builder should be engaged to (a) confirm why the fixtures were removed, (b) inspect for any concealed defects/damage, and (c) reinstate the bathtub for safe use or formally remove/replace it in a compliant manner. The key concern is that the enclosure may be concealing a past defect, and undiscovered moisture damage (if present historically) can lead to deterioration of adjoining materials and future repair costs.

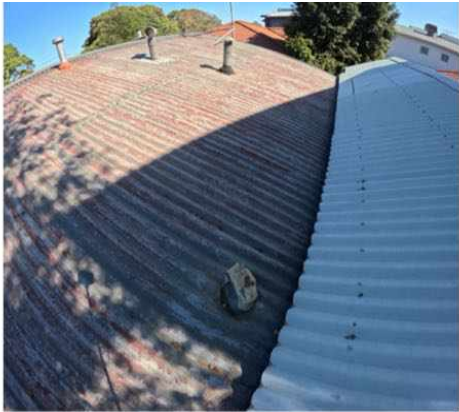
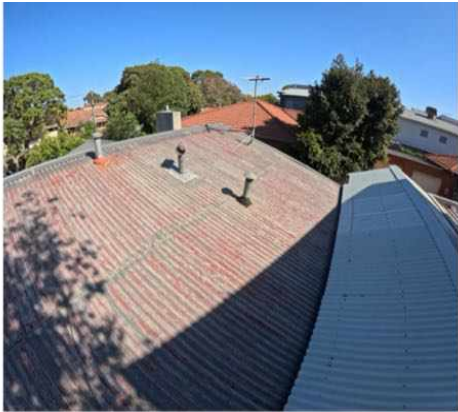
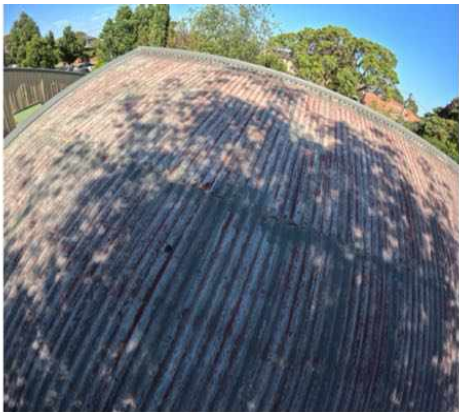
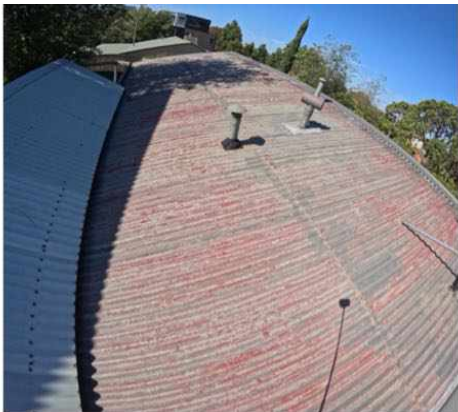
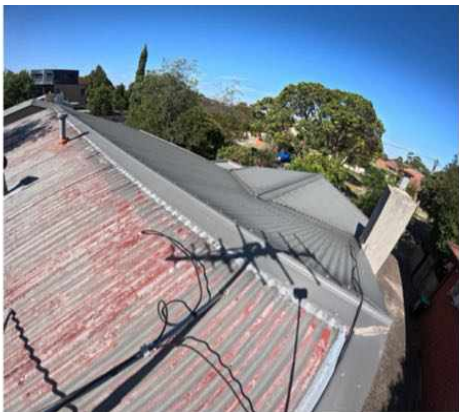
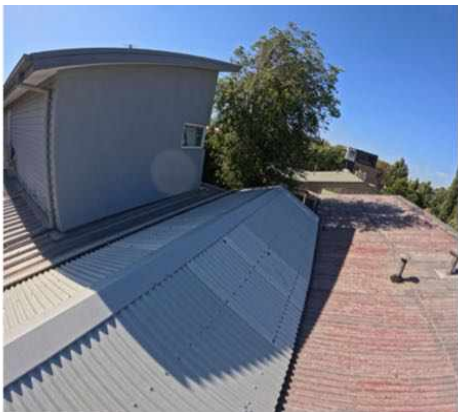
Finding 3.02

Building:	Main Building
Location:	Roof Exterior
Finding:	Roof Sheeting Condition – Rear Section Showing Minor Rust
Information:	Overall, the roof was found to be in generally good condition. It was noted that the rear section of the roof sheeting appeared older and showed minor surface rusting, while the front section appeared newer and in sound condition.

No specific defects were observed such as loose/open Colorbond sheets or visible damage. However, it is recommended that the rear section be maintained and, where possible, treated with a suitable rust treatment and protective waterproof/anti-rust coating to help minimise further deterioration. Rectification can be carried out by a

suitably qualified roofing contractor/handyman as required.

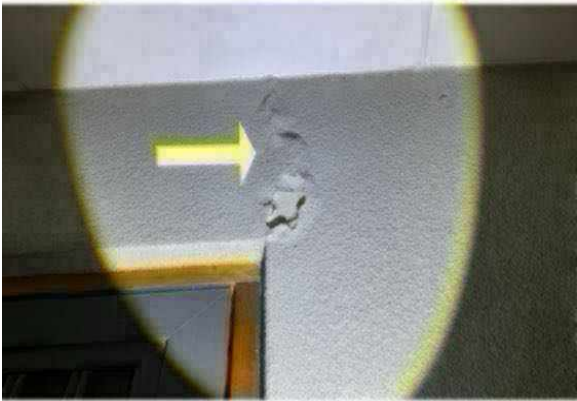
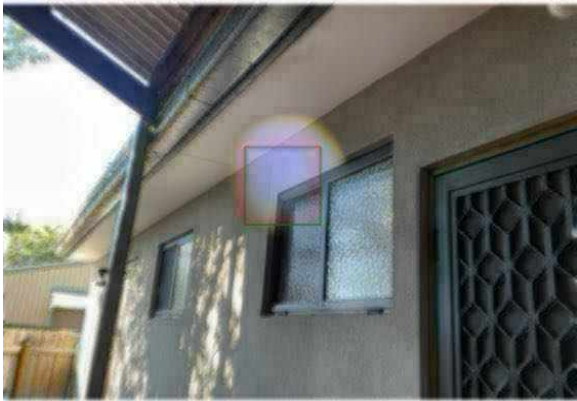
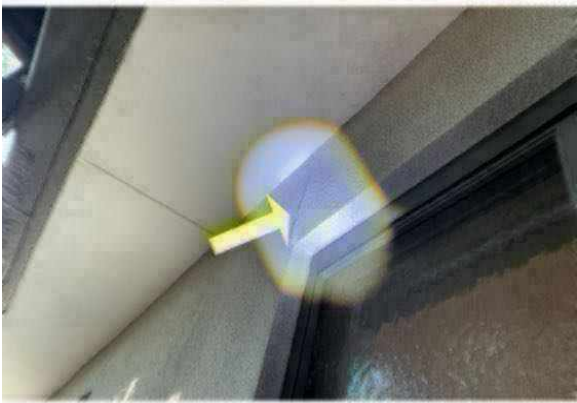
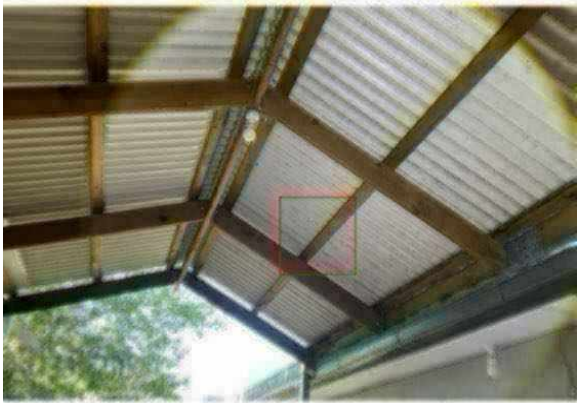
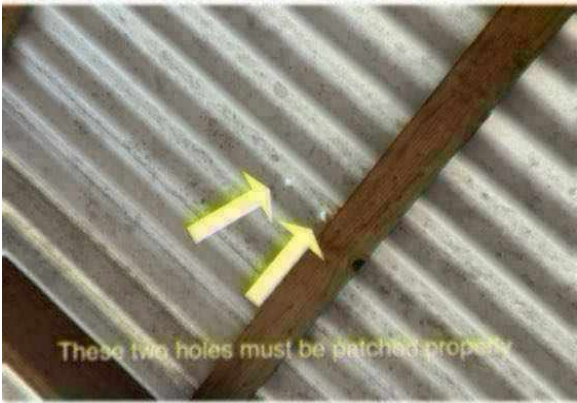
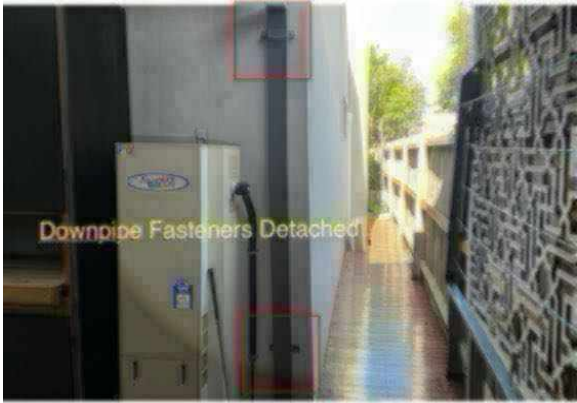
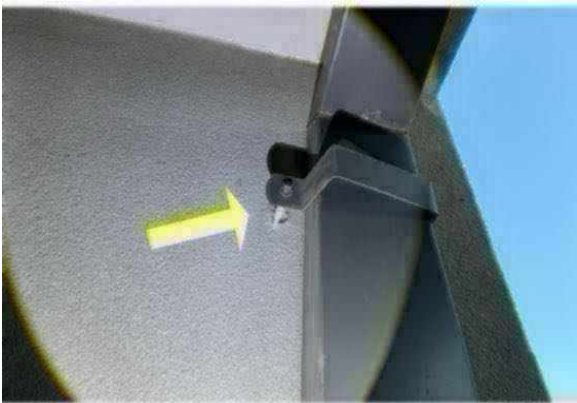
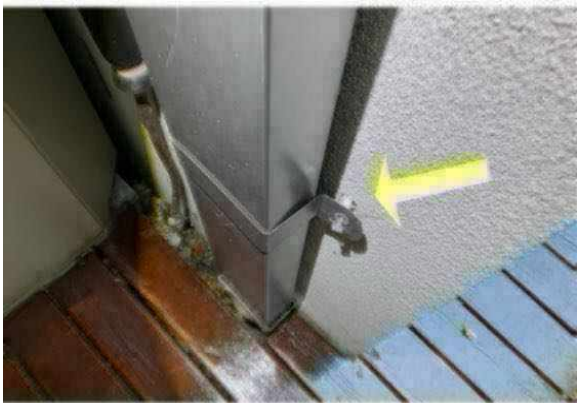
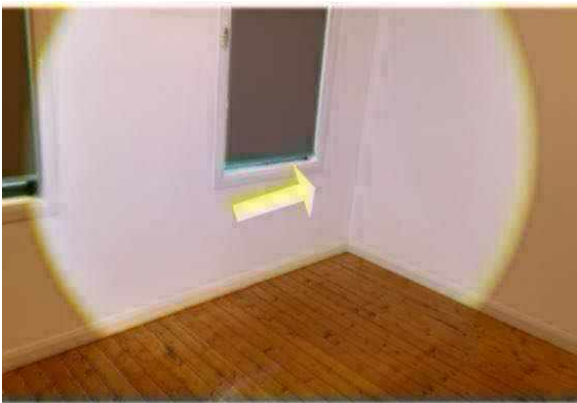
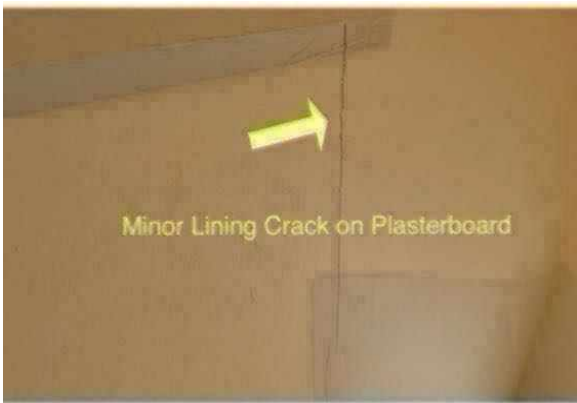
Finding 3.03

Finding: Common Maintenance Defects (Wear and Tear)

Information: In every home, regardless of age, there are maintenance defects or normal wear and tear that occur over time. These issues are completely normal and can be grouped under a broad category of expected wear, which can either be overlooked as part of the home's character or addressed through repairs. Examples of these defects might include hairline cracks in concrete or walls, loose door or window handles, patched sections on walls, and dents or deformities in fences or other building elements. These are all typical issues that arise from the natural aging of a house.

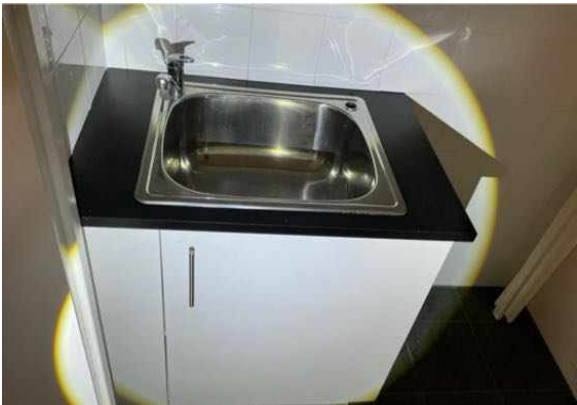
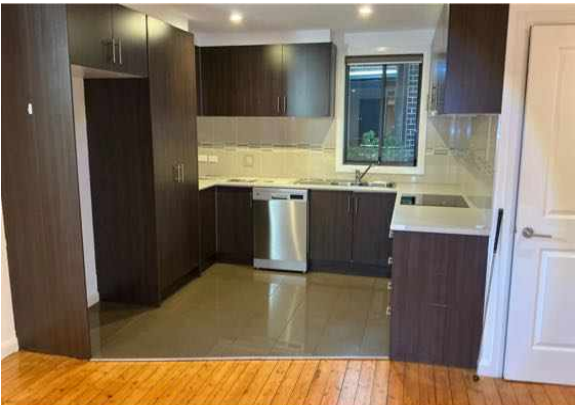
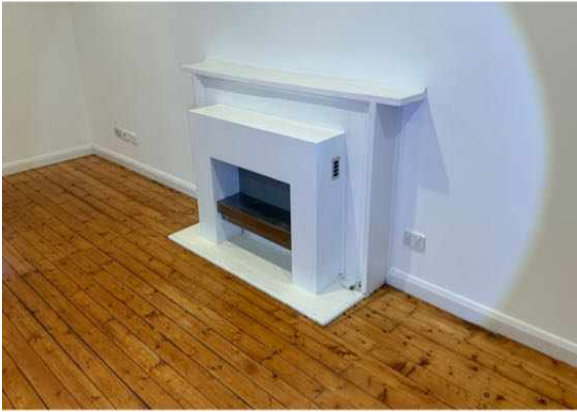
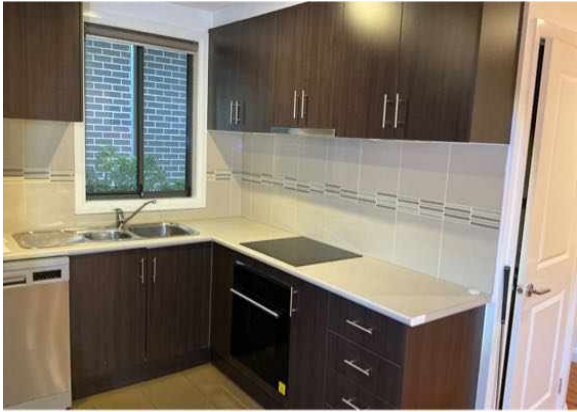
Building: Main Building
 Location: All Areas
 Finding: Additional Photos - Obstructions and Limitations
 Information: These photographs are an indication of the obstructions and limitations which impeded full inspection of the property at the time of inspection. These obstructions can hide an array of defects and should be removed to allow full inspection to be carried out. A re-inspection is recommended once the areas are made accessible.

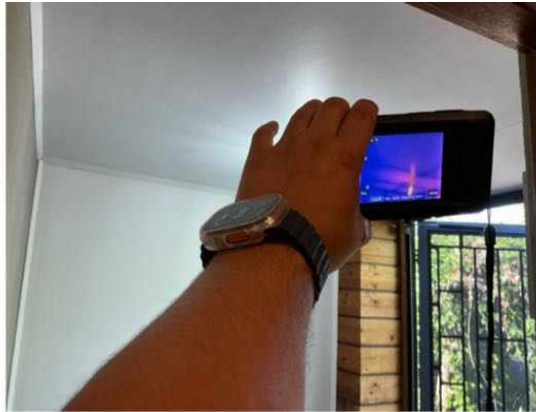
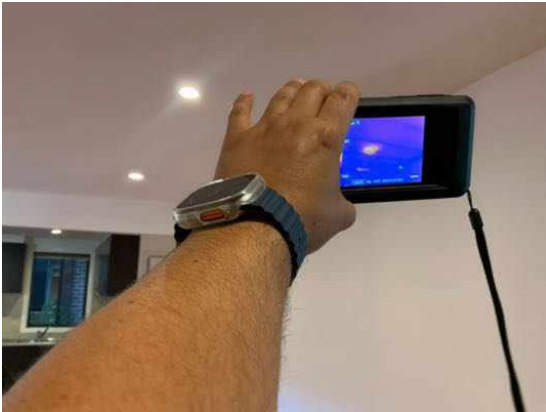
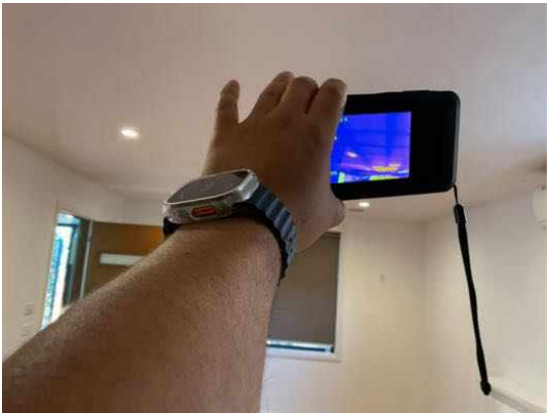
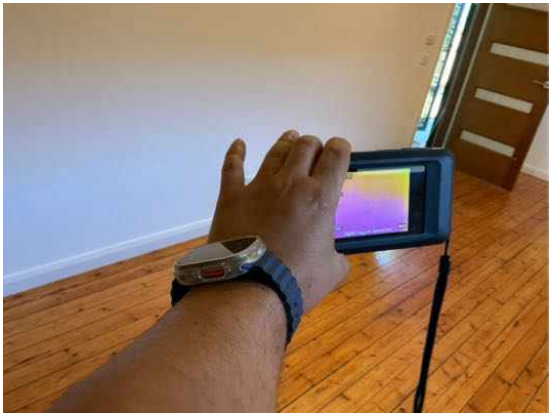
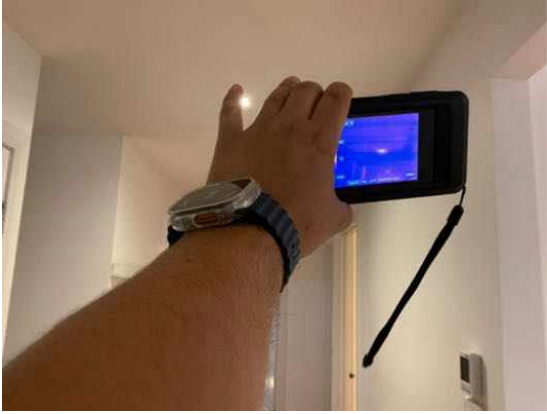
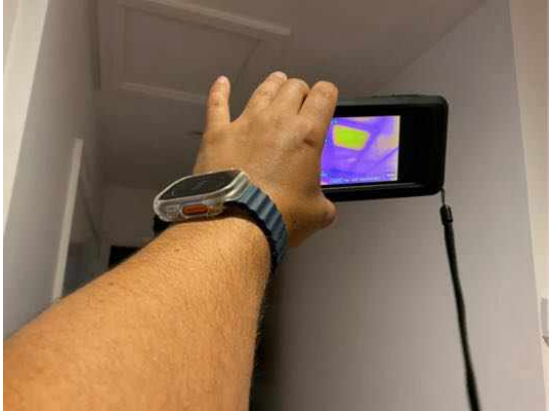
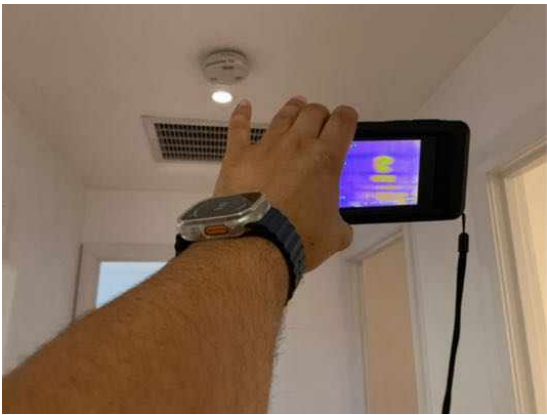
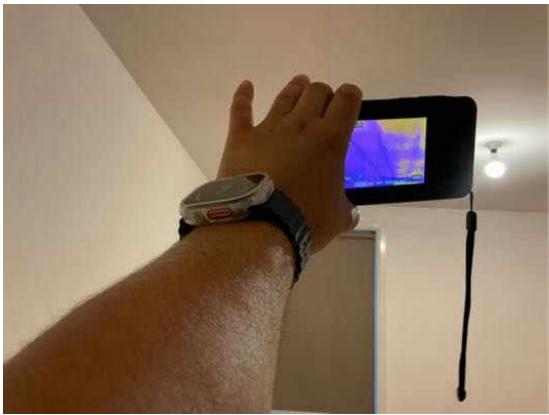
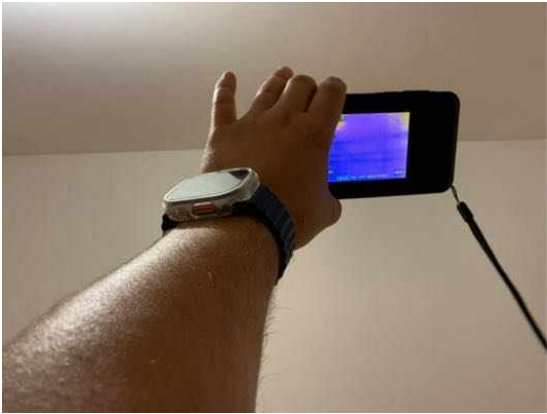
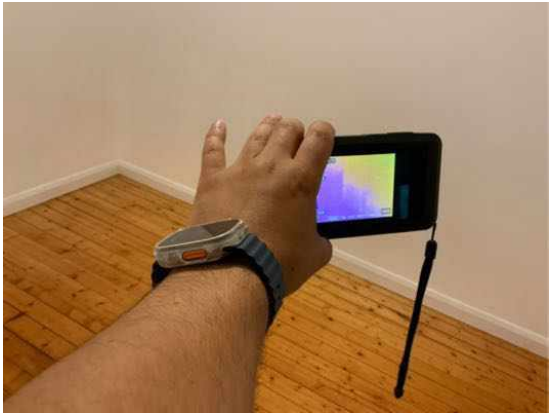
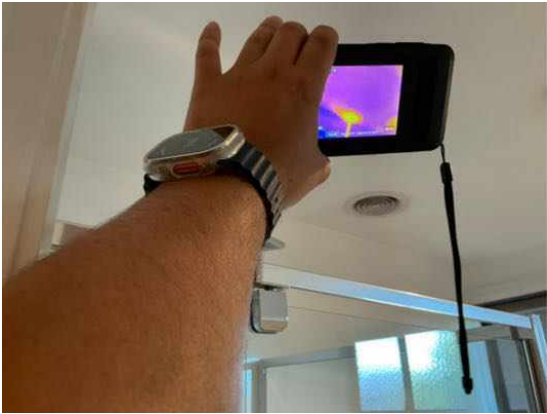
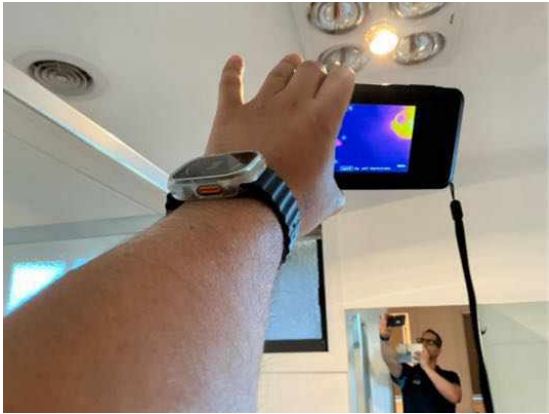
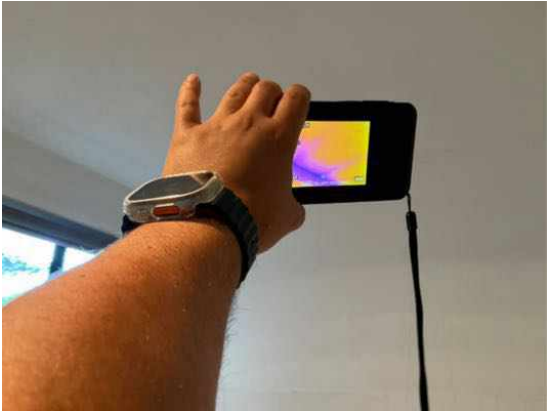
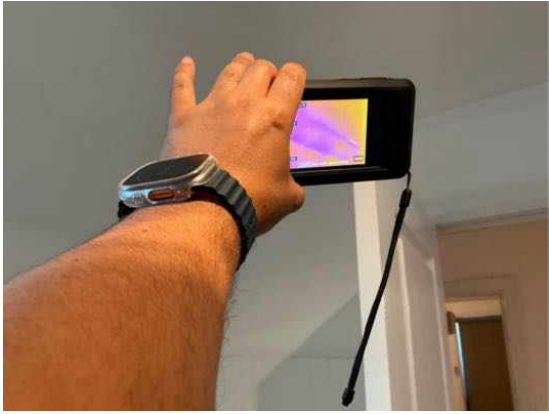
Building: Main Building
Location: All Internal Areas
Finding: No moisture was present at the time of inspection - Good condition
Information: During the inspection, a moisture meter and thermal camera were used to check for the possible existence of excessive moisture, particularly in wet areas, walls adjacent to wet areas, and around all openings.

As can be seen in the attached pictures, no high moisture readings were present at the time of inspection. This suggests that there were no significant moisture issues detected in these areas.

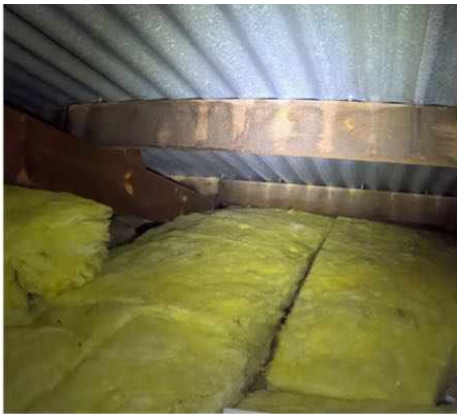
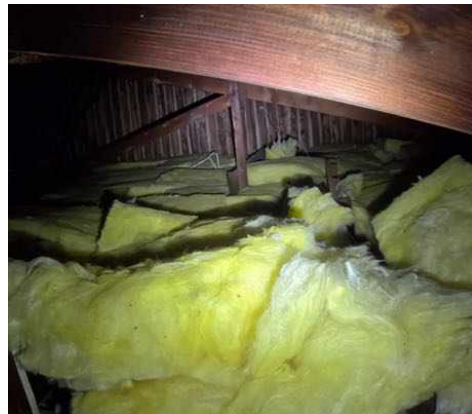
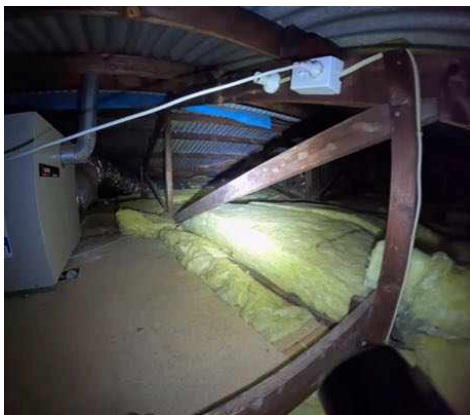
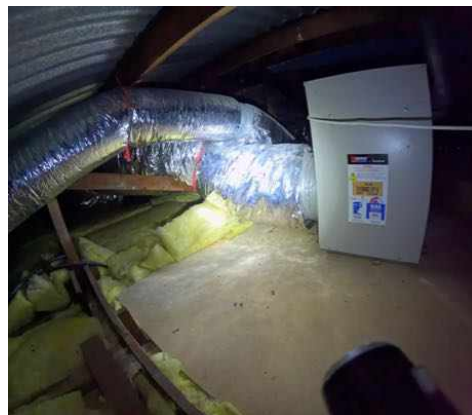
Finding: Additional Photos - Obstructions and Limitations

Information: These photographs are an indication of the obstructions and limitations which impeded full inspection of the property at the time of inspection. These obstructions can hide an array of defects and should be removed to allow full inspection to be carried out. A re-inspection is recommended once the areas are made accessible.

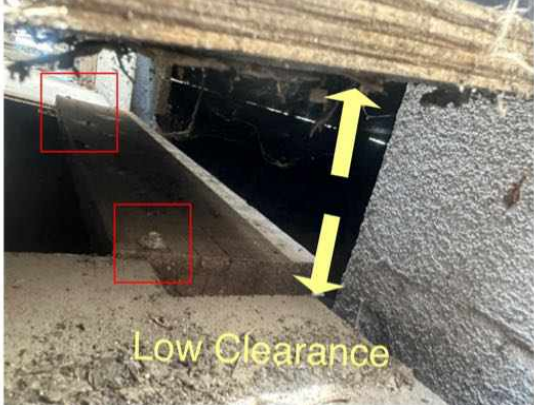
Building:	Main Building
Location:	Subfloor
Finding:	Subfloor Access Hatch – Inadequate / Non-Professional Installation
Information:	The subfloor access in the external side area was found to be non-professionally installed. Instead of a proper hatch/lid, two timber boards had been screwed over the opening, and they could not be removed during the inspection (only slightly lifted). Even if removed, the opening appeared too narrow for safe entry, limiting subfloor inspection and future maintenance.

It is recommended that a proper, adequately sized subfloor access hatch be installed as soon as practicable to allow safe access for future inspections and plumbing/maintenance works. Rectification should be completed by a registered builder/carpenter or a suitable handyman.
