# Building and Timber Pest Inspection Report

Inspection Date: Mon, 16 Feb 2026

Property Address: 96 Lieutenant Bowen Rd, Bowen Mountain  
NSW 2753, Australia

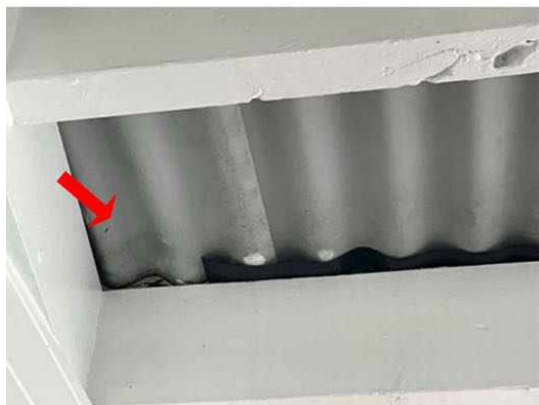
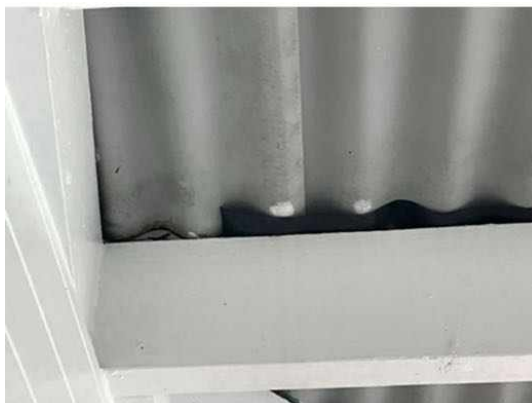
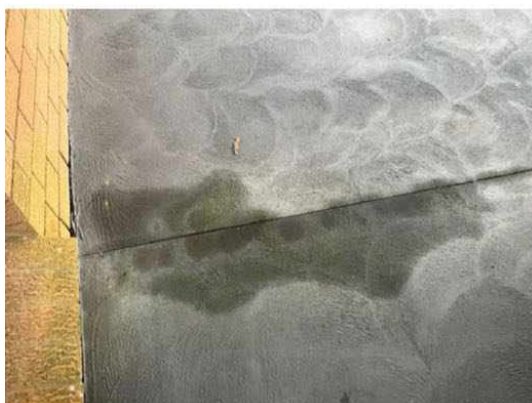
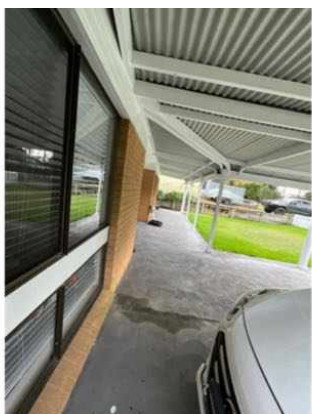
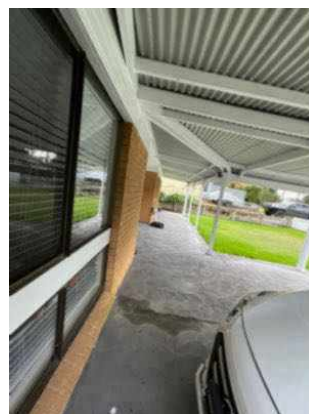
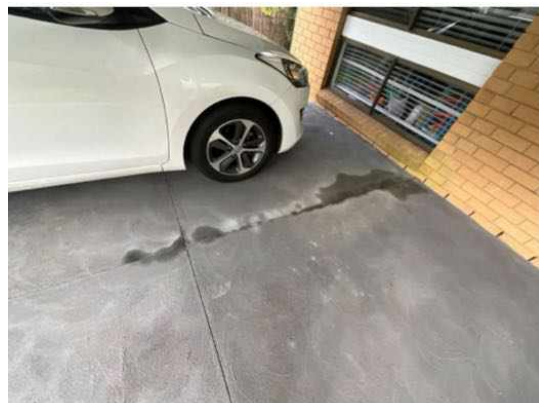
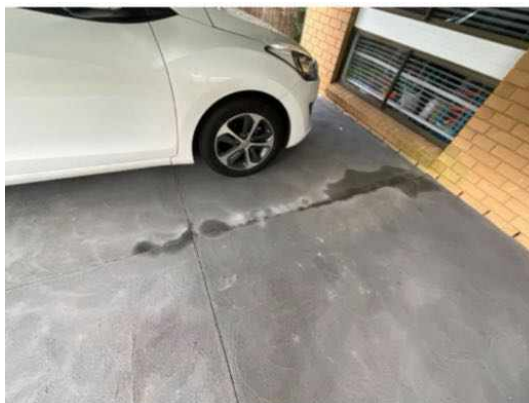
Building: Main Building  
Location: Carport  
Finding: Roof Leakage Suspected – Carport  
Information: Evidence of moisture staining and active water ponding was observed to the carport concrete slab below the roof structure. Water marks appear to align with the roof sheeting above. Inspection of the underside of the corrugated roof sheeting indicates potential gaps at sheet laps and/or inadequate sealing at junctions.

The observed staining and pooling suggests water ingress from the roof covering, possibly due to:

- Deteriorated or missing flashings
- Inadequate sheet overlaps
- Failed or missing fastener seals
- Lack of sarking or waterproof membrane
- Inadequate fall causing backflow during rainfall

- Timber beam deterioration and rot
- Corrosion of fixings and roof sheeting
- Mould growth
- Structural deterioration over time

Recommendation

- Conduct further inspection during rainfall or water testing

- Inspect sheet laps, flashings and fixings
- Reseal, refix or replace defective components as required
- Confirm adequate fall and drainage compliance

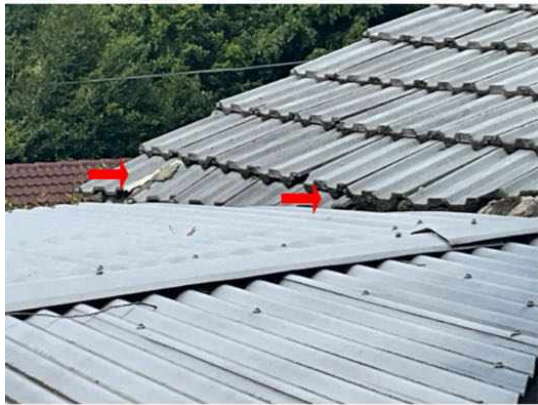
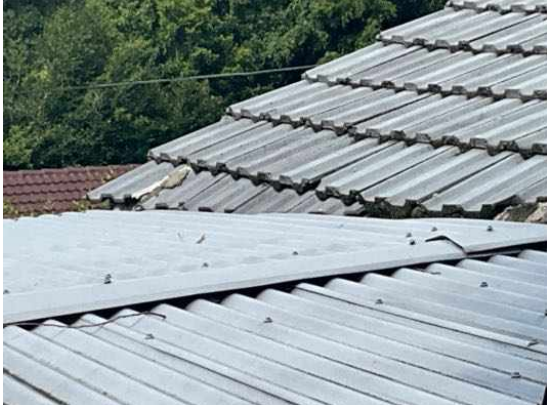
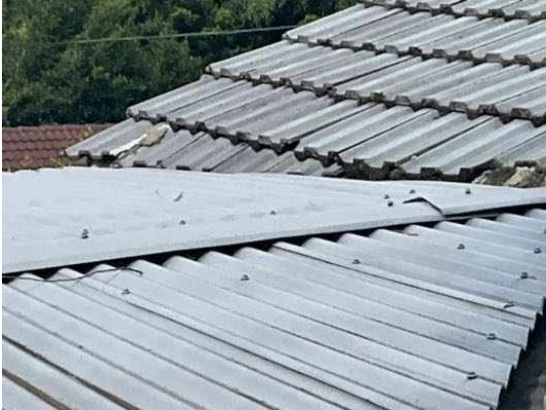
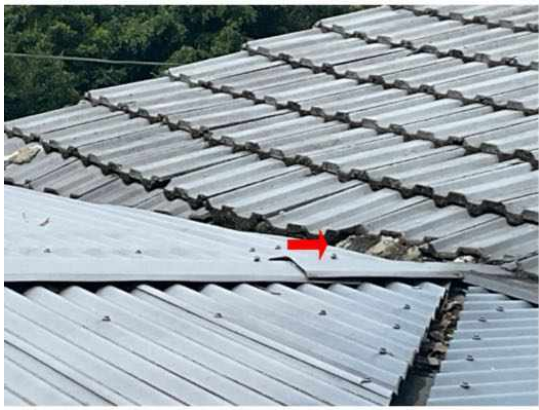
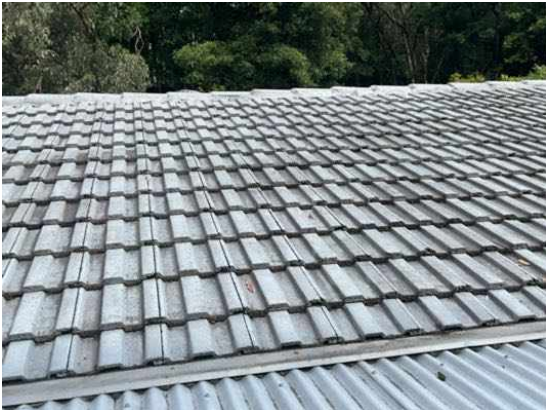
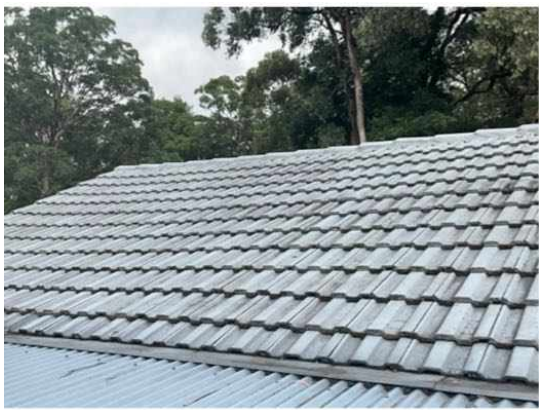
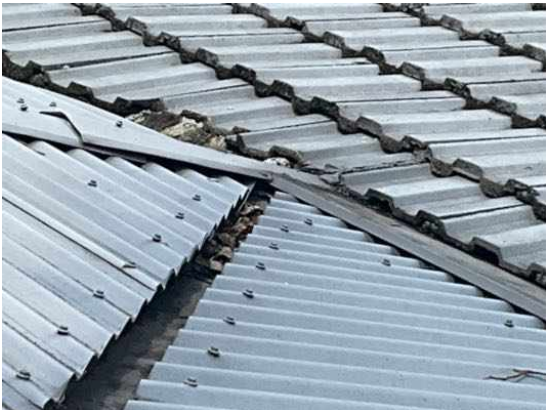
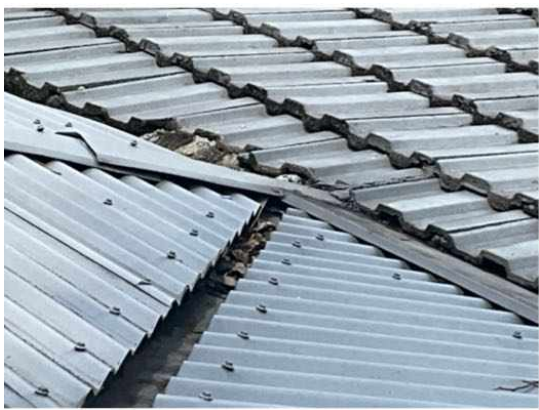
## Finding 2.02

Building:	Main Building
Location:	Roof Exterior
Finding:	Roof Weathered
Information:	Upon inspection of the exterior roofing, the majority of roof was not in a fair condition. While weathering of the roof is consistent with the age of the property, maintenance works are required.

Isolated areas of mortar have come loose in the valleys and minor cracking is also present. Re-pointing and re-sealing the may be considered as an interim solution by the client to help preserve and extend the life span of the tiles.

Where left unmanaged, deteriorating roof are likely to lead to a number of secondary defects, including minor water leaks and weather exposure to internal roofing structures.

Consultation with a roofing contractor is highly advised to gain advice on cost of remedial works that may be required in the short to medium term. Remedial works are likely to increase the longevity of the exterior roofing structure.

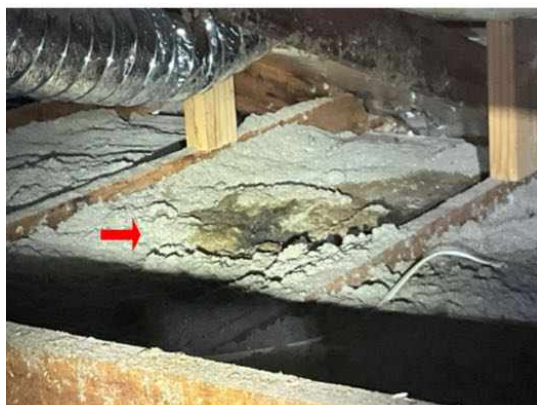
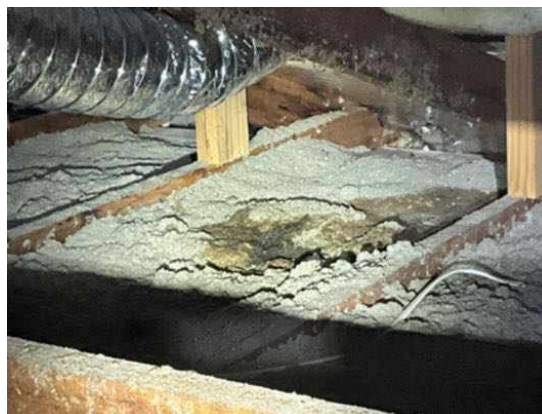
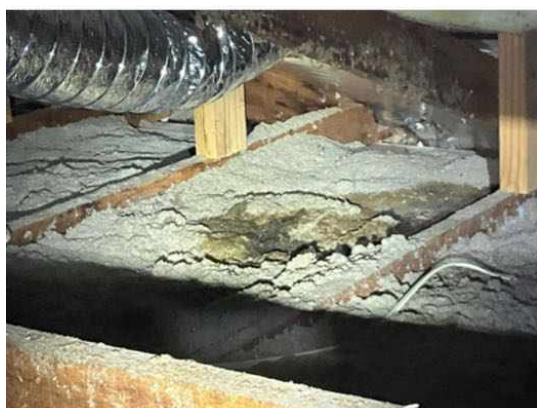
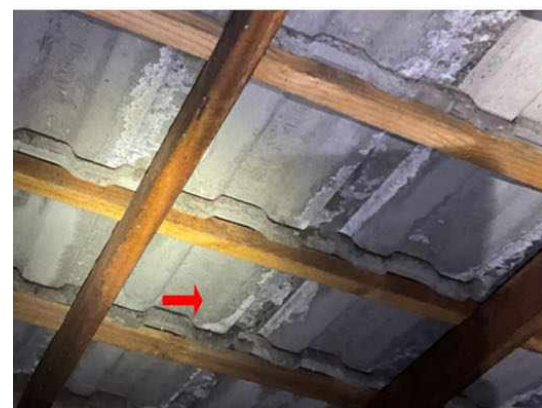
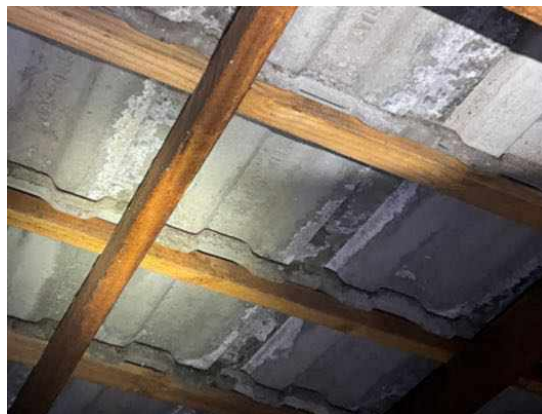
Finding 2.03

Building: Main Building  
Location: Roof Void  
Finding: Roof void - Suspected water leak  
Information: Suspected water leak in the roof void, as evidenced by the presence of water stains, indicating potential gaps or holes.

- **Structural Damage:** Continuous water leakage can weaken the structural integrity of the roof and ceiling, leading to potential collapse.
- **Mold and Mildew:** Persistent moisture can promote the growth of mold and mildew, posing health risks such as respiratory problems and allergic reactions.
- **Electrical Hazard:** Water intrusion near electrical wiring can create a risk of short circuits, fires, or electrical shocks.
- **Insulation Damage:** Prolonged exposure to moisture can damage insulation, reducing its effectiveness and increasing energy costs.

Resolution:

A licensed roofing contractor should be contacted immediately to inspect, diagnose, and repair the source of the leak to prevent further damage.

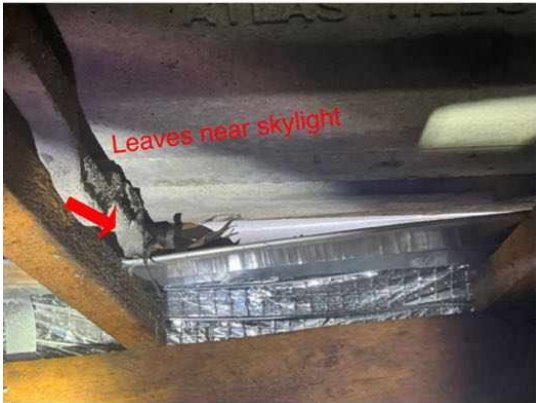
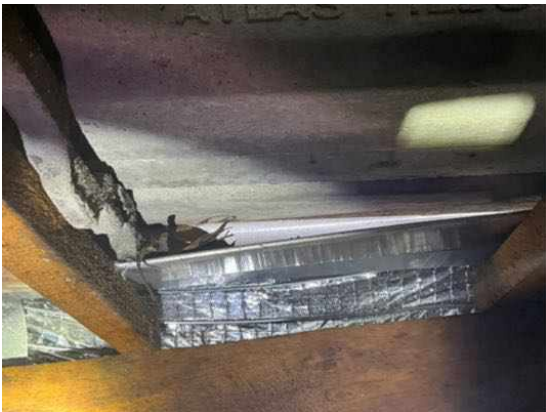
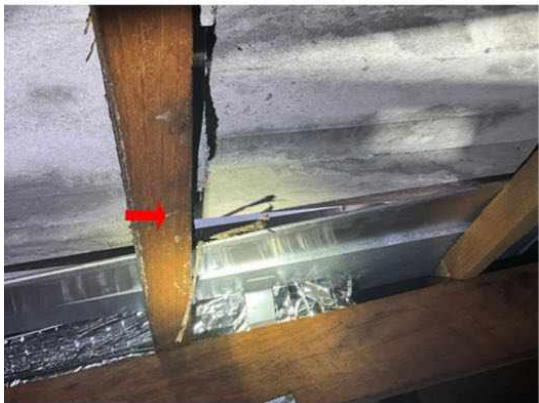
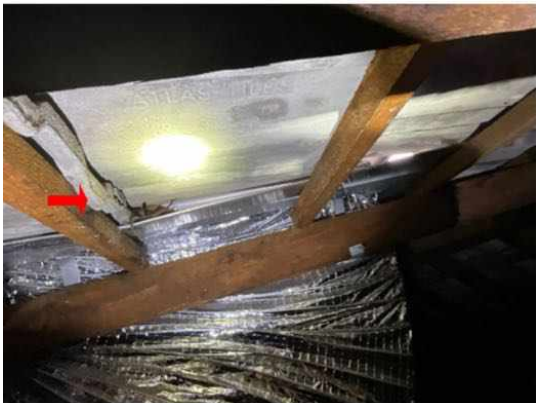
### Finding 2.04

Building:	Main Building
Location:	Roof Void
Finding:	Skylight Installation – Visible Daylight Entry
Information:	Daylight is observed entering the roof cavity through the perimeter of a skylight installation. The light penetration appears to be occurring around the flashing or junction between the skylight and the roof sheeting.

- **Water Ingress:** Poorly sealed skylight installations are a common entry point for rainwater, which can lead to water damage, ceiling staining, and mould growth.
- **Pest Intrusion:** Unsealed gaps may allow insects or small pests into the roof cavity.
- **Energy Inefficiency:** Lack of insulation or air sealing can reduce thermal performance and increase energy consumption.

#### Recommendation:

Have a licensed roofing or skylight contractor inspect the skylight installation. Flashing and sealing should be assessed to ensure the skylight is weathertight and thermally sealed to prevent future issues.

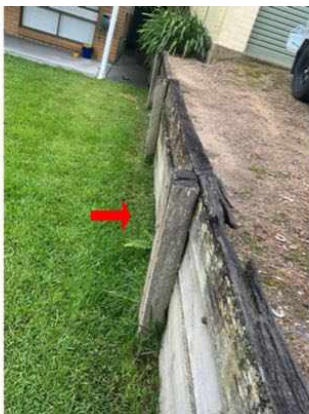
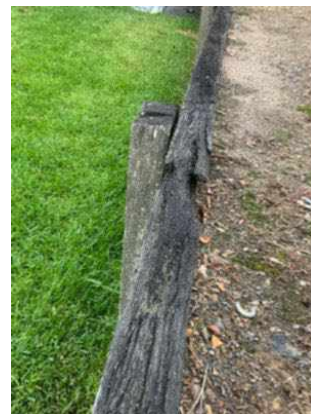
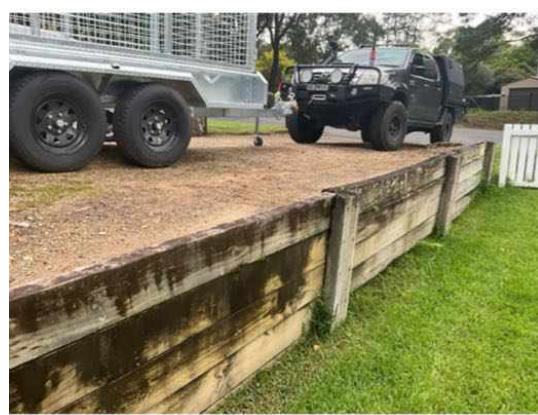
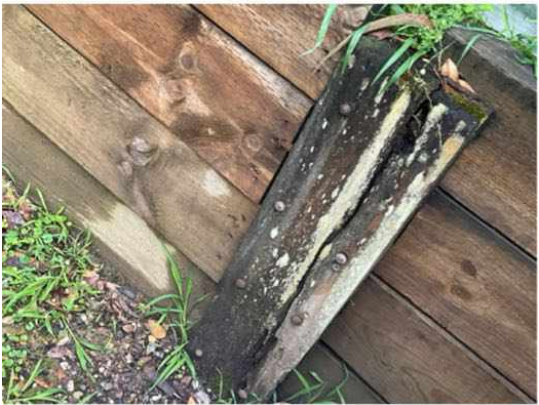
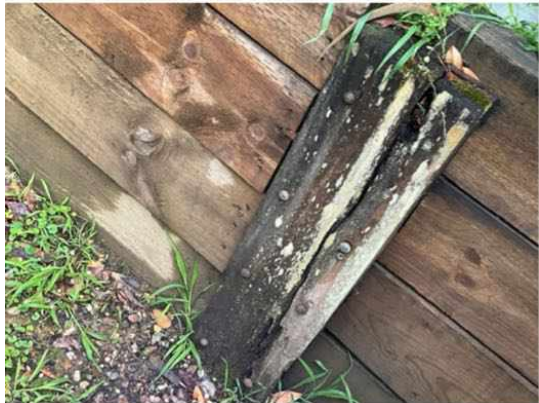
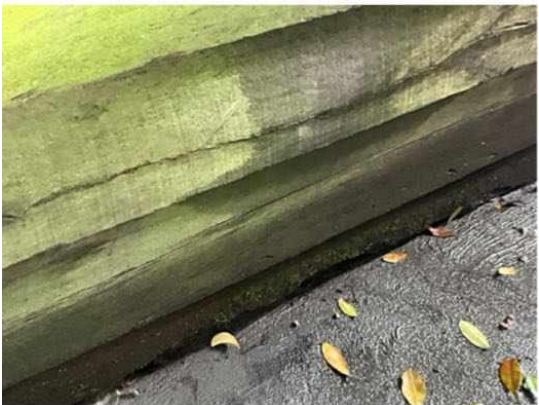
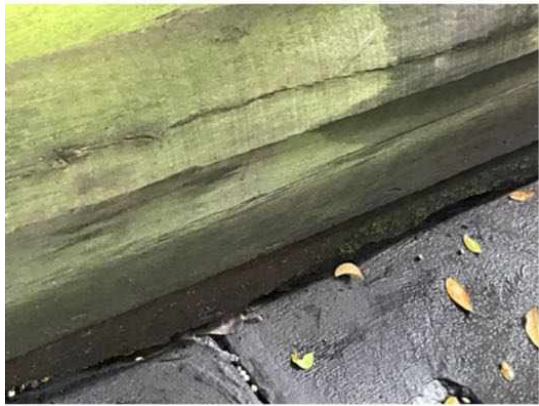
### Finding 3.01

Finding: Retaining wall - Defective

Information: The retaining wall in this area was found to be defective at the time of inspection. Generally, defective retaining walls are caused by poor original design or material use. However, deteriorated retaining walls may also be a result of substandard construction, poor site drainage or unmanaged stormwater flows.

If left unmanaged, the retaining wall may become a safety hazard if it continues to destabilise. Where retaining walls further rot and decay, an environment is created that is conducive to termite and pest infestation.

Significant repair and replacement should be expected. Where retaining walls are considered structural walls, a structural engineer / surveyor should be consulted regarding required remedial works. Otherwise, a landscaper or retaining wall installer may be appointed to repair or replace the wall, at the discretion of the client.

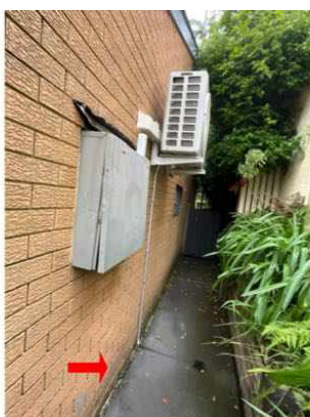
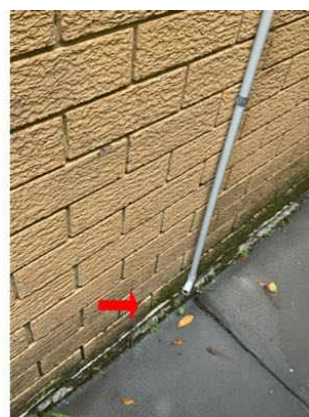
Finding 3.02

Building:	Main Building
Location:	Exterior walls - right side
Finding:	Air conditioner - Disconnected overflow
Information:	The Air Conditioner (A/C) overflow was found to be disconnected from storm water drainage and is creating excessive moisture in the surrounding area.

Such leaking creates an environment which is conducive to an array of defects, including water damage to associated building elements and the attraction of termite or timber pest infestation.

It is highly recommended that a licensed plumber be appointed to connect the A/C overflow in order to prevent such an environment from being created. These minor works should be carried out as soon as possible.

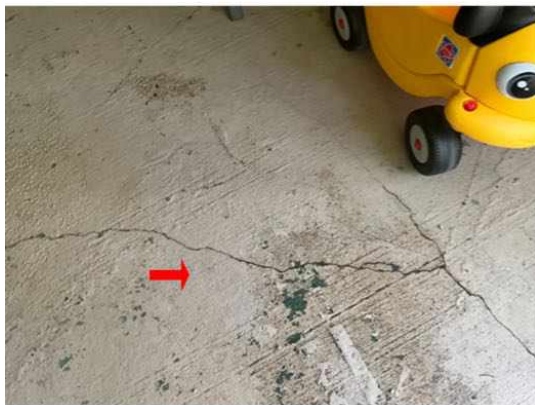
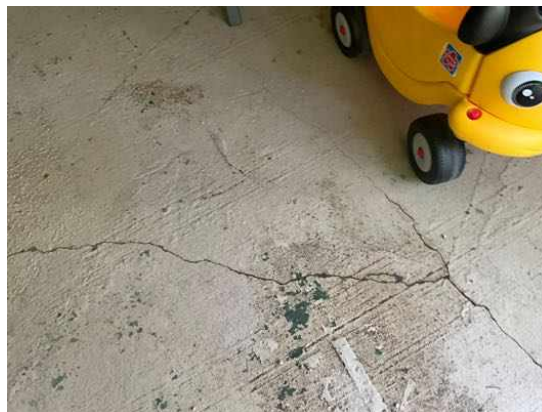
### Finding 3.03

Building:	Main Building
Location:	All Areas
Finding:	Noticeable Cracking in Concrete Slab
Information:	Noticeable cracking has been observed in the concrete slab, failing to meet the required construction and quality standards.

- Cracks are visible on the surface and may extend through the depth of the slab.
- Evidence of improper curing or inadequate reinforcement leading to cracking.

The presence of noticeable cracks in the concrete slab can result in:

- Compromised structural integrity of the slab, potentially leading to failure under load.

- Water ingress through cracks, causing corrosion of reinforcement and further weakening the structure.
- Potential trip hazards and aesthetic issues, reducing the overall value and safety of the property.
- Increased maintenance and repair costs due to ongoing deterioration.

- A structural engineer should be engaged to assess the extent of the cracking and recommend appropriate repair methods.
- A licensed contractor or concrete repair specialist should carry out the recommended repairs under the guidance of the structural engineer.

A detailed inspection should be conducted post-repair to confirm compliance with the required standards and to ensure that the structural integrity of the concrete slab has been restored.

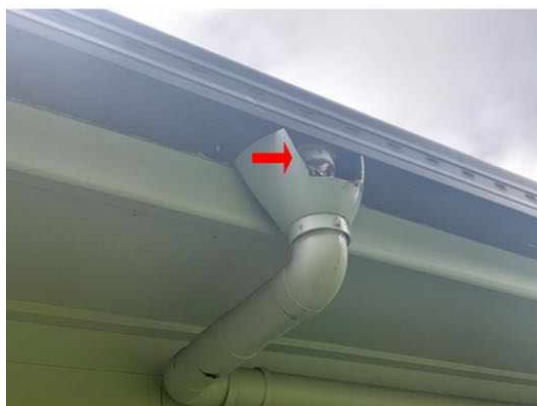
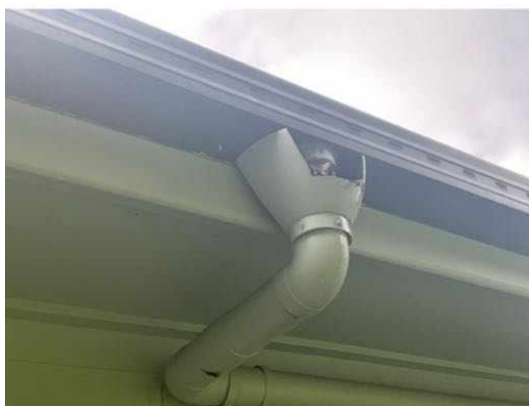
### Finding 3.04

Building:	Main Building
Location:	Exterior walls - rear
Finding:	Downpipe cracked and damaged
Information:	The downpipe is visibly cracked and damaged, compromising its ability to effectively discharge rainwater.

- Water leakage at the break point may lead to pooling near the building foundation, increasing the risk of moisture ingress and structural damage.
- Soil erosion and deterioration of landscaping around the area.
- Potential blockage due to debris entering through the cracked section.

#### Who Can Fix It:

- A licensed plumber or roof plumber should be engaged to replace or repair the damaged section of the downpipe and ensure proper reconnection to the stormwater system.

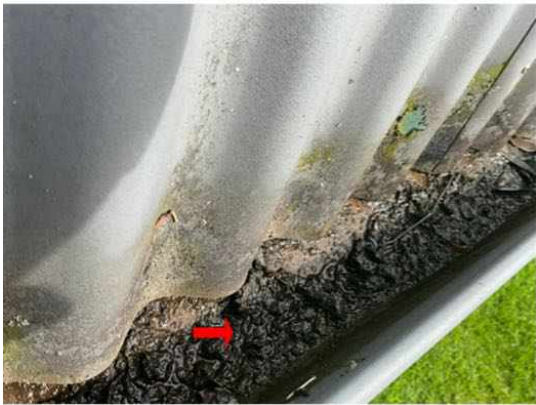
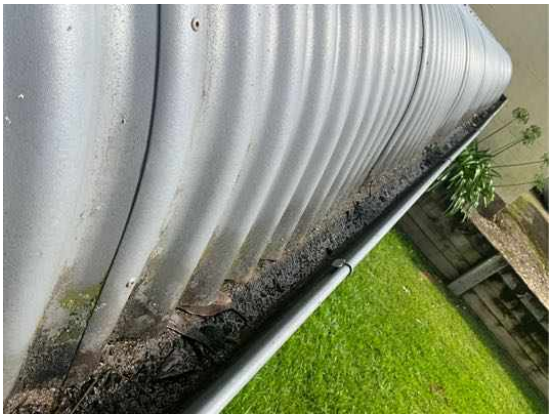
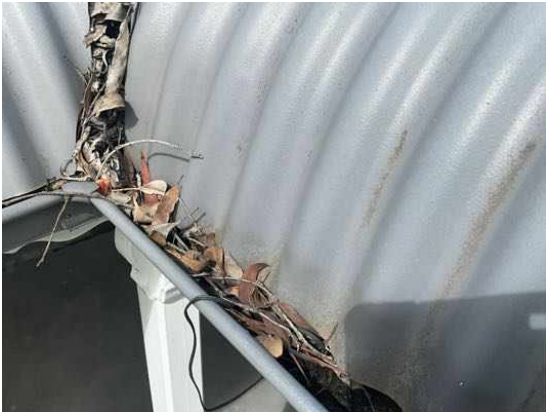
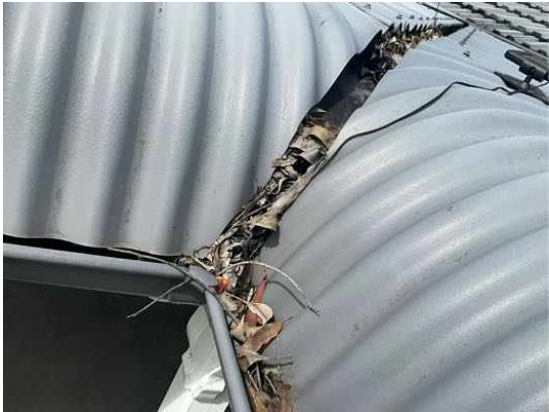
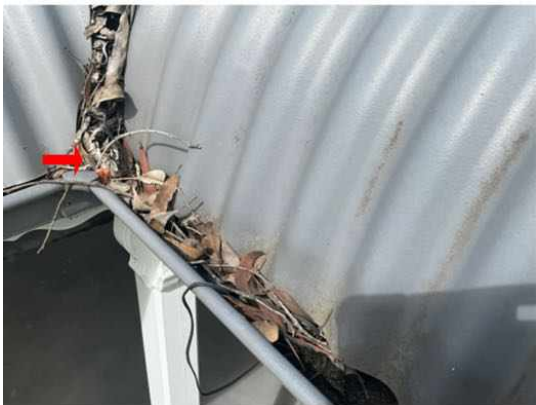
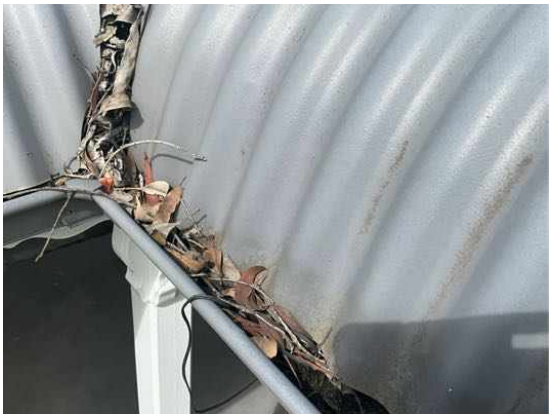
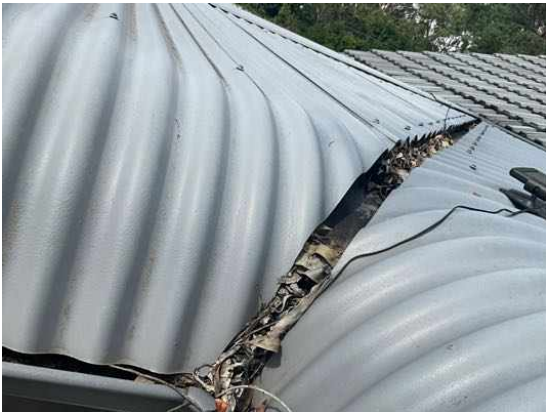
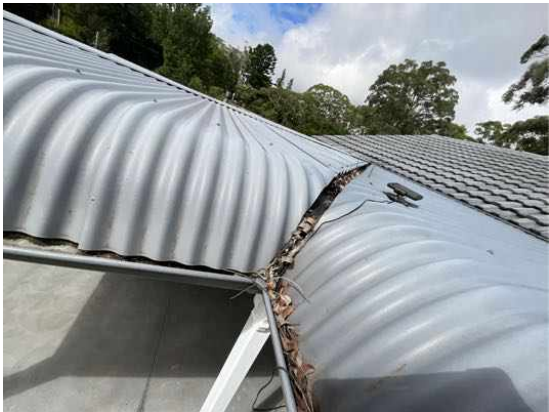
Building:	Main Building
Location:	Roof Exterior
Finding:	Blocked gutters - organic debris
Information:	The roof gutter system was observed to be blocked with organic debris and moss growth, as evident in the provided images.

- Water ingress into the eaves or walls,
- Timber rot or deterioration of fascia and soffits,
- Accelerated moss and algae growth, promoting further blockages,
- Potential foundation issues if water pools near the base of the structure.

A licensed roofing contractor or qualified gutter cleaning service should be engaged to remove the debris and inspect the system for any further issues.

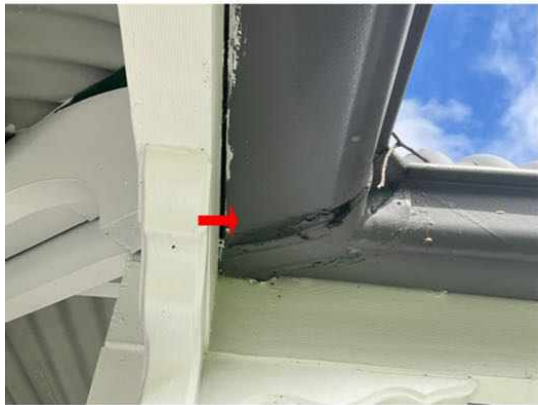
**Finding 3.06**

Building: Main Building  
Location: Roof Exterior  
Finding: Roofing Gutters - leak  
Information: Roofing gutters are experiencing leaks, compromising their ability to channel water effectively, posing a risk of water damage to the building structure and surroundings.

Risk: "The gutter leaks may result in water seepage into the foundation, potential interior damage, and deterioration of the building's exterior surfaces."

Resolution: "To address the issue, it is recommended to hire a licensed roofing plumber or gutter specialist to inspect, identify, and repair the leaks promptly."

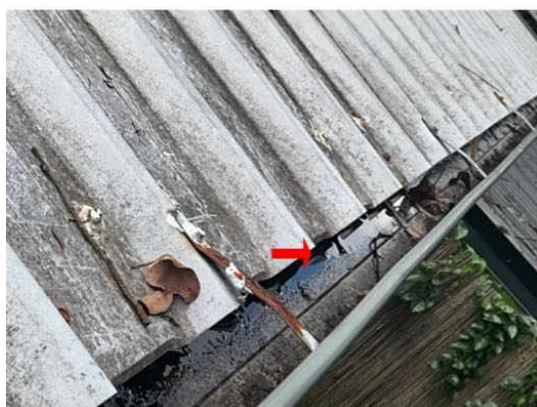
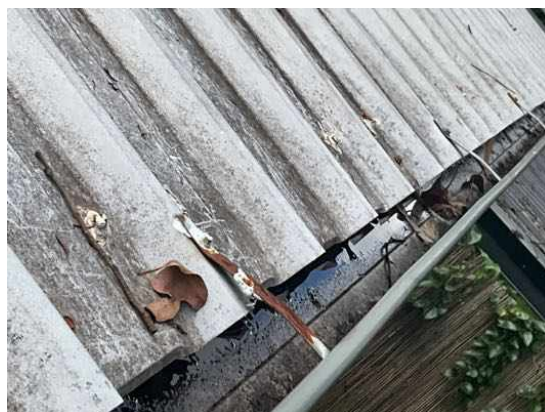
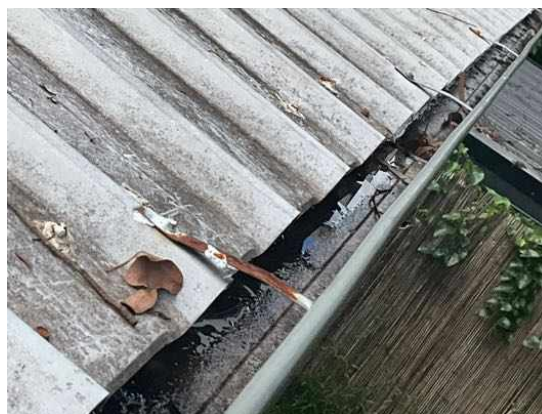
### Finding 3.07

Information: Water was found to be pooling in sections of the roof guttering. This is generally a secondary defect caused by blocked or partially blocked gutters. Such blockages and subsequent water pooling are likely to lead to rust and water damage to associated structures if left unattended.

Any areas of guttering that shows evidence of water pooling should be checked for partial or full blockages and any secondary damage that may have occurred as a result. Depending on the extent of the damage, building elements may require repair and/or replacement to ensure adequate roof drainage and function of exterior plumbing system.

A roofing plumber should be appointed as soon as possible to rectify this issue. It is highly advised that all gutters be maintained on a frequent basis to ensure the condition of roof plumbing.

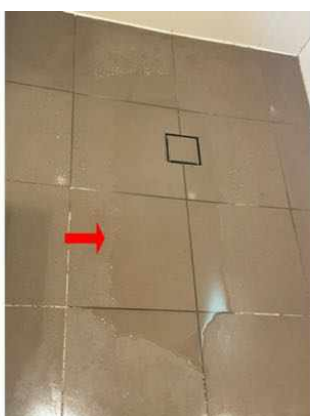
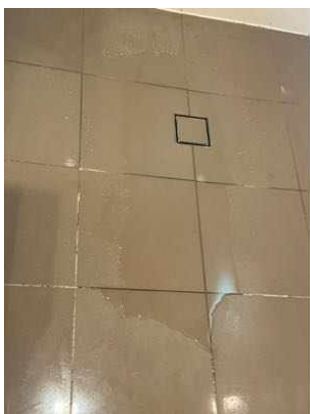
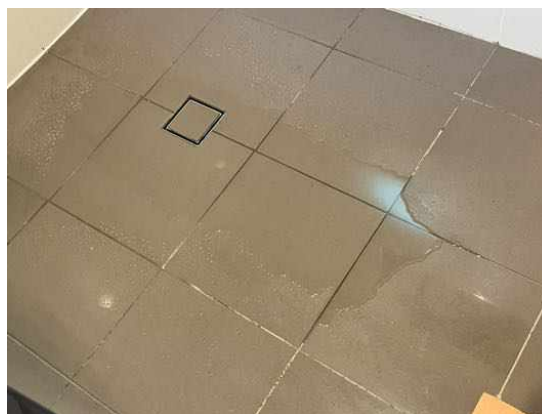
### Finding 3.08

Building:	Main Building
Location:	Bathroom
Finding:	Shower base - Water pooling
Information:	Evidence of water pooling around the floor waste in the shower recess was noticed at the time of inspection. It is suspected that this excessive moisture is attributed to insufficient fall in the shower floor tiles.

This pooling is minor overall but is still considered unsatisfactory, as standard tiling practices would not permit this situation to occur. Pooling water around floor wastes can create a slip hazard in extreme cases and create conditions that are conducive to mould growth over time. Where left unmanaged, the degradation of sealant and grouting is also likely to occur, possibly necessitating further repair works.

Remedial works may involve some sections of tiling and flooring repair and replacement. A tiling contractor or bathroom specialist should be appointed to provide further advice on reparation options and to perform works as necessary.

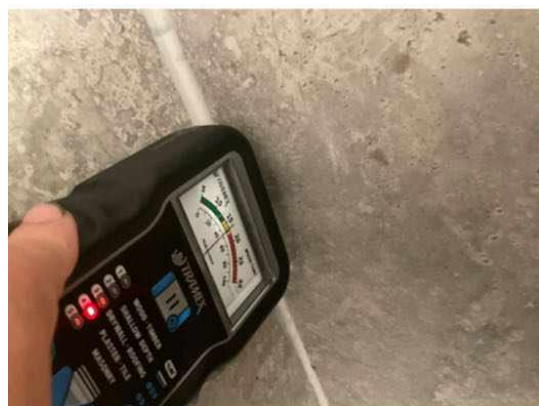
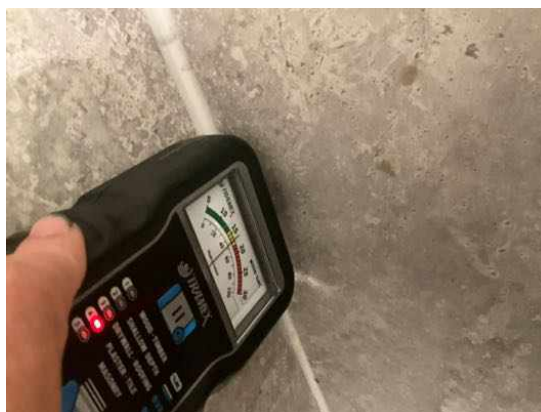
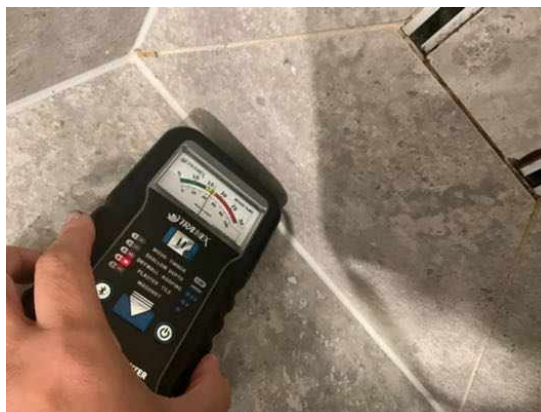
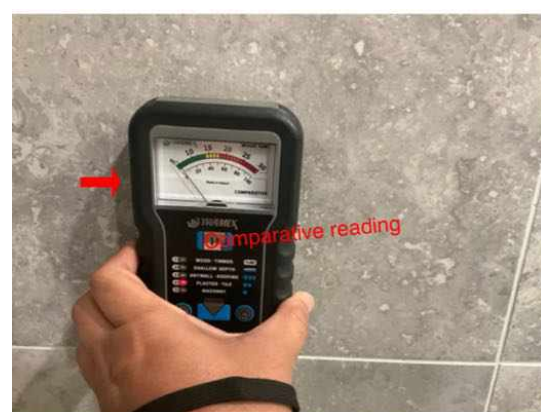
### Finding 3.09

Building:	Main Building
Location:	Ensuite
Finding:	Shower - Damp
Information:	Damp is evident to the lower 300mm of wall to the shower alcove. This defect is quite common, and is suspected to have been caused by moisture permeating through the grouting in this area, which shows evidence of deterioration. Leaking pipes within the adjoining wall is also a possible cause.

Unmanaged damp in the shower recess is likely to facilitate the formation and development of mould and fungi growth, decaying associated building materials and compromising their structural integrity. It is important to address damp conditions, as the World Health Organisation notes that excess moisture leads - on almost all indoor materials - to growth of microbes such as moulds, fungi and bacteria, which subsequently emit spores and other matter into the indoor air. Exposure to these contaminants is associated with a wide range of respiratory and other health-related problems.

Consultation with a qualified plumber or bathroom specialist is advised immediately to identify the cause of damp and to perform remedial works as required. Where excessive mould growth is present, further inspection by a specialist environmental health inspector should also be considered.

Always ensure that sealant and grout is in good condition to prevent any moisture issues occurring in the future.

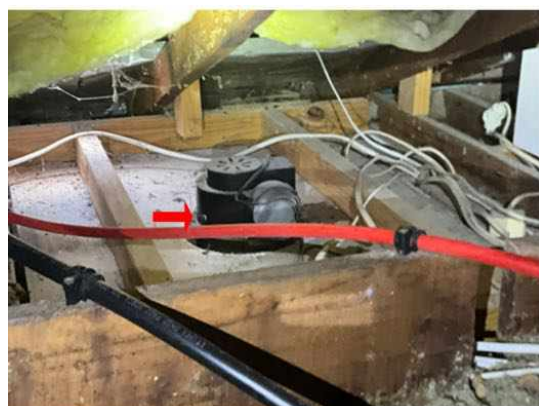
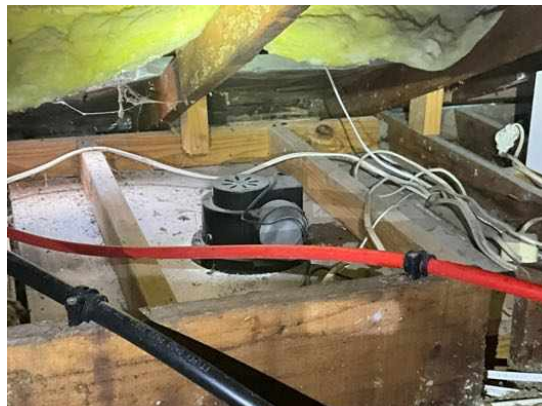
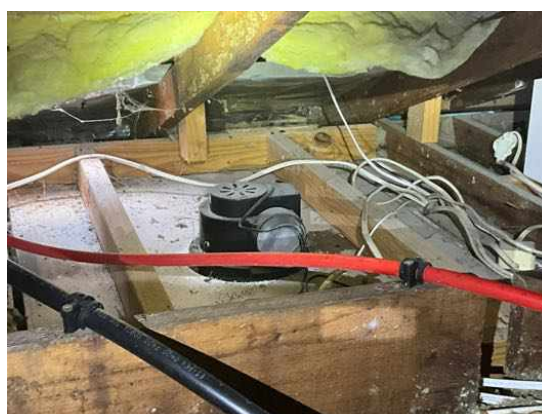
### Finding 3.10

Information: The exhaust fan located within the roof void is not appropriately ducted to the external atmosphere and is currently discharging moist air directly into the roof space. This is considered a defect under AS 4349.1, as it does not meet the minimum standard of residential building performance expected under normal residential building practices.

This condition may lead to excessive condensation within the roof void, increasing the

risk of mould growth, deterioration of insulation, timber decay, and overall reduced durability of building elements. It may also result in poor indoor air quality, potentially affecting occupant health.

It is recommended that the exhaust fan be modified by a licensed HVAC contractor or qualified builder, ensuring it is properly ducted to discharge externally in accordance with manufacturer specifications, the National Construction Code (NCC), and applicable Australian Standards.

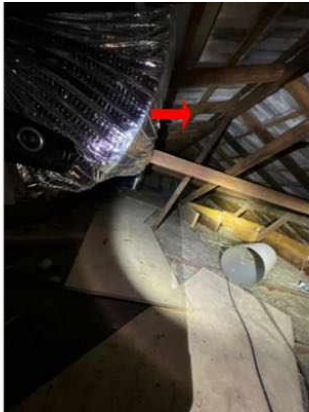
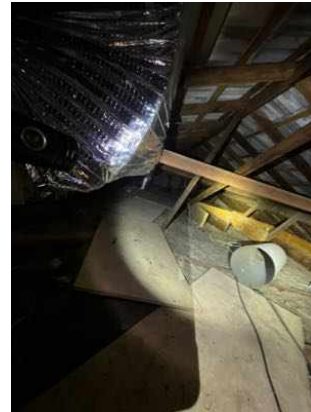
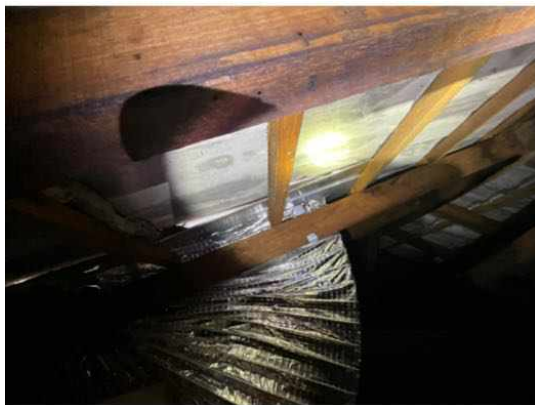
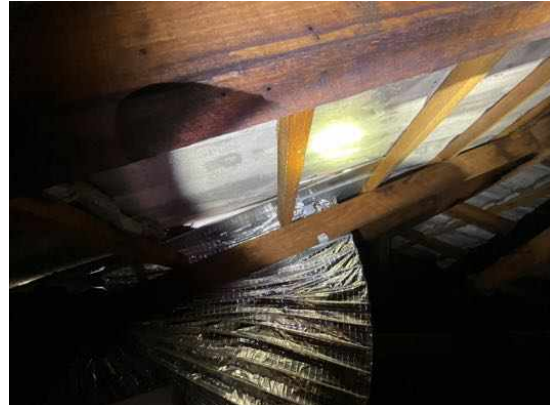
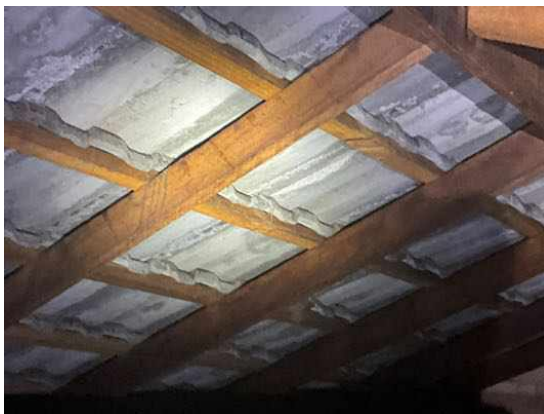
### Finding 3.11

Building:	Main Building
Location:	Roof Void
Finding:	Sarking - Missing
Information:	Sarking is missing under the roof sheeting. Sarking acts as an insulator that helps with noise reduction and protects against water penetration. Sarking plays a key role in the operation and function of the overall roofing structure and its performance.

Although not a requirement at the time of construction, replacement of any missing building element is advisable (although this can be quite expensive to do after the time of construction). Where sarking is missing, regular inspections of the roof tiles for cracking and potential moisture penetration is required.

Sarking may be retrospectively fitted by a registered builder at the discretion of the client.

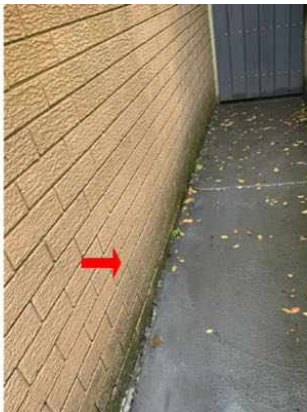
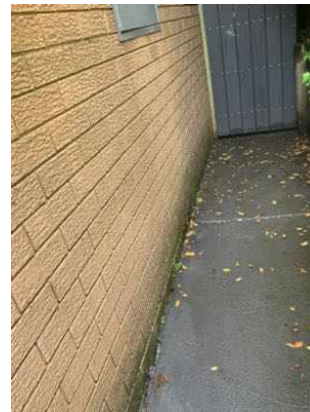
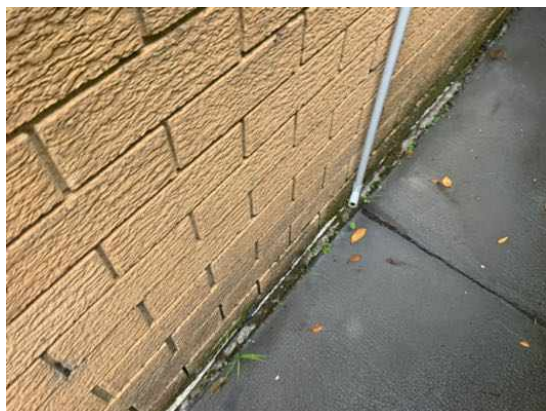
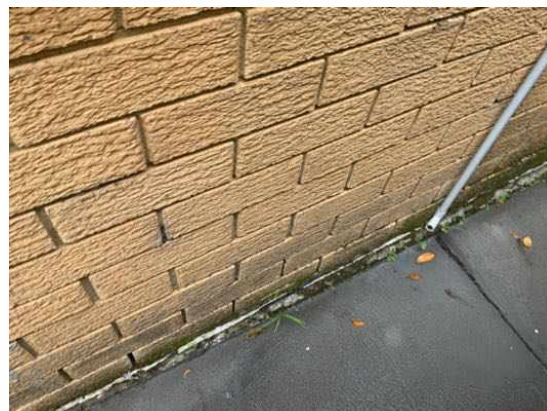
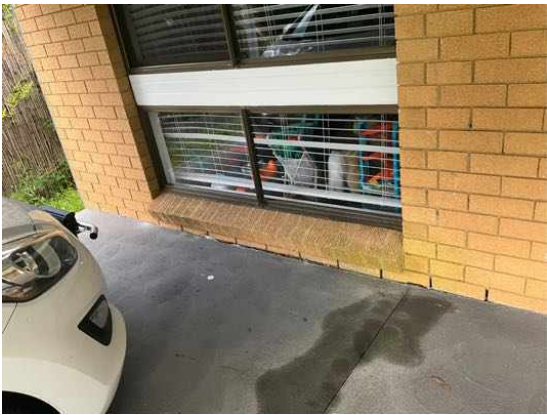
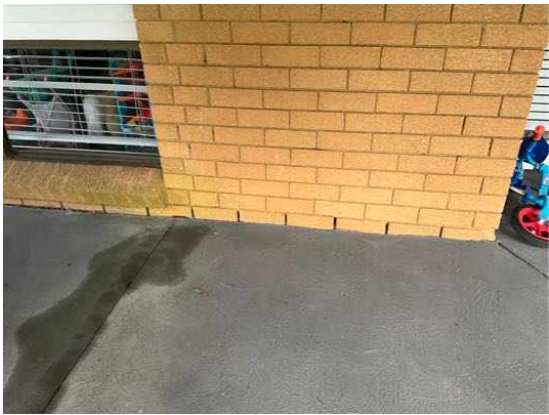
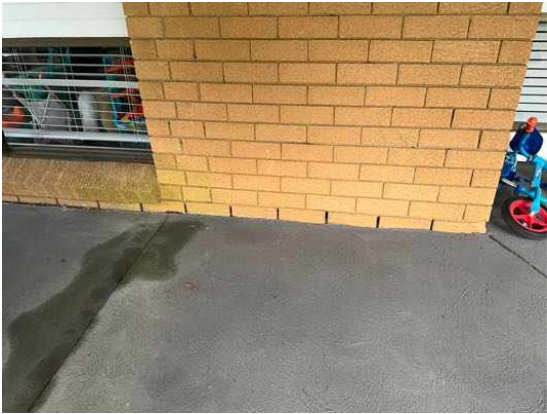
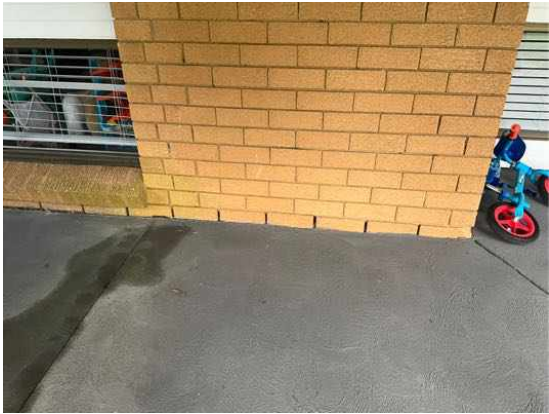
If the slab edge is not properly exposed there is a high risk of termite attack. Sometimes, in order to determine the type of slab, a suitably qualified person such as an architect or builder may be required to consult the construction plans.

Where the slab edge cannot be properly inspected, it is highly recommended that termite or timber pest inspections be carried out every 6-12 months to aid protection of the property against infestation.

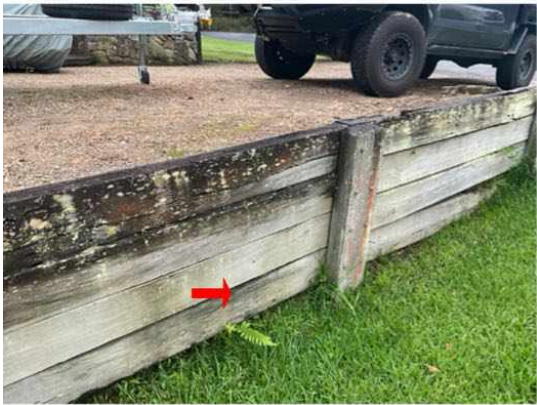
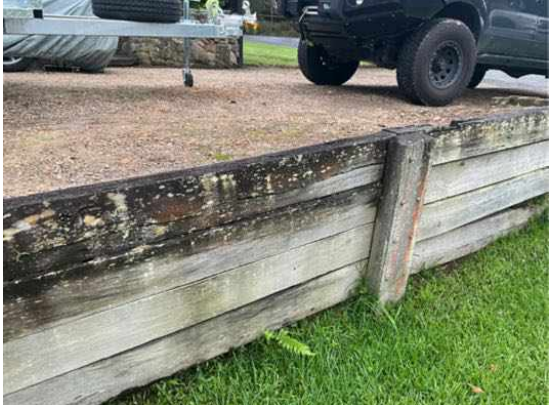
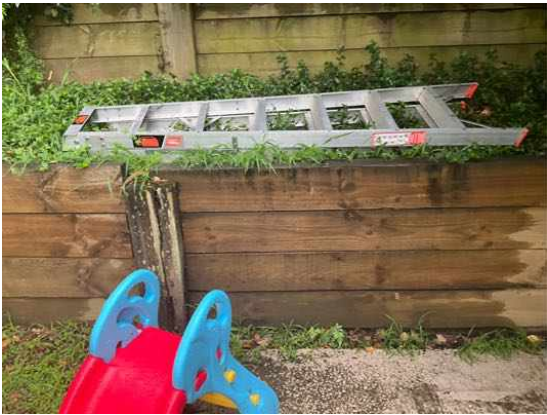
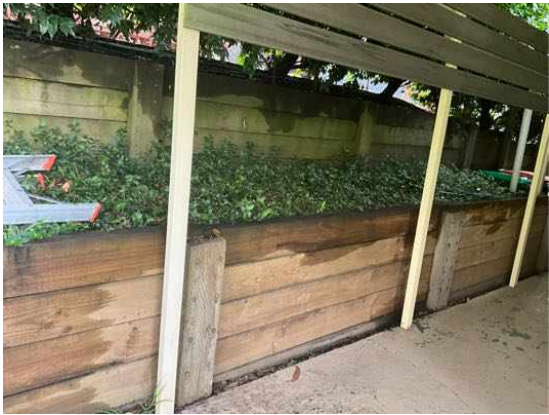
**Finding 6.02**

Building: Main Building  
Location: All Areas  
Finding: Timber on ground / conducive conditions to termite damage  
Information: Timber on the ground is indeed conducive to termite damage. Termites are known to thrive in moist environments, and wood in contact with soil or moisture is more susceptible to infestation.

To prevent this, it's important to keep timber elevated and away from direct ground contact. Regular inspections and proper termite control measures are also essential to protect your wooden structures from termite damage.

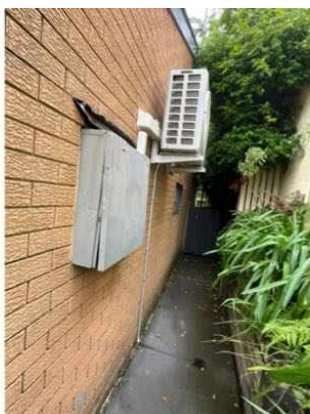
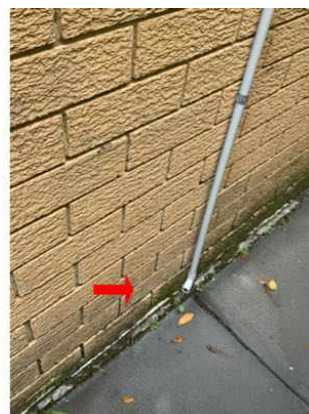
### Finding 6.03

Building:	Main Building
Location:	Exterior walls - right side
Finding:	Aircon - Excessive moisture conducive condition near Air-conditioner
Information:	<p>Excessive moisture near an air conditioner can indeed create conducive conditions for termites. Termites are attracted to damp and decaying wood, which can be found in areas with high moisture levels. To fix this issue:</p> <ol style="list-style-type: none"> <li>1. Fix Leaks: Check for any leaks or condensation around your air conditioning unit. Repair any damaged pipes, drains, or insulation that may be causing moisture buildup.</li> <li>2. Proper Drainage: Ensure that your air conditioner has proper drainage. Make sure the condensate drain line is clear and directed away from your home's foundation.</li> <li>3. Ventilation: Improve ventilation around the unit. Ensure that the area is well-ventilated to reduce humidity levels.</li> <li>4. Regular Maintenance: Schedule regular maintenance for your air conditioning system. This can help prevent leaks and ensure</li> </ol>

5. Please consult a HVAC Technician: HVAC (Heating, Ventilation, and Air Conditioning) technicians are trained to diagnose and

repair a wide range of air conditioning problems. They can handle issues with the cooling system, refrigerant, electrical components, and more.

6. Consult an appropriate and Qualified Professional: For severe moisture issues or persistent termite problems, consult with a

pest control professional who can provide targeted solutions.

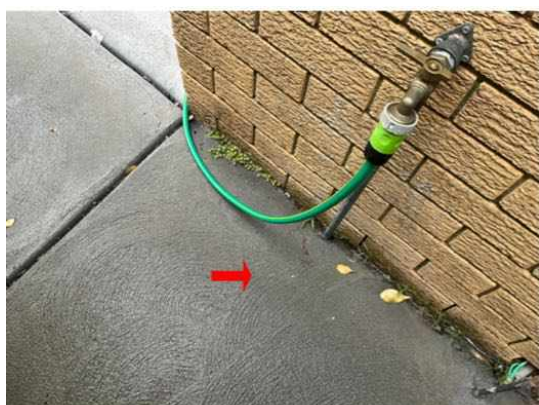
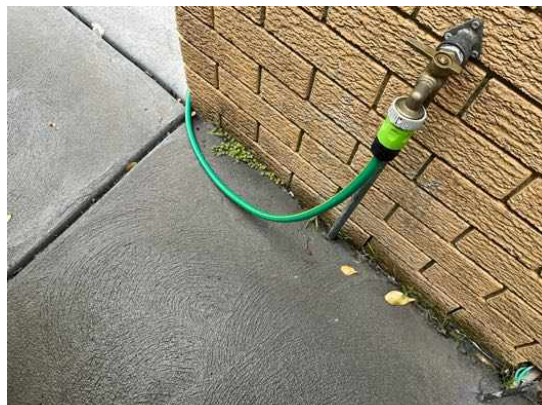
### Finding 6.04

Building:	Main Building
Location:	Exterior walls - right side
Finding:	No Drain under tap
Information:	There is no drain installed under the tap, leading to water accumulation and creating conducive conditions for timber pests. This defect needs immediate attention to prevent potential damage and pest infestation.

1. Water Accumulation: Without proper drainage, water can accumulate around the base of the tap, leading to persistent dampness in the surrounding area.
2. Timber Pest Infestation: The damp environment created by standing water is highly conducive to timber pests, such as termites and wood borers, which thrive in moist conditions and can cause significant damage to wooden structures.
3. Structural Damage: Prolonged exposure to moisture can lead to wood rot and deterioration of structural timber, compromising the integrity of the building.

4. Health Hazards: Persistent dampness can also promote mold and mildew growth, posing health risks to occupants.

5. Aesthetic Damage: Water stains and damage to finishes and materials around the tap area can detract from the appearance of the building and lead to costly repairs.

A licensed plumber or a qualified building contractor can address this defect by:

1. Assessment: Evaluating the area to determine the best approach for installing a proper drainage system under the tap.
2. Installation: Installing a drain that effectively channels water away from the base of the tap, preventing water accumulation and dampness.
3. Repair and Prevention: Inspecting and repairing any existing water damage and implementing measures to prevent future water accumulation and pest infestations.

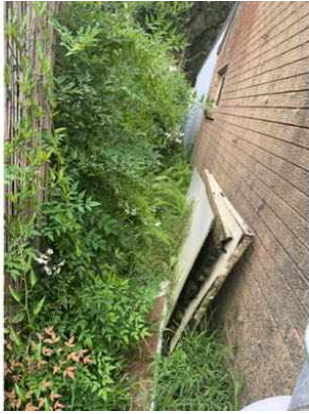
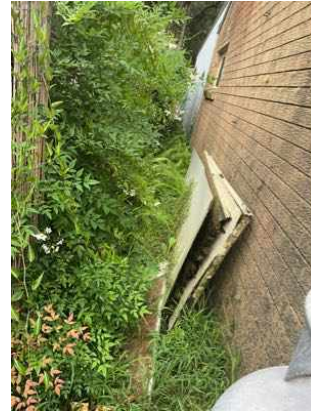
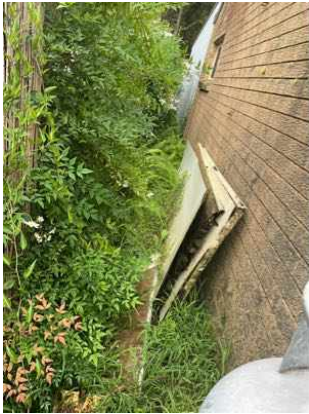
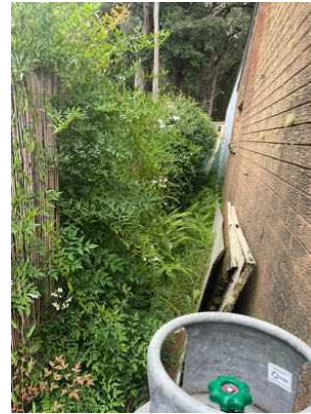
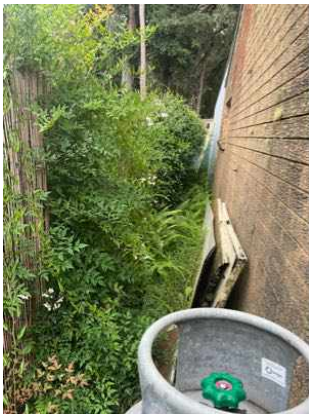
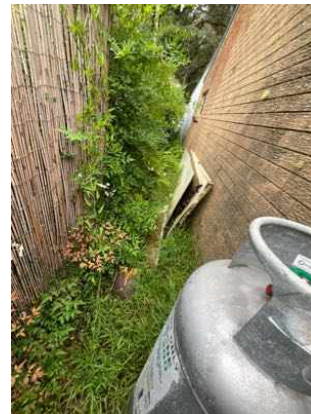
### Finding 6.05

Building:	Main Building
Location:	All Areas
Finding:	Dense vegetation around a property can increase the risk of termite infestation
Information:	The presence of dense vegetation around a property can increase the risk of termite infestation, as it provides a conducive environment for them. To address this, consider maintaining a clear space between the vegetation and your home. If you suspect a termite issue, it's advisable to consult with a licensed pest control professional for inspection and treatment.
