# Building and Timber Pest Inspection Report

Inspection Date: Mon, 16 Feb 2026

Property Address: 96 Lieutenant Bowen Rd, Bowen Mountain  
NSW 2753, Australia

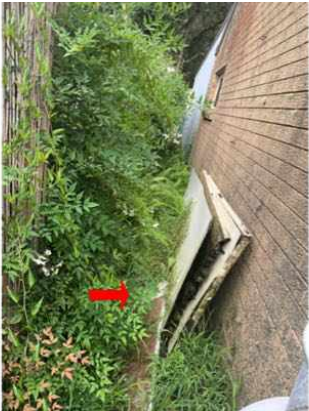
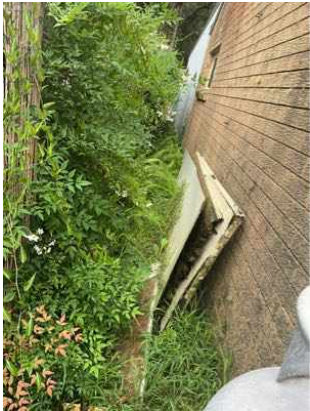
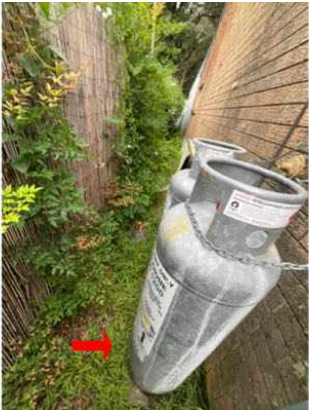
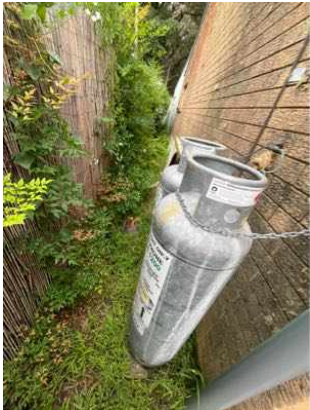
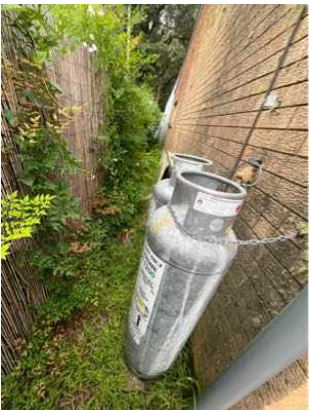
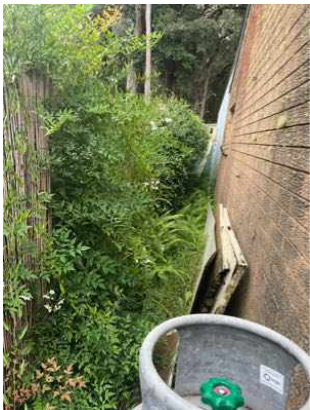
### Finding 6.06

Building:	Main Building
Location:	All Areas
Finding:	Bridging or Obstruction Conducive environment for Termites
Information:	Bridging of termite barriers occurs when termites bridge (usually by building a mud tunnel) a termite barrier or inspection inspection zone or where termites have a passage, allowing them to bridge the barrier.

Recommended moving obstructions away from the external walls for further and future inspections.

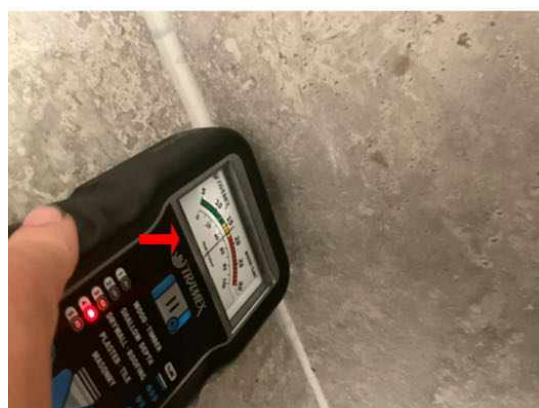
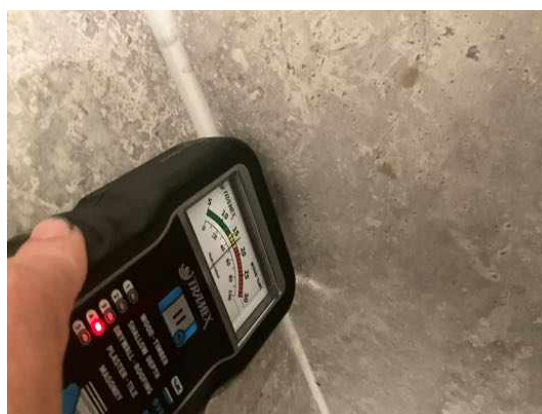
**Finding 6.07**

Building: Main Building  
Location: Ensuite  
Finding: Excessive moisture - Conducive to Timber pest  
Information: Excessive moisture can attract termites and produce conditions that promote fungal growth and wood decay.

Excessive moisture is generally caused by deteriorated inadequate or missing roof drainage leaking plumbing pipes or fixtures poorly plumbed HWS overflows or condenser units and poor site drainage.

Prior to any remedial works being performed a qualified plumber should be appointed to further inspect the property and to identify the cause of the excessive moisture. Works to remove affected building elements may then be necessary and should be performed by an appropriate tradesperson.

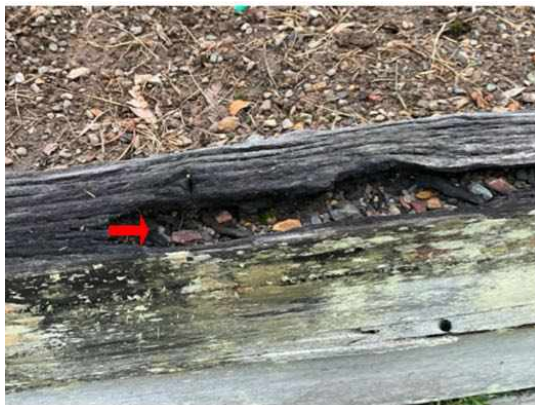
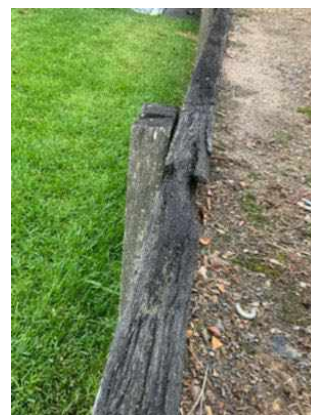
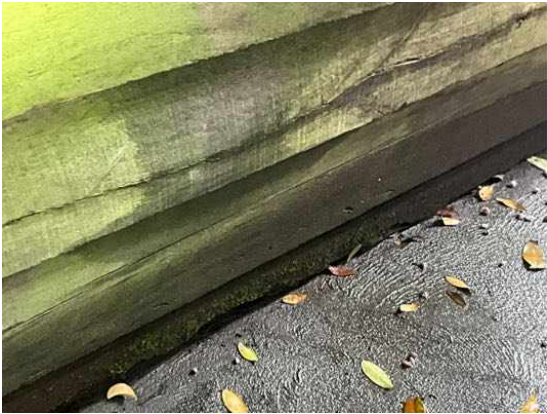
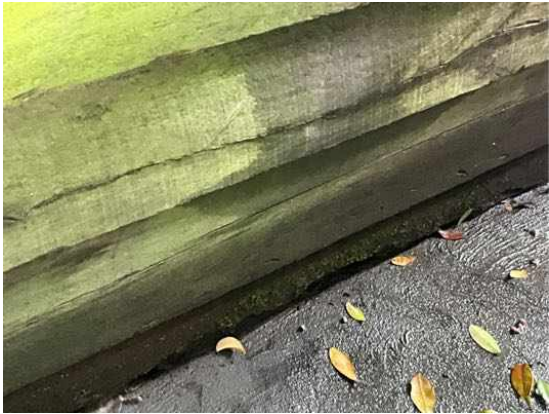
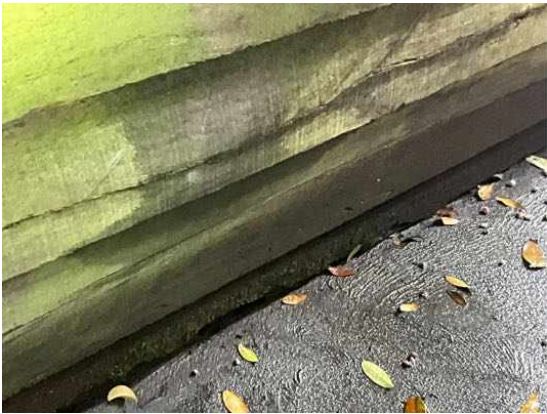
### Finding 7.01

Building:	Main Building
Location:	All Areas
Finding:	Wood rot
Information:	This building element shows evidence of wood rot. Wood rot, also known as Fungal Decay, occurs when timbers and other cellulose building materials are exposed to

damp conditions on an ongoing basis. This could be the result of exposure to weathering over a prolonged period of time, or the attraction of excessive moisture from other abutting building materials. Contributing factors also include poor air ventilation in the area.

Wood rot is often associated with general damp problems and is evidenced by a 'musty' smell or mould and mildew occurring on surfaces. If left unmanaged, damp conditions can lead to further health problems and the decay of timbers will continue.

Early intervention and regular maintenance, particularly of exterior timbers, will prolong the useful life of these building elements. Prior to any works being performed, the cause of the moisture that has created the visible wood rot should be identified and addressed in a suitable manner. Replacement of affected timbers may then be a necessary step in protecting surrounding building elements from such deterioration.

A qualified plumber may be appointed to assess the cause of excessive moisture and to provide advice on any remedial works as required. A qualified carpenter or registered builder may also be required to replace affected building materials.

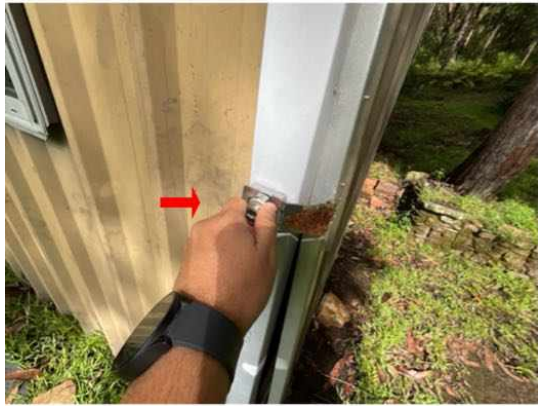
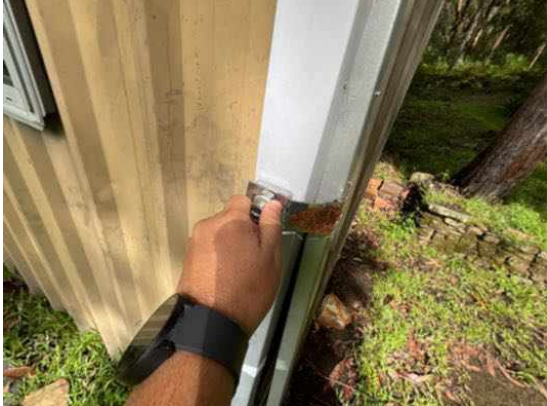
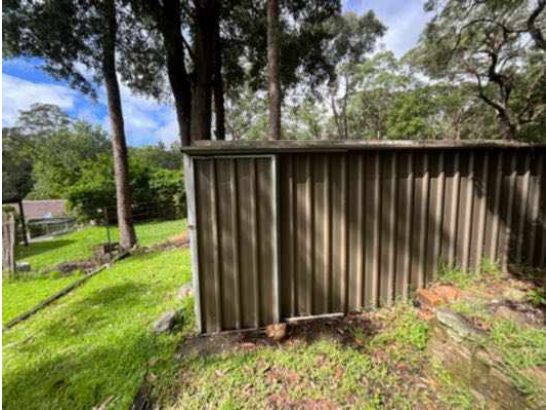
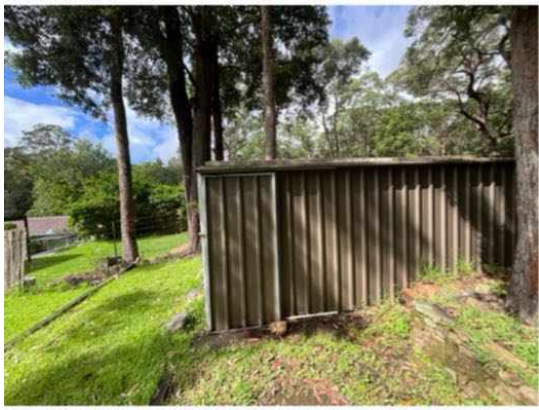
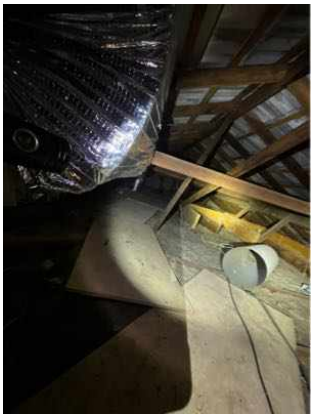
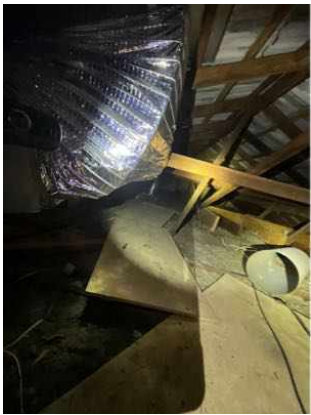
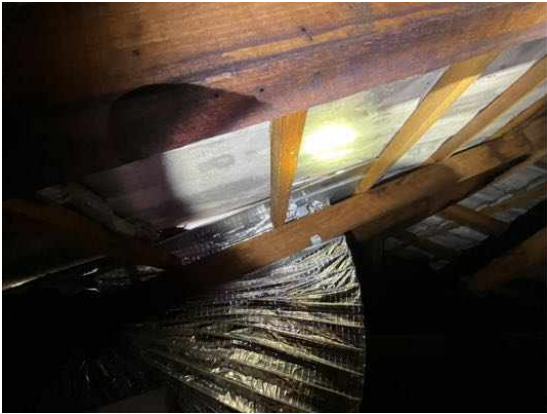
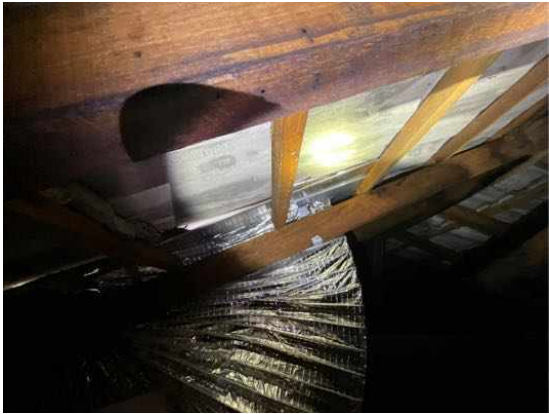
#### Noted Item

Building: Main Building  
Location: All Areas  
Finding: Additional Photos - Obstructions and Limitations  
Information: These photographs are an indication of the obstructions and limitations which impeded full inspection of the property at the time of inspection. These obstructions can hide an array of defects and should be removed to allow full inspection to be carried out. A re-inspection is recommended once the areas are made accessible.

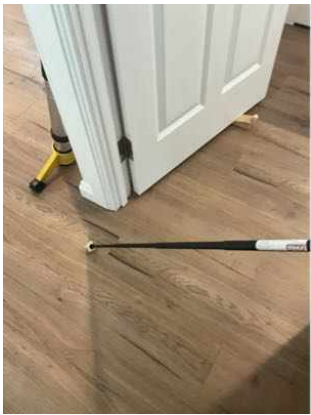
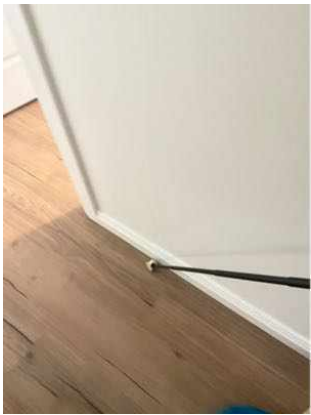
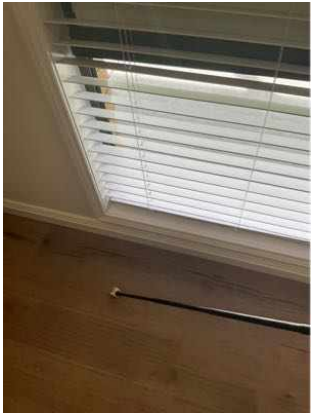
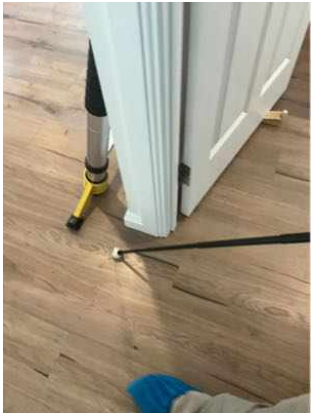
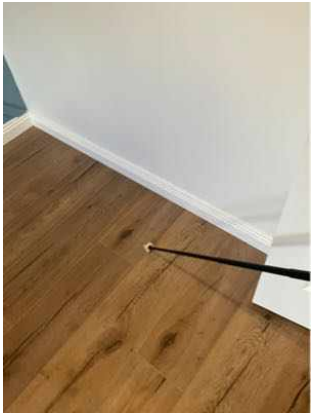
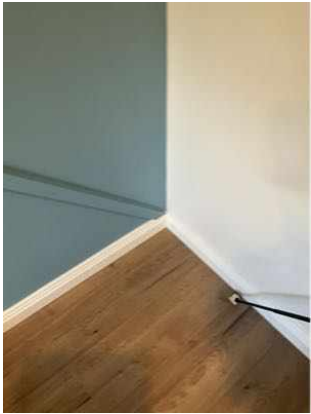
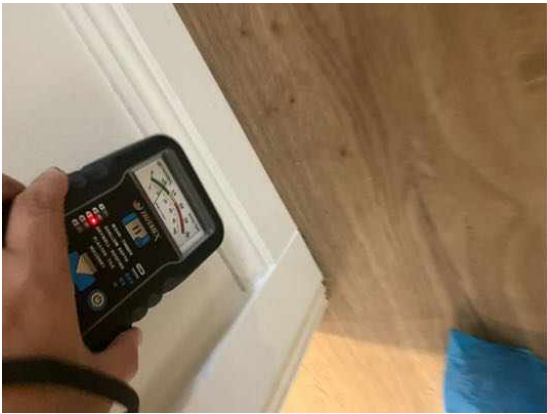
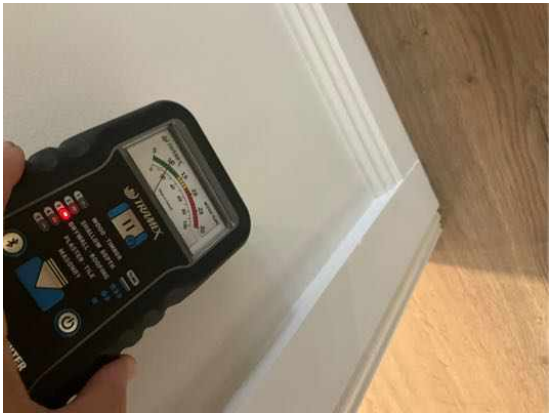
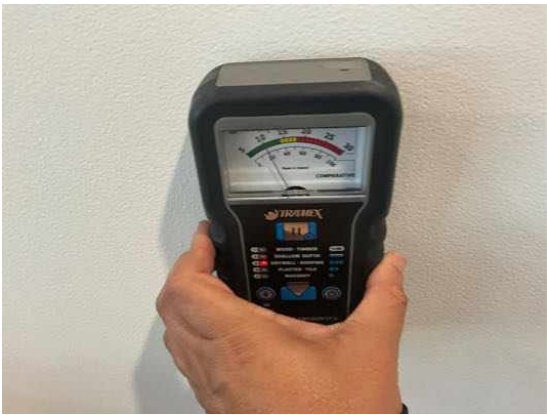
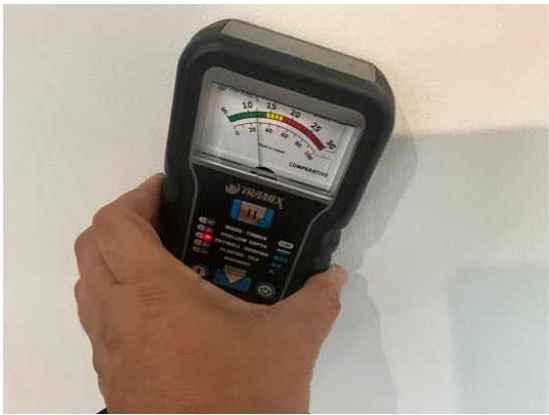
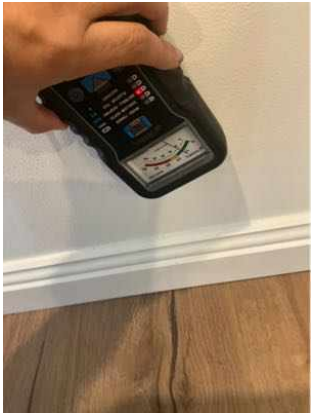
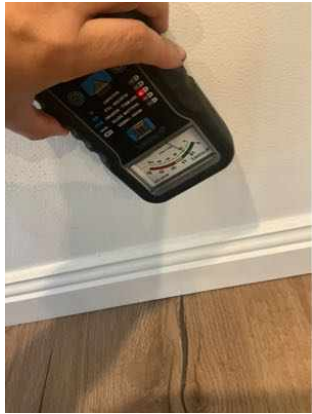
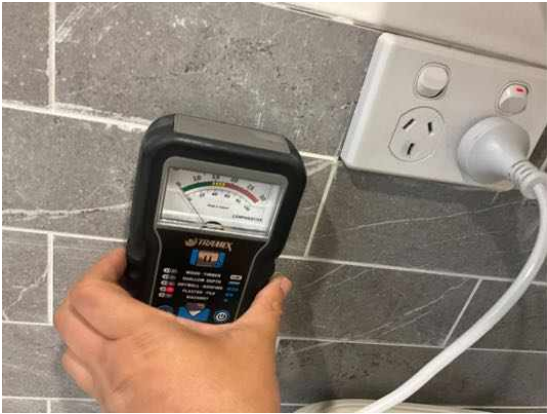
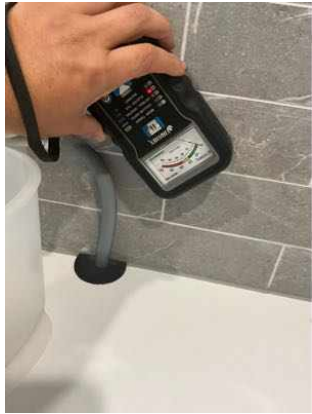
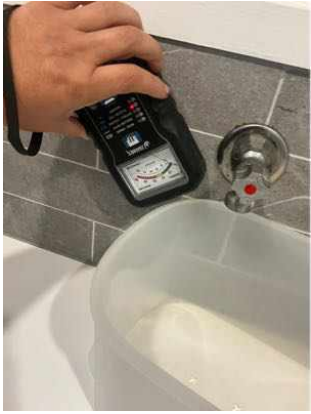
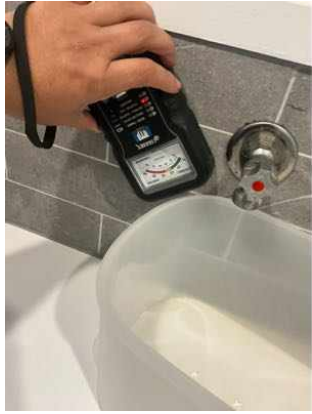
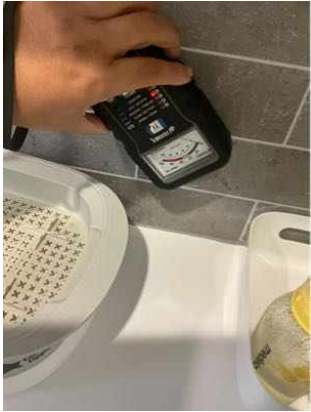
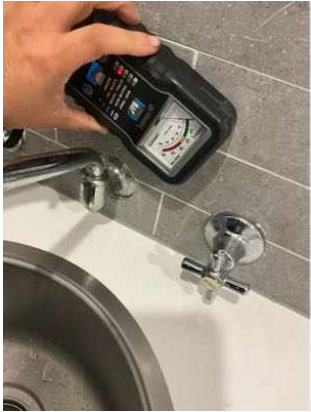
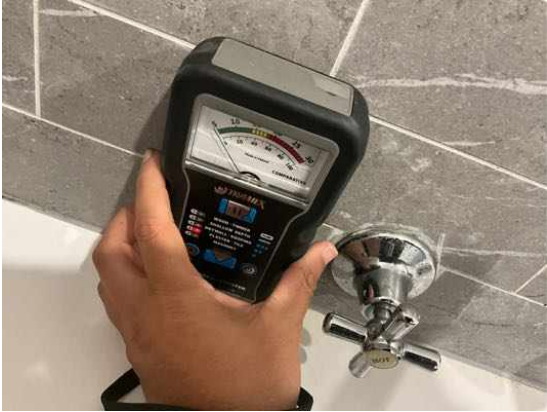
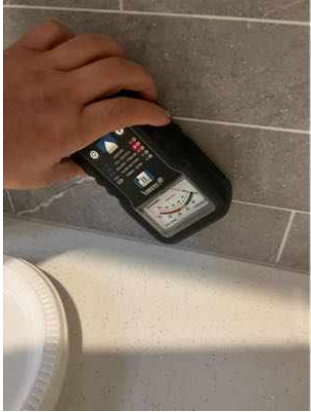
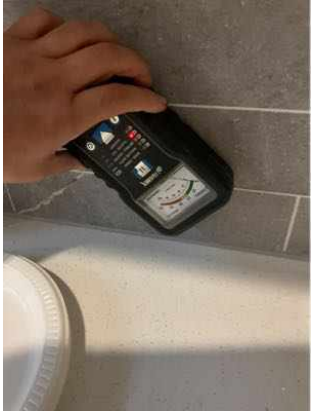
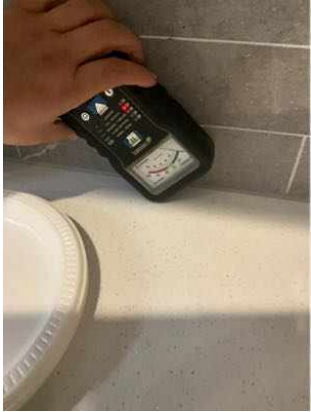
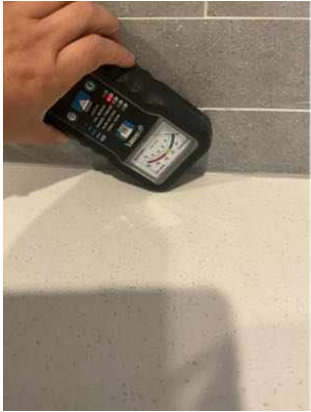
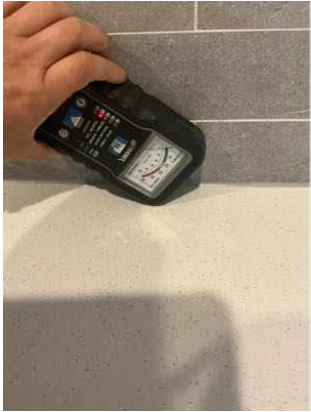
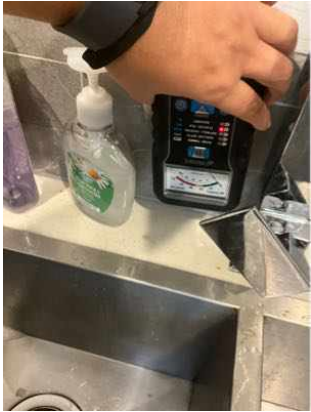
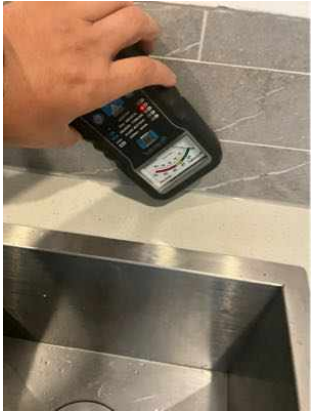
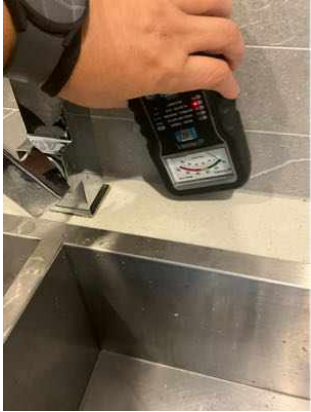
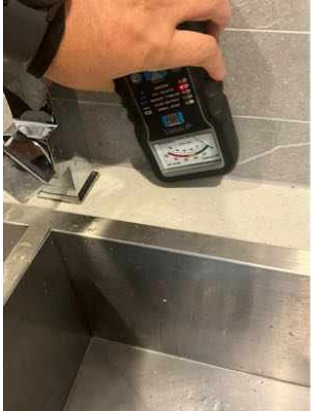
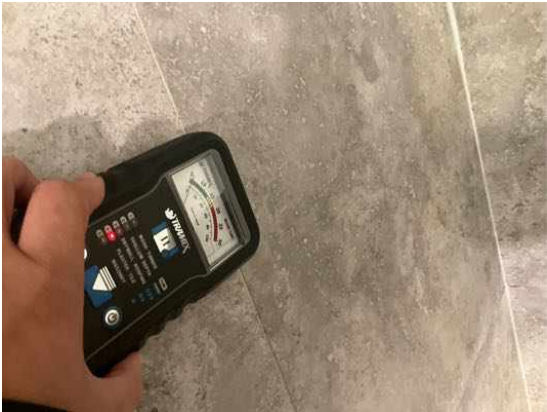
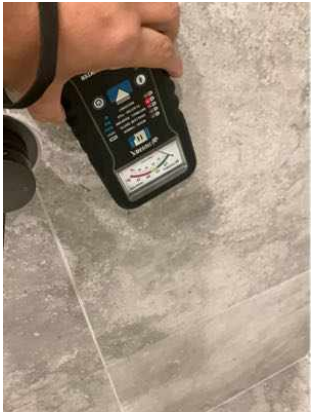
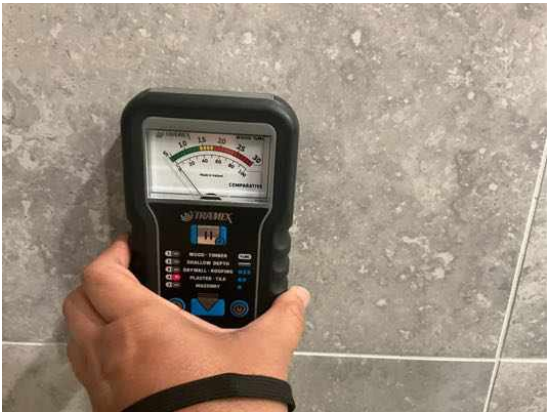
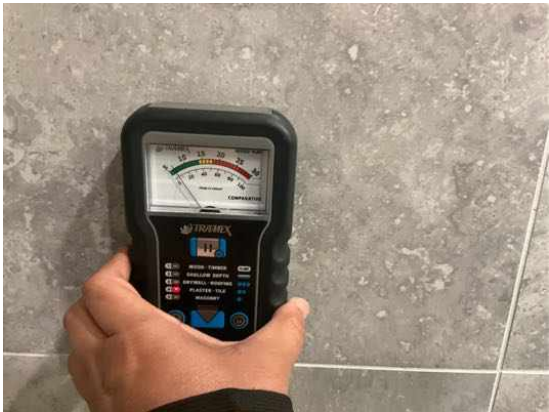
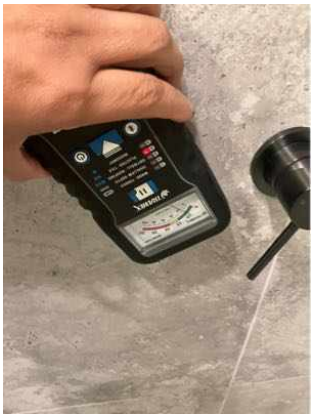
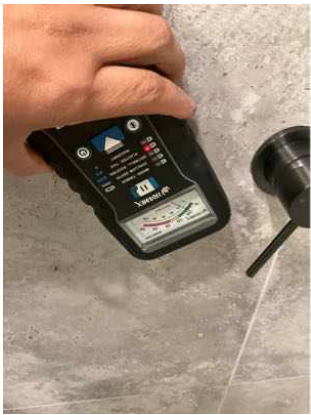
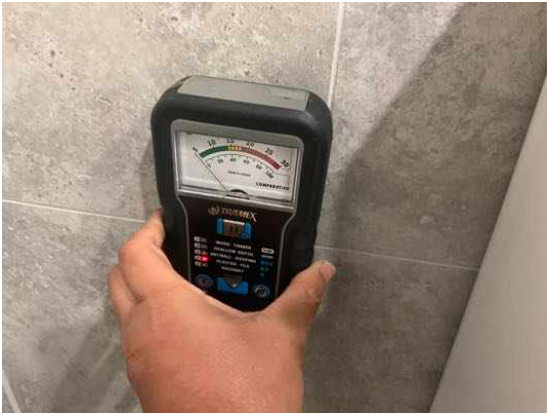
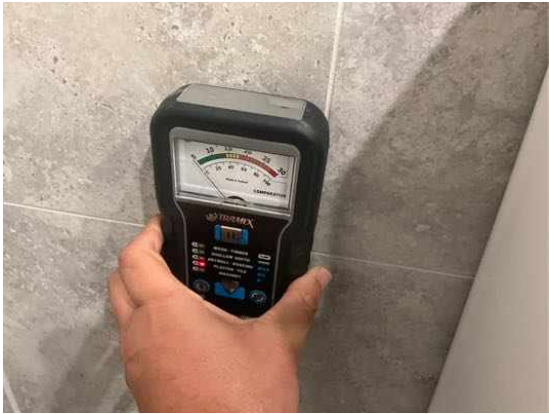
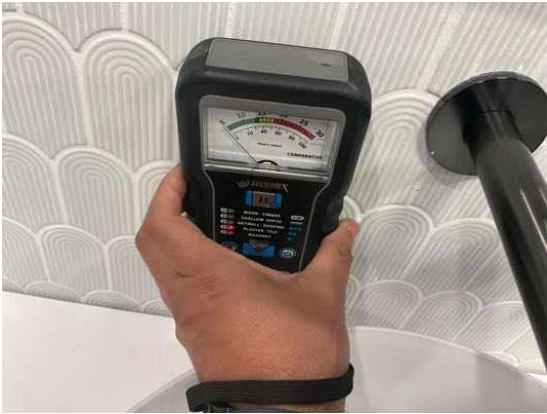
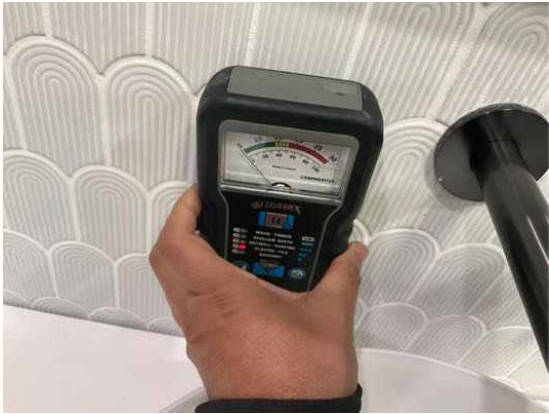
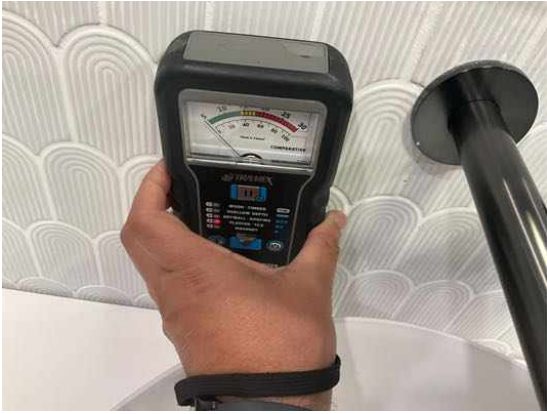
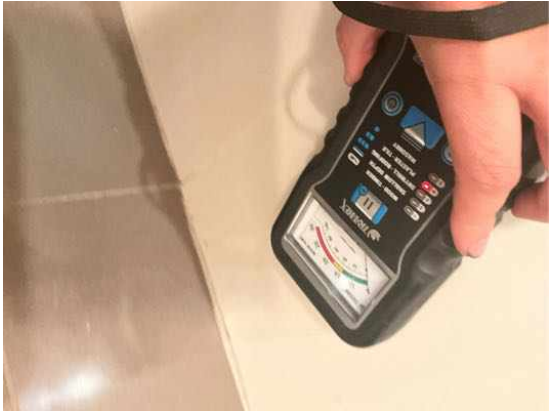
Building: Main Building  
Location: All Areas  
Finding: Additional Photos  
Information: Additional photos are provided for your general reference

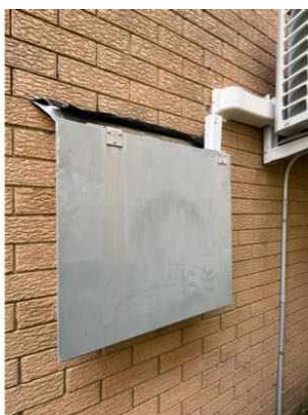
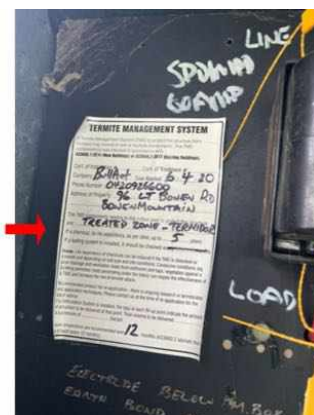
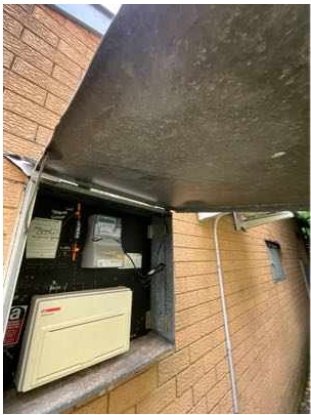
- Building: Main Building
- Location: Exterior walls - right side
- Finding: Evidence of Termite Management System - Durable notice / Legible Sticker - seek further information
- Information: The application of a pre & post-construction chemical termite barrier is highly recommended for all properties. Such barriers are highly effective in preventing termite attack on any timber building elements throughout the property.

A durable notice placed in the switchboard unit to indicate termite barriers at the time of inspection.

Client must seek further information from the vendor or real estate agent if the conditions of termite management systems were maintained as per the label or seek advise from licensed pest controller.
