# Building and Timber Pest Inspection Report

Inspection Date: Tue, 20 Jan 2026

Property Address: unit 19/1740 Pacific Hwy, Wahroonga NSW  
2076, Australia

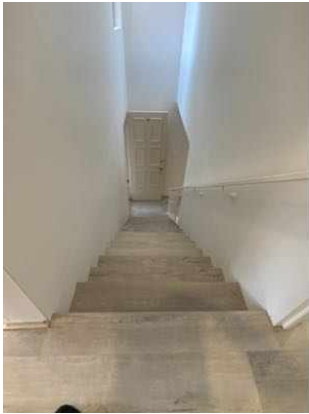
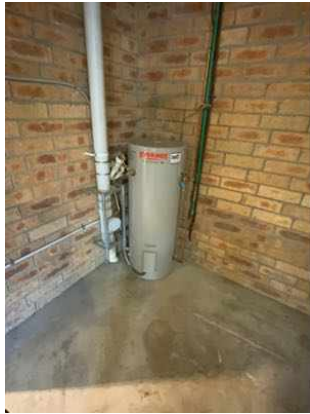
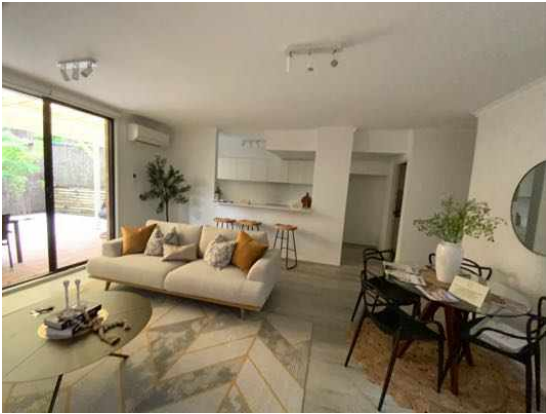
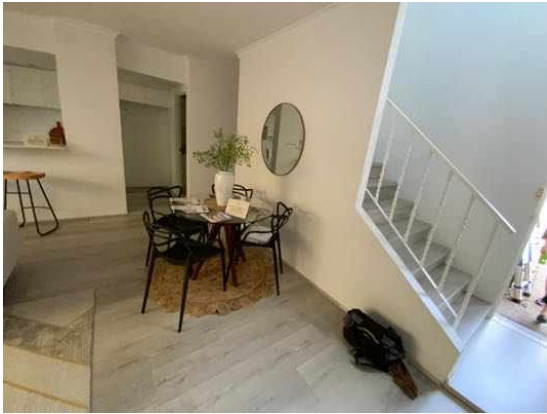
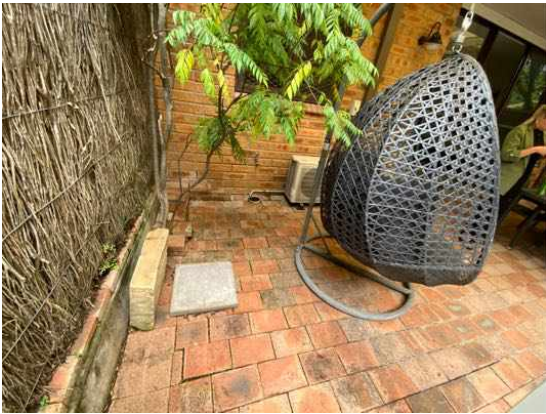
Information: These photographs are an indication of the obstructions and limitations which impeded full inspection of the property at the time of inspection. These obstructions can hide an array of defects and should be removed to allow full inspection to be carried out. A re-inspection is recommended once the areas are made accessible.
