Building and Timber Pest Inspection Report

Inspection Date: Wed, 14 Jan 2026

Property Address: u5/6 Runway Dr, Marcoola QLD 4564,
Australia

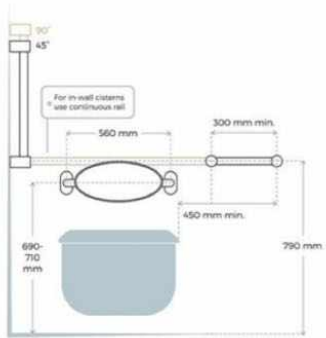
DDA TOILET AS1428.1 WHEELCHAIR ACCESSIBLE (FRONT)

Building:	Main Building
Location:	Bathroom
Finding:	Toilet facilities compliant
Information:	During the inspection the toilet facilities are assessed against AS 1428 - 2009 for compliance. All elements comply except for the vanity basin, which is 60mm above the specified height of 840mm.

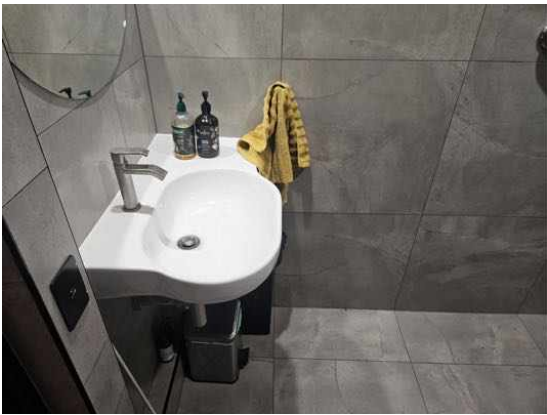
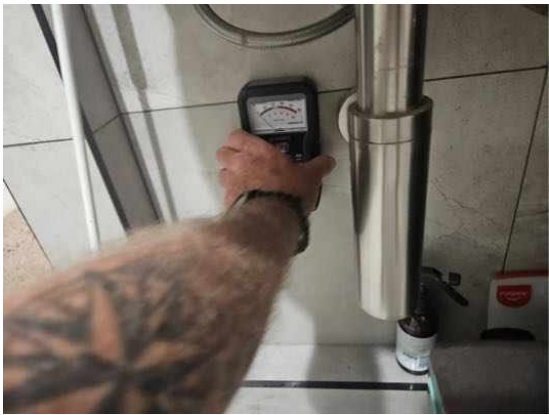
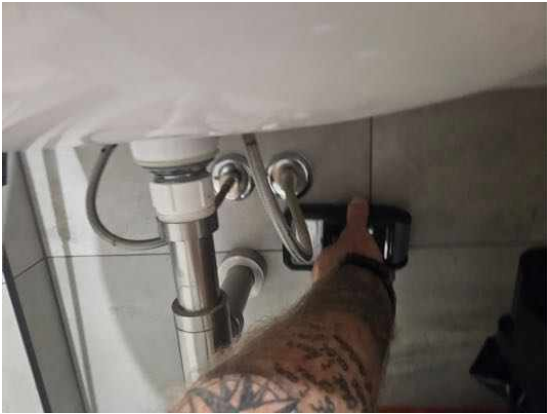
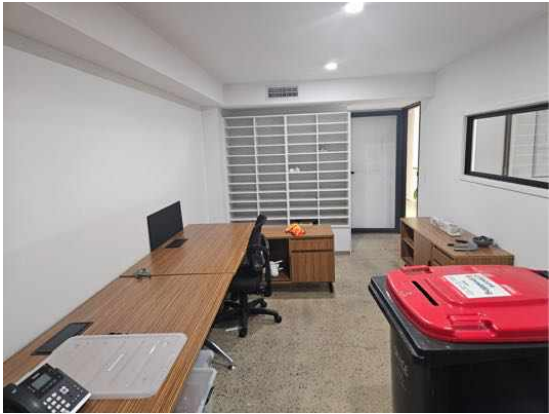
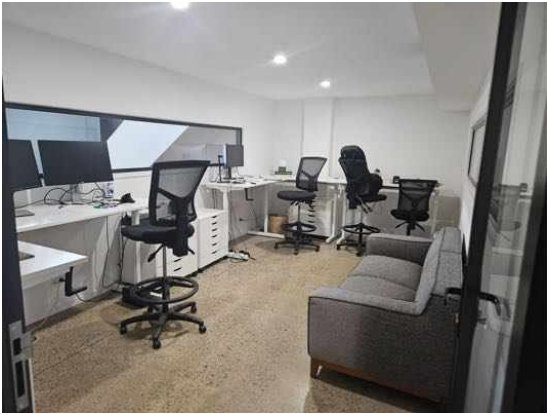
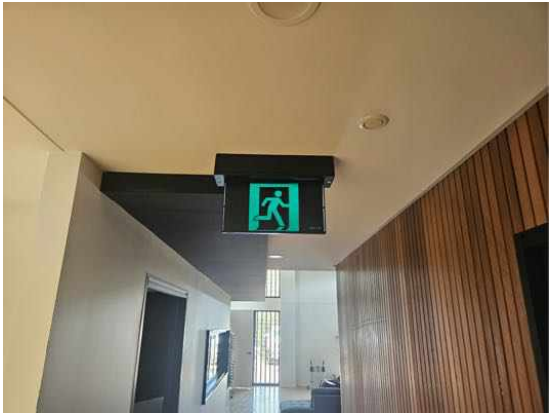
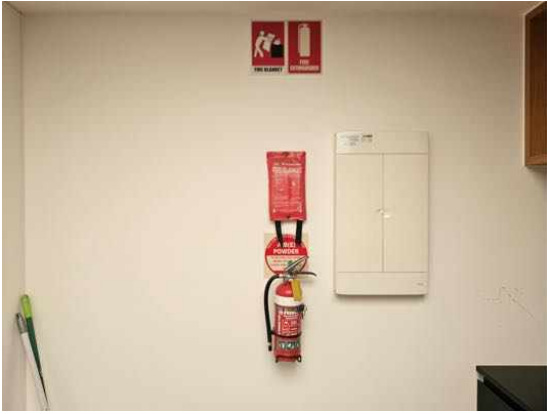
Information: These photographs are an indication of the obstructions and limitations which impeded full inspection of the property at the time of inspection. These obstructions, some of which cannot be removed, can hide an array of defects and, where possible, should be inspected when removed. A re-inspection may be carried out should it be required, once the areas are made accessible.
