# Building and Timber Pest Inspection Report

Inspection Date: Mon, 30 Mar 2026

Property Address: 55 Glenfields Blvd, Mountain Creek QLD  
4557, Australia

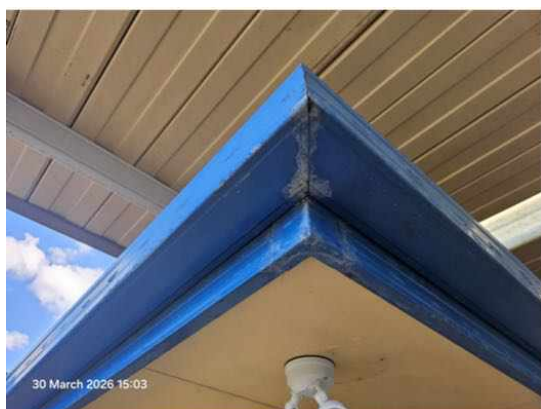
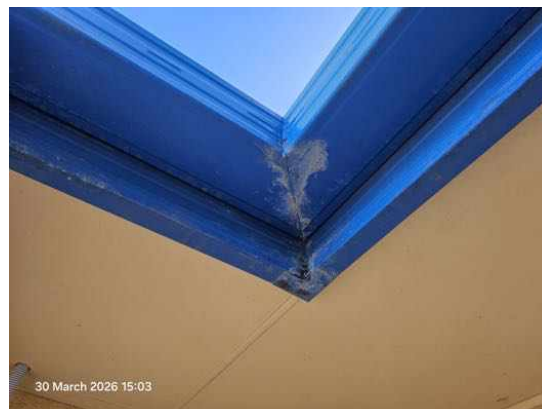
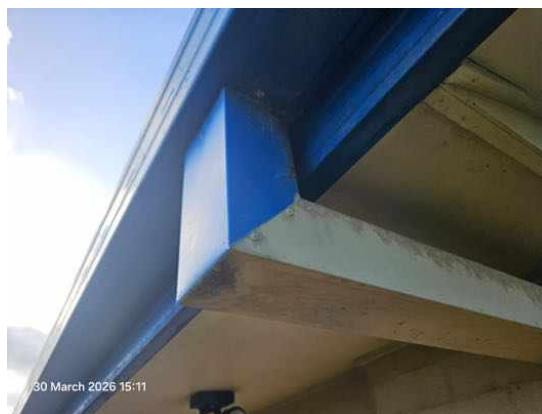
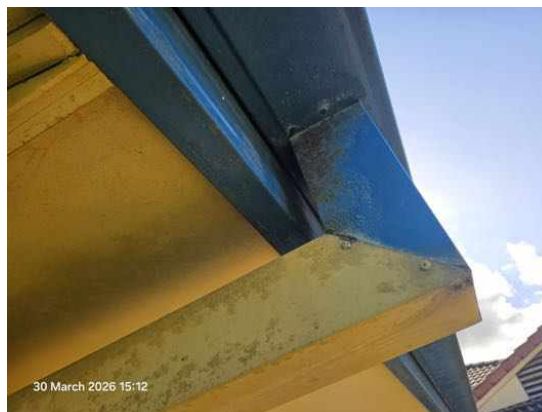
Building:	Main Building
Location:	All Areas
Finding:	Roof gutter rusted
Information:	The sections of the fascia and roof gutter shown in the photos has areas of surface rust visible.

Rusted roof plumbing will generally develop holes and leaks that can affect other building elements with poor drainage of storm water. Poorly drained roof areas will also lead to damp conditions surrounding the base perimeter of the building which, if left unmanaged, can lead to a range of secondary building defects.

Repair of rusted roof plumbing and gutters is required in order to maintain the roof drainage system in a fully operational level. To further maintain these areas, gutters should be cleaned frequently, allowing the avoidance of any partial blockages. They can also have an effect on the moisture levels in the soil against the building edge, this could become a conducive condition for timber pests.

A licensed painter could be appointed to undertake these works. It is advised that such works be completed in the short term to prevent any further damage and deterioration.

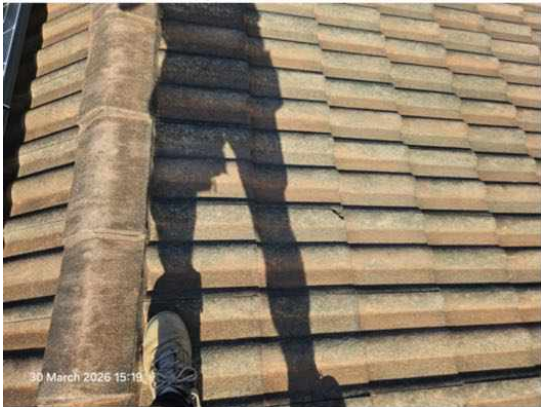
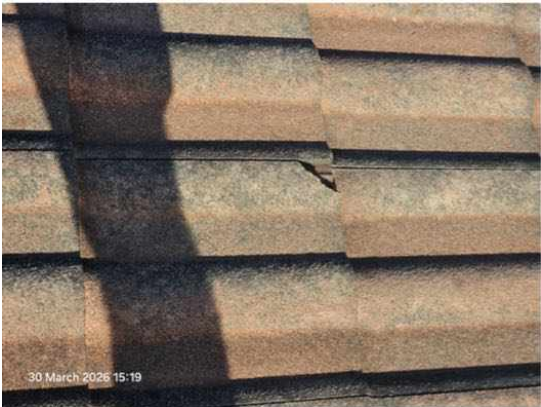
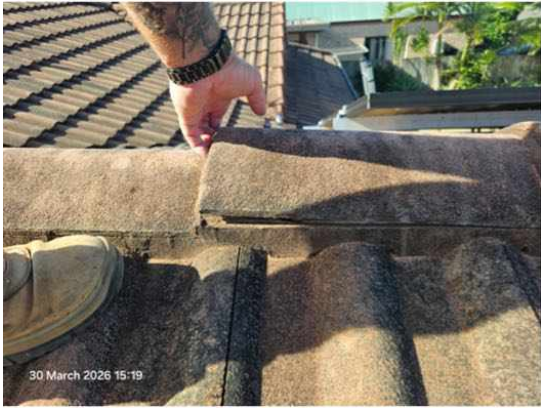
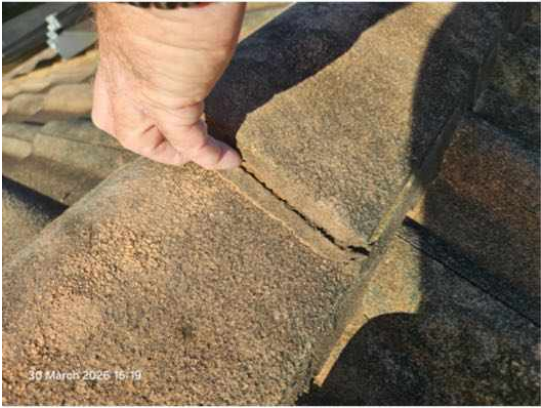
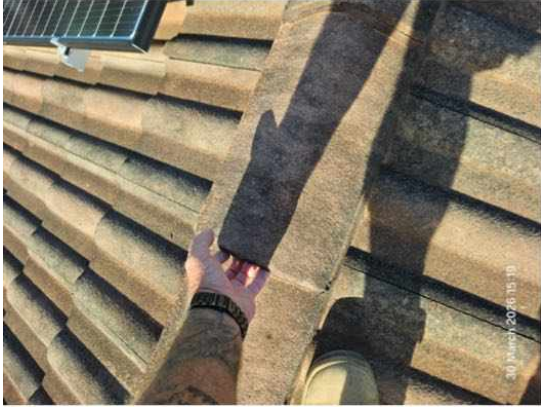
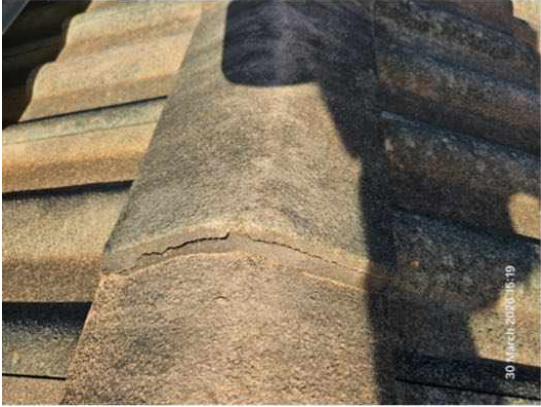
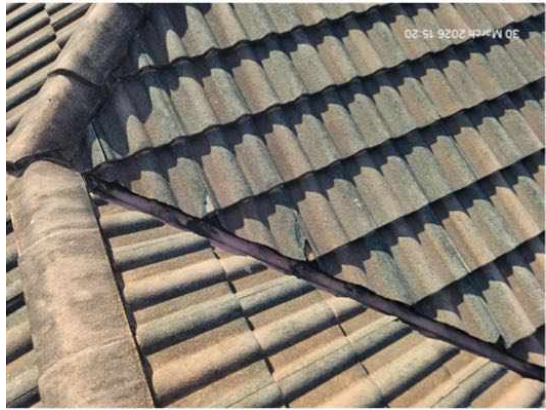
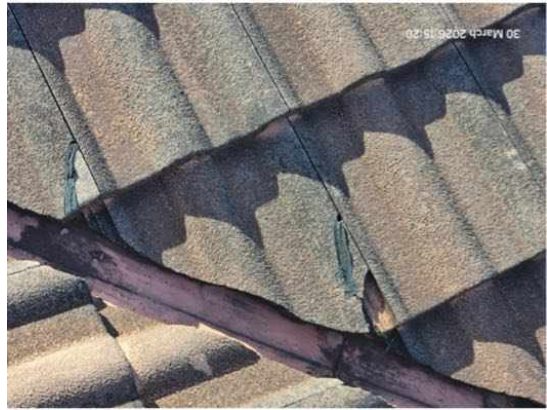
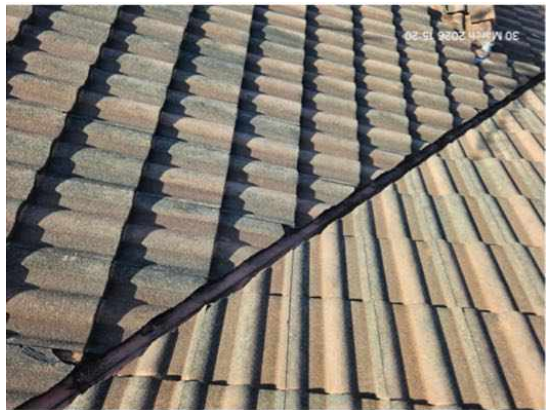
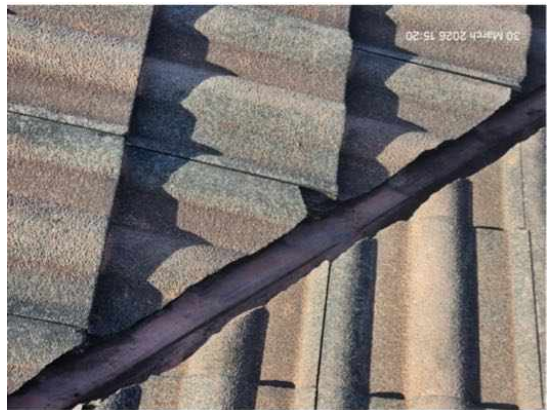
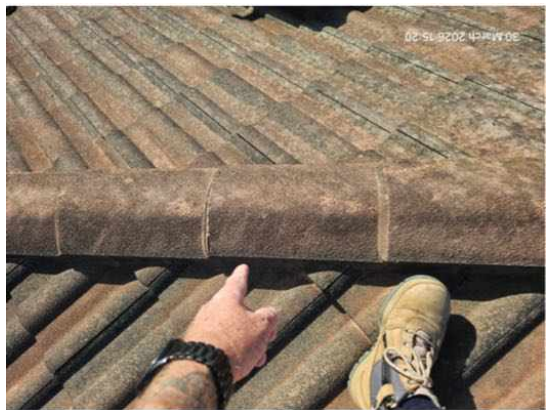
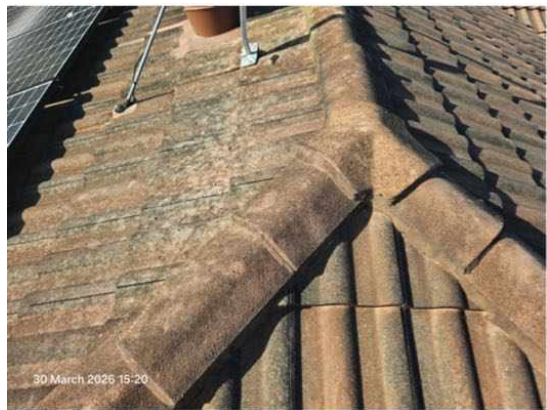
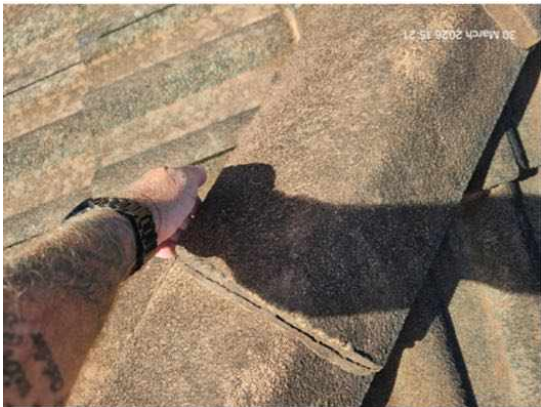
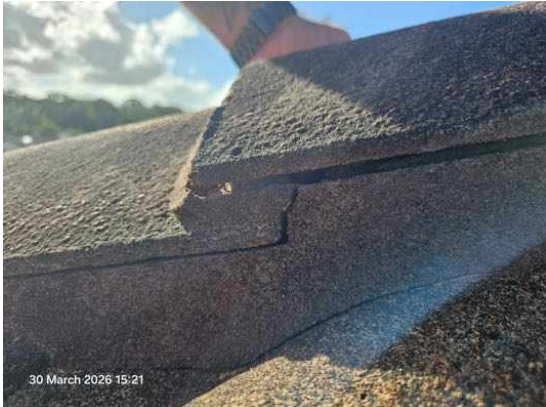
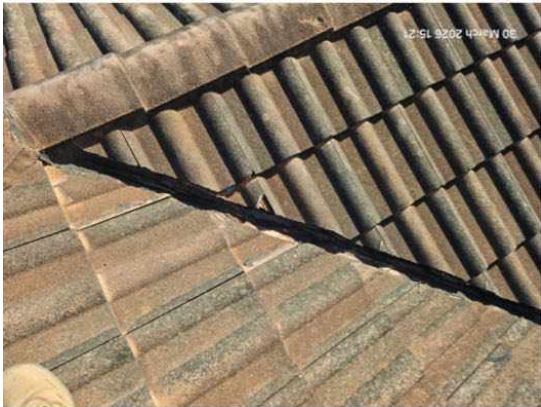
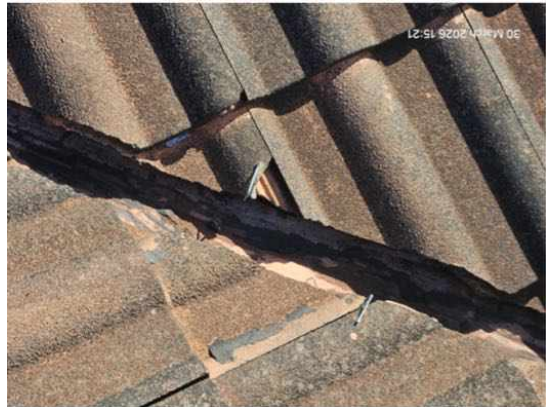
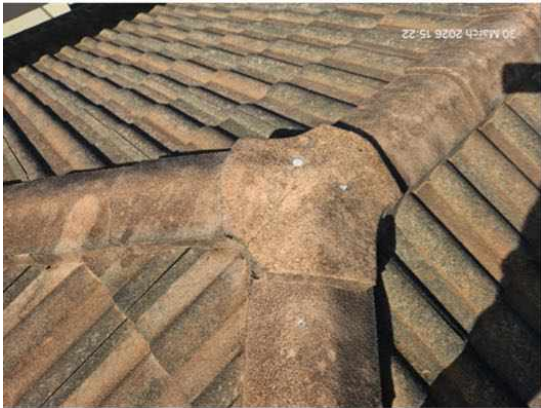
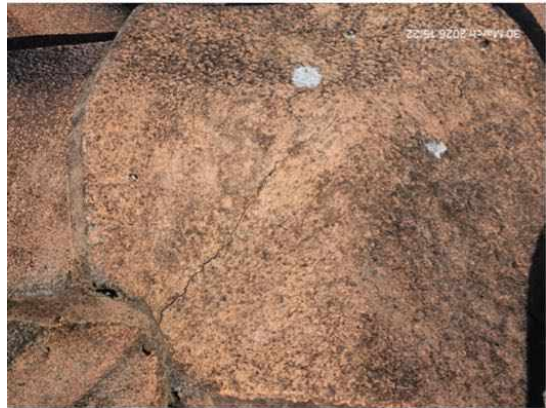
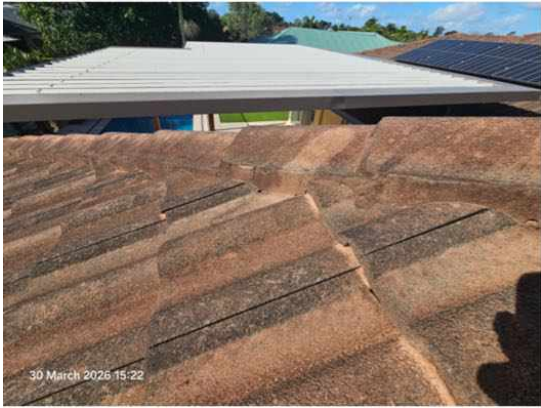
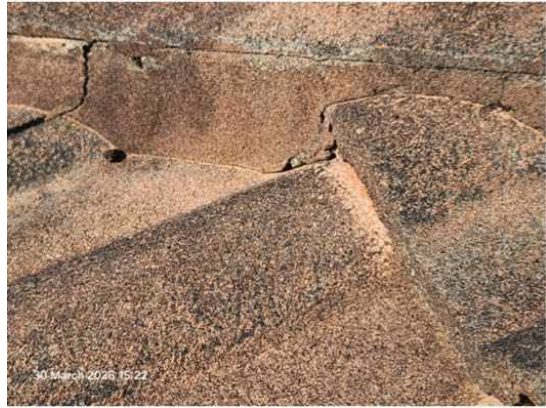
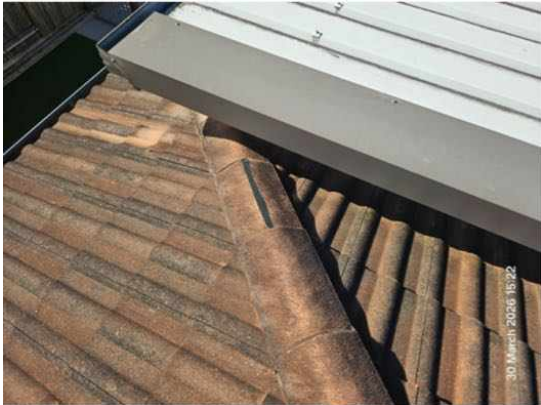
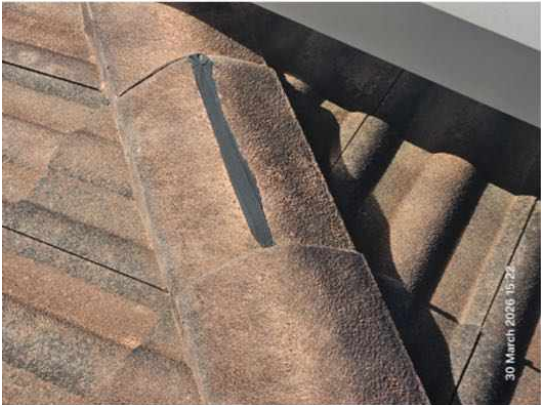
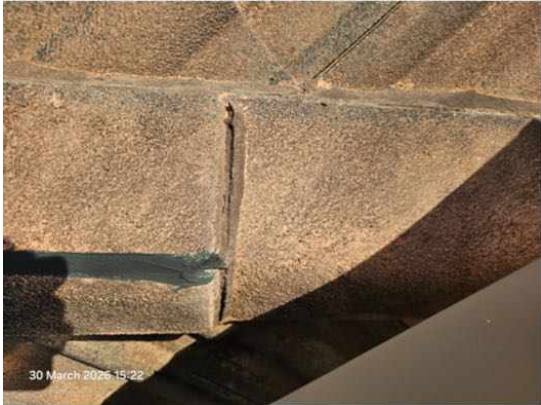
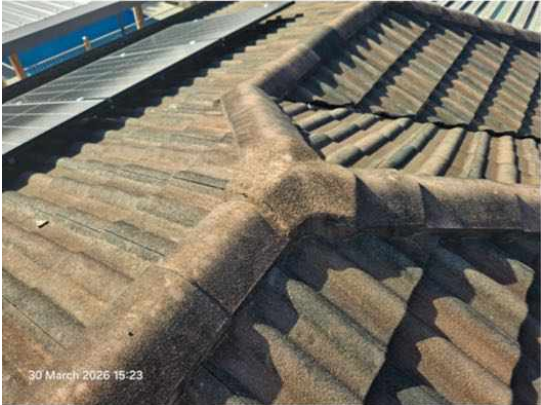
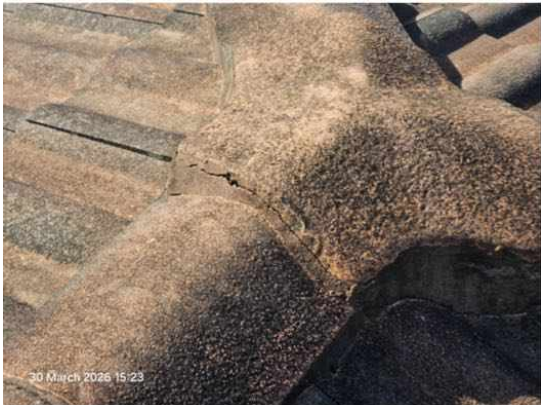
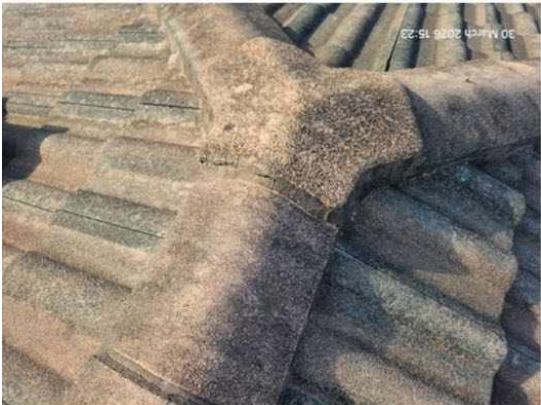
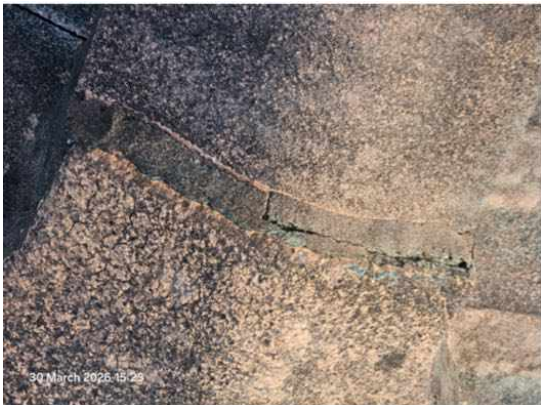
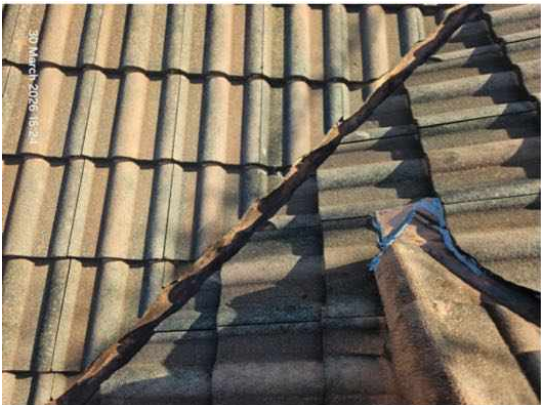
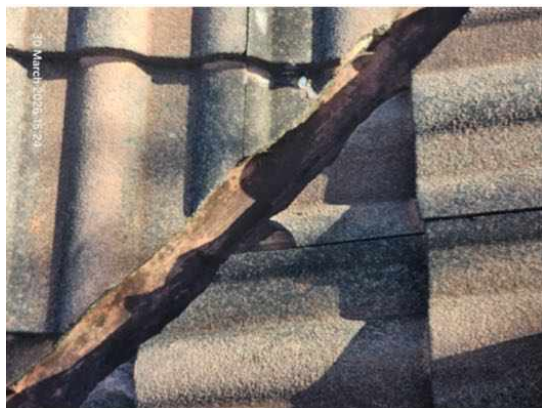
### Finding 3.02

Building:	Main Building
Location:	All Areas
Finding:	Roof tiles - bed and point
Information:	Upon inspection of the exterior roofing, the majority of roof tiles were considered to be in a fair to good condition. While weathering of the tiles is consistent with the age of the property, maintenance works are required. The ridge cap tiles require re-bedding and pointing. Some ridge tiles were tested for fixing adherence, an of the tiles tested they were found to be loose showing that the bedding has reached its service life. There were chipped tiles noted.

This has the potential to become a major defect if not rectified in the short term. The

roof has sisalation fitted under the tiles, which will eliminate much of the leak risk.

A roofing tiling contractor should be engaged to carry out the required repairs.

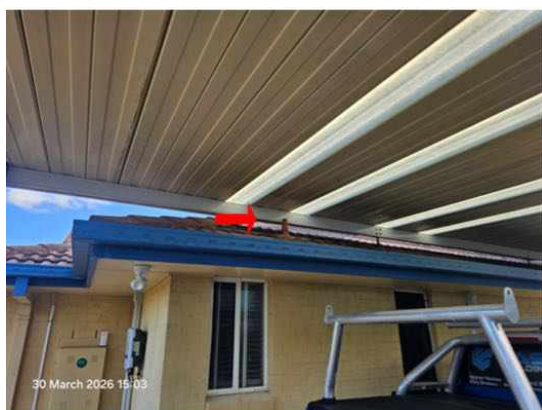
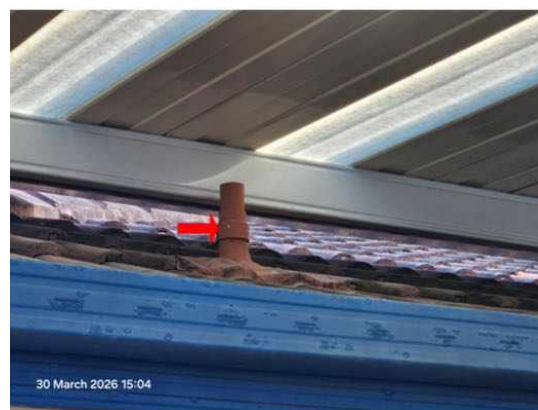
### Finding 3.03

Building:	Main Building
Location:	Carport
Finding:	Sewer vent altered
Information:	It was noted during the inspection that the sewer vent pipe at the carport has been cut short to accommodate the carport roof. It is possible that this should have been taken through the carport roof and flashed above. There are particular rules and specifications for sewer vents pertaining to position and height above the finished roof surface.

It is recommended that a licensed plumber be engaged to assess and make alterations accordingly to make compliant.

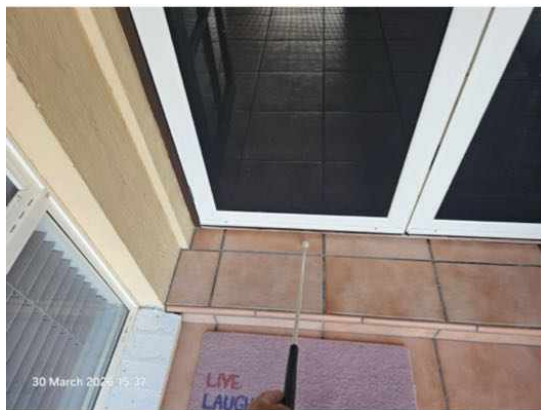
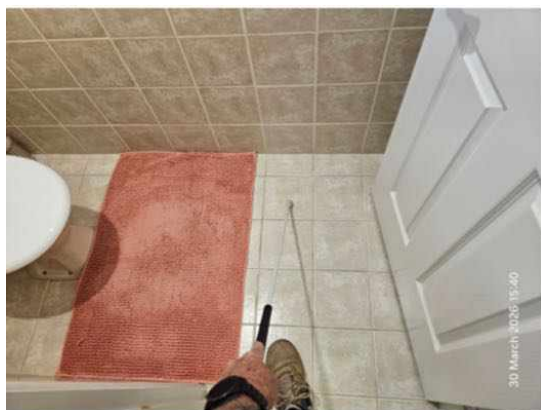
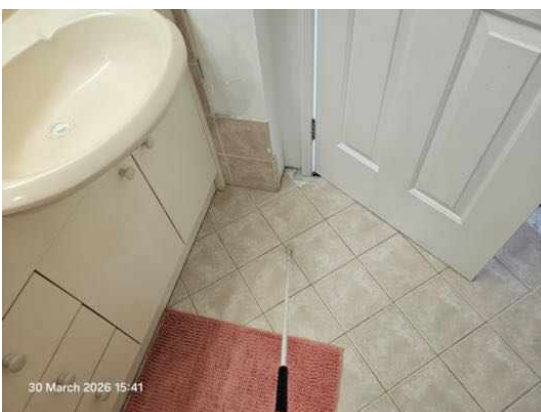
### Finding 3.04

Building:	Main Building
Location:	As shown
Finding:	Tiles - Drummy and / or cracked
Information:	Drummy and / or cracked tiled areas were identified at the time of inspection.

The term 'drummy' refers to tiles that have become detached from their fixing, despite otherwise being in relatively good condition. Such defects are generally caused by

physical or moisture damage to the area. Drummy tiled areas may also be a direct result of poor workmanship during the construction process.

Tiled areas may swell and shrink with changes in air humidity if the area has sustained moisture damage. Any exposure to moisture is capable of causing tiled areas to become drummy and/or cracked over a prolonged period of time. Drummy tiled areas generally require removal and replacement of affected tiles.

Specialist trades are available for these types of services. A licensed builder may be required to undertake works if damage is extensive or if secondary building defects have resulted. Otherwise, it is advised that a tiling contractor be appointed to perform works as necessary.

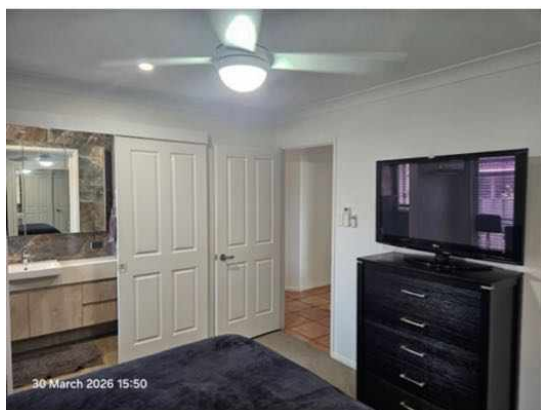
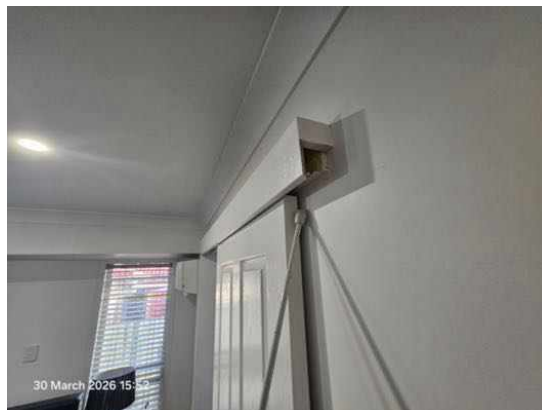
Finding 3.05

Building:	Main Building
Location:	Bedroom 3
Finding:	Cavity sliding door - defective
Information:	During the inspection the cavity slider to the ensuite of bedroom 3 was noted as being damaged at the end of the track. There is no stop fitted and the door has broken the pelmet. It falls off the track if not controlled.

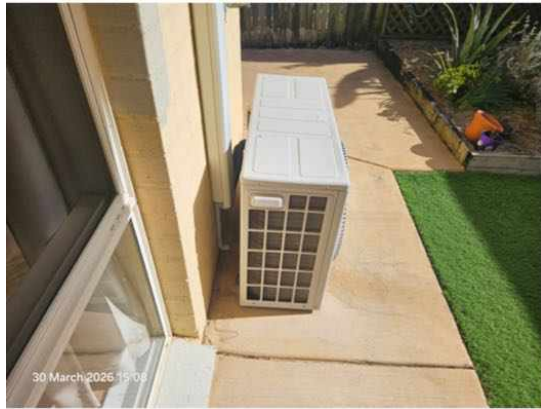
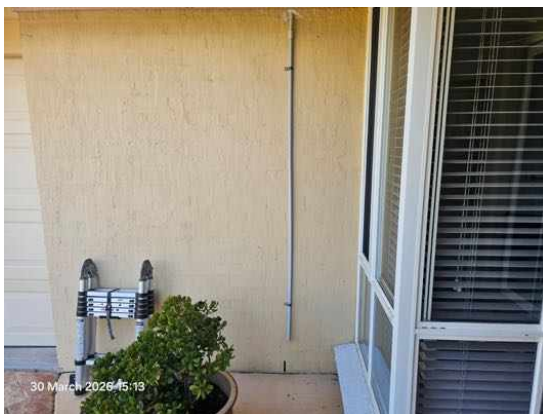
Building:	Main Building
Location:	As shown
Finding:	Air conditioner - Disconnected drain
Information:	The Air Conditioner (A/C) overflow was found to be disconnected from storm water drainage and could create excessive moisture in the surrounding area.

Such leaking creates an environment which is conducive to an array of defects, including water damage to associated building elements and the attraction of termite or timber pest infestation.

It is recommended that a licensed plumber be appointed to connect the A/C overflow to a drainage source in order to prevent such an environment from being created. An alternative is to extend the overflow further into the garden away from the building perimeter.

These minor works should be carried out in the short term.

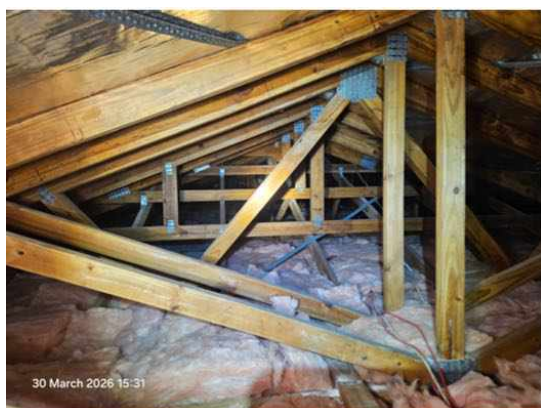
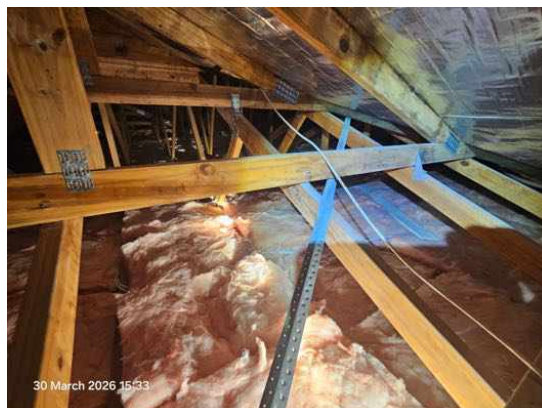
Other trades and services will enquire access to the ceiling at different times and movement in and out of the area needs to be freely available. This will also restrict the ability for pest control to manage timber pest and general pest inspections in the future.

The client should consider the installation of an alternative access hatch in a location that enable access to the main roof area.

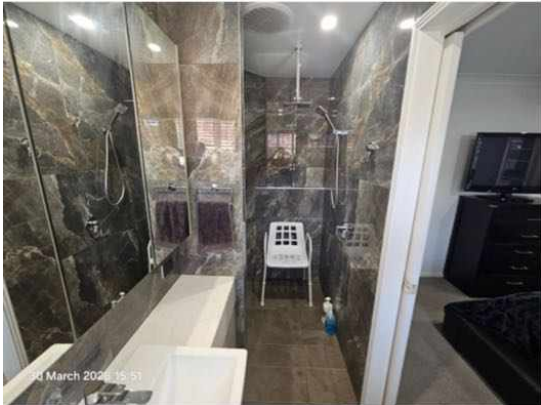
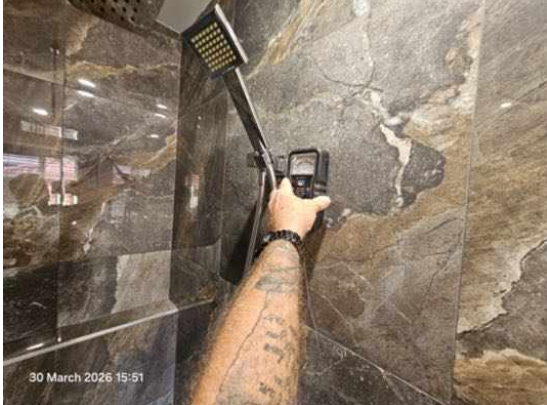
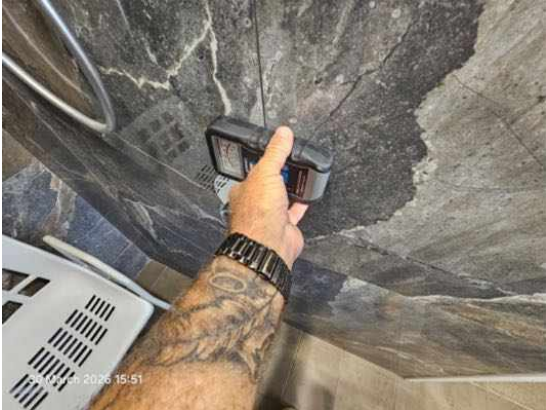
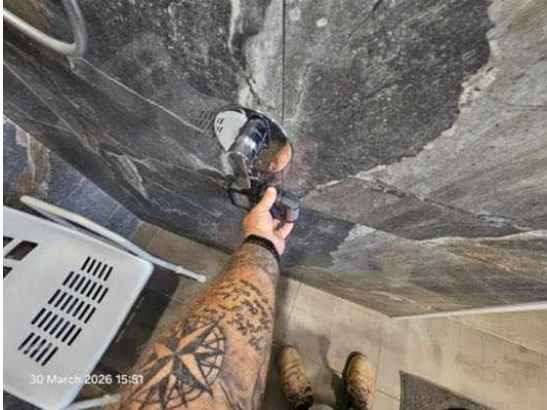
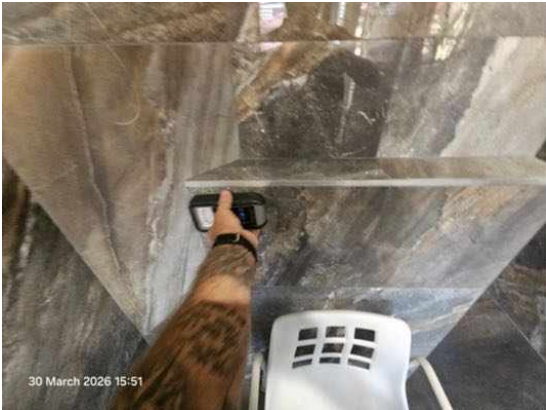
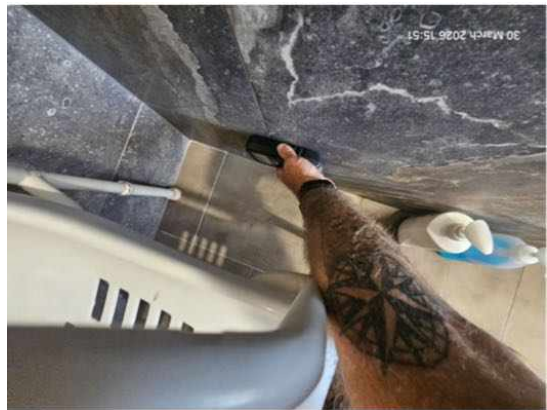
Building: Main Building  
 Location: Bathroom, ensuites  
 Finding: No moisture detected in bathroom / ensuite  
 Information: On the day of inspection the showers in the bathroom/s and ensuite/s are measure for moisture using a "Tramex" moisture meter. During this inspection no moisture was detected in these areas and the tiled / sheeted surfaces appear to be in good order.

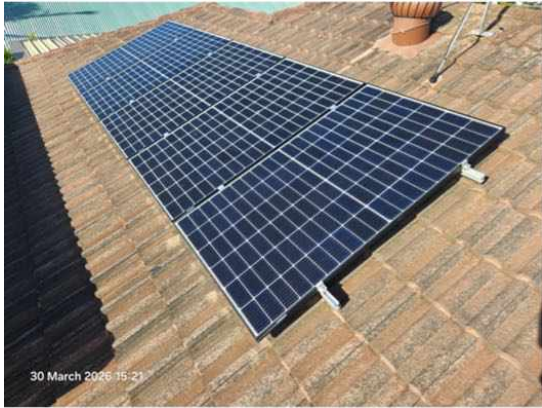
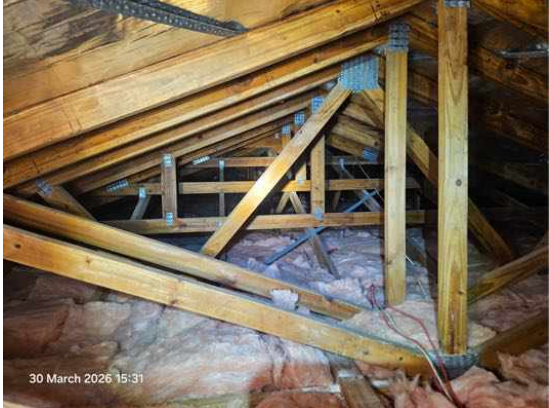
Building: Main Building  
 Location: All Areas  
 Finding: Additional Photos - Obstructions and Limitations  
 Information: These photographs are an indication of the obstructions and limitations which impeded full inspection of the property at the time of inspection. These obstructions can prevent full inspections of the areas shown.

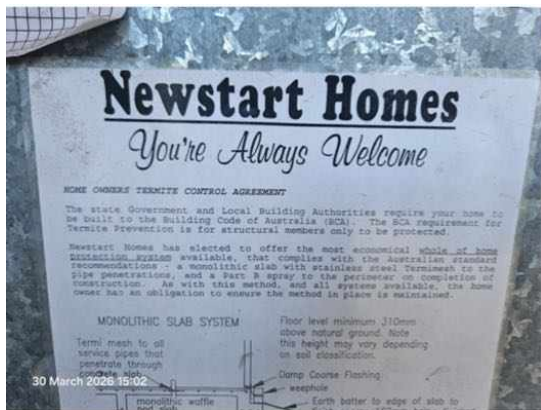
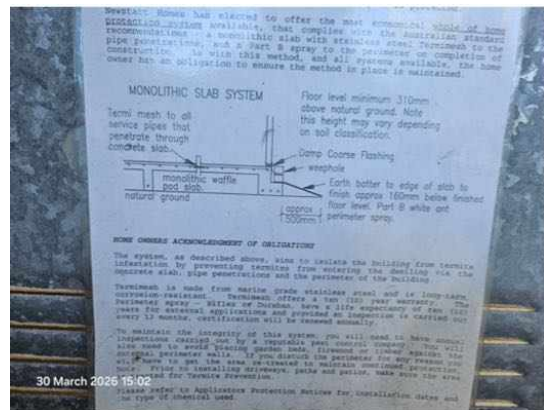
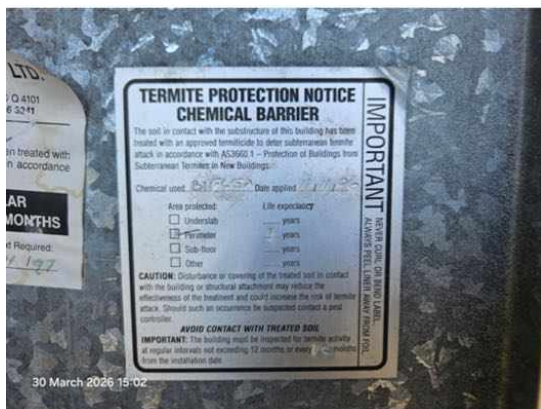
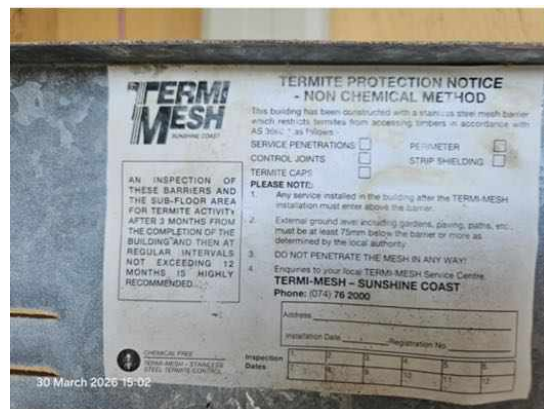
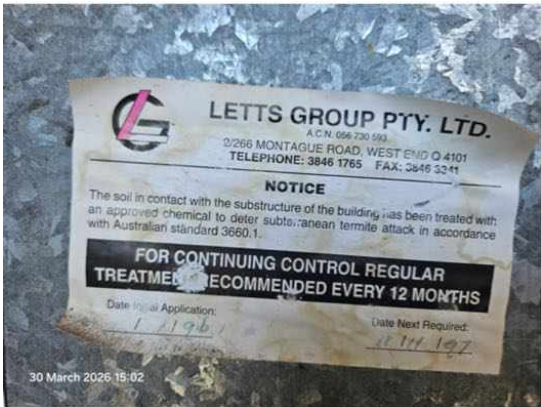
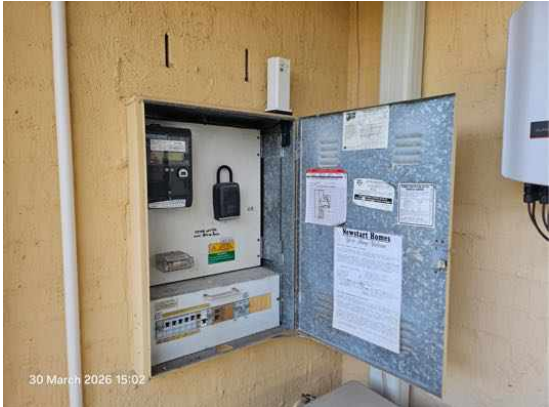
The building employs a “termimesh” physical barrier system to the slab penetrations and has had previous chemical barriers applied to the perimeter. The currency of these is out of date. It is strongly recommended that the perimeter chemical barriers are renewed.

In order for a barrier system to be effective, the property must have regular inspections at intervals of not greater than 12 months. Depending on the risk profile attributed to the property, these inspections may be recommended at lesser time periods.
