Building and Timber Pest Inspection Report

Inspection Date: Wed, 11 Mar 2026

Property Address: 4/45 Galloway Dr, Ashmore QLD 4214,
Australia

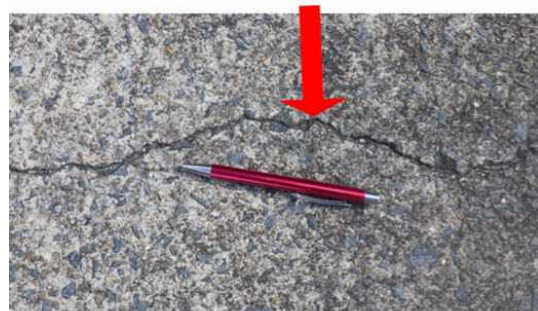
Building: Main Building
Location: Driveway > Ground Level
Finding: Cracking in concrete slab - Category 1 - 2
Information: Cracking coded as Category 1 was identified in the driveway and footpaths concrete slabs (as per example photos). A Category 1 crack is described as a fine but noticeable crack, with the slab at an otherwise reasonable level.

To be considered Category 1, the approximate width of the crack is less than 1.0mm, or a less than 10mm change in offset when a 3m straight edge is placed over the defect.

Category 1 cracks should be monitored for a period of 12 months. At the end of the monitoring period, identified cracks that are rated greater than Category 2 are considered defects, and require rectification.

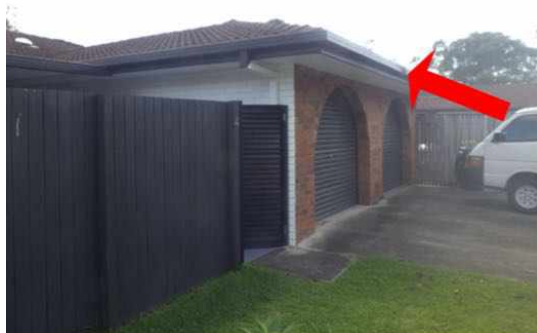
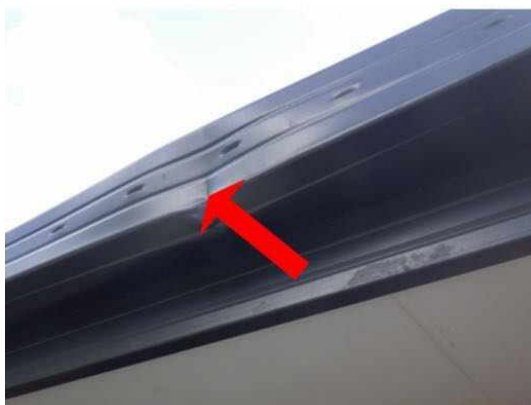
Finding 3.02

Building: Main Building
 Location: Roof Exterior > Front
 Finding: Gutters - damaged
 Information: At the time of inspection there was dent type damage to a section of the roof guttering to the front of the garage area. The dent or damage to the roof guttering appears to be the result of impact.

A roofing plumber or general handyman could be appointed to rectify this issue. It is highly advised that all gutters be maintained on a frequent basis to ensure the condition of roof plumbing.

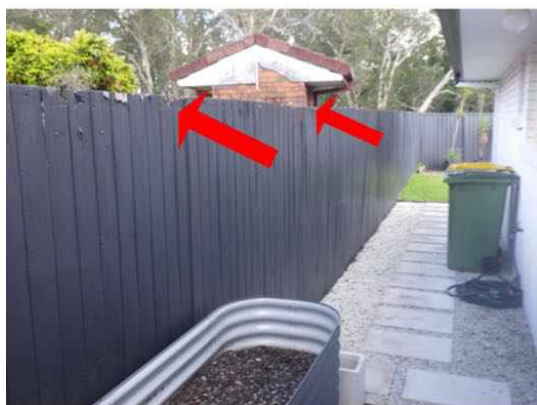
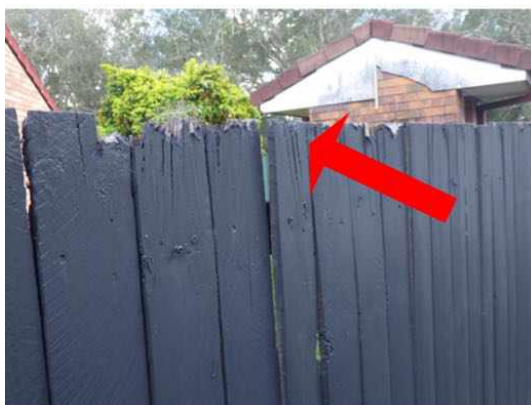
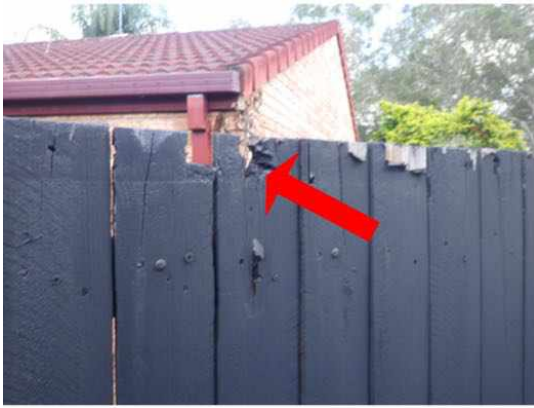
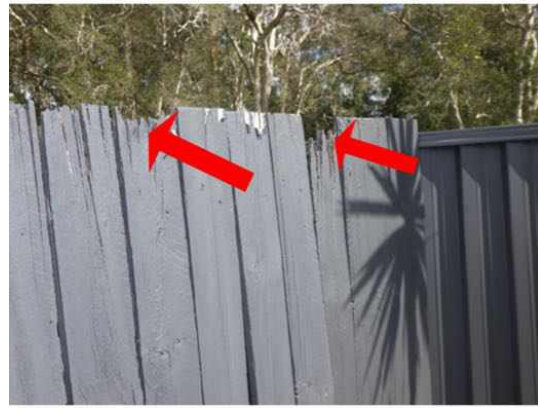
Finding 3.03

Building: Main Building
Location: Yard - Side > Existing
Finding: Fencing - Deteriorated

Information: It was noted at the time of inspection that sections of the timber fencing to the left side of the property have deteriorated. Typically fencing deteriorates due to age and or wear, rot and or rust which is generally expected for a structure of this age, due to prolonged exposure to weather conditions. Sometimes inadequate installation or maintenance can be to blame.

If left unattended, it is likely that further damage will occur. It is suspected that repair of several elements of the fencing may be required however replacement may be a consideration of the client also.

A licensed fencing contractor should be appointed to provide further advice and perform rectification works as necessary.

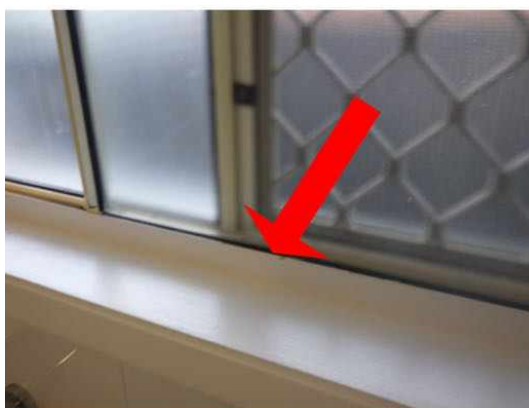
Building: Main Building
 Location: Bathroom > Centre Right
 Finding: Window - Stiff to Slide
 Information: The aluminium sliding window in the bathroom area was stiff to operate at the time of the inspection. Windows provide ventilation to the adjoining area and should be at a fully operational level to ensure user comfort. Restricted function of the window may also pose as a potential safety hazard if required for emergency egress from the building.

Generally, factors such as general age of the building element and a lack of maintenance are the usual causes for this type of defect.

An aluminium window service agent will be required to repair the affected windows.

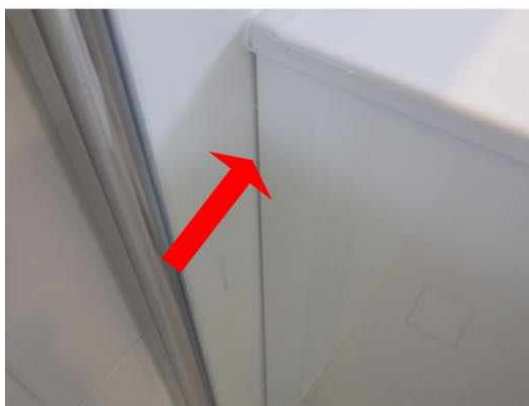
Finding 3.06

Building: Main Building
 Location: Bathroom > Centre,Rear
 Finding: Sealant Missing
 Information: It was noted on inspection that sealant is missing from the bathroom vanity / tiled floor and wall intersections. It is important these areas are sealed to prevent moisture or liquids penetrating the generally unsealed edges. Sealant also prevents vermin from accessing and or nesting in these areas.

A flexible sealant is required to allow for expected expansion and contraction, while keeping the joint water tight and protective of all associated building materials.

A sealant specialist or tiling contractor should be appointed to complete these works as soon as possible.

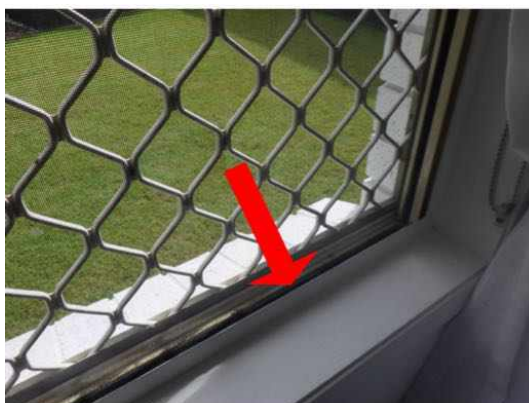
Finding 3.11

Location: Bedroom - Master > Rear
 Finding: Window - Stiff to Slide
 Information: The aluminium sliding window in the main bedroom area was stiff to operate at the time of the inspection. Windows provide ventilation to the adjoining area and should be at a fully operational level to ensure user comfort. Restricted function of the window may also pose as a potential safety hazard if required for emergency egress from the building.

Generally, factors such as general age of the building element and a lack of maintenance are the usual causes for this type of defect.

An aluminium window service agent will be required to repair the affected windows.

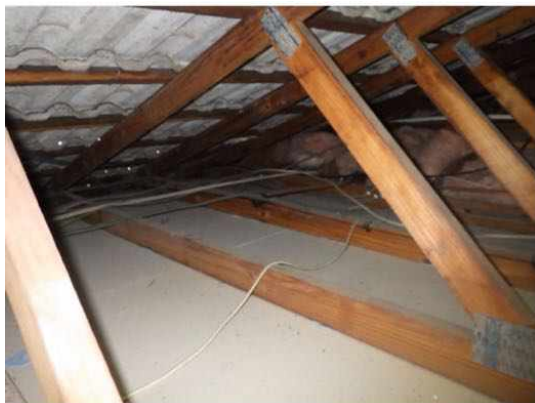
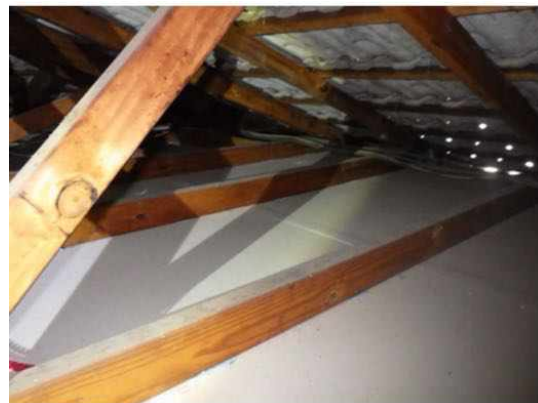
Finding 3.15

Building:	Main Building
Location:	Attic > Existing
Finding:	Insulation - Poor Installation
Information:	Insulation has been installed in the roof void with some large gaps in the coverage found at the time of inspection. A number of insulation batts have been installed on top of piping and other building materials within the roof cavity, decreasing the effectiveness of the insulation.

Insulation batts should be fitted correctly in the roof void, with no gaps around piping and each insulation batt lying flat on the ceiling surface. As a general rule, a 5% gap in the coverage of the total surface area may lead to an energy loss of up to 50%.

An insulation contractor or general handyman should be engaged to undertake rectification work.

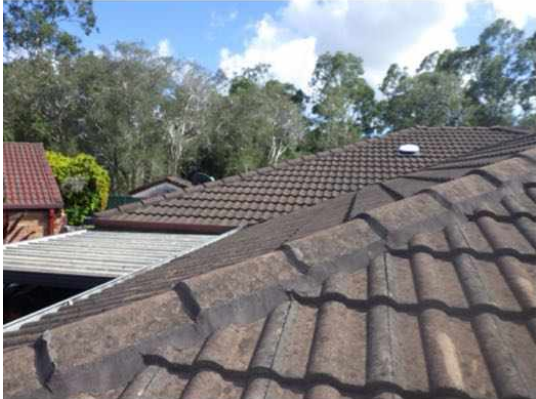
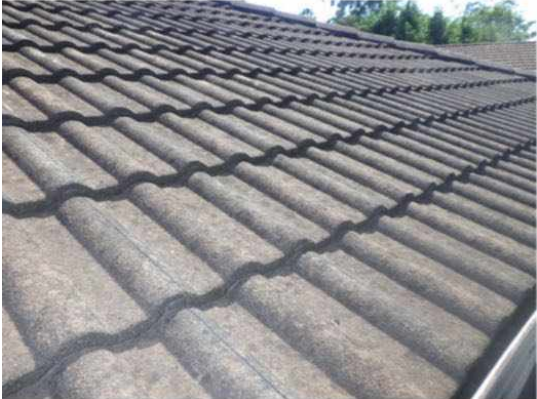
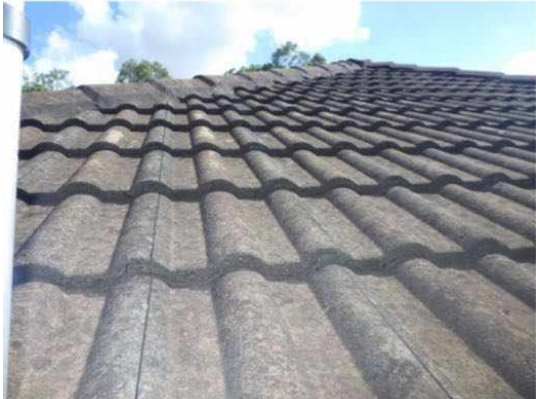
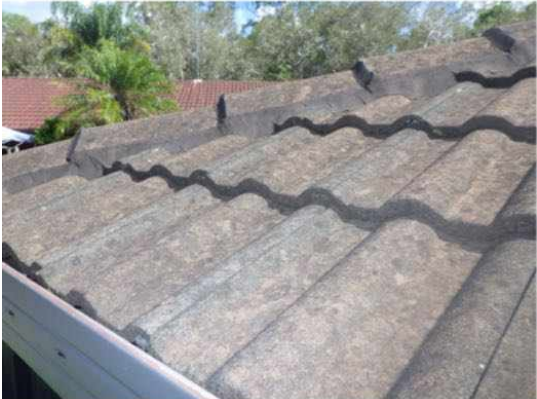
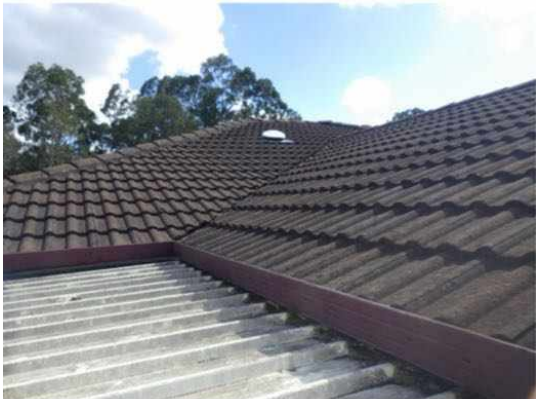
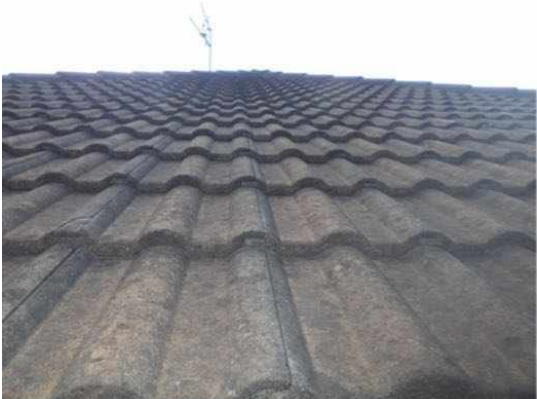
Finding 3.16

Building: Main Building
 Location: Roof Exterior > Existing
 Finding: Roof tiles - Weathered
 Information: Upon inspection of the exterior roofing, the majority of roof tiles were considered to be in a fair condition. While weathering of the tiles is consistent with the age of the property, maintenance works will be required.

works that may be required in the short to medium term. Remedial works are likely to increase the longevity of the exterior roofing structure.

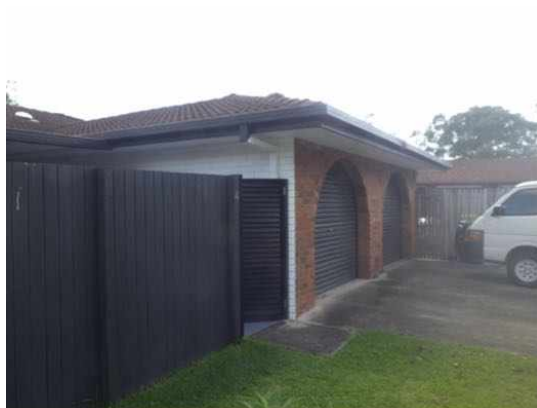
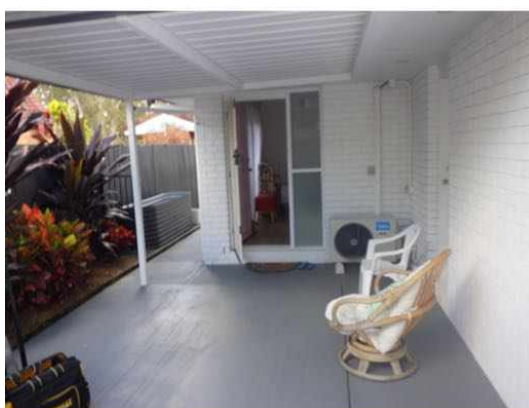
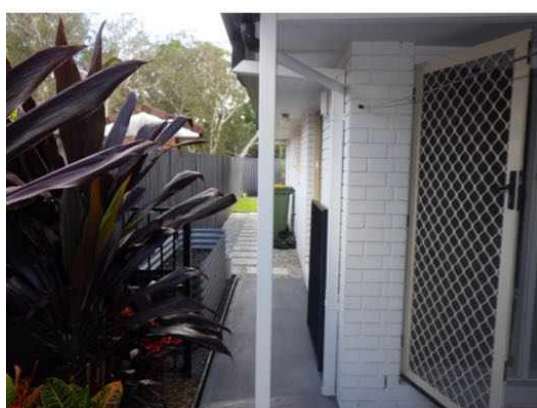
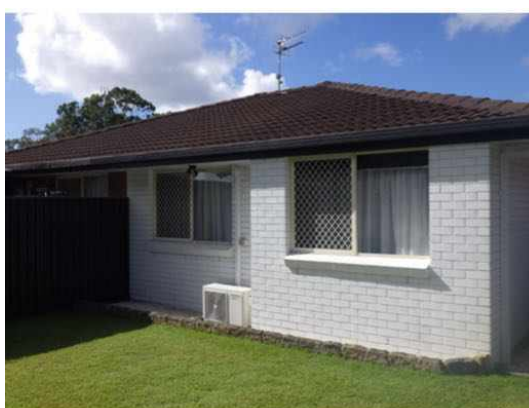
The application of a post-construction chemical termite barrier is highly recommended for all properties, particularly if live termite activity has been found on the site previously. Such barriers are highly effective in preventing termite attack on any timber building elements throughout the property.

A durable notice should be placed in the switchboard unit or the under sink cabinetry to indicate current termite barriers.

The client should consider gaining further advice from a licensed timber termite pest technician as to the costs and procedures involved with this application. It is highly recommended that obtaining such advice be a short-term priority.

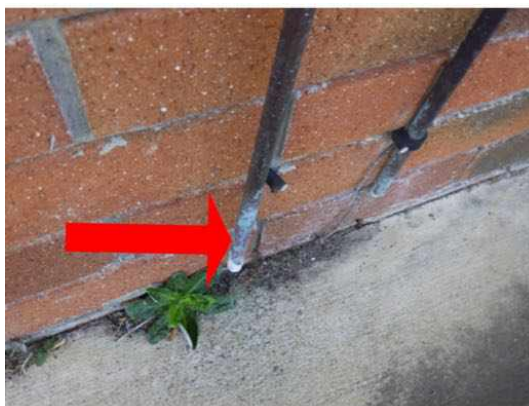
Finding 6.02

Building:	Main Building
Location:	Exterior walls - front > Front Right

Finding: Overflow - Not plumbed for drainage

Information: The hot water system overflow is not plumbed or connected to suitable drainage, which can result in the surrounding area becoming excessively damp. These damp conditions can lead to secondary defects such as rot, rust or corrosion of associated building elements, the formation of fungal decay, or even the creation of potential slip hazards. When coupled with poor site drainage, pooling of water may also attract termite activity to this area. It is highly recommended that a qualified plumber be appointed to install adequate drainage to the overflow. These works will ensure that the area remains dry and free of any secondary defects.

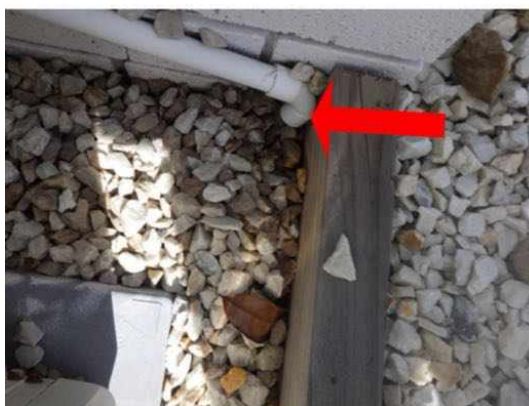
Finding 6.03

Building: Main Building

Finding: Overflow - Not plumbed for drainage

Information: The air conditioning unit overflow is not plumbed or connected to suitable drainage, which can result in the surrounding area becoming excessively damp. These damp conditions can lead to secondary defects such as rot, rust or corrosion of associated building elements, the formation of fungal decay, or even the creation of potential slip hazards. When coupled with poor site drainage, pooling of water may also attract termite activity to this area. It is highly recommended that a qualified plumber be appointed to install adequate drainage to the overflow. These works will ensure that the area remains dry and free of any secondary defects.

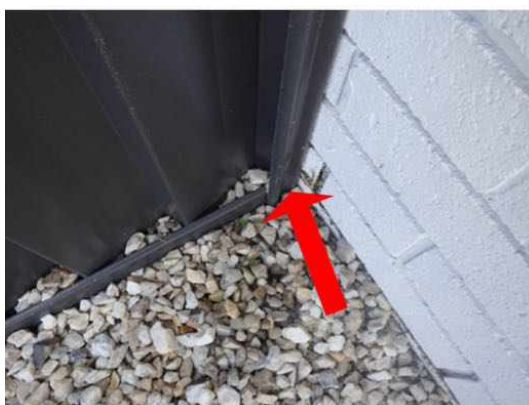
Finding 6.04

Building:	Main Building
Location:	Exterior walls - rear > Rear Right
Finding:	In ground contact
Information:	The metal fence post fixed to the exterior wall brickwork is in direct contact with the finished ground surface.

Any materials in direct ground contact provide opportunity for concealed termite entry and are likely to be subject to premature rust and decay as the ground retains moisture or damp conditions against the materials.

Ideally these types of fencing members would be clear of the ground area by a minimum of 50mm to provide a clear inspection zone.

Frequent pest inspections are advised to readily identify any termite activity in these areas.

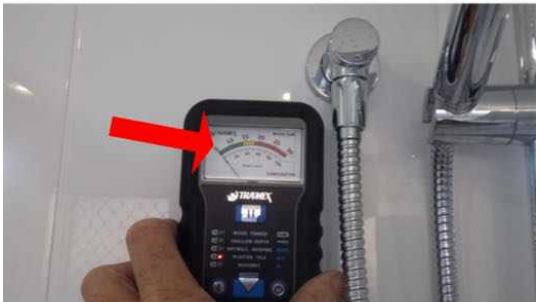
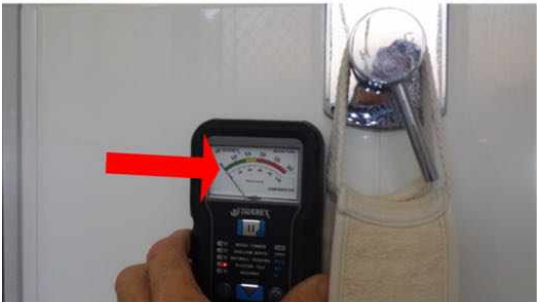
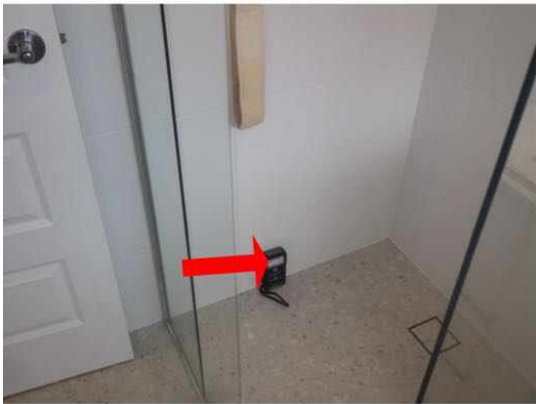
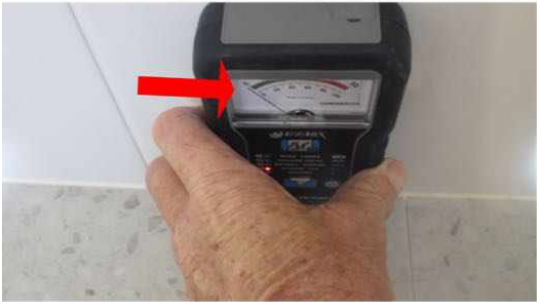
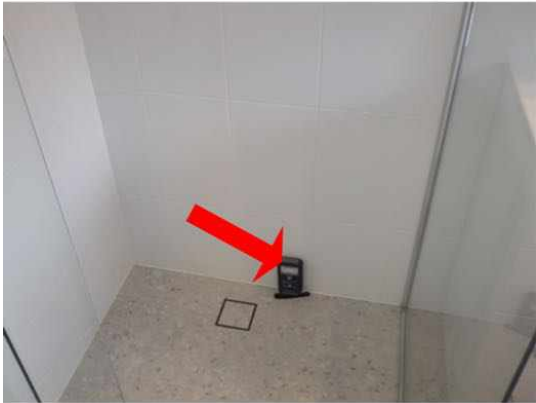
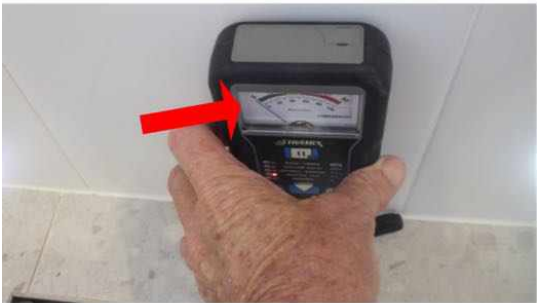
Building: Main Building
 Location: Bathroom > Existing
 Finding: Moisture Level Readings

Information: At the time of inspection the bathroom shower cubicle areas checked with the Tramex Moisture Meter returned low - normal moisture level readings.

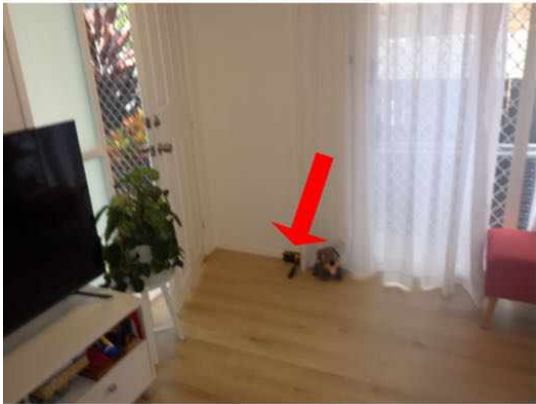
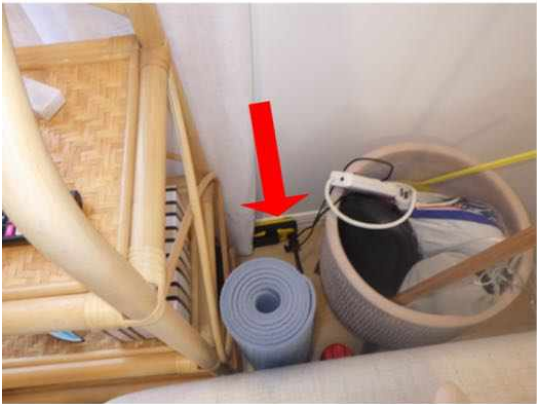
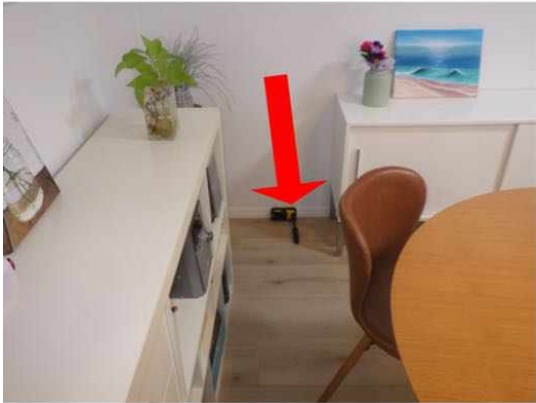
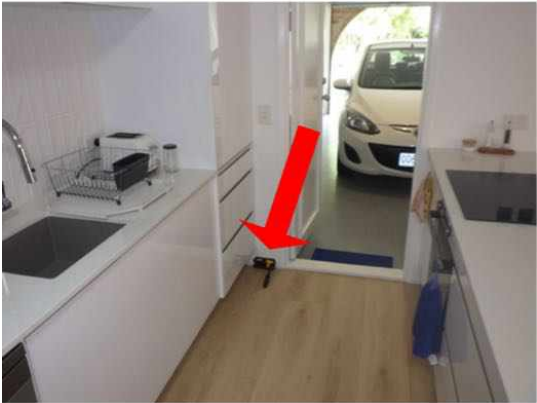
Building: Main Building
Location: Internal Areas > Existing
Finding: Termitracker
Information: The termitracker itracker was positioned randomly to internal wall, timber skirting and window frame areas checking for signs of termite activity.

No activity was recorded at the time of inspection.

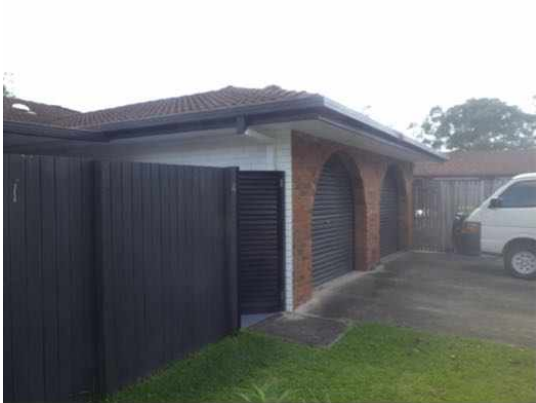
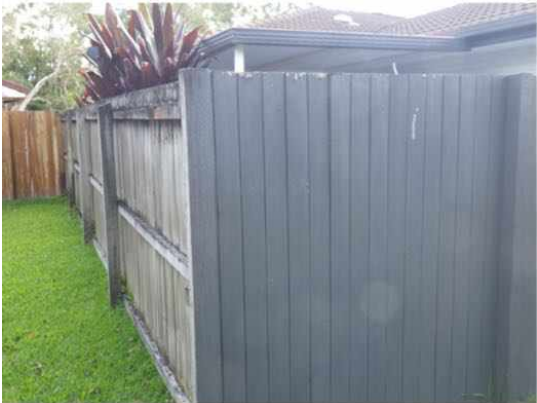
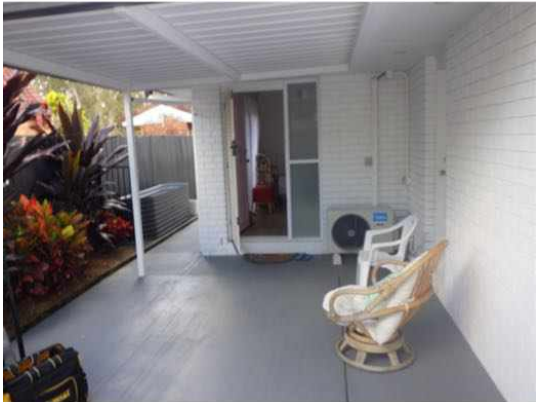
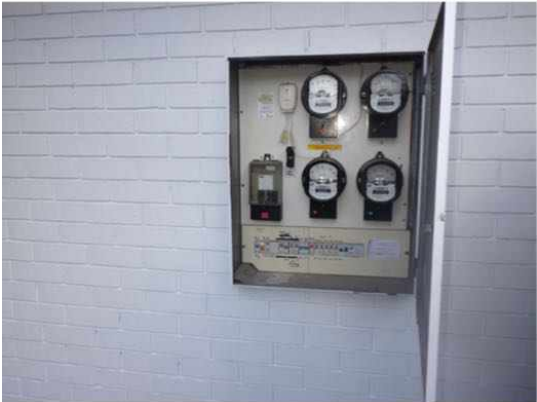
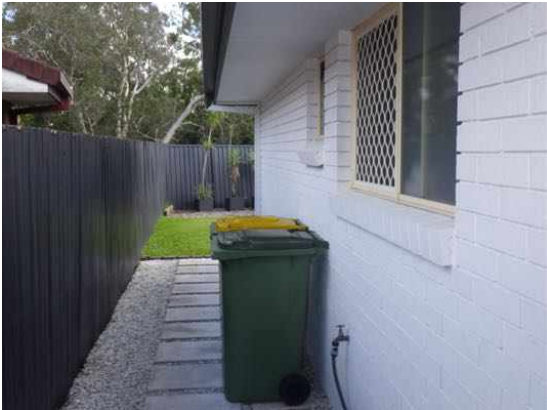
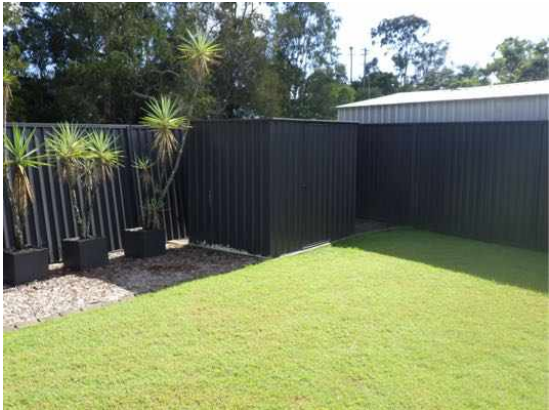
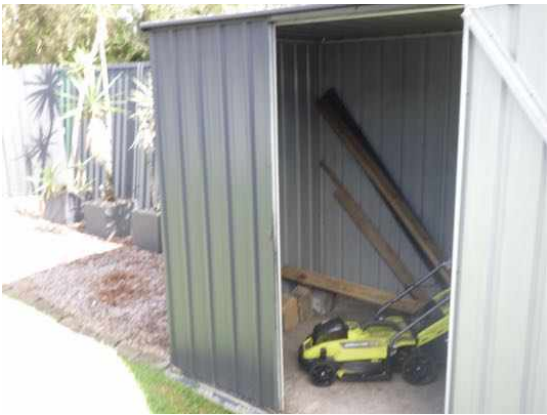
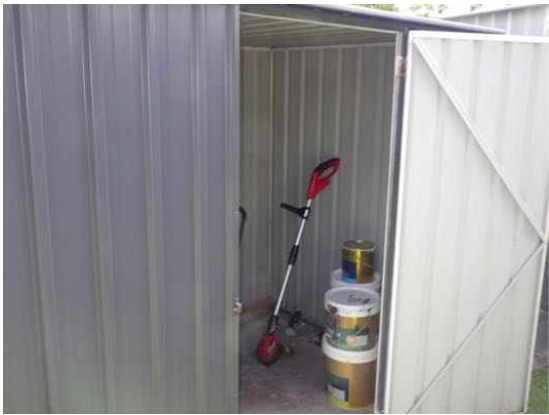
Building: Main Building
Location: External Areas > Existing
Finding: Additional Photos
Information: Additional photos are provided for your general reference
