Building and Timber Pest Inspection Report

Inspection Date: Tue, 24 Mar 2026

Property Address: 34 Kabi Cres, Widgee QLD 4570, Australia

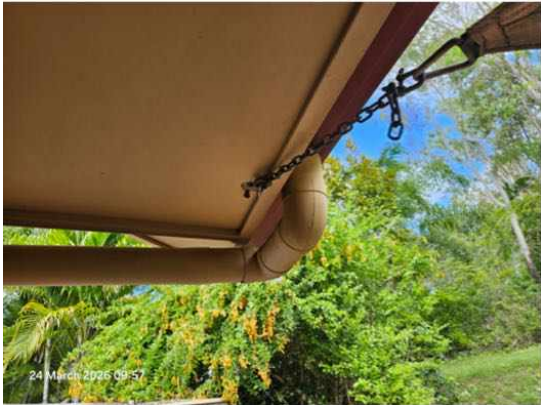
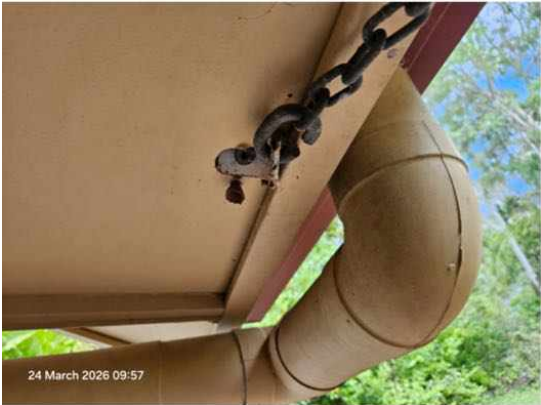
Building: Main Building
Location: Rear side
Finding: Shade sail post - connections deteriorated
Information: The shade sail at the rear of the property, at the point where the house connections are, shows signs of deterioration. It appears that the connection method used is not satisfactory. The screws appear to be attached to the soffit / eaves battens and through constant movement, are causing damage to the eaves sheets and possibly to the eaves framing.

With continued movement this could become a major defect.

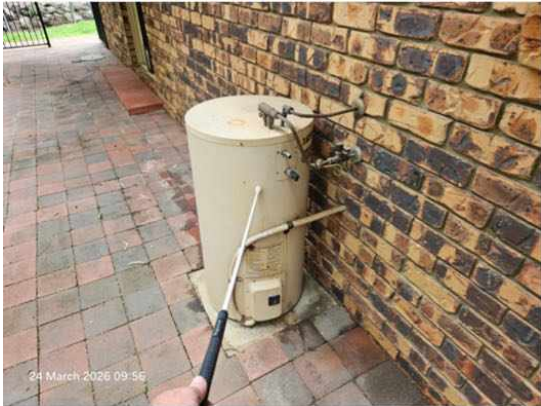
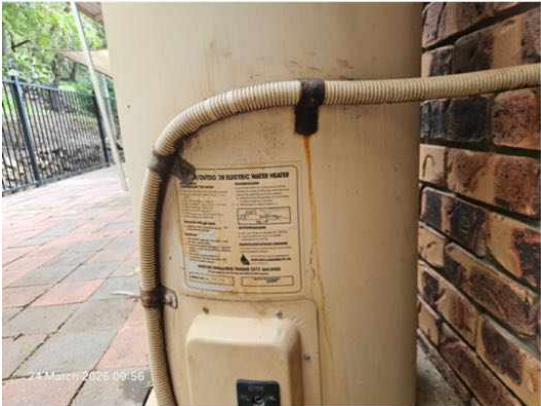
Finding 3.02

Building: Main Building
Location: Left side
Finding: Conduit saddles - rusting
Information: On the day of inspection it was noted that the conduit saddles for the hot water system electrical conduit are rusting and will require replacement. These should be replaced with galvanised or stainless steel products, which are fit for purpose.

A suitably qualified iced handy person could be engaged at the clients discretion to carry out the repair.

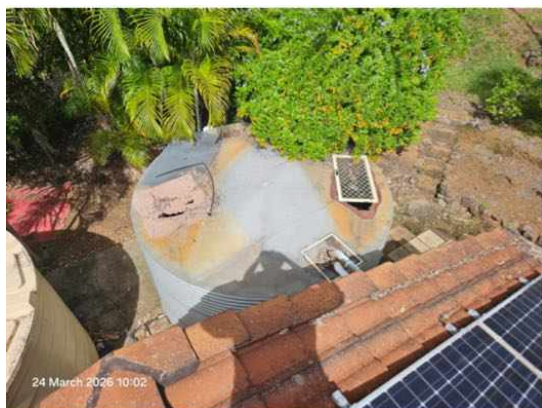
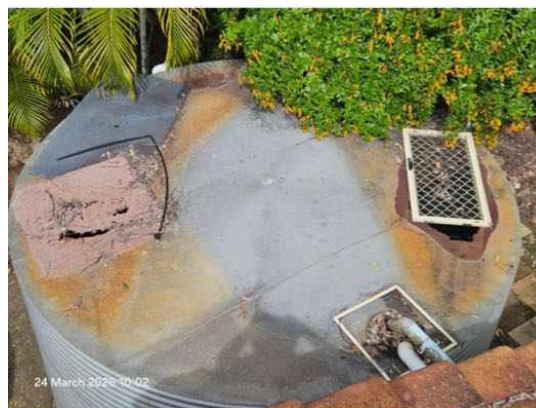
Finding 3.03

Building:	Yard
Location:	As shown
Finding:	Rust - rain water tank
Information:	The top surface of the rain water tank is severely rusted showing large holes. Maintenance / repair works will be required to prevent rust and debris from settling into the interior of the tank.

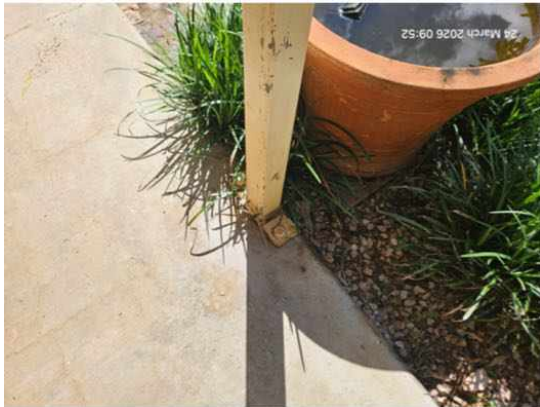
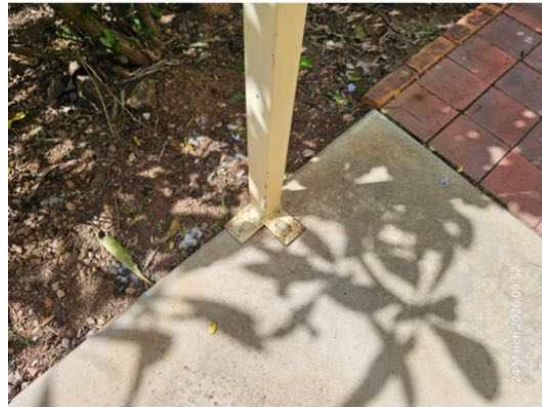
Finding 3.04

Building:	Main Building
Location:	Carport
Finding:	Pergola steel frame - surface rust present.
Information:	On the day of inspection it was noted that the steel framing members of the rear pergola at the front of the house had surface rust developing. The surface coating / paint has deteriorated and the base metal could be exposed if not re-coated.

It is advised that an application of a suitable moisture resistant protective coating and a rust treatment method be implemented.

Engaging the services of a licensed painter or suitably qualified handy person could assist with providing a solution.

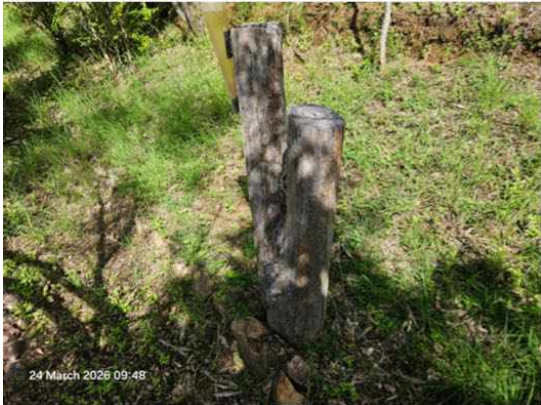
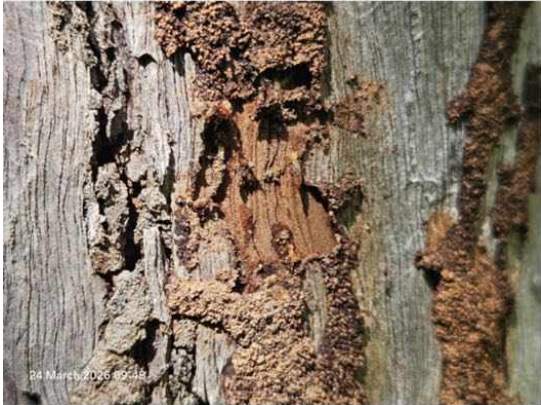
Building:	Yard
Location:	As shown
Finding:	Termite damage - active presence
Information:	During the inspection of the stump at the rear of the building termite activity was observed. As shown in the photographs, active termites are seen.

It is highly recommended that a pest controller be engaged to carry out the required program to eliminate this activity.

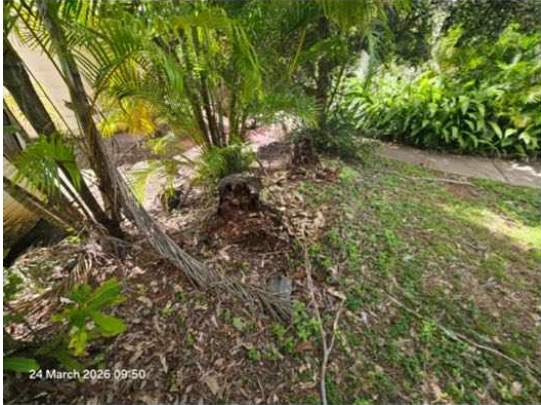
Finding 5.01

Finding: Evidence of previous inactive termite damage

Information: On the day of inspection multiple areas of minor to moderate inactive termite damage were noted. The damage is localised and appears to be confined to the stumps shown.

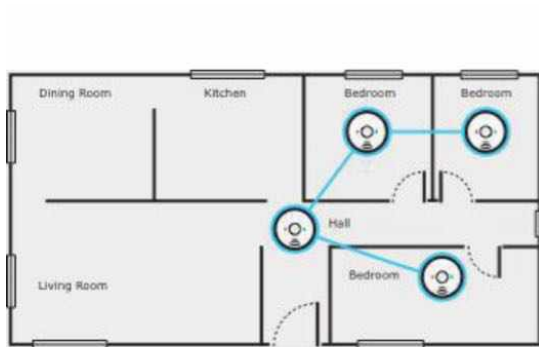
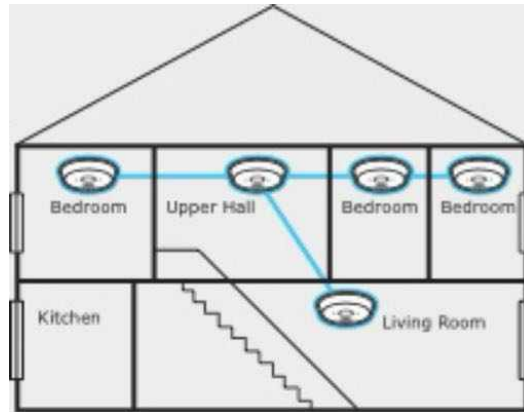
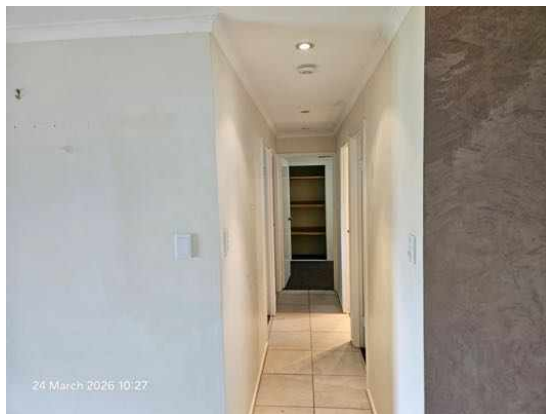
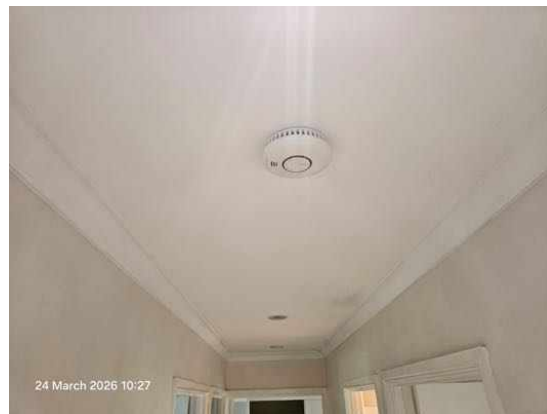
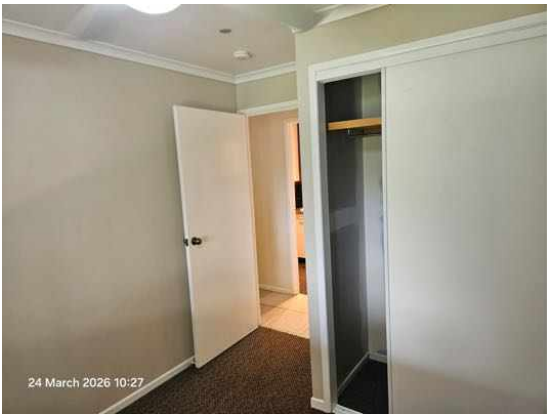
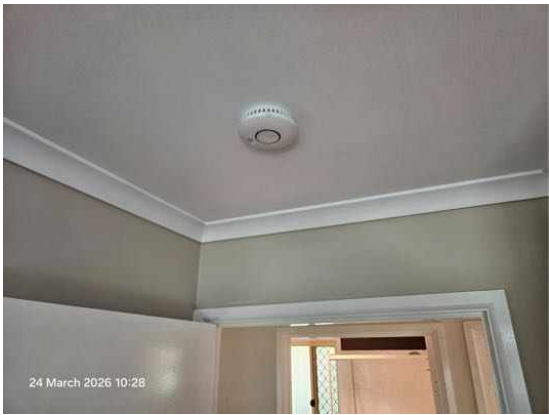
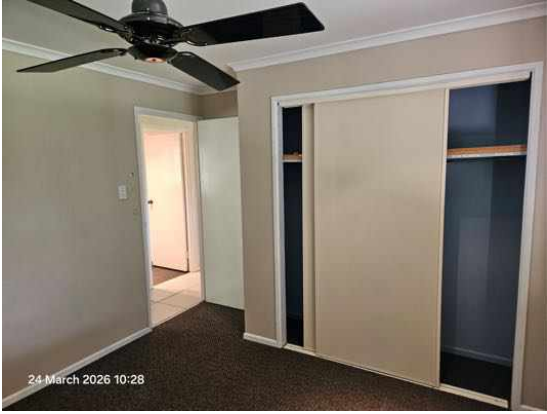
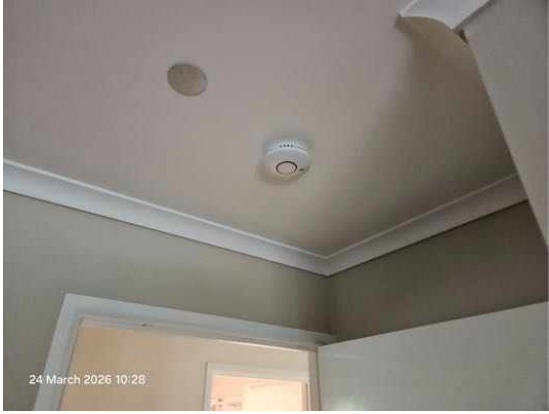
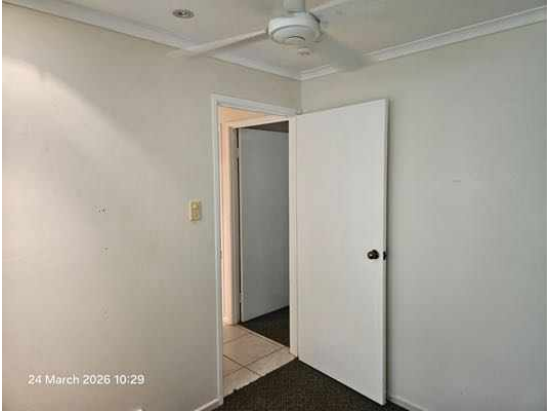
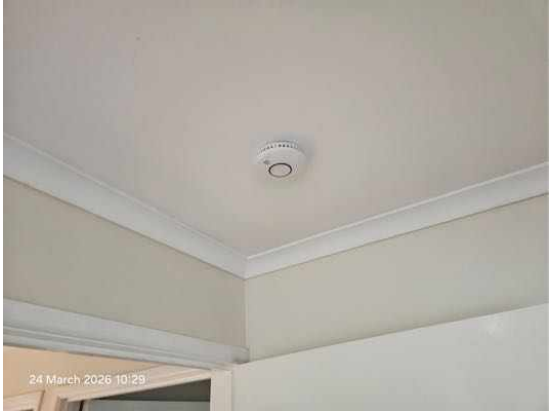
Avoid installing smoke alarms in dead air space. This is an area in which trapped hot air will prevent smoke from reaching the alarm. The space generally occurs at the apex of cathedral ceilings, the corner junction of walls and ceiling, and between exposed floor joists.

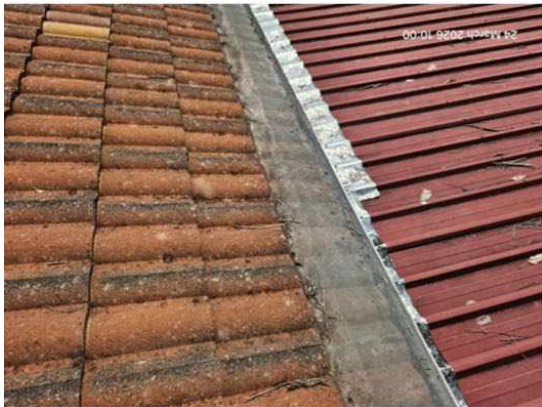
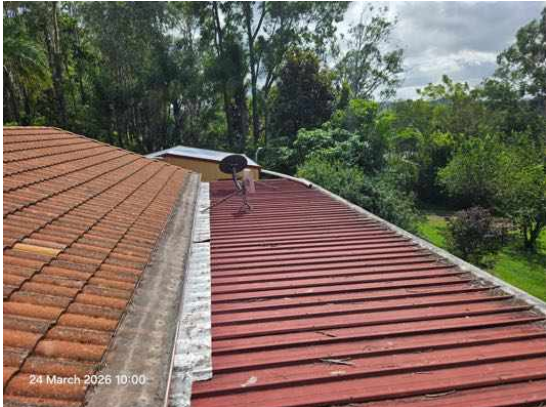
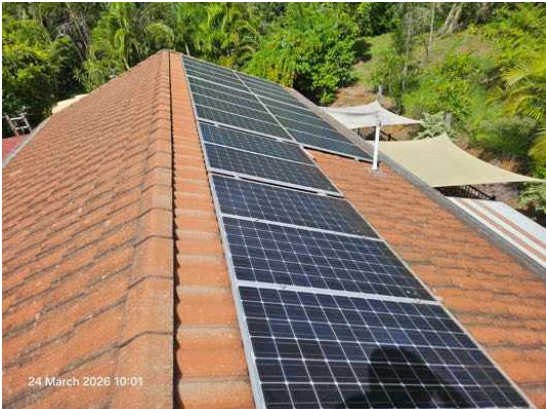
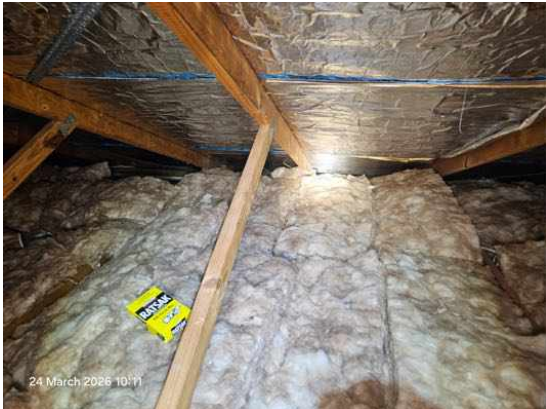
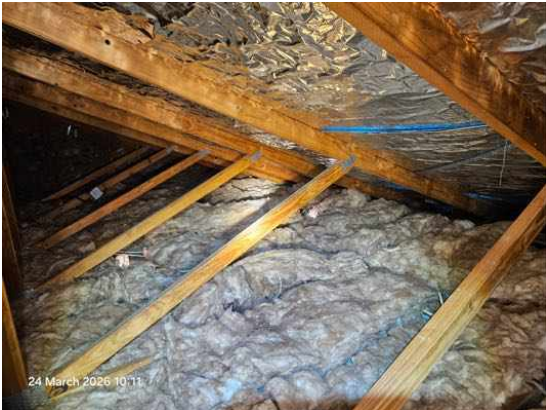
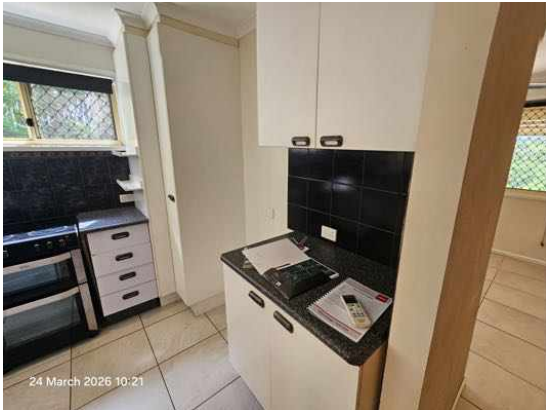
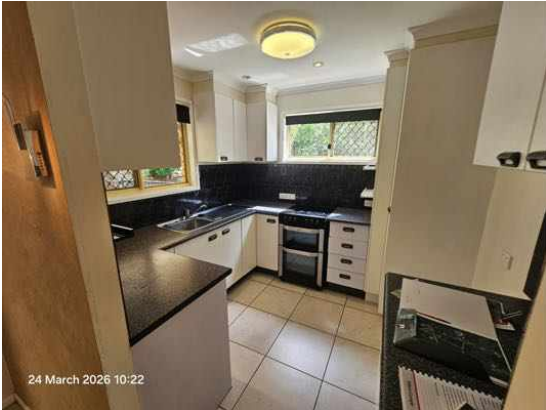
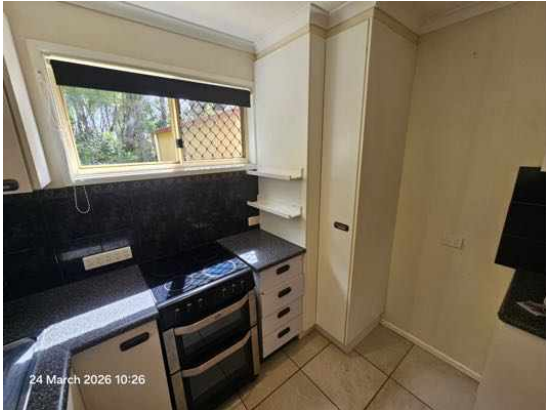
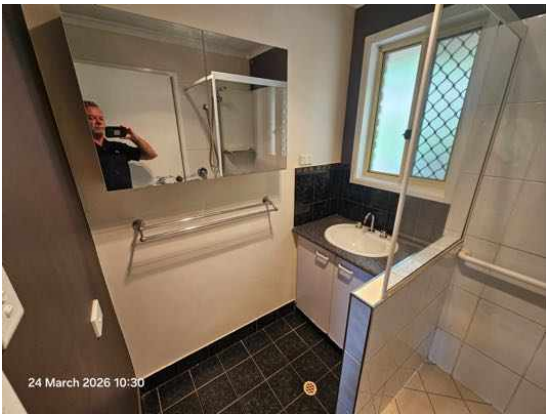
Building: Main Building
Location: All Areas
Finding: Additional Photos - Obstructions and Limitations
Information: These photographs are an indication of the obstructions and limitations which impeded full inspection of the property at the time of inspection. These obstructions can prevent full inspections of the areas shown.

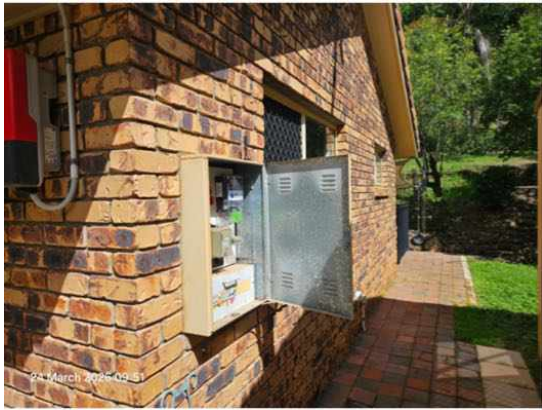
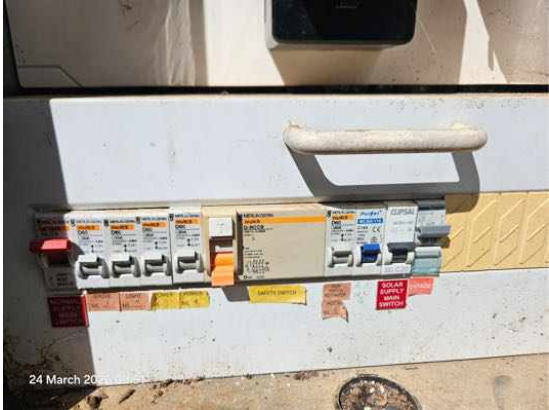
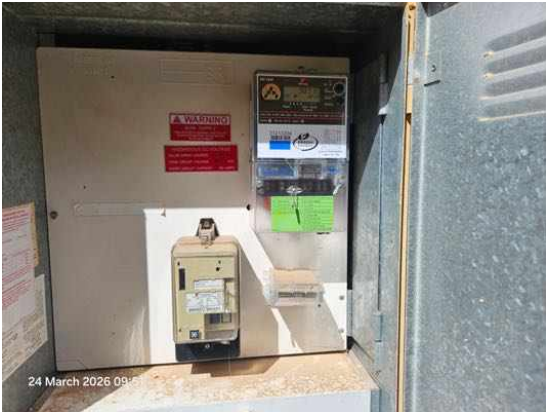
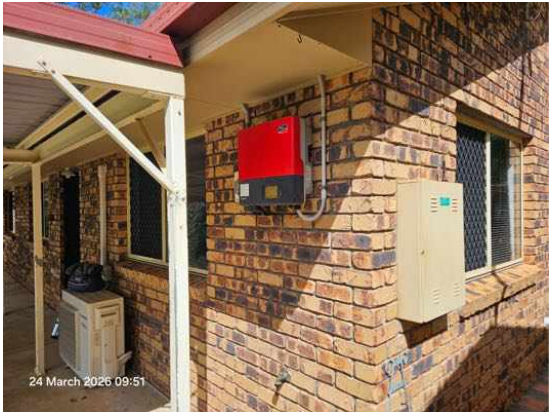
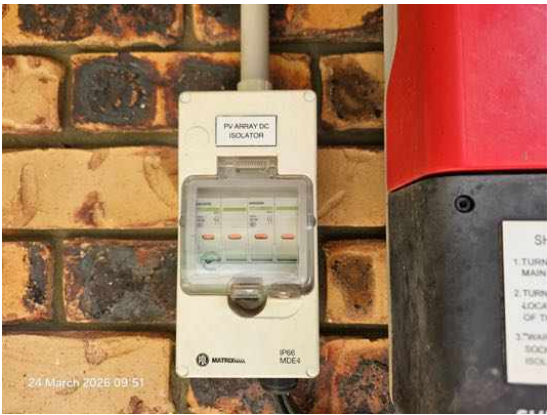
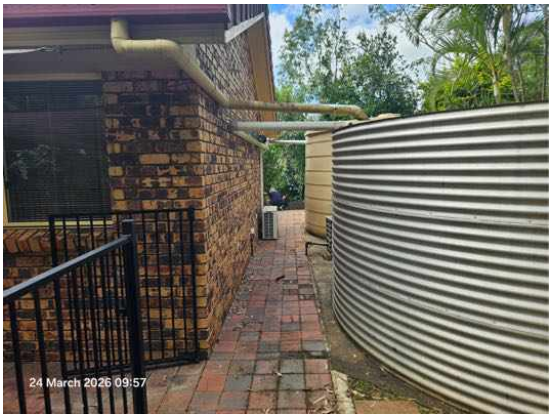
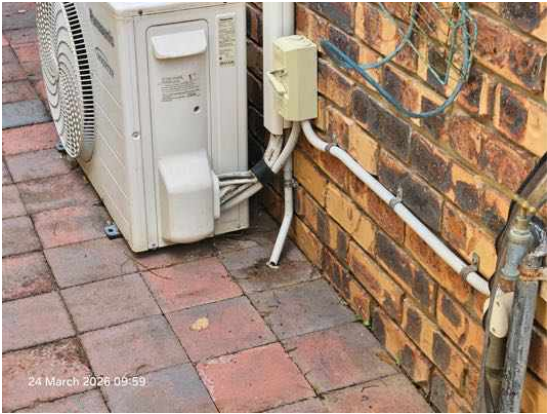
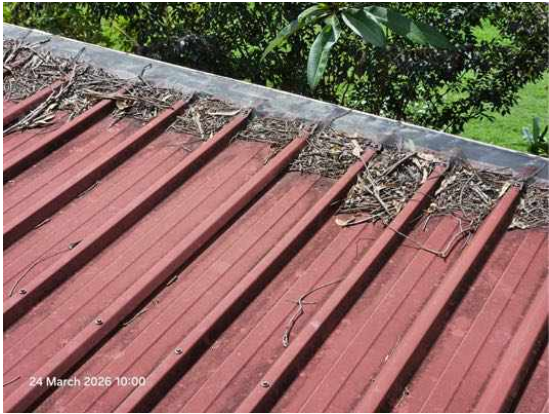
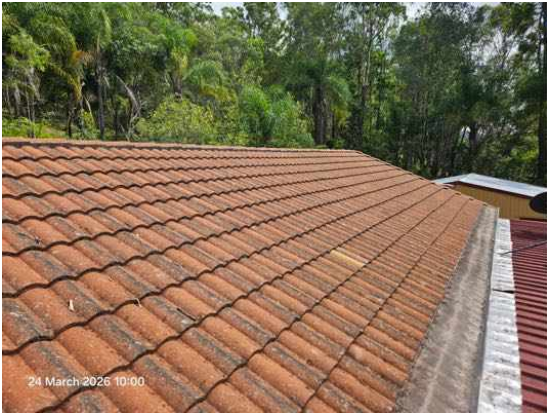
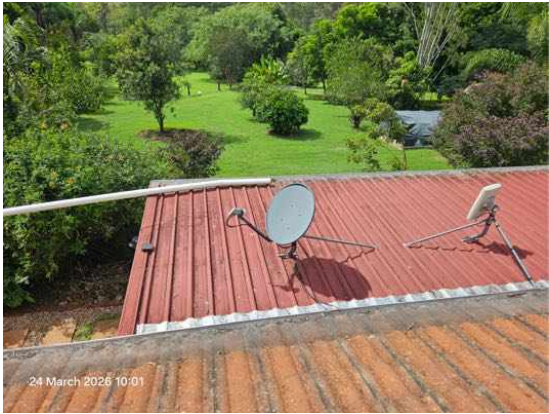
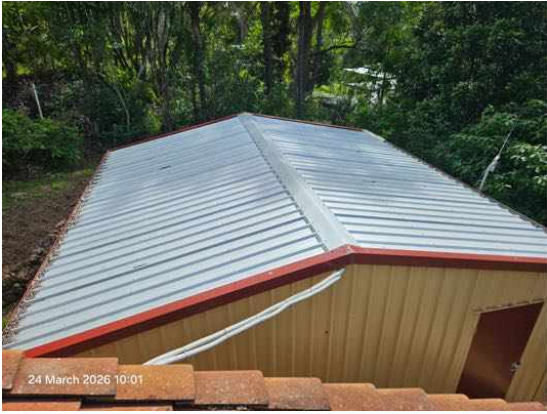
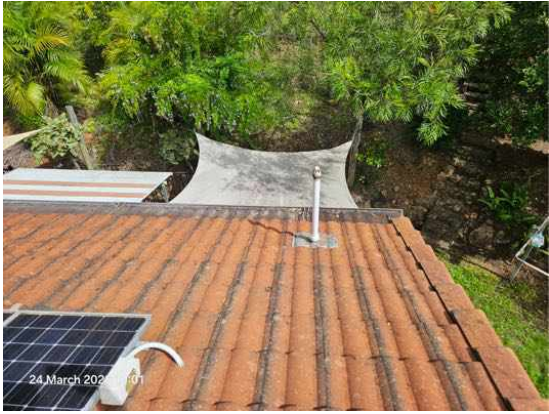
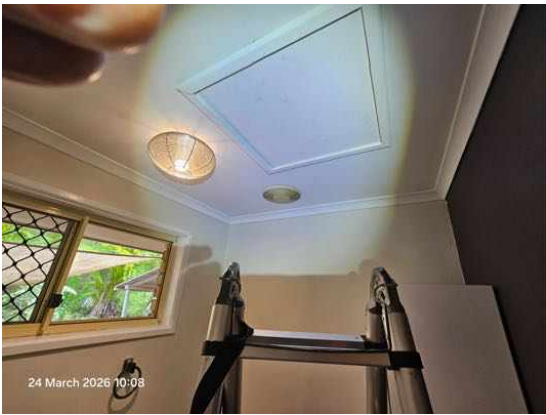
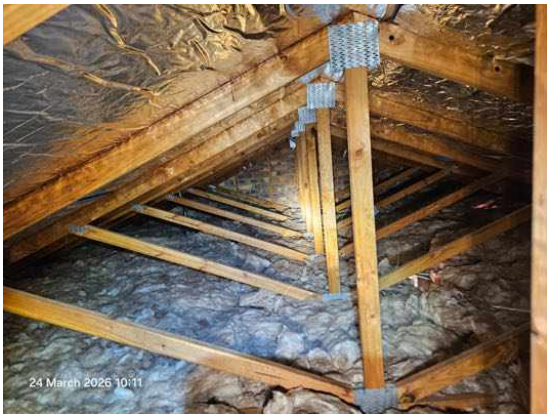
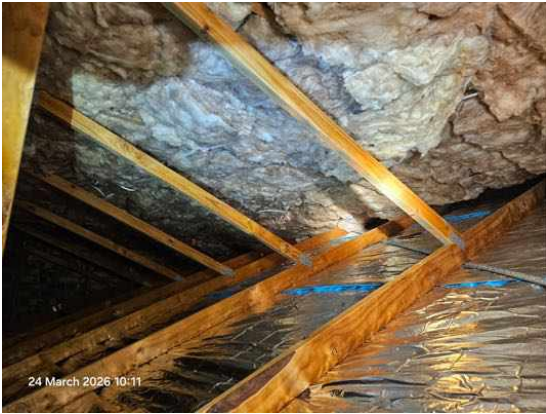
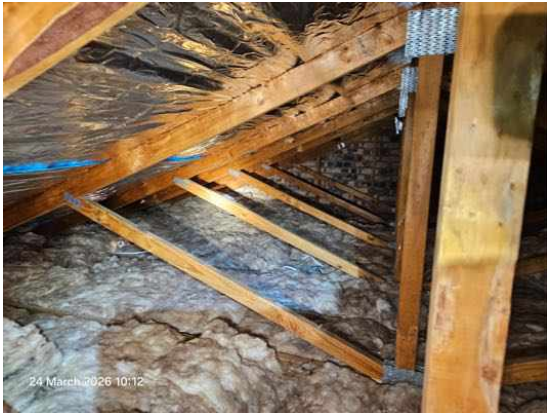
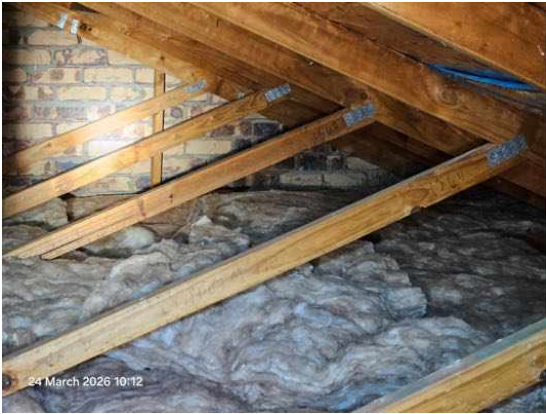
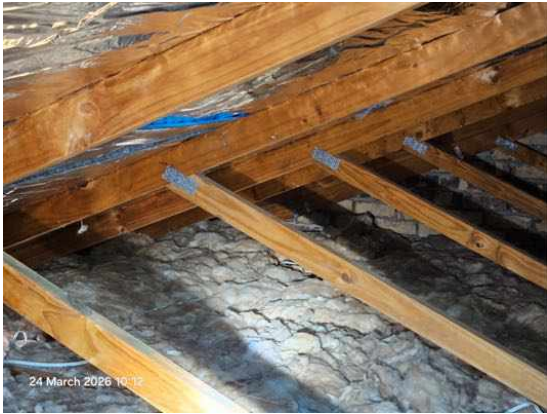
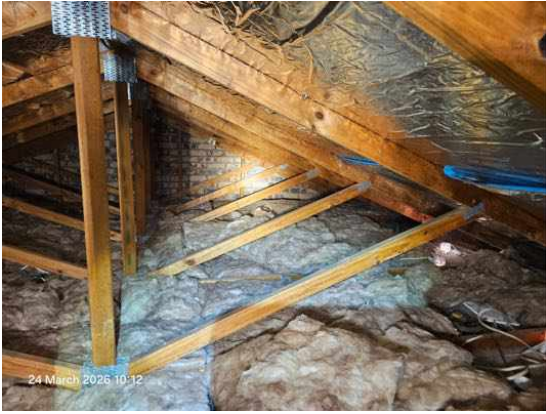
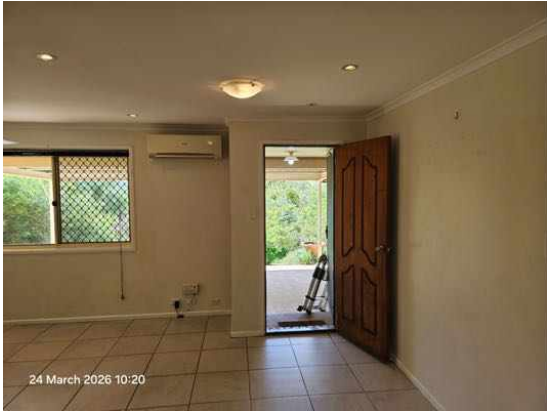
Building: Main Building
 Location: All Areas
 Finding: Additional Photos for client reference
 Information: Additional photos are provided for your general reference.

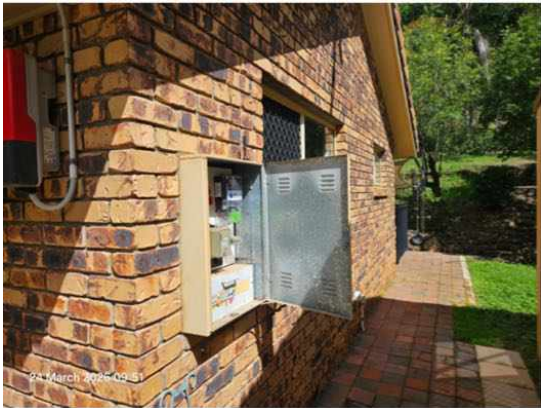
The building previously employed a "Slabset" chemical barrier system to the perimeter and slab penetrations. A more recent system has been implemented; however, the notice is faded and it cannot be determined what type or brand is. It is recommended that a timber pest controller be engaged to recharge the barrier system.
