Building and Timber Pest Inspection Report

Inspection Date: Mon, 9 Mar 2026

Property Address: 137 Halcrows Rd, Glenorie NSW 2157,
Australia

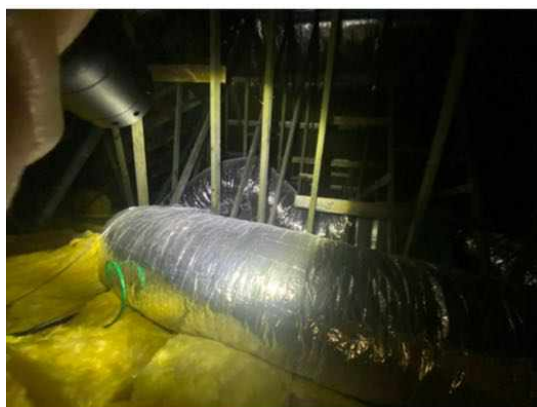
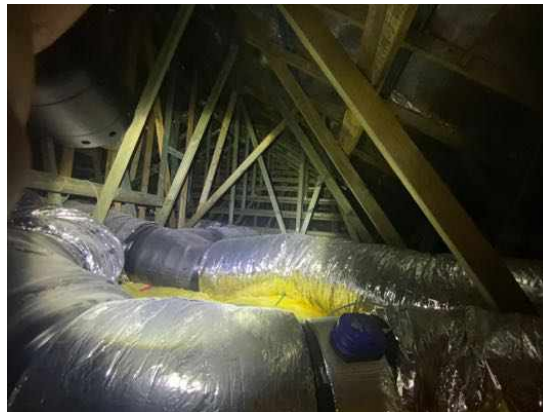
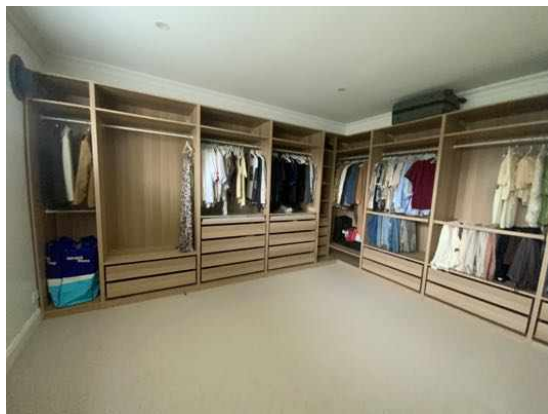
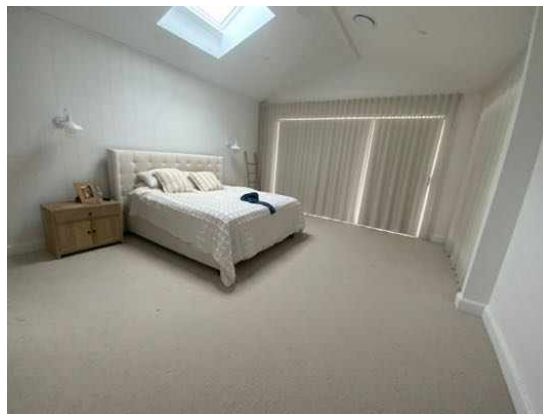
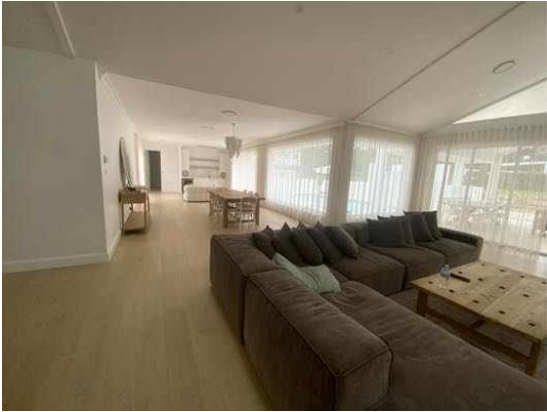
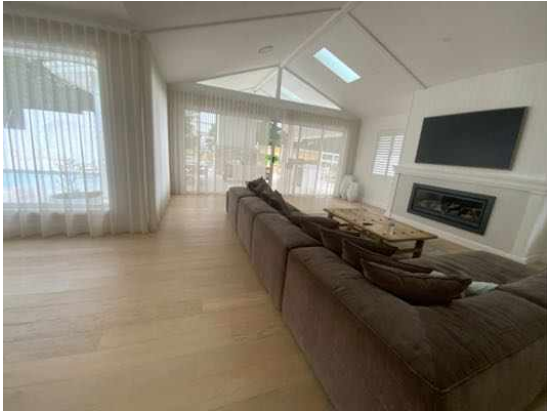
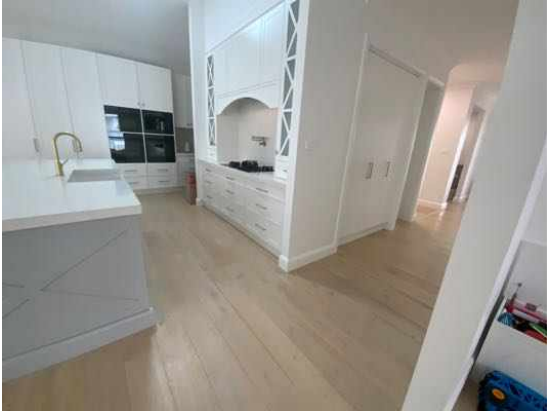
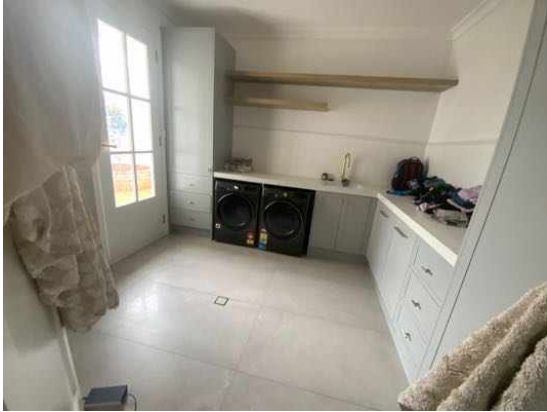
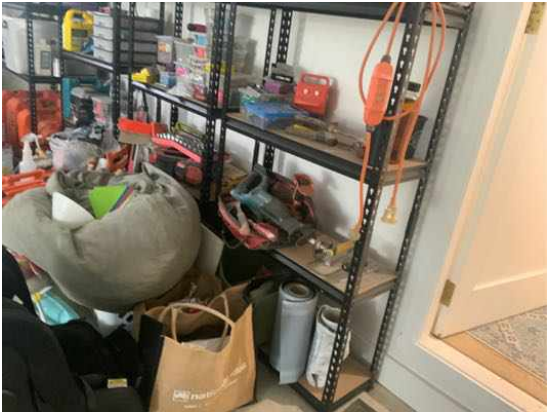
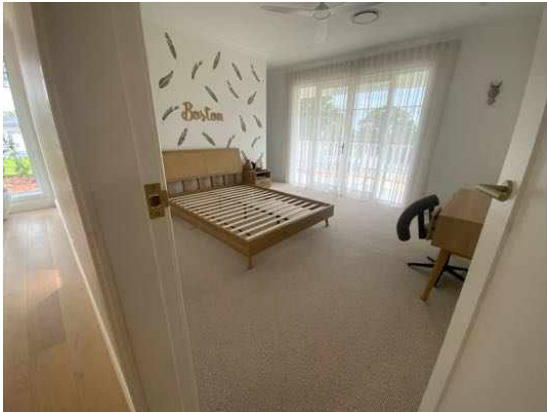
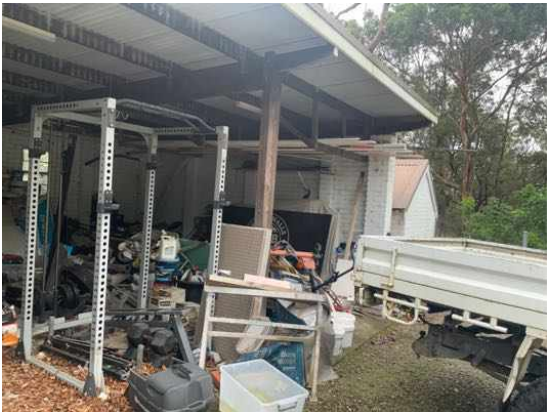
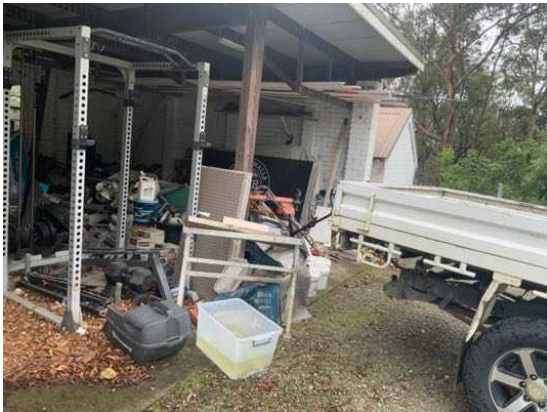
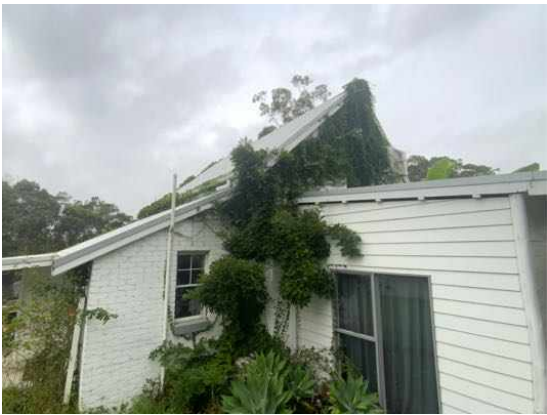
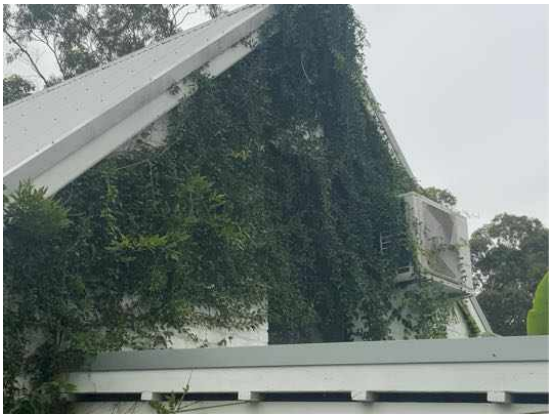
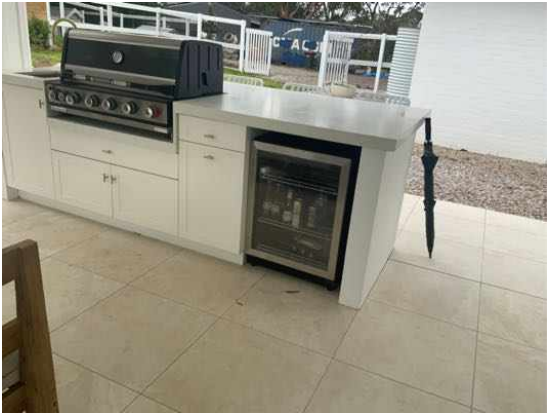
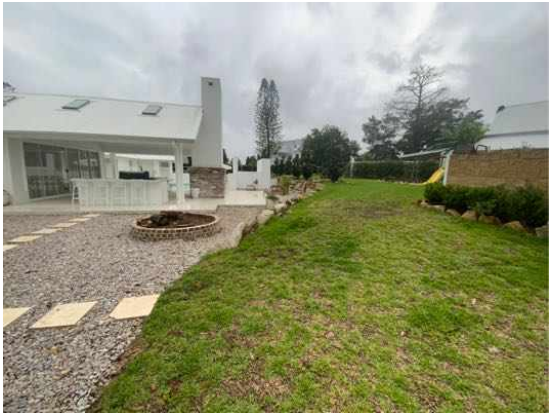
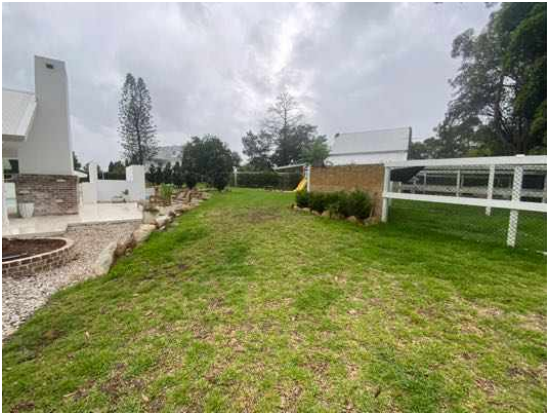
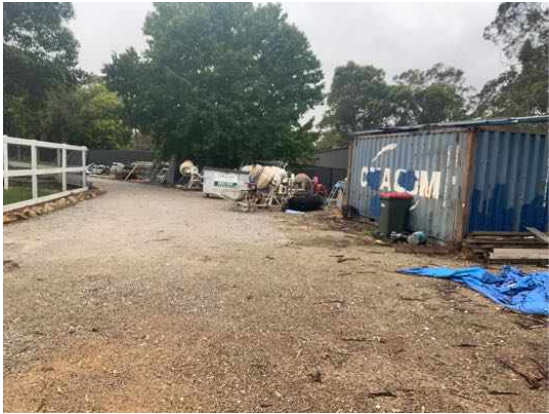
Building: Main Building
Location: All Areas
Finding: Additional Photos - Obstructions and Limitations
Information: These photographs are an indication of the obstructions and limitations which impeded full inspection of the property at the time of inspection. These obstructions can hide an array of defects and should be removed to allow full inspection to be carried out. A re-inspection is recommended once the areas are made accessible.
