Building and Timber Pest Inspection Report

Inspection Date: Tue, 3 Mar 2026

Property Address: 28/6 Ruby St, Carramar NSW 2163, Australia

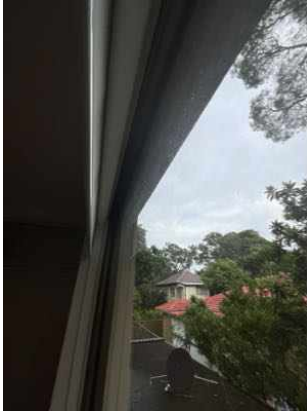
Building:	Main Building
Location:	All Areas
Finding:	Window child lock missing
Information:	The window in question lacks a child lock mechanism, which poses a potential safety risk to young occupants in the premises. As per Australian Standards windows accessible to children should be equipped with appropriate child safety locks to prevent accidental opening, reducing the risk of falls and ensuring compliance with safety regulations.

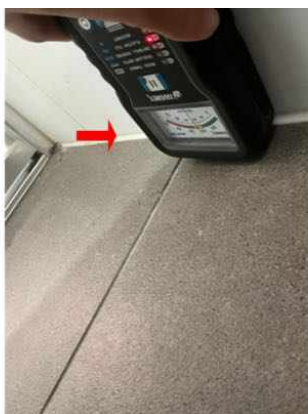
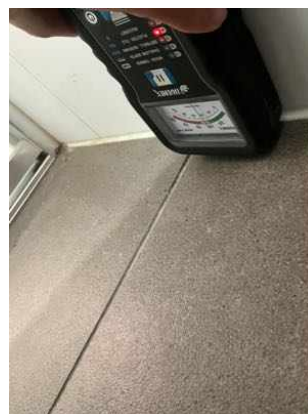
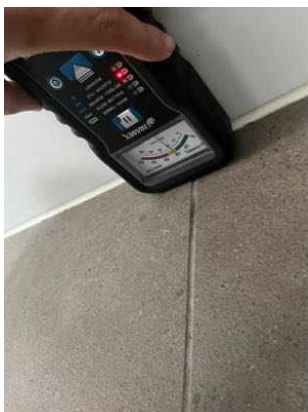
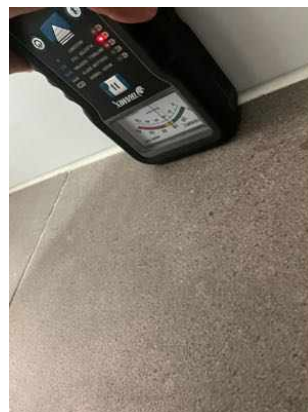
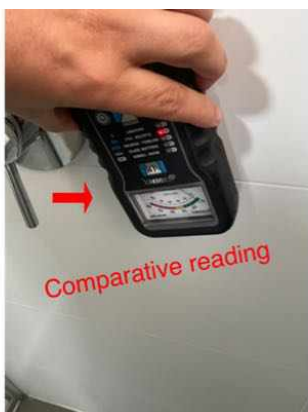
Such leaking creates an environment which is conducive to an array of defects, including water damage to associated building elements and the attraction of termite or timber pest infestation.

Consultation with a qualified plumber or bathroom specialist is advised immediately to identify the cause of damp and to perform remedial works as required. Where excessive mould growth is present, further inspection by a specialist environmental health inspector should also be considered.

Always ensure that sealant and grout is in good condition to prevent any moisture issues occurring in the future.

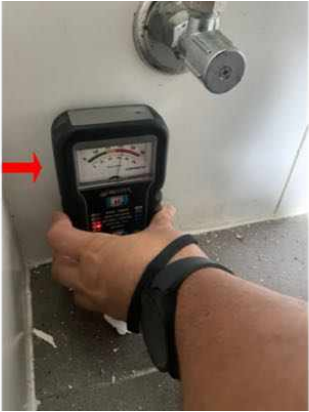
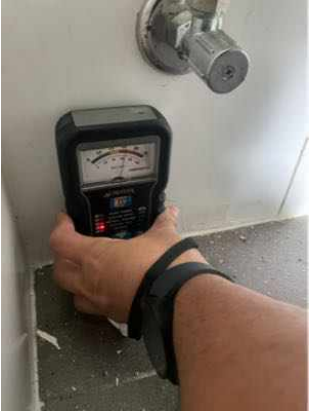
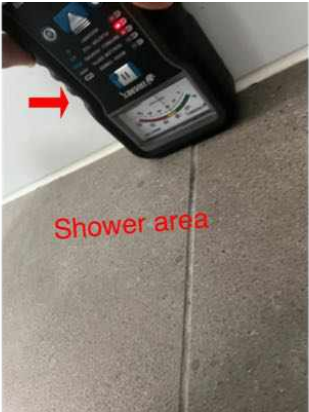
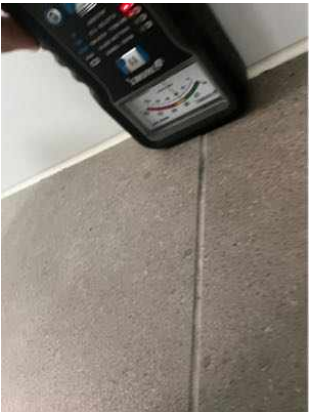
If mould growth has been found there may be environmental biological or health issues involved. In these cases an appropriately qualified inspector should also be contacted.

Prior to any remedial works being performed a qualified plumber should be appointed to further inspect the property and to identify the cause of the excessive moisture. Works to remove affected building elements may then be necessary and should be performed by an appropriate tradesperson.

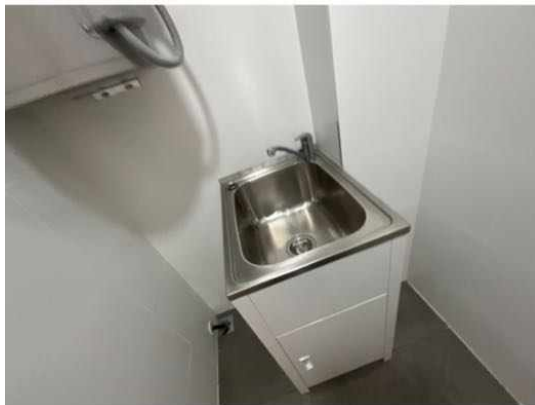
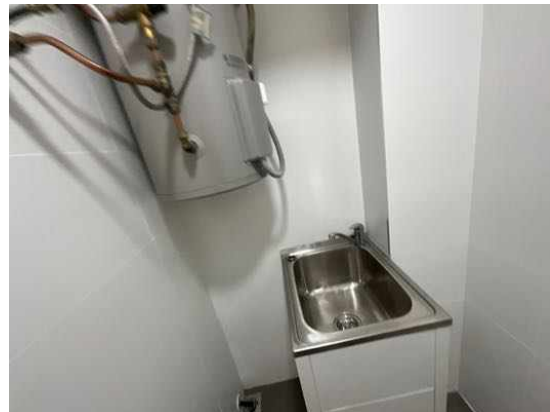
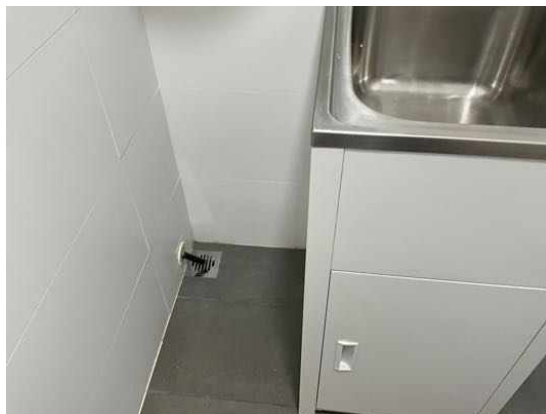
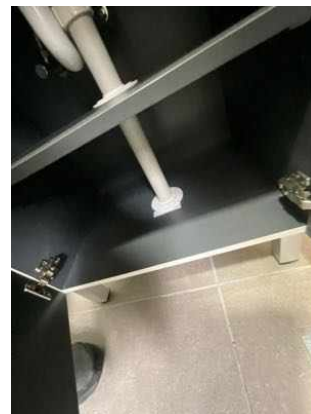
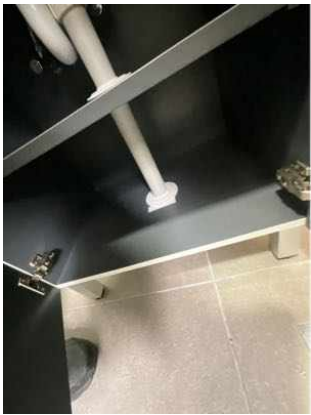
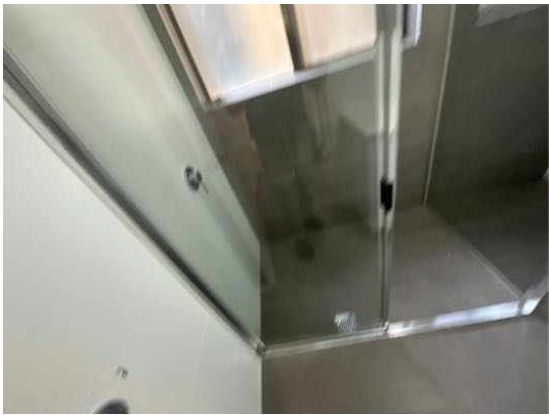
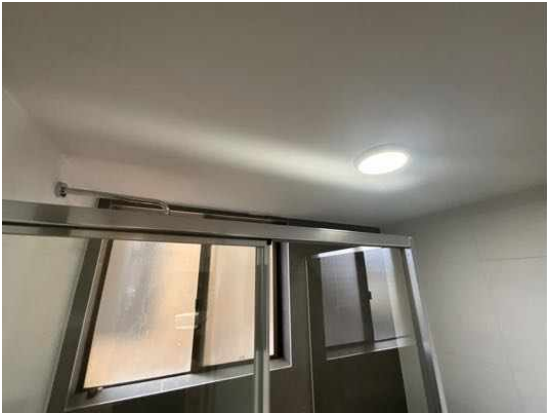
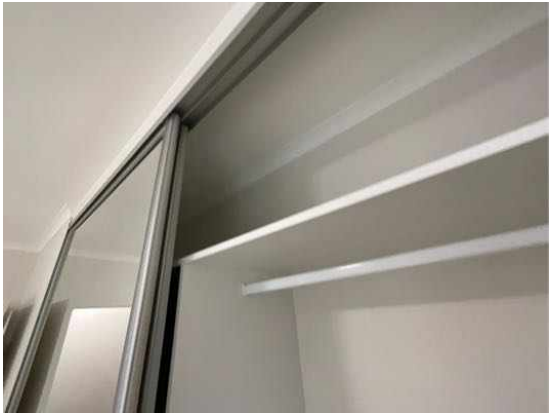
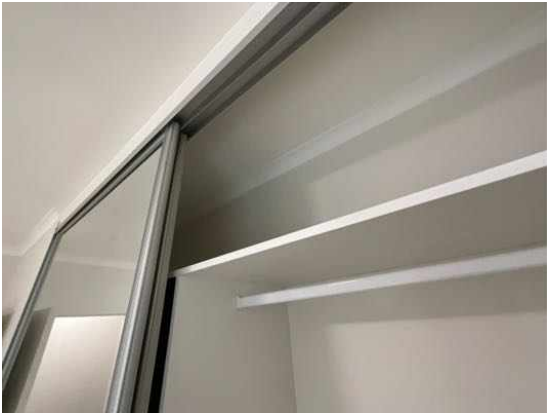
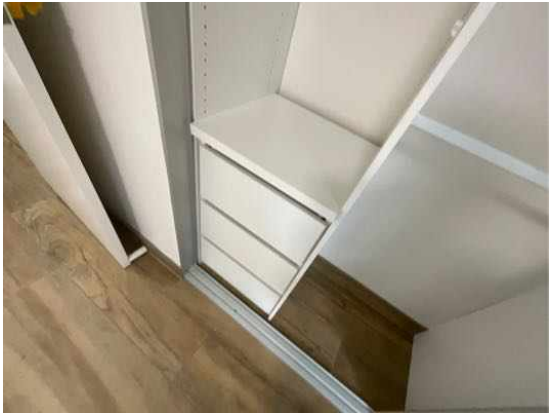
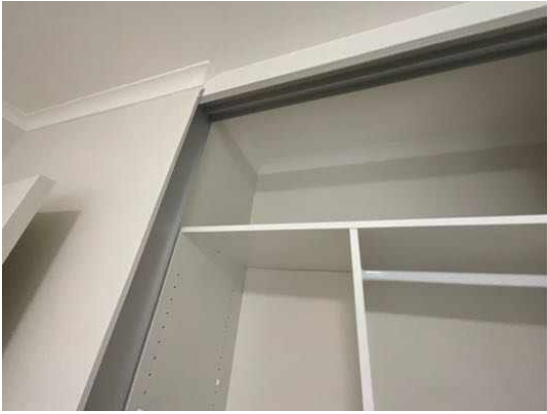
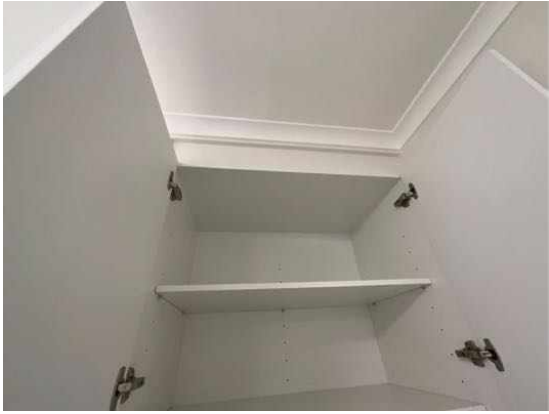
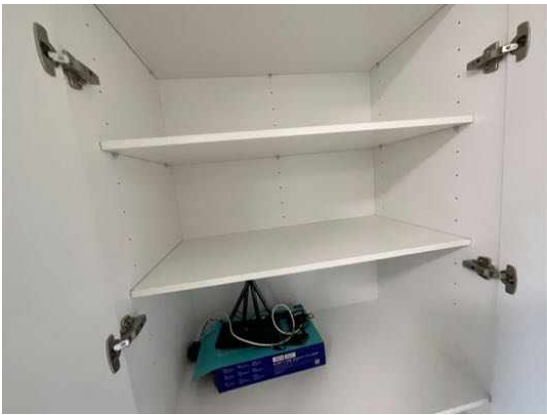
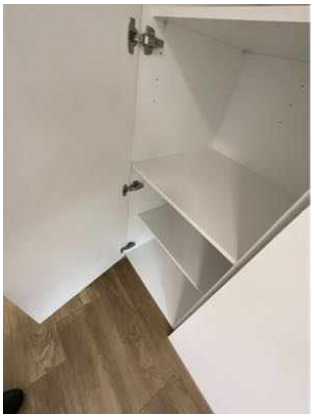
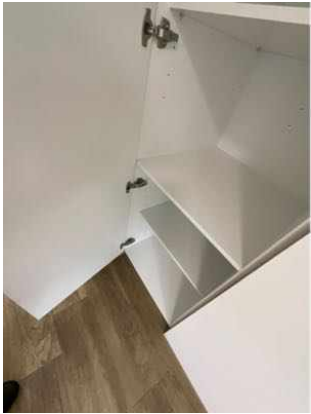
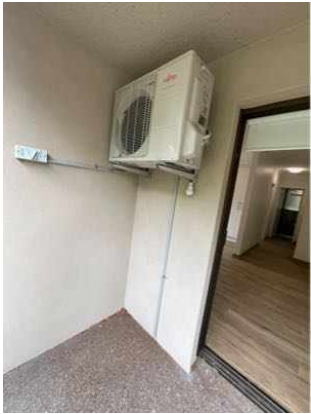
Finding: Additional Photos - Obstructions and Limitations

Information: These photographs are an indication of the obstructions and limitations which impeded full inspection of the property at the time of inspection. These obstructions can hide an array of defects and should be removed to allow full inspection to be carried out. A re-inspection is recommended once the areas are made accessible.
