Building and Timber Pest Inspection Report

Inspection Date: Wed, 8 Apr 2026

Property Address: 7/11 Harrington Ave, Castle Hill NSW 2154, Australia

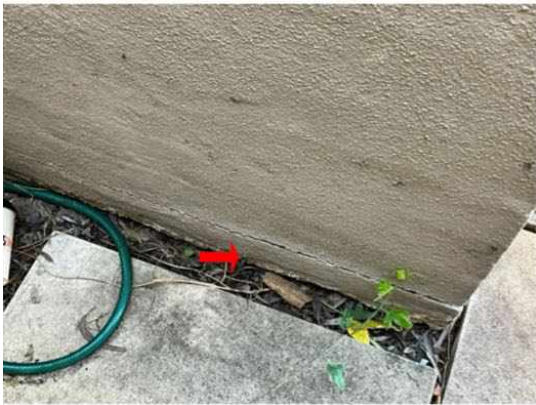
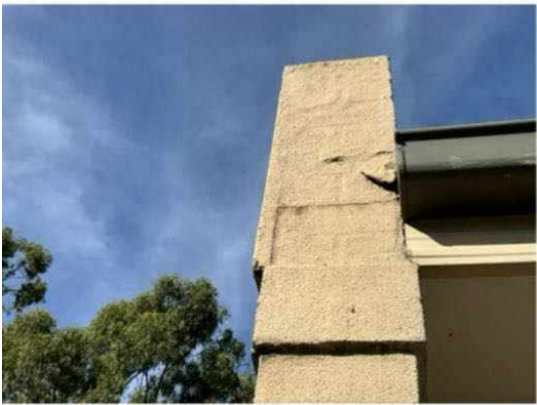
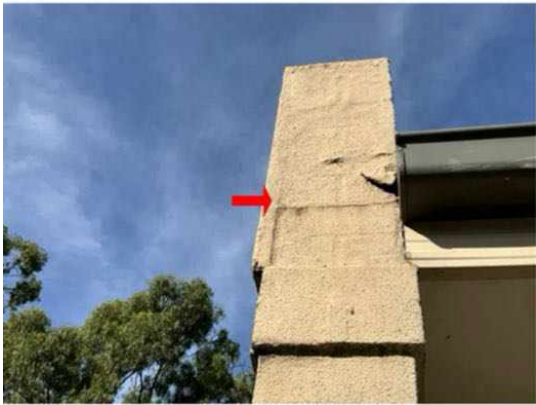
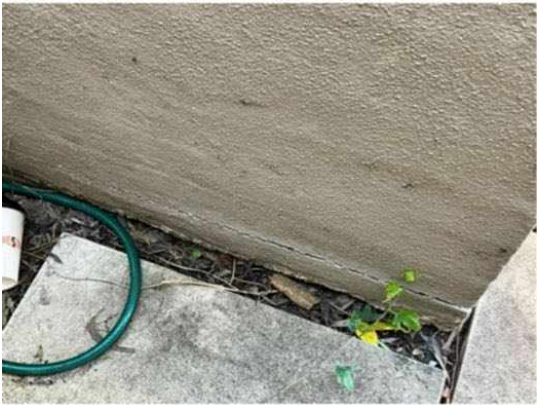
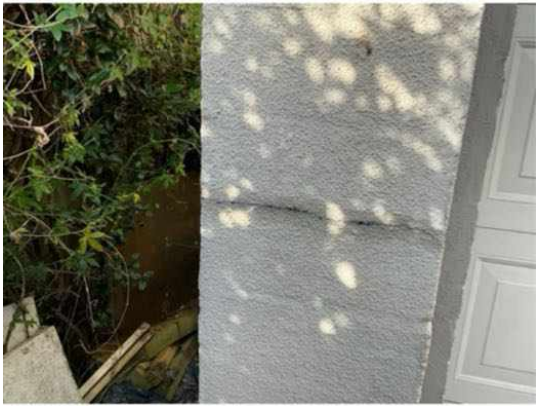
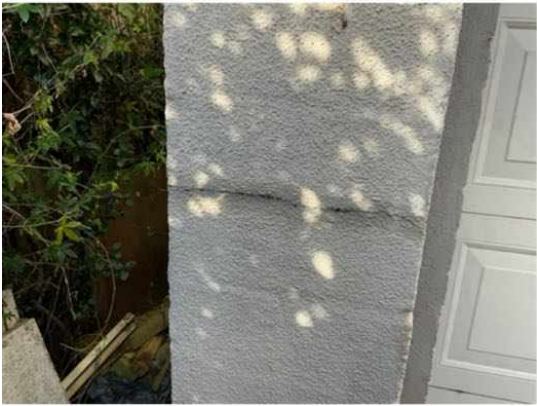
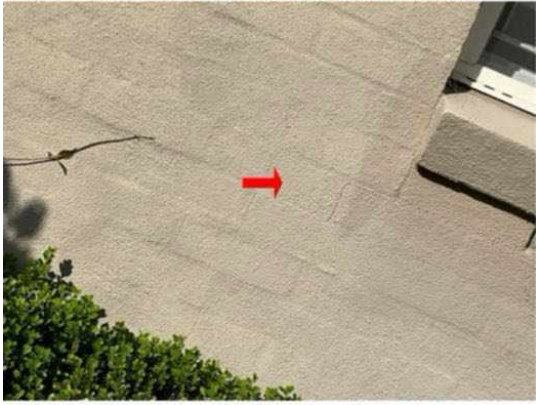
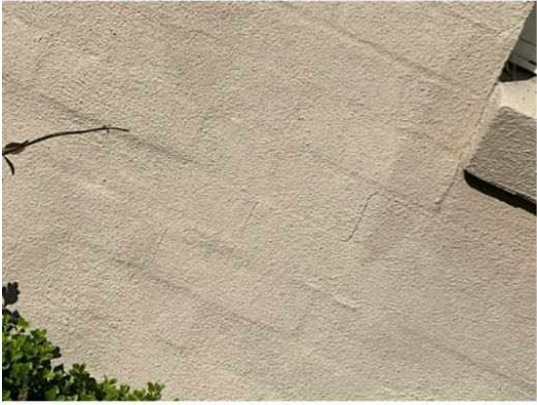
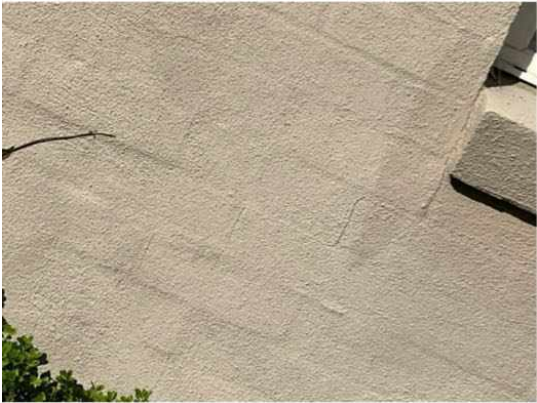
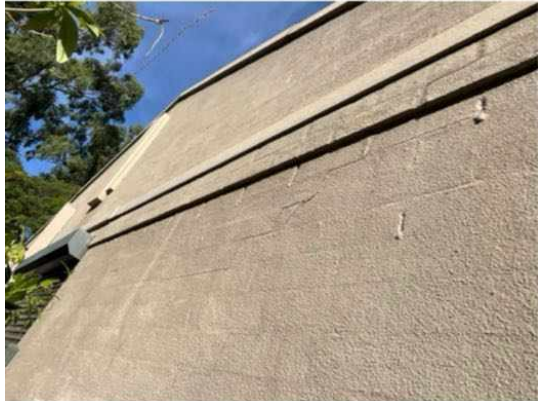
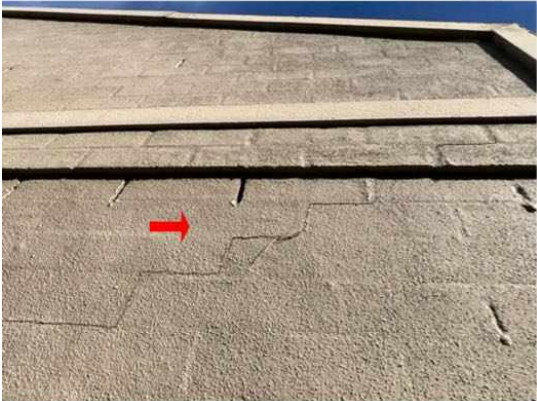
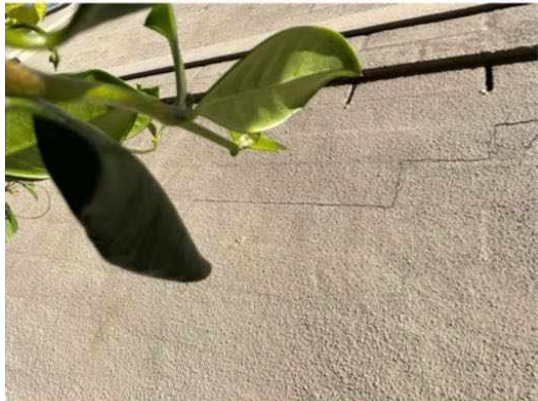
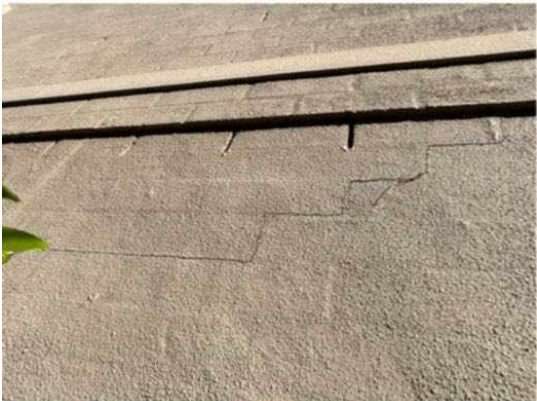
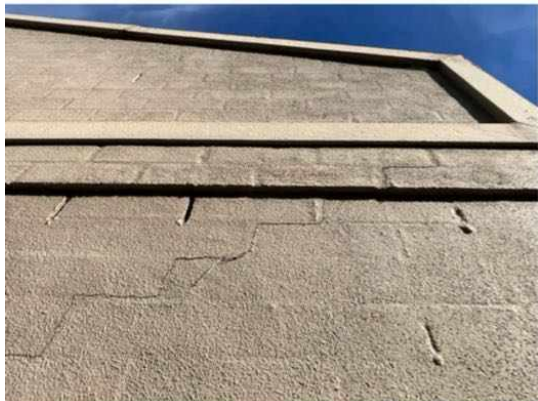
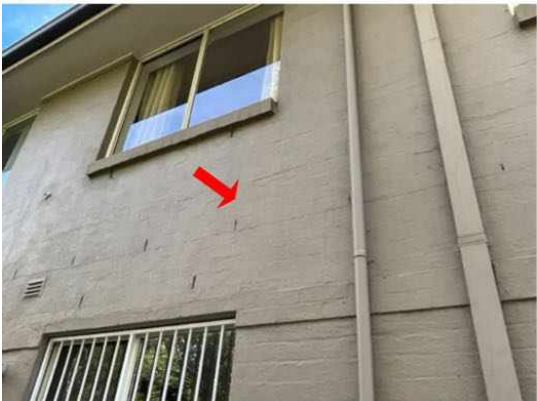
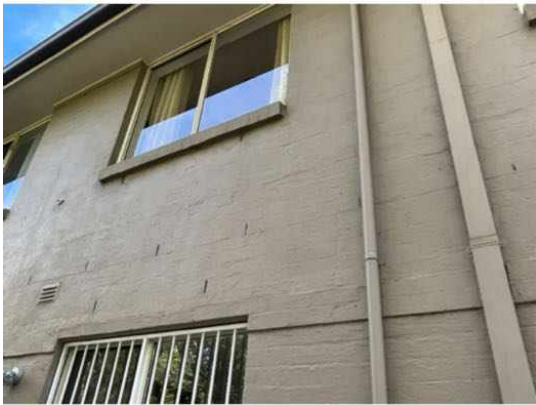
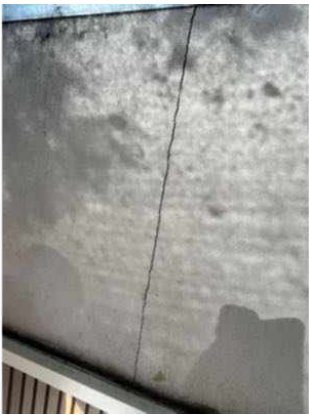
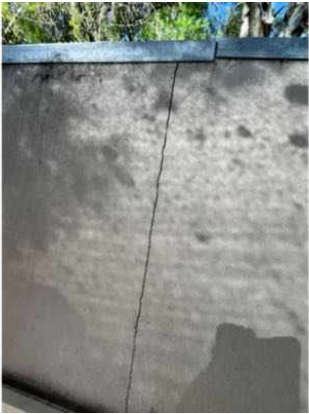
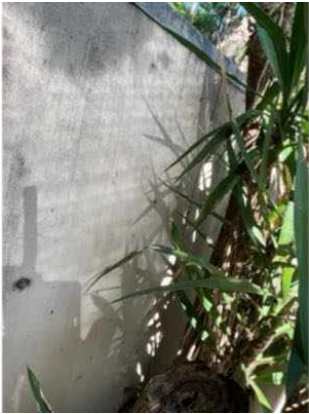
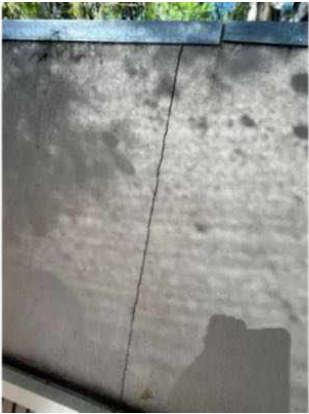
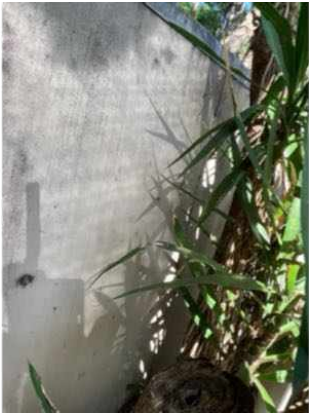
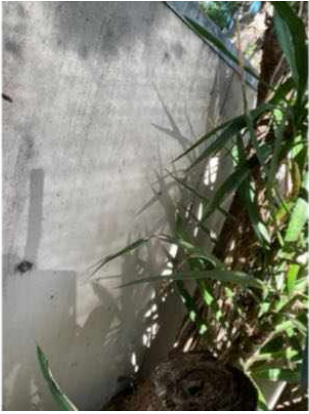
Finding 2.01

Building: Main Building
 Location: All Areas
 Finding: Brickwork - Cracking [Repair required]
 Information: cracking was identified to the brickwork in this area. Cracks of this type are likely to have been caused by minor expected movement of building elements, but may also have a structural cause that is more significant.

A crack of this size may be repaired by extensive filling. Additionally, further remedial works to associated building elements,

A qualified bricklayer should be contacted immediately to estimate and perform repair and restoration works. Consultation with a structural engineer may be required where structural instability is found to be the underlying cause of the cracking.

Always contact a building inspector should cracks widen, lengthen, or become more numerous.

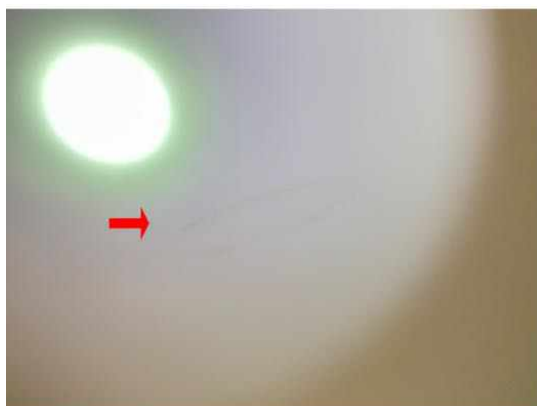
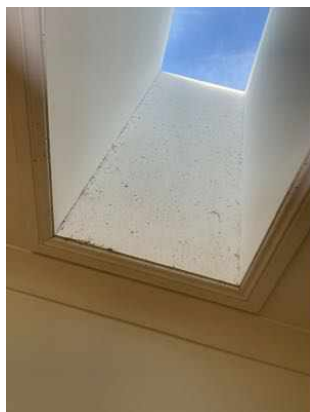
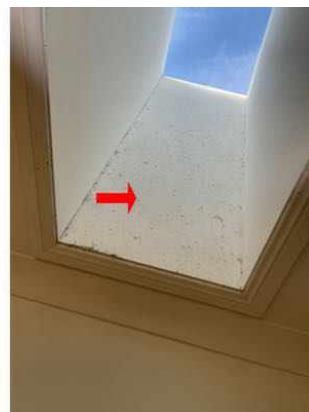
Finding 2.02

Building: Main Building
Location: Roof Exterior
Finding: Roof Leaks
Information: The roof has developed leaks, allowing water to penetrate the building envelope. These leaks may be due to damaged or missing shingles/tiles, deteriorated flashing, clogged gutters, or other roof system failures.

1. Structural Damage: Continuous water ingress can weaken the structural integrity of the roof and supporting structures, leading to potential collapse or costly repairs.

2. Mold and Mildew Growth: Persistent moisture promotes mold and mildew growth, which can cause health issues for occupants, including respiratory problems and allergic reactions.

3. Electrical Hazards: Water infiltration can come into contact with electrical wiring and fixtures, increasing the risk of short circuits, electrical fires, or electrocution.

4. Insulation Damage: Wet insulation loses its effectiveness, leading to reduced energy efficiency and higher heating and cooling costs.
5. Interior Damage: Leaks can cause staining, peeling paint, and damage to interior ceilings, walls, and personal property.

6. Pest Infestation: Moist environments can attract pests such as termites, ants, and rodents, which can further damage the property.

A licensed roofing contractor or qualified roofer should be contacted to inspect and repair the roof leaks. They will:

- Identify the source of the leaks and assess the extent of the damage.
- Repair or replace damaged shingles, tiles, flashing, or other roofing materials.
- Ensure proper sealing around roof penetrations, such as vents, chimneys, and skylights.
- Clean and maintain gutters and downspouts to ensure proper drainage.
- Provide recommendations for any additional necessary repairs or preventive measures to avoid future leaks.

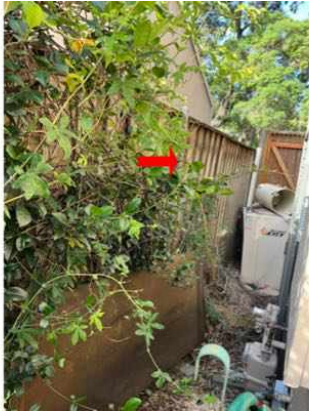
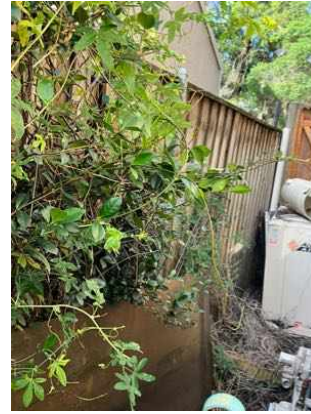
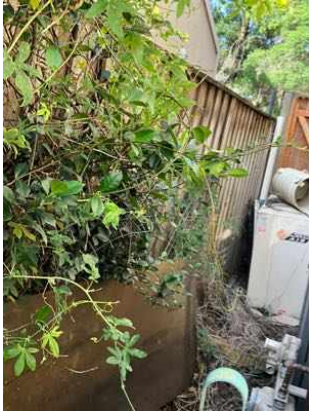
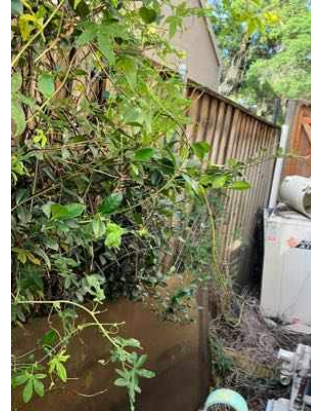
Building:	Main Building
Location:	Fencing
Finding:	Detoriated fence
Information:	The fence along the property boundary has deteriorated significantly, showing signs of rot, rust, and structural weakness. Several sections are leaning or have become detached, compromising the integrity of the fence and its ability to perform its intended function.

The deteriorated fence poses multiple risks:

1. **Safety Hazard:** The unstable fence may collapse, posing a risk of injury to residents, visitors, and passersby.
2. **Security Concern:** The compromised fence may allow unauthorized access to the property, increasing the risk of theft, vandalism, or trespassing.
3. **Property Damage:** Falling sections of the fence could damage nearby structures, plants, or other property features.

- **Licensed Fencing Contractor:** A professional fencing contractor should be hired to assess the extent of the damage and either repair or replace the deteriorated sections.
- **Handyman Services:** For minor repairs, a qualified handyman could be engaged to reinforce or repair specific sections of the fence.
- **Landscaper (if the fence is part of a larger garden feature):** If the fence is integrated into the landscape design, a landscaper with experience in fencing could be involved in the repair or replacement process.

It's important to ensure that whoever is hired is experienced and qualified to ensure the fence is restored to a safe and functional condition, compliant with local regulations.

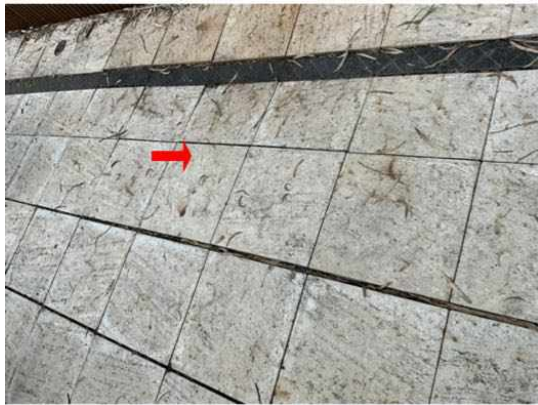
Finding 3.03

Finding: loose pavers and improper proper drainage

Information: The yard of the property have uneven, loose pavers, which may impede proper drainage and access. The area shows signs of poor maintenance, potential water pooling, and trip hazards due to moss-covered, unstable surfaces.

Risk: Increased risk of personal injury due to slips and trips, mosquito breeding from stagnant water, and potential structural moisture damage from inadequate site drainage.

Recommended Action: A licensed landscaper or drainage specialist should be engaged to clear vegetation, regrade the area for proper water runoff, and relay or replace pavers to ensure a safe and accessible walkway.

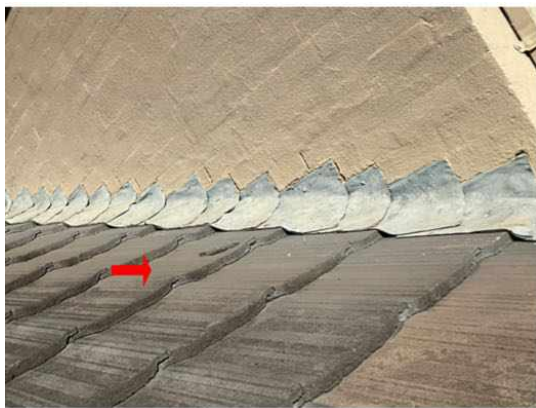
Finding 3.04

Building: Main Building
Location: All Areas
Finding: Roof Weathered
Information:

Inspection of the roof revealed widespread weathering to the tiled roof surface. The tiles show loss of surface finish, colour fading, and age-related deterioration typical of older roof coverings. Although no significant cracking was noted, weathering can lead to increased porosity, reduced water-shedding capability, and a higher risk of future cracking or displacement during adverse weather conditions.

A licensed roofer should be engaged to undertake a closer inspection, carry out routine maintenance, and replace any tiles that may be compromised. Ongoing monitoring is recommended due to the age and condition of the roof covering.

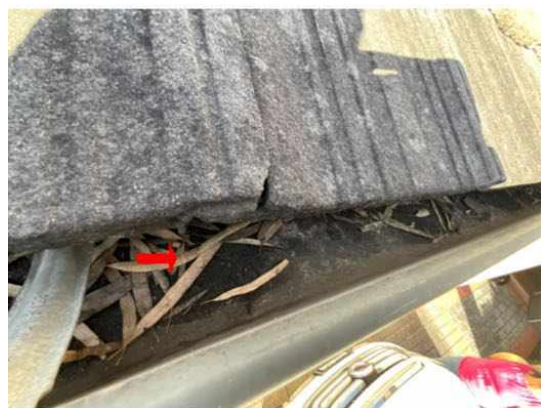
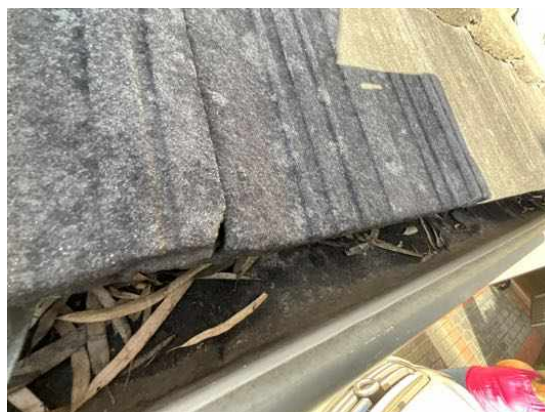
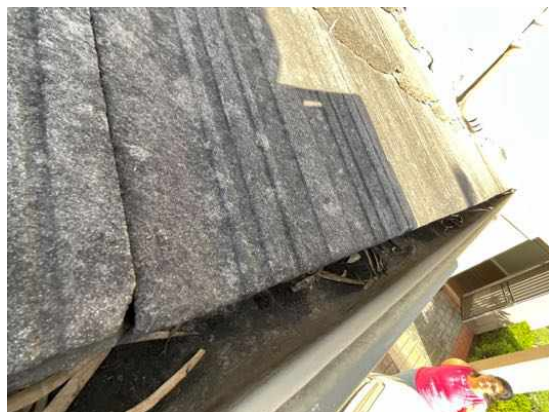
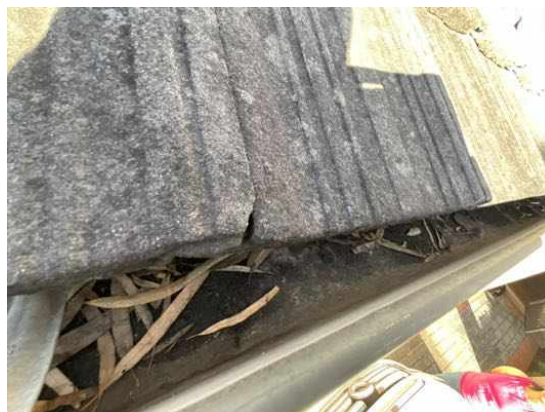
Finding 3.05

Building:	Main Building
Location:	All Areas
Finding:	Blocked gutters - organic debris
Information:	The roof gutter system was observed to be blocked with organic debris and moss growth, as evident in the provided images.

- Water ingress into the eaves or walls,
- Timber rot or deterioration of fascia and soffits,
- Accelerated moss and algae growth, promoting further blockages,
- Potential foundation issues if water pools near the base of the structure.

A licensed roofing contractor or qualified gutter cleaning service should be engaged to remove the debris and inspect the system for any further issues.

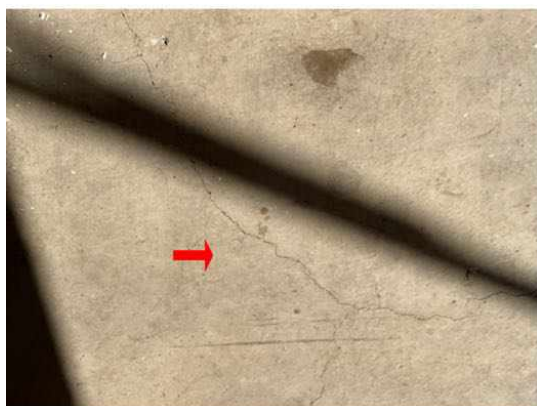
Finding 3.06

Finding: Crack in concrete slab - Category 0

Information: A crack coded as Category 0 was identified in the slab. A Category 0 crack is described as a hairline crack, representing insignificant movement of slab from level.

The approximate width of the crack to be considered Category 0 is 0.3mm, or change in offset of less than 8mm when a 3m straight edge is placed over the defect.

No rectification is required at this time. However, all cracking should be monitored over a 12 month period to identify any further damage in the area.

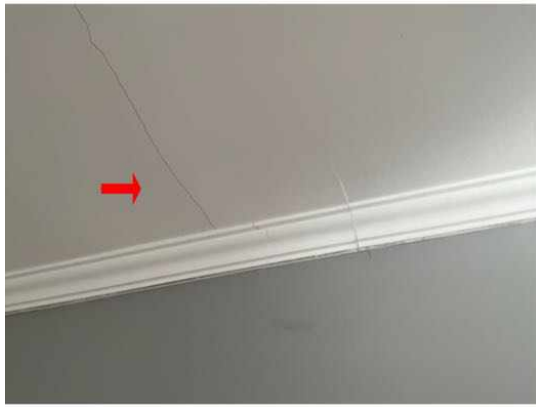
Finding 3.07

Building:	Main Building
Location:	Living Room
Finding:	Ceiling – Plasterboard Fine Cracking
Information:	Fine cracking was observed to the ceiling plasterboard. This is commonly associated with normal building movement, shrinkage, or minor settlement and is generally cosmetic in nature.

However, cracking may worsen over time and affect appearance if left unattended.

Recommendation / Who can fix it: Repair and monitoring by a qualified plasterer or painter is recommended.

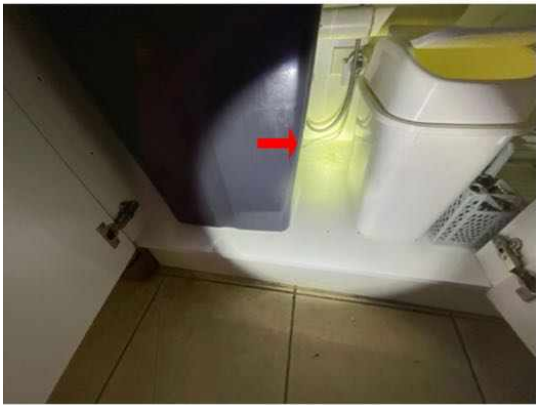
Finding 3.08

Building: Main Building
Location: Kitchen
Finding: Water Stains in Vanity
Information: "Water stains observed in the vanity area, compromising its appearance and potentially causing damage."

Continued water exposure may lead to material damage, mold growth, and diminished aesthetic appeal.

A licensed plumber or maintenance professional should assess and fix any leaks contributing to the water stains, while a cleaning or restoration service may be needed to address the visible stains and prevent further damage.

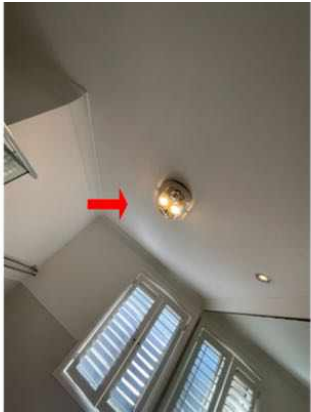
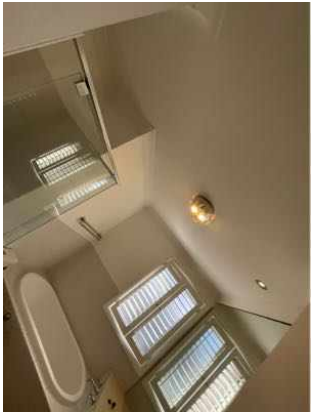
Finding 3.09

Building: Main Building
Location: Bathroom
Finding: Heating light in exhaust fan not working / operating
Information: "The heating light in the exhaust fan is not operating, failing to provide the intended heating function."

A qualified electrician or HVAC technician can fix the issue by inspecting the heating element, wiring, and controls to identify and repair any faults or damages.

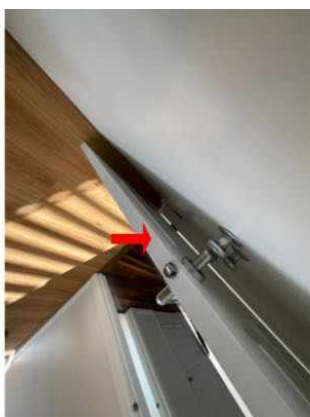
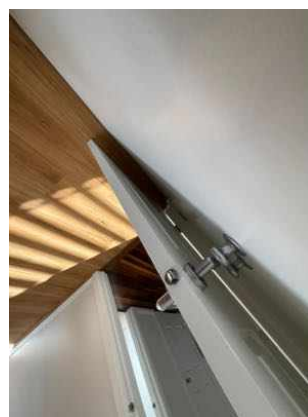
Building: Main Building
 Location: All Areas
 Finding: Missing Door Stopper
 Information: The door lacks a stopper, which is essential to prevent the door from swinging too far and potentially damaging the wall or the door handle. The absence of a door stopper increases the likelihood of impact damage to both the door and surrounding surfaces over time.

- **Damage Risk:** Moderate risk of damage to the door handle, wall, or door itself from repeated impacts when the door is opened forcefully or by a gust of wind.
- **Wear and Tear Risk:** Increased wear on door hardware and hinges due to the potential for abrupt stops without a dedicated stopper.

This issue is a minor defect but should be addressed to prevent potential damage and

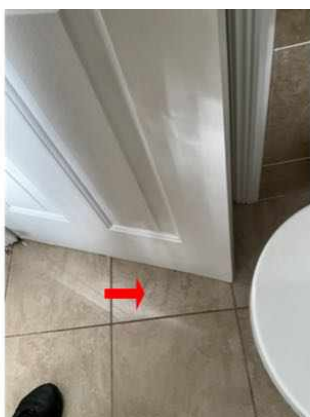
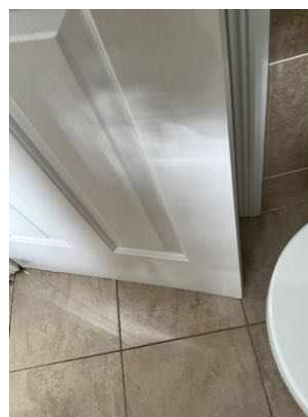
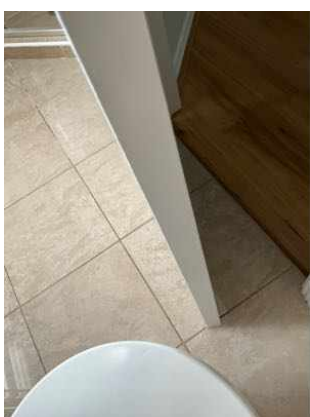
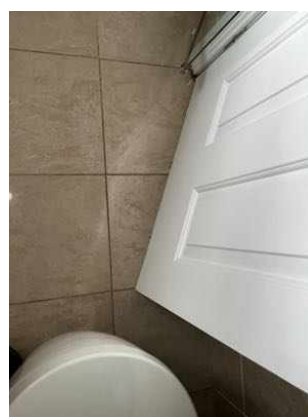
Building: Main Building
 Location: Ensuite
 Finding: Door - Binding/jamming
 Information: Binding and/or jamming of this door is evident during standard operation. This defect inhibits the functionality of the affected door as well as creating potential for secondary defects to associated building elements.

A door that binds to flooring or to the associated door frame may have several causes, ranging from minor defects, such as poor installation of the door or deteriorated hinges, through to major structural issues. For minor causes, a qualified carpenter or general handyperson should be appointed to perform minor rectification

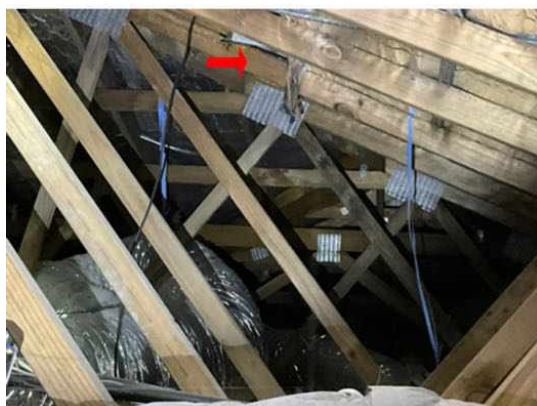
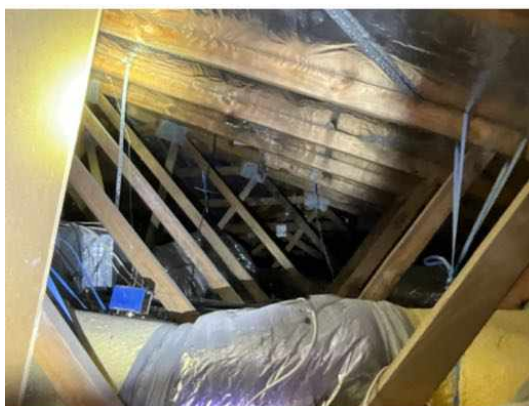
Finding 3.14

Building:	Main Building
Location:	Roof Void
Finding:	Sarking - Damaged
Information:	Sarking, a laminated aluminium foil applied to the interior of the roof covering, assists in insulating the property and acting as a vapour-barrier to the roof void and, subsequently, to the household.

Where sarking is damaged, both insulation and moisture protection of the property are inhibited. This creates a loss of energy and thus negatively impacts the energy efficiency of the property, allowing potential for moisture ingress from condensation or leaking roof tiles.

It is important to repair any holes or damaged sections of sarking to ensure that the building material is fully functional. A registered builder or qualified carpenter should be consulted to provide further advice on this defect and to perform rectification works at client discretion.

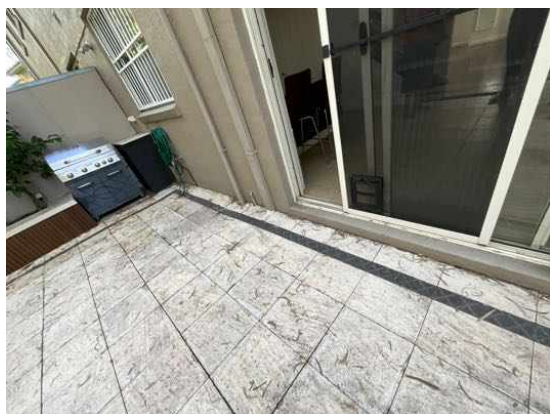
If the slab edge is not properly exposed there is a high risk of termite attack. Sometimes, in order to determine the type of slab, a suitably qualified person such as an architect or builder may be required to consult the construction plans.

Where the slab edge cannot be properly inspected, it is highly recommended that termite or timber pest inspections be carried out every 6-12 months to aid protection of the property against infestation.

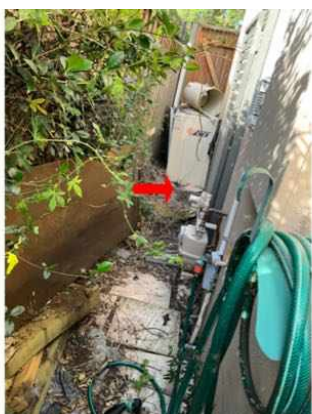
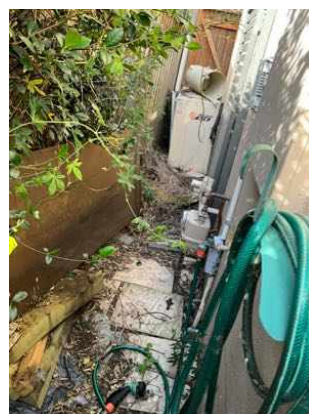
Finding 6.02

Building:	Main Building
Location:	Yard - Side
Finding:	Bridging or Obstruction Conducive environment for Termites
Information:	Bridging of termite barriers occurs when termites bridge (usually by building a mud tunnel) a termite barrier or inspection inspection zone or where termites have a passage, allowing them to bridge the barrier.

Where bridging has occurred full inspection is prevented and termites may enter a property in a concealed or undetected manner.

Recommended moving obstructions away from the external walls for further and future inspections.

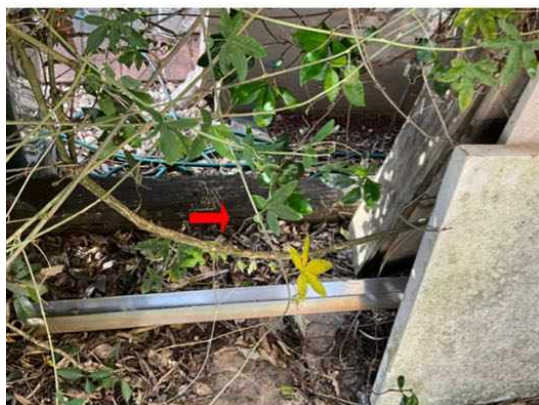
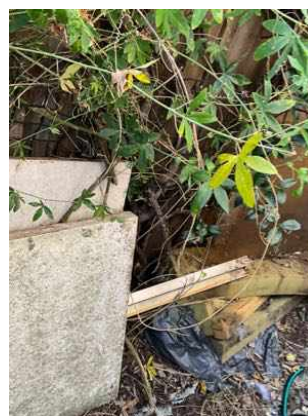
Finding 6.03

Building:	Main Building
Location:	All Areas
Finding:	Timber on ground / conducive conditions to termite damage
Information:	Timber on the ground is indeed conducive to termite damage. Termites are known to

thrive in moist environments, and wood in contact with soil or moisture is more susceptible to infestation.

To prevent this, it's important to keep timber elevated and away from direct ground contact. Regular inspections and proper termite control measures are also essential to protect your wooden structures from termite damage.

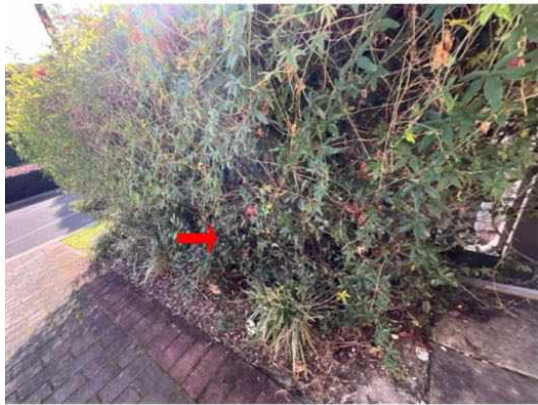
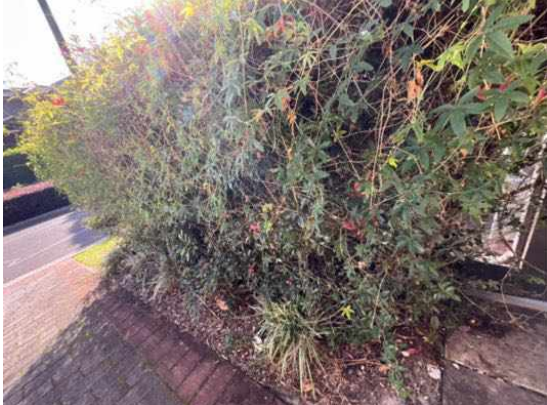
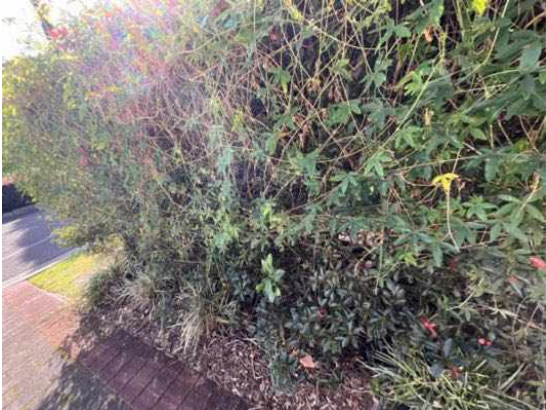
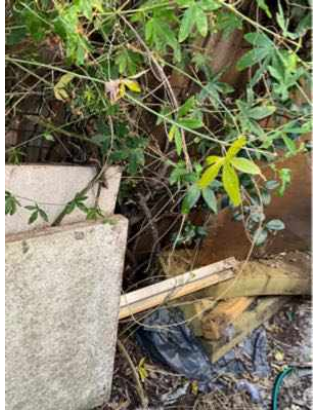
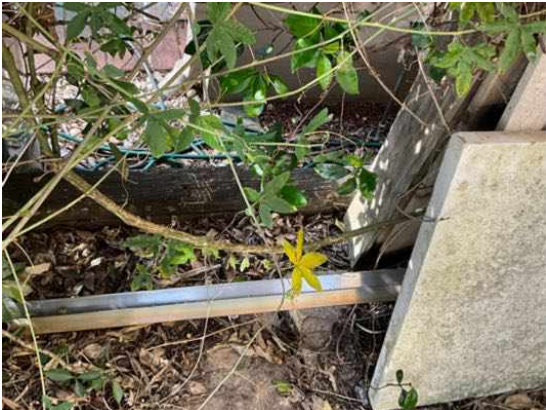
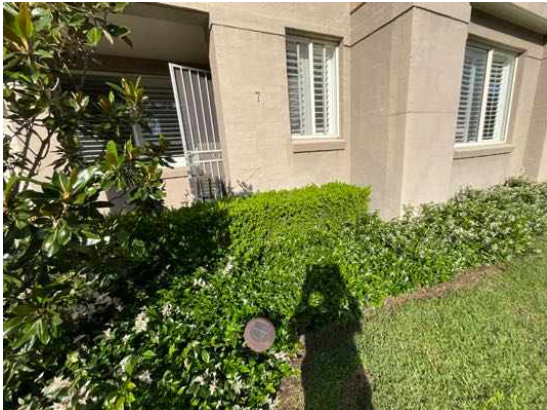
Finding 6.04

Building:	Main Building
Location:	All Areas
Finding:	Dense vegetation around a property can increase the risk of termite infestation
Information:	The presence of dense vegetation around a property can increase the risk of termite infestation, as it provides a conducive environment for them. To address this, consider maintaining a clear space between the vegetation and your home. If you suspect a termite issue, it's advisable to consult with a licensed pest control professional for inspection and treatment.

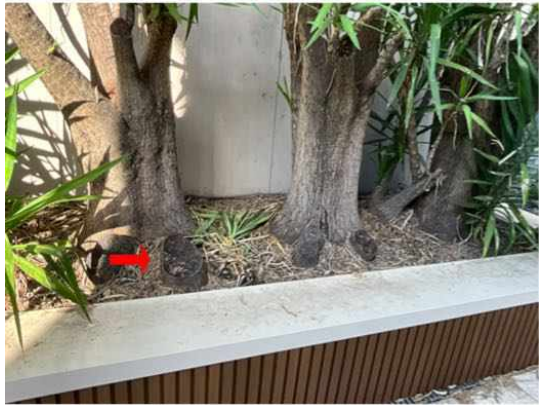
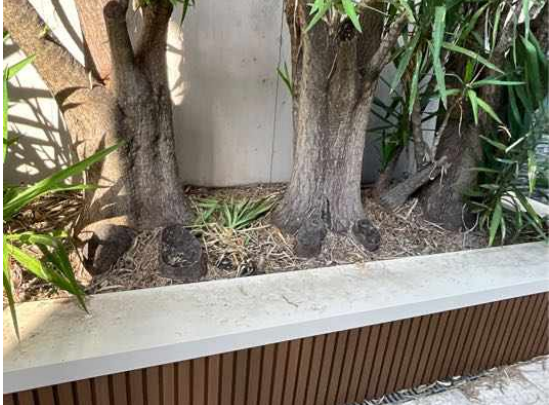
Finding 6.05

Building: Main Building
Location: All Areas
Finding: Cut and Exposed tree Stumps
Information: The tree stump, which has been cut and exposed, poses a potential risk of termite infestation due to its increased vulnerability to termite attacks.

Please contact Licenced pest controller for further advice. Pictures attached for your reference.

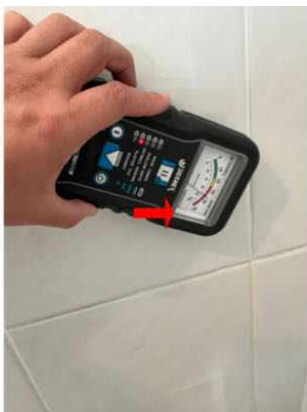
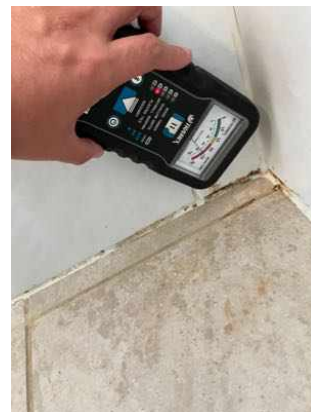
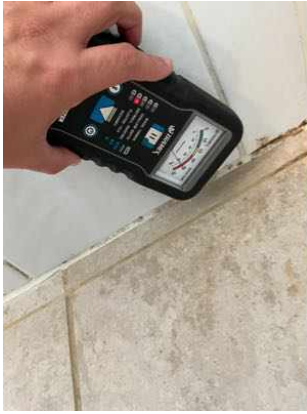
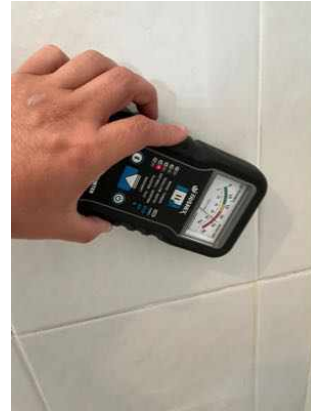
Finding 6.06

Building:	Main Building
Location:	Bathroom
Finding:	Excessive moisture - Conducive to Timber pest
Information:	Excessive moisture can attract termites and produce conditions that promote fungal growth and wood decay.

Excessive moisture is generally caused by deteriorated inadequate or missing roof drainage leaking plumbing pipes or fixtures poorly plumbed HWS overflows or condenser units and poor site drainage.

If mould growth has been found there may be environmental biological or health issues involved. In these cases an appropriately qualified inspector should also be contacted.

Prior to any remedial works being performed a qualified plumber should be appointed to further inspect the property and to identify the cause of the excessive moisture. Works to remove affected building elements may then be necessary and should be performed by an appropriate tradesperson.

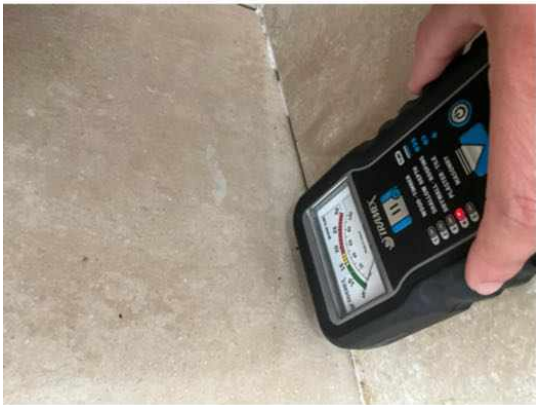
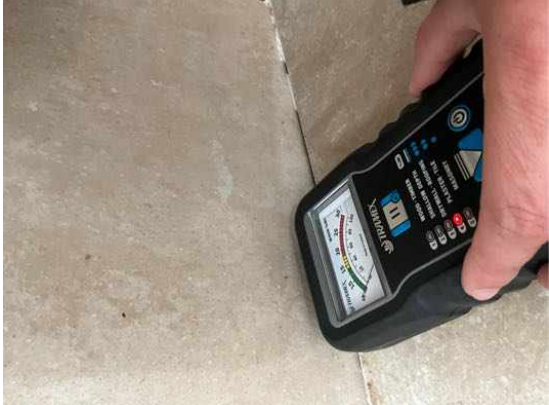
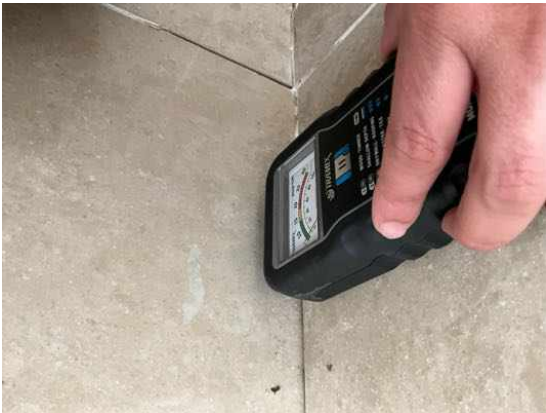
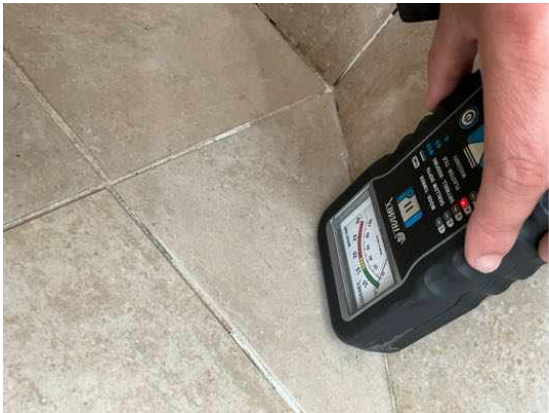
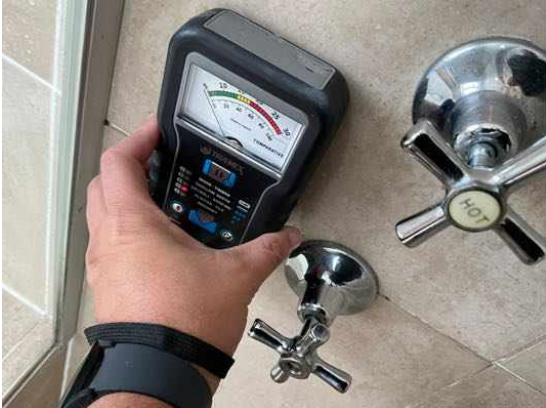
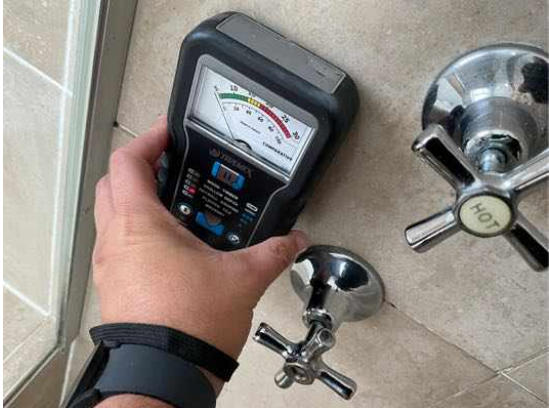
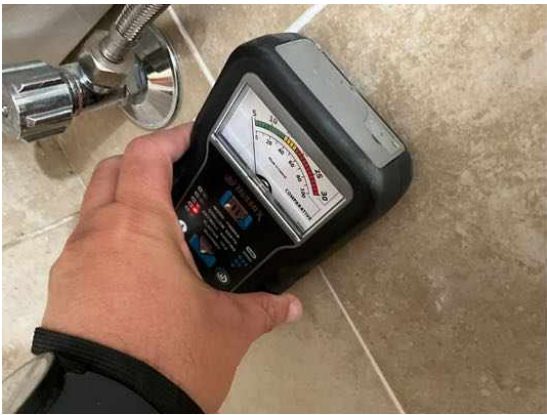
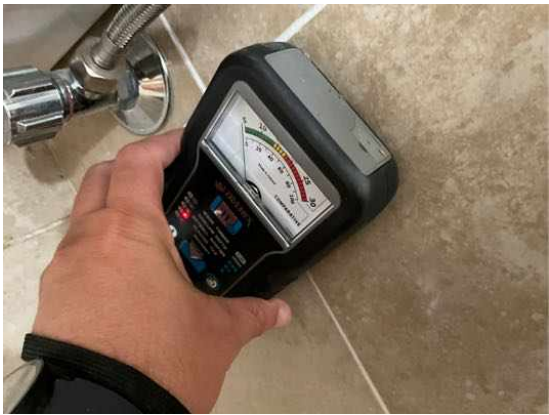
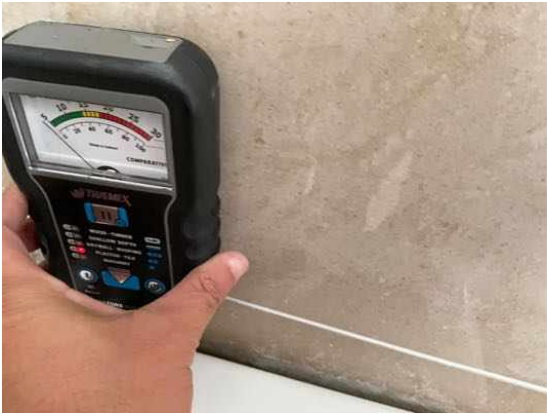
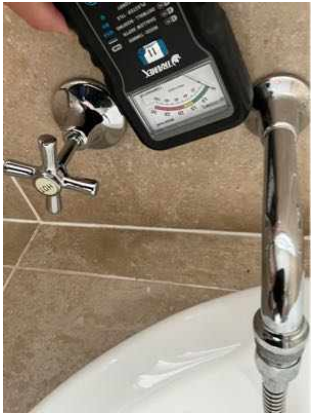
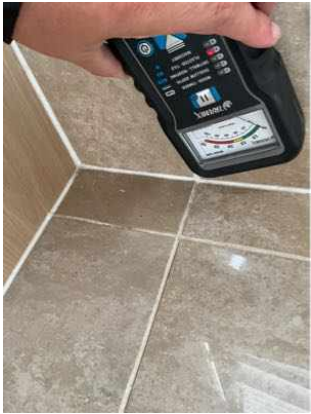
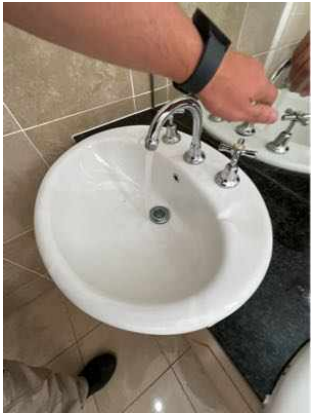
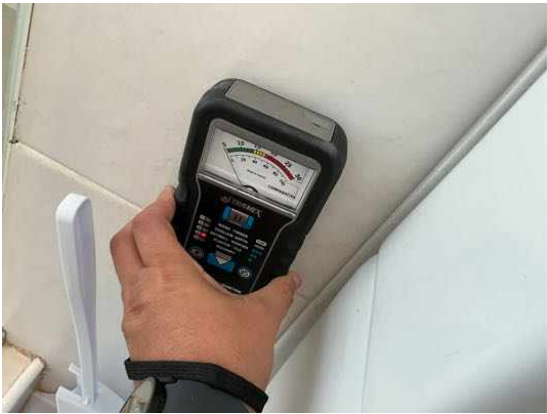
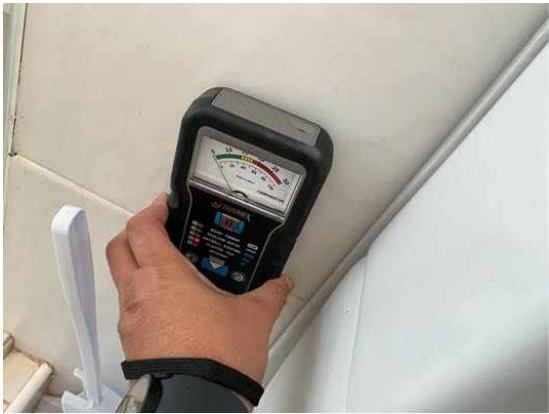
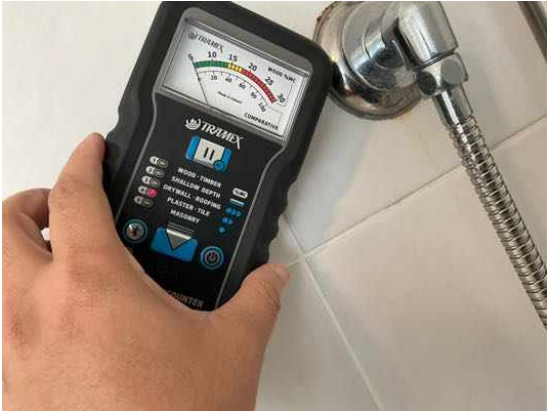
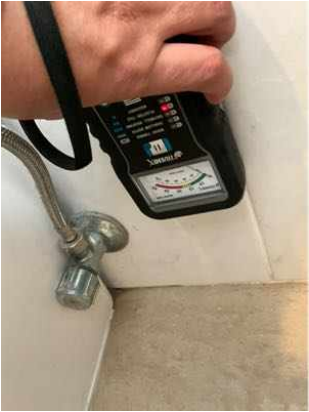
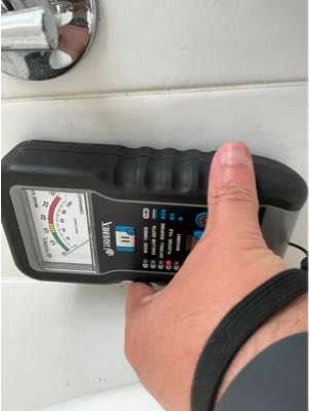
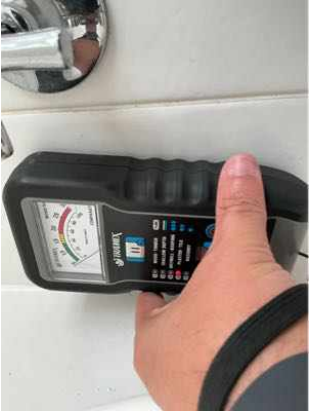
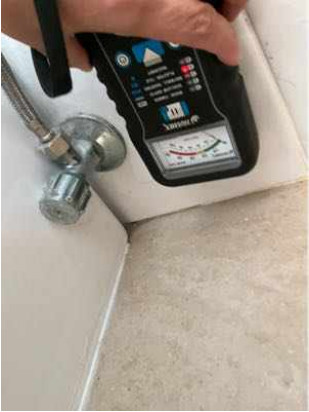
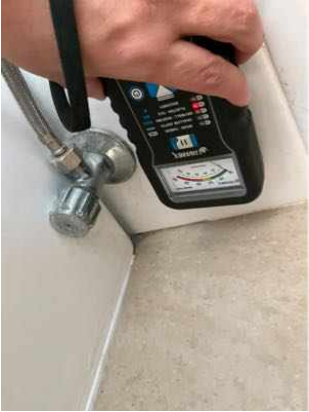
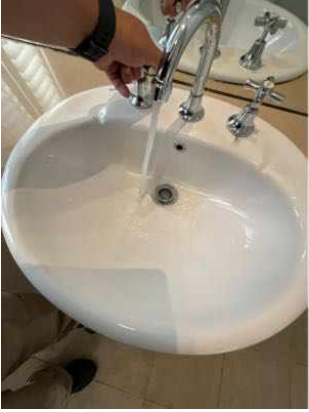
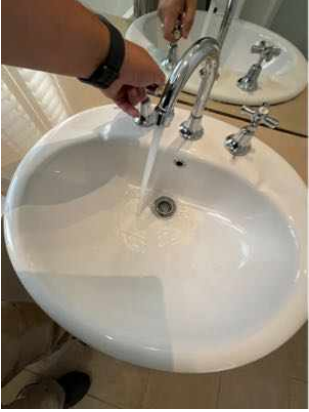
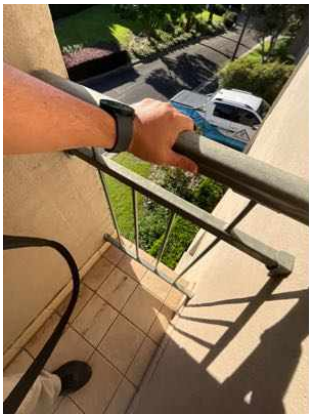
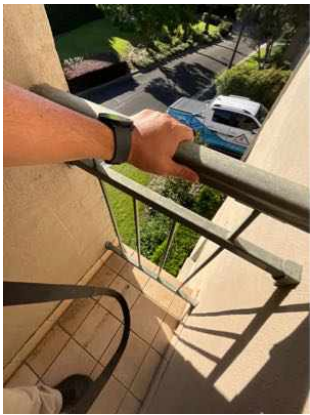
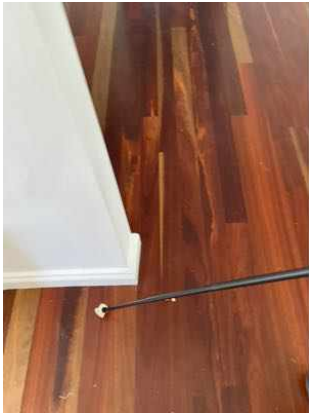
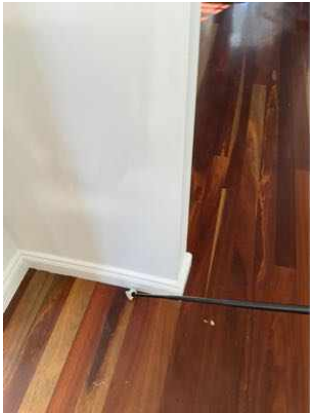
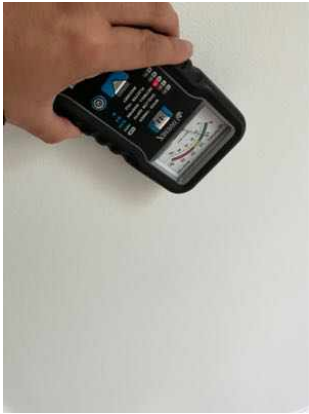
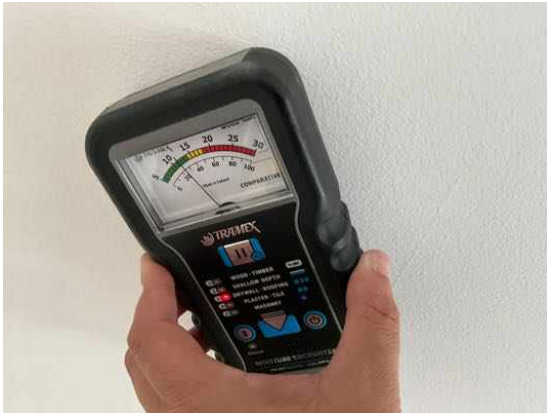
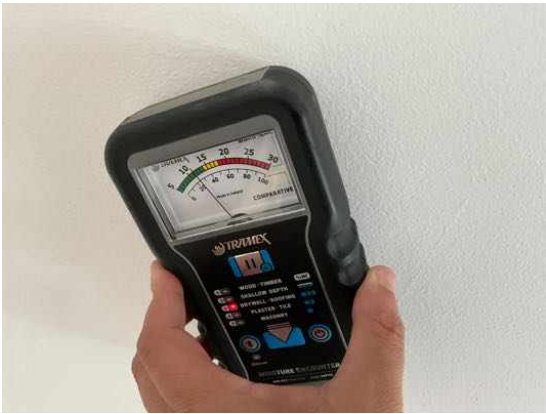
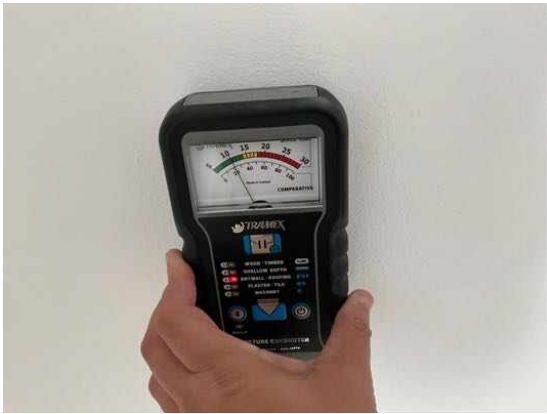
Building: Main Building
Location: All Areas
Finding: Additional Photos
Information: Additional photos are provided for your general reference
