Building and Timber Pest Inspection Report

Inspection Date: Wed, 8 Apr 2026

Property Address: 7/11 Harrington Ave, Castle Hill NSW 2154, Australia

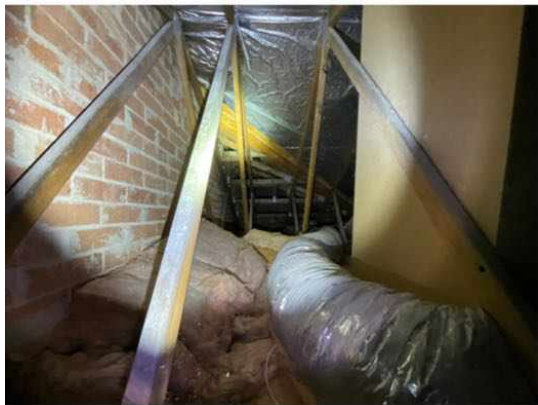
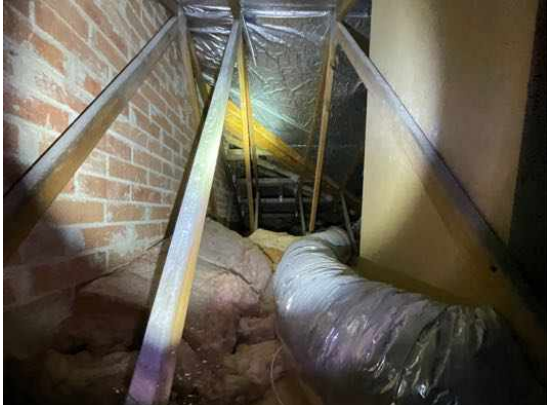
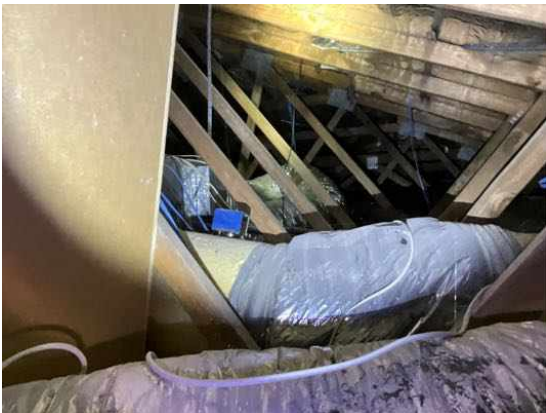
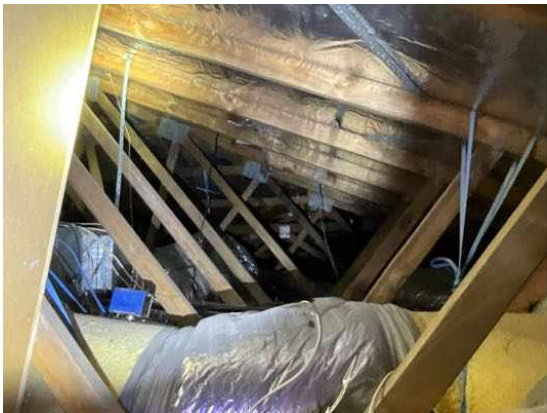
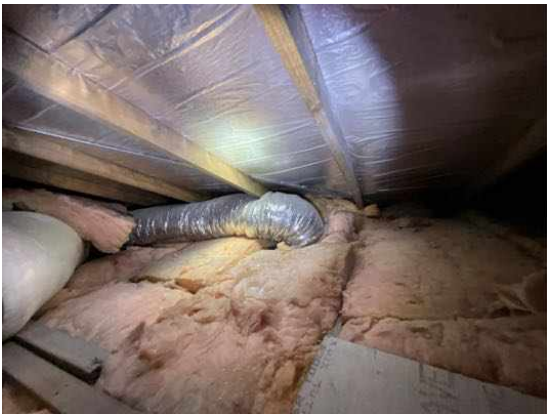
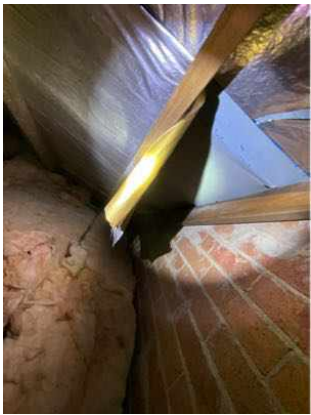
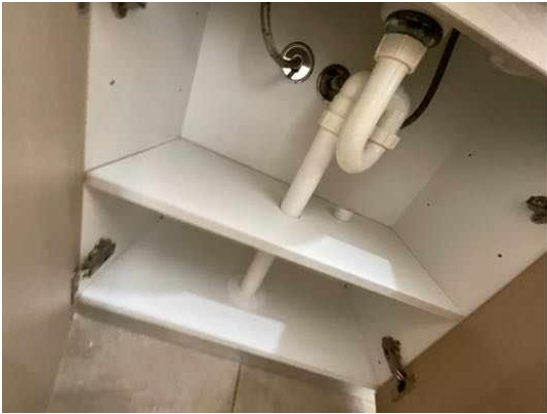
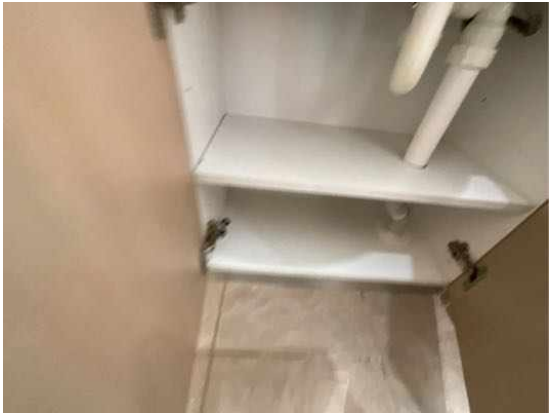
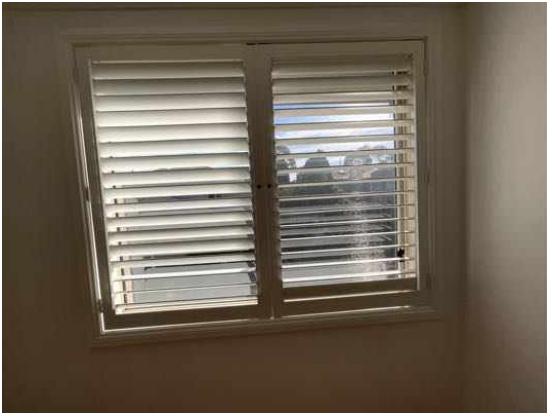
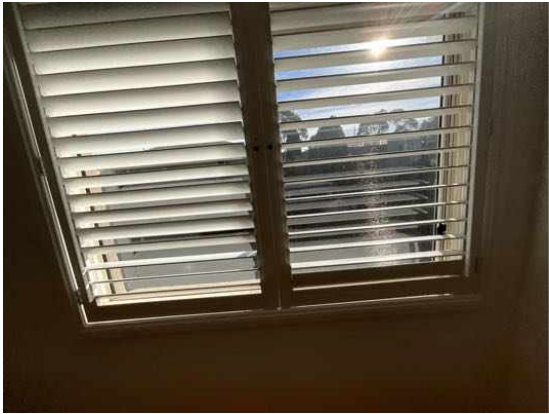
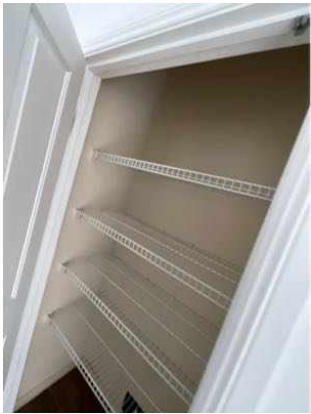
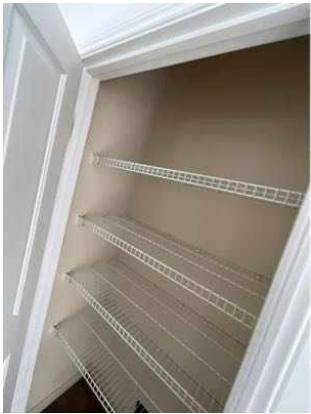
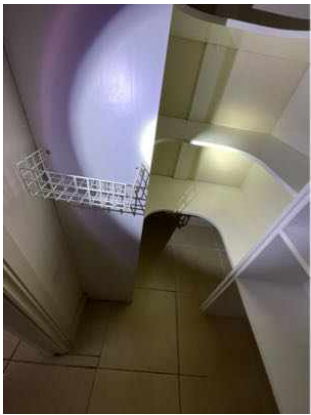
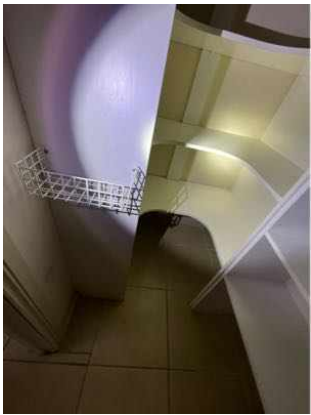
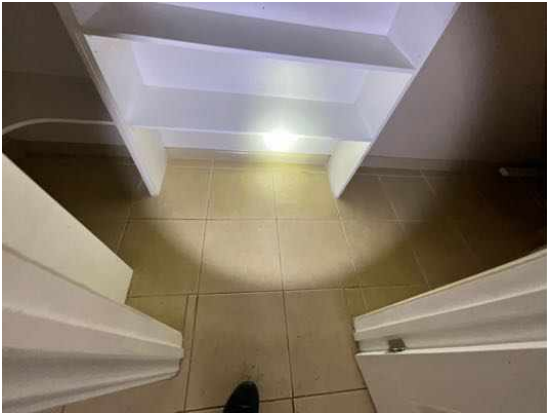
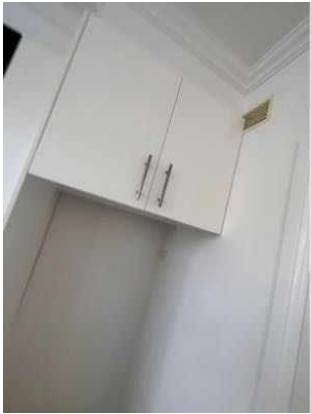
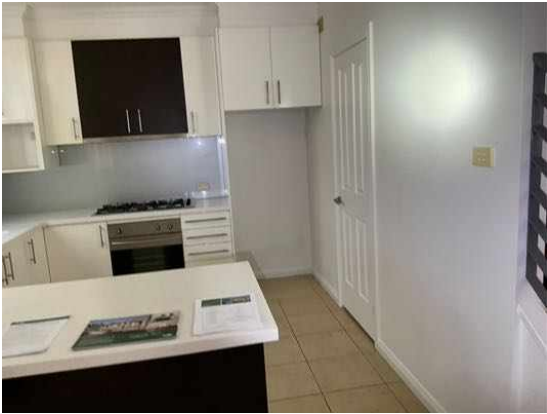
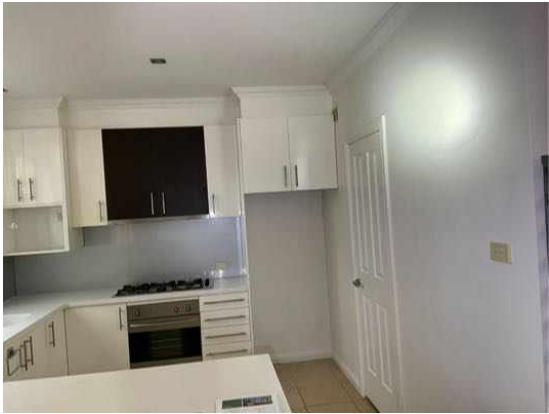
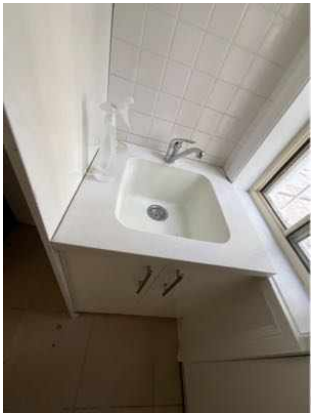
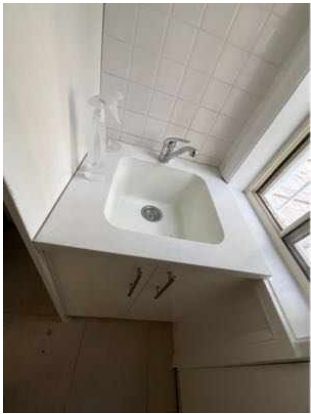
Building: Main Building
Location: All Areas
Finding: Additional Photos - Obstructions and Limitations
Information: These photographs are an indication of the obstructions and limitations which impeded full inspection of the property at the time of inspection. These obstructions can hide an array of defects and should be removed to allow full inspection to be carried out. A re-inspection is recommended once the areas are made accessible.

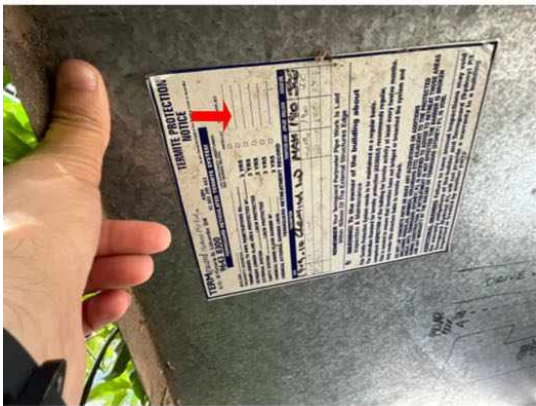
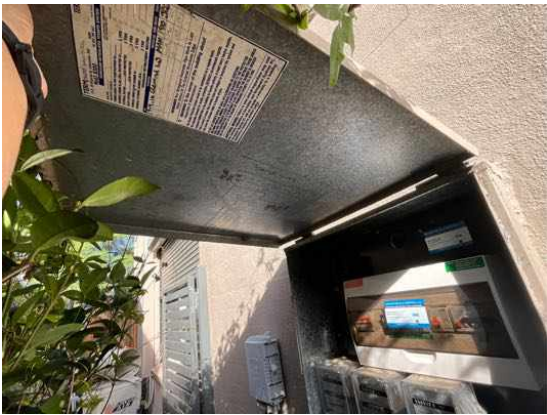
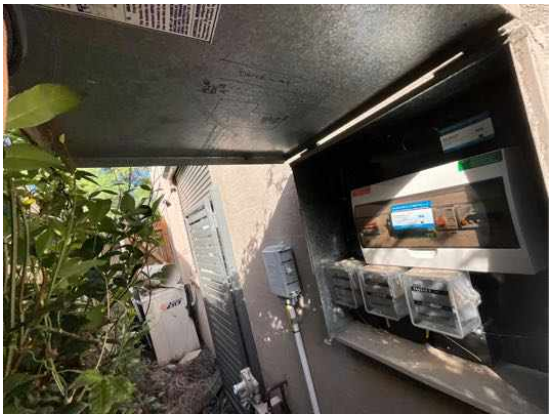
Building: Main Building
 Location: Exterior walls - left side
 Finding: Evidence of Termite Management System - Durable notice / Legible Sticker - seek further information
 Information: The application of a pre & post-construction chemical termite barrier is highly recommended for all properties. Such barriers are highly effective in preventing termite attack on any timber building elements throughout the property.

A durable notice placed in the switchboard unit to indicate termite barriers at the time of inspection.

Client must seek further information from the vendor or real estate agent if the conditions of termite management systems were maintained as per the label or seek advise from licensed pest controller.
