Building and Timber Pest Inspection Report

Inspection Date: Wed, 11 Feb 2026

Property Address: 46 Dulcimere St, Tahmoor NSW 2573,
Australia

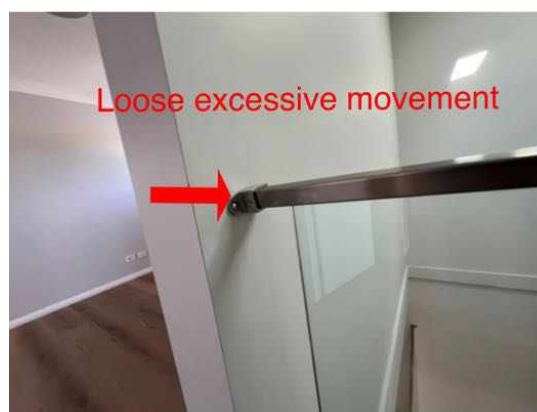
Building:	Main Building
Location:	Stairs - Internal > Upstairs
Finding:	Stair Balustrade - Excessive Movement
Information:	Excessive movement was observed in the stairs' balustrade at the time of inspection. This may be due to inadequate fixings, deterioration of materials, or substandard installation.

A loose balustrade presents a significant safety risk, as it may not provide adequate support or restraint, particularly under load. If left unmanaged, further movement or potential failure of the structure may occur.

It is recommended that a registered builder be engaged urgently to assess and rectify the issue to ensure the balustrade is securely fixed and meets safety requirements.

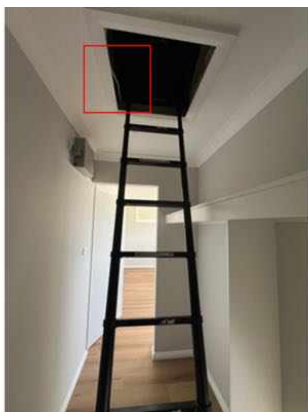
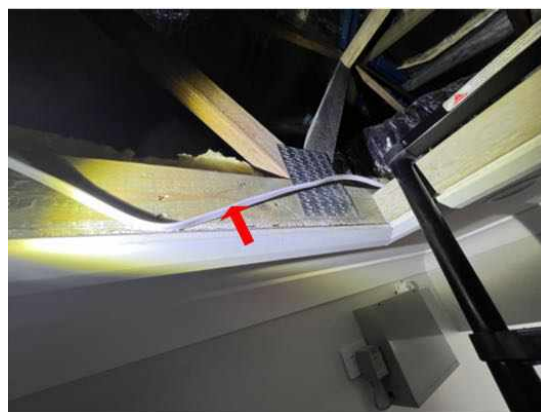
Finding 1.02

Building:	Main Building
Location:	Walk-In Robe - Master > Upstairs
Finding:	Electrical wires exposed - manhole access
Information:	Electrical wiring was observed running directly across the manhole access within the ceiling void. This installation may pose a safety hazard when accessing the roof space, as personal contact or accidental damage to the wiring may occur when using the manhole.

Best practice is for electrical wiring to be routed away from access points to minimise risk. The client should engage a licensed electrician to assess the installation and, if necessary, reposition or protect the wiring in accordance with current electrical standards and safety requirements.

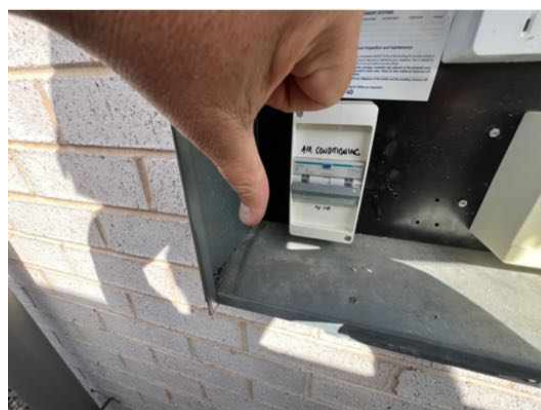
Finding 1.03

Building:	Main Building
Location:	Exterior walls - right side
Finding:	Air Conditioning - Electrical Fault Indicated
Information:	The air-conditioning system was observed to trip the main circuit via the residual current device (RCD) during operation. Tripping of an RCD indicates the presence of an electrical fault condition, such as current leakage, which may be associated with the air-conditioning unit, associated wiring, or connected components.

While the RCD is functioning as intended to protect occupants, repeated tripping indicates an underlying issue that requires attention. If left unmanaged, this condition may affect the reliability of the electrical system and presents an ongoing safety concern.

It is recommended that a licensed electrician assess the air-conditioning system and associated electrical components to identify the cause of the RCD tripping and carry out any necessary rectification.

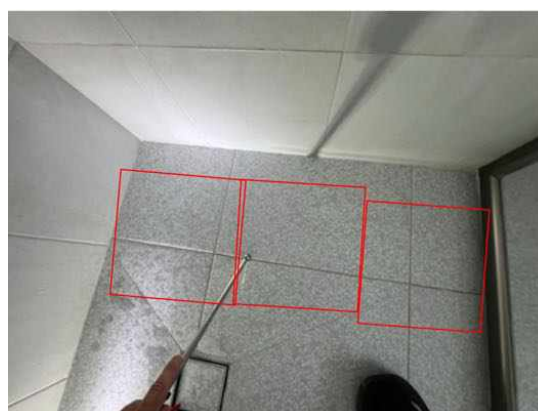
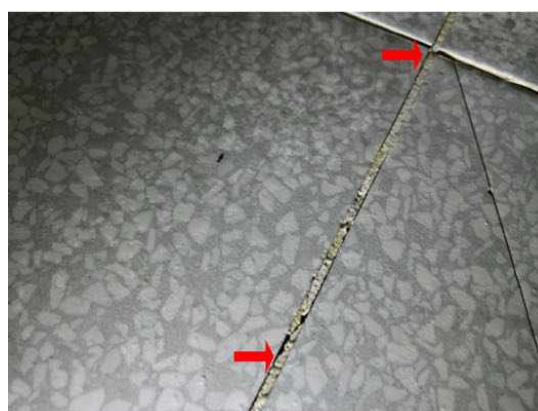
Finding 2.01

Building:	Main Building
Location:	Bathroom > Upstairs
Finding:	Shower Recess - Drummy and Popped Tiles
Information:	Grout deterioration and several popped or drummy tiles were observed within the tiled shower recess. Drummy or loose tiles indicate that the bond between the tile and substrate has weakened, likely due to moisture ingress, thermal movement, or substandard installation at the time of tiling.

This condition compromises the waterproofing integrity of the recess, allowing moisture to track behind the tiles and into concealed wall or floor structures. If left unmanaged, progressive water penetration may result in mould development, decay of framing materials, and deterioration of finishes.

A qualified tiler should be engaged to assess the extent of detachment and replace affected tiles to restore proper bonding and surface waterproofing.

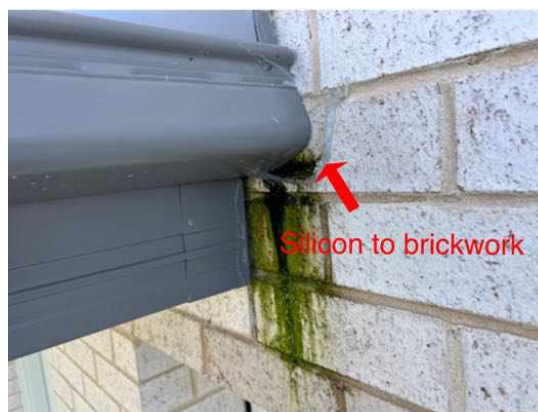
Finding 2.02

Building:	Main Building
Location:	Verandah >
Finding:	Gutter Termination - Moisture Discharge to Wall

Information: The guttering was observed to terminate directly against the masonry wall without an appropriate end stop or formed termination detail. Sealant has been applied at the junction; however, staining and biological growth to the adjacent brickwork indicate ongoing moisture discharge at this location.

Gutters should be adequately terminated to prevent water escaping at wall interfaces. Discharge against masonry can allow moisture penetration into the wall cavity and contribute to deterioration of finishes and concealed structural elements over time.

This installation is considered substandard and poses an elevated risk of water ingress. Assessment and rectification by a licensed roof plumber or registered builder is recommended.

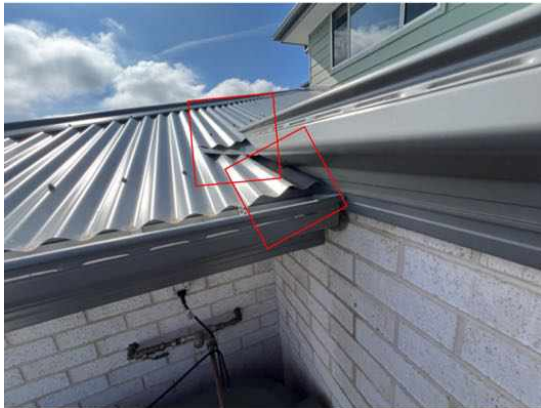
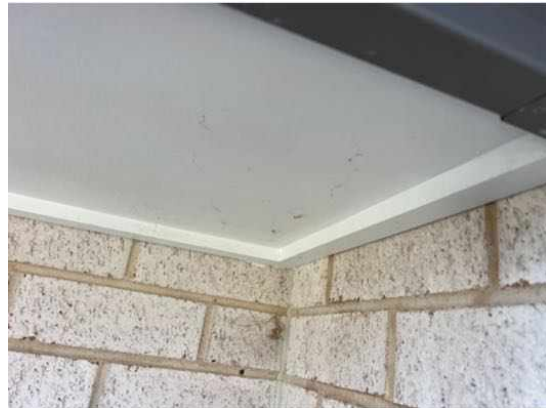
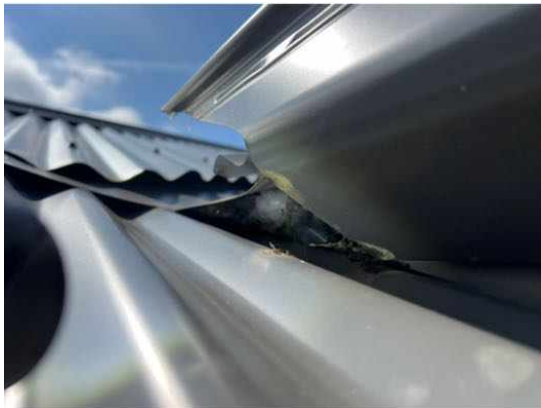
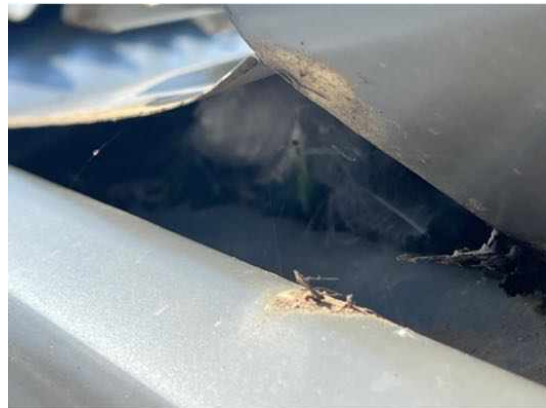
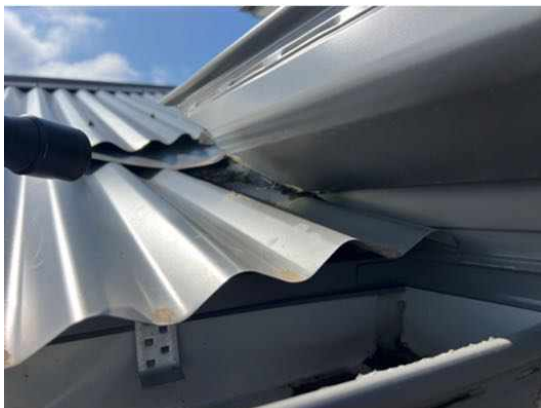
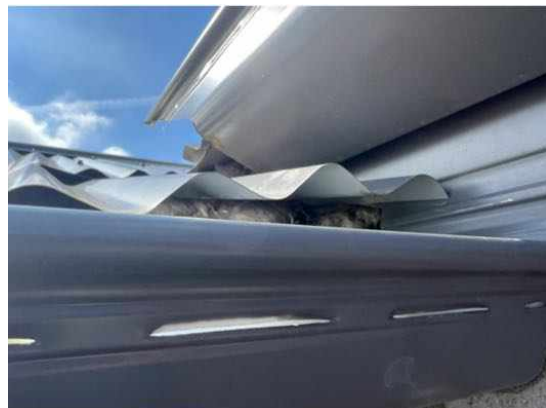
Finding 2.03

Building: Main Building
 Location: Roof Exterior
 Finding: Roof plumbing - Flashing inadequate
 Information: Some sections of the roof were observed to be missing or fitted with inadequate flashings at junctions between roof coverings and adjoining building elements. Flashings are installed to seal and protect intersections and transitions within the roof system and to direct water away from vulnerable areas.

Where flashings are missing, incorrectly installed, or inadequately detailed, there is an increased risk of water penetration into concealed building components. Ongoing moisture exposure may result in deterioration of building materials and the development of secondary defects if not addressed.

A licensed roofing plumber should be appointed to assess the affected areas and install or rectify flashing details as required to ensure adequate weatherproofing and roof plumbing performance.

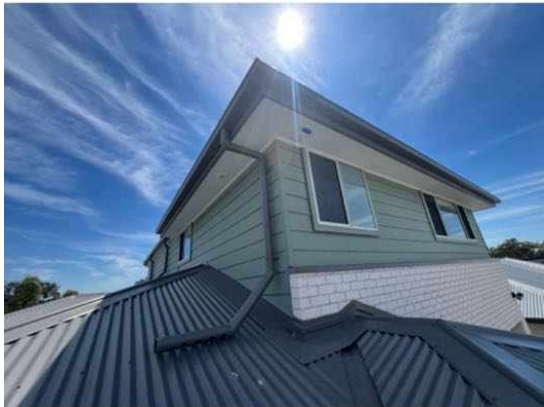
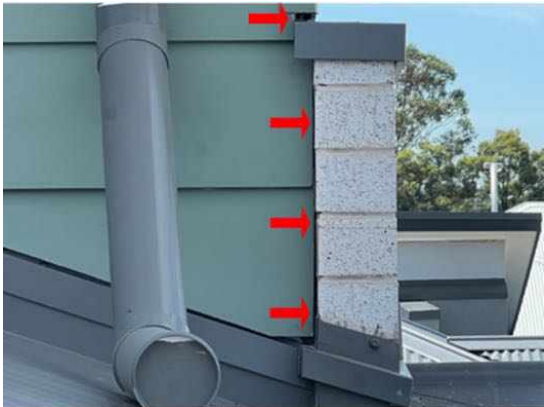
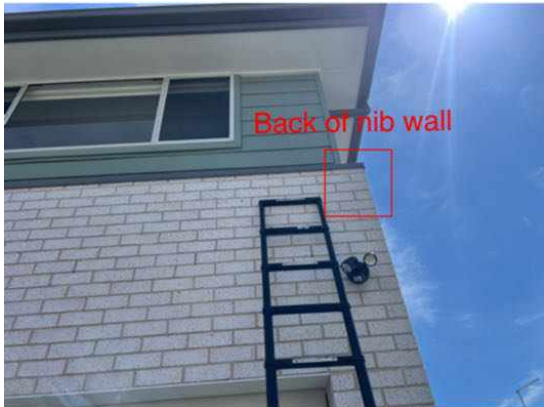
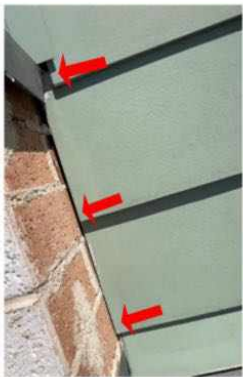
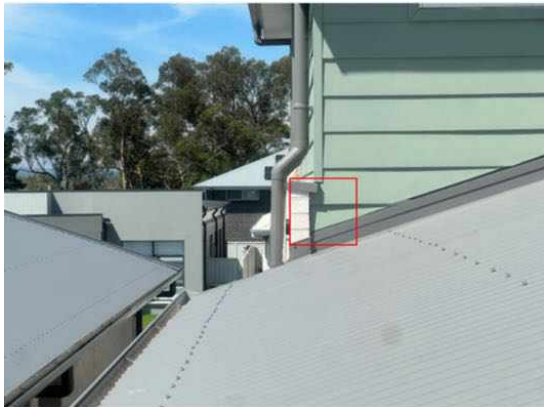
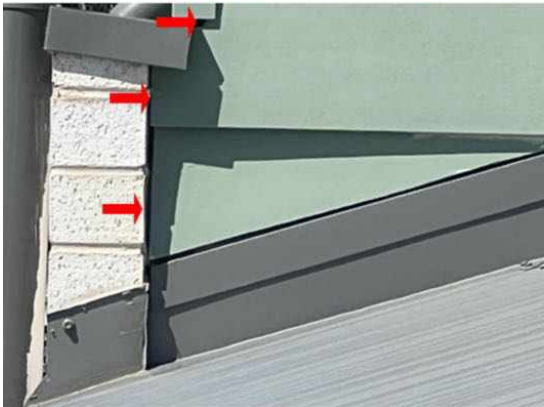
Finding 2.04

Location: Exterior walls - 1st floor > Upstairs
Finding: Cladding to Masonry Junction - Inadequate Flashing
Information: The upper lightweight cladding was observed abutting directly against the brick half-wall without a clearly defined or compliant flashing detail at the junction. Noticeable separation gaps were present where the cladding interfaces with the masonry structure.

Junctions between differing materials are particularly vulnerable to moisture ingress where appropriate flashing and weatherproof detailing is incomplete or absent. The absence of a visible flashing at this interface increases the likelihood of water penetration behind the cladding system and into concealed wall cavities.

Prolonged moisture exposure in these areas may result in deterioration of framing members, corrosion of fixings, and damage to internal finishes. Given the exposed location and visible detailing deficiencies, this condition presents an elevated risk of concealed moisture ingress and is considered a major defect.

Further assessment by a licensed roof plumber or registered builder is recommended to determine the adequacy of the installation and to address any required remedial works.

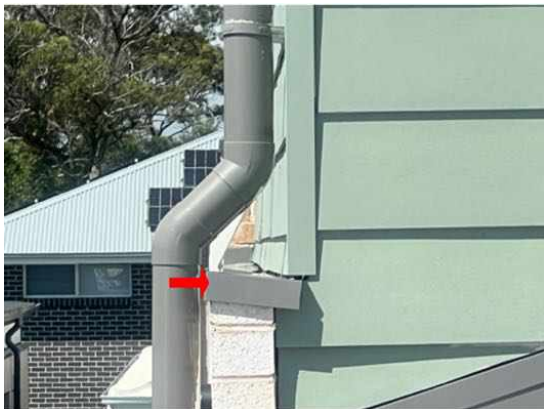
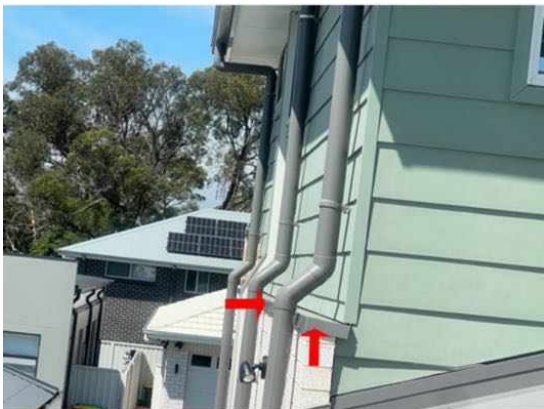
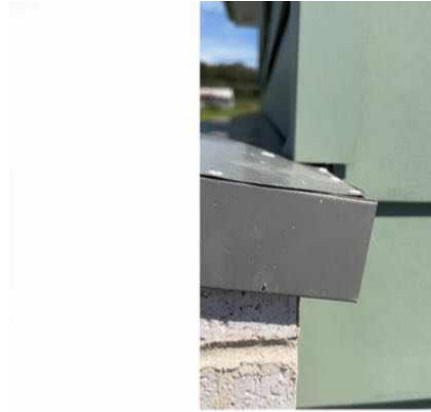
Finding 2.05

Building: Main Building
Location: Exterior walls - 1st floor > Upstairs
Finding: Parapet Flashing - Negative Fall
Information:

The parapet flashing to the upper-level roof area was observed to be installed with a fall directed back toward the wall rather than away from the structure. Flashings are intended to shed water away from building elements, and incorrect fall may allow water to pond or track toward the building envelope.

Where parapet flashings do not adequately discharge water, there is an increased risk of moisture penetration into adjoining cladding and wall systems. If left unmanaged, this condition may lead to concealed deterioration of internal building elements.

It is recommended that a registered builder assess the parapet flashing installation and undertake rectification as required to ensure adequate drainage and weatherproofing.

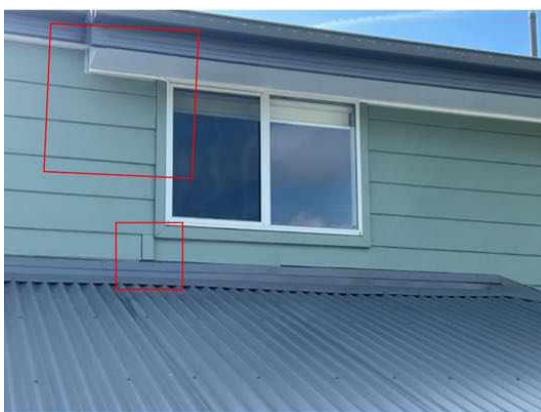
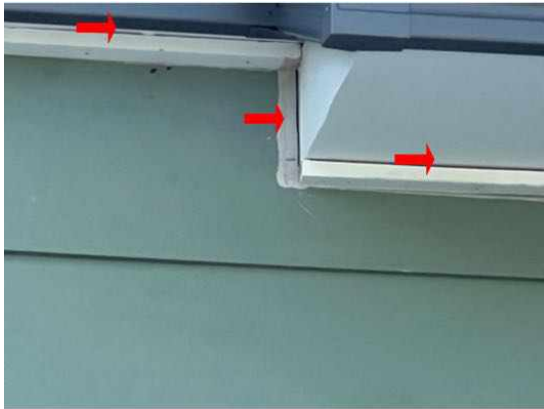
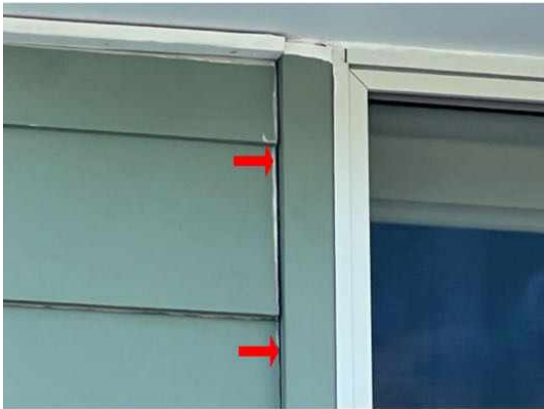
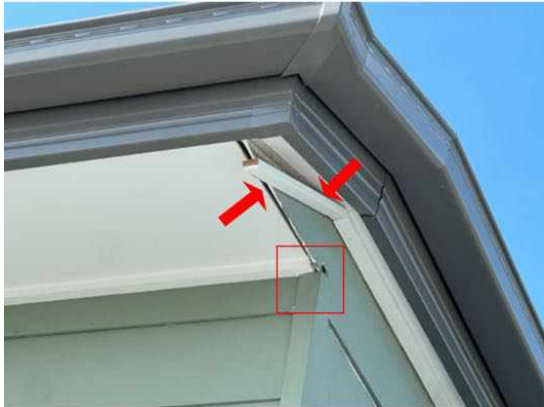
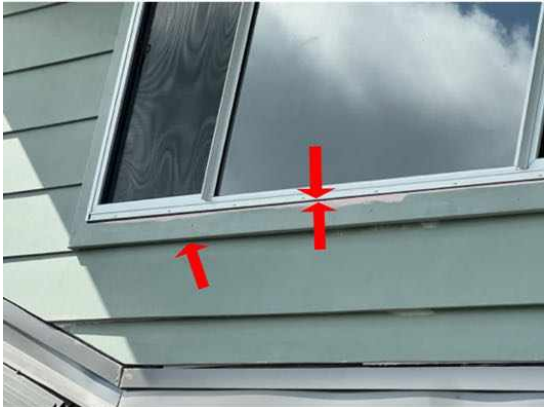
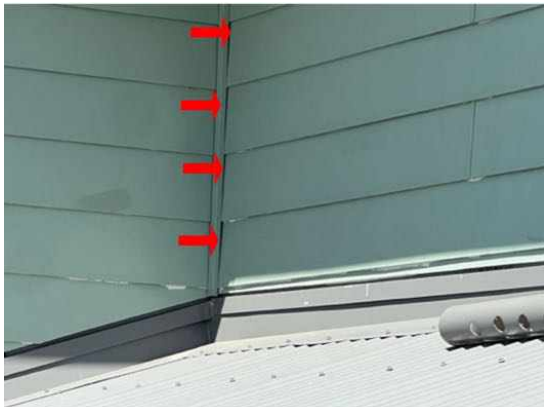
Finding 2.06

Building:	Main Building
Location:	Exterior walls - 1st floor > Upstairs
Finding:	Window Trims - Inadequate Sealing to Cladding
Information:	Gaps were observed between the external cladding boards and window trims, with junctions not sealed using an appropriate flexible sealant. Inconsistent detailing was noted, including trims installed over the face of cladding in some locations and cladding butting into trims in others without effective sealing. Based on visual assessment, the installation appears substandard and not in keeping with typical weatherproof detailing practices.

Perimeter junctions around windows are particularly susceptible to moisture ingress where sealing and detailing are incomplete. Unsealed interfaces at these locations increase the risk of water penetration into concealed wall cavities, which may lead to deterioration of framing members, corrosion of fixings, and damage to internal linings over time.

Further assessment by a registered builder is recommended to determine the adequacy of the installation and to address the weatherproofing detailing as required.

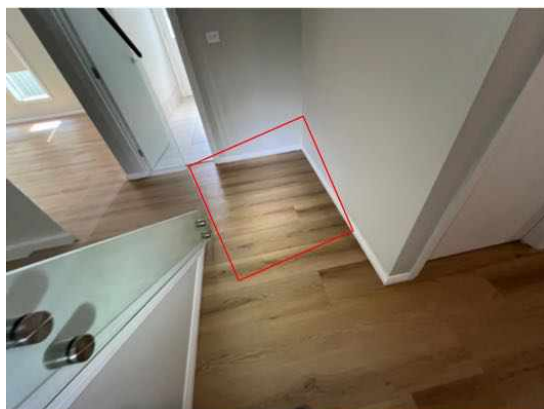
Finding 3.01

An unlevel floor can create aesthetic issues, such as visible gaps between boards and uneven transitions at doorways, which detracts from the overall appearance. Functional problems may arise, including difficulty in closing doors, improper furniture placement, and increased wear on floor finishes. Significant unevenness may indicate underlying issues with the concrete slab, such as settling, moisture problems, or inadequate preparation during installation, which could compromise the integrity of the flooring system.

Consult a Flooring specialist or a registered builder to assess the extent of the unevenness and determine the underlying causes.

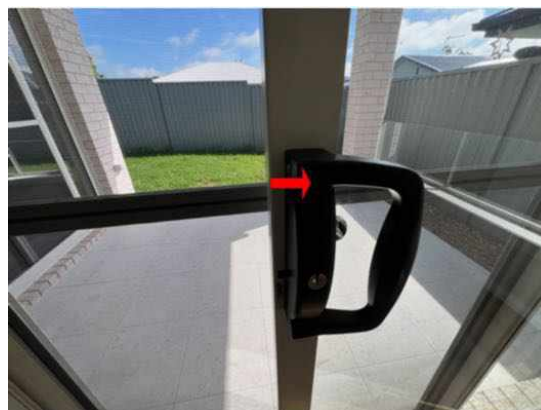
Finding 3.02

Building:	Main Building
Location:	Bedroom - Guest, Dining Room
Finding:	Door Handle - misaligned/loose
Information:	The door handle in this area was found to be misaligned/loose at the time of inspection. Breakage occurs generally when the building materials have aged and decayed, but may be indicative of impact damage (accidental or deliberate).

Adjustment/securing of door handle is advised to improve the operational state of the associated door.

A qualified carpenter or general handyman should be appointed to repair the door handle at the client's discretion.

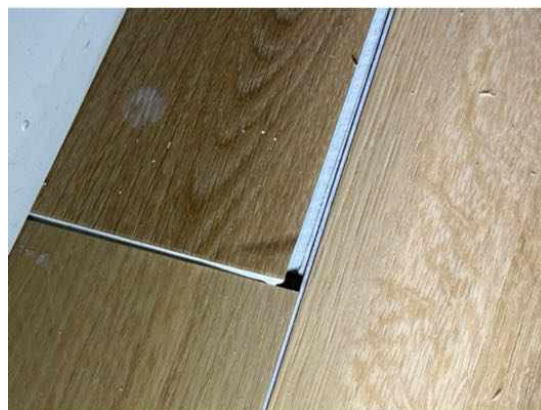
Finding 3.03

Building:	Main Building
Location:	Walk-In Robe - Guest
Finding:	Laminate Floor – Board Separation
Information:	Sections of the floating laminate flooring were observed with visible separation between adjoining boards. The flooring is installed over a concrete slab and no expansion joints were identified throughout the floor area. Floating floor systems rely on adequate expansion allowances to accommodate natural movement, and the absence of these joints can lead to board separation or uneven gaps forming over time.

While the condition appears cosmetic, it may indicate installation practices that do not fully align with manufacturer recommendations. Further advice should be sought from a qualified flooring installer if confirmation of installation quality or long-term performance is required.

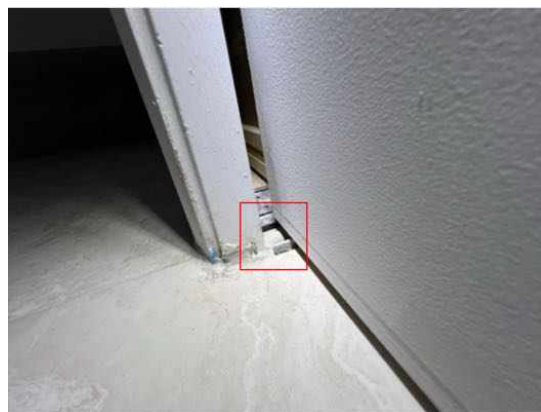
Finding 3.04

Building:	Main Building
Location:	Ensuite - Guest
Finding:	Cavity Sliding Door – Door Guide Missing
Information:	The cavity sliding door was noted to be misaligned or not running correctly within its floor or wall guide. This condition is typically caused by loose fixings, missing door guides, movement within the door frame, or lack of proper adjustment to the guide mechanism.

If left unadjusted, the door may scrape, jam, or fail to close properly over time.

A carpenter should be engaged to realign and adjust or install door guides to ensure smooth and correct operation.

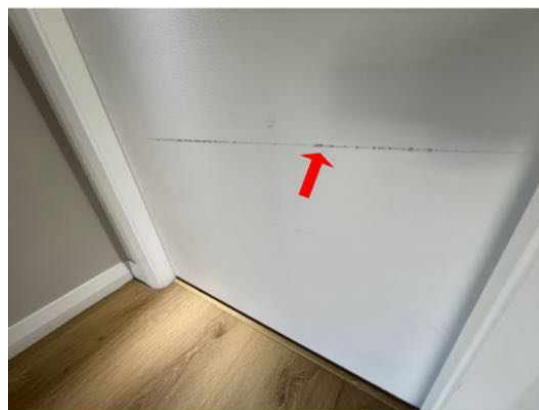
Finding 3.05

Building:	Main Building
Location:	Ensuite - Guest
Finding:	Cavity Slider Door - Scratched Surface
Information:	A scratch was observed on the cavity slider door at the time of inspection. The damage appears to have been caused by a protruding nail or fixing inside the door pocket, which has made contact with the door surface during operation.

If left unmanaged, continued use of the door may result in further deterioration of the door surface and potential operational issues.

It is recommended that a qualified carpenter be engaged to assess and rectify the issue by removing or adjusting the protruding fixing and, if necessary, repairing or refinishing the affected door surface.

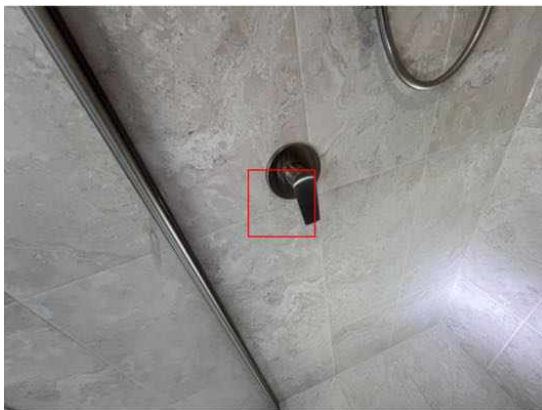
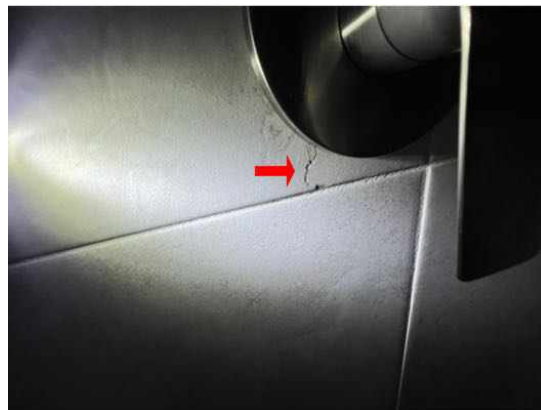
Finding 3.06

Building:	Main Building
Location:	Ensuite - Guest
Finding:	Tiles - Cracked or damaged
Information:	Cracking was evident to the tiling in this area at the time of inspection. While the cracking appears to be minor, this area is frequently exposed to water, allowing potential for water penetration into adjoining sections of walls or flooring.

If left unmanaged, water penetration to these areas may lead to subsequent water damage, which is likely necessitate repair work to affected building elements.

A tiling contractor should be appointed to ensure that no further water damage occurs. The re-application of silicone and grouting throughout remaining tile work is also advised, to further protect the area against water penetration.

Where water penetration has led to water damage, appointment of a relevant tradesperson may be required to repair damaged building elements.

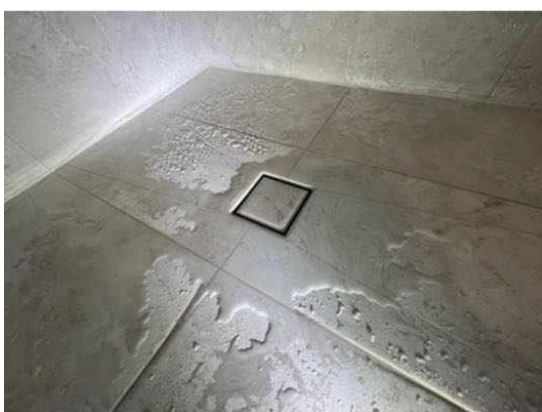
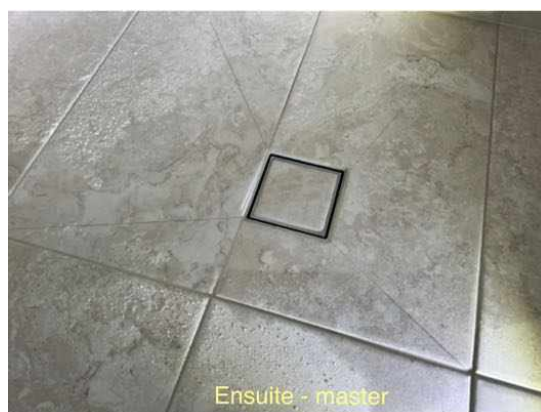
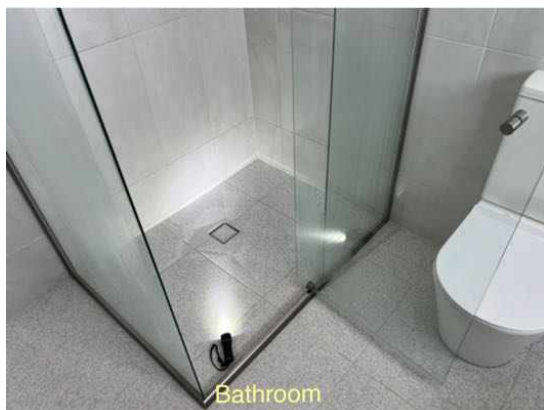
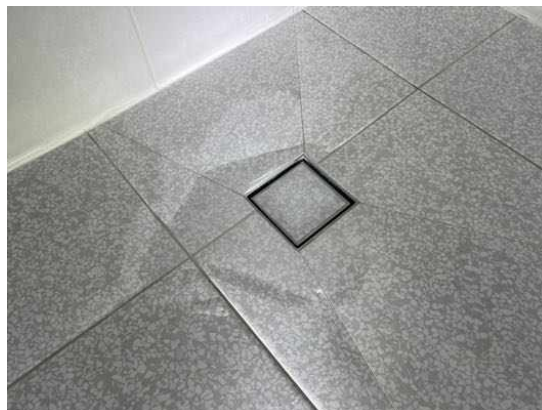
Building:	Main Building
Location:	Ensuite - Guest, Ensuite - Master, Bathroom
Finding:	Shower base - Water pooling
Information:	Evidence of water pooling around the floor waste in the shower recess was noticed at the time of inspection. It is suspected that this excessive moisture is attributed to insufficient fall in the shower floor tiles.

This pooling is minor overall but is still considered unsatisfactory, as standard tiling practices would not permit this situation to occur. Pooling water around floor wastes can create a slip hazard in extreme cases and create conditions that are conducive to mould growth over time. Where left unmanaged, the degradation of sealant and grouting is also likely to occur, possibly necessitating further repair works.

Remedial works may involve some sections of tiling and flooring repair and replacement. A tiling contractor or bathroom specialist should be appointed to provide further advice on reparation options and to perform works as necessary.

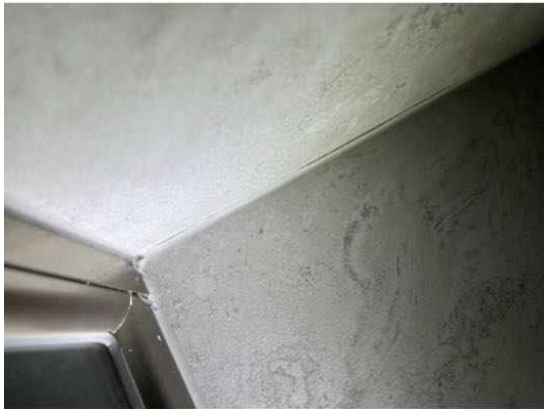
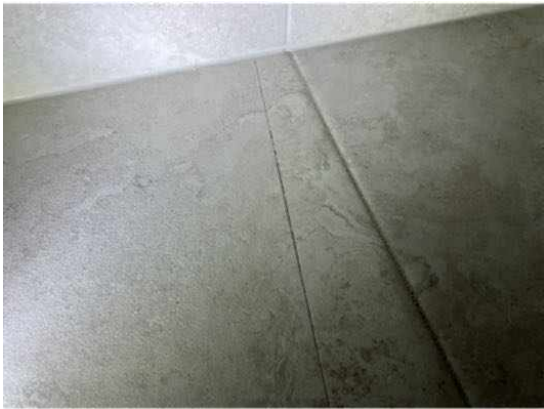
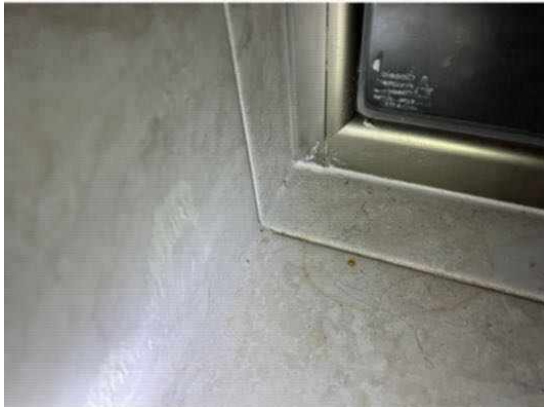
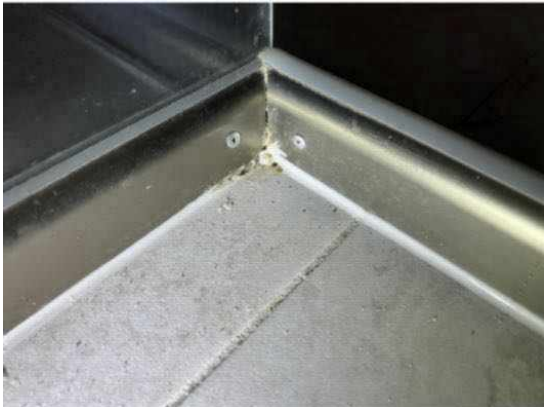
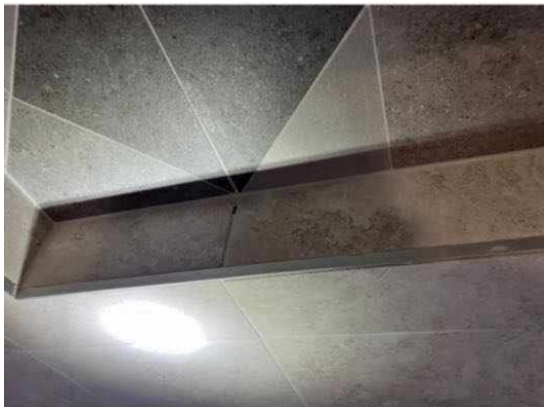
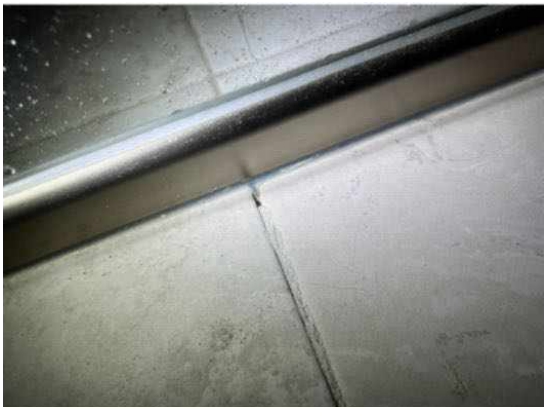
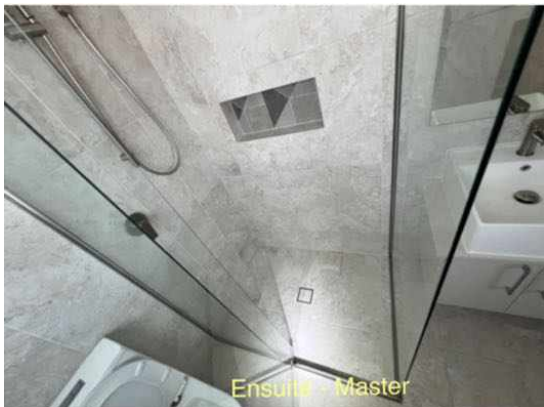
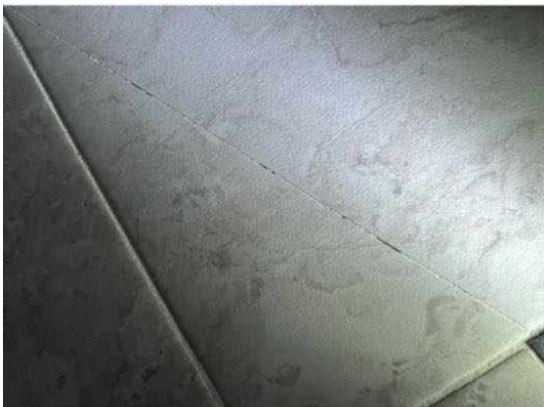
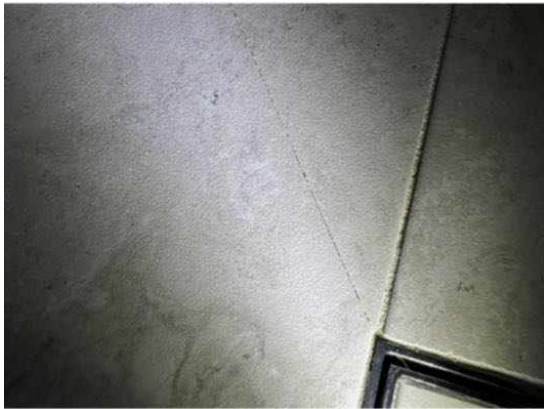
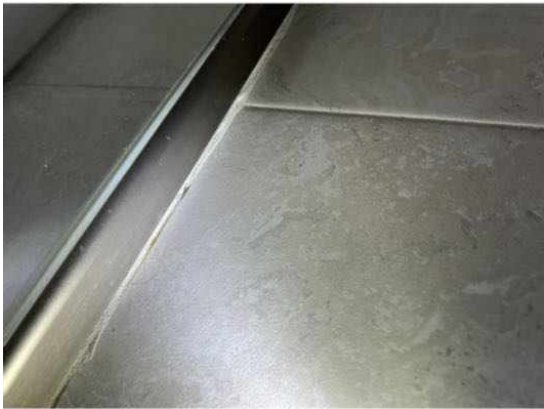
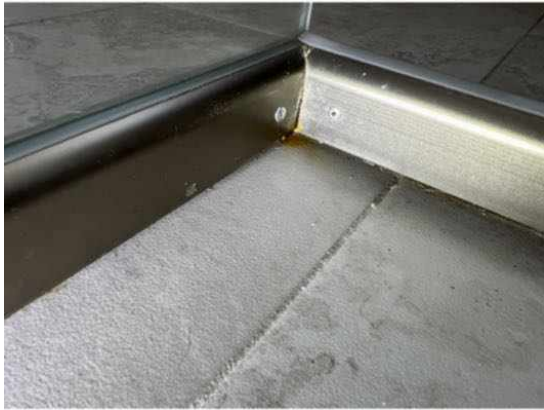
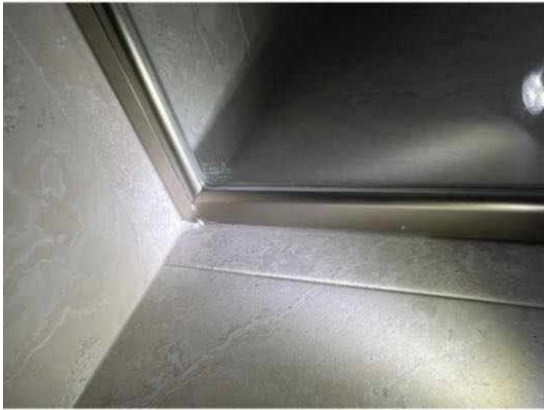
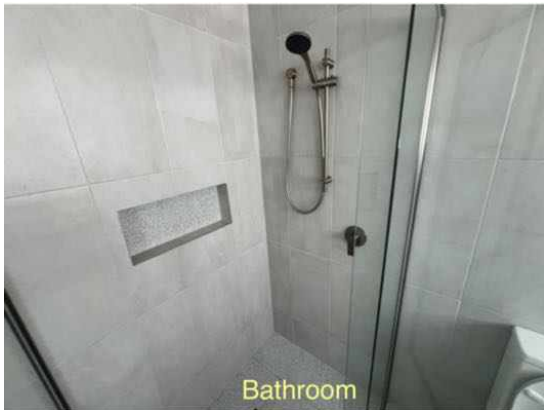
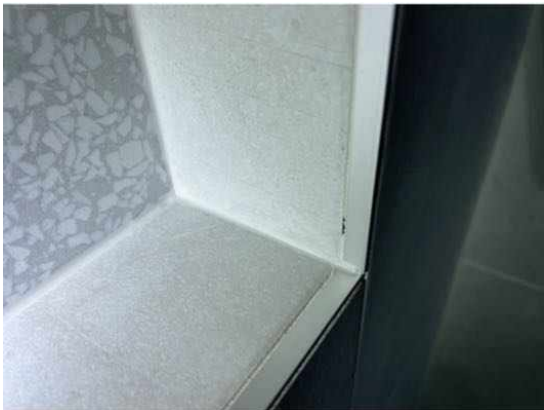
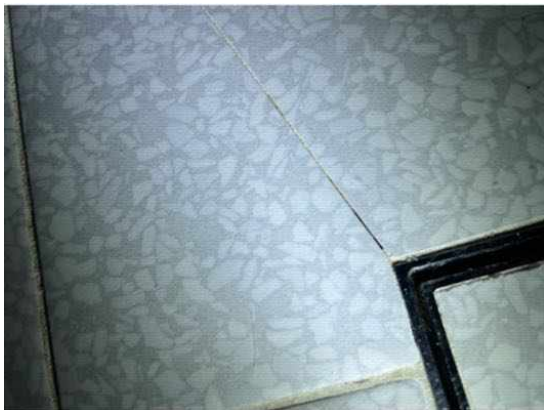
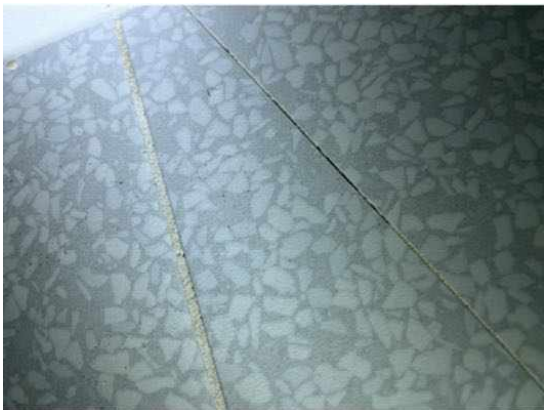
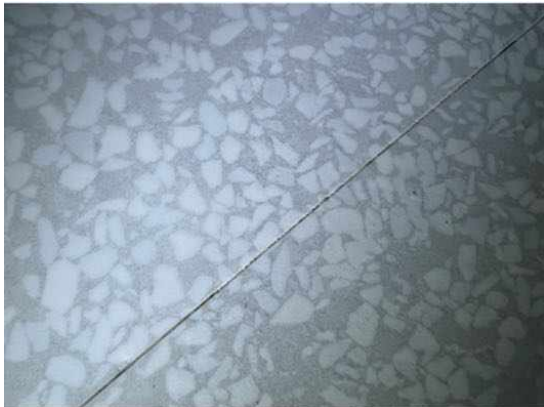
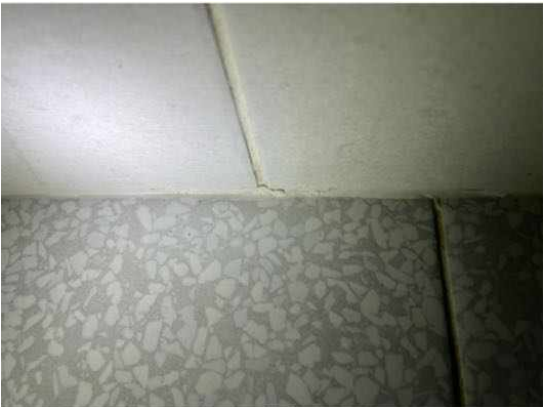
Finding 3.08

Building:	Main Building
Location:	Ensuite - Guest, Ensuite - Master, Bathroom
Finding:	Sealant and grouting - Missing or damaged
Information:	It was noted on inspection that sealant or grout is degraded to the tiled shower alcove and or other areas of the bathroom.

Different materials and floor areas move at different rates, generally causing cracking to grout or sealant at this point. A flexible sealant is required to allow for expected expansion and contraction, while keeping the joint water tight and protective of all associated building materials.

There appears to be excessive mould to the sealant and grout which will likely require scraping out and replacement.

Flexible and mould resistant materials should be applied to affected areas to prevent any subsequent water damage that is likely to occur. Regular maintenance and replacement of damage or missing or damaged sealant and grout is highly recommended to the wet areas, as this is a regular wear and tear defect. Sealant and grouting in areas that come into regular contact with water should be maintained for the long term care of your property.

A sealant specialist or tiling contractor should be appointed to complete these works as soon as possible

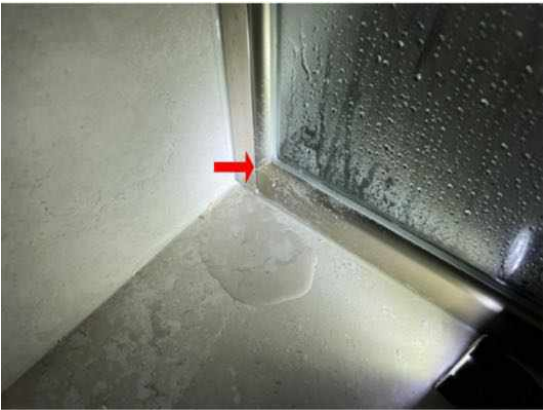
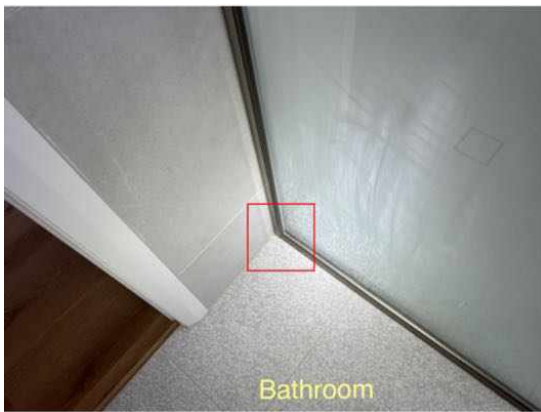
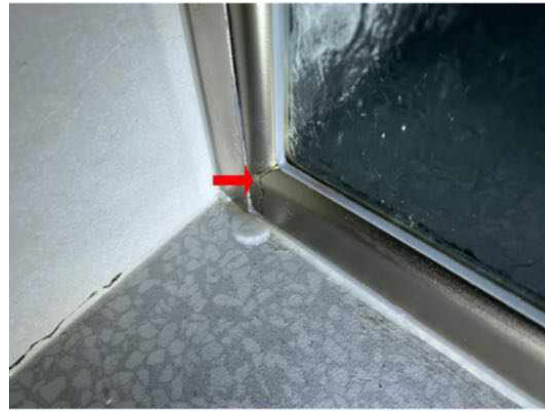
Finding 3.09

Building: Main Building
Location: Ensuite - Guest, Ensuite - Master, Bathroom
Finding: Shower screen - active leak
Information: A active leak was identified to the shower screen, likely due to deteriorated or inadequate sealant. If left unmanaged, water ingress may lead to damage to adjacent walls and flooring, as well as creating conditions conducive to mould growth.

Resealing is recommended to restore a watertight seal and prevent further deterioration.

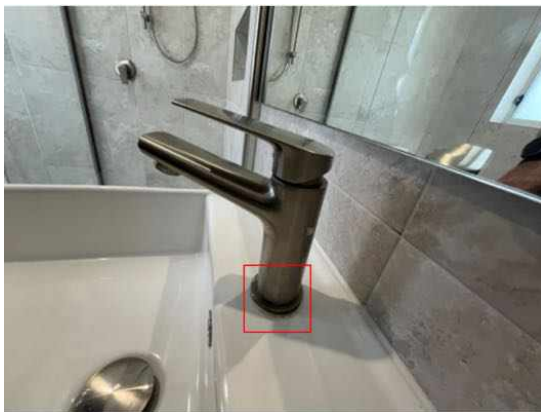
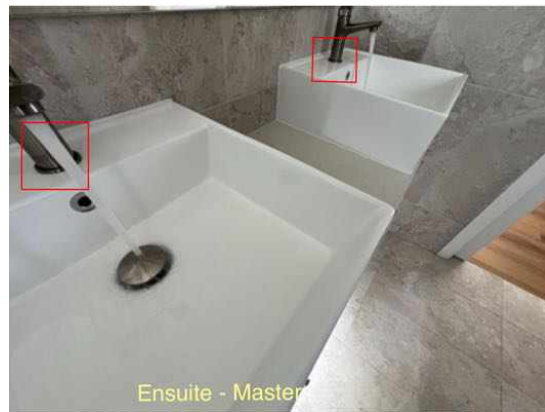
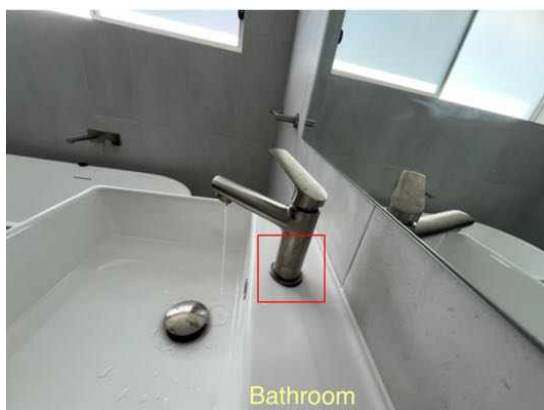
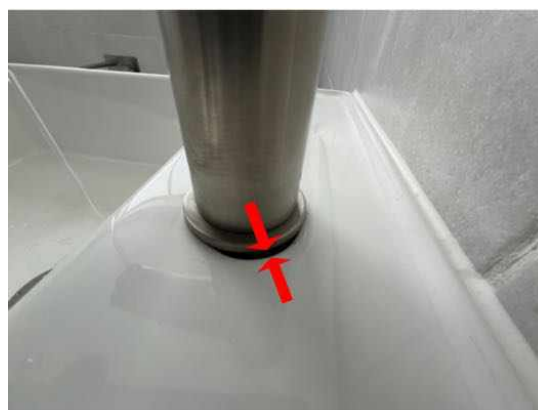
Finding 3.10

Finding: Tap - Loose at connection

Information: The tap was observed to be loose at its connection point at the time of inspection. This condition is commonly caused by poor installation, deterioration of sealant, or movement in the fixture over time.

The tap may lead to water leakage behind the wall/floor, potentially causing moisture damage and deterioration of associated building elements if left unmanaged.

It is recommended that a licensed plumber be engaged to assess and properly secure the tap to prevent further movement and potential water ingress.

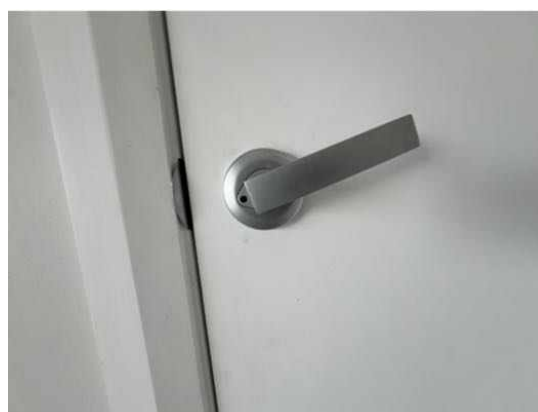
Finding 3.11

Building: Main Building
 Location: Garage
 Finding: Door - Broken handle
 Information: The door handle in this area was found to be broken at the time of inspection. Breakage occurs generally when the building materials have aged and decayed, but may be indicative of impact damage (accidental or deliberate).

Repair and/or replacement of the broken door handle is advised to improve the operational state of the associated door.

A qualified carpenter or general handyman should be appointed to repair/replace the door handle at the client's discretion.

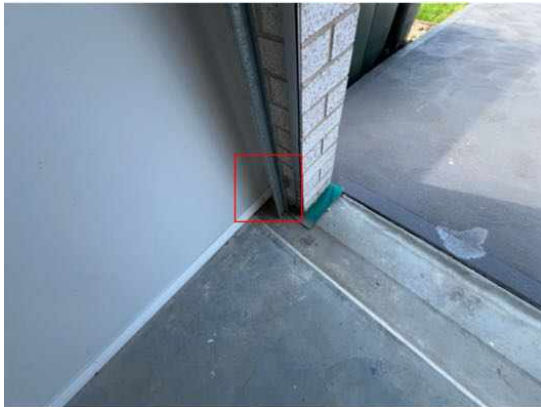
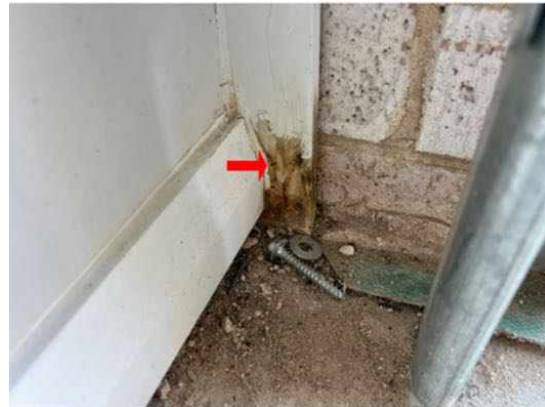
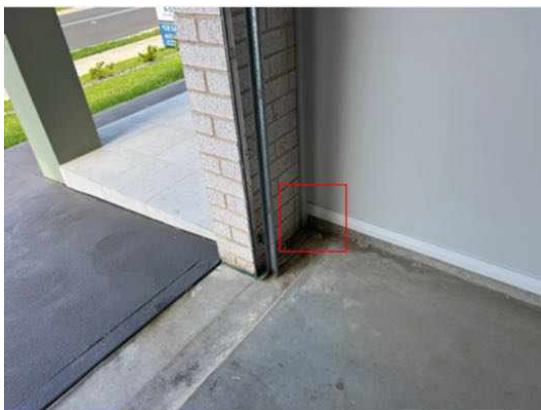
Finding 3.12

Building: Main Building
 Location: Garage
 Finding: Timber - Water Stained
 Information: Water staining was observed to sections of the timber element. The staining pattern indicates intermittent or prolonged exposure to moisture rather than a single isolated event.

Continued moisture exposure may result in deterioration of protective coatings and surface finishes, increasing the risk of timber degradation over time. If left unmanaged, this condition may contribute to swelling, surface breakdown, or decay of the affected timber.

Further investigation is recommended to identify the source of moisture and determine whether remedial works are required. Maintenance or repair may include drying, surface treatment, or repair of affected timber elements, depending on the extent of deterioration.

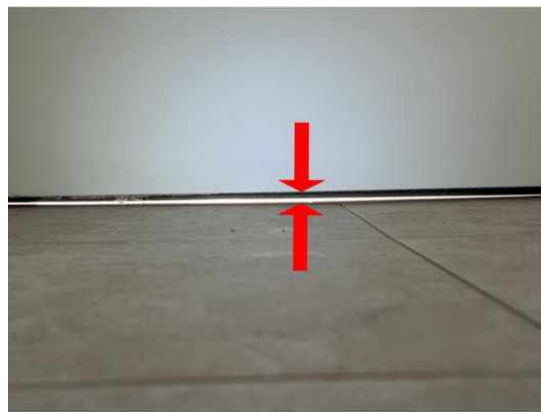
Finding 3.13

Finding: Door - weather seals (inadequate)

Information: The weather seals to the external door appear to be either missing, incomplete, or inadequately installed. Properly fitted weather seals are essential for preventing air and water infiltration, improving energy efficiency, and ensuring compliance with standard construction practices. Where seals are not installed correctly, gaps may allow drafts, moisture ingress, or pest intrusion. The fix out carpenter should assess the installation and undertake corrective work as required to ensure the weather seals are fitted to an acceptable standard.

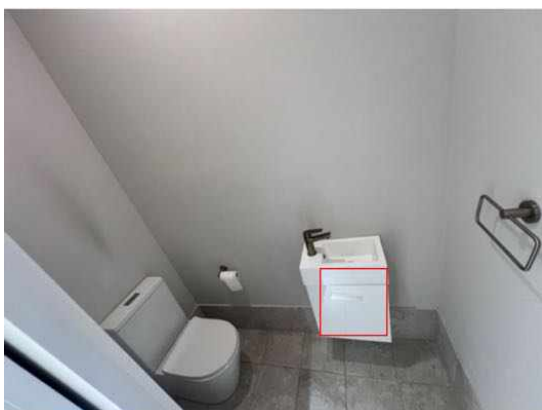
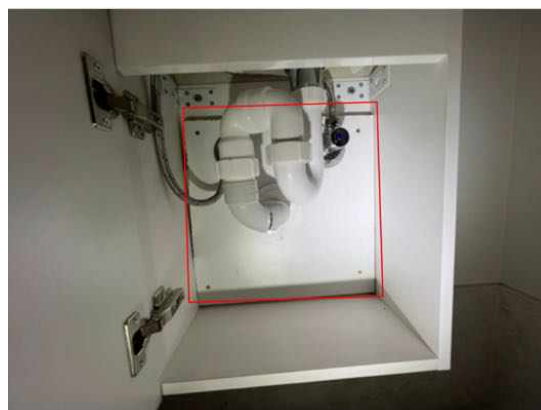
Finding 3.14

Building:	Main Building
Location:	Toilet (WC)
Finding:	Joinery - Incomplete or substandard works
Information:	The joinery to this area appear to be incomplete or have been completed to a substandard level.

Works that have not been completed to a satisfactory level create potential for the development of building defects and may impede on the safety and integrity of the overall structure.

It is highly recommended that a joiner/cabinetmaker be appointed to complete these works and ensure the safety of the area and the longevity of all associated building elements.

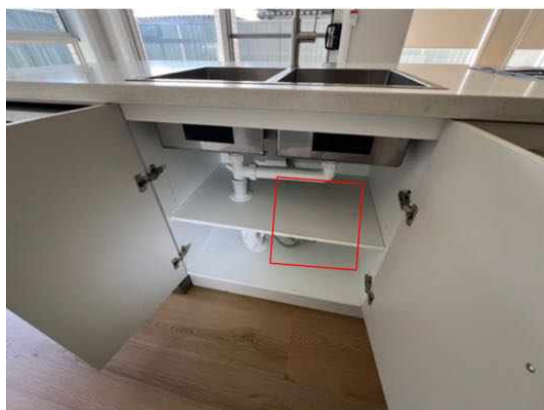
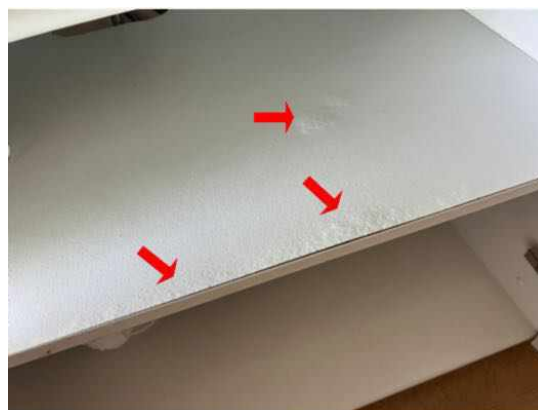
Finding 3.15

Building:	Main Building
Location:	Kitchen
Finding:	Shelving - water damage
Information:	Water damage was observed to the shelving within the sink cabinet. This type of defect is typically caused by prolonged moisture exposure from minor plumbing leaks,

If left unmanaged, water ingress can lead to swelling, delamination, or deterioration of the joinery, potentially compromising its functionality and hygiene. Moist conditions in enclosed cabinetry may also create an environment conducive to mould or timber pest activity.

It is recommended that a licensed plumber be engaged to inspect the sink plumbing for leaks or seepage. A cabinetmaker or qualified joiner may also be required to replace the affected shelving or restore the unit where practical.

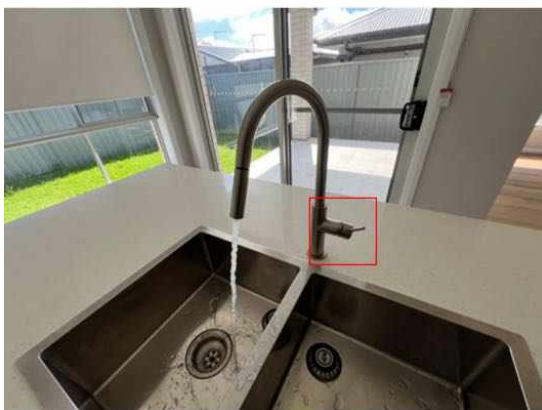
Finding 3.16

Building:	Main Building
Location:	Kitchen
Finding:	Tap - Water hammer
Information:	This tap shows evidence of water hammer being present. Water hammer, a pressure surge resulting when a fluid is forced to suddenly change direction, is a common defect in plumbing fittings, particularly those that are aged and not frequently maintained. Water hammer is generally caused by factors that create high water pressure in the affected plumbing fixture, usually evidenced by a faint banging noise during operation of the affected tap.

Although water hammer is generally considered to be a minor defect, subsequent damage such as erosion of tap hardware and/or water damage to associated building elements is likely to occur if left unmanaged.

A licensed plumber should be appointed as soon as possible to replace any affected tap hardware and perform any remedial works as necessary. Please be advised that the appointment of a cabinet maker or qualified carpenter may be necessary if water damage to associated building elements has occurred.

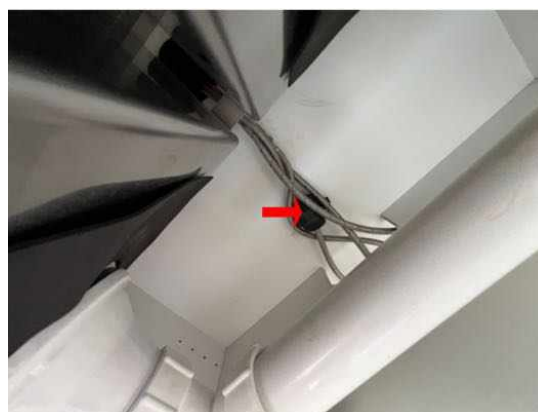
Finding 3.17

Building:	Main Building
Location:	Kitchen
Finding:	Mixer (veggie sprayer) - counterweight
Information:	The counterweight for the mixer with a veggie sprayer is obstructed by the plumbing beneath the benchtop, preventing smooth retraction of the hose. This issue is typically caused by insufficient clearance or poor positioning of the plumbing in relation to the mixer assembly. Where movement is restricted, the functionality of the sprayer is compromised, leading to potential strain on the fittings. The responsible plumber should assess the installation and undertake corrective work as required to ensure the counterweight operates freely without obstruction.
