Building and Timber Pest Inspection Report

Inspection Date: Wed, 11 Feb 2026

Property Address: 46 Dulcimere St, Tahmoor NSW 2573,
Australia

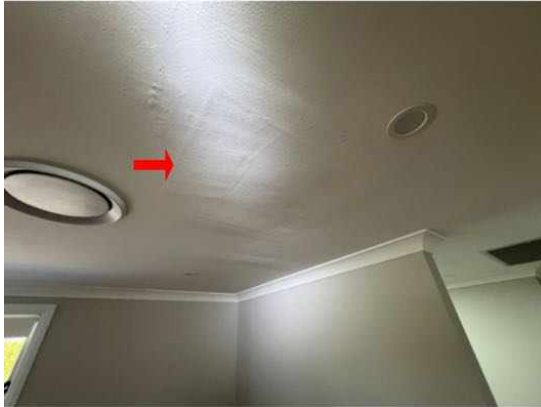
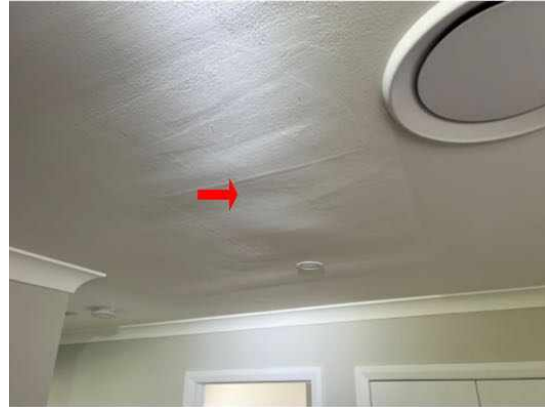
Works that have not been completed to a satisfactory level create potential for the development of building defects and may impede on the safety and integrity of the

overall structure.

It is highly recommended that a licensed plasterboard contractor should be appointed to repair the ceiling. To ensure the safety of the area and the longevity of all associated building elements.

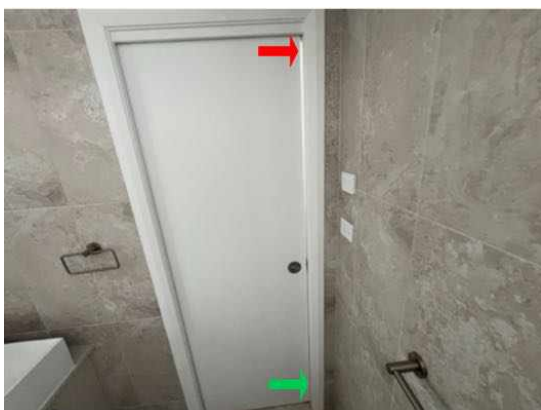
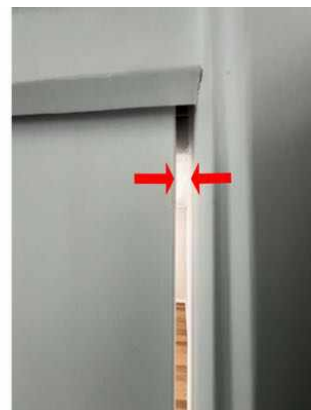
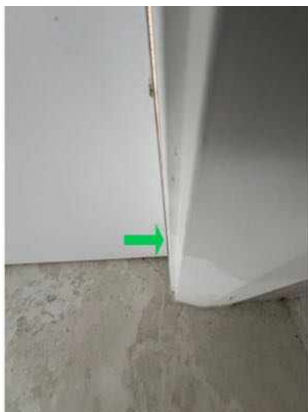
Finding 3.19

Building: Main Building
 Location: Living Room 2 > Upstairs
 Finding: Cavity Sliding Door – Guide Out of Alignment
 Information: The cavity sliding door was noted to be misaligned or not running correctly within its floor or wall guide. This condition is typically caused by loose fixings, movement within the door frame, or lack of proper adjustment to the guide mechanism.

If left unadjusted, the door may scrape, jam, or fail to close properly over time.

A carpenter should be engaged to realign and adjust the door guide to ensure smooth and correct operation.

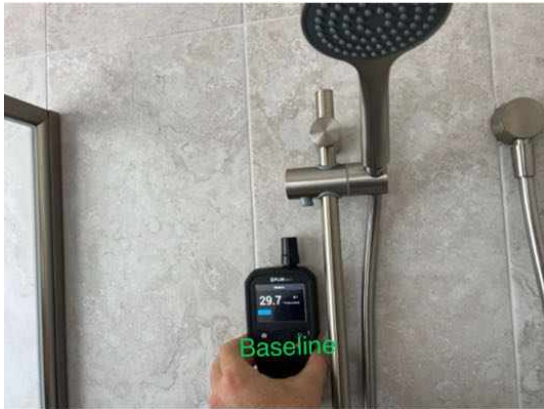
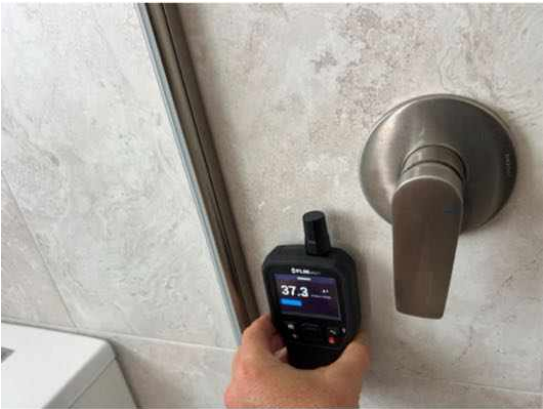
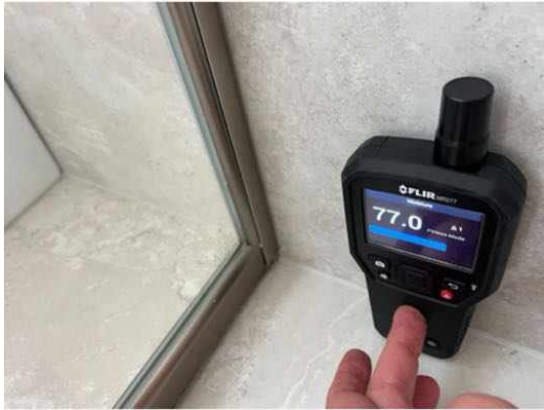
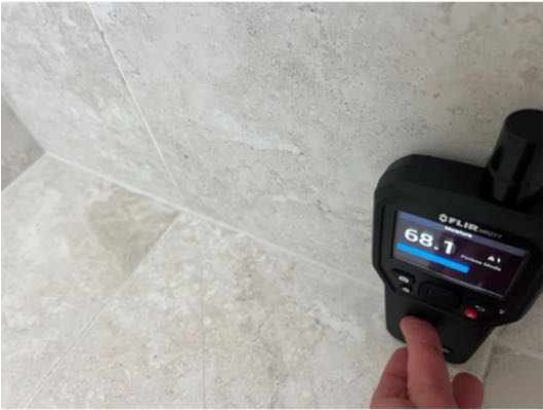
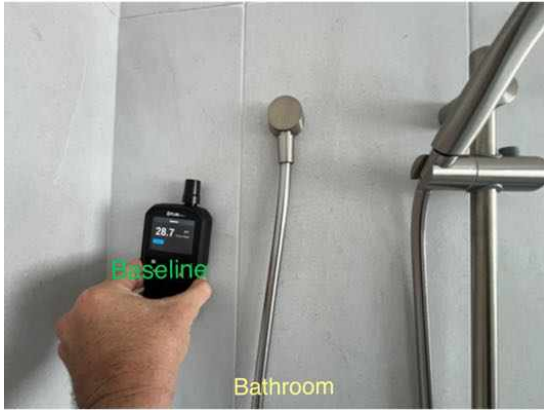
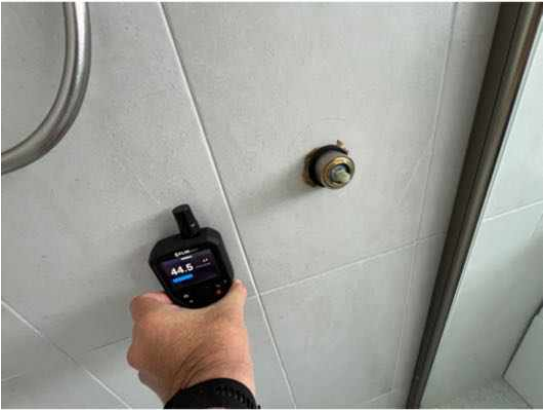
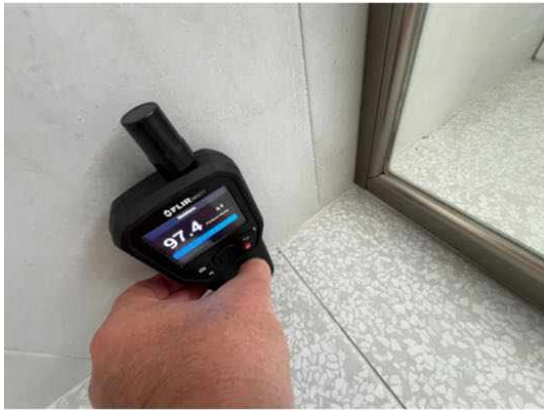
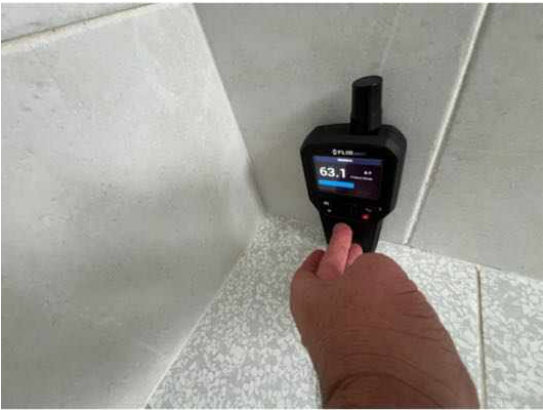
Finding 3.20

Building:	Main Building
Location:	Ensuite - Master, Bathroom > Upstairs
Finding:	Moisture in Shower
Information:	Moisture is evident behind the tiles to the shower alcove. This defect is quite common, and is suspected to have been caused by moisture permeating through the grouting in this area. Leaking pipes within the adjoining wall is also a possible cause.

Damp (or structural damp) refers to the presence of unwanted moisture in the structure of a building, either as the result of intrusion from outside, or condensation from within the structure. In the shower area, internal water leaks or other sources of excessive moisture are generally the cause of damp. Always ensure that sealant and grout is in good condition to prevent any moisture issues occurring in the future.

Building:	Main Building
Location:	Ensuite - Master, Bathroom
Finding:	Moisture in Shower (Photos shown in previous defect section)
Information:	Moisture is evident behind the tiles to the shower alcove. This defect is quite common, and is suspected to have been caused by moisture permeating through the grouting in this area. Leaking pipes within the adjoining wall is also a possible cause.

Consultation with a qualified plumber or bathroom specialist is advised to identify the cause of damp and to perform remedial works as required.

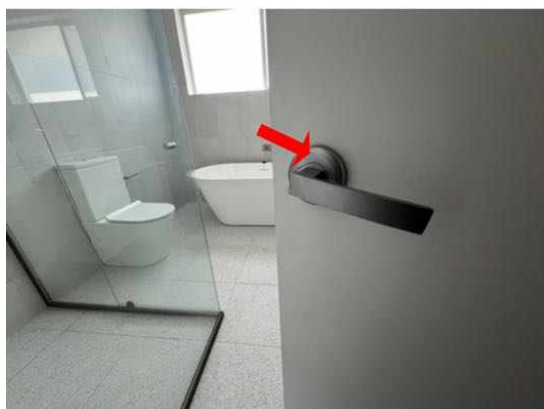
Finding 3.21

Building: Main Building
Location: Bathroom > Upstairs
Finding: Door Handle - Loose
Information: The door handle in this area was identified as loose at the time of inspection. A loose door handle can impede the proper operation of the door and, if left unattended, may lead to further deterioration or damage to the associated door structure.

This defect is typically caused by wear and tear, insufficient fixing, or deterioration of the handle's components.

It is recommended that a qualified carpenter or general handyperson be appointed to secure or replace the handle to restore its functionality and ensure proper operation.

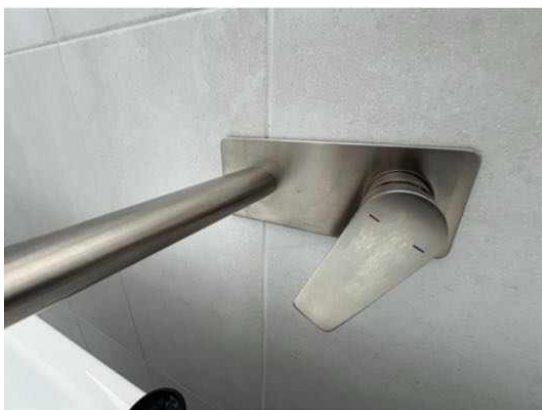
Finding 3.22

Building: Main Building
Location: Bathroom > Upstairs
Finding: Bath spout - Loose
Information: The bath spout was observed to be loose at its connection point at the time of inspection. This condition is commonly caused by poor installation, deterioration of sealant, or movement in the fixture over time.

A bath spout may lead to water leakage behind the wall/floor, potentially causing moisture damage and deterioration of associated building elements if left unmanaged.

It is recommended that a licensed plumber be engaged to assess and properly secure the spout to prevent further movement and potential water ingress.

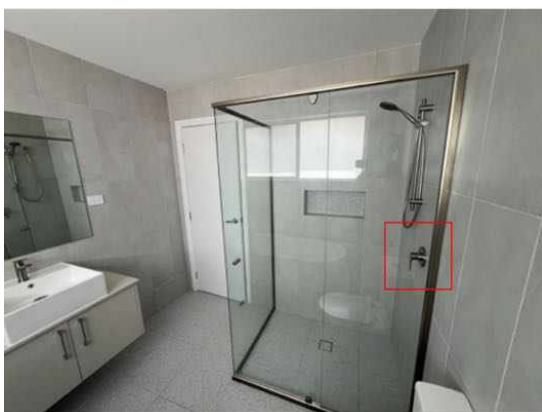
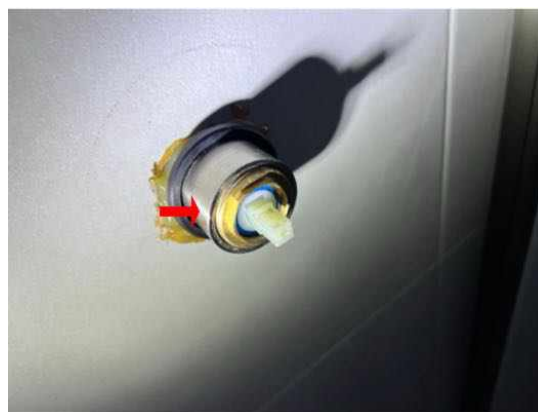
Finding 3.23

Building:	Main Building
Location:	Bathroom > Upstairs
Finding:	Mixer Tap - damage
Information:	The mixer tap was identified as damaged at the time of inspection. Damage to the mixer tap may impair its functionality, including water flow control, and may result in leaks over time, leading to potential water damage to surrounding cabinetry and building elements.

It is recommended that a licensed plumber be appointed to inspect the mixer tap and undertake necessary repairs or replacement to ensure the fixture operates as intended.

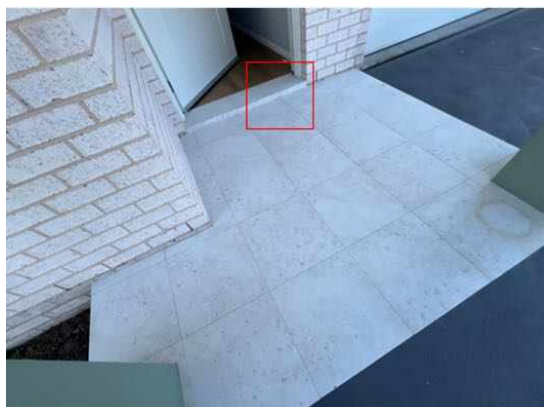
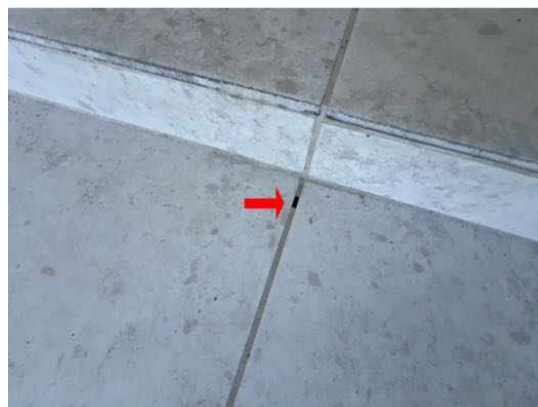
Finding 3.24

Building:	Main Building
Location:	Verandah
Finding:	Grout - Missing
Information:	Grout is missing in this area. Grout is used to protect gaps and crevices in building materials to ensure that they are water-tight and prevent water penetration to the associated structures.

Where grout is missing, a tiling contractor should be appointed immediately to apply grout and re-apply any silicone where necessary. Failure to do so is likely to lead to water damage to the surrounding area.

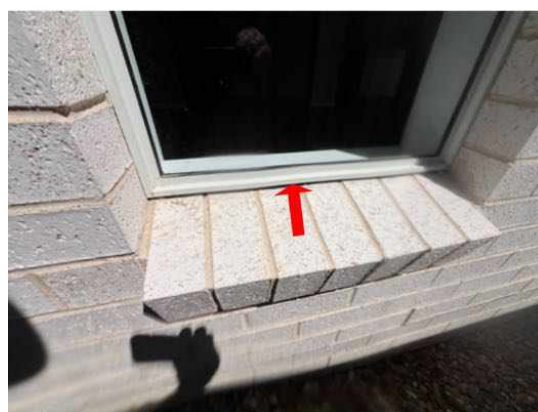
Building:	Main Building
Location:	Exterior walls - right side
Finding:	Window Sill Seals - damaged/compromised
Information:	The window seals have been damaged/compromised at the time of installation and subsequent failure to provide adequate protection and coverage. Due to frequent exposure to weather conditions and subsequent moisture, will lead to water ingress, energy loss and even pest entry.

Where window seals have not fully covered the gap between the brickwork and window, the window is no longer weather-tight; rain penetration and subsequent water damage is therefore likely to ensue. Insulation of the area against external weather conditions will also be compromised.

It is recommended that all window sill seals be replaced by a general handyman or sealant expert to prevent any further damage and to restore the window to a fully functional level.

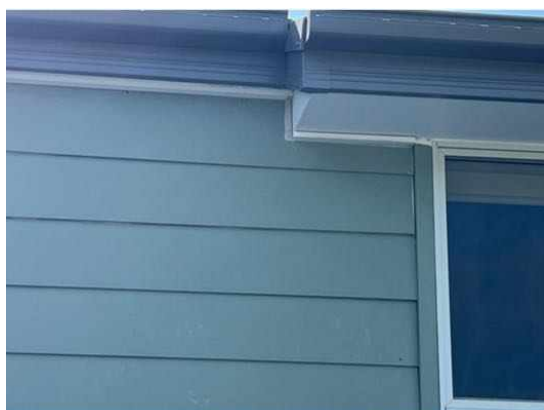
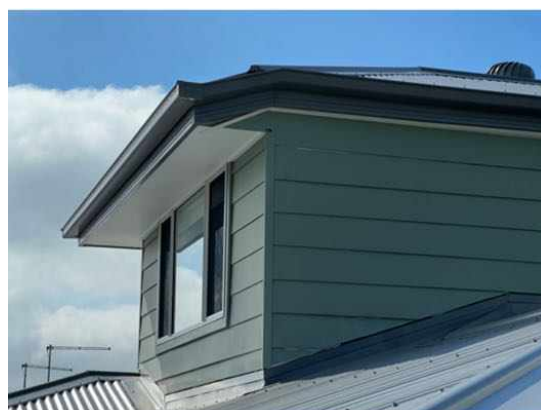
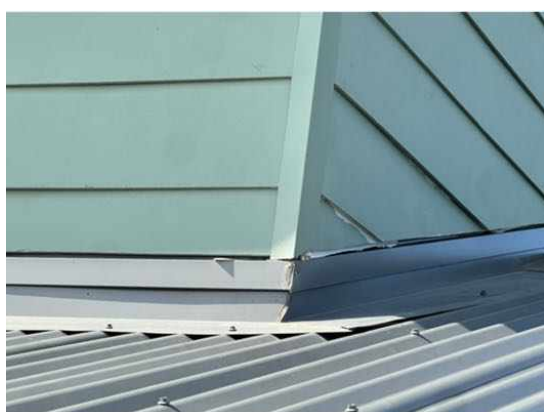
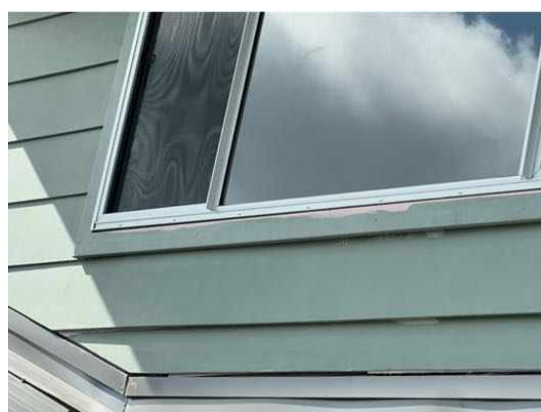
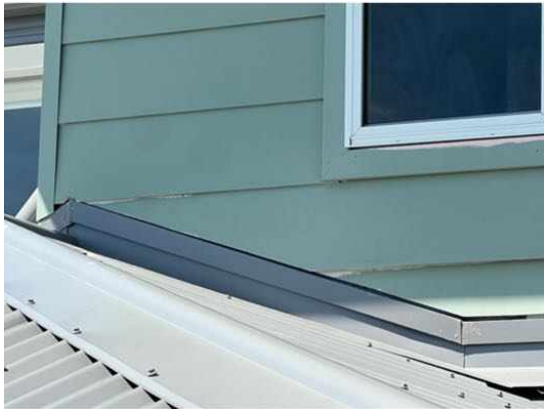
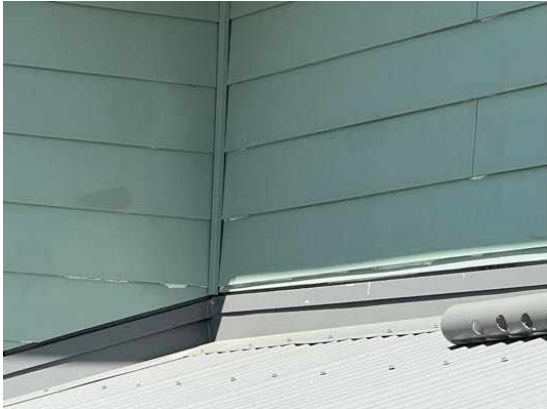
Finding 3.27

Building:	Main Building
Location:	Exterior walls - 1st floor

Information: The paint finish in this area was found to have been completed to a substandard level. Substandard painting is generally classified as an appearance defect. However, the substandard appearance may also be indicative of poor surface preparation and substandard workmanship.

If this applies, further areas of poor and incomplete finishes could develop over time. Furthermore, substandard paint finishes in areas exposed to moisture, e.g. external areas or wet areas, could lead to deterioration of underlying building materials.

Substandard paint finishes should be sanded back, filled, leveled and repainted, as applicable. Where inadequate paint protection has led to the deterioration of the associated building element, repair and/or replacement of this building element may be required.

A painting contractor should be appointed as soon as possible to perform necessary works to aid the appearance of the affected area and to ensure that the area is protected against further deterioration. Alternatively, the homeowner following manufacturer instructions may be able to provide this service.

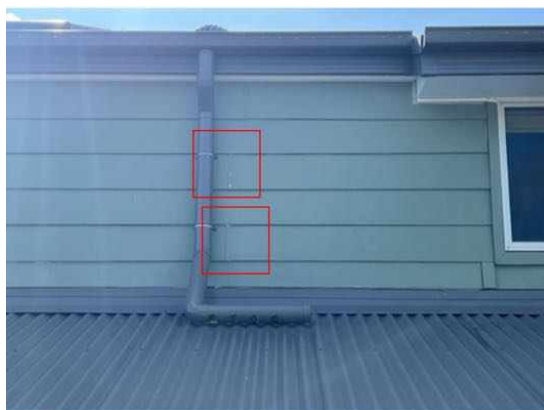
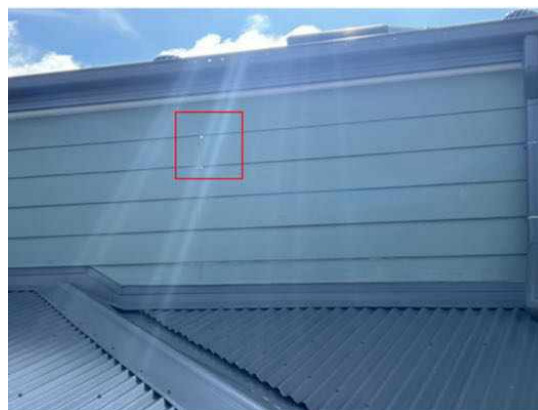
Finding 3.28

Building: Main Building
Location: Exterior walls - 1st floor
Finding: Cladding - Joining Strips Slipping / Insecure
Information: Cladding joining strips were observed to be slipping or not fully engaged with adjoining boards in several areas. While no immediate structural failure was evident, loose joining components may allow movement and create minor gaps over time.

These areas should be monitored and secured to maintain alignment and performance of the cladding system.

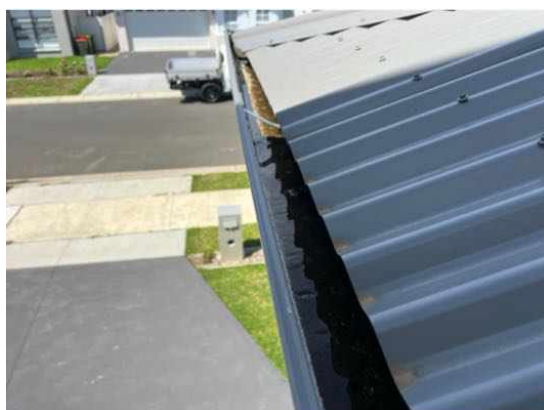
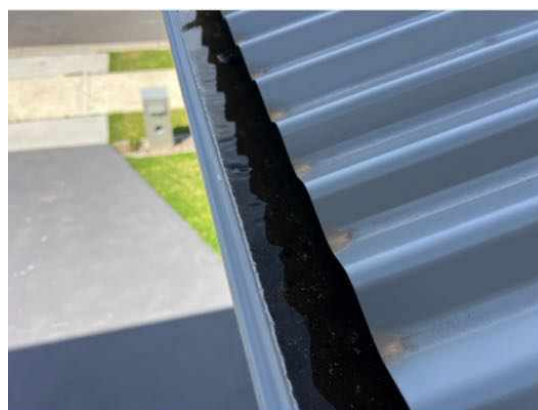
Finding 3.29

Building:	Main Building
Location:	Verandah
Finding:	Gutters - Water pooling
Information:	Water was found to be pooling in sections of the roof guttering. This is generally a secondary defect caused by blocked or partially blocked gutters. Such blockages and subsequent water pooling are likely to lead to rust and water damage to associated structures if left unattended.

Any areas of guttering that shows evidence of water pooling should be checked for partial or full blockages and any secondary damage that may have occurred as a result. Depending on the extent of the damage, building elements may require repair and/or replacement to ensure adequate roof drainage and function of exterior plumbing system.

A roofing plumber should be appointed as soon as possible to rectify this issue. It is highly advised that all gutters be maintained on a frequent basis to ensure the condition of roof plumbing.

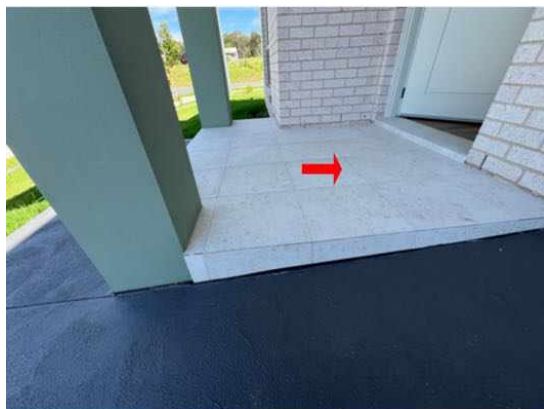
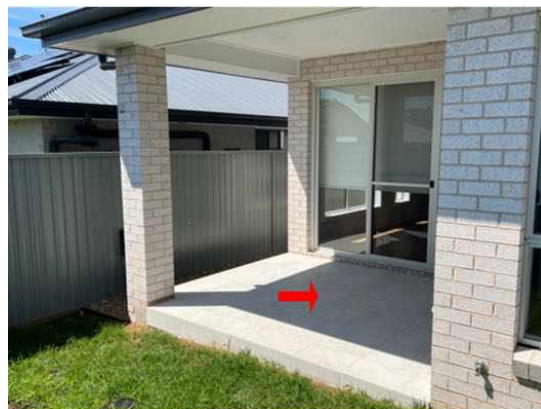
Finding 6.03

Building: Main Building
 Location: Verandah, Alfresco
 Finding: Bridging of physical termite barriers - Concrete Patio
 Information: The tiled concrete pad to the verandah and alfresco including other areas directly abuts dwelling causing bridging. Bridging is the span of a physical termite barrier or inspection zone so that subterranean termites have an entry point over or around that barrier.

The client should consider obtaining further advice from a timber pest technician regarding treatments required in this area. It is recommended that obtaining such

advice be a short-term priority.

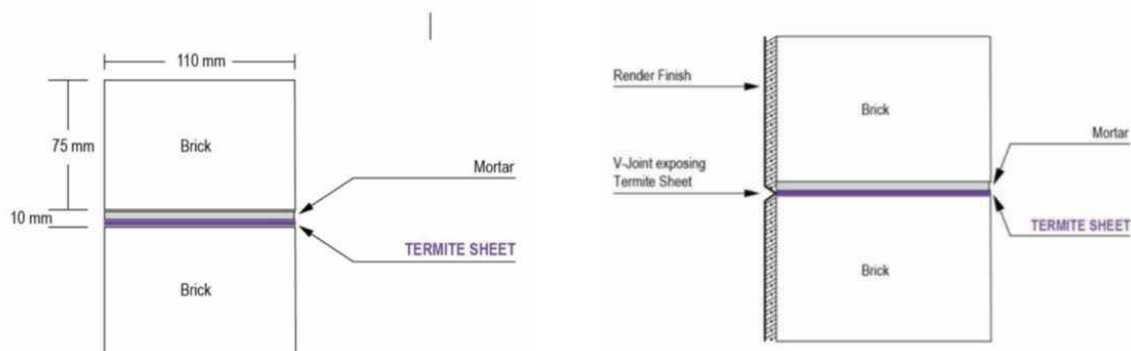
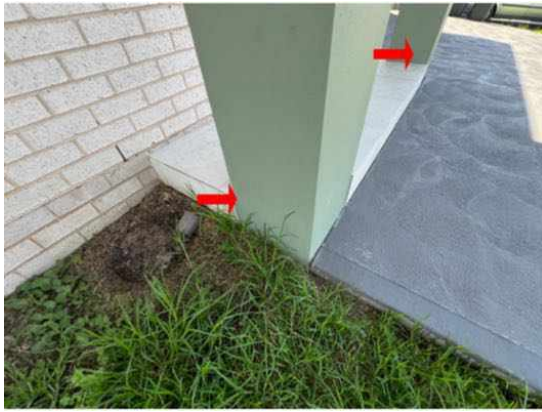
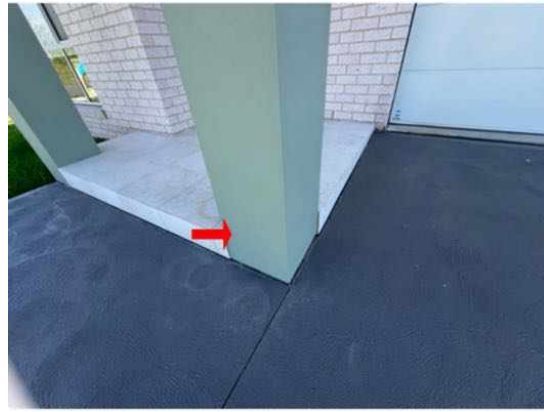
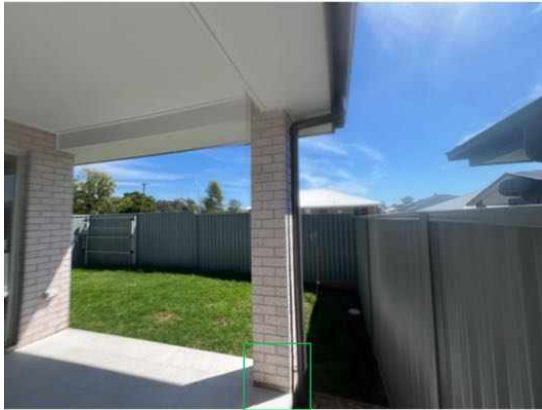
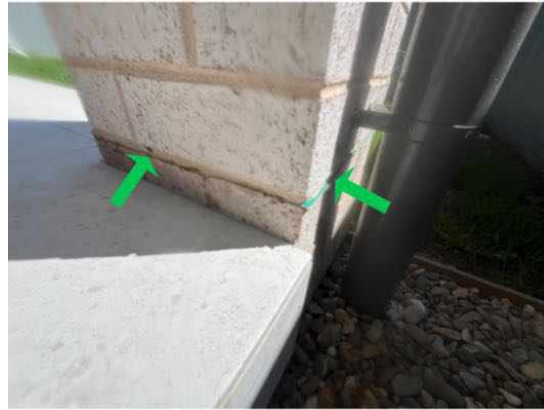
Finding 6.05

Building: Main Building
 Location: Verandah, Alfresco
 Finding: Bridging of termite barrier - brick piers.
 Information: Brick pier that are attached from ground to structure without a visible inspection zone (barrier 75mm AFL) causes a bridging point. Bridging of termite barriers occurs when termites bridge (usually by building a mud tunnel) a termite barrier or inspection zone or where termites have a passage allowing them to bridge the barrier.

Generally this takes the form of finished ground levels external paving or concrete being retrospectively installed above the damp course level the adjacent internal floor level or weep and ventilation holes.

Where bridging has occurred full inspection is prevented and termites may enter a property in a concealed or undetectable manner.

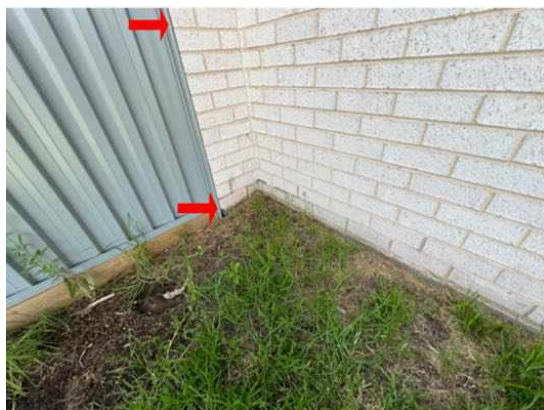
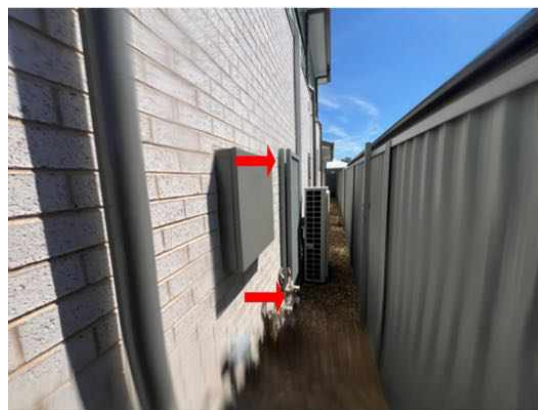
Finding 6.06

Building:	Main Building
Location:	All External Areas
Finding:	Bridging - Attachments to Buildings.
Information:	Bridging occurs when items against a building provide a concealed entry point for termites into the building or by passing around a termite management system.

Where any part of an attachment to a building is not isolated and is not provided with a clear gap of not less than 25mm from the building, bridging occurs. Attachments to buildings such as hot water services, downpipes, verandahs, decks, steps, fences, service conduits and the like provide the opportunity for concealed entry.

Building attachments of this nature need to be frequently inspected for termite activity by a qualified inspector

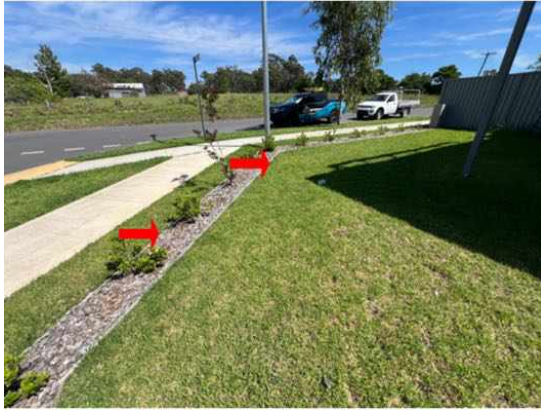
Building:	Yard
Location:	Yard - Front
Finding:	In ground contact
Information:	Any timbers in direct ground contact provide opportunity for concealed termite entry and are likely to be subject to premature rot and decay as the soil retains moisture or damp conditions against the timbers.

Remove untreated timber that is in direct contact with external grounds. Consider replacement with more durable materials i.e. treated timber or non timber elements. Frequent pest inspections are advised to readily identify any termite activity in these areas.

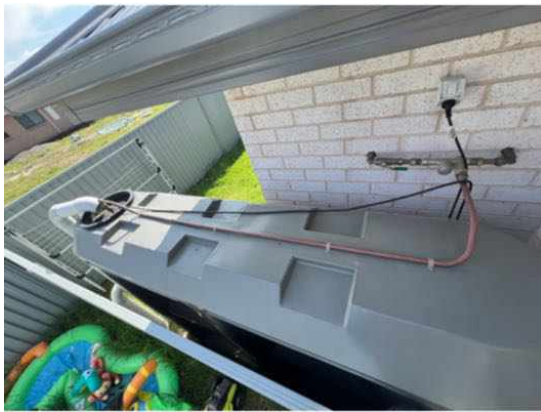
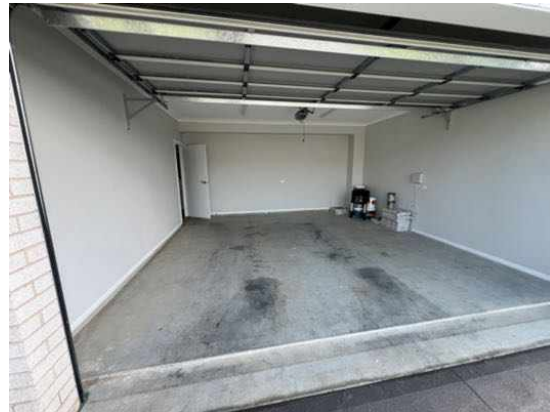
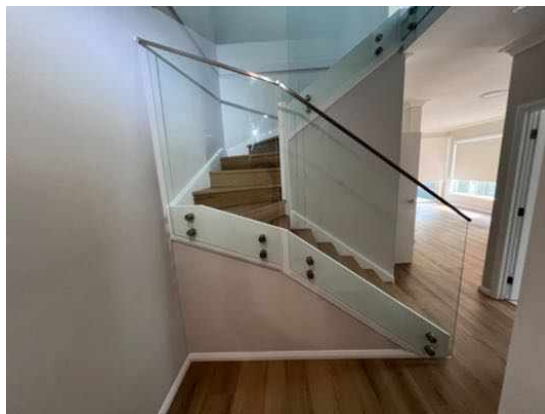
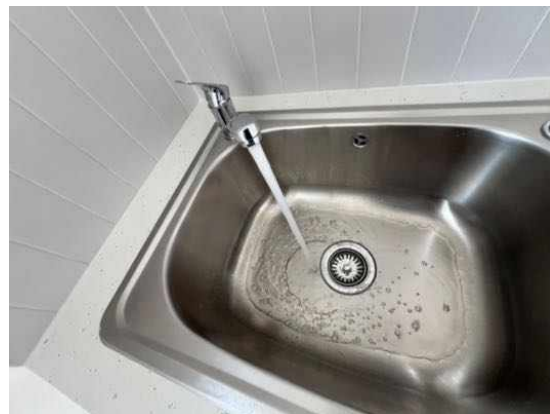
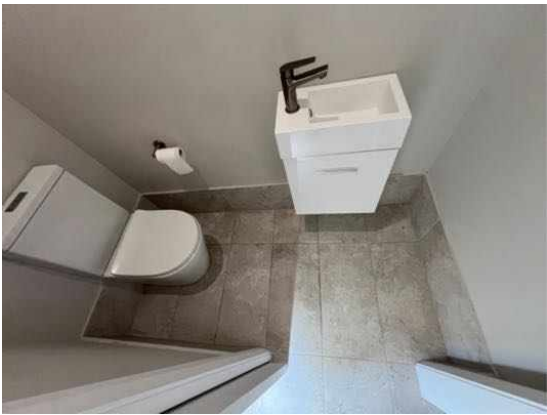
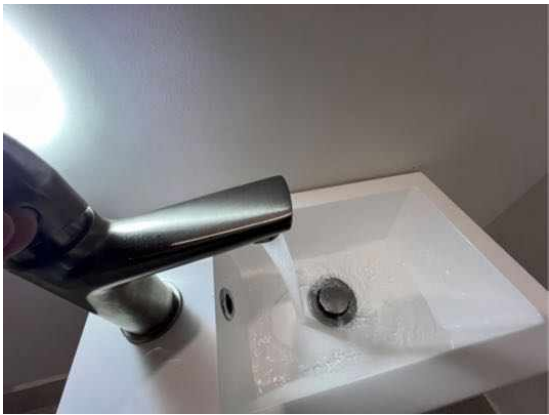
Finding: FYI - Additional Photos

Information: Additional photos are provided for your general reference and may include obstructions, testing of water & windows, moisture readings or minor maintenance items.

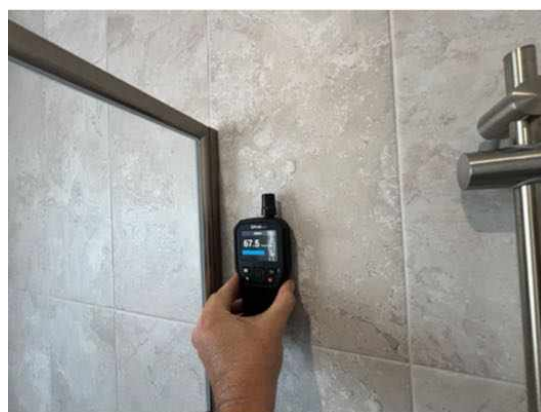
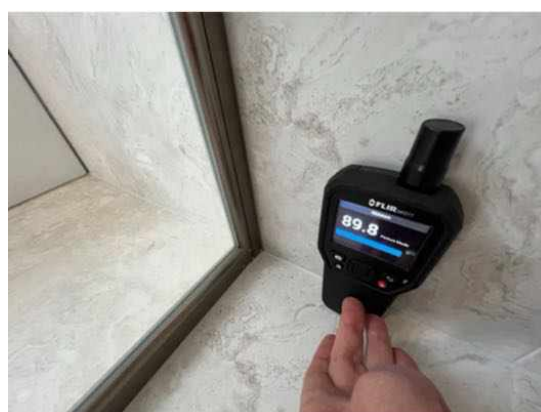
Building: Main Building
Location: Ensuite - Guest
Finding: Moisture in shower - No action required
Information: Moisture is evident behind the tiles to the shower alcove. This defect is quite common, and is suspected to have been caused by moisture permeating through the grouting in this area.

Given that no moisture was detected around plumbing and at the other side of the wall, no action is required on this defect.

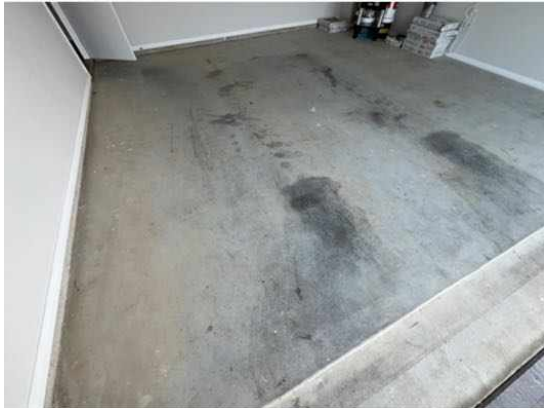
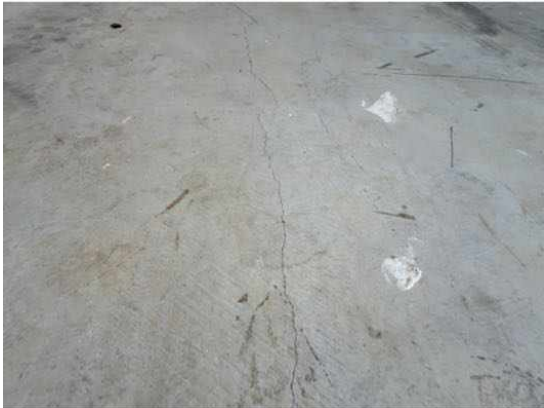
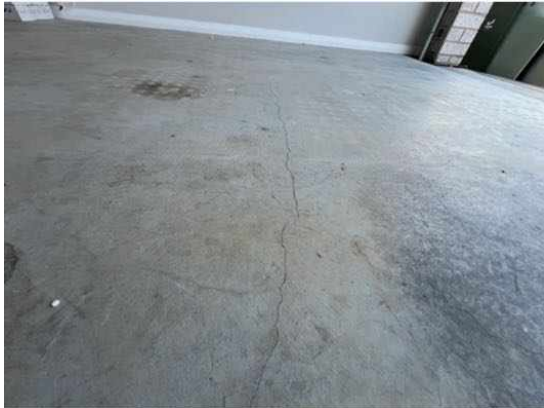
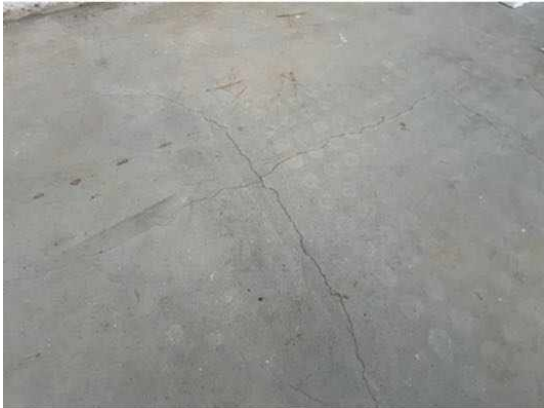
Location: Garage
Finding: Cracking - External Concrete Paving Damage Category 0 - Hairline (less than 1mm)
Information: Hairline cracks were identified in external concrete paving. Hairline cracks are very minor in nature and generally are only ever an appearance defect. To be classified as a Category 0 or hairline crack, the crack width would be less than 0.3mm. While such cracking may be noticeable in some cases, it is common and does not indicate any structural damage.

Generally the cause of a hairline crack in existing concrete paving such as driveways and pathways is indicative of the expansion and contraction of the concrete. Such causes are generally due to environmental factors, such as moisture levels, weather conditions, root systems of nearby trees or the soil types on which they are laid.

Hairline cracks may also be due to poor original installation of the concrete. Factors such as poor compaction of the sub surface and/or inadequate reinforcing of the slab may create cracking and other secondary defects.

Monitoring of all cracking should be conducted frequently. Always contact a building inspector should cracks widen, lengthen, or become more numerous.

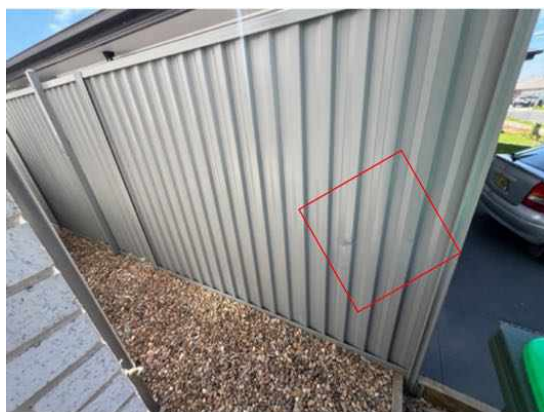
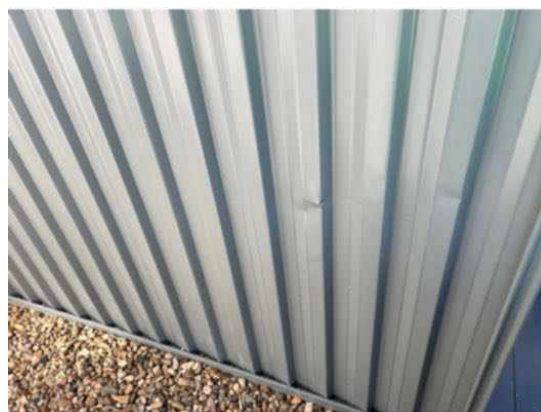
Location: Yard - Side
Finding: Colourbond Fencing - damage
Information: Sections of the Colorbond fencing were identified as damaged at the time of inspection. Damage to fencing panels may occur due to impact, weathering, or improper installation, potentially affecting the structural integrity and appearance of the fence.

Where Colorbond panels are compromised, they may be more susceptible to corrosion and further deterioration over time.

It is recommended that a licensed fencing contractor be appointed to assess the extent of the damage and provide advice on remedial options to restore the fencing.

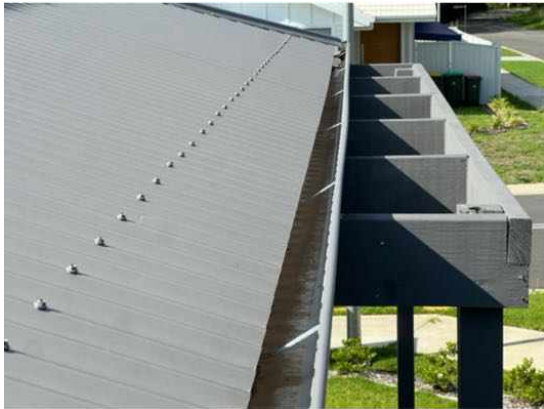
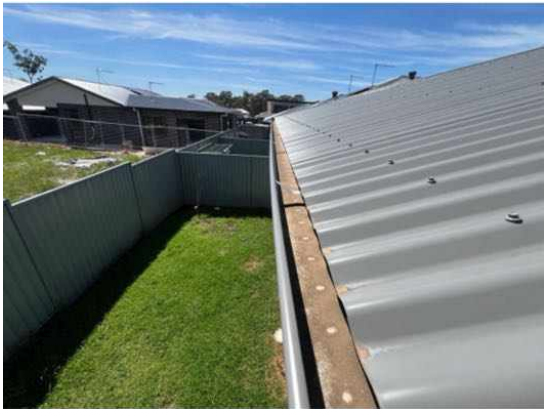
Building: Main Building
Location: Roof Exterior
Finding: Gutter - Clear and clean
Information: At the time of inspection, the gutters were found to be clear of debris and in a clean condition. Blocked gutters are a common cause of water ingress and associated damage to eaves, walls, and internal ceilings. While no concerns were noted at present, it is essential that gutters are routinely maintained and kept free of debris to ensure proper stormwater flow and to avoid potential overflow issues during periods of heavy rainfall.

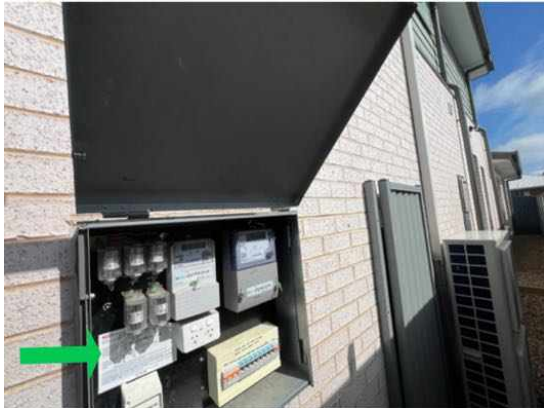
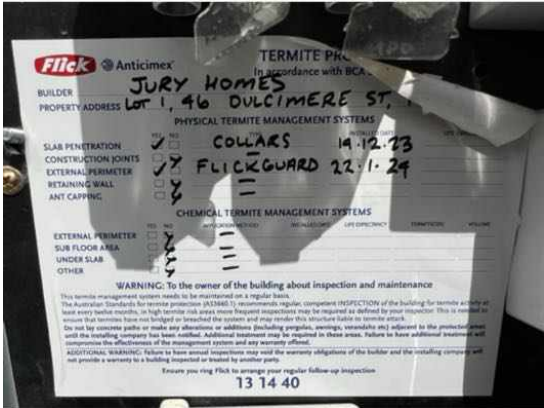
The following items were noted as - Evidence of a previous termite management program

Where a Termite Management System has been identified you should refer to the type of barrier date of installation warranty conditions and any documentation provided by a builder or past owner. Consult the company who installed the barrier to confirm whether the system is still under warranty.

Most chemical termite management systems expire and require replenishment and all physical systems are primarily designed to prevent concealed entry.
