Building and Timber Pest Inspection Report

Inspection Date: Thu, 9 Apr 2026

Property Address: 402/8 Ada Ave, Wahroonga NSW 2076,
Australia

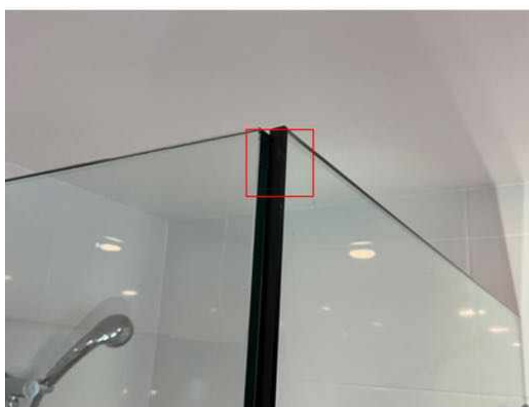
Binding and/or jamming of shower doors were evident during standard operation at the time of inspection. This defect is a potential safety hazard if the shower screen breaks due to impact or jamming force.

It appears this is due to poor initial installation of the shower components.

A licensed glazier is required immediately for repairs and to ensure the safety of the area.

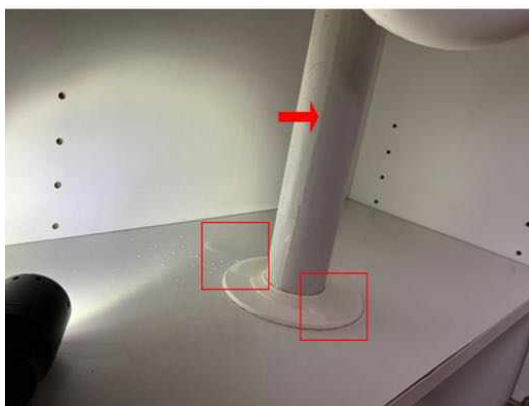
Finding 3.01

| Finding: | Water leak - Active |
| Information: | Generally, water leaks occur when a particular area of the property is not weather or water tight. As the surrounding area was found to be damp at the time of inspection, the leak is considered ongoing and hence requires urgent action. |

It is highly advised that the cause of the leak be identified and resolved immediately by a licensed plumber to prevent any further damage. Depending on the extent of the damage previously sustained, repair and/or replacement of any affected building materials may be required.

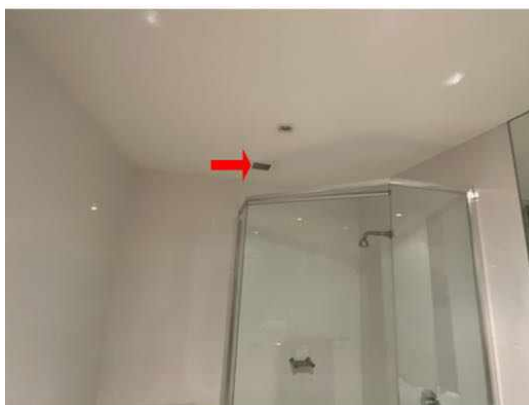
Finding 3.02

| Information: | The exhaust fans to the following areas appear to be damaged or blocked and is not operating as intended. If left unmanaged, a lack of general maintenance is likely to lead to the development of more significant defects, such as water damage to surrounding building materials from inadequate ventilation. If left unattended for a prolonged period of time, poor ventilation in this area may also be conducive to the development of mould. |

Where no secondary damage has developed, the Homeowner may undertake minor

cleaning of the area and consider replacement of the exhaust fan. Alternatively, consultation with a Licensed Electrician is required to check for any secondary or concealed damage and consider repair or replacement.

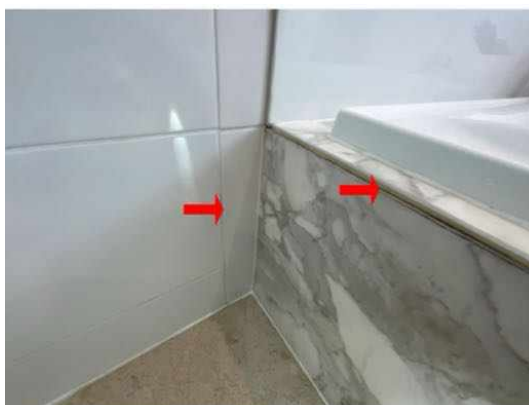
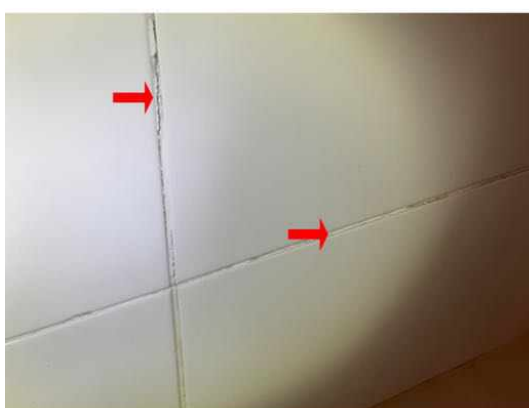
Finding 3.03

Building: Main Building
 Location: All Wet Areas
 Finding: Sealant and grouting - Missing or damaged
 Information:

It was noted on inspection that sealant or grout is degraded to this area.

Different materials and floor areas move at different rates, generally causing cracking to grout or sealant at this point. A flexible sealant is required to allow for expected expansion and contraction, while keeping the joint water tight and protective of all associated building materials.

Flexible and mould resistant materials should be applied to affected areas to prevent any subsequent water damage that is likely to occur. Regular maintenance and replacement of damage or missing or damaged sealant and grout is highly recommended to the wet areas, as this is a regular wear and tear defect. Sealant and grouting in areas that come into regular contact with water should be maintained for the long term care of your property.

A sealant specialist should be appointed to complete these works as soon as possible.

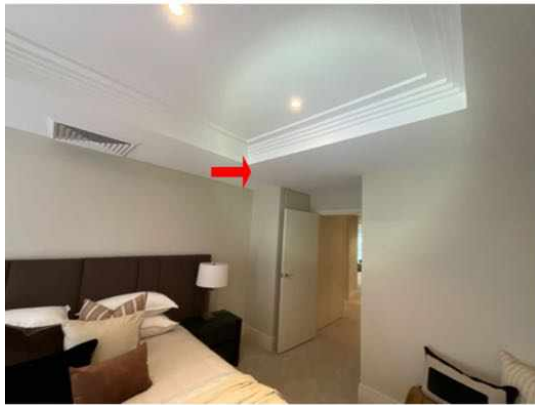
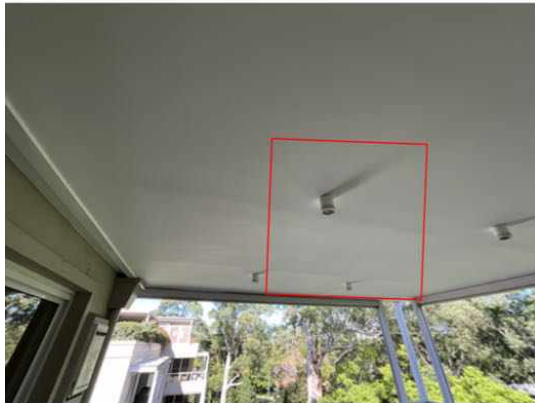
Finding 3.04

| Finding: | Cracking - Damage Category 1 - Fine (up to 1mm) |
| Information: | Although fine cracks are quite noticeable, they are often only considered to be an appearance defect, and usually do not indicate any structural damage. Generally, the cause of a fine crack is indicative of a separation between building materials and finishes (e.g. paint, plaster, etc.) along joints. |

Cracking of this nature can generally be repaired with minor sanding, filling and/or repainting. Such works should be performed by a qualified painter or a general handyman.

Monitoring of all cracking should be conducted frequently. Always contact a building inspector should cracks widen, lengthen, or become more numerous.

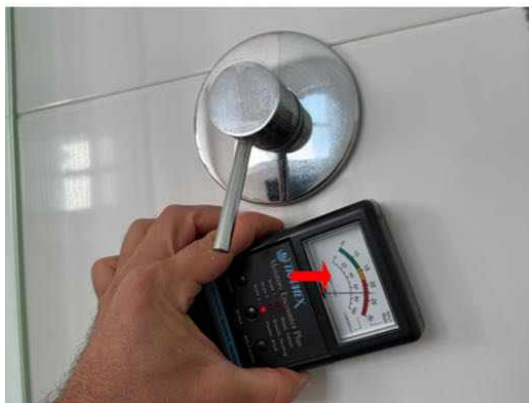
Building: Main Building
 Location: Bed 1 Ensuite
 Finding: Water leak - Suspected
 Information: A water leak is suspected in this area as excessive moisture was detected at the time of inspection. Another potential cause maybe moisture ingress behind the tiles from around the wall fittings and penetrations.

Internal water leaks can be detrimental to surrounding building elements; their potential causes include damage to plumbing fittings and fixtures, through to water damage and deterioration of associated building elements.

In extreme cases, structural damage may develop due to a prolonged water leak. It is highly advised that internal water leaks be addressed by a licensed plumber as a matter of relative urgency.

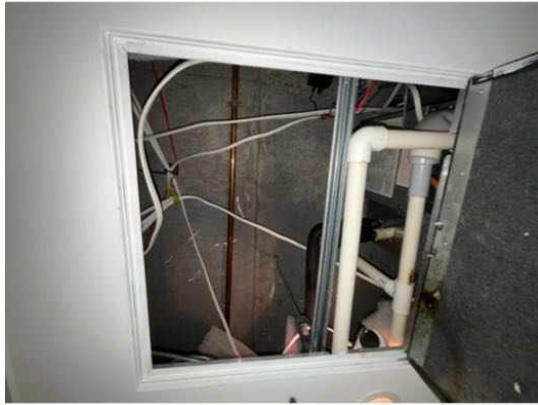
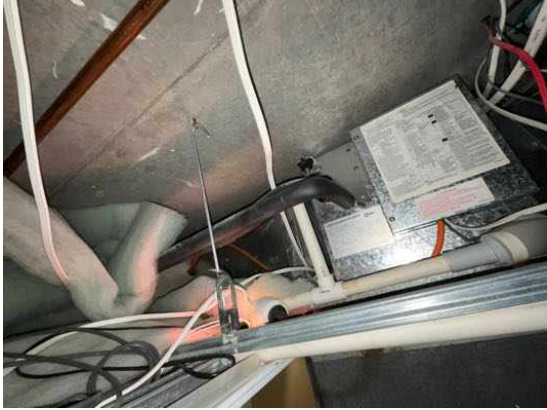
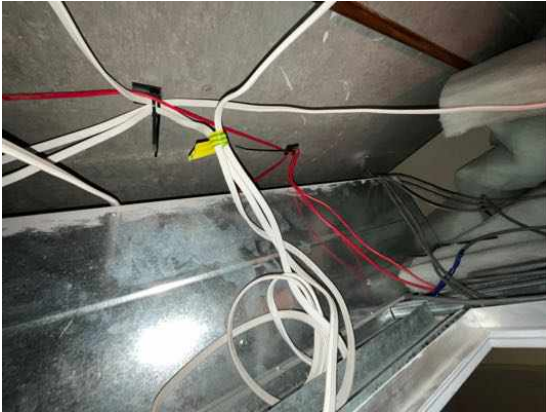
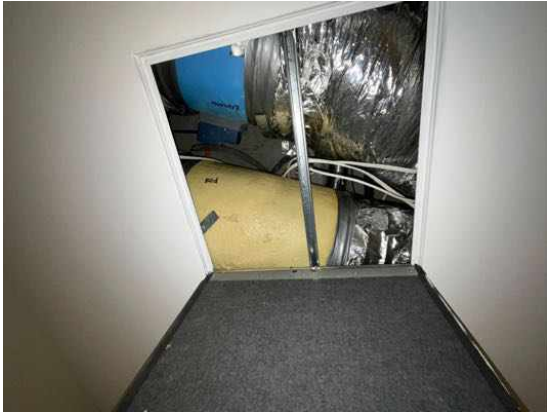
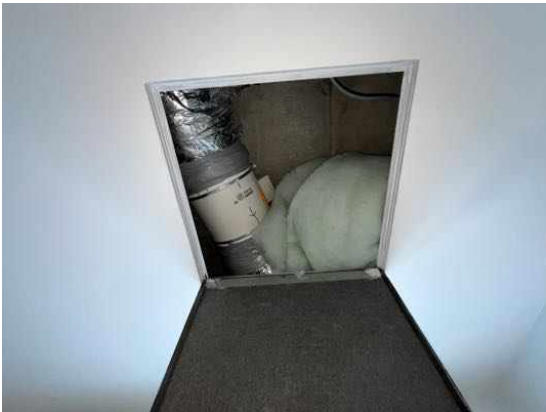
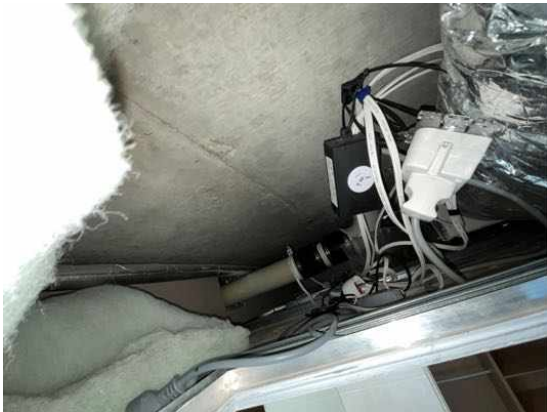
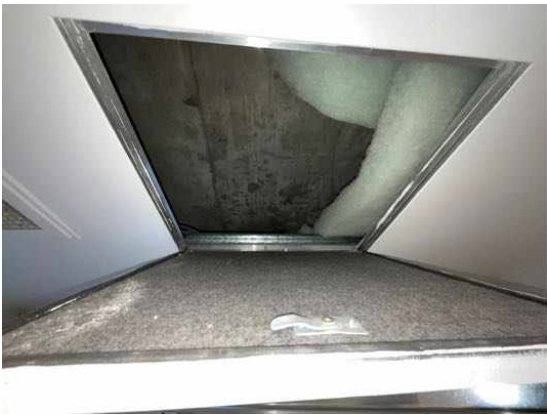
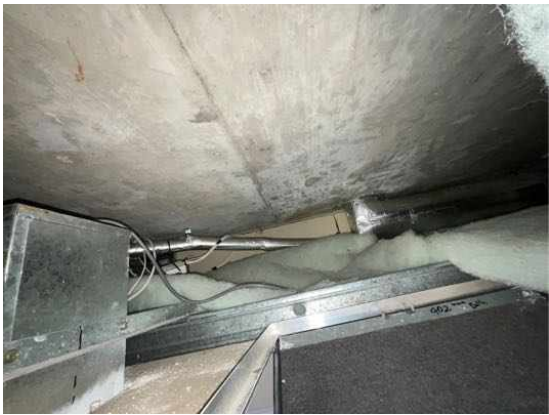
Building: Main Building
Location: Ceiling cavity
Finding: Additional Photos- ceiling cavity
Information: Additional photos are provided for your general reference. Arrows may have been included to highlight areas of importance. Please discuss these photos with your building consultant for clarification.

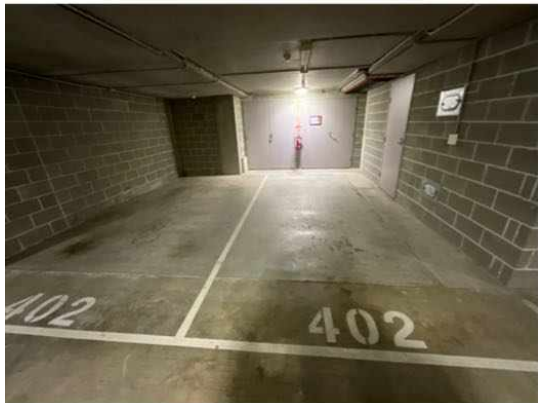
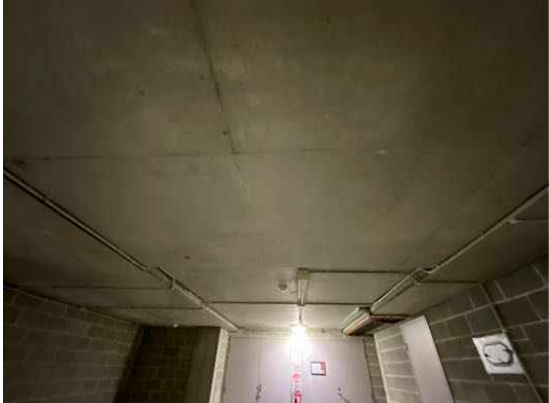
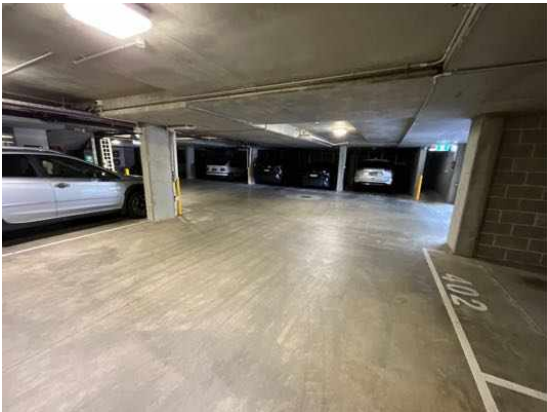
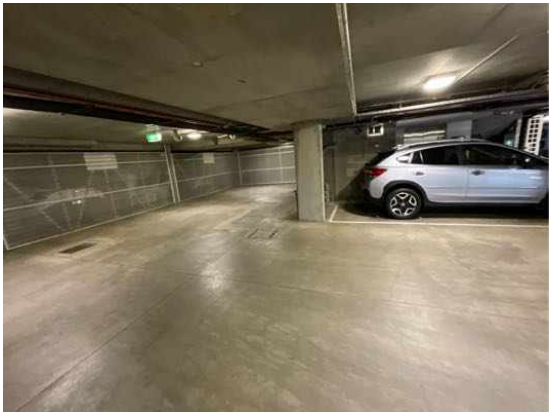
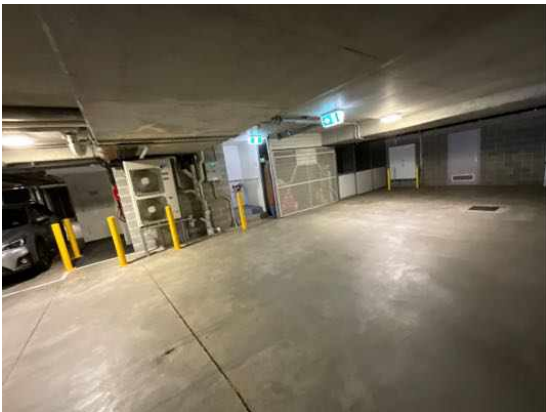
Building: Main Building
Location: Garage
Finding: Additional Photos- Garage
Information: Additional photos are provided for your general reference. Arrows may have been included to highlight areas of importance. Please discuss these photos with your building consultant for clarification.

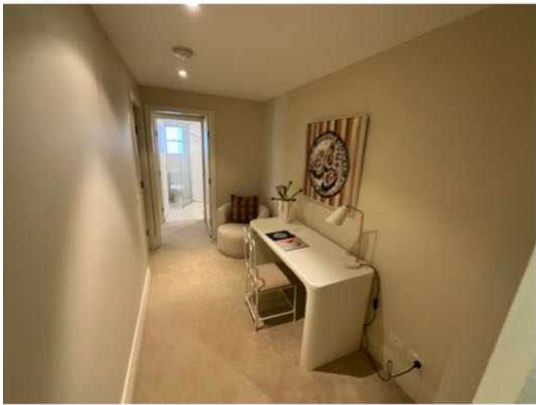
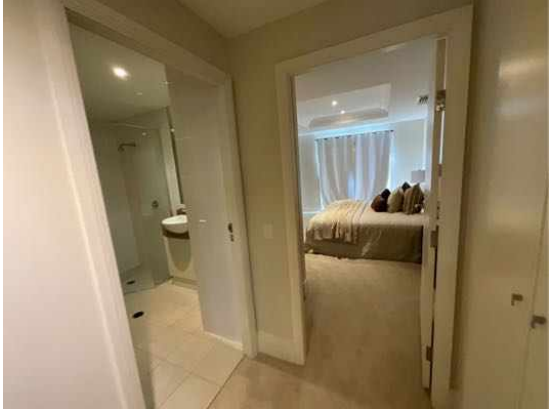
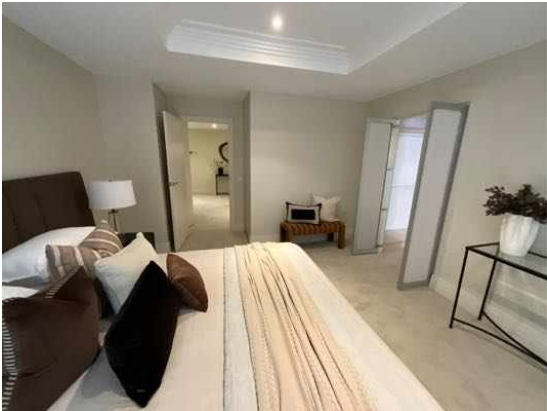
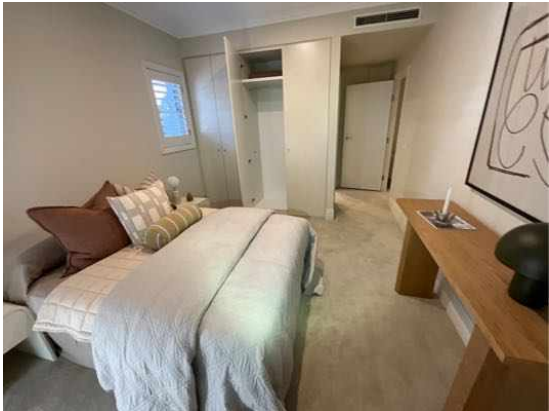
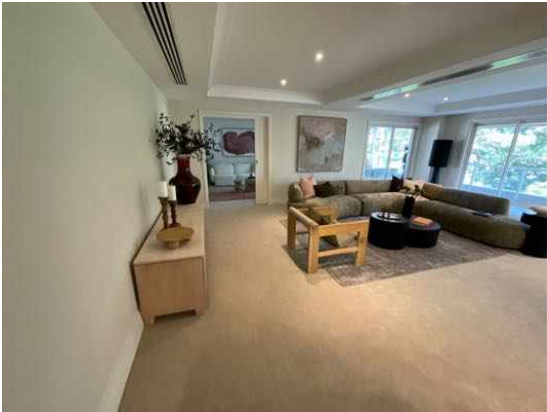
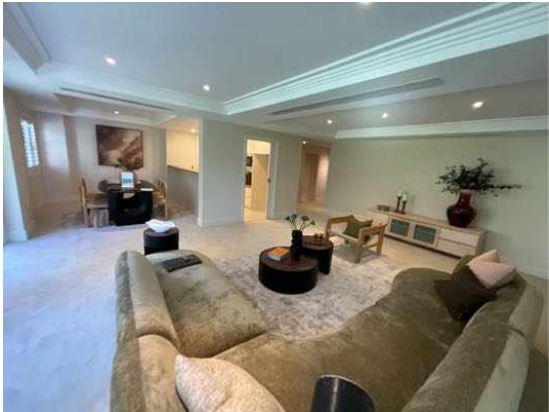
Finding: Additional Photos - Obstructions and Limitations
Information:

These photographs are an indication of the obstructions and limitations which impeded full inspection of the property at the time of inspection. These obstructions can hide an array of defects and should be removed to allow full inspection to be carried out. A re-inspection is recommended once the areas are made accessible.
