Building and Timber Pest Inspection Report

Inspection Date: Mon, 19 Jan 2026

Property Address: 39 Epaulet Circuit Jordan Springs NSW
2747

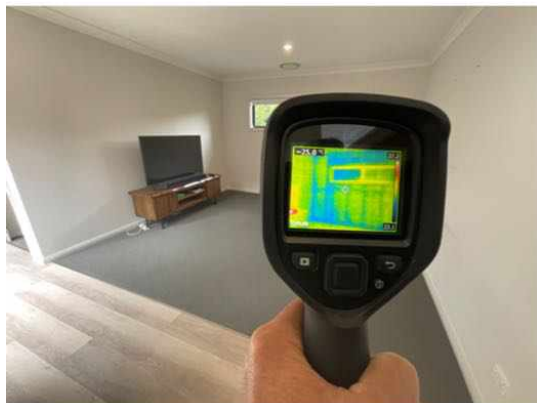
At the time of the inspection, no abnormalities indicating live termite activity were observed. However, it's important to note that various factors—such as obstructions, ambient temperature, and wall material/thickness—can impact the accuracy of thermal readings. In cases where surfaces are visually restricted or obstructed, a comprehensive thermal scan may not always be feasible.

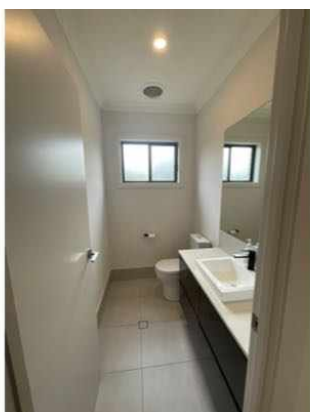
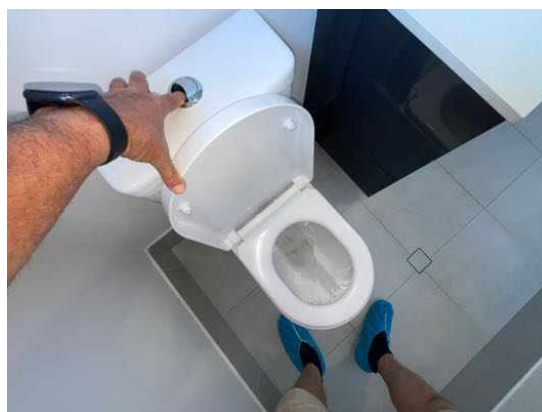
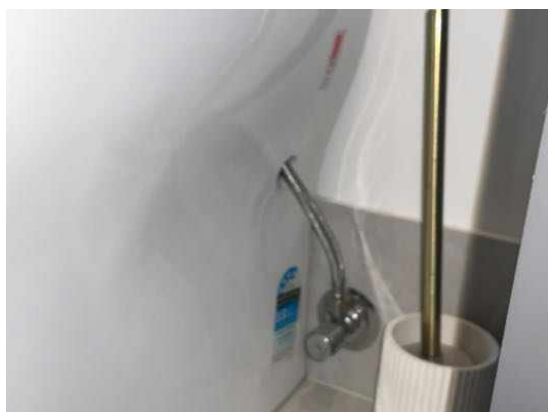
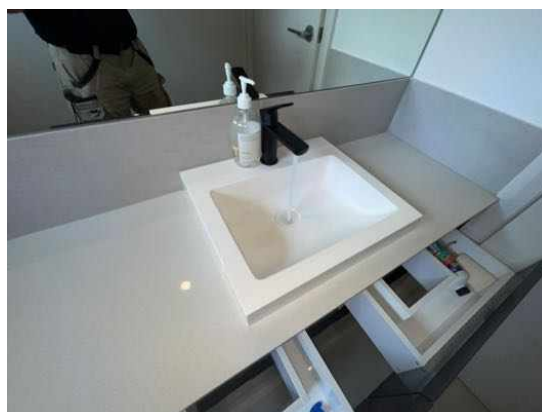
- Sealant around the basin and wall junctions appeared to be in serviceable condition
- Regular maintenance of sealant and grouting in wet areas is essential to prolong the life of surrounding materials and reduce the risk of water damage.

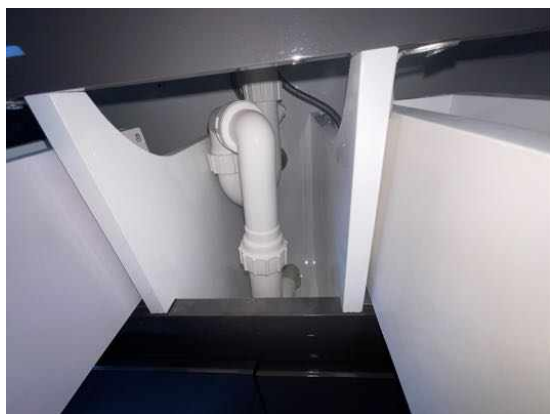
Building: Main Building
 Location: All Areas
 Finding: Water Pressure – Observation Only.
 Information: During the inspection, water pressure appeared to be within a normal operating range based on a basic functional check. However, this observation was made without the use of pressure testing equipment and does not constitute an assessment by a licensed plumber.
