# Building and Timber Pest Inspection Report

Inspection Date: Tue, 20 Jan 2026

Property Address: 27 Mount Keira Rd, West Wollongong NSW  
2500, Australia

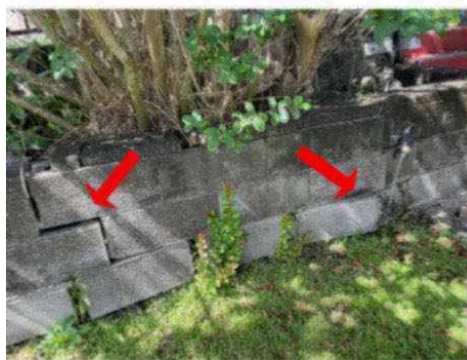
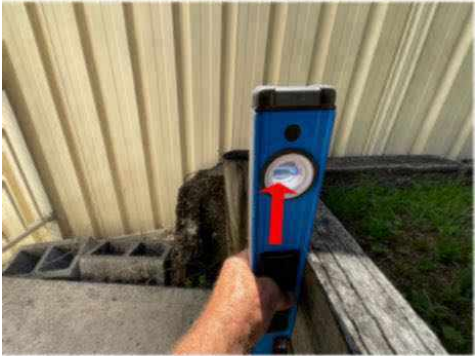
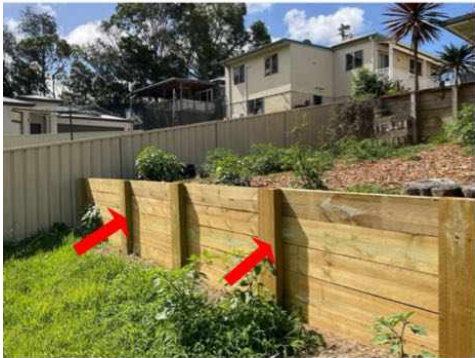
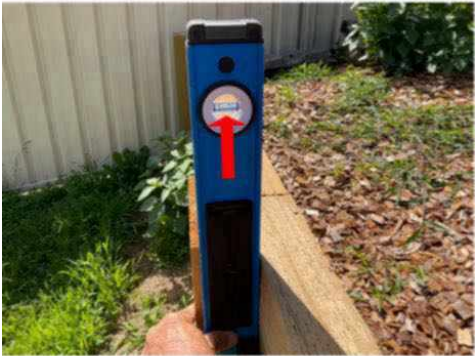
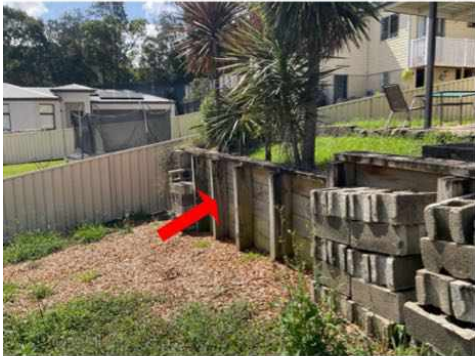
Building: Building 1  
Location: Most retaining walls  
Finding: Retaining walls - Defective  
Information: Most retaining walls were found to be defective at the time of inspection. Most are leaning and some have major and minor step cracking to the blockwork.

Generally, defective retaining walls are caused by poor original design or material use. However, deteriorated retaining walls may also be a result of substandard construction, poor site drainage or unmanaged stormwater flows. Where timber retaining walls further rot and decay, an environment is created that is conducive to termite and pest infestation.

Significant repair and replacement should be expected. A landscaper or retaining wall installer may be appointed to repair or replace the wall, at the discretion of the client.

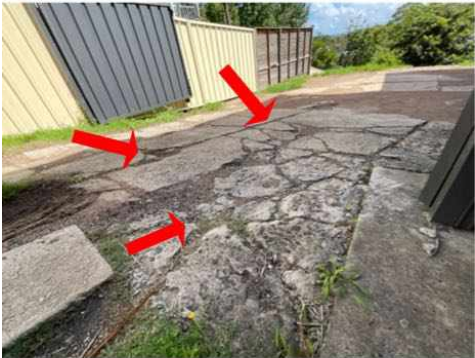
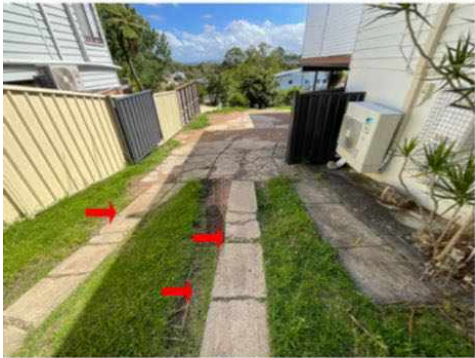
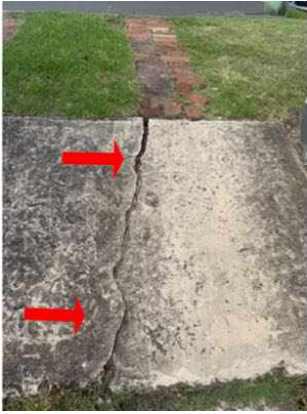
**Finding 2.02**

Building: Building 1  
Location: Driveway  
Finding: Cracks in concrete slab - Category 4  
Information: Numerous cracks coded as Category 4 was identified in the driveway. A Category 4 crack is described as a crack that appears as a gap in the slab, with disturbing curvature or change in level affecting the slab.

The approximate width of the these cracks or gaps is 4mm-10mm or a change in offset of greater than 25mm when a 3m straight edge is placed over the defect.

Category 4 cracking to slabs exceeds allowable Standards and Tolerances, and are therefore considered as major defects that require rectification.

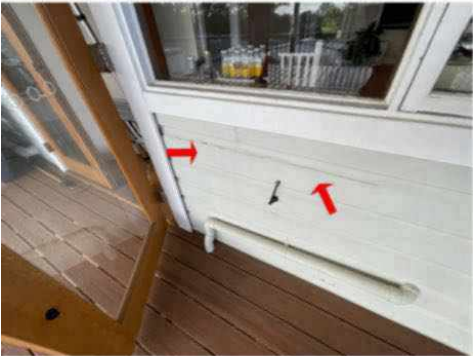
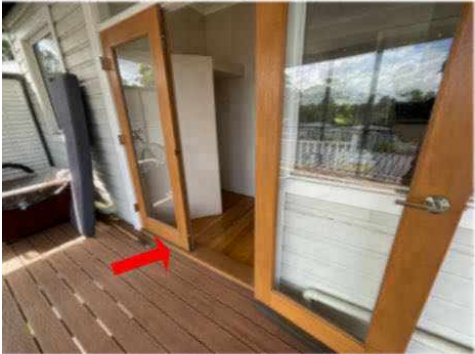
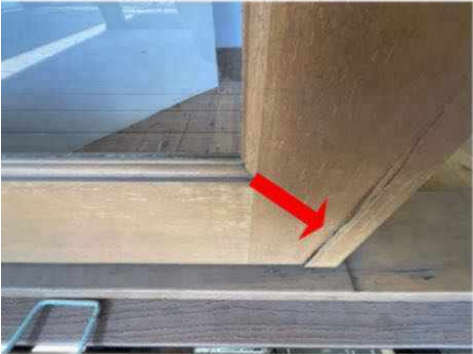
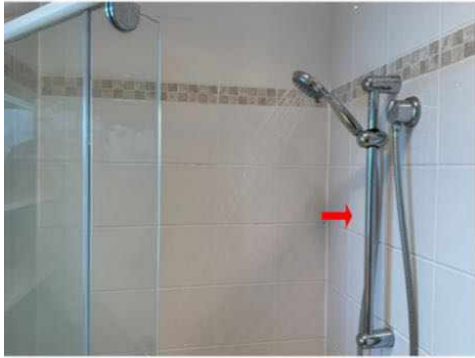
Building:	Building 1
Location:	Pictured areas
Finding:	Building elements - Damaged
Information:	Evidence of minor missing or damaged areas was identified at the time of the inspection. These include -

1. One panel of front upper cladding has cracked and some rear timber cladding has minor damage.

2. The right rear timber kitchen door has split at the bottom, this door was not opened so as not to cause further damage to this door.

4. The towel rail is loose requiring refixing and the vanity shows minor swelling at the base.

A carpenter would be the trade responsible for rectification of these areas when convenient.

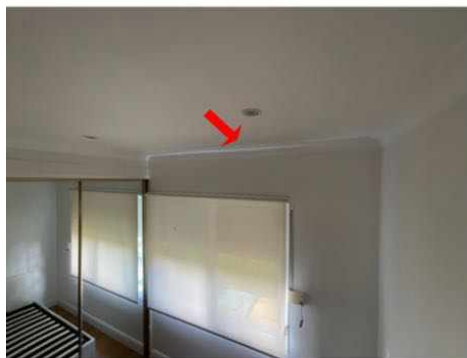
### Finding 3.04

Building:	Building 1
Location:	Upstairs areas
Finding:	Ceiling - minor sagging/deflection evident
Information:	These pictured upstairs ceilings were found to show very minor sagging at the time of inspection. Sagging to the fixed ceiling structure generally indicates that the building materials have swollen, due to contact with water, or that fixings (e.g. nails or glue) have become loose and require reattachment. The ceiling over the rear upstairs door showed repairs evident.

Where minor sagging is evident, comparatively minor works, such as re-gluing of ceiling sheets, may be required. Such works may be performed by relevant tradespeople, such as plasterers or carpenters. Monitoring of all ceilings annually is required to ensure movement does not continue.

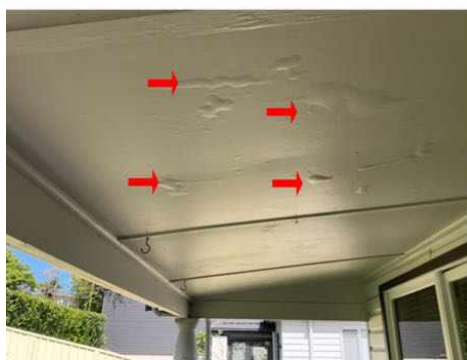
Building:	Building 1
Location:	Pictured areas
Finding:	External painting deteriorated
Information:	Much of the external paintwork including but not limited to windows, fascias, guttering, veranda and other external fitments have been neglected and require attention to prepare and re-paint.

Whilst incomplete or missing paint finish is generally an appearance defect, it can also lead to the development of secondary building defects over time. Incomplete areas of paint finish expose the area to moisture, potentially accelerating the deterioration of underlying building materials.

Degraded paint finishes should be sanded back, filled, leveled and painted, as applicable. Where inadequate or missing paint protection has led to the deterioration of the associated building element, repair and/or replacement of this building element may be required.

A painting contractor should be appointed as soon as possible to perform necessary works to aid the appearance of the affected area and to ensure the area is protected against further deterioration. Alternatively, the homeowner following manufacturer instructions may perform these works.

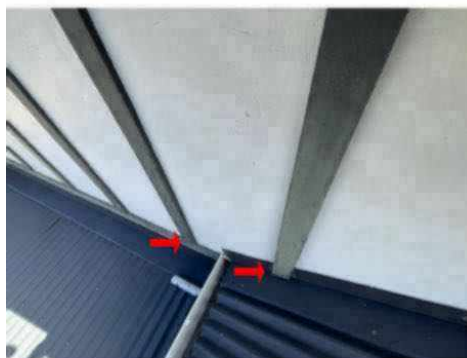
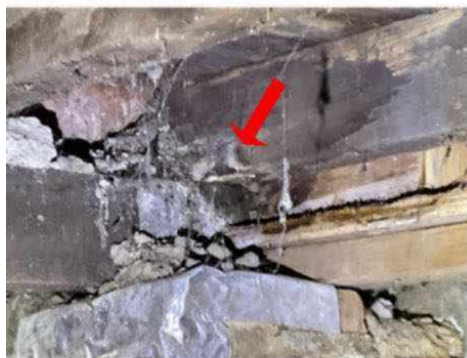
### Finding 3.07

Building:	Building 1
Location:	Pictured areas
Finding:	Wood rot
Information:	The building shows evidence of wood rot. It all appears to be minor in nature. Wood rot, also known as Fungal Decay, occurs when timbers and other cellulose building materials are exposed to damp conditions on an ongoing basis. This could be the result of exposure to weathering over a prolonged period of time, or the attraction of excessive moisture from other abutting building materials.

Early intervention and regular maintenance, particularly of exterior timbers, will prolong the useful life of these building elements. Prior to any works being performed, the cause of the moisture that has created the visible wood rot should be identified and addressed in a suitable manner. Replacement of affected timbers may then be a necessary step in protecting surrounding building elements from such deterioration.

A qualified carpenter or registered builder may also be required to replace affected building materials in pictured 1-4 in the next year. The rot in picture 1 can be refilled with builders bog and repainted.

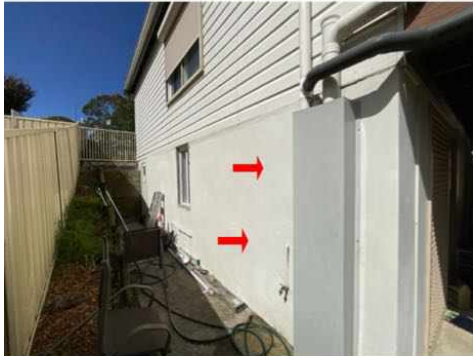
refers to render that has become detached from its fixing, despite it still being solid. Such defects are generally caused by physical or moisture damage to the area. Drummy render may also be a direct result of poor workmanship during the construction process.

Render may swell and shrink with changes in air humidity if the area has sustained moisture damage. Any exposure to moisture is capable of causing rendered areas to become drummy and/or cracked over a prolonged period of time. Drummy render generally requires chipping off and re-rendering or painting in the future.

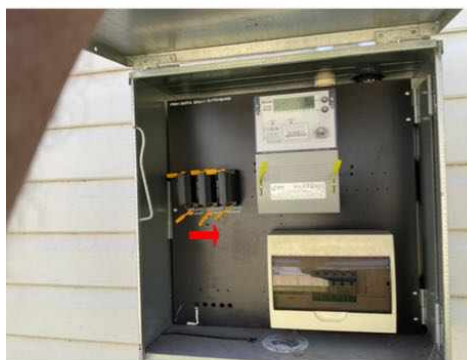
Building:	Building 1
Location:	Meter Box
Finding:	Termite Management System - no evidence of a chemical installation
Information:	The application of a post-construction chemical termite barrier is highly recommended for all properties. Such barriers are highly effective in preventing termite attack on any timber building elements throughout the property.

A durable notice should be placed in the switchboard unit to indicate current termite barriers. At the time of inspection, no durable notice was evident and it appeared as though no chemical termite management system has been installed, with no evidence to suggest preventative works taking place since the property was built.

The client may consider gaining further advice from a pest controller as to the costs and procedures involved with a 'chemical' application. It is recommended that obtaining such advice be a short-term priority.

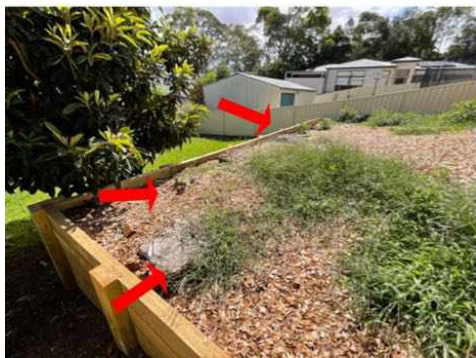
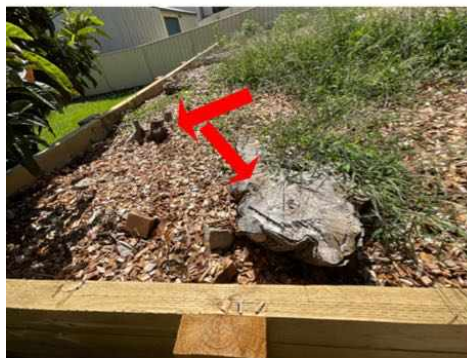
Building:	Building 1
Location:	Pictured yard area
Finding:	Tree stumps - left in ground
Information:	Over a dozen tree stumps left in ground provide opportunity for termite attack as they are likely to be subject to rot and decay providing an attractive food source.

Treatment and/or Removal of all stumps is highly recommended. A pest controller and tree removalist should be engaged to perform such works.

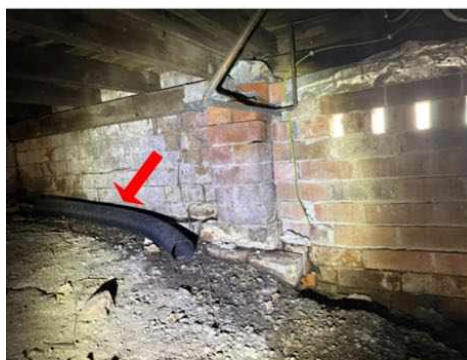
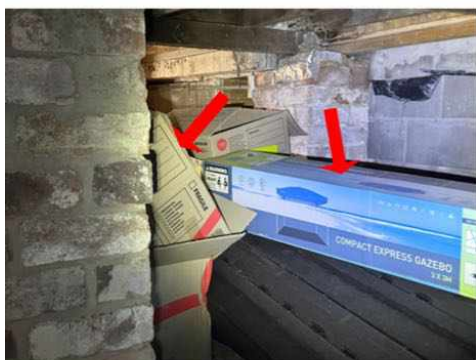
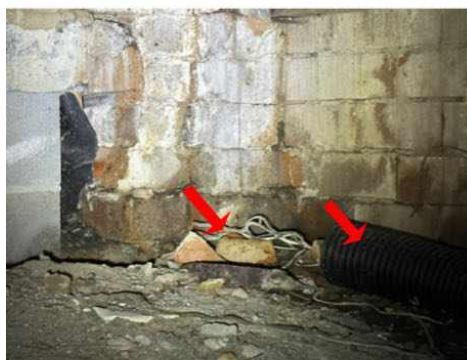
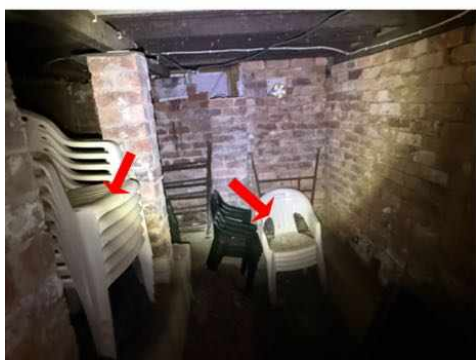
### Finding 6.04

Information: An array of debris was found in the subfloor area at the time of inspection. Debris in this area restricts subfloor ventilation and creates potential for concealed pest entry. Stored timbers and other materials may also make the area susceptible to termite activity and wood rot.

A clear and empty subfloor will be better ventilated and easier to maintain in a dry condition. The removal of any timber debris is vital in minimising the risk of termite or wood borer activity.

Debris in the subfloor should be removed as soon as possible. Depending on the location and amount of debris and stored items, the homeowner may elect to undertake this task. Alternatively there are a large number of rubbish removal subcontractors that could undertake these works.

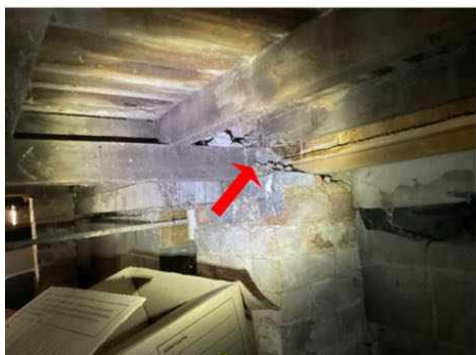
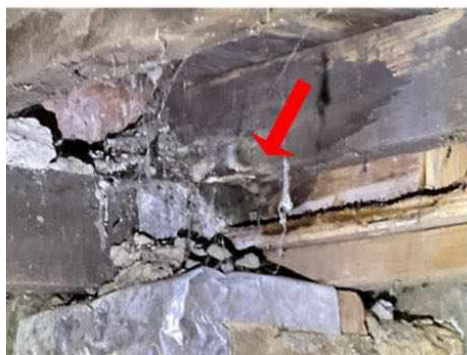
In this case, the affected timber elements in pictured 3 & 4 are in a decaying state and will need repair or replacement by a carpenter or licensed builder.

Note - See ALL wood rot photos, all these show fungal decay.

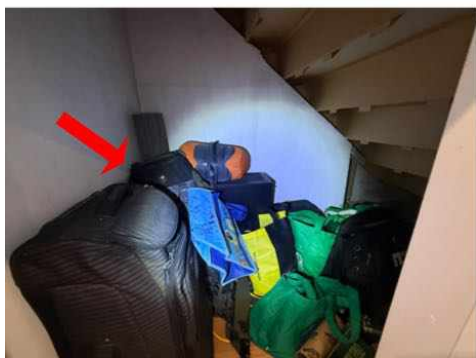
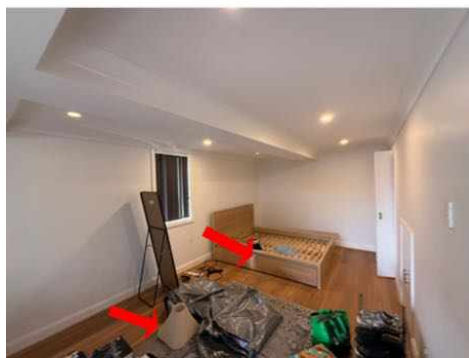
Building: Building 1  
Location: All Internal Areas  
Finding: Additional Photos - Obstructions and Limitations of INTERNAL AREAS  
Information: These photographs are an indication of the obstructions and limitations which impeded full inspection of Internal areas at the time of inspection. These obstructions can hide an array of defects and should be removed to allow full inspection to be

carried out. A re-inspection is recommended once the areas are made accessible.

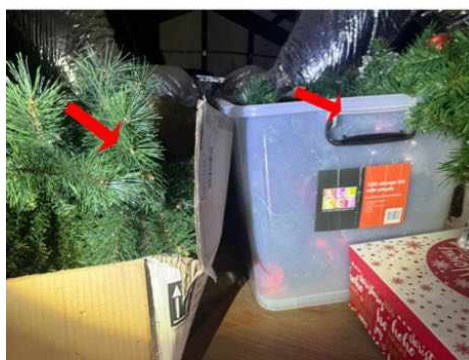
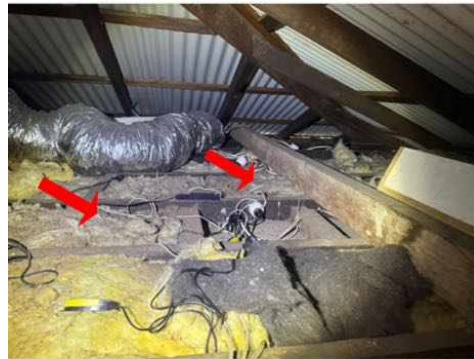
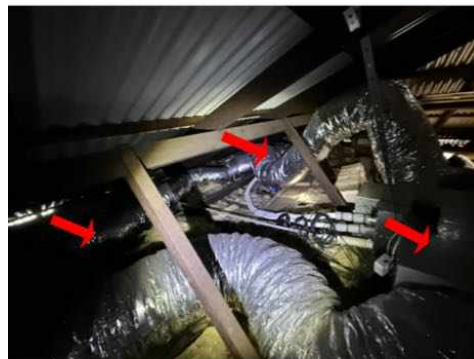
Building: Building 1  
 Location: All Roof cavity areas  
 Finding: Additional Photos - Obstructions and Limitations of the ROOF CAVITY  
 Information: These photographs are an indication of the obstructions and limitations which impeded full inspection of roof cavity areas at the time of inspection. These obstructions can hide an array of defects and should be removed to allow full inspection to be carried out if applicable. A re-inspection is recommended once the areas are made accessible.

The inspection was also limited to areas with an allowable crawl space of 600mm x 600mm, in particular towards the external walls where the roof line diminishes, these areas were not accessible.

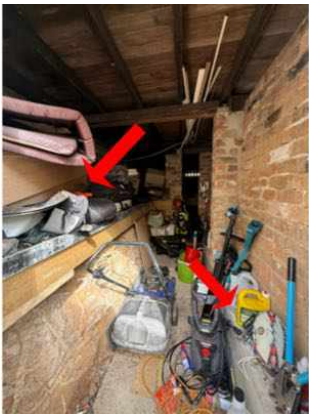
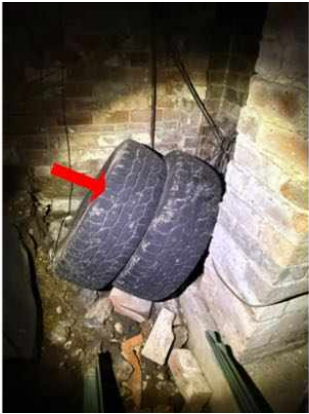
Building:	Building 1
Location:	All Subfloor Areas
Finding:	Additional Photos - Obstructions and Limitations of SUBFLOOR AREAS
Information:	These photographs are an indication of the obstructions and limitations which impeded full inspection of subfloor areas at the time of inspection. These obstructions can hide an array of defects and should be removed to allow full inspection to be carried out. A re-inspection is recommended once the areas are made accessible.

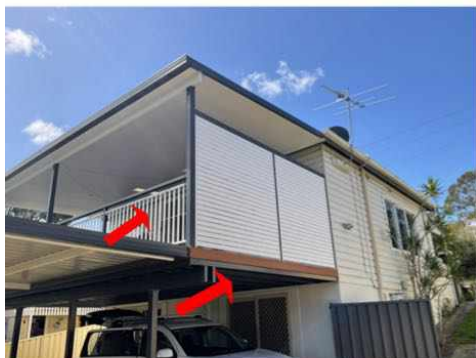
**Noted Item**

Building: Building 1  
 Location: Rear deck area  
 Finding: Elevated structure inspections  
 Information: Where any elevated Structure (deck, balcony, verandah etc) is present, and this elevated structure is designed to accommodate people, you MUST have this structure checked by an engineer or other suitably qualified person.

Nothing contained in this report should be taken as an indicator that an assessment has been made, on any elevated structure, as suitable for any specific number of people or purpose. This can only be done by a qualified engineer. For the purpose of this report, the Structure includes the elevated rear deck and handrails.

You should also arrange annual inspections of the structure by an engineer or other suitably qualified person to ensure any maintenance, that may become necessary, is identified. Care must be taken not to overload the structure.

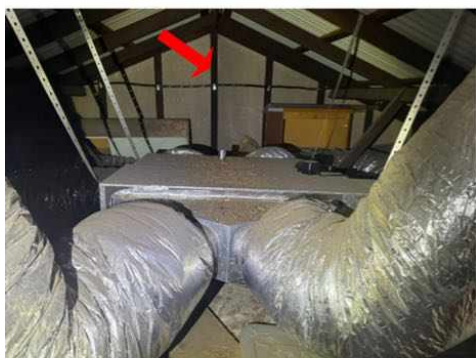
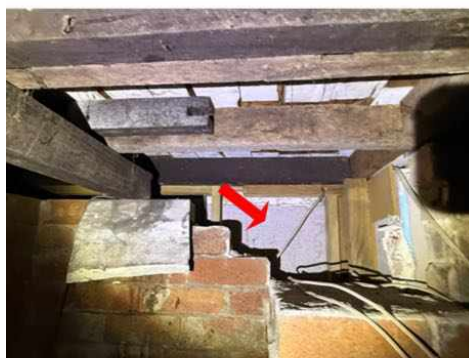
Building: Building 1  
Location: Some roof cavity and subfloor areas  
Finding: Asbestos - Suspected ACM Identified on Site  
Information: Reporting on Asbestos is outside the Scope of this Report. This suspected defect is highlighted as a caution only. We suspect, based on our experience in the building industry, that there is a higher risk of the identified building element containing asbestos.

As Asbestos Reporting is outside the scope of this report, we advise that you consider a separate Asbestos Inspection and Condition Audit, which can include the taking of samples for definitive confirmation of the presence of Asbestos.

In the interim, the client is advised to act with caution, especially when considering any damage to building materials general wear and tear renovations extensions demolition and general maintenance activities due to the suspected presence of Asbestos.

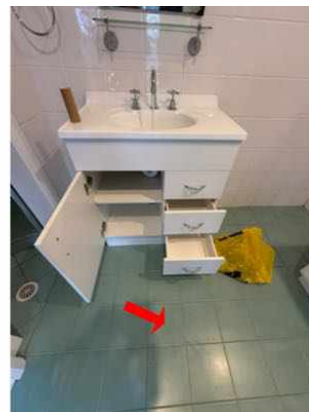
Building: Building 1  
Location: Bathrooms and laundry  
Finding: Waterproofing membranes - Information Only  
Information: Internal Water Proofing Membranes, are crucial in preventing water ingress into the property is important to know that the Membrane System used is to Australian Standards and has been installed correctly.

With older property's where this information is unavailable all wet areas should be monitored. If any leaks, water staining, peeling or bubbling of the paint become evident to any adjacent walls or ceilings below a licensed builder or waterproofing specialist is recommended to investigate further.
