Building and Timber Pest Inspection Report

Inspection Date: Thu, 22 Jan 2026

Property Address: 73 Cecily St, Lilyfield NSW 2040, Australia

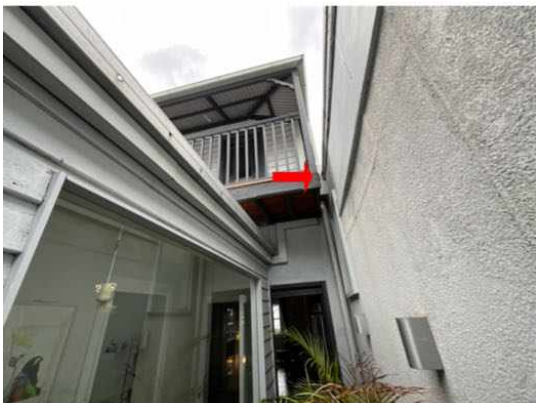
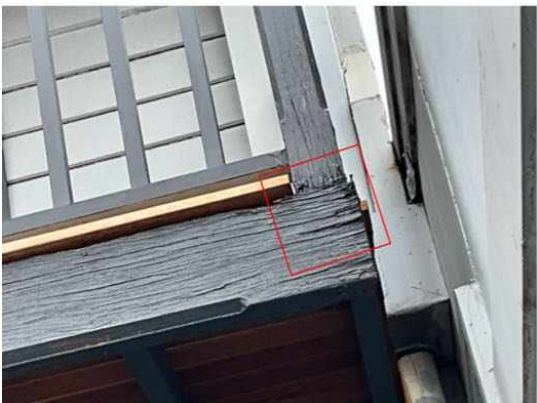
Finding 3.01

| Information: | Chemical delignification also known as wood defibration refers to the chemical breakdown of timber building elements. This breakdown of the Lignin deteriorates the wood impacting on the structural integrity and tensile strength of the affected building element. |

Chemical delignification is most common near marine environments due to the high levels of salt in the air however this deterioration may also occur in other areas where timber elements are frequently exposed to damaging gases chemicals etc.

Where timber building elements have deteriorated repair and / or replacement is required immediately to ensure the safety of the associated structures. The likely cause of the defibration should also be investigated and dealt with accordingly.

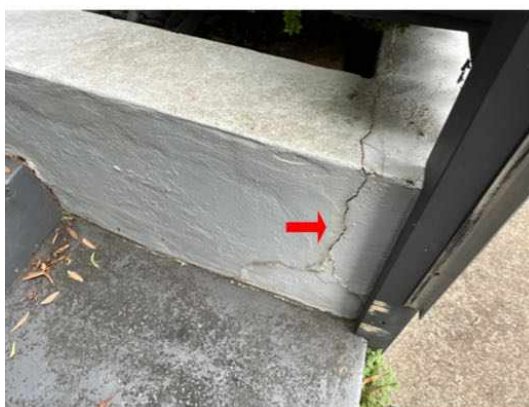
| Finding: | Retaining wall — Cracking |
| Information: | Cracking on retaining walls were identified in these areas. Generally, defective retaining walls are caused by poor original design or material use. However, deteriorated retaining walls may also be a result of substandard construction, poor site drainage or unmanaged stormwater flows. |

A landscaper must be appointed for rectifications.

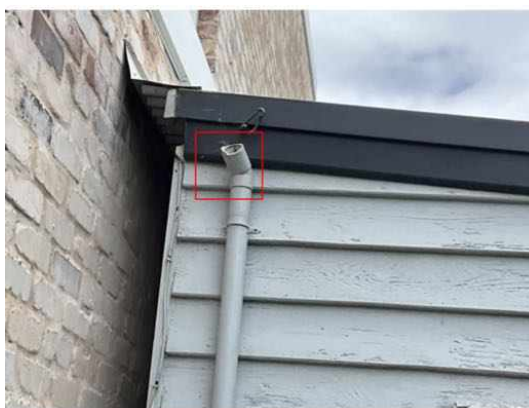
Finding 3.04

Works that have not been completed to a satisfactory level create potential for the development of building defects and may impede on the safety and integrity of the overall structure.

It is highly recommended that the relevant trades be appointed to complete these works and ensure the safety of the area and the longevity of all associated building elements.

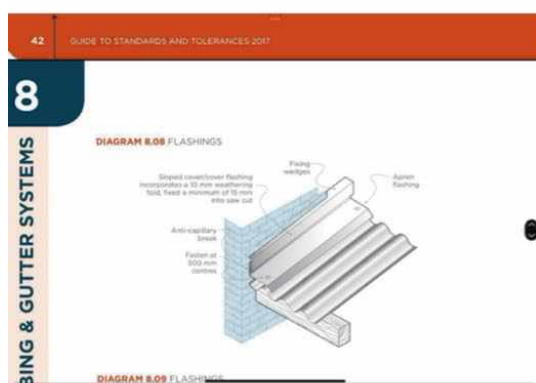
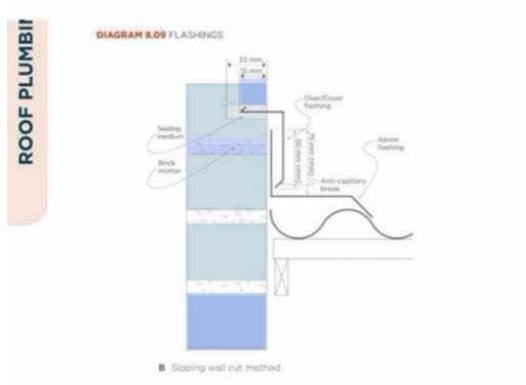
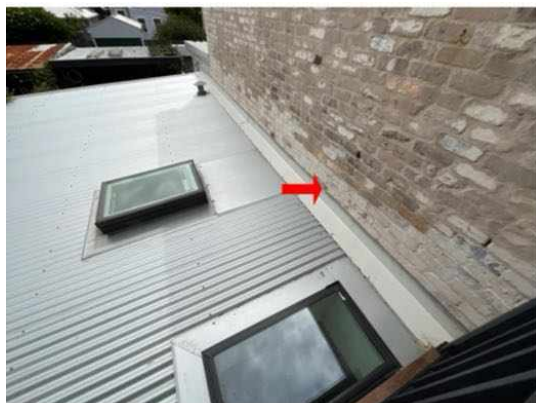
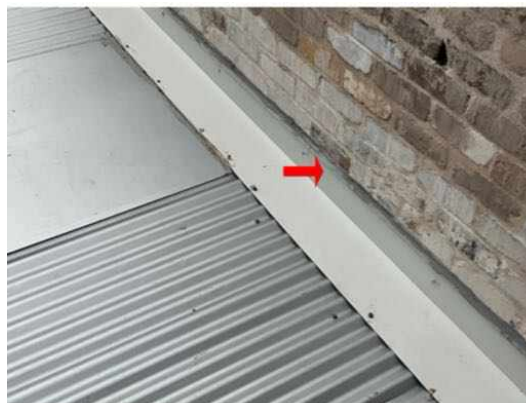
| Finding: | Flashing - Defective |
| Information: | Instances where over-flashings are missing were noted. It is expected the silicon to wear out causing water leaks in this area. |

Flashings that are not installed adequately or are missing are likely to result in water penetration to the interior of the property, as well as creating excessively damp conditions against the exterior surfaces and around the base perimeter of the building.

Premature ageing and secondary building defects are imminent where roof plumbing is missing or inadequately installed. Additionally, water pooling also creates an environment that is susceptible to termite and pest infestation.

This must be rectified immediately by a licensed roof contractor. The solution is to chase the brickwork and insert the flashing or otherwise to install over flashings with appropriate fixings.

The client is highly advised to ensure the manufacturer installation guide is followed.

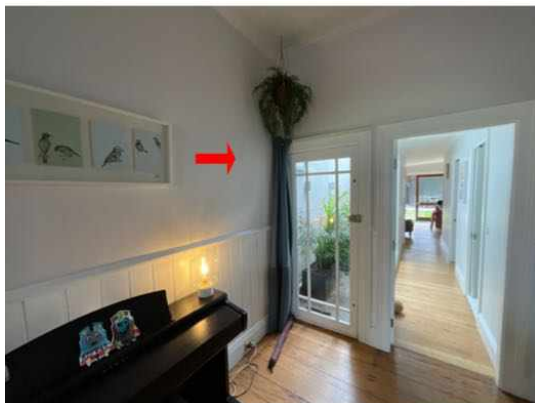
| Finding: | Cracking - Damage Category 1 - Fine (up to 1mm) |

Cracking of this nature can generally be repaired with minor sanding, filling and/or repainting. Such works should be performed by a qualified painter or a general handyman.

Monitoring of all cracking should be conducted frequently. Always contact a building inspector should cracks widen, lengthen, or become more numerous.

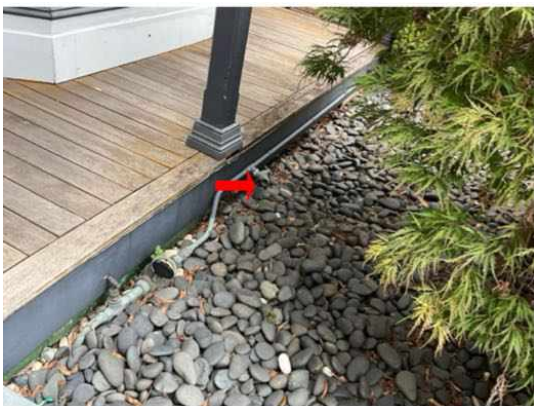
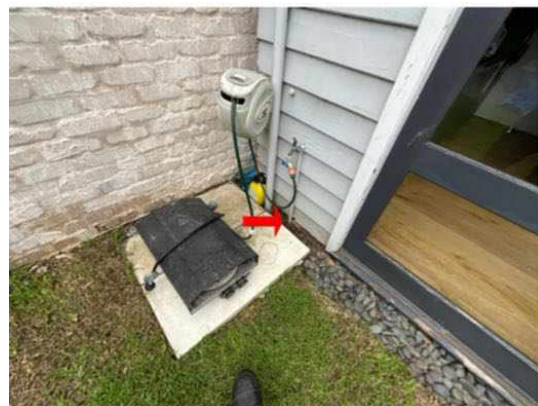
Finding 6.04

This keeps the surrounding surfaces damp while using the tap, which becomes conducive to termite activity.

A licensed plumber must be appointed to ensure an appropriate drain is installed.

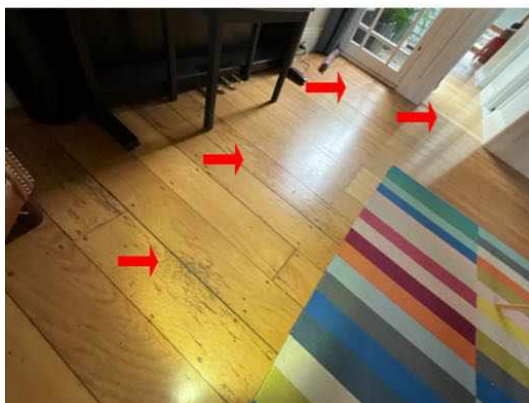
Finding 8.01

The other commonly known borer the Anobium borer is more likely to attack floorboards and may cause severe structural damage to flooring areas.

As no live wood borer activity was identified treatment is not required at this time. Replacement of affected timbers may be considered by the client for superficial reasons.

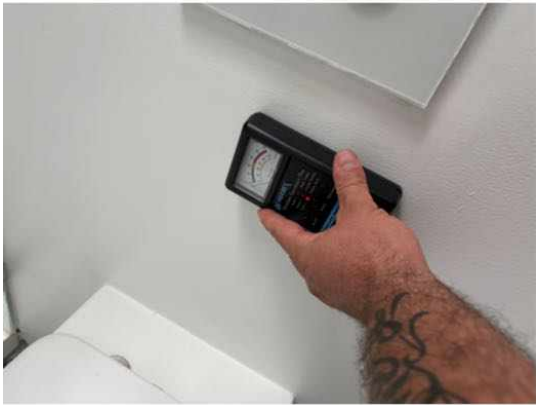
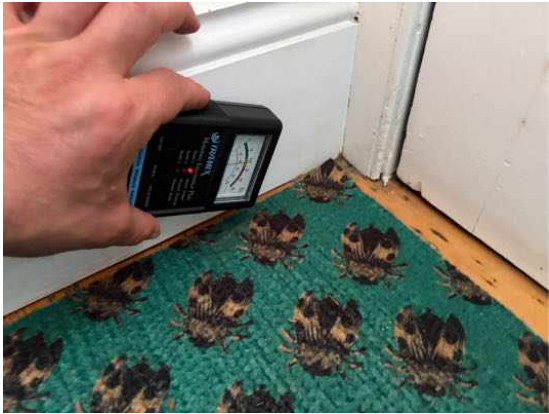
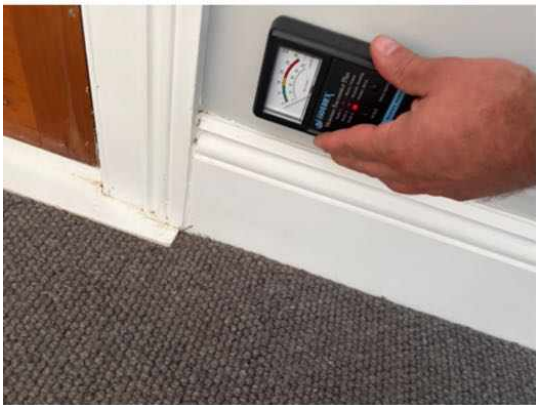
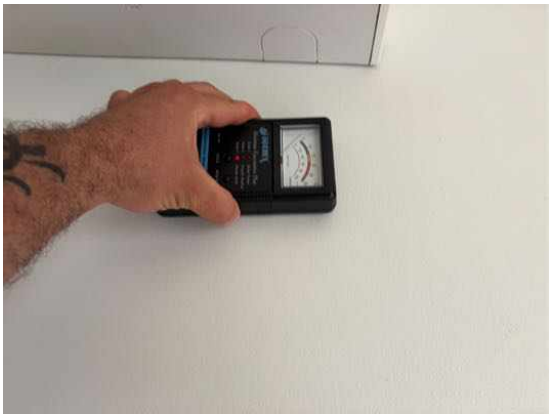
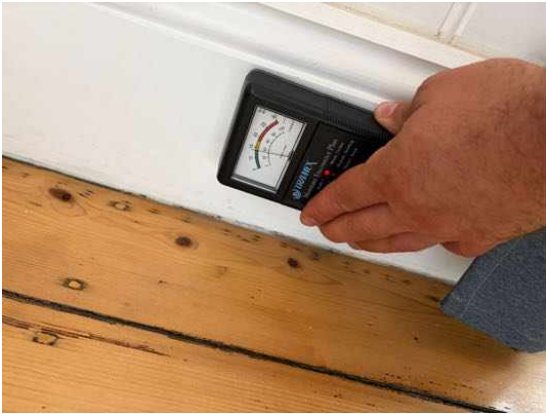
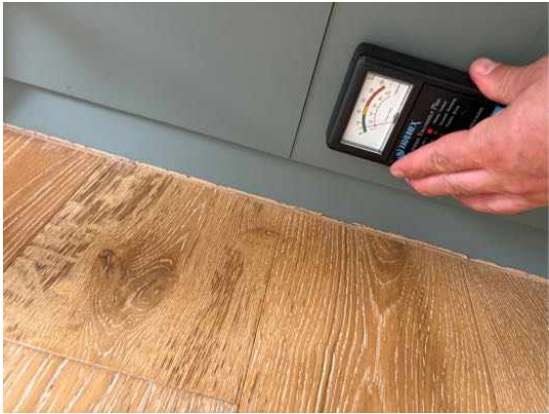
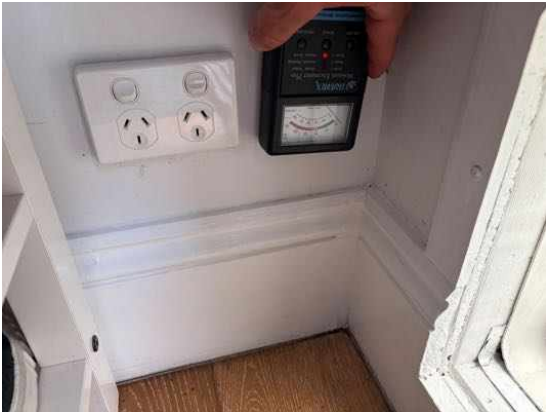
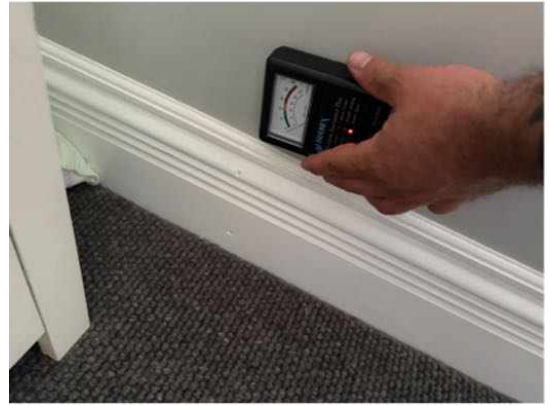
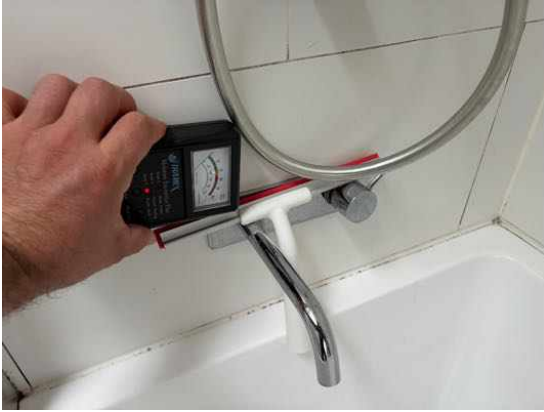
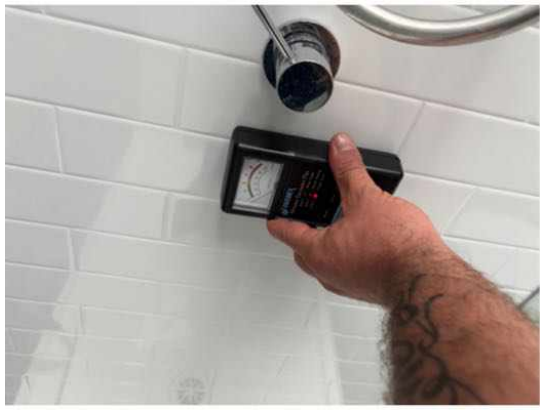
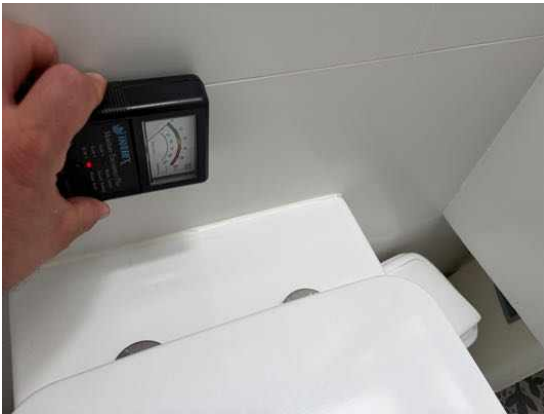
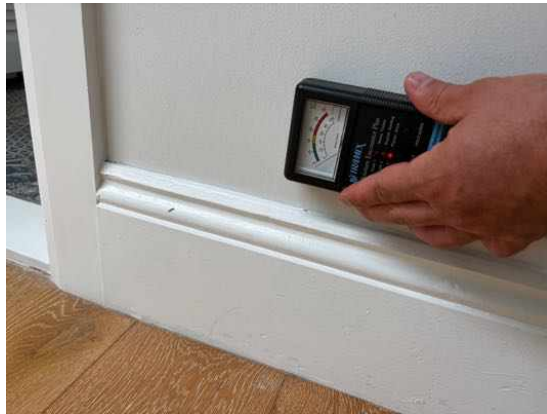
| Finding: | Moisture metre |
| Information: | During the inspection the property was checked for moisture using a moisture metre. |

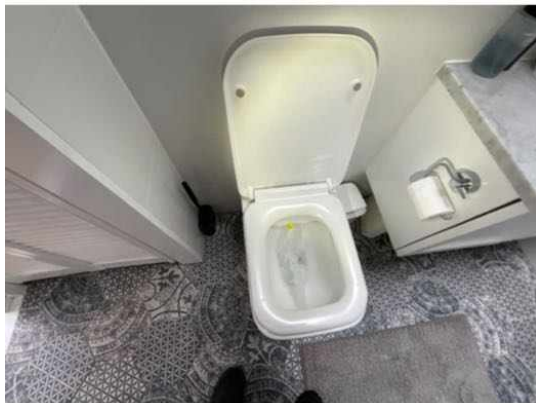
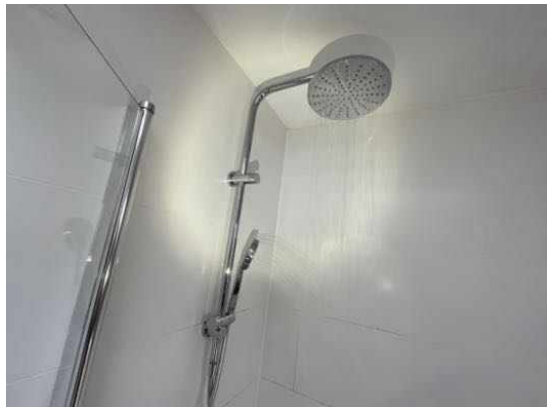
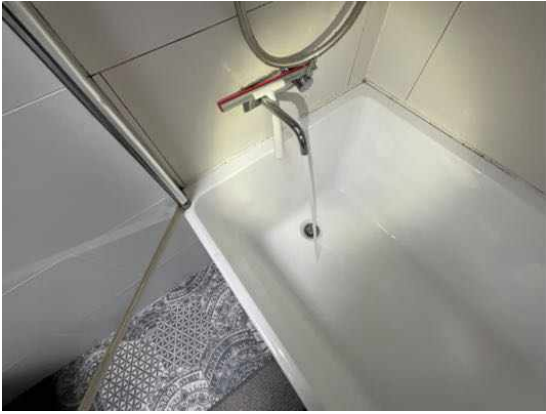
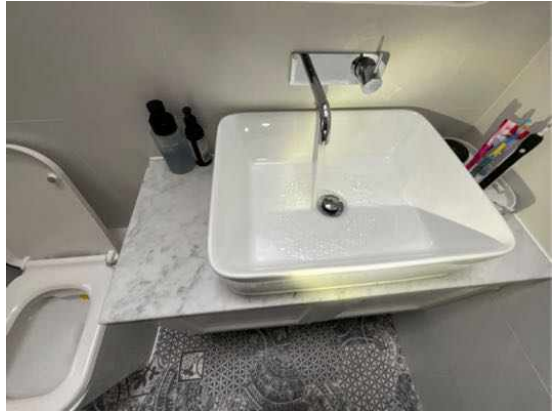
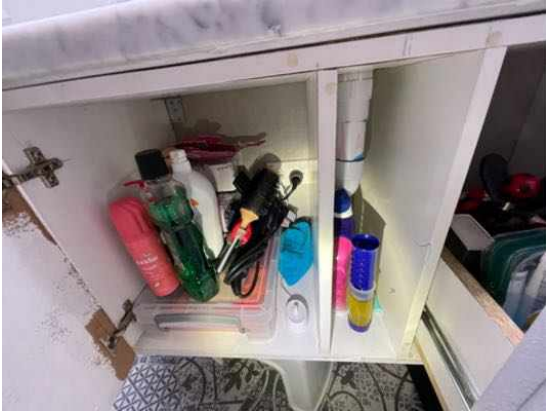
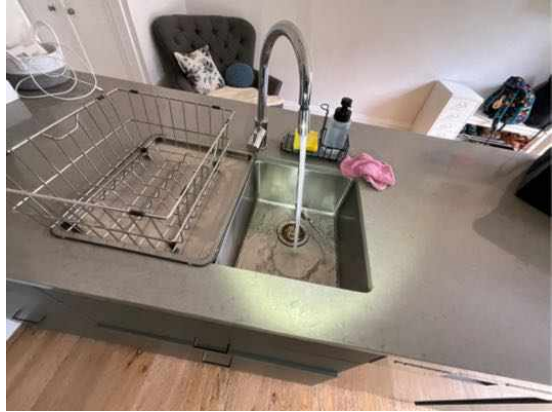
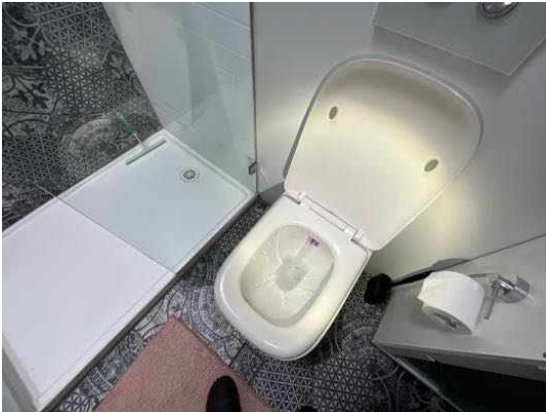
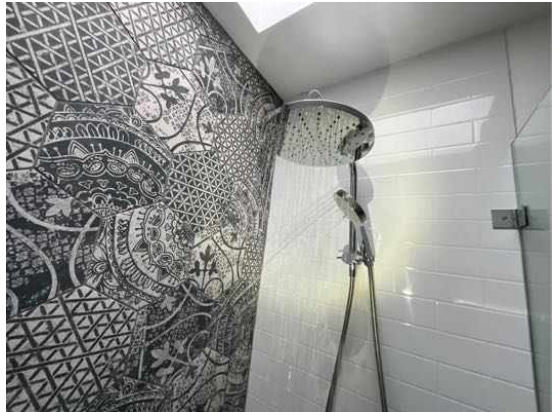
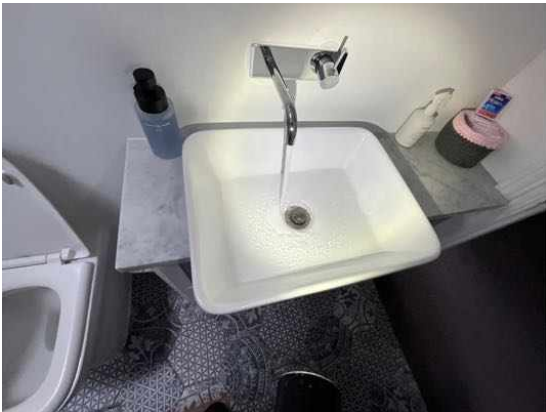
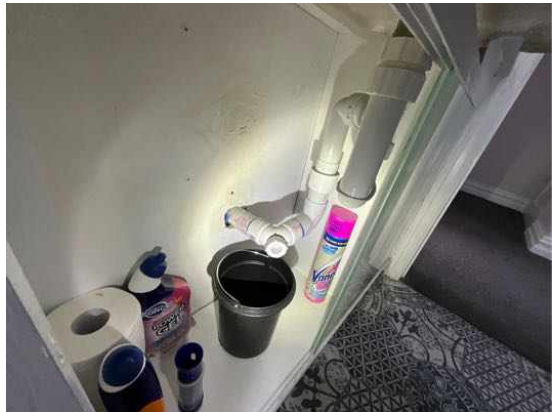
Building: Main Building
Location: All Wet Areas
Finding: Additional Photos
Information:

Additional photos are provided for your general reference.

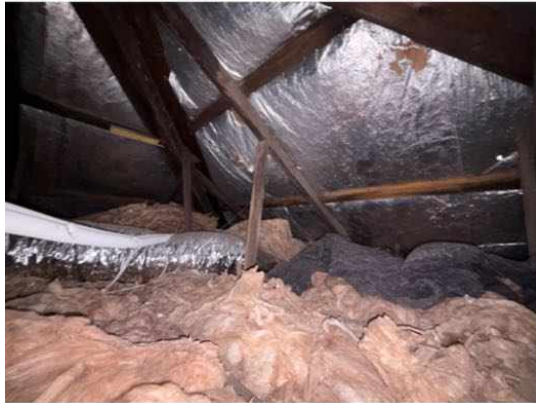
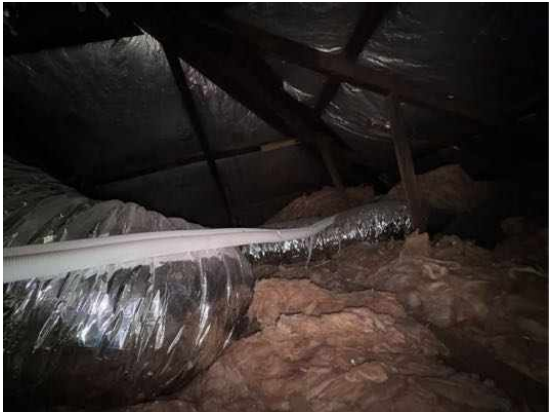
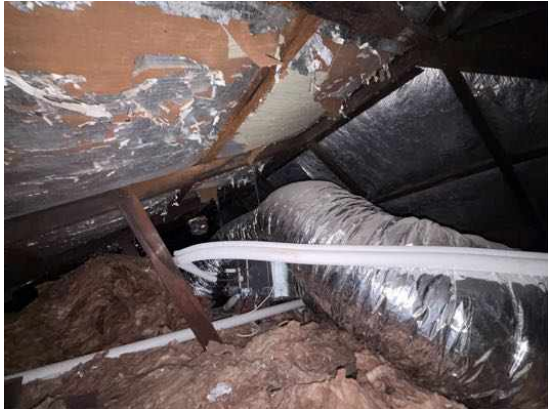
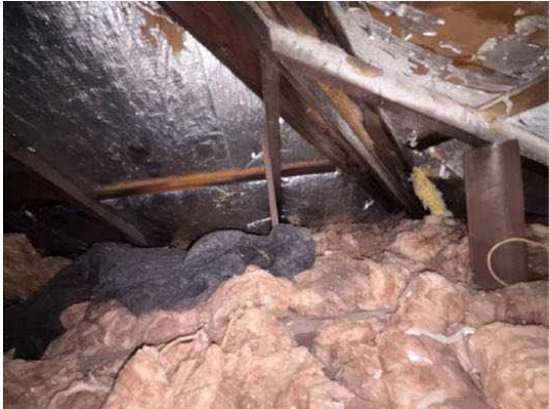
Building: Main Building
Location: Roof Void
Finding: Additional Photos
Information:

Additional photos are provided for your general reference.

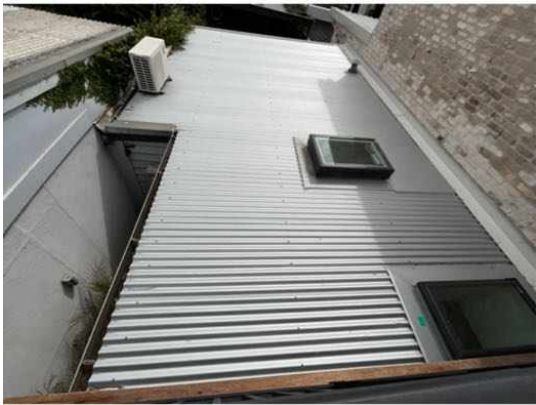
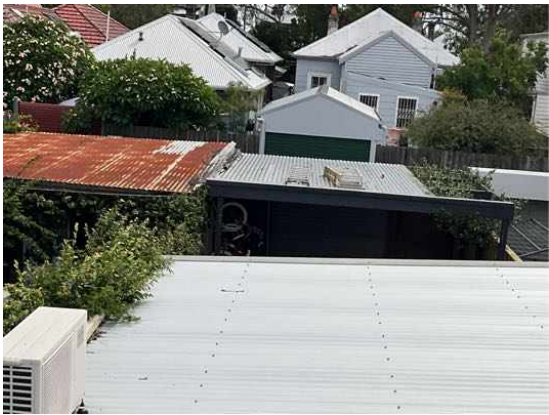
Building: Main Building
Location: Roof Exterior
Finding: Additional Photos
Information:

Additional photos are provided for your general reference.

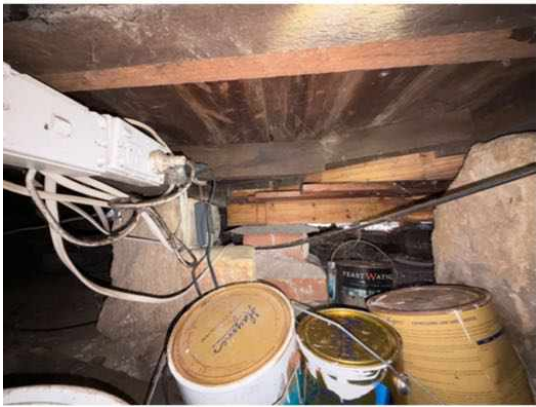
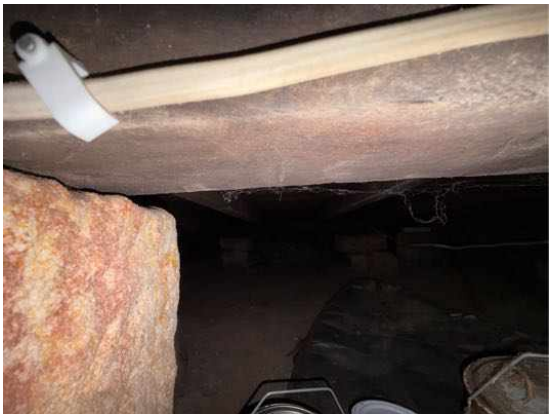
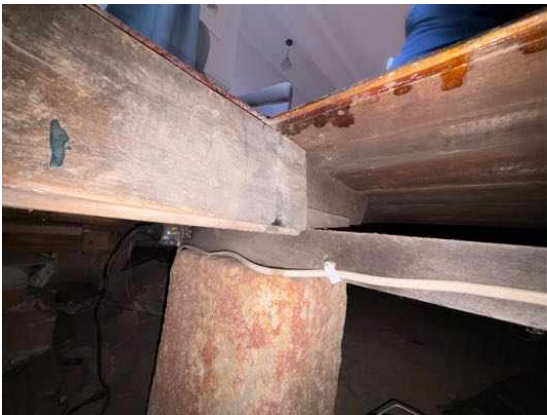
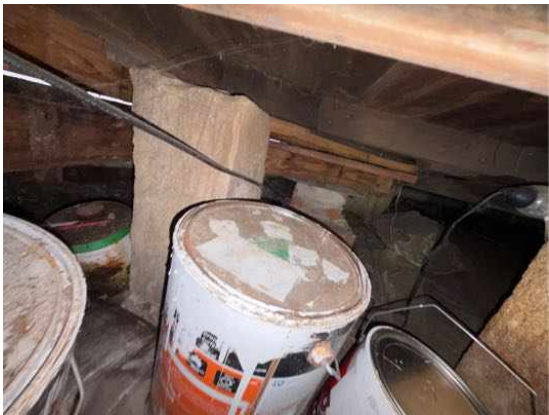
Building: Main Building
Location: Subfloor
Finding: Additional Photos
Information:

Additional photos are provided for your general reference.

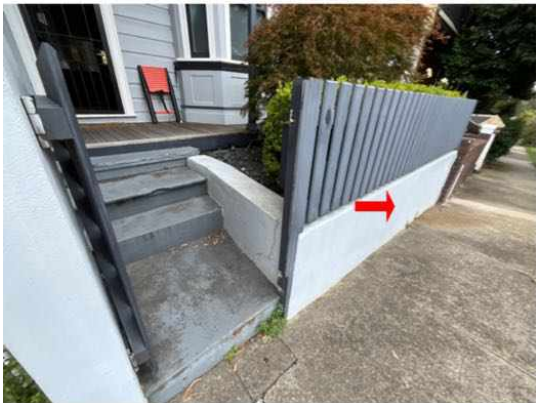
Building: Main Building
 Location: Retaining walls
 Finding: Retaining walls
 Information: At the time of inspection the retaining walls were checked and no defects were observed other than those which May have been mentioned earlier in this report.

AS4349.1-2007 requires all retaining walls in excess of 700mm to be inspected by a licensed and practicing structural engineer.

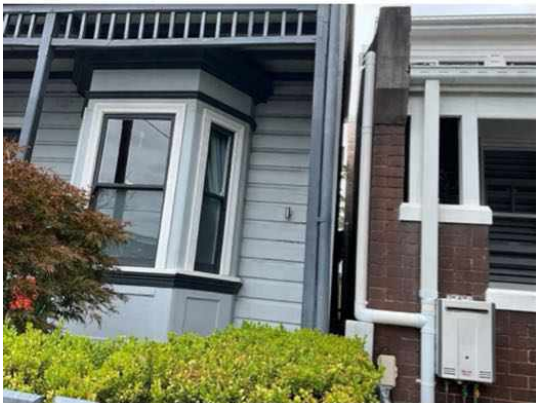
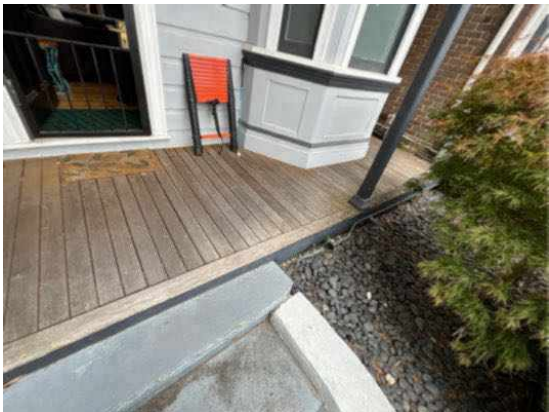
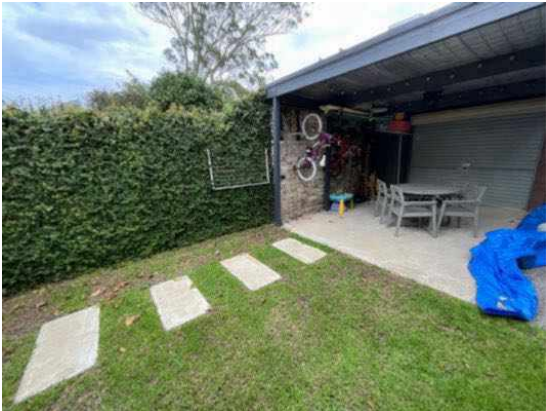
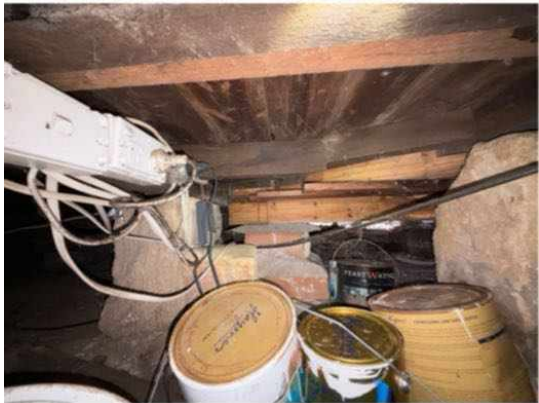
Building: Main Building
Location: All Areas
Finding: Additional Photos - Obstructions and Limitations
Information:

These photographs are an indication of the obstructions and limitations which impeded full inspection of the property at the time of inspection. These obstructions can hide an array of defects and should be removed to allow full inspection to be carried out. A re-inspection is recommended once the areas are made accessible.
