Building and Timber Pest Inspection Report

Inspection Date: Mon, 23 Mar 2026

Property Address: 13 Betula Grove, Bundanoon NSW 2578,
Australia

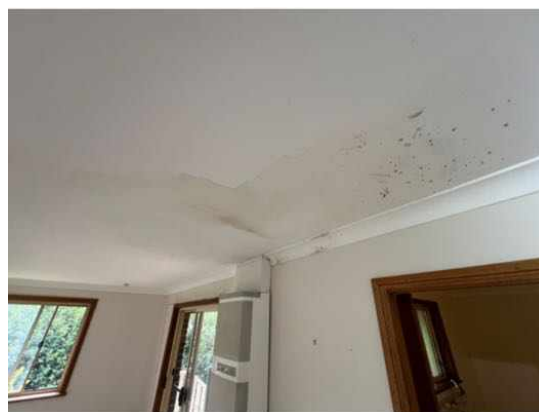
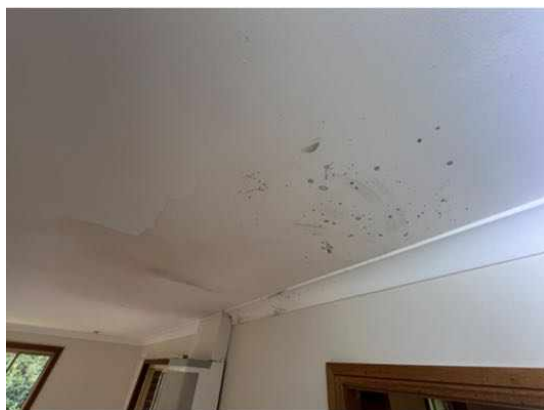
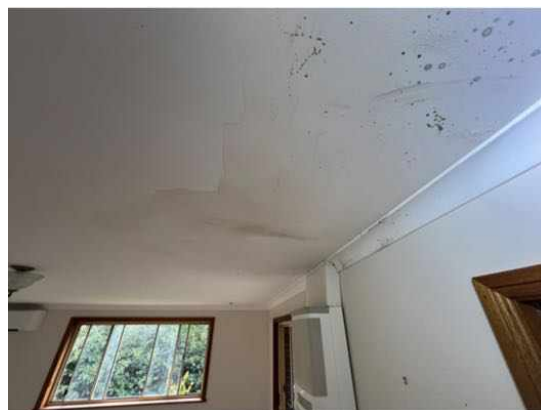
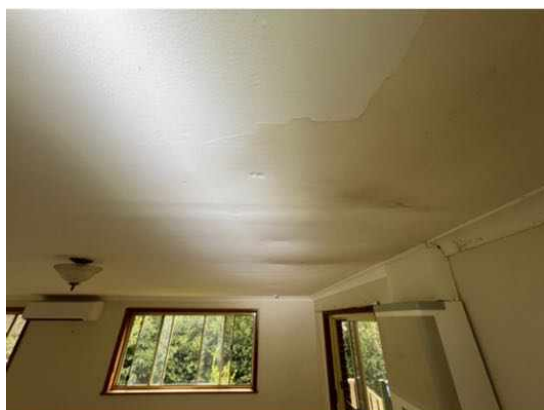
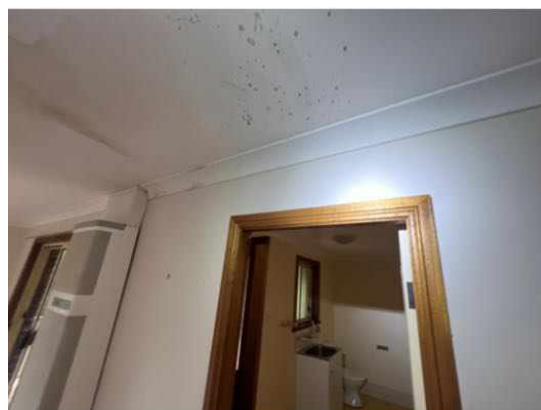
Building: Main Building
Location: Family Room
Finding: Ceiling - Water damaged
Information: Water damage to the ceiling lining is generally an indication of excessive moisture being present in the roof void, usually via a leak to the roof covering.

Where water damage is evident to the ceiling, the primary requirement is to identify and rectify the source of the leak. A roofing plumber should be appointed as soon as possible to identify the leak and perform rectification works as necessary, ensuring the water damage is restricted.

Once the leak is repaired, consultation with relevant tradespeople, including plasterers and painters, is advised. Rectification works may include replacement of ceiling lining or minor repainting, depending on the extent of the damage.

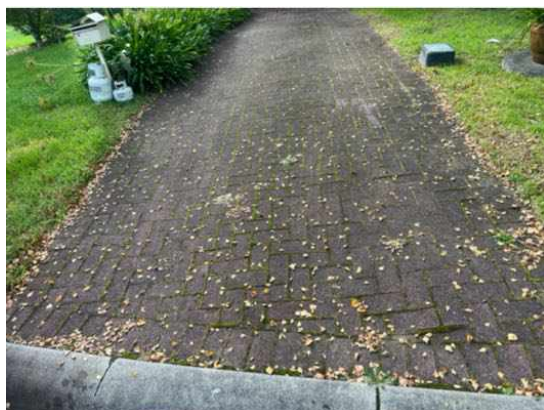
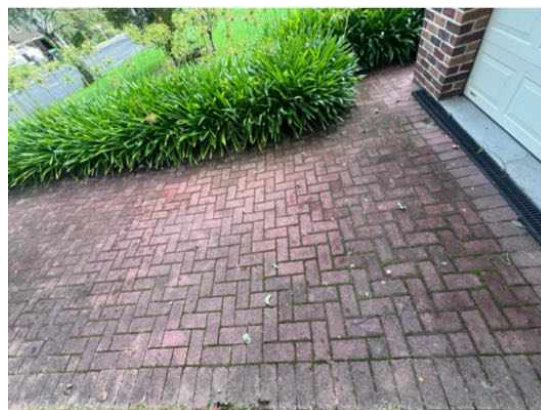
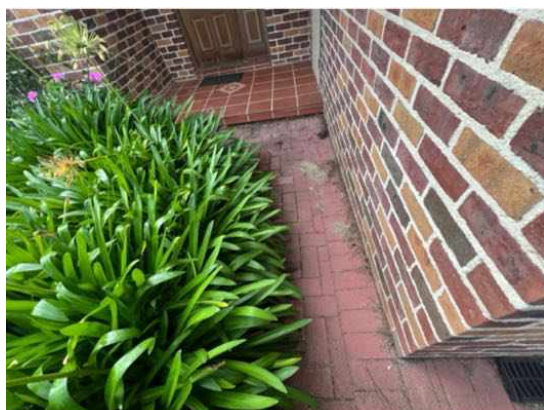
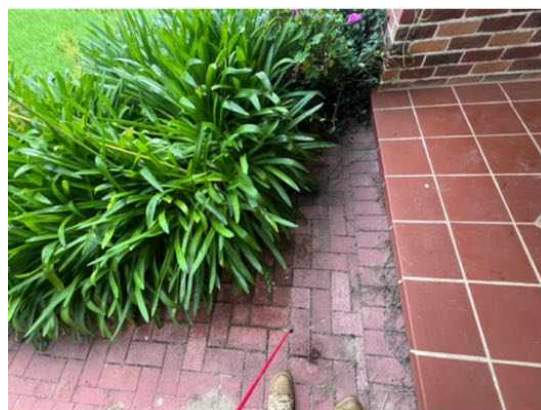
Finding 3.01

Building:	Main Building
Location:	Driveway, Path
Finding:	Paving - Uneven
Information:	Sections of the external paved area are uneven, creating a potential trip hazard. It appears as though the area has been subject to rough installation, or that paving sections have lifted due to movements in the foundation of the property.

Where paving creates a trip hazard, personal injury may ensue if due caution is not taken by all persons within this area.

Re-paving of the area is required as soon as possible to remedy this situation. Further consultation with a specialist concreter is advised.

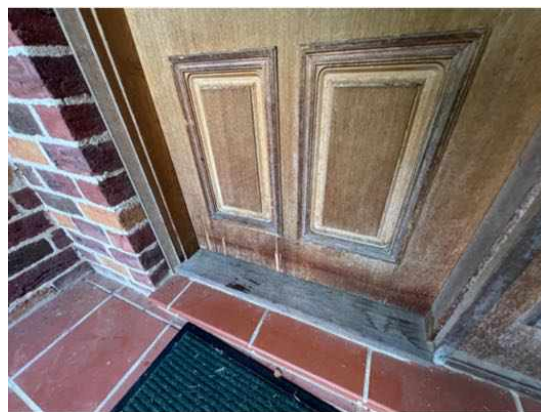
Finding 3.02

Building:	Main Building
Location:	Porch
Finding:	Timber door - exposed to weather
Information:	External timber doors that are frequently exposed to harsh weather conditions require adequate protection in order to maintain their condition. Where timbers have not been painted or treated adequately, general deterioration is likely to occur at an accelerated rate.

If left unattended, replacement of these timber doors is likely to be necessary in the short-term future by a licensed carpenter. Adequate treatment of these timber door/jamb is required as soon as possible by a painting contractor or general handyman.

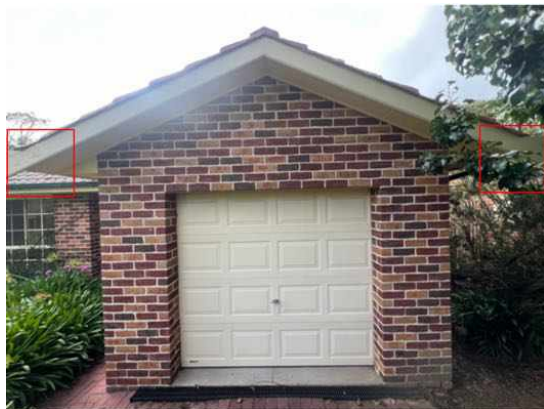
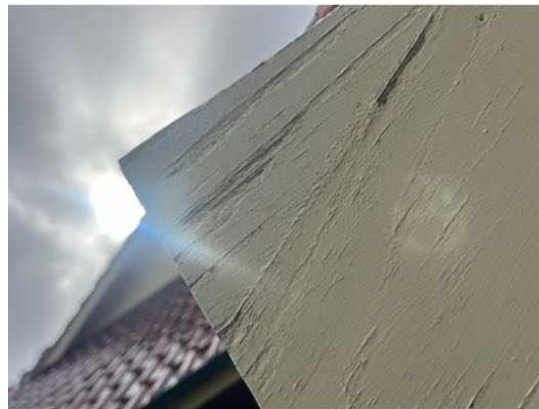
Location: Garage
Finding: Barge - Wood rot
Information: Wood rot was found to be affecting fascias and barges in this area, evidenced by the presence of mould on the surface in some areas. Wood rot, also known as Fungal Decay, occurs when timbers and other cellulose building materials are exposed to damp conditions on an ongoing basis.

It is likely that this wood rot has developed as a result of faults in the roof plumbing, creating excessive moisture in this areas. Frequent exposure to rain and other weather conditions also make fascias and barges susceptible to accelerated deterioration.

Early intervention and regular maintenance will prolong the useful life of these building elements. Prior to any works being performed, the cause of the moisture that has created the visible wood rot should be identified and addressed in a suitable manner.

It is advised that a roof plumber be appointed to inspect all roof plumbing and subsequently identify the cause of the wood rot. Replacement of affected fascias and barges may then be a necessary step in protecting surrounding building elements from such deterioration.

A qualified plumber may be appointed to assess the cause of excessive moisture and to provide advice on any remedial works as required. A qualified carpenter or registered builder may also be required to replace affected building materials.

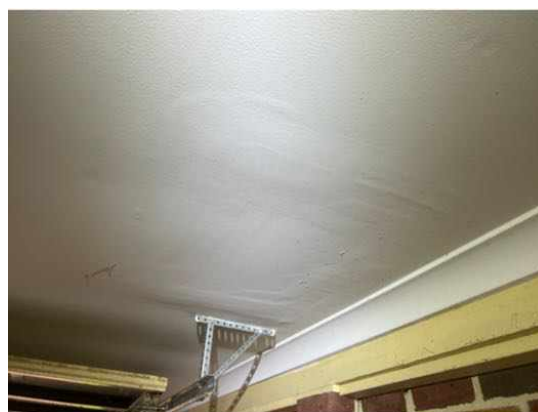
Finding 3.05

Building:	Main Building
Location:	Garage
Finding:	Ceiling - Incomplete or substandard works
Information:	The works to this area appear to be incomplete or have been completed to a substandard level.

Works that have not been completed to a satisfactory level create potential for the development of building defects and may impede on the safety and integrity of the overall structure.

It is highly recommended that a licensed plasterboard contractor and or painter should be appointed to repair the ceiling. To ensure the safety of the area and the longevity of all associated building elements.

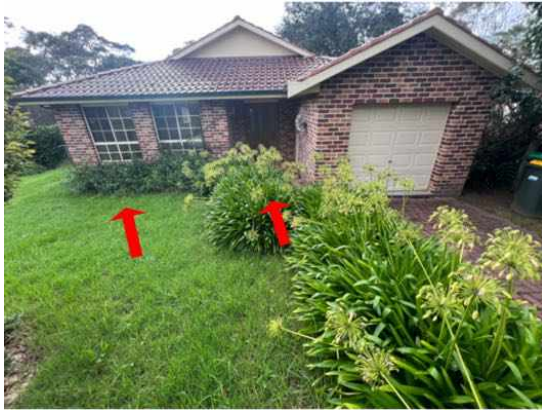
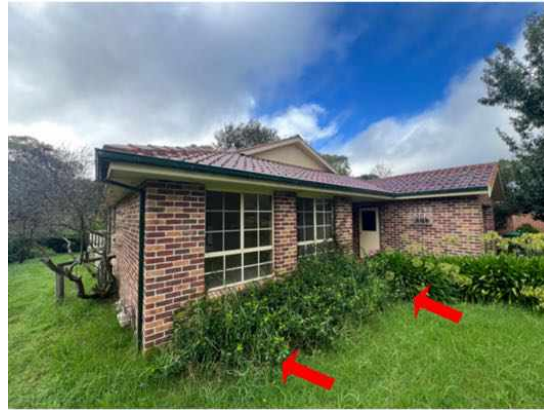
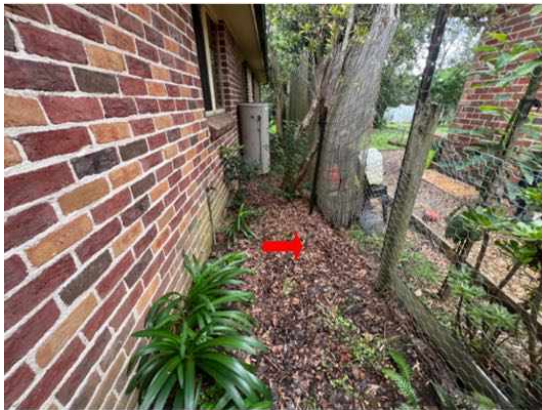
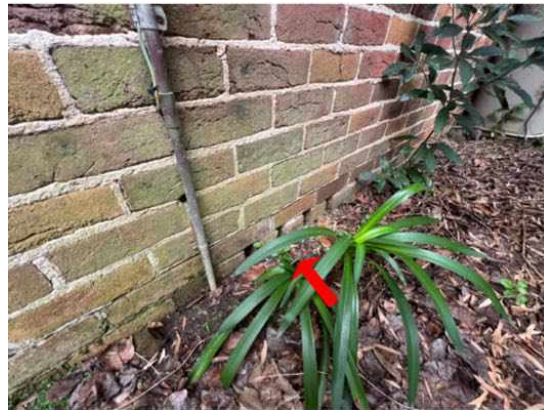
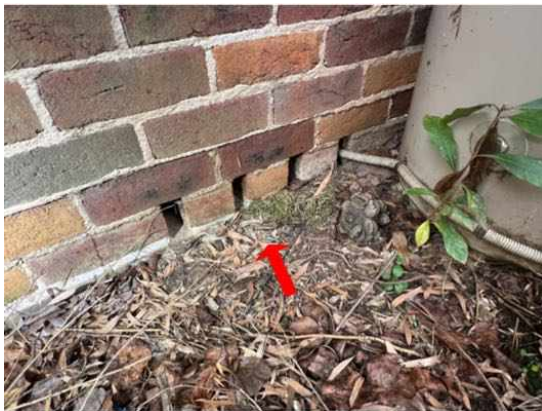
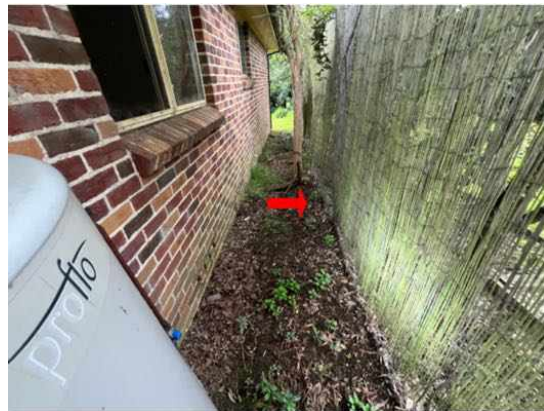
Finding 3.06

Building:	Main Building
Location:	Exterior walls - front, right
Finding:	Site drainage - Inadequate
Information:	The site drainage in this area was found to be inadequate at the time of inspection, creating potential for subsequent water damage to associated building elements.

It is important that water does not lie against the base of walls; surrounding paths and ground levels should be sloped to drain water away from walls. Downpipes should not discharge stormwater onto lower walls or plinths. Stormwater should be carried away by large, regularly cleaned drains. Ground levels may need to be lowered to expose a buried DPC.

Where site drainage is inadequate, installation of an Agricultural (Aggie) Drain may be required. A qualified plumber should be appointed to further inspect the property and perform any remedial works as necessary. Water damage and secondary defects are likely to occur if left unmanaged.

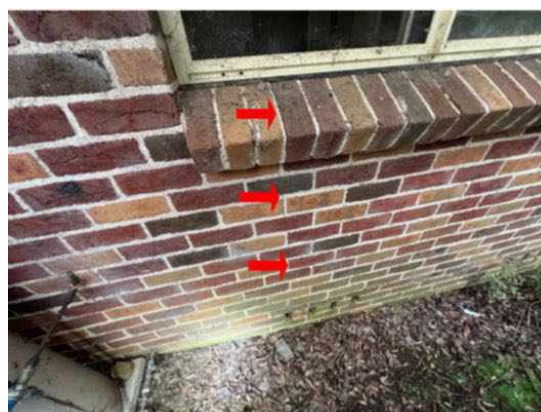
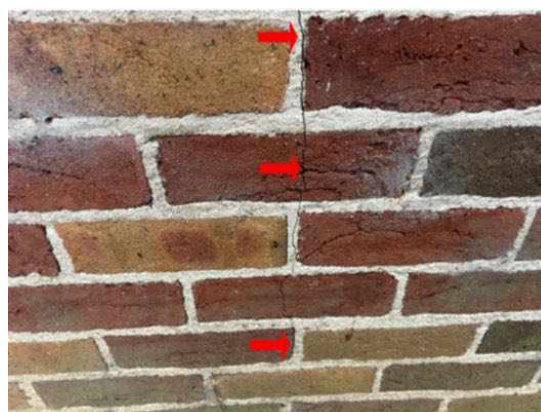
Finding 3.07

Building:	Main Building
Location:	Exterior walls - right side
Finding:	Brickwork - Cracking noticeable
Information:	There were several cracks and or crack repairs evident to external brickwork.

Noticeable cracks are a common occurrence in external brickwork and are a likely result of age expected building movement, general expansion, and/or contraction of building materials in different weather conditions. Noticeable cracks in brickwork may develop if left unattended, with potential for necessitating major remedial works or

replacement of the brickwork.

It is highly advised that a qualified bricklayer be appointed to provide necessary works to cracked brickwork to prevent any further damage. Such works should be conducted as soon as possible.

Always monitor these cracks and contact a building inspector should cracks widen, lengthen, or become more numerous.

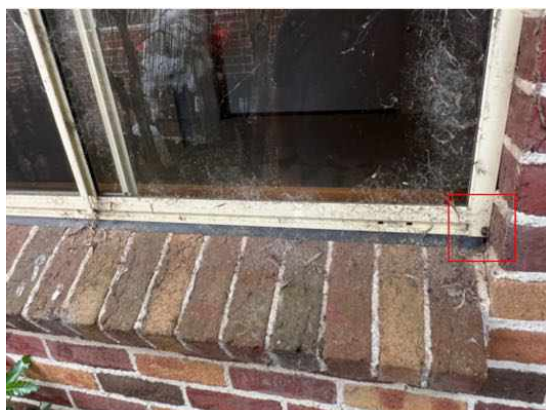
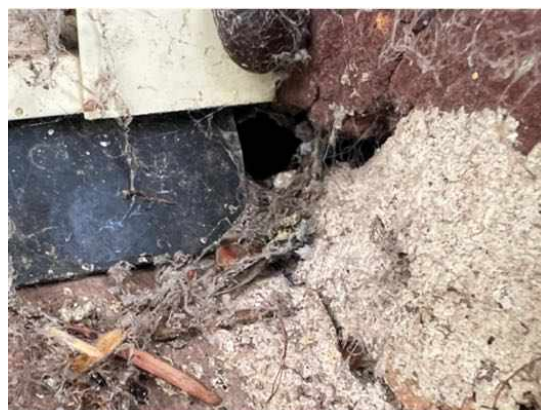
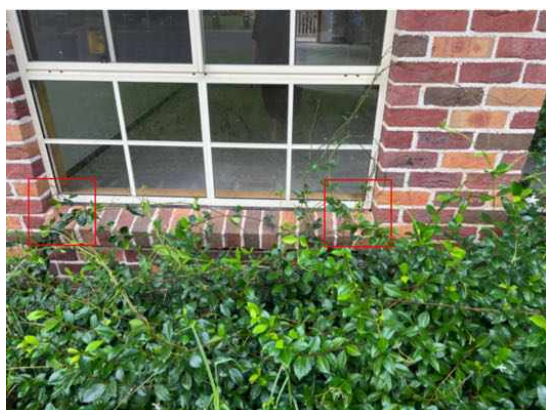
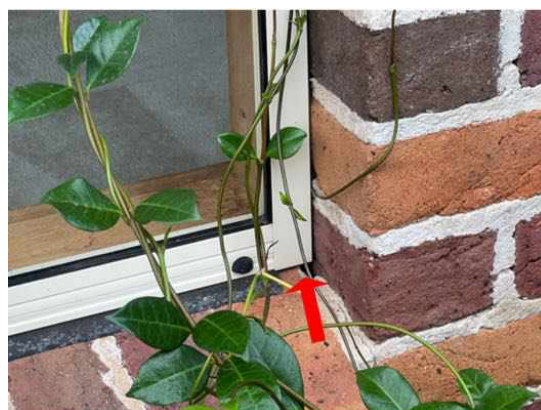
Finding 3.08

Building:	Main Building
Location:	All External Windows
Finding:	Window Sill Seals - damaged/compromised
Information:	The window seals have been damaged/compromised at the time of installation and subsequent failure to provide adequate protection and coverage. Due to frequent exposure to weather conditions and subsequent moisture, will lead to water ingress, energy loss and even pest entry.

Where window seals have not fully covered the gap between the brickwork and window, the window is no longer weather-tight; rain penetration and subsequent water damage is therefore likely to ensue. Insulation of the area against external weather conditions will also be compromised.

It is recommended that all window sill seals be replaced by a general handyman or sealant expert to prevent any further damage and to restore the window to a fully functional level.

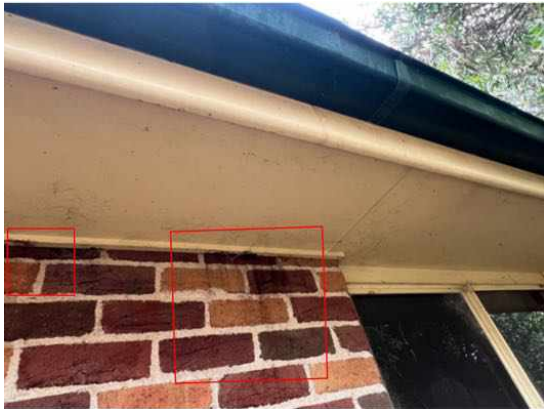
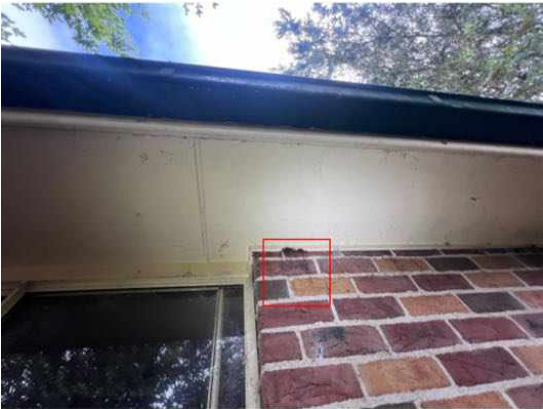
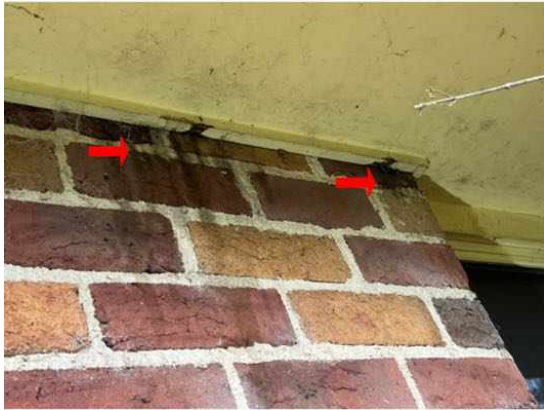
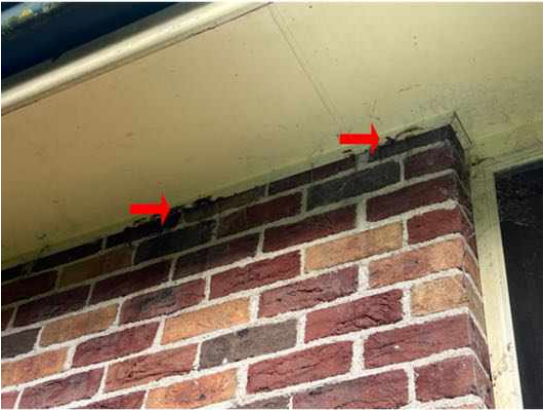
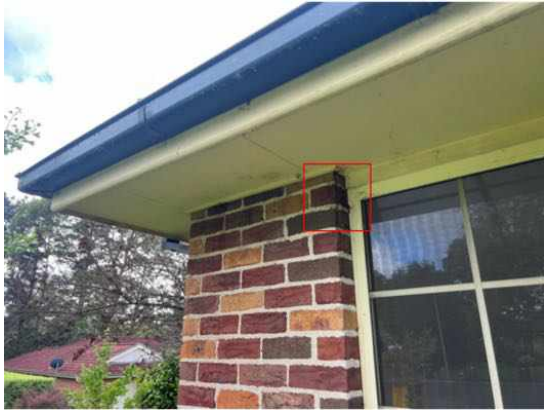
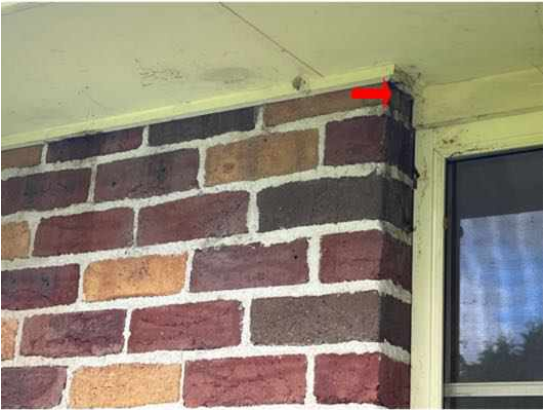
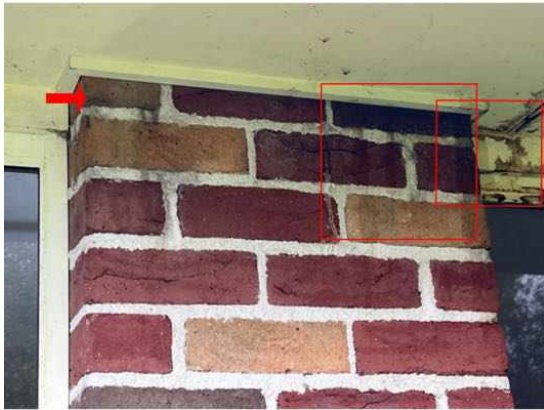
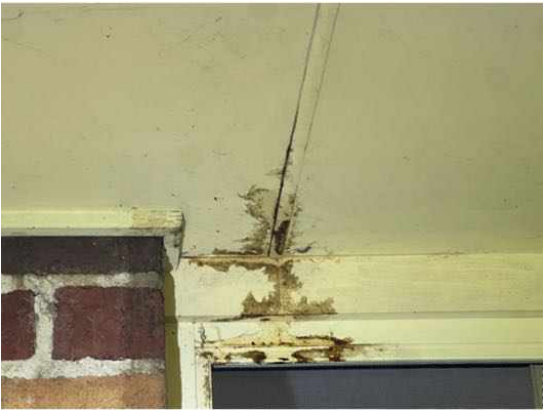
Finding 3.09

Building:	Main Building
Location:	All External Areas
Finding:	Eaves - Water Staining
Information:	Water staining was observed to sections of the eave lining at the time of inspection. This staining is typically the result of moisture ingress from roof drainage issues, such as blocked or overflowing gutters, damaged flashing, or roof leaks above the affected area.

While no active leak was confirmed, the presence of water staining suggests a history of water exposure that may lead to material deterioration over time if left unaddressed. The appearance of staining also detracts from the overall condition of the eaves and associated roofing structures.

It is recommended that a licensed roof plumber be engaged to assess the area, identify the source of the staining, and carry out any required repairs to prevent further water ingress and deterioration.

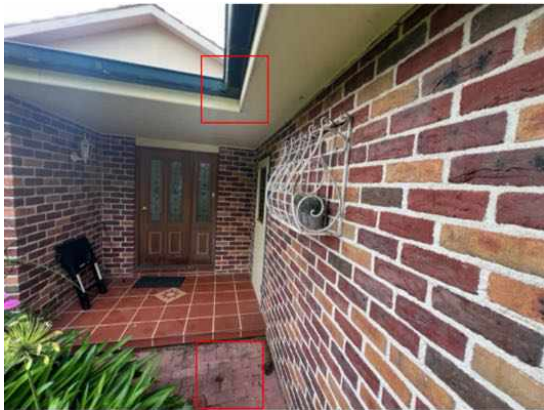
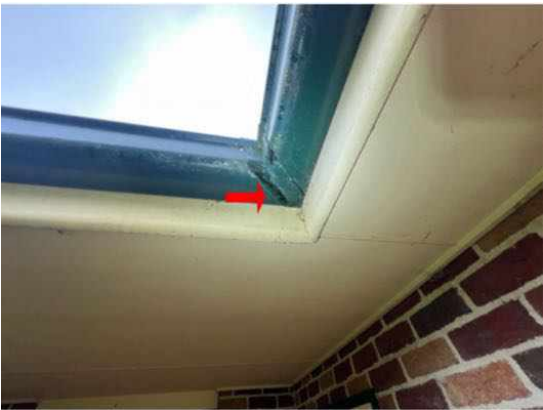
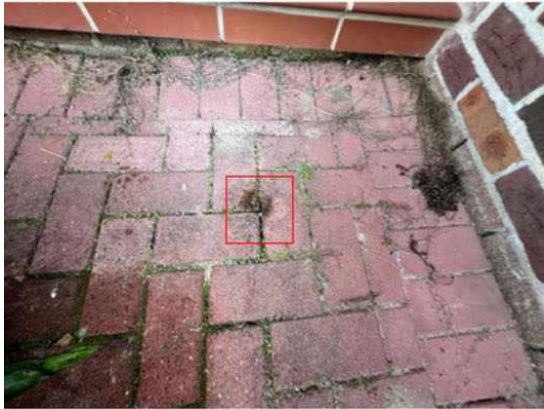
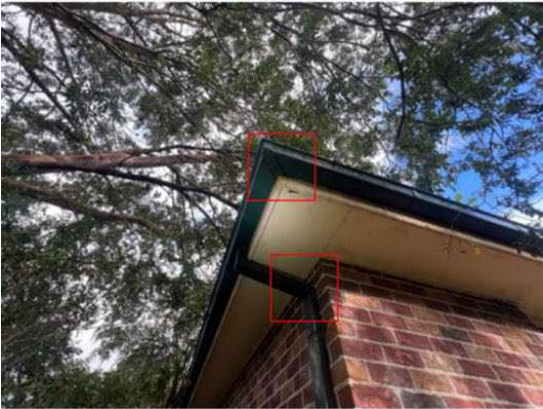
Finding 3.10

Building: Main Building
Location: All External Areas
Finding: Water leak - External - Gutters
Information: Water leaks were found to be present to exterior plumbing work. Leaks are generally caused by deterioration of the plumbing elements over time, due to exposure to weather conditions, but may have also been caused by minor impact damage.

Such leaking creates damp conditions in the affected area, causing potential for water pooling and subsequent water damage if left unattended. These conditions may also attract termite attack, particularly if the area is subject to minimal levels of sun throughout daylight hours.

It is highly advised that a licensed plumber be appointed to rectify any water leaks that may be present. Areas of repair and replacement of plumbing fittings and fixtures may be required and, as such, a quotation should be sought.

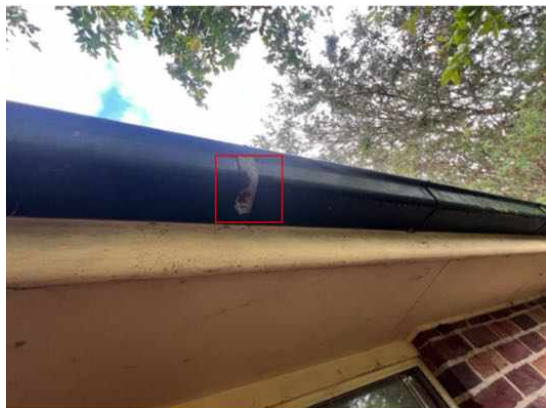
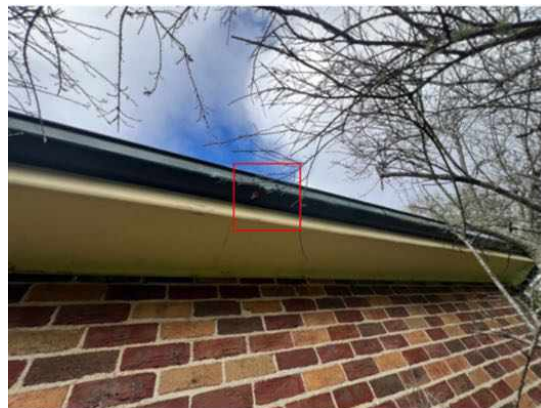
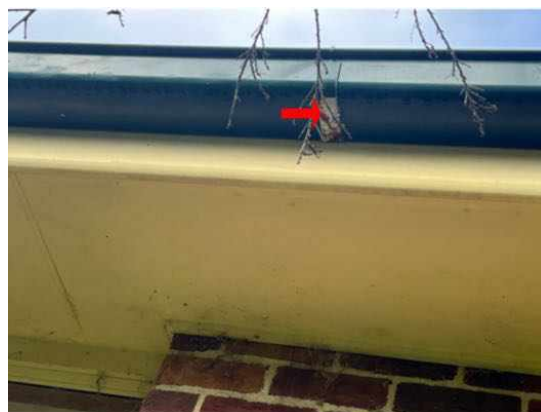
Finding 3.11

Building: Main Building
 Location: All External Areas
 Finding: Gutter brackets - Rusted or corroded
 Information: This building element shows evidence of rusting and corrosion, which is likely to have developed as a result of excessive exposure to moisture and or inadequate coatings.

As surface rust provides no protection to the underlying iron, the deteriorating condition is likely to worsen if not addressed in the short-term future.

Rusting and corrosion should be managed by ideally removing or limiting the affected surface from exposure to moisture. A registered builder may be appointed to replace any building elements that have been severely affected by rust or water damage.

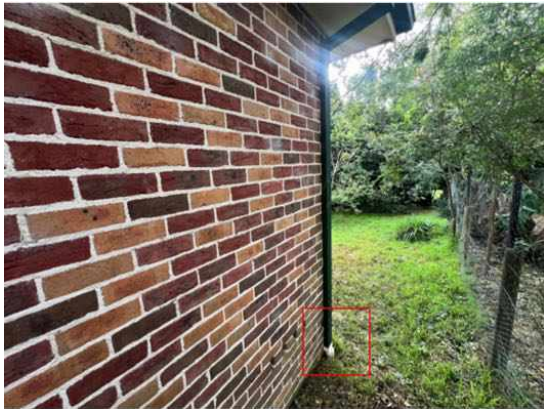
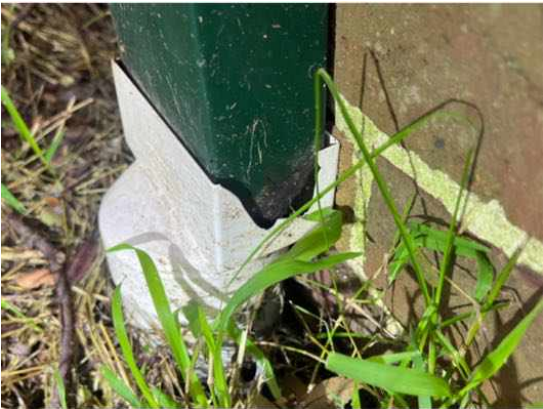
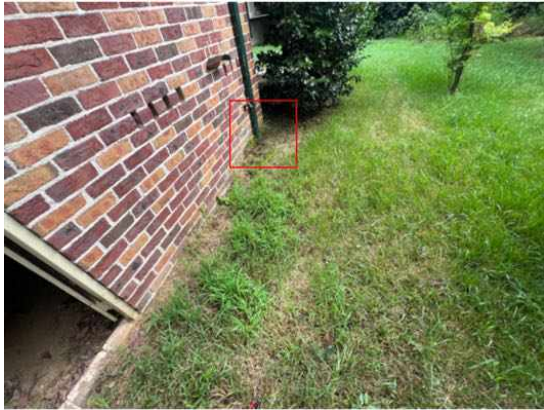
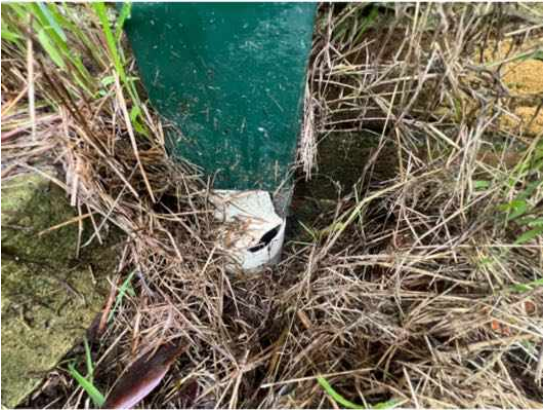
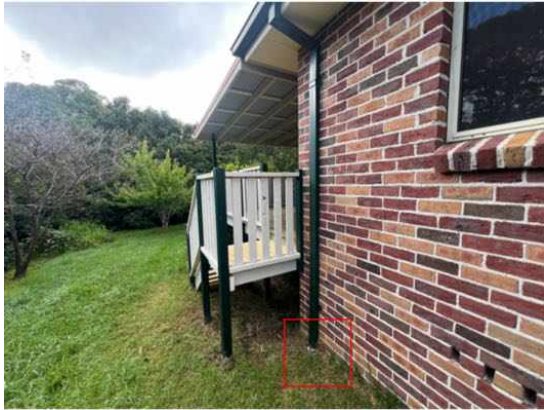
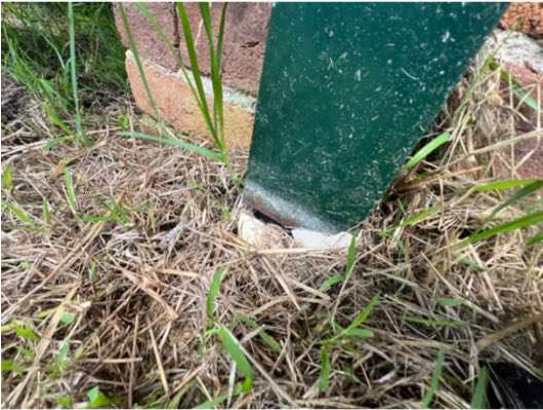
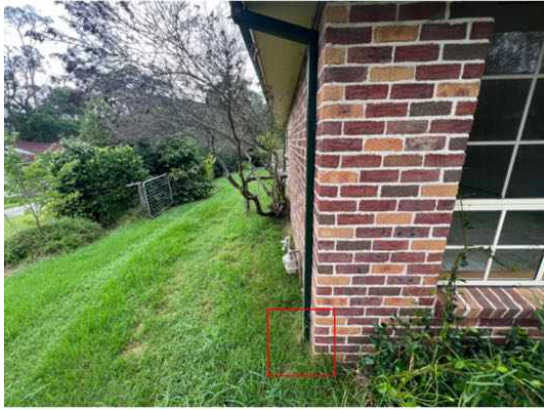
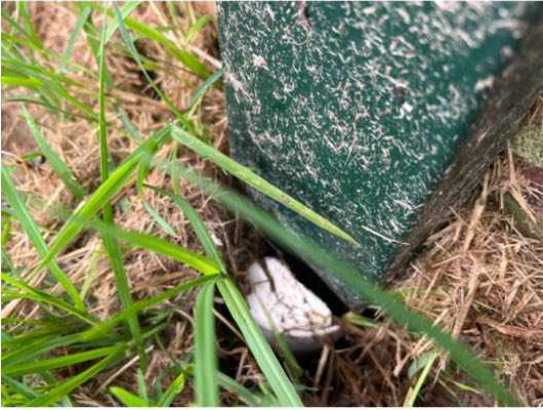
Finding 3.12

Building:	Main Building
Location:	All External Areas
Finding:	Downpipe - Damage, conditions conducive to termites
Information:	The downpipe in this area shows visible damage, which hinders its ability to effectively direct water away from the building. This creates conditions conducive to termite activity by increasing the likelihood of water pooling around the foundation. Prolonged moisture retention can lead to structural degradation, soil erosion, or water ingress into lower building areas, all of which may attract and sustain termite infestations.

The observed damage may be attributed to impact, corrosion, or general wear. It is recommended that a licensed roof plumber be engaged to inspect the downpipe and carry out necessary repairs or replacement as a priority to mitigate moisture-related risks and potential termite activity.

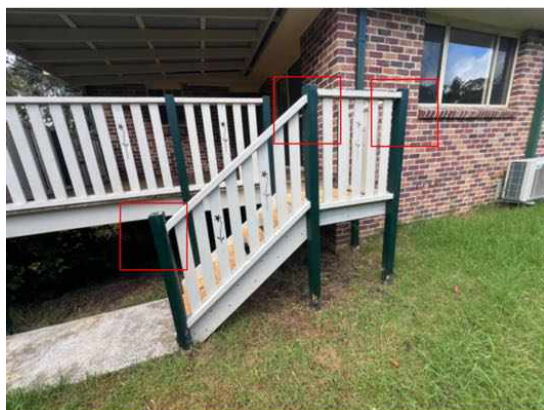
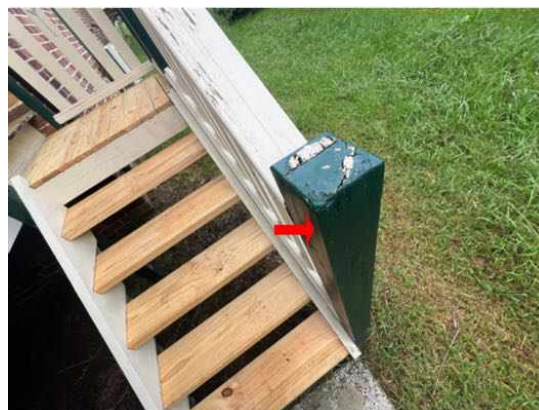
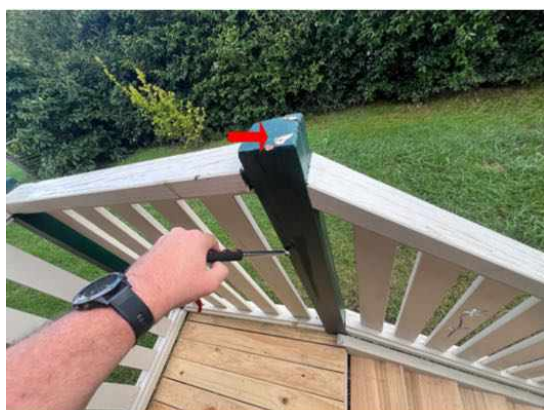
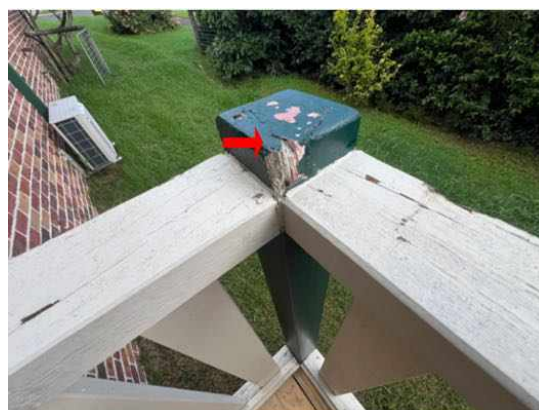
Finding 3.13

Building: Main Building
Location: Deck
Finding: Wood rot - Deck Posts
Information: This building element shows evidence of wood rot. Wood rot, also known as Fungal Decay, occurs when timbers and other cellulose building materials are exposed to damp conditions on an ongoing basis. This could be the result of exposure to weathering over a prolonged period of time, or the attraction of excessive moisture from other abutting building materials. Contributing factors also include poor air ventilation in the area.

Wood rot is often associated with general damp problems and is evidenced by a 'musty' smell or mould and mildew occurring on surfaces. If left unmanaged, damp conditions can lead to further health problems and the decay of timbers will continue.

Early intervention and regular maintenance, particularly of exterior timbers, will prolong the useful life of these building elements. Prior to any works being performed, the cause of the moisture that has created the visible wood rot should be identified and addressed in a suitable manner. Replacement of affected timbers may then be a necessary step in protecting surrounding building elements from such deterioration.

A qualified plumber may be appointed to assess the cause of excessive moisture and to provide advice on any remedial works as required. A qualified carpenter or registered builder may also be required to replace affected building materials.

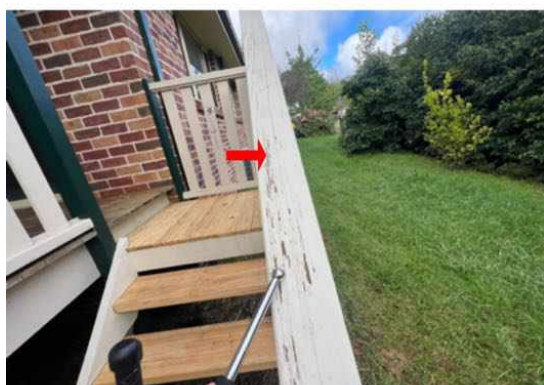
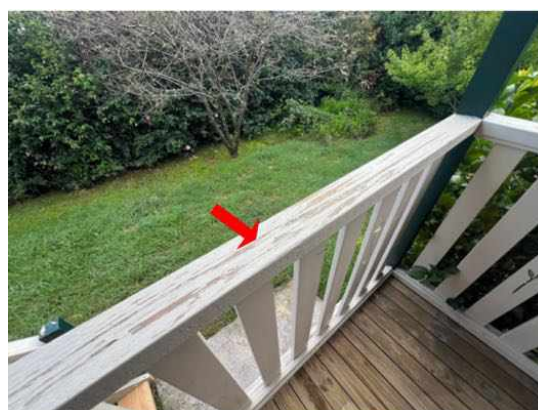
Finding 3.14

Building:	Main Building
Location:	Deck
Finding:	Painting deteriorated
Information:	The paint work in these areas of the property require attention to prepare and re paint. Whilst incomplete or missing paint finish is generally an appearance defect, it can also lead to the development of secondary building defects over time. Incomplete areas of paint finish exposes the area to moisture, potentially accelerating the deterioration of underlying building materials.

Degraded paint finishes should be sanded back, filled, leveled and painted, as applicable. Where inadequate or missing paint protection has led to the deterioration of the associated building element, repair and/or replacement of this building element may be required.

A painting contractor should be appointed at the clients discretion to perform necessary works to aid the appearance of the affected area and to ensure the area is protected against further deterioration. Alternatively, the homeowner following manufacturer instructions may perform these works

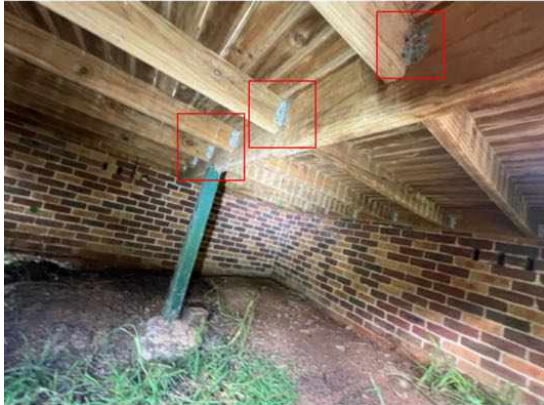
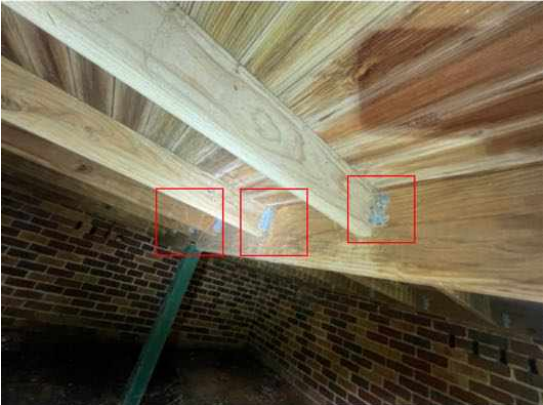
Finding 3.15

Building:	Main Building
Location:	Deck
Finding:	Nails - Rusted or corroded
Information:	This building element shows evidence of rusting and corrosion, which is likely to have developed as a result of excessive exposure to moisture and or inadequate coatings.

As surface rust provides no protection to the underlying iron, the deteriorating condition is likely to worsen if not addressed in the short-term future.

Rusting and corrosion should be managed by ideally removing or limiting the affected surface from exposure to moisture. A registered builder may be appointed to replace any building elements that have been severely affected by rust or water damage.

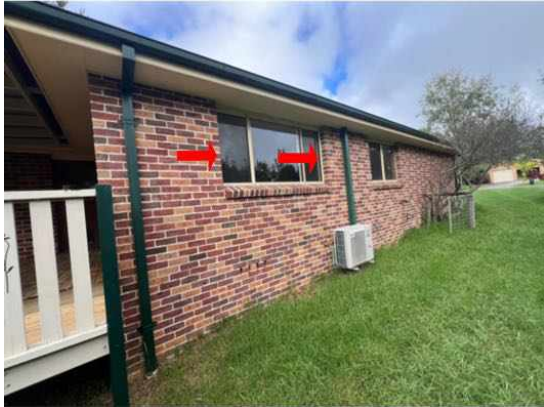
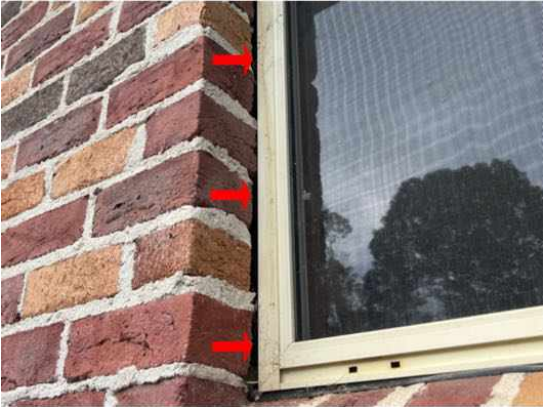
Finding 3.16

Building: Main Building
Location: Exterior walls - left side
Finding: Window - Gap to brick reveals
Information: Large gaps were observed between the aluminium window - lintel and/or reveals. It is suspected that the installation of sealant was completed to a substandard level of workmanship or is incomplete.

Gaps and holes makes the area susceptible to insect and vermin ingress, as well as allowing water penetration. As such, associated building elements are likely to deteriorate at an accelerated rate, and major implications are expected if Gaps are left unmanaged.

All excessive holes, gaps or cracks should be adequately filled by a suitable sealant or trimmings as soon as possible to prevent any further damage. Such works may be conducted by a general handyperson or licensed carpenter.

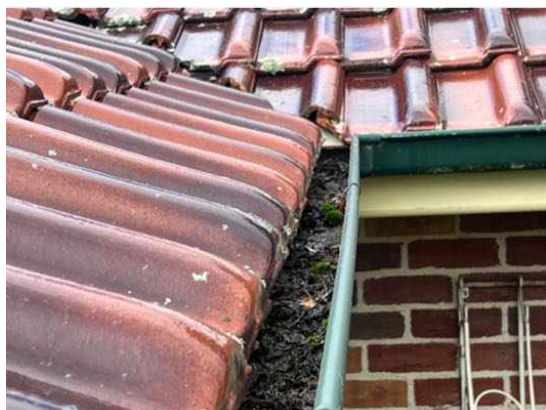
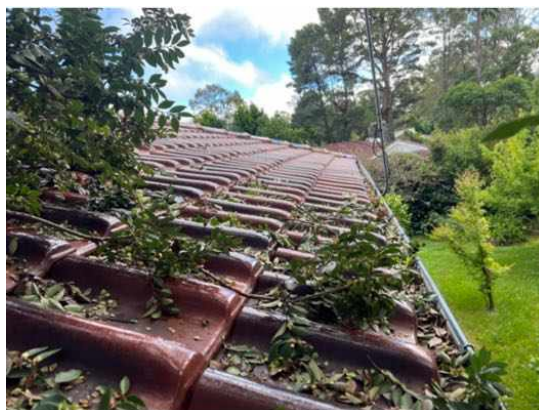
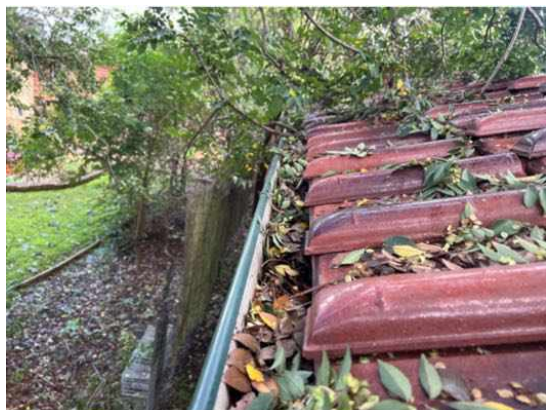
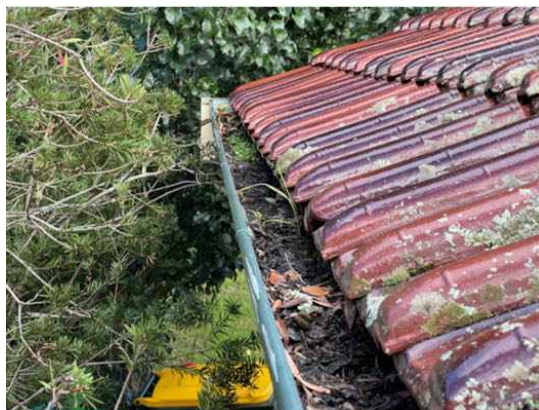
Finding 3.18

Building:	Main Building
Location:	Roof Exterior
Finding:	Trees - Overhanging and filling gutters
Information:	Overhanging trees often result in excessive amounts of leaf debris accumulating in gutters.

Gutters are a critical part of the building's management of storm water and rain. It is therefore important that they be kept clear to prevent secondary damage to associated building elements, including exterior and interior walls, ceiling linings and any adjoining building elements. Where gutters are blocked, pooling of rainwater is likely to occur, fast-tracking rust and corrosion of the roof plumbing elements.

It is highly advised that all overhanging tree branches be removed as soon as possible to prevent any further damage. Repair and/or replacement of sections of damaged guttering may also be required where the extent of the damage necessitates.

Such works should be performed by the homeowner; however, appointment of a landscape contractor or an arborist may be required. Consultation with a licensed roof plumber is required where guttering has been damaged.

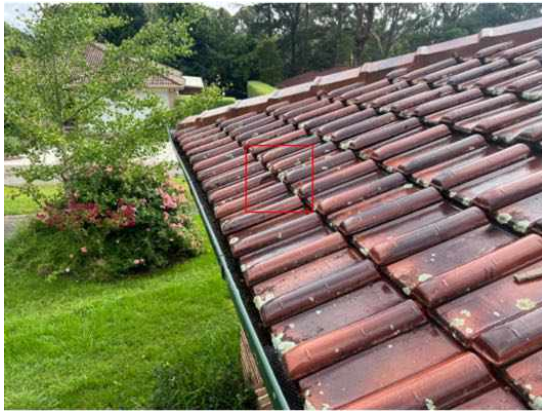
Building:	Main Building
Location:	Roof Exterior
Finding:	Roof tiles - Broken
Information:	Upon inspection of the exterior roof covering, broken roofing tiles were identified. Broken and friable roof tiles are generally the result of ageing and weathering of what is essentially a porous material.

If left to further deteriorate, broken and brittle roof tiles are likely to lead to water penetration via the roof into the ceiling space, causing secondary damage to ceiling linings, insulation and roof structures. Broken roof tiles are also likely to detract from the effectiveness of the roof drainage system, creating potential for secondary damage

to the exterior roof covering and roof plumbing.

Replacement of broken tiles is required and should be performed by a roofing contractor as soon as possible.

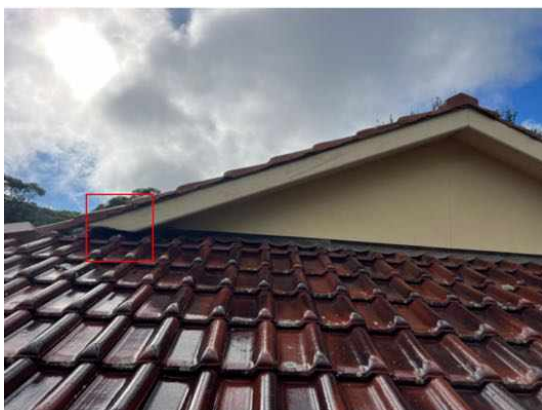
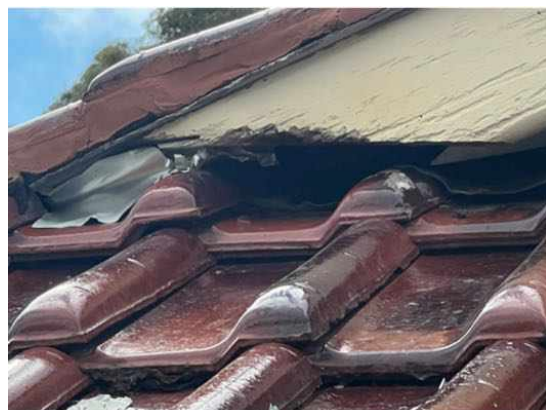
Finding 3.20

Information: An external hole was located at the time of inspection. This hole appears to be large enough to allow bird rodent or other pest ingress creating the potential for nesting or infestation of live animals.

To ensure no such infestation occurs this hole should be adequately covered. Holes such as these are also likely to attract rain penetration which may lead to subsequent water damage to associated structures if left unmanaged.

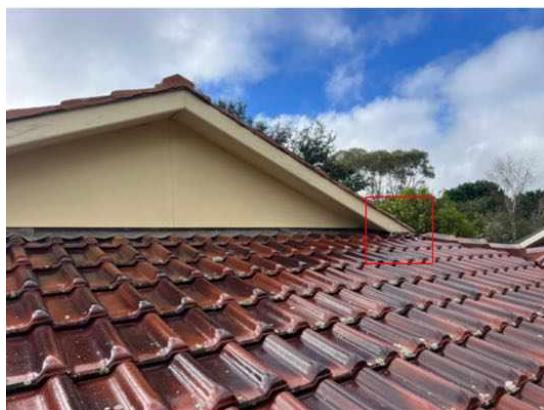
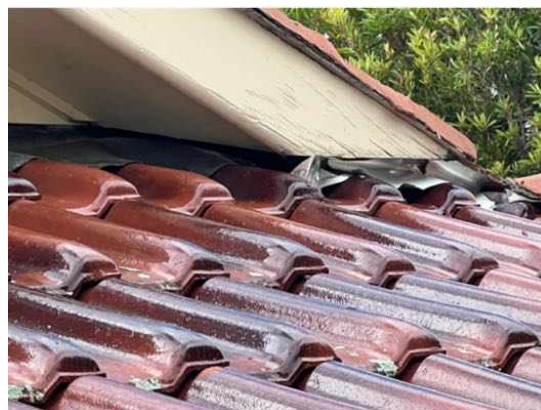
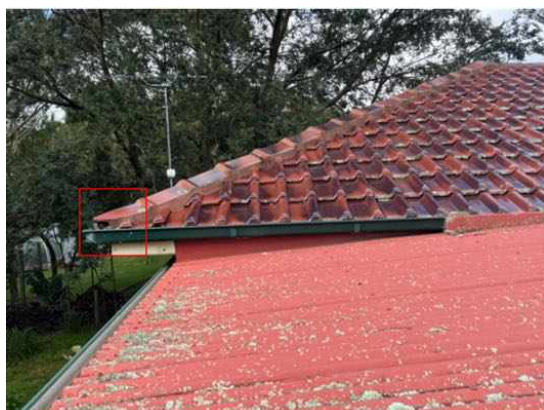
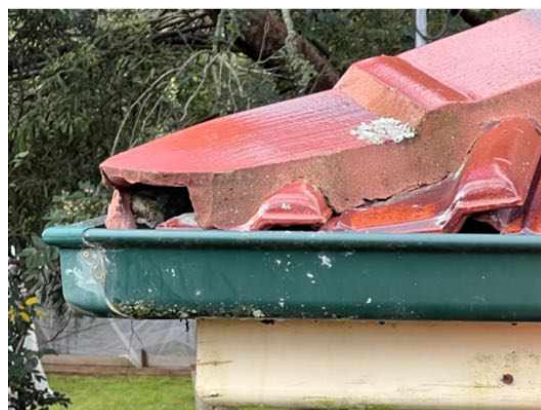
Finding 3.21

Building:	Main Building
Location:	Roof Exterior
Finding:	Flashing - Lead Not Dressed to Tiles
Information:	Lead flashing was observed to be inadequately dressed to the roof tiles, with visible gaps present between the flashing and tile profile.

Flashings in this condition are unlikely to provide an effective seal against water ingress and may allow moisture to penetrate beneath the roof covering.

If left unmanaged, this condition may result in water ingress and deterioration of underlying building elements.

A licensed roofing plumber should be appointed to assess and rectify the flashing to ensure it is properly fitted and weatherproof,

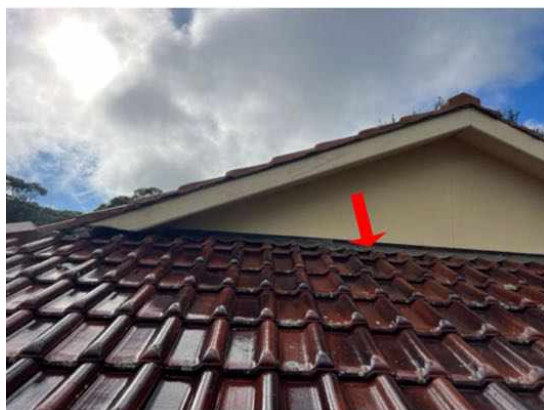
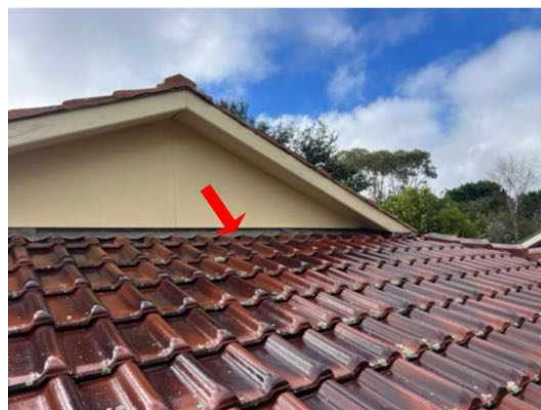
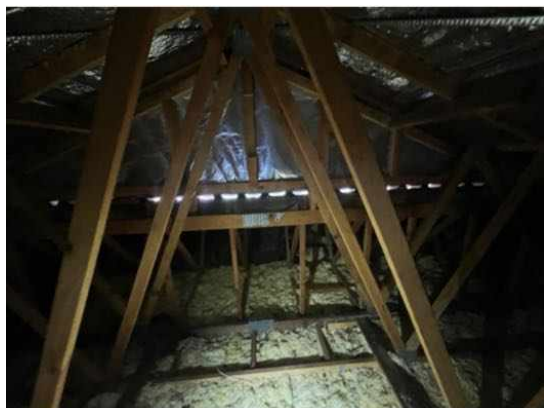
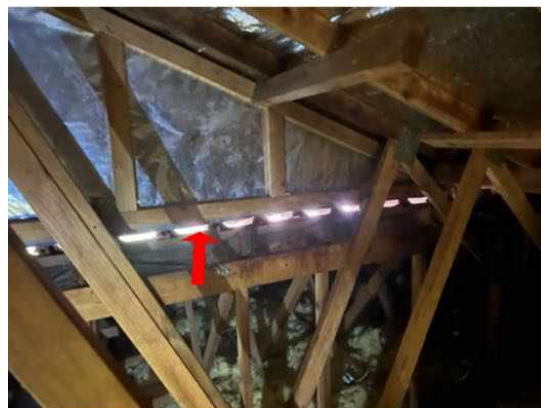
Finding 3.22

Building:	Main Building
Location:	Roof Exterior
Finding:	Roof Mortar - Deterioration
Information:	Mortar, or 'bedding, is the material which fills joints and intersections between tiles and other building elements on the exterior roof covering, such as gable ends, hip capping and valleys.

Upon inspection of the exterior roof, it was noted that sections of the mortar show varying levels of deterioration.

Mortar generally deteriorates as a result of frequent exposure to weather conditions over a prolonged period of time. Mortar that is deteriorating may allow water ingress into the roof void, putting associated building elements and roofing structures at risk of water damage. Deteriorated mortar also detracts from the functionality of roof tiles and other roofing elements, potentially decreasing weather tightness and roof drainage.

Mortar deterioration can be attended to by a licensed roofing contractor

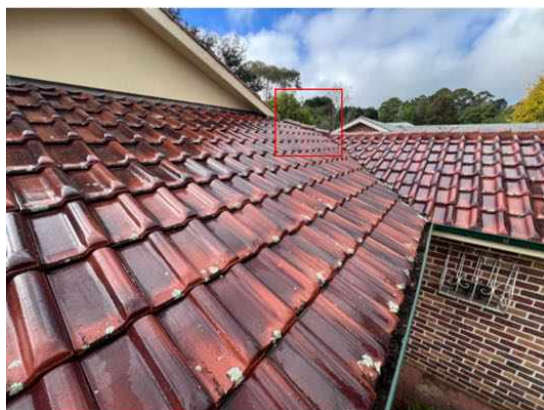
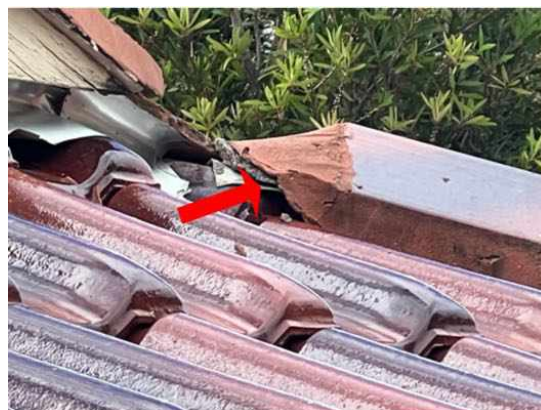
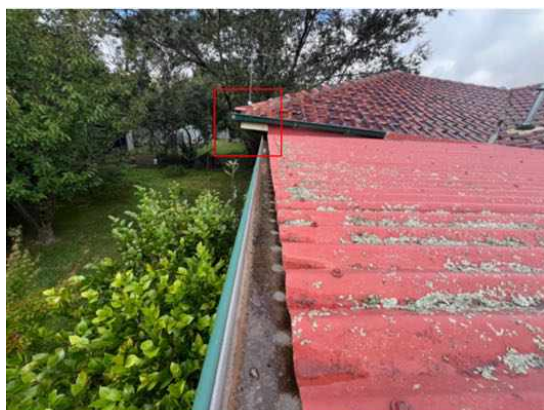
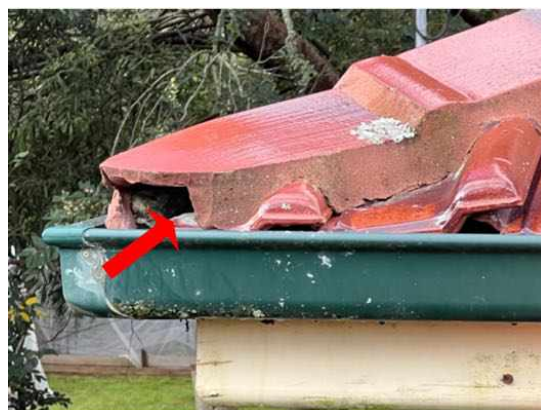
Finding 3.23

Building:	Main Building
Location:	Roof Exterior
Finding:	Roof tiles - Excessive silicone work
Information:	The silicone repair work performed to the roofing tiles appears to have been completed to an unsatisfactory standard. Excess silicone was evident in many sections of the tiled area providing a blemish on the appearance as well as detracting from the drainage of the area.

While weather-tight the excess silicone should be removed in order to increase roof drainage and to prevent accelerated deterioration of the roof tiles. A roofing contractor or general handyman may be appointed to perform these works at client discretion.
