Building and Timber Pest Inspection Report

Inspection Date: Mon, 23 Mar 2026

Property Address: 13 Betula Grove, Bundanoon NSW 2578,
Australia

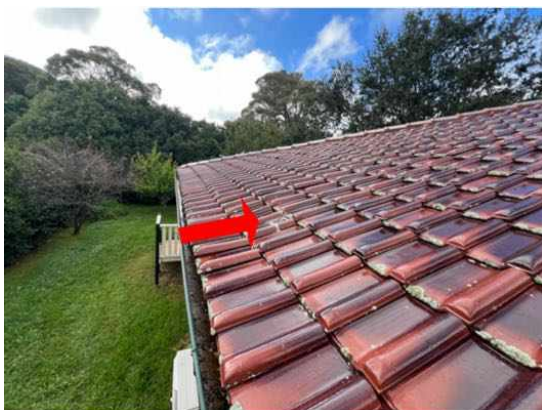
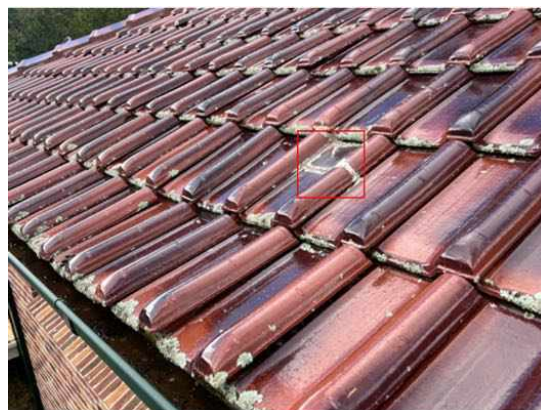
Finding 3.24

Building:	Main Building
Location:	Roof Exterior
Finding:	Roof - Localised Sagging
Information:	A localised sag was observed to the tiled roof surface, with sections of tiles deviating from the general roof plane.

Sagging of this nature is commonly associated with movement or deflection of supporting elements such as battens or roof framing, or deterioration of underlying components.

If left unmanaged, this condition may result in ineffective water shedding and potential water ingress to underlying building elements.

Appointment of a licensed roofing contractor is advised to inspect the affected area and determine the cause of the sagging and any necessary works required.

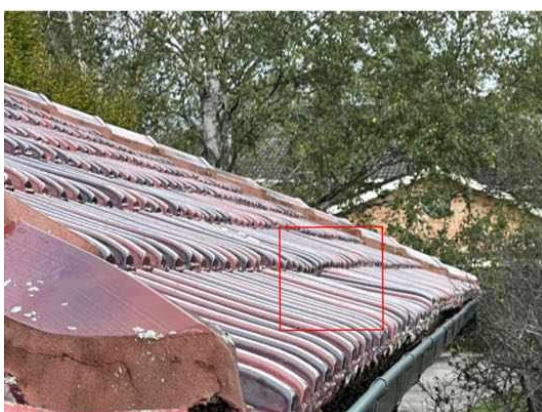
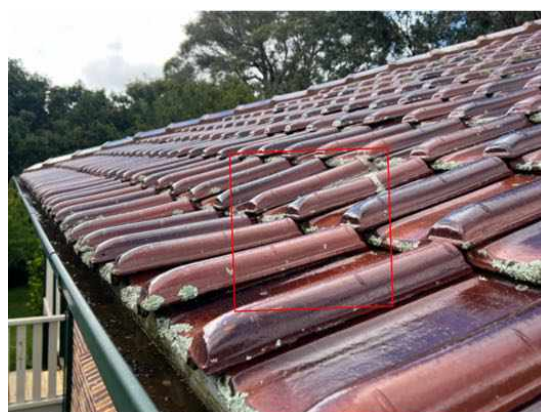
Finding 3.25

Building:	Main Building
Location:	Roof Exterior
Finding:	Roof tiles weathered - Lichen build up
Information:	Upon inspection of the exterior roofing, the majority of roof tiles were considered to be

in a fair condition. While weathering of the tiles is consistent with the age of the property, maintenance works are required.

Concrete roof tiles are typically cleaned to have the visible moss and lichen removed. Concrete tiles are made from a product which is a naturally moist material. Moss and lichen is attracted to the roof tiles surface, and if left will continue to grow and most likely restrict the flow of rain water over the tiles surface, into the roofs gutters. An application of an environmentally friendly anti-fungal solution should be applied to all moss and lichen, prior to undertaking the roof cleaning process.

A roof restoration company can be contacted for further advice at the clients discretion.

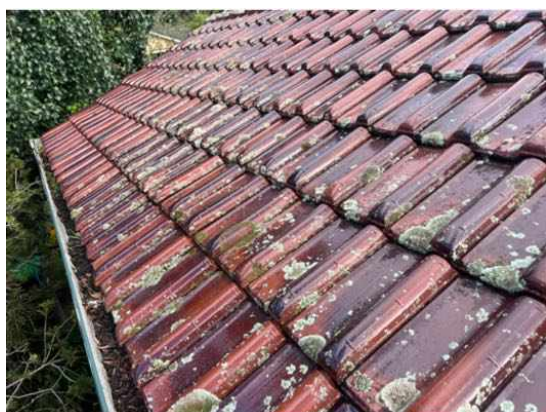
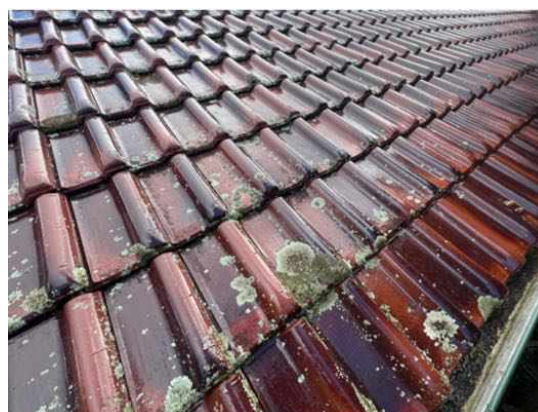
Finding 3.26

Building:	Main Building
Location:	Roof Exterior
Finding:	Metal Roof - Lichen Growth
Information:	Upon inspection of the exterior roofing, sections of the Colorbond metal roof were observed to have lichen growth present. While the roof sheeting itself appeared to be in generally fair condition, the presence of lichen indicates ongoing exposure to moisture and environmental conditions.

Lichen growth on metal roofing can retain moisture against the roof surface and, if left unmanaged, may contribute to deterioration of protective coatings over time. In addition, accumulated growth may restrict the effective flow of rainwater toward gutters and drainage points.

It is recommended that the roof be cleaned to remove lichen growth using appropriate, non-abrasive methods suitable for metal roofing. A roof maintenance or roof restoration contractor can be consulted for further advice at the client's discretion.

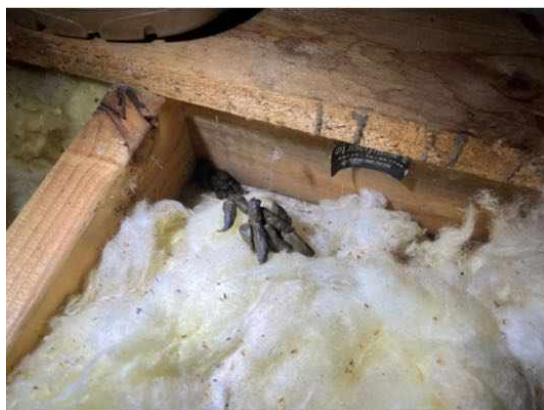
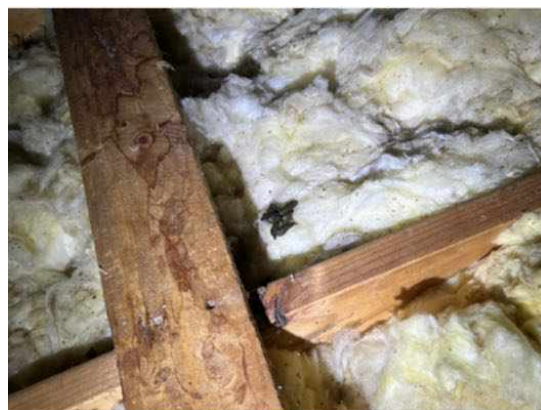
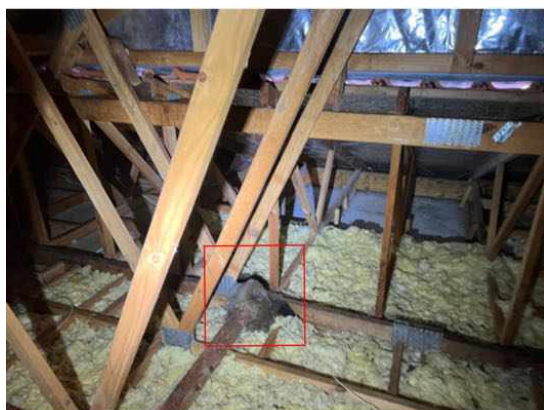
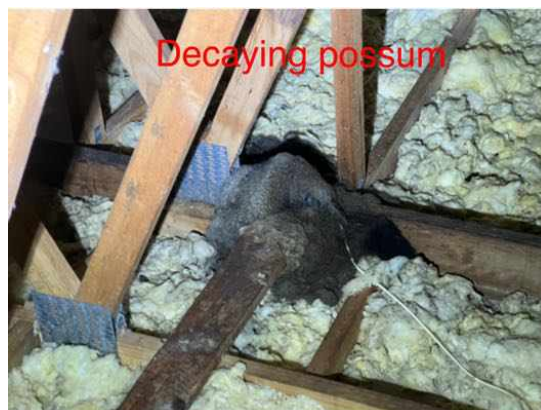
Finding 3.30

Building:	Main Building
Location:	Roof Void
Finding:	Insulation - Reduced coverage due to vermin activity
Information:	Upon inspection of the roof void it was noted that insulation coverage is reduced and inconsistent, with sections displaced and reduced in volume, likely due to disturbance from vermin activity within the roof space.

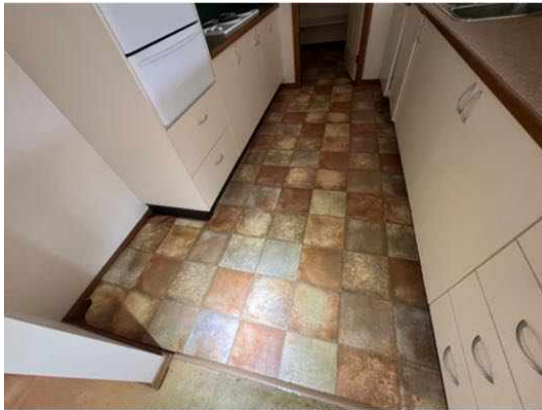
Finding 3.32

Building:	Main Building
Location:	Kitchen
Finding:	Vermin Activity - Evidence Observed
Information:	Evidence of vermin activity was observed within the property, including droppings and odour in accessible areas.

Vermin presence within a building may lead to contamination, unpleasant odours, and damage to building elements such as insulation, wiring, and linings.

If left unmanaged, vermin activity may continue and result in further deterioration of building materials and hygiene concerns.

It is highly advised that a licensed pest controller be appointed to address the infestation and implement appropriate control measures.

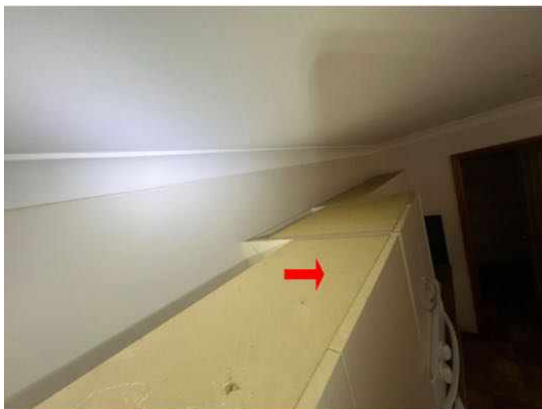
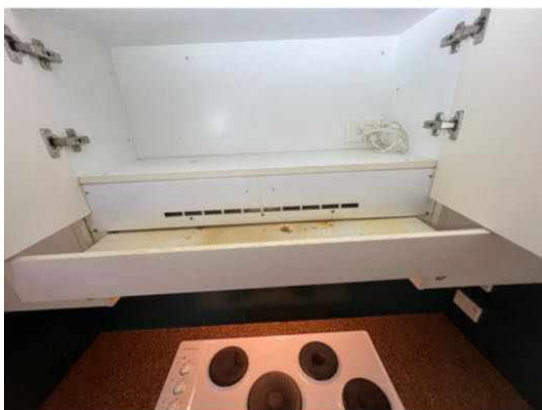
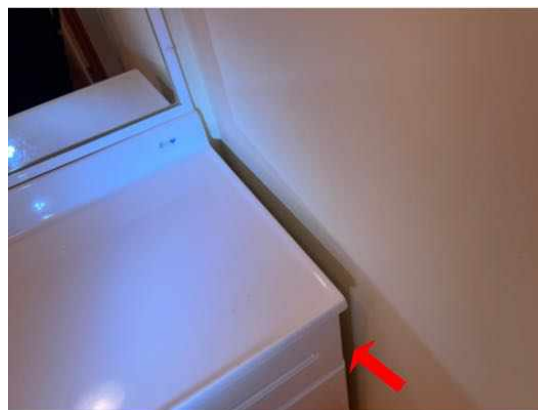
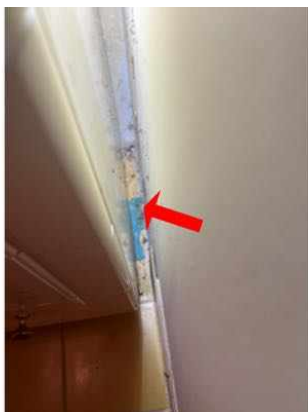
Finding 3.33

Building:	Main Building
Location:	Kitchen, Bathroom
Finding:	Surface - Requires cleaning
Information:	Regular cleaning and maintenance improves the longevity of all building elements. A build up of dirt and debris can reduce the useful life of building materials and may result in earlier replacement of items being required.

Excessive dirt is also likely to lead to secondary hazards, including potential health hazards, as the building elements begin to harbour bacteria and/or mould.

Remedial cleaning is recommended in order to improve the appearance of this area as well as to counteract the development of bacteria. Such works can be performed by a cleaning contractor and should be completed at the discretion of the client.

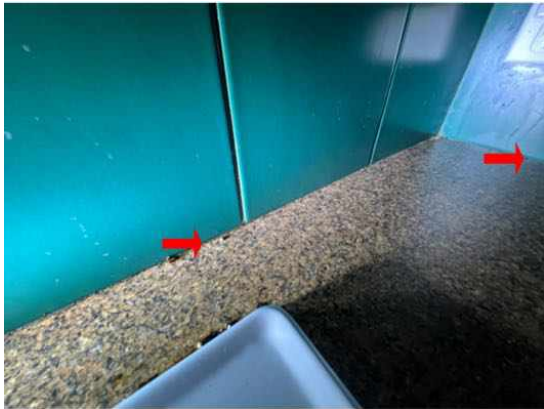
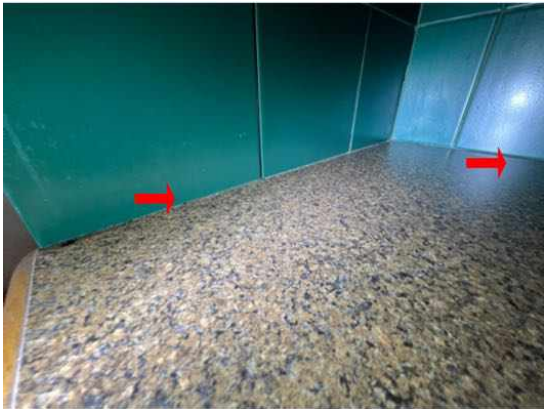
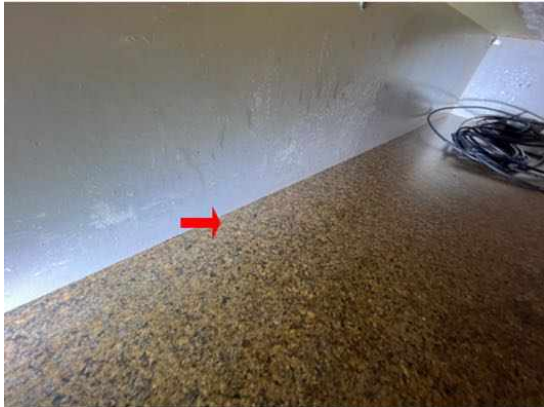
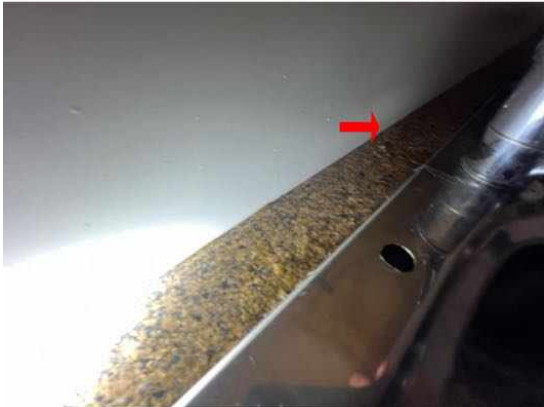
Finding 3.34

Building:	Main Building
Location:	Kitchen
Finding:	Sealant - missing
Information:	It was noted on inspection that sealant or grout is missing to this area.

Different materials move at different rates, generally causing cracking to grout or sealant at this point. A flexible sealant is required to allow for expected expansion and contraction, while keeping the joint water tight and protective of all associated building materials.

Flexible and mould resistant materials should be applied to affected areas to prevent any subsequent water damage that is likely to occur. Regular maintenance and replacement of damage or missing or damaged sealant and grout is highly recommended to the wet areas, as this is a regular wear and tear defect. Sealant and grouting in areas that come into regular contact with water should be maintained for the long term care of your property.

A sealant specialist or tiling contractor should be appointed to complete these works as soon as possible

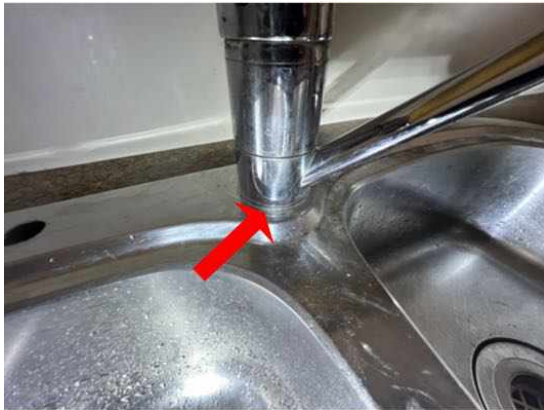
Finding 3.35

Building: Main Building
Location: Kitchen
Finding: Tap - Loose
Information: The tap in this area has not been installed correctly, or has deteriorated with age, and is consequently loose. This tap being loose creates potential for water leaks and subsequent water damage to the surrounding area.

Where taps or spouts are loose, a qualified plumber should be appointed to re-fix the plumbing fitting.

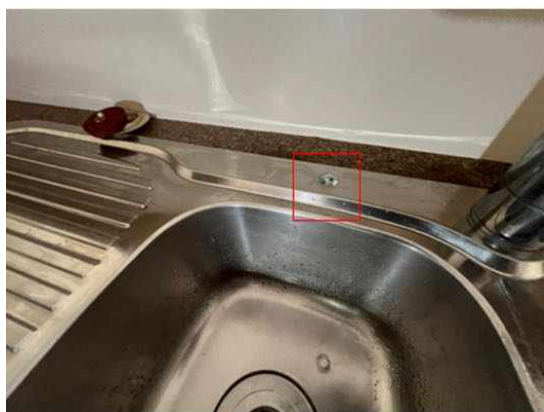
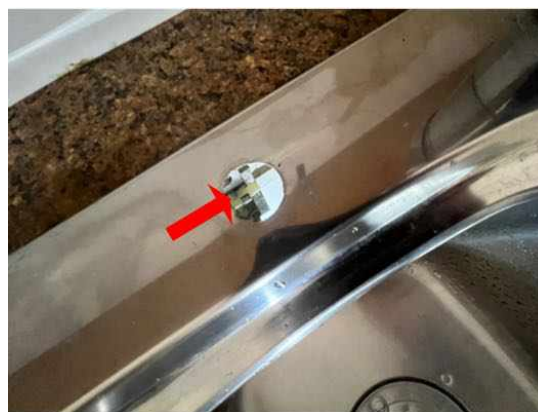
Finding 3.36

Building: Main Building
 Location: Kitchen
 Finding: Sink - Redundant Penetration
 Information: A redundant penetration was observed to the sink consistent with a previous water filter or similar fixture, with the opening no longer in use.

If left unmanaged, moisture may lead to deterioration of adjacent materials.

It is highly advised that the opening be appropriately sealed to prevent water ingress.

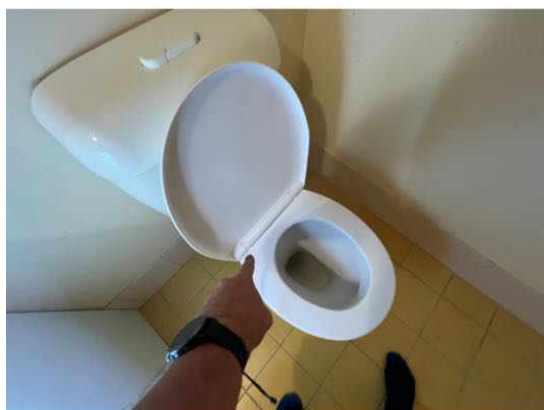
Finding 3.39

Building: Main Building
 Location: Laundry
 Finding: Toilet seat - Loose
 Information: The toilet seat in this area is loose and requires adjustment to tighten.

If left unmanaged, the fitting may further deteriorate, causing potential for the development of other minor secondary defects.

A handy person or plumber should be appointed to perform these rectification works at discretion of the client.

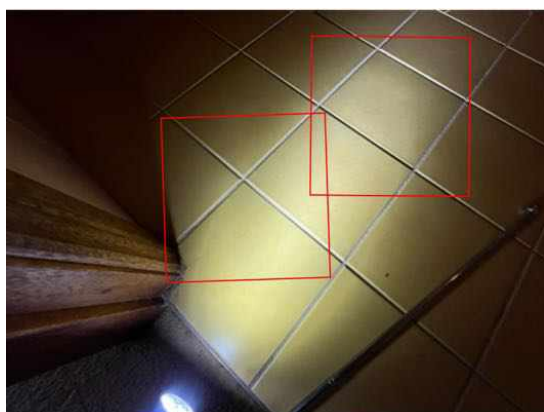
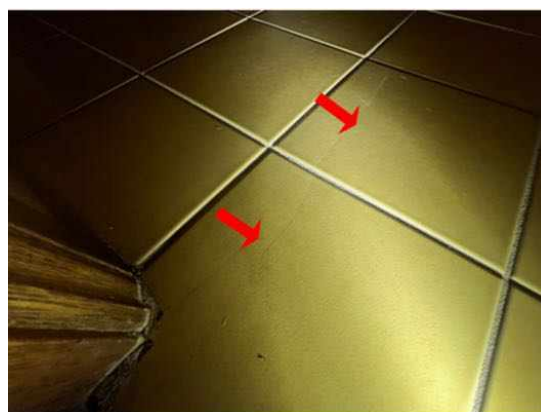
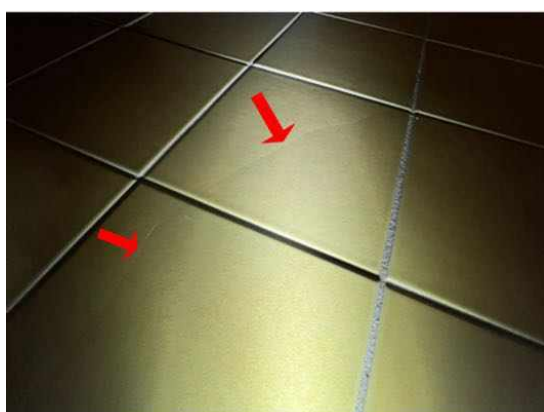
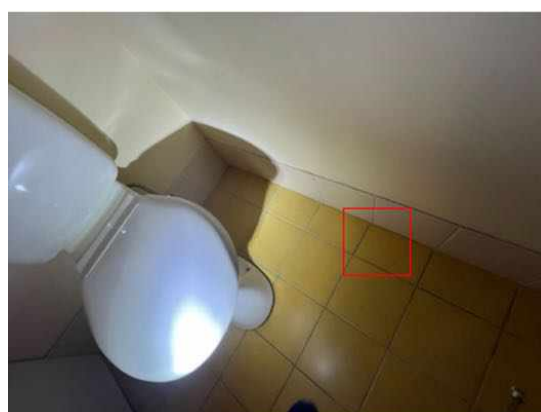
Finding 3.40

Building: Main Building
Location: Laundry, Bathroom
Finding: Tiles - Cracked or damaged
Information: Cracking was evident to the tiling in this area at the time of inspection. While the cracking appears to be minor, this area is frequently exposed to water, allowing potential for water penetration into adjoining sections of walls or flooring.

If left unmanaged, water penetration to these areas may lead to subsequent water damage, which is likely necessitate repair work to affected building elements.

A tiling contractor should be appointed to ensure that no further water damage occurs. The re-application of silicone and grouting throughout remaining tile work is also advised, to further protect the area against water penetration.

Where water penetration has led to water damage, appointment of a relevant tradesperson may be required to repair damaged building elements.

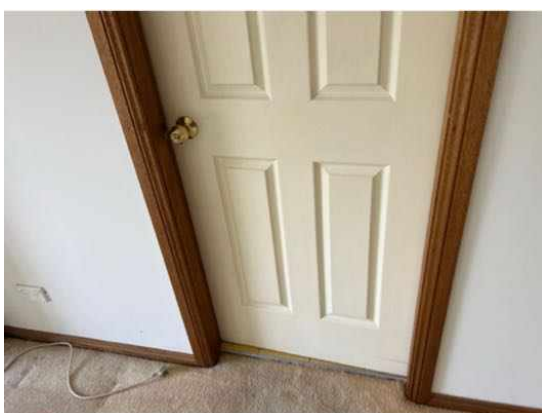
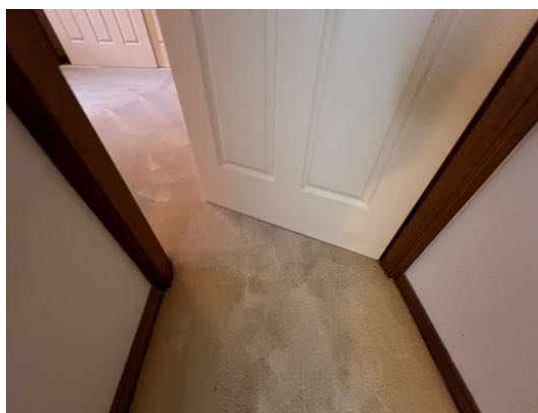
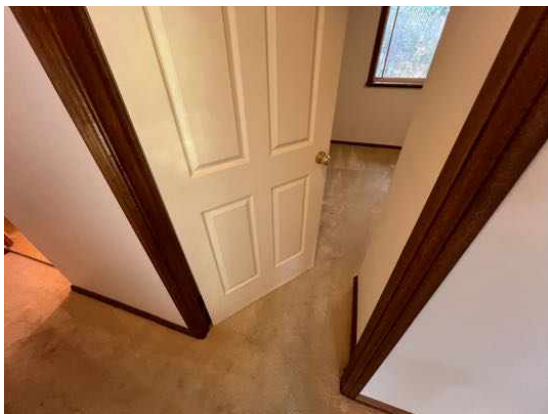
Finding 3.41

Building:	Main Building
Location:	Laundry, Bedroom 3, Bedroom 2
Finding:	Doors - Binding/Jamming
Information:	Binding and/or jamming of several doors throughout the property were evident during standard operation. This defect inhibits the functionality of affected doors as well as creating potential for secondary defects to associated building elements, such as damage to the floor covering.

A door that binds to flooring or to the associated door frame may have several causes, ranging from minor defects, such as poor installation of the door or deteriorated hinges, through to major structural issues, such as damage to subfloor structures.

Where door binding/jamming appears to indicate major structural issues, a registered builder specialising in re-stumping should be appointed to provide an estimate on the cost of rectification.

For minor causes, a qualified carpenter or general handyman should be appointed to perform minor rectification works at client discretion.

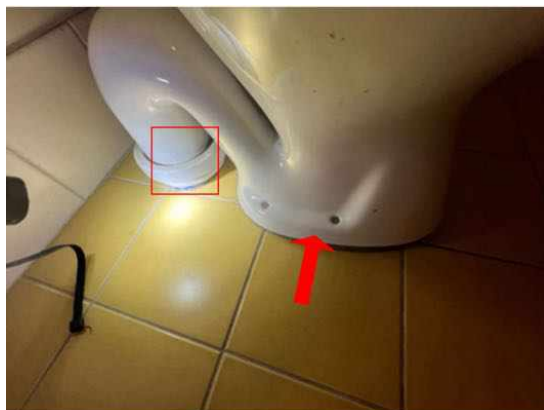
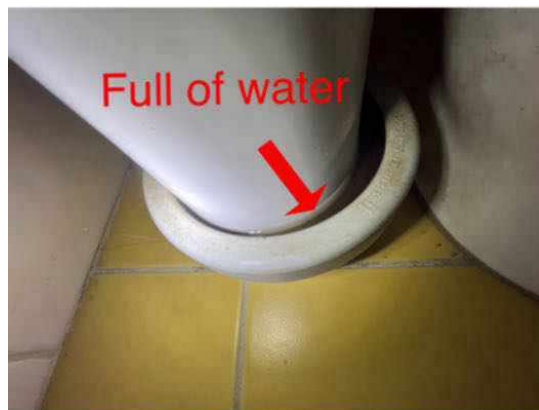
Finding 3.42

Building: Main Building
 Location: Laundry, Bathroom, Ensuite
 Finding: Toilet pan - Loose
 Information: The toilet pan was found to be loose and relatively unstable at the time of inspection. It is suspected that this defect has developed due to general aging of the toilet pan and associated materials. However, the loose fixing may also be a result of impact damage.

If left unmanaged, the toilet pan could deteriorate further, leading to greater destabilisation and the potential for water leaks to surrounding building elements.

It is recommended that the pan be refixed to the floor with concrete or silicone by a licensed plumbing contractor.

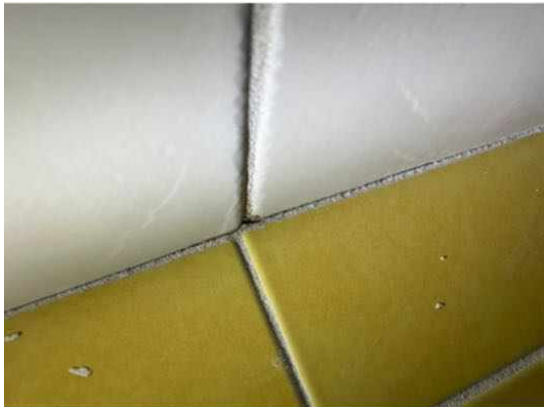
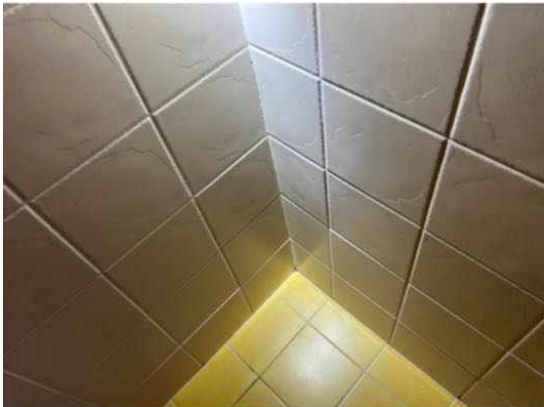
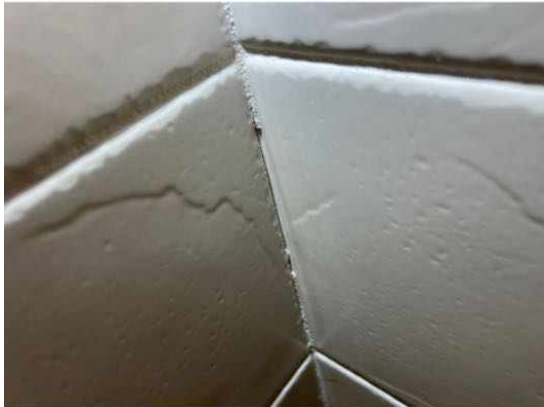
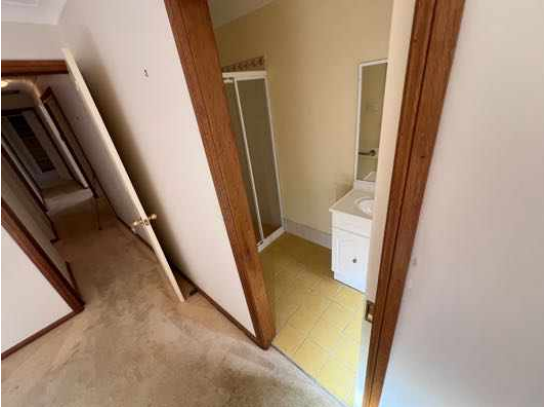
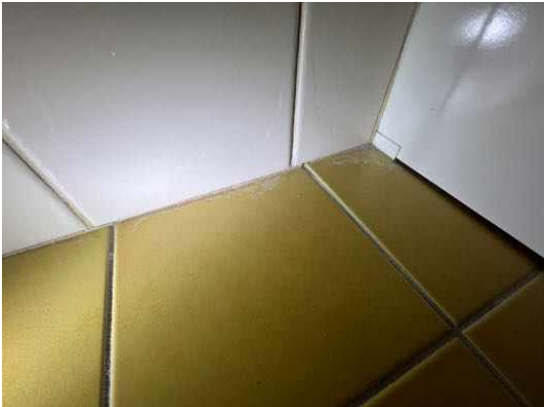
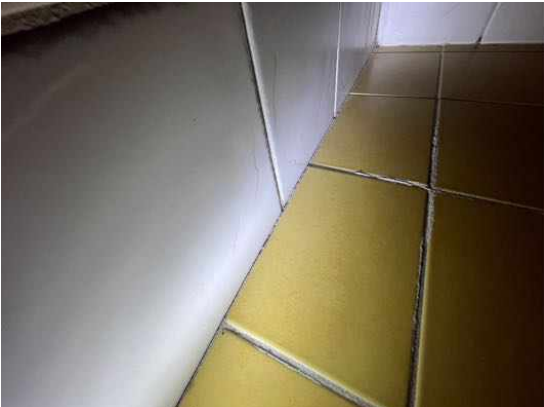
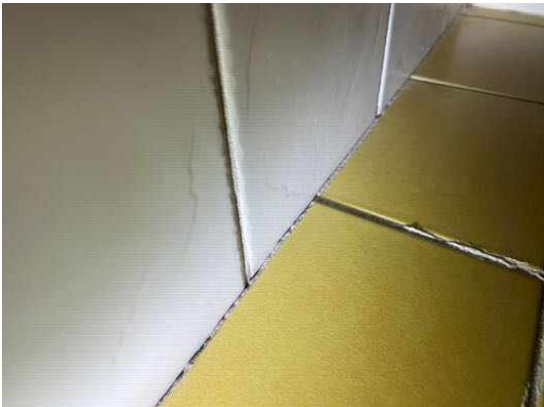
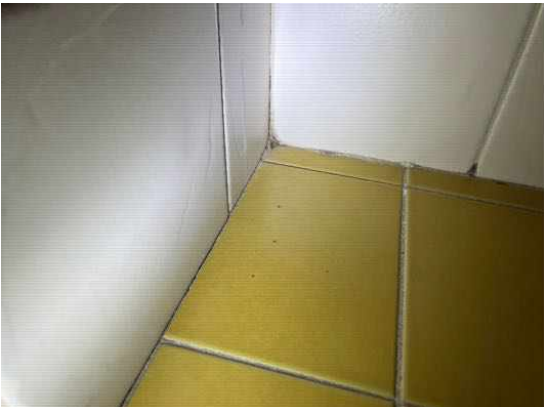
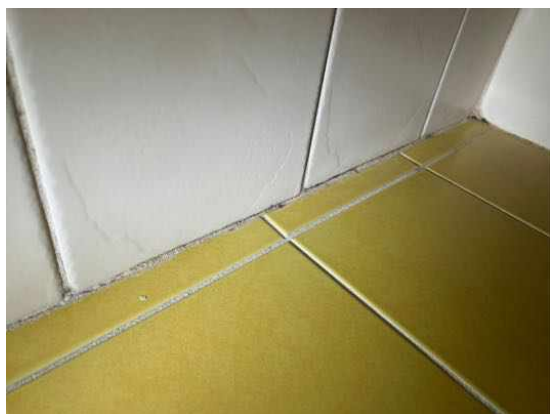
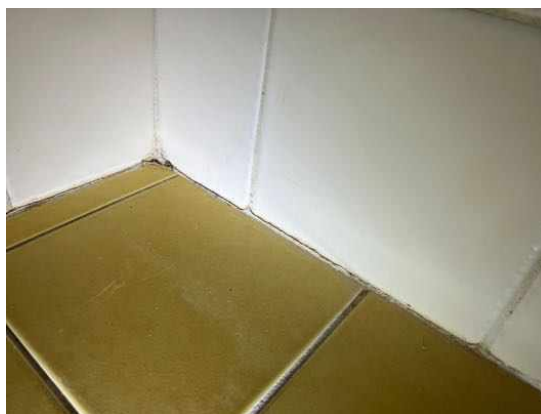
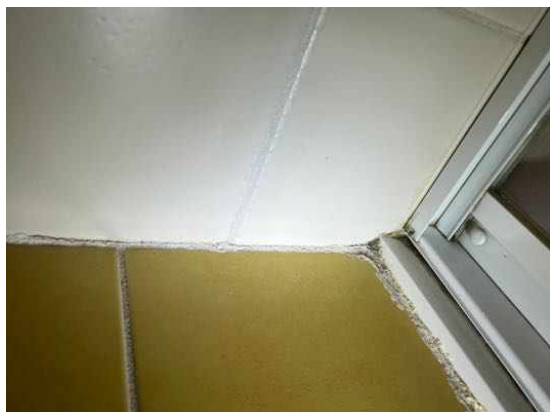
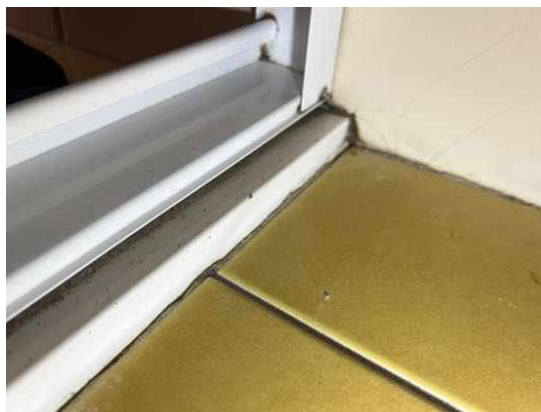
Building: Main Building
 Location: Bathroom, Ensuite
 Finding: Sealant and grouting - Missing or damaged
 Information: It was noted on inspection that sealant or grout is degraded to the tiled shower alcove and or other areas of the bathroom.

Different materials and floor areas move at different rates, generally causing cracking to grout or sealant at this point. A flexible sealant is required to allow for expected expansion and contraction, while keeping the joint water tight and protective of all associated building materials.

There appears to be excessive mould to the sealant and grout which will likely require scraping out and replacement.

Flexible and mould resistant materials should be applied to affected areas to prevent any subsequent water damage that is likely to occur. Regular maintenance and replacement of damage or missing or damaged sealant and grout is highly recommended to the wet areas, as this is a regular wear and tear defect. Sealant and grouting in areas that come into regular contact with water should be maintained for the long term care of your property.

A sealant specialist or tiling contractor should be appointed to complete these works as soon as possible

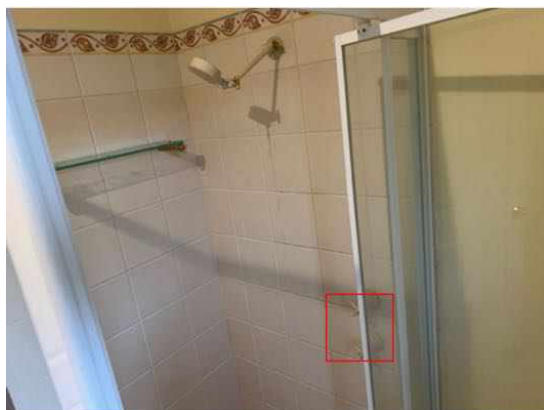
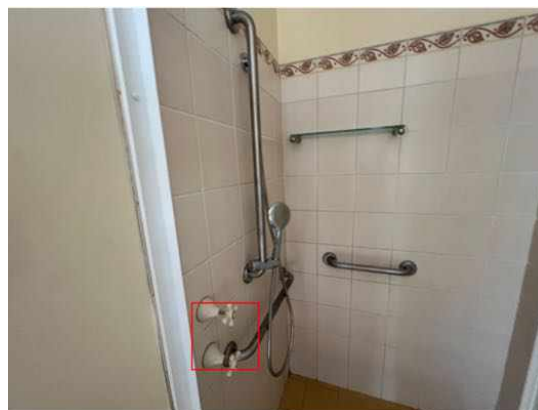
Finding 3.49

Building:	Main Building
Location:	Bathroom, Ensuite
Finding:	Tap - Water hammer
Information:	This tap shows evidence of water hammer being present. Water hammer, a pressure surge resulting when a fluid is forced to suddenly change direction, is a common defect in plumbing fittings, particularly those that are aged and not frequently maintained. Water hammer is generally caused by factors that create high water pressure in the affected plumbing fixture, usually evidenced by a faint banging noise during operation of the affected tap.

Although water hammer is generally considered to be a minor defect, subsequent damage such as erosion of tap hardware and/or water damage to associated building elements is likely to occur if left unmanaged.

A licensed plumber should be appointed as soon as possible to replace any affected tap hardware and perform any remedial works as necessary. Please be advised that the appointment of a cabinet maker or qualified carpenter may be necessary if water damage to associated building elements has occurred.

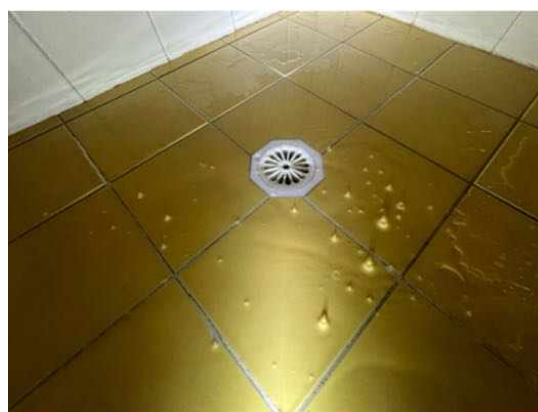
Finding 3.50

Building:	Main Building
Location:	Bathroom, Ensuite
Finding:	Shower base - Water pooling
Information:	Evidence of water pooling around the floor waste in the shower recess was noticed at the time of inspection. It is suspected that this excessive moisture is attributed to insufficient fall in the shower floor tiles.

This pooling is minor overall but is still considered unsatisfactory, as standard tiling practices would not permit this situation to occur. Pooling water around floor wastes can create a slip hazard in extreme cases and create conditions that are conducive to mould growth over time. Where left unmanaged, the degradation of sealant and grouting is also likely to occur, possibly necessitating further repair works.

Remedial works may involve some sections of tiling and flooring repair and replacement. A tiling contractor or bathroom specialist should be appointed to provide further advice on reparation options and to perform works as necessary.

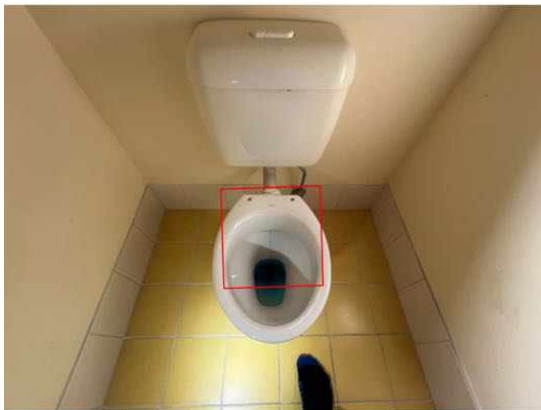
Finding 3.51

Building:	Main Building
Location:	Ensuite

Finding: Toilet seat - Missing
 Information: Although some building elements may seem irrelevant or unnecessary, all building elements play a key role in the operation and function of the overall structure and its performance.

Replacement of any missing building element should be conducted as soon as possible to ensure that no damage or functional issues occur to associated building materials.

The appropriate tradesperson should be appointed as soon as possible to replace the missing building element.

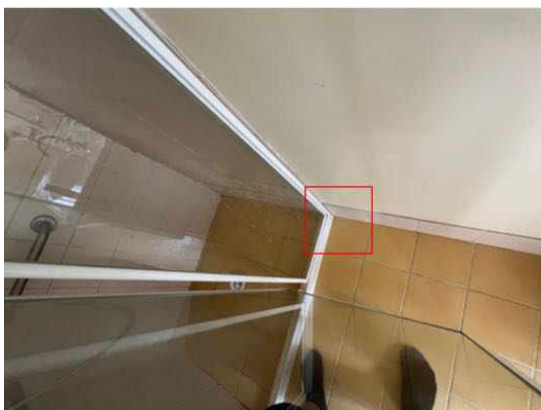
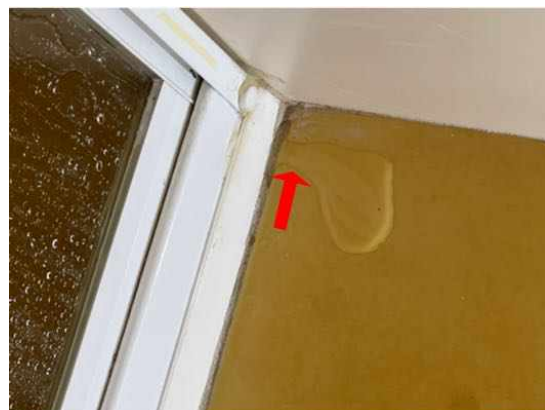
Finding 3.52

Building: Main Building
 Location: Ensuite
 Finding: Shower screen - active leak
 Information: A active leak was identified to the shower screen, likely due to deteriorated or inadequate sealant. If left unmanaged, water ingress may lead to damage to adjacent walls and flooring, as well as creating conditions conducive to mould growth.

Resealing is recommended to restore a watertight seal and prevent further deterioration.

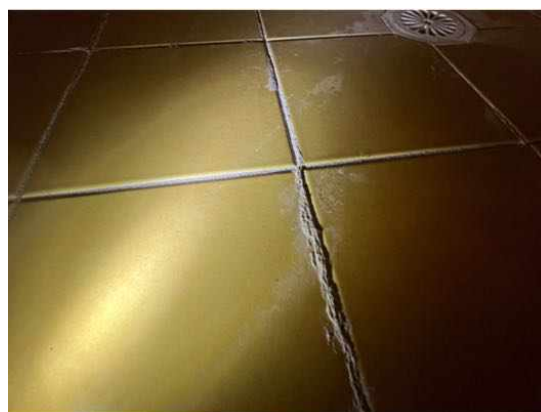
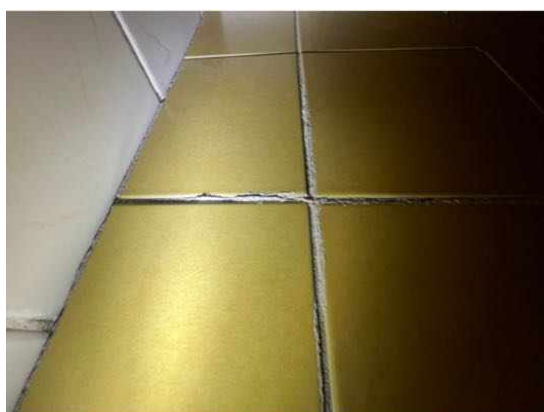
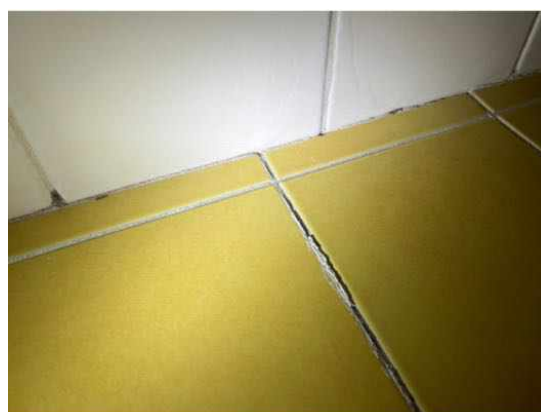
Finding 3.53

Building:	Main Building
Location:	Ensuite
Finding:	Shower Base - Efflorescence to Tile Joints
Information:	Efflorescence was observed to the tiled shower base, with white crystalline deposits present along grout joints.

Efflorescence in wet areas commonly occurs where moisture migrates through the tile bed and grout, drawing soluble salts to the surface as it evaporates. This is typical in shower bases due to the layered construction including screed, adhesive, tiles, and grout.

If left unmanaged, this condition may contribute to gradual deterioration of grout joints and affect the overall presentation of the surface.

Cleaning and maintenance of the affected areas is advised to manage buildup and maintain the condition of the tiled surface.

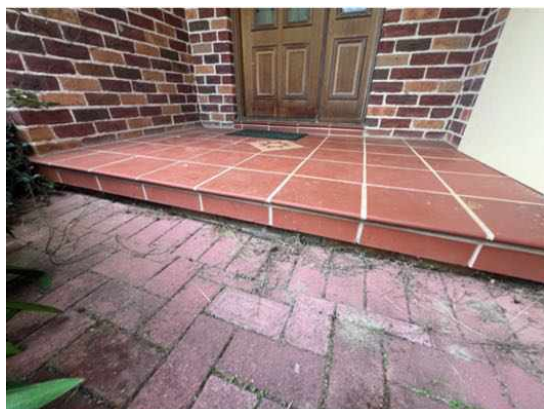
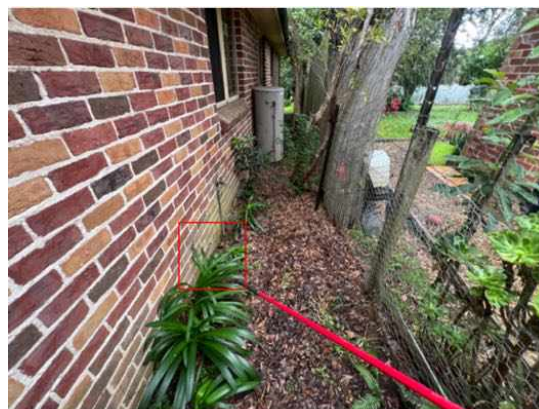
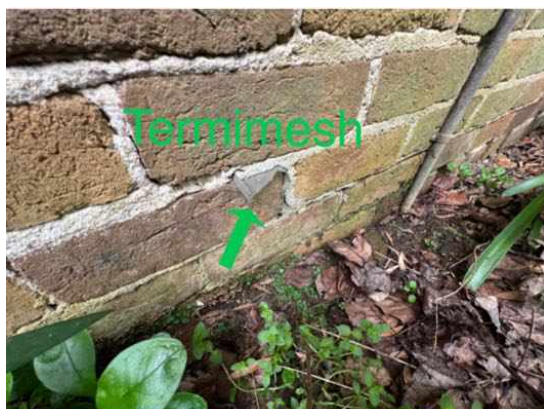
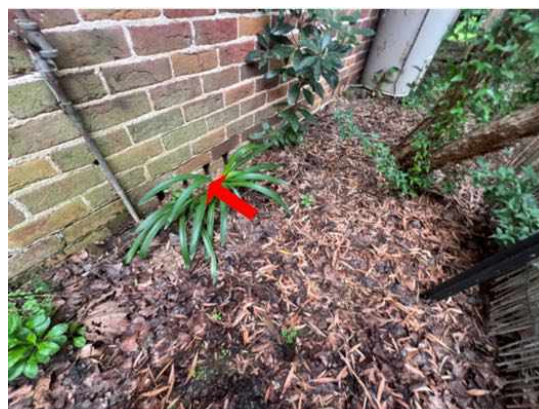
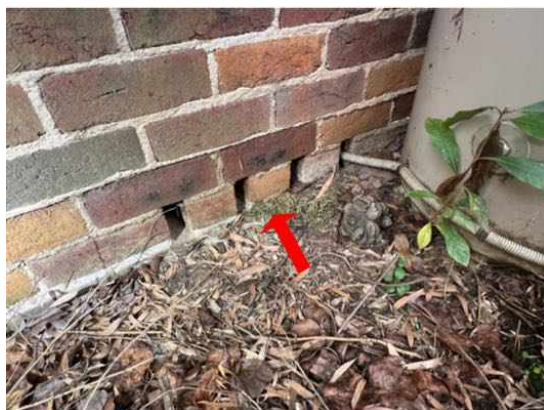
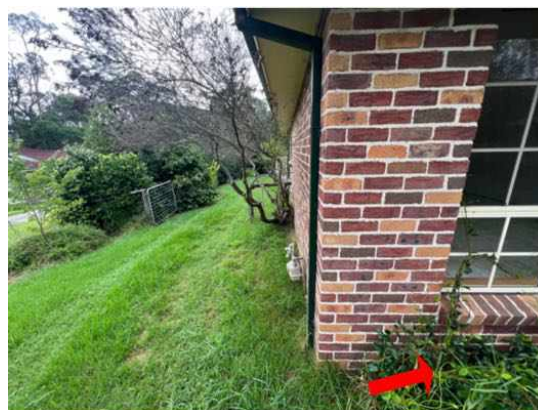
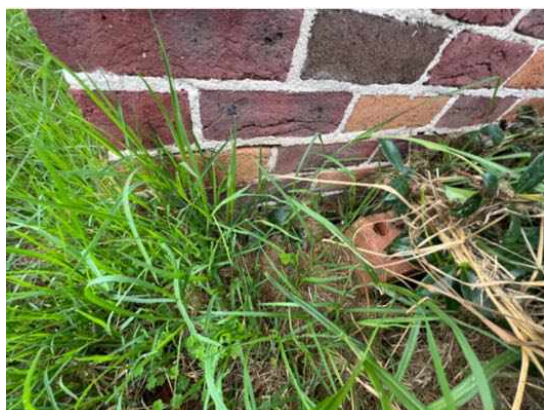
Generally this takes the form of finished ground levels external paving or concrete being retrospectively installed above the damp course level the adjacent internal floor level or weep and ventilation holes.

Where bridging has occurred full inspection is prevented and termites may enter a property in a concealed or undetectable manner.

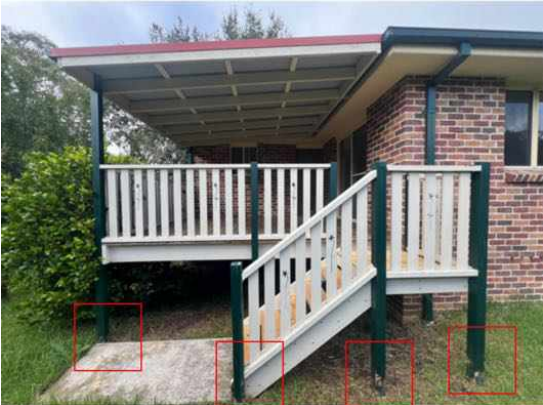
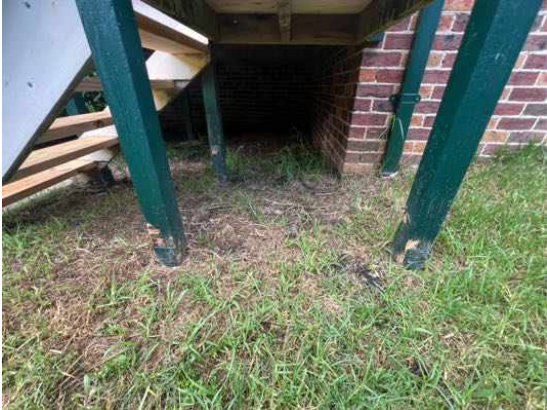
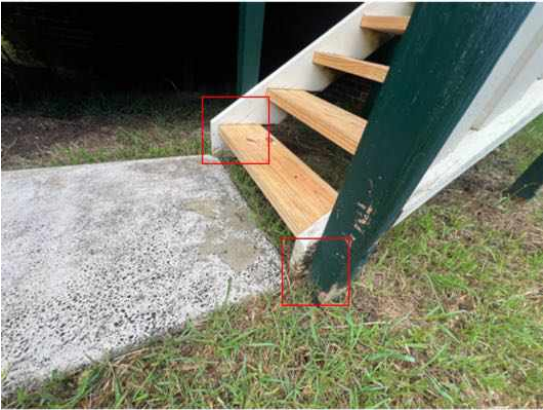
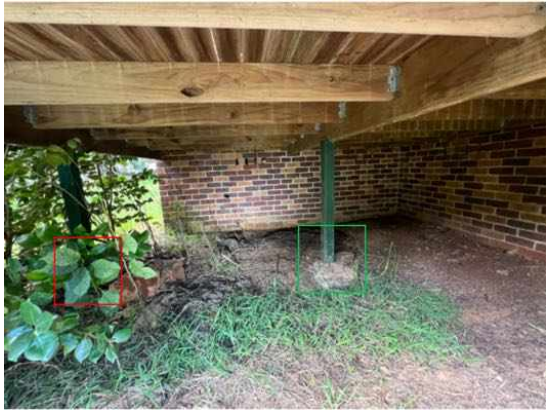
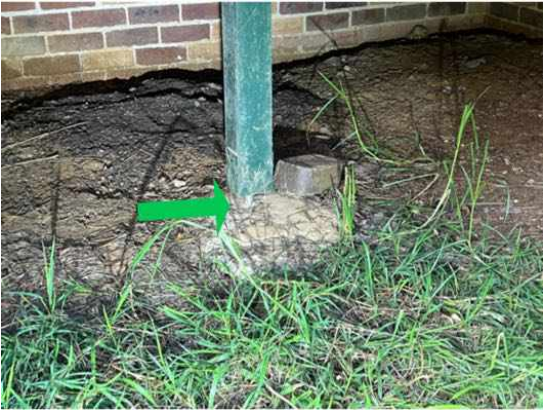
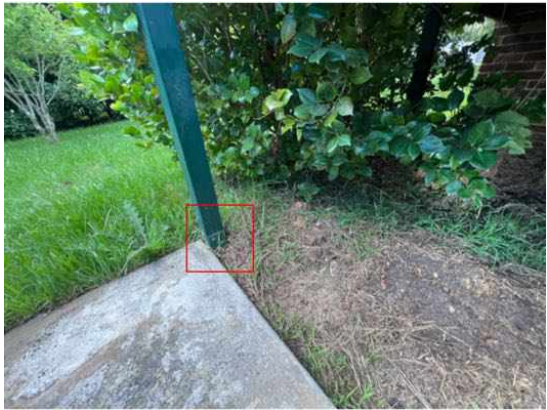
Finding 6.02

Building:	Main Building
Location:	Porch, Alfresco
Finding:	Bridging of termite barrier - Posts.
Information:	Posts that are attached to home from ground to structure without a 75mm inspection zone (metal stirrup) causes a bridging point. Bridging of termite barriers occurs when termites bridge (usually by building a mud tunnel) a termite barrier or inspection zone or where termites have a passage allowing them to bridge the barrier.

Generally this takes the form of finished ground levels external paving or concrete being retrospectively installed above the damp course level the adjacent internal floor level or weep and ventilation holes.

Where bridging has occurred full inspection is prevented and termites may enter a property in a concealed or undetectable manner.

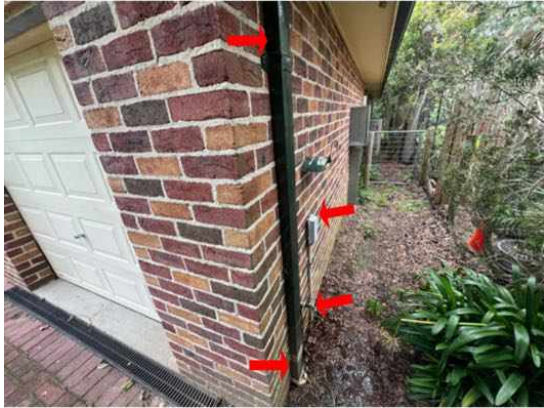
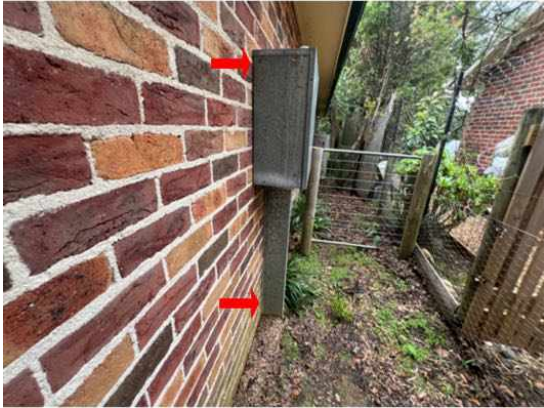
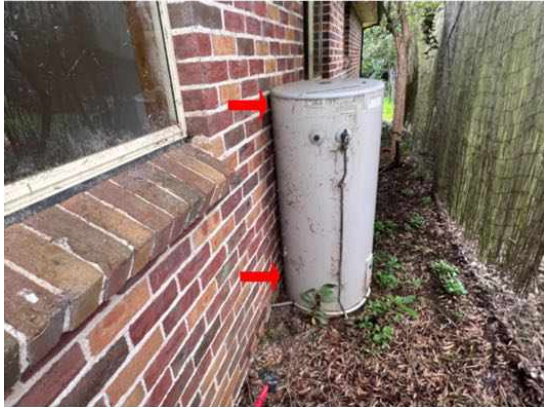
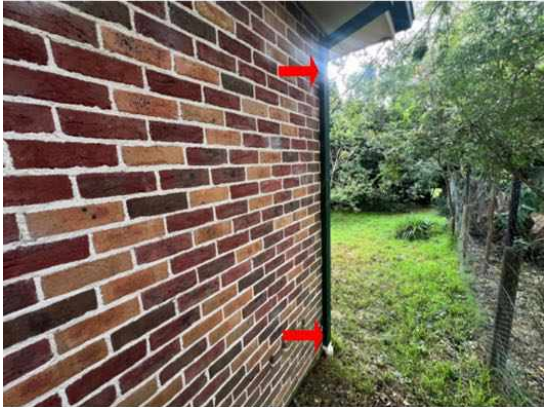
Finding 6.03

Building: Main Building
Location: All External Areas
Finding: Bridging - Attachments to Buildings.
Information: Bridging occurs when items against a building provide a concealed entry point for termites into the building or by passing around a termite management system.

Where any part of an attachment to a building is not isolated and is not provided with a clear gap of not less than 25mm from the building, bridging occurs. Attachments to buildings such as hot water services, downpipes, verandahs, decks, steps, fences, service conduits and the like provide the opportunity for concealed entry.

Building attachments of this nature need to be frequently inspected for termite activity by a qualified inspector

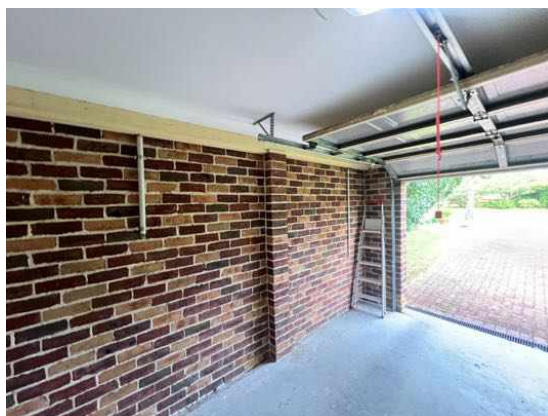
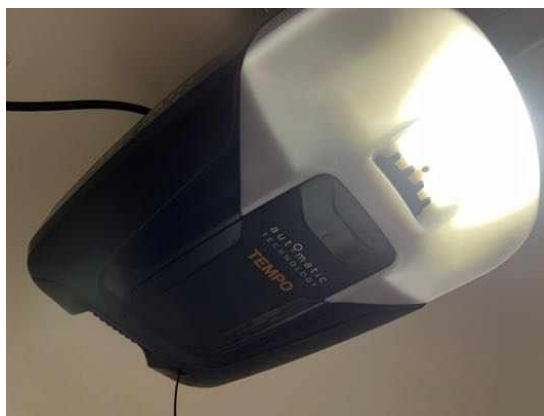
Noted Item

Building: Main Building
Location:
Finding: FYI - Additional Photos
Information: Additional photos are provided for your general reference and may include obstructions, testing of water & windows, moisture readings or minor maintenance items.
