Building and Timber Pest Inspection Report

Inspection Date: Mon, 23 Mar 2026

Property Address: 13 Betula Grove, Bundanoon NSW 2578,
Australia

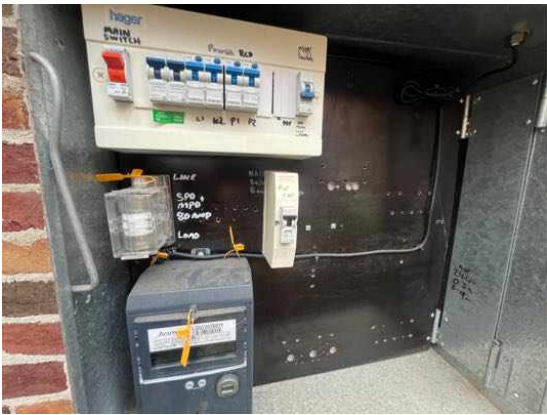
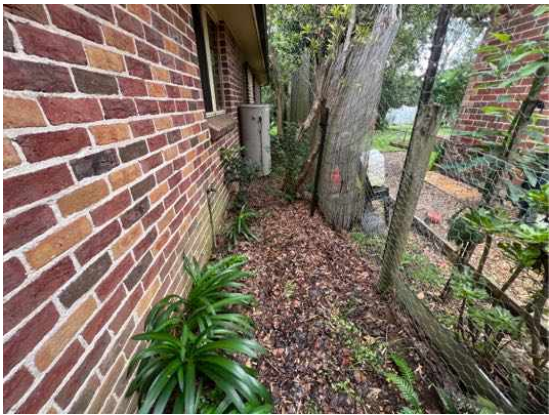
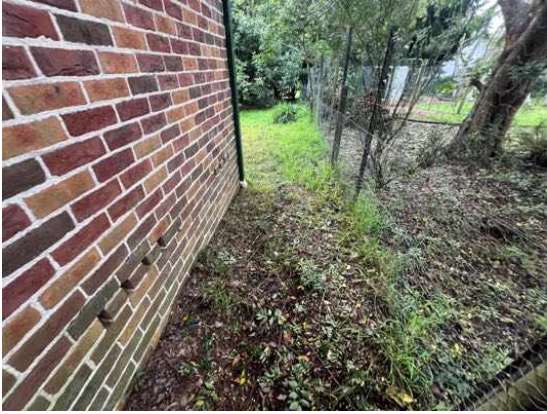
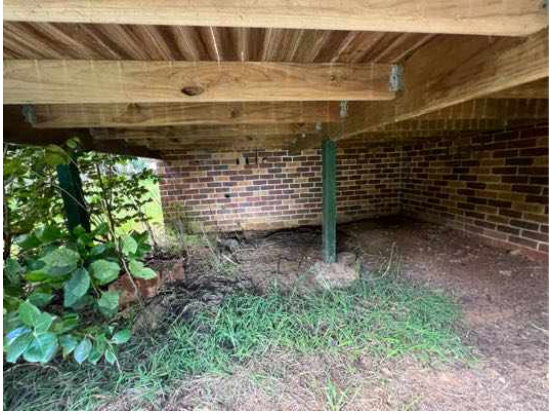
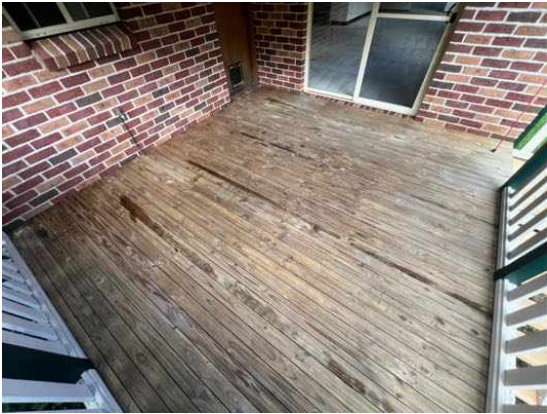
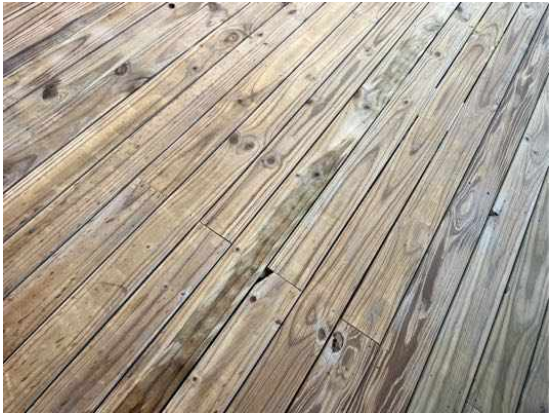
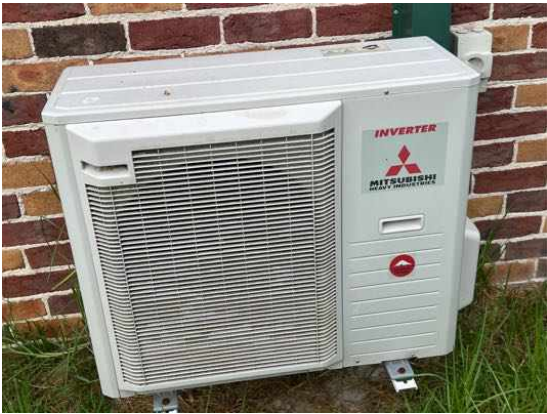
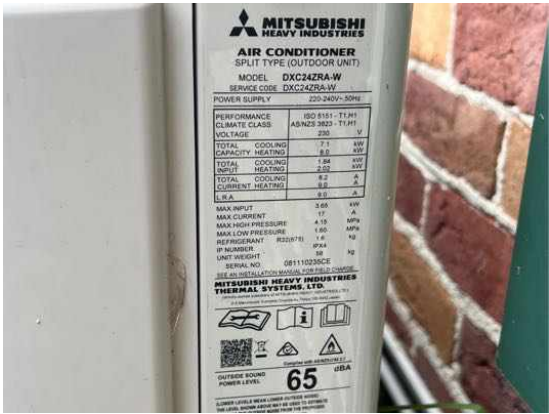
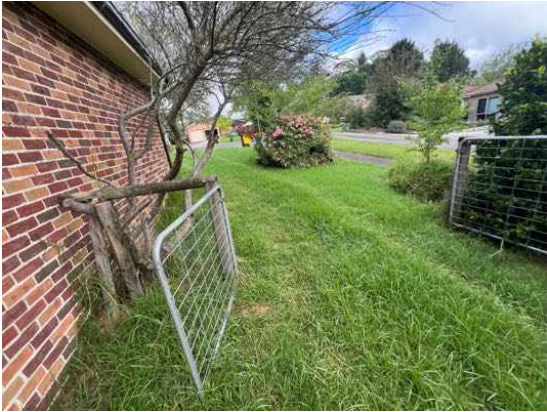
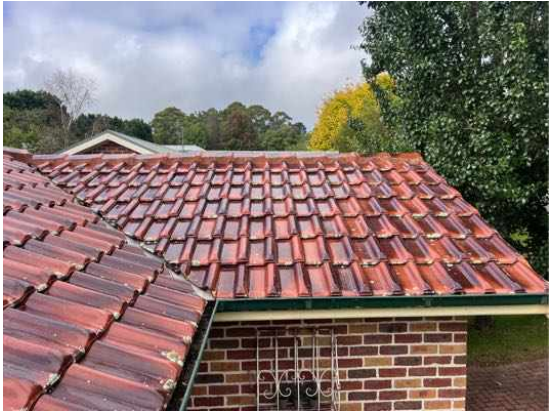
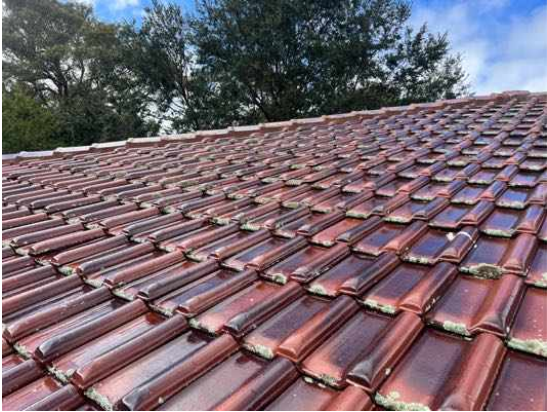
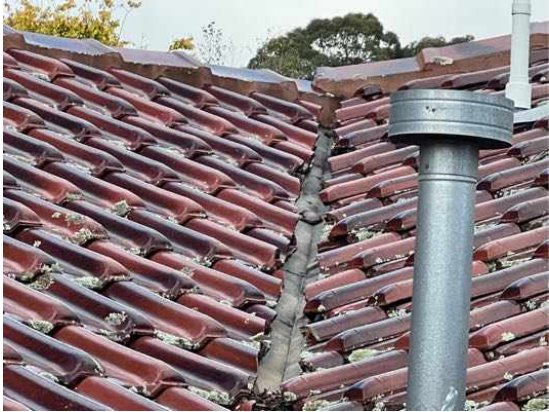
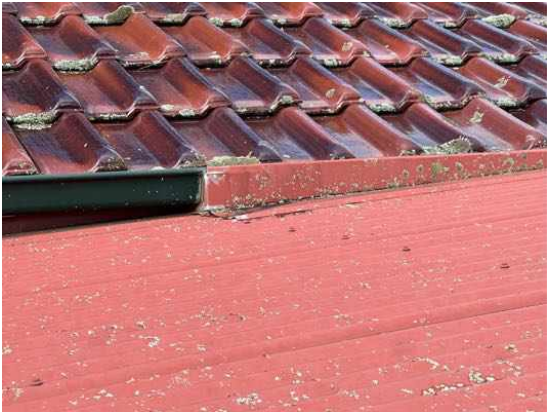
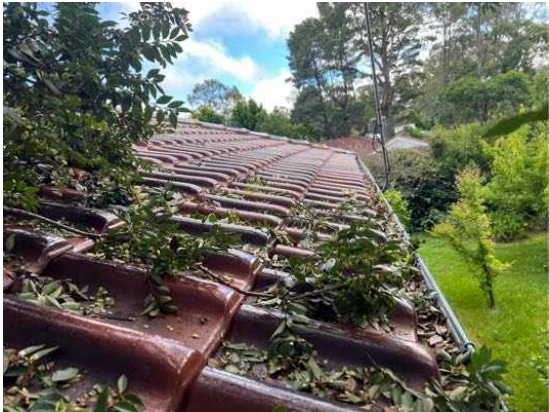
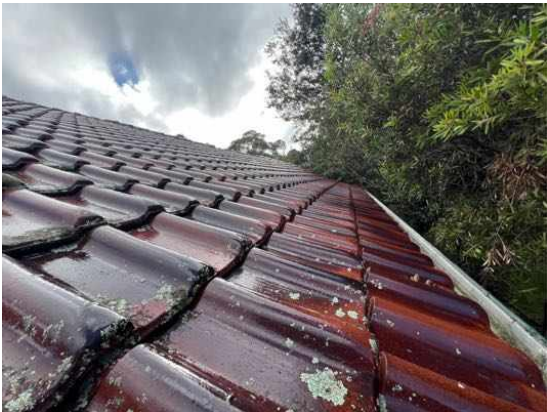
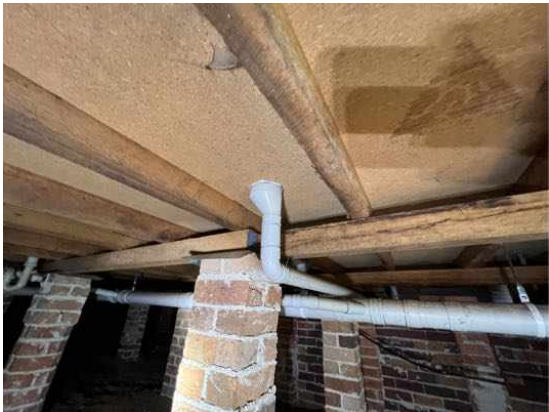
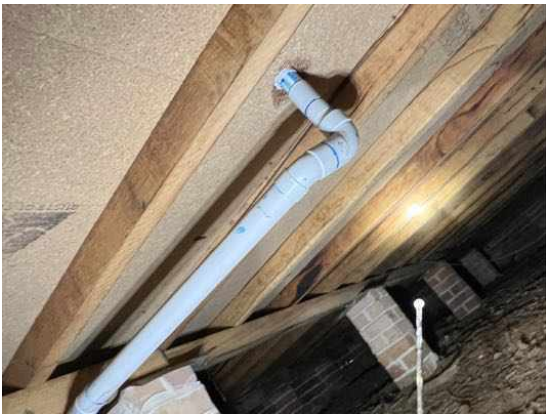
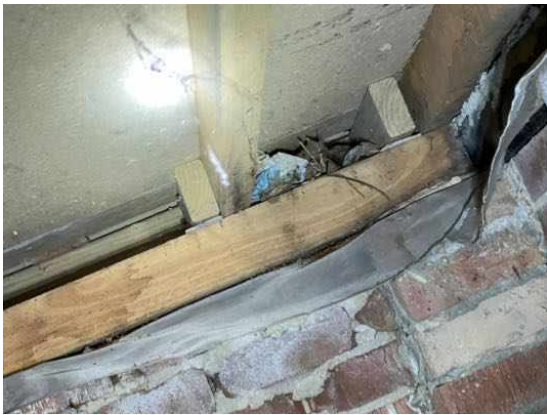
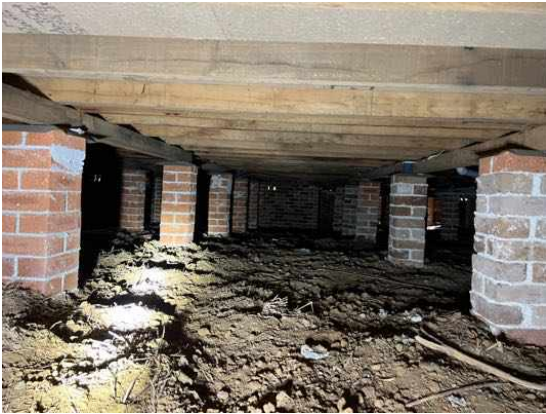
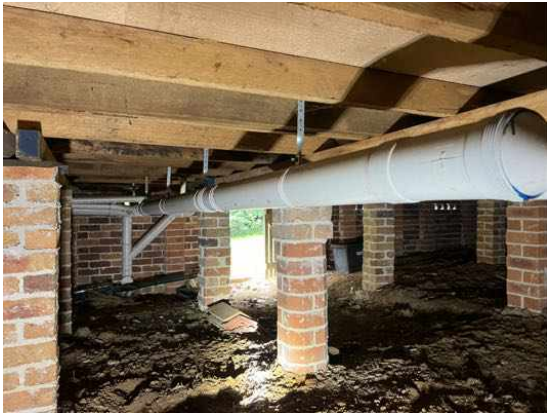
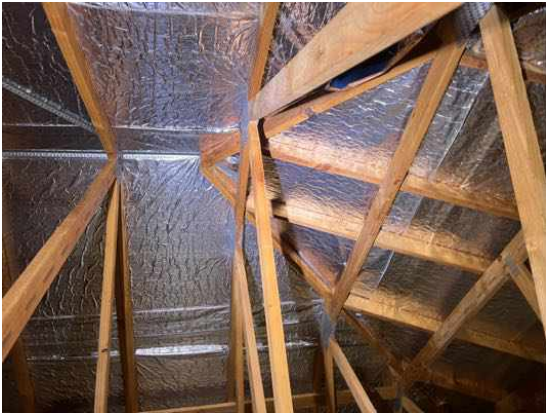
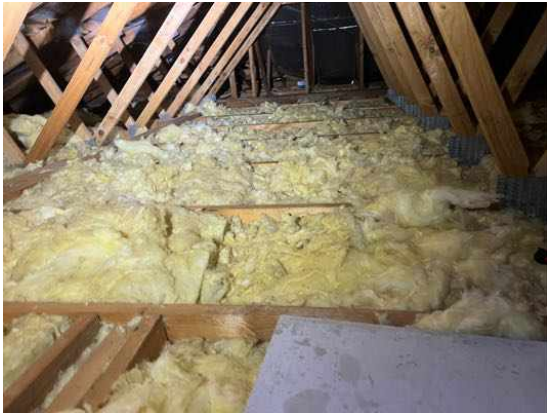
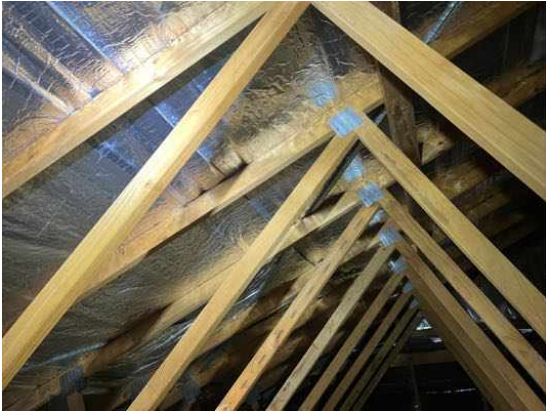
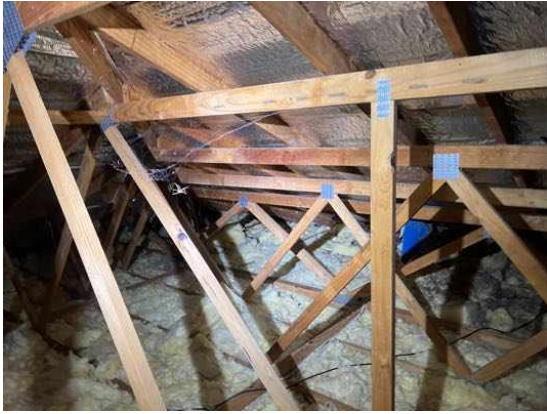
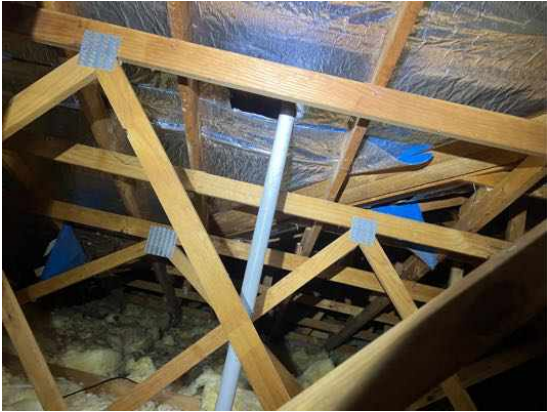
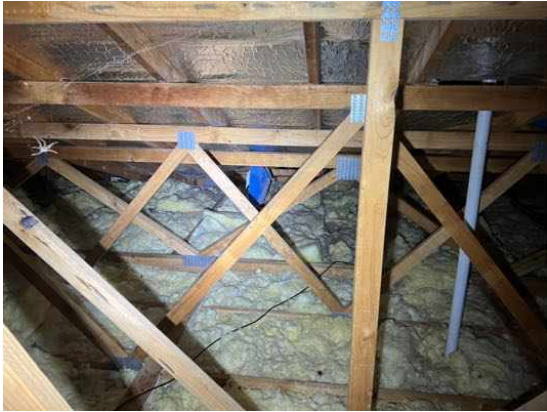
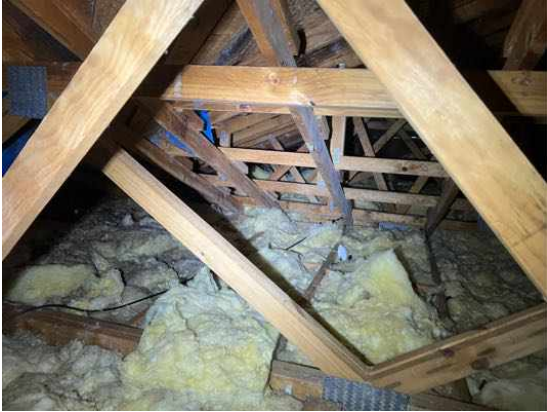
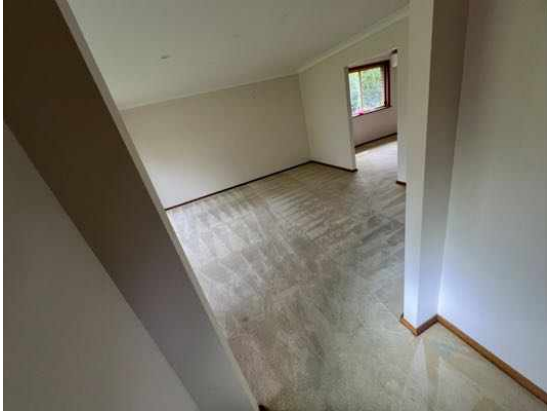
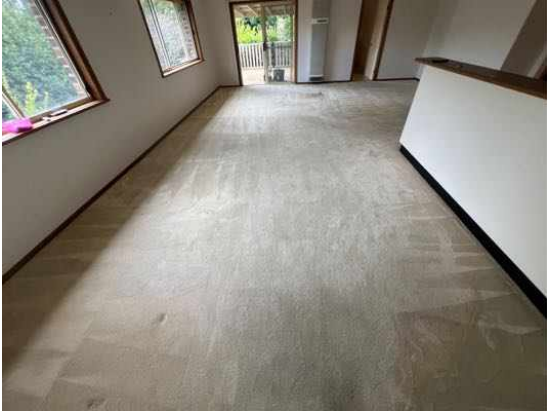
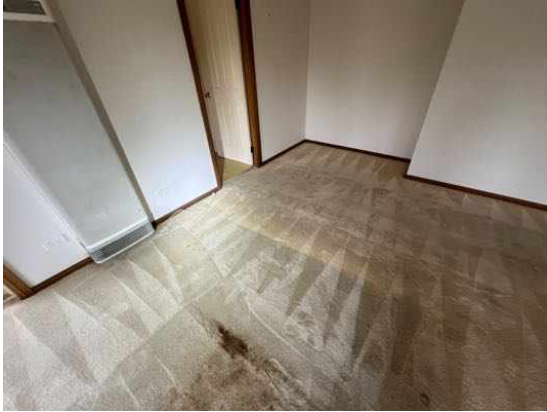
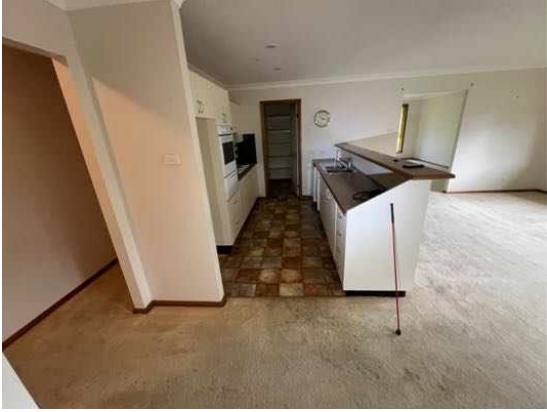
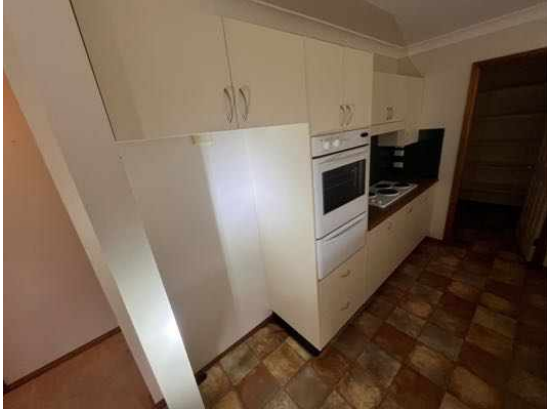
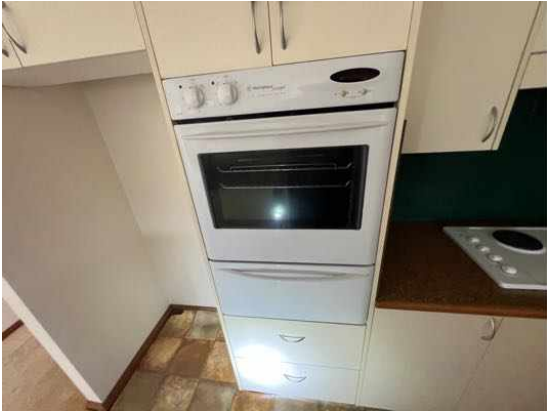
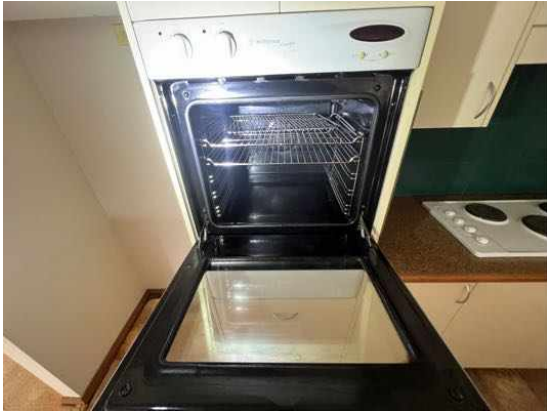
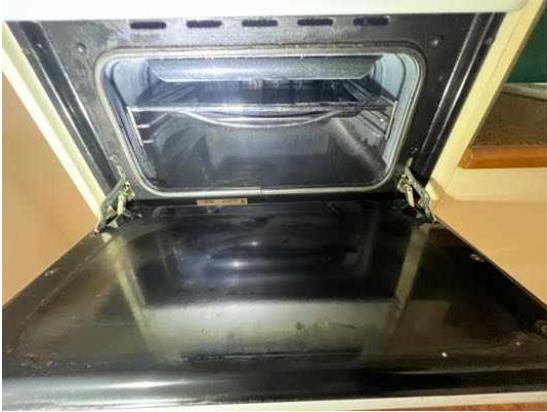
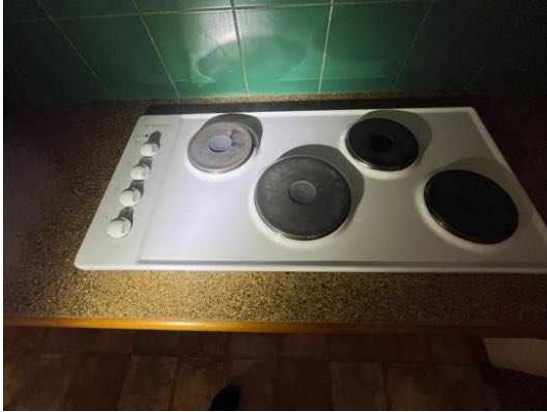
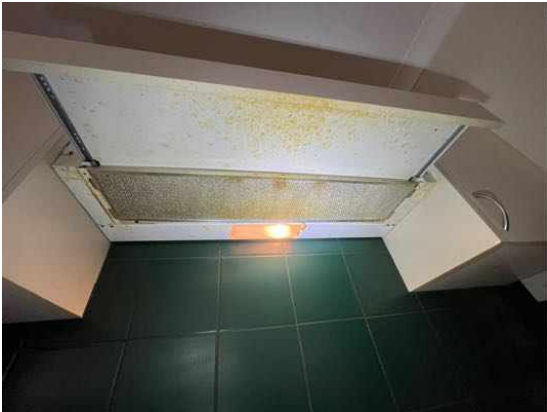
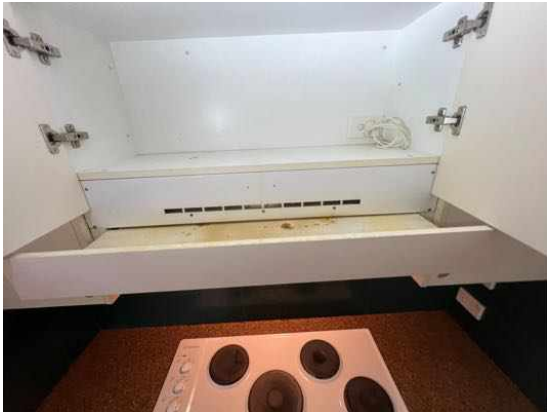
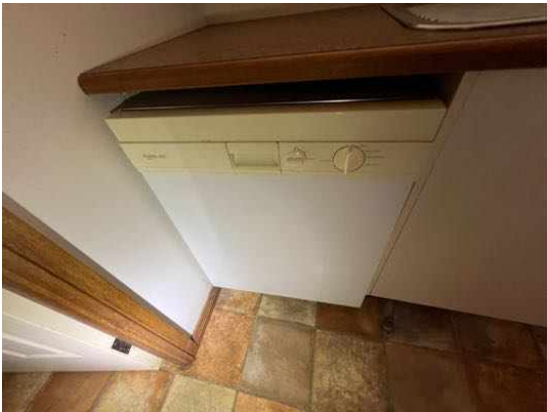
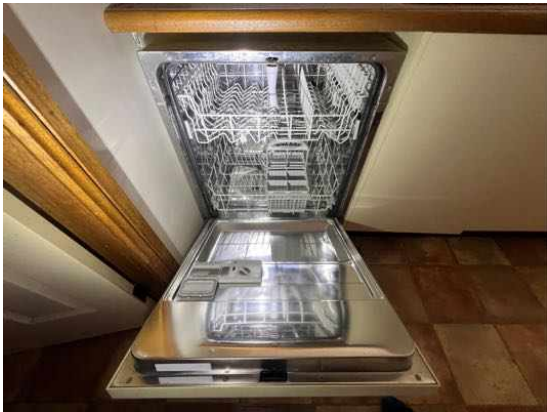
Building: Main Building
Location:
Finding: FYI - Additional Photos
Information: Additional photos are provided for your general reference and may include obstructions, testing of water & windows, moisture readings or minor maintenance items.

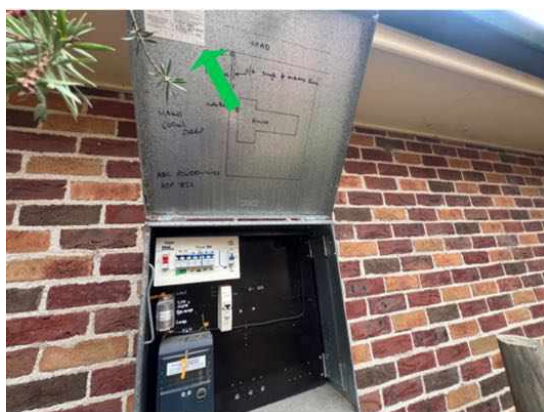
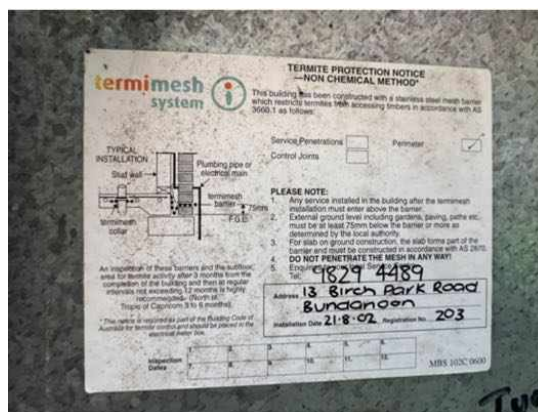
The following items were noted as - Evidence of a previous termite management program

Where a Termite Management System has been identified you should refer to the type of barrier date of installation warranty conditions and any documentation provided by a builder or past owner. Consult the company who installed the barrier to confirm whether the system is still under warranty.

Most chemical termite management systems expire and require replenishment and all physical systems are primarily designed to prevent concealed entry.
