Building Inspection Report

Inspection Date: Thu, 9 Apr 2026

Property Address: 55 Seaway Rd, Hallett Cove SA 5158,
Australia

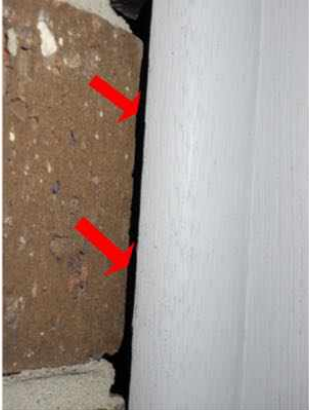
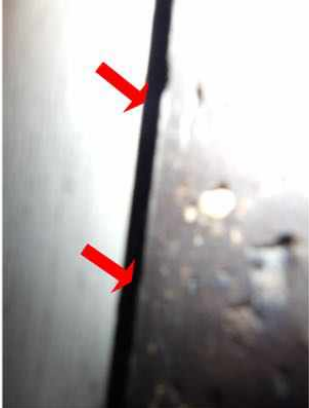
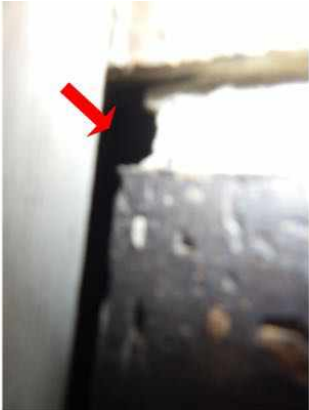
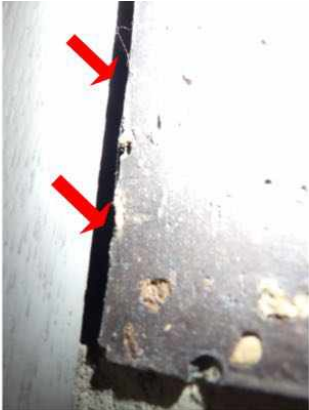
Defects 3.02

Breakage occurs generally when the building materials have either aged and decayed, or as a result of damage (accidental or deliberate).

Repair and/or replacement of broken elements is advised to ensure that additional secondary defects do not arise as a consequence. Such works are necessary, as all building elements play a key role in the operation and function of the overall structure and its performance.

A relevant tradesperson should be appointed to repair or replace the affected building element prior to any subsequent damage being caused.

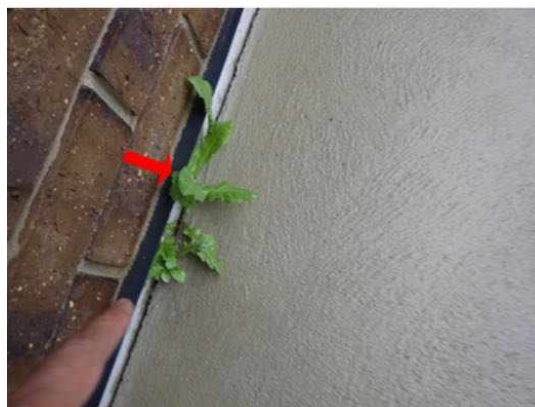
Defects 3.04

as it provides a bridging point for the access of termites, full inspection can not be achieved. Consequently moisture or dampness may be present and the areas becomes conducive to termite activity. Plants against or very close to buildings provide cover, shade and can provide an environment that is attractive to termite infestation.

The removal and replanting of species that do not provide "cover" or cutting back of existing vegetation will assist greatly in preventing Bridging from occurring.

The removal of any such materials that may be conducive to termite activity should be carried out as soon as possible and arrange re inspection to minimize the risk of termite attack.

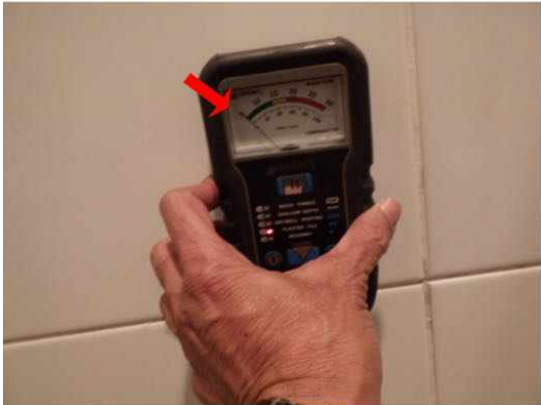
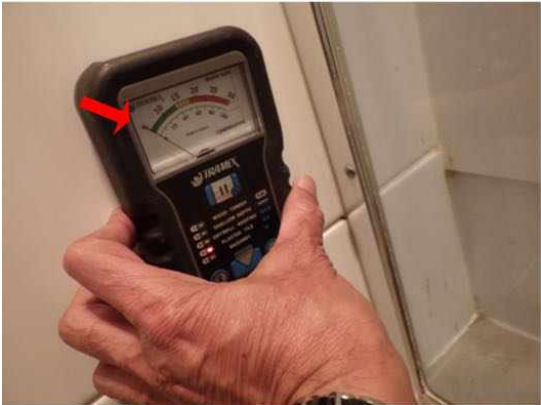
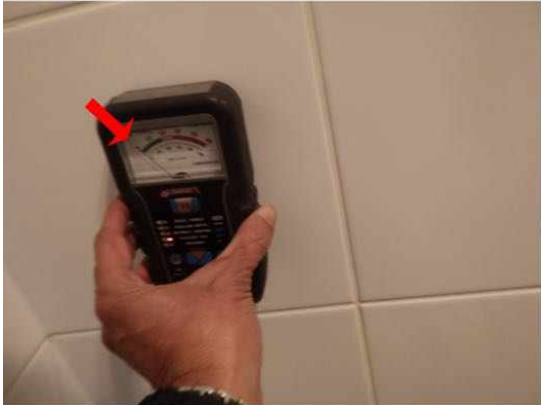
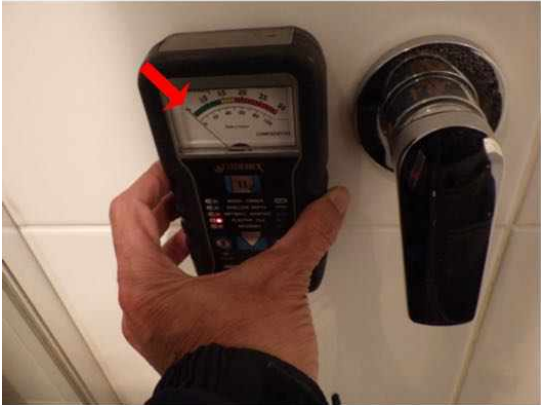
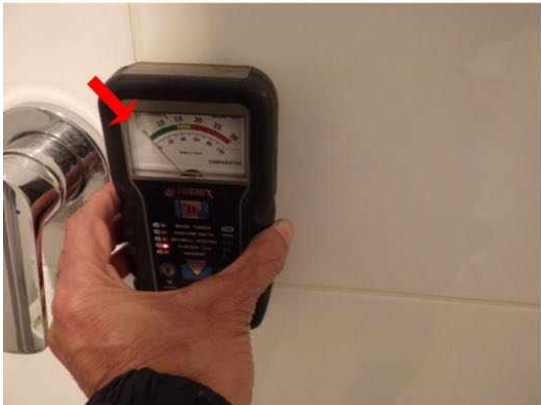
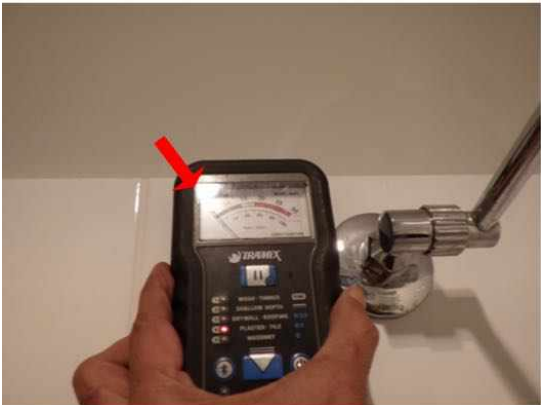
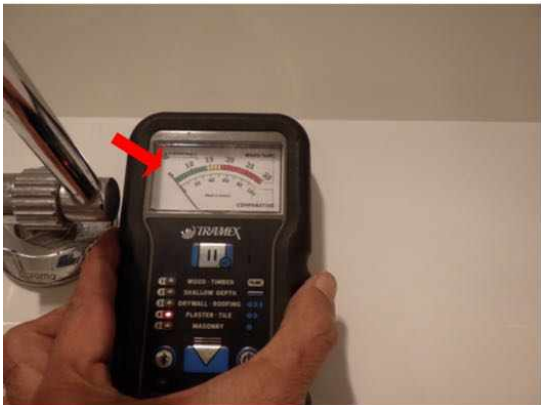
Noted Item

Building: Building 1
Location: Bathroom 2
Finding: Shower Alcove - No Damp
Information: At the time of inspection it was noticed that damp is not evident to the shower alcove.

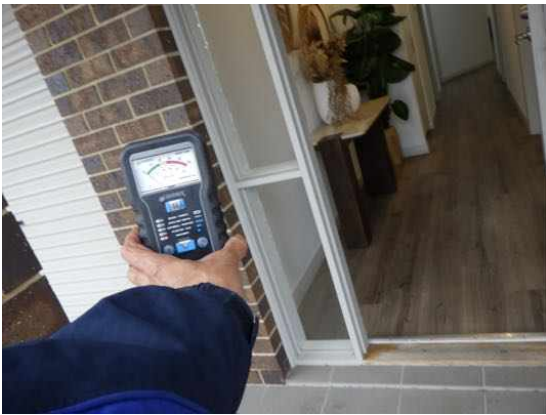
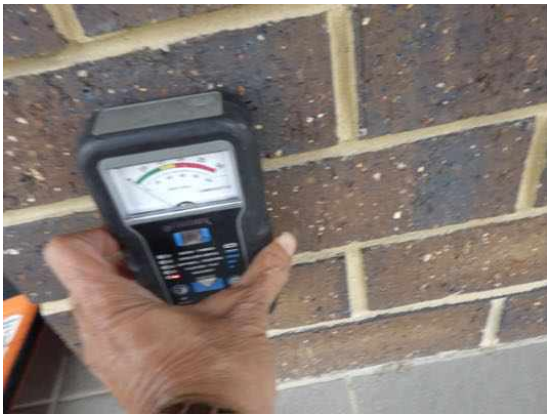
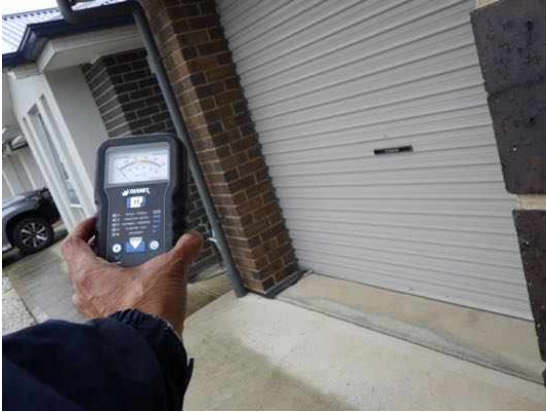
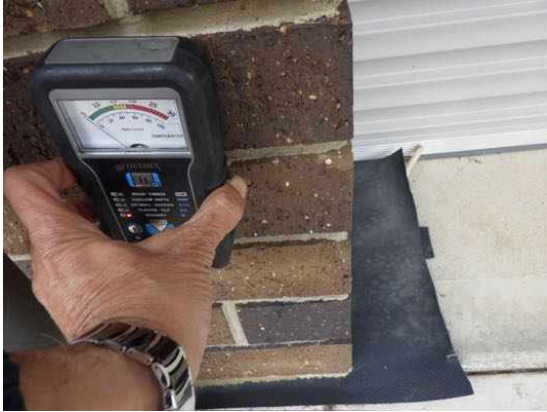
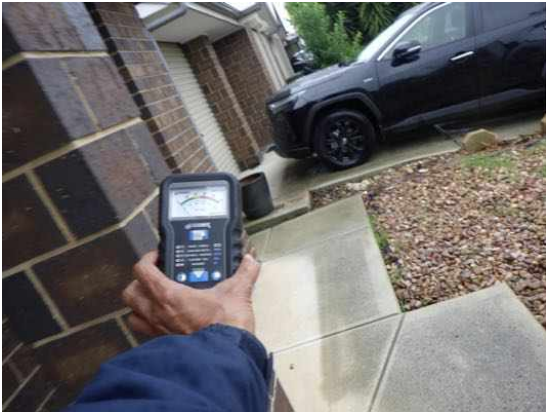
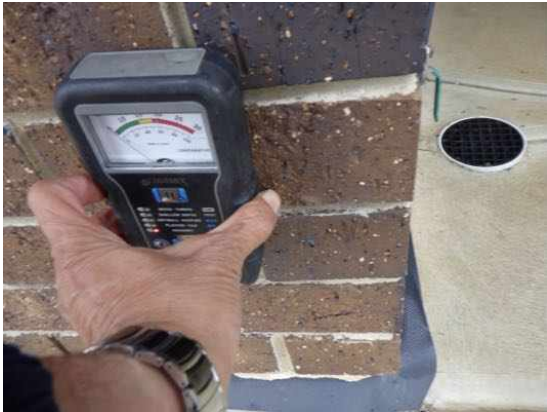
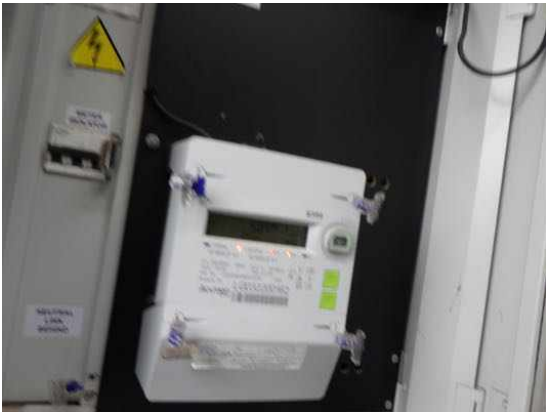
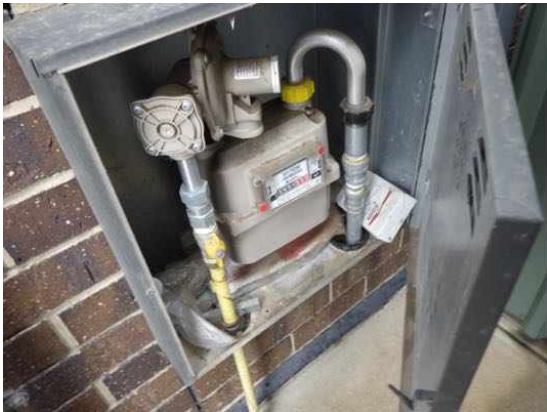
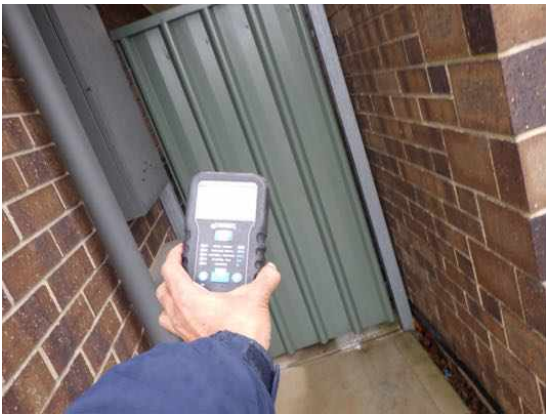
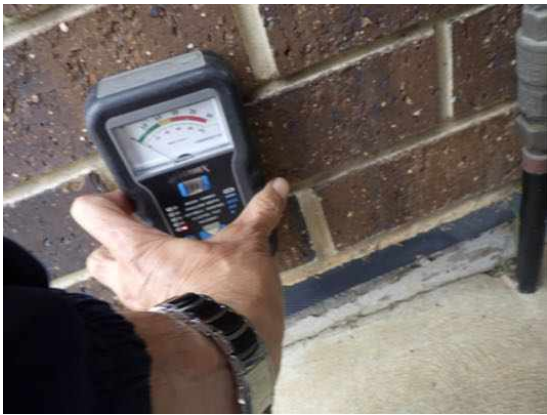
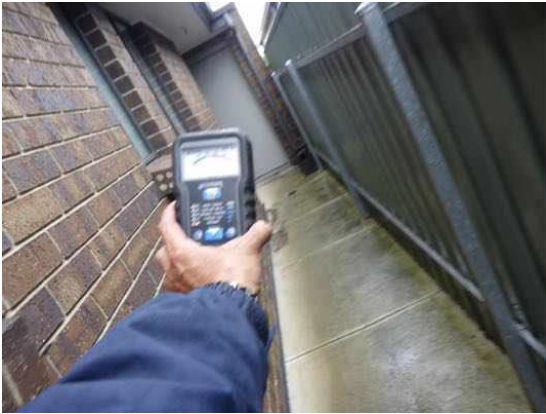
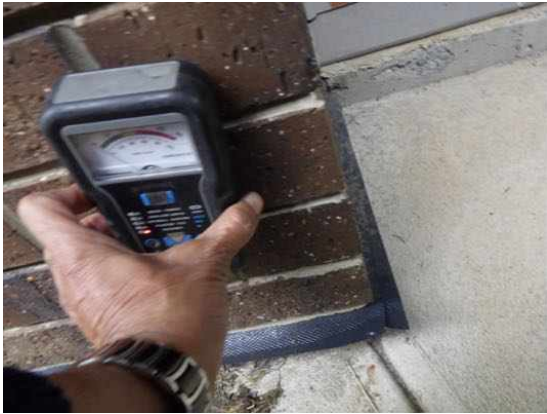
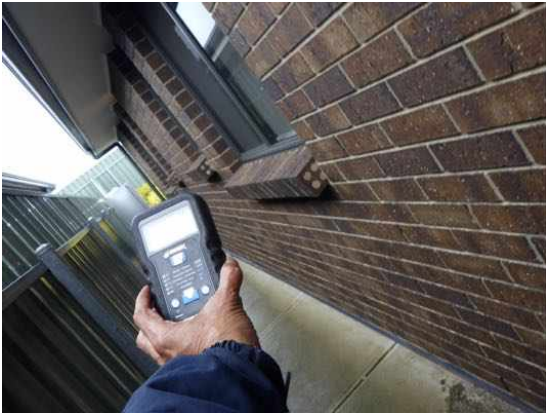
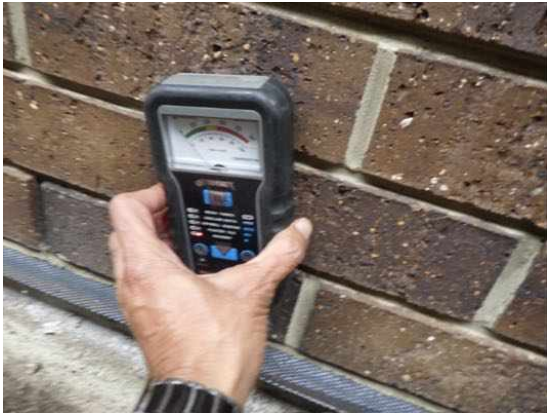
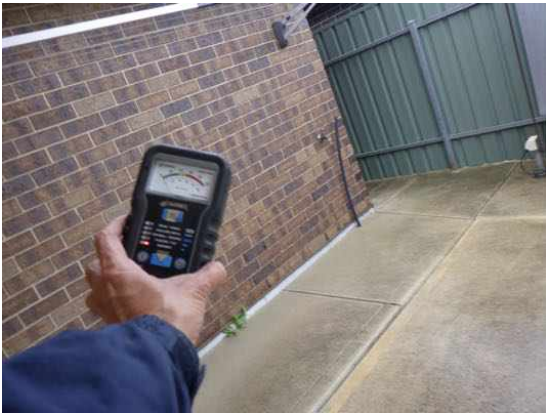
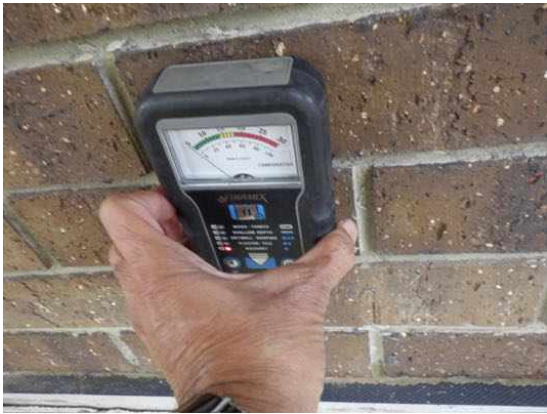
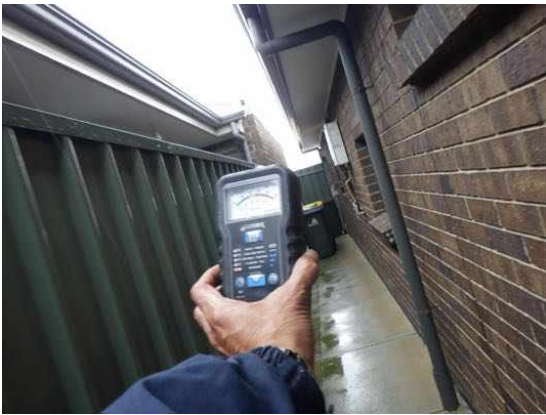
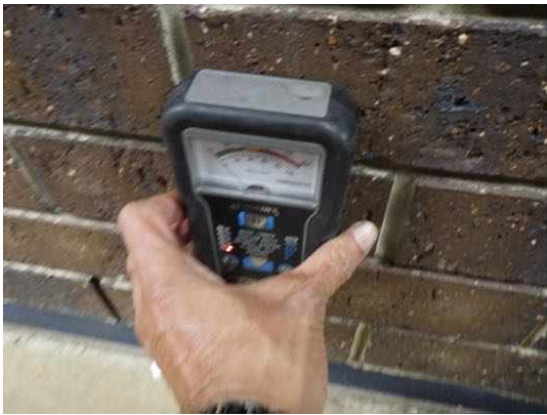
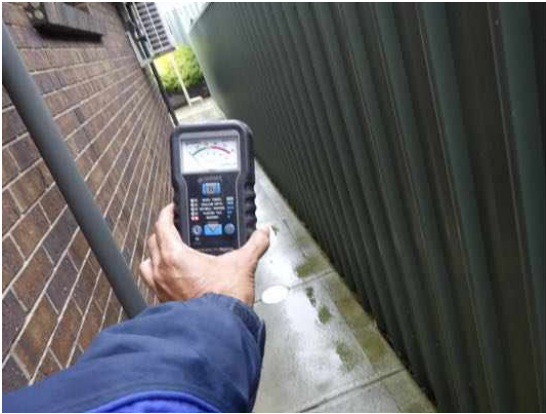
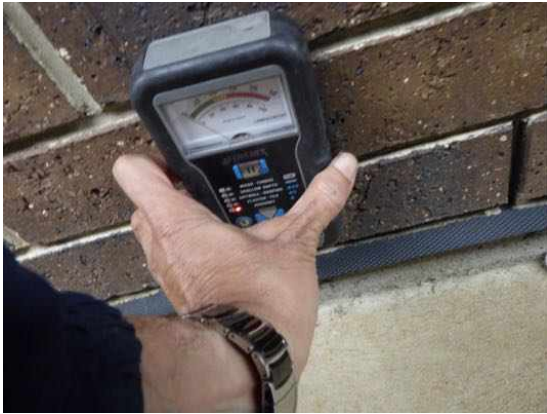
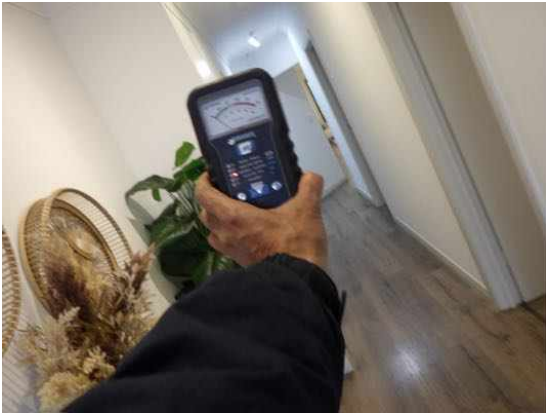
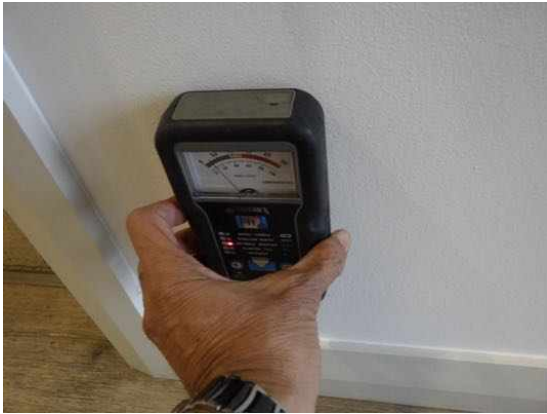
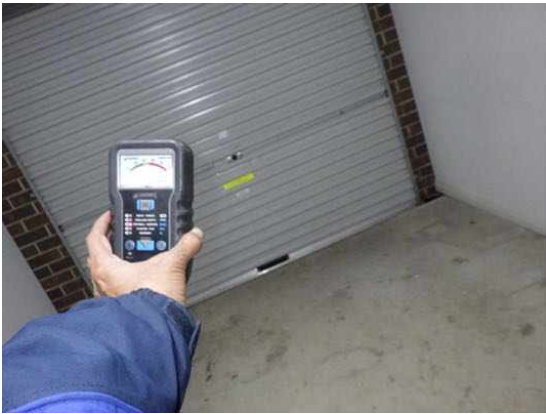
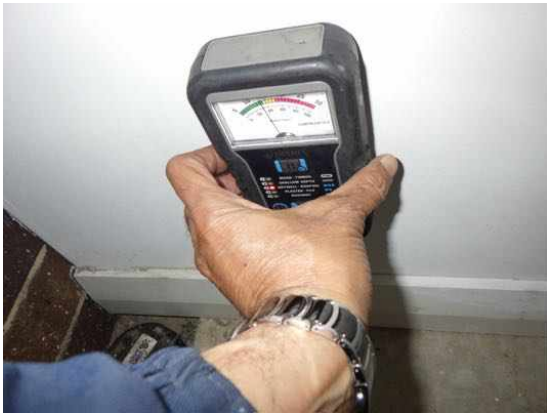
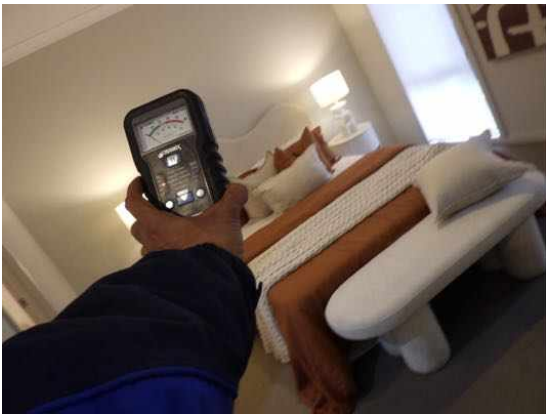
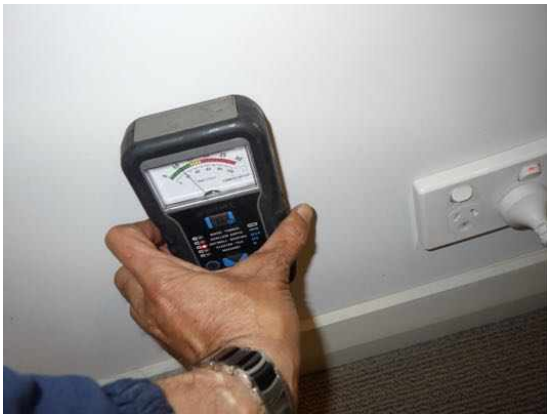
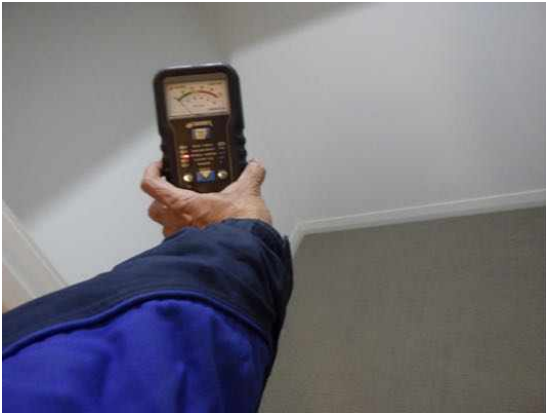
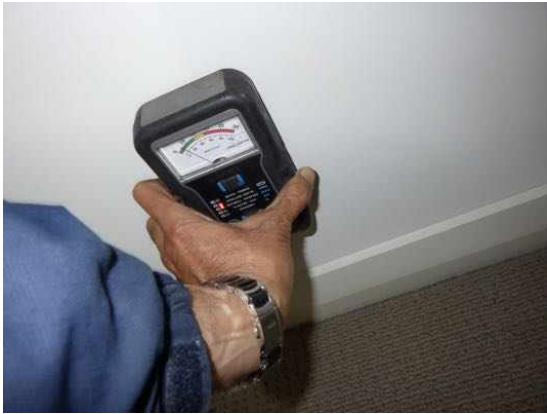
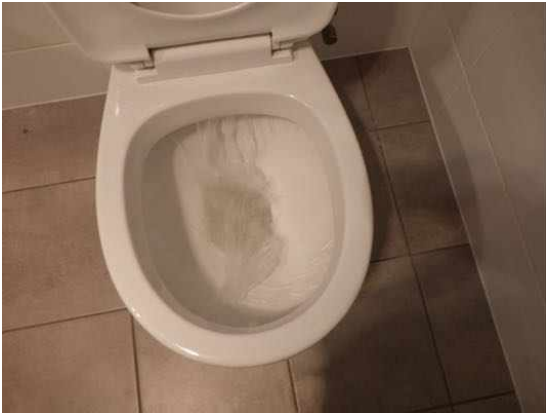
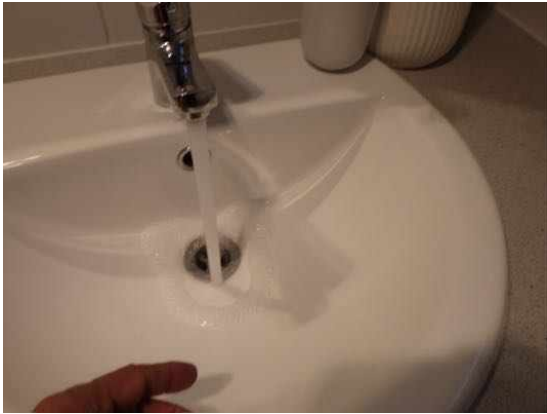
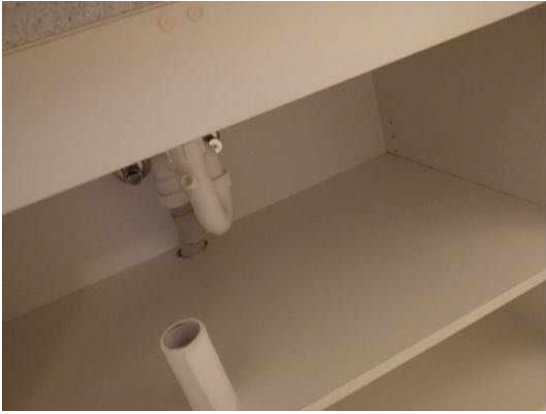
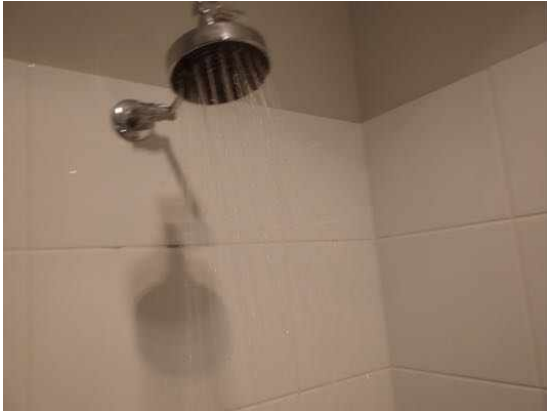
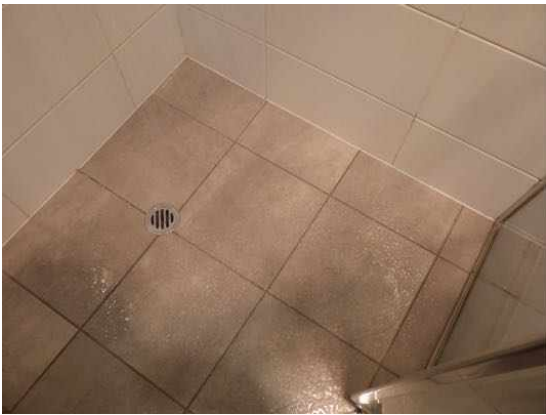
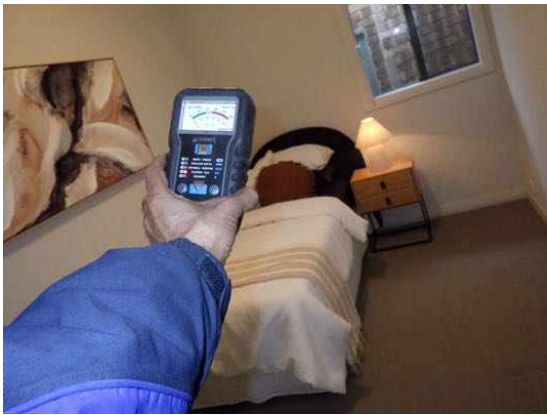
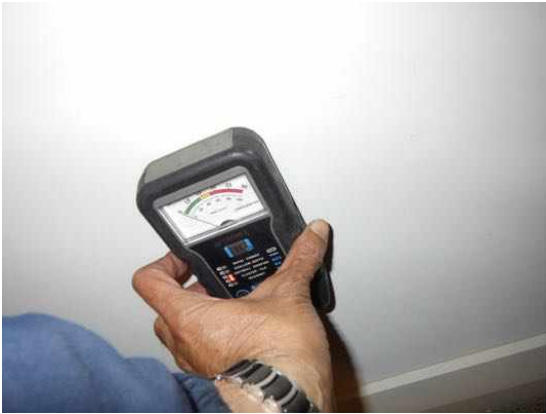
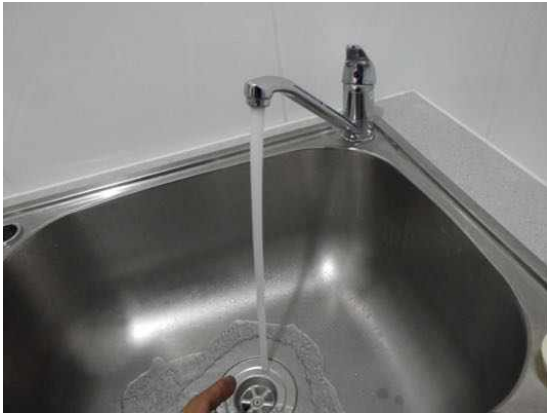
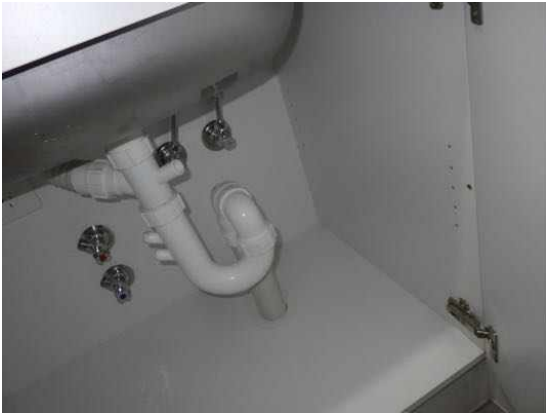
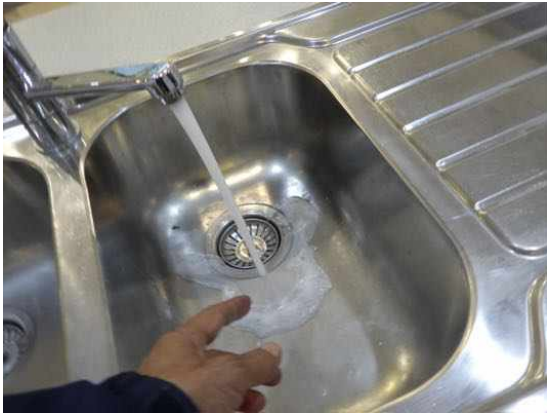
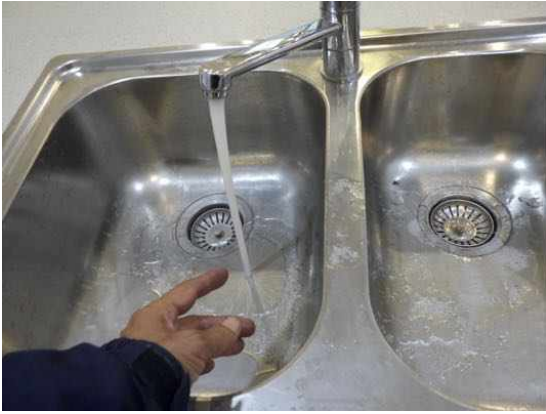
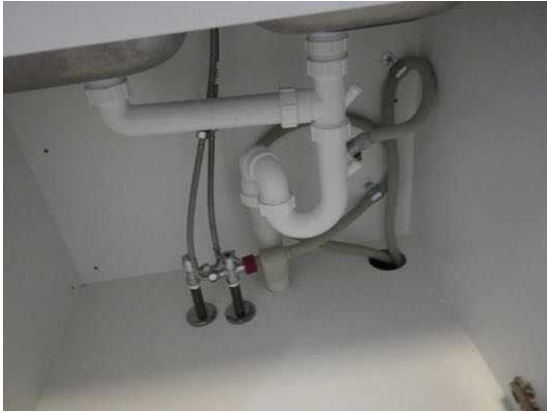
Building: Building 1
Location: All Areas
Finding: Additional Photos
Information: Additional photos are provided for your general reference
