Building Inspection Report

Inspection Date: Thu, 1 Jan 2026

Property Address: 37 Leopold St, Caulfield South VIC 3162,
Australia

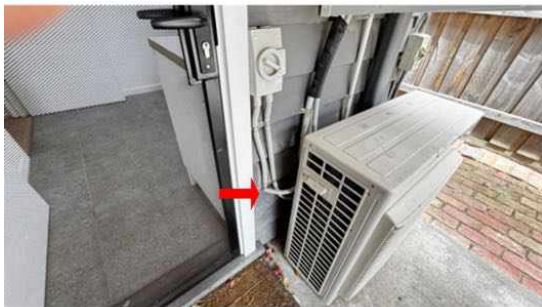
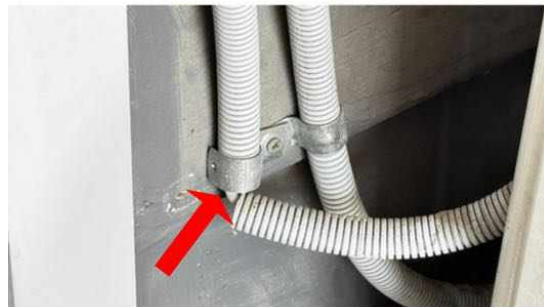
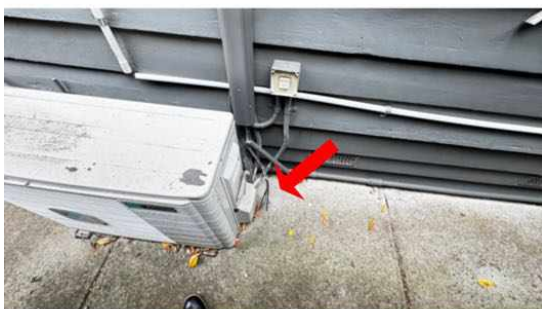
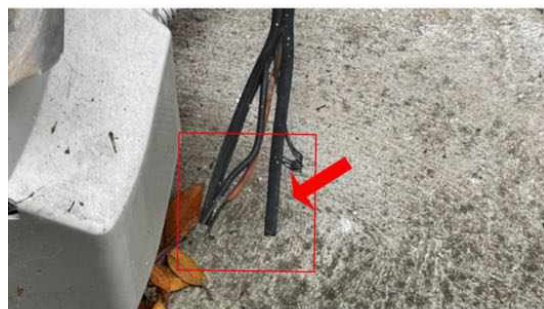
Defects 1.01

Building:	Main Building
Location:	External Walls
Finding:	Electrical - Exposed Wiring
Information:	Exposed electrical wiring was observed in this area. This condition presents a significant risk of electric shock, fire, or injury if left unattended.

Possible causes include previous incomplete or unlicensed electrical work, accidental damage during renovations or maintenance or relocation of fittings leaving wiring exposed.

Immediate inspection and rectification by a licensed electrician is strongly recommended. The wiring should be secured, protected, and made compliant with current electrical safety standards without delay.

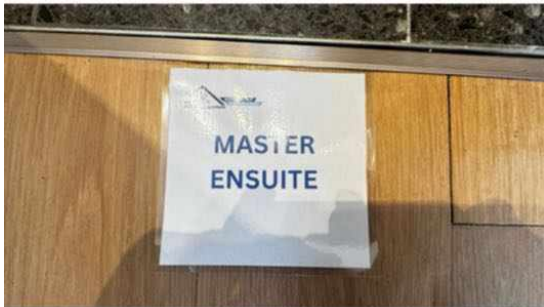
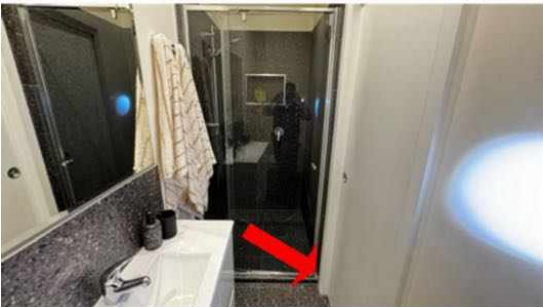
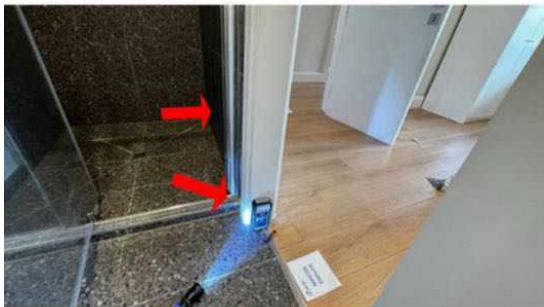
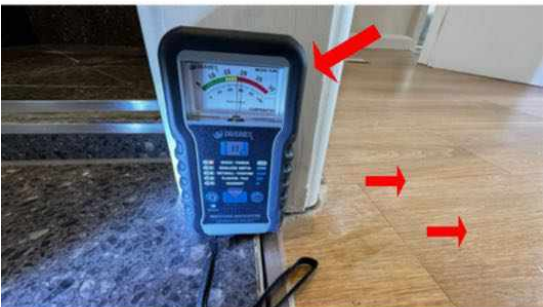
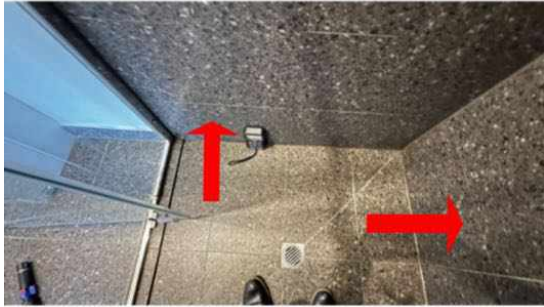
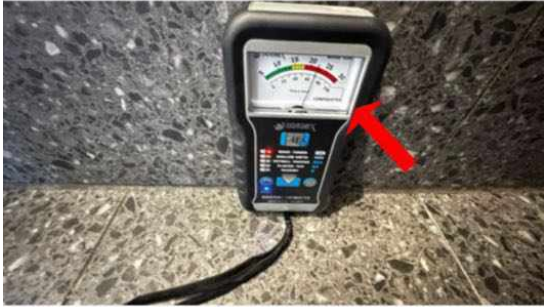
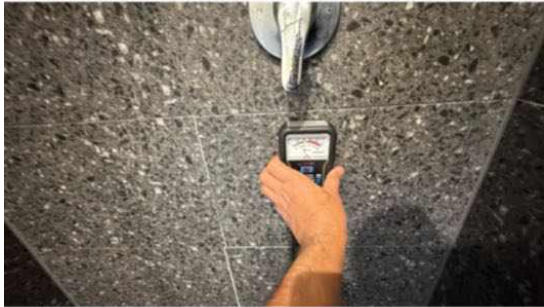
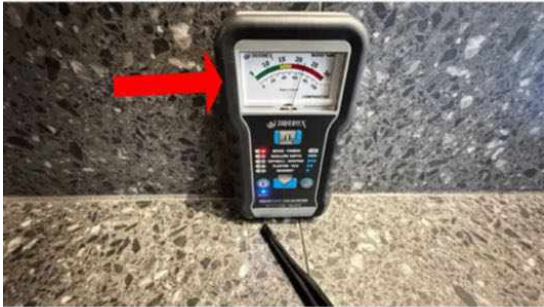
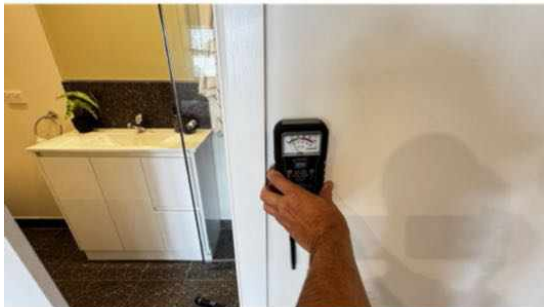
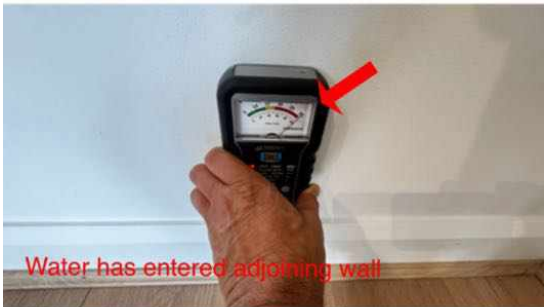
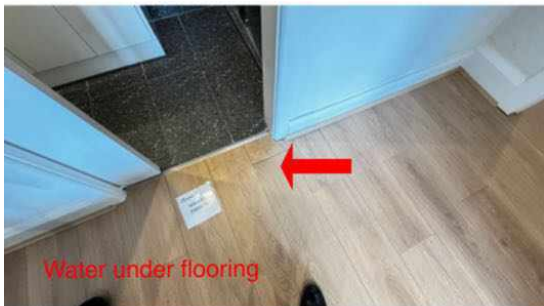
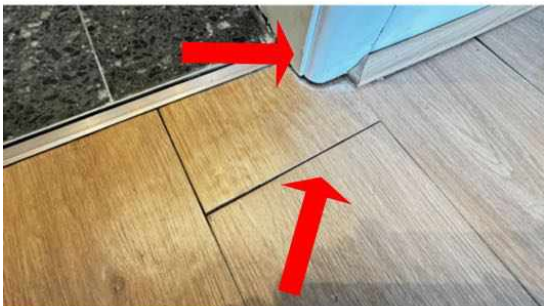
Defects 2.01

Finding: Showers - Leaking

Information: Leaking was observed in this area at the time of inspection and is suspected to be due to poor original waterproofing and maintenance. While the leakage appears minor, unfortunately moisture has now spread to adjoining walls and other building elements.

Ongoing water penetration may result in damage to surrounding cabinetry, wall linings, or flooring, potentially leading to further deterioration and mould growth.

It is recommended that a licensed plumber be engaged immediately to assess the shower and carry out any necessary repairs or replacement to prevent further damage.

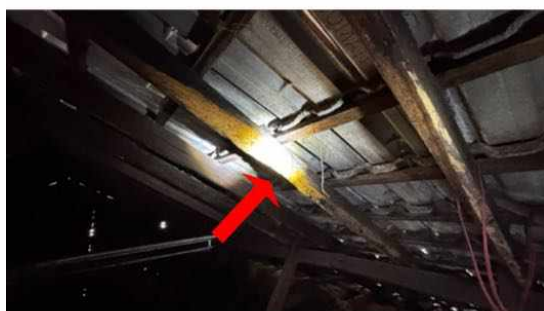
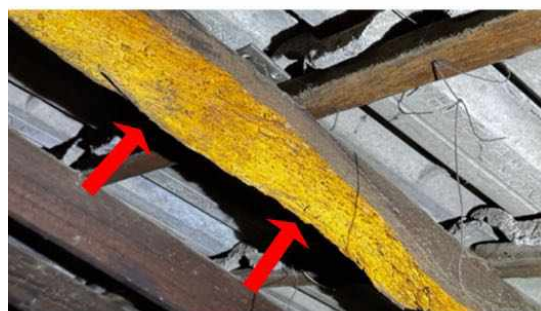
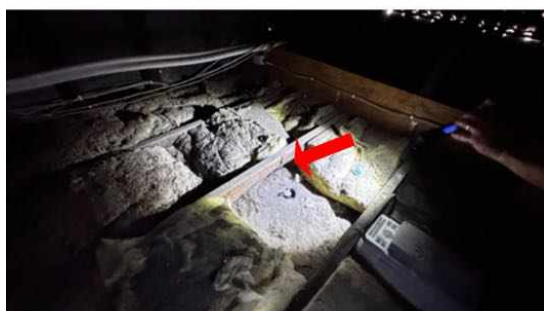
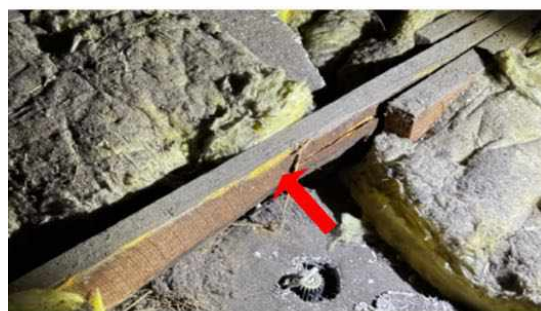
Defects 2.02

Building: Main Building
Location: Roof Void >
Finding: Roof Void - Structural Roof Framing Damaged - Timber Borers
Information: During inspection of the roof space, structural members including rafters, trusses, and/or joists were observed to be significantly damaged as a result of timber borer activity. This condition constitutes a major defect, as deterioration of primary structural members can compromise the load-bearing capacity, stability, and long-term performance of the roof structure.

Timber borer damage is progressive in nature and, if not promptly addressed, may result in further loss of structural integrity and increased risk of failure to affected elements.

It is recommended that a registered builder be engaged immediately to assess the extent of damage and carry out replacement of all affected structural members as required. A licensed pest control specialist should also be consulted to treat the infestation and prevent further attack prior to or in conjunction with structural repairs.

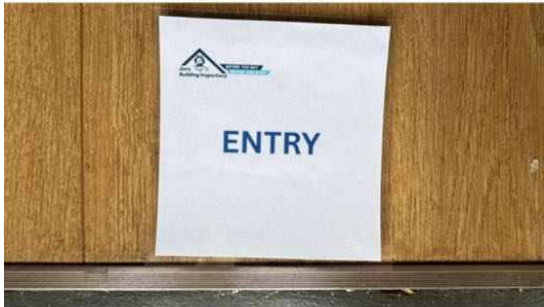
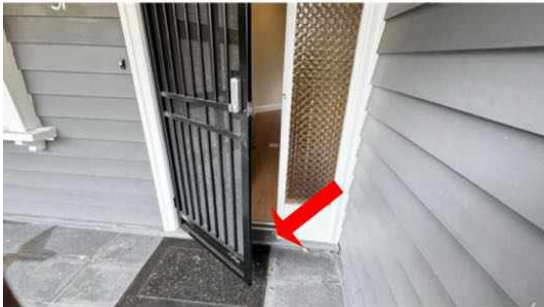
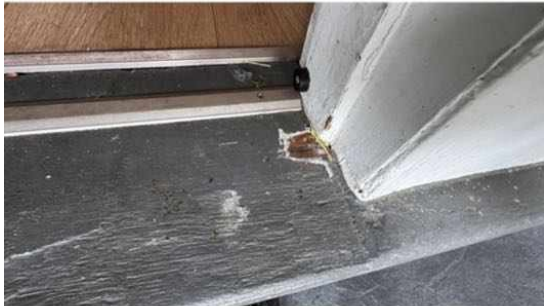
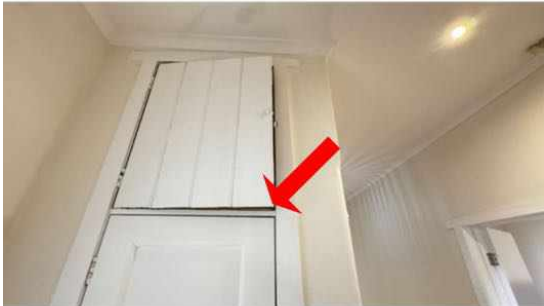
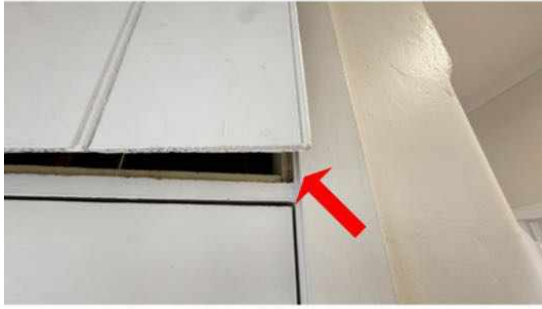
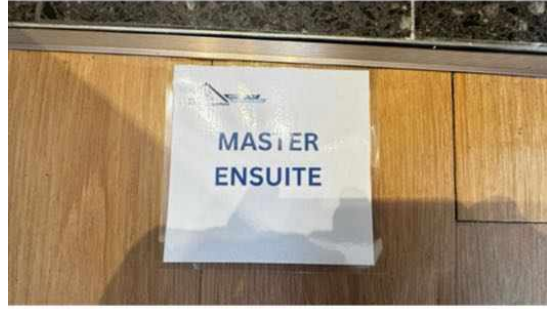
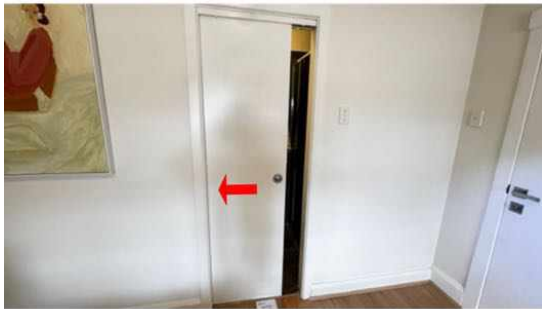
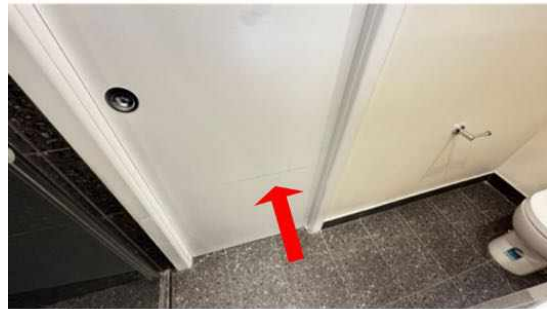
Defects 3.01

Building: Main Building
Location: All Areas
Finding: Doors - Doors Binding
Information: Binding or jamming of the door was observed in this area. This affects door functionality and may cause secondary damage to surrounding building elements, such as floor coverings.

Binding can result from minor issues, including poor installation, worn hinges, or misalignment, or from more significant structural problems, such as subfloor movement or damage.

When practical, a qualified carpenter should be engaged to inspect and carry out necessary repairs. If the door continues to bind after repair, or if further movement is observed, a registered builder or structural engineer should be engaged immediately to inspect for underlying structural issues.

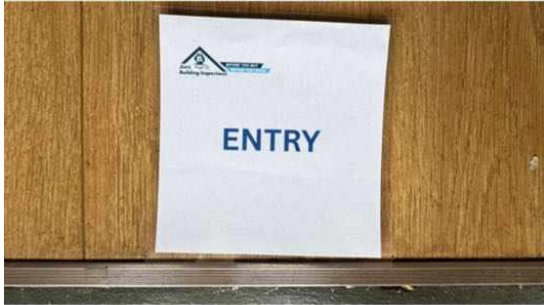
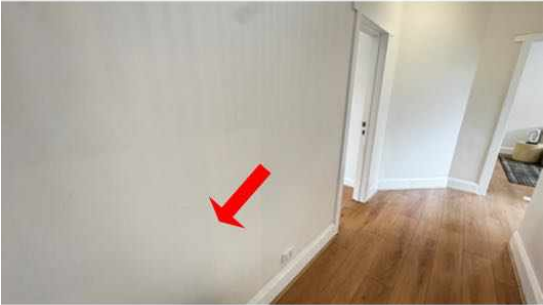
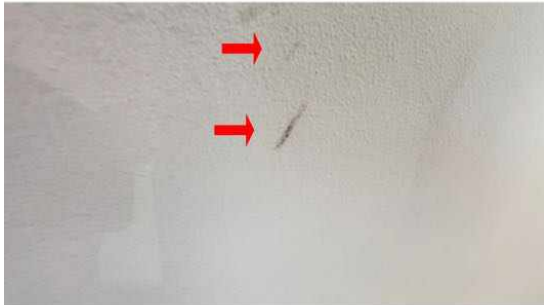
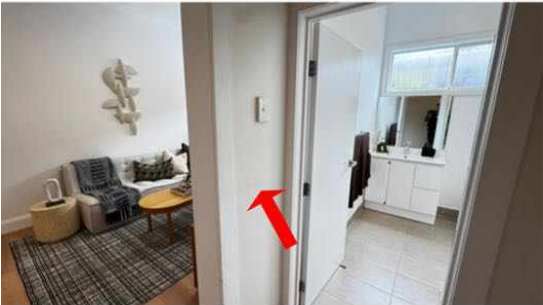
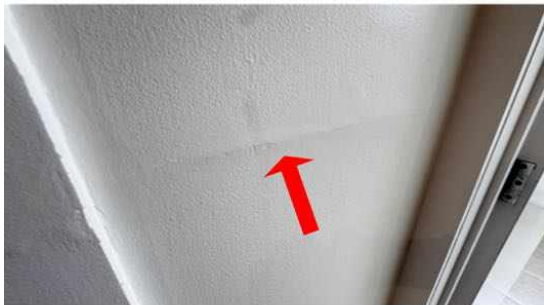
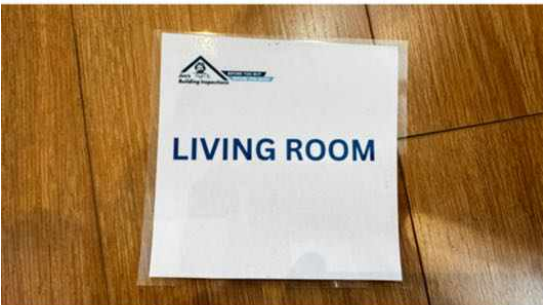
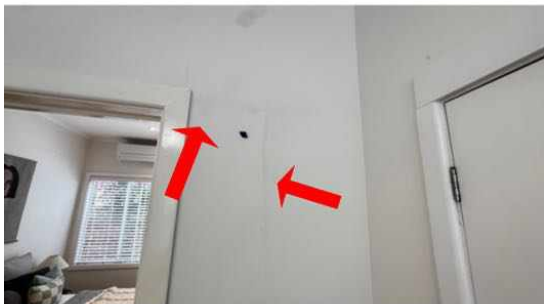
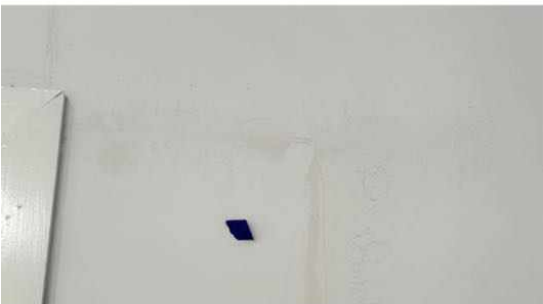
Defects 3.02

Information: The walls were inspected for paint condition, and discolouration was observed. While primarily a cosmetic issue, deteriorated paint may indicate poor surface preparation, or age-related wear.

Possible causes include age-related wear and impact damage.

A qualified painter should be engaged when practical to prepare and repaint affected areas. Addressing paint deterioration improves aesthetics and protects wall materials from further wear.

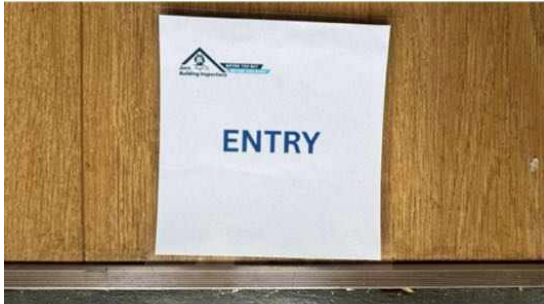
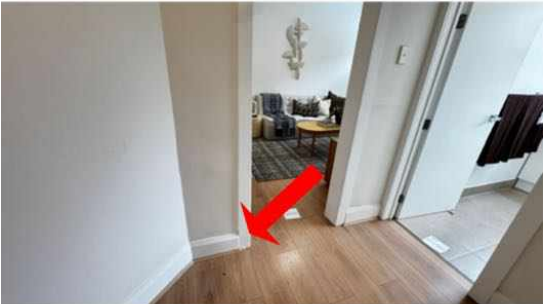
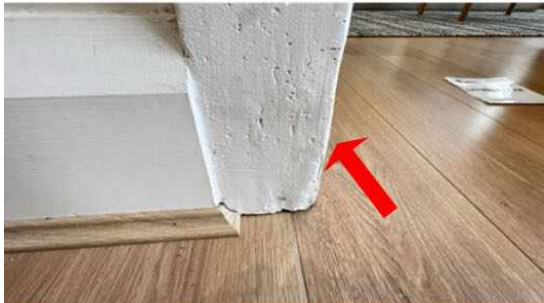
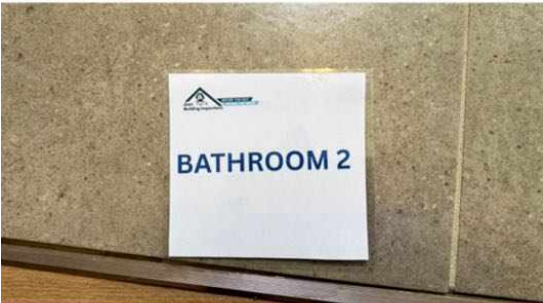
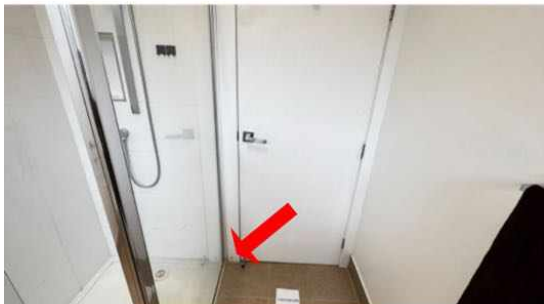
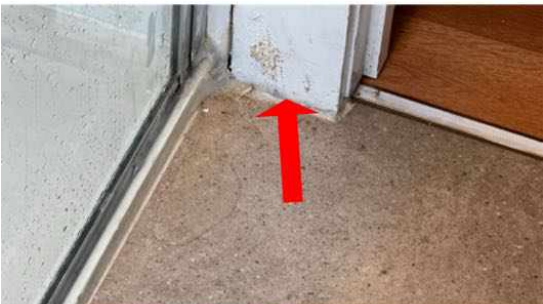
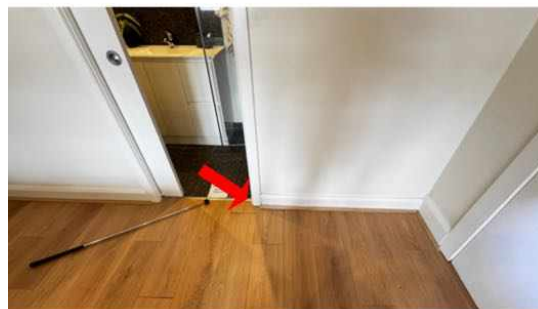
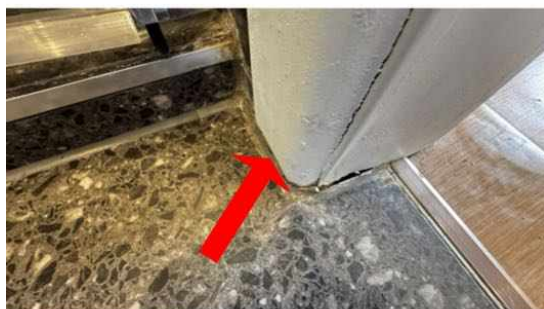
Defects 3.03

Building: Main Building
Location: All Areas >
Finding: Building Element - Swollen
Information: Swollen building elements generally indicate that the building materials have been affected by excessive moisture over a prolonged period of time, and have swollen as a result.

The formation and development of mould/fungi or mildew is also a likely consequence of excessive moisture if left unattended. Excessive moisture is likely to lead to the development of secondary damage to any associated building elements.

Rectification of the cause of the water leak should be addressed prior to any remedial works to the swollen building elements. It is also likely given the previous fridge leaks and damaged the surrounding building elements.

A licensed plumber, bathroom specialist or licensed remedial builder should be appointed to identify the cause of the leak and provide advice on remedial works as necessary.

Repair and/or replacement of swollen building elements may then be conducted by a qualified carpenter or general handyman at the clients discretion.

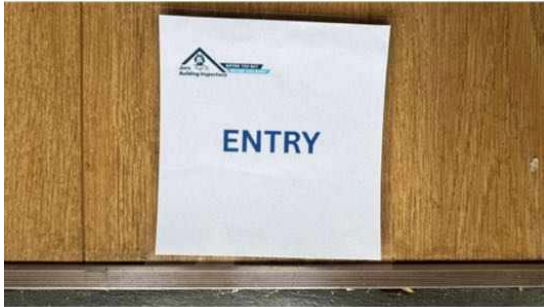
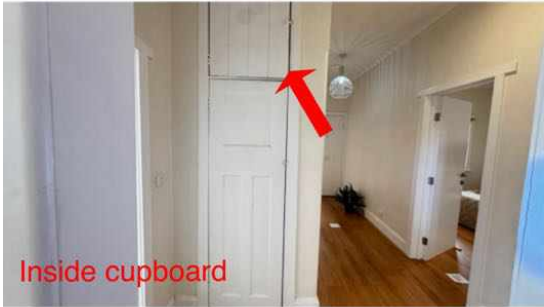
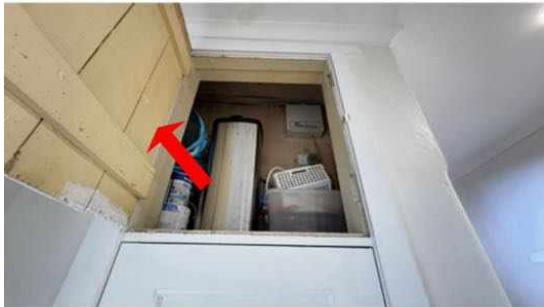
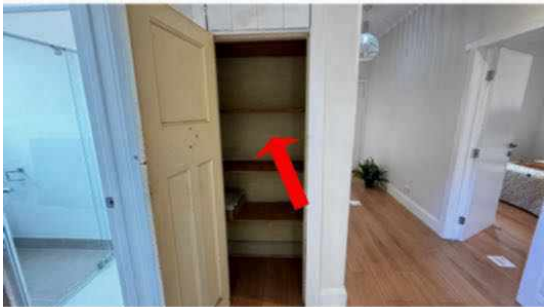
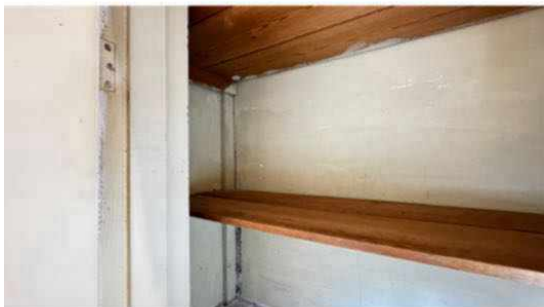
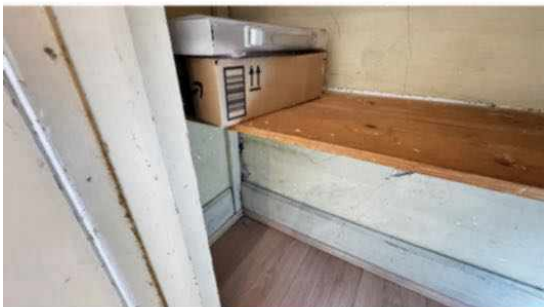
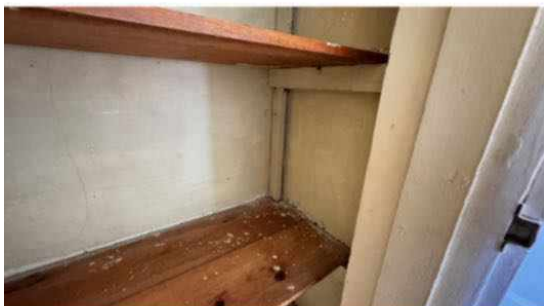
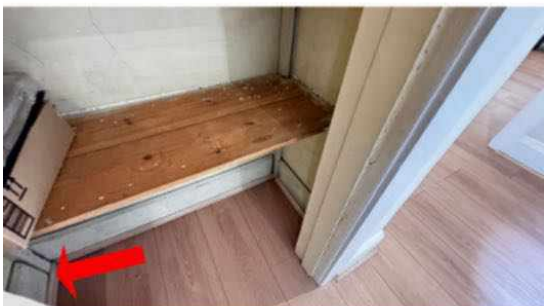
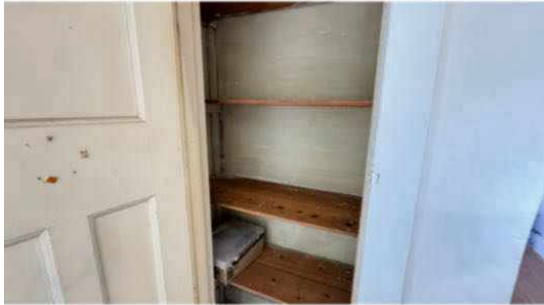
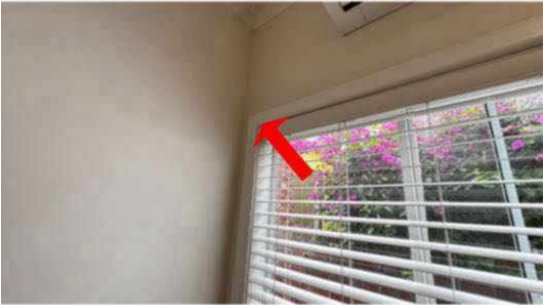
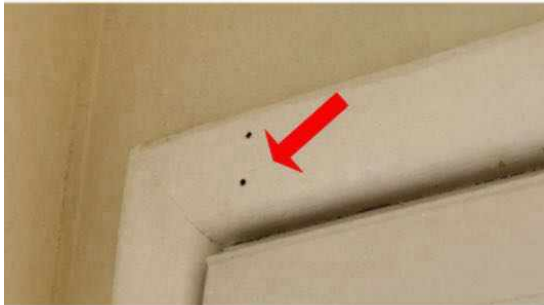
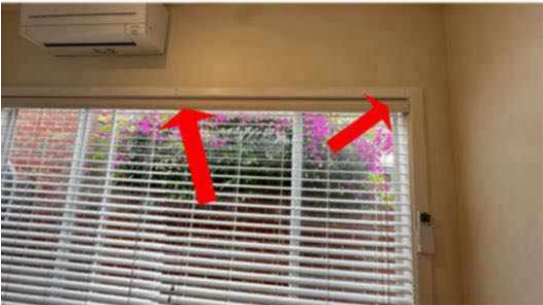
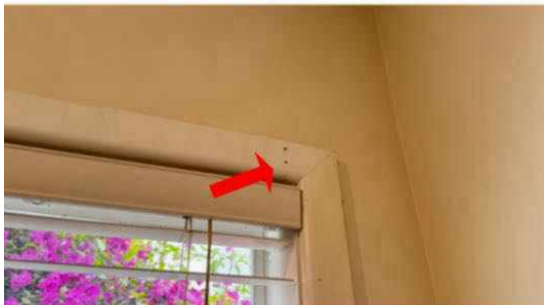
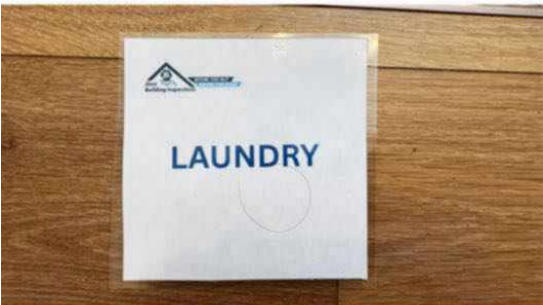
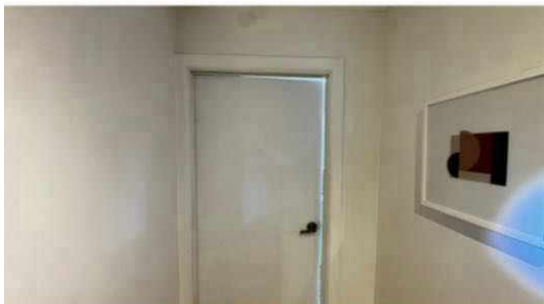
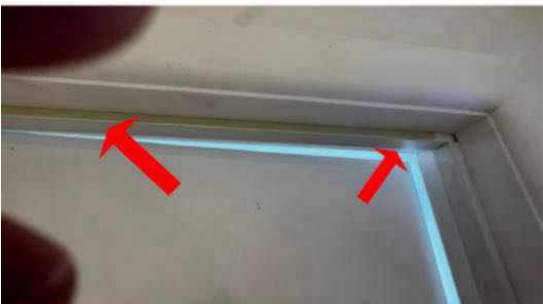
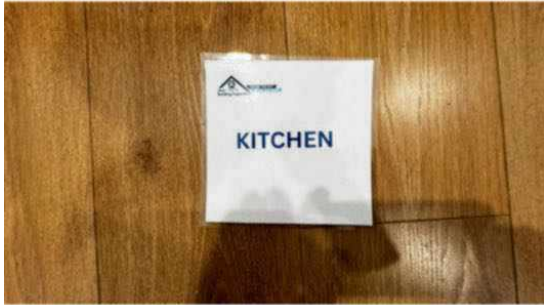
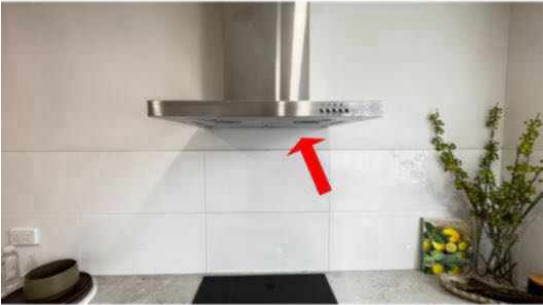
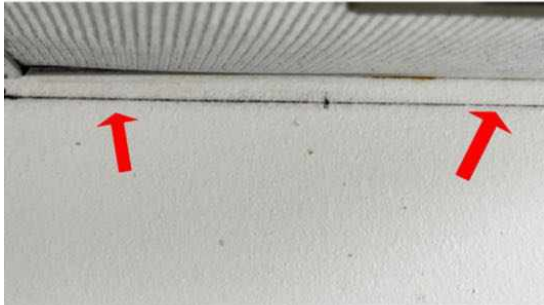
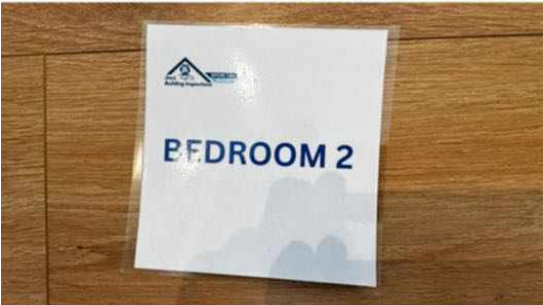
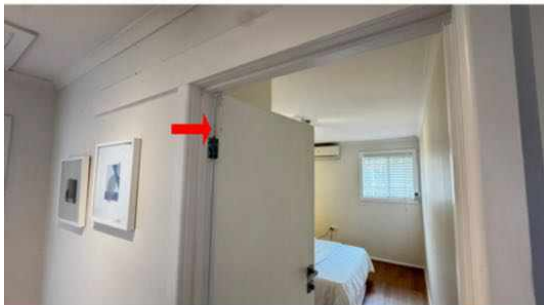
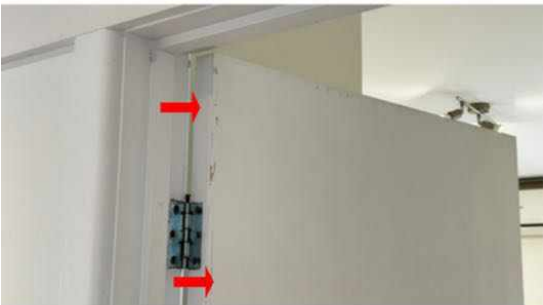
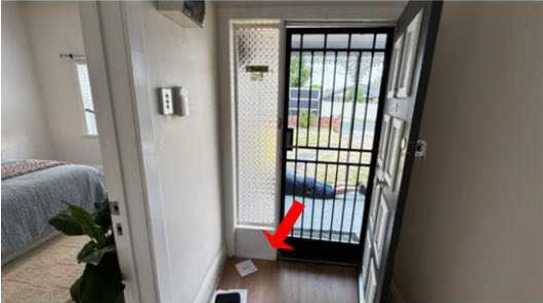
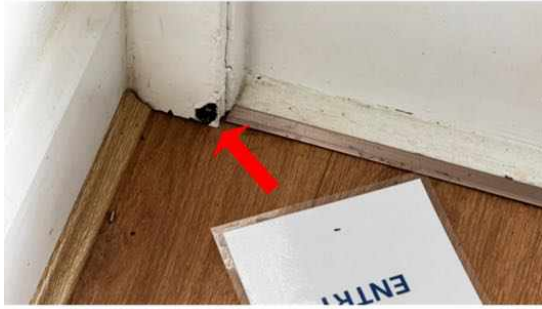
Defects 3.04

Building:	Main Building
Location:	All Areas >
Finding:	Paint - Paint Finish Substandard
Information:	The paint finish in this area was found to have been completed to a substandard level. Substandard painting is generally classified as an appearance defect. However, the substandard appearance may also be indicative of poor surface preparation and substandard workmanship.

If this applies, further areas of poor and incomplete finishes could develop over time. Furthermore, substandard paint finishes in areas exposed to moisture, e.g. external areas or wet areas, could lead to deterioration of underlying building materials.

Substandard paint finishes should be sanded back, filled, leveled and repainted, as applicable. Where inadequate paint protection has led to the deterioration of the associated building element, repair and/or replacement of this building element may be required.

A painting contractor should be appointed as soon as possible to perform necessary works to aid the appearance of the affected area and to ensure that the area is protected against further deterioration. Alternatively, the homeowner following manufacturer instructions may be able to provide this service.

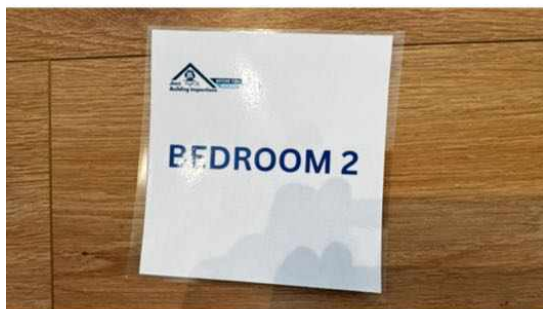
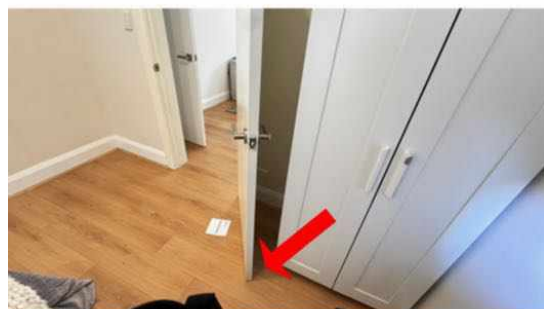
Defects 3.05

Finding: Doors - Missing Door Stops

Information: The inspection identified missing door stops in this area. Missing door stops can lead to damage to walls or doors and may impair the proper operation of the doors.

The absence of door stops may be due to them not being installed during construction or having been removed after installation.

It is recommended that a qualified carpenter or competent handyman be engaged promptly to install the missing door stops. Correct installation will protect doors and walls and ensure proper door functionality.

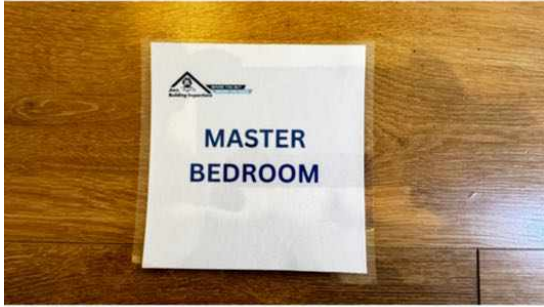
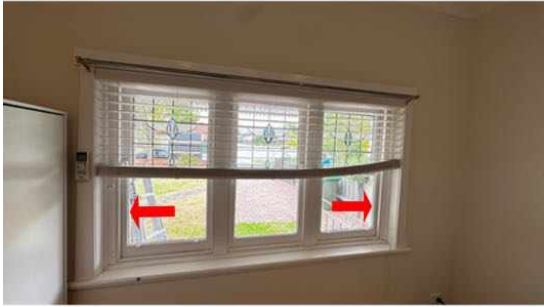
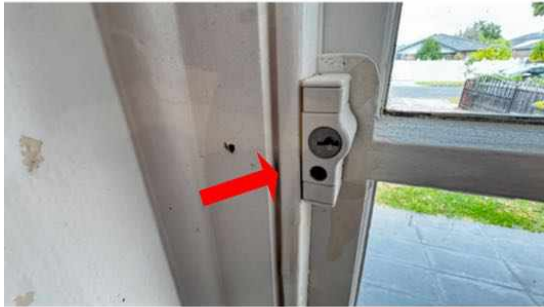
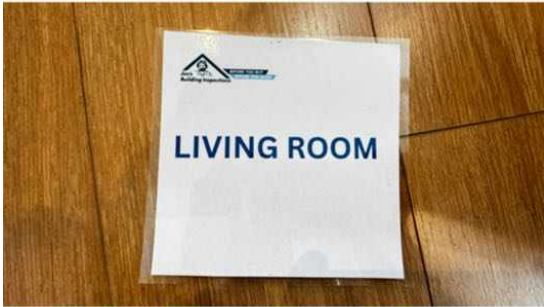
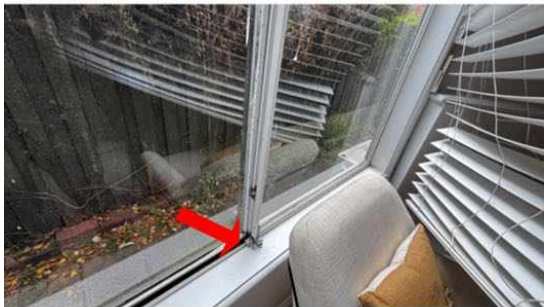
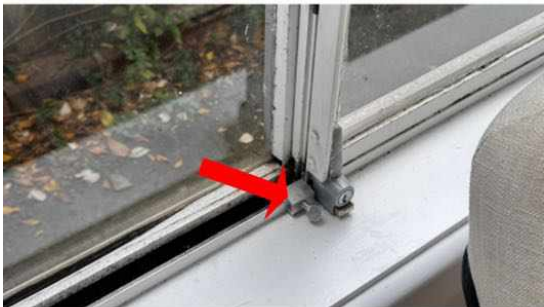
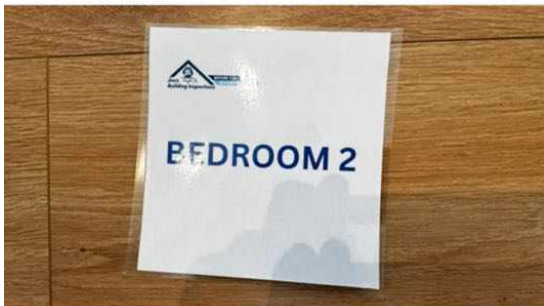
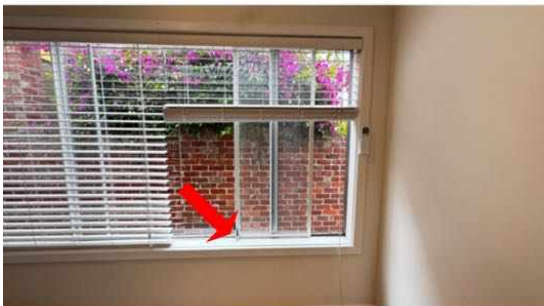
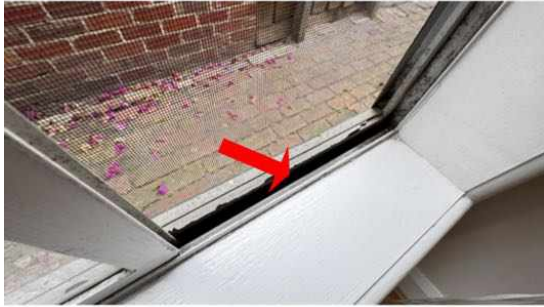
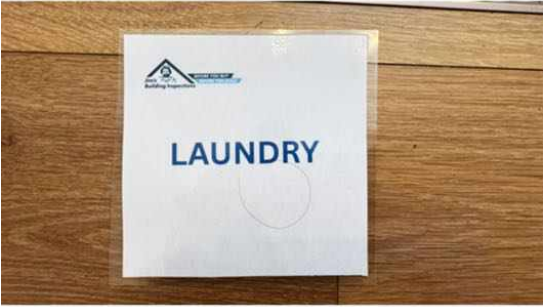
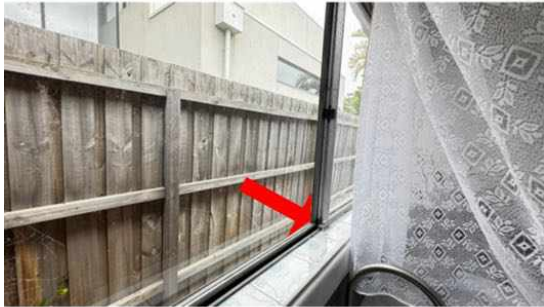
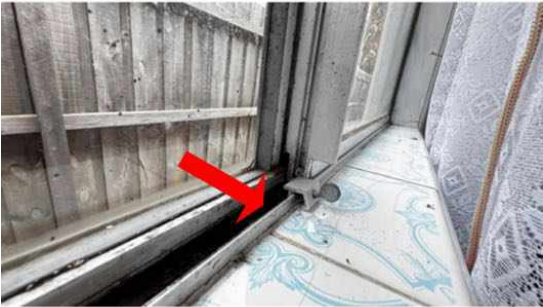
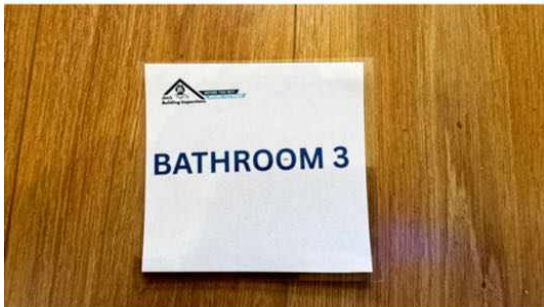
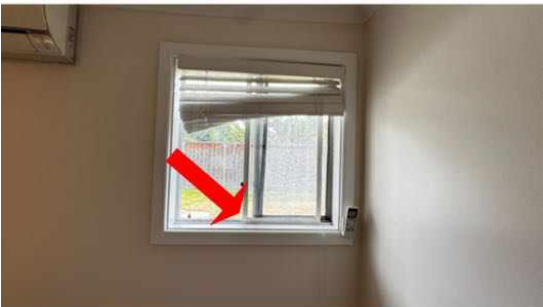
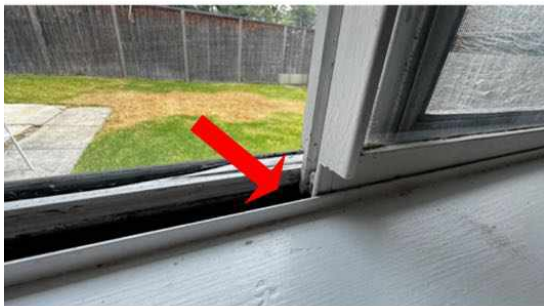
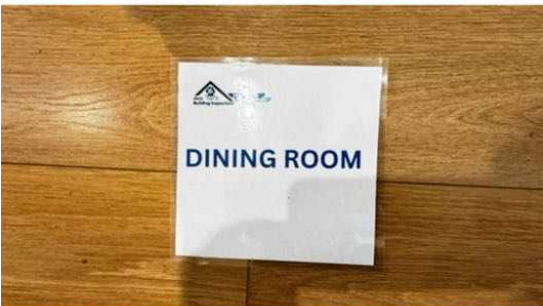
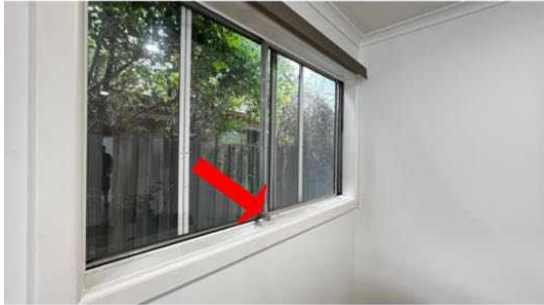
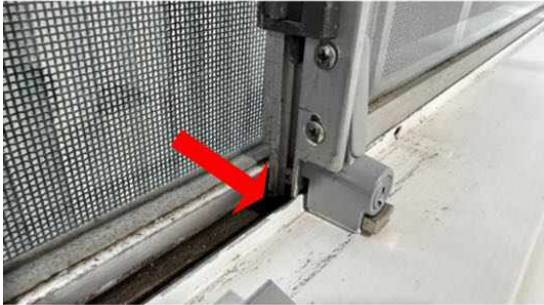
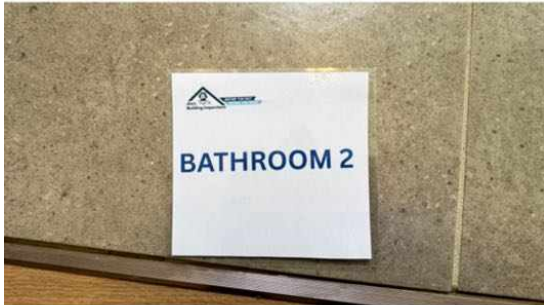
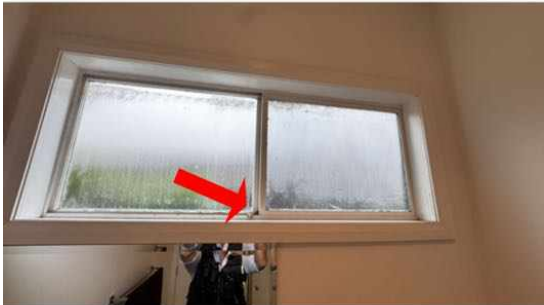
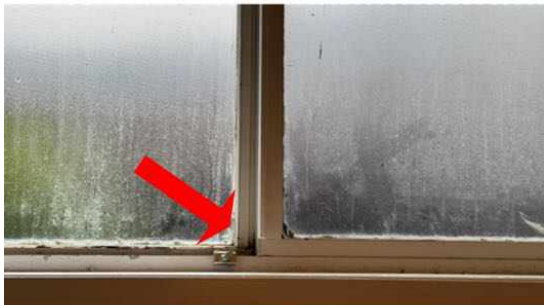
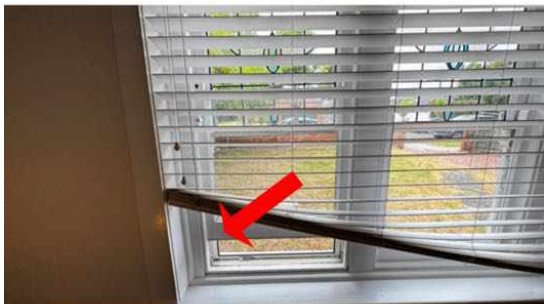
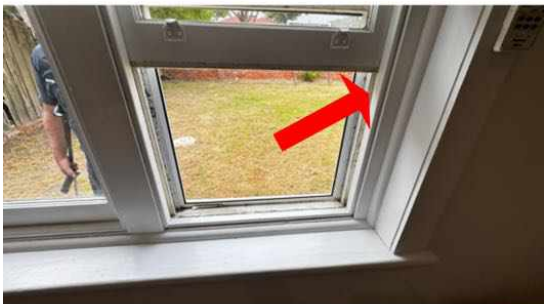
Defects 3.06

Building: Main Building
 Location: All Areas >
 Finding: Windows - Stiff To Open
 Information: Windows were observed to be stiff to open in this area. The stiffness can make the window difficult to operate, reduce usability, and may increase the risk of damage if force is applied.

Possible causes include misalignment, worn hardware, or buildup of debris.

It is recommended that the building owners engage a window specialist or registered builder immediately to assess the window and adjust, repair, or service it to restore smooth operation.

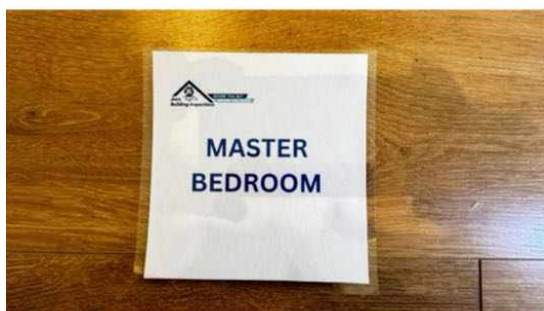
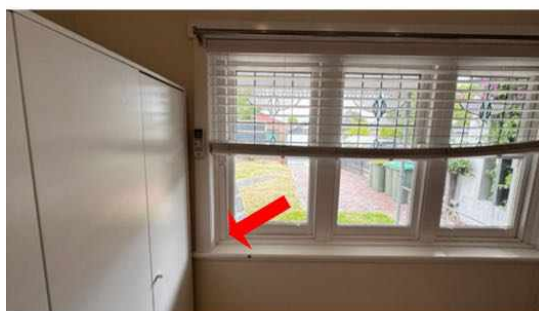
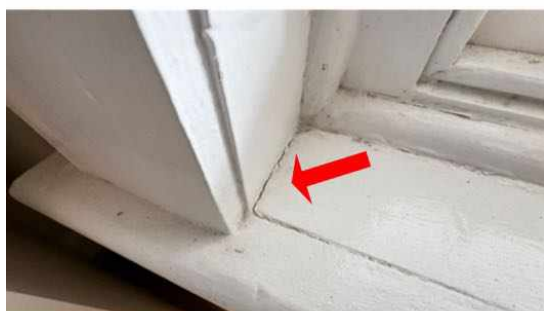
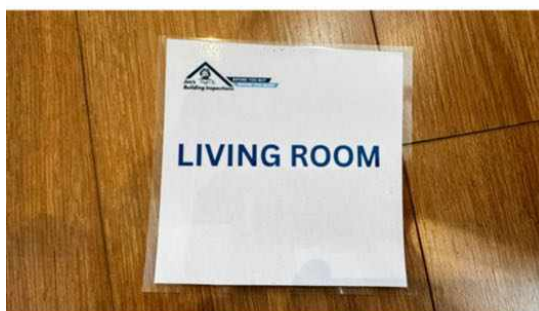
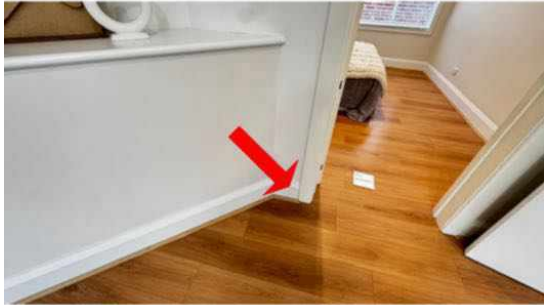
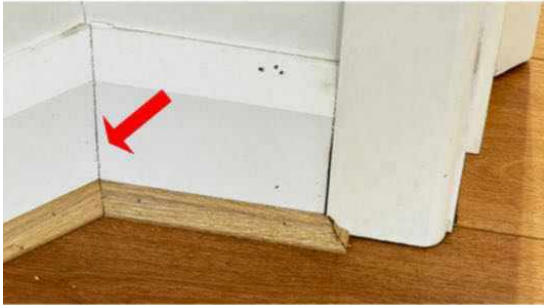
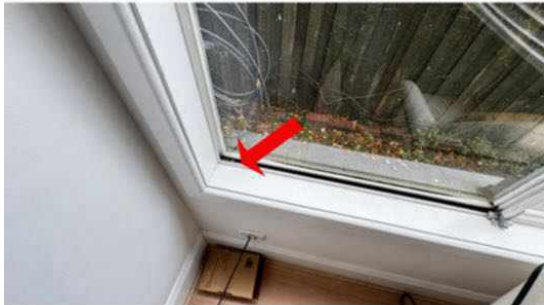
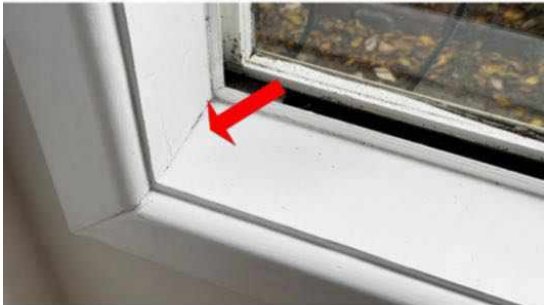
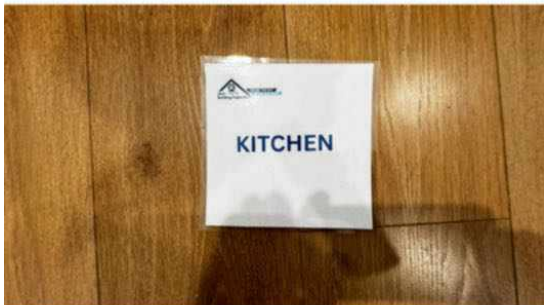
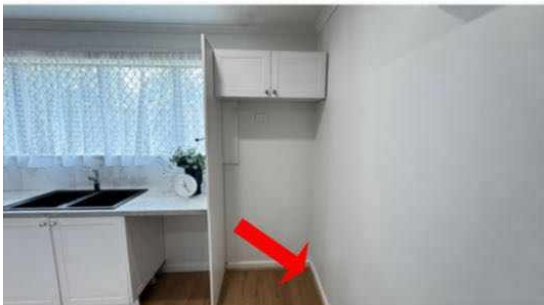
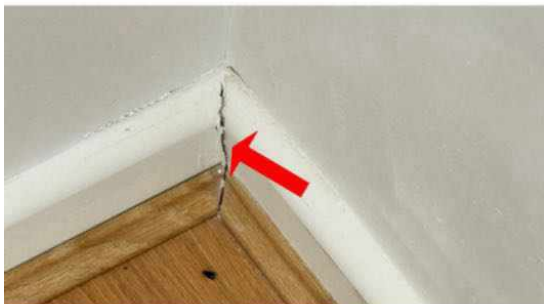
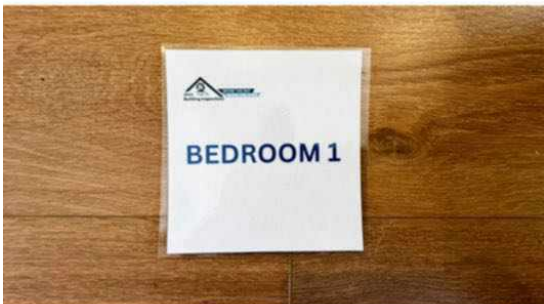
Defects 3.07

Building: Main Building
Location: All Areas
Finding: Architraves & Skirting Boards - Minor Movement
Information: Minor movement was noted in the architraves and skirting boards in this area, with small gaps at joints, slight separations from adjoining surfaces, and minor cracking in paint and sealant. This movement appears superficial and is generally related to normal timber behaviour or minor building settlement.

Common causes include seasonal timber shrinkage or expansion, slight building settlement, historic moisture or thermal movement, or insufficient fixing during installation. While largely cosmetic, these gaps and cracks can affect the appearance of finishes. If left unaddressed, minor deterioration may continue over time.

When practical, a qualified painter should be engaged to fill and repaint affected areas, to restore a neat finish.

Ongoing monitoring is advised, especially after seasonal changes. If movement worsens, a structural engineer should be consulted immediately to assess and recommend any necessary repairs.

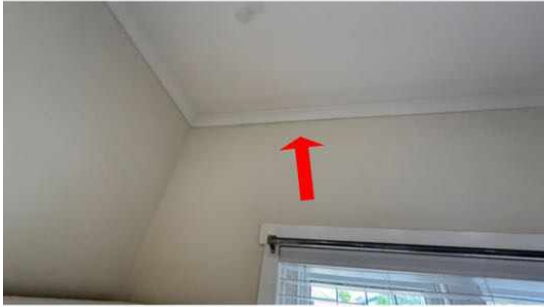
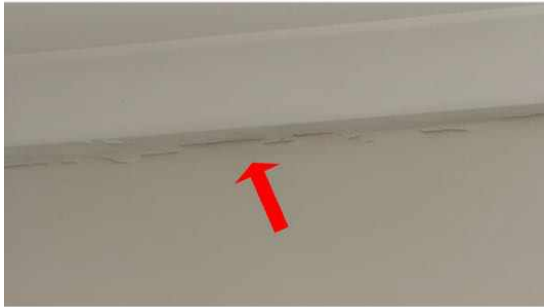
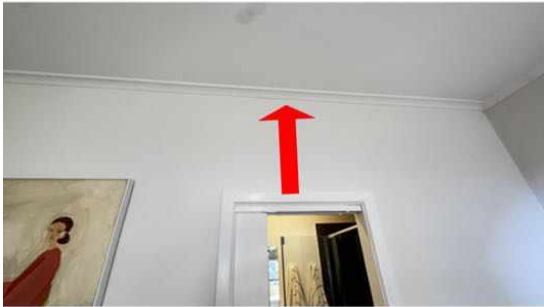
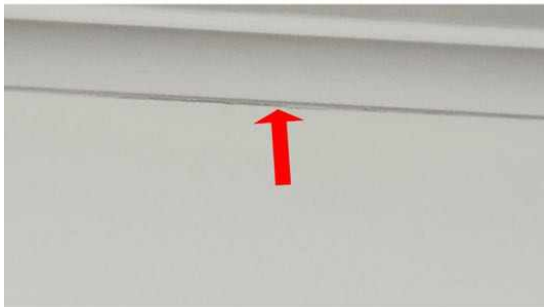
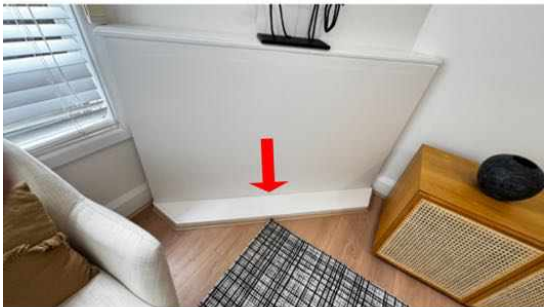
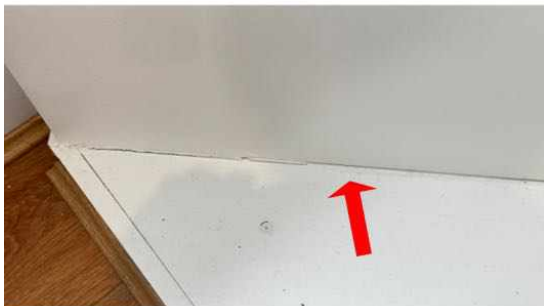
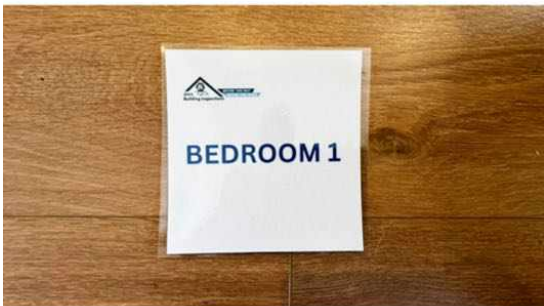
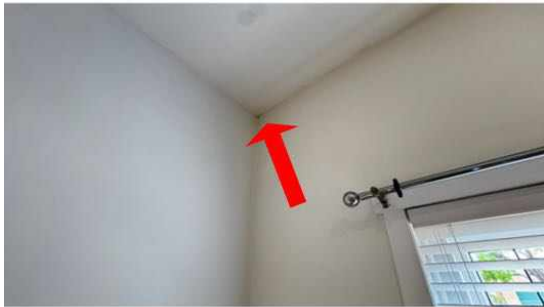
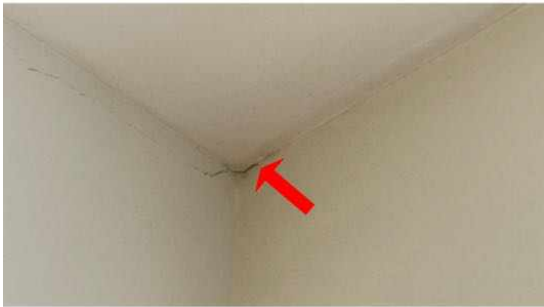
Defects 3.08

Building:	Main Building
Location:	All Areas
Finding:	Walls - Minor Plaster Cracking
Information:	Cracking was observed in this area. While generally cosmetic in nature, plaster cracks can result from minor building movement, seasonal expansion and contraction, or poor jointing and finishing at the time of construction.

Possible causes may include normal building settlement and movement, seasonal expansion and contraction of building materials and or poor installation or finishing of plasterboard joints.

Cracking should be monitored over time to assess whether movement is ongoing. Where cracking is purely cosmetic, patching and repainting may be undertaken as part of routine maintenance by a qualified plasterer or painter.

If cracks widen, reoccur after repairs, or appear in conjunction with other structural signs, further investigation by a registered builder or structural engineer is recommended immediately.

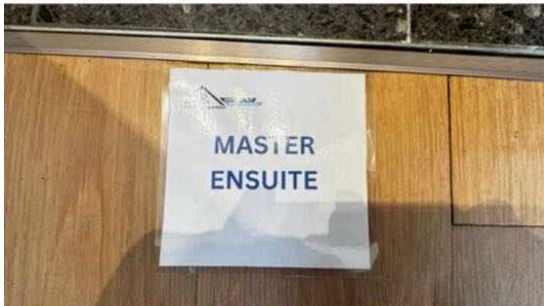
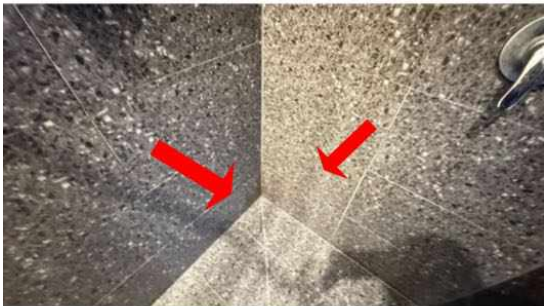
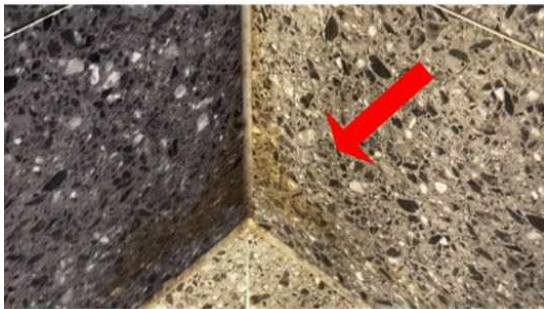
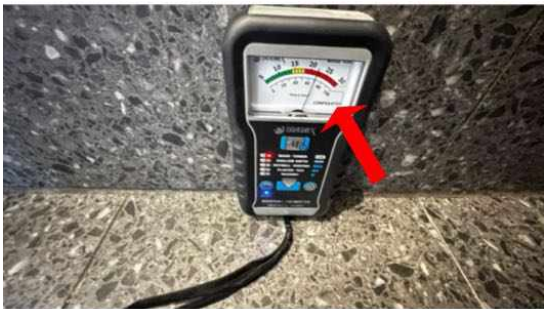
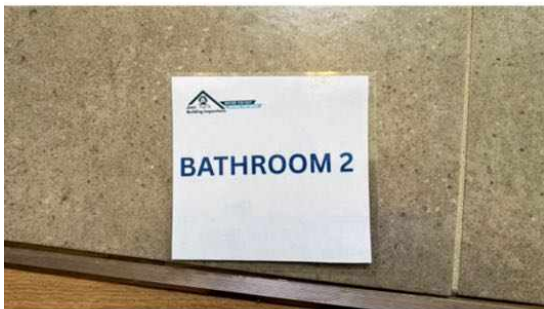
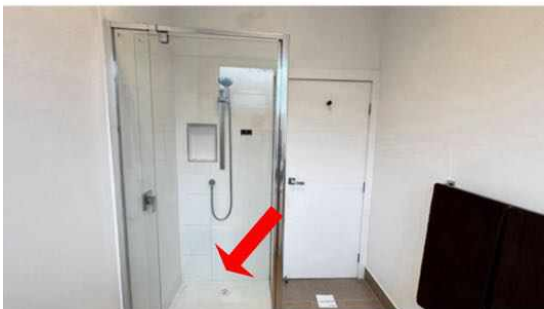
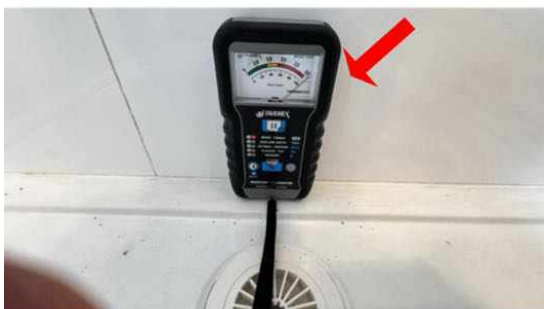
Defects 3.09

Building: Main Building
Location: Ensuite & Bathroom 2 >
Finding: Shower Damp - To Be Monitored & Epoxy Grout
Information: Damp is evident to the lower wall to the shower alcove and acceptable level moisture reading were found to the reverse side of the shower. Moisture readings were not found to the wall adjacent to the shower.

Damp (or structural damp) refers to the presence of unwanted moisture in the structure of a building, either as the result of intrusion from outside, or condensation from within the structure. In the shower area, internal water leaks or other sources of excessive moisture are generally the cause of damp.

It is advised to engage an epoxy grout specialist to remove and replace the grout with epoxy grout and install epoxy to all floor wall corner joints.

Always ensure that sealant and grout is in good condition to prevent any moisture issues occurring in the future
