Building Inspection Report

Inspection Date: Thu, 1 Jan 2026

Property Address: 37 Leopold St, Caulfield South VIC 3162,
Australia

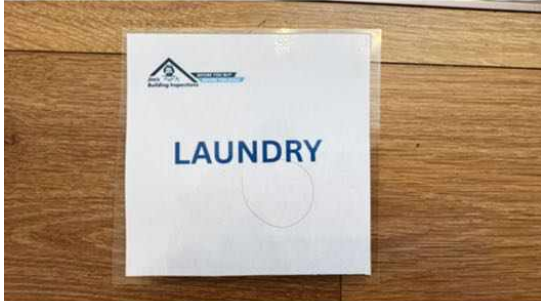
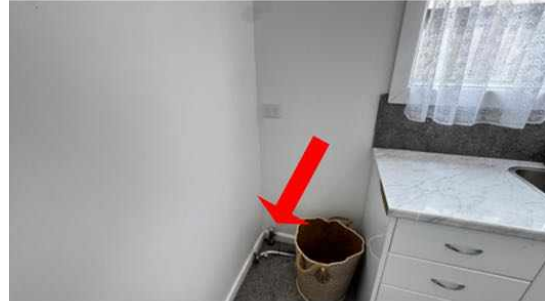
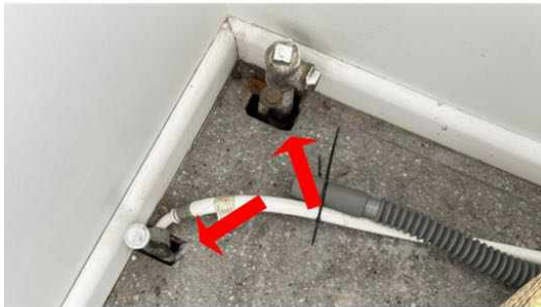
Defects 3.10

Building: Main Building
 Location: Laundry >
 Finding: Pipe Penetrations - Unsealed Internal
 Information: Unsealed pipe penetrations were observed in this area, with gaps visible where pipes pass through cabinetry or wall linings. These openings can allow moisture and odours to enter and may cause deterioration of surrounding materials.

Common causes include missing or inadequate sealant during plumbing installation, incomplete sealing of service penetrations, or poor workmanship.

If left unaddressed, these gaps can lead to moisture damage, mould growth, material

deterioration, and reduced hygiene in this area.

A licensed plumber or qualified handyman should be engaged immediately to seal all pipe penetrations with a suitable flexible sealant to prevent moisture ingress.

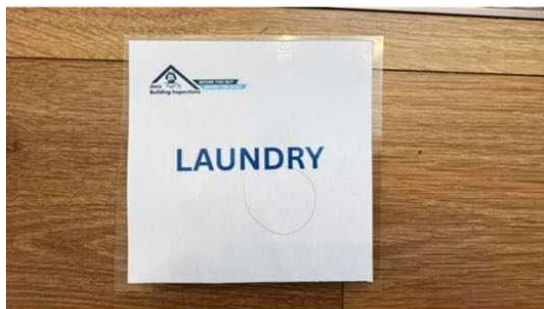
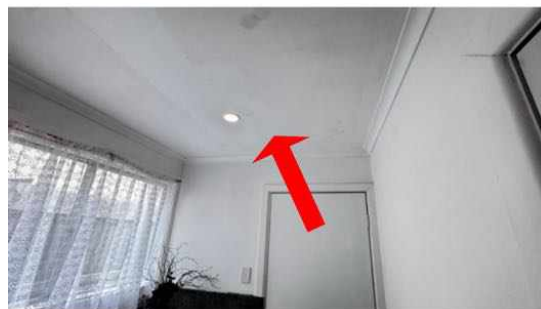
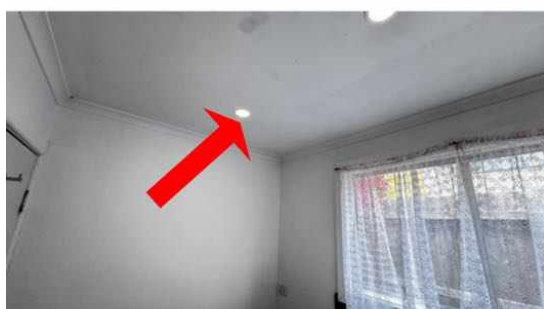
Defects 3.11

Finding: Laundry Ventilation - Missing

Information: Ventilation systems were observed to be missing in the laundry during the inspection. Missing ventilation can reduce air circulation, increase humidity, promote condensation and mould growth, and affect indoor air quality and occupant comfort.

The absence was observed at the ventilation system locations. This may be due to the systems being removed or not installed during construction.

A licensed HVAC technician or licenced electrician should be engaged immediately to inspect and install adequate ventilation. This may include installing new compliant ventilation systems. Prompt action will help improve air quality, reduce condensation and mould risk, and ensure compliance with building standards.

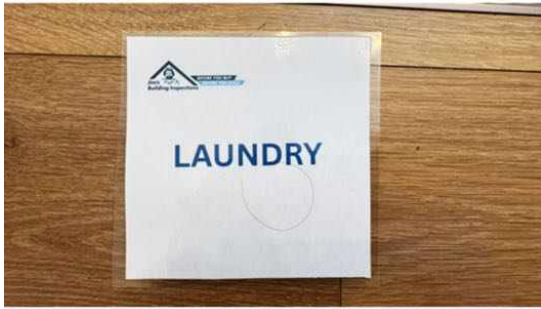
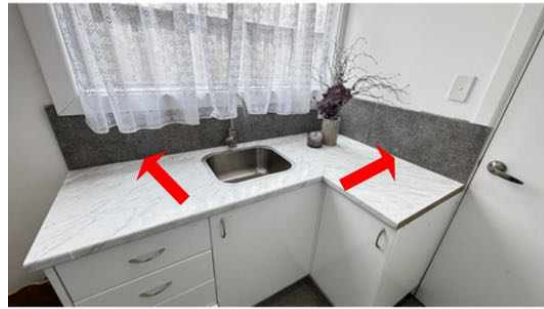
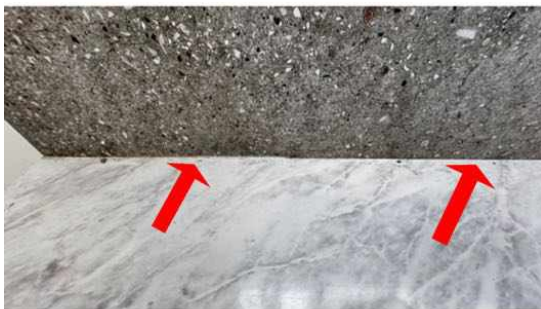
Defects 3.12

Building:	Main Building
Location:	Laundry >
Finding:	Caulking - Inadequate Sealant At Junctions
Information:	The junctions in this area were inspected, and inadequate and deteriorated sealant was observed. Missing or compromised sealant can allow moisture ingress, promote mould growth, and reduce the durability of tiled surfaces and underlying substrates.

This condition may be due to age-related wear, poor initial application, or lack of maintenance.

A licensed tiler or competent caulking specialist should be engaged immediately to remove old sealant and apply new, compliant materials. Prompt rectification will protect the building elements, maintain hygiene, and prevent possible water-related damage.

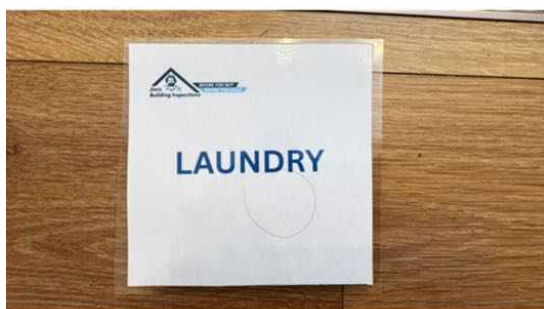
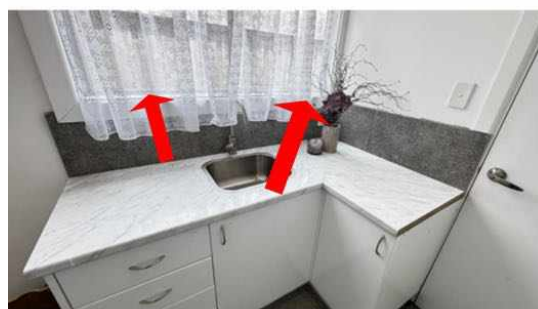
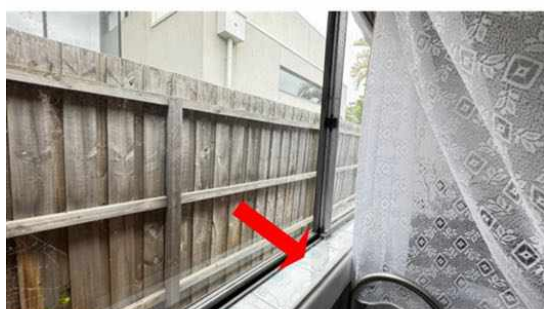
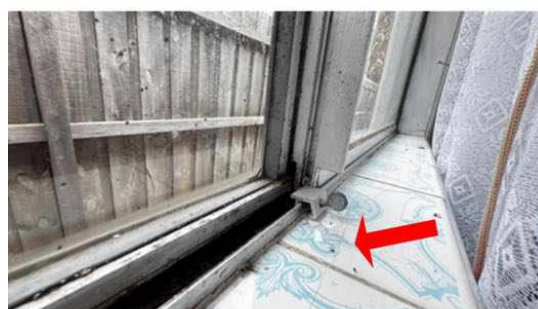
Defects 3.13

Building:	Main Building
Location:	Laundry >
Finding:	Laundry - Tiles Cracked
Information:	Cracked tiles were observed in the laundry. Cracked tiles can reduce durability and appearance and, if left unaddressed, may result in further detachment or damage.

This condition may be due to inadequate adhesive during installation, movement of the substrate, age-related deterioration of the tile bonding, or impact from normal use.

A qualified tiler or competent handyman should be engaged immediately to secure or replace the affected tiles. Prompt attention will restore surface integrity, maintain hygiene, and protect the long-term appearance of the tiled area.

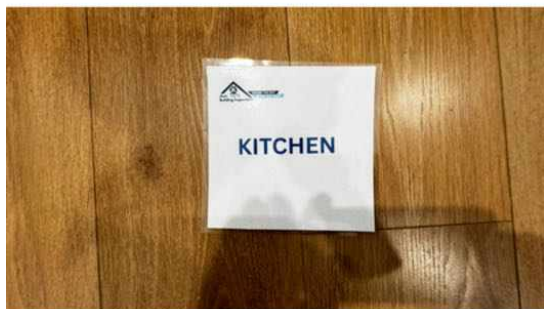
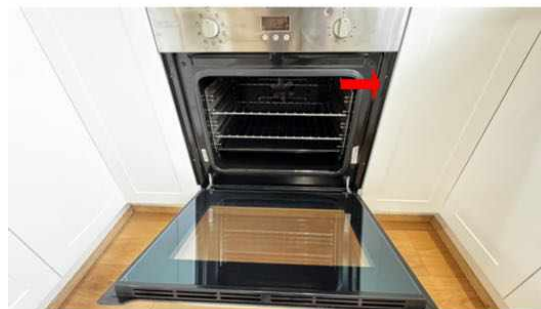
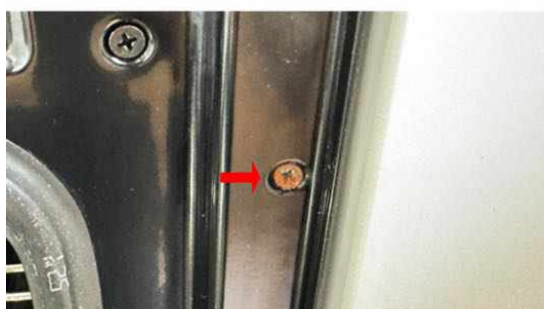
Defects 3.14

Finding: Building Element Hardware - Rust & Corrosion

Information: This building element shows evidence of rusting and corrosion, which is likely to have developed as a result of excessive exposure to moisture and or inadequate coatings. As surface rust provides no protection to the underlying iron, the deteriorating condition is likely to worsen if not addressed in the short-term future.

These items can sometimes be treated but more than likely will require replacement. Where possible, the use of galvanized (treated) metals or aluminium coated metals aid in rust prevention, as does regular general maintenance. Rust formation can be controlled with coatings, such as paint, that isolate the iron from the environment.

Rusting and corrosion should be managed by ideally removing or limiting the affected surface from exposure to moisture. A qualified handyman or carpenter may be appointed to replace any building elements that have been affected by rust or water damage.

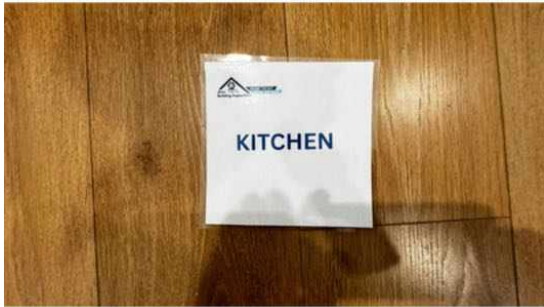
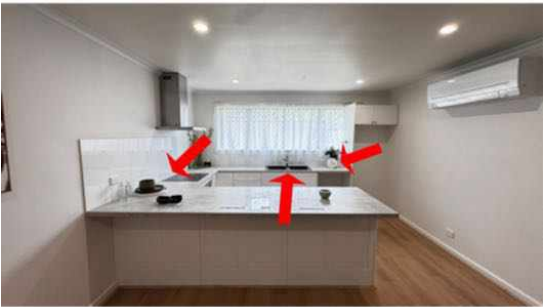
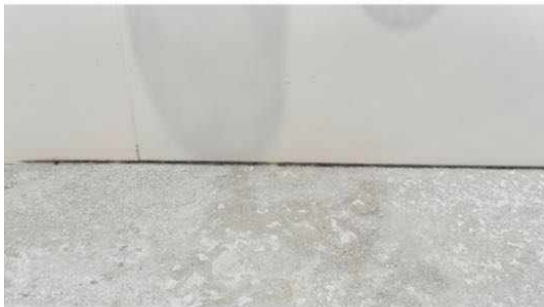
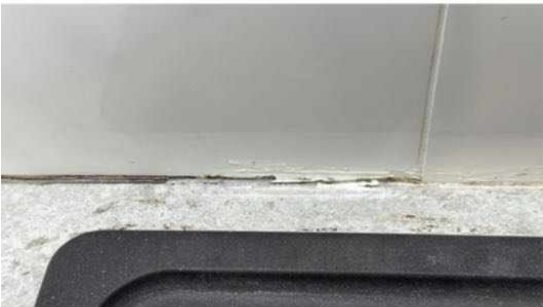
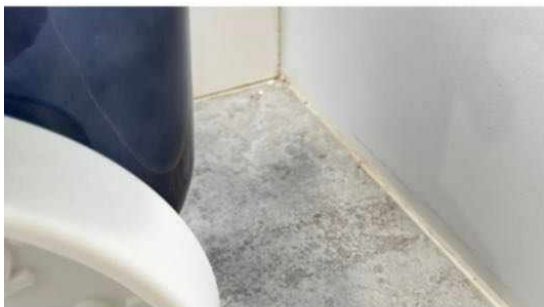
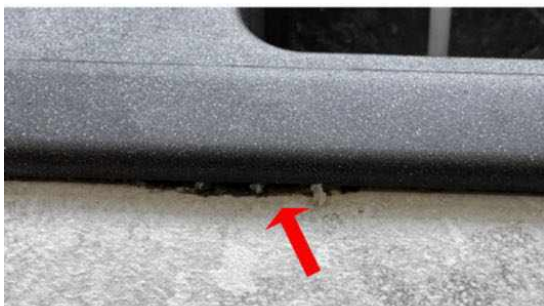
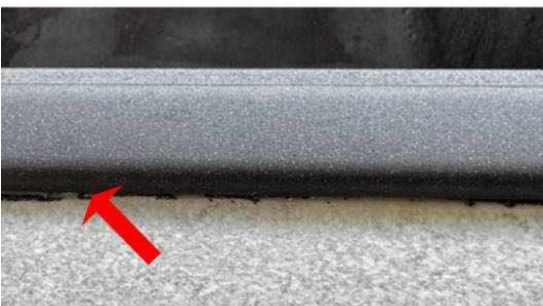
Defects 3.15

Building:	Main Building
Location:	Kitchen >
Finding:	Kitchen - Sealant Deteriated
Information:	The inspection identified sealant in the kitchen that is cracked, missing, deteriorated and failing. Defective sealant can allow moisture ingress, promote mould growth, and reduce the durability and hygiene of tiled surfaces and joinery.

This may have been caused by age-related deterioration of sealant, prolonged exposure to moisture, heat, or cleaning chemicals, or lack of routine maintenance and re-sealing.

A qualified tiler or competent handy man should be engaged immediately to remove the deteriorated sealant and apply new, compliant materials. Properly maintained sealant will prevent water ingress, maintain hygiene, and extend the life of tiled surfaces and cabinetry.

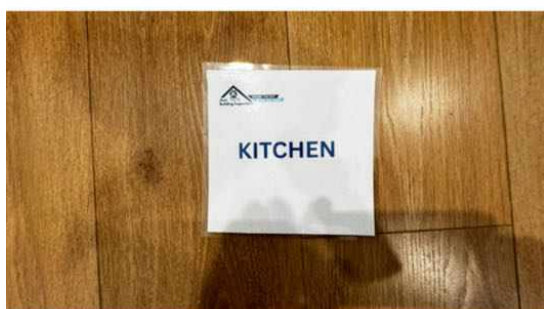
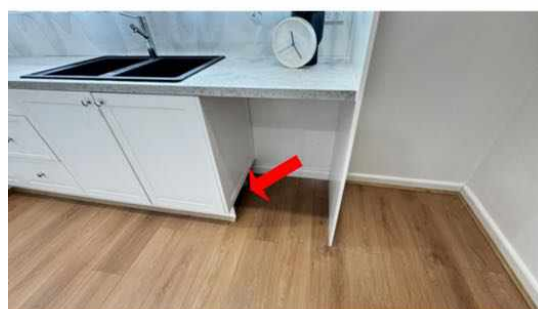
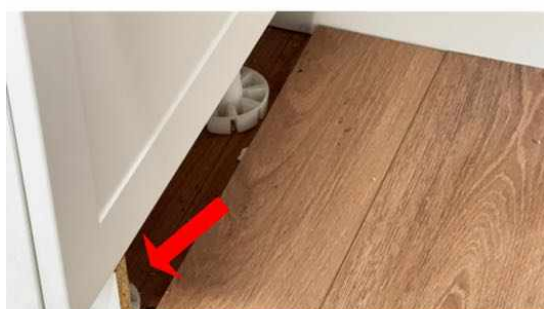
Defects 3.16

Building: Main Building
 Location: Kitchen
 Finding: Cabinets - Poor Installation & Detailing
 Information: Cabinets were observed to have poor installation and detailing. These issues affect both the visual appearance and functional performance of the cabinetry.

This may be due to inadequate installation techniques, misalignment during installation, use of incorrect fixings or poor craftsmanship.

When practical, a qualified cabinetmaker or qualified carpenter should be engaged to address these detailing issues. Prompt action will help ensure proper fit, finish, and durability of the cabinetry.

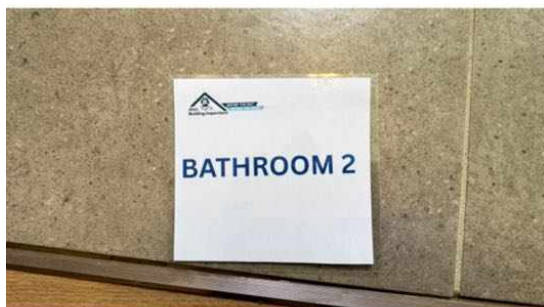
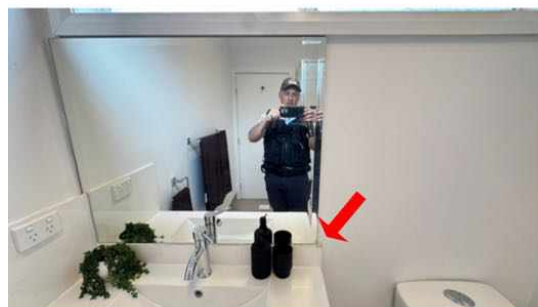
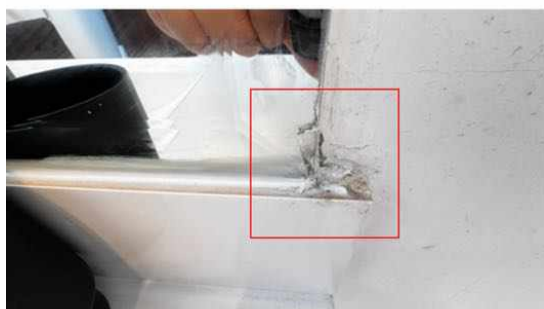
Defects 3.17

Building: Main Building
 Location: Bathroom
 Finding: Bathroom Mirrors - Cracking
 Information: The bathroom mirror was observed to have cracks in this area. Damaged mirrors can be a safety hazard due to sharp edges, reduce visual appeal, and affect functional use.

This may be due to impact or accidental damage, age-related wear, poor installation,

or exposure to moisture.

A licensed glazier or bathroom specialist should be engaged immediately to inspect and repair or replace the damaged mirrors. This may include replacing cracked or chipped mirrors, securing the mounting, and ensuring edges are properly sealed. Prompt action will help prevent injury, restore functionality, and maintain appearance.

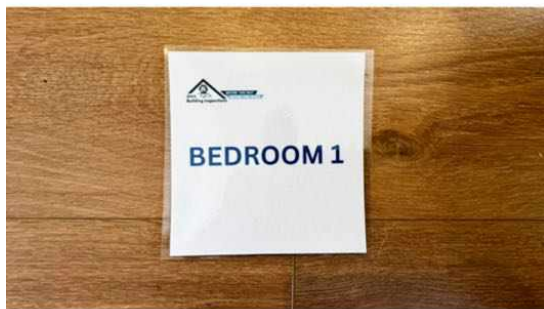
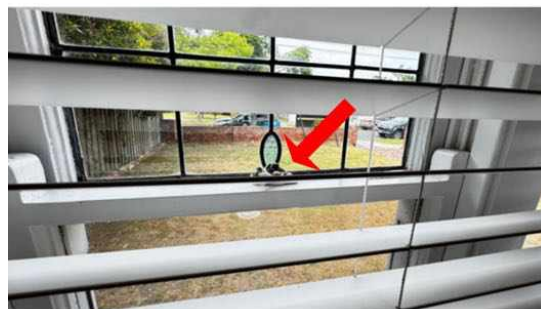
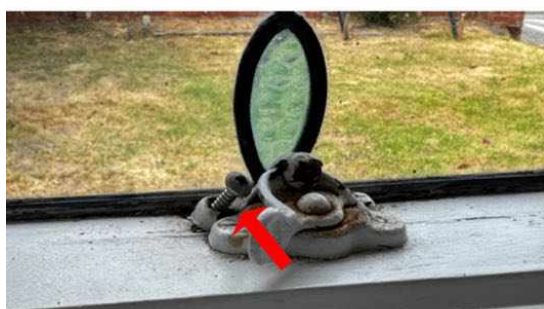
Defects 3.18

Building:	Main Building
Location:	Bedroom 1
Finding:	Locks - Not Operational
Information:	The lock in this area was found to be non-operational during the inspection.

When locks deteriorate to the point where they can no longer be used, the security of the property is compromised.

Repair or replacement of the lock is strongly recommended. It is advisable to consult a locksmith or general handyman as soon as possible to repair the lock and explore additional security options for the area.

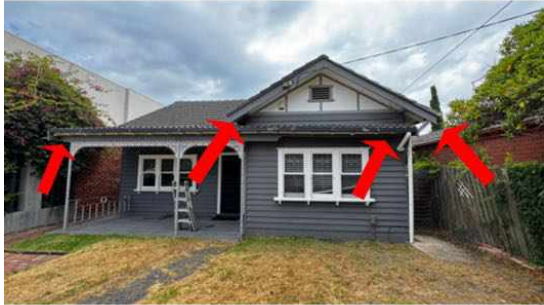
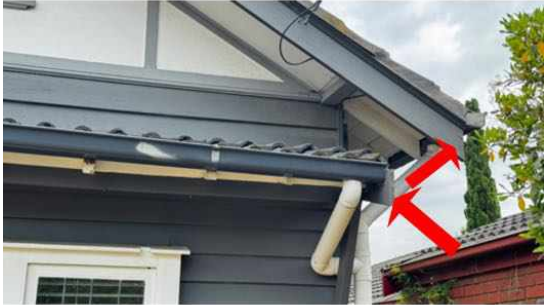
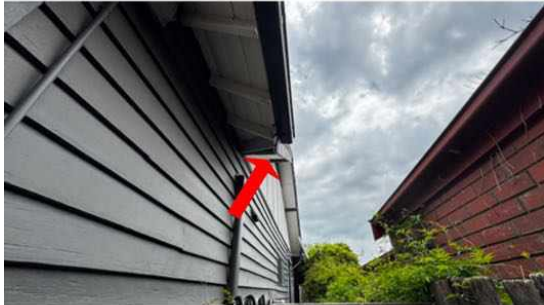
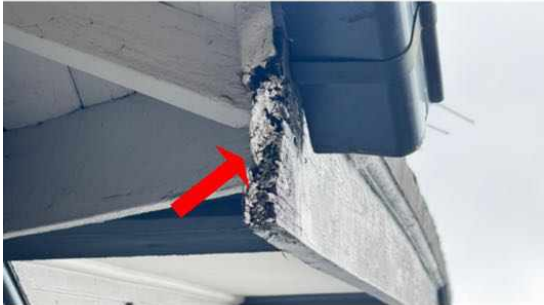
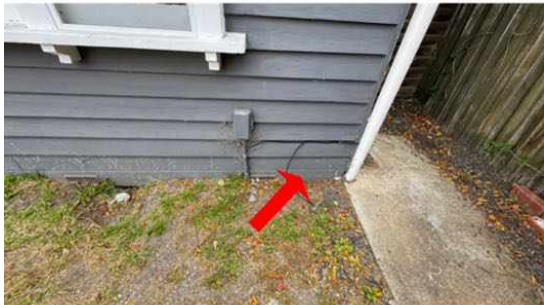
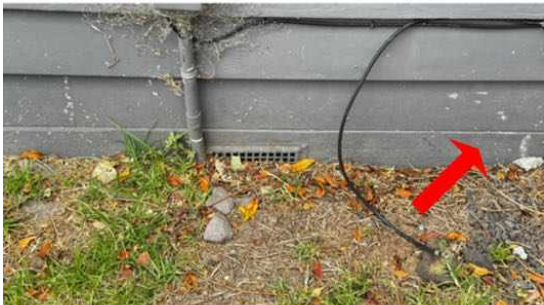
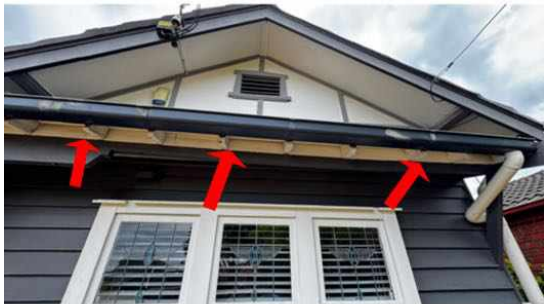
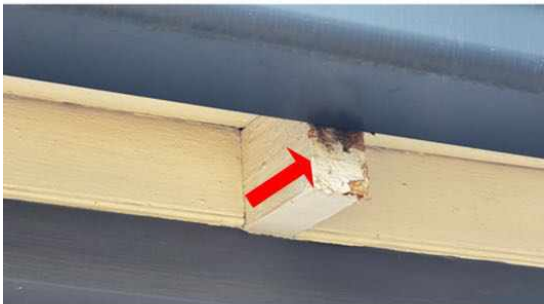
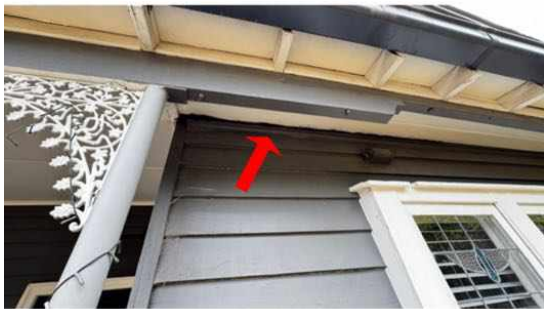
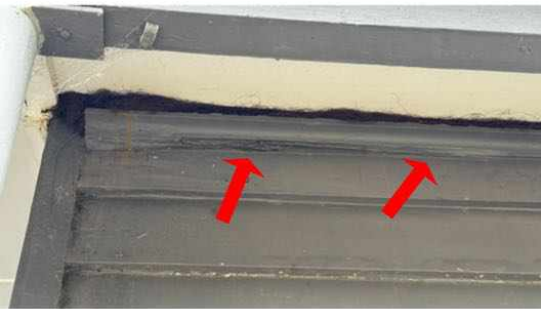
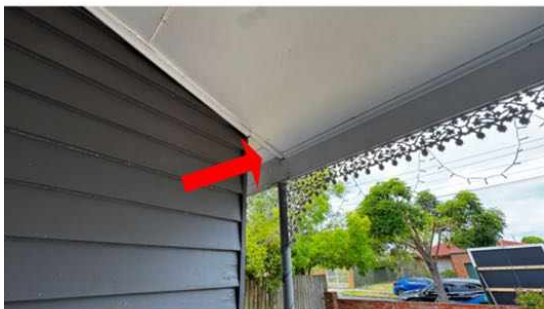
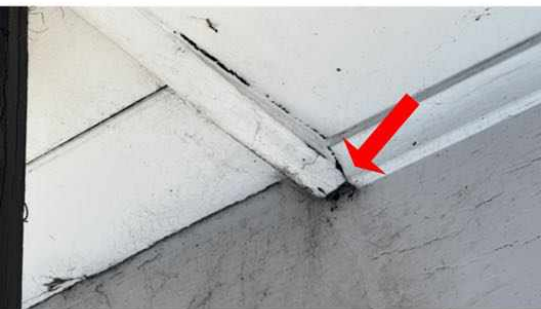
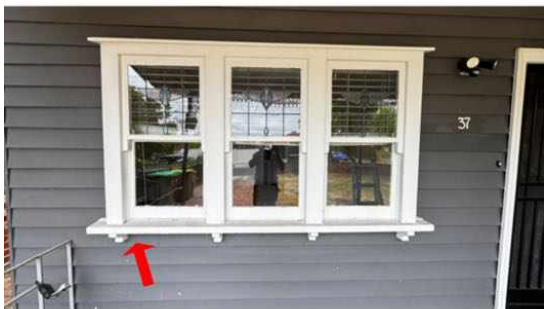
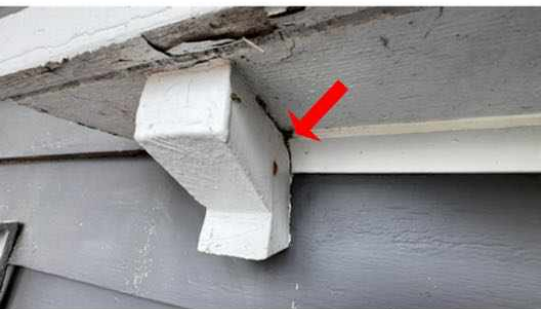
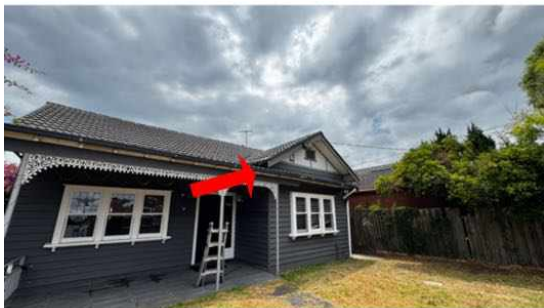
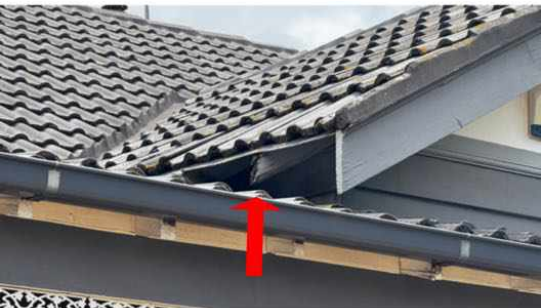
Defects 3.19

Building:	Main Building
Location:	All External Areas
Finding:	External Timber - Timber Rot
Information:	Timber elements including wall claddings, timber rails & posts, landscaping timbers, and other external timber surfaces were inspected and show signs of rot, decay and fungal attack in these areas. Softening, discoloration, splitting, and moisture penetration indicate ongoing timber degradation.

This is likely caused by prolonged moisture exposure, inadequate protective coatings or maintenance, direct contact with soil or water, or poor detailing that traps water or limits ventilation.

If left unaddressed, the affected timber may lose structural integrity, leading to progressive decay, potential collapse of walls, decks, or landscaping features, mould growth, and reduced durability and appearance of the building exterior.

A registered builder or timber specialist should inspect the affected areas immediately to determine the extent of damage. Damaged timbers should be repaired or replaced, protective treatments applied, and drainage or detailing corrected to prevent recurrence. Ongoing monitoring and urgent remedial action are required to prevent further deterioration.

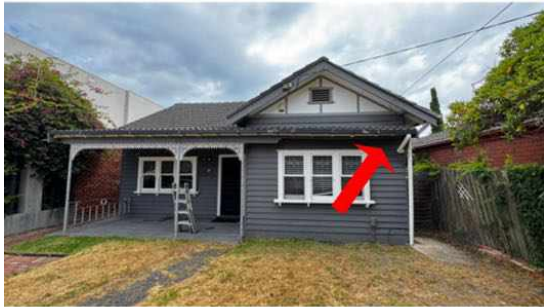
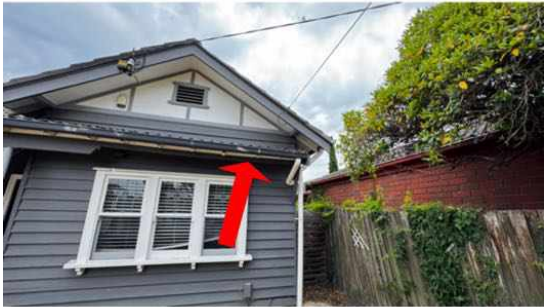
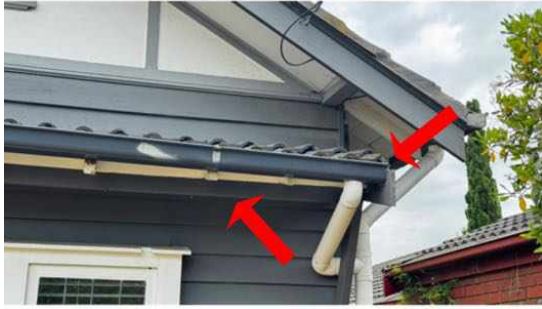
Defects 3.20

Building: Main Building
Location: All External Areas >
Finding: Building Element - Deteriated
Information: Deterioration occurs generally when the building materials have either aged and decayed, or as a result of damage (accidental or deliberate).

Repair and/or replacement of this building element is advised to ensure that additional secondary defects do not arise as a consequence. Such works are necessary, as all building elements play a key role in the operation and function of the overall structure and its performance.

A registered builder should be appointed to repair or replace the affected building element immediately.

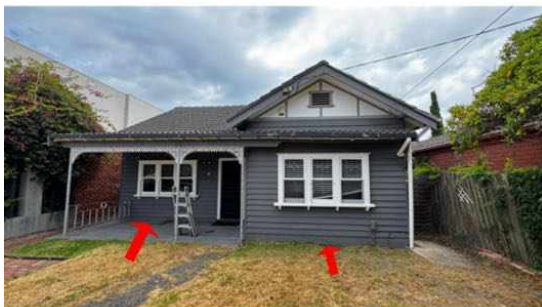
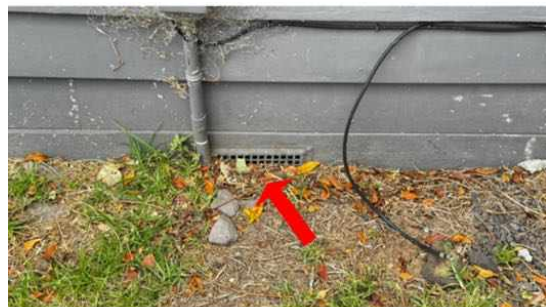
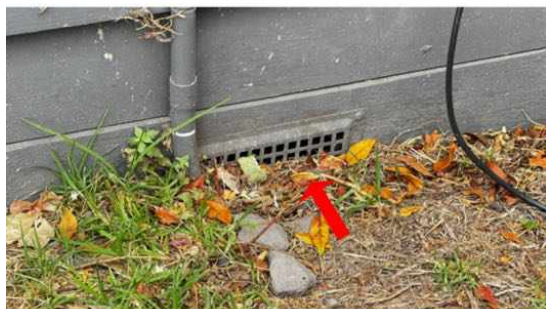
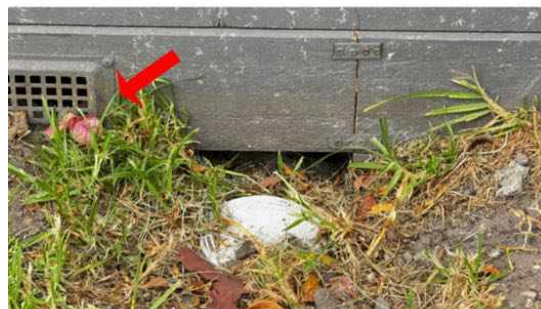
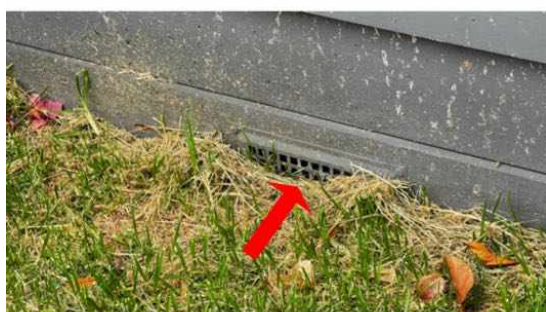
Defects 3.21

Building:	Main Building
Location:	External Walls
Finding:	Sub Floor - Inadequate Ventilation
Information:	The subfloor was observed to have restricted airflow due to blocked vents and insufficient ventilation openings. The issue is present where airflow beneath the floor is limited.

This has likely occurred due to blocked and obstructed vents, inadequate vent size or number, and lack of maintenance. Poor ventilation can lead to dampness, decay, mould growth, termite activity, and compromise structural integrity and occupant health.

A registered builder is required to assess and rectify ventilation deficiencies immediately. This may include unblocking vents, installing additional openings, and ensuring clear airflow under the floor. Rectification should be completed promptly to protect the structure and prevent moisture-related damage.

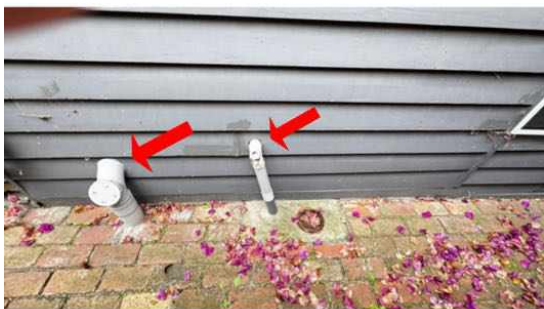
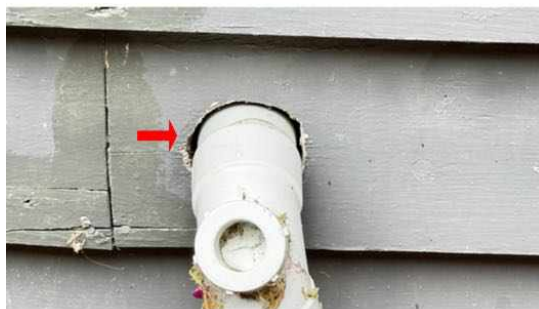
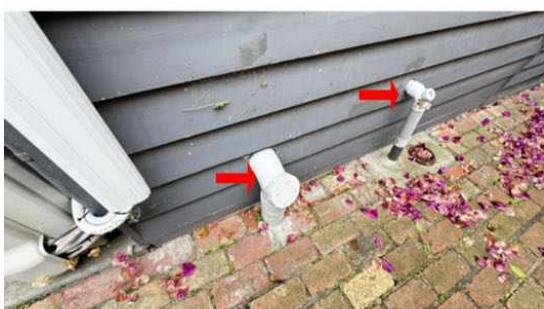
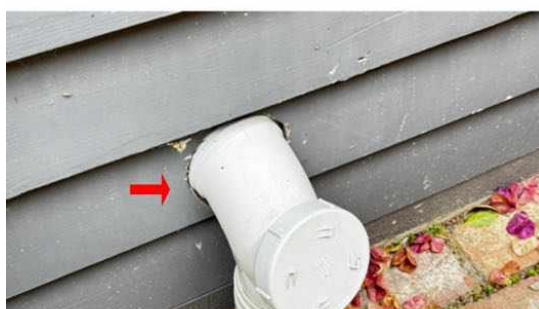
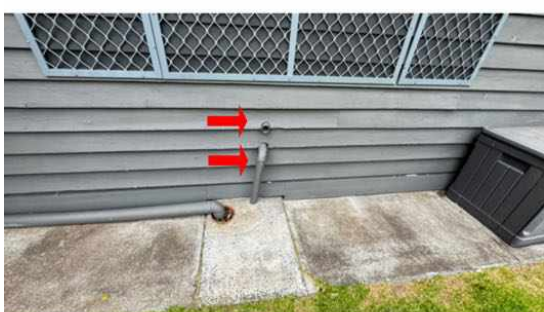
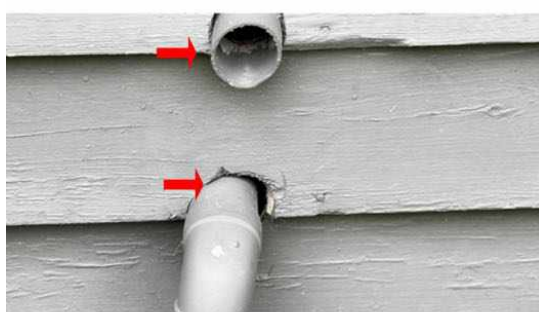
Defects 3.22

Building:	Main Building
Location:	External Walls
Finding:	Pipe Penetrations - Unsealed External
Information:	Unsealed pipe penetrations were observed in this area, with gaps visible where pipes pass through external walls. These openings can allow moisture and pests to enter the building and will cause deterioration of surrounding materials over time.

Common causes include missing or inadequate sealant during plumbing installation, incomplete sealing of service penetrations, or poor workmanship.

If left unaddressed, these gaps will lead to moisture damage, mould growth and material deterioration.

A licensed plumber or qualified handyman should be engaged immediately to seal all pipe penetrations with a suitable flexible sealant to prevent moisture ingress.

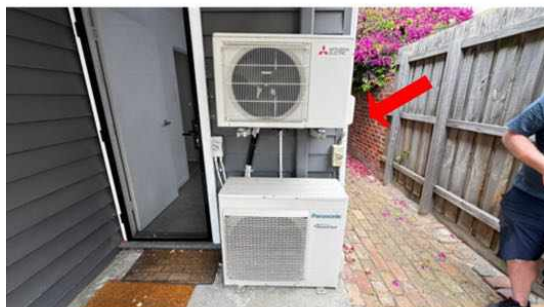
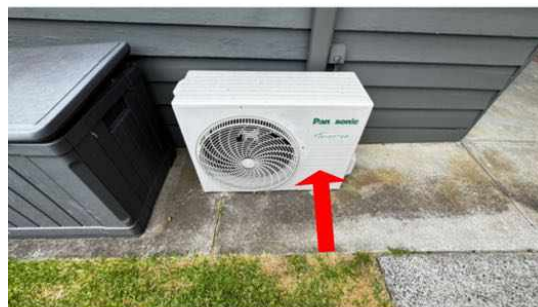
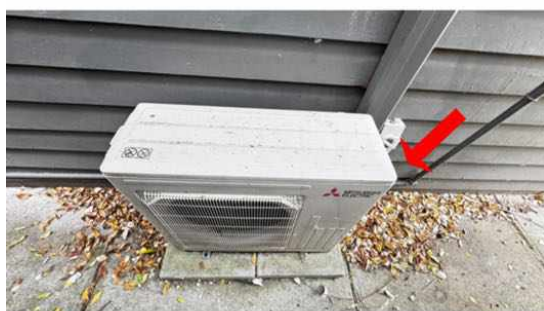
Defects 3.23

Building:	Main Building
Location:	All External Areas >
Finding:	AC Condensate Drain - Not Connected To Storm Water
Information:	The air conditioning condensate drain in this area was observed to be disconnected from stormwater drainage.

When condensate is not properly directed to a stormwater outlet, water can accumulate around the building or air conditioning unit, creating damp conditions that may lead to secondary defects such as timber rot, corrosion of nearby metal components, mould growth, or slippery surfaces. Prolonged pooling of water may also attract termites and contribute to long-term deterioration of surrounding building

elements.

A qualified HVAC technician or licensed plumber should be engaged immediately to connect the condensate drain to a suitable stormwater outlet. Prompt rectification will ensure proper drainage, protect the building fabric, and reduce potential health and safety risks.

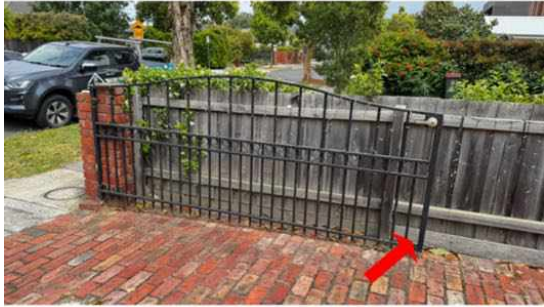
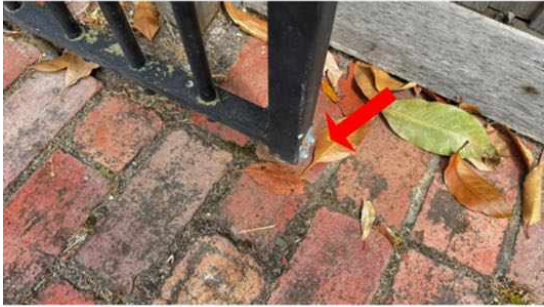
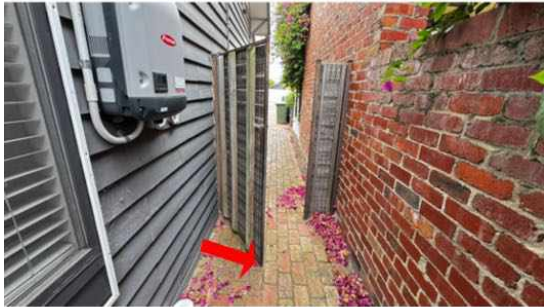
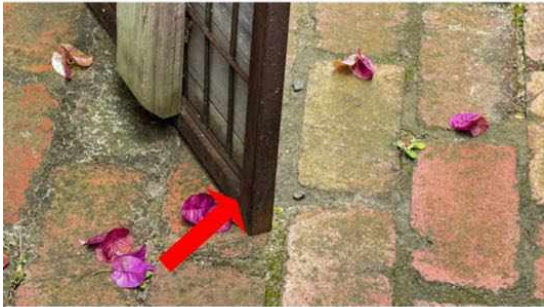
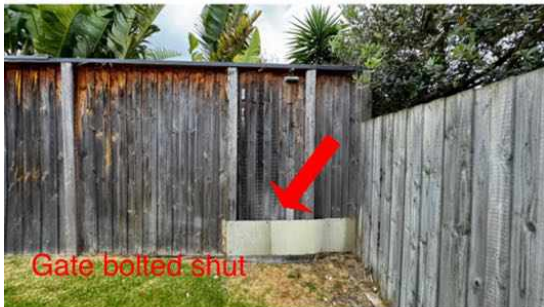
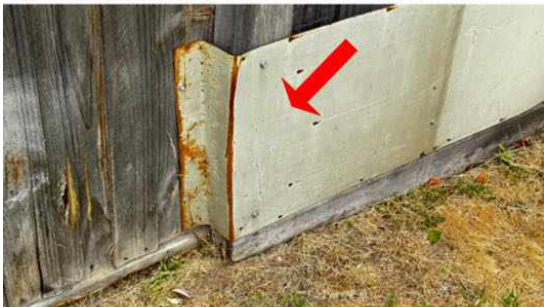
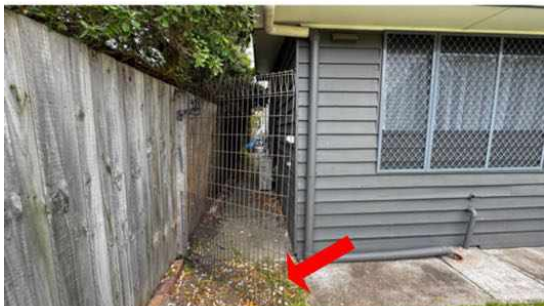
Defects 3.24

Building:	Main Building
Location:	All External Areas >
Finding:	Gates - Gate Binding
Information:	Binding or jamming of the gate was observed in this area. This affects functionality and may cause secondary damage to surrounding building elements.

Binding can result from minor issues, including poor installation, worn hinges, or misalignment.

When practical, a qualified carpenter should be engaged to inspect and carry out necessary repairs.

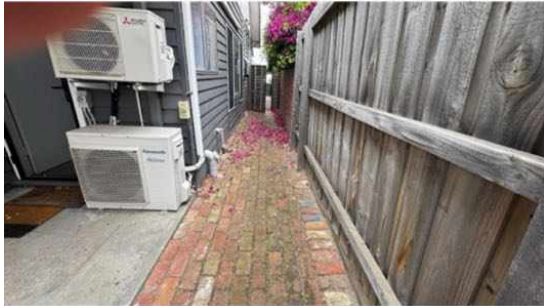
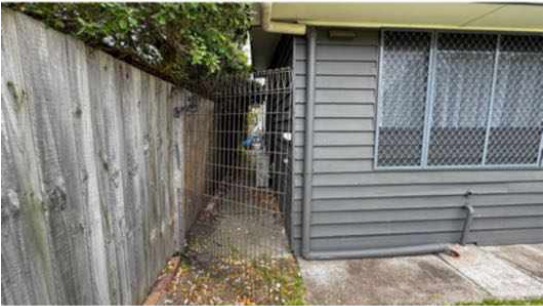
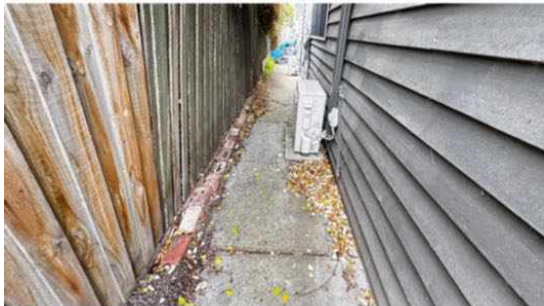
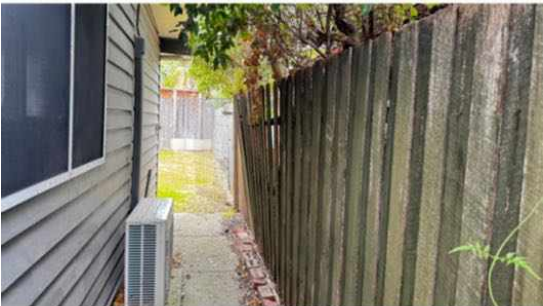
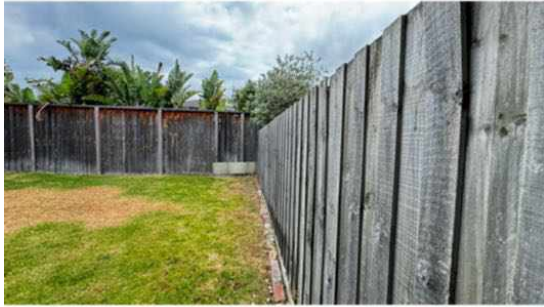
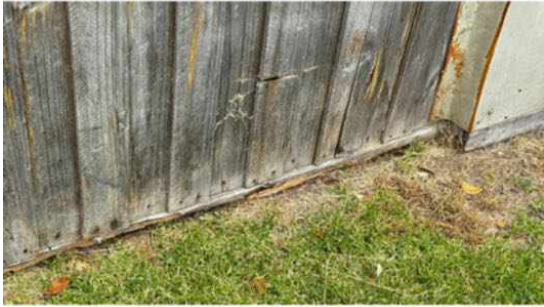
Defects 3.25

Building: Main Building
Location: All External Areas
Finding: Fencing - Deteriated & Leaning
Information: Timber fencing was inspected and deterioration was observed in this area. Deteriorated fencing can compromise structural stability, reduce privacy, and may allow pest ingress or accelerated decay if left unaddressed.

Possible causes include age-related timber decay, prolonged exposure to moisture or sunlight, poor maintenance, or impact damage.

When practical, a qualified carpenter or fencing specialist should be engaged to repair or replace affected sections, and a qualified painter should be engaged to restore protective finishes. Prompt rectification will maintain structural performance, improve appearance, and extend the lifespan of the fencing.

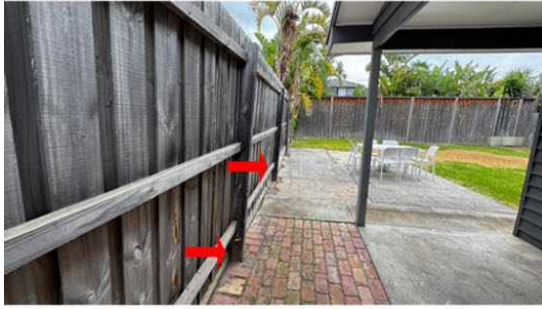
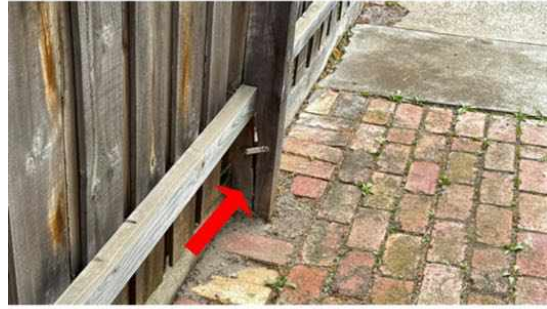
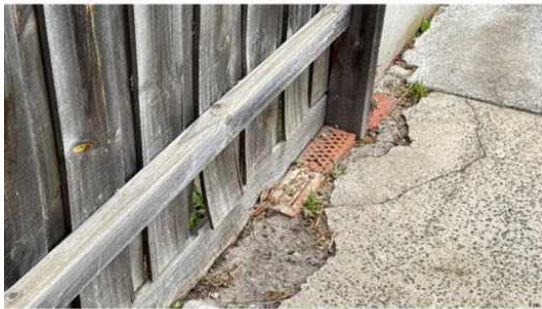
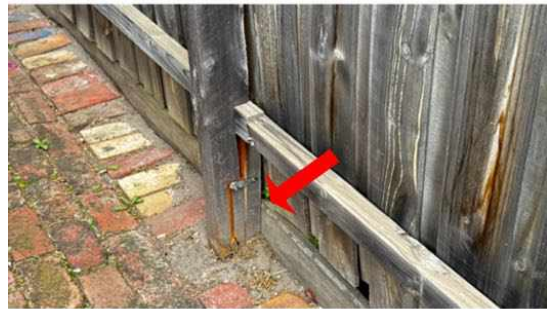
Defects 3.26

Building:	Main Building
Location:	All External Areas
Finding:	Paving - Minor Cracking
Information:	<p>The external paved areas were visually inspected. Minor cracking, uneven surfaces, and general wear were observed in this area. These defects do not currently affect structural safety but may reduce durability, appearance, and safe pedestrian access.</p> <p>This may be caused by age-related deterioration of concrete, pavers, or other materials, soil movement or settlement beneath paved surfaces, tree root intrusion or erosion, or inadequate original installation or sub-base compaction.</p> <p>A qualified landscaper should be engaged as soon as possible to repair or resurface sections as required. Rectification will restore even surfaces, reduce trip hazards, and improve the serviceability and appearance of the paved areas.</p>

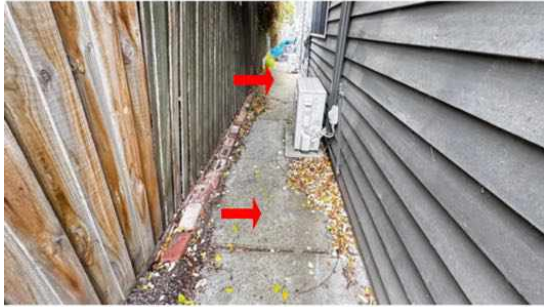
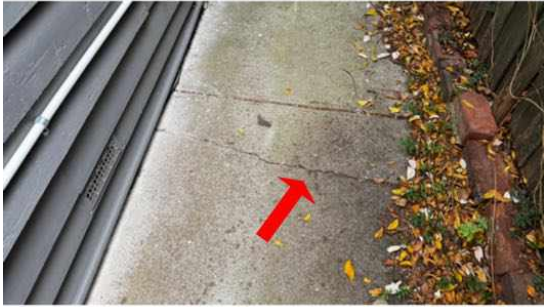
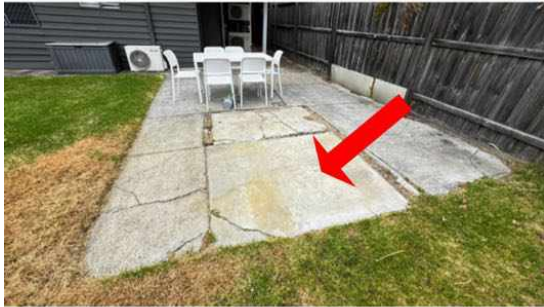
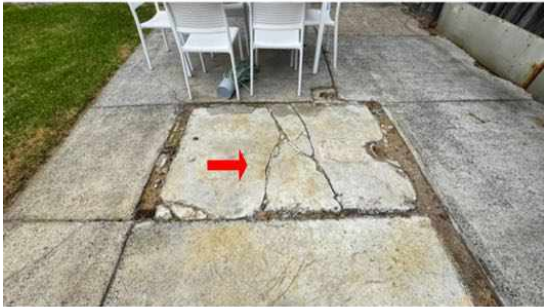
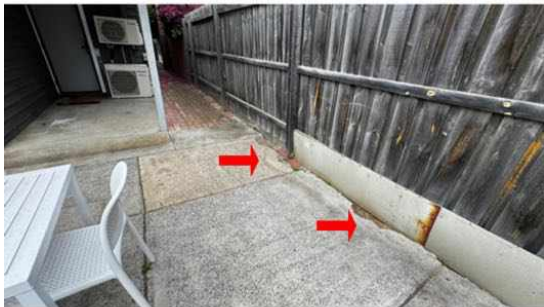
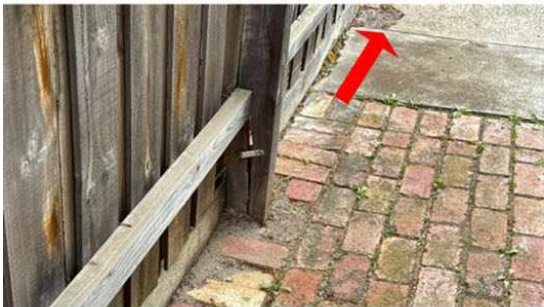
Defects 3.27

Building: Main Building
Location: Driveway >
Finding: Driveway - Minor Cracking & Surface Imperfections
Information: The external driveway was visually inspected. Minor cracking, surface settlement, and minor unevenness was observed in this area. While these defects do not currently compromise structural safety, they may affect long-term durability, appearance, and vehicle access.

These issues may be caused by age-related wear, soil movement or settlement beneath the driveway, possible tree root intrusion, or inadequate original construction or reinforcement.

A qualified concreter should be engaged when practical to repair or resurface affected areas. Prompt rectification will restore a smooth surface, improve appearance, and prevent further deterioration.

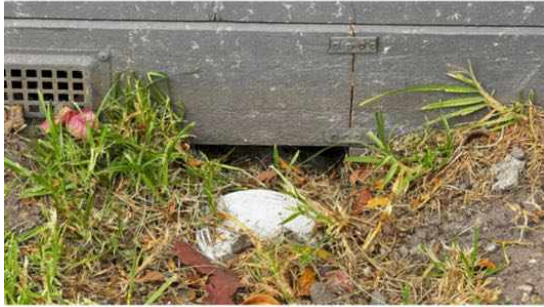
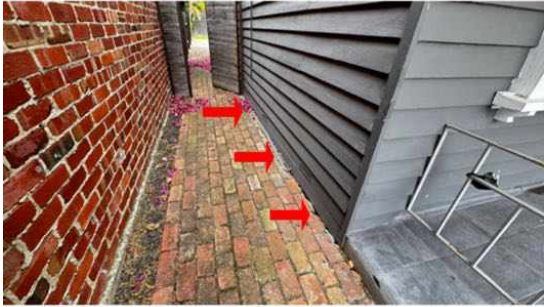
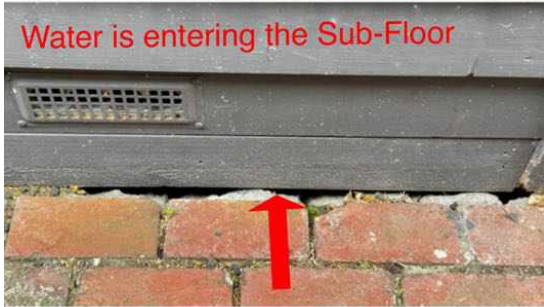
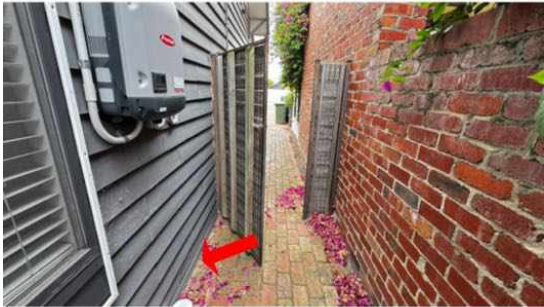
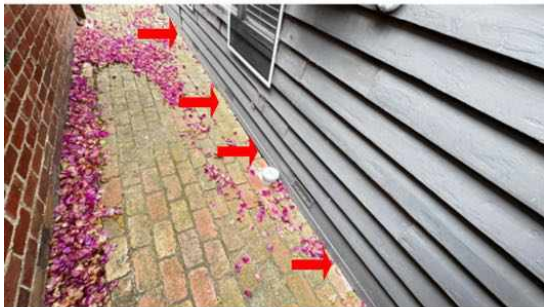
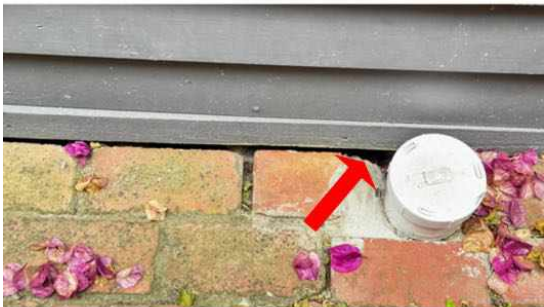
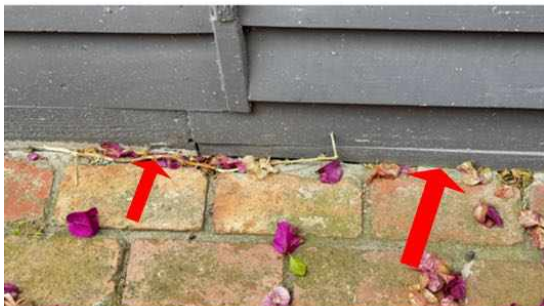
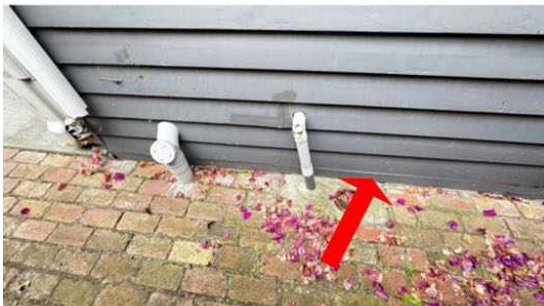
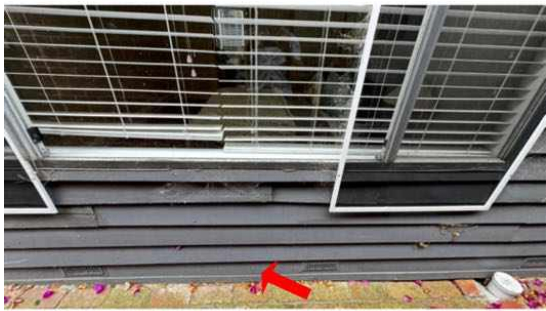
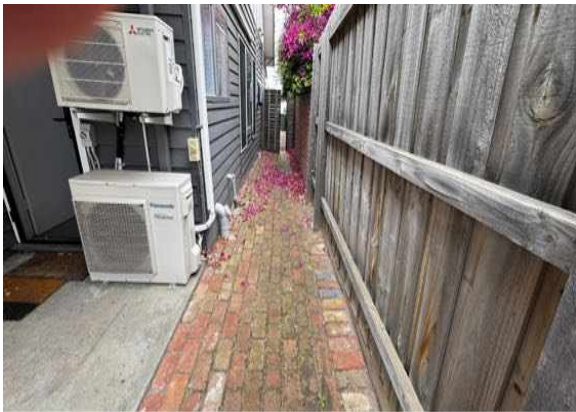
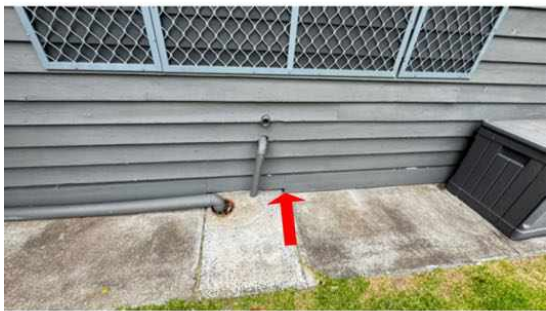
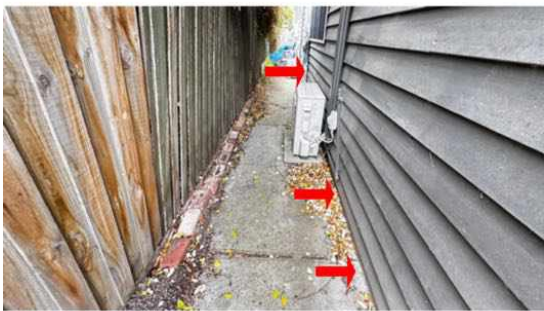
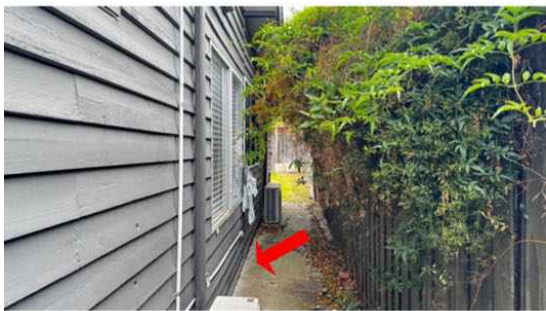
Building:
 Location: All External Areas
 Finding: Site Drainage - Inadequate
 Information: The overall site drainage was observed to be inadequate at the time of inspection.

Poor drainage can cause water to pond near external walls, increasing the risk of rising damp, foundation movement, timber decay, and deterioration of associated building elements.

A licensed plumber should be engaged promptly to investigate and recommend suitable remedial works, which may include the installation of an agricultural (aggie) drain or other site drainage improvements. Immediate action is strongly recommended, as inadequate drainage can lead to progressive water damage and secondary building defects over time.

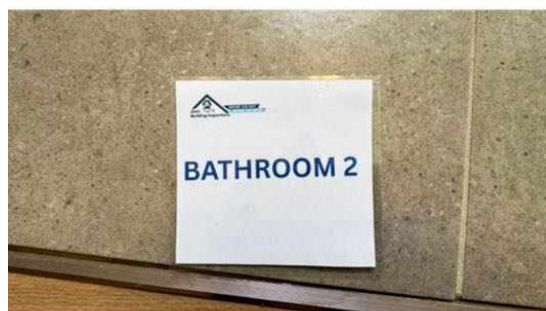
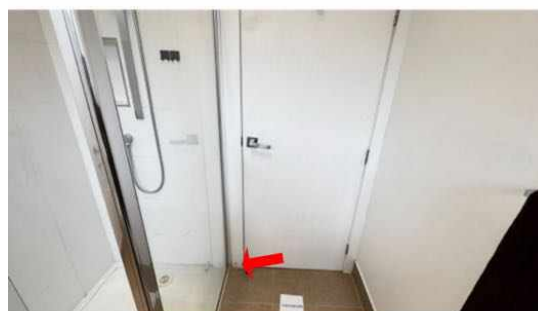
Building:	Main Building
Location:	Bathroom 2
Finding:	Shower Screen - Leaking - Inadequate Sealant
Information:	The shower screen in this area was inspected, and water leakage was observed, which appears to be caused by inadequate or deteriorated sealant at joints and connections.

Defective sealant can allow water to escape the shower enclosure, leading to damage of surrounding floor finishes, wall linings, and potentially underlying structures. Prolonged leakage may also promote mould growth and compromise hygiene.

This condition may result from poor original installation, age-related deterioration of the sealant, or lack of maintenance.

A licensed plumber, qualified tiler, or bathroom specialist should be engaged immediately to remove any deteriorated sealant and reapply a compliant, waterproof seal. Prompt rectification will prevent water damage, maintain hygiene, and ensure the shower functions as intended.

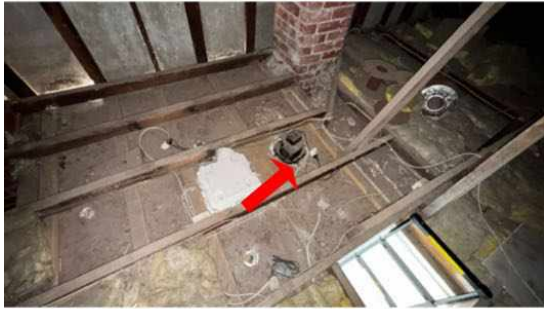
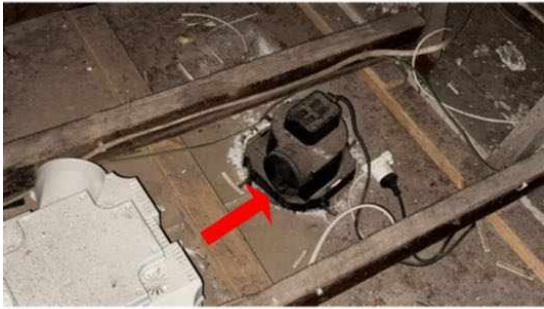
Building: Main Building
Location: Roof Void >
Finding: Asbestos - Suspected ACM Identified On Site
Information: Reporting on Asbestos is outside the Scope of this Report. This suspected defect is highlighted as a caution only. We suspect, based on our experience in the building industry, that there is a higher risk of the identified building element containing asbestos to areas inside and outside the property.

As Asbestos Reporting is outside the scope of this report, we STRONGLY advise that you consider a separate Asbestos Inspection and Condition Audit, which can include the taking of samples for definitive confirmation of the presence of Asbestos.

In the interim, the client is advised to act with caution not only to the areas within the report but all areas within the property, especially when considering any damage to building materials general wear and tear renovations extensions demolition and general maintenance activities due to the suspected presence of Asbestos
