Building Inspection Report

Inspection Date: Thu, 1 Jan 2026

Property Address: 37 Leopold St, Caulfield South VIC 3162,
Australia

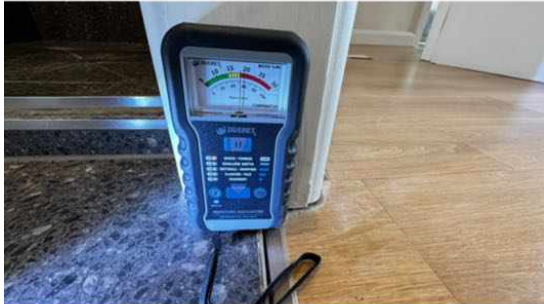
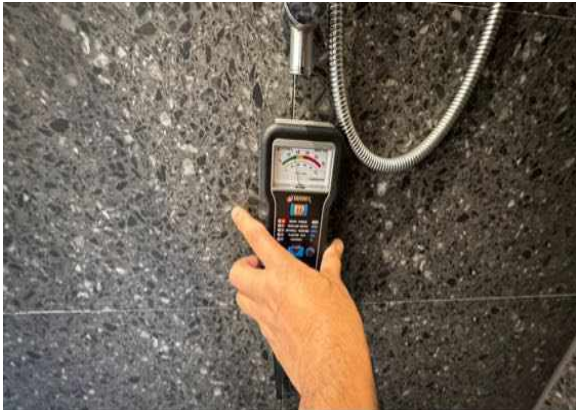
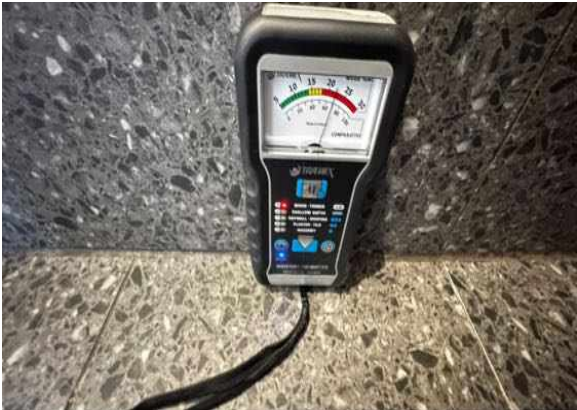
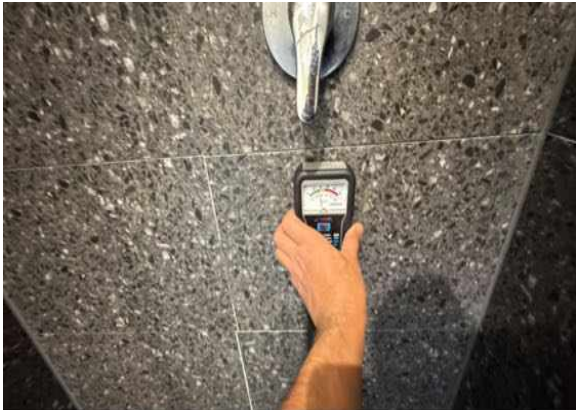
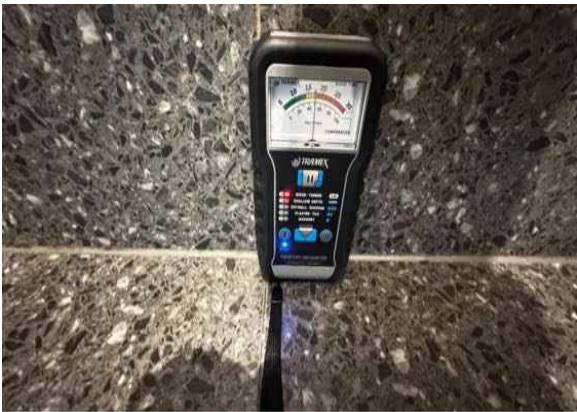
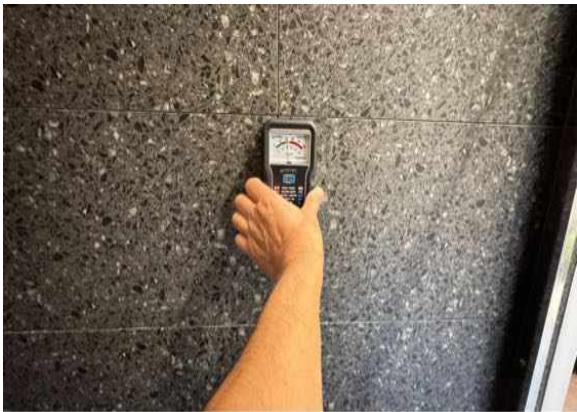
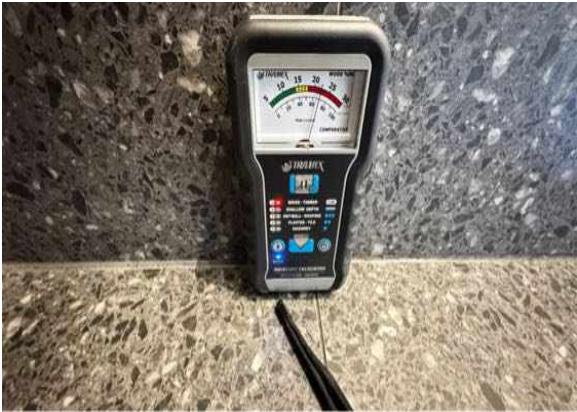
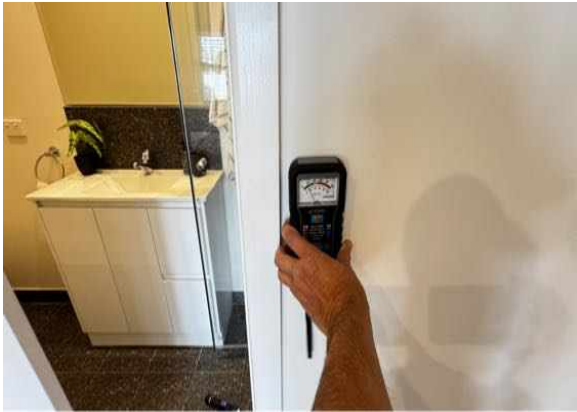
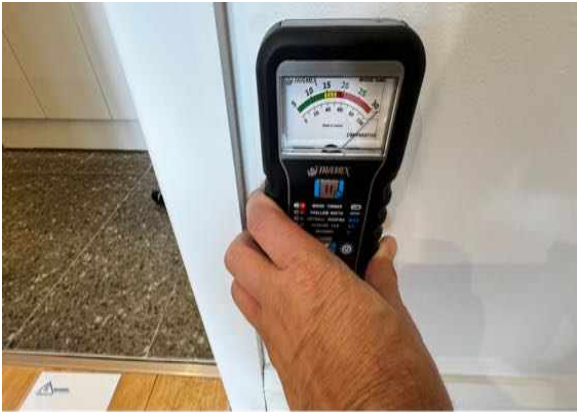
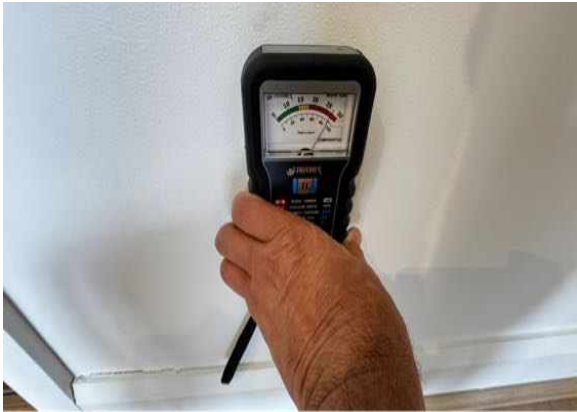
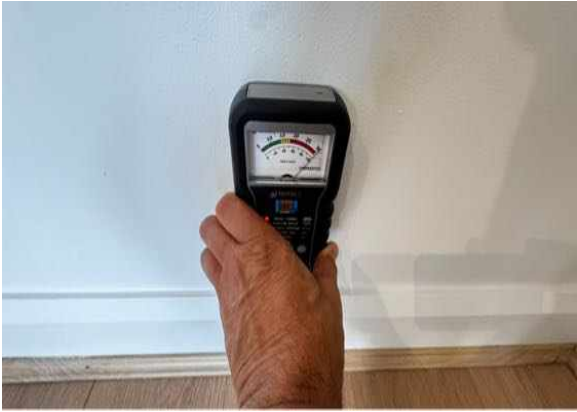
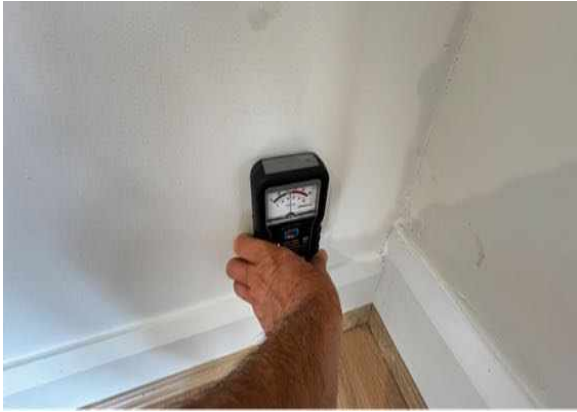
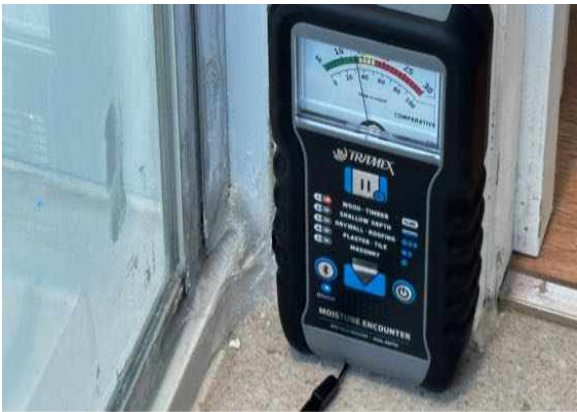
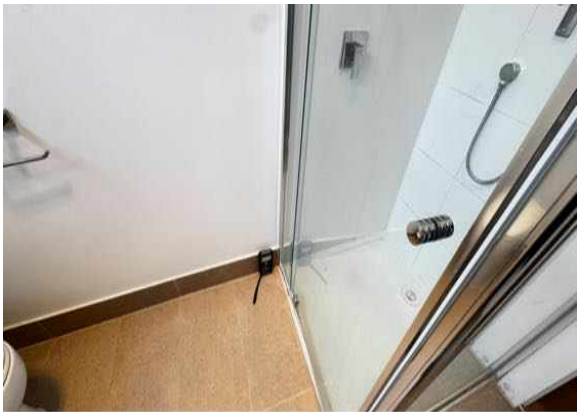
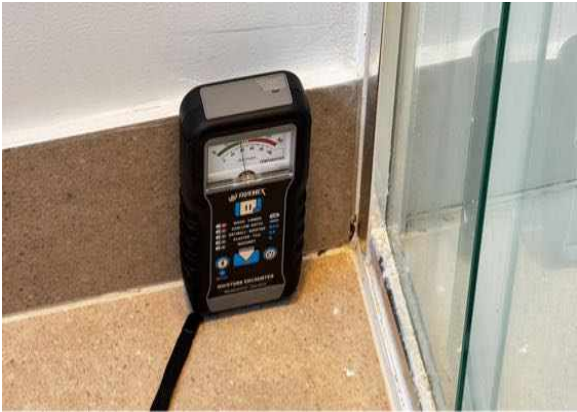
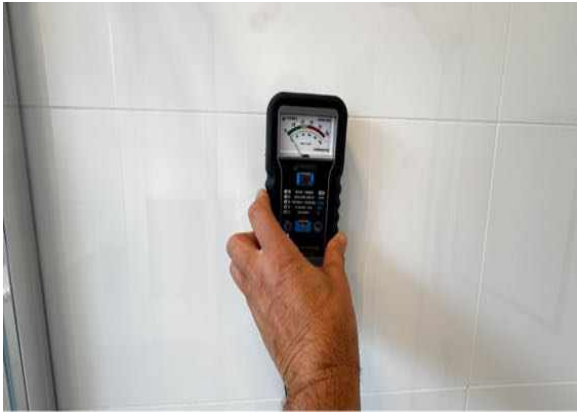
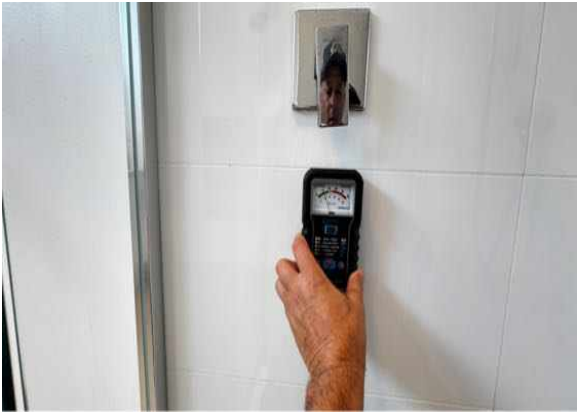
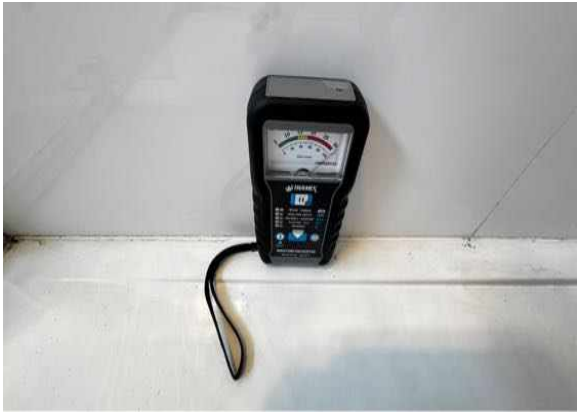
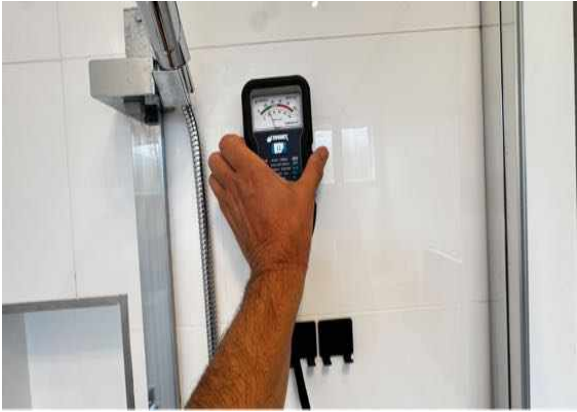
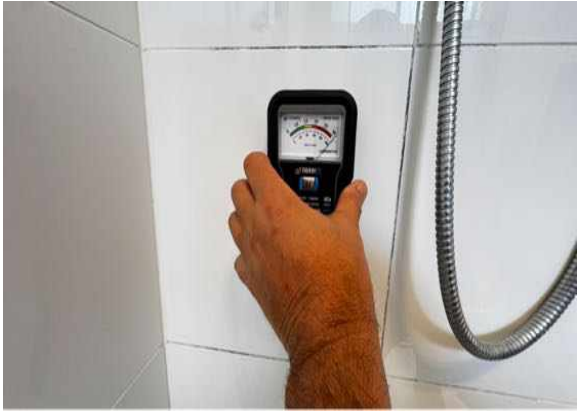
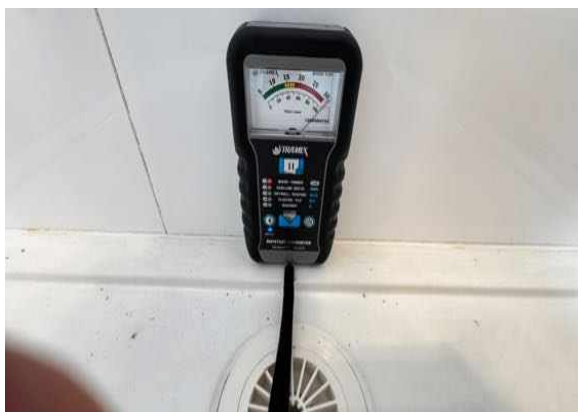
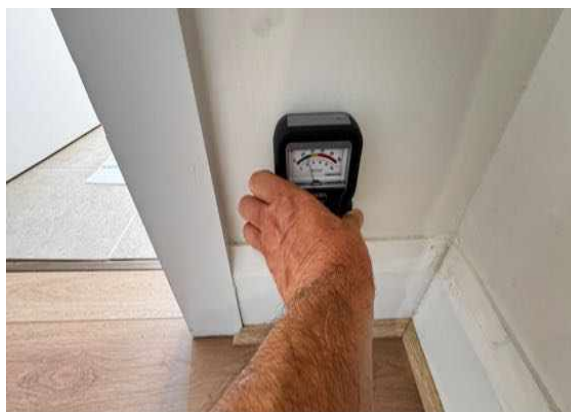
Building: Main Building
Location: All Areas Interior & Exterior
Finding: Moisture Levels - Advisory - No Elevated Moisture Levels Present
Information: At the time of inspection, no elevated moisture levels were detected in these areas. Moisture readings were taken (using a Tramex Moisture Meter) and non-invasive testing methods and reflect conditions present at the time of inspection only. This item is noted for advisory purposes and should not be relied upon as a guarantee that moisture issues are not present elsewhere or may not occur in the future.

It is important to note that moisture levels can fluctuate due to weather conditions, plumbing usage, seasonal changes, or intermittent leaks. Concealed moisture within wall cavities, subfloor areas, or other inaccessible locations may not be detected during a visual or limited moisture assessment.

Ongoing monitoring of the property is recommended, and further investigation by a qualified tradesperson should be considered if signs of water ingress, dampness, staining, mould growth, or material deterioration become apparent.

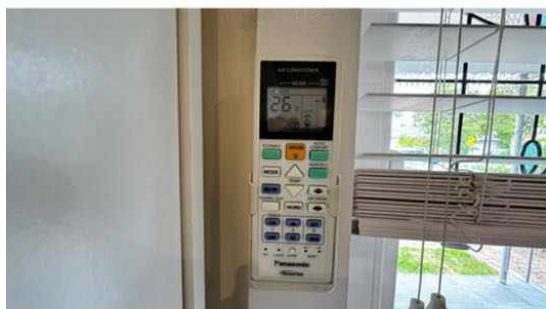
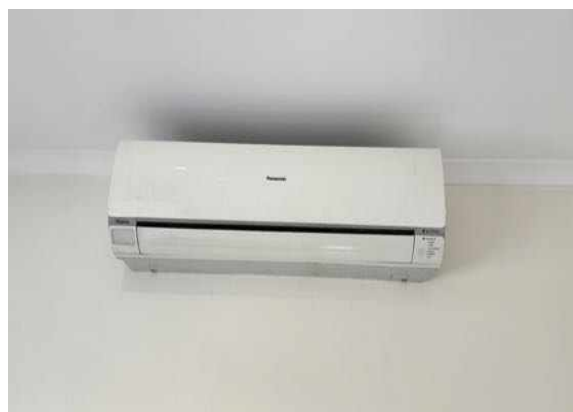
Building: Main Building
 Location: All Areas, Interior & Exterior
 Finding: Appliances, Heating & Cooling Systems, Mechanical Systems, Plumbing, Electrical, Fireplaces - Advisory
 Information: The inspection did not include testing, operation, safety, or assessment of any installed or portable appliances or mechanical systems. This includes, but is not limited to, ovens, cooktops, microwaves, rangehoods, dishwashers, ducted vacuum systems, air-conditioning units, heating systems, hot water services, ceiling fans, exhaust fans, intercoms, security systems, fireplaces, and solid fuel heaters.

Appliances may be worn, damaged, or malfunctioning. Electrical or gas appliances can pose serious safety hazards if incorrectly installed or maintained.

Service, repair, or replace equipment as necessary, particularly where service history or warranty coverage is unknown.

Inspect any water, gas, or electrical connections associated with appliances to ensure safety and compliance.

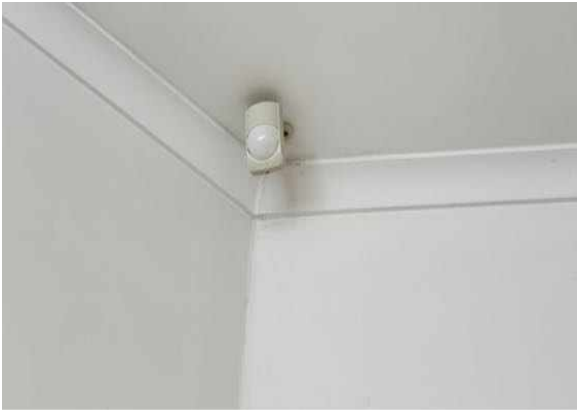
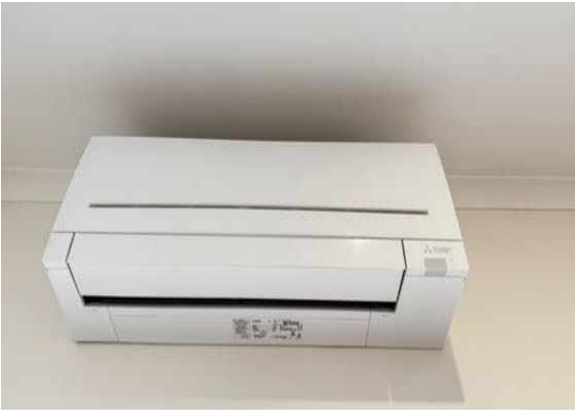
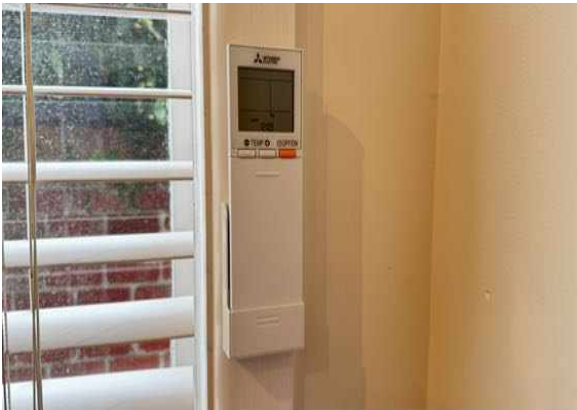
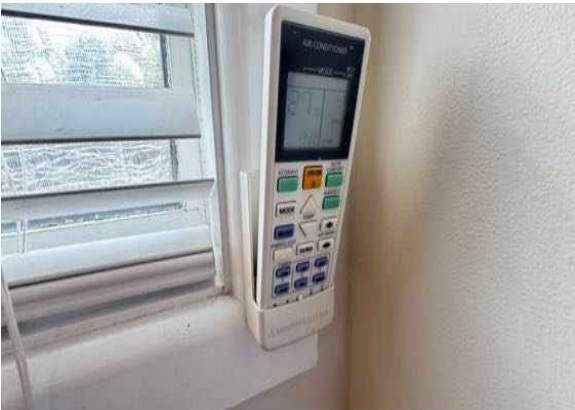
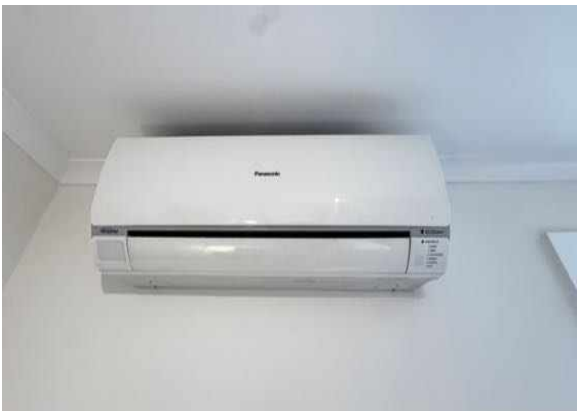
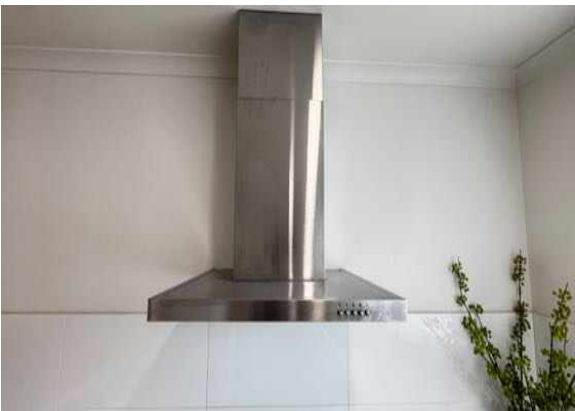
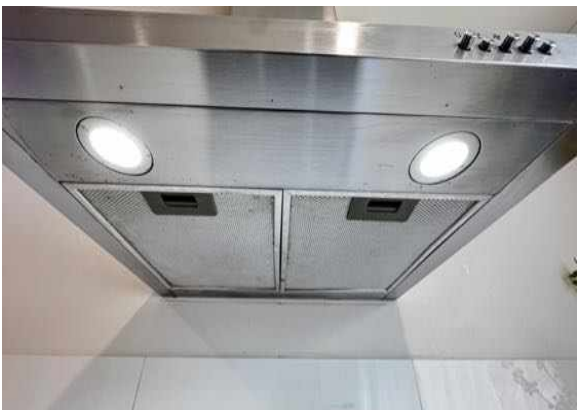
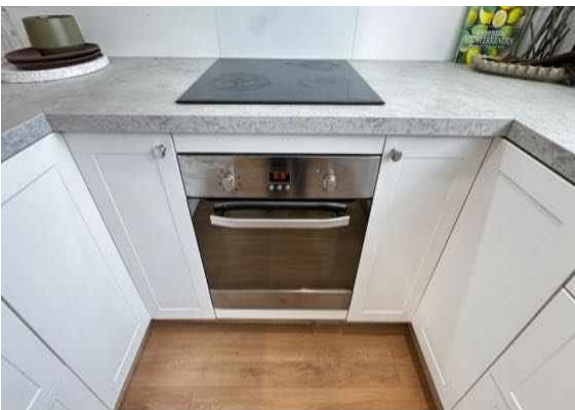
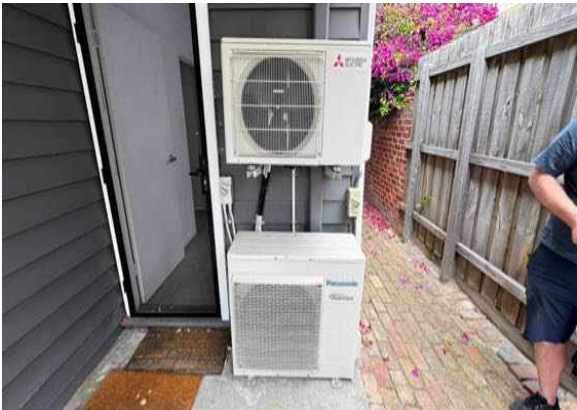
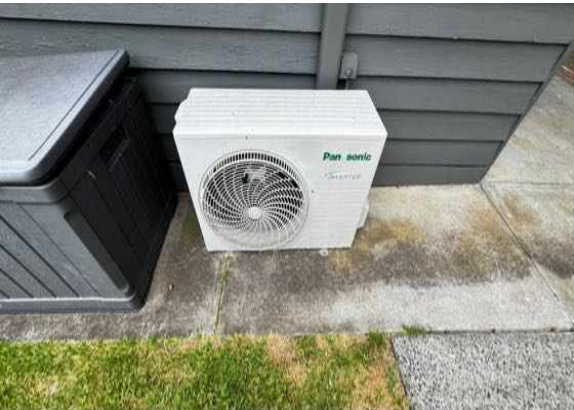
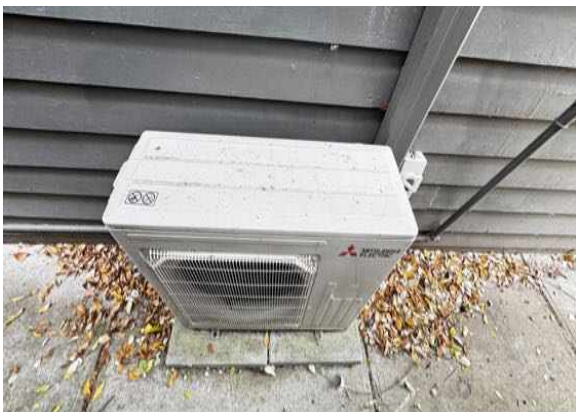
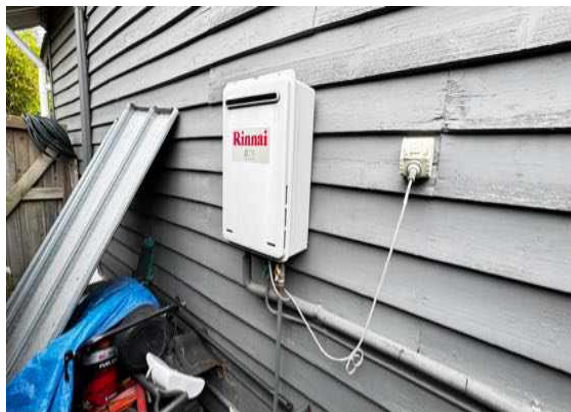
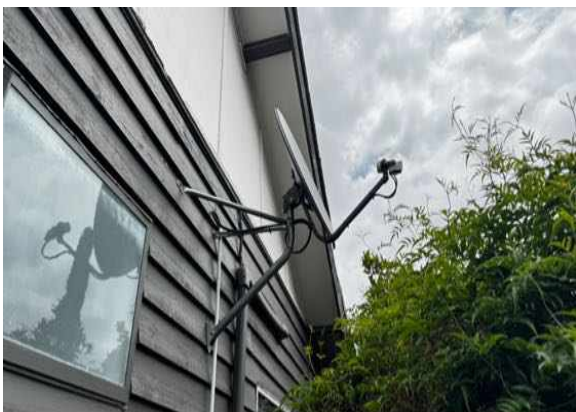
Observations and images of appliances are for informational purposes only and do not form part of the formal building inspection.

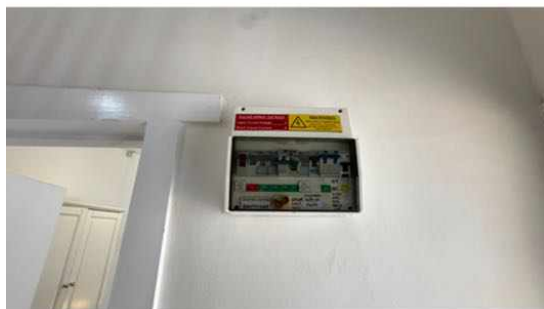
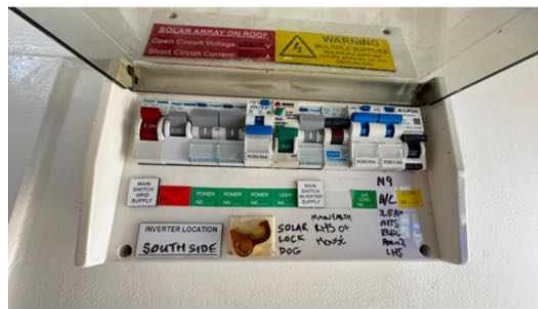
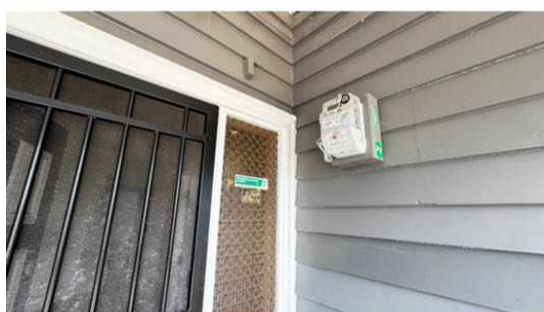
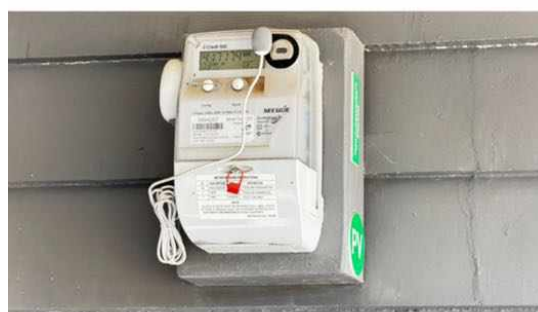
(AS 4349.1-2007: Electrical Switchboard & meter inspections are for your information only, as functional testing is outside the scope of a standard pre-purchase building inspection.)

For full compliance and safety verification, a licensed electrician should be engaged to inspect the switchboard, test all circuits, and ensure all components are functioning correctly. This will help maintain electrical safety and prevent potential hazards.

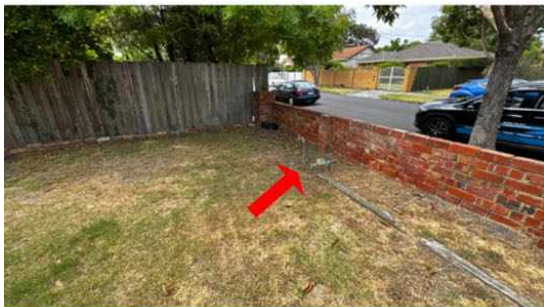
Water meters can be affected over time by age, environmental exposure, accidental impact, or poor maintenance. Potential issues could include leaks, corrosion, or malfunction that may impact water supply or cause water damage.

(AS 4349.1-2007: Water meter images are for your information only, as functional testing is outside the scope of a standard pre-purchase building inspection.)

It is recommended that a licensed plumber carry out routine inspections and maintenance to ensure continued safe and compliant operation. Observations are for informational purposes only and do not form part of a full safety or compliance inspection.

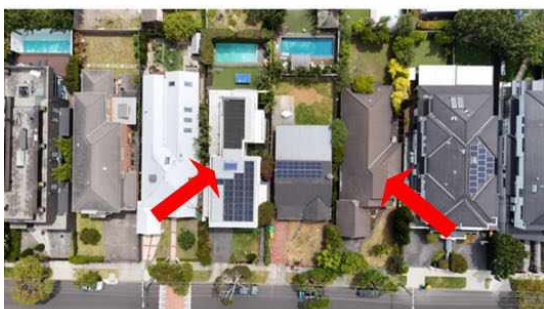
(AS 4349.1-2007: inspection of neighbouring properties is not included in standard pre-purchase building inspections; this statement is for your information only.)

Recommendation: For concerns regarding noise, encroachments, or structural issues affecting neighbouring properties, it is recommended to engage relevant specialists (e.g., acoustic consultant, building surveyor, or a registered builder) and/or contact the local council.

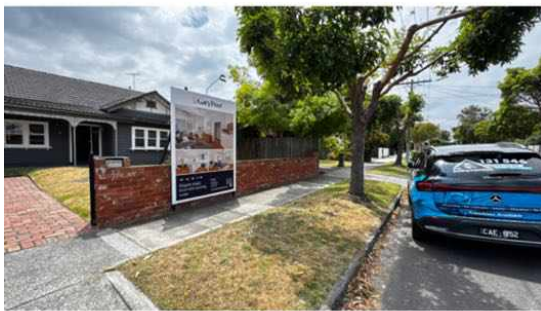
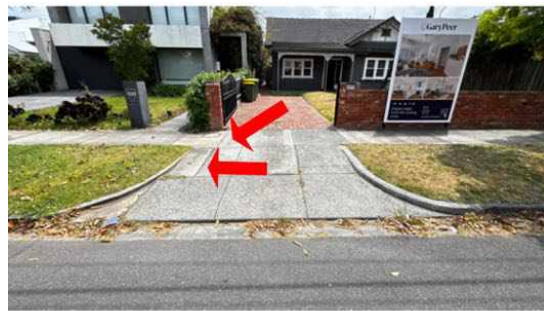
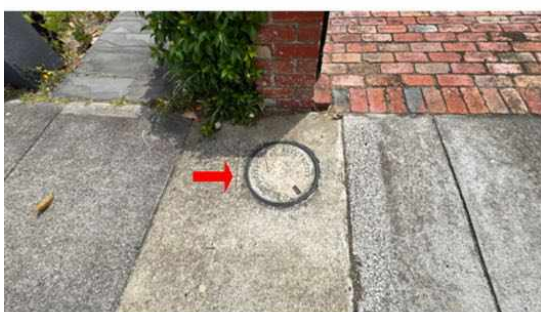
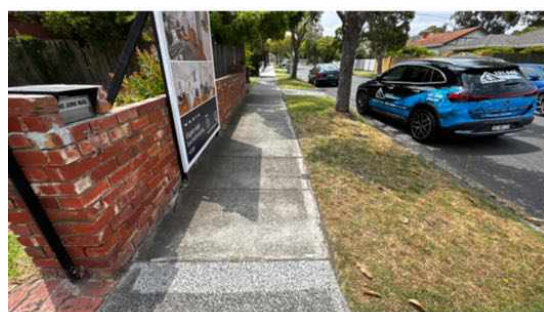
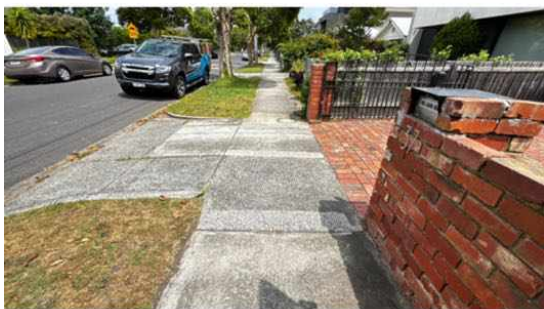
During the inspection, minor cracking, surface wear, or uneven sections were observed on footpaths or crossovers. Some accessible metal components, such as street signage or grates, showed signs of rust or deterioration. Debris accumulation and vegetation encroachment were also noted around council infrastructure. Access or visibility was limited to certain council-owned assets.

(AS 4349.1–2007: inspection of council-owned infrastructure is not included in standard pre-purchase building inspections; this statement is for your information only.)

These areas should be monitored, and for detailed assessment, maintenance, or compliance verification, the relevant local council authority should be contacted immediately. Regular monitoring of adjacent council assets is recommended to ensure ongoing safety and proper maintenance.

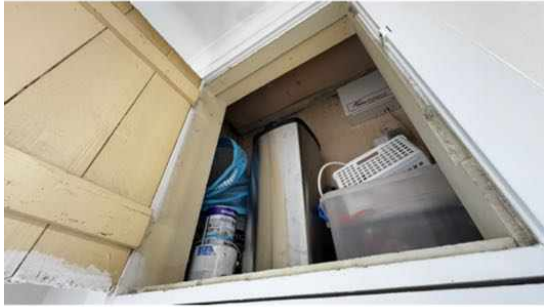
It is important to note that these restrictions can conceal a wide range of building defects, including but not limited to:

Because these areas could not be visually assessed, no comment can be made on their condition within this report.

It is strongly recommended that obstructions be removed and concealed areas made fully accessible immediately. A re-inspection should then be carried out to allow a complete assessment of the property's condition. This is particularly important prior to purchase, as defects in concealed areas can carry significant rectification costs.
