Building and Timber Pest Inspection Report

Inspection Date: Wed, 18 Mar 2026

Property Address: 5/45 Kirkham Rd, Auburn NSW 2144,
Australia

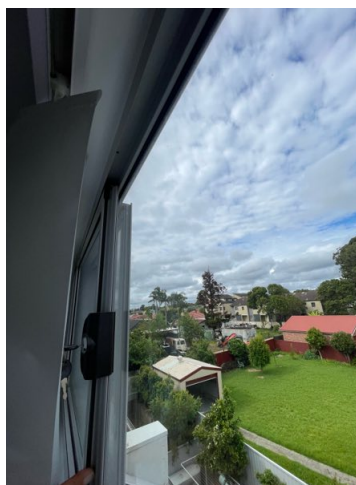
Window opening control devices and barriers are important safety features intended to limit excessive opening and reduce the likelihood of accidental falls. Their absence indicates the window may not provide an adequate level of occupant protection in its current condition.

A qualified builder or suitably licensed contractor should be engaged to assess the affected window and install an appropriate window opening restrictor and/or compliant barrier system as required. This issue should be treated as a safety concern and addressed without delay.

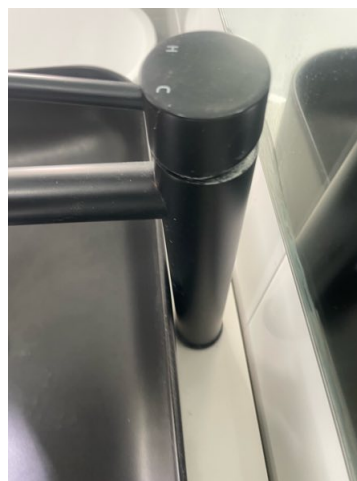
In addition, the tap handle to the bathtub basin was missing at the time of inspection. Missing handles reduce the functionality of the plumbing fixture and can make operation difficult or impossible. This condition also increases the likelihood of strain on the tap mechanism, leading to further deterioration or leakage.

It is recommended that a licensed plumber be appointed to re-secure the loose tap fitting and to supply and install a new handle for the bathtub basin tap. All remedial works should be completed in accordance with plumbing best practices to restore both safe operation and serviceability.

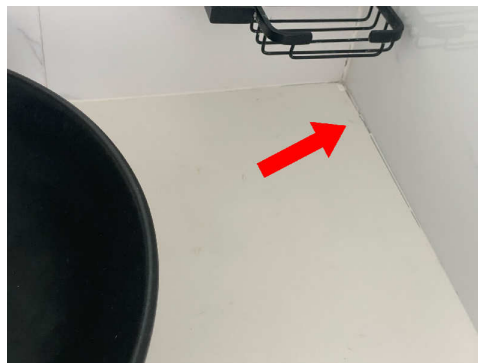
Incomplete or deteriorated sealant can allow water, moisture, or debris to penetrate behind cabinetry panels, which may lead to swelling, staining, or damage to the cabinetry materials over time. It also detracts from the overall finish and appearance of the installation.

This matter is considered a maintenance defect. It is recommended that the affected cabinetry corners be re-sealed by a suitably qualified tradesperson to restore protection and appearance.

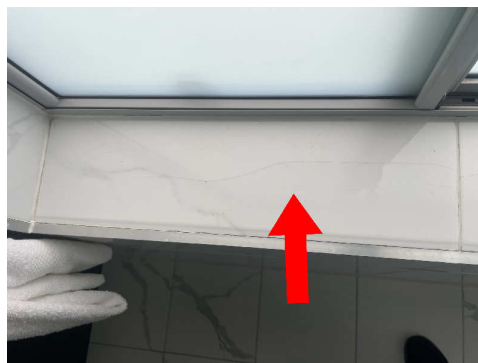
Cracked tiles throughout the household detract from the overall appearance of the affected areas however it is unlikely to create or lead to any secondary defects.

While not considered a matter of urgency, replacement of cracked floor tiles is recommended at the clients discretion. A tiling contractor may be appointed to perform these works. Where cracks become more numerous, contact a licensed building inspector for further investigation.

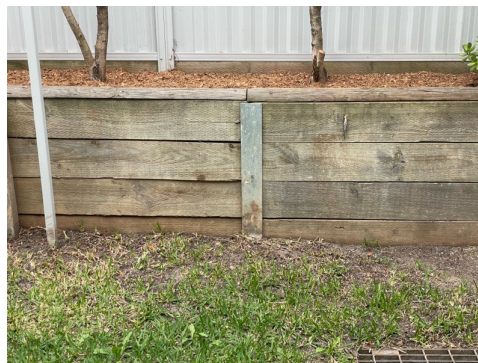
Finding 6.02

Building:	Main Building
Location:	Yard
Finding:	In ground contact
Information:	<p>Any timbers in direct ground contact provide opportunity for concealed termite entry and are likely to be subject to premature rot and decay as the soil retains moisture or damp conditions against the timbers.</p> <p>Remove untreated timber that is in direct contact with external grounds. Consider replacement with more durable materials i.e. treated timber or non timber elements. Frequent pest inspections are advised to readily identify any termite activity in these areas.</p>
