Building and Timber Pest Inspection Report

Inspection Date: Wed, 8 Apr 2026

Property Address: 884 Chiltern-Yackandandah Rd, Indigo Valley VIC 3688, Australia

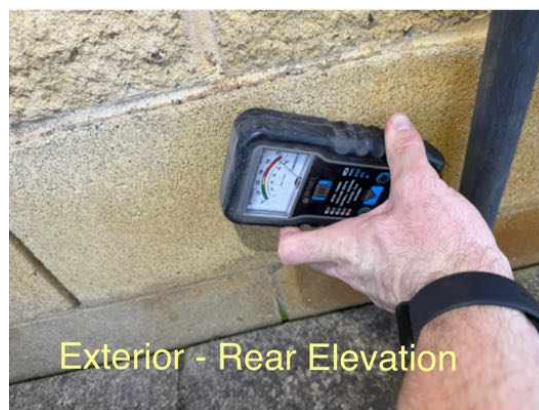
Building:	Main Building
Location:	Rear elevation, rear bedroom, laundry (granny flat)
Finding:	Rising Damp
Information:	It appears that damp conditions are evident to the base of the masonry walls, at but not limited to the rear bedroom, rear elevation (external) and laundry (granny flat) Rising damp refers to the upward movement of moisture through brickwork.

Causes of this defect include but aren't limited to, improper installation or deterioration of the DPC (damp-proof course) and/or water pooling against the brickwork. For areas of potential water pooling, a licensed plumber should be engaged in the short term, to provide further advice.

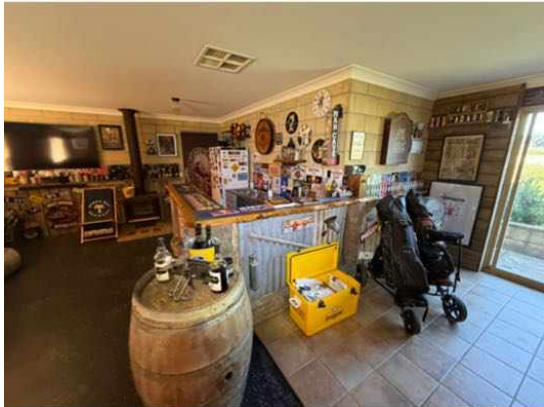
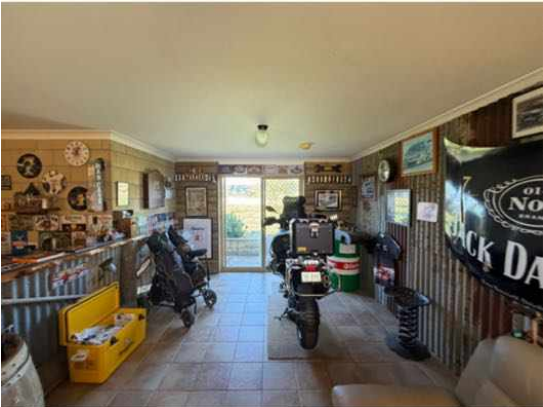
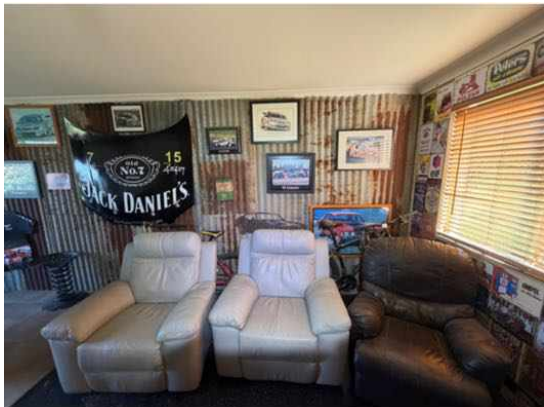
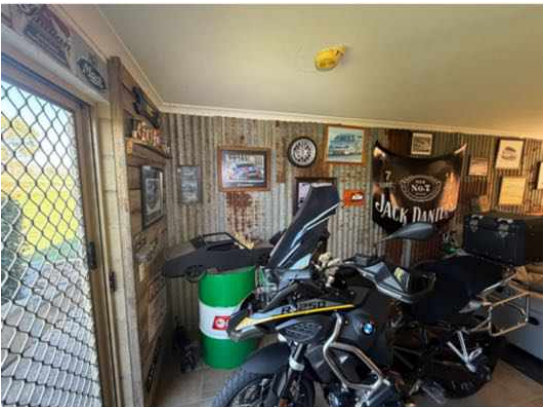
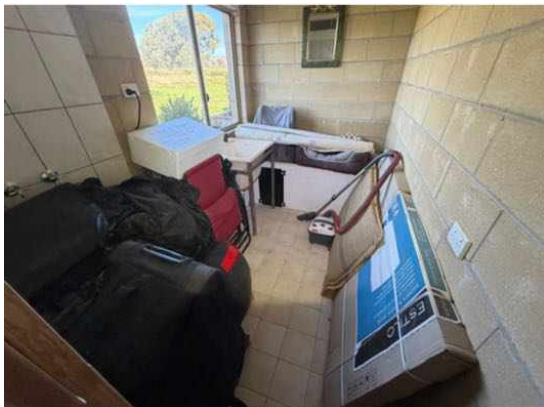
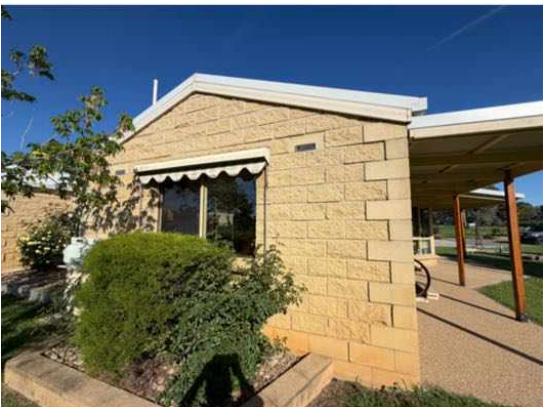
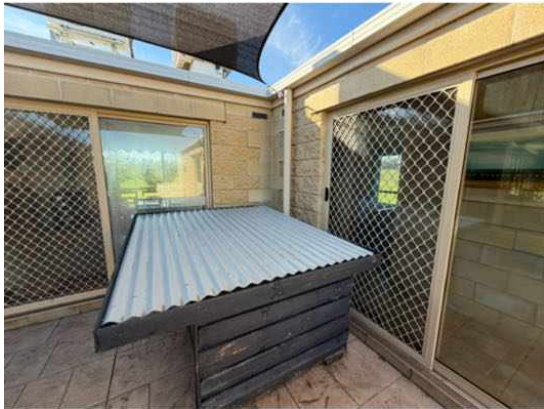
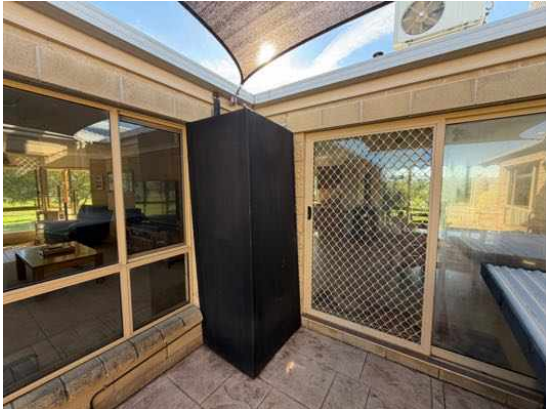
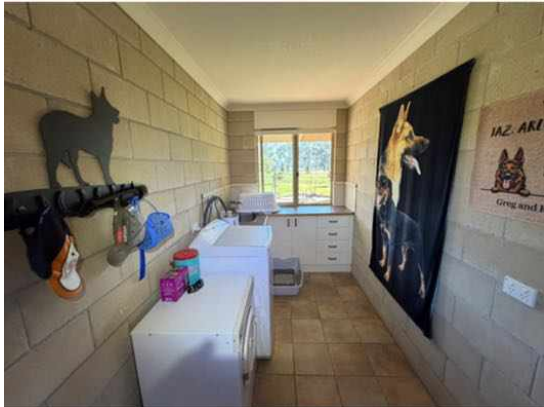
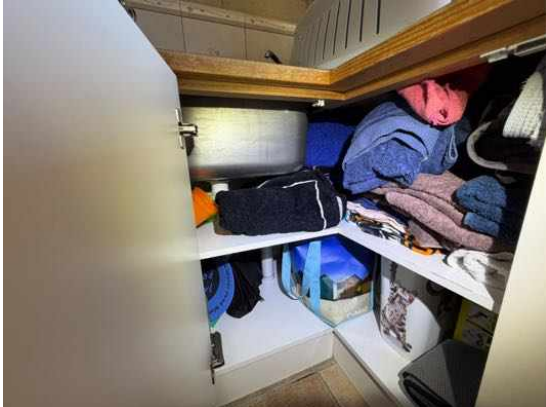
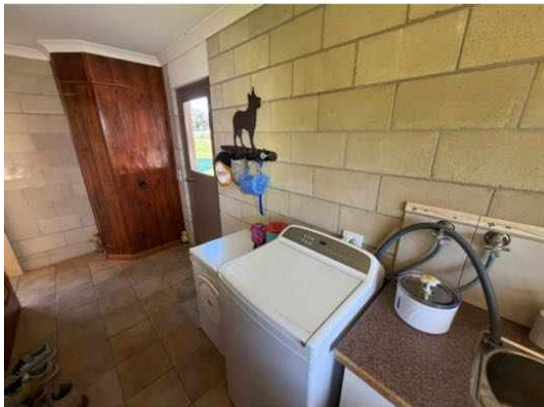
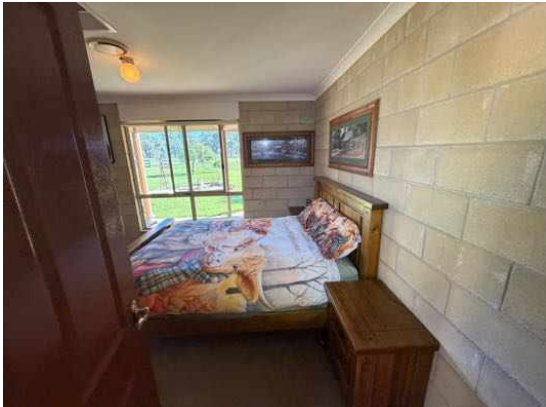
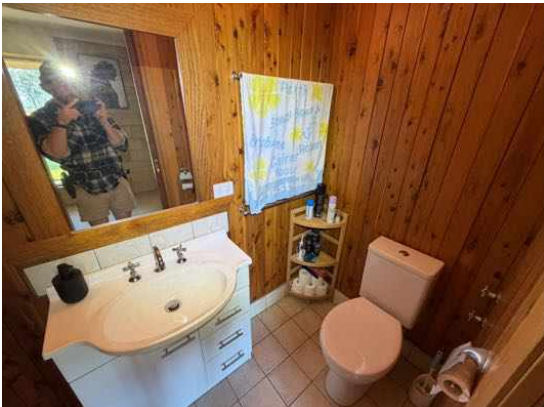
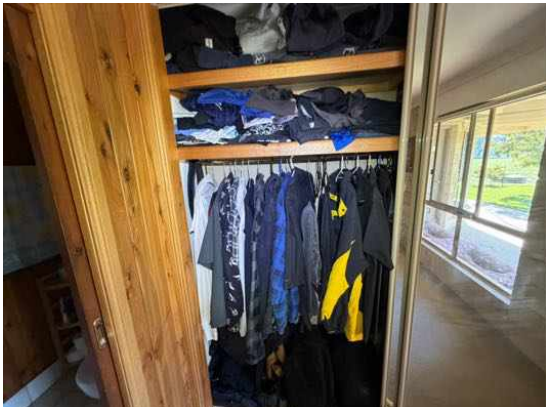
Building: Main Building
Location: All Areas
Finding: Additional Photos - Obstructions and Limitations
Information: These photographs are an indication of the obstructions and limitations which impeded full inspection of the property at the time of inspection. These obstructions can hide an array of defects and should be removed to allow full inspection to be carried out. A re-inspection is recommended once the areas are made accessible.

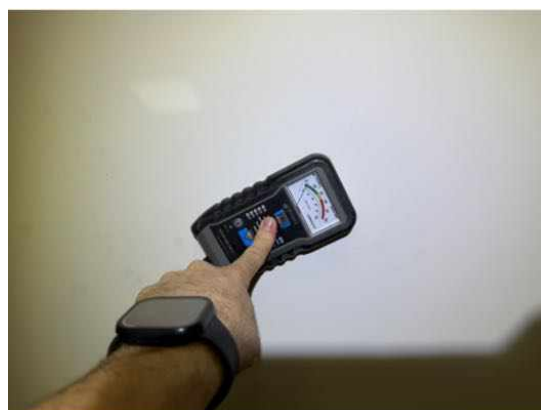
Building: Main Building
 Location: Laundry, Dining Room Ceilings
 Finding: Water Staining Present
 Information: It appears that water staining was present at but not limited to, the laundry & dining room ceiling. No high moisture was evident in these areas at the time of inspection. Recommend the client closely monitor these areas and engage a licensed roof plumber promptly, should the leak persist or return.

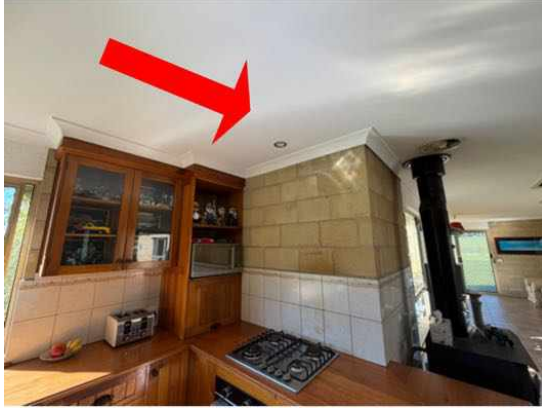
Building: Main Building
Location: Kitchen
Finding: Exhaust fan - Not Installed
Information: It was noted that an exhaust fan has not been installed above the kitchen stove. Recommend engaging a licensed electrician to install an exhaust fan, at clients discretion.
